Chapter

A Wear Analysis Carried On Connecting Rod Bearings From Internal Combustion Engines

Abstract

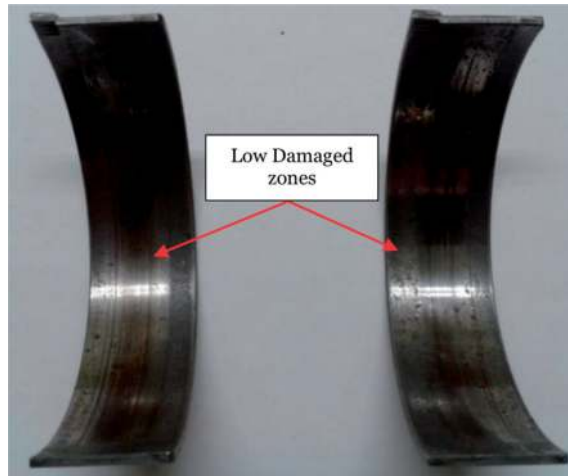
Firstly, small samples were extracted from worn bearings, approximately 1 cm^2 , from different areas to perform measurements of hardness, roughness, chemical analysis of the materials that compound these mechanical components, and of course to identify the wear mechanisms. Micrographs of the damaged surfaces and identification of the different chemical elements were obtained using a scanning electron microscope (SEM) Quanta 3D FEG (FEI) equipped with an energy-dispersive X-ray spectrometer (EDS). In addition, roughness profiles of worn bearings after real service from different zones are obtained. **Figure 3** shows the damage zones of the connecting rod metals that were slightly affected by the contact with the rod bearing journals from the crankshaft. It is assumed that in this particular case, the lead and tin layer was not completely detached, and the bearing only suffered normal wear due to

friction, applied load, contact speed, contact temperature, and fine abrasive wear by small strange particles that could be the same oil or inserted debris.

Figure 3.
Lower wear damage on bearings.

In the case of the bearing surfaces with the least wear (**Figure 3**), it is possible to mention that although the wear was less pronounced, delamination of the surface layers was observed, as the magnification of the damage zones increased (**Figure 15a–c**). In addition, it was possible to see particles embedded on the surface

On the other hand, the bearings with the lowest wear exhibited high polished areas on the surfaces in the sliding direction as shown in **Figure 3**, two factors could be significant, the absence of an oil film between the bearing and the shaft led to a metal-to-metal contact, and initial wear debris could act as polisher in the surfaces. In addition, pits on the surfaces were caused by a few wear debris inserted on the bearings. It can be inflicted by the contact pressure between the bearing and the shaft.

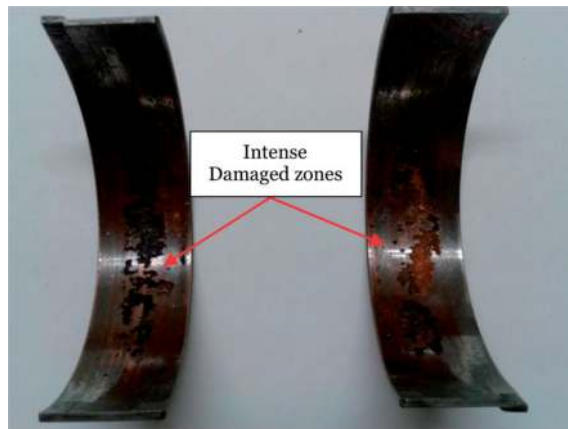
On the other hand, the wear produced in the bearings shown in **Figure 4** is very intense. In the bearing on the left, it is possible to observe that the lead and tin layer was completely torn off in the central part and a dark color was clearly seen, which was due to the oxidation wear that occurred in the steel layer that is the base layer of the bearing. In addition, the bearing on the right exhibited pronounced wear, although in this case the reddish-orange copper layer was clearly located. Here, it is possible to identify wear mechanisms such as sliding wear that became high abrasive damage (scoring) for high loads, fatigue wear due to constant contact with foreign particles, and high temperature.

Figure 4.
Pronounced wear damage on bearings.

In relation to the rod bearings that suffered higher wear damage (**Figure 4**), it was possible to observe that a Cu content appeared after the real service in the chemical analysis which confirmed the severe wear rate was caused by the absence of correct lubrication due to the long service life, roughly 8 years, and probable foreign particles (dust, wear debris) in the interface between the bearings and the shaft. The common sliding/abrasion action with particles between the two surfaces could be a major factor to inflict the wear intensity. In addition, the wear areas could lead to an uneven distribution of the loads, causing an abnormally high pressure area in some specific points on the bearing surface. In addition, Sn content was identified in the chemical results. Both protective layers were totally shifted due to the high abrasive action in some areas. SEM images showed a number of particles embedded on the bearing surface, large cracks, and clear abrasive wear due to the particles acting directly on the surfaces. Optical images presented wear areas with material totally detached from the surface.

The roughness results showed the surface modifications due to the contact action between the rod bearings and connecting rod journal shafts. The main changes were identified in the high wear areas in the rod bearings in **Figure 4**, where a higher depth was obtained in the profiles. The roughness behavior in the rod bearings with the lowest damage was consistent in all the measured section. Finally, hardness tests were performed to show the differences between the inner part (lead-tin layer) and the two protective layers (steel and copper). The results presented a low hardness value of the inner part (21.89 ± 1.20) compared to the other two, 192.97 ± 8.7 HV, copper layer, and 196.61 ± 5.11 HV, steel layer, with close values.

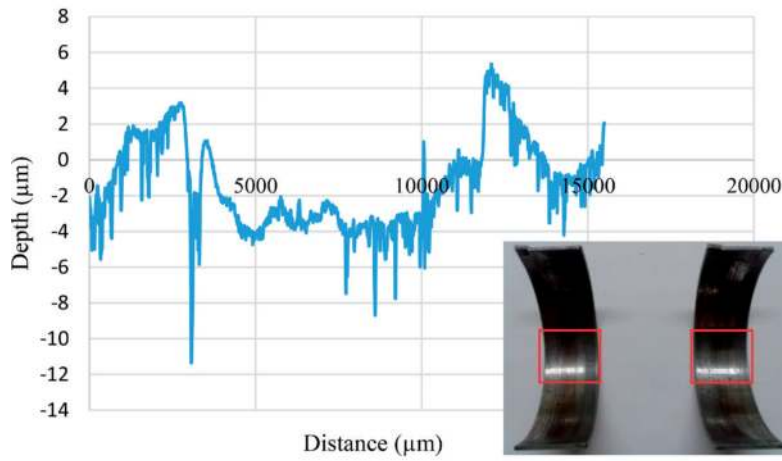
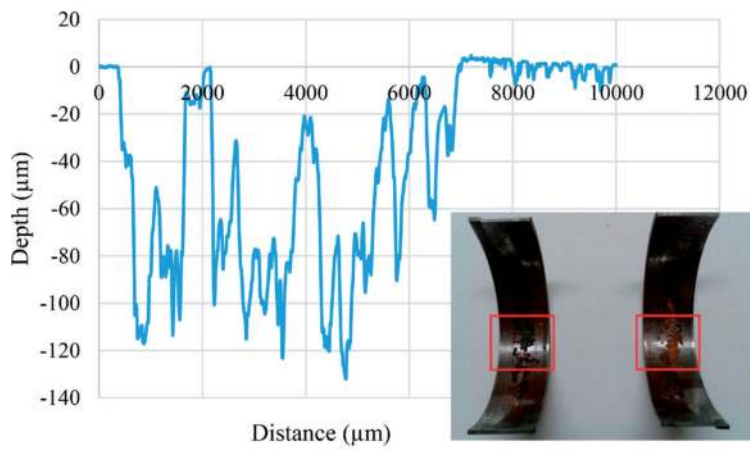
The photograph presented in **Figure 10a** shows how the surface of the damaged area changes in a consistent manner in the central part. In this particular case, the sliding wear was much less compared to **Figure 10b**, where the wear damage was more intense, with a high detachment of the outer layers, showing areas of greater depth due to the wear intensity.

Figure 10.
Roughness profiles of the low wear area.

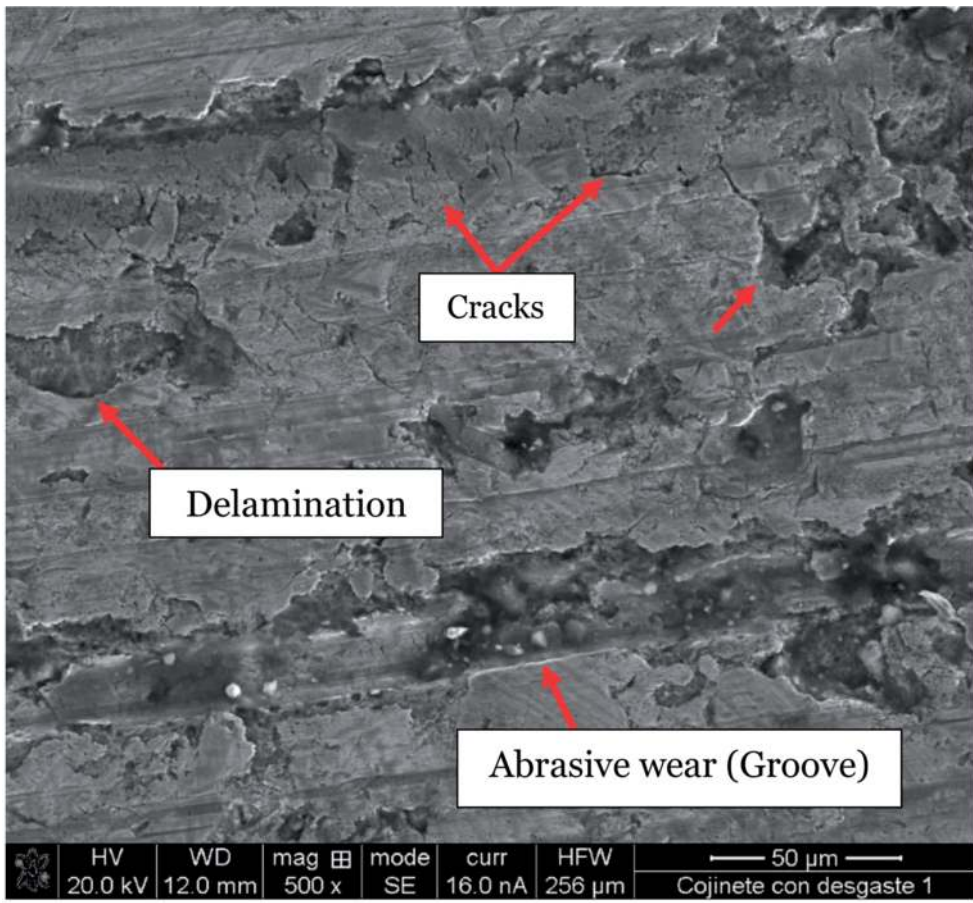
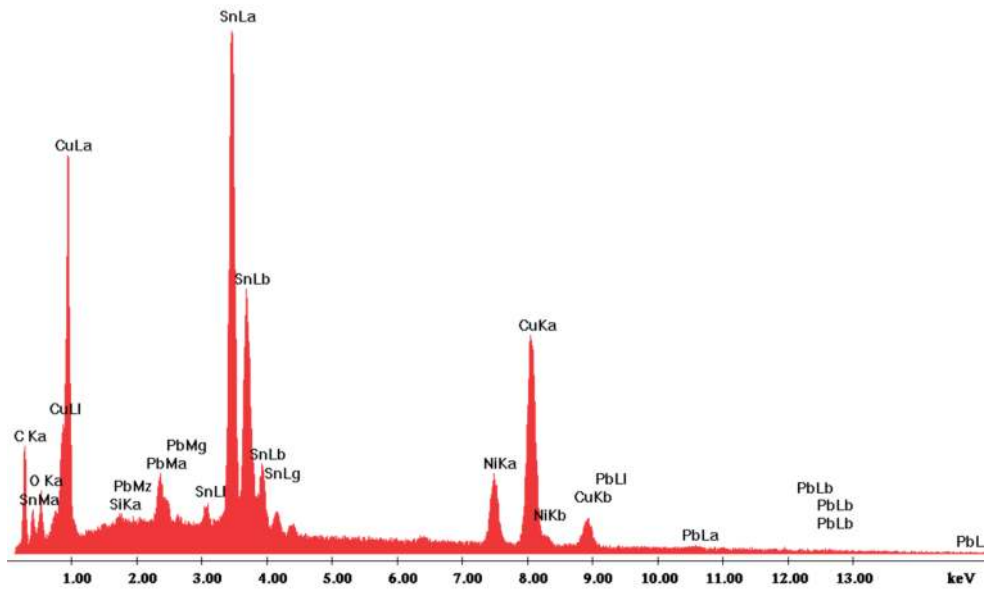
On the other hand, once the rod bearings have been working during the actual service, the wear occurs on the surface as shown in **Figure 13a**. It was detected that the chemical composition was modified with respect to that presented with the bearing without any wear. Here, the Cu content was new, and this took place because the lead and tin layer was removed by the constant wear due to sliding, friction, and three-body abrasion that is generated by the wear debris insertion, contaminants, and foreign particles coming from of the oil filter or the atmosphere.

A comparison of the chemical composition of a rod bearing that suffered wear and an unworn bearing is presented in **Table 3**. In the chemical composition of the worn bearing, there is a reduction in the lead content (Pb) and an increase in the tin content (Sn). In addition, elements such as copper (Cu) and nickel (Ni) appeared after real service, which could be due to the foreign particles and contaminants produced during the contact with the crankshaft journal. This indicated that the layer of lead, tin, and antimony (metal Babbitt) was torn out from that area, so the copper content that is one of the intermediate layers in the bearing was clearly identified.

Figure 13. (a) Worn rod bearing surface and (b) EDS analysis.

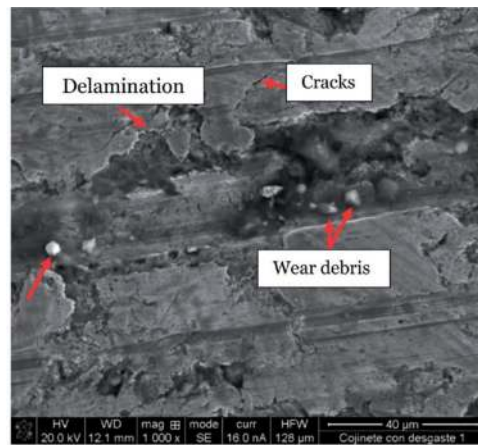
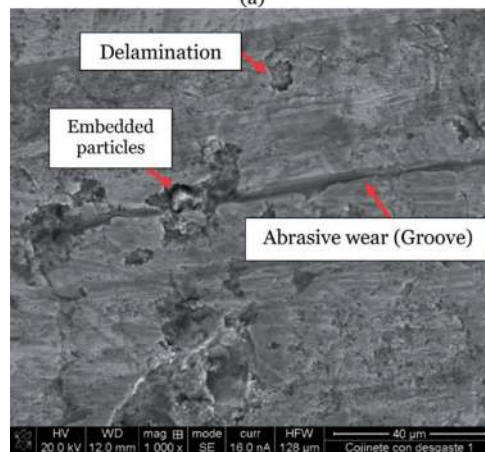
Figure 14.
 (a) and (b) Worn rod bearing surface at 1000× in two areas.

damage. On the other hand, **Figure 14a** and **b** exhibited the damage caused in the bearings of the connecting rods after 8 years of actual service with proper and constant maintenance. On the bearing surfaces with the greatest wear (**Figure 4**), it was possible to observe cracks on the surface, delamination due to severe tearing of outer layers produced by sliding wear, and particles that were detached by the same action [2–5]. Some particles observed in the grooves are formed on the surface, and as the magnification of the damage area is increased, this wear mechanism is much clearer.

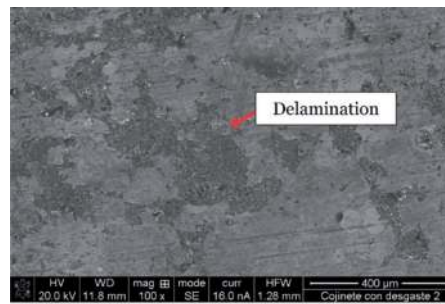
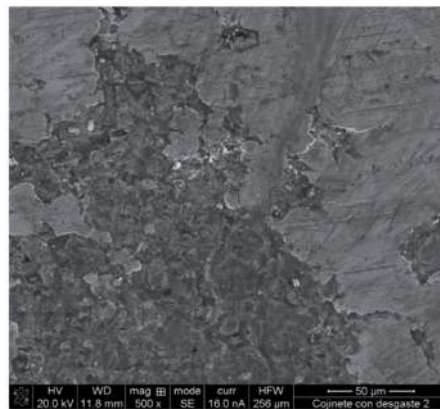
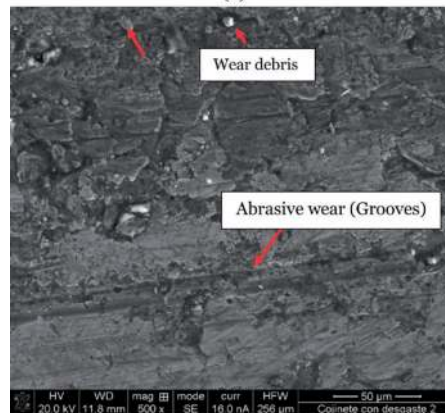
Figure 15.
(a)–(c) Worn rod bearing surface at 100× and 500× in different damaged areas.

by the same sliding action of the two surfaces in contact and grooves with less depth and intensity than those observed in **Figure 14a** and **b**.

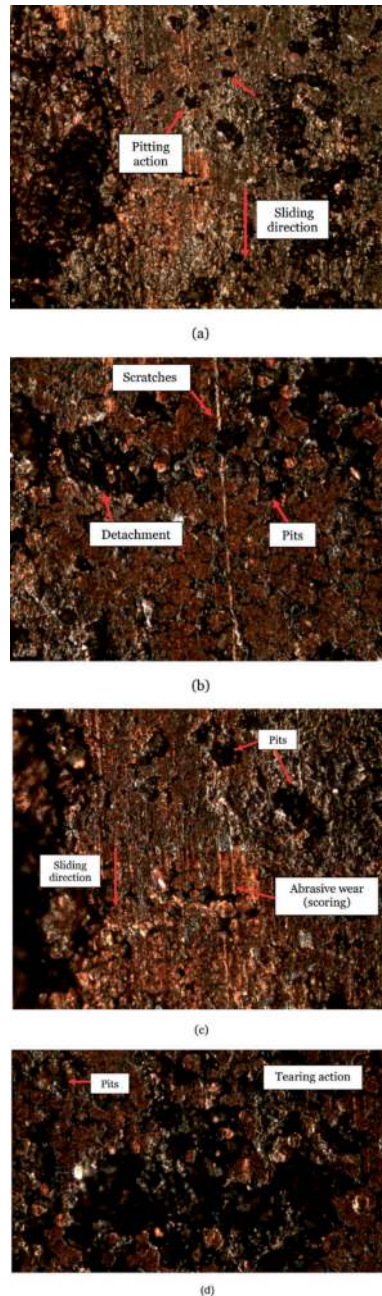
Figure 16.
(a)–(d) Worn rod bearing surface in different damage areas.

In **Figure 16a–d**, it is possible to observe images of the wear damage in the bearings shown in **Figure 4**, caused by the intense tearing of a part of the first protective layer (Babbitt metal layer, composed of lead, tin, and antimony). An Olympus GX-51 optical microscope was used to obtain these micrographs. In a magnification of the same area, it was possible to observe that the fatigue damage was important since there are areas of severe material detachment, pitting action was also identified. In this particular, high abrasion wear (scoring) was the main wear mechanism to be considered by the action of foreign particles of various shapes and sizes on the surfaces that could lead to accelerate the wear process [5–7].
