Severe Adverse Local Tissue Reactions Associated with Gross Trunnion Failure of THR with a Beta Titanium Femoral Component

Deborah J. Hall, Songyun Liu, Jennifer L. Wright, Craig J Della Valle, Robert M. Urban, Robin Pourzal
Department of Orthopedic Surgery, Rush University Medical Center, Chicago, IL

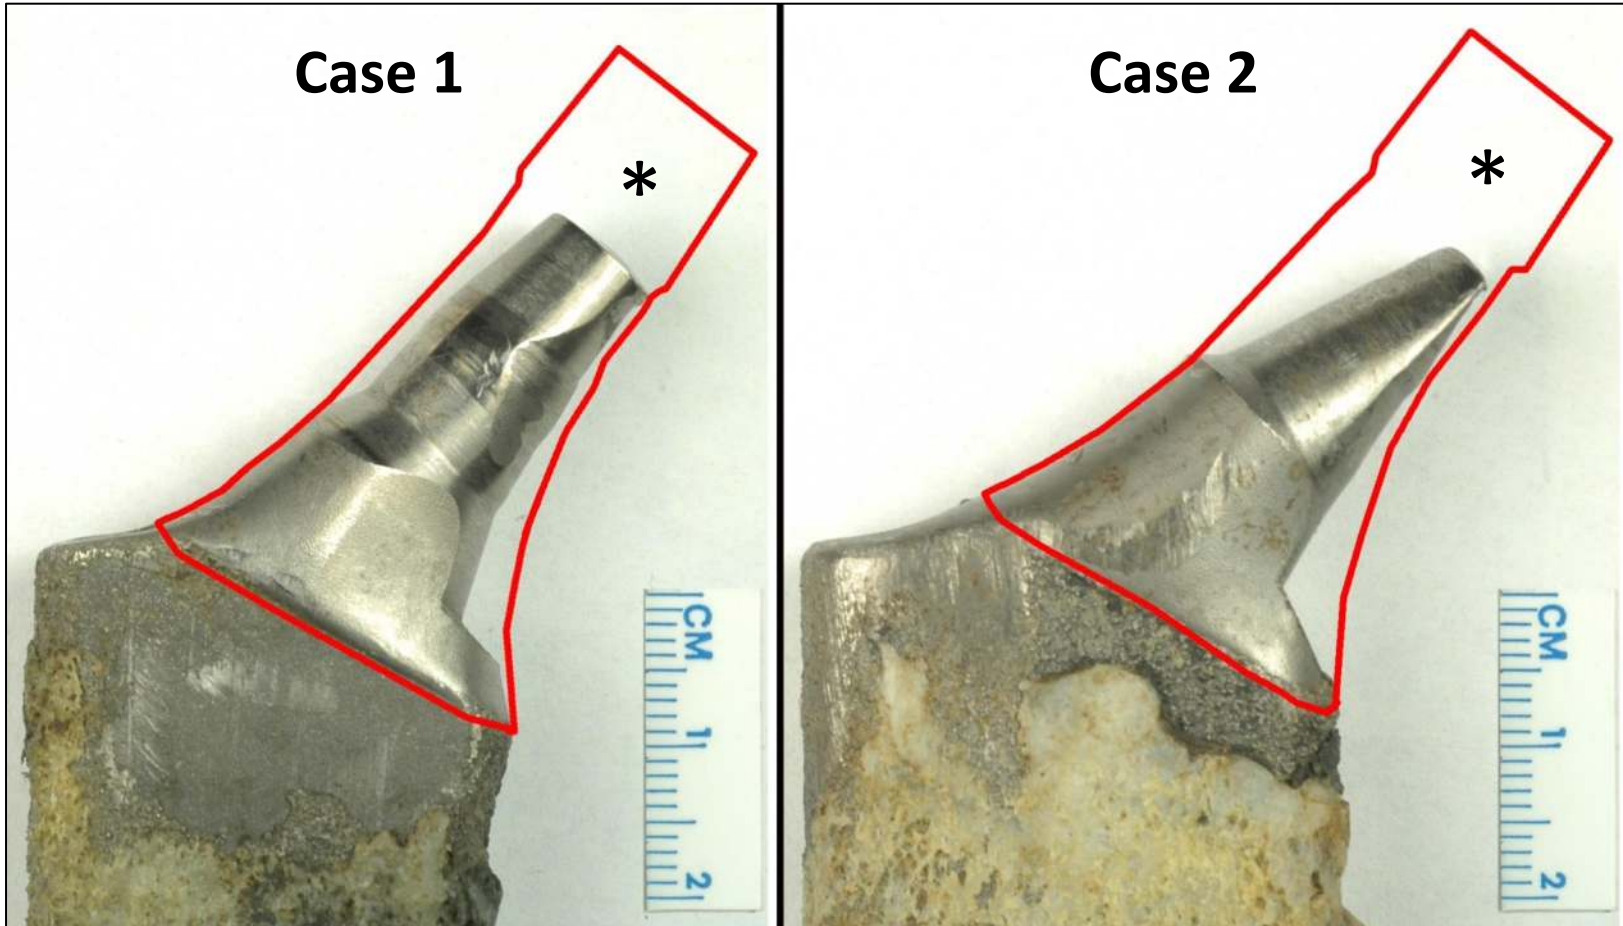
Figure 1. Both stem tapers (asterisks) were completely worn away due to abrasion resulting in at least 5,000 mm³ material volumetric loss for each component. The total material loss, however, was even greater as much of the femoral necks were also severely worn (red outlines), giving both femoral necks the previously described characteristic “bird beak” appearance².

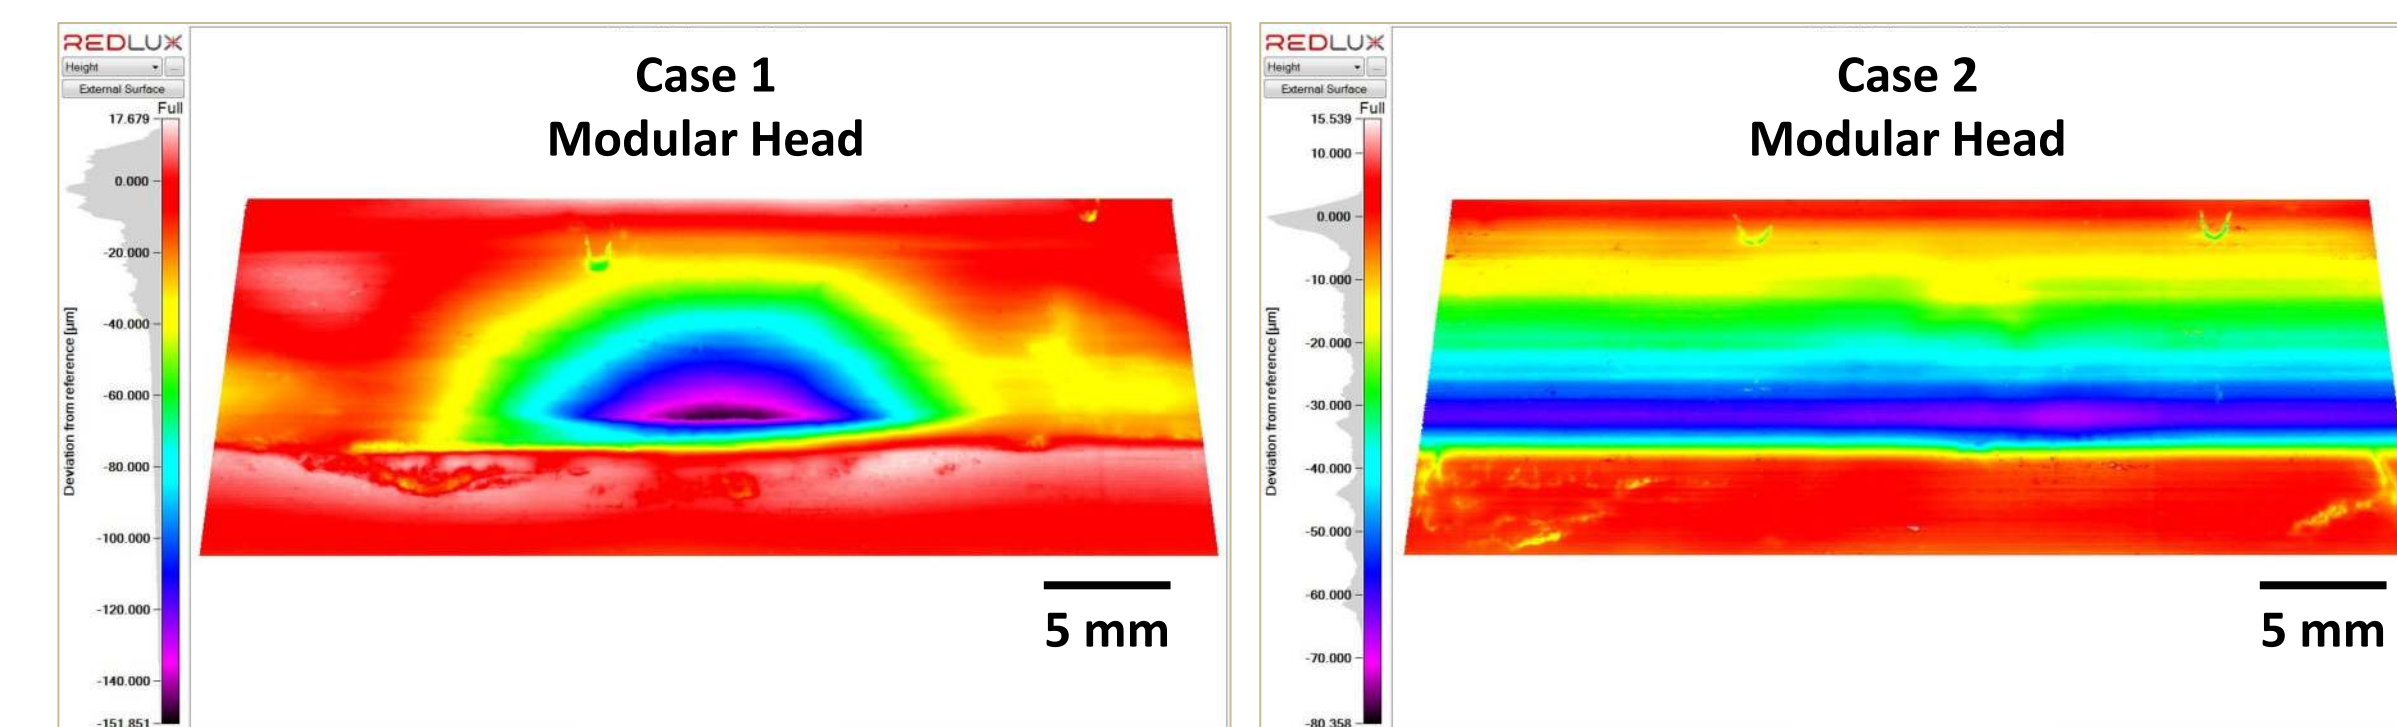
Figure 2. “Unwrapped” head taper surfaces generated by optical CMM data. Case 1 showed the deepest wear (blue-purple-black) was concentrated to one side. Case 2 demonstrated wear depths (blue-purple-black) increasing superior to distal.

Volumetric Material Loss within Head Taper
Case 1: 12.86 mm³
Case 2: 11.24 mm³

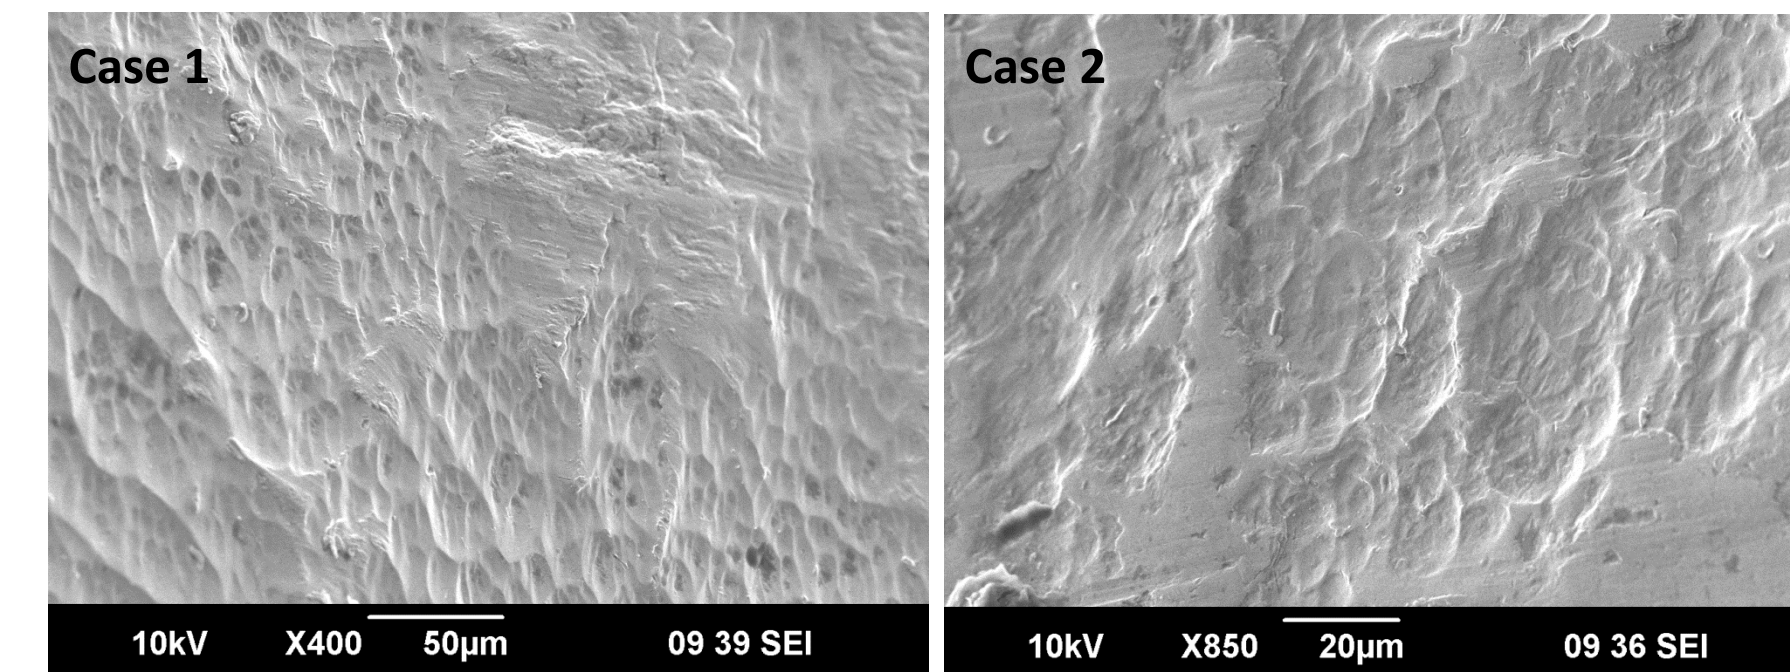
Figure 4. Fretting corrosion, with its characteristic scalloped appearance was seen within the modular head tapers of both cases.

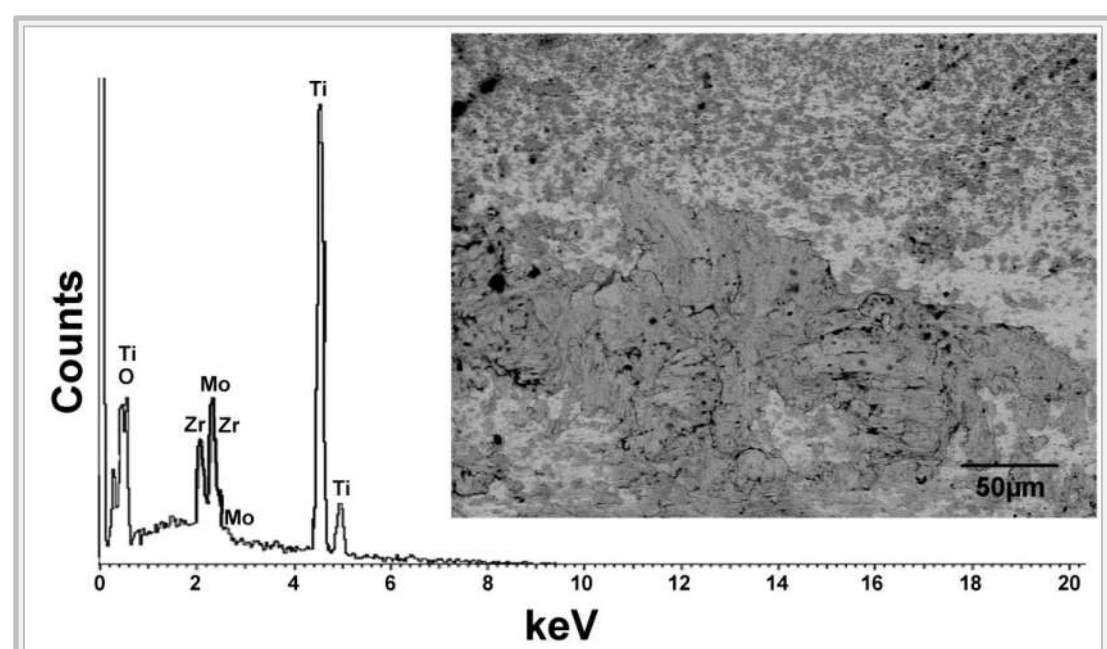
Figure 3. SEM/EDS analysis of the modular head tapers revealed that material transfer of the TiMoZr-alloy covered the entire head taper surfaces. **Inset:** Backscattered SEM image (x350) of head taper from Case 1. Dark-gray material is the transferred TiMoZr-alloy from femoral stem.

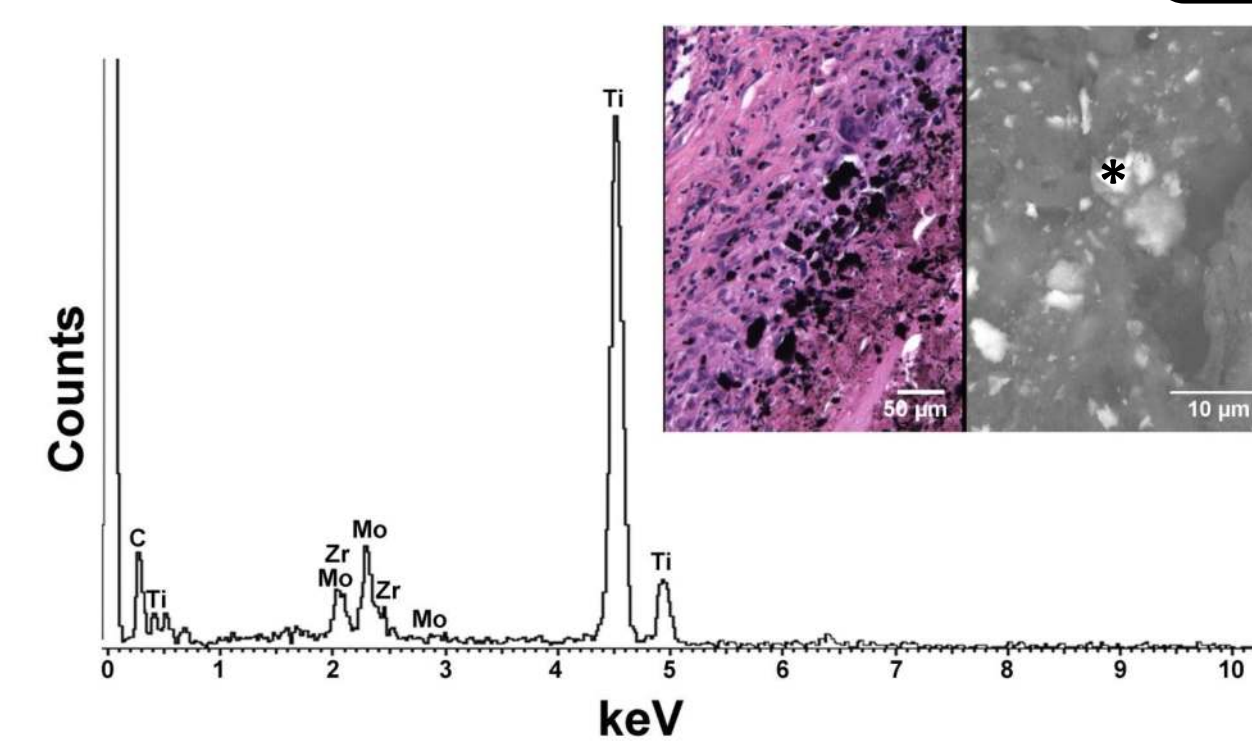
Figure 5. SEM/EDS analysis identified the dense, black particles in the pseudocapsule of Case 2 as TMZF alloy wear particles. **Left inset:** H&E, x200; **Right inset:** Backscattered SEM, x2000, the asterisk marks the 3.4 μm particle analyzed for the spectrum.

- Identified by SEM/EDS analysis as either Ti-oxide or particles of Ti, Mo and Zr, indicating TMZF alloy debris
- Micro-Raman identified the rutile phase of Ti-oxide

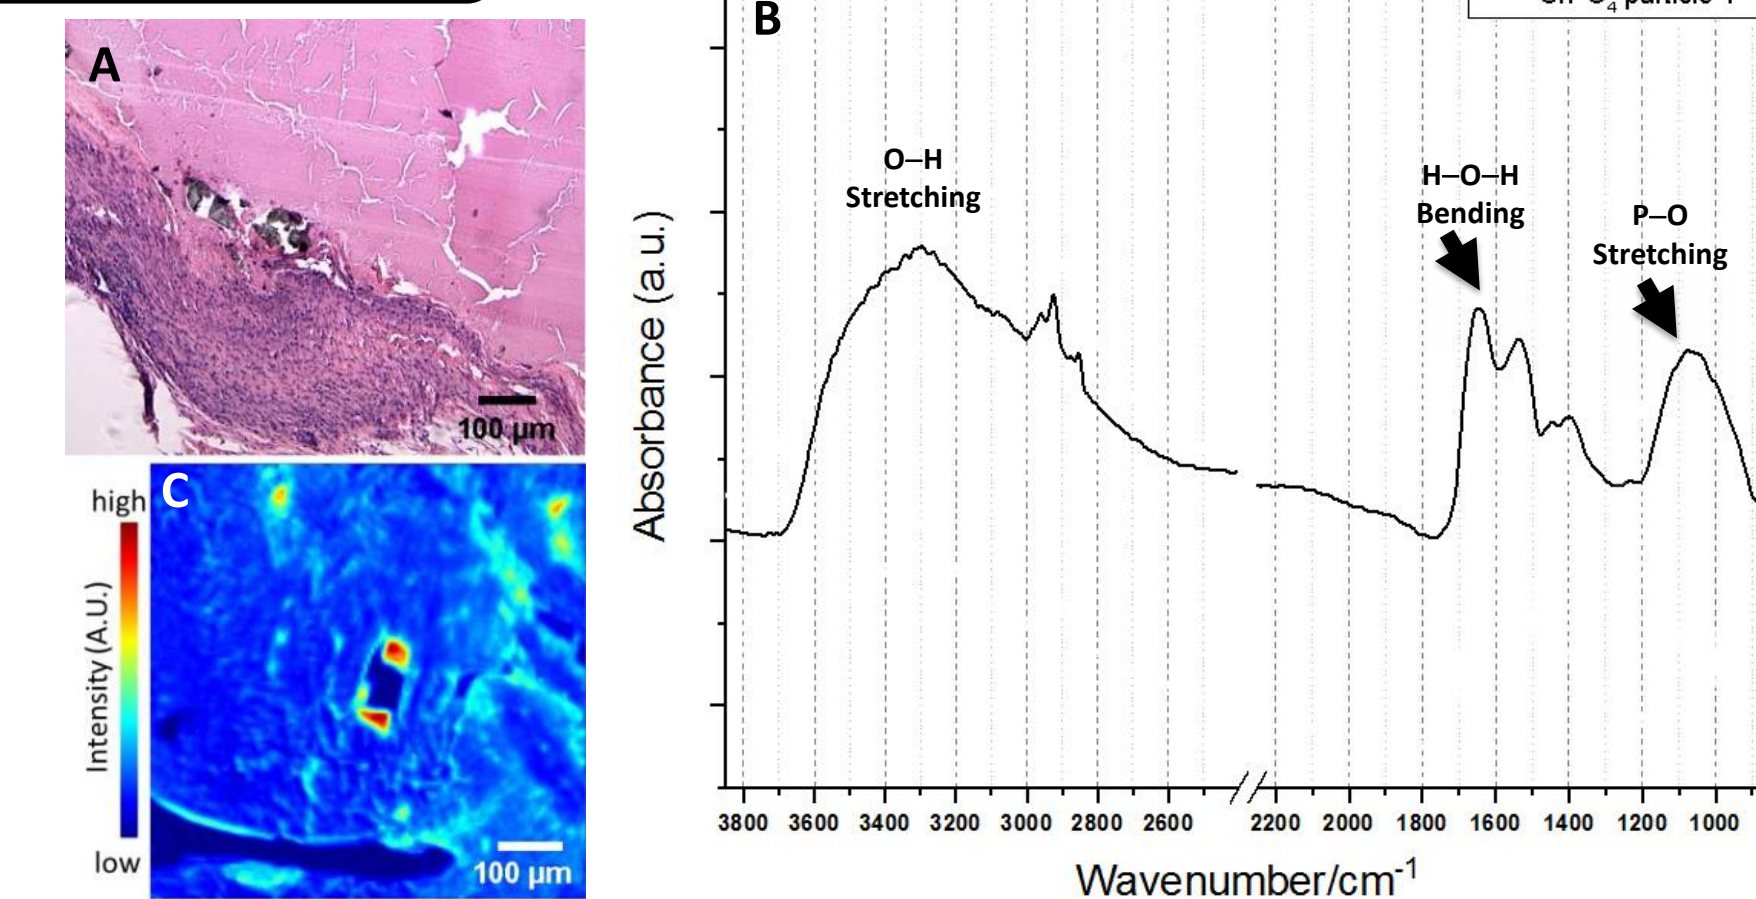
Figure 6. The presence of CrPO₄ particles within the necrotic regions (A, H&E, x40) was confirmed by FTIR-I with characteristic peaks on the infrared spectra (B, arrows) and chemical image (C) plotted at 1080-1030 cm⁻¹.

- However, the presence of CrPO₄ clearly indicates that at an earlier stage corrosion of the CoCrMo surface took place leading to the characteristic histopathological pattern of a lymphocyte dominated ALTR to corrosion products.

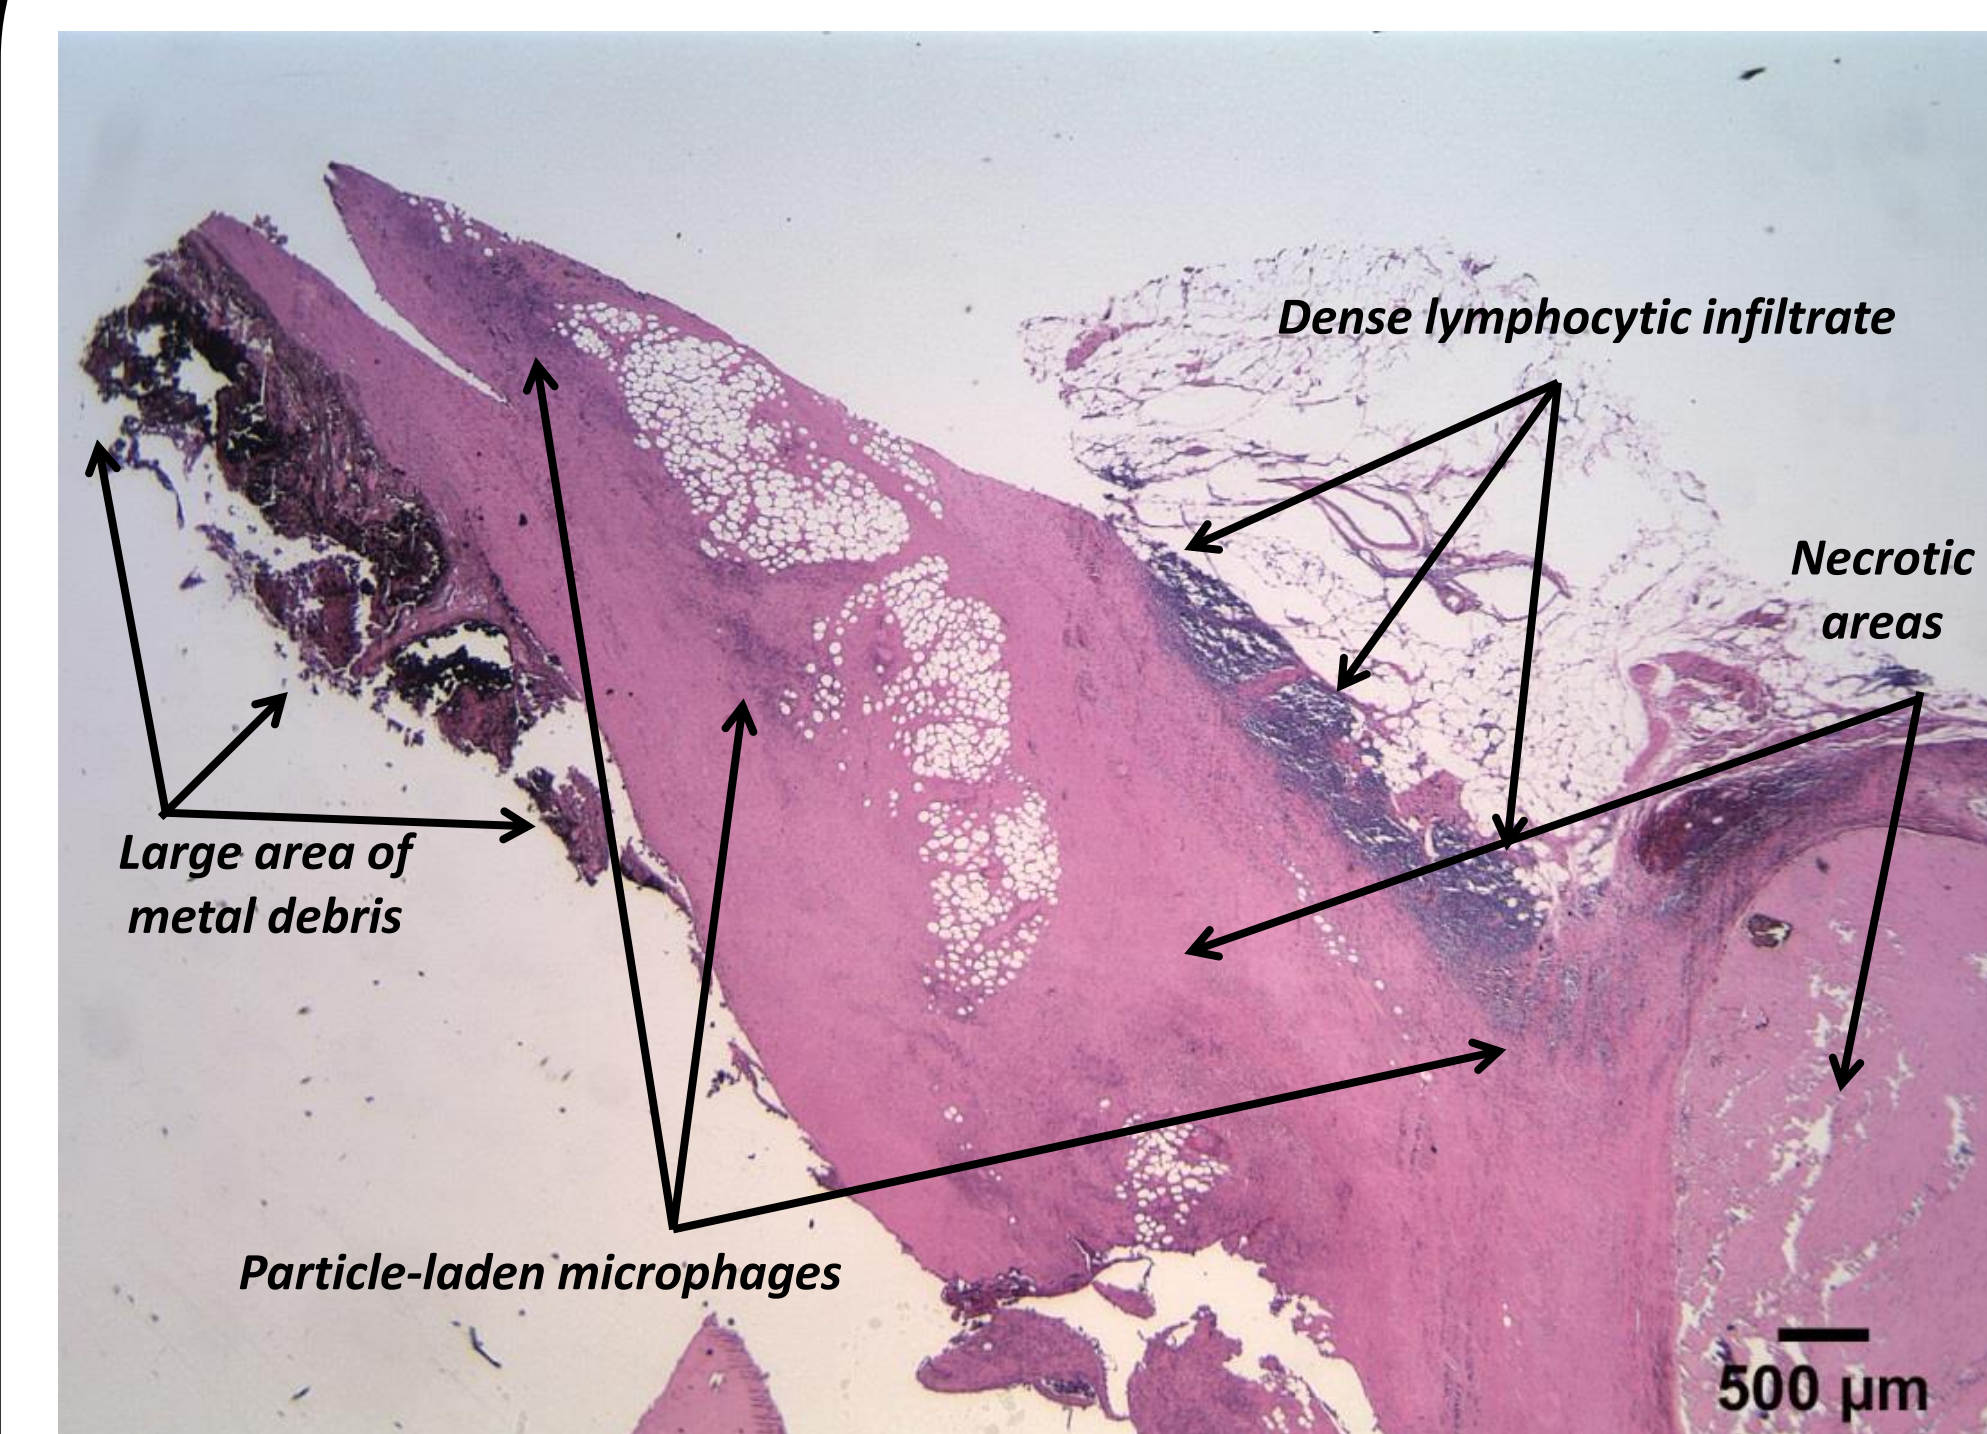
Figure 7. Low power photomicrograph illustrating the mixed inflammatory pattern seen in the pseudocapsule of Case 2, with both a marked presence of lymphocytes and particle-laden macrophages adjacent to large areas of necrotic tissue (H&E, x13)

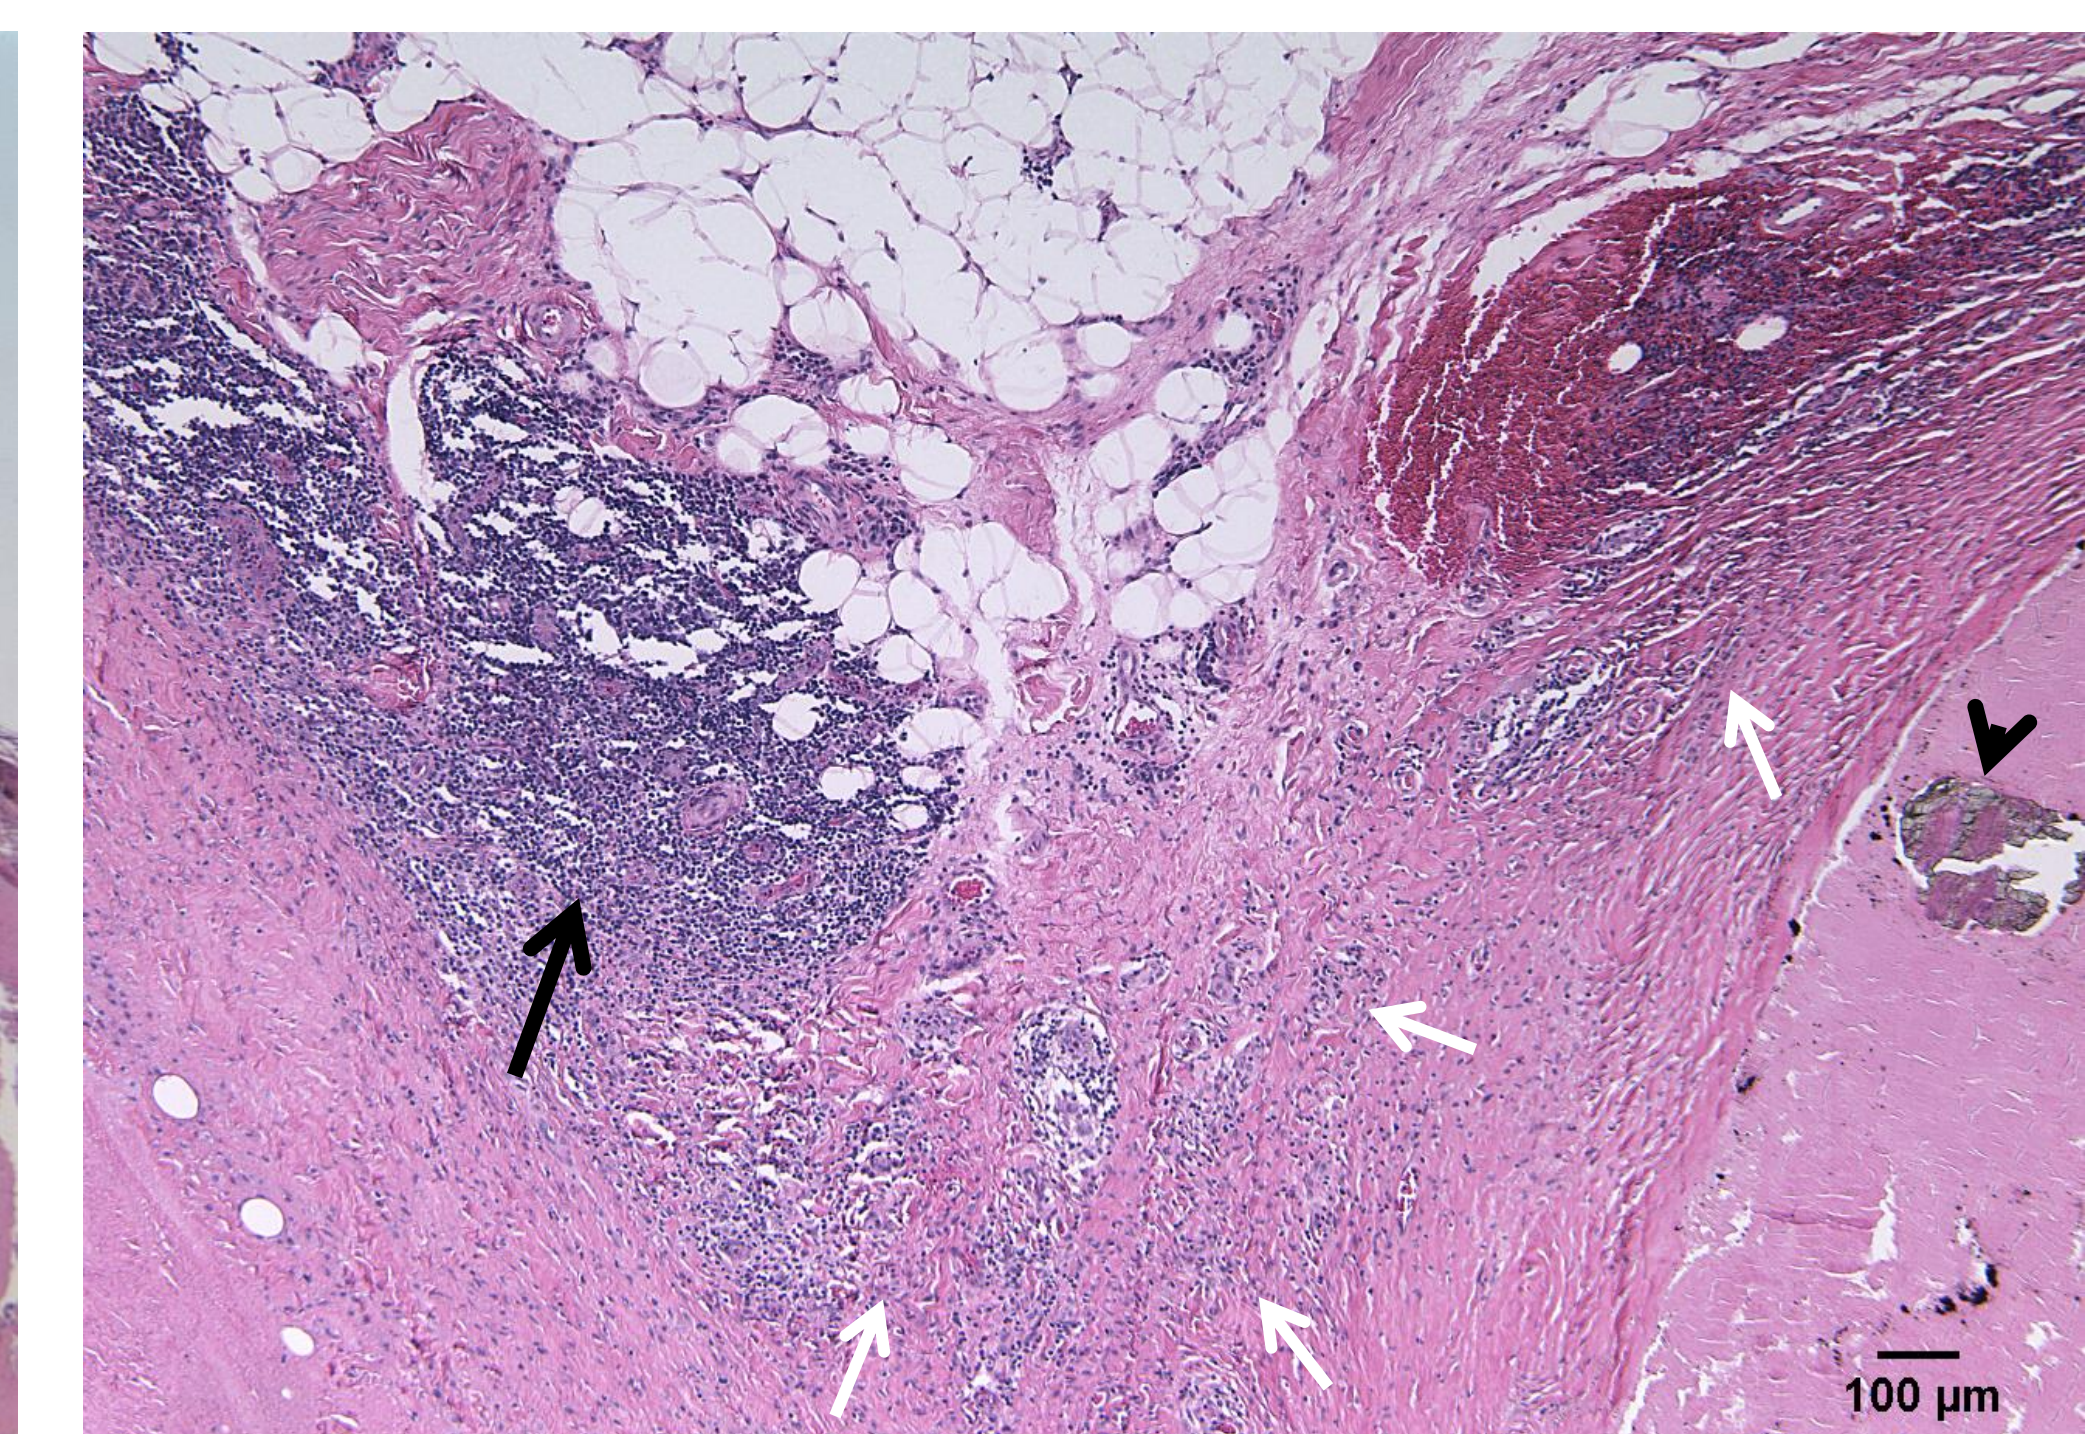
Figure 8. Higher power of an area of the mixed inflammatory pattern seen in Figure 7. The dense lymphocyte region is indicated by the black arrow. The macrophage-rich area (white arrows) also contains foreign body giant cells. A large translucent green CrPO₄ particle (arrow head) is seen in the necrotic area (H&E, x50).

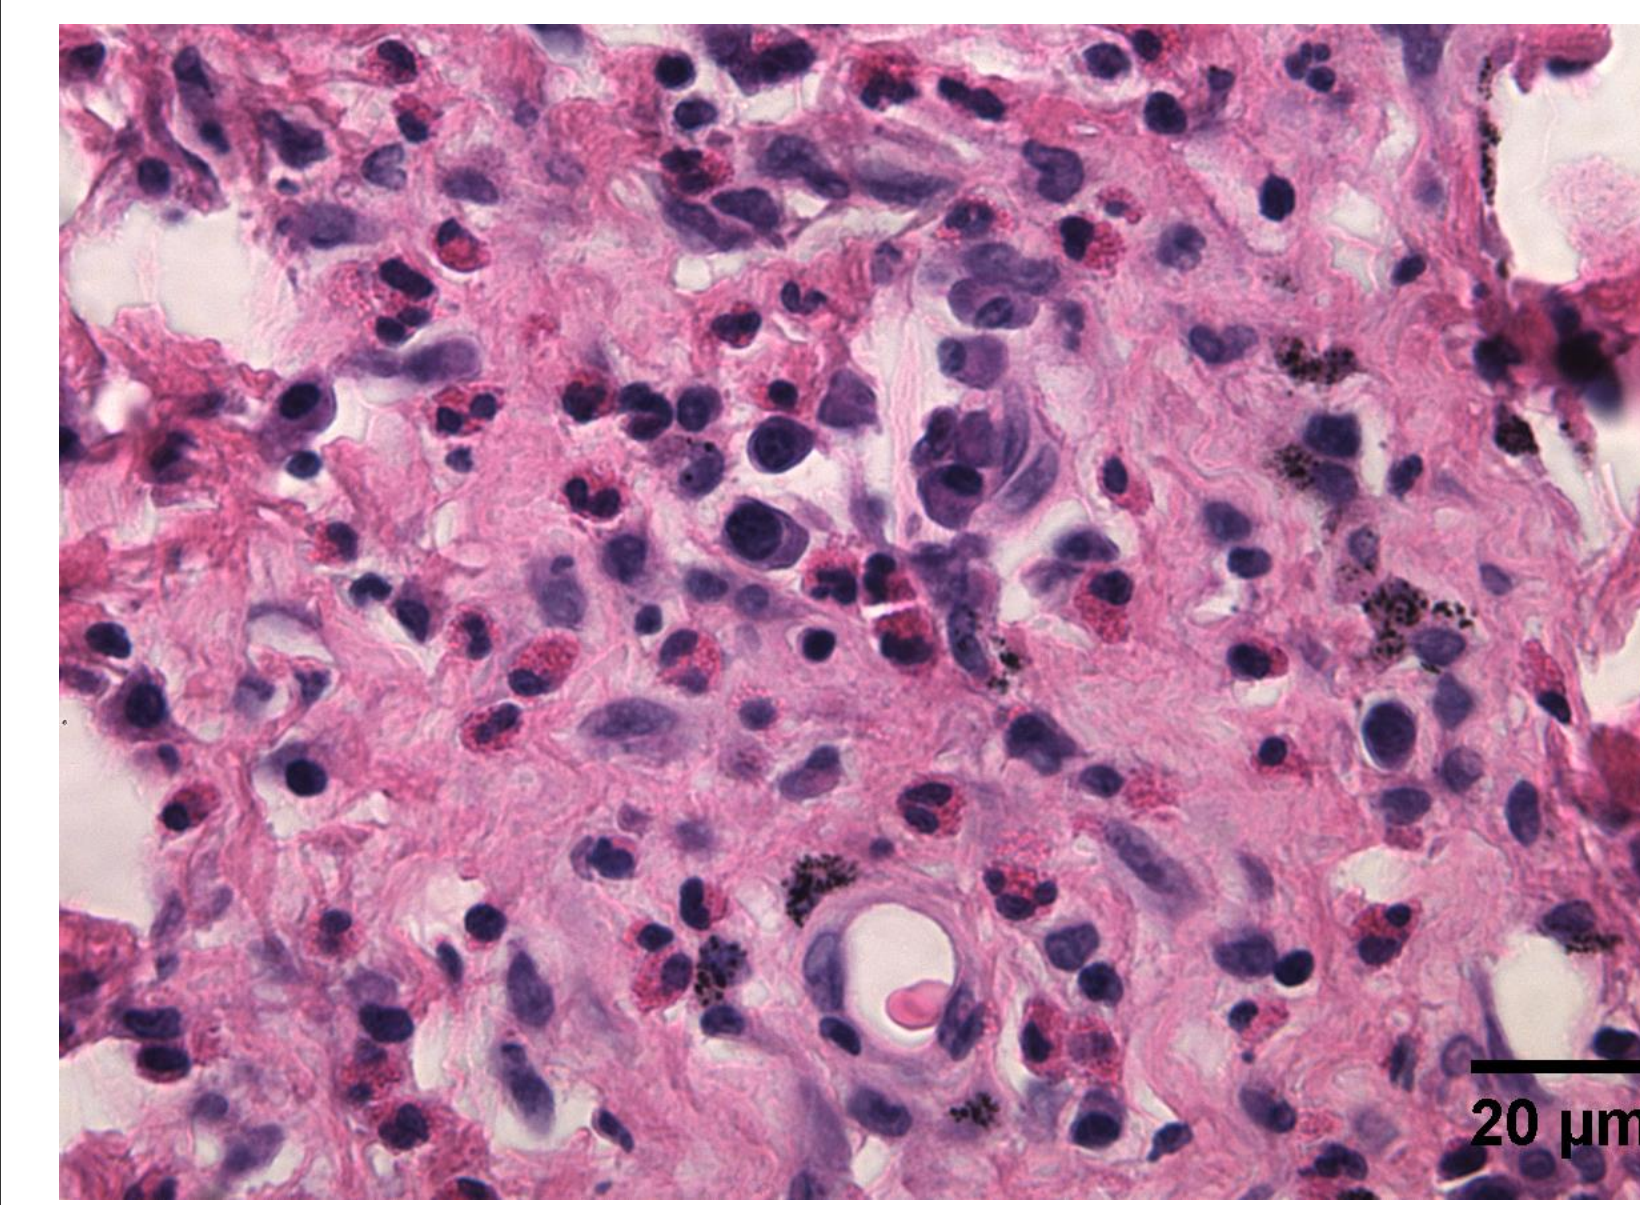
Figure 9. Plasmacytes and eosinophils were also observed among the lymphocytes (H&E, x600).

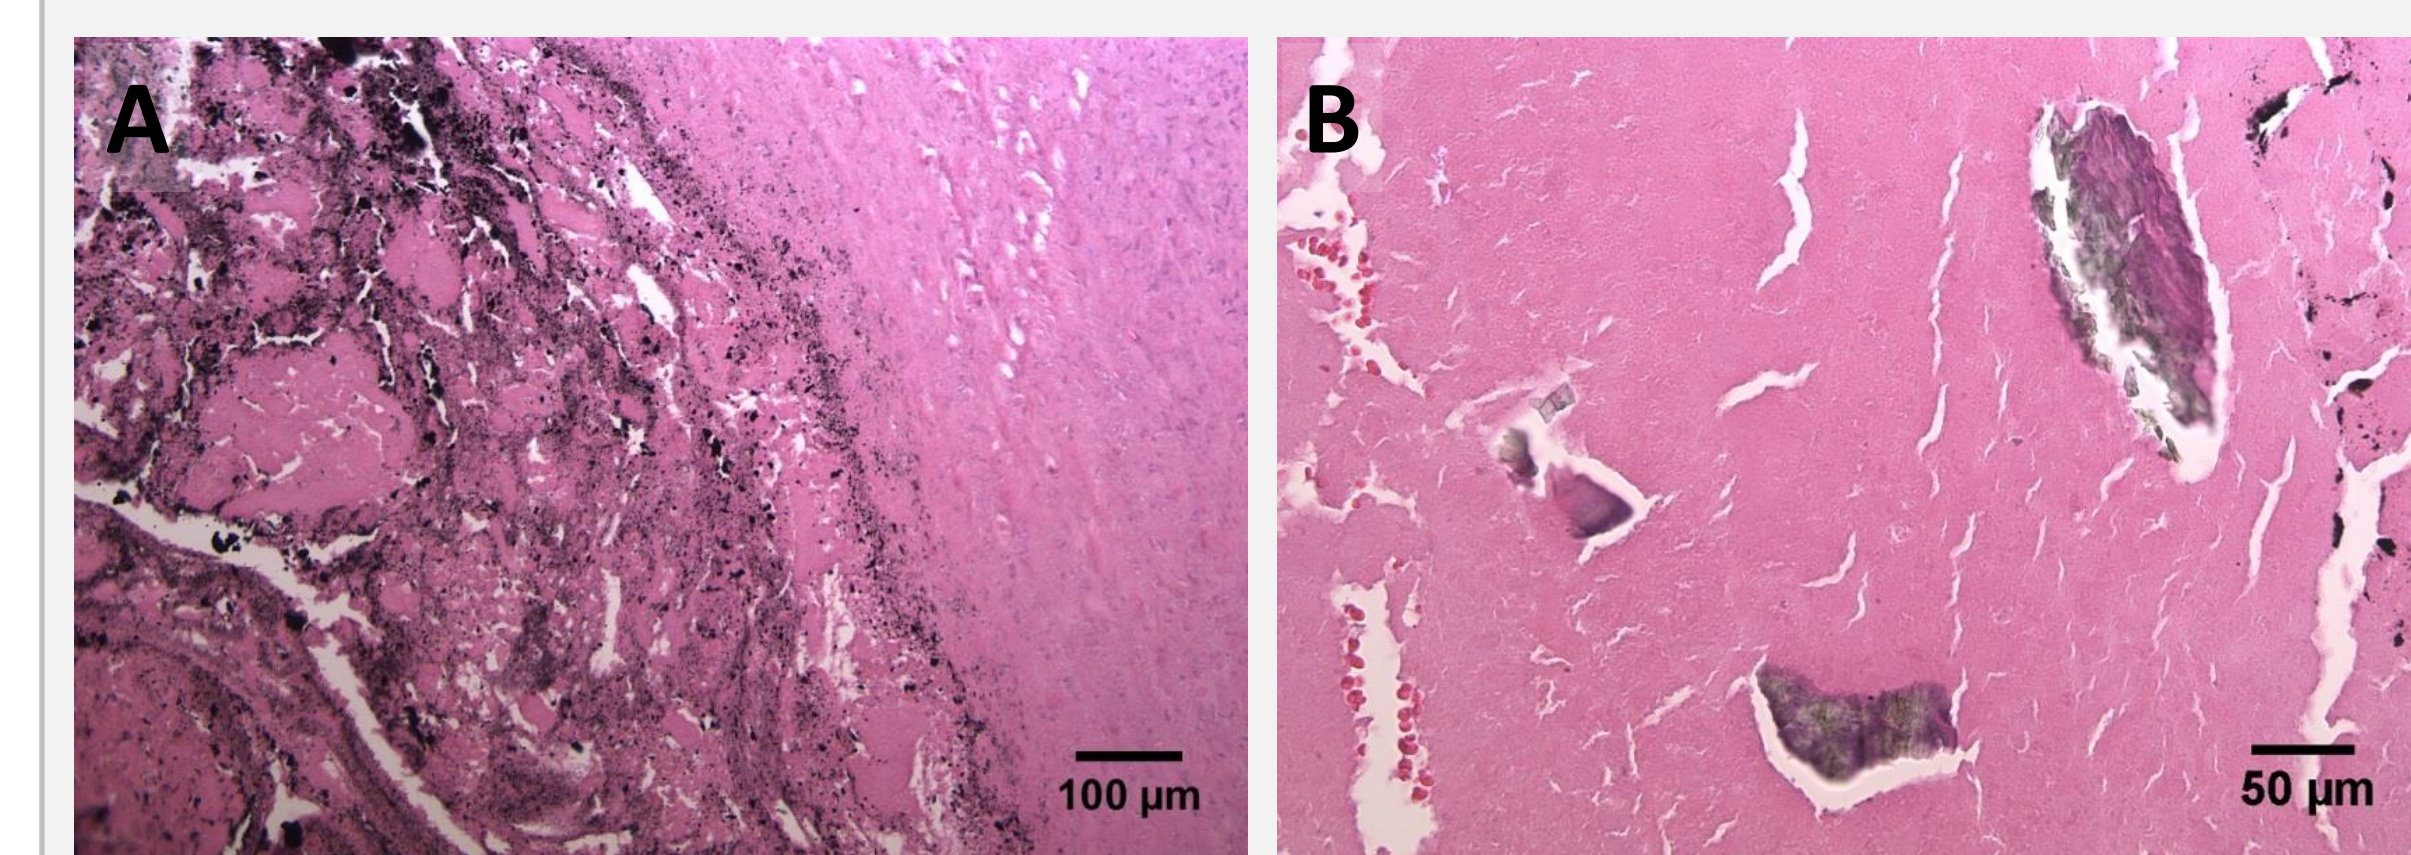
Figure 10. A: A large accumulation of dense, black particles was seen within the fibrin exudate that covered the synovial surface (H&E, x100). B: Within the necrotic areas, multiple translucent green particles were observed (H&E, x200).
