Fatigue Behavior of Reinforced Welded Hand-Holes in Aluminum Light Poles with a Change in Detail Geometry

Cameron R. Rusnak and Craig C. Menzemer

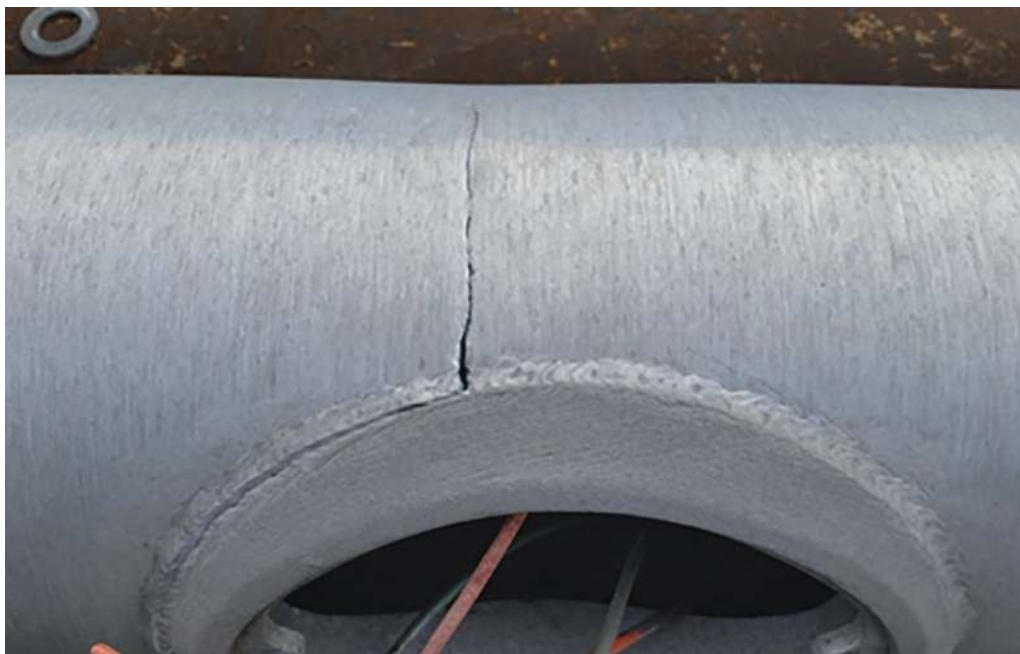
Observations have confirmed the existence of fatigue cracking associated with different hand-holes in the field. NCHRP report number 469 describes fatigue cracks found on welded steel structures near and around the hand-holes in several states. These states included New York, California, New Mexico and Minnesota [7]. In Iowa, there was a failure in a high-mast welded pole that was found to contain cracking around the hand-hole. This failure prompted further investigation into other poles and towers, in which multiple contained some form of fatigue cracking. Fatigue cracking was found in welded aluminum light poles mounted on the Mullica River Bridge after a violent storm in 2011 [8]. **Figure 1** depicts a fatigue failure associated with a hand-hole on an aluminum light pole that occurred in the field.

Figure 1.
Fatigue crack in welded aluminum light pole hand-hole.

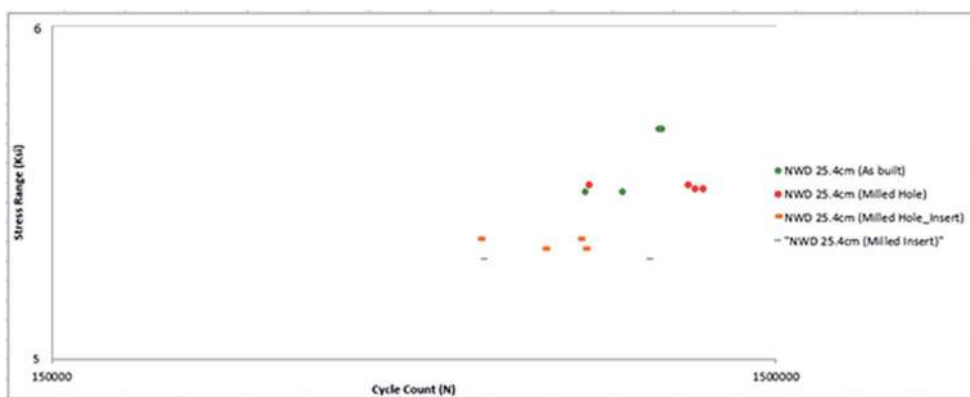
The data shown in **Figure 6** reveals that changes to the weld detail do not have a drastic effect on fatigue life. In fact, some of the changes appeared to have a negative effect on the fatigue life. This was most prevalent in the milling of the cast insert. The only test that appeared to have any positive effect was when the hole itself was milled. In this case, the fatigue life was increased slightly. **Figure 7** shows the compilation of previous data compared to the change in details [11].

Figure 6.
Fatigue test results of new weld hand-hole details.

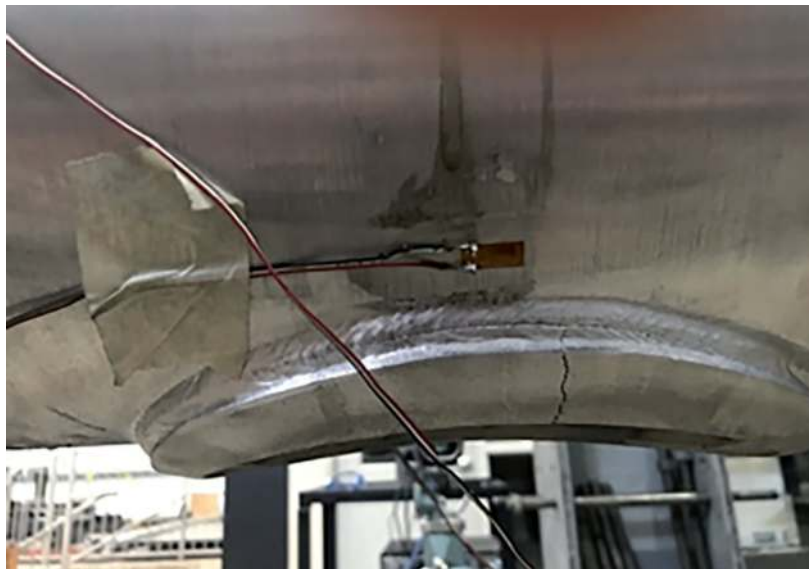
During testing, cracks were first observed in the throat of the fillet weld that joins the tube to the reinforcement ring. These cracks were first observed along the minor axis of the hand-hole at either the 3:00 or 9:00 position in Ref. to a clock. A sample of one of these cracks may be seen in **Figure 8**. These cracks would normally start at the weld root and propagate through the throat of the weld and then progress around the handhole. **Figure 9** shows an example of the crack surface after failure. Note that this

Figure 8.
Fatigue crack through weld throat between reinforcement and tube.

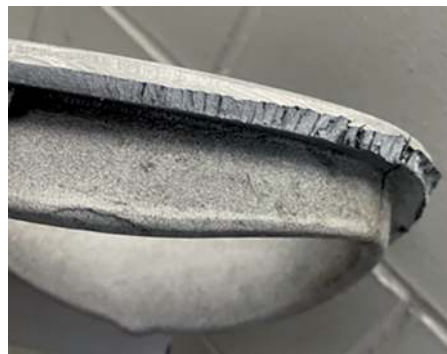
Figure 9.
Jagged crack edge.

is similar to that of a previous study conducted at the University of Akron [10]. The edges of the jagged surface appear to coincide with the weld bead ripples.

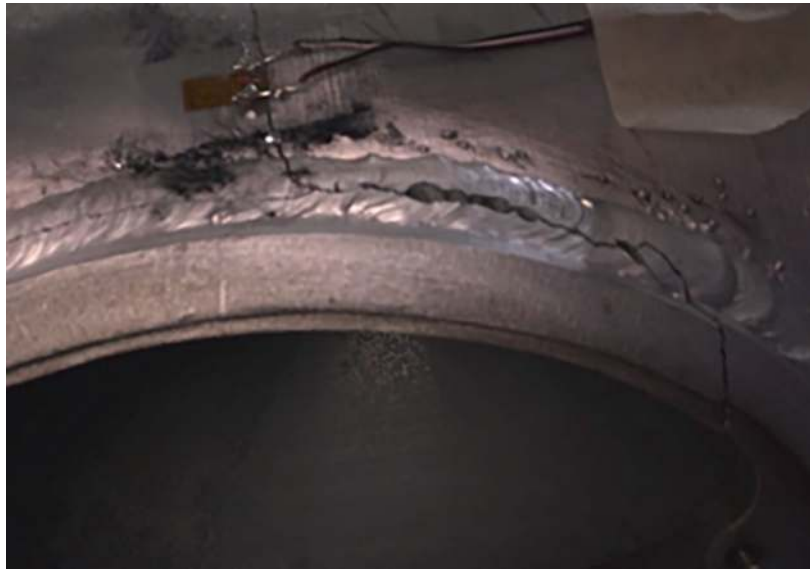
Figure 10.
Typical final failure of hand-hole details.

Final failure typically occurred as the crack progressed through the cast insert near either the 11:00 or 5:00 position (**Figure 10**). In these cases, the fatigue cracks spent most of the cyclic life while small. In every case there was a definite transition from the time of the development and propagation of visible fatigue cracks within the fillet weld throat to the final failure. In most cases, cracks would develop and progress around the hand-hole. At this point, they would appear to stop, and only after a significant number of load cycles were applied, would failure occur.

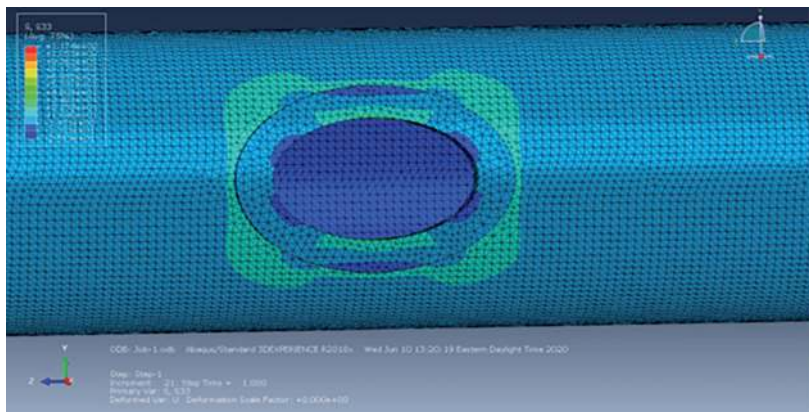
Stress “hot spots” indicate where fatigue cracking is likely to develop. **Figure 12** shows a longitudinal stress map along the “Z” axis. Under bending, longitudinal stress developed and the distribution, sense, and magnitude are affected by the presence of the hand-hole detail. This is shown in **Figure 12** with the shade of blue being a relatively low stress while elevated stress (**Figure 11**) is green. Hot spots appear alongside most of the hand-hole, maximum values between the 10:00 and 2:00 positions,

Figure 12.
Contours of longitudinal stresses around the hand-holes.

as well as between the 5:00 and 7:00, indicated by a lighter shade of blue. Elevated stresses are apparent on the inside edge of the reinforcement. Stresses are larger near the junction of the inside and outside legs of the reinforcement [9]. This makes sense because, as the tube bends, the cast reinforcement attempts to elongate on the tension side. This stretches the reinforcement insert and results in transverse bending.

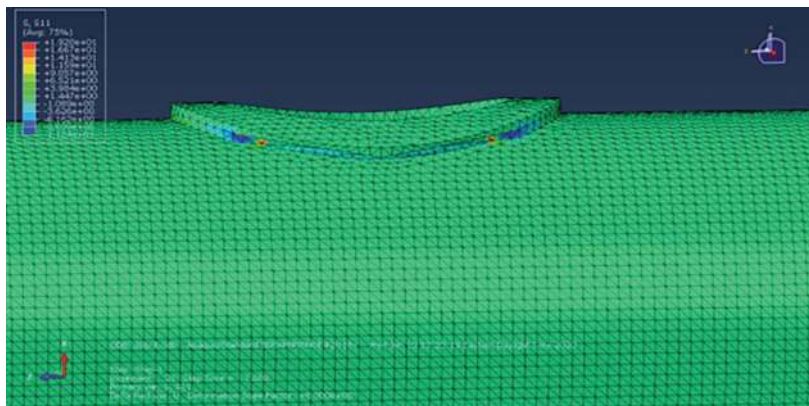
Figure 13.
Stress concentration X direction.

Figures 13 and **14** show how a crack within the detail effects the stress hot spots. In **Figure 13**, to be precise, the stress is along the “X” axis and shows that the highest concentration of stress is located at the “end” of the crack with a red color. **Figure 14** shows this exact same phenomenon along the “Z” axis.

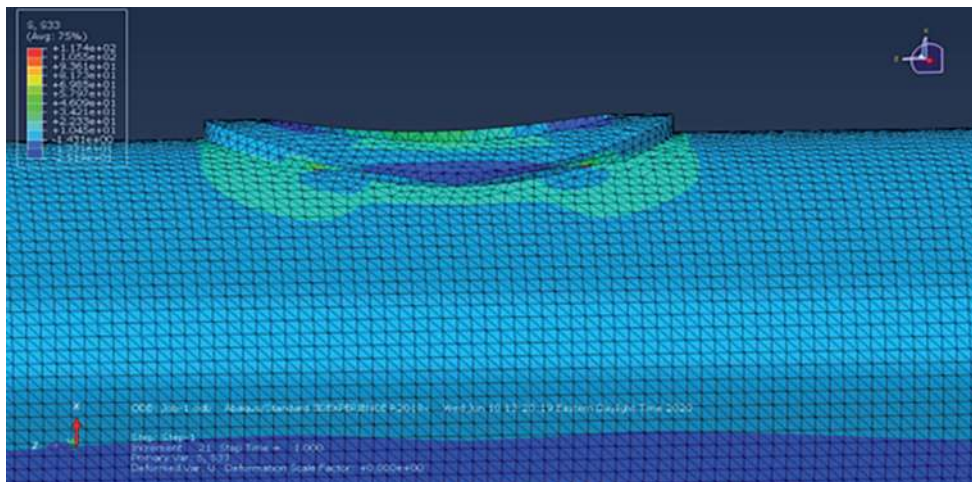
Figure 14.
Stress concentration Z direction.
