Bibiana Vertakova Krakovska, MD., PhD; Maros Kunderlik, MD
Department of medical oncology, St.Elizabeth Cancer Institute, Bratislava, Slovakia

Multiple factors can cause difficulties with PICC-port insertion and the right tip position is in rare cases difficult to access, as shown in our case-report.

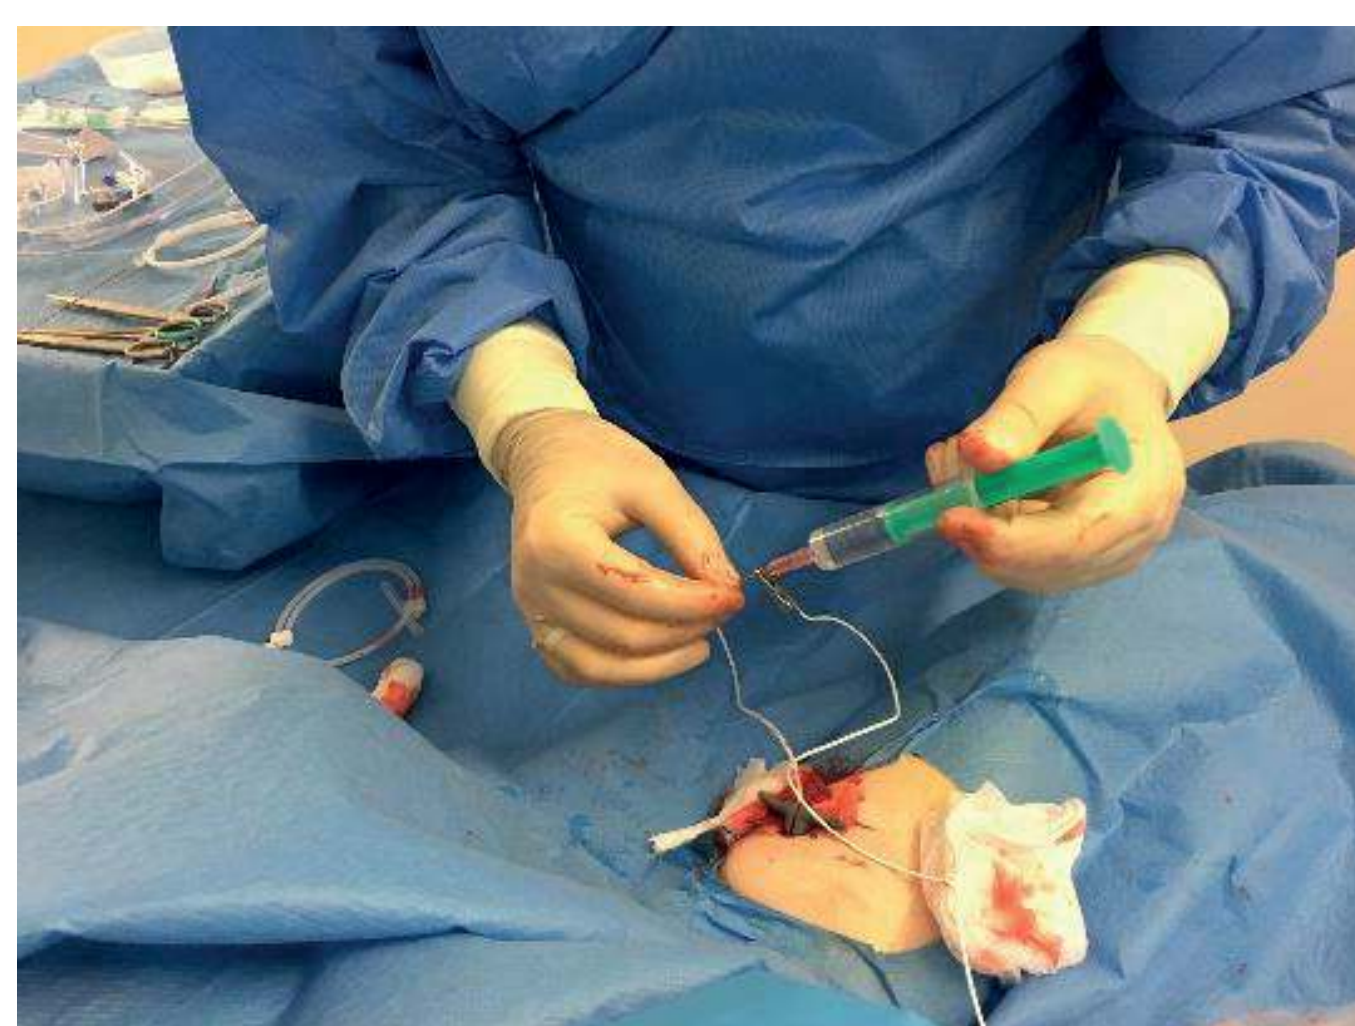
- During the procedure using ECG navigation, P-wave elevation was shown indicating the position of the end of the catheter in the cavo-atrial junction. PICC- PORT was placed without problems and treated according to the standard (picture nr. 1,2)

Picture Nr.1: ECG navigation during PICC insertion

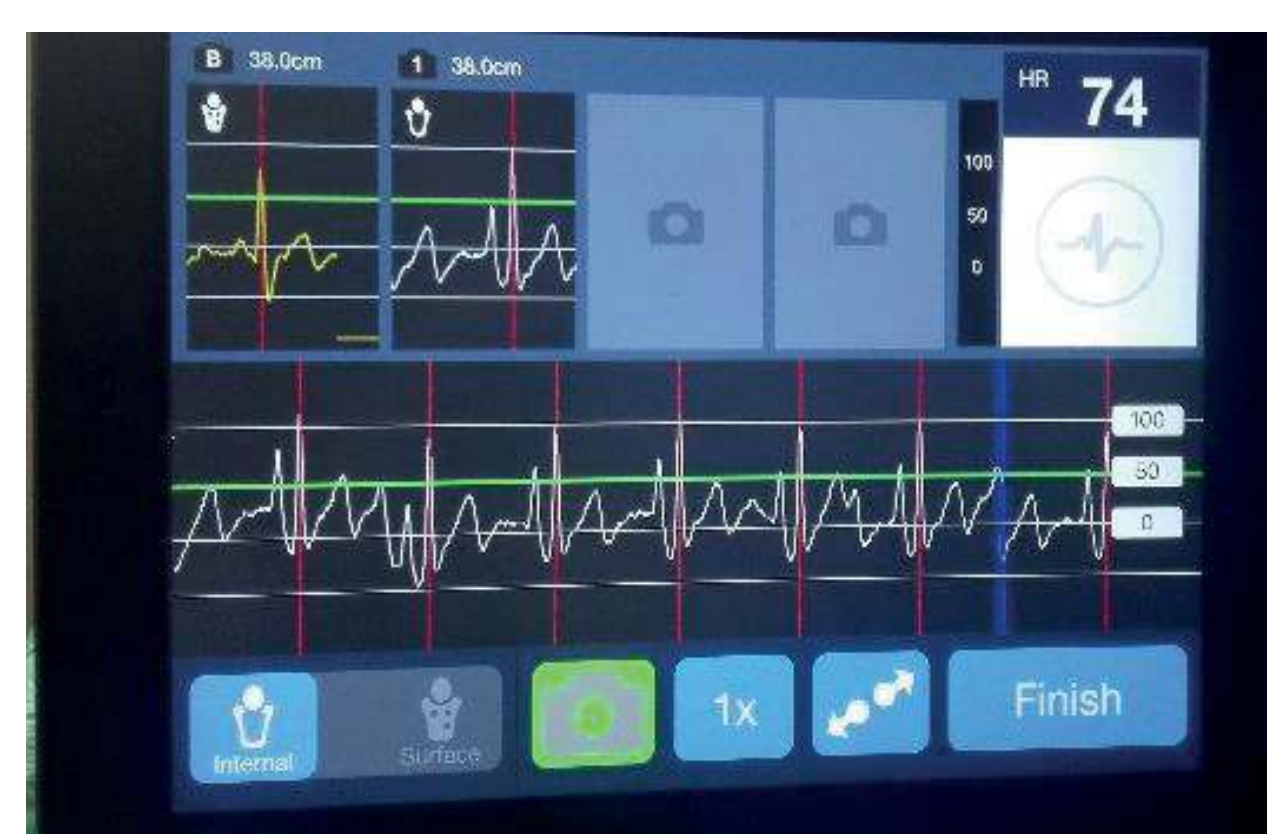
Picture Nr.2: P wave elevation – indicates the right position of catheter end

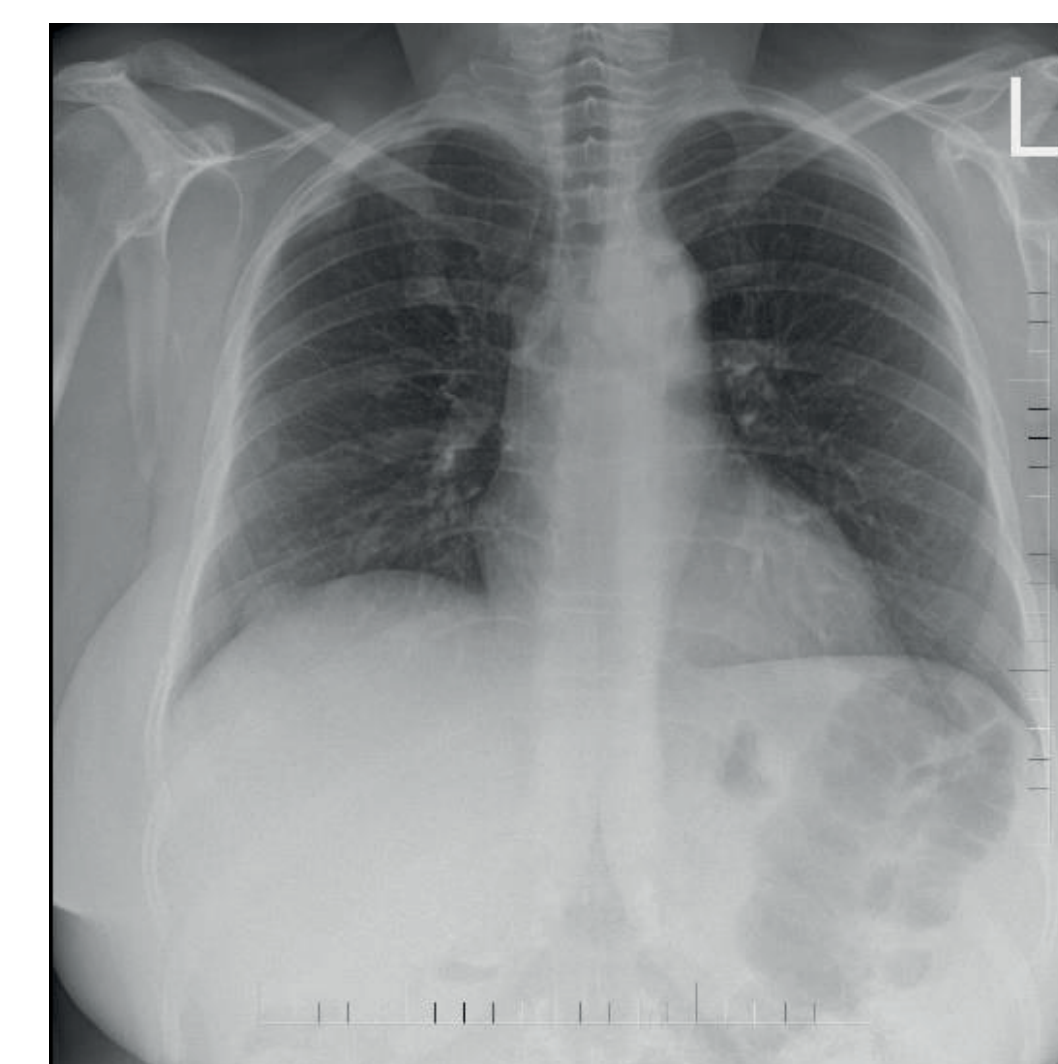
- Control chest X-ray, badly readable for obesity and large breasts, after first reading described the position of the catheter in the right atrium - the exact tip position was not exactly specified (picture nr.3)

- Detailed analysis of the 1st X-ray image showed the exact position of the PICC tip deeply in the right atrium, creating a loop, with the position of the catheter tip at the entrance to the right atrium. Therefore, the presence of P-wave elevation on intra-cardiac ECG was present.

Picture Nr.3: First chest X-ray - position of catheter end – inconclusive

- The position of the catheter was subsequently modified, catheter was pulled-out by 5 cm and properly fixed
- Second chest X-ray, after correction, showed the tip position of the catheter without any change

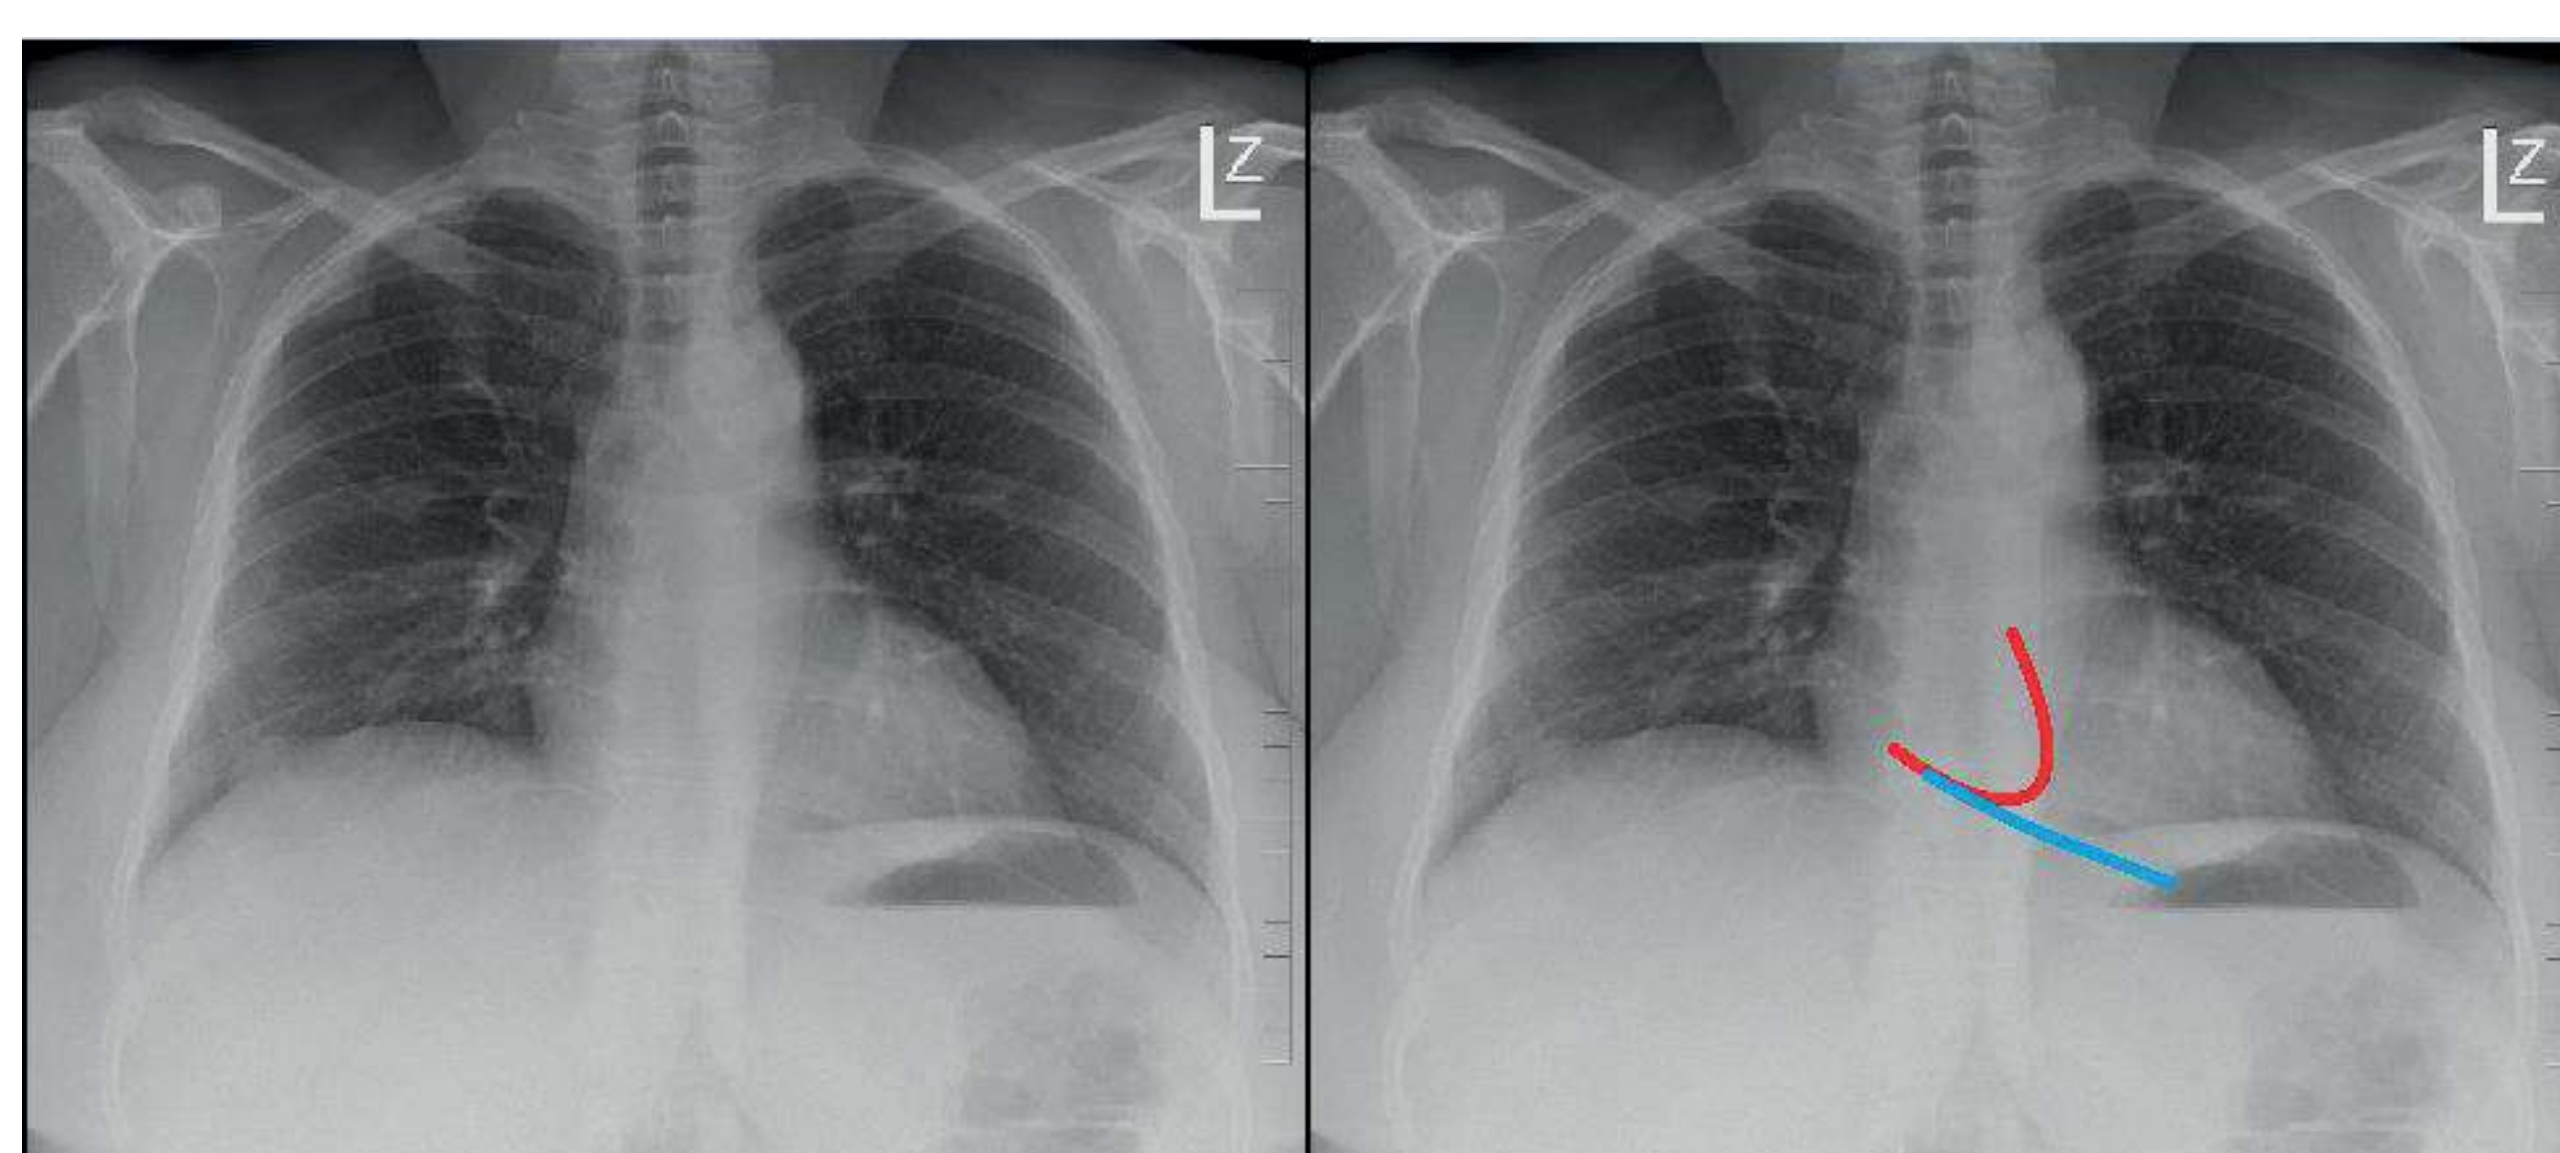
- Our hypothesis is, that at first (immediately after catheter insertion, when the guide wire was still placed inside the catheter) - the tip of the catheter was located in the right atrium (picture nr.4 – marked red). It formed a loop, so it was possible that the ECG showed P wave elevation indicating

the right tip position (we did not have the option of fluoroscopy to check the tip position in real time

- Then, when we removed the guide wire, the loop resolved and the tip moved to the right ventricle (picture nr.4- marked blue)
- We performed echocardiography to locate the catheter tip /using second method (picture nr.5) : the end of the catheter was seen on the echocardiography in the right atrium touching the right tricuspid valve, influencing the movement of the valve. Because of this malposition, the line was extracted, without any complications.

Picture Nr.4: control X-ray (first position of catheter tip in the right atrium forming a loop- marked red; definitive position of catheter tip after the guide wire removal- marked blue)

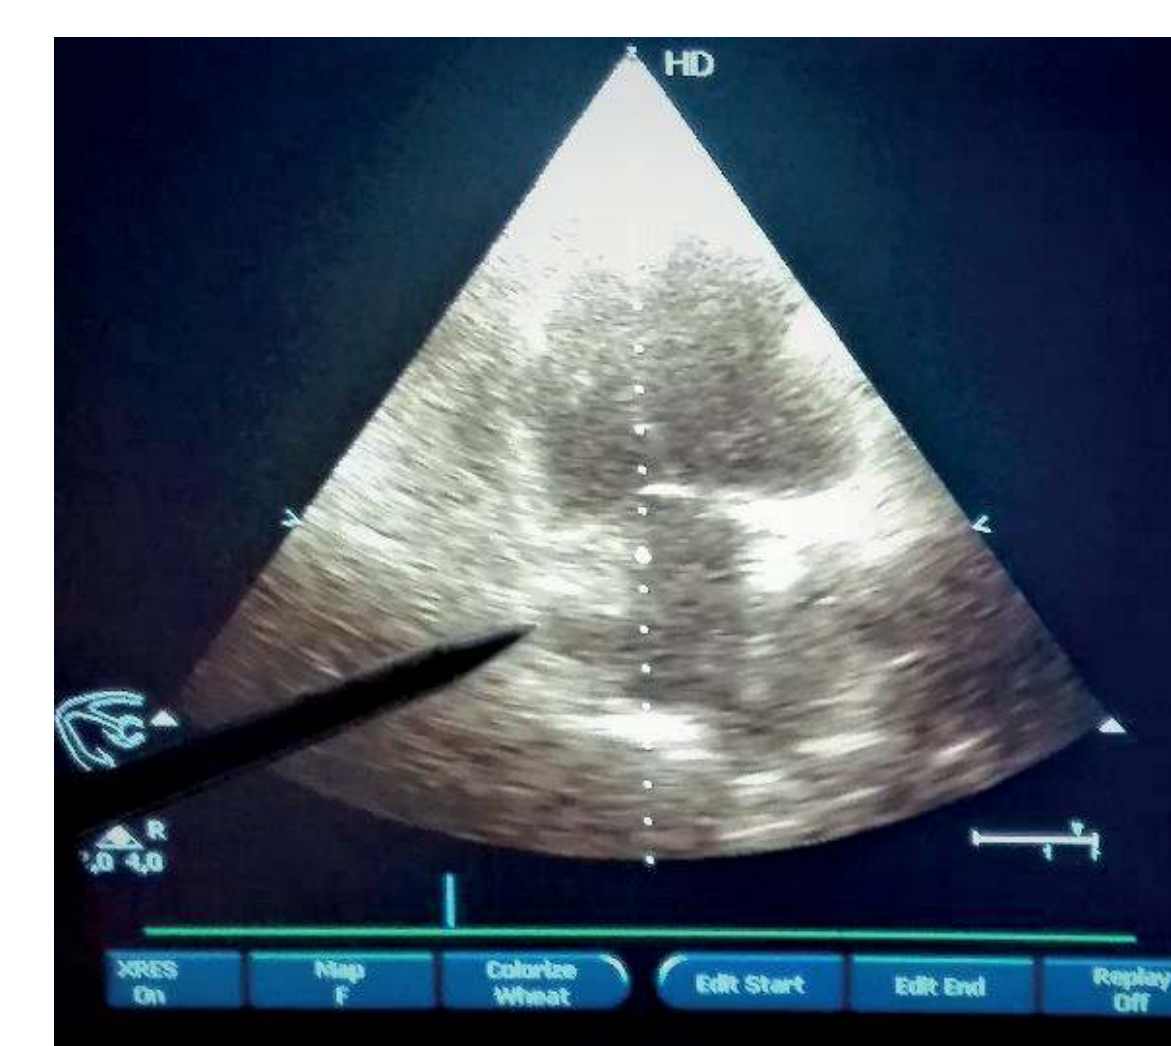
Picture Nr.5: echocardiography – reveals the catheter end in the right atrium touching the mitral valve
