# Cumulative Tensile Damage and Consolidation Effects on Fracture Properties of Sandstone

Martin Šperl and Miloš Drdácký

<http://dx.doi.org/10.5772/intechopen.81434>

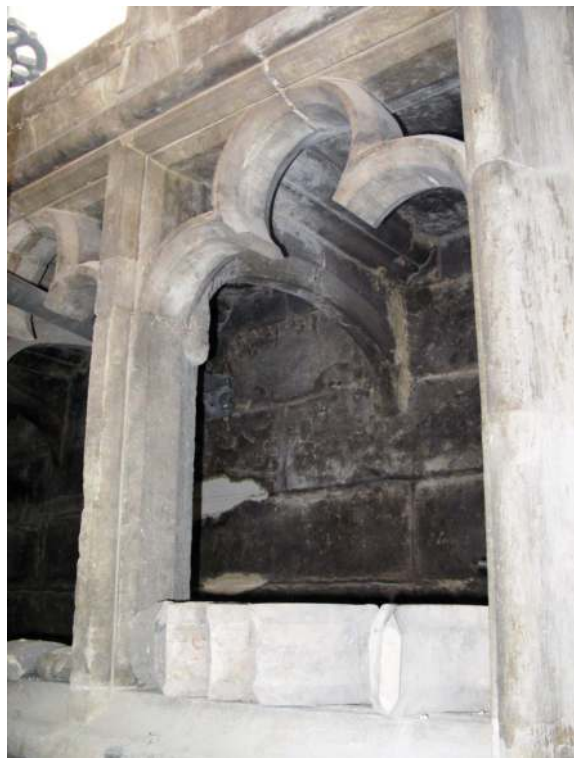
**Figure 2.** Repaired tracery with damaged elements in Notre Dame du Sablon (photo by M. Drdácý).

Similar damage has been observed on other historic buildings, for example, on the church of Notre Dame du Sablon in Brussels (see **Figure 2**) where several failed original elements have been replaced.

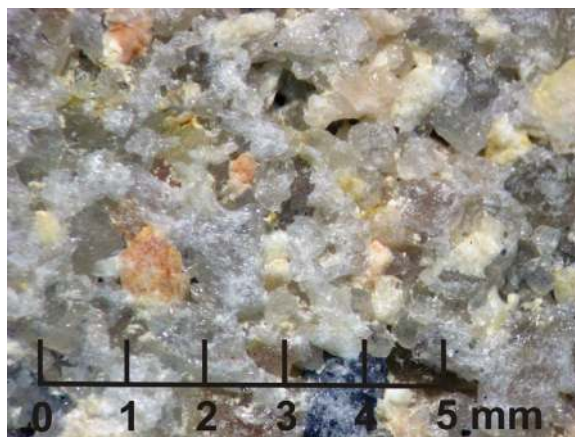
**Figure 3.** Macro photo of the Božanov sandstone (arkose) structure (photo J. Frankl).

Božanov stone is a grayish beige gross grain strong arkose sandstone without marked layering (**Figure 3**). The material used in the tests was extracted from the 11th arch of the Charles Bridge parapet wall, which had to be replaced during recent repairs. It has a rather deeply located detachment crack parallel to the surface, probably due to some previous surface treatment which had locked moisture inside the stone. The material can be characterized as a quasi-brittle inelastic silicate composite.

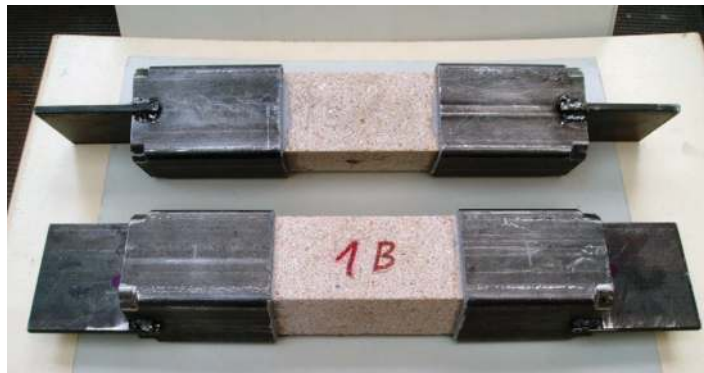
Figure 4. Test compression/tension specimens (photo by M. Šperl).

Test specimens  $50 \times 50 \times 200 \text{ mm}^3$  in dimensions were fixed into rectangular steel tubes with axially welded flat steel hangers, which served to fix the set into the hydraulic grips of the loading frame (**Figure 4**). Two-component Sikadur-31 CF RAP resin was used for gluing. The fixtures had to be prepared with great precision in order to ensure perfect alignment and perpendicular arrangement for tension and combined loading. The specimens in prismatic form were cut with negligible geometrical imperfections in a precise prismatic form.

Twelve experiments were carried out—four on the specimens from **Figure 4** and eight on prismatic beams cut out of the broken parts after the tension tests. The tests therefore involved (i) compression, (ii) very-low-cycle fatigue, (iii) tension, (iv) fatigue (an alternating nonsymmetrical cycle)—all on the specimens from **Figure 4**—and (v) three-point bending tests on small size beams with a  $20 \times 20 \text{ mm}^2$  cross section.

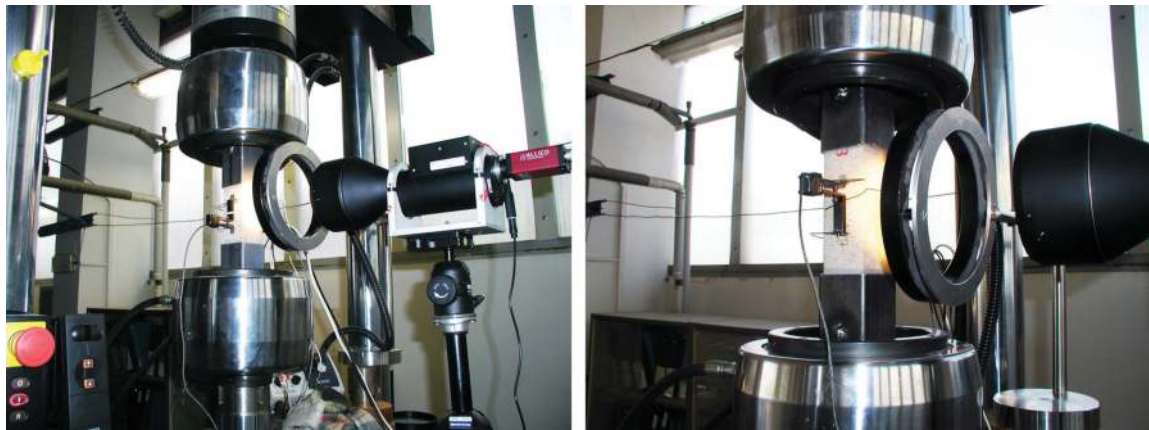
Figure 5. Arrangement of pure tension tests on the stone specimens (photo by M. Šperl).

The specimens were loaded into an Instron 1343 electrohydraulic testing frame with force capacity of 100 kN (**Figure 5**) using an Instron 100 kN load cell, a FastTrack 8800 controller, two Instron extensometers type 2620-602 (accuracy class 1, with maximum possible error of 0.5% of the read value, measurement base  $l_0 = 50 \text{ mm}$ ), and WaveMatrix measurement software. The extensometers were placed on opposite sides of the specimen, and their read values were arithmetically averaged. The contacts on the surface of the stone were provided with glued thin aluminum sheets to protect the extensometer wedges. The deformations were also

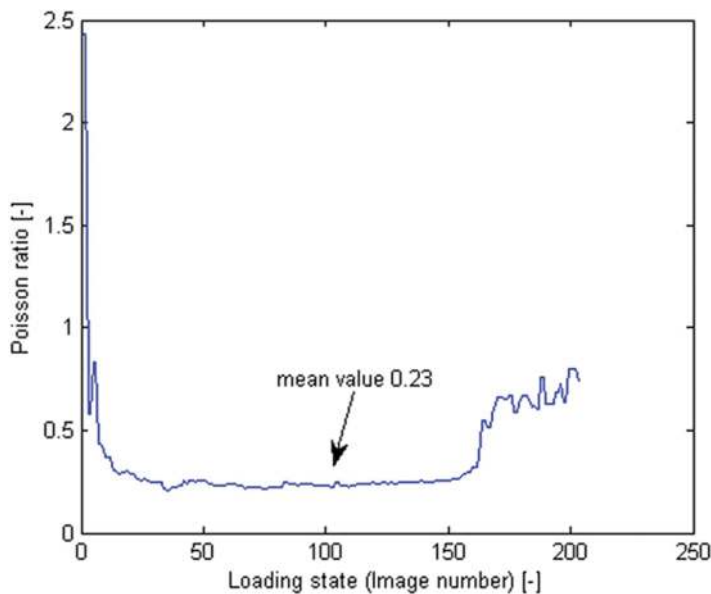
**Figure 7** Poisson ratio measured using the DIC method.

The compression force was applied in three stages:  $-1.5$ ,  $-26$ , and  $-37 \text{ MPa}$ . Deformation was measured during the tests in order to study the change in Young's modulus and the Poisson number with relation to applied load (**Figures 6** and **7**). Hysteresis and irreversible deformation were observed, and the Poisson number reached a value of 0.23. The diagram shows that the tested sandstone increased in stiffness with an increasing number of compression cycles at the beginning of the tests. The change in the slope of the interpolated linear approximations of the load-displacement diagrams reflects this fact. The modulus of elasticity rose from an initial value of  $11,360 \text{ MPa}$  to a value of  $19,237 \text{ MPa}$  for the third cycle of loading, i.e., a 70% increase. This differs from the results of other tests on sandstone as presented in the cited literature. At the same time, hysteresis occurs with irreversible deformations. During the first loading cycle to  $-1.5 \text{ MPa}$ , no irreversible deformation was observed. It seems that irreversible deformation occurs after the material has been subjected to some limit compression load. The Czech standard for tests on natural stone prescribes that the modulus of elasticity is to be evaluated after three loading cycles.

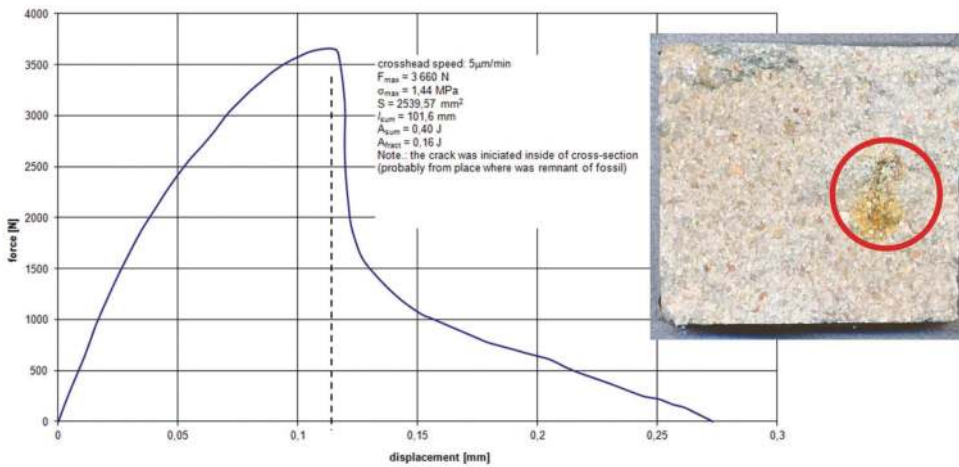
**Figure 8.** Load-crosshead displacement diagram for the tension test with a calculation of the absorbed energies and an indication of the probable place with an initial defect in the cross section of the specimen.

defect present within the specimen (**Figure 8**). The load-displacement graph shows the overall energy absorbed during the test (0.4 J) and during crack growth (0.16 J). This corresponds to the behavior of highly brittle material. The strength decreased (to 1.43 MPa) due to the defect in the material. The course of the stress and deformation up to fracture can be described well by means of a suitable power function (see **Figure 9**), which presents a detailed diagram.

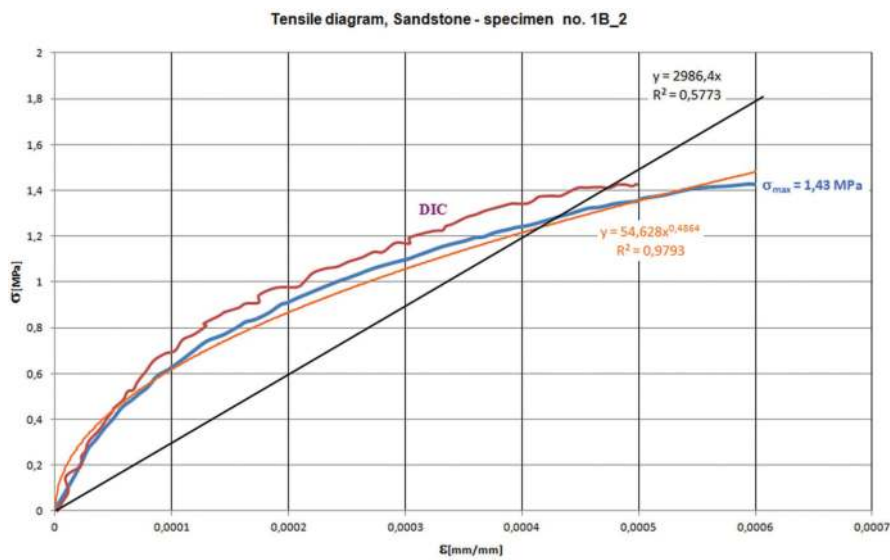
**Figure 9.** Tension diagram of the tested Božanov sandstone, comparing the conservative measurement with the DIC measurement and presenting a suitable power function approximation.

It follows from **Figure 9** that a suitable power function appropriately describes the material behavior up to rupture. The tangent to the curve gives the modulus of elasticity value:

The DIC record exhibits a slight difference in comparison with the conservative measurement approach. This may be caused by a small change in the geometric relations between the specimen and the camera objective during loading. However, the agreement is still very good.

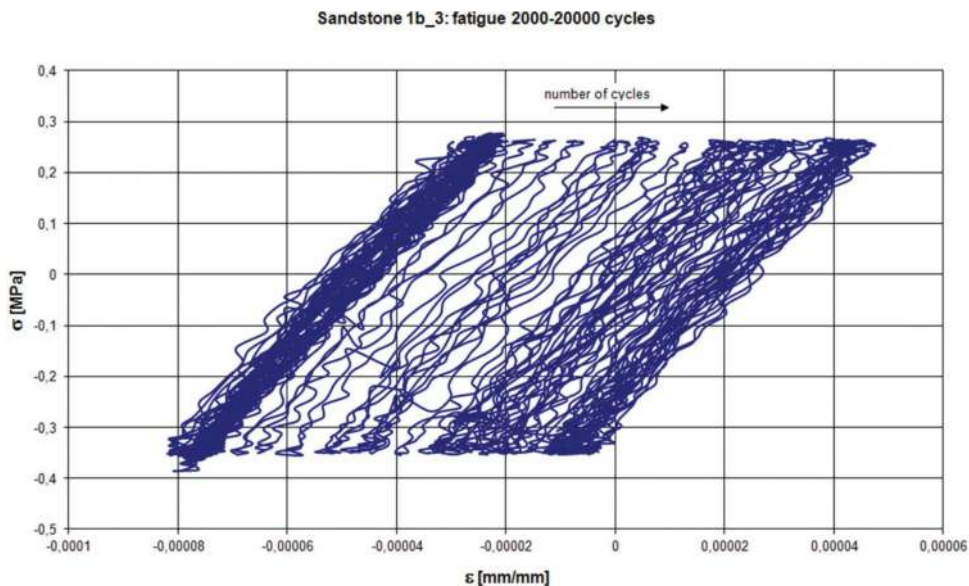
Figure 13. Temperature caused a drift in specimen deformation due to dilation (2000–20,000 cycles).

In **Figure 11**, the observed shift of the measured data toward negative strain values with the increasing number of cycles is caused by thermal dilation of the specimens. The average change in temperature in the testing hall was about 4°C. The temperature change dilations were checked by computations, taking into account the coefficient of dilation of sandstone equal to  $\alpha = 10 \times 10^{-6} \text{ K}^{-1}$  and the equation  $\Delta l = \alpha \cdot \Delta T \cdot l$ . **Figure 13** presents examples of the temperature drift.

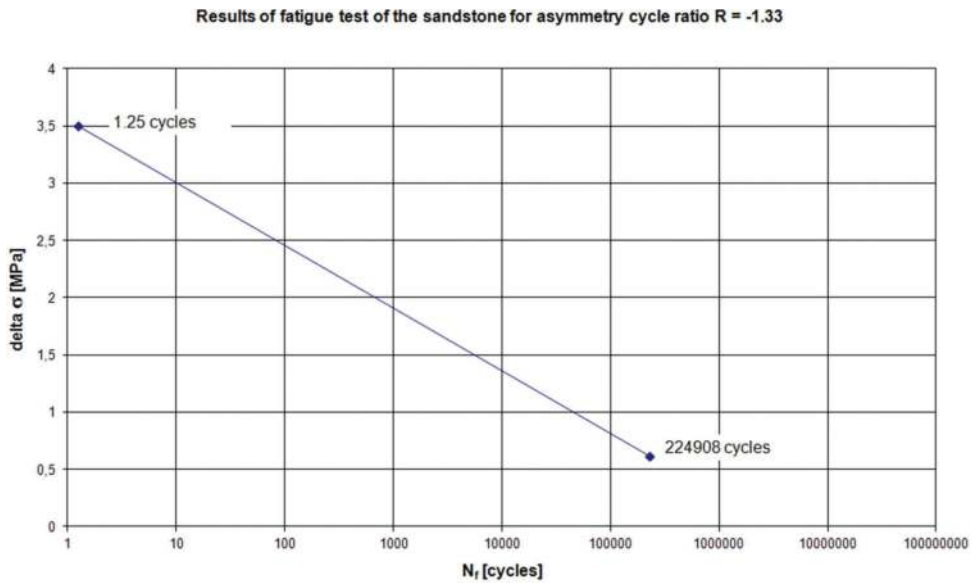
**Figure 14.** Fatigue test results for Božanov sandstone for cycle asymmetry of  $R = -1.33$ .

Figure 14 presents a very rough representation of the probable life estimate of the tested sandstone between two applied stress levels. Of course, many more tests will be required before the true Wöhler curve can be constructed.

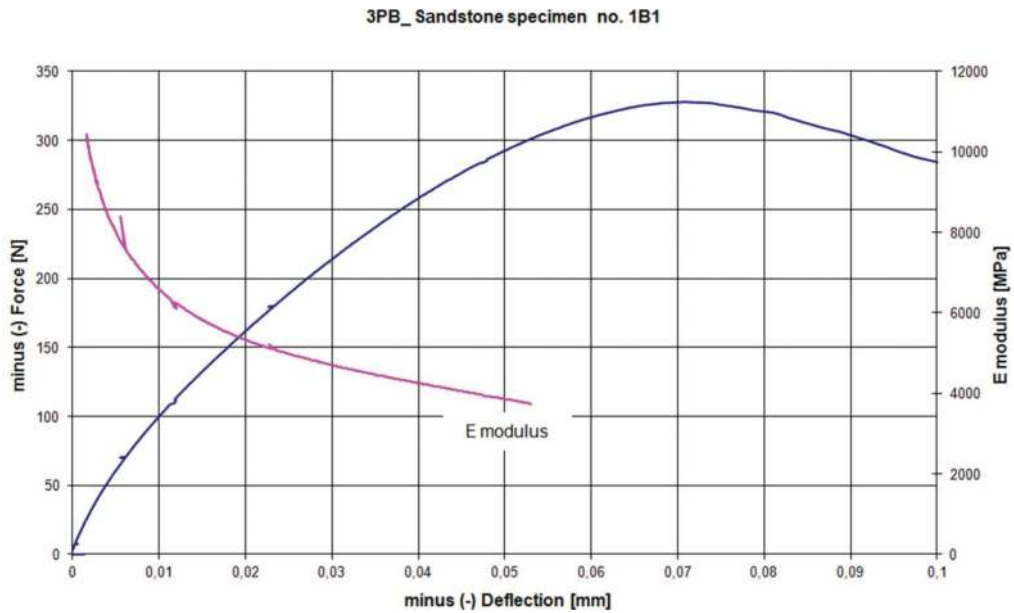
Figure 16. Loading force-deflection diagram during three-point bending testing and calculated modulus of elasticity.

However, the moduli of elasticity were lower than those measured during the previous tests (though still higher than those measured by the first author on thin plates during tests on the characteristics of the Charles Bridge sandstone—Čechová et al. [13]). It is clear that both the load-displacement diagram and the change in the modulus of elasticity can be well approximated by a suitable mathematical model (**Figure 16**).
