**HISTORICAL AGRICULTURE
AND SOIL EROSION IN THE
UPPER MISSISSIPPI
VALLEY
HILL COUNTRY**

STANLEY W. TRIMBLE

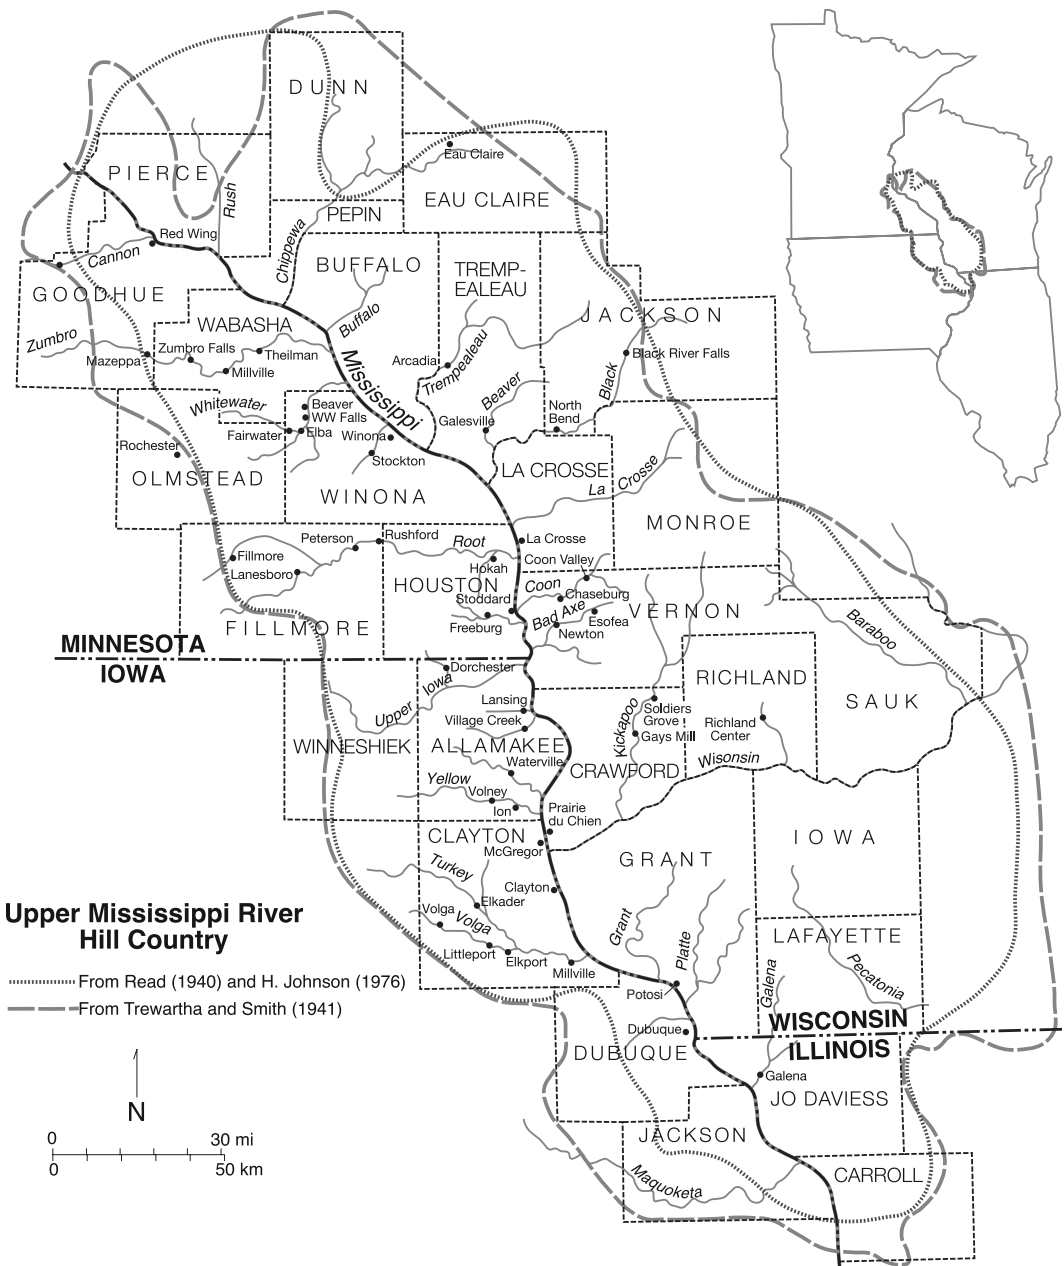
Figure 0.1 The Upper Mississippi River Hill Country. The delineations shown were used because of previous historical work done on the region. This is also quite similar to the delineation of the region into a Major Land Resource Area (MLRA) by the USDA-NRCS (Argabright et al., 1996). Termed by the USDA as the Northern Mississippi Valley Loess Hills, it would exclude most of Dunn County, Wisconsin, and Carroll County, Illinois, but include Clinton County, Iowa.

What is the Upper Mississippi River Hill Country region, and how is it delineated (Figure 0.1)? It might be defined on the basis of bedrock or glacial geology. The region has a fairly uniform and simple, relatively flat-lying geology and is sometimes called the “Paleozoic Plateau” for its common geologic age. A fairly complete geologic cross section for the areas of greatest relief is that found in Houston County, Minnesota (Figure 1.2), but some other areas may have a somewhat different cross section, particularly the more maturely dissected areas in the northeastern part of the region for which parts of the upper strata shown in Figure 1.2 are missing.

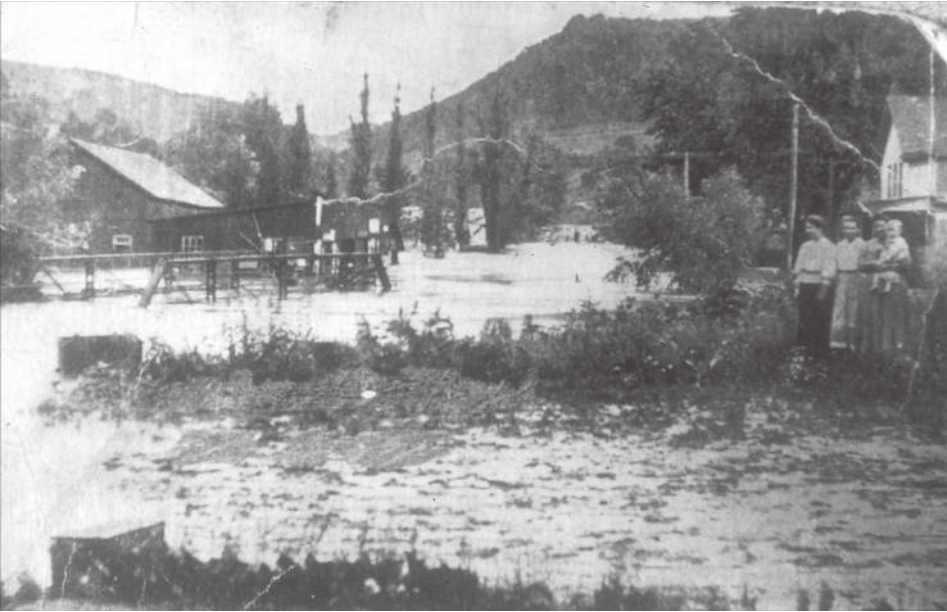
Figure 0.2 The Great Flood of 1907 in lower Chaseburg, Wisconsin, the highest on record up to that time. The photo was made looking east on Mill Street near the front of the present Hideaway Tavern. Since that time, the floodplain has aggraded to a level about 4 or 5 ft (1.2–1.4 m) above the flood level of 1907. The remains of lower Chaseburg were purposefully demolished in 2009 because of the continued flooding.

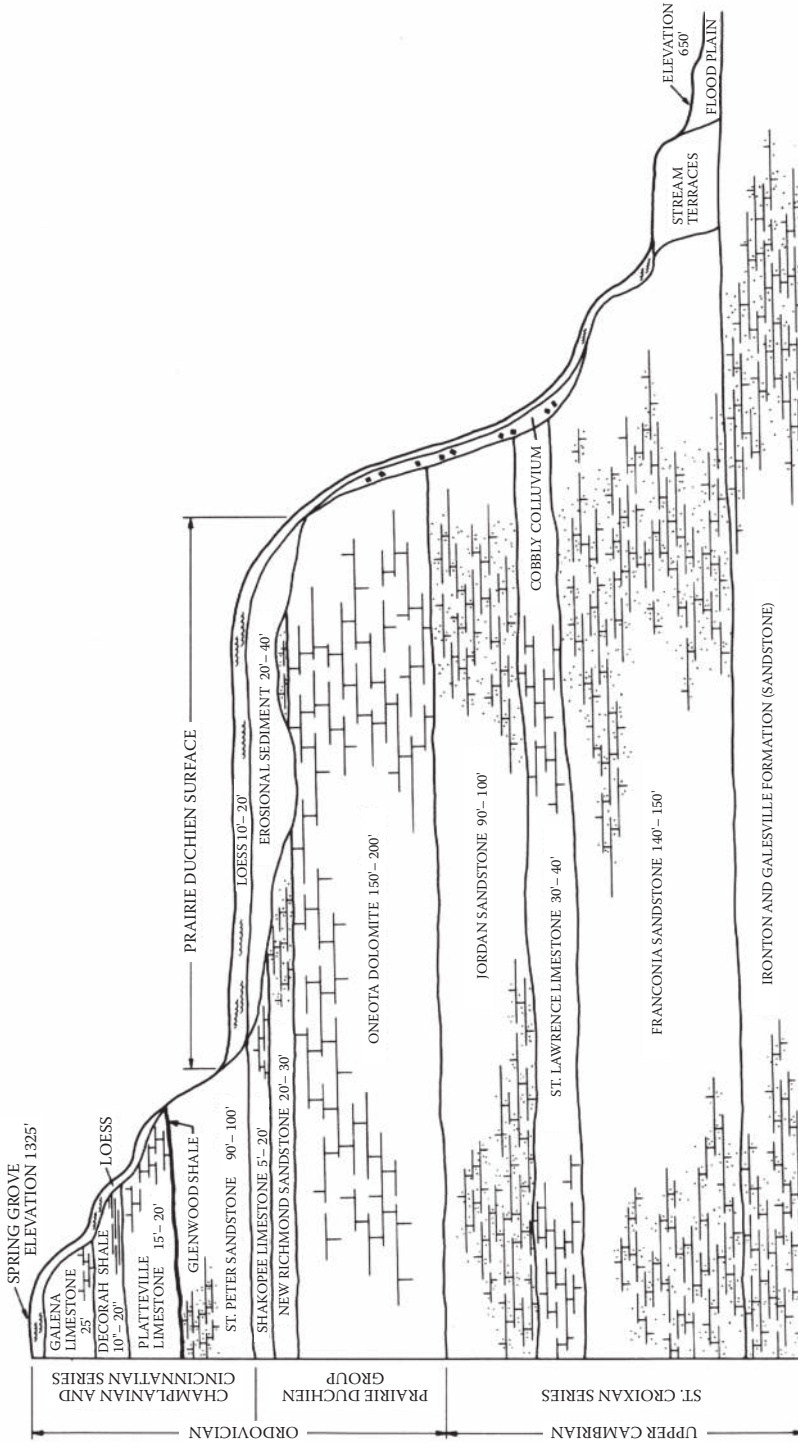
Figure 1.2 Geologic cross section of Houston County, MN, drawn in a west to east direction. (USDA, NRCS, Soil Survey of Houston County, Minnesota, 1984.)

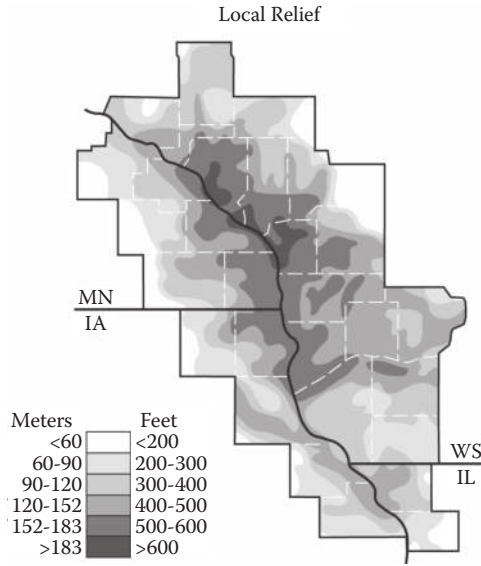
Figure 1.3 Local relief in the Hill Country. (Modified from Trewartha, G. and Smith, G.-H, *Annals, Assoc. Am. Geogs.*, 31, 26, 1941.)

Perhaps the best available quantitative description of this hilly topography is the map of local relief created by Trewartha and Smith in 1941 (Figure 1.3). It is based on topographic relief within a rectangle of about 17 mi² (44 km²). Note that the threshold relief to be included in the region is 200 ft (67 m) but that the relief increases toward the Mississippi River to more than 600 ft (183 m) in some areas. Trewartha and Smith (1941) also attempted to come up with a map of slopes. Using a threshold average slope of 5%, they outline the region in a pattern similar to the average relief map above (Figure 1.3). Moreover, the degree of slope shown on their map also accords well with the amount of relief. Unfortunately, data were inadequate to complete the slope map for the entire region. Other studies (Read, 1941; H. Johnson, 1976; Argabright, et al., 1996) outlined the region in a similar way (Preface, Figure 0.1).

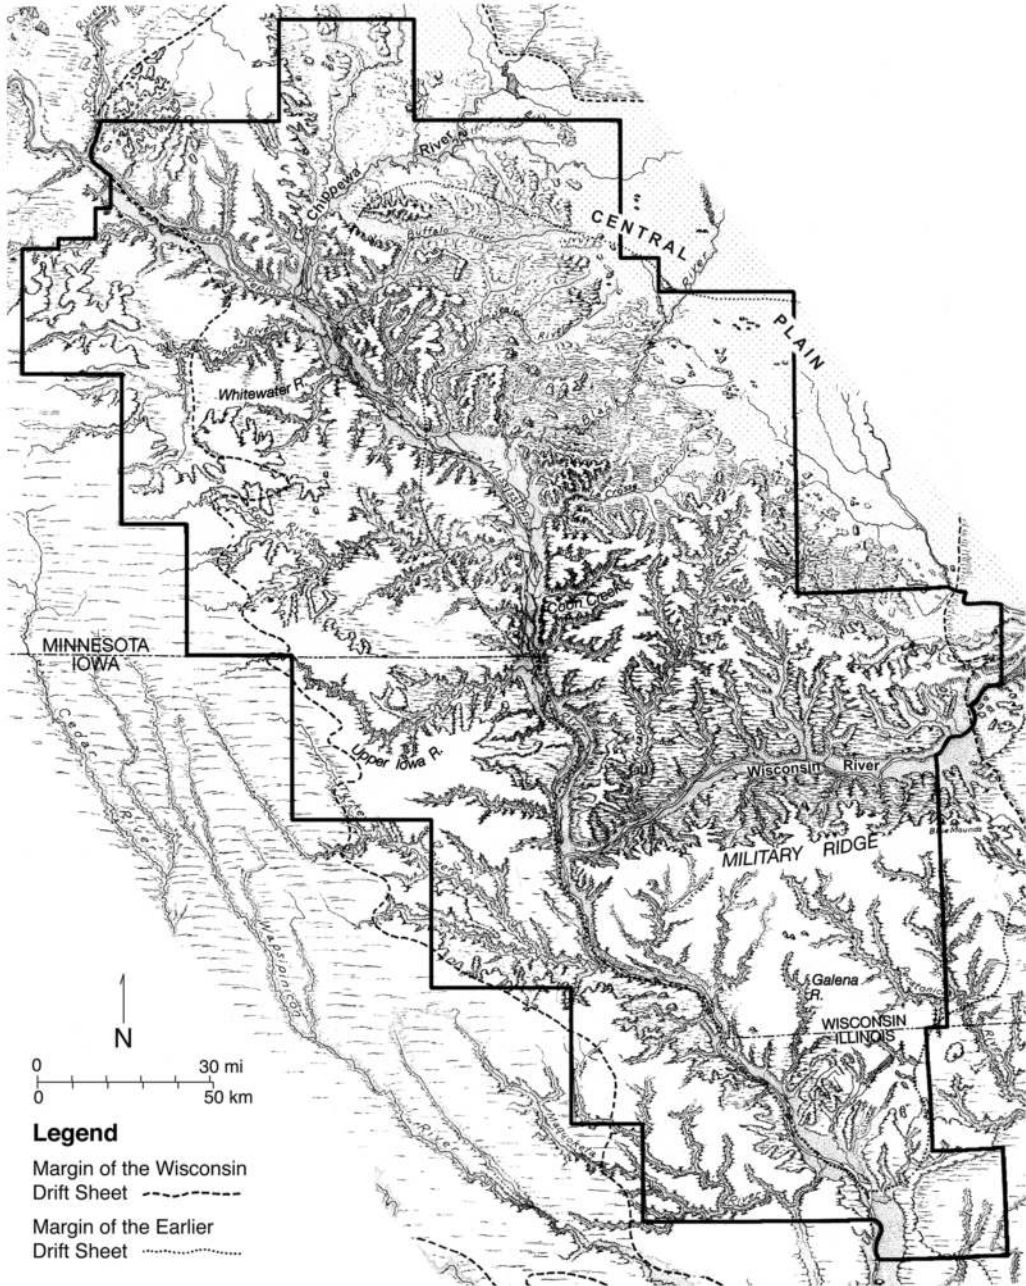
Figure 1.4 Physiographic diagram of the Hill Country. (Modified from Trewartha, G. and Smith, G.-H., *Annals, Assoc. Am. Geogs.* 31. foldout map 1941.) (Refer to Figure 0.1 for more detailed place names.)

By far the best qualitative depiction of the physiography of the region is the diagram drawn by Trewartha and Smith (Figure 1.4), which shows the landscape as it might be seen from near space on a perfectly clear day. As already noted, the mature dissection of

landscape or “hilly” quality with only remnants of the original rolling upland is clearly greatest between the Wisconsin and Chippewa Rivers in Wisconsin. Scattered but large areas of such hilly land can also be seen in Minnesota, Iowa, and Illinois. These are areas of high soil erosion potential as a function of slope. The major exception is the northeast edge of the region, part of what is often termed the “Central [Wisconsin] Plain,” which is largely glacial outwash or old glacial lake beds. Much of it is wetland or sandy or both. Most of this is poorer agricultural land and, as will be seen in the following analysis (Chapter 2), was relatively unused for agriculture.

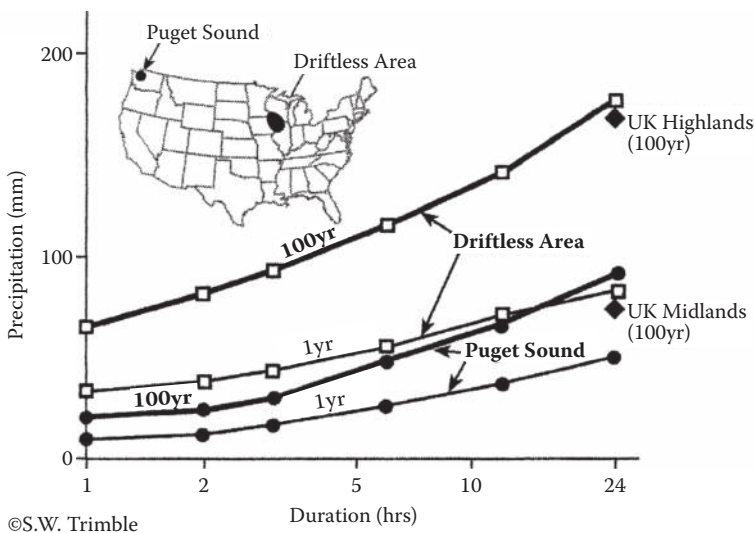
Figure 1.5 Frequency-magnitude relationships for precipitation events, Hill Country or Driftless Area (humid continental) and Puget Sound and United Kingdom (marine west coast). (From Trimble, S., in Bennett, S., and Simon, A. (eds.), *Riparian Vegetation and Fluvial Geomorphology*. American Geophysical Union, Washington, 2004.) Note that the 24-hour, 100-year event is about 2 times greater in the Hill Country while the 1-hour, 100-year event is 3 times greater.

The contrast between rainfall intensities in the Hill Country and Western Europe is much greater than most people, even geographers, may realize (Figure 1.5). Because data are incomplete for Western Europe, the northwestern United States, which has a similar west coast marine climate, is used as a surrogate with supplementary data from the UK lowlands, the agricultural heart of Britain. It will be noted that the 100-year storm in the Hill Country is about twice as great for longer storm durations of up to 24 hours but for

shorter durations is about 3 times greater. For smaller storms like the 1-year storm presented, the contrast is similar; storms are 2 to 3 times greater in the Hill Country than in western-most Europe. Note, however, that 100-year storms in Britain for all durations are about equal in magnitude to 1-year storms of the Hill Country! Indeed, they are actually greater in the Hill Country for the shorter-duration events. This means that storm rainfall totals equaled or exceeded on the average every *year* in the Hill Country are equal to storms equaled or exceeded only once per *century* in Britain. While continental locations in Europe would experience somewhat higher intensities than Britain, they would still be moderated by the marine influence.

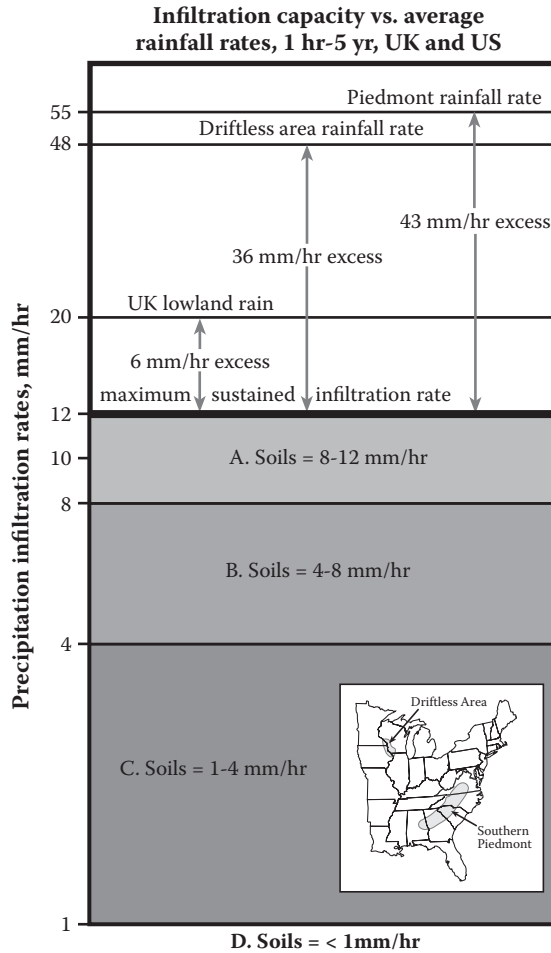
Figure 1.6 Infiltration capacities of soils versus average rainfall rates, United States and United Kingdom. The difference is excess rainfall that flows off the surface as overland flow. Note that it is much greater for the United States than for the United Kingdom. (Modified from Trimble, S., in Brunn, S. (ed.), *Engineering Earth*. Springer, Berlin.)

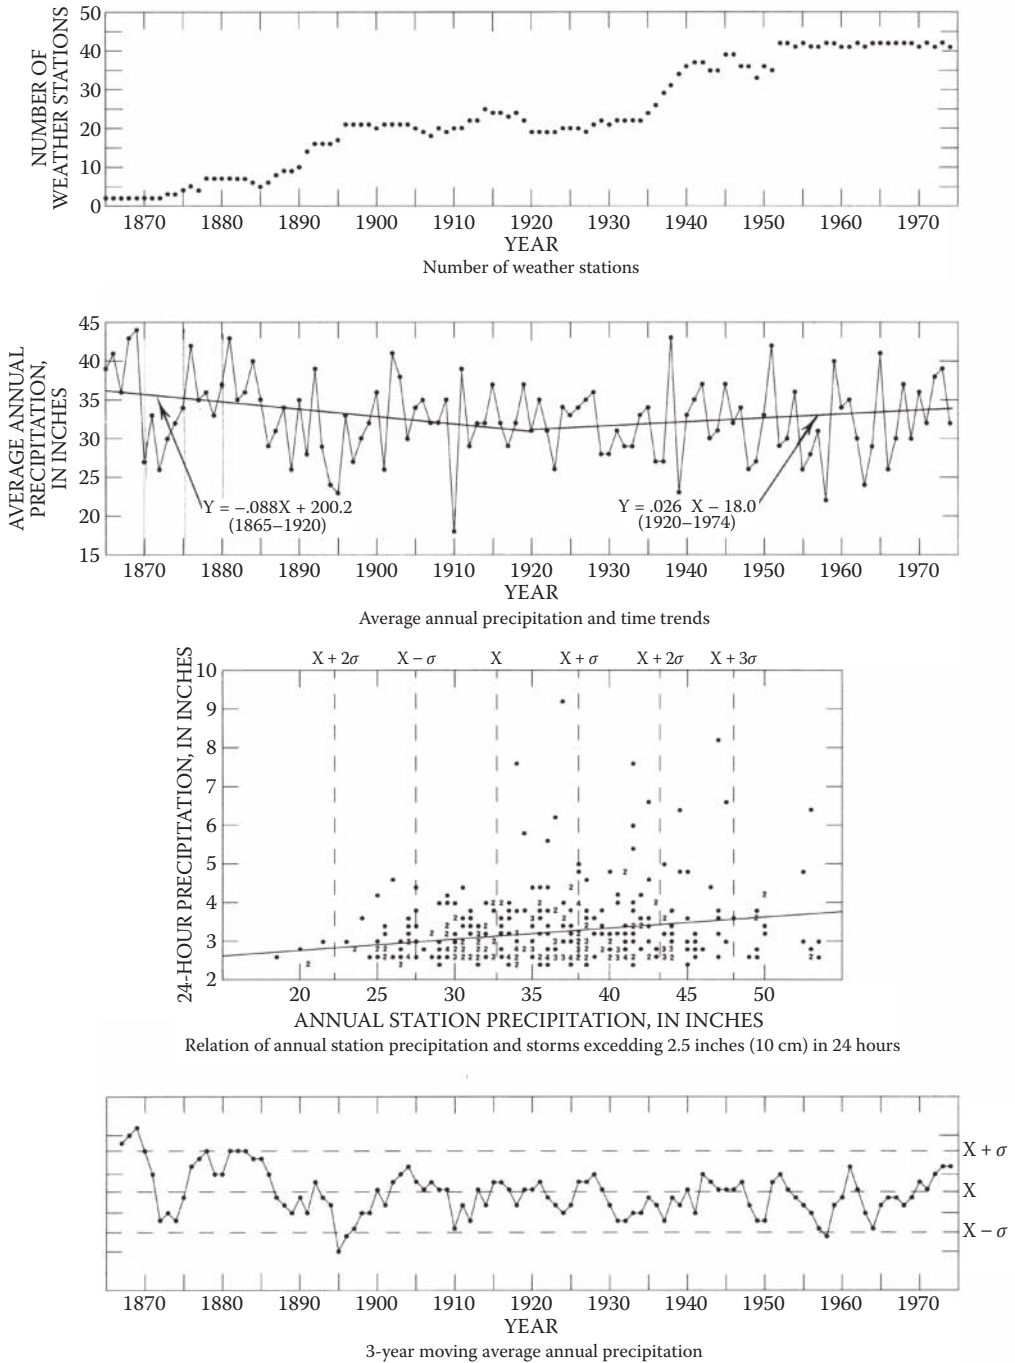
Figure 1.7 Historical precipitation trends in the Hill Country (from Trimble, S., and Lund, S., *US Geol. Surv. Prof. Paper*. 1243, 1982). The data show a nadir of precipitation in the early 20th century and increasing wetness and storms since 1930. See also the annual flood series for the Upper Mississippi River for the period c. 1850–1975, which shows a similar pattern (Knox et al., 1975). (Continued)

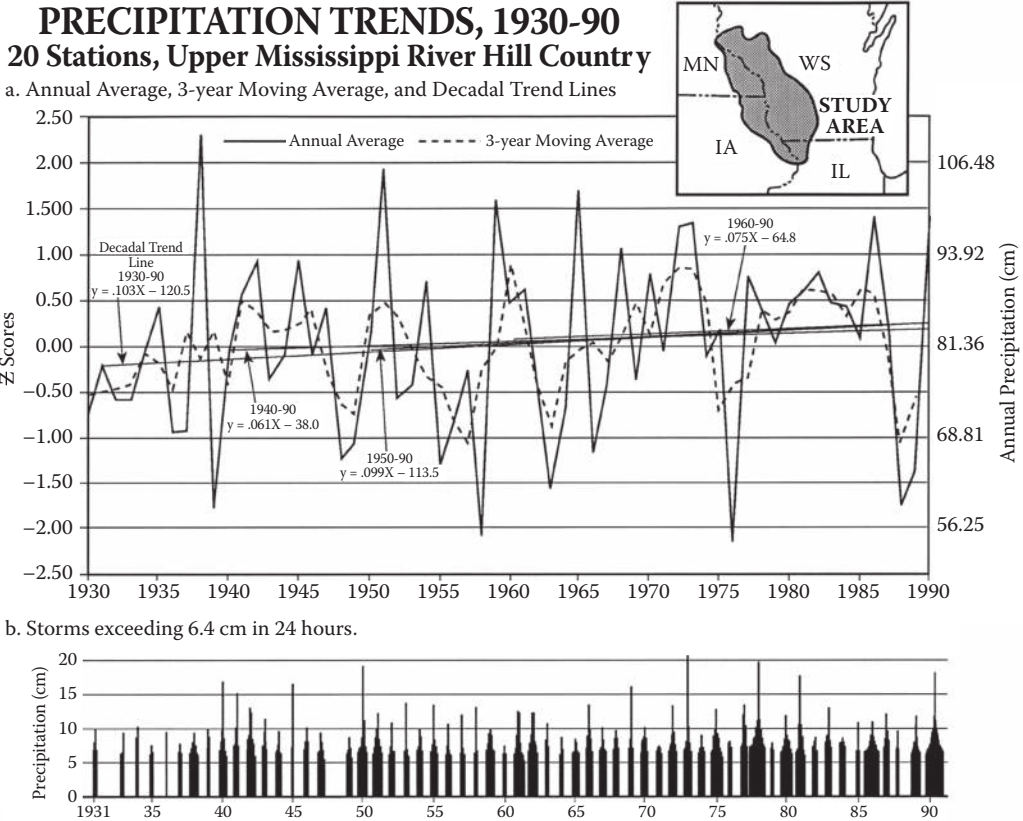
Figure 1.7 (Continued) Historical precipitation trends in the Hill Country (Trimble, unpublished). The data show a nadir of precipitation in the early 20th century and increasing wetness and storms since 1930.

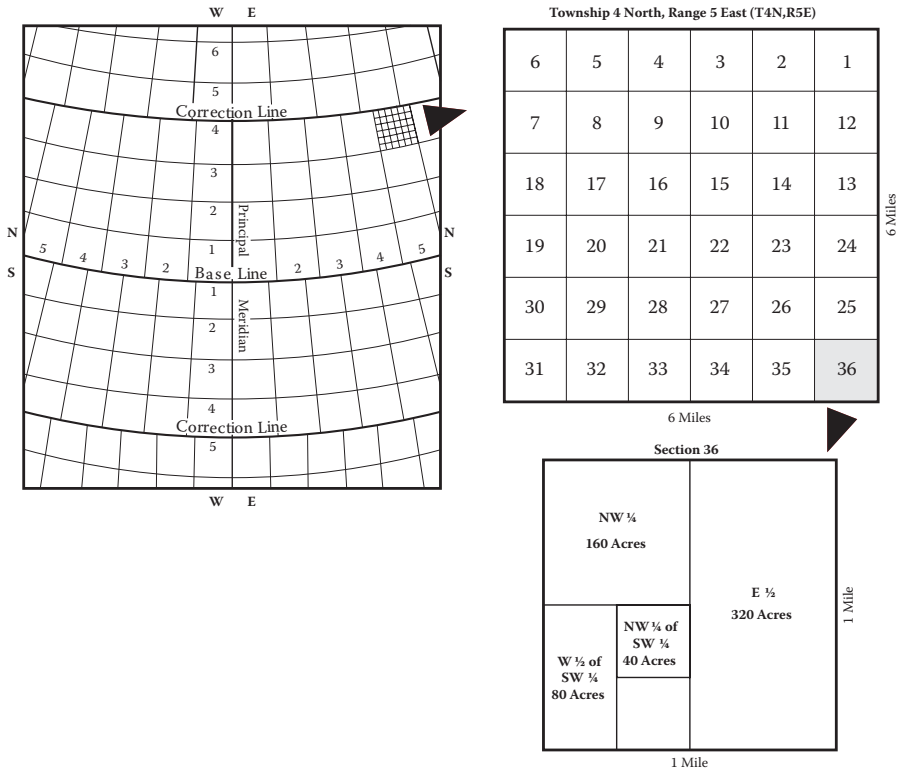
Figure 2.1 The US Rectangular Survey System (redrawn from Johnson, H., *Order upon the Land*, Oxford, 1976). Thus, the location of the NW quarter of the one square mile unit at the lower right of the diagram (termed a “section”) would be northwest quarter of Section 36, Township 4 North, Range 5 East, abbreviated NW ¼, Sec. 36, T4N, R5E. In the Hill Country, tracts as small as 40 acres (16 ha) could be purchased, and tracts were not always contiguous.

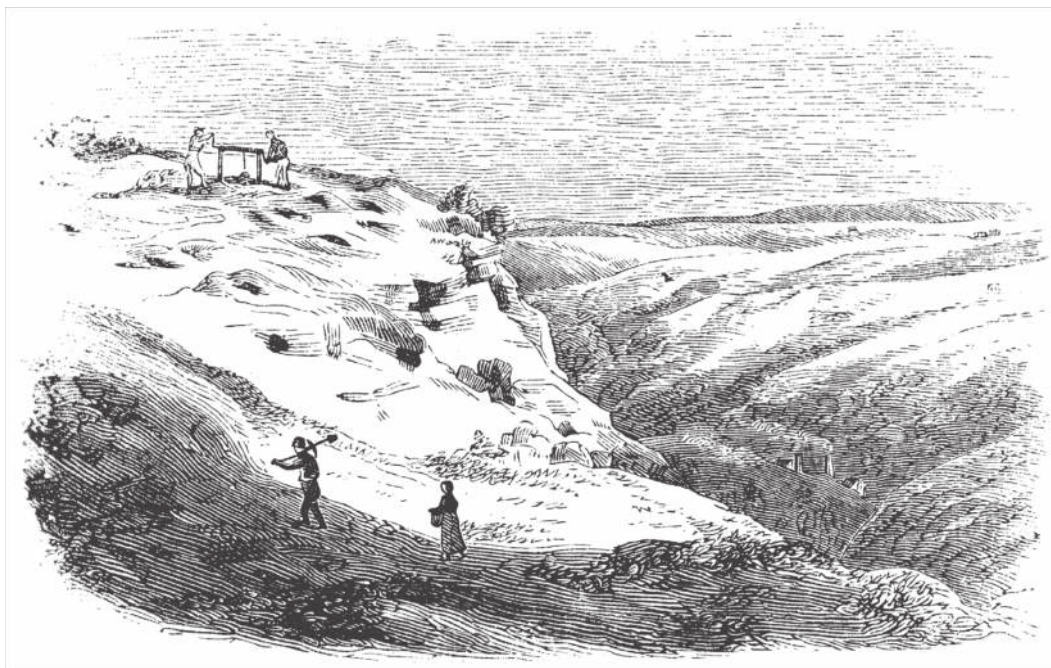
Figure 2.2 Sketch of the Lead Region (from *Harper's New Monthly Magazine*, 1853). Note the barren, almost lunar-like quality of the landscape and the scattered mine pits, or "diggings."

Early mining around Galena was done at the surface, termed *diggings*, and the spoil was left on slopes, the irregular piles being particularly vulnerable to erosion. Later, subsurface mining and the processing of the ore left even greater spoil piles, which also eroded. Contemporary descriptions of the landscape suggest little beauty, and a sketch done for *Harper's Magazine* in 1853 shows an almost moon-like terrain with obvious gashes and no trees (Figure 2.2).

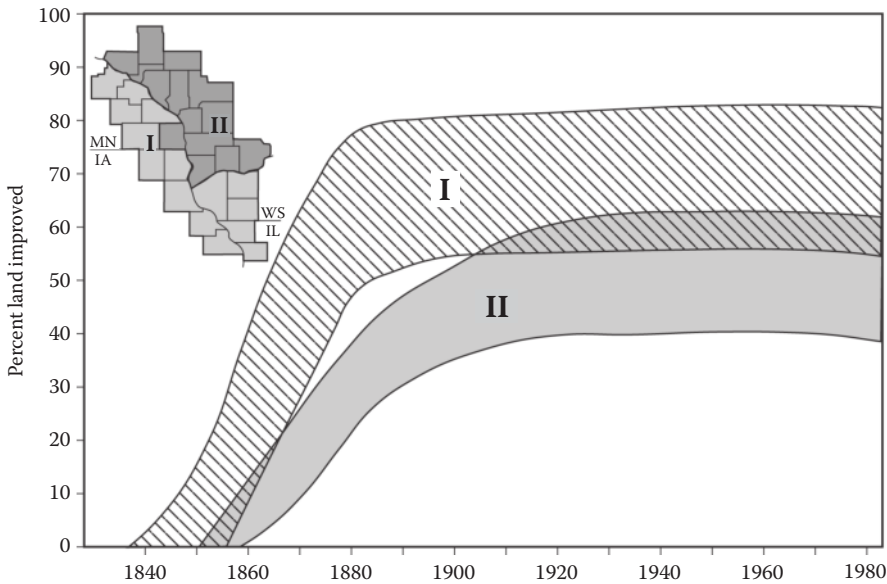
Figure 2.3 Regionalization of the Hill Country based on historical trends of agricultural land use.

Based on the historical trends of improved land for agriculture, there are two major agricultural regions in the Hill Country (Figure 2.3), and they are strongly influenced by the physiography and soils. "Improved Land" is the US Census classification for land that has been converted from forest and prairie to agriculture: cropland, pastures, orchards, and farmsteads. Given a choice, farmers will improve the more level and fertile parts of their farms, that is, the land that will give the best economic return.

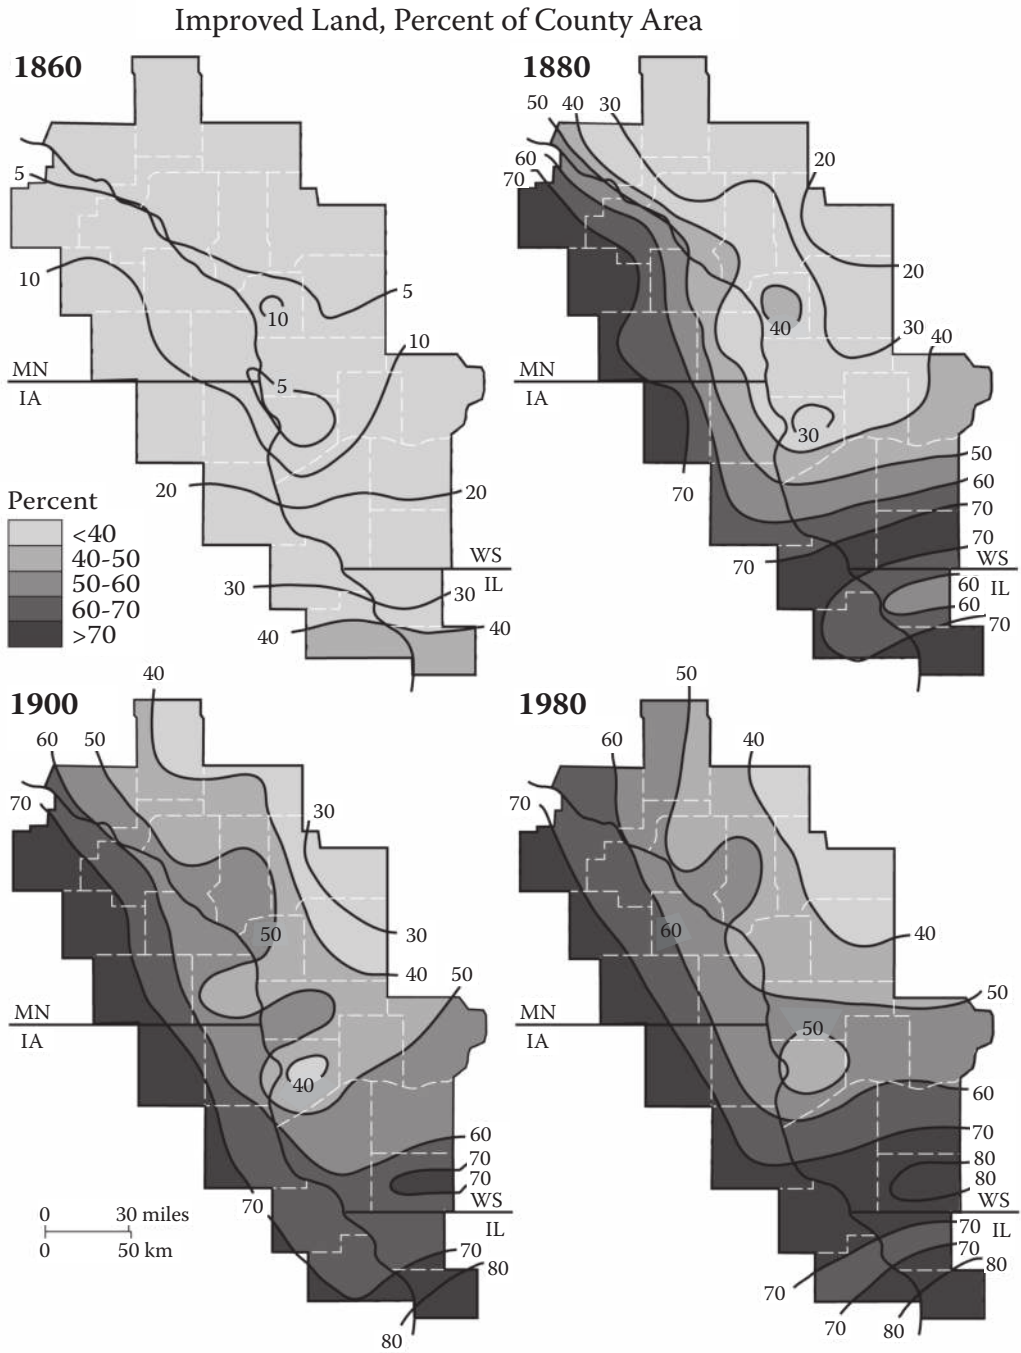
Figure 2.4 Improved land, 1860, 1880, 1900, and 1980 (US Census of Agriculture).

Monroe, Eau Claire, and Jackson Counties (Wisconsin) in the extreme east of the region. For reasons of land and soil suitability already mentioned, only 80%, 75%, and 60%, respectively, of the land areas were taken up as farmland in those counties. Land in farms was slightly greater in Region I than in Region II. In almost every county, land in farms has decreased over the past century or so, sometimes by as much as 10%. The reasons are usually urban expansion, rural housing, highway rights of way, and public land acquisition such as for parks, reservoirs, recreational areas, and wildlife refuges, mostly at the expense of "land in farms" as opposed to active farmland. Improved land has also generally decreased but not as much as land in farms. This suggests that the land reverting from agriculture is generally less suitable for agriculture: farmers are selling off land less desirable for agriculture.

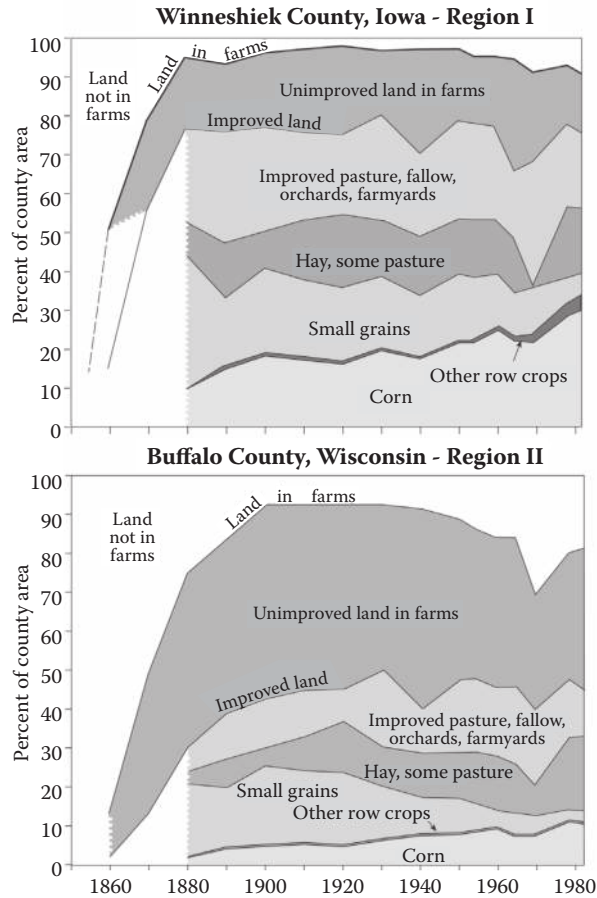
Figure 2.5 Agricultural land use, 1860–1982, Winneshiek, Co., IO (Region I), and Buffalo Co., WI (Region II). US Census of Agriculture.

Another way to demonstrate these land use trends is to show two sample counties, each being more or less representative of its region. For Region I, Winneshiek County, Iowa, well demonstrates what happened in the west (Figure 2.5). The land was rapidly patented, and over 90% was put into farms by 1880. Almost as rapidly, the farmland was improved, reaching 76% of the county by 1880. This means that only about 14% of the county was left unimproved. Small grains, mostly wheat, covered almost 35% of the county in 1880 but were rapidly reduced thereafter, covering only about half as much in 1890. At the same time, corn was rapidly expanding, presumably displacing small grains on the better fields. Corn and other row crops (mostly potatoes), covered about 19% of the county in 1930 but over 34% in 1980, with soybeans comprising about one-seventh of that. Soybeans were more important toward the northwest in the Hill Country. In Goodhue County, Minnesota, for example, soybeans were about one-fourth of the row crops in 1980. To the south in Region I, wheat and, later, soybeans were not as important as seen in the western part of the region.

For Region II, Buffalo County, Wisconsin, is typical (Figure 2.5). There are both similarities and contrasts with Region I. For example, note that the land was patented almost as rapidly as in Winneshiek County and to almost the same proportion (over 90%), but the improvement of farmland followed much more slowly and to a lower level, exceeding only 40% by 1890. Thus, unimproved land was about three times as great in Region II as in Region I. Wheat and other small grains were never commercially important as they were in Goodhue County, and about half of reported small grains was oats grown for farm animals. Corn and other row crops (mostly potatoes) were never dominant, remaining below 10% until the grain boom of the 1970s. As in the southern part of Region I, soybeans were not important. Hay and pasture were important in both Regions I and II. But by far the major difference between Regions I and II was the amount of unimproved land. At least part of this unimproved land might have been former farmland, temporarily abandoned because of depletion or erosion, and being allowed to grow up in brush. Winneshiek

Wheat and other small grains have continued in the Hill Country, but they have declined greatly with time (Figure 2.5). Oats, in particular, were important for feeding horses used as farm draft animals, but the advent of the tractor in the 1920s virtually meant the eventual demise of oat growing. As with wheat, these small grains usually caused minor soil erosion, and they made the soil more vulnerable to erosion with the later growing of corn.

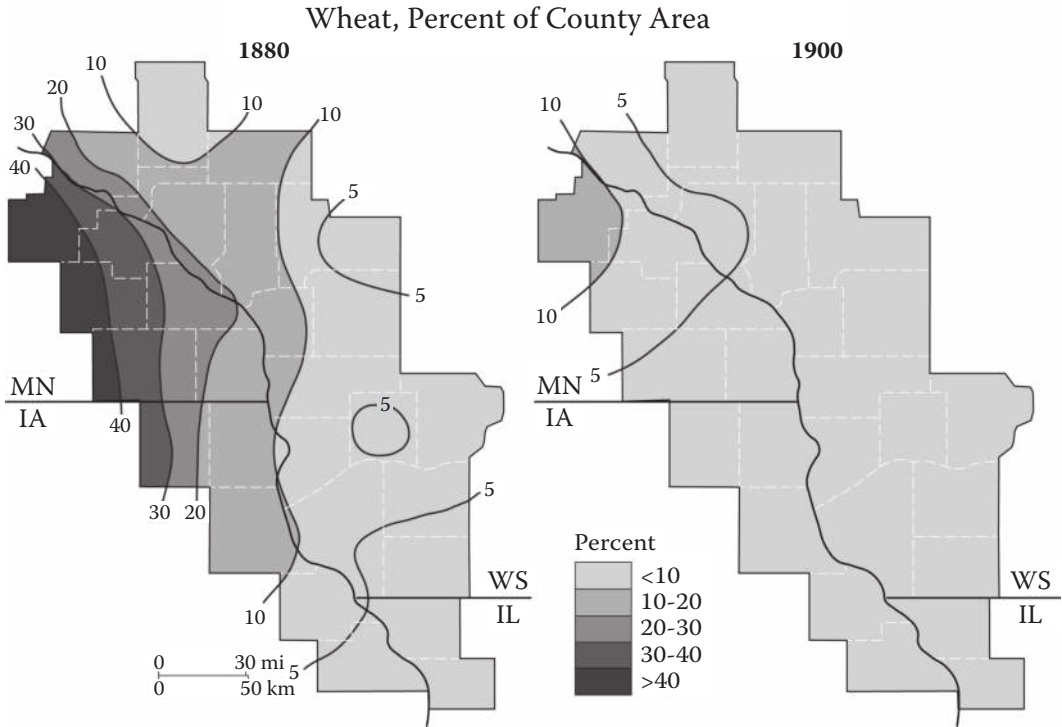
Figure 2.6 The decline of wheat cultivation. Proportion of land in wheat, 1880 and 1900 (US Census of Agriculture).

In the Hill Country, wheat was the first big cash crop, rolling across the region with settlement, and known as "King Wheat" in some areas (H. Johnson, 1957, 1976). Because the census of agriculture reported crop acreages beginning only in 1880, it captures only the end of the wave (Figure 2.6). While wheat had been an important market crop all across the region, nowhere was it more important than on the prairie of Minnesota, especially in the western parts of Goodhue, Olmstead, Fillmore, and Winona Counties, where the wheat crop peaked in 1877 (H. Johnson, 1976). While perhaps no one became rich from growing wheat, a very hefty profit was made from it, and this wealth is suggested by some of the fine churches built in the area, especially in Minnesota, during this early period. Farther south in Winneshiek County, Iowa, even with the limitations of the census, it is clear that much of the land being cleared or "improved" went directly into wheat (Figure 2.5). By 1865 in Olmsted County, Minnesota, only 12 years after the beginning of settlement, 65% of all cultivated land was in wheat (Colby, 1924). In Goodhue County, wheat occupied 81% of all cultivated land by 1875 (Colby, 1924). But competition from better wheat lands to the west, declining markets, declining yields, cinch bugs, and wheat "rust," a fungal disease, caused its virtual disappearance from most of the region by 1900 (Robinson, 1915, Figure 2.6).

The precipitous decline of wheat is portrayed in a graph by Colby (1924, p. 216): Goodhue County produced about 30,000 bushels of wheat in 1875 but only about 6000 in 1880! The other counties of Minnesota experienced similar declines. By 1880, only the western tip of the region was still active, and even that soon diminished (Figure 2.6).

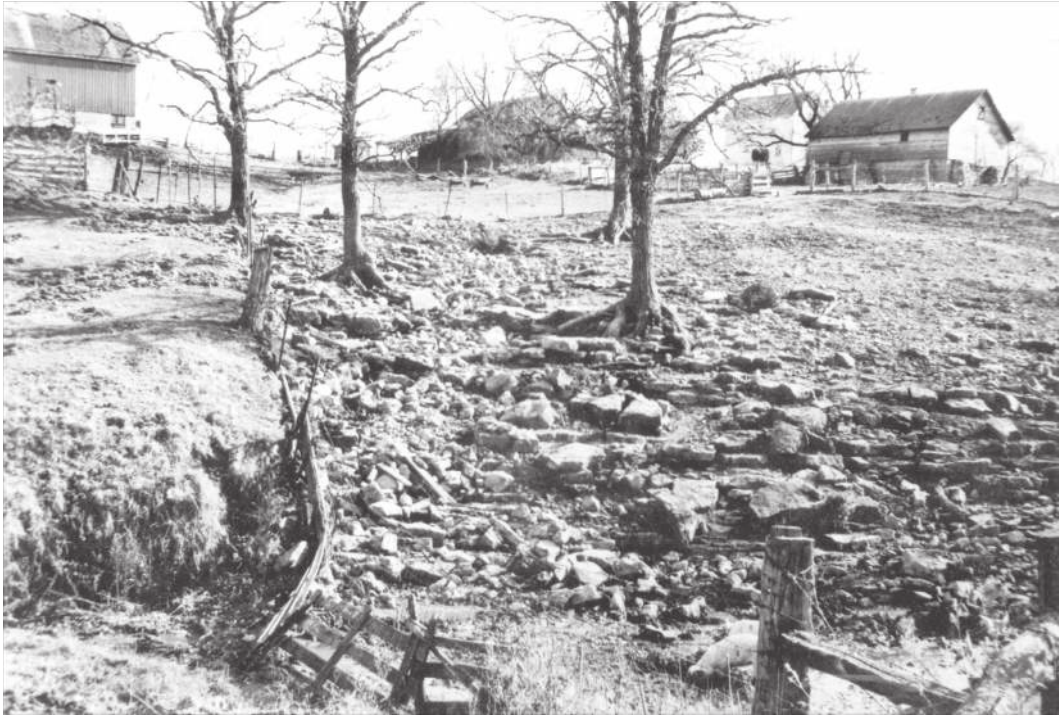
Figure 2.8 An eroded hillside from overgrazing, probably 1950s. (Photo credit: R. Sartz.)

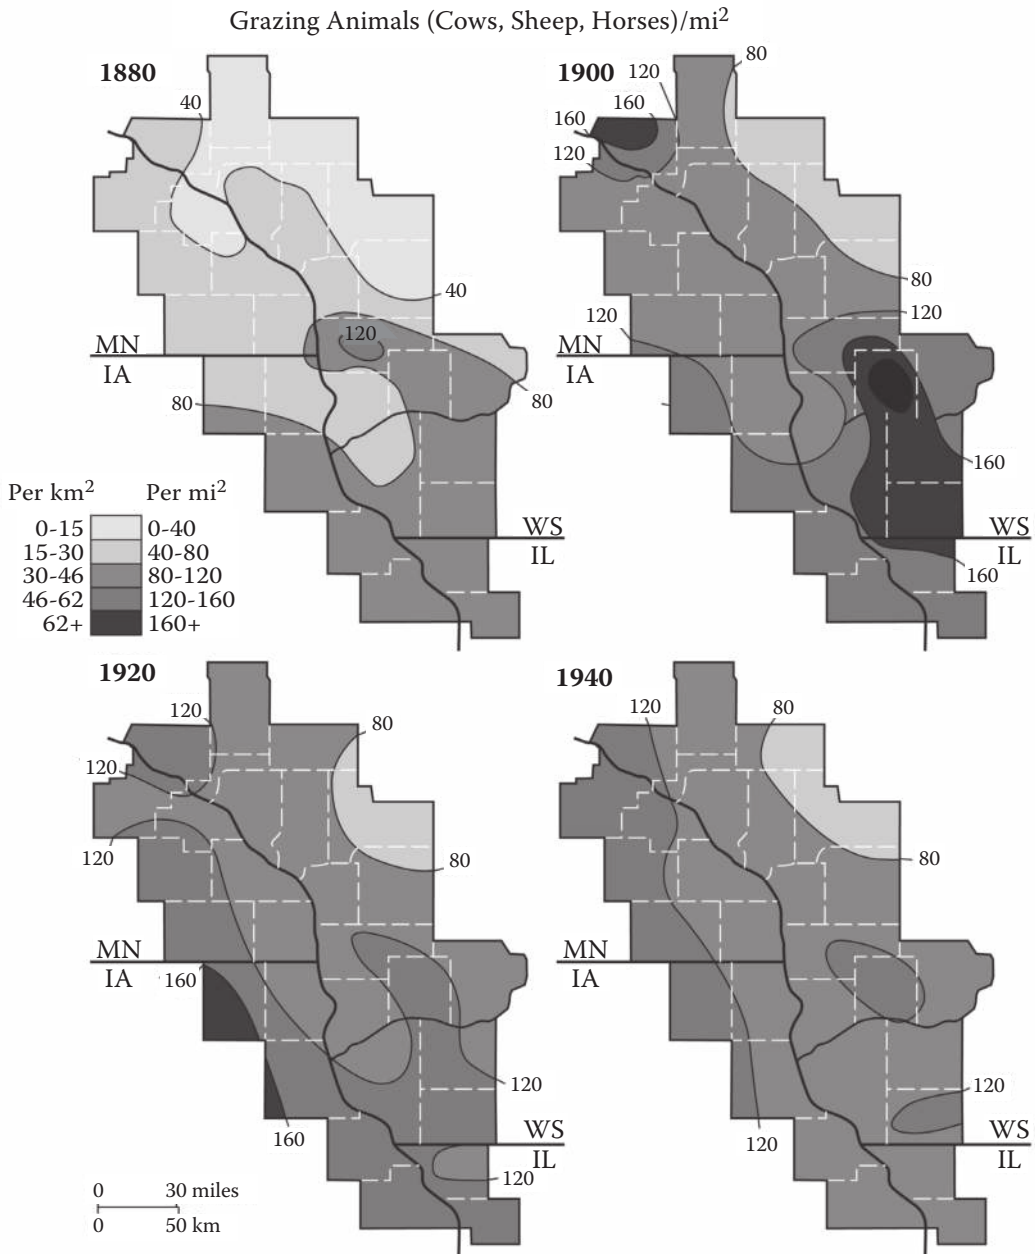
Figure 2.9 Density of grazing animals (cows, sheep, horses), 1880, 1900, 1920, 1940 (US Census of Agriculture).

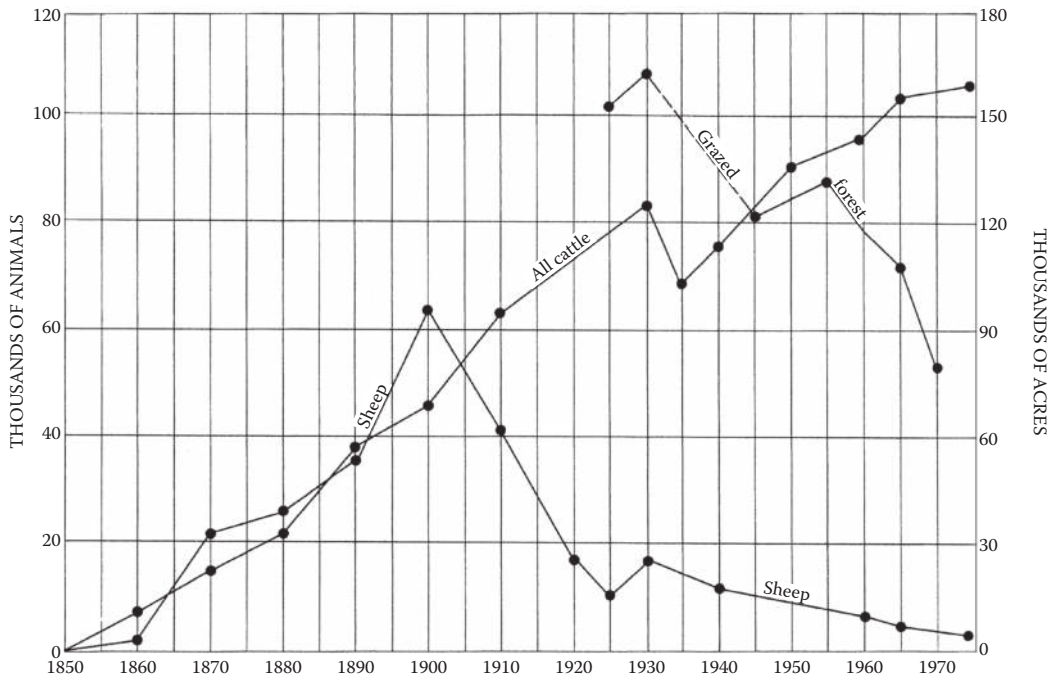
Figure 2.10 Grazing animals, 1850–1975, and grazed forest, 1925–1970, Vernon Co., WI (Trimble, S. and Lund, S., *US Geol. Surv. Prof. Paper 1234*, 1982).

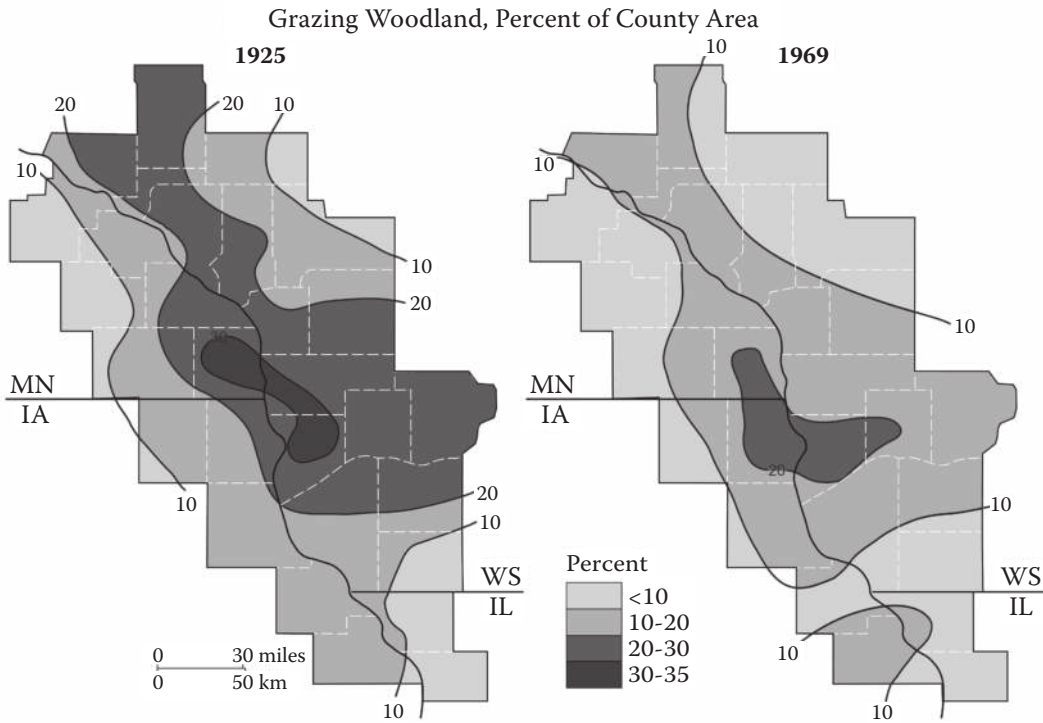
Figure 2.11 Grazed woodland, percentage of county area, 1925 and 1969 (US Census of Agriculture).

But mere numbers of animals do not tell the complete story. Greatly improved pastures and hay yields since the 1930s have allowed farmers to remove grazing animals from the steep forested slopes so that grazed forest has decreased radically (Figure 2.11). By 1969, the last year the US census listed grazed forest, most counties had only about 40%–60% as much as in the period 1925–1930, perhaps the peak of forest grazing. Since 1969, moreover, there has been a strong decline of forest grazing as farmers (1) increasingly realize that grazing of forests and woodlands produces little net nutrition for animals, (2) have better pastures and more hay as the result of better agronomic practices, (3) realize that grazing not only can cause more runoff and erosion but can also degrade their soil as well as their woodland resource both for wood production and for wildlife habitat, and (4) recognize the offsite damage from runoff and sediment to their own land and to the land of others downslope and downstream.

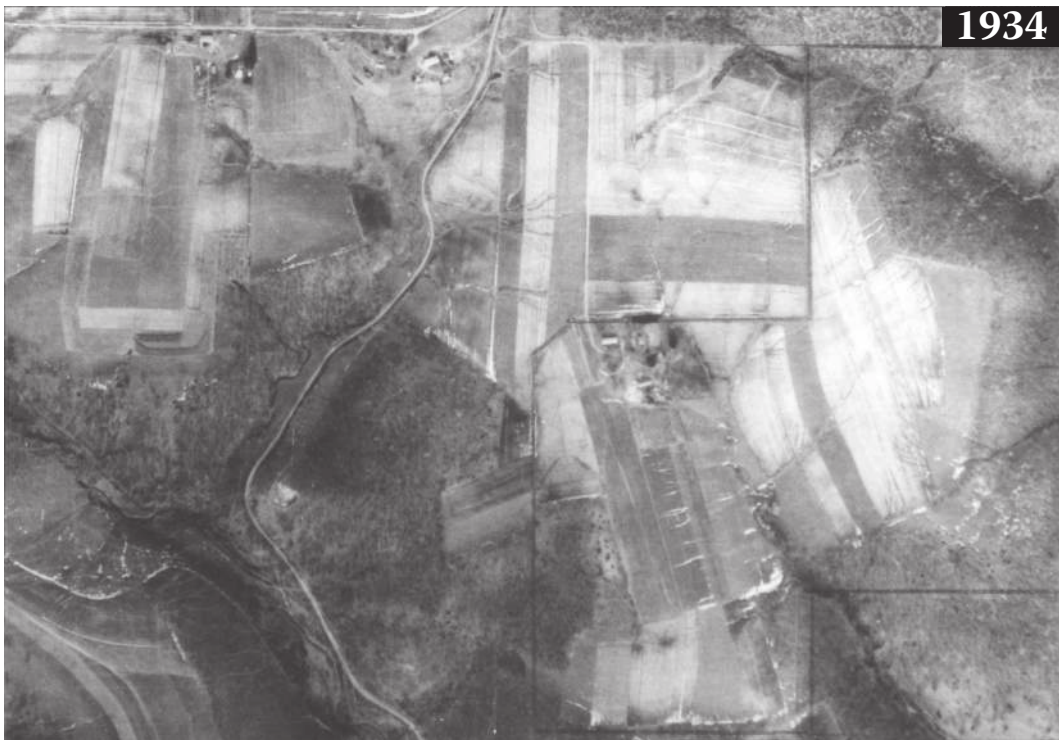
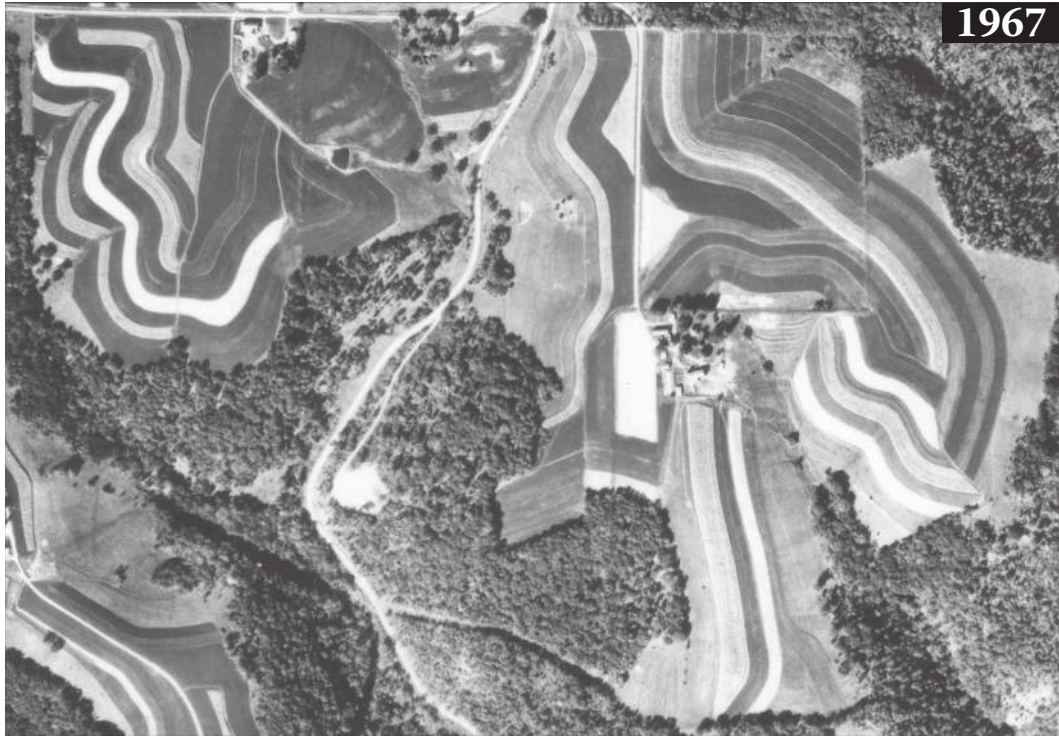
Figure 2.12 Air photos of Coon Creek landscape, 1934 and 1967, just north of Coon Valley (SE1/4,T15N, R5W, Vernon Co.). 1934: Note rectangular fields and gully systems extending into upland cultivated fields. (From Trimble, S. and Lund, S., *US Geol. Surv. Prof. Paper 1234*, 1982.) (Continued)

Figure 2.12 (Continued) Air photos of Coon Creek landscape, 1934 and 1967, just north of Coon Valley (SE1/4,T15N, R5W, Vernon Co.). 1967: Note contoured and strip cropped fields with no rills or gullies. (From Trimble, S. and Lund, S., *US Geol. Surv. Prof. Paper* 1234, 1982.)

Thus, the combination of gradual soil deterioration, inadequate rotations, plowing up and down slope, and overgrazing led to increasing runoff and soil erosion, with rills and gullies eventually scarring the landscape (Figure 2.12). As soils became progressively

While some of the level fields in both Regions I and II may have eroded only slightly, most of the steeper Hill Country was highly affected by channel erosion. Most eroding agricultural fields had obvious rills (Figure 2.12). With time, larger channels formed, becoming hillside gullies where the overland flow from cultivated fields ran off the field and down a steep, grazed hillside (Figure 3.1). Another type of gully was a valley gully or “trench” (Happ et al., 1940). Some of these were just the enlargement of preexisting channels, while others were in valleys or draws where there had been no presettlement channel. Of these, the most notorious were the gullies across high Pleistocene terraces, and these as well as hillside gullies will be covered in some detail in the next chapter.
