**HISTORICAL AGRICULTURE
AND SOIL EROSION IN THE
UPPER MISSISSIPPI
VALLEY
HILL COUNTRY**

STANLEY W. TRIMBLE

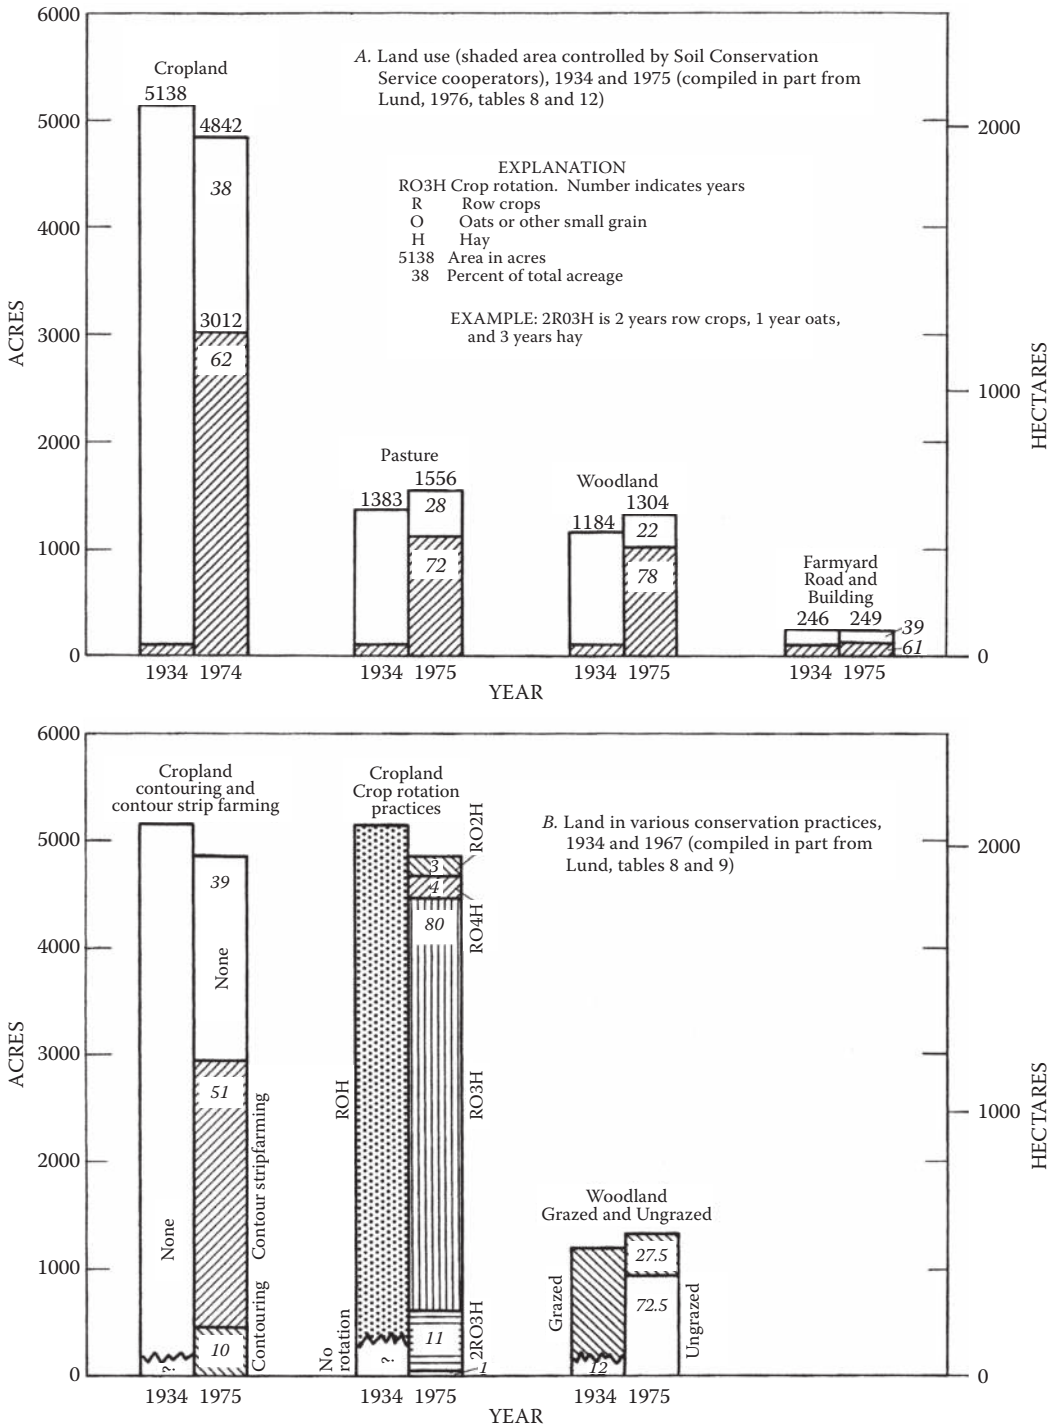
Figure 2.13 Changes of land use and management in 10 sample basins, Coon Creek, WI, 1934 and 1974. (From Trimble, S. and Lund, S., *US Geol. Surv. Prof Paper 1234*, 1982.)

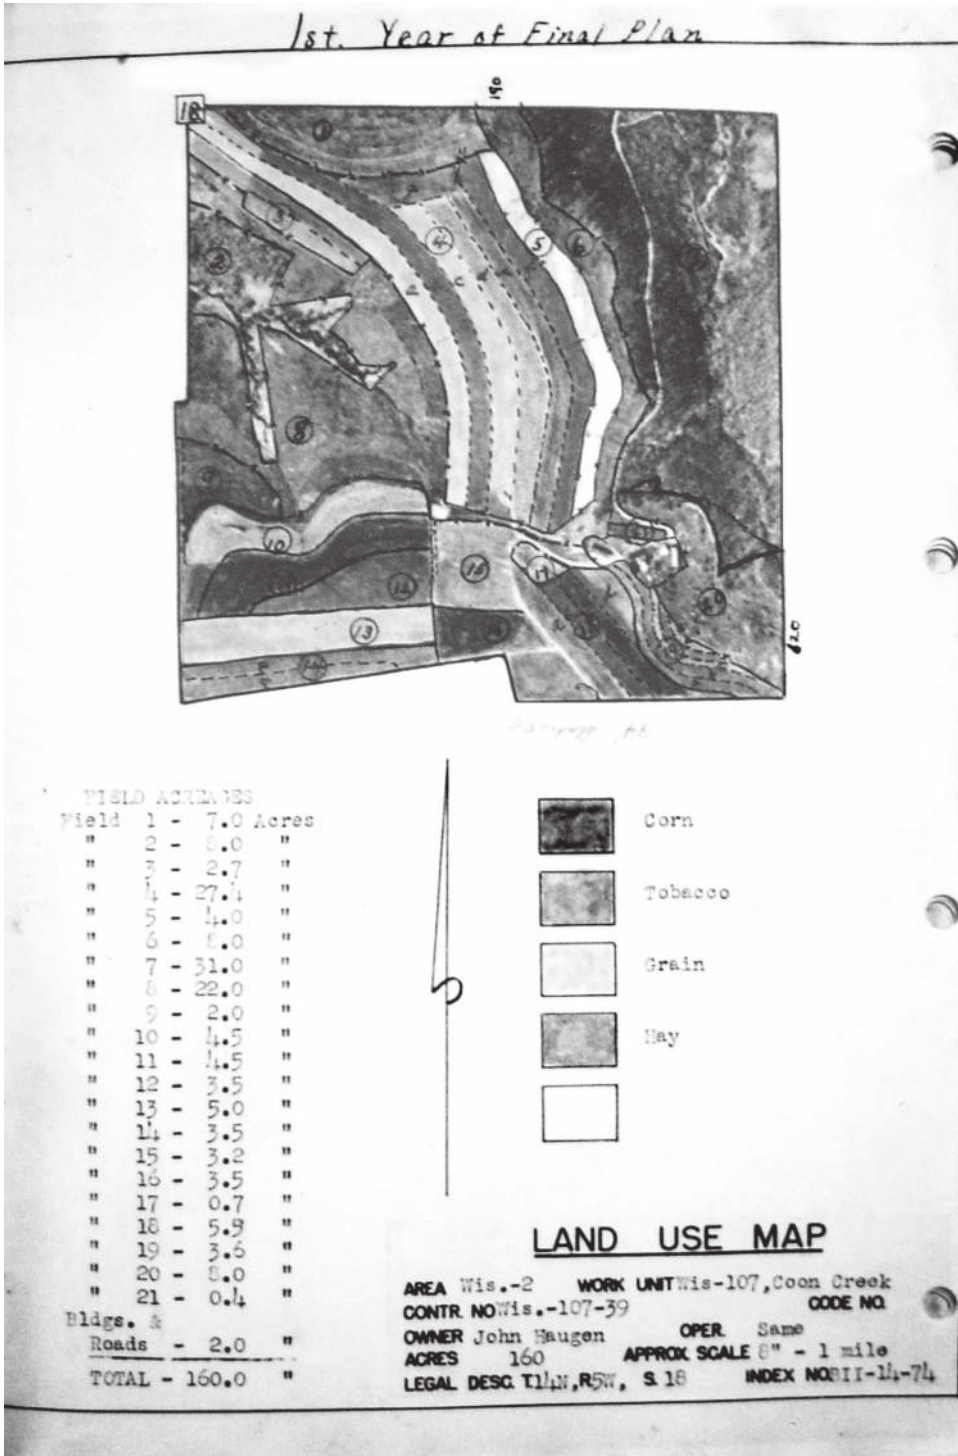
Figure 2.14 Partial farm plan for John Haugen for his 160-acre farm south of Coon Valley, WI, 1939. (SE1/2 T14 N R5W, Vernon Co.) (Courtesy of Ernest and Joseph Haugen, Coon Valley, WI, Photo credit: Nadine Kleinhenz, July 2006.)

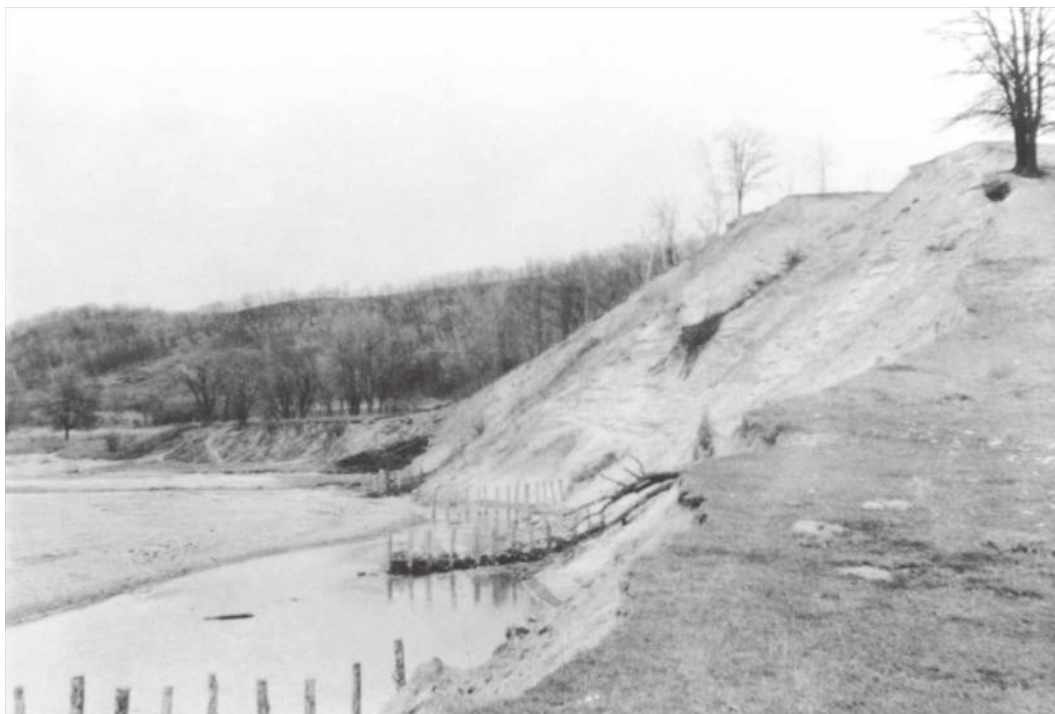
Figure 2.16 CCC project to stabilize high Pleistocene terrace undercut by stream. Exact location unknown but probably Trempealeau Co., WI, late 1930s. SCS Photo.

Yet another federal project of that period was the Civilian Conservation Corps (CCC), a military-type organization that executed construction-type projects in conservation such as building small dams, stabilizing gullies, and protecting eroding streambanks (Figure 2.16). There were several CCC camps in the Hill Country; perhaps the best known is the one at Coon Valley, Wisconsin. Soil erosion problems in the Hill Country as compared to the surrounding glaciated landscape may be shown by the fact that of nine CCC camps established in Wisconsin in 1933–1943, eight were in the Hill Country (Johnson, 1991).

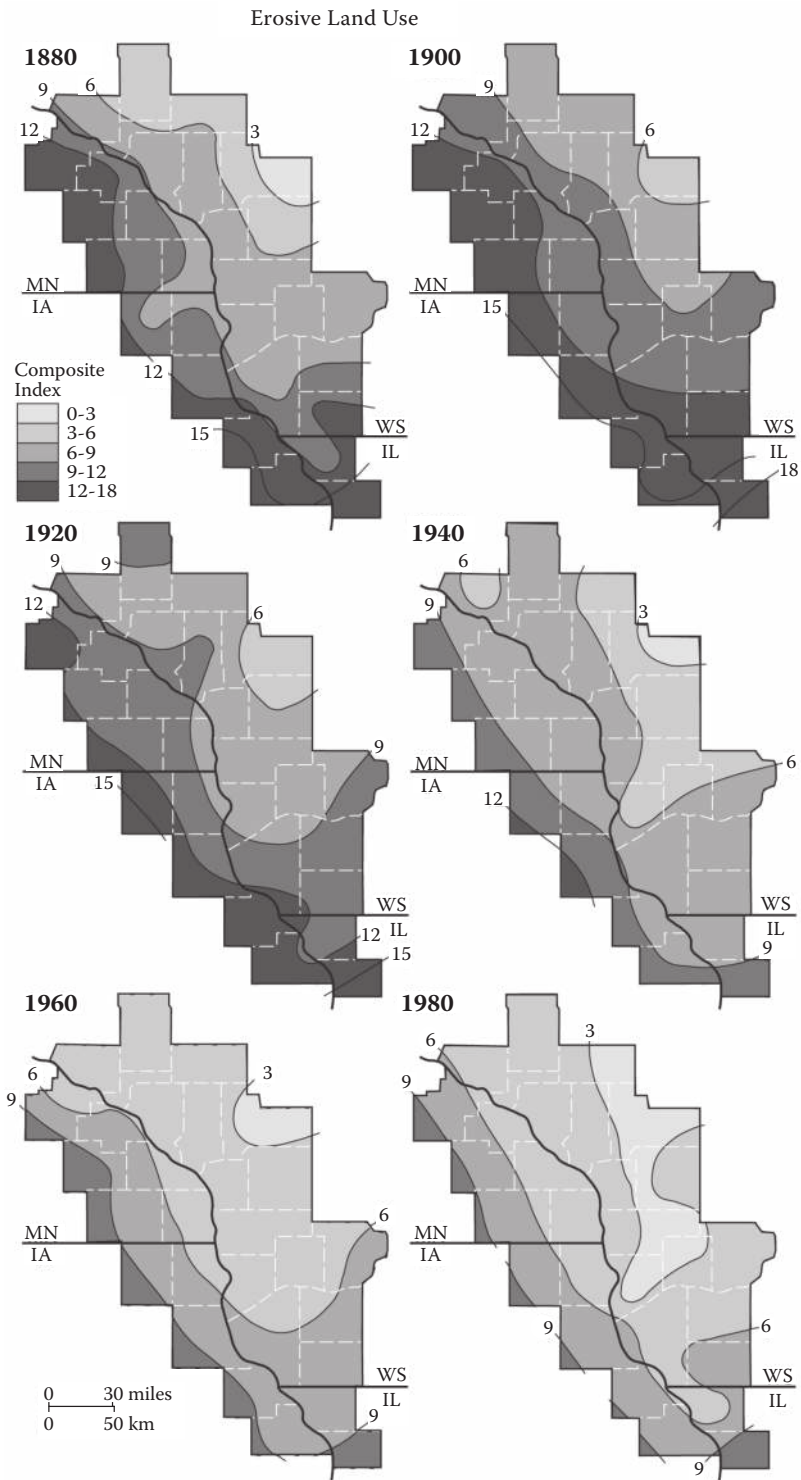
Figure 2.17 Erosive land use, Hill Country, 1880–1980. See text for definitions and explanation.

Thus, a county entirely in corn (1853–1930) would be presumed to be eroding at a rate of about 0.45, or 45%, of bare earth while a county entirely in ungrazed forest at the present time would be eroding at a rate of 0.002, or 0.2%, of bare earth. Of course, each county is a composite of many land uses, and the mapped values reflect that (Figure 2.17). It is important to note here that the values are conservative and reflect *only* land use and management and do not account for slope, soils, or rainfall. In other words, this is a very conservative estimate of the *human input*. Note that it does not extend to the present period of no-till.

The first map is 1880, the first year that the US census of agriculture reported acreages of crops (Figure 2.17). ELU increases to maximum in about the 1920s to early 1930s and then decreases to about half of that maximum value by 1980. Since that time, significant increases in no-till farming would reduce the value of ELU much more, but no attempt is made here to quantify that.

For each year, values of ELU in Region I are much greater than in Region II. As might be expected, the minimum values are in the northeast area, a much poorer farming area as already explained. While the maximum spatial disparity of values is over 3 times, the more general difference between Regions I and II is more like two times. While these methods are imperfect, they do suggest that Region I was subjected to much more erosive land use than Region II. In Chapter 3, we will examine the results of this land use and management in the context of landforms and other factors in the Hill Country.

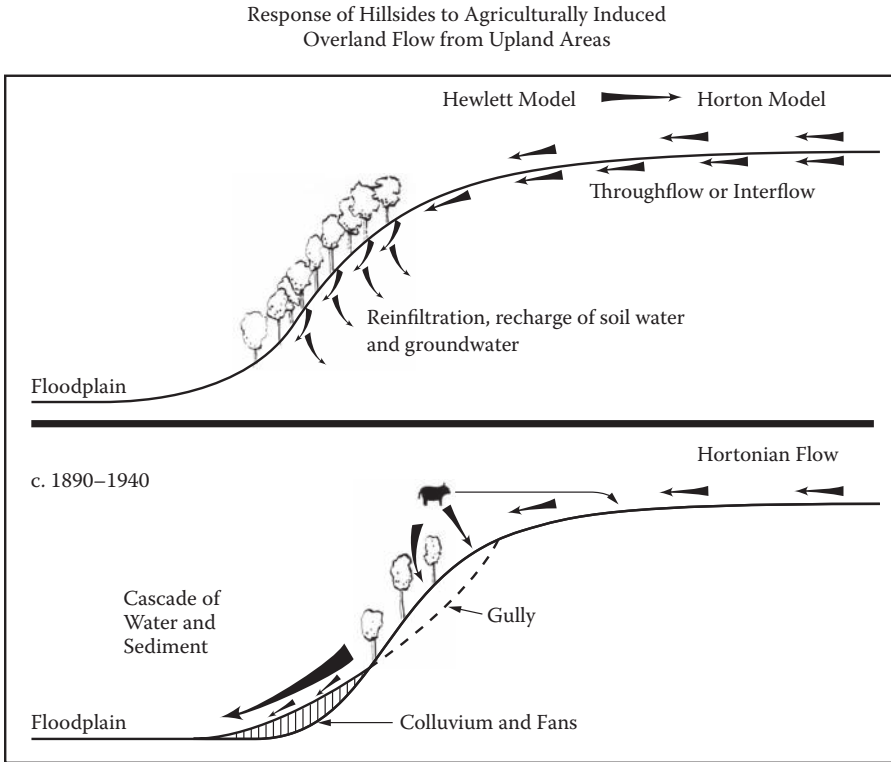
Figure 3.1 Schematic of response of hillsides to agriculturally induced overland flow from upland areas. Top: Early; with increasing crops on the upland and deteriorating soil hydrologic conditions, runoff increasingly becomes surface (Horton Model) rather than subsurface (Hewlett Model), but hillside woodlands are able to reinfiltrate much of this. Bottom: With increasing overland flow from above and decreased infiltration on grazed hillsides, gullies form and create fans at the toe of the slope.

Figure 3.1 Schematic of response of hillsides to agriculturally induced overland flow from upland areas. Top: Early; with increasing crops on the upland and deteriorating soil hydrologic conditions, runoff increasingly becomes surface (Horton Model) rather than subsurface (Hewlett Model), but hillside woodlands are able to infiltrate much of this. Bottom: With increasing overland flow from above and decreased infiltration on grazed hillsides, gullies form and create fans at the toe of the slope. 56

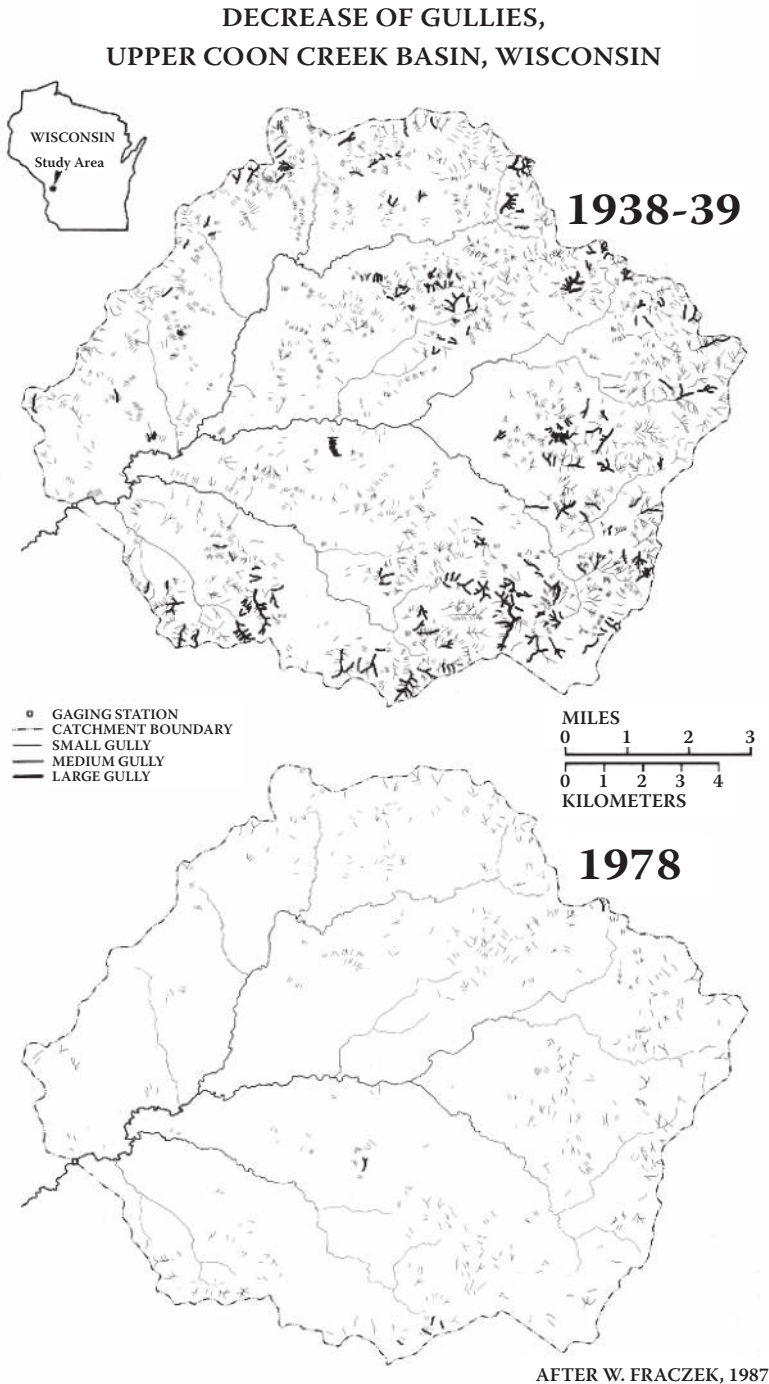
Figure 3.2 Decrease of gullies in the upper Coon Creek basin as the result of improved land use and management, 1938–1978. This decrease of drainage density is strong evidence of decreased overland flow and, in turn, decreases the rapidity of runoff. (Redrawn from Fraczek, W., Unpublished MS thesis, University of Wisconsin, Madison, 1987.) See also Trimble and Lund, 1982, p. 6.

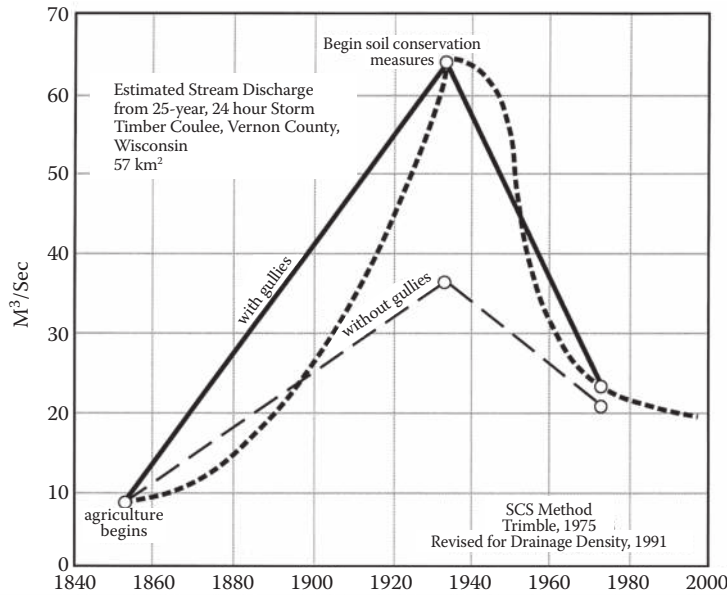
Figure 3.3 Estimated change of stream discharge from a small tributary of Coon Creek for a moderately large storm, 1853–1995. The vertical axis is discharge in cubic meters per second ($1 \text{ m}^3 = 35 \text{ ft}^3$). Calculations suggest the significance of (a) land use and management and (b) the formation of gullies for increasing storm flow peaks. The short dashed line suggests the role of response lag discussed in the text. (Redrawn from Trimble, S., *Geomorphology* 108, 8–23, 2009.)

These channels formed because of the excess overland flow. And as those formed, water and sediment were more efficiently conveyed off the upland landscape, further enhancing erosion, a positive feedback process. An estimate of the increase of storm flow from a small basin, resulting from the formation of rill and gullies, suggests that the runoff peak for a large storm was almost doubled compared to what it would have been without the channels (Figure 3.3). This is an excellent example of connectivity; that is, the uplands become better hydrologically connected to the streams. While the numbers are only approximations, this demonstrates part of the vicious downward spiral that characterized the Hill Country landscape of the early 20th century. And more brightly, in the late 20th century, it gives an indication of the efficacy of soil conservation on the regional hydrology. Again, understanding these physical processes and effects is essential to understanding the dramatic landscape changes in the Hill Country that are about to be presented.

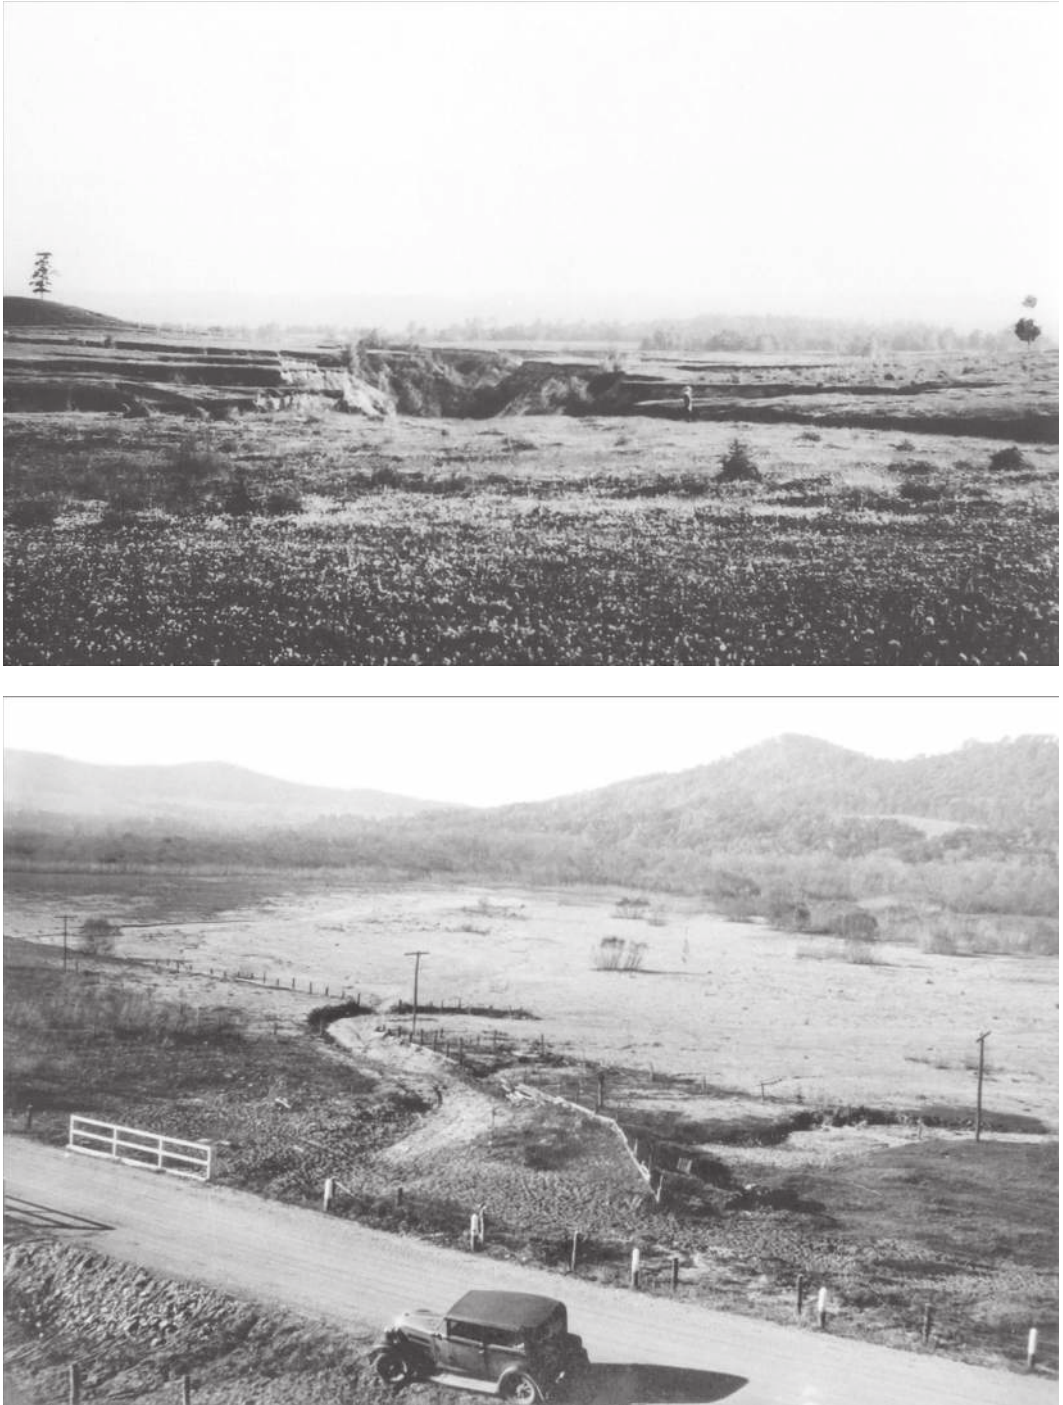
Figure 3.4 Alarming erosion and sedimentation in the Hill Country, 1929–1931. Top: Severe gully-ing in the Black River terrace, 3 mi (5 km) east of North Bend, Jackson Co., WI, June 15, 1929. See also book cover. Bottom: a 40-acre (16 ha) fan, deposited mainly 1923–1929, covers formerly good hay land on the Buffalo River floodplain, 10/24/31. (Photos credit: C.G. Bates.)

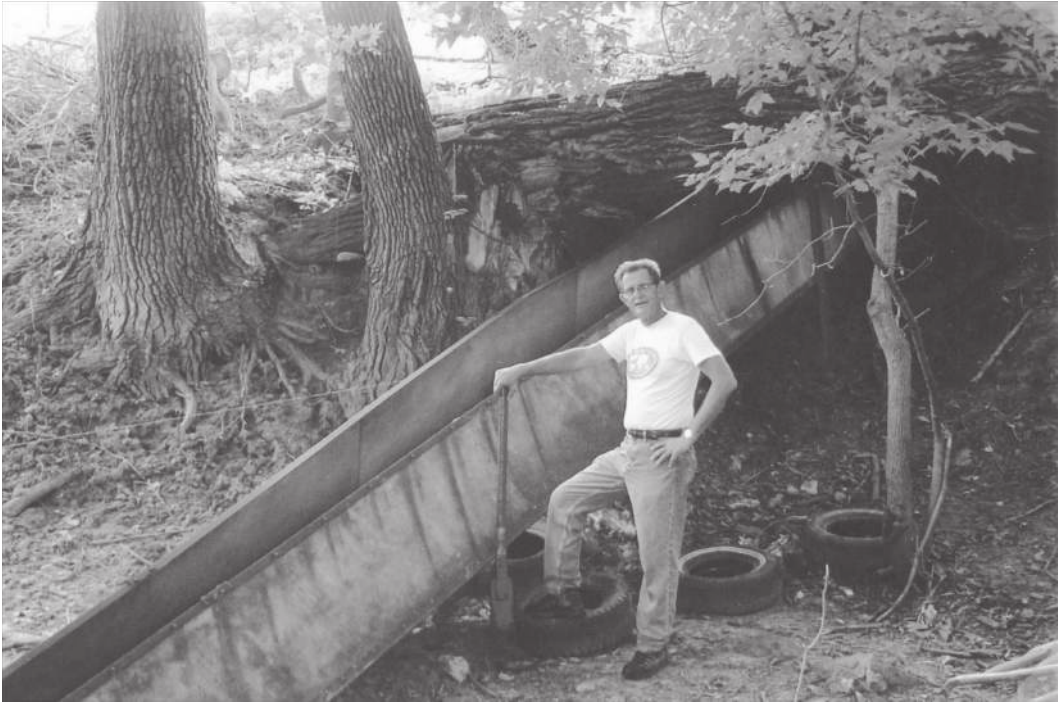
Figure 3.5 Early private erosion control. Sheet metal flume used to convey water around the head of gullies, Proksch Coulee gully, Vernon Co., WI (see Chapter 4). (Photo credit: Nadine Kleinhenz.)

Such a regional disaster elicited even the entrepreneurial spirit in the Hill Country. Locally, some contractors built stone steps to allow water to cascade safely downslopes, especially at the heads of gullies. Another device, made at least locally in central Region II by Gottlieb Muehleisen, an inventor from Alma, Wisconsin, was a metal flume to direct water around or over the head or overfall of a gully (McLeod, 1984). These were sometimes used by townships where the head of a gully threatened a road (Figure 3.5).

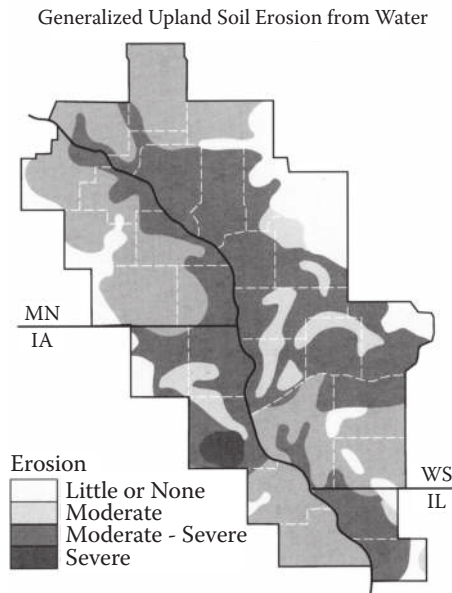
Figure 3.6 Generalized upland soil erosion from water, 1933, Hill Country. Compiled from state maps of WI, IO, MN, and IL. USDA-SES *Reconnaissance Erosion Survey*, 1933, 1:500,000.

The state RES maps were used to make a highly generalized map of erosion for the Hill Country (Figure 3.6). It is important to note that this is a subjective appraisal primarily of impact on agriculture rather than just volume of soil lost. It was done rather hurriedly, and the categories do not necessarily correspond to quantitative measures such as depth or volume. It will be noted that there is a general correlation with relief or slope (or land-form ruggedness) so that the western part of Region II shows moderate to severe erosion (note here that “severe” erosion would suggest that an area is essentially destroyed for agriculture). Given that slope appears to be a controlling factor, Region I had perhaps surprisingly severe erosion. However, that may be easily explained by erosive land use (ELU; Figure 2.16). And within Region I, it will be seen that severity of erosion does generally correlate with relief, although the erosion appraisal shown for the three northern counties of Iowa appears to be excessive.

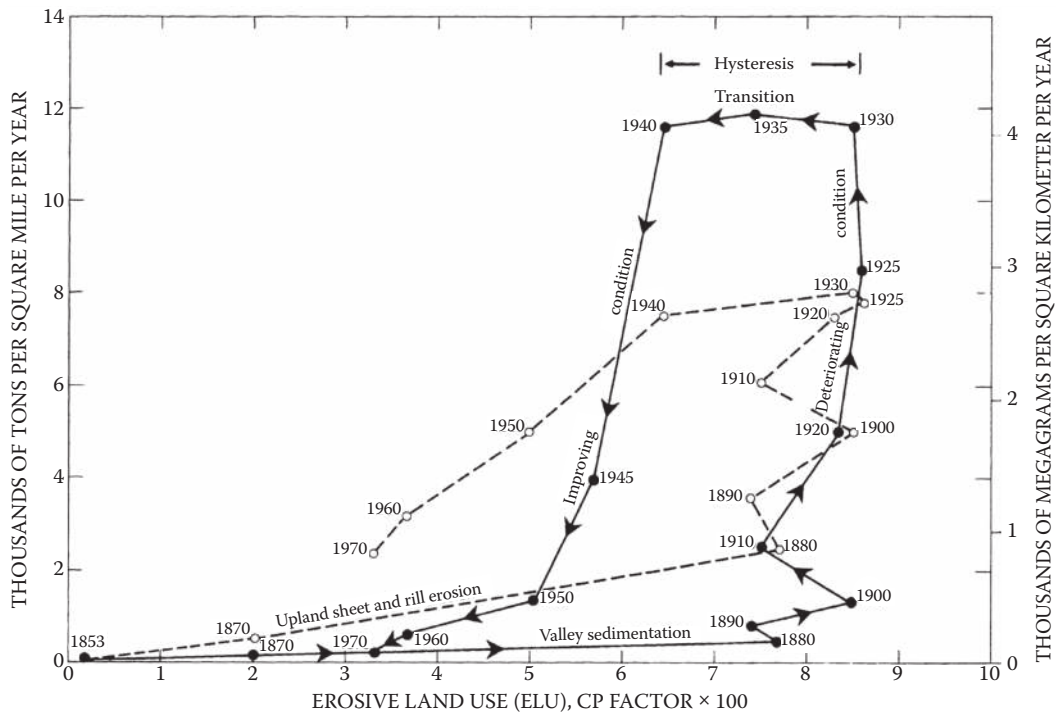
Figure 3.7 Nonlinear and hysteretic relationship of erosion and sedimentation to erosive land use, 1853–1975, Coon Creek. Sedimentation rates were measured but erosion was modeled with the Universal Soil Loss Equation. The lags are largely functions of (a) soil condition and (b) connectivity between uplands and bottoms by rills and gullies. See text for more explanation. (From Trimble, S. and Lund, S., *US Geol. Surv. Prof. Paper 1234*, 1982.)

- Figure 3.7** Nonlinear and hysteretic relationship of erosion and sedimentation to erosive land use, 1853–1975, Coon Creek. Sedimentation rates were measured but erosion was modeled with the Universal Soil Loss Equation. The lags are largely functions of (a) Soil condition and (b) connectivity between uplands and bottoms by rills and gullies. See text for more explanation. (From Trimble, S. and Lund, S., *US Geol. Surv., Prof. Paper 1234*, 1982.) 66

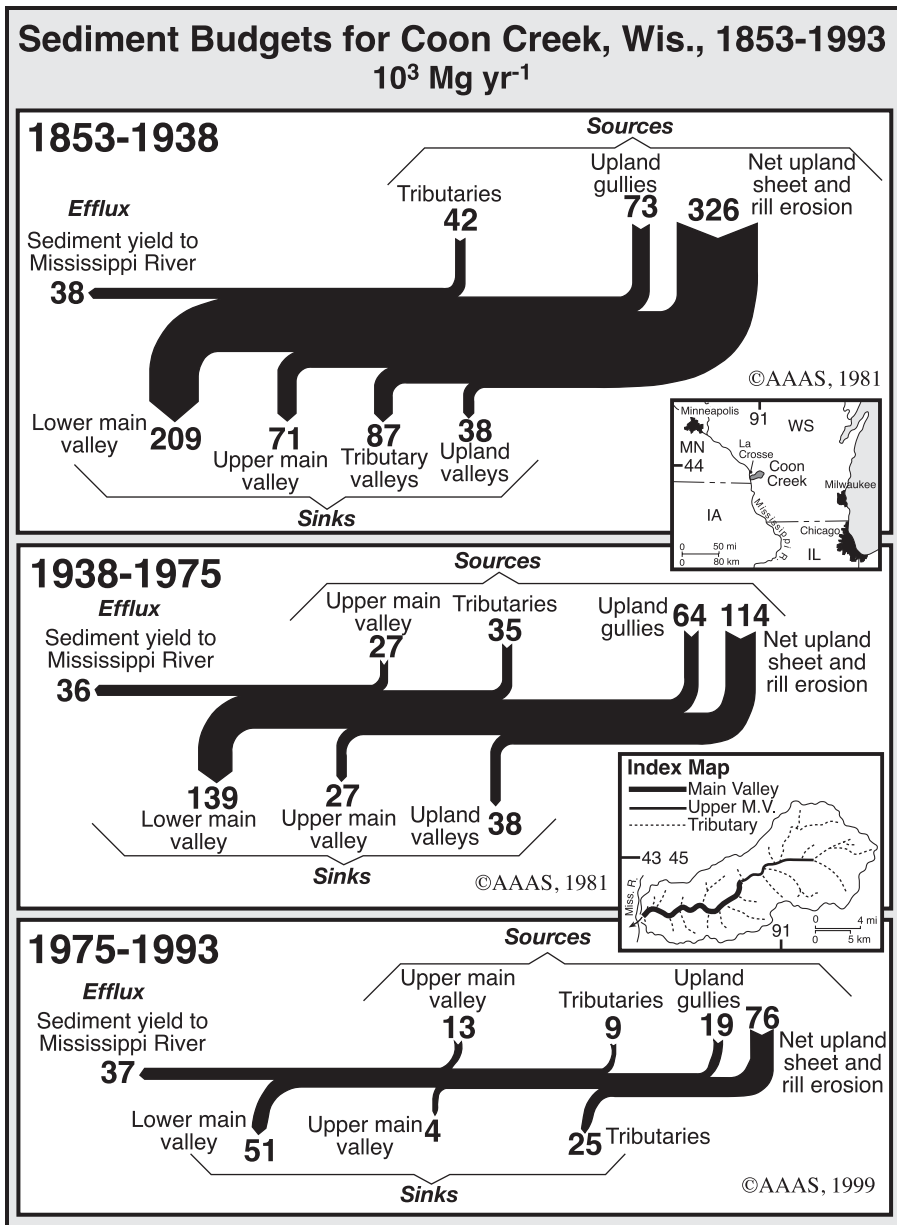
Figure 3.8 Sediment budgets for Coon Creek, 1853–1993, showing the complexity of sources, sinks, fluxes, and efflux over time. Numbers are annual averages for the periods in tonnes/yr (1 tonne = 1.1 short tons). All values are direct measurements except net upland sheet and rill erosion, which is a tare: the sum of all sinks and the efflux minus the measured sources. The lower main valley and tributaries are sediment sinks, whereas the upper main valley has been a sediment source. Note that sediment yield to the Mississippi River has held relatively constant over historical time. (From Trimble, S., *Science* 285, 1244–46, 1999. With permission.)

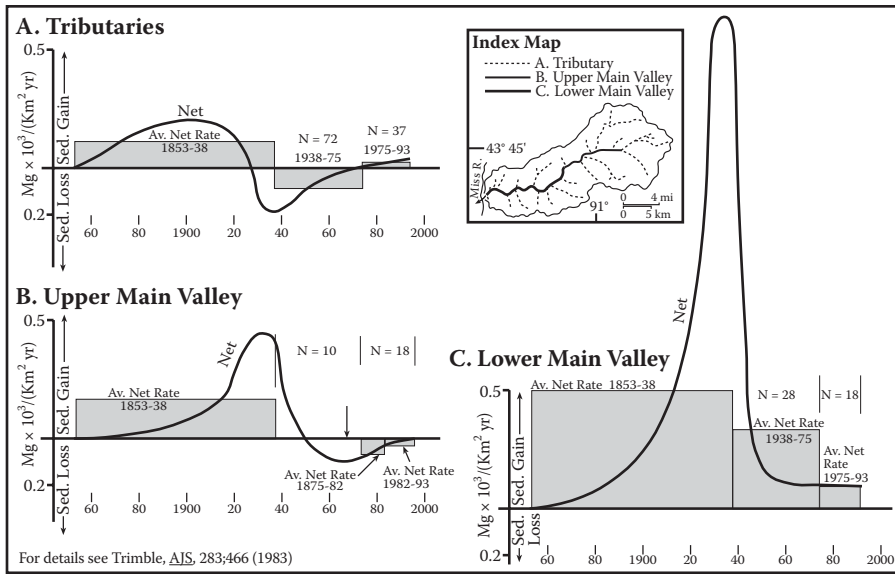
Figure 3.9 Differential stream and valley sediment budgets, Coon Creek, WI, 1853–1993 (1 Mg = 1 tonne = 1.1 short tons). (Redrawn from Trimble, *S. Geomorphology* 108, 8–23, 2009.)

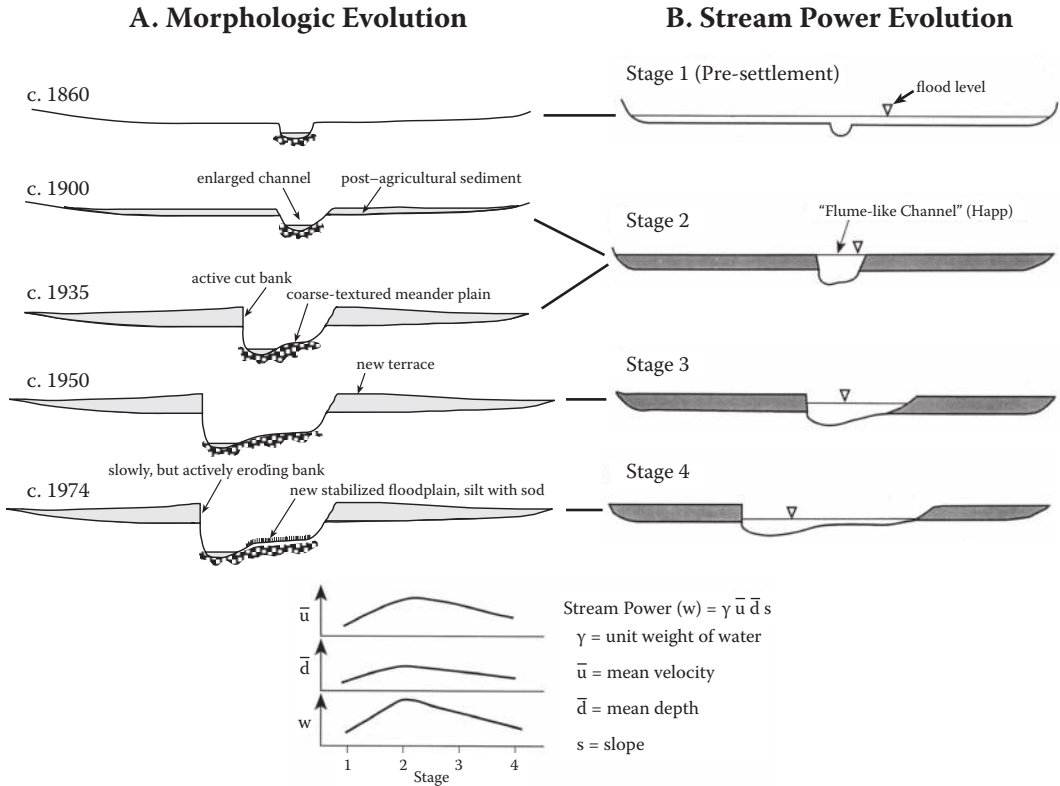
Figure 3.10 (A) Schematic model of changes of historic stream and valley morphology for Coon Creek and other Driftless Area tributaries, 1860 to 1974 (from page 16 of a mimeographed pamphlet by S.W. Trimble for a field trip to the Driftless Area, April 1975, sponsored by the Association of American Geographers and led by G. Dury, J.C. Knox, W.C. Johnson and S.W. Trimble [Trimble, 1975b]). Lateral migration of the stream is not shown in this model. (B) Changes of stream power and the transformation of stream and valley morphology. This model assumes a constant discharge for each stage. With the small stream channel of stage 1, floods spread out over the floodplain, keeping depth, velocity, and stream power low. With accretion of the floodplain and stream banks with historic sediment in stage 2 (c. 1900), greater flows were restricted to the channel, thus increasing depth, velocity, and stream power so that the channel erosion shown in the 1900 stage (left) must have been very rapid. In stages 3 and 4, the channel erodes laterally, so that floods are spread, with decreases of depth, velocity, and stream power. By the latter stage, fine sediment covered the old gravel meander plains and new floodplains are formed as shown to the left (from presentation to the Association of American Geographers, San Diego, CA., April 20, 1992. Ron Shreve of UCLA made important suggestions for preparation of this diagram in 1991, from Ward, A. and Trimble, S., *Environmental Hydrology*, CRC, Boca Raton, 2004).

With increasing runoff from upland fields, rapidly concentrated by expanding rills and gullies, the tributary channels began to erode and enlarge, sending copious sediment cascading downstream (Figure 3.10). This was especially true when violent bank erosion

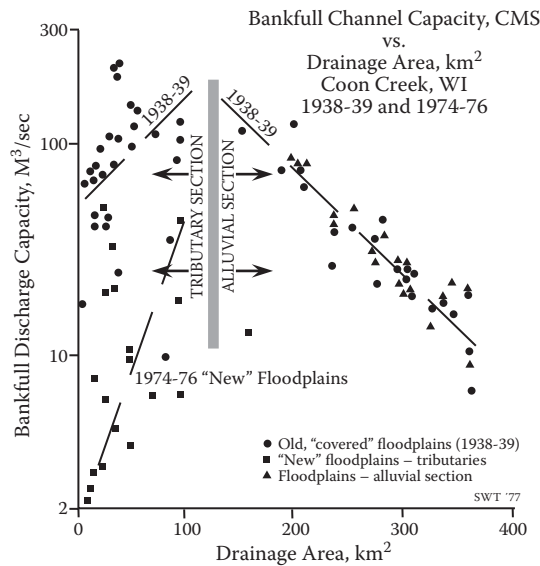
Figure 3.11 Changes of bankfull discharge capacity (BFQ) for tributaries, 1930s vs. 1970s, Coon Creek ($1 \text{ m}^3 = 35 \text{ ft}^3$, $1 \text{ km}^2 = 0.37 \text{ mi}^2$). Alluvial reaches downstream of tributaries (upper and lower main valley) were not calculated for the 1970s, but this analysis suggests a different set of channel forming conditions from the tributaries, at least for the 1930s. The overall relationship between BFQ and drainage area (DA) in the 1930s is a third-degree polynomial curve (Gatwood, 1989). For selected streams elsewhere in the Hill Country, Knox and others found a log-linear relationship for bank widths and DA (e.g., Knox, 1987). The relationship of stream size in the Hill Country, however measured, is a function of many factors, including land use and basin morphology, particularly drainage network.

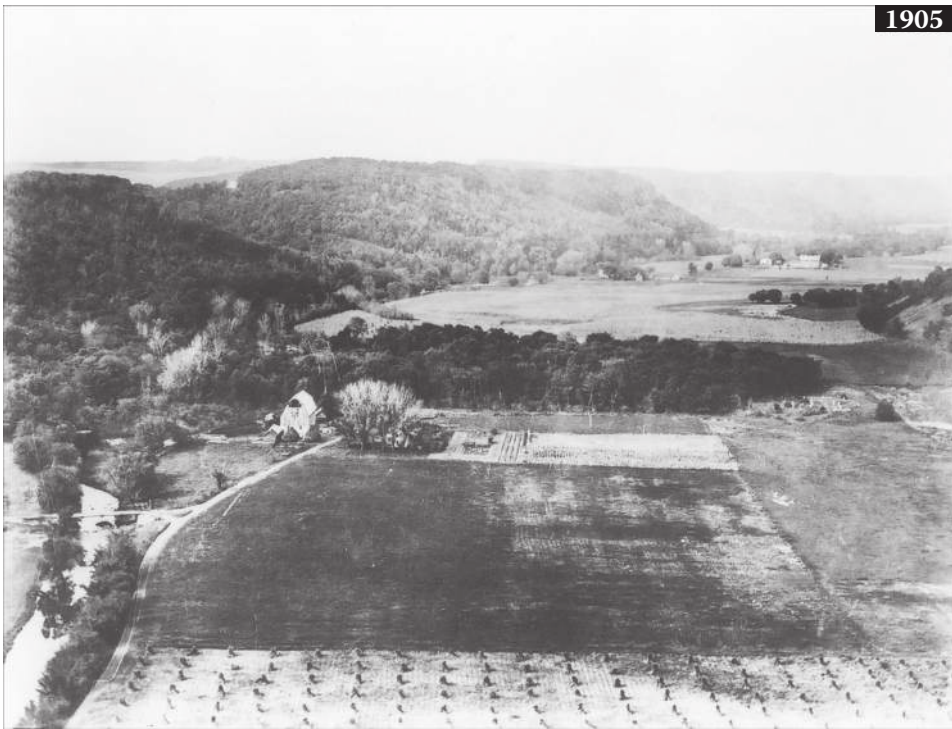
Figure 3.12 Evolution of tributary channels as explained in the text and in Figures 3.10 and 3.11. North Branch, Whitewater River, MN, 1 mi (1.6 km) west of Elba, MN, looking upstream (west) (NE1/4, Sec9, T107NR10W, Winona Co.). For reference, note barn, bridge, and road intersection. 1905, Note narrow, apparently deep stream lined with trees and dense riparian vegetation. (Photo credit: 1905 and 1940 photos by Soil Conservation Service [SCS].) (Continued)

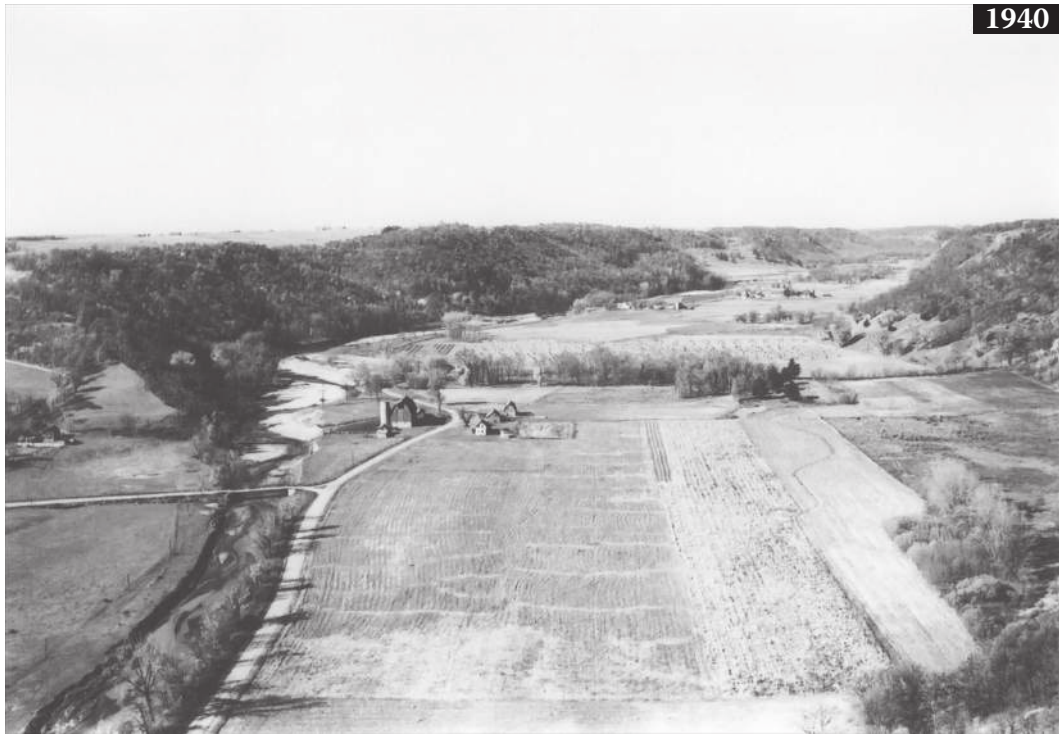
Figure 3.12 (Continued) Evolution of tributary channels as explained in the text and in Figures 3.10 and 3.11. North Branch, Whitewater River, MN, 1 mi (1.6 km) west of Elba, MN, looking upstream (west) (NE1/4, Sec9, T107NR10W, Winona Co.). For reference, note barn, bridge, and road intersection. By 1940, by lateral erosion, the stream has widened 2 to 5 times in response to increased storm flow and the abundant supply of bedload from hillside gullies and the eroded stream itself. Indeed, a hillside gully and rock fan is barely visible in the top right quadrant. (Photo credit: 1905 and 1940 photos by Soil Conservation Service [SCS].) (Continued)

because less-laden flows (Kondolf, 1997 used the term “hungry water”) had the power to erode and transport sediment. Fish shelters installed since c. 1975 by governmental agencies along tributaries have marginally helped stabilize channels, but such fish shelters could never have worked had the stream regime not been moderated already (Trimble, 1997, 2009). Presently, tributaries are generally stable and are mild sediment sinks. Indeed, the transformation of tributaries from the disheveled conditions of the 1930s to the stable conditions of today is sometimes hard to believe without much visual reinforcement (Figures 3.12, 3.13; see also Trimble and Crosson, 2000, p. 249).

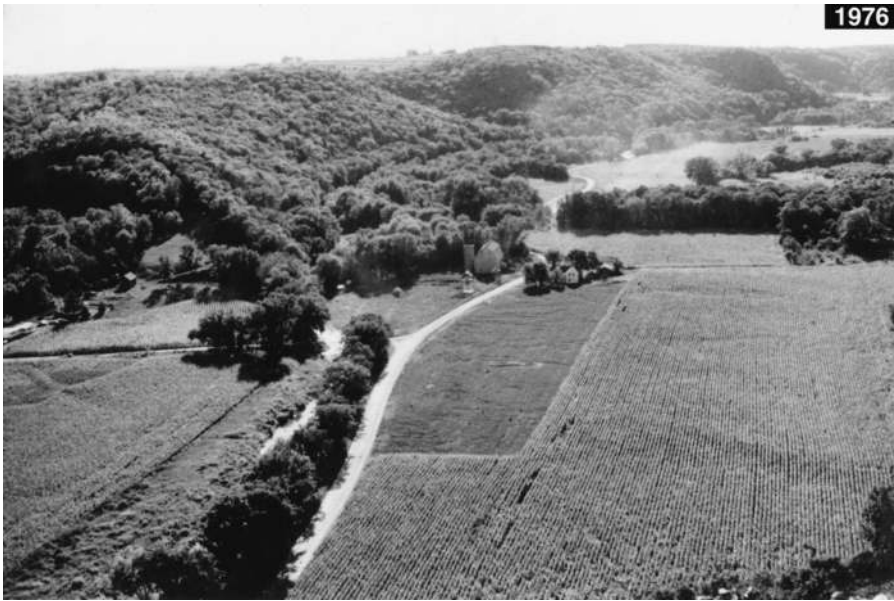
Figure 3.12 (Continued) Evolution of tributary channels as explained in the text and in Figures 3.10 and 3.11. North Branch, Whitewater River, MN, 1 mi (1.6 km) west of Elba, MN, looking upstream (west) (NE1/4, Sec9, T107NR10W, Winona Co.). For reference, note barn, bridge, and road intersection. 1976: The stream has narrowed again to similar dimensions as seen in 1905 with dense riparian vegetation. (Photo credit: 1905 and 1940 photos by Soil Conservation Service [SCS].)

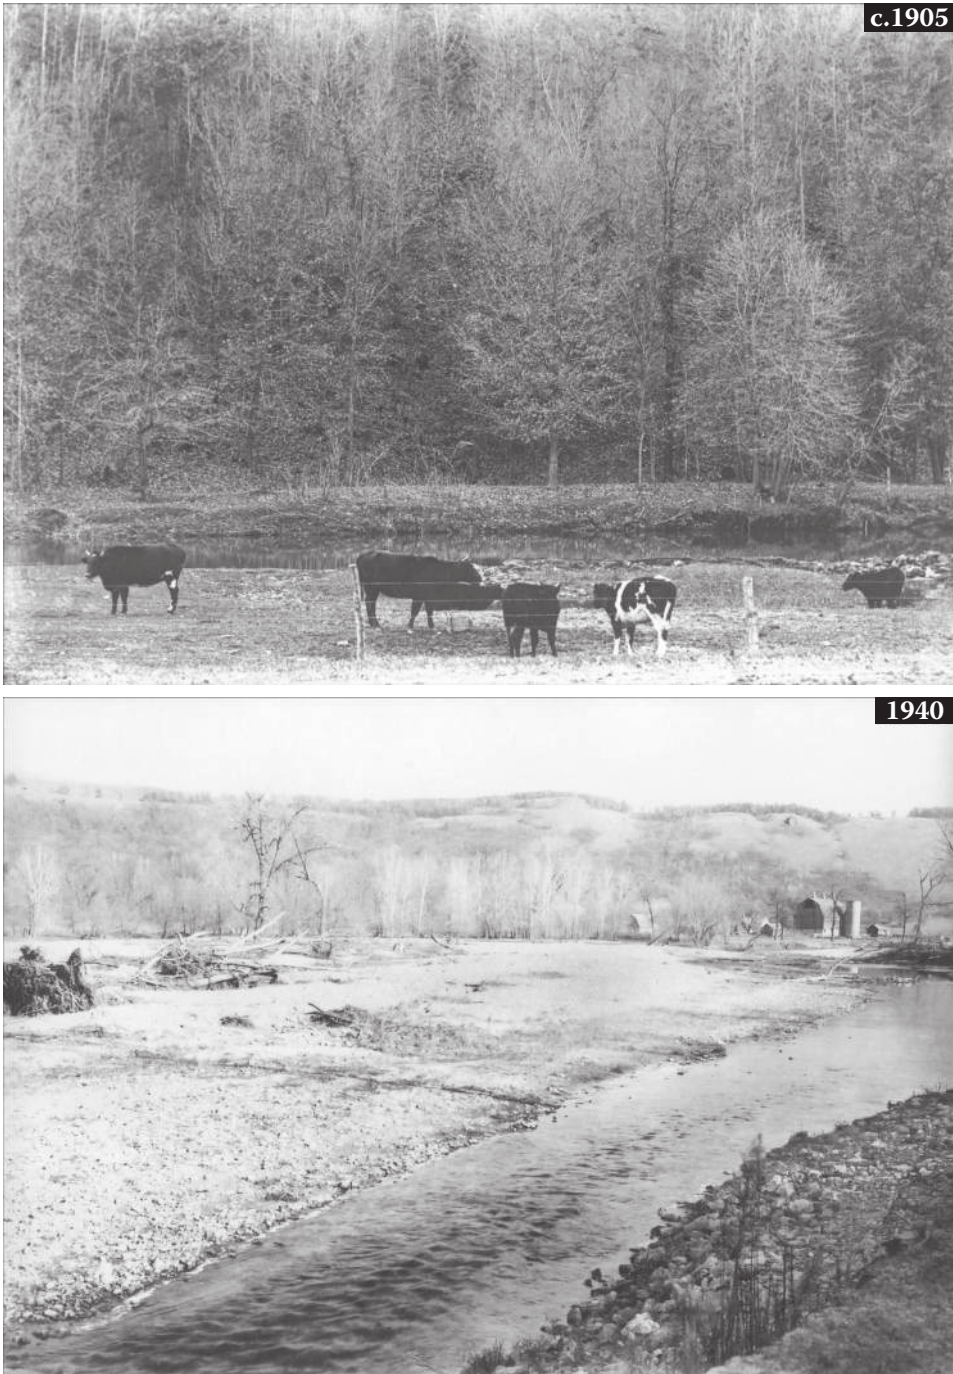
Figure 3.12 (Continued) Evolution of tributary channels as explained in the text and in Figures 3.10 and 3.11. North Branch, Whitewater River, MN, 1 mi (1.6 km) west of Elba, MN, looking downstream west (NE1/4, Sec9, T107NR10W, Winona Co.). For reference, note barn, bridge, and road intersection in the first three frames. 1905, close-up of the reach just downstream of the barn. 1940, close-up of the reach upstream of the barn looking east (downstream). (Photo credit: 1905 and 1940 photos by Soil Conservation Service [SCS].)

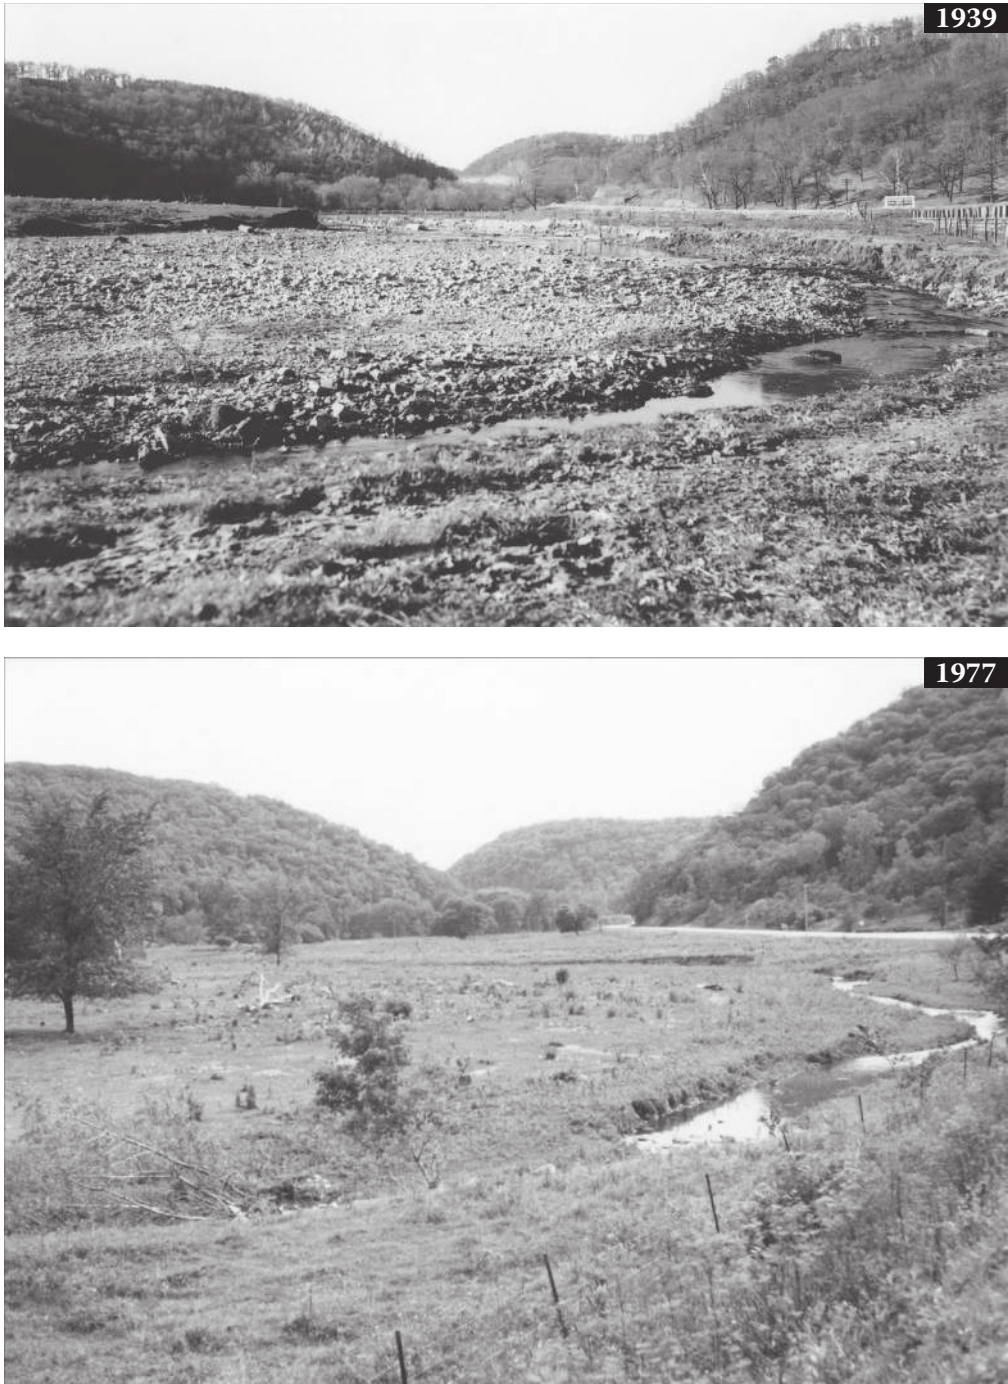
Figure 3.13 Lewiston Fork of Garvin Branch, 2 mi (3 km) SW of Stockton, MN, on US Hwy 14, looking upstream. Top: 11/2/39. This is the typical “gravel road” tributary of that period, which Stafford Happ described here as a “bouldery torrent plain formed by bank erosion.” Bottom: July 1977; rocks have been covered with silt, and the floodplain is a fine pasture. Note the eroded silt banks where cows have trampled them. (Continued)

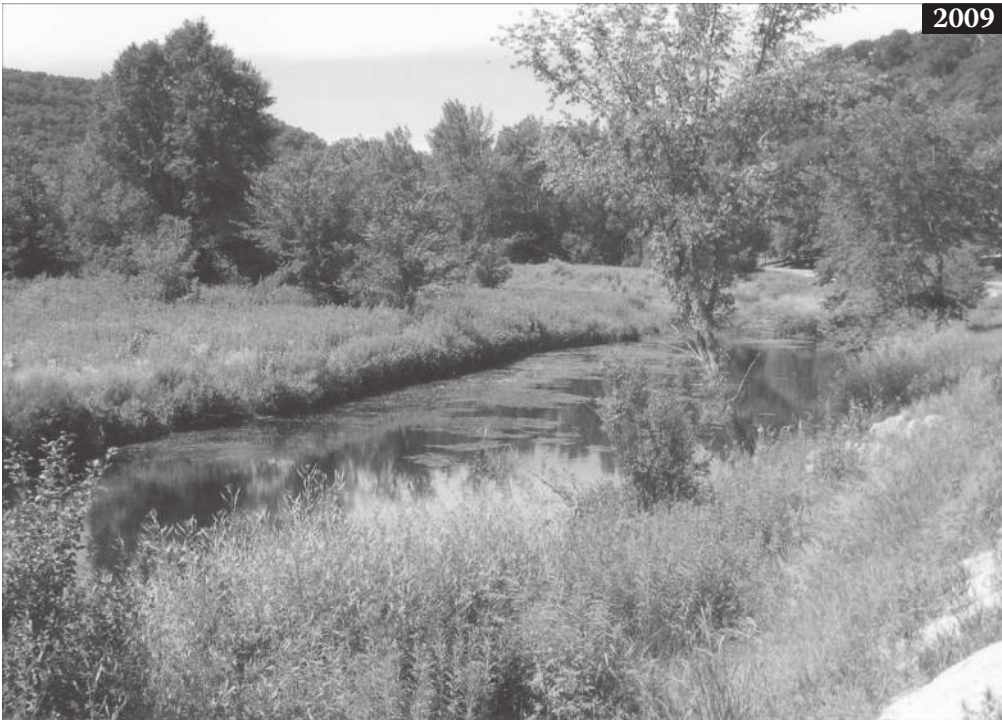
Figure 3.13 (Continued) Lewiston Fork of Garvin Branch, 2 mi (3 km) SW of Stockton, MN. on US Hwy 14, looking upstream, July 2009; With cessation of grazing, floodplain has now grown up with woody plants.
