**HISTORICAL AGRICULTURE
AND SOIL EROSION IN THE
UPPER MISSISSIPPI
VALLEY
HILL COUNTRY**

STANLEY W. TRIMBLE

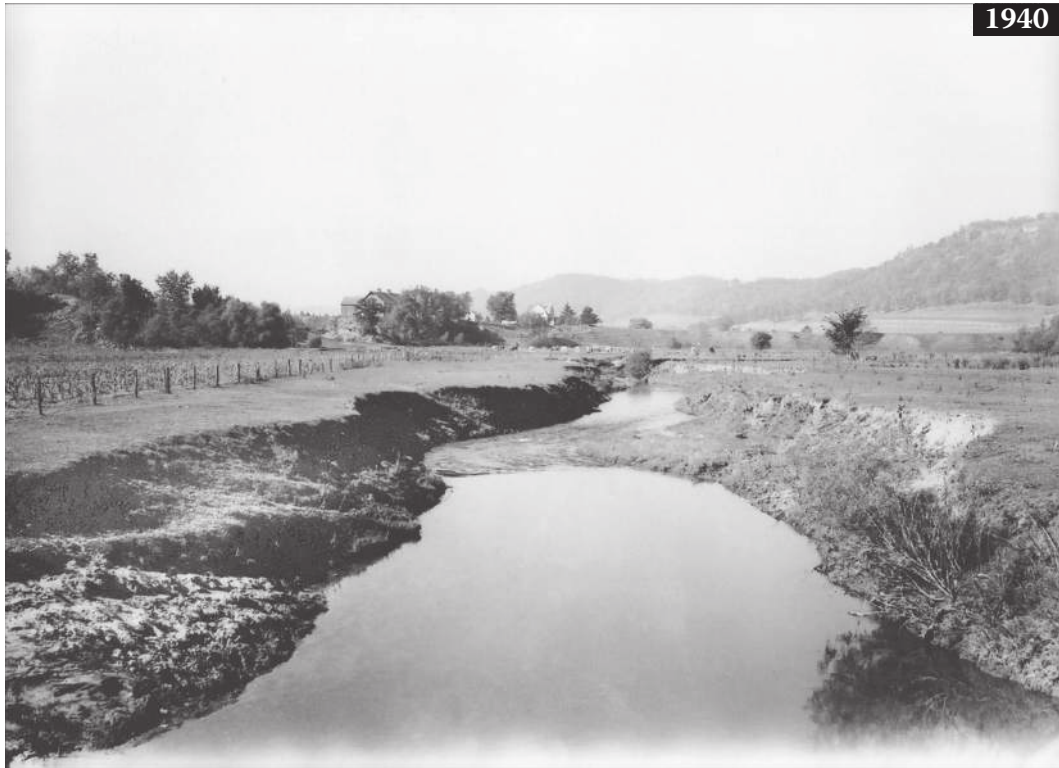
Figure 3.14 Downstream end of the Upper Main Valley of Coon Creek, as defined by the process of a stream eroding a high bank and depositing a lower bank on the other side of the stream adjusted to a lower flood regime. 1940; looking downstream from bridge on Lietke Lane, just off WI Hwy 162, stream is fairly straight at this point. (Photo credit: S. C. Happ.) (Continued)

And the amount being deposited, at least for the period 1975–1993, has become almost as great as the amount being eroded. Therefore, these reaches appear to be no longer major sediment sources as they were c. 1950–1980 (Trimble, 1999, 2009a). Hence, the long-term prognosis for this reach is uncertain. While this reach may not be presently a large net source of sediment, it has an effect on sediment texture. As material is eroded from the high bank, the fine material is carried downstream to the floodplain or even out of the valley as sediment yield. The sand, however, is more likely to be retained in the channel, where it migrates downstream, resulting in effects described in the next section. As the hydrologic regime continues to moderate, the processes in this region move downstream (Figure 3.14).

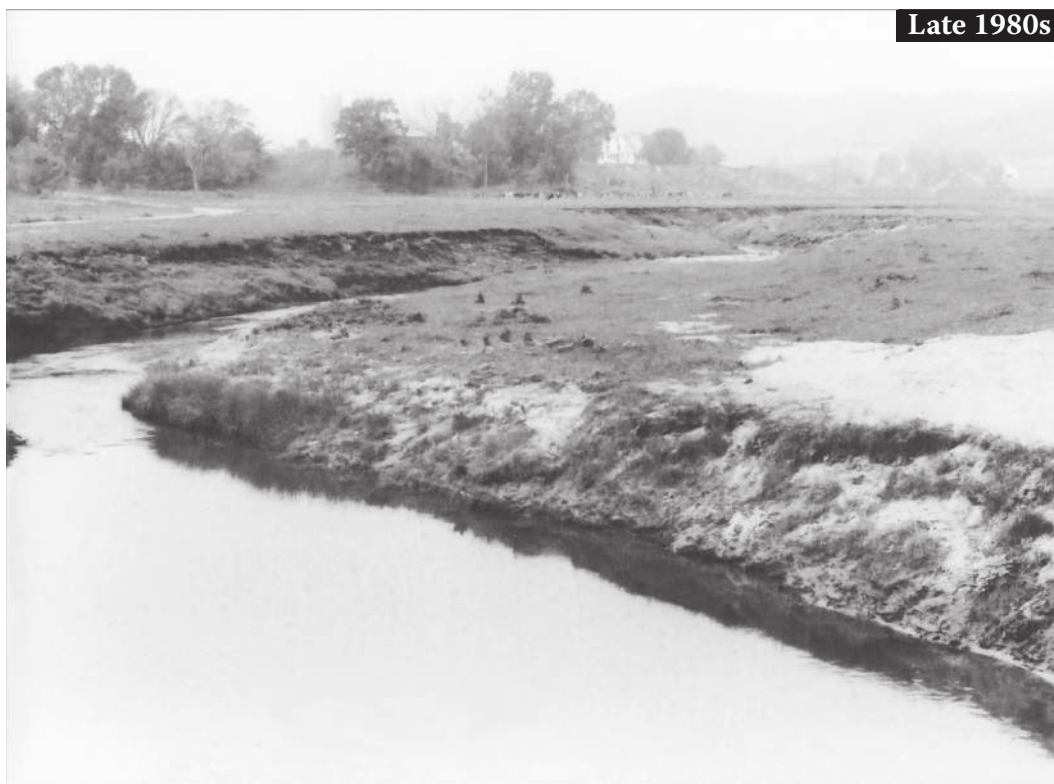
Figure 3.14 (Continued) Downstream end of the Upper Main Valley of Coon Creek, as defined by the process of a stream eroding a high bank and depositing a lower bank on the other side of the stream adjusted to a lower flood regime. Late 1980s. Note that the stream has cut away the bank to the left foreground and is depositing a slightly lower bank in the right foreground. The same pattern exists for two more meander loops in the distance (looking downstream from bridge over Coon Creek, NW1/4, Sec 24,T14N, R6W).

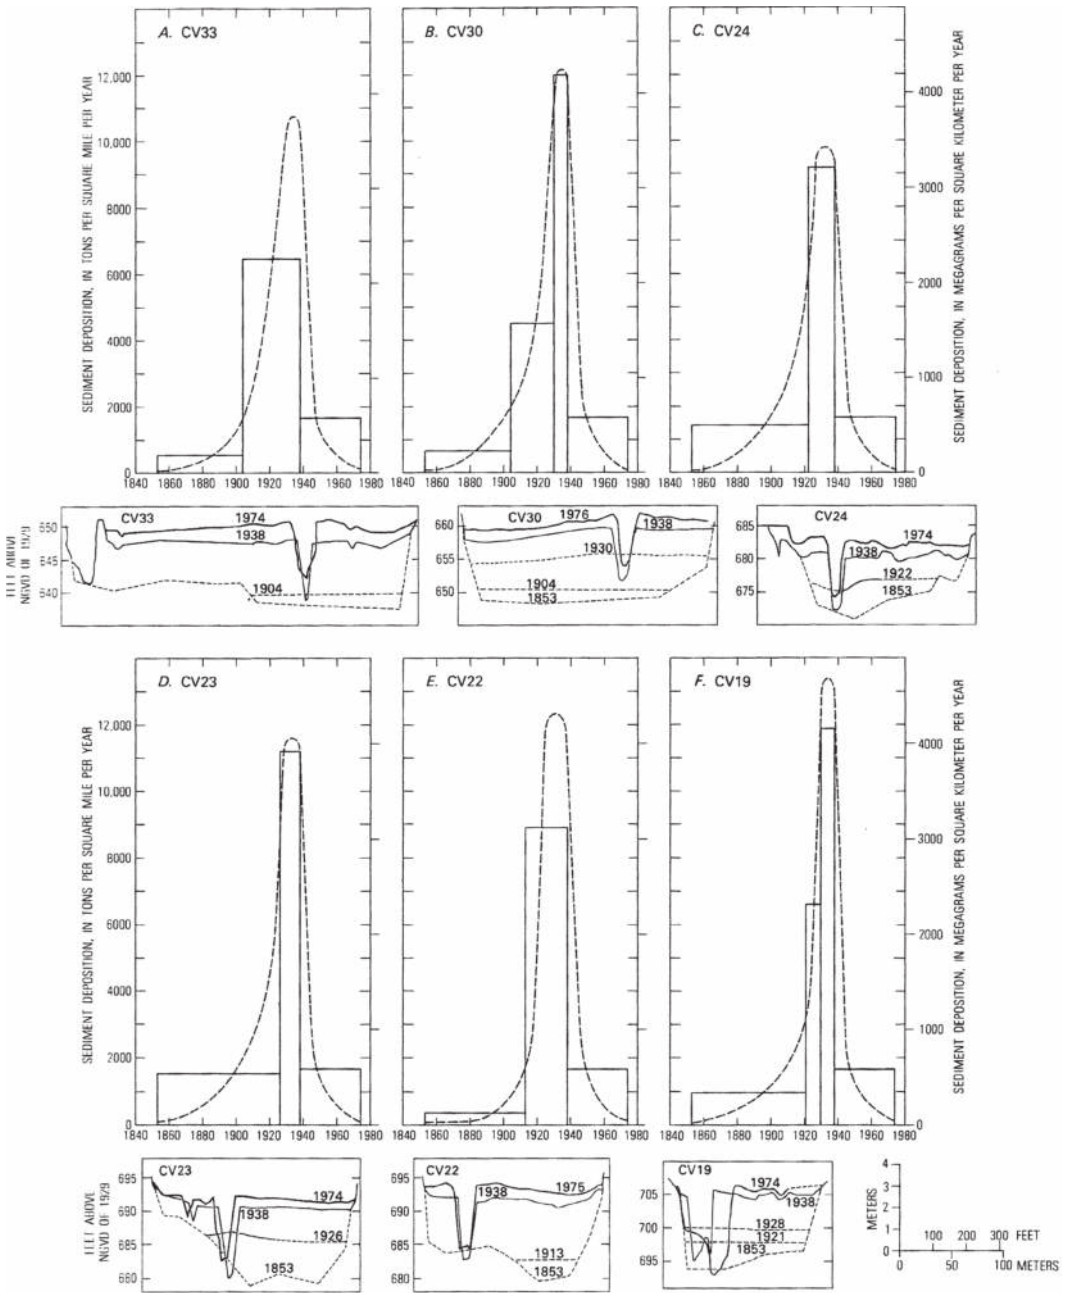
Figure 3.15 Deposition rates at selected Lower Main Valley sites in Coon Creek, 1853–1977. These are derived from cross-sectional reconstructions of deposition rates based on surveys, excavations of soils, bridges, roadways, and other dating methods. (From Trimble, S. and Lund, S., *US Geol. Surv. Prof. Paper 1234*, 1982).

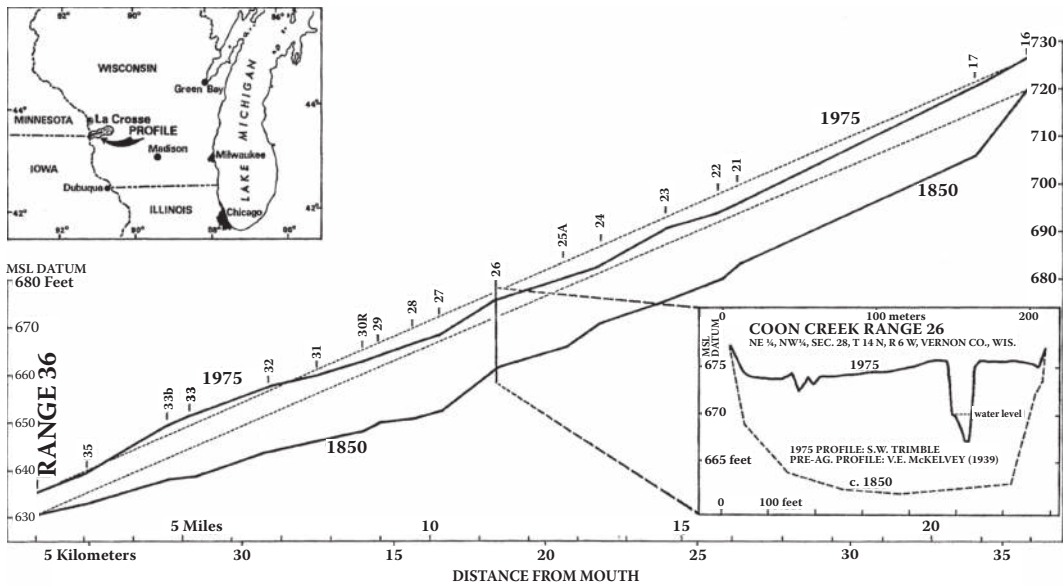
Figure 3.16 Longitudinal profile of Coon Creek stream banks showing depth of historical sediment accretion for the entire main valley, 1850 and 1975. Dashed lines in the longitudinal profile are straight lines for reference. Profile 16 is 2 mi (3 km) upstream from Coon Valley and Range 36 is less than a mile (1.6 km) from the Mississippi River. Note that the longitudinal profile in 1850 was concave upward, typical for a humid area stream in equilibrium. By 1975, however, the profile has become almost straight, indicating a stream overloaded with sediment. Indeed, from Range 32 to 35, where erosion from high Pleistocene terraces in Wing Hollow was especially severe, the profile became convex upward. Note also that the raising of the base level of about 8 ft (2.5 m) by navigation pool 8 in 1938 seems to have had negligible effects on sediment depths in the lower 5 mi of the stream. In fact, the accretion rate near the mouth 1938–75 was less than in mid-valley.

Locally, the depth of historical sediment is usually great where tributaries flow into the main valley, creating alluvial fans. In some cases, a “hump” or convexity was formed in the longitudinal profile. This may be seen between profiles 33 and 33b, where several tributaries were bringing in massive amounts of sand from the erosion of high terraces. In a few cases, such tributary fans forced the main stream to move some distance laterally across a valley. An example is the mouth of Wing Creek, which, between 1924 and 1983, pushed Coon Creek more than 200 ft (60 m) to the west (SE $\frac{1}{4}$ Sec 25, T14N, R7W, Vernon County, WS). See Chapter 4 for examples of gully fans displacing master streams.

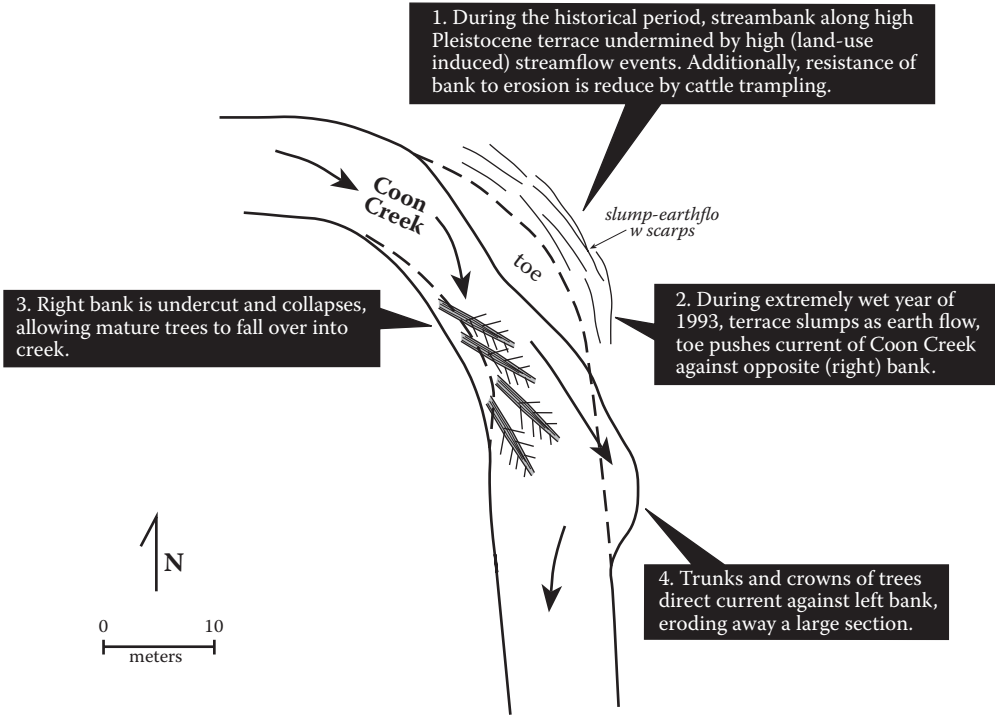
Figure 3.17 Destabilization of stream reach by collapse of undercut high terrace, showing natural and human factors. This reach may be observed by looking upstream (south) from WI State Highway 162 bridge over Coon Creek (see Fig. 8.14).

Figure 3.17 Destabilization of stream reach by collapse of undercut high terrace, showing natural and human factors. This reach may be observed by looking upstream (south) from WI. State Highway 162 bridge over Coon Creek (see Fig. 8.14). 84

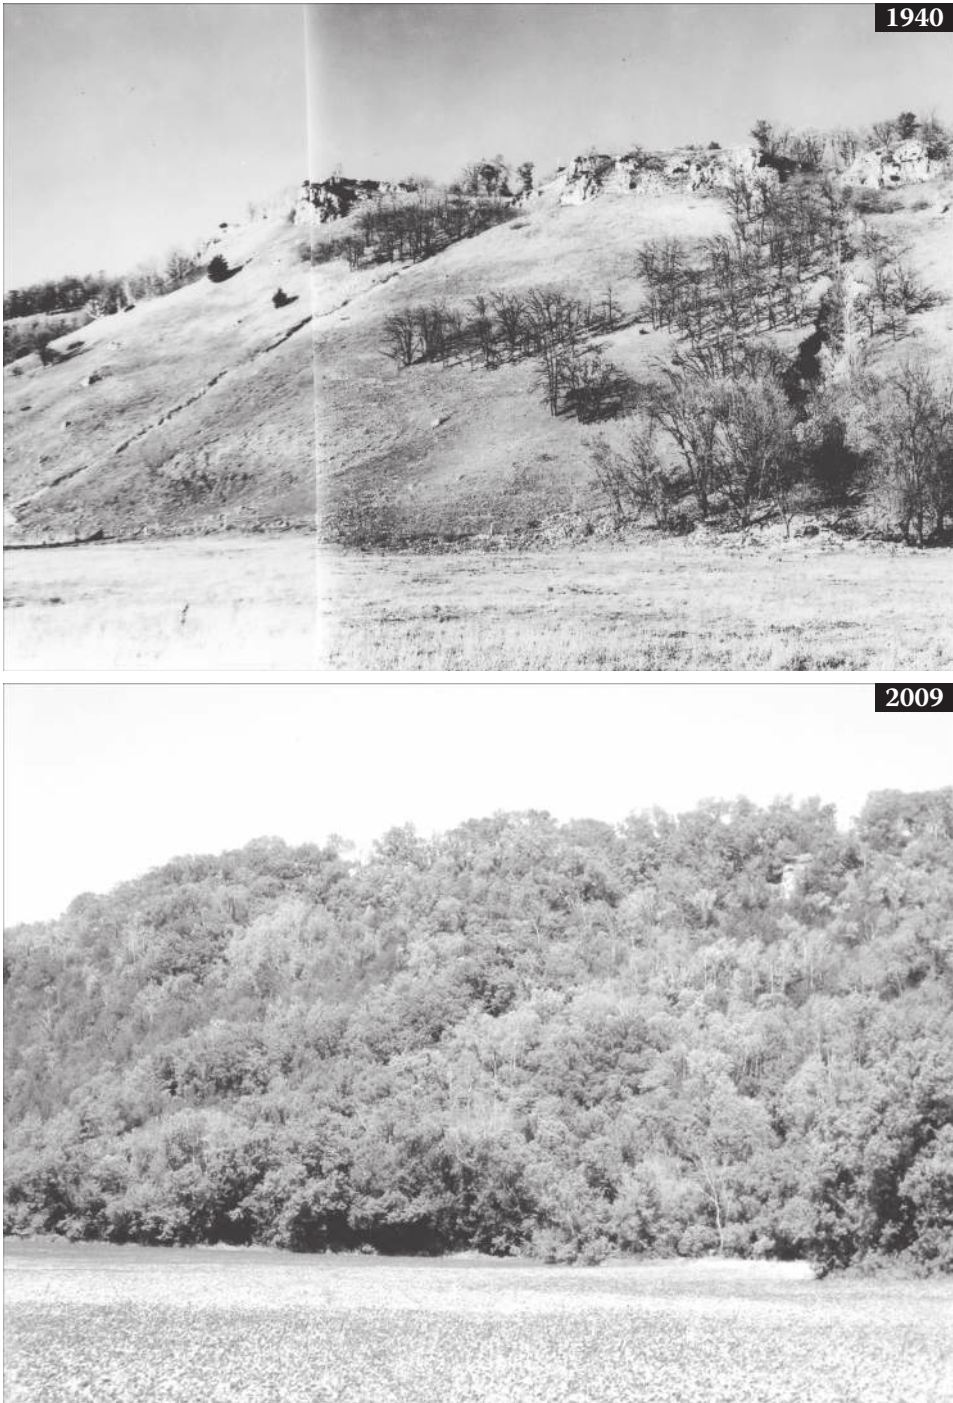
Figure 4.1 Stabilization of hillside and gullies, North Fork Whitewater River, looking north just east of Fairwater, MN (SE1/4, Sec 5, T107N, R10W, pan of two photos made 10/23/40). Top: 1940, note treeless “goat prairie” and two hillside gullies with fans at base of slope. Bottom: July 2009, note the transformation from “goat prairie” to mostly deciduous forest. Gullies and fans are relatively inactive. Compare to Chapter 5, Figure 5.1 of the same slopes. (See also Trimble, 2009a, p. 18.)

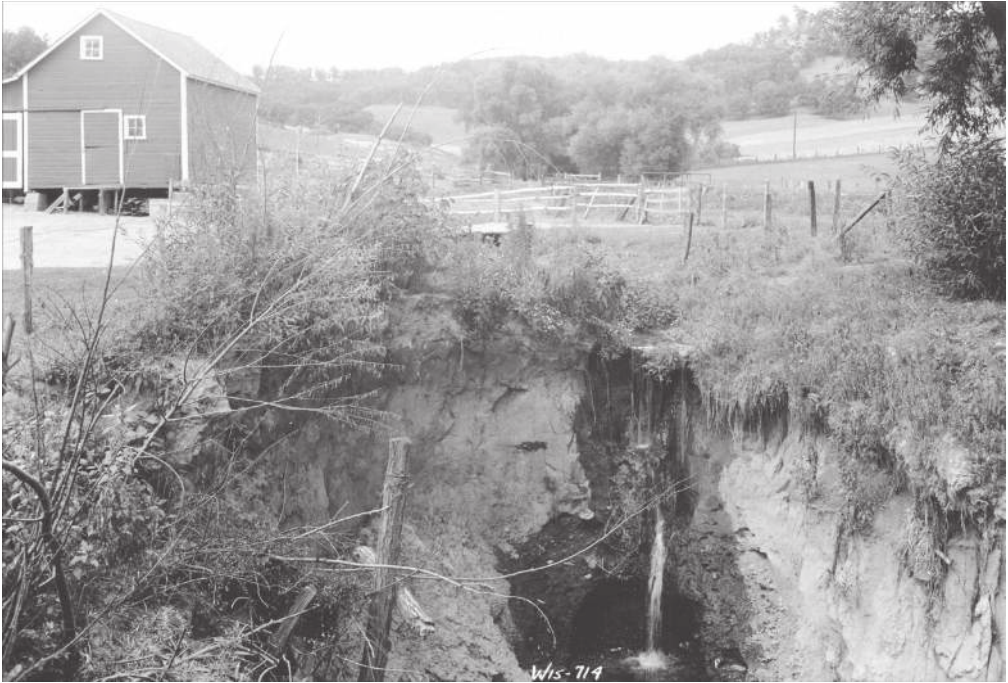
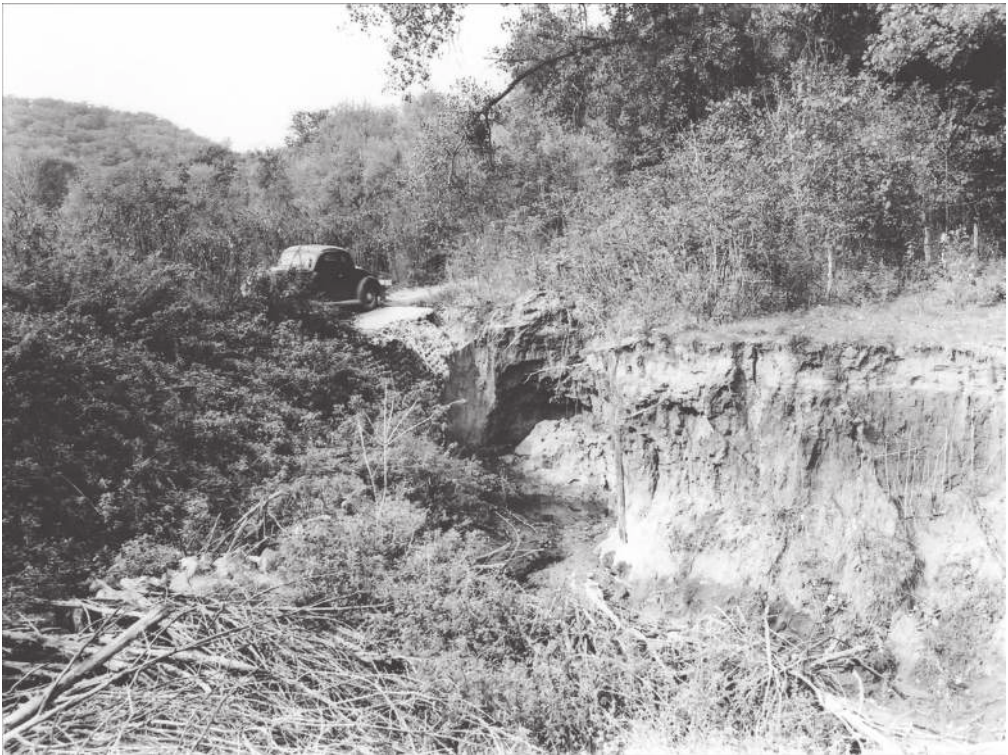
Figure 4.2 Gully heads (overfalls) threatening economic activity in the late 1930s. Top: A threatened farm possibly in Trempealeau Co., WI. Bottom: A threatened roadway in Wabasha Co, MN, 2 mi (3 km) SW of Weaver.

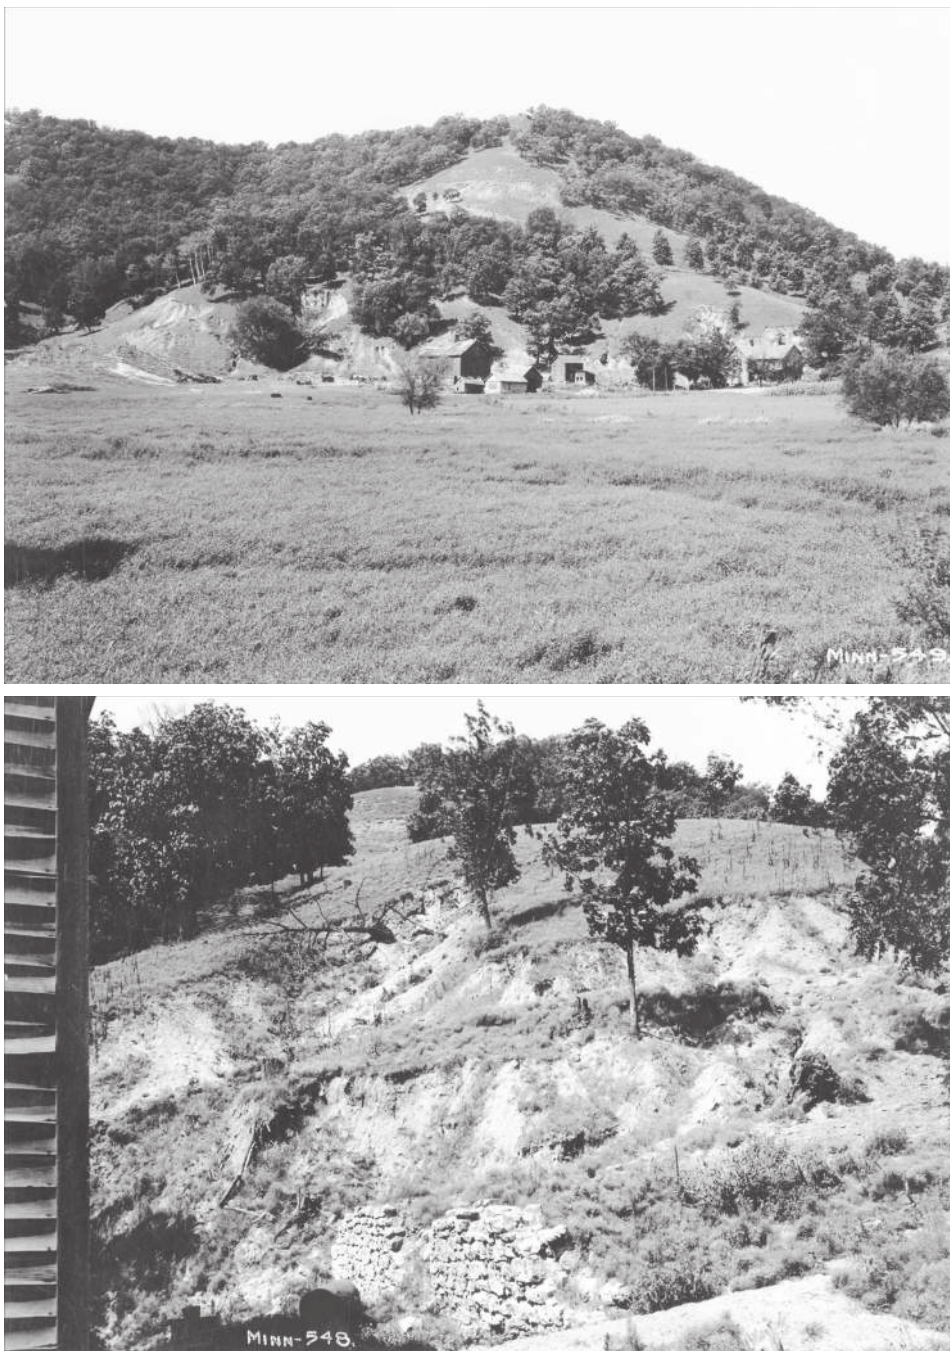
Figure 4.3 The Appleby farm, Whitewater Valley looking north (NW1/4, Sec 10, T108N, R10W, Winona County, MN). Top: The farm seen across the floodplain, grown too wet for grazing. Thus, Appleby was forced to turn his animals loose on the hillside behind the house, and gullies are visible. Bottom: Close-up of gullied hillside behind house with partially buried stone wall visible. Corner of house visible to left. Both photos 8/27/37. A present remake of the top photo would show the lake formed in the foreground as the main channel of the Whitewater River aggraded to a level higher than the distal floodplain here (see Chapter 7).

Figure 4.3 The Appleby farm, Whitewater Valley looking north (NW1/4, Sec 10, T108N, R10W, Winona County, MN). Top: The farm seen across the floodplain, grown too wet for grazing. Thus, Appleby was forced to turn his animals loose on the hillside behind the house, and gullies are visible. Bottom: Close-up of gullied hillside behind house with partially buried stone wall visible. Corner of house visible to left. Both photos 8/27/37. A present remake of the top photo would show the lake formed in the foreground as the main channel of the Whitewater River aggraded to a level higher than the distal floodplain here (see Chapter 7). 89

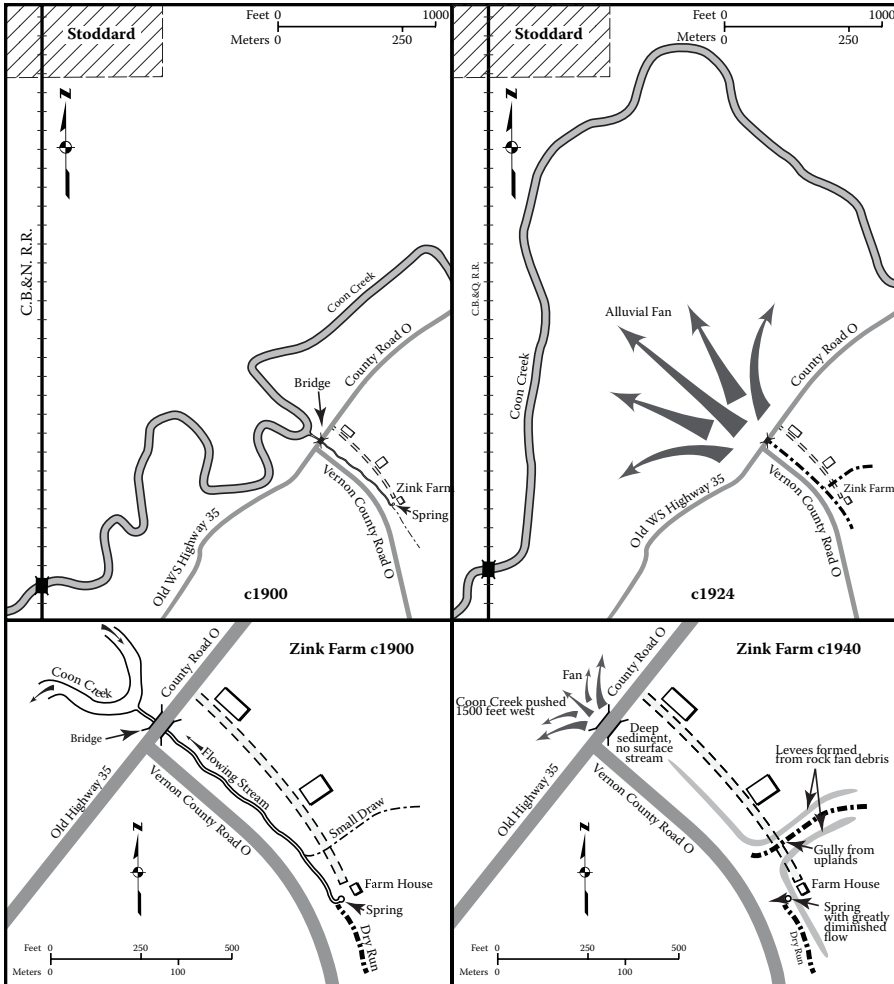
Figure 4.4 Changes at the Zink farm about 1 mi (1.6 km) southeast of Stoddard, WI, c. 1900–1940 (NE1/4, Sec33, T14N, R7W). In 1900, Coon Creek still ran on the east side of the valley close to the Zink farmstead. By 1924, the small tributary from the southeast had formed an alluvial fan that has pushed the creek across to the west side of the valley. This process clearly demonstrates the rapid onset of disastrous erosion in the early 20th century.

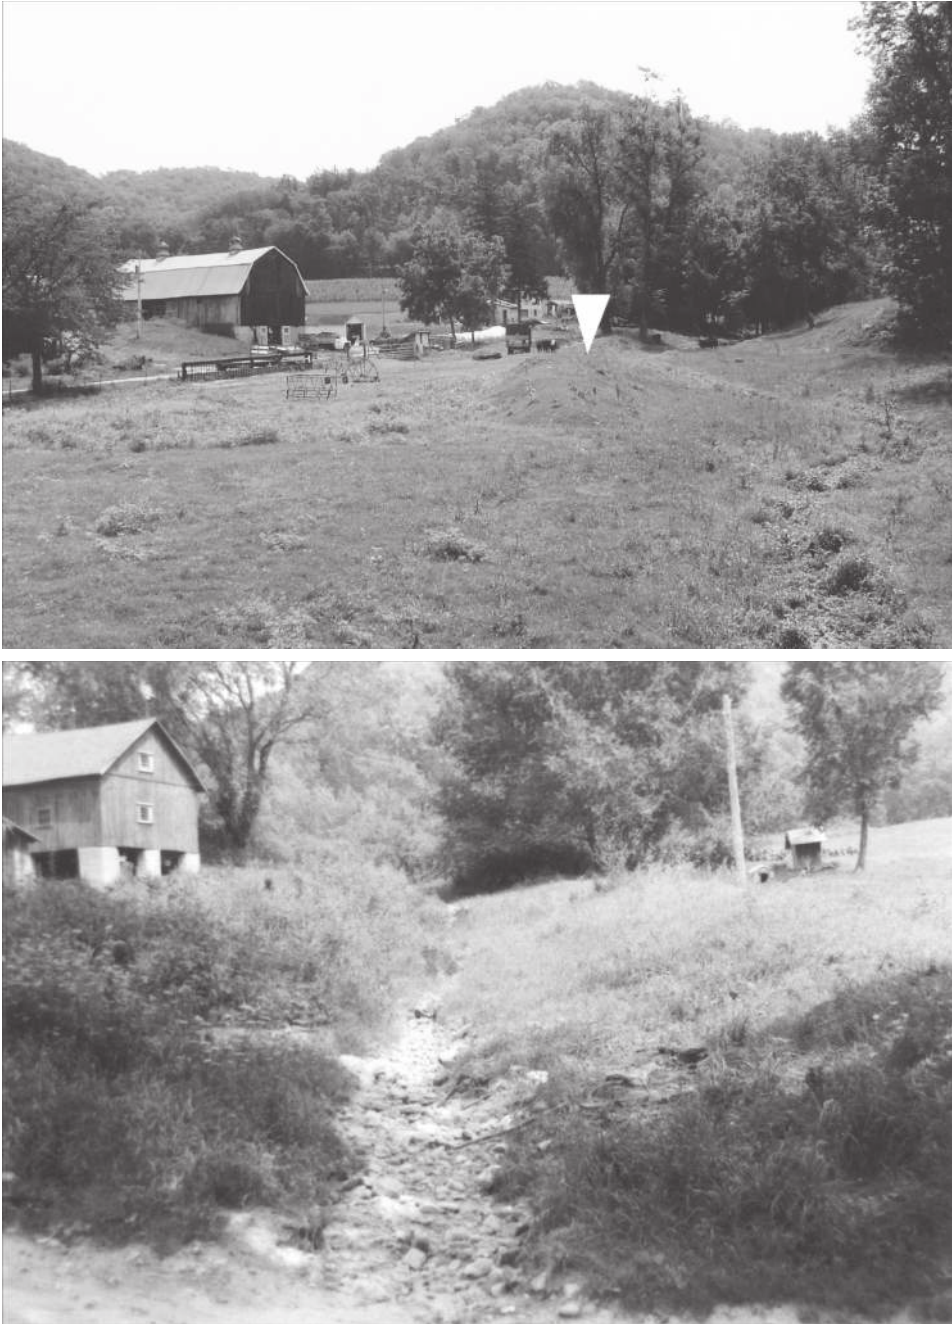
Figure 4.5 The Zink farm, Coon Creek basin. Top: Looking southeast (upstream) from bridge on County Road O. Note dike in middle background to protect farm from flooding (arrow). The former gully and fan, now a stream, flows toward viewer on the bridge. The side channel flows in from the left (north) between the barn and the house. (Photo credit: Nadine Kleinhenz, 2006.) Bottom: Looking upstream (northeast). Mostly dormant rock fan between barn and house reshaped into flume with dikes to either side. The fan formed in the early 20th century and carried water and rock with most rainfall events in the early 20th century. Material from the fan was used to construct the dikes. Flume is shown after 4 in. (10 cm) rainfall event, c. 1990.

With the implementation of the soil conservation program and the resulting improvements in land use and land treatment, the storm flows subsided. Presently, the side channel and dikes are largely vegetated and carry water only during major rainstorms (Figure 4.5; see Chapter 8 for effects of an extreme storm on the Zink farm).

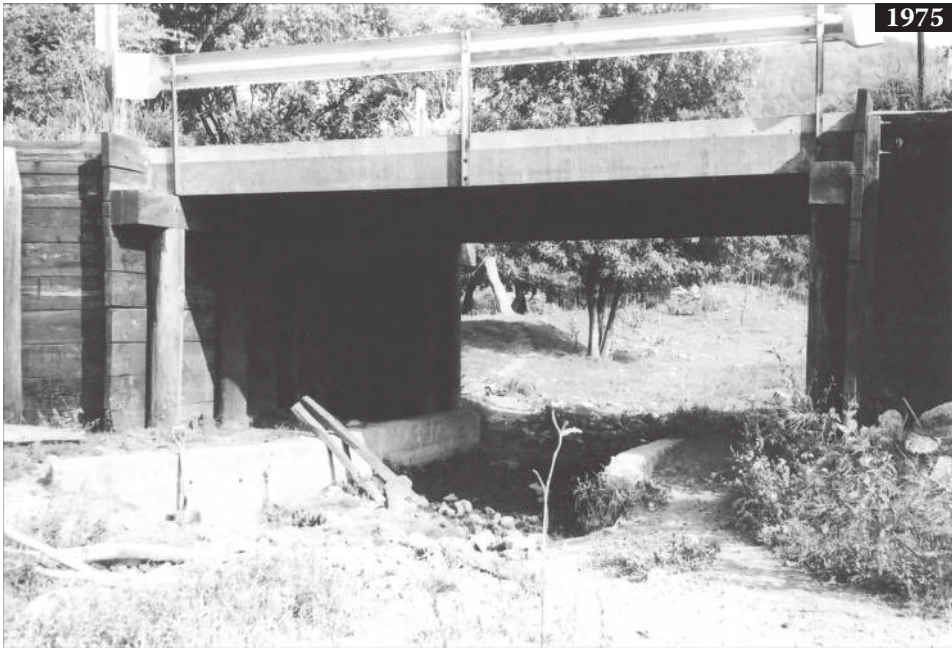
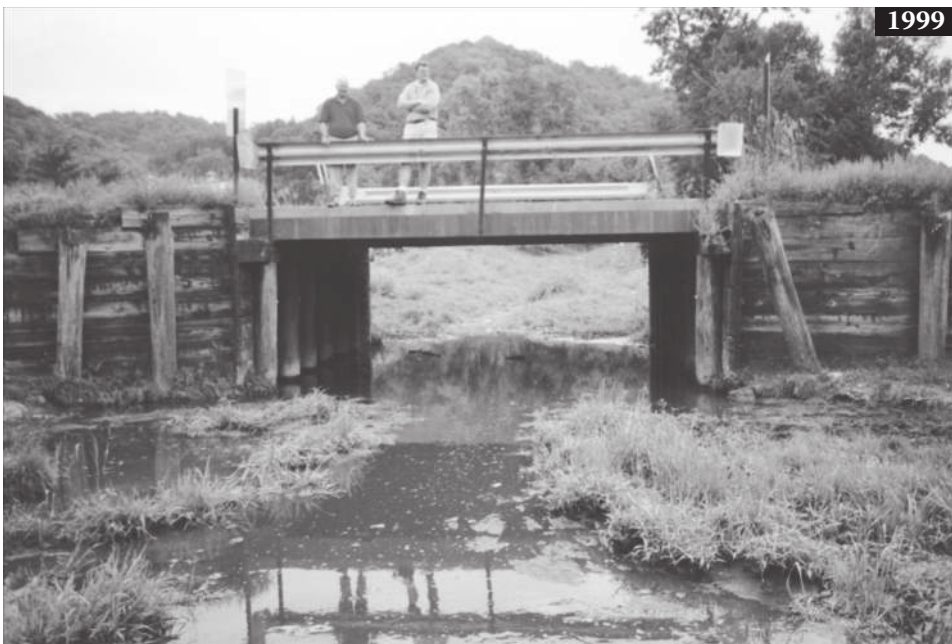
Figure 4.6 The Zink farm. Standing on fan looking east (upstream) at bridge on County Road O. Top: 1975. Wingwalls of buried earlier bridge are still visible. An excavation 5 ft (1.5 m) deep here in 1975 and 1976 did not reach the base of the wingwalls nor did it fill with water, indicating the lack of permanent flow and significant underflow at that time. Bottom: 1999. The wingwalls have been buried in the aggrading fan. Most notable to observe is the permanent streamflow, which began in 1988. For scale, the person to the right is 77 in. (193 cm) tall.

Streamflow trends at the Zink farm are similar to those found elsewhere in the Hill Country. The presence of spring here was a determining reason for locating the house but, by the early 20th century, the spring was failing so that the local stream was dry most of the time. But by the 1980s, as the result of improved land use and increased infiltration of rain, the spring was rejuvenated and has increased in strength ever since (Figure 4.6).

The present bridge over the fan on County Road O (old Wisconsin Highway 35) at the Zink farm is the latest in a long line of bridges there. I excavated the wingwalls of an earlier bridge in 1975, but those were since buried by the fan (Figure 4.6). The small but permanent stream now flowing under the bridge and off to the southwest in a ditch deserves

special mention. From the first time I saw the channel in 1973 until 1988, it was always dry. The wingwalls of the buried bridge shown in Figure 4.6 were excavated to depths of about 5 ft (1.5 m) in both 1975 and 1976, but no water even seeped into the hole, thus showing that there was no underflow at that level. But by 1988, a trickle of surface water was passing under the bridge. Coming from the rejuvenated Zink spring, the flow has grown stronger with each passing year. This pattern has been repeated countless times in the Hill Country and accounts for the higher base flow of streams (Gebert and Krug, 1996; Potter, 1991; Kent, 1999; Shilling and Libra, 2003).

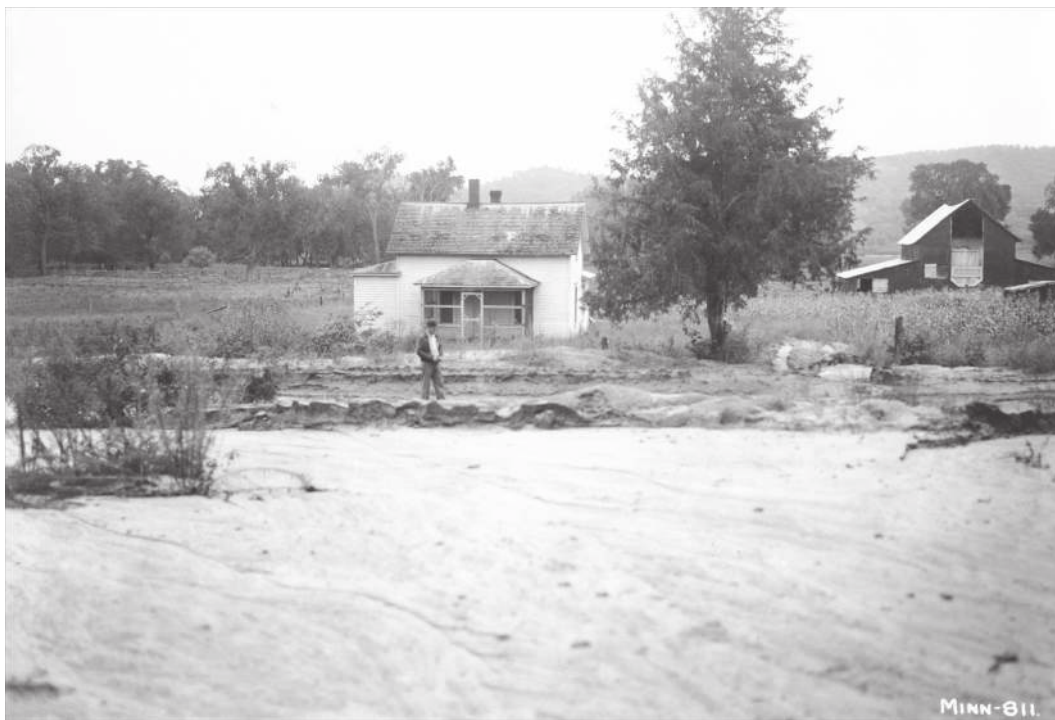
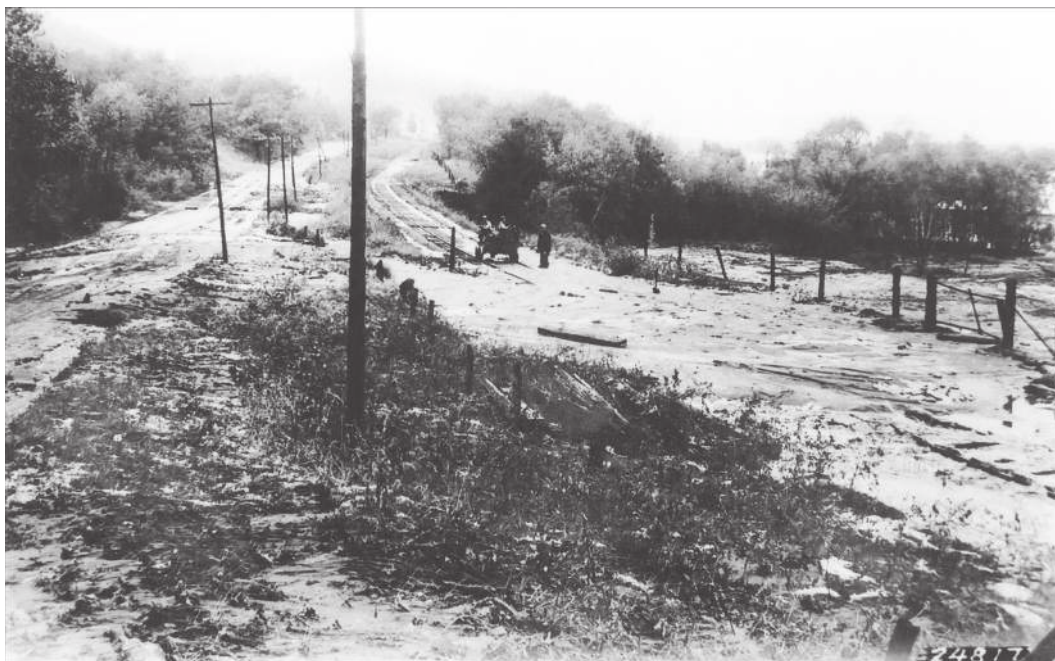
Figure 4.7 Examples of gully fans covering roads and railroads. Top: Sand fan over MN highway 74, 2 mi (3 km) west of Weaver, 9/7/38, looking south. (Photo credit: Vince McKelvey). Farm in background was already abandoned. Bottom: sand fan over railroad, location unknown. (Photo credit: C.G.Bates, 8/2/30.)

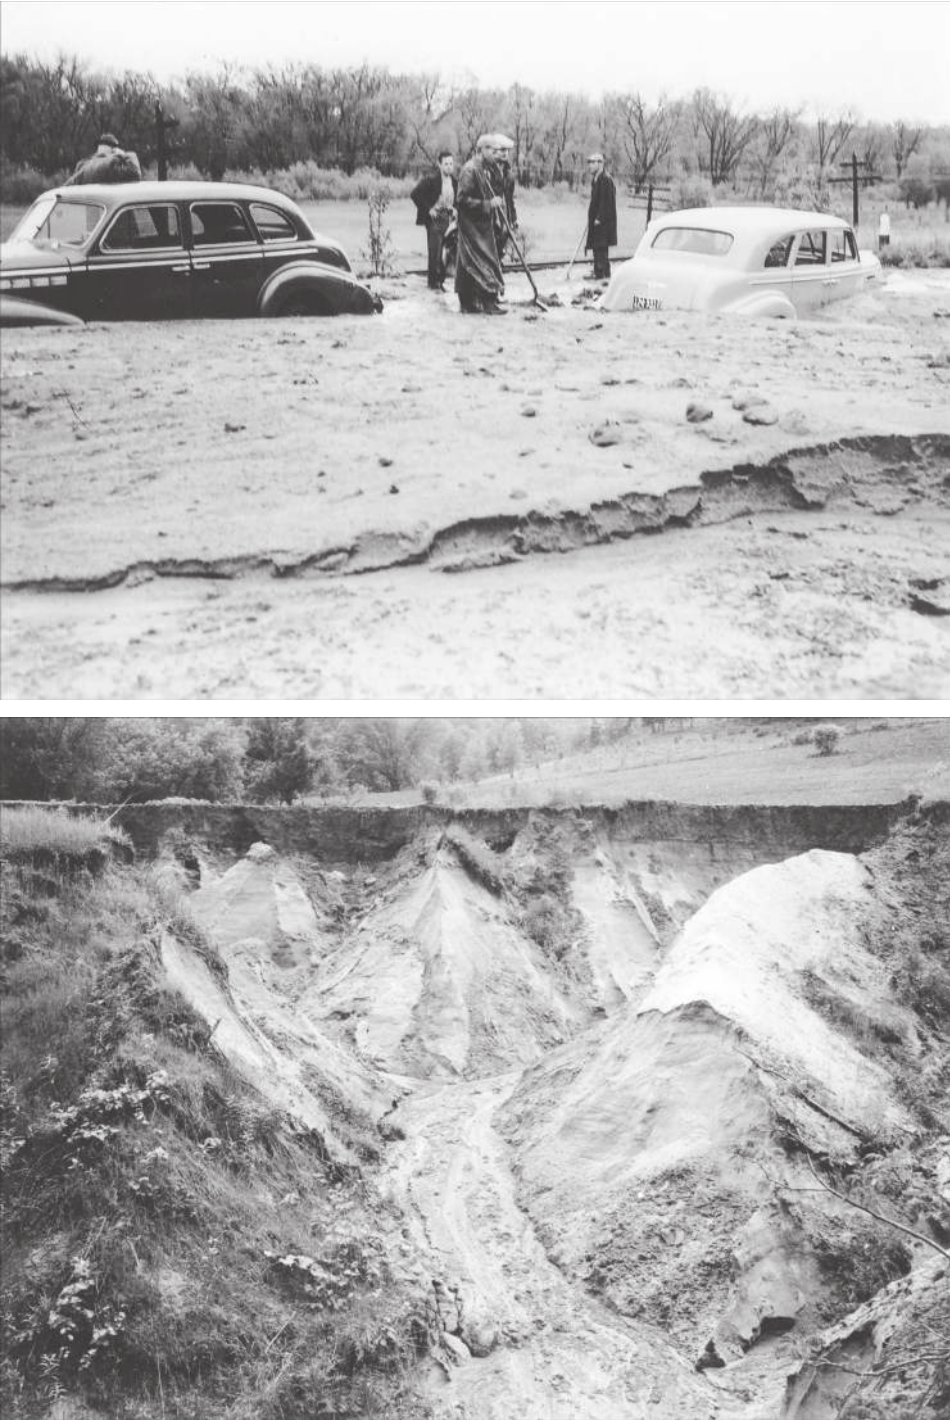
Figure 4.8 Top: cars halted and partially buried by sand fan on US Highway 61 about 2.5 mi (4 km) north of Weaver, Wabasha Co., MN, 6/7/40. The fan covered 0.2 acre (0.08 ha), was 7 ft (2.1 m) thick at the apex, and contained 4.6 acre-feet (5,700 m³). Bottom: The gully that created the fan, 6/9/40. Note the almost vertical walls. (Photo credit Soil Conservation Service [SCS].)

Many hillside gullies debouched onto farms, farmsteads, roads, and railroads (Figure 4.7). In at least one incident, cars were actually buried in the fan of a gully while under way on a federal highway (Figure 4.8). The event happened so fast that the occupants were trapped in their cars by the sediment that was 7 ft (2.1 m) thick in some places, and they had to be rescued. The nearest rain gauge at Beaver, 8 mi (13 km) east, showed only 2.91 in. (7.5 cm) in 2 h (*Winona [Minnesota] Republican-Herald*, June 8, 1940).

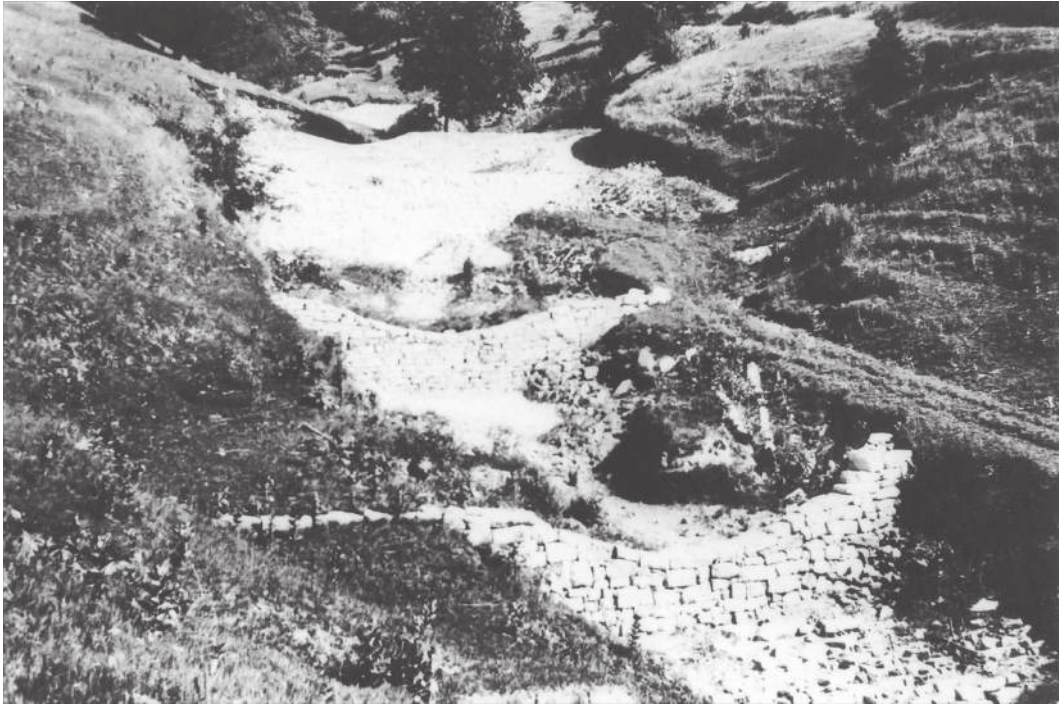
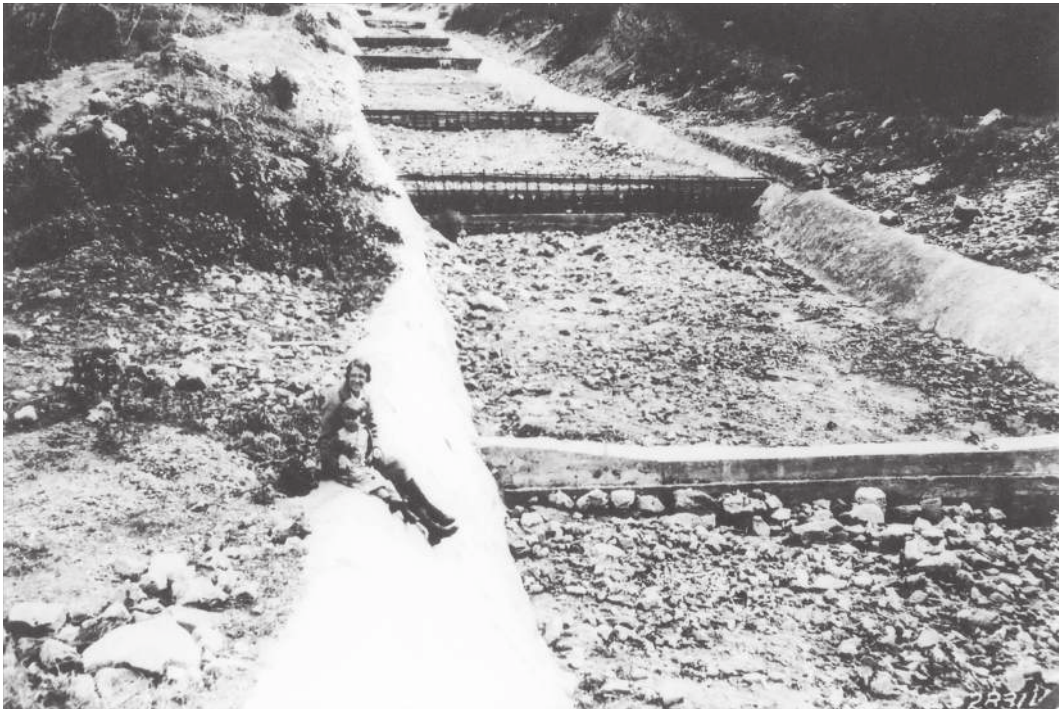
Figure 4.9 Examples of elaborate drop structures to control hillside gullies creating rock fans on transportation routes. Top: Near Genoa, WI, to protect railroad, 6/27/30. Bottom: Between Wabasha and Lake City, MN, 1932. (Photos credit: C.G. Bates.)

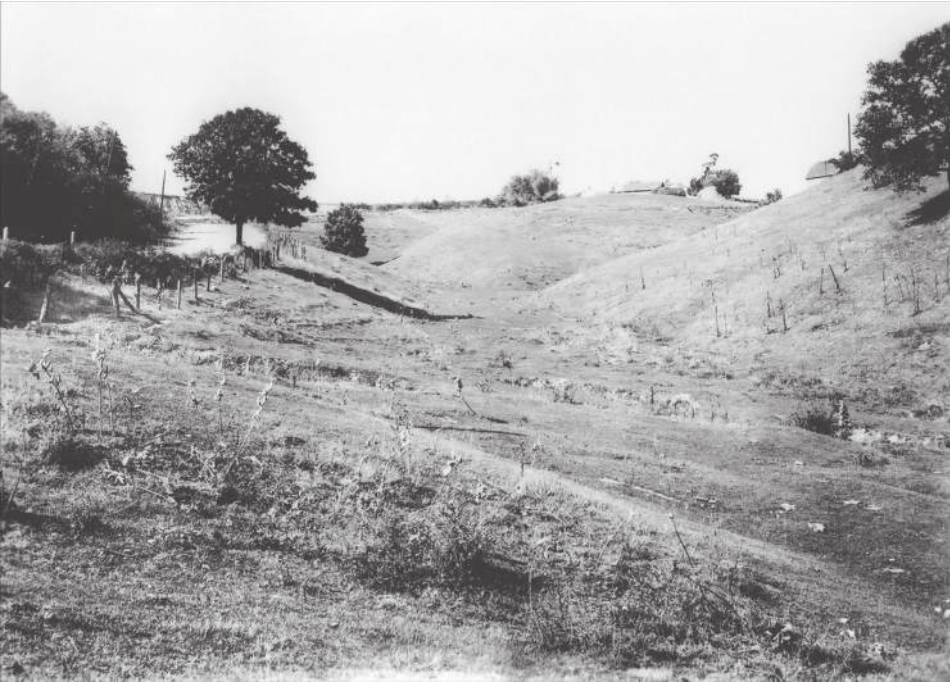
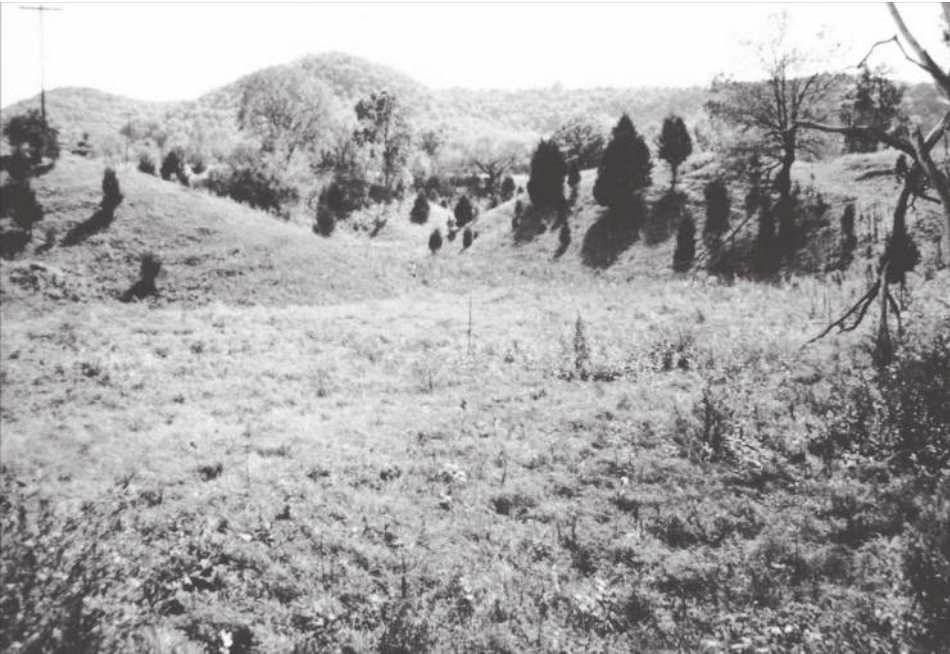
Figure 4.10 Untraced drainageways in Pleistocene terraces showing how such valleys appeared before trenching. Such untraced valleys are now rare. Historical sediment usually covers the valley floor to a depth of several feet. Top: Legue Coulee, 6 mi (10 km) NE of Etrick, Trempealeau Co., WI. (Photo credit: Stafford Happ, 9/26/40.) Bottom: Small valley leading into Coon Creek. (Photo made from Cedar Valley Drive, looking downstream (south) about 1 mi [1.6 km] southeast of Proksch Coulee gully [SE1/4, Sec 26, T14N, R 7W], c. 1977.)

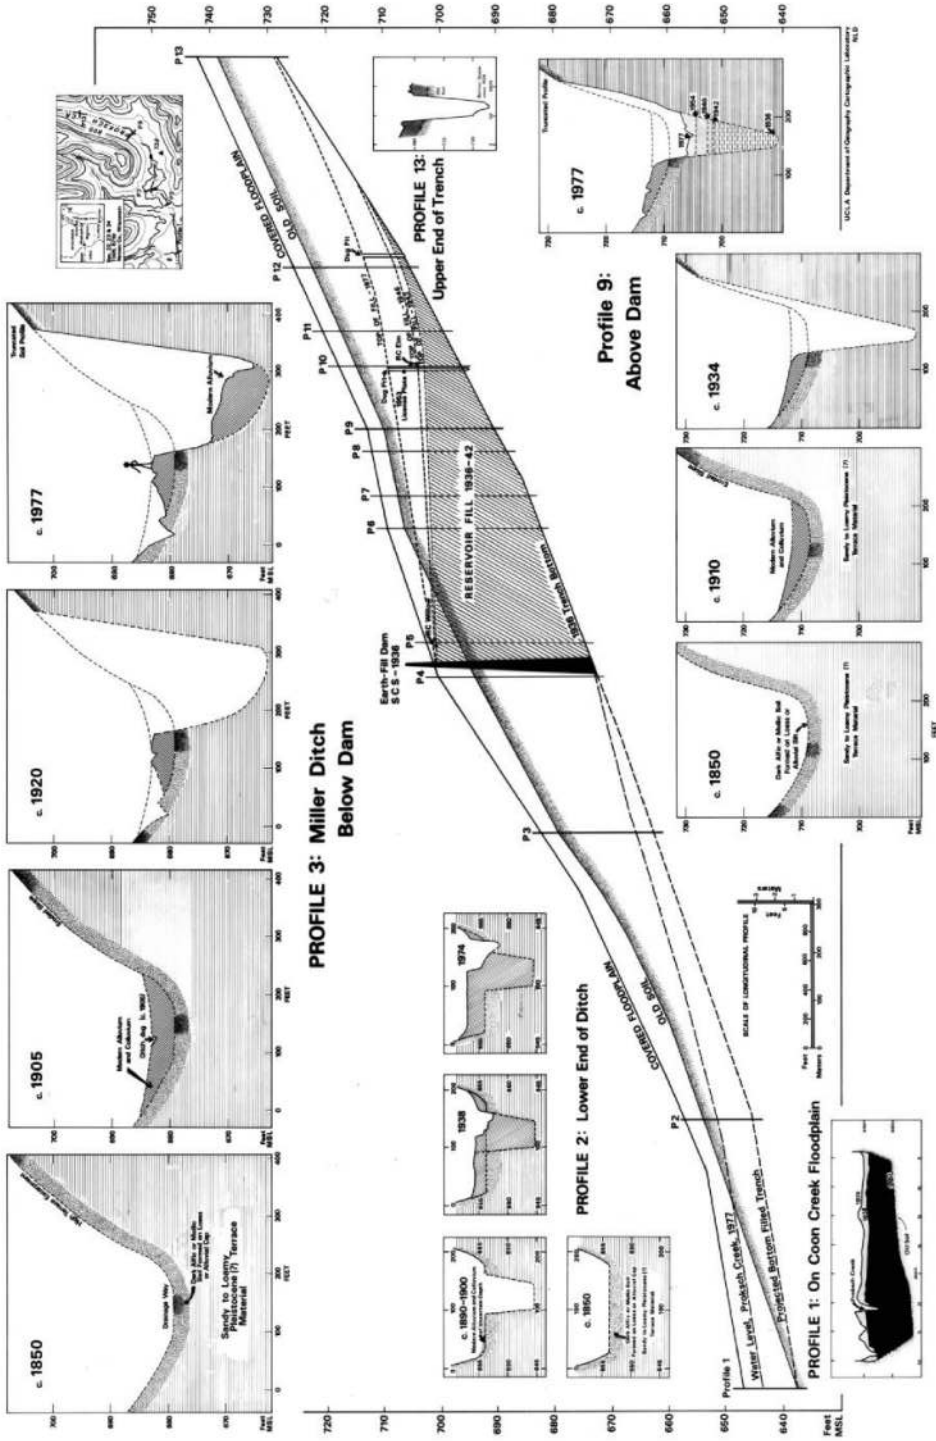
Figure 4.11 Explanatory diagram of Proksch Coulee Trench (Gully) development based on intensive field research and precise surveys done 1974-1977.

The “solution” was to cut a drainage ditch down the vale with a plow. This concentrated the flow, increased stream power, and caused incision (Figure 4.12, Profile 3). Since there was little vegetation in the vale, the water cut rapidly through the mud, further concentrating flows and stream power (Figures 4.11 and 4.12) so that the buried native turf was easily breached. Soon, there was a huge gully looking much like an arroyo in the western United States. Indeed, some of the western arroyos were started in much the same way as in Proksch Coulee (Cooke and Reeves, 1976; Sir Ron Cooke, personal oral communication, April 1985).

During the 1920s and 1930s, before the dam was built, much of the sandy debris from this gully was deposited in a huge fan on the Coon Creek floodplain, only a few thousand feet downstream (Figure 4.11, Profile 1), accreting it to depths of more than 10 ft (3 m). Crops were destroyed several times during that period, and the coarse debris and wetness lowered the agricultural value of this land (Figure 4.15).
