**HISTORICAL AGRICULTURE
AND SOIL EROSION IN THE
UPPER MISSISSIPPI
VALLEY
HILL COUNTRY**

STANLEY W. TRIMBLE

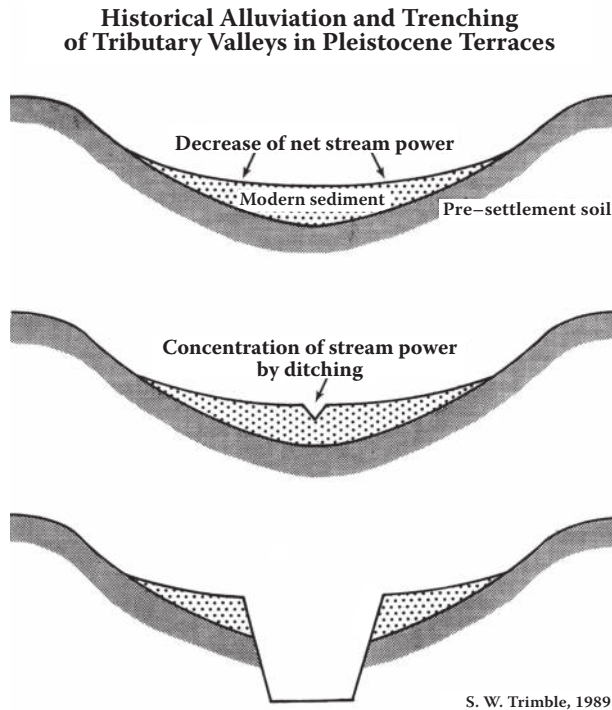
Figure 4.12 Schematic explanation of the trenching of Proksch Coulee. Concentrating the flow and increasing the depth increased the power of the stream to erode (see Chapter 3, Figure 3.10). This diagram may apply to many if not most of the trenched Pleistocene terraces of the Hill Country.

The “solution” was to cut a drainage ditch down the vale with a plow. This concentrated the flow, increased stream power, and caused incision (Figure 4.12, Profile 3). Since there was little vegetation in the vale, the water cut rapidly through the mud, further concentrating flows and stream power (Figures 4.11 and 4.12) so that the buried native turf was easily breached. Soon, there was a huge gully looking much like an arroyo in the western United States. Indeed, some of the western arroyos were started in much the same way as in Proksch Coulee (Cooke and Reeves, 1976; Sir Ron Cooke, personal oral communication, April 1985).

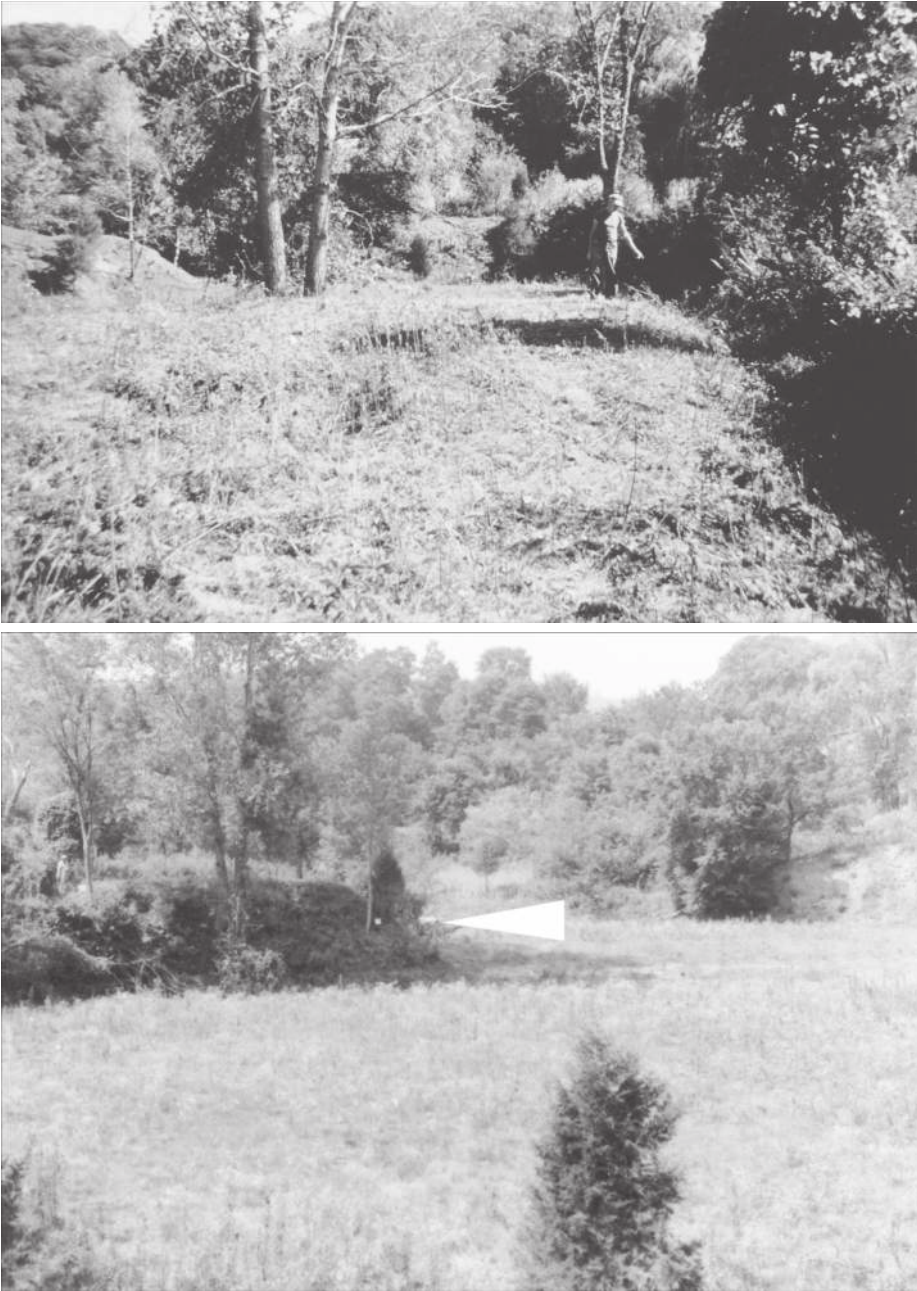
Figure 4.13 Top: Elmer Miller in 1977 points to a portion of the ditch his grandfather dug in 1905 to drain the bottom of the channel. Subsequent trenching bypassed this reach of the ditch and cut around the left side (to the viewer here looking upstream) leaving this part isolated and elevated. Bottom, 1977: Looking downstream at the terrace floor remnant on which Miller stands in top photo. Dr. Stafford Happ stands in the gully remnant. For some reason, perhaps a blocked channel, the gully cut around to the right and bypassed this site. The two white flags on slope to right (arrow) mark the buried dark soil of the original (pre-trench) valley bottom, covered with about 6 ft (2 m) of historical sediment. The gully floor in the foreground to the right is now covered with about 6 ft (2 m) of alluviation adjusted to the aggraded floodplain of Coon Creek 1000 ft (300 m) downstream.

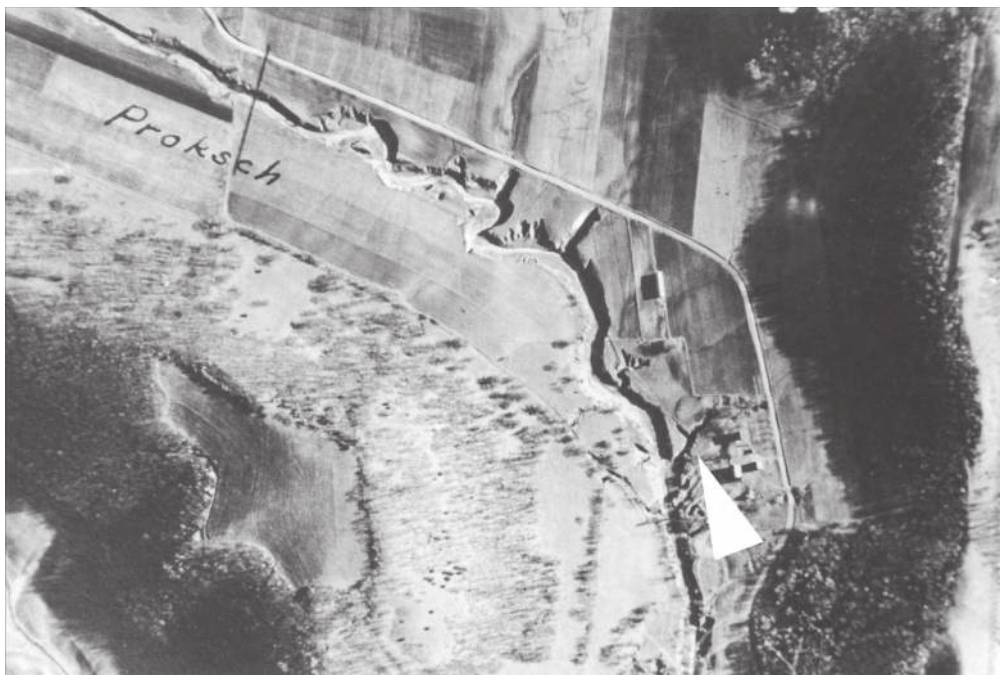
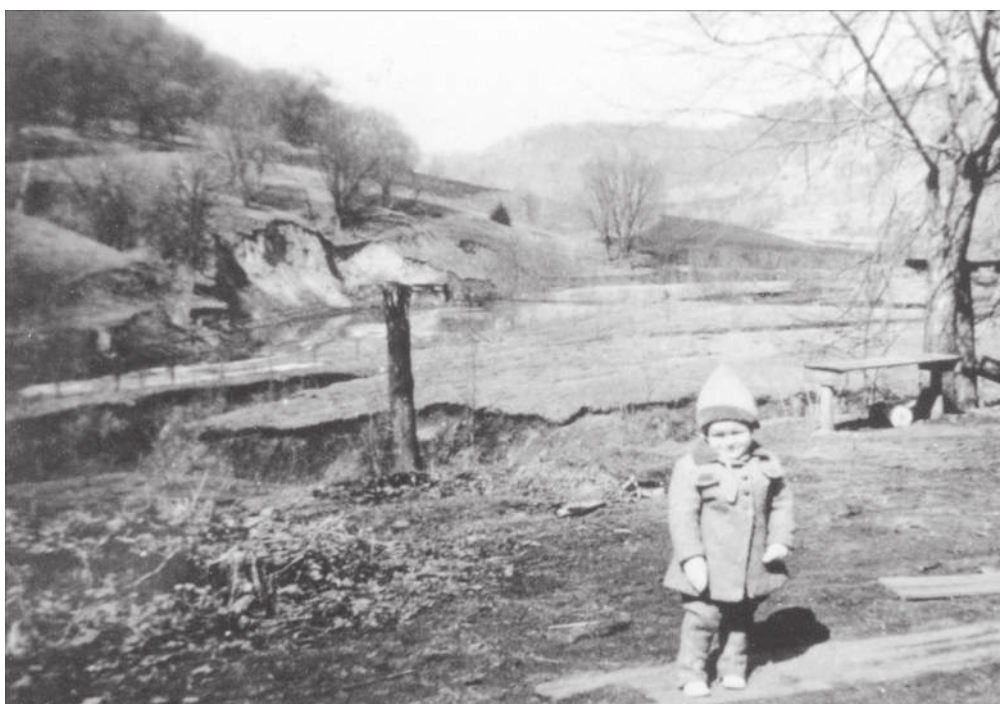
Figure 4.14 Proksch Coulee Trench. Top: air photo, Feb 1934. North is to the left and the photo covers about 4000 ft (1,220 m) of the trench. Bottom: photo made in the Clement farmyard (arrow in top photo) looking up the valley, late 1930s. Note the bare, almost lunar-like, grazed landscape and the recent, vertical quality of the gully walls in the background.

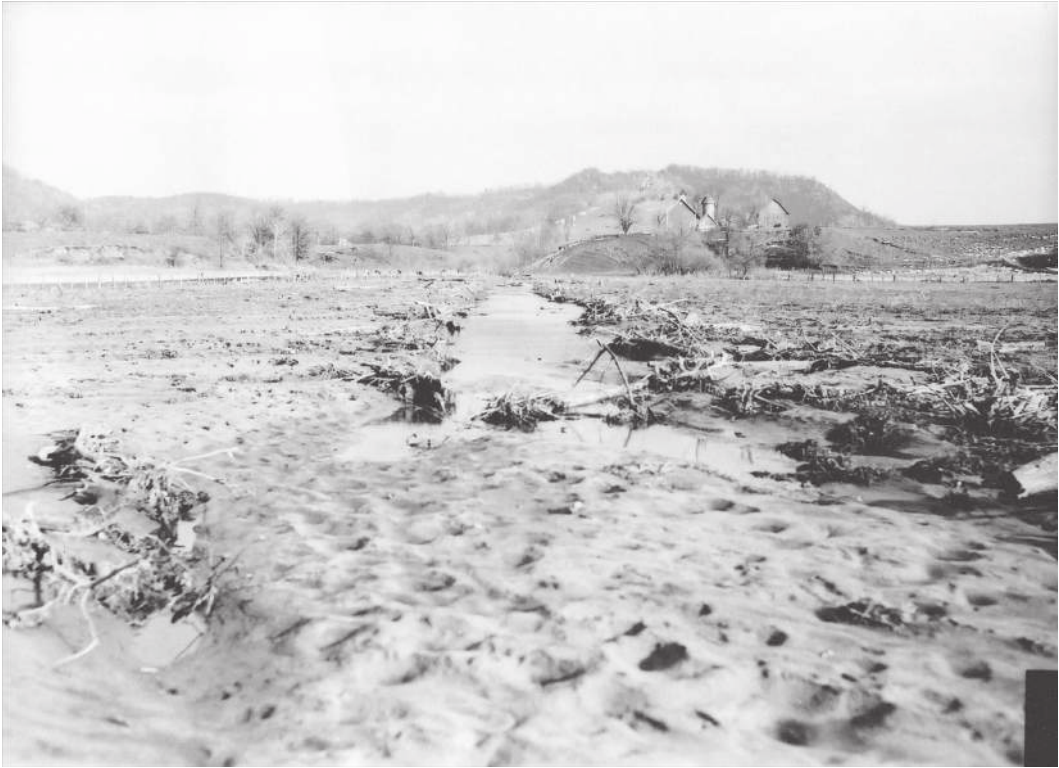
Figure 4.15 Alluvial fan from Proksch Trench on Coon Creek floodplain looking northeast up the channel. (Photo credit: S.C. Happ, 11/11/38 (NW1/4, Sec27, T14N, R7W, Vernon Co.) The extremely straight channel appears to have been dug and is completely occluded (filled up) in the foreground. Note sandy wash on floodplain and obviously wet conditions. However, this huge influx of sand has created an elevated fan out across the floodplain quite visible on the most recent USGS *Stoddard* sheet (1:24,000, 1983).

completely occluded (filled up) in the foreground. Note sandy wash on floodplain and obviously wet conditions. However, this huge influx of sand has created an elevated fan out across the floodplain quite visible on the most recent USGS *Stoddard* sheet (1:24,000, 1983). 104

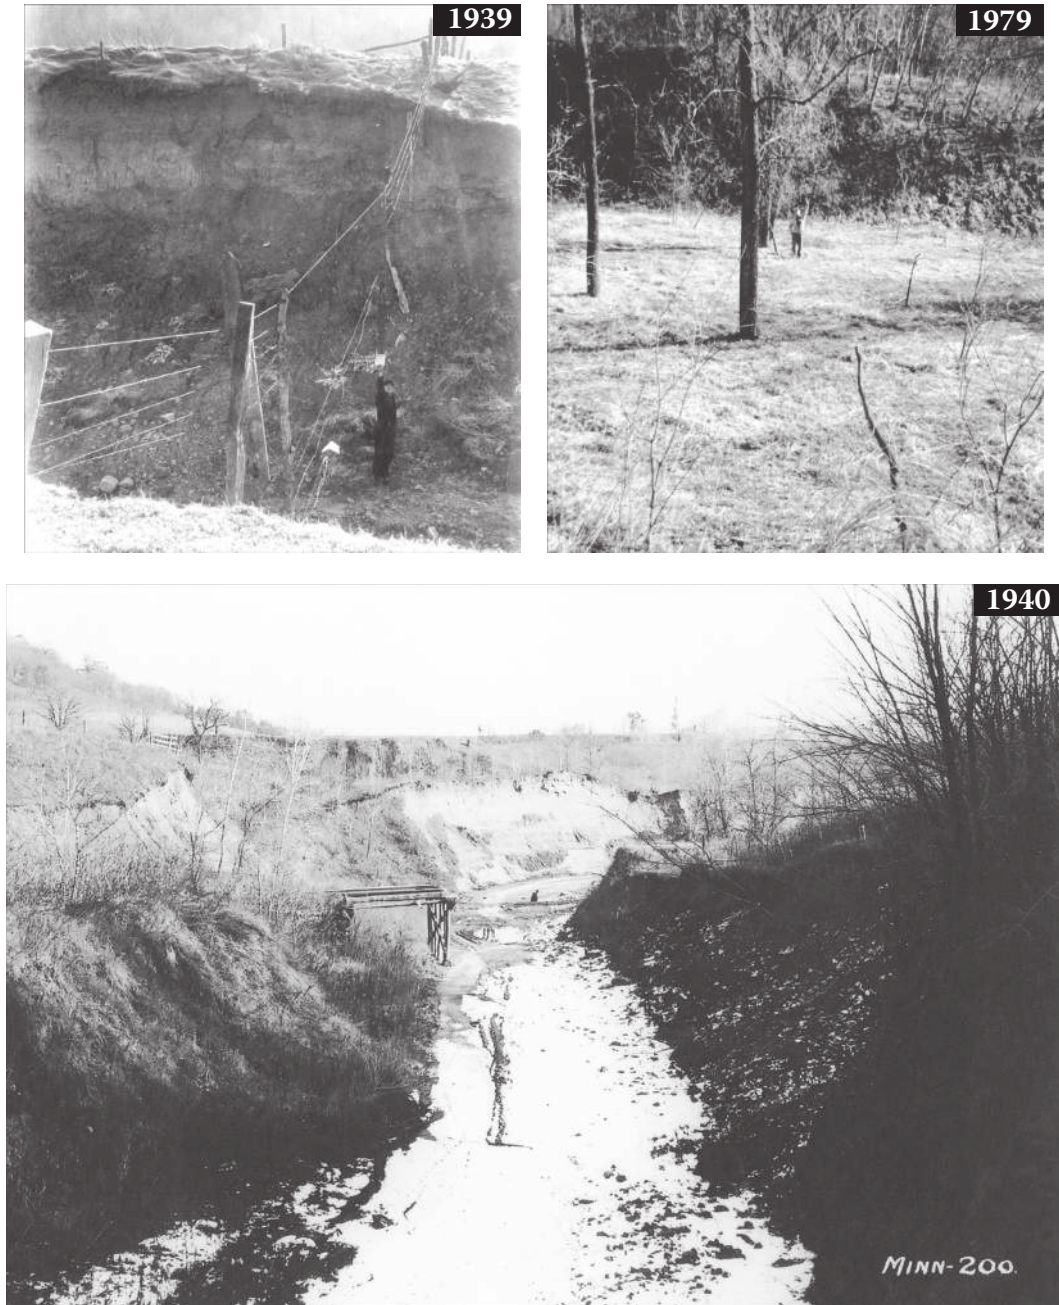
Figure 4.16 Ratz gully. Top left: 11/27/39, looking south (between Sec 3 and 4, T108N, R10W, Winona County, MN). Line fence was rebuilt 1933–34, but just 6 years later was undercut and suspended about 10 ft (3 m) above the valley floor. Distance to far bank was about 50–60 ft (16–19 m). Top right: repeat of photo, made July 1979. Distance to far bank was about 275 ft (84 m). Bottom: c. 1940, looking downstream (east) toward remains of Ratz bridge, constructed in the 1930s after the gully became too deep to cross. Gully has cut around right side, isolating the Ratz farm to the left (north).

One of the most spectacular gullies in the Hill Country was the Ratz gully located 2 mi (3 km) north of Beaver, Minnesota, in Glendale Hollow, a tributary valley to the Whitewater River coming in from the west. The time and immediate cause of the initiation is not known exactly, but the gully was obviously recent and out of control by the mid-1930s. Photographs made in 1939 show a line fence, rebuilt in 1933 or 1934, suspended about 10 ft (3 m) above the abyss of the gully, suggesting how rapidly the gully was eroding (Figure 4.16; for another time-lapse photo of this gully, see Trimble, 1998, p. 292–293). The gully separated the Ratz farmstead from the public road so that it was necessary for the Ratz family to traverse it on a regular basis. A bridge was erected across a narrow part of the new gully, but the rapid growth meant that arrangement would not last long. A tragic yet humorous story was told about a member of the Ratz family returning to the farm late on a very dark night. It had rained during the day and, unbeknownst to him, the gully had enlarged significantly. Trudging in the gloom along his familiar route on his way to cross the bridge, he fell into the newly enlarged section where just that morning, his road had been (Figure 4.16). While he was reportedly unhurt, the tragedy was that access to the farm had been cut off again, but the point of the story is the extreme rapidity of erosion. Using several photos of the fence crossing and later detailed surveys, a cross section of the gully was reconstructed (Figure 4.17).

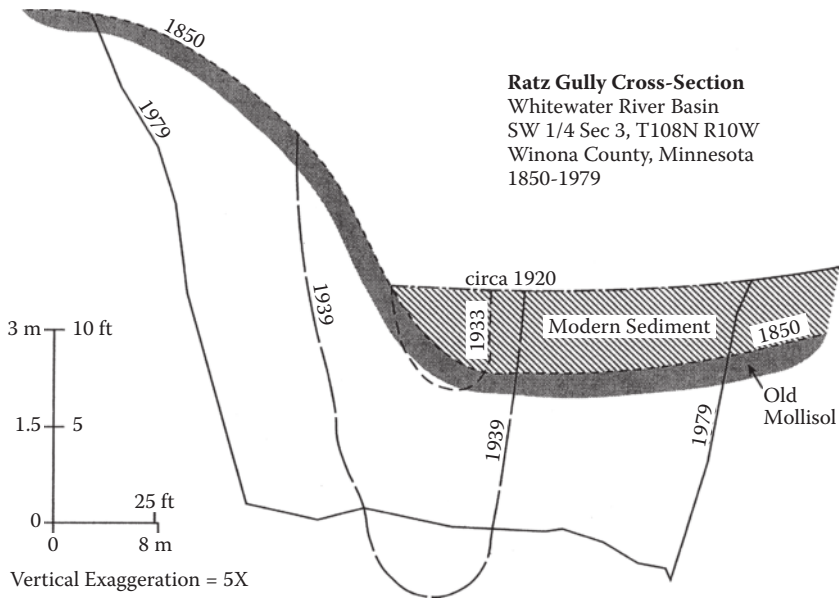
Figure 4.17 Cross-sectional reconstruction, growth, and change of Ratz gully based on photos, surveys, and soils. (Redrawn from Trimble, S., *Catena* 32, 1998, 283–304.)

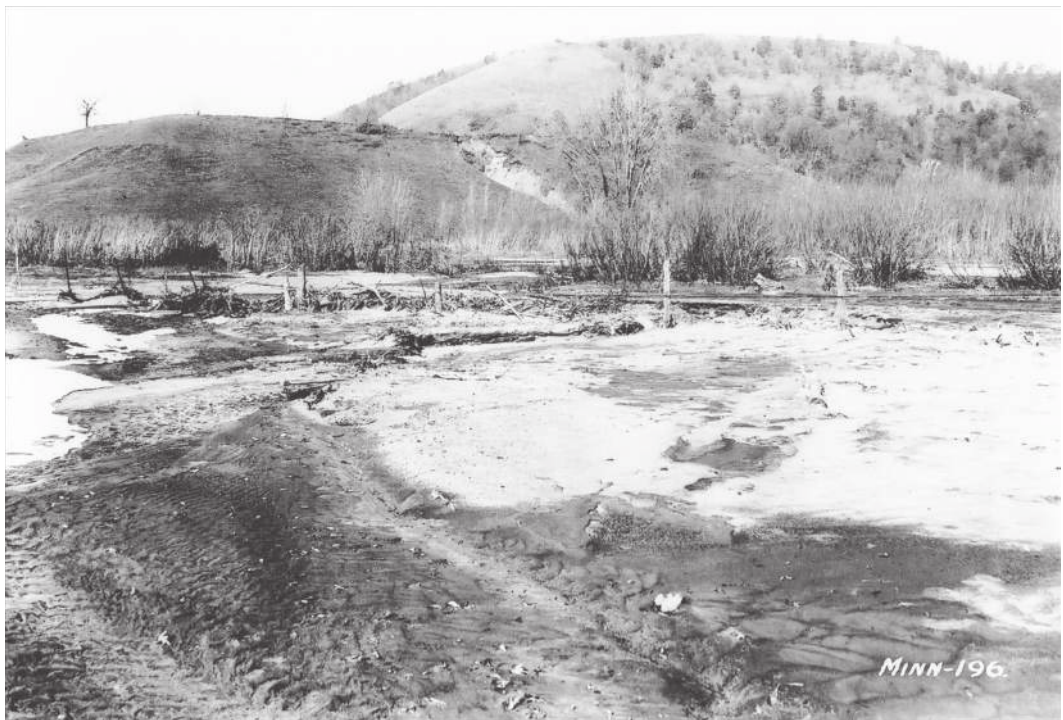
Figure 4.18 Mouth of Glendale hollow and fan of Ratz gully on Whitewater River floodplain looking northwest, 1939 (NW1/4, Sec 10, T108N, R10W). Note sandy deposits in the foreground and partially buried fence in middle background. In far left background is the face of the Pleistocene terrace with a new gully actively incising.

While the Ratz gully itself affected only a few farms in Glendale Valley, the fan of its debris spread out to the east over the already aggrading floodplain of the Whitewater River and the State Highway 74, which ran along the west side of the river. A 1939 photo of the fan shows the almost barren sandy landscape with a partially buried fence in the foreground. In the background is the terrace face with a small active gully visible (Figure 4.18). With almost every rain, copious amounts of sand were washed out onto and over the road to the rear of the photo.

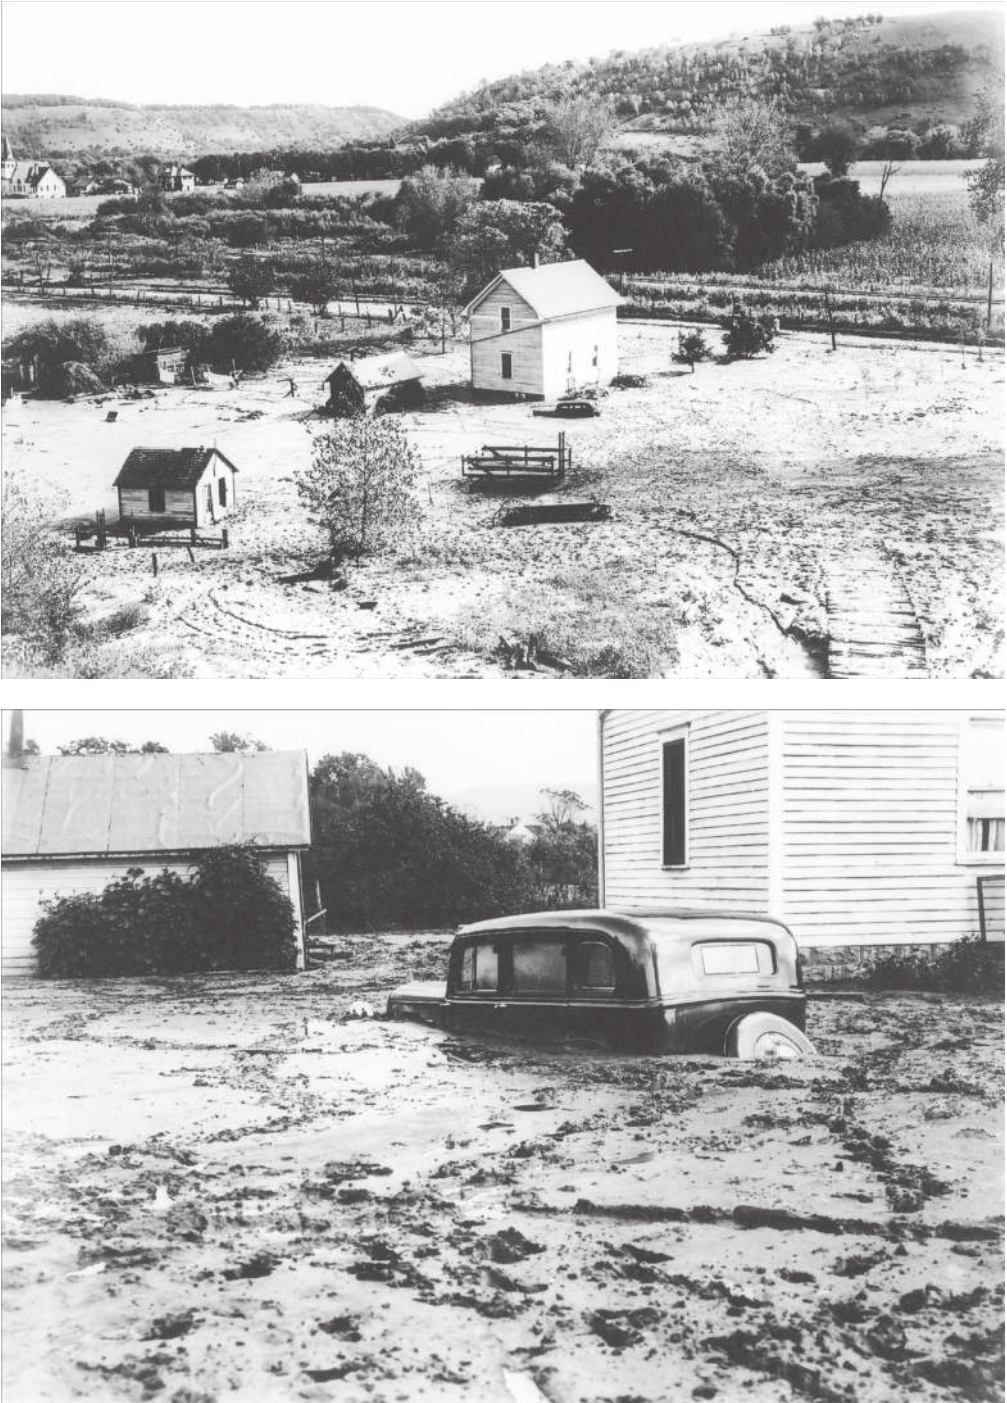
Figure 4.19 Fan from gully near Peterson, MN, 9/12/38. Top: standing on Pleistocene terrace face looking south toward the village of Peterson on the Root River. Methodist church in village in left background for reference. Gully to rear of viewer. Bottom: detail of car and house. (SCS Photos.)

As with the hillside gullies, there were hundreds if not thousands of terrace gullies active in the Hill Country during the 1930s. Three large ones have been recorded here, but most of the rest, especially the small ones, are undocumented. However, one in Peterson, Minnesota, was recorded on film simply because it was public, and it was so dramatic. So dramatic, in fact, that the frontispiece of this book depicts that event. In September 1938, the entire yard of a house was buried in a fan from a gully behind the house (Figure 4.19). Although no further details are known, the circumstances suggest that this event was a surprise, that neither the gully nor the fan were particularly active beforehand. For example, an active fan would have probably elicited a diversion wall of some kind in the yard to keep the water and sediment away from the house, but none appears in the photo. This demonstrates the fragility of these Pleistocene terraces and how out of control the Hill Country environment was by the 1930s. A visit to the site in 1977 revealed that the photo had been made from the top of the terrace, which was 30–35 ft (9–10 m) high. Several relict gullies, completely stable in 1977, were evident on the terrace surface and face, and these had presumably furnished the sediment.

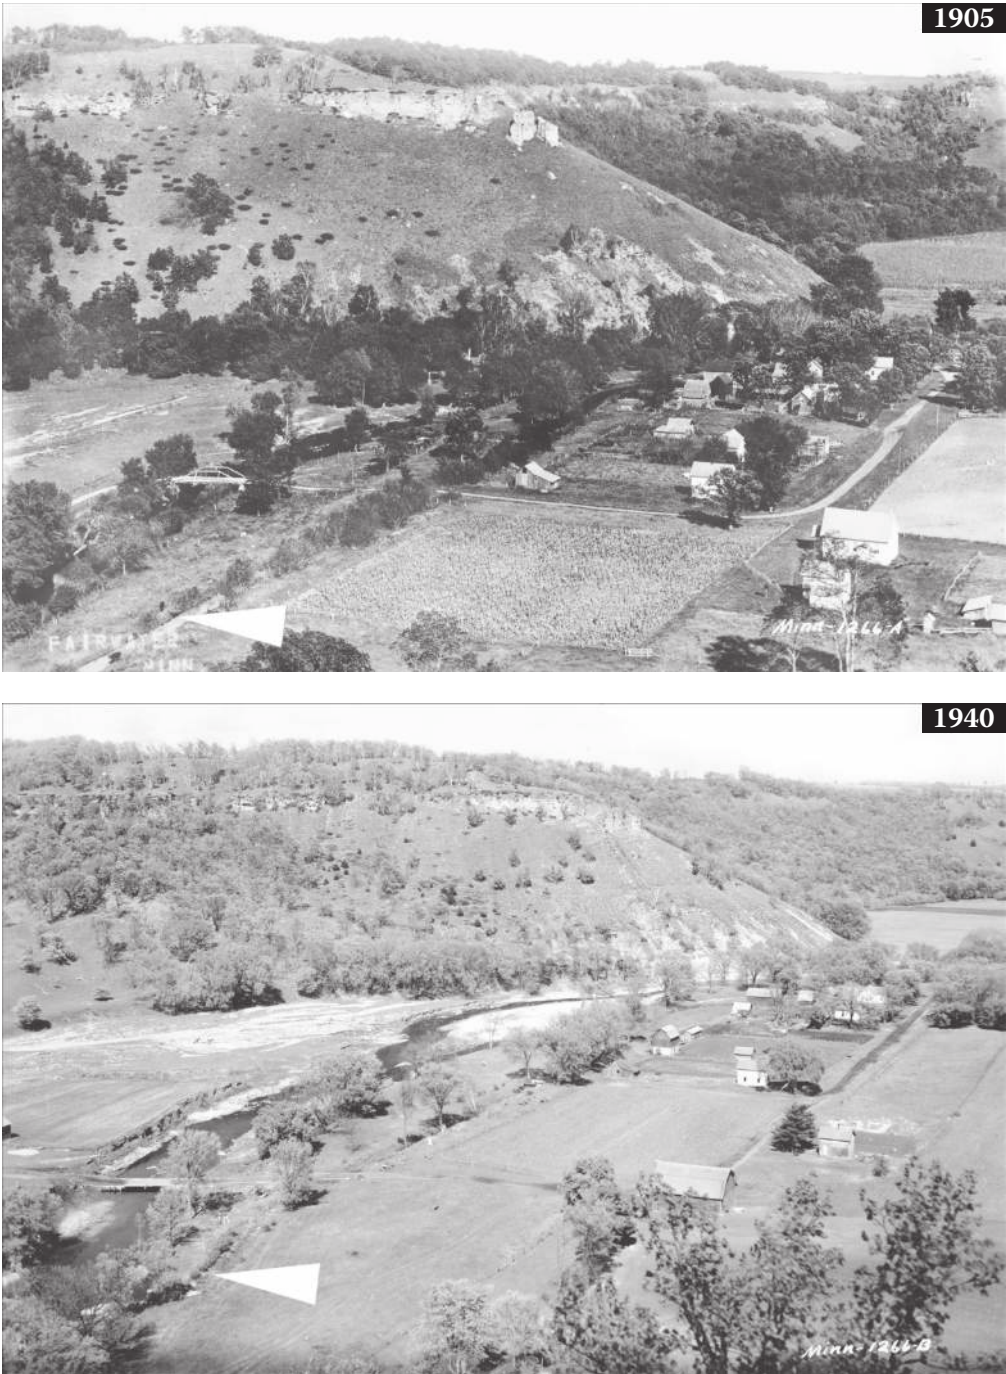
Figure 5.1 Fairwater, MN. Top: c. 1905; photo made from bluff west of town looking northeast (downstream). Note tree-lined stream (North fork, Whitewater River) and millrace (arrow). Bottom: 1940. Stream has widened by 2–5 times. Bridge in left foreground has been destroyed and a new one placed about 500 ft (150 m) upstream. Millrace is filled with sediment. Note bare “goat prairies” in background. (Continued)

By about 1940, the cumulative effects of poor land use were manifest and the stream had eroded its banks severely, widening to 2–3 times its earlier width, destroying the milldam and both bridges. Just downstream of the village, the stream had cut into a high Pleistocene terrace, destroying several acres of excellent farmland and sending vast amounts of sediment downstream to the upper main valley of the Whitewater River, just upstream of Elba. The gully active on the west side of the village had deepened and cut through its own fan all the way to the creek. It, along with many other gullies unseen in this photo, was also sending more coarse material (cobbles, small boulders) into the creek, which was helping to further destabilize the stream by widening it. The millrace appears to be almost filled with sediment. Only scattered buildings remain in the once-flourishing village. By 1975, modern soil conservation measures had taken effect, and the 1975 photos show a much more stable, tree-lined stream with no other visible signs of erosion or sedimentation.

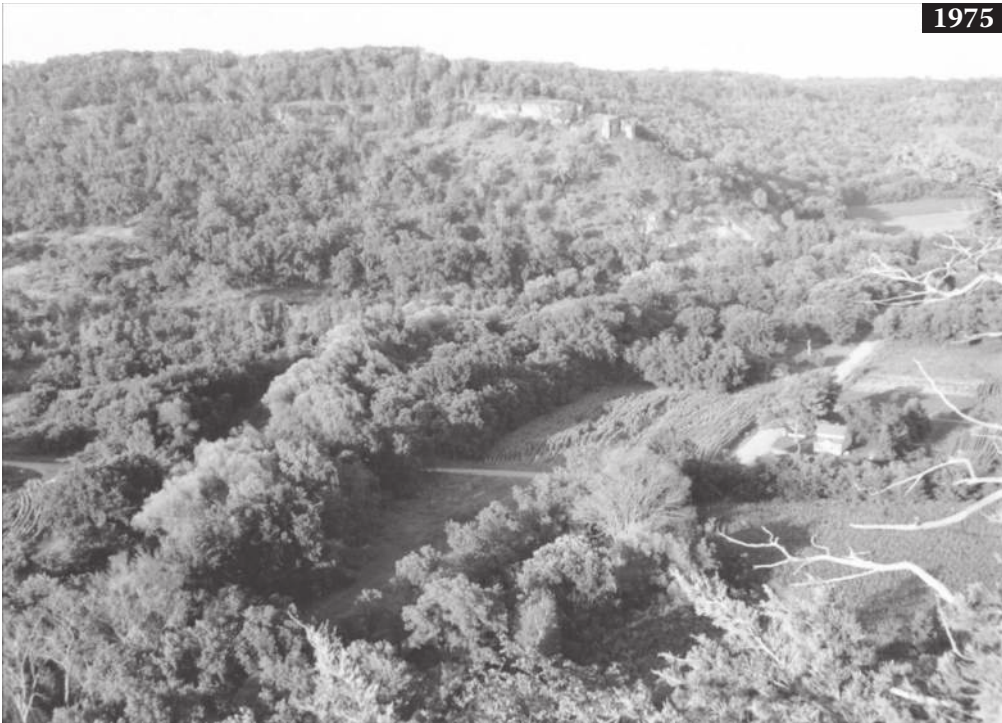
Figure 5.1 (Continued) Fairwater, MN. 1975: stream channel is again lined with trees and is no longer visible from this vantage point. Goat prairies are becoming revegetated.

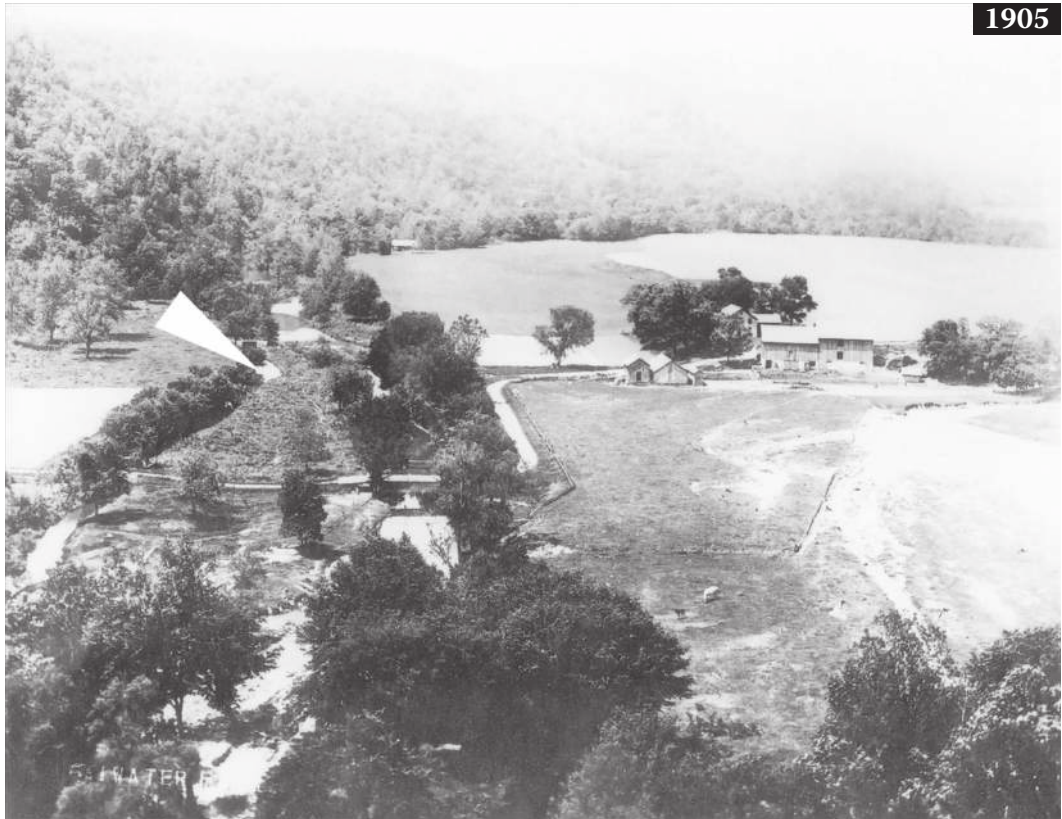
Figure 5.2 Fairwater, MN. Photos made from bluff on N. side of town (visible in Figure 5.1) looking upstream (west). c. 1905. Stream and millrace (arrow) lined with trees. Note small sand fan on right from hillside gully from valley to the right (north). (Continued)

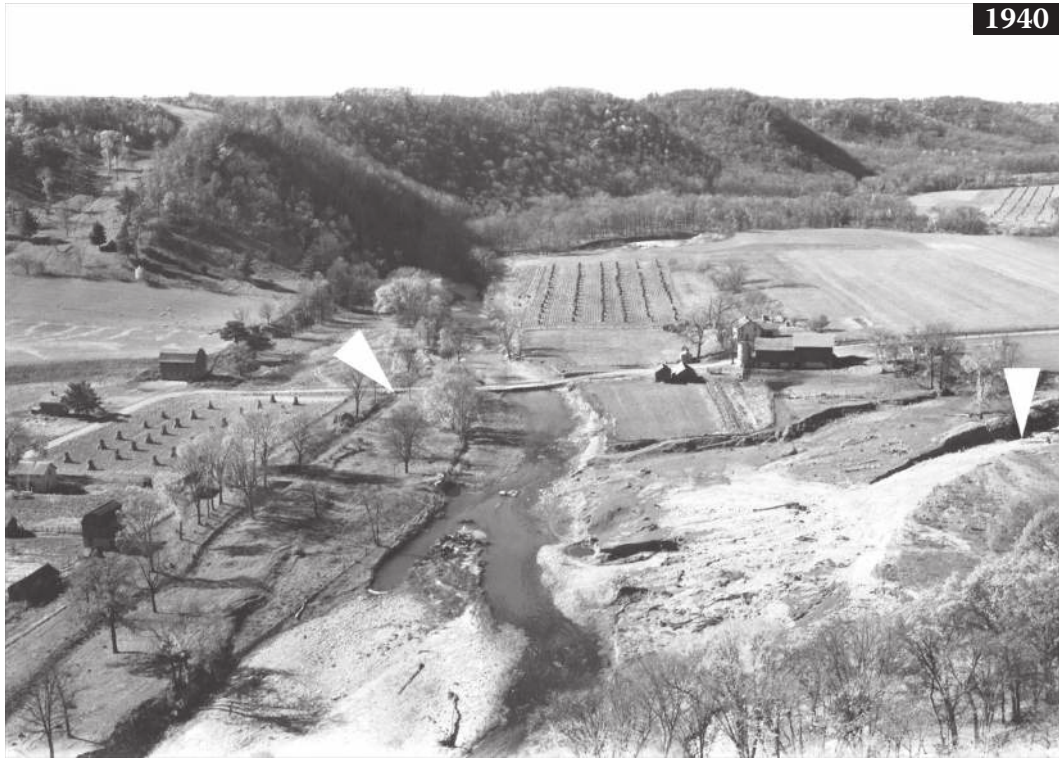
Figure 5.2 (Continued) Fairwater, MN. Photos made from bluff on N. side of town (visible in Figure 5.1) looking upstream (west). October 22, 1940. Stream has widened by 2–5 times, millrace (arrow) has filled with sediment, and gully from the right (north) has enlarged and deepened, and has created a boulder fan into the creek. The coarse bedload from this and other sources in this reach probably have played an important role in the severe bank erosion and widening of the stream. (Continued)

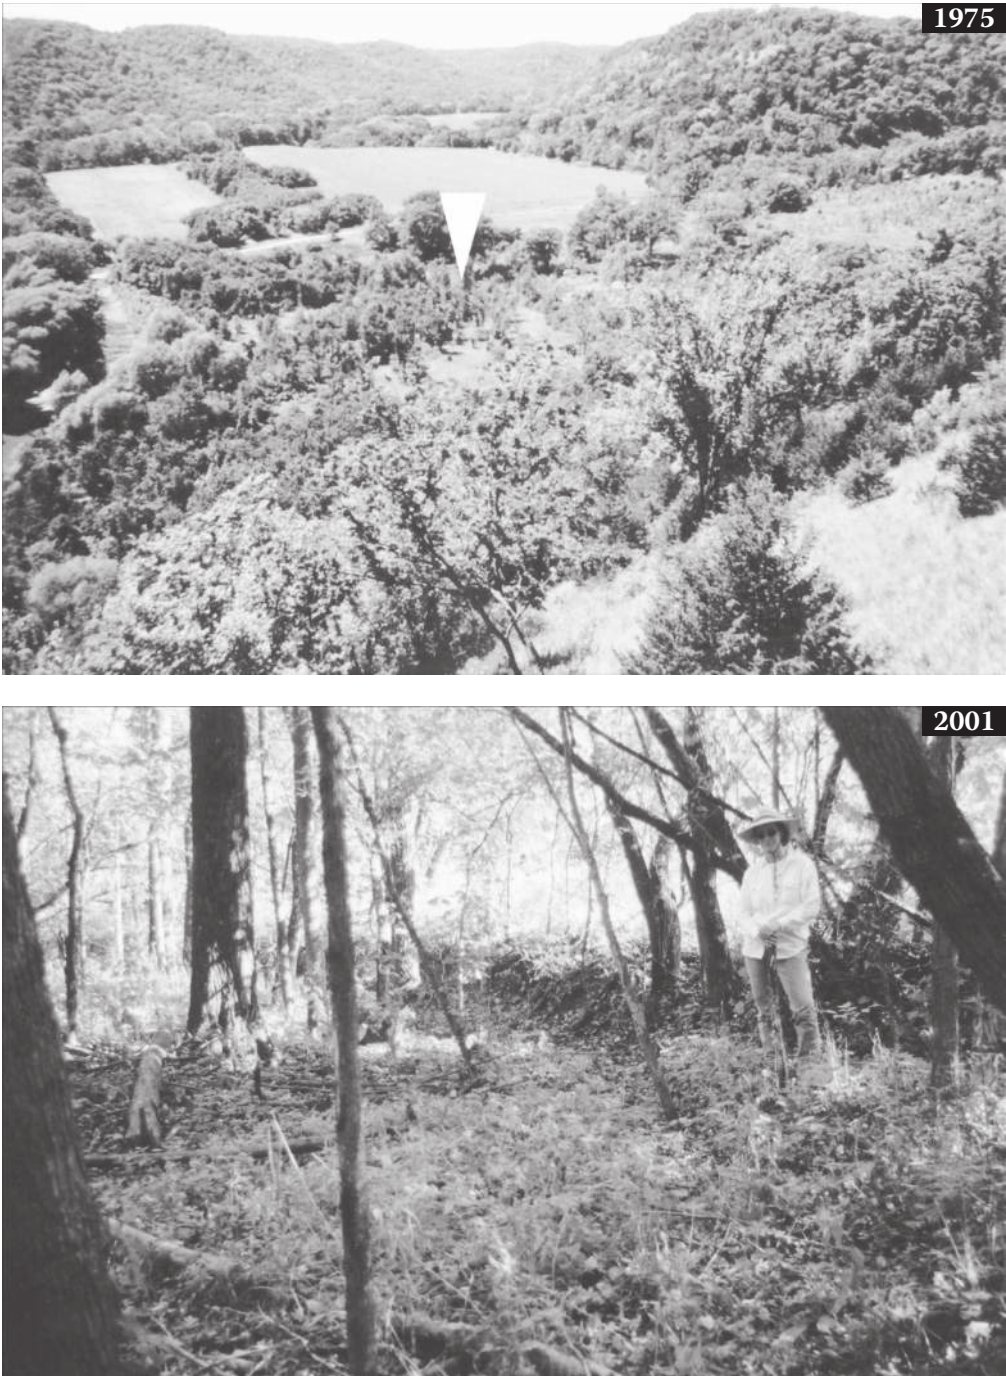
Figure 5.2 (Continued) Fairwater, MN. Photos made from bluff on N. side of town (visible in Figure 5.1) looking upstream (west). 1975: channel is again narrow, lined with trees and all is stable. 2001: old gully from the north now stable (arrow on 1940 and 1975). Note trees growing on old gully bottom. This is presently typical of most old gullies in the Hill Country.

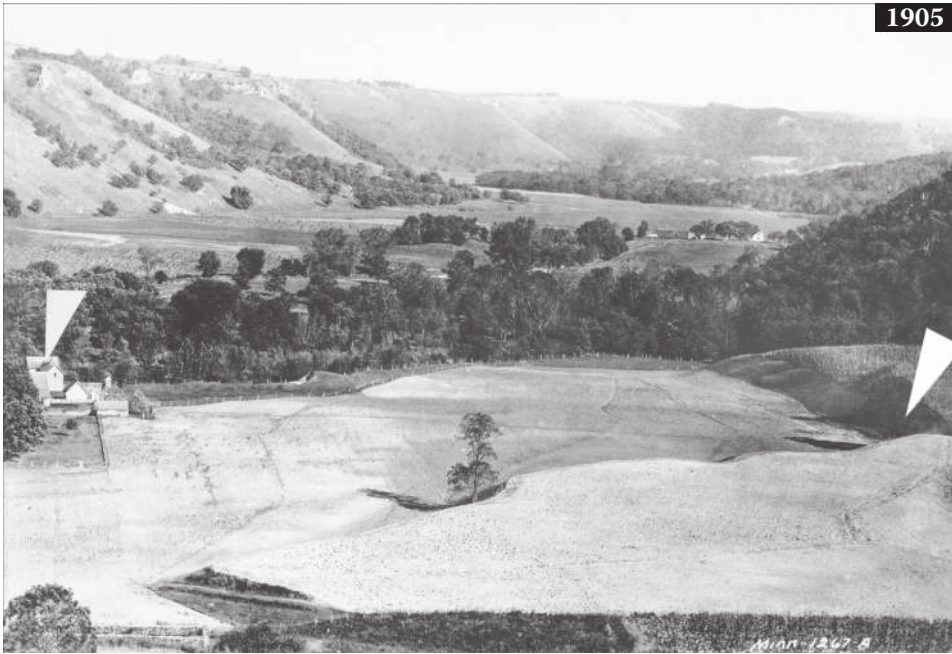
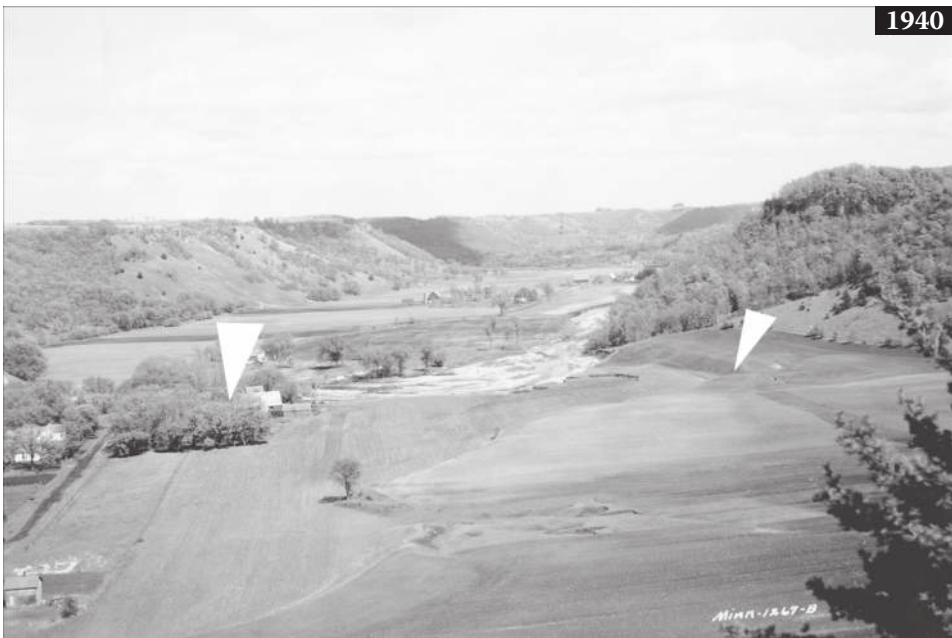
Figure 5.3 Fairwater, MN looking downstream (east). Top: c. 1905. Pleistocene terrace in fore and middle background. Stream in middle background is hidden by riparian trees. Goat prairies on hillsides in background to left on south side of hills. 1940: Stream has widened and eroded deeply into terrace. As the result of floods and the coarse sediment, the stream is now braided. Goat prairies in background now have more trees (see Figure 4.1 for a close-up of the same hillsides). The same farmhouse is marked by an arrow in all photos for reference. (Continued)

An interesting and significant landscape feature seen best in Figure 5.3 is the disappearance of the “goat prairie,” the south- and west-facing hillslopes that were largely grass at the time of settlement, environments once thought to be treeless because of xeric edaphic conditions. But the absence of trees was related to fire and grazing. Once those practices were curtailed, trees appeared. In Figures 5.1 and 5.3, one can, c. 1905, still see a long stretch of grassy hills facing south. By 1940, there is scattered woody vegetation, much of it juniper. Then by 1975, the slopes are covered in trees. When I last visited the hilltop photo sites in 2001, the trees had grown too tall to allow a repeat of the 1975 photos. The forest, now largely deciduous, has responded to the absence of fire and grazing. There are two important implications of these changes to this study. First, the absence of grazing improves the infiltration capacity of the slopes. Second, the trees transpire more water than the grass, providing more potential water storage in the soil. The result is less overland flow and erosion. The ridge seen in Figure 5.2 had several active hillside gullies in the 1930s, but none are active now (see the same hillside in Chapter 4, Figure 4.1). To see more forest growth on previous goat prairies, one should climb the old fire tower just east of Elba. Photos of the main valley c. 1900 are posted there, showing most slopes in goat prairie, so that one may contrast those with the mostly forested slopes at present.

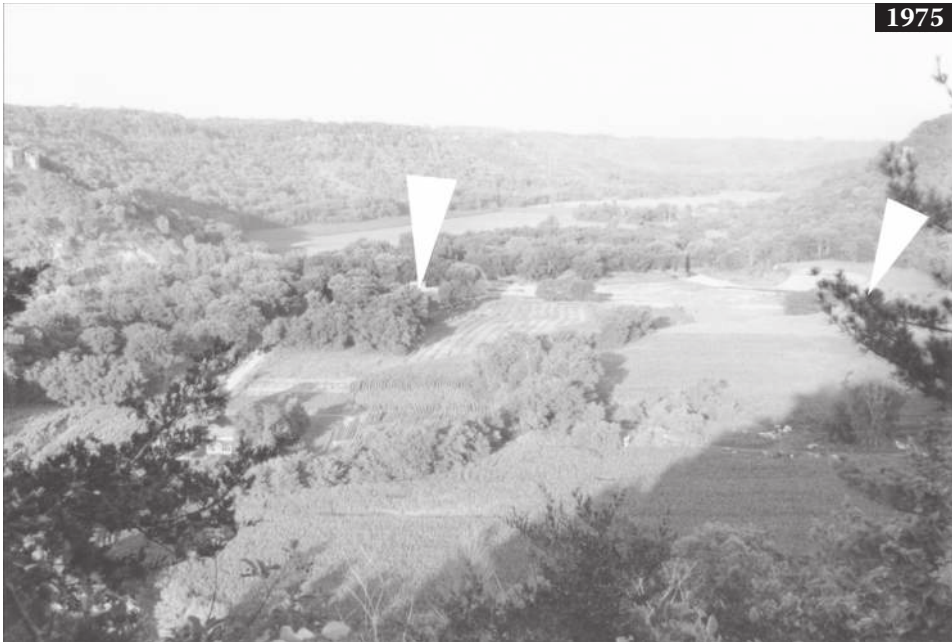
Figure 5.3 (Continued) Fairwater, MN looking downstream (east). 1975: stream had cut further into very high Pleistocene terrace. The arrow to the right points to the same spot on all three photos and indicates the extent of lateral bank erosion by 1940 and 1975. Thus, it can be seen that the stream had cut several hundred feet into the high terrace. Note that the high cut bank of the terrace in 1975 is partially obscured by a tree branch. See Figure 5.4. (Continued)

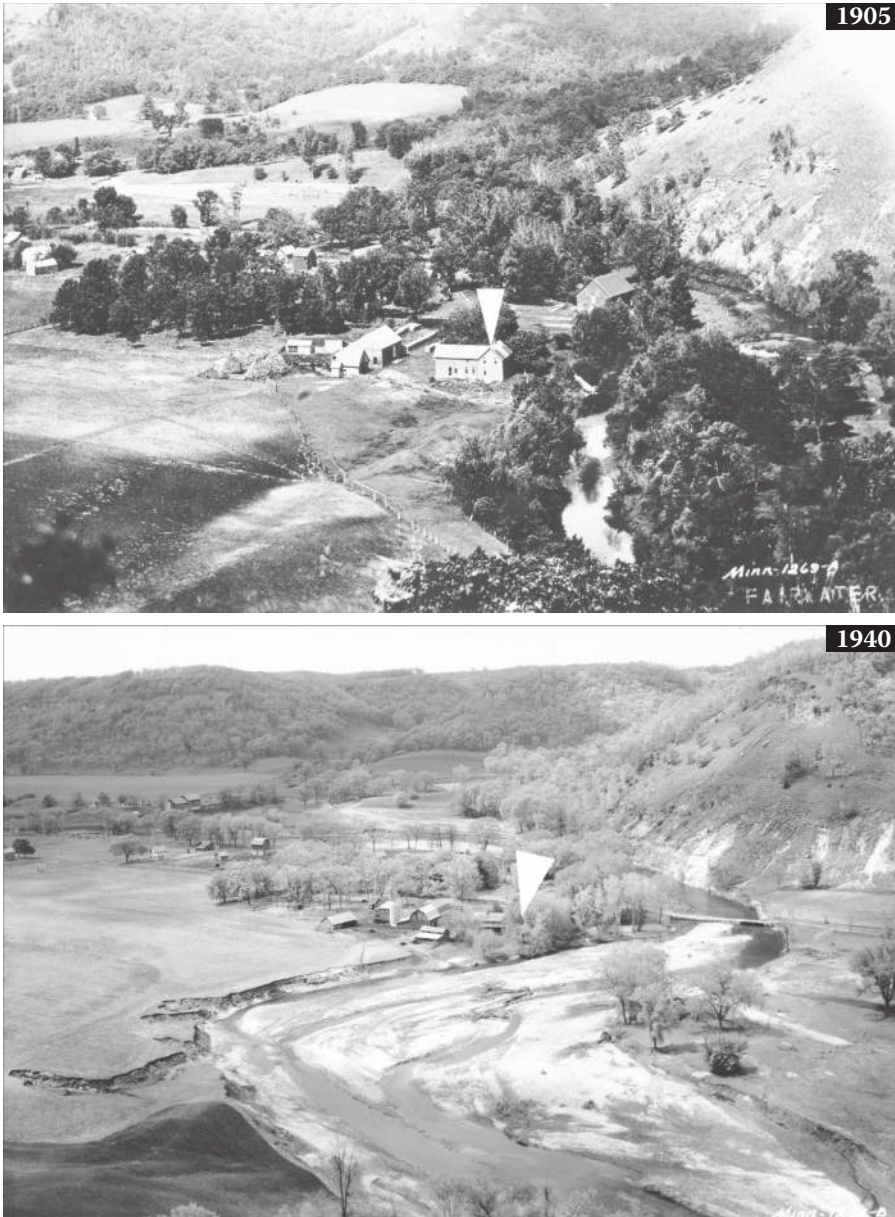
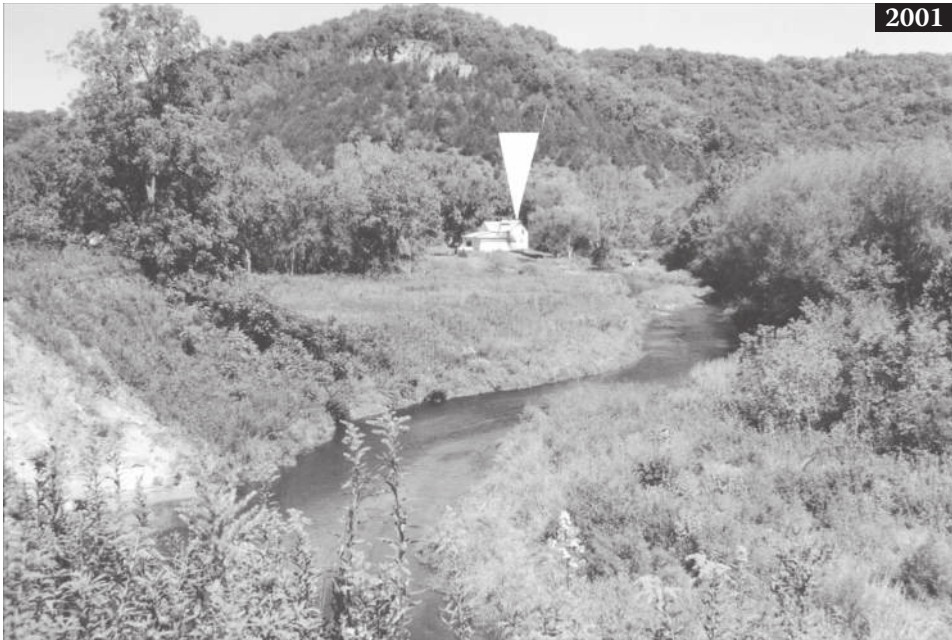
Figure 5.4 Fairwater, destruction of the high Pleistocene terrace, looking north/northwest (upstream) from hill on southeast side of the village. c. 1905: stream is narrow and tree-lined. House (arrow) is the same as marked in 5.3. Large, dark building just upstream from house is the mill. 1940: same view but taken farther back. Using the house as a marker, it will be seen that the stream had eroded laterally perhaps 150–200 ft to the left (west) and a comparable distance toward the viewer (south, see Figure 5.3). Not only is the high terrace eroding from stream action but is also eroding from agricultural runoff as evidenced by the lateral gullies. As a result of flooding and coarse sediment, the stream is now braided. The visible bridge is a replacement for a bridge similar to the one seen in Figure 5.5. A comparison of this area c. 1940 (Brown and Nygard, 1940) with the 1972 USGS topographic sheet *Elba* (1:24,000) suggests that about 4 acres (1.6 ha) of terrace were eroded away in those 32 years. Conservatively, assuming an average net removal depth of 10 ft (3 m), about 40 acre-feet (49,400 m³) of material were lost here with much being moved to the main valley of the Whitewater River. Note that goat prairie in background is now covered with cedar (same as seen in Figure 5.1). (Continued)

Figure 5.4 (Continued) Fairwater, destruction of the high Pleistocene terrace, looking north/northwest (upstream) from hill on southeast side of the village. 2001: view now shifted to north/northeast because old camera position was eroded away. For reference, note different perspective on house. Stream has cut several hundred additional feet to the west and south and is now cutting deeply into the high terrace in the immediate foreground and on which the viewer is standing.

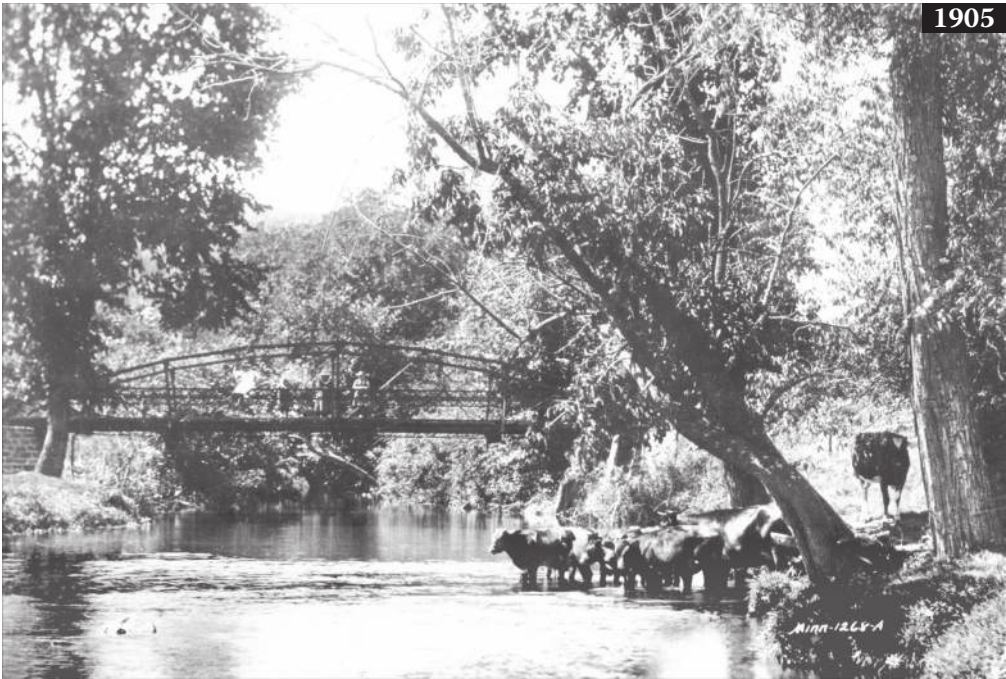
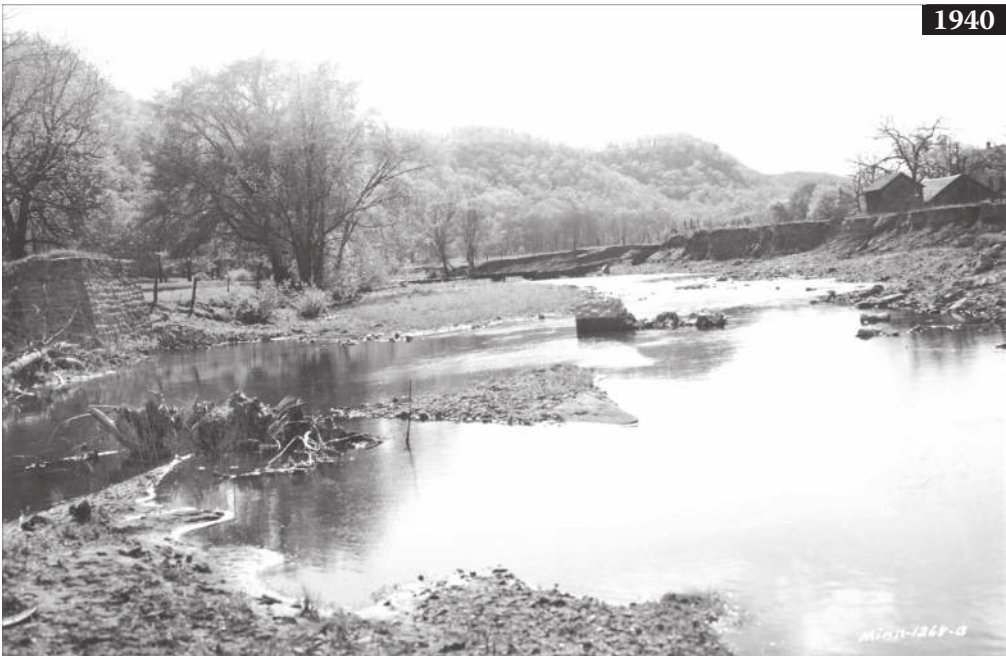
Figure 5.5 Fairwater, bridge crossing visible in 5.1 and 5.2 looking upstream. c. 1905: the structure is probably slightly later than the one visible in 5.1 and 5.2 but is at the same crossing. Note stability of stream and banks. 1940: stream widened by about three times here so that right pier is near the center of the widened stream. The left pier is still visible (2006) in the village, but the recovering (narrowing) stream has buried the right pier in the new bank.

While flooding was obviously later perceived as a problem of living in Fairwater, another concern was communication. Roads close to eroding tributaries were very vulnerable and were often severely undermined and even washed away. Already seen is the effect on the bridges in town. Farther out, the two roads into the village were interrupted on several occasions. Indeed, much of the road eastward to Elba was taken out by a flood in
