**HISTORICAL AGRICULTURE
AND SOIL EROSION IN THE
UPPER MISSISSIPPI
VALLEY
HILL COUNTRY**

STANLEY W. TRIMBLE

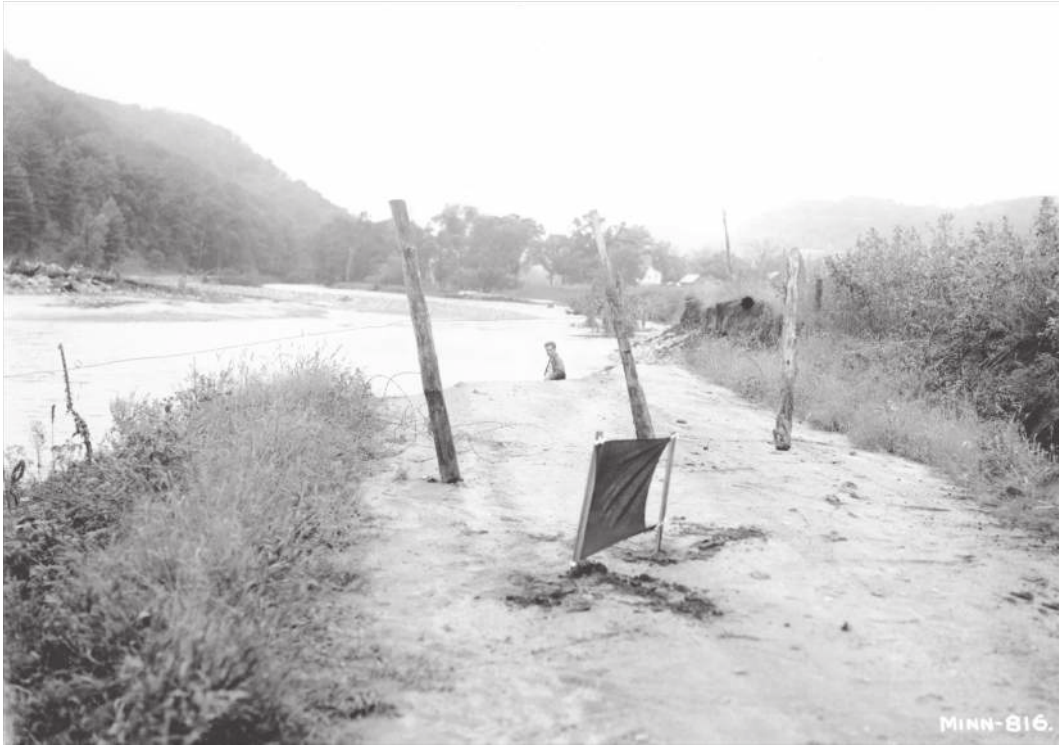
Figure 5.6 Fairwater, road from Elba to Fairwater about 1 mi east of Fairwater, 9/38, looking west. Several hundred feet of roadway eroded away.

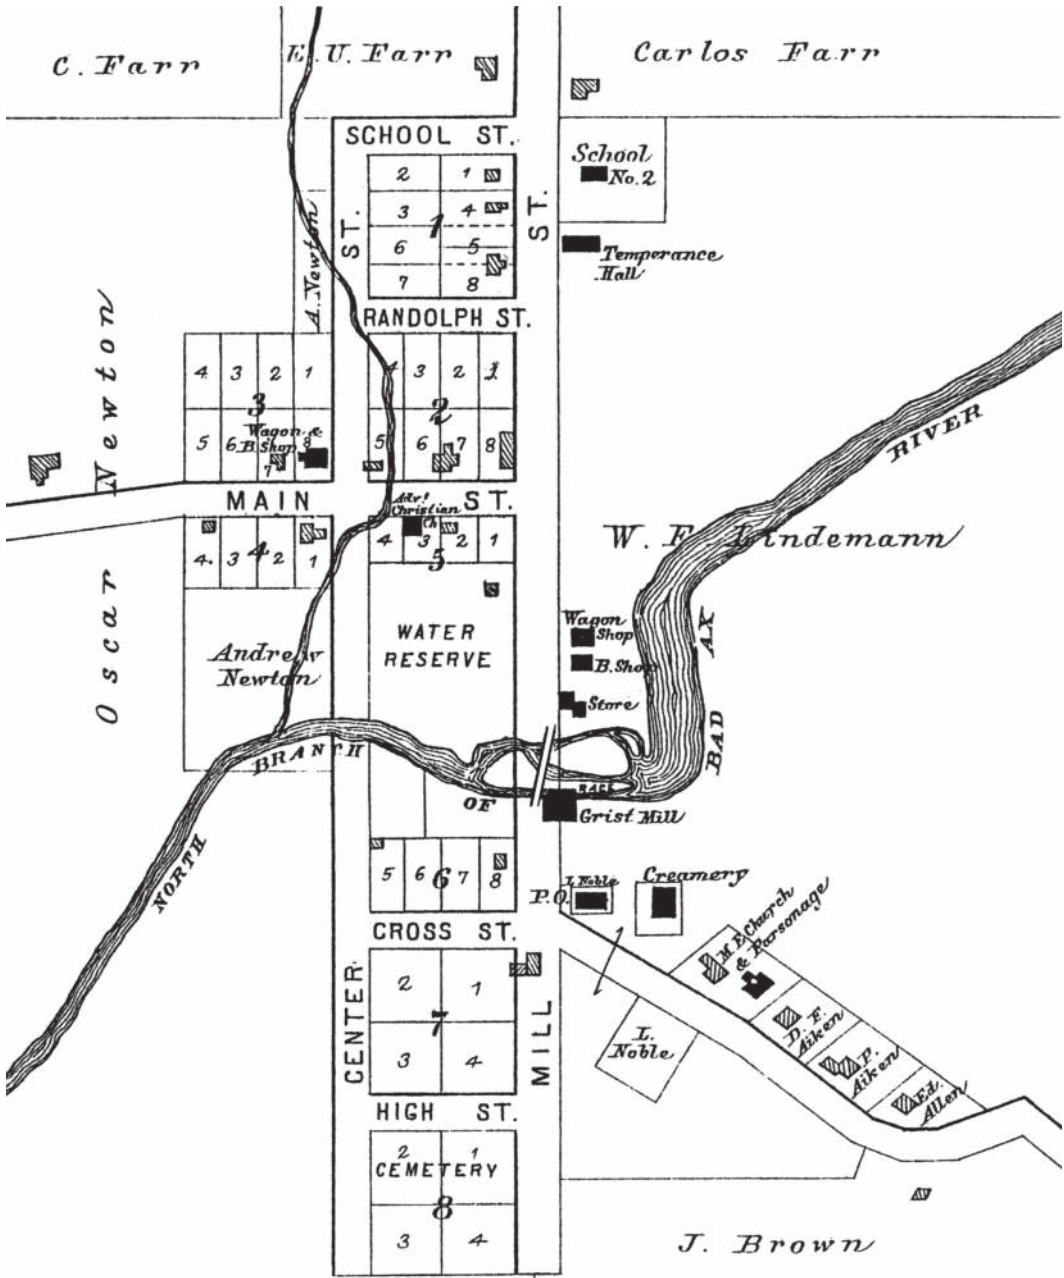
Figure 5.7 Newton, WI, on the north branch of Bad Axe River (Sec 23, T13N, R6W, Vernon Co.), 1896 (from Hood, E., *Plat Book of Vernon County*, 1896). The mill and dam are now buried and only one original building remains. The river flows westward (right to left).

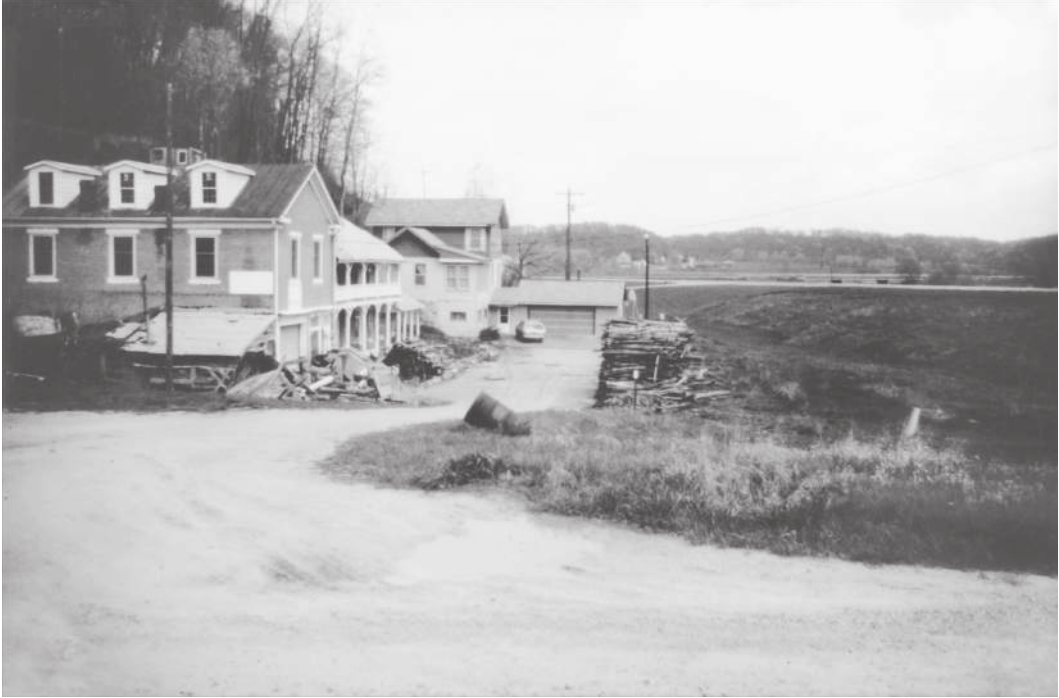
Figure 5.8 Millville, Clayton Co., IA, on Little Turkey River near the confluence with Turkey River. In 1886, it was already an established village built around a millsite. In 1989 (top), only these two buildings were left, huddled inside a flood dike. The highway in the background is on the far dike. The nearest, a once-beautiful Federal-style building suggests the one time wealth of Millville and how long it has existed.

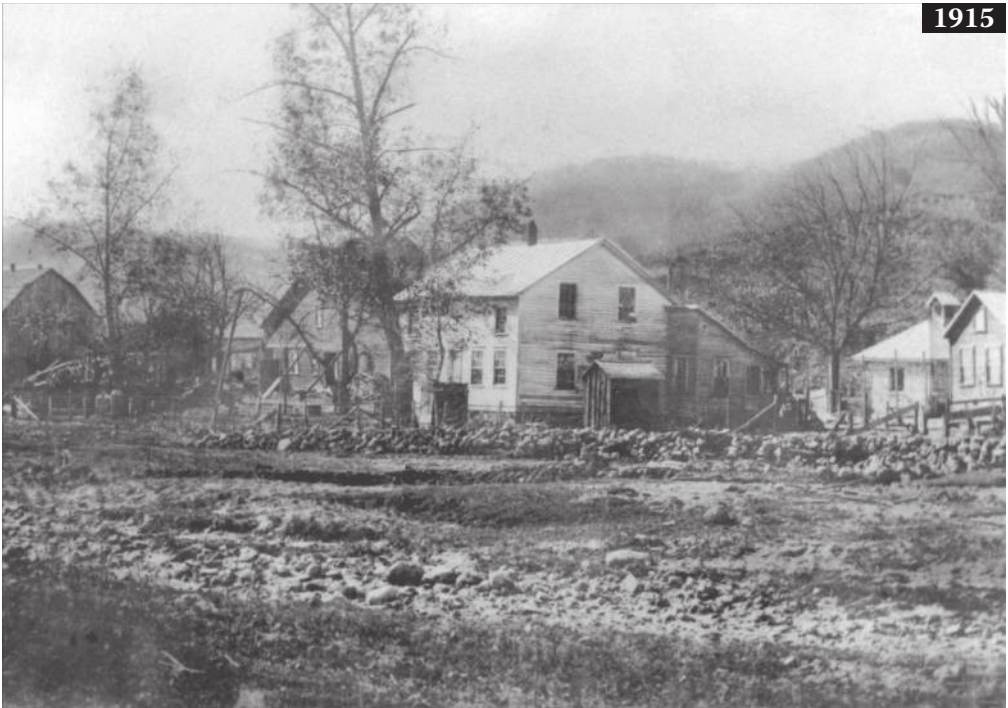
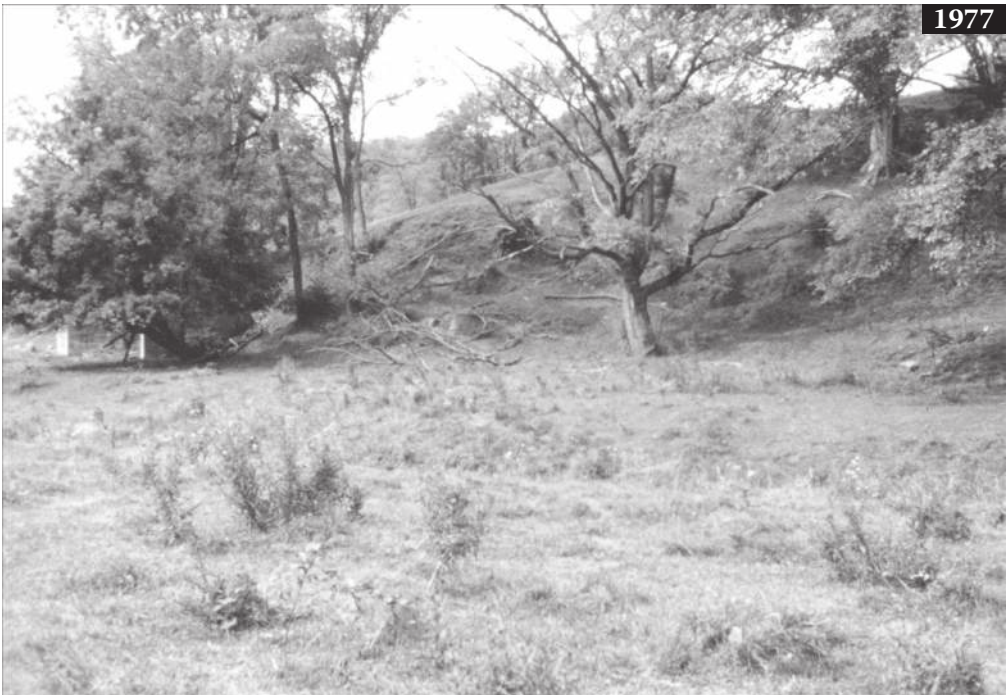
Figure 5.9 Hass house, Deadman's Creek (NE 1/4 Sec 19, T10N, R6W, Vernon County, WI). 1915: Creek in the foreground flowing to the left (east). House sits behind flood dike made of boulders brought down by creek. 1977: stable, grassy floodplain, stream out of view in foreground. House foundation is buried in floodplain in middle ground.

Figure 5.9 Hass house, Deadman’s Creek (NE 1/4 Sec 19, T10N, R6W, Vernon County, WI). 1915: Creek in the foreground flowing to the left (east). House sits behind flood dike made of boulders brought down by creek. 1977: stable, grassy floodplain, stream out of view in foreground. House foundation is buried in floodplain in middle ground..... 123

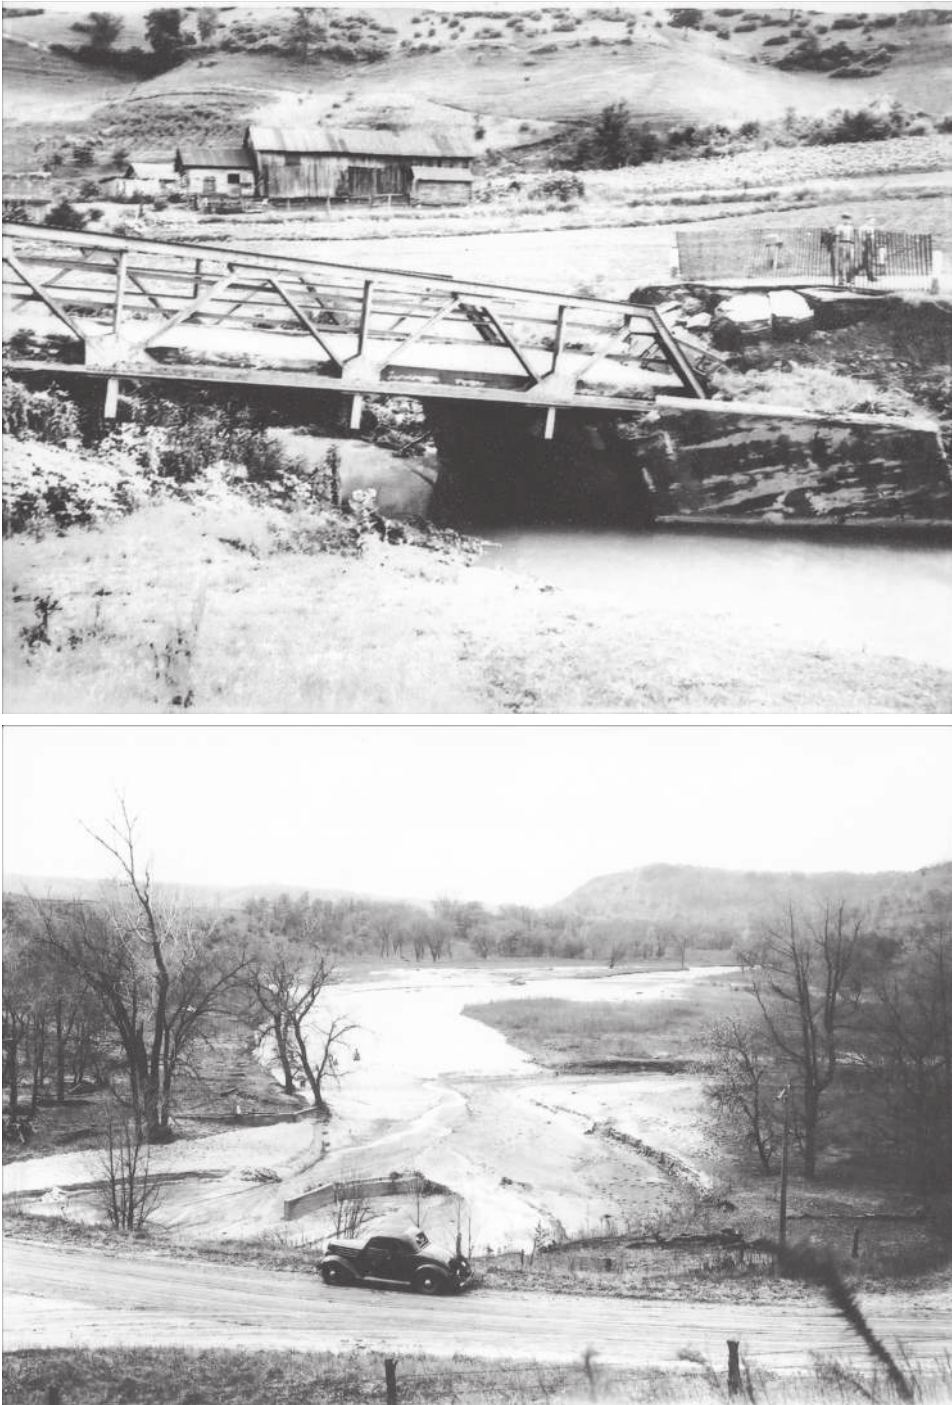
Figure 5.10 Bridges over tributaries destroyed by flooding and sediment. Top: Undermined bridge in the Coon Creek basin, exact location unknown, 1938 (from McKelvey, V.E. 1939. Stream and valley sedimentation in the Coon Creek drainage basin, Wisconsin: M.A. thesis, University of Wisconsin-Madison). Bottom: Abutment of destroyed bridge over Trout Brook near Dumfries, MN. Zumbro River Valley, 1939 (Sec 10, T110N, R11W, Wabasha County) (SCS Photos).

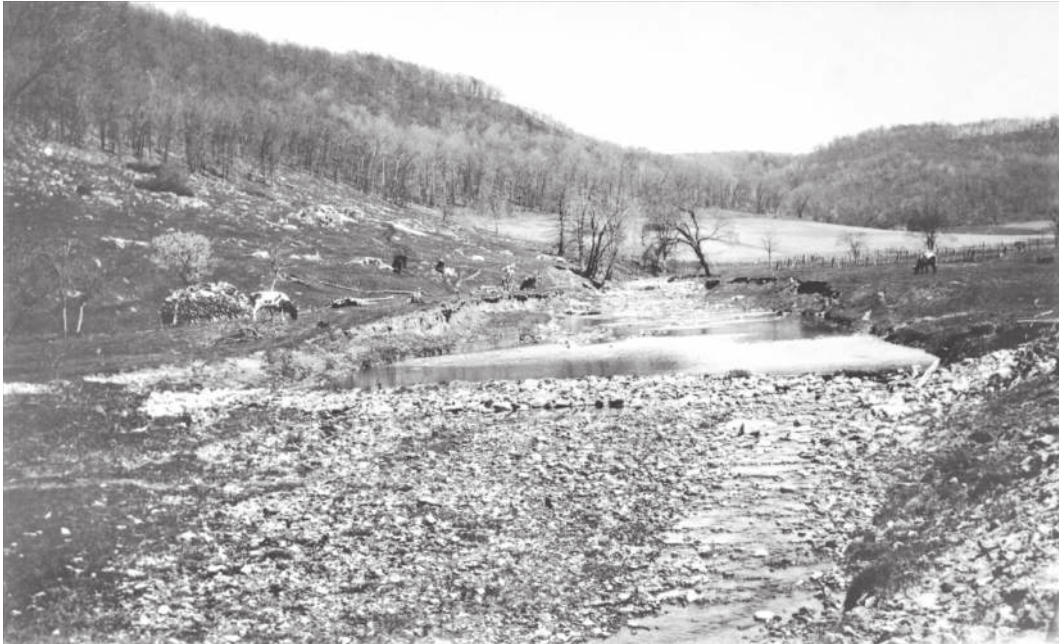
Figure 5.11 Oium Mill dam site, Timber Coulee, Coon Creek basin (N1/2, Sec8, T14N, R4W, Vernon County, WI), looking upstream from bridge on Lars Hill Road, 1919. Note typical “gravel road” appearance of stream and the almost lunar, bare quality of the heavily grazed landscape behind it. The expendable rock dam, rebuilt after every flood, diverted water into a race (to the right, not visible) that led to a reservoir excavated into a terrace downstream. This was above most floods thus saving it from destruction. The mill was about ¼ mi (400 m) downstream at the edge of the terrace (Files of Wisconsin Railroad Commission).

However, one clever miller in Vernon County, Wisconsin, was able to keep his mill operating right through the critical period and even operated until 1968. Instead of creating an in-channel reservoir, he located his mill on a tributary having an adjacent stream terrace. The reservoir was then excavated from the terrace, and the mill was located on the terrace alongside the stream but above most floods. A low diversion dam was built upstream to shunt water from the stream through a canal to the reservoir (Wisconsin Dam Commission, 1913). The dam itself was expendable, being merely a low, linear pile of the plentiful rock swept down by each flood, allowing the floodwater and sediment to bypass the pond and mill. The accumulation of rock in the channel was a fortunate circumstance because the dam had to be rebuilt after each flood (Figure 5.11).

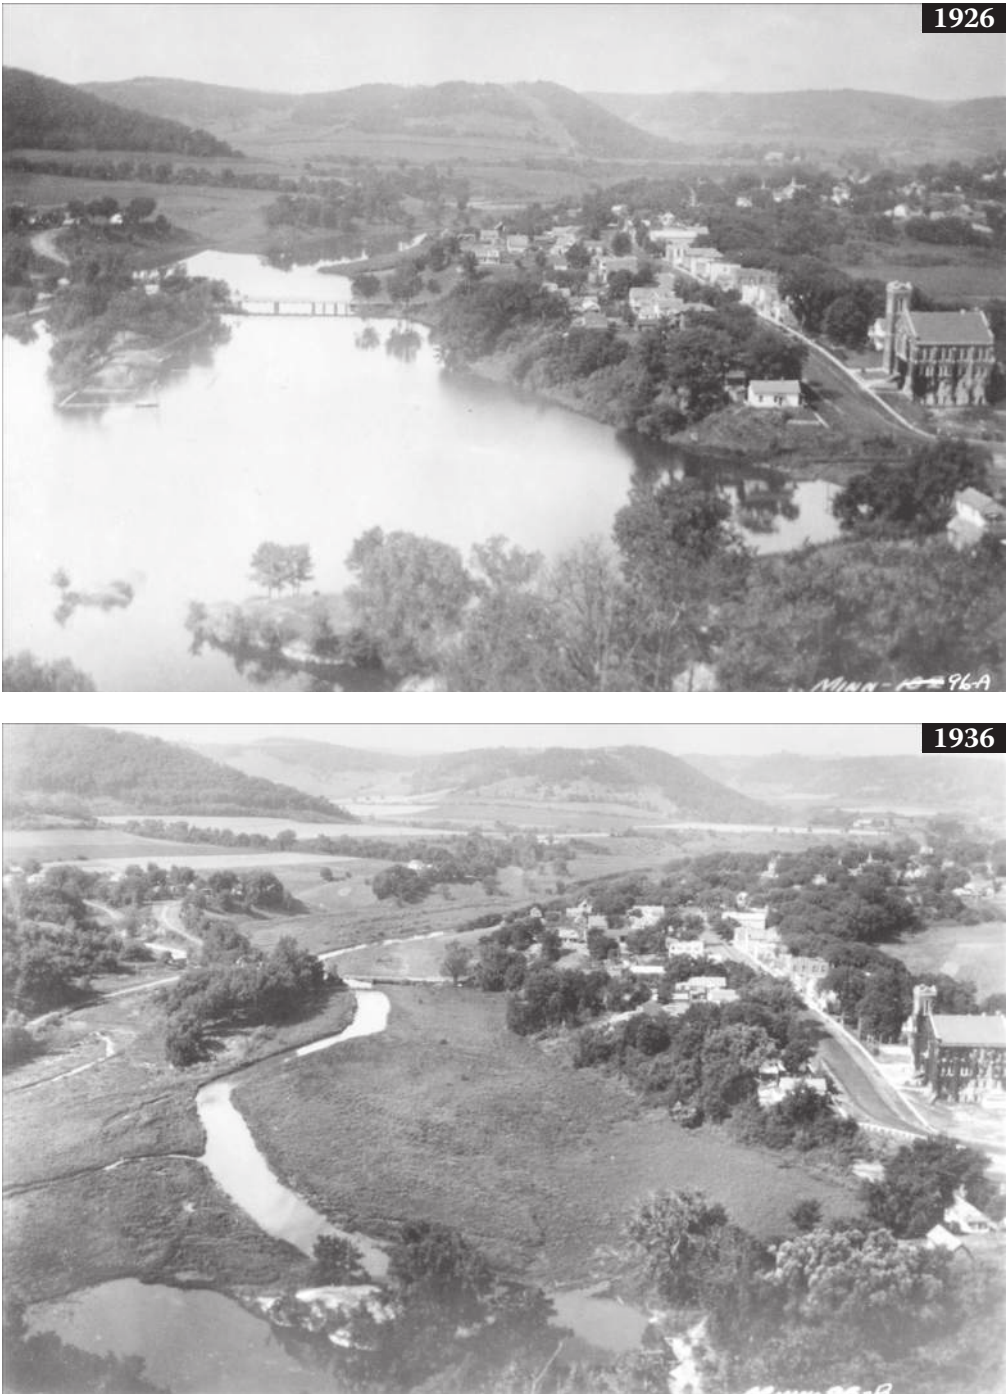
Figure 5.12 Lake Como, Hokah, MN, looking south 1926: lake full and 20 ft. deep. Note barriers in water (left middle ground) to prevent swimmers from venturing too far into deep lake. 1936: lake completely filled with sediment. Old lake bed now used by villages for recreation and gardens. (Photo credit Soil Conservation Service [SCS].)

At least two relatively large reservoirs were built on Hill Country tributaries. One of these, Lake Como at Hokah, Minnesota (Houston County), experienced dramatic physical changes. Originally built in 1858 near the confluence with Root River, the lake covered 90 acres (36 ha) and was 20 ft (6 m) deep. Because of the lake’s clarity and attractive natural setting, it soon became a regional resort with excursion trains bringing bathers and boaters from surrounding towns (Bissen, 1975). A flood in 1909 broke the dam and allowed the lake to drain. The dam was eventually rebuilt and the reservoir refilled in 1922 (Figure 5.12). But hydrologic matters were now far different: the massive erosion and sedimentation already described was under way. Thus, the lake was extremely turbid after storms, resulting in fish kills and water unsuitable for recreation. In a matter of just a decade or so, the reservoir was completely filled with sediment, thus ending Lake Como (Figure 5.12). Today, the filled lake serves as a playground for the village youth and as garden plots.

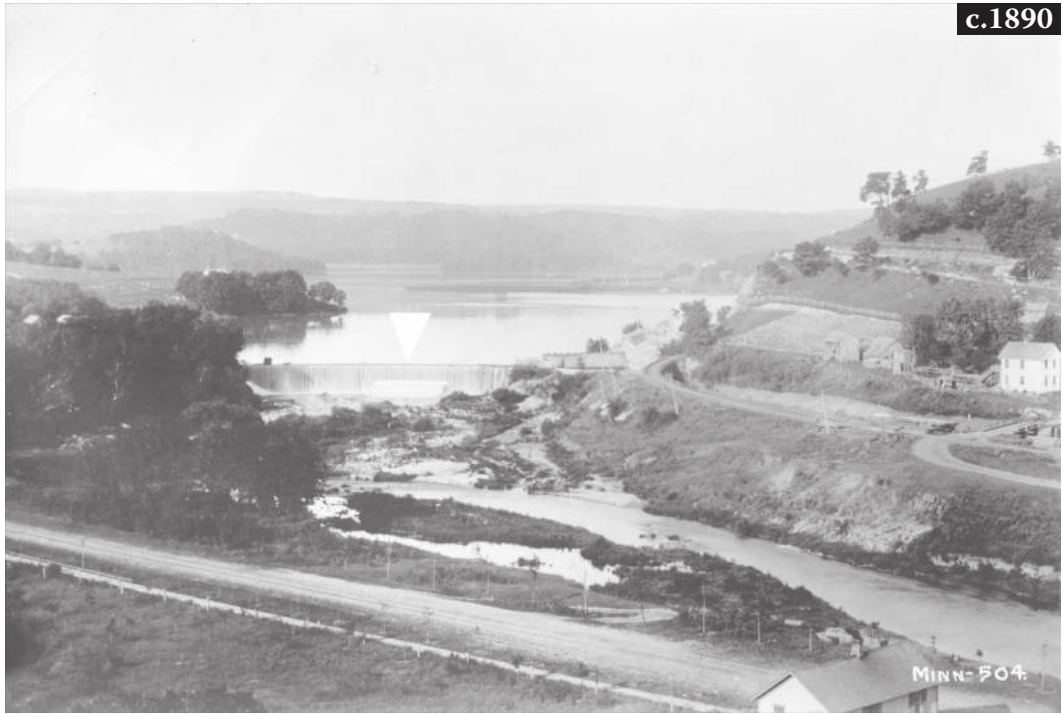
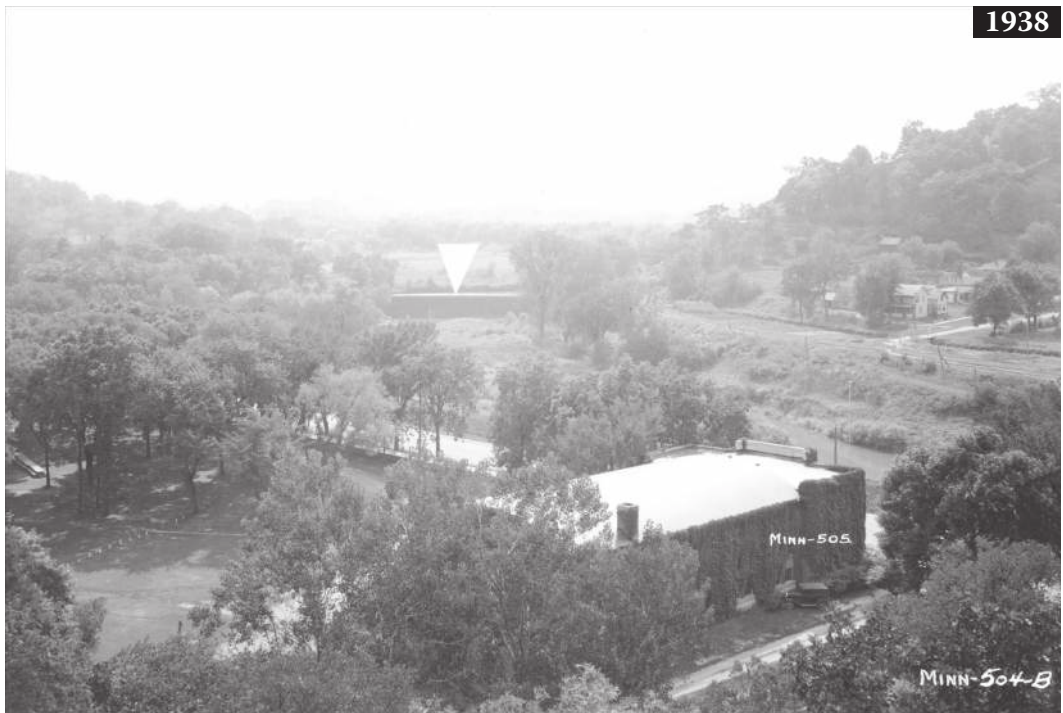
Figure 5.13 Lanesboro Lake, Lanesboro, MN, on the upper Root River. C. 1890: large expanse of water. 1938: completely filled with sediment. Arrow marks top of dam in both photos. (Photo credit Soil Conservation Service [SCS].)

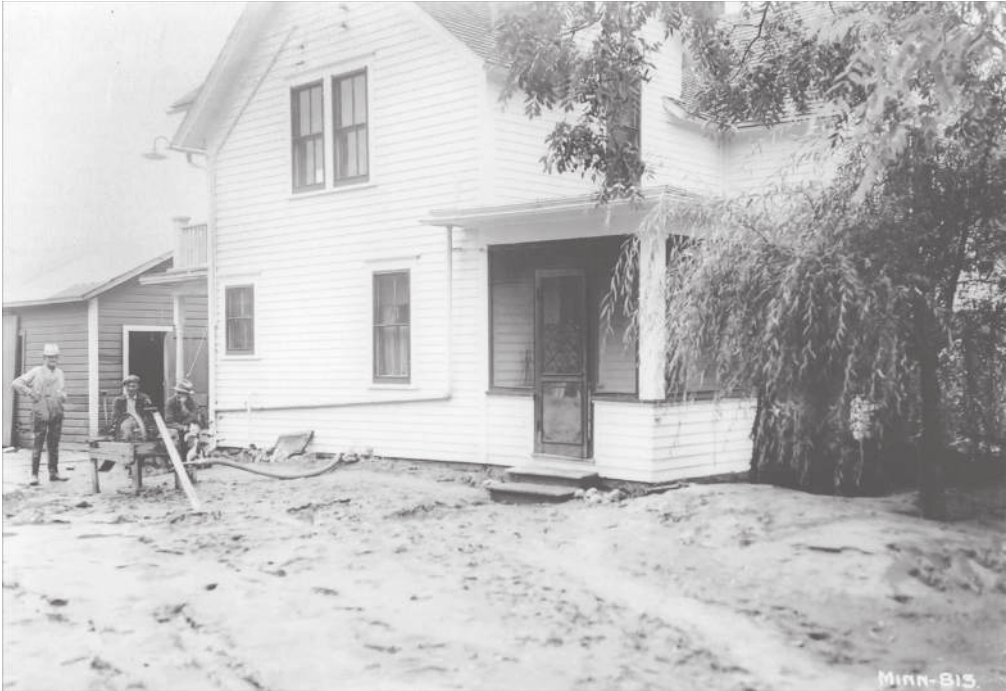
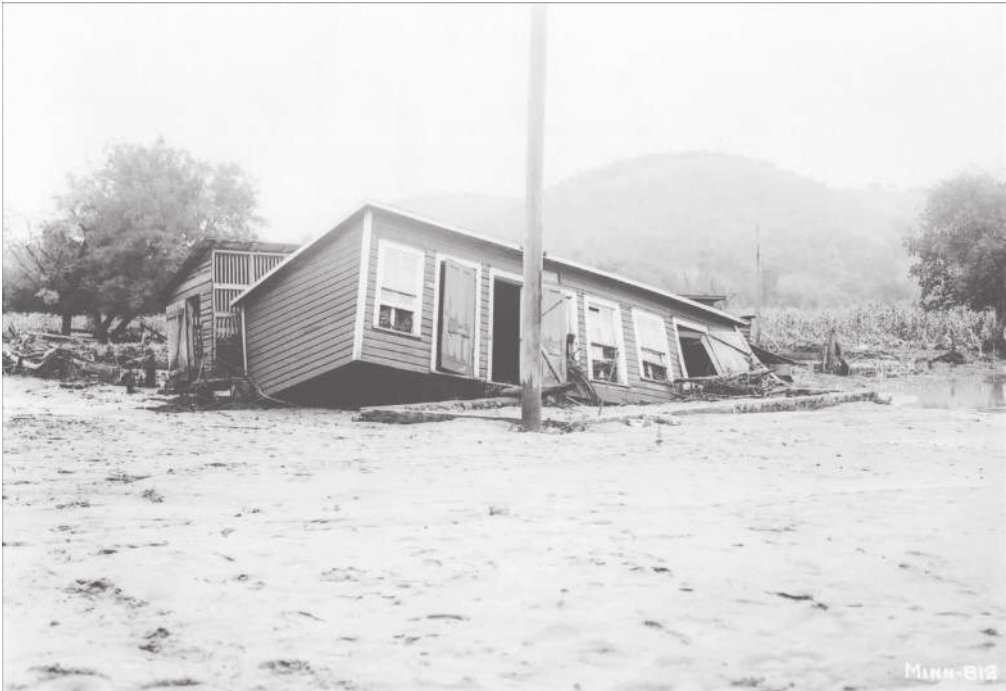
Figure 6.1 Nick Siebenaler's house just upstream from Elba, MN, on a terrace above the Whitewater River. Flood 9/8/38. Top: Floodwater was up halfway on screen door. The men are pumping out the basement. Bottom: Siebenaler's chicken house was moved off the foundation by the flood. Note sediment deposits in foreground. (Photo credit Soil Conservation Service [SCS].)

Figure 6.1 Nick Siebenaler’s house just upstream from Elba, MN, on a terrace above the Whitewater River. Flood 9/8/38. Top: Floodwater was up halfway on screen door. The men are pumping out the basement. Bottom: Siebenaler’s chicken house was moved off the foundation by the flood. Note sediment deposits in foreground. (Photo credit Soil Conservation Service [SCS].)..... 130

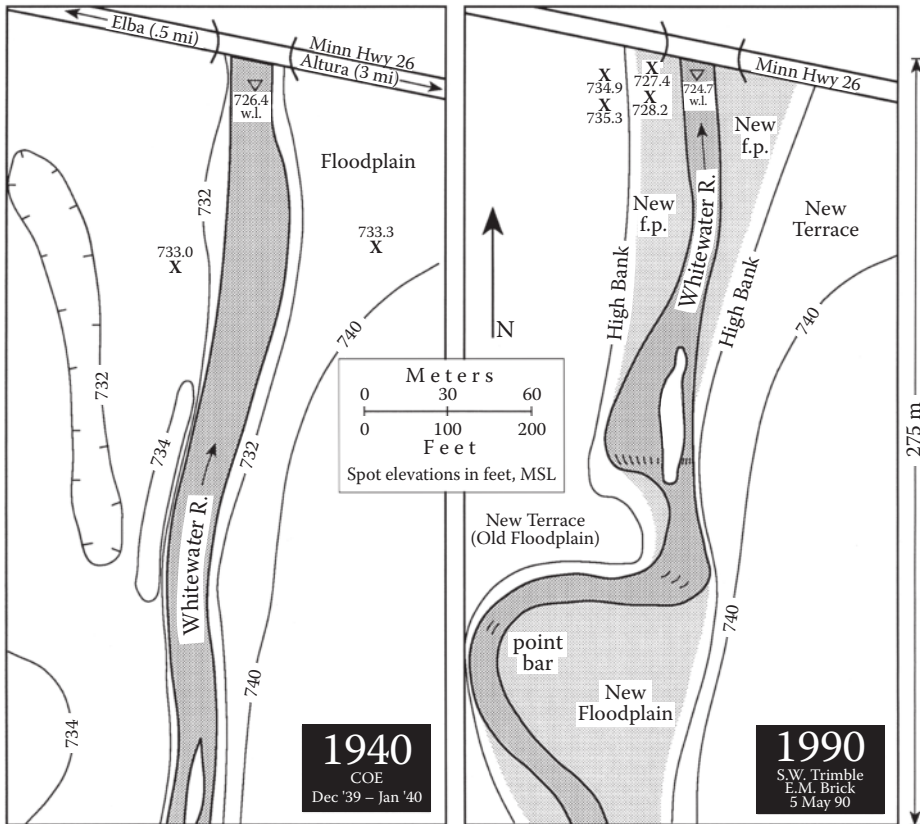
Bank Erosion and Channel Enlargement Whitewater River at Elba

Figure 6.2 Bank erosion and channel enlargement of Whitewater River at Elba, MN, 1940–1990. In 1940, the river flowed through a flume-like reach with high banks (the aggraded historical floodplain) to either side. Between 1940 and 1990, the floodplain aggraded an additional 1 ft (30 cm) or so and the channel was later greatly enlarged by bank erosion. This process, creating a greater floodway but sending copious amounts of sediment downstream, has been typical of the Upper Main Valley Zone since soil conservation measures took full effect. (From Ward, A., and Trimble, S., *Environmental Hydrology*, CRC, Boca Raton, 2004. With permission.)

The reaction of the village was to build a flood dike, which gave some relief, but the worst floods still invaded. By the 1970s, however, the stream channel, as defined by the historic floodplain, was eroding and enlarging. High banks that were 25 m (83 ft) apart in 1940 were 55 m (180 ft) apart by 1990, the process in this one reach sending about 16,500 m³ (13.4 acre-feet) of sediment downstream (Trimble, 1993; Figure 6.2). Meanwhile, the old historical floodplain had aggraded about another 1 ft (30 cm) or so, probably before most of the channel erosion occurred, and a new, lower, floodplain was created within the bounds of the high banks. Thus, it will be seen that the floodway is now much larger and the danger of flooding has probably decreased. However, the biggest floods still get into the village, as happened in 2007. There is no place for the village to move since it is backed by bluffs.

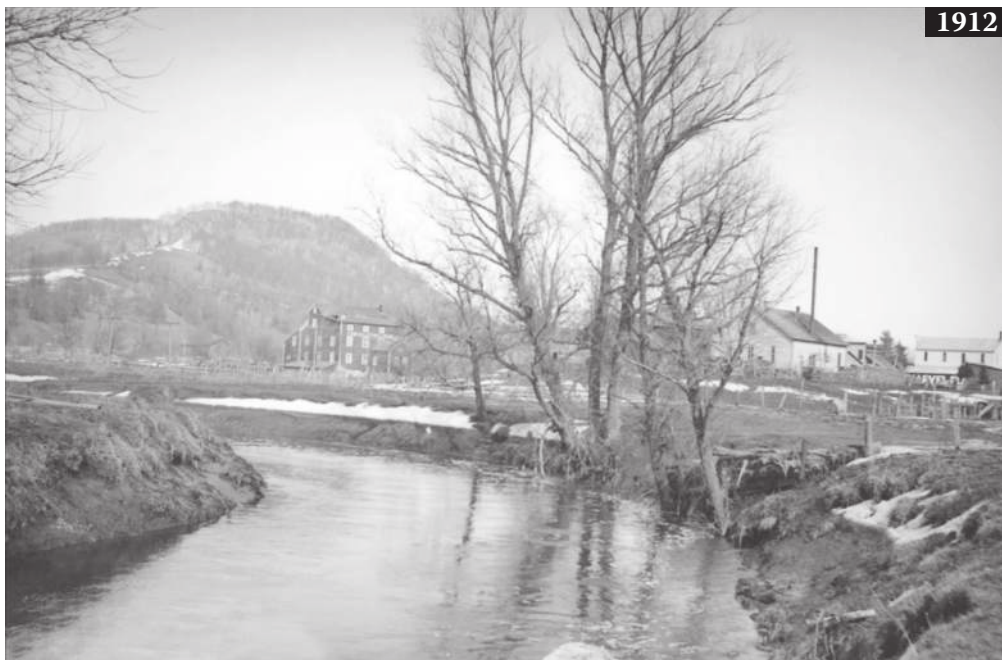
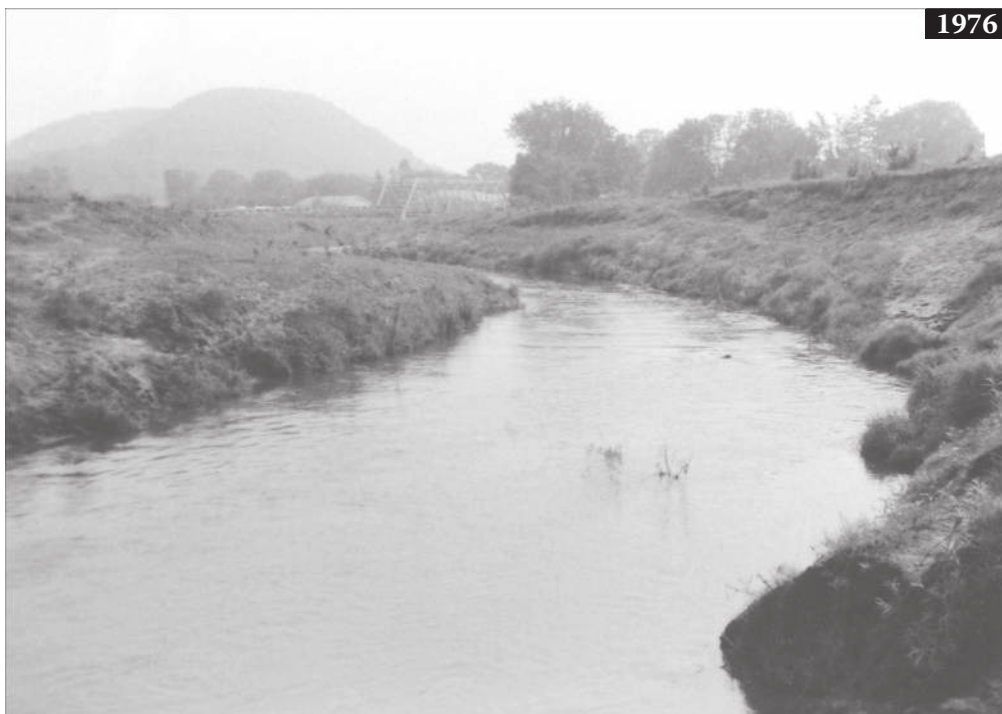
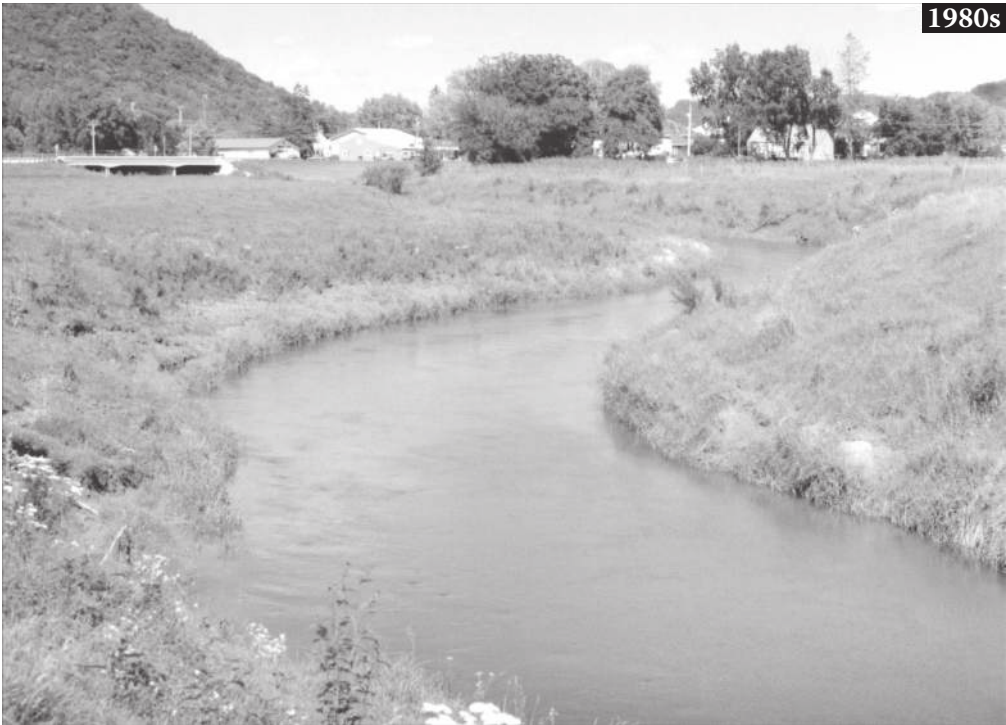
Figure 6.3 Coon Valley, Coon Creek, looking upstream Vernon Co., WI. Top, 1912: photo by Lloyd Thruene. Streambanks are about 6 ft (2 m) high, and terrace face in background with cheese factory (white building) is about 10 ft (3 m) high. 1976: bank to right is about 12 to 13 ft (4 m) high and is eroding, but new bank (new floodplain) accreting to left is only about 6 ft (2 m) high, diagnostic of the newer, milder flood regime of the stream. (Continued)

Figure 6.3 (Continued) Coon Valley, Coon Creek, looking upstream Vernon Co., WI. Mid-1980s: photo made farther back and standing about 12 ft (4 m) higher. From this view, one can more clearly see the meandering stream with the retreating high bank to the right and the advancing low bank to the left. In the background, it will also be seen that the floodplain has aggraded to the level of the old cheese factory. As at Elba, a large floodway was being created here that would make Coon Valley safer from flooding, but that process has been artificially curtailed at Coon Valley (Figure 6.4).

The situation for the lower part of Coon Valley is clearly shown by Figure 6.3. The 1912 photo of the west end of the village is remarkable because it shows the relationship of the floodplain and terrace so clearly and because it has such high resolution. Moreover, the cheese factory on the terrace surface in the right middle background was like a Rosetta Stone in allowing the measurement of heights by oblique photogrammetry. Another contemporary photo showed the same corner of the building along with standard milk cans. This allowed the determination of a precise height of the building, which in turn allowed approximating the height of the terrace face and the floodplain. The floodplain was still only 6 ft (1.9 m) higher than normal stream level although it would have already aggraded somewhat by 1912. The terrace surface in the background where the cheese factory is located was about 10 ft (3 m) higher than the floodplain.

By the late 1930s, the streambanks had aggraded to stand about 12–13 ft (4 m) above the stream level so that the floodplain was only a few feet lower than the terrace in the background, giving grounds to the fears that the village would be destroyed by floods. But by 1976, as is characteristic of this UMV zone, channel erosion was well under way (Figure 6.3). The high bank on the right was retreating from erosion, but the new, lower floodplain on the left was being built at a height of about 6 ft (1.9 m). In general terms, this morphological change suggests the stream here had by 1976 returned to the flood regime of about 1912. The presettlement bank height is not known but presumed to be considerably lower than 6 ft (1.9 m) because the flood regime was milder than in 1912.

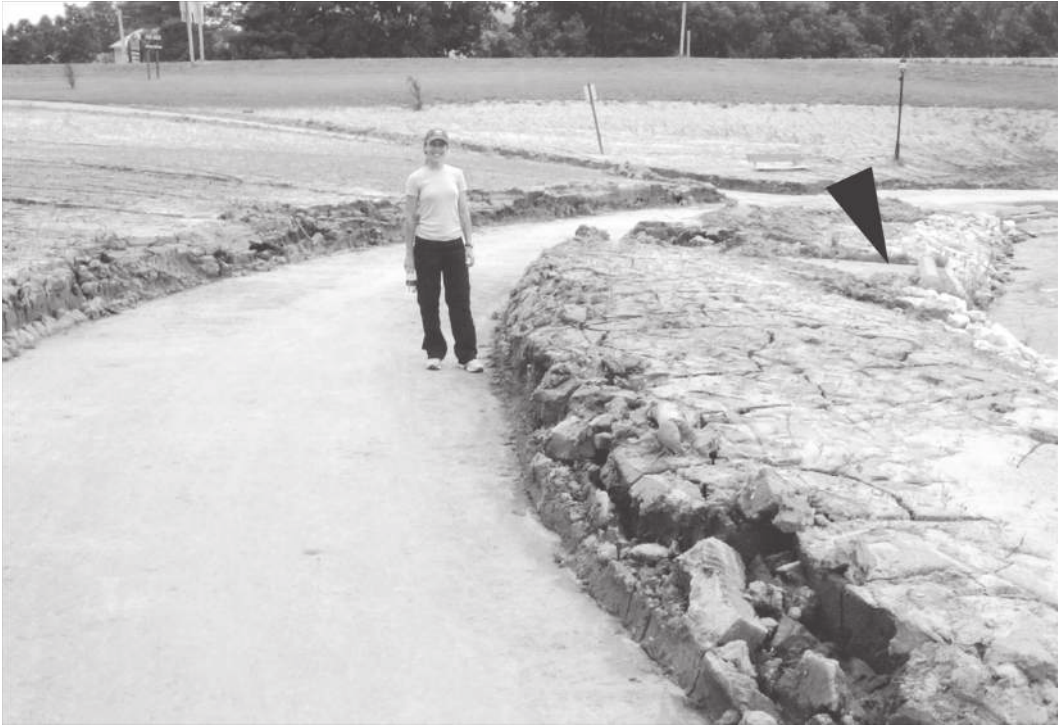
Figure 6.4 Aggrading “new” floodplain in Coon Valley Village Park. Floodplains were cut down to facilitate handicapped access ramps (arrow) to Coon Creek (seen on far right). Subsequently, the stream has attempted to rebuild its floodplains to the height dictated by the present flood regime, that height being about 6 ft (2 m). The elevation of the lowered floodplain is shown by the paved walk on which the person stands, and the recent deposits are up to 2 ft (60 cm) thick. However, the formerly retreating high banks have been stabilized with rock so that the previously expanding floodway is now stable and is decreasing in size. Photo made July 2008.

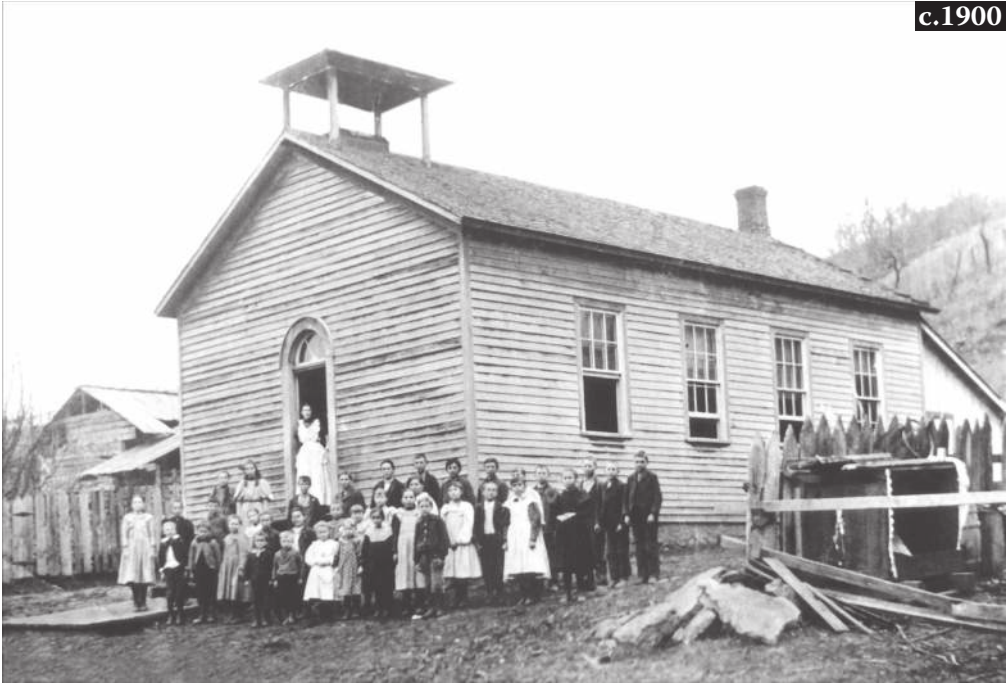
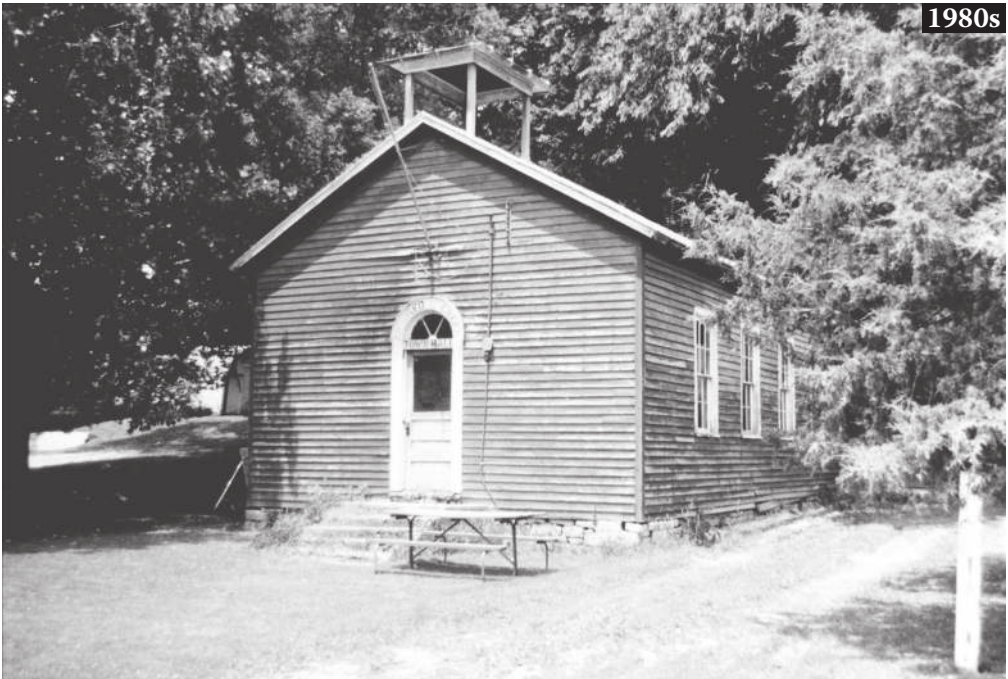
Figure 6.5 Freeburg, Crooked Creek, Houston Co., MN. Crooked Creek Township Hall. Top: Turn of century, photo made from road. Viewer's eyes are at a level about 4 ft (1.2 m) below the bottom of wooden siding on the building. Bottom: Again standing on the road, 1980s. Viewer's eyes are level with bottom of first board below windows. This suggests that road is now about 8 ft (2.5 m) higher.

Back across the Mississippi River in Houston County, Minnesota, is Crooked Creek, a direct tributary of the Mississippi. There are found the remnants of the village of Freeburg in a situation roughly comparable to Elba and Coon Valley. Located on a high terrace, the village was reportedly about 25 ft (8 m) above the floodplain in the mid-1880s (Minnesota Geological Survey, 1885). By 1929, Gray et al. reported that an average of 15 ft (4.6 m) of modern sediment covered the floodplain, suggesting that the village was then only about 10 ft (3 m) higher. Presently, the old terrace is hardly distinguishable from the aggraded floodplain and the 25 ft (8m)-high escarpment has disappeared (Figure 6.5). Not surprisingly, Freeburg has had many serious floods in recent decades, so its situation is actually more similar to that of Elba than Coon Valley. Only three or four buildings remain.

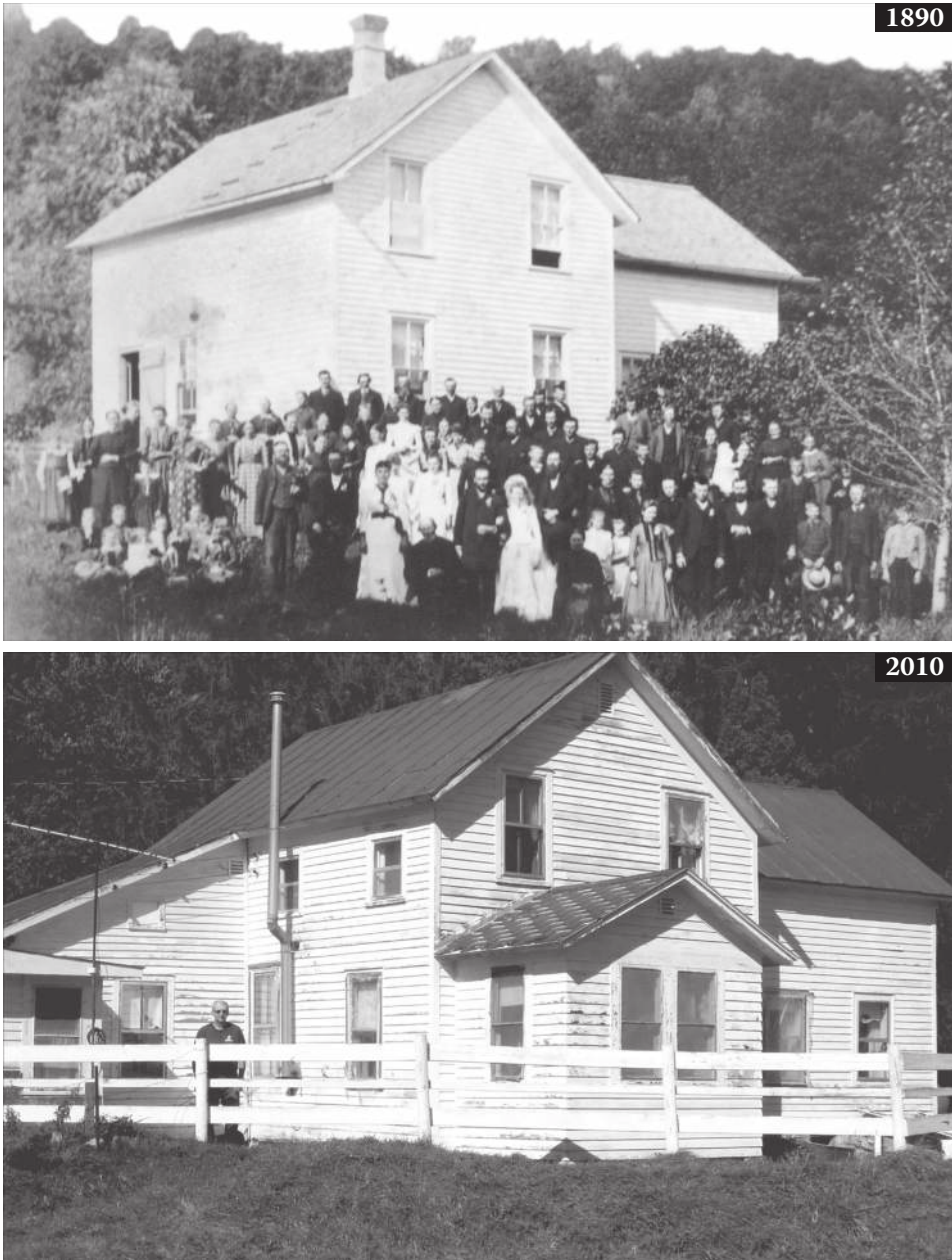
Figure 6.6 Daffinrud house, near confluence of Spring Creek and Coon Creek about 2 mi west of Coon Valley (SE1/4, SE1/4, Sec 5, T14N, R5W, Vernon Co.). House was originally built on a terrace about 7 to 8 ft (2.5 m) above the floodplain. Top: Wedding at Daffinrud house in 1890. The crowd in front of the house makes it difficult to perform oblique photogrammetry, but the eye of the viewer appears to be below the base of the house. Bottom: Same view, 2010. The eye level is now slightly above the bottom of the windows. Note that there is a dike about 2½ ft (75 cm) high around the house on which Carl Daffinrud stands and which hides the bottom of the house. The floodplain is now almost level with the terrace on which the house sits.

Most farmers in the UMV were able to find high places such as terraces on which to place their houses and farmsteads and thus kept them above flooding. But not all were that lucky, at least not with the passage of time. The Daffinrud farm about 2 mi (3 km) east of Coon Valley is a case in point. Built on a terrace about 7 to 8 ft (2.5 m) above the original floodplain of Spring Creek just as it enters the upper main valley of Coon Creek, it was safe from flooding for many years (Figure 6.6). But as the floodplain aggraded, the house came under siege and a dike was built around the house. Nevertheless, the house is still flooded on occasion. Much like the situation at Coon Valley, the stream has been artificially stabilized so that it cannot enlarge its channel, and the new floodplain continues to aggrade. Thus, the natural process that might have eventually saved the house from flooding has not been allowed to happen here.

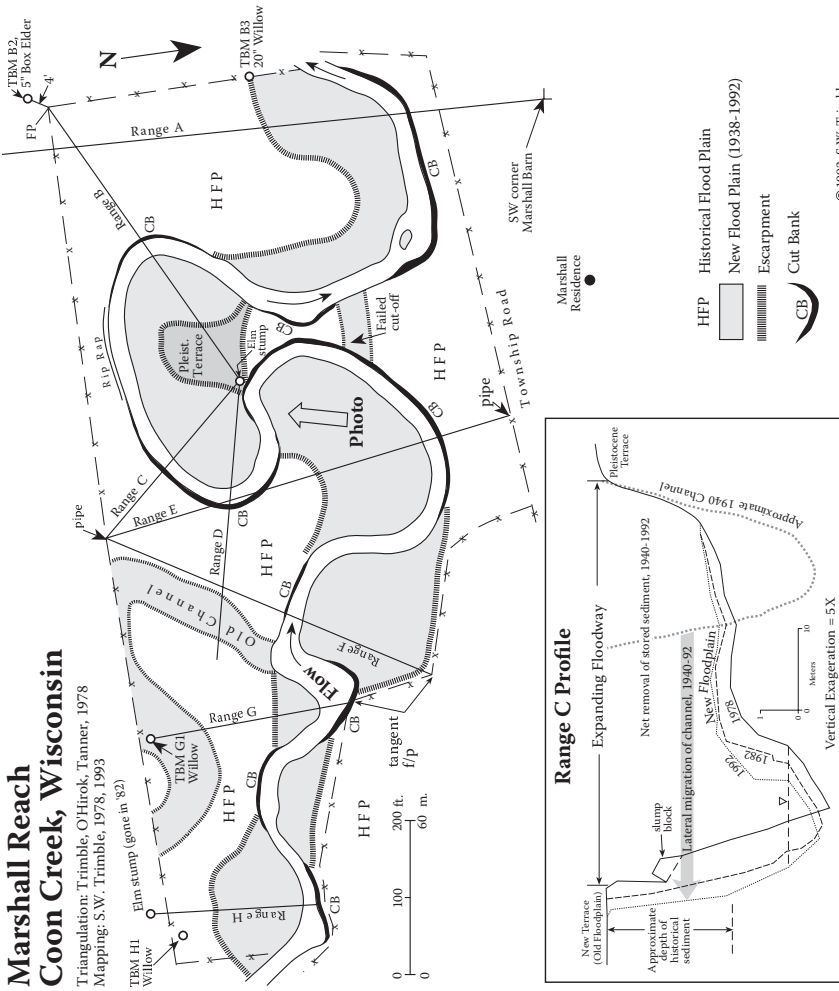
Figure 6.7 An active agricultural reach of Upper Main Valley showing typical UMV processes and morphology, virtually untouched and unaltered by artificial modification. In 1940, the stream channel was like a flume with high banks on either side. Since then, it has cut away the high banks and left low ones as seen in Range C (inset) and the process continues. Just this short reach has furnished perhaps 20–30 acre-feet (25,000–38,000 m³) of sediment to downstream locations since c. 1940. This morphological transformation has both benefits and drawbacks to the landowner. The new, low floodplains, being sandy, are less fertile than the old floodplain, and they flood much more frequently. However, the increased size of the floodway between the high banks means that flooding on the historical floodplain is less probable. The old floodplain is now a new fluvial terrace and is now more valuable. Stream flows from left to right (westward).

bank toes with riprap and wooden fish structures. Only one “natural” reach remains at this writing, the “Marshall reach” just downstream of county roads P and G (NE1/4, Sec 5, T14N, R5W, Vernon County). I’ve had this reach under intense study since 1978 and as reflected in the declining elevation of the floodplain, it perhaps best demonstrates stream processes in the UMV (Figure 6.7).

Net erosion from such reaches as this has, over the past 70 years, furnished huge amounts of sediment to be moved downstream, the amounts approximated by the depth (difference between the old and new floodplain, here about 7 to 8 ft or about 2.5 m) multiplied by the width of lateral migration times the length of the reach. It will be seen that the Marshall reach alone has furnished much sediment downstream, perhaps as much as 25–35 acre-feet (31,000–43,000 m³). While it is true that such reaches of the UMV have been significant net sources of sediment in the past, that is not necessarily true at the present. As the new floodplains become wider, there is more space for deposition. So while the high banks are still eroding, the amount of sediment being simultaneously deposited over the period 1982–1993 approximated that being eroded, so there was no net loss, a negative feedback from morphological change (Trimble, 1993). In the longer run, however, the continuing difference of height between the high and low banks means that there would have to be continuing loss of material to downstream reaches (Figure 6.8). Also to be noted is the fact that the processes and form of the UMV are slowly moving downstream. The downstream-most reach of the Coon Creek UMV is shown in Chapter 3, Figure 3.14.
