**HISTORICAL AGRICULTURE
AND SOIL EROSION IN THE
UPPER MISSISSIPPI
VALLEY
HILL COUNTRY**

STANLEY W. TRIMBLE

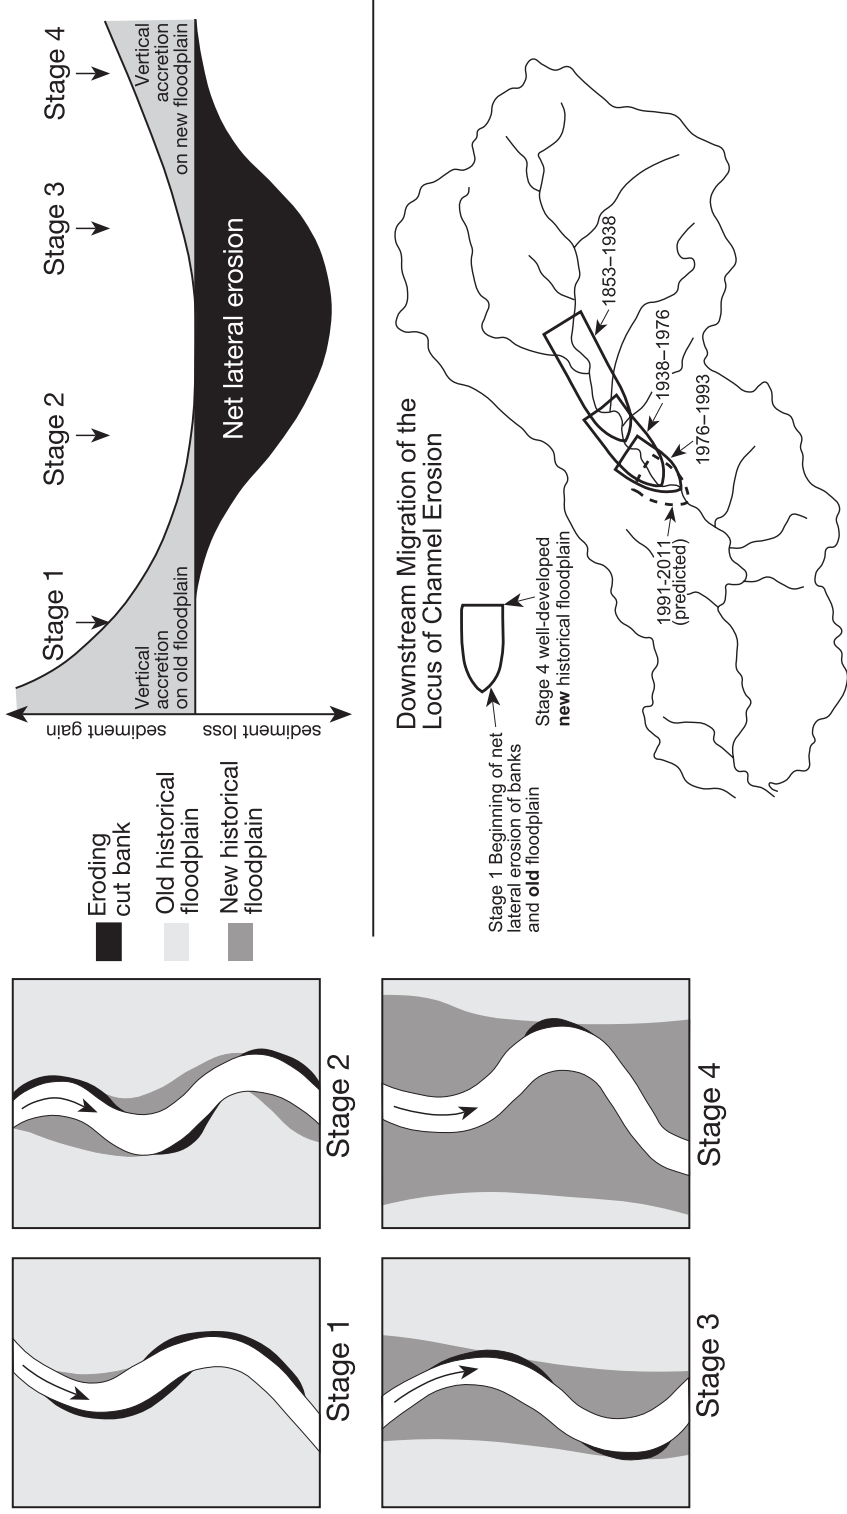
Transformation of Middle Valley Morphology and Accompanying Changes of Sediment Budget

Figure 6.8 Diagram showing how UMV reaches have developed since c. 1940 and why they might not be a long-term net sediment source: the expanding "new" floodplains may eventually accumulate more sediment than the high-cut banks lose. The inset shows how these processes move downstream. (From Ward, A., and Trimble, S., *Environmental Hydrology*, CRC, Boca Raton, 2004. With permission.)

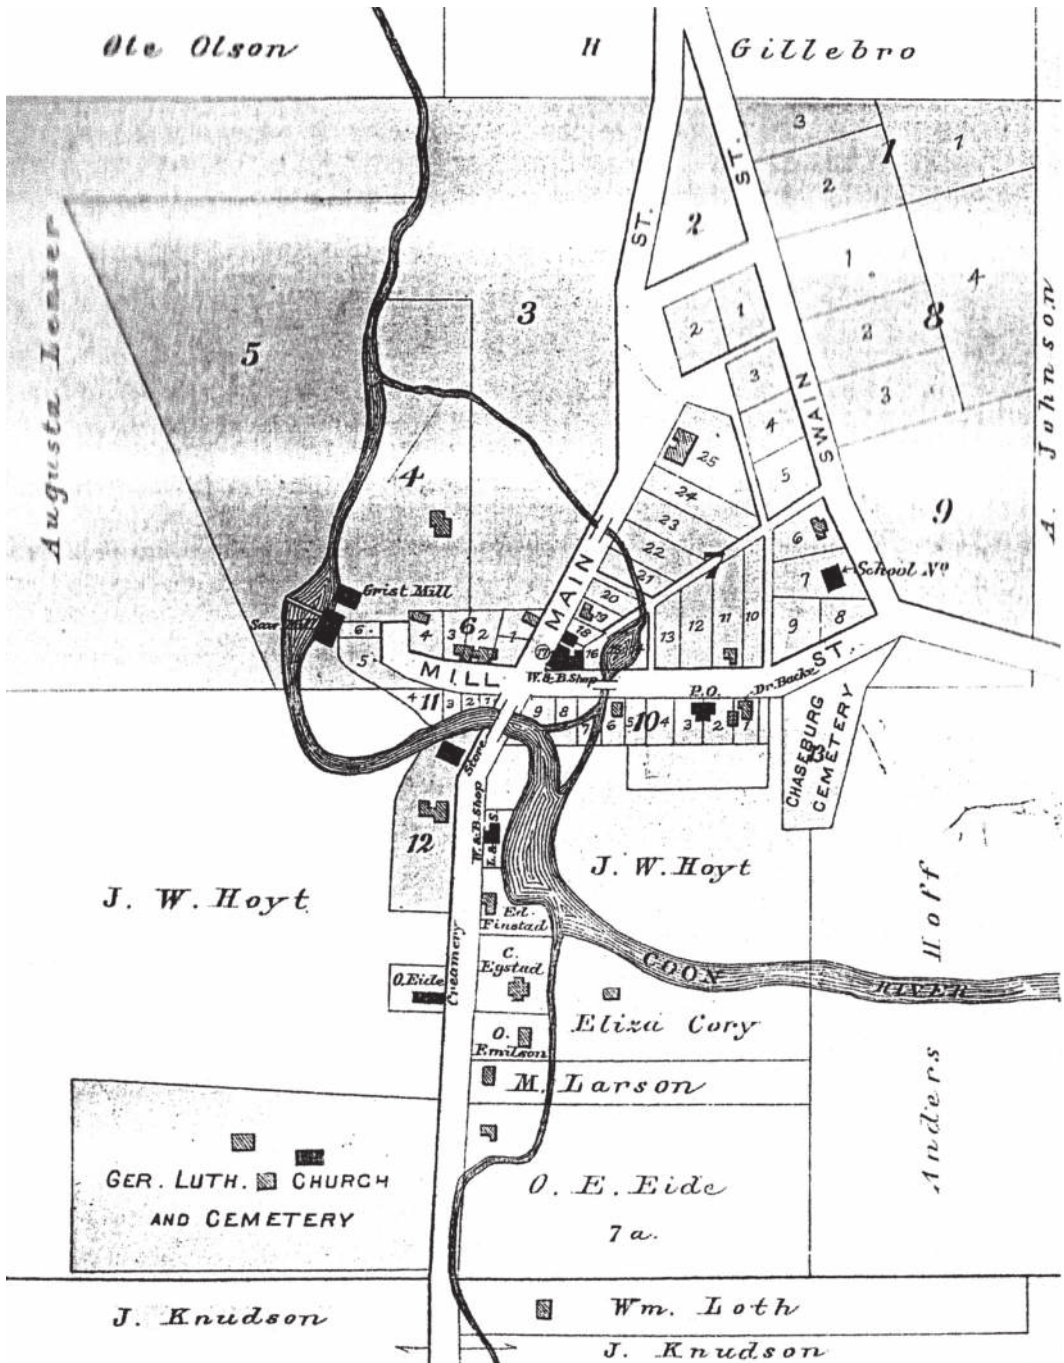
Figure 7.1 Chaseburg, WI, on Coon Creek in 1896 (Hood, E. *Plat book of Vernon County*, 1896). Note that all buildings except two are in lower Chaseburg (on or near the island). By 2010, only one building was left in the lower part of the village. Stream flows right to left (northwestward).

Chaseburg, Wisconsin (Vernon County, Region II), is a village that was forced to move uphill. If Fairwater, Minnesota, is the “poster child” village for tributaries, Chaseburg is the one for the LMV. It was established about 1855 on the low and intermediate alluvial terraces of an island on Coon Creek and was a flourishing town by the late 19th century (Figure 7.1). Bedrock outcropped in the streambed, creating shoals on either side of the island, and a saw mill and grist mill were built there in 1865. The magnitude and chronology of sedimentation was established from historical data on Chaseburg, especially dam inspections by the Wisconsin Dam Commission, together with two years of excavations and surveys (1976–1977) and later surveys in 1993. This chronology is approximated in Figure 3.15, and the local magnitude is shown by an archaeological cross section of the village (Figure 7.2). Perspectives on the village and the cross section are given in photographs made in the early 20th century (Figure 7.3).

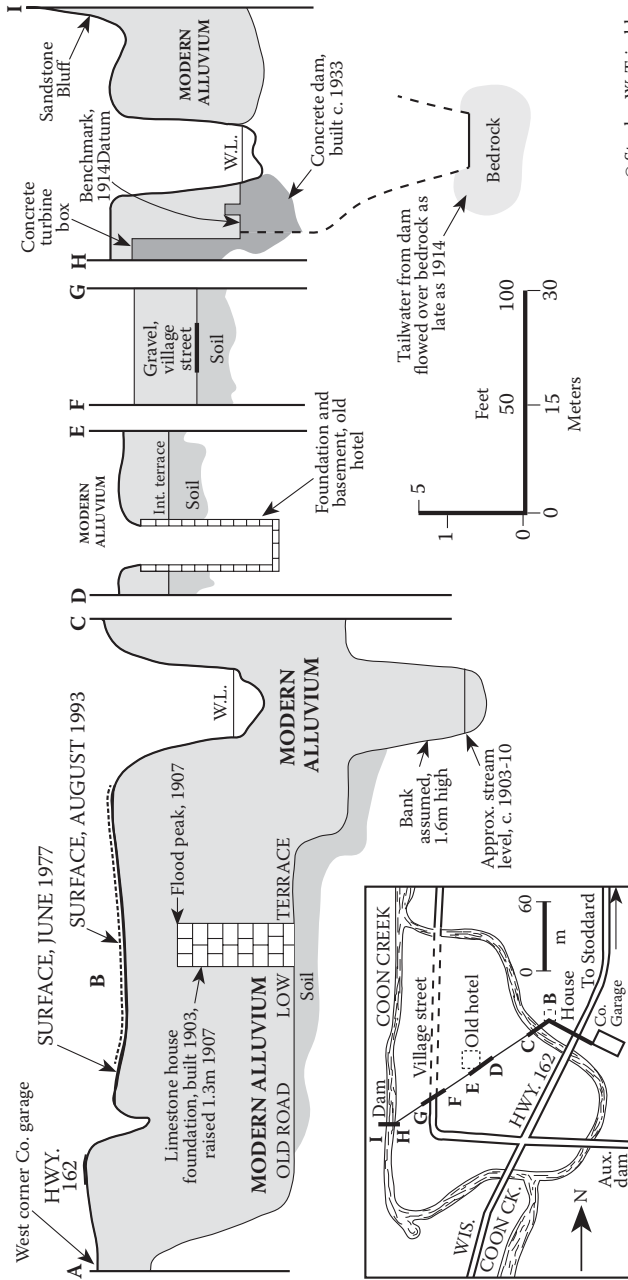
Figure 7.2 Cross section of Chaseburg from field research and excavations, 1976–1977. The limestone foundation to the left is that of the Martiny house, built 1903. A new surface survey in 1993 indicated about 3–6 in. (7–15 cm) of additional sediment accumulation since 1977.

Developments at the Martiny House (Figure 7.2) give a good idea of what happened to the village itself. The house was built on a low terrace in 1903 by Ole Martiny, an older, long-term resident of Chaseburg. One presumes that a half-century of observing the stream behavior would have instructed the village residents as to where flood damage would be probable, especially considering that other buildings existed, so that frequent flood damage would have been obvious and common knowledge in a small place such as Chaseburg. It thus appears that with this collective half-century of experience, Mr. Martiny believed it appropriate to locate his house on the low terrace.

Only 4 years later in 1907, a disastrous and unprecedented flood hit Chaseburg, submerging the Martiny house about 4 ft or 1.2 m (see Figure 0.2). Nothing had been experienced like this before, so Mr. Martiny decided to raise his house to the level of the 1907 flood. His reasoning was that being above the highest flood on record would preclude future flood damage. He was wrong: the flood plain aggraded, and floods became progressively higher so that the house had to be abandoned in 1925, only about two decades after initial construction

(Figure 7.6). Note that the flood stage of 1907 was about 3 ft (0.9 m) *below* the 1993 *floodplain* (Figure 7.2).

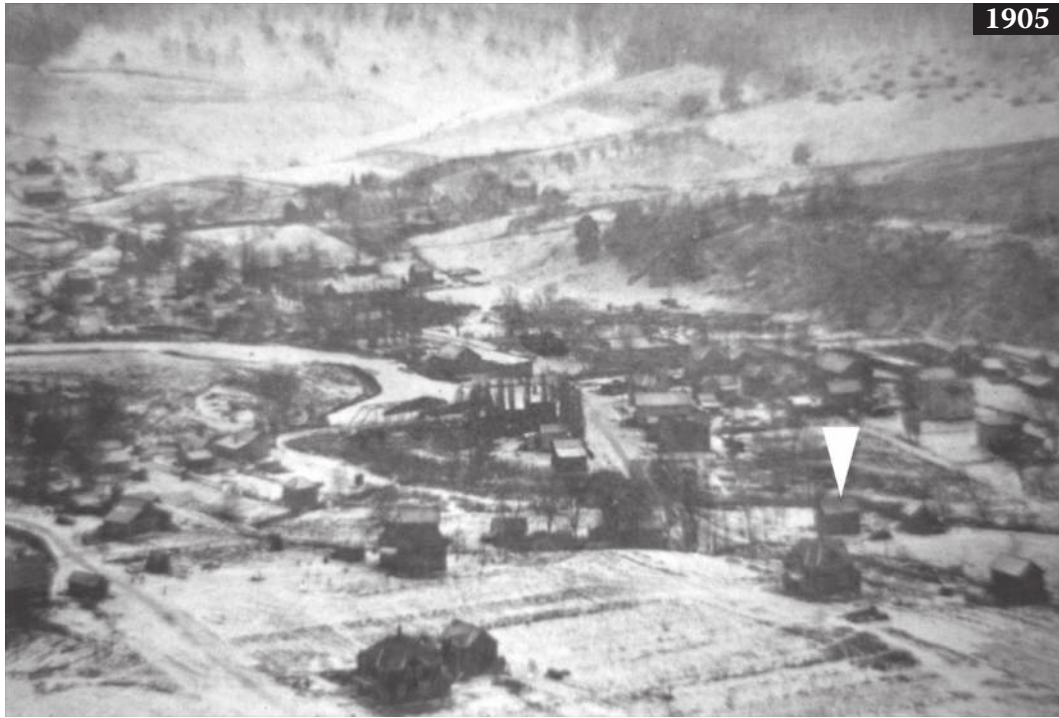
Figure 7.3 Chaseburg, refer to Figures 7.1 and 7.2. View southward across the village, c. 1905. The Martiny house west of Main Street is marked with an arrow. (Continued)

By the time we conducted our detailed surveys and excavations in 1977, much of the lower village was buried, and most of the remaining buildings had been raised to a higher position. The village hotel, a fine Italianate building, had been located on an intermediate terrace (Figures 7.1, 7.2, 7.3). The structure was abandoned in the 1930s and demolished in the 1940s. Although almost filled with rubble, water, and sediment and grown up bushes and small trees, the basement and foundation could still be discerned in the 1970s. The fact that buildings on the island had basements tells much about the lower stream levels at the time of construction and the low expectation of floods.

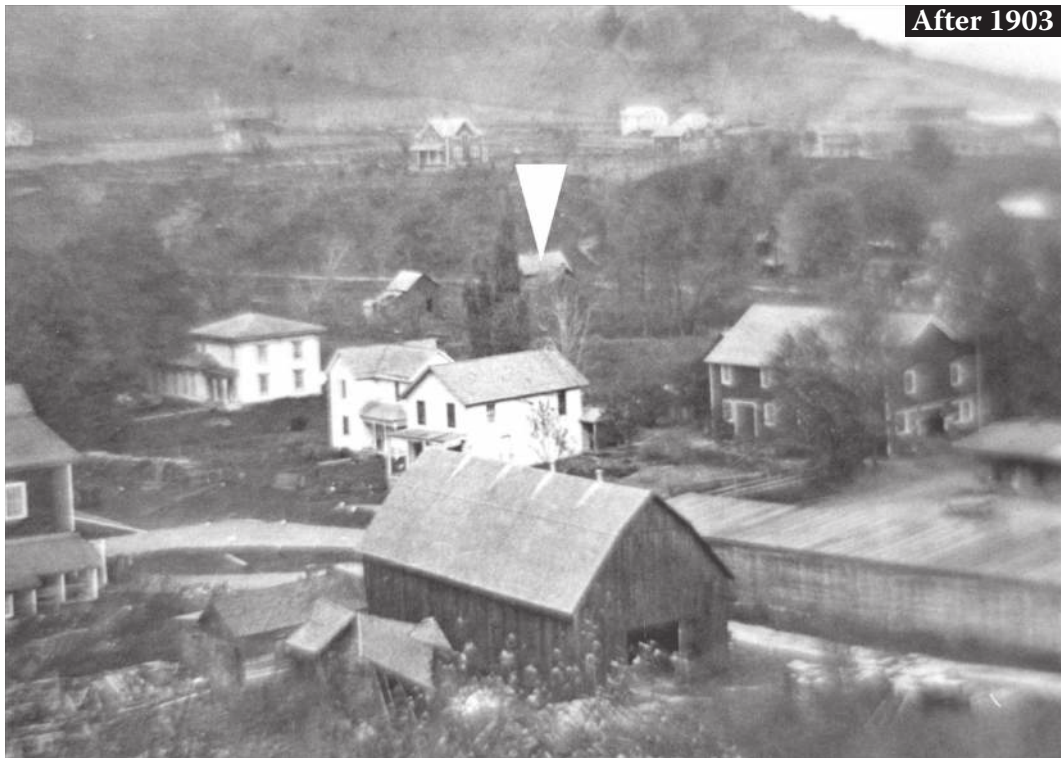
Figure 7.3 (Continued) Chaseburg, refer to Figure 7.1 and 7.2. View to the northeast. Martiny house west of Main Street marked with arrow. Dark building with white trim to far left is the mill. The white Italianate building to the right of, and beyond, the mill is the village hotel. In the background is the site of the “new” town. Photo date unknown but after 1903. (Continued)

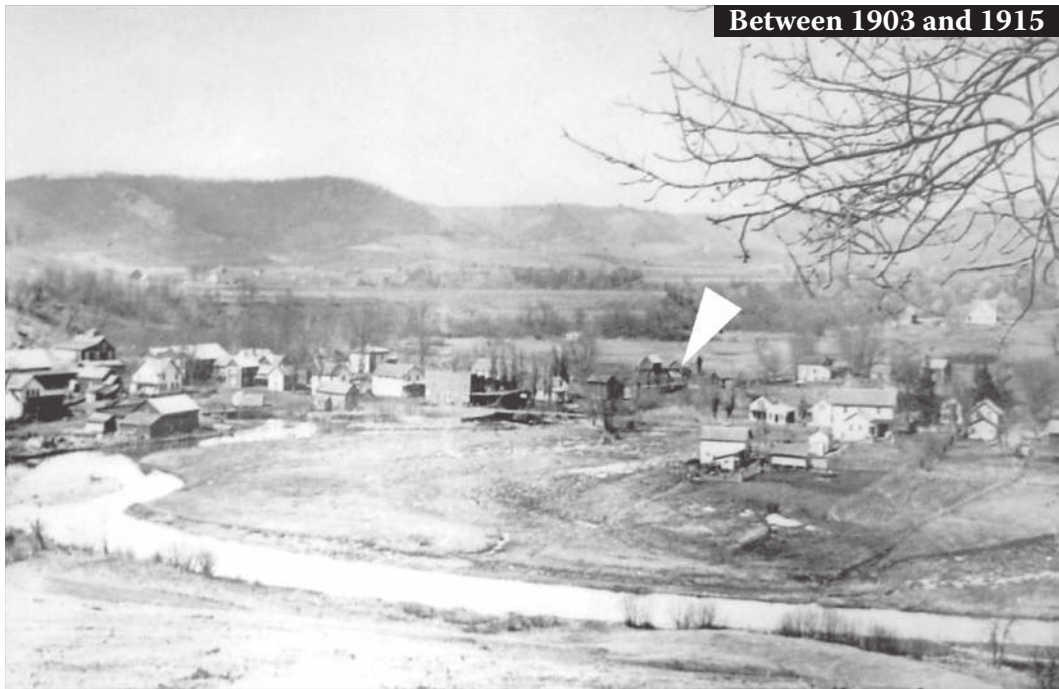
Figure 7.3 (Continued) Chaseburg, refer to Figures 7.1 and 7.2. View across the millpond and village looking northwest. Martiny house west of Main Street marked with arrow. Note recent sediment deposits on banks of millpond. Date: between 1903 and 1915.

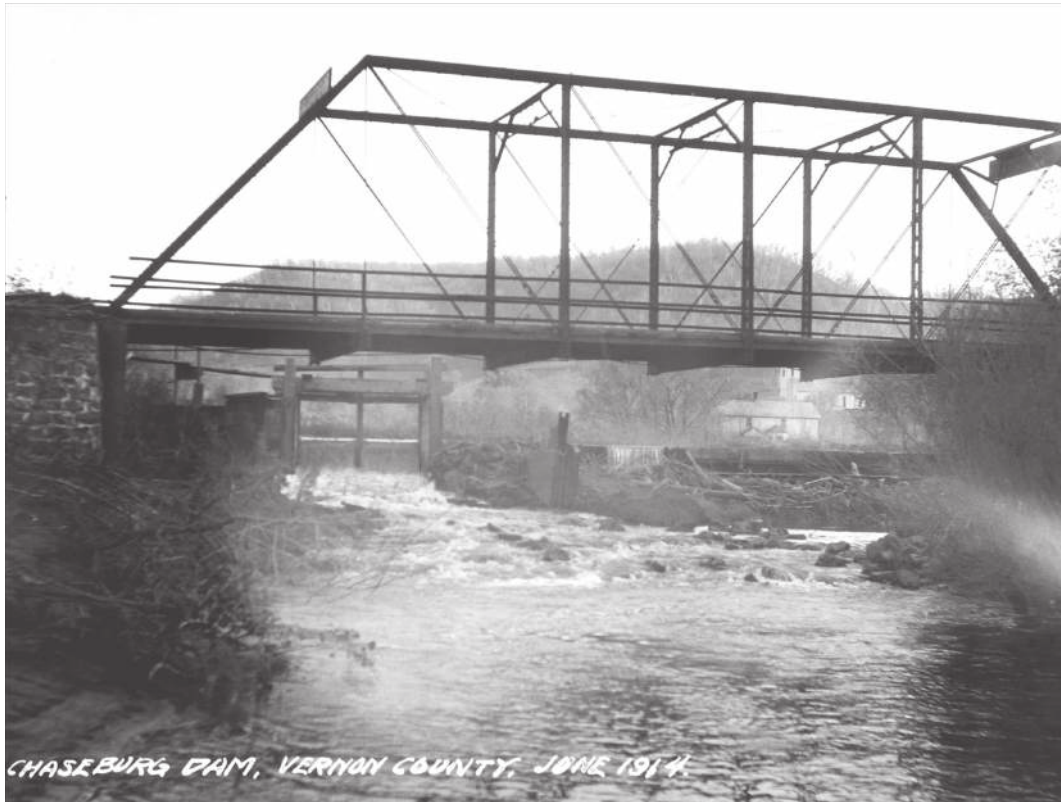
Figure 7.4 Bridge over Coon Creek on Mill Street in Chaseburg just below auxiliary dam (seen in background), looking southwest (upstream), June 1914. Note rock shoals below dam. The sills of the bridge were about 13 ft (4 m) above the water. For locational reference, note Lutheran church in background. (Continued)

Figure 7.4 Continued 1975: Replacement bridge at the same site as above, looking southeast (upstream). The newer bridge sat about 1 ft (30 cm) higher than the old bridge but had only about 4 ft (1.2 m) of clearance above the water in 1977. The 2011 water level here is 10–12 ft (3–4 m) higher than in 1914.

There were two dams at Chaseburg creating a single millpond. The first was an auxiliary dam above a rock shoal at the head of the island on the east side of the island. It diverted most flow toward the west side of the island but had gates to sluice floodwater (and, later, sediment) around the east side. In the 1914 photograph made by the Wisconsin Dam Commission, (Figure 7.4) the sills of the bridge are about 13 ft (4 m) above the water at the foot of the shoals. The newer bridge there in 1977 sat about 1 ft (30 cm) higher than its predecessor but had only 4 ft (1.2 m) of clearance at that time. Thus, there was about 10 ft (3 m) of aggradation there between 1914 and 1977.

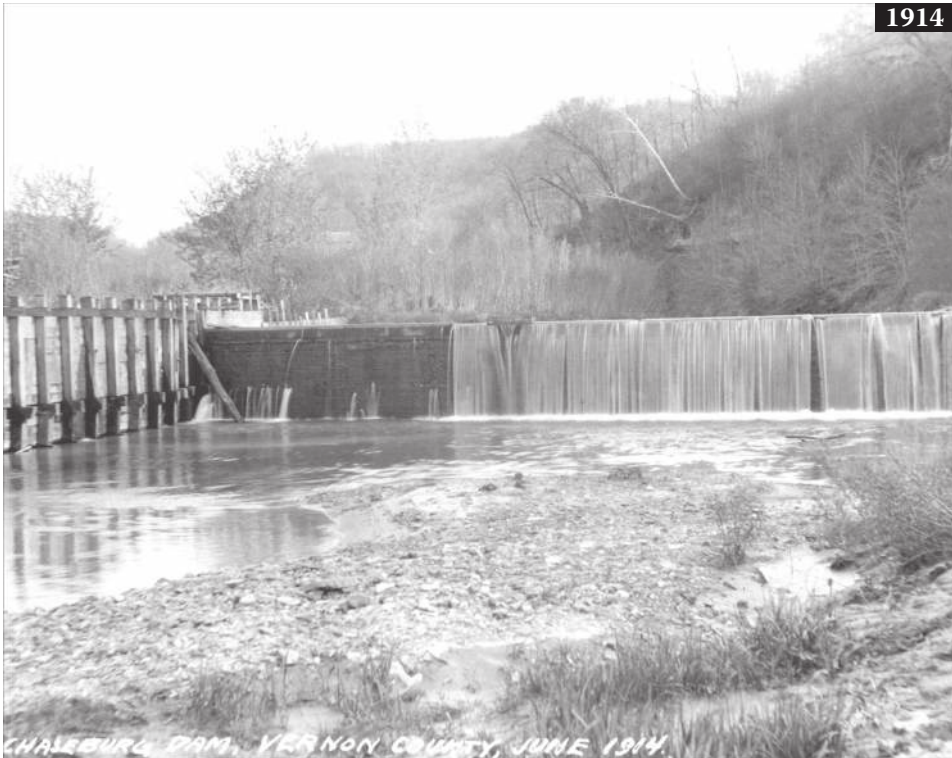
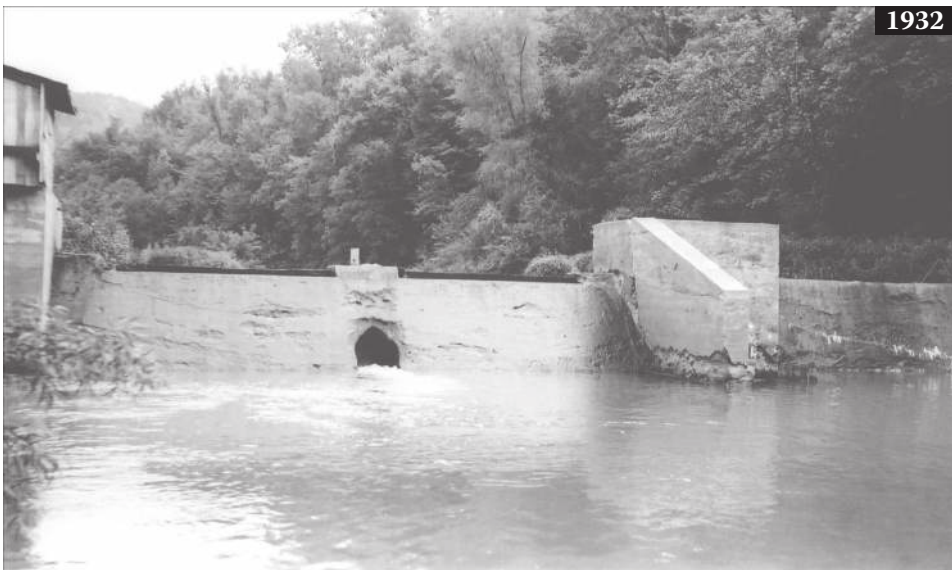
Figure 7.5 The main dam at Chaseburg looking upstream; refer to Figure 7.2. Top: wooden dam in 1914 at head of shoals. The race on the left extends 140 ft (44 m) to the mill, which originally gave 3 ft (1 m) more head or fall. This much fall meant that the dam was built on bedrock and that the bedrock extended at least to the mill. Bottom: Concrete dam built downstream at mill in 1932. Note sluice gate (center). (Continued)

The main dam on the west side of the island was at the head of bedrock shoals and 6 ft (1.9 m) high, the probable height of the banks at that time. The race extended 140 ft (43 m) to the turbine at the mill, gaining another 3 ft (0.9 m) of hydraulic head or fall of the water for power (Figure 7.5). In 1932, the wooden dam was replaced by one of concrete but now relocated downstream at the mill. The hope was that sluice gates built into the dam would allow sediment to be flushed through but that failed and the dam was dynamited in 1946. By 1977, the top of that dam was 5 ft (1.5 m) below the surface of the floodplain (Figure 7.5). Presently, the only visible trace of the old mill is about 2 ft (0.6 m) of the vertical turbine shaft protruding from the floodplain right behind the Hideaway Restaurant and Inn.

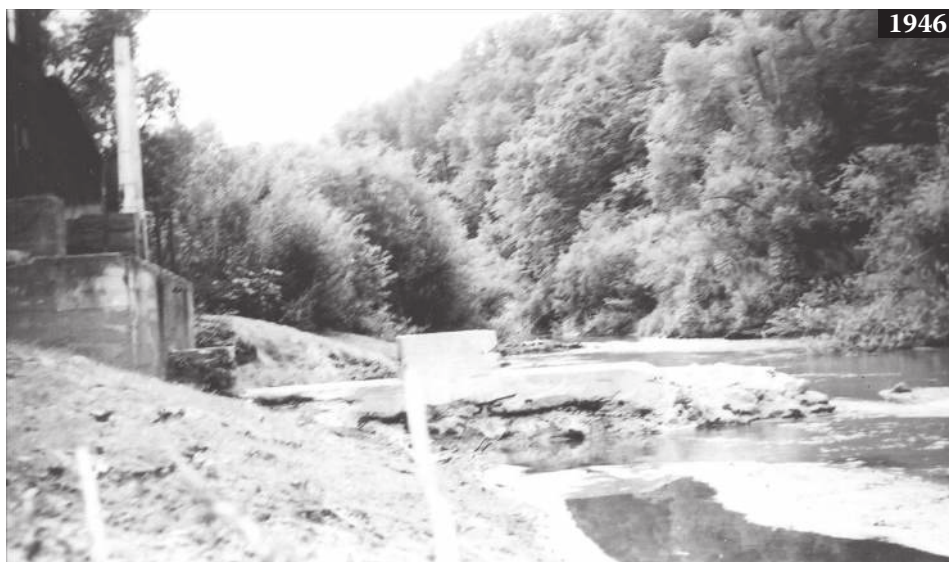
Figure 7.5 (Continued) The main dam at Chaseburg looking upstream; refer to Figure 7.2. 1946. Dam has been demolished and is rapidly being buried. Note rectangular concrete pier on dam to hold flash boards, probably a delaying tactic to keep the mill going a few more months. (Continued).

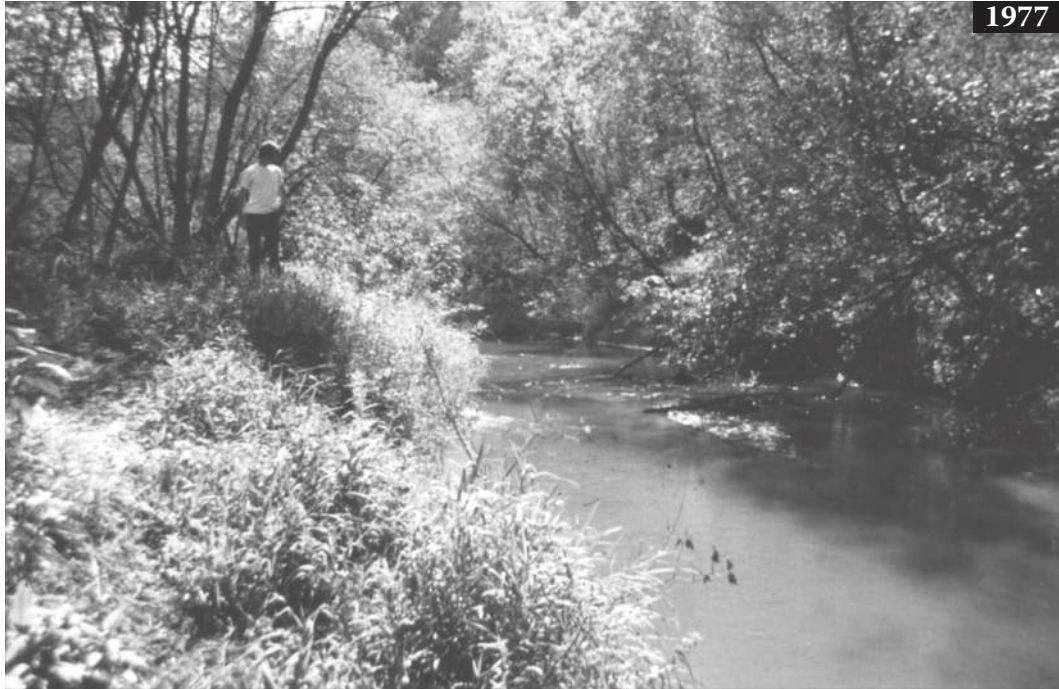
Figure 7.5 (Continued) 1977: All has been buried in floodplain. The person is 6 ft (2 m) tall. (Continued)

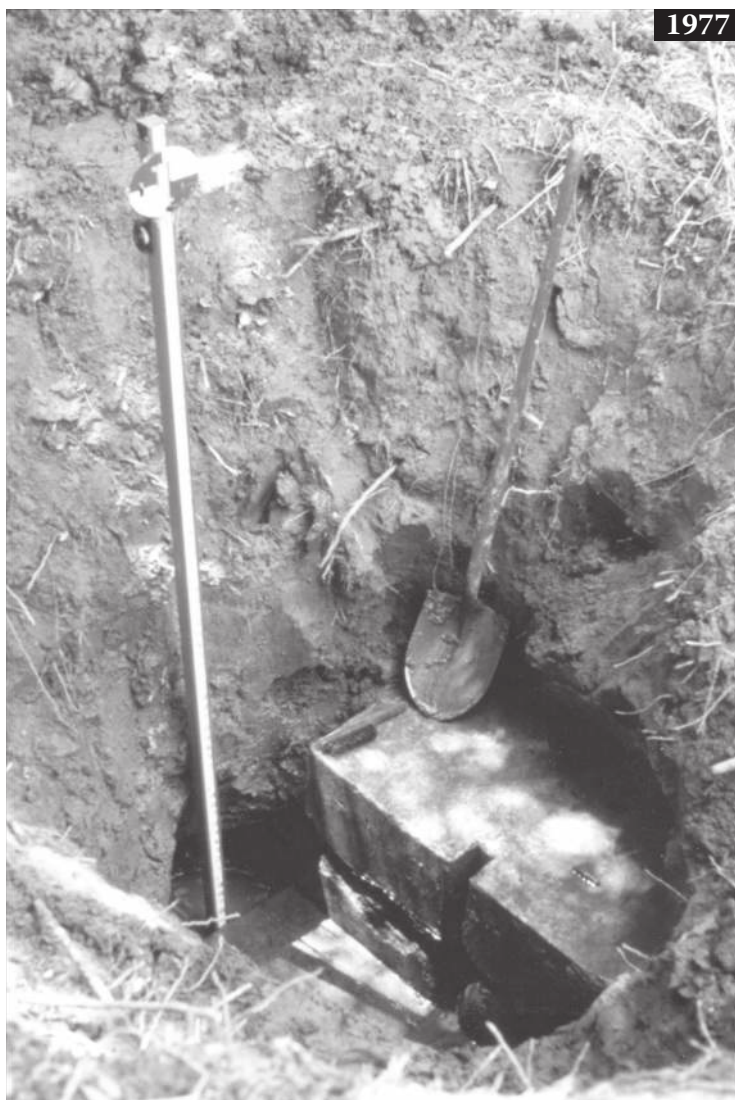
Figure 7.5 (Continued) 1977. Rectangular pier to hold flashboards (seen in the 1946 photo), excavated 1977. An elevation placed on the dam in 1932 tied into earlier surveys by the WI Dam Commission and allowed reconstruction of village elevations back to 1914 (Figure 7.2).

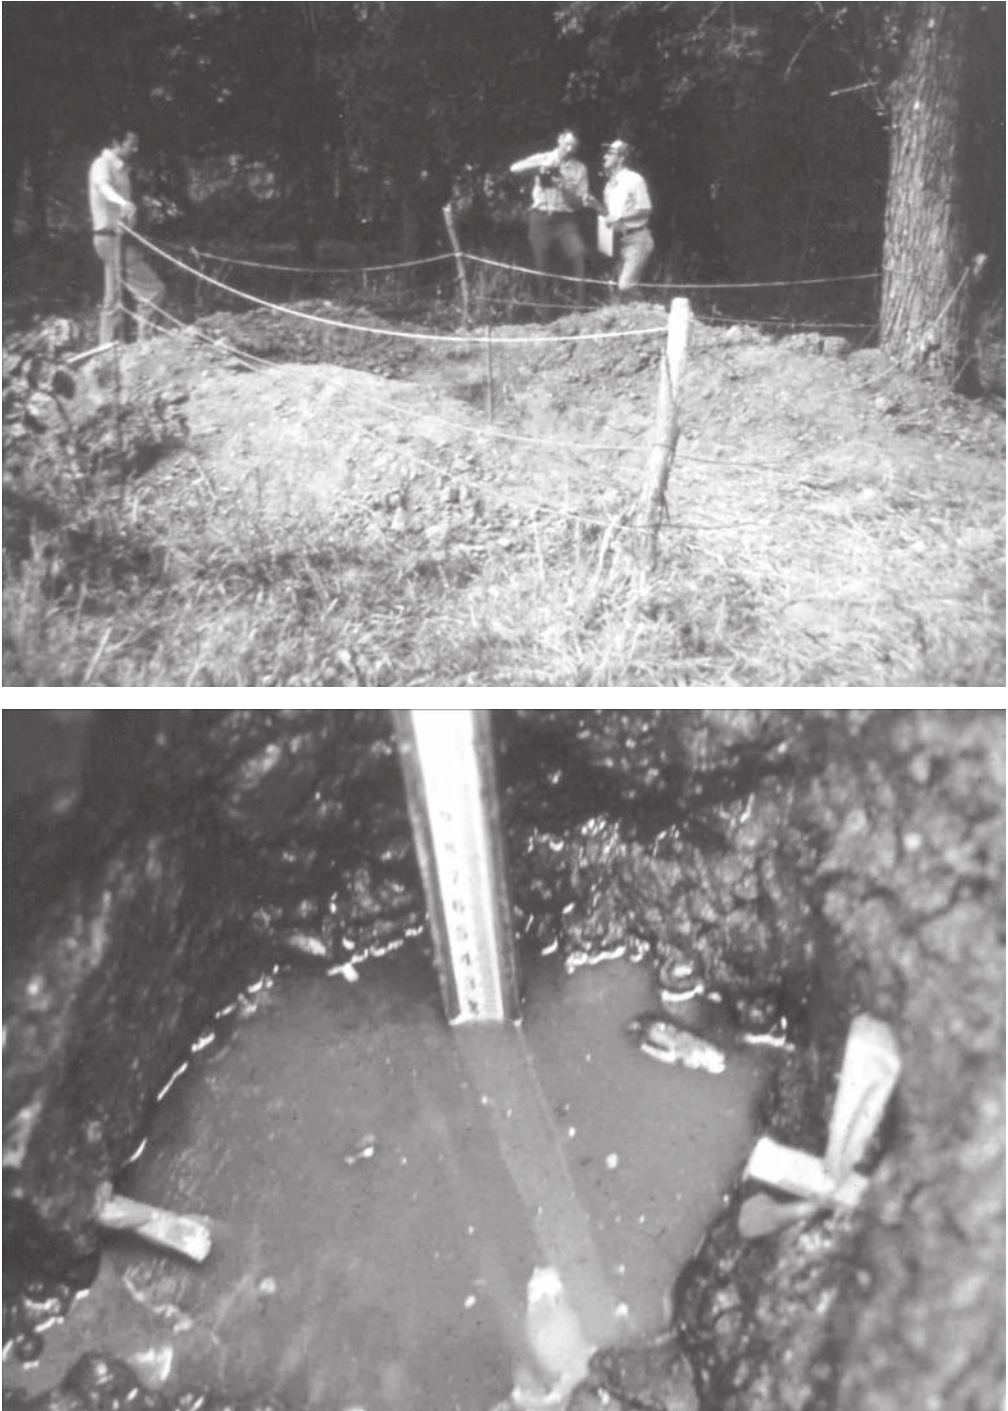
Figure 7.6 Martiny house, west of Main Street, Chaseburg, refer to Figure 7.2. Top: Excavation of foundation, August 1975. The vertical pipe marks the spot. Bottom: Base of excavated foundation, August 1975. Flag on left marks base of foundation. Flag on right marks contact of old, dark Mollisol and the lighter, highly stratified historical sediment deposited since 1903.

Figure 7.6 Martiny house, west of Main Street, Chaseburg, refer to Figure 7.2. Top: Excavation of foundation, August 1975. The vertical pipe marks the spot. Bottom: Base of excavated foundation, August 1975. Flag on left marks base of foundation. Flag on right marks contact of old, dark Mollisol and the lighter, highly stratified historical sediment deposited since 1903..... 154

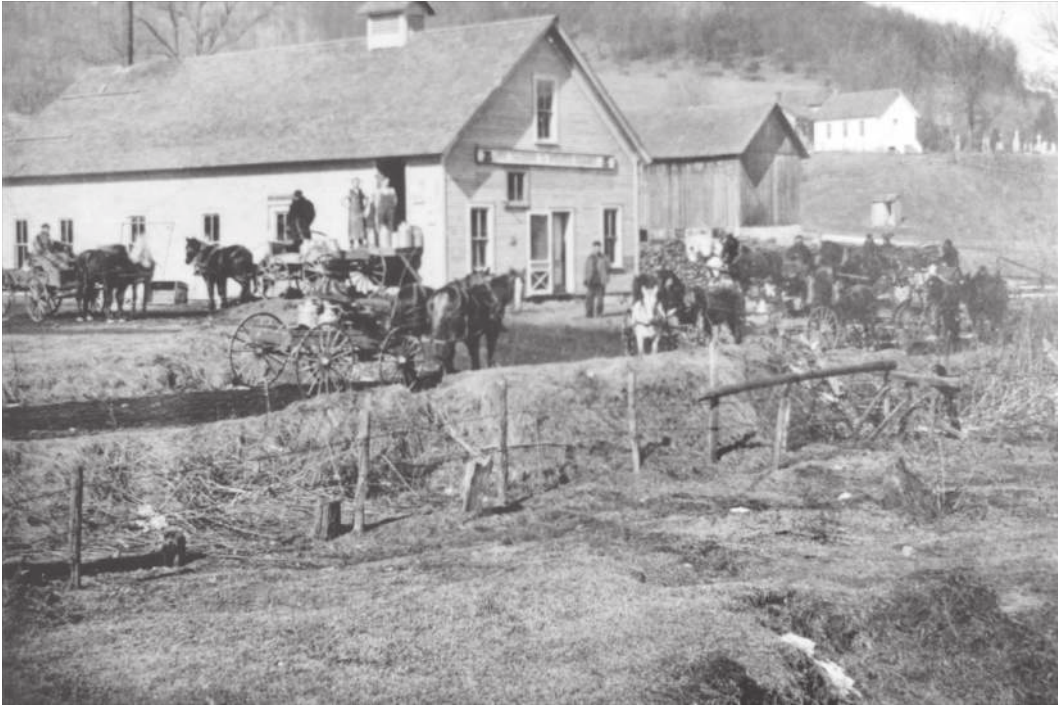
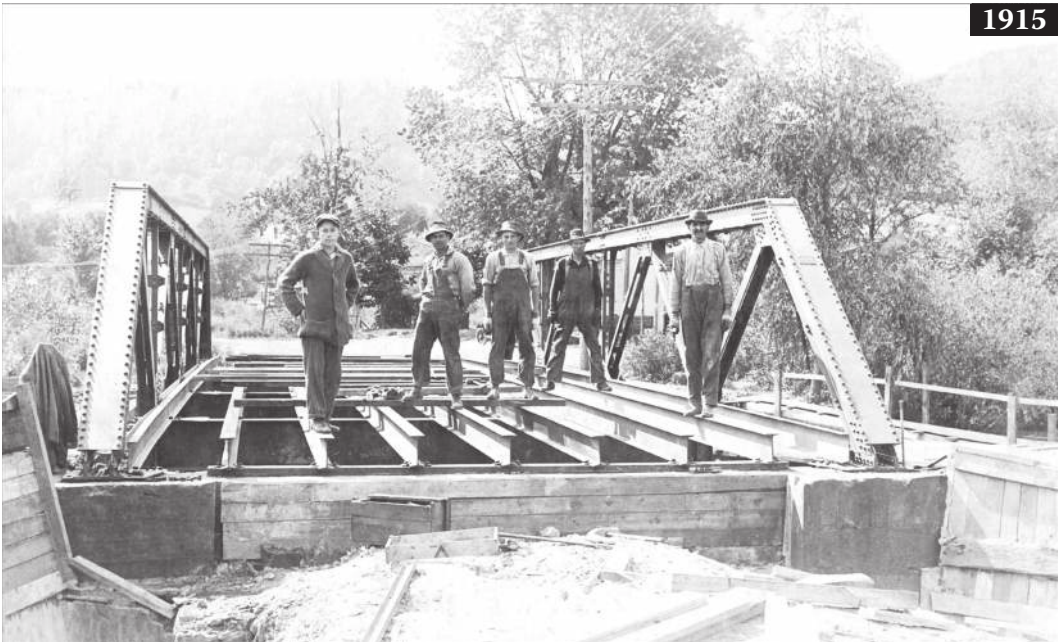
Figure 7.7 Early harbingers of a dark future for lower Chaseburg. Looking northwest at the cheese factory on south side of town, early 1900s. Floodplain of tributary from south in foreground with buried fence posts by road (now County Road K). Chaseburg cheese factory to left. For reference, Lutheran cemetery in right background. Bottom, raising the Main Street (now County Road K) bridge over the millpond on south side of village, 1915 presumably, to place it above floods. This channel is now completely occluded.

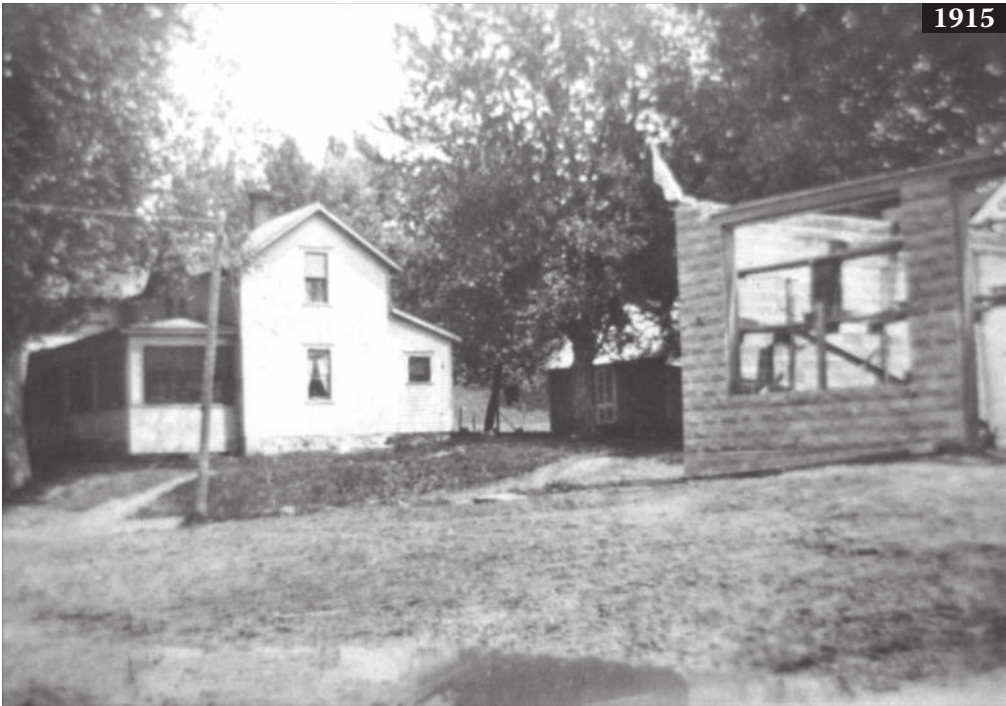
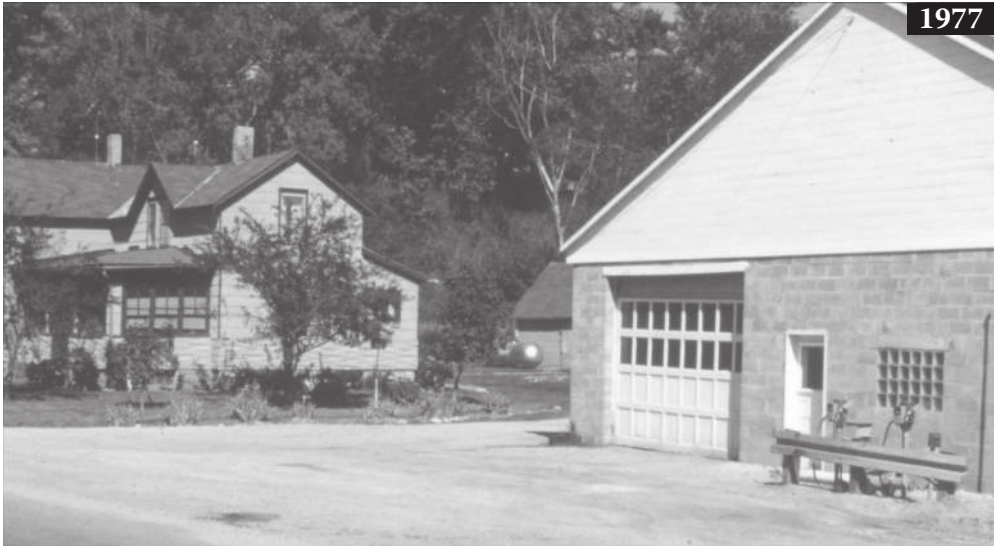
Figure 7.8 Top: Gardner's garage (later Vernon County Highway Dept. garage) under construction on top of terrace, 1915. This was directly across Main Street from the Martiny House by the bridge. Viewer stands on road (now WI Highway 162), but eye level is well below the floor of the garage. The house in the background sits on a terrace about 3 ft (1 m) higher than the base of the garage. Bottom: County highway garage, 1977. Façade had been changed, building remains the same. Viewer stands on road, eye level far up on the building. More than 2 ft (60 cm) of building are buried in fill. Approximately 10 ft (3 m) of stream and floodplain aggradation have occurred here, and the road has been raised accordingly (see Figure 7.2). Note that the floodplain had built up the level of the terrace on which the house in background sits. (Continued)

One older building which remained in slightly modified form to 2009 was the county road maintenance garage. Originally built about 1915 as Gardner Garage, it later became the Chevrolet dealership. There was a steep terrace face leading up to the garage door (Figure 7.8), and older residents of Chaseburg in the mid-1970s could remember this well: many of their period automobiles had been incapable of climbing the steep slope in low forward gear, so reverse gear had to be used to back up the slope. Both photos were made from the road in front of the garage, but in 1975 the elevation of the road was at least 10 ft higher than in 1915

(Figure 7.8). Although the area immediately next to the building has been built up about 2 ft from the road, one then looked *down* into the garage door. The front facade had been changed, but the rest of the building remained the same. The house in the left background was built on another terrace surface about 3 ft (1 m) higher than that of the garage, but the house site was by 2008 almost level with the road and the terrace face had almost disappeared. Frequent flooding caused the county to abandon the garage, and the 2008 photo was made just after the June 2008 flood. Along with the rest of the buildings remaining in lower Chaseburg, the garage was demolished in 2009. Only the Hideaway restaurant remains, where one may see an excellent collection of historical photographs of Chaseburg and the surrounding area.

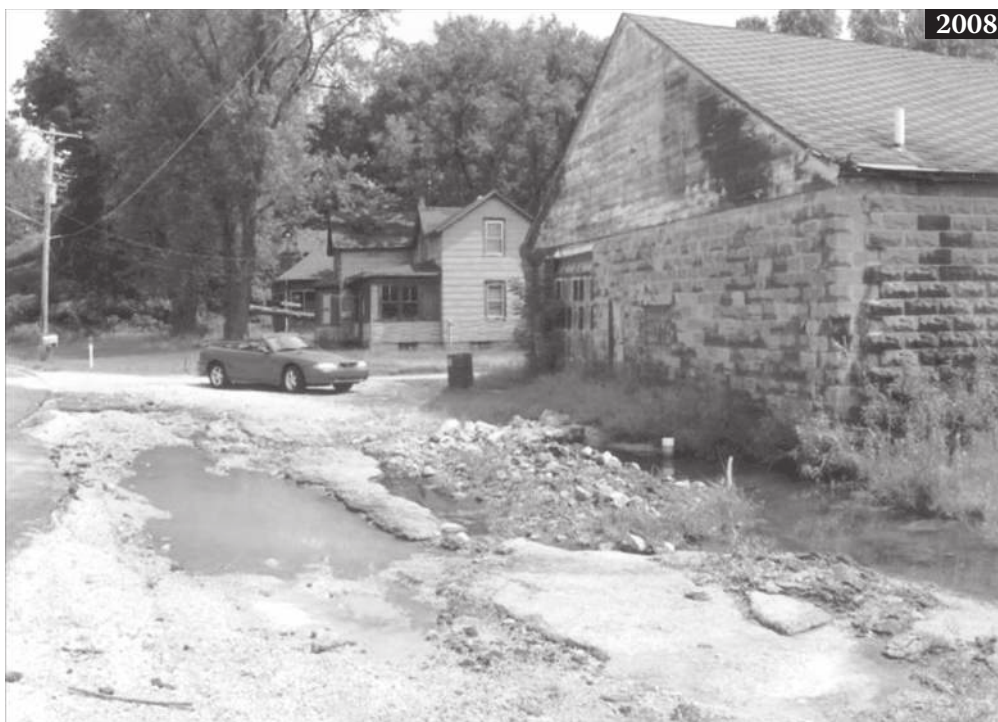
Figure 7.8 (Continued) July 2008. Two large floods had passed though in the preceding 10 months and the building was abandoned and derelict.

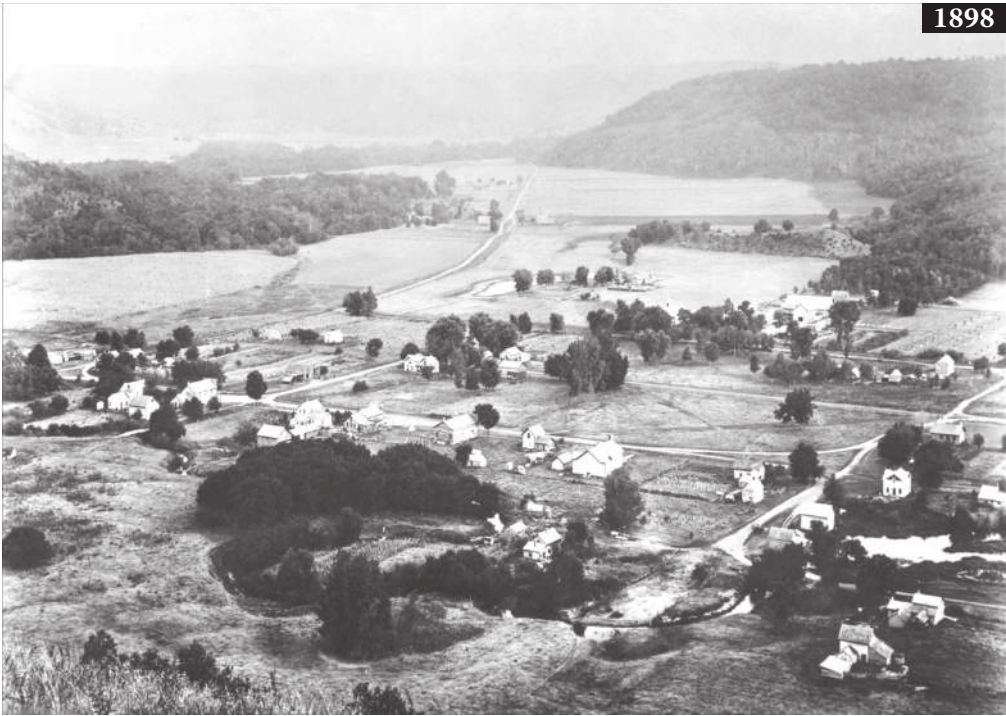
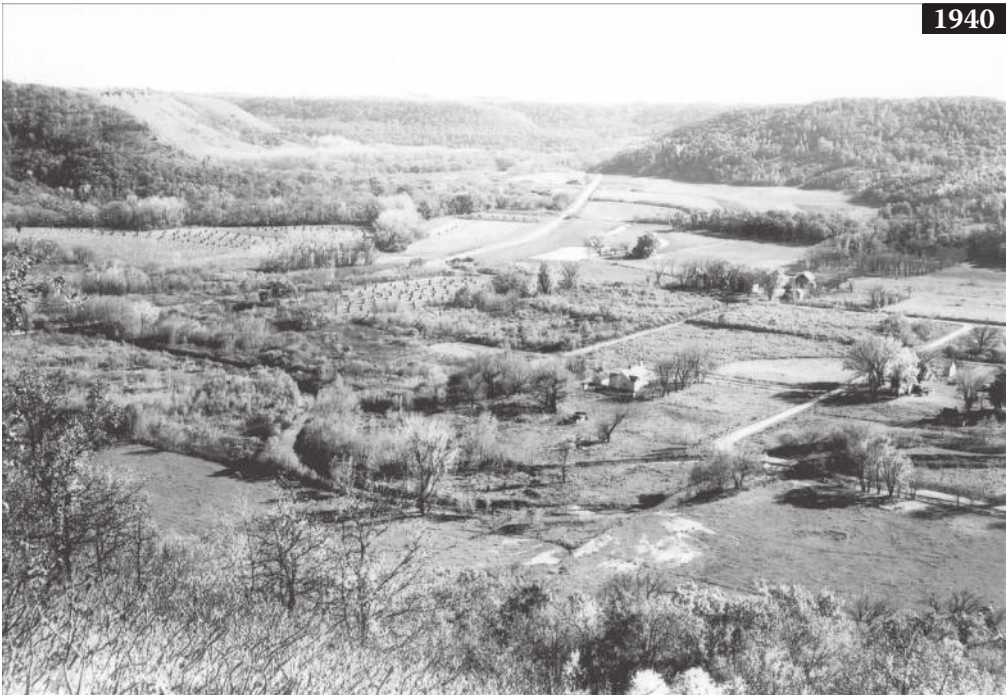
Figure 7.9 Beaver, MN, on Beaver Creek, Whitewater River valley, Winona County, looking upstream Beaver Creek flows right to left (eastward). Top, Beaver in 1898. The downstream millpond is visible in the right foreground. Bottom: Repeat of previous shot, 10/15/40. Only two buildings remain. Presently, only a forested valley floor can be seen from this photo site.

short distance before flowing into the Whitewater River. The village of about 125 residents prospered for 60 years (Figure 7.9), but floods were becoming a nuisance by the second decade of the new century. With any large storm, the village was flooded first by Beaver Creek and then, a few hours later, the Whitewater itself would crest, flooding the village again. So rapid was the sedimentation of the valley and the increase in flood discharges that flooding was becoming disastrous by the 1920s. In 1938 alone, Beaver was flooded 27 times (Saari, 1956; Horn, 1972; Sillman, 1976). In one of those floods, the living room of one home was filled with sediment to the top of the keys on the piano (Siebenaler, 1955). The magnitude of aggradation at Beaver is suggested by the fact that several houses were originally built with basements, indicating the water table was at least 10 ft (3 m) deep. But by the late 1930s, some houses were buried almost to the second story floor, and the site was becoming wet. In one case, the second story floor had become the ground floor. By 1940, the village had been almost abandoned (Figures 7.9 and 7.10).

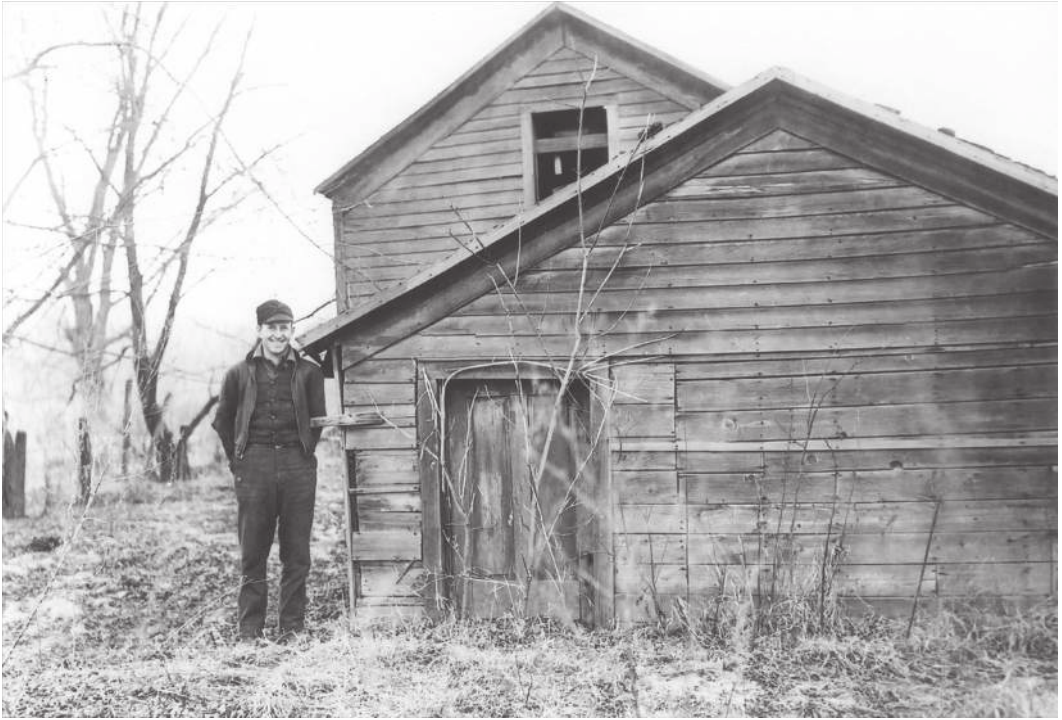
Figure 7.10 A partially buried house in Beaver, 11/28/39. See H. Johnson (1976, pp. 212-213) for another example).

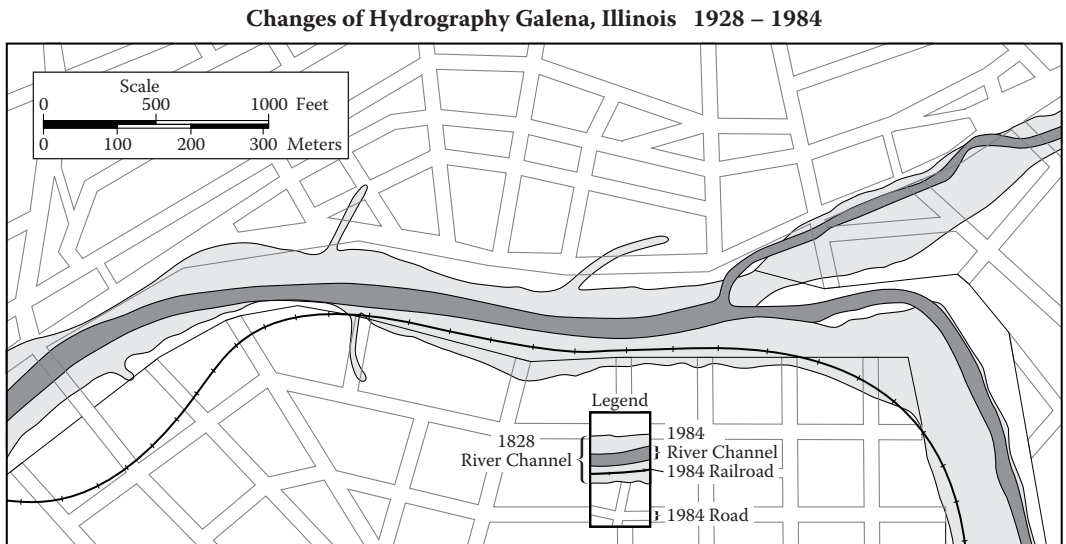
Figure 7.11 Galena, Ill. Overlay of modern topographic map on 1828 map showing how the Galena River has narrowed from the influx of sediment. As late as 1850, large steamboats could turn around in the river. Early map from the Wisconsin State Library and Archives.

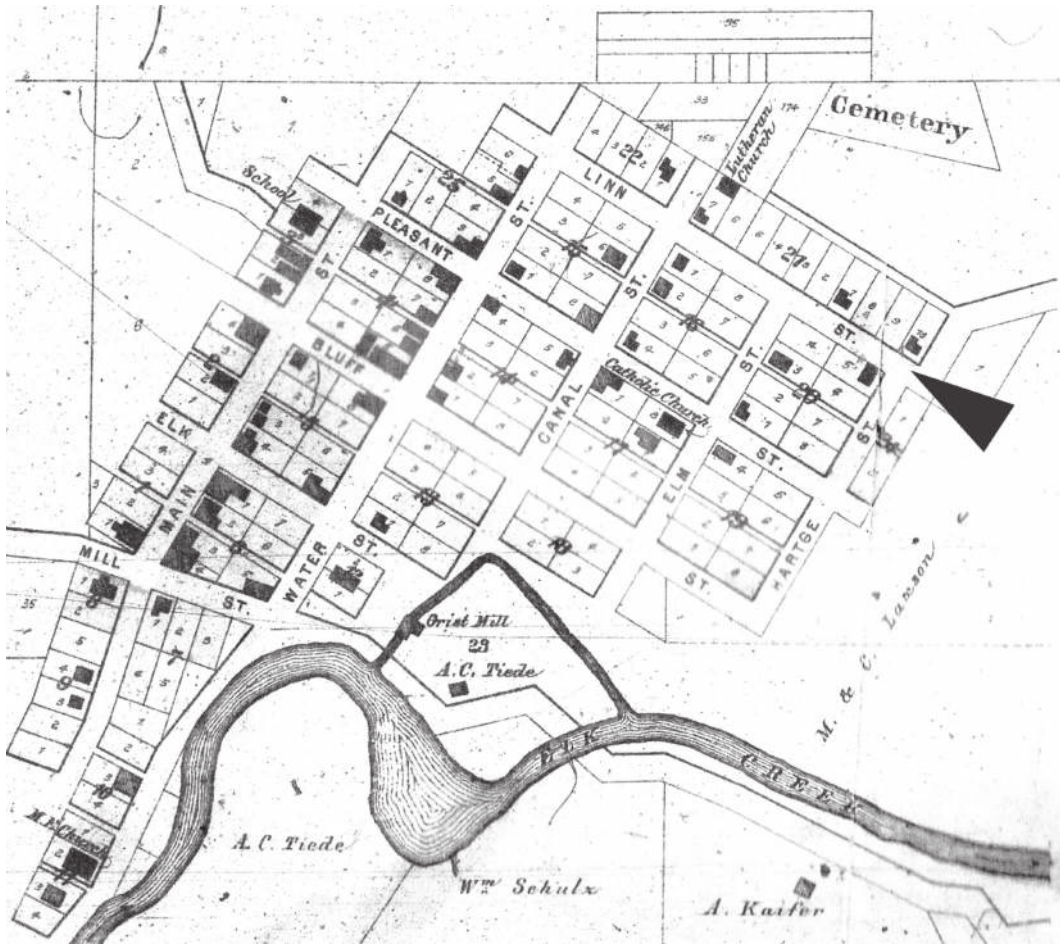
Figure 7.12 Elkport, Clayton County, IO, 1886. At confluence of Elk Creek and the Turkey River. Arrow marks Linn Street and photo site in Figure 7.13. Note Lutheran church farther down the street on right and Catholic Church and other buildings off to the left. (*Plat Book of Clayton Co, Iowa, 1886*). Stream flows left to right (eastward).

Elkport, Iowa, at the confluence of Elk Creek and the Turkey River was a thriving community by 1886 (Figure 7.12). By 1905, the Iowa Geological Survey reported that about 6 in. (15 cm) of sediment had been deposited on the floodplain there. Flooding and sedimentation continued, and most of the village eventually had to be abandoned. Of the old village, only the Lutheran church, sitting on higher ground, still exists. The ruins of the rest of the village, including the Catholic church and school, now lie under a large cornfield (Figure 7.13). Local farmers say they sometimes plow up parts of the old buildings. The entire village is now surrounded by a flood dike.
