**HISTORICAL AGRICULTURE
AND SOIL EROSION IN THE
UPPER MISSISSIPPI
VALLEY
HILL COUNTRY**

STANLEY W. TRIMBLE

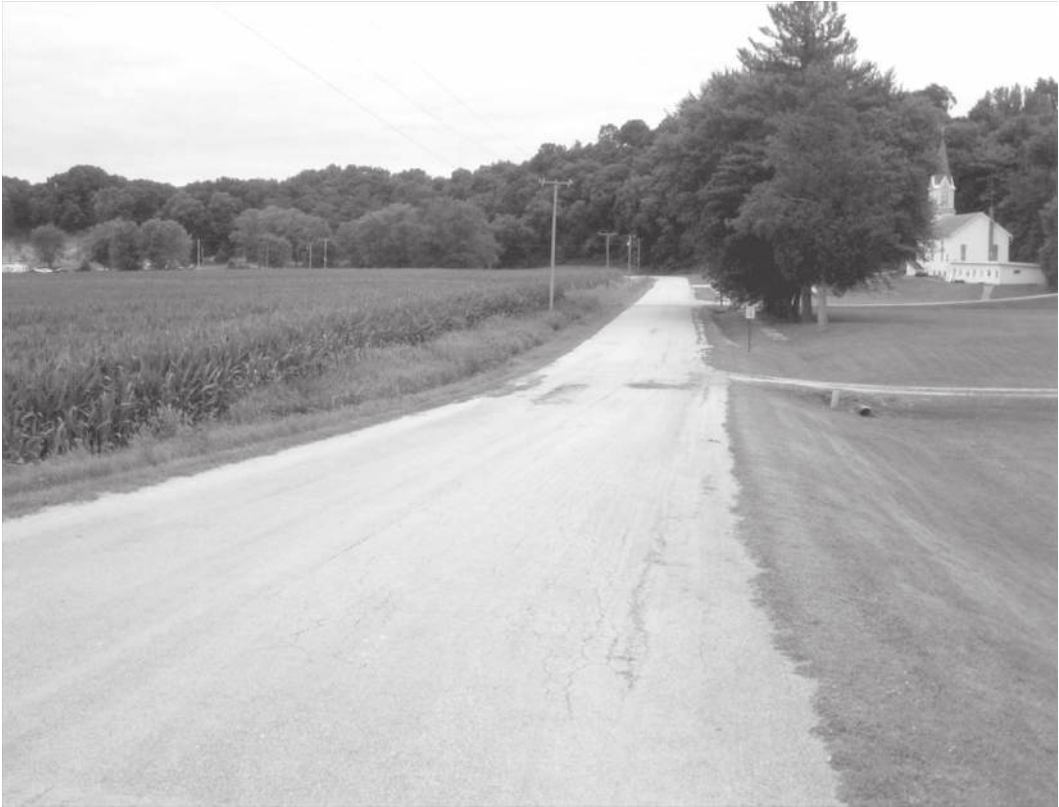
Figure 7.13 View down Linn Street in Elkport in 2009 (see arrow in Figure 7.12). The Lutheran church on higher ground to the right is the only building left. The remains of the other buildings lie beneath the sediment on the field to the left now growing corn. The whole village is now protected by a flood dike from which this photo was made.

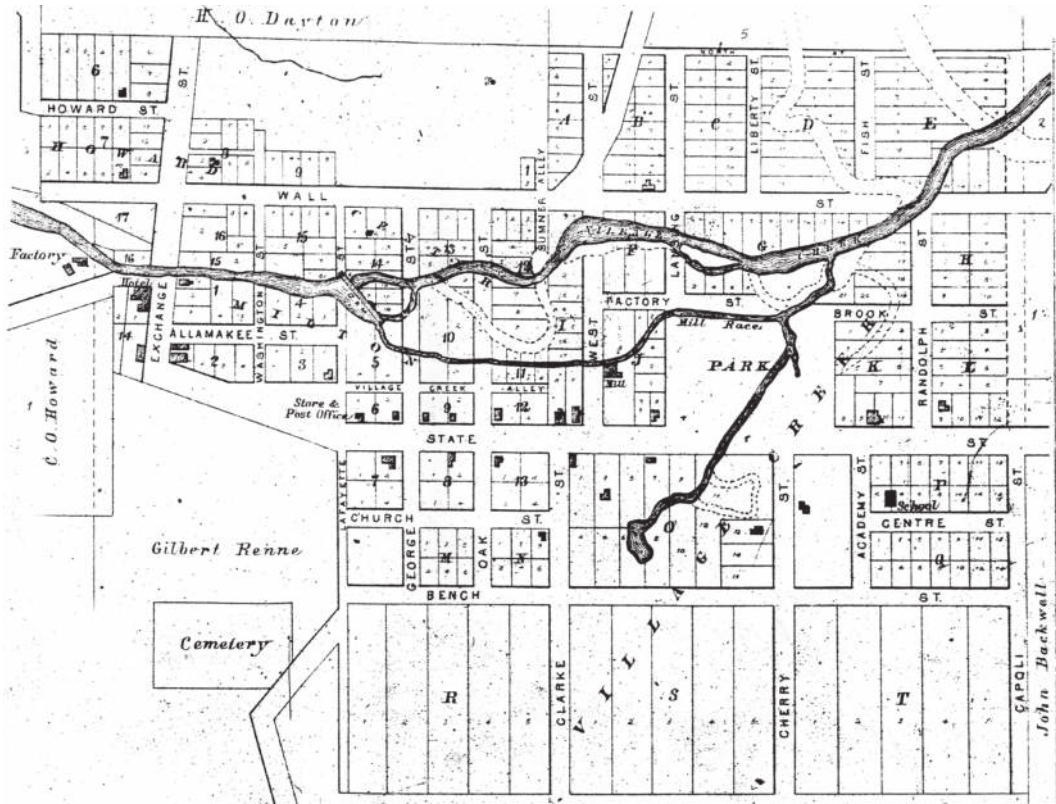
Figure 7.14 Village Creek, Iowa, on Village Creek about 10 mi (16 km) southwest of Lansing, Iowa, 1886. Note the number of water-powered developments there (*Plat Book of Allamakee County, Iowa, 1886*). There is presently no trace of any of these dams, factories, and canals, all presumably buried by sediment. Stream flows eastward (left to right).

Village Creek, Iowa (Allamakee County), was founded in 1857 and seemingly destined to become a significant industrial community (Figure 7.14). By 1862, there were two or three mills here (Hancock, 1913). By 1865, a 3 1/2 story stone woolen mill with 15 employees was operating (Alexander, 1882). By c. 1880, three other mills were also operating, and the village population was 167; but later, flooding was a constant problem (Hancock, 1913). By 1913, only one mill still operated (Hancock, 1913). Village Creek is now a ghost town, and there is no sign of the several shoals and mill sites that inspired its location; they are presumably buried. The only old building still standing is the very substantial stone school, built in 1860 (Figure 7.15). Despite being located on the south side of the village on what was apparently higher land, it has been buried about 4 ft (1.2 m) so that the windows are almost at ground level.

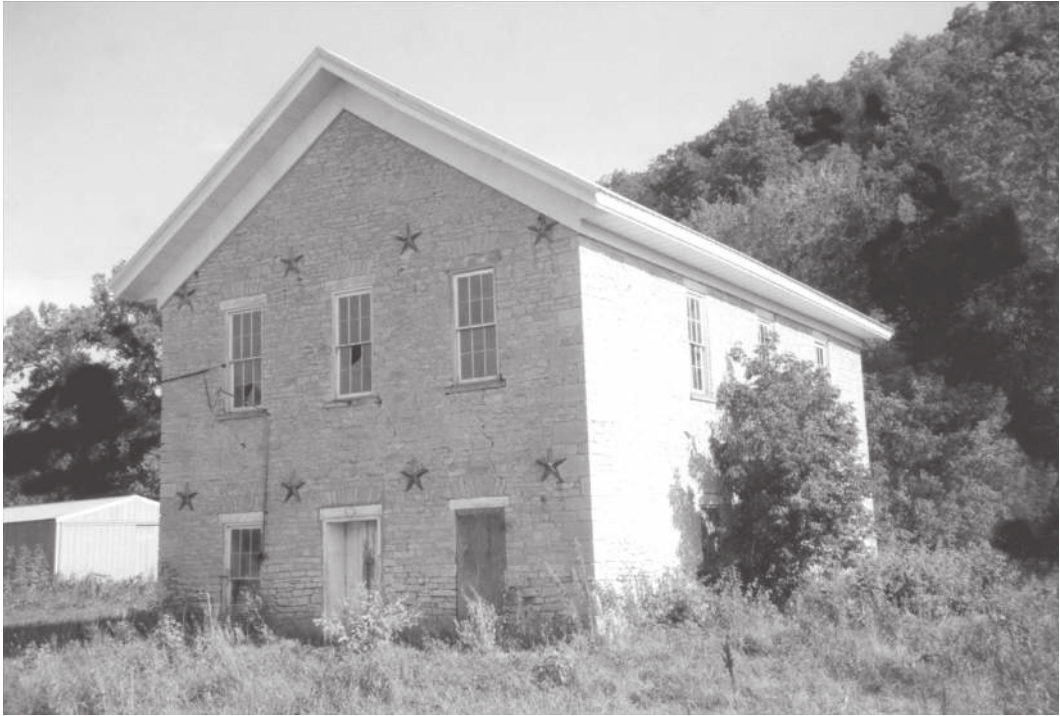
Figure 7.15 Village Creek. The schoolhouse, built in 1860, is the only old building left. Although in a higher part of the village, it has been buried 4 ft (1.2 m) so that downstairs windows are at ground level. (Photo credit: Nadine Kleinhenz, 2006.)

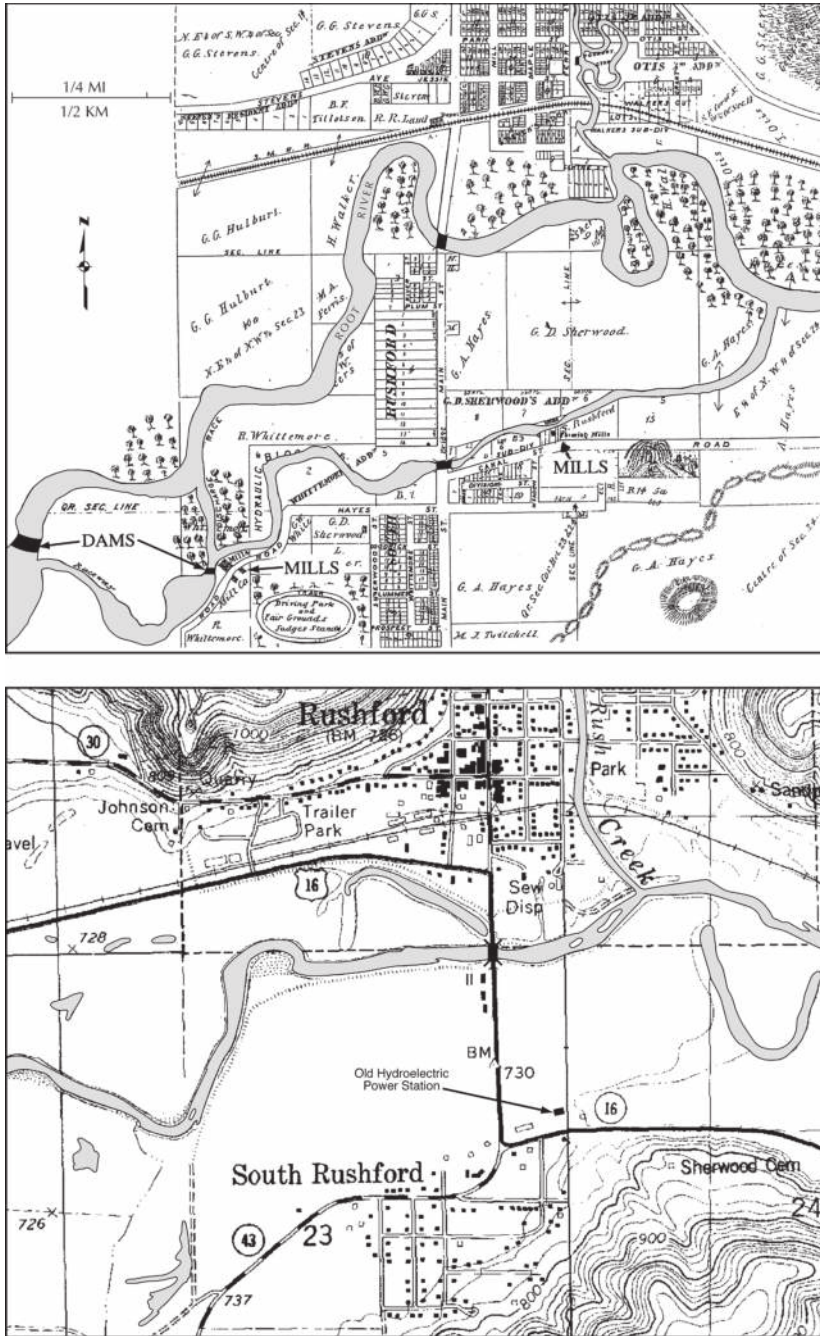
Figure 7.16 Rushford, MN, Root River. Top: 1874. Stream flows eastward (left to right). Note the large “industrial park” of canals, dams, mills, and houses south of the Root River (*Illustrated Historical Atlas of the State of Minnesota*, 1874). 1980s (USGS 1:24,000 topographic maps): Note the straighter configuration of both the Root River and Rush Creek coming from the north and running through North Rushford. There is now little trace of the old industrial area, it being buried, but there are the remains of a hydroelectric power station about 500 ft (150 m) east of the south end of the present causeway. Styled in Art Deco, the power station was probably built in the early 1920s.

Historical Atlas of the State of Minnesota, 1874). Now, there is only a featureless floodplain to be seen there, most everything having been removed or buried (Figure 7.16). However, if one looks about 500 ft (150 m) east (downstream of the south end of the causeway) across the Root River floodplain, one will find a derelict early 20th century Art Deco-style hydroelectric power station (Figure 7.16), the only vestige of the water power development at this location. There is no longer a canal leading into and away from it, indicating the massive sediment accretion that has occurred there.

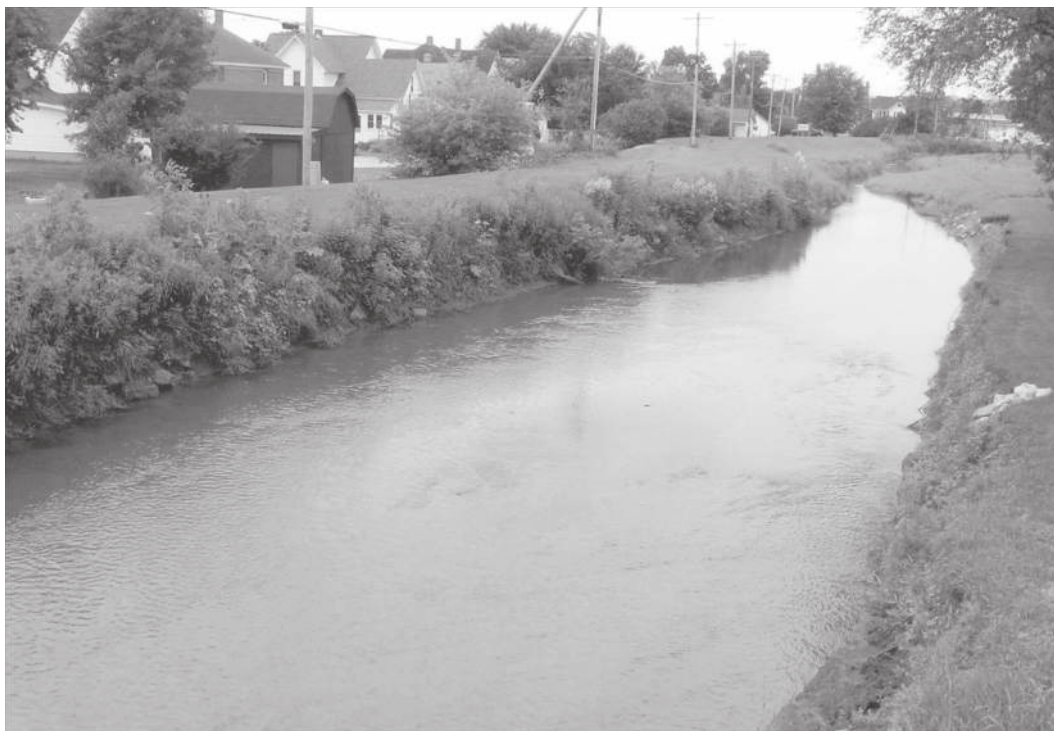
Figure 7.17 Arcadia, WI. Turton Creek at an old mill site, looking downstream towards the Trempeleau River, 2011. The stream flows along the north side of the town. Note that the water surface of the creek at normal flow is presently almost as high as the land on the other side of the flood dike. The dike to the left is about 4 ft (1.2 m) high. The fact that most of the houses in town had a basement suggests that the original water level was at least 10 ft (3 m) lower. Even the level of the millpond here would have been considerably lower than the present level of the stream. Otherwise, it would have flooded the areas to either side and would have raised local groundwater levels. The higher present stream levels, including the Trempeleau River, just 2 mi (3 km) downstream from this site, have caused groundwater to rise and flood basements in the town.

The migration of sediment continues, and the lower portions of the LMV are still aggrading. In Arcadia, Wisconsin, at the confluence of Turton Creek and the Trempeleau River (Trempeleau County), basements have become increasingly wet during the past three decades, an indication of rising groundwater. My investigation indicated that migrating sand has aggraded the stream channels of both Turton Creek and the Trempeleau River, thereby raising local groundwater. In some places, stream levels are almost level with the streets and yards of the city (Figure 7.17). Thus, the physical model given in Chapter 3 is not only explanatory, it is also predictive; the downstream portions of the LMV zone can

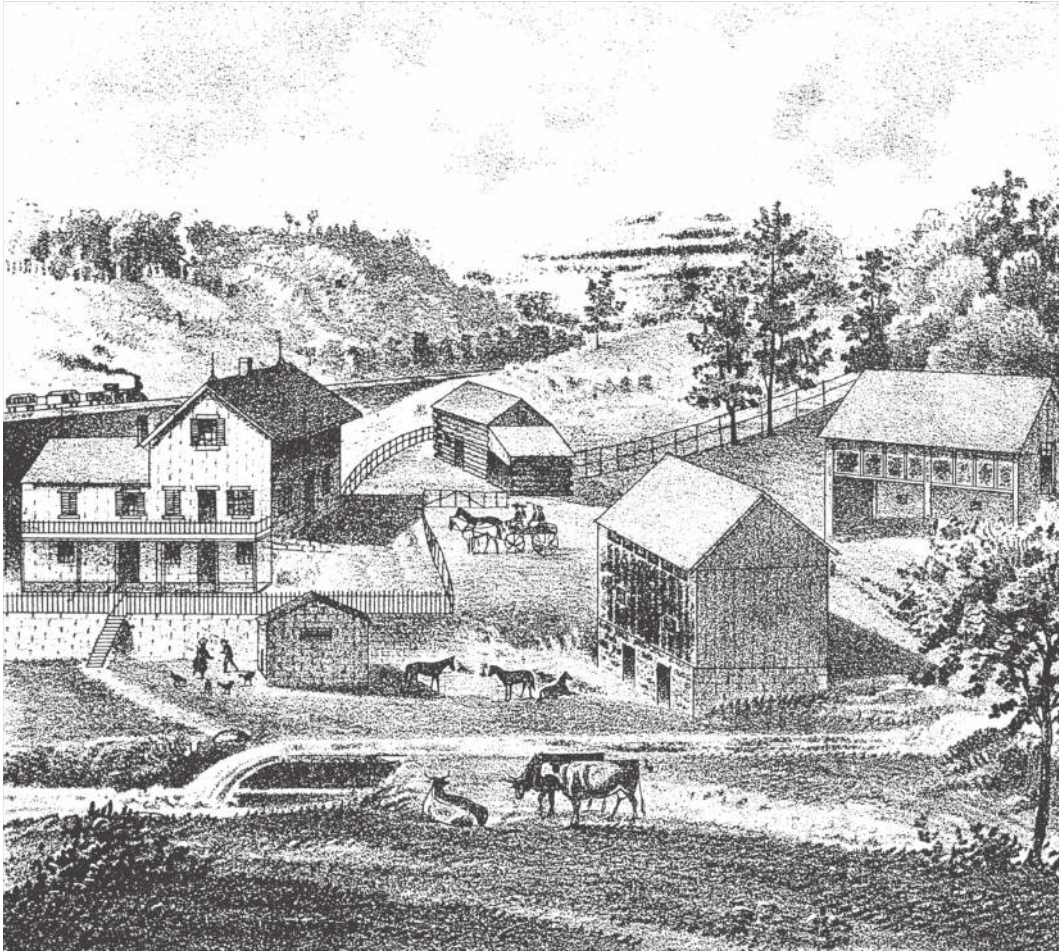
Figure 7.18 Drawing of the residence of Jacob Roth, Crooked Creek (NW $\frac{1}{4}$, Sec 27, R4W, T13N, Houston County, MN, from *Illustrated Historical Atlas of the State of Minnesota*, 1874). Note the stone wall in front of the house which, in comparison to the house and the figures, was about 9–10 ft (3 m) high. Note further that the stream in the foreground is at least 5 ft (1.5 m) lower than the base of the wall. For this water to flow out, the floodplain (to the left or south) would have had to be even lower. Thus the house sat at least 14–15 ft (4.5 m) above the floodplain. Also note the train in the distance going up the valley. The tracks to Caledonia were completed in 1871. (Continued)

An excellent example of a farmstead impinged upon by an aggrading floodplain is the very handsome Jacob Roth house on Crooked Creek, Minnesota. A beautiful drawing of the farm was included in an 1874 atlas (Figure 7.18). It shows the house sitting high above the floodplain as evidenced by a high stone wall in front of the house and by a tributary at an even lower level with a waterfall. Scaling from drawings is always problematic, but it suggests that the house sat 14–15 ft (4.5 m) above the lowest level of water shown in the drawing, which would approximate the level of the floodplain. The same drawing shows a train going up the valley on the new railroad (Caledonia branch of the Chicago, Milwaukee, and St. Paul), which was completed in 1871 (Hancock, 1913). Crooked Creek has since aggraded deeply, burying most of the railroad embankment and almost destroying the village of Freeburg 5 mi (8 km) upstream (Chapter 6). A photo of the Roth house made in 2009 looking across the floodplain from the public road suggests the floodplain has aggraded to near the level of the house since 1874, suggesting 14–15 feet (4.5 m) of accretion here (Figure 7.18).

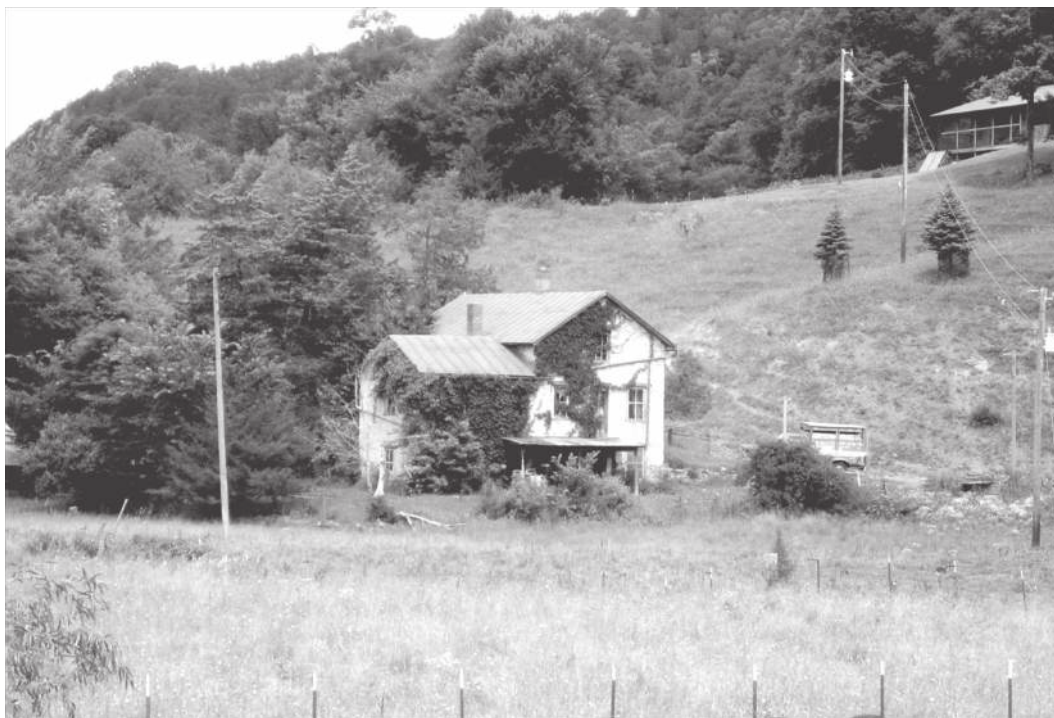
Figure 7.18 (Continued) View of the Roth house from the public road across the floodplain, 2009. The level of the floodplain appears to be close to the base of the house, suggesting aggradation of more than 10 ft (3 m) since 1874.

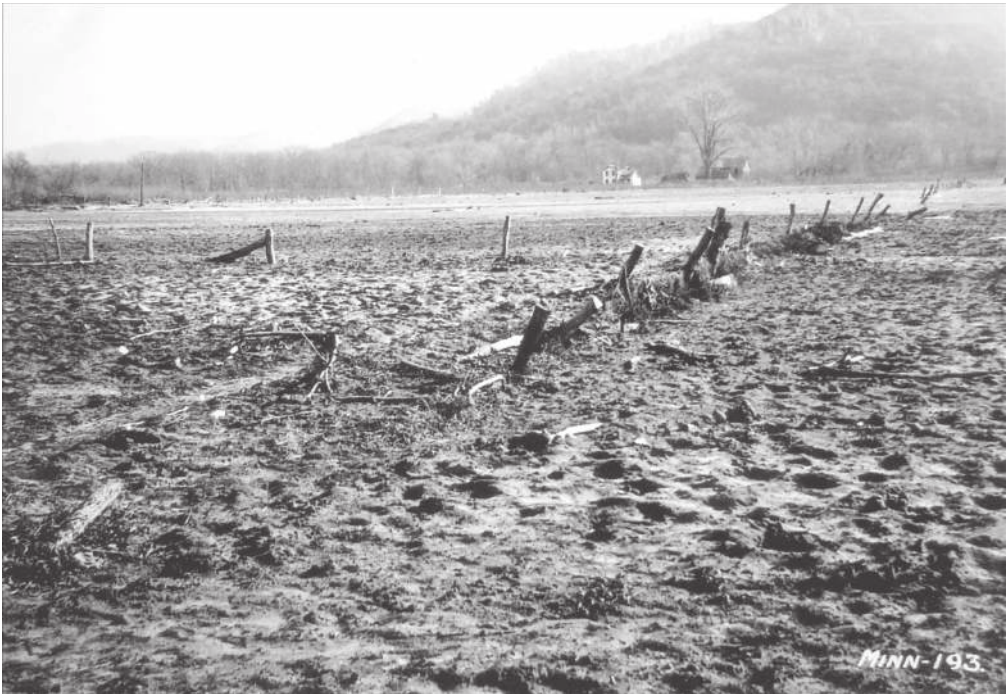
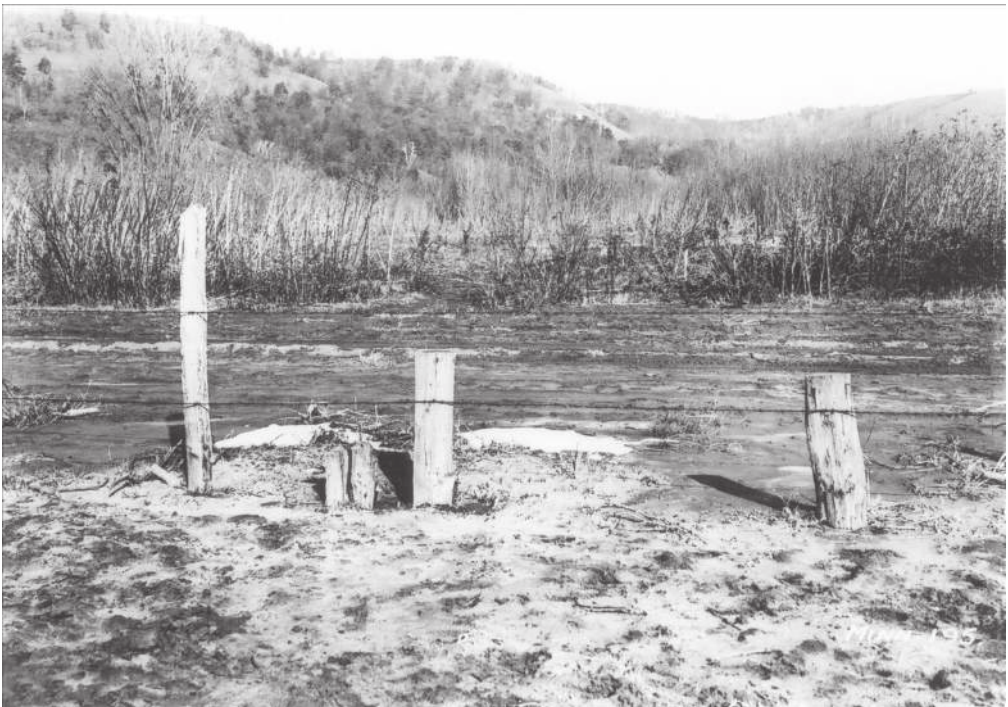
Figure 7.19 Floodplain covered with sandy sediment with buried and damaged fences, Whitewater River Valley, 1940. Note three generations of fences in lower photo. (From Trimble, S. and Lund, S., *U.S. Geol.Surv. Prof. Paper 1234*, 1982.)

Figure 7.19 Floodplain covered with sandy sediment with buried and damaged fences, Whitewater River Valley, 1940. Note three generations of fences in lower photo. (From Trimble, S. and Lund, S., *U.S. Geol. Surv. Prof. Paper* 1234. 1982..... 168

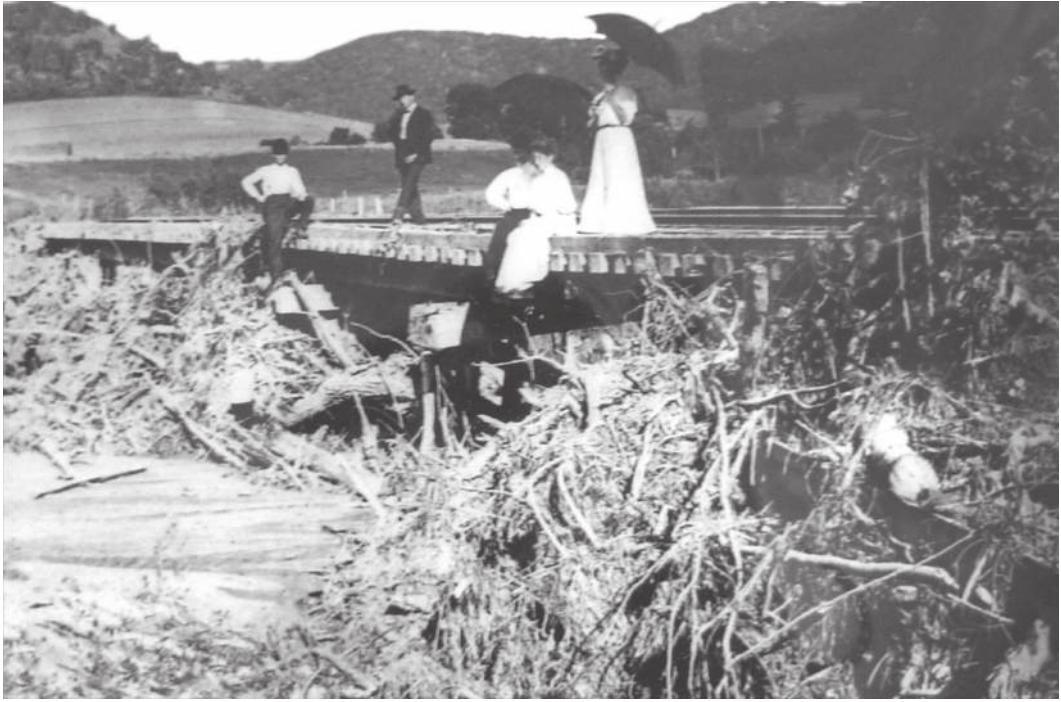
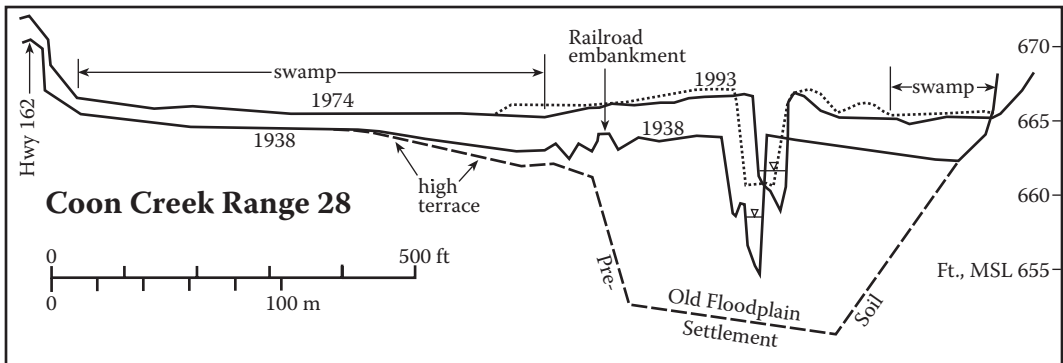
Figure 7.20 La Crosse and Southeastern Railroad, Coon Creek Valley, built 1904. Top: A railroad bridge seen near Chaseburg in the early 20th century, probably before 1915 based on the apparel. Note that the top of the rails is about 7 ft (2.2 m) above the channel, giving a small bridge opening. Note also woody debris from flooding partially occluding the bridge opening. Bottom: Surveyed cross section between Chaseburg and Stoddard. Railroad embankment was built here on edge of terrace about 10 ft (3 m) above the old floodplain. By 1938, the embankment was only 1–2 ft (30–60 cm) high. By 1974, it was completely buried. Note also the highway (left or north side of the profile), which had to be raised to stay well above the aggrading floodplain of Coon Creek (NW1/4, Sec. 29, T14N, R6W).

The LaCrosse and Southeastern Railroad, opened in 1904, ran from Stoddard to Westby, Wisconsin, along the Coon Creek Valley. Because the hydrologic problems were just getting under way, it was not a good time to build a railroad down a stream valley, and problems were evident within a decade (Figure 7.20). After only 30 years, the line was abandoned in 1934, in part from escalating costs of maintaining the right of way caused by sediment and frequent floods. A reading of the records of the railroad in the archives of the Wisconsin Railroad Commission showed constant bridge repairs, but whether the culprit was floods and sediment was not always clear.

But perfectly clear was the sedimentary history: much of the railroad bed, normally elevated 5–15 ft (1.5–4.5 m) above the floodplain, was vulnerable to small floods by the 1930s and buried by the 1970s. A valley profile about halfway between Chaseburg and Stoddard (Figure 7.20) shows that the railroad embankment was originally built on the top edge of a terrace escarpment, the surface of which had been about 10 ft (3 m) above the floodplain at the time of settlement. Evidence at two other sites, 2–5 mi (3–5 km) downstream, respectively, indicates the floodplain had already accumulated about 2 ft (0.6 m) of historical sediment accretion in 1904 when the railroad was built (Figure 3.15, “1904” on profiles). Thus, with the added height of the embankment (3 ft or 0.9 m), the railroad, when built in 1904, would still have been over 10 ft (3 m) above the active floodplain (Figure 7.20). By 1938, the floodplain had aggraded a total of about 11–12 ft (3.5 m), bringing it to within a few inches of the embankment top. This suggests a precarious existence for the railroad during its twilight time of the early 1930s. By 1974 when I resurveyed the profile, the embankment was completely buried and there was no visible sign at this site that the railroad had ever existed (Figure 7.20). A similar situation existed in the Crooked Creek Valley across the river in Minnesota. The Caledonia branch of the Chicago, Milwaukee, and St. Paul Railroad was completed in 1871, but there are few signs of the railroad embankment or bridges to be seen in the valley today.

from one side of the valley to the other, necessitating many bridge crossings of the stream. To some degree, each bridge slowed the flow of water and thus increased the deposition of sediment. And as shown in Figure 7.20, woody debris carried by floods collected along bridge openings, turning bridges into dams, further enhancing aggradation of the stream and floodplain. To make matters even worse, some railroad companies installed bridges with small stream openings that restricted streamflow and caused deposition of sediment (Gray et al., 1929). And, of course, aggradation of the stream made the bridge openings smaller over time.

There are many buried highways in the LMV zone of the Hill Country. One may be seen in a profile surveyed across Coon Creek (left or north side of Figure 7.20, bottom). Between 1938 and 1974, Wisconsin State Highway 162 had to be raised about 2 ft to stay well above the aggrading floodplain of Coon Creek. A particularly striking example is Minnesota State Highway 74, which ran along the west side of the main valley of the Whitewater River (Figure 7.21). The narrow concrete roadway was built in 1918 on a constructed embankment about 6 ft (1.9 m) high, the latter being necessary because extreme flooding was already evident and a route across high terraces was not available. By 1939, the floodplain had aggraded to the level of the road and, where alluvial fans debouched near the road, it was often well below the surface, in some places several feet (Siebenaler, 1955; see Chapter 4). Precise resurveys in the Whitewater Valley in the early 1990s by Robert Bird and William Lorenzen of NRCS showed that the present road has been built up as much as 8 ft (2.4 m) since 1938, but it is barely higher than the floodplain in many places so that any flood (overbank flow) stops traffic.

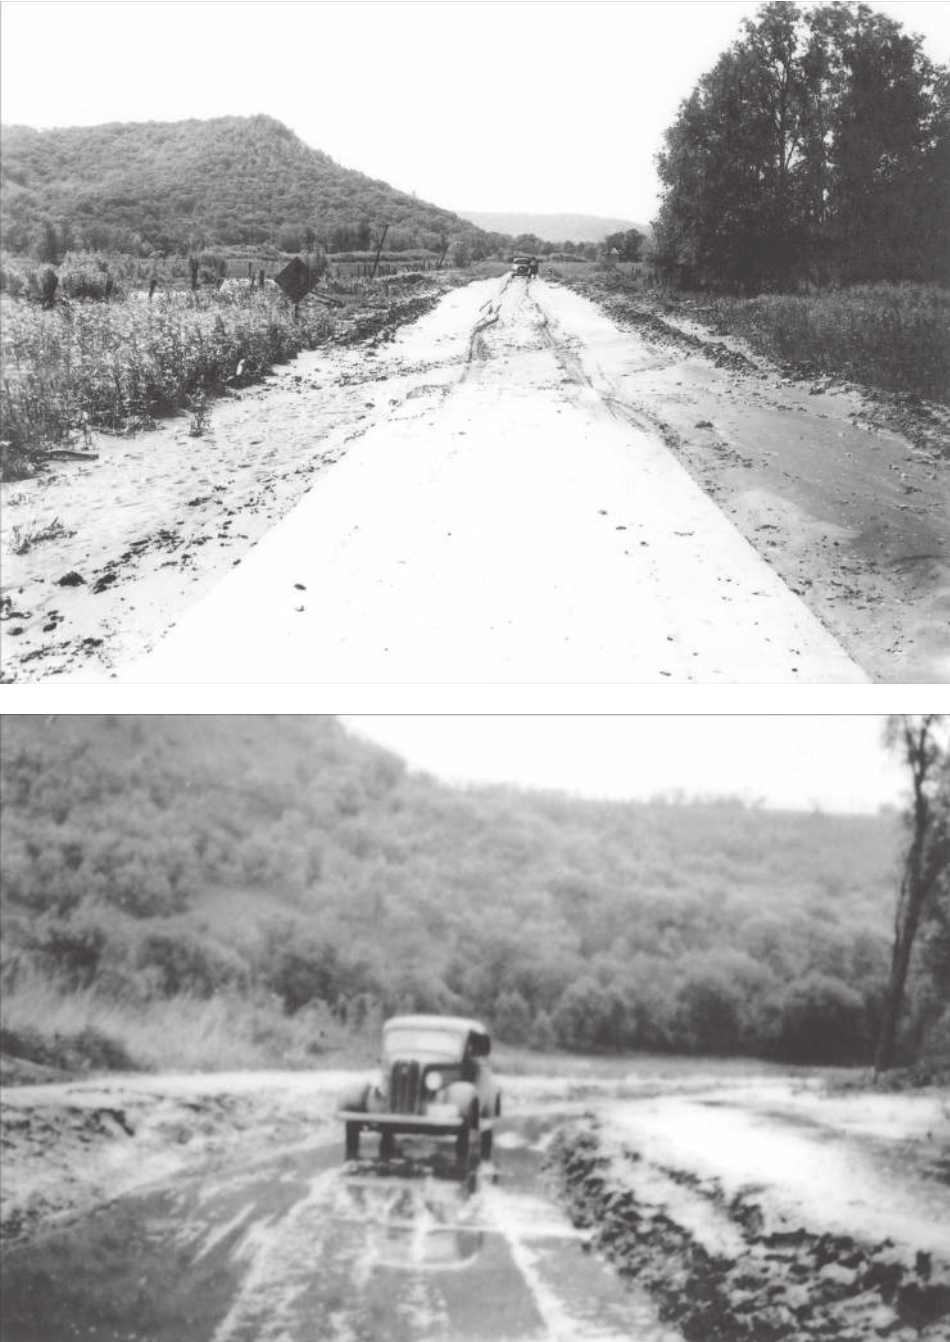
Figure 7.21 Minnesota State Highway 74 along the north and west side of Whitewater River on the floodplain. In an attempt to escape the increasing flooding and sediment accretion, it was built in 1918 on a 6 ft (2 m) high embankment with a narrow concrete roadway. By the late 1930s, the floodplain had aggraded to the level of the road or even above it. Top, 6/2/38 near Beaver. Bottom: Reach of Highway 74, probably near Beaver. The floodplain had aggraded above the highway, which had to be cleared.

This highway along the Whitewater River has acted as a dike in some places much like the railroad embankment along Coon Creek described earlier. In surveys done in 1938, 1964 and 1991, the floodplain on the stream side of Highway 74 is in many places higher than the west (upland or distal) side. The wet areas to the west side of the road have been induced in part by this road, beginning in 1918 when it was constructed. An additional problem is that the road acts as a dike preventing water flowing from the distal hillsides

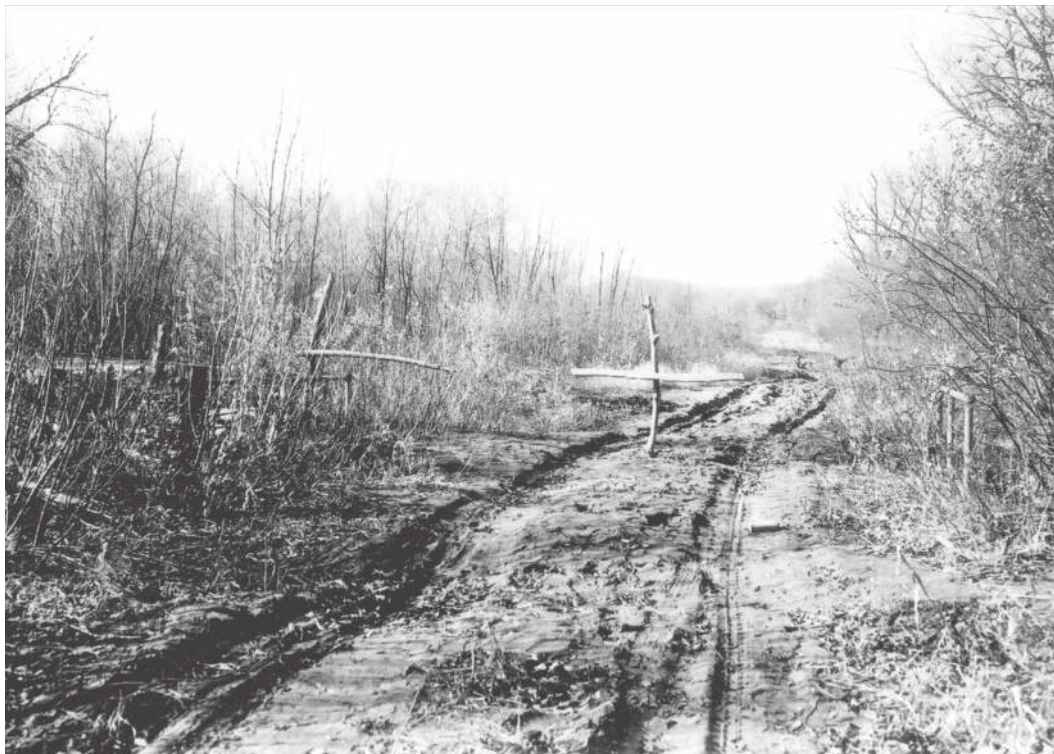
Figure 7.22 Minnesota State Aid Highway 9 on the south side of the Whitewater River, 11/6/37. Bridge in right foreground was covered by 18 in. (45 cm) of sediment by June 1938. This road, the lifeline for people on the south side of the river, was becoming impassable by the late 1930s. By 1989, it was underwater, impassable even on foot. (Photo credit Soil Conservation Service [SCS].)

from reaching the stream. Indeed, the problems at the Appleby farm (Chapter 4) were probably brought on in part by this highway blocking the lateral movement of sediment to the distal parts of the floodplain and also blocking the movement of water from the distal floodplain to the stream. Thus, the Appleby land became wetter as the Whitewater River aggraded. On the south side of the lower Whitewater Valley, State Aid Highway 9 was usually passable with some difficulty as late as the 1930s but had already been rerouted around the mouth of Trout Creek where it had been buried (SE $\frac{1}{4}$, Sec 31R9W T109N) (SCS, 1940). By the late 1930s, a 400 ft (120 m) stretch of the road had been buried in a fan over 12 ft (3.6m) deep (NW $\frac{1}{4}$, Sec 6, R9W T108N) (SCS, 1940). The old road is now covered by a swamp with ponded water and is impassable even by foot (Figure 7.22).

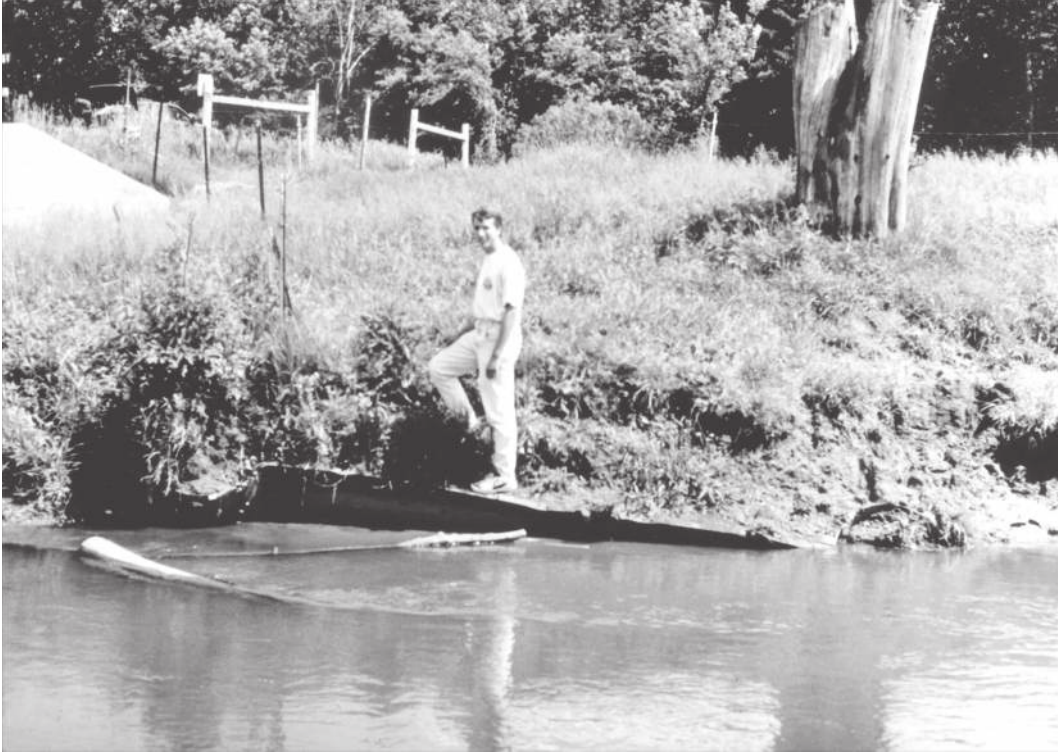
Figure 7.23 The south abutment of an old Dodson Hollow Road bridge over Coon Creek (SE1/4, Sec 22, T14N, R6W, Vernon, Co., WI). This bridge was replaced in 1926 as the creek rapidly aggraded, and the abutment was later buried in the floodplain. When built, probably in the early 1900s, this abutment was at least 10 ft (3 m) above the water. A small lateral shift by the stream in 1993 exposed the old abutment. The newest bridge (c. 1990) is seen to the far left.

Figure 7.23 The south abutment of an old Dodson Hollow Road bridge over Coon Creek (SE1/4, Sec 22, T14N, R6W, Vernon, Co., WI). This bridge was replaced in 1926 as the creek rapidly aggraded, was later buried in the floodplain. When built, probably in the early 1900s, this abutment was at least 10 ft (3 m) above the water. A small lateral shift by the stream in 1993 exposed the old abutment. The newest bridge (c. 1990) is seen to the far left..... 174

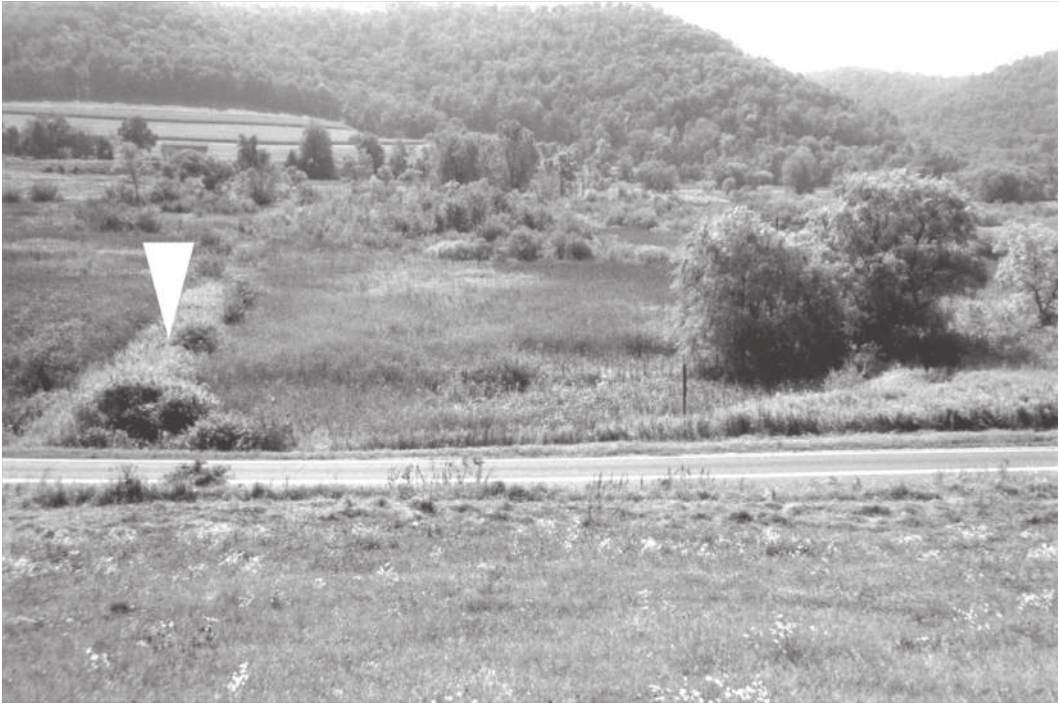
Figure 7.24 Looking southward across the lower main valley of Coon Creek along Range 28 as seen in Figure 7.20. In the left middle ground (arrow) is the trace of an old private road across the valley. The tree canopies to the right are willows marking an old house site. Both the private road and the house site are buried in the floodplain, and only a difference in vegetation marks them. In the distance, the old railroad bed runs down the valley but is totally buried (see profile in Figure 7.20) and there is little to mark it at the surface.

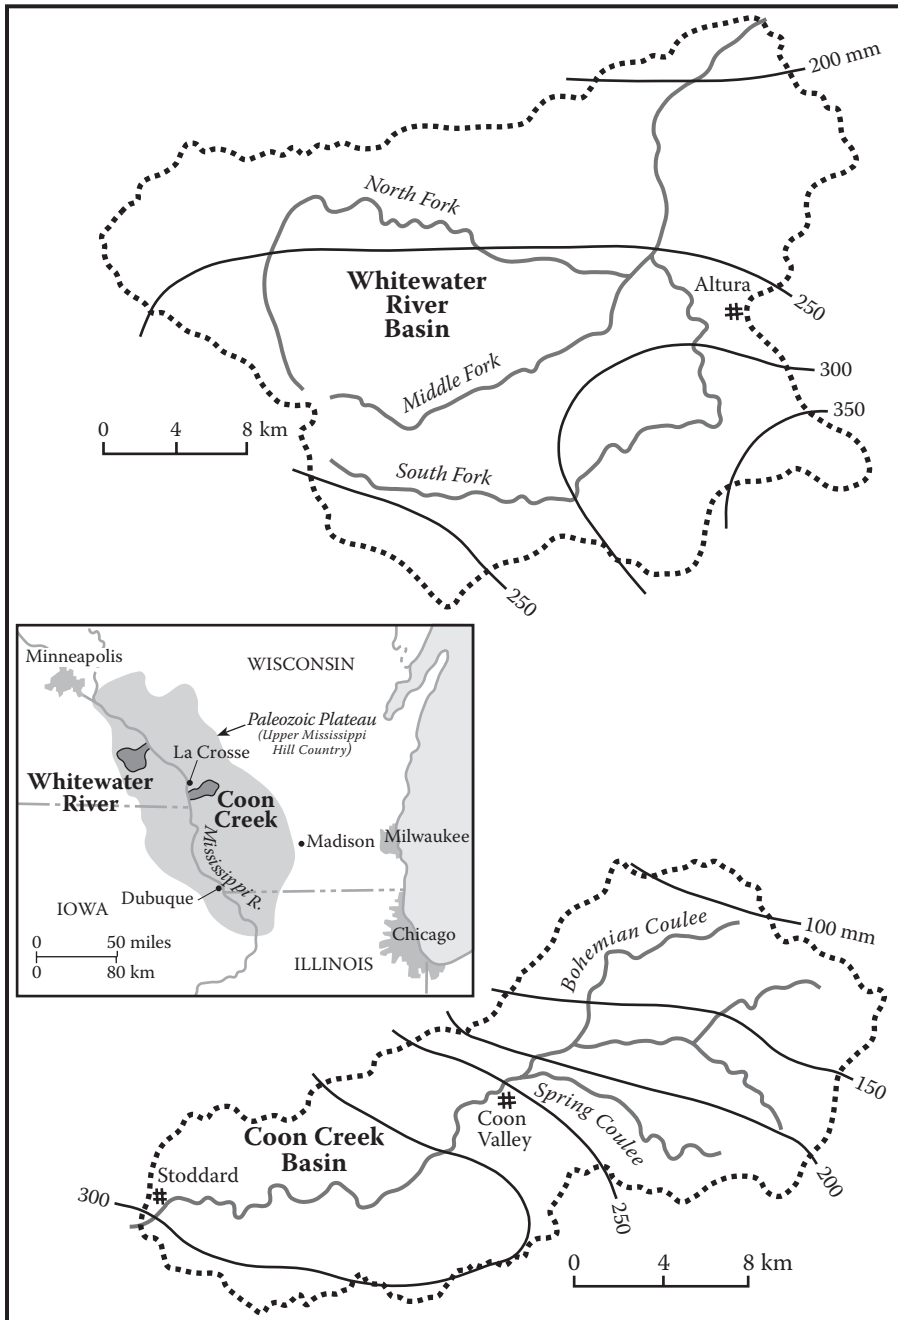
Figure 8.1 24-hour precipitation totals for the August 18–19, 2007 storm for Coon Creek and the Whitewater River. 1 in. = 2.5 cm. Data from National Weather Service.

The chance to find out came on August 18–19, 2007, when over 12 in. (300 mm) of rain fell on parts of Coon Creek and the Whitewater River (Figure 8.1). If such a storm had to happen, this one was incredibly fortuitous for my research because these are the primary study basins for which I have many baseline data, including thousands of photos. Moreover, I had spent time in both basins in July 2007 making hundreds of photos, and the comparisons with the storm damage in August were used to great advantage. Even

Mass movement was clearly related to rainfall amounts. That is, with more than 12 in. (30 cm)/24 h, the mass movements were almost ubiquitous. In the areas having 10–12 in. (25–30 cm), they were quite frequent. There were a few with 6–10 in. (15–25 cm) and almost none with less than 6 in. (15 cm). Time in the field did not permit mapping of mass movements, but such a map would have correlated extremely well with the isohyet map (Figure 8.1).

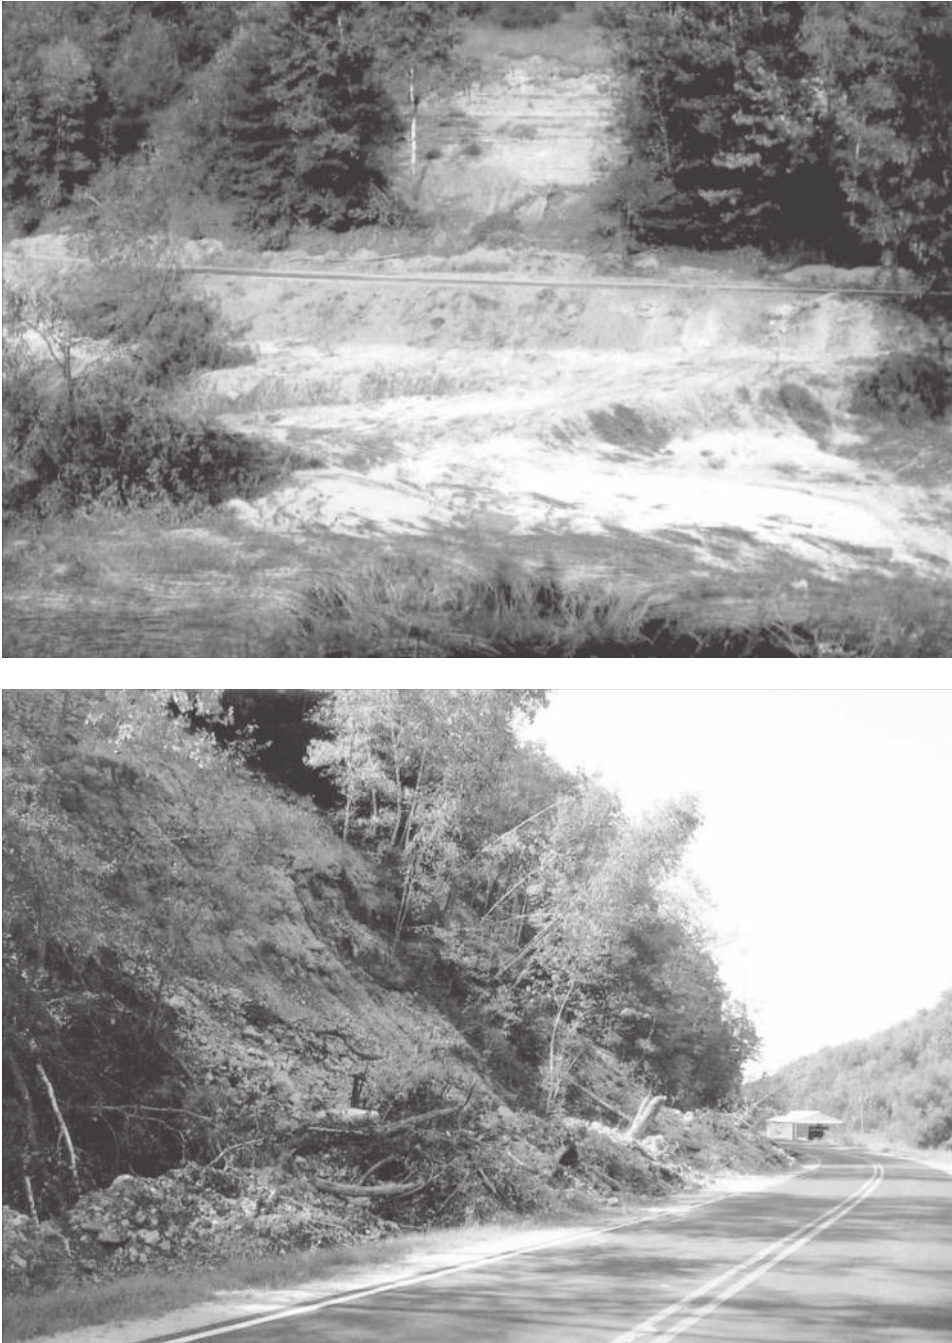
Figure 8.2 Mass movements from the August 2007 storm. Top: What appears to be a debris flow about 2 mi (3 km) north of Chaseburg, WI, at junction of Hohlfeld Road and County K, looking west from north end of bridge ($P > 12$ in. or 30 cm, NW1/4, Sec 21, T14 N. R 6W). Note that the sediment flow from the undercut road bank moved across the road, across the floodplain, and into Swain Creek. Bottom: Mass movement in Timber Coulee about 3 mi (5 km) north of Westby ($P = 6-8$ in., or 15–20 cm). (Photos credit: Edyta Zygmunt, 2–9 September 2007.)

Other than slumping of streambanks and severe undercutting of road banks, I don't recall seeing an appreciable mass movement in the Hill Country previous to August 2007. But in steep areas that received 8–12 in. (20–30 cm) of rain, there were literally thousands. Most of these were small slumps along rural roads, but some were very large. On the steep bluffs along the Mississippi River, there were several major slips that took the form of "chutes," or elongated slips of a semicircular or semi-oval cross section. One of these near Goose Island in Vernon County, Wisconsin, was several hundred feet long and closed Wisconsin Highway 35 for some time. In a few cases, there occurred what appeared to be debris flows. In at least one case, part of a hillside above a road cut gave way, and a massive amount of highly liquefied debris collapsed, flowed across a road, and then flowed across the floodplain of a tributary with part of the material actually going into the stream (Figure 8.2). While that event was exceptional, there were many simple mass slips of material along road cuts (Figure 8.2).

While there were thousands of mass movements, small to large, they all had one common characteristic: *they all occurred on undercut slopes*. That is, the base of the slope had been cut away by some sort of construction, usually a roadway. In hundreds of miles of terrain traversed by car, I did not see a single natural slope failure.

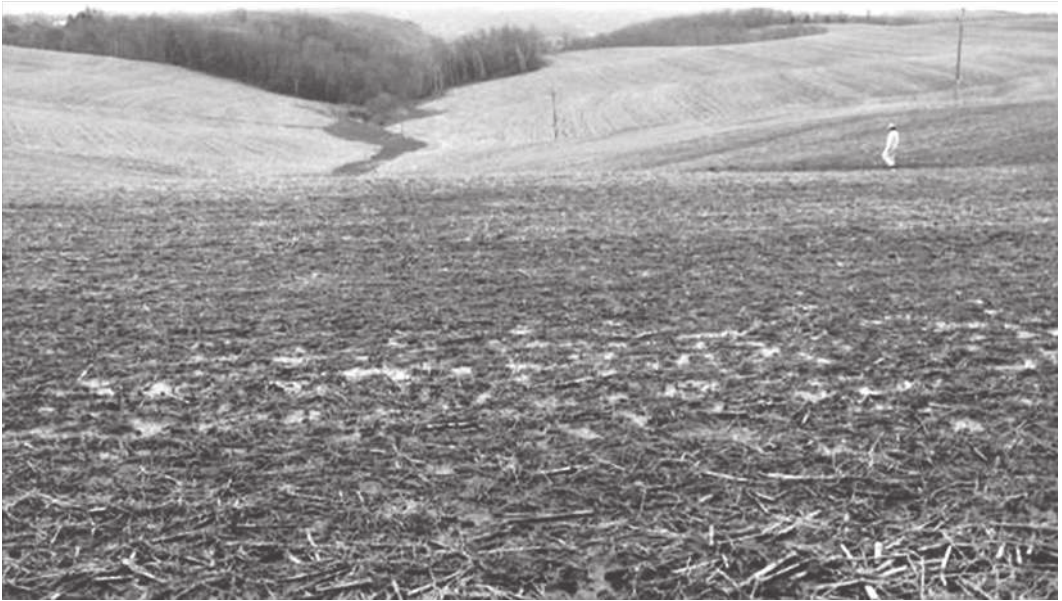
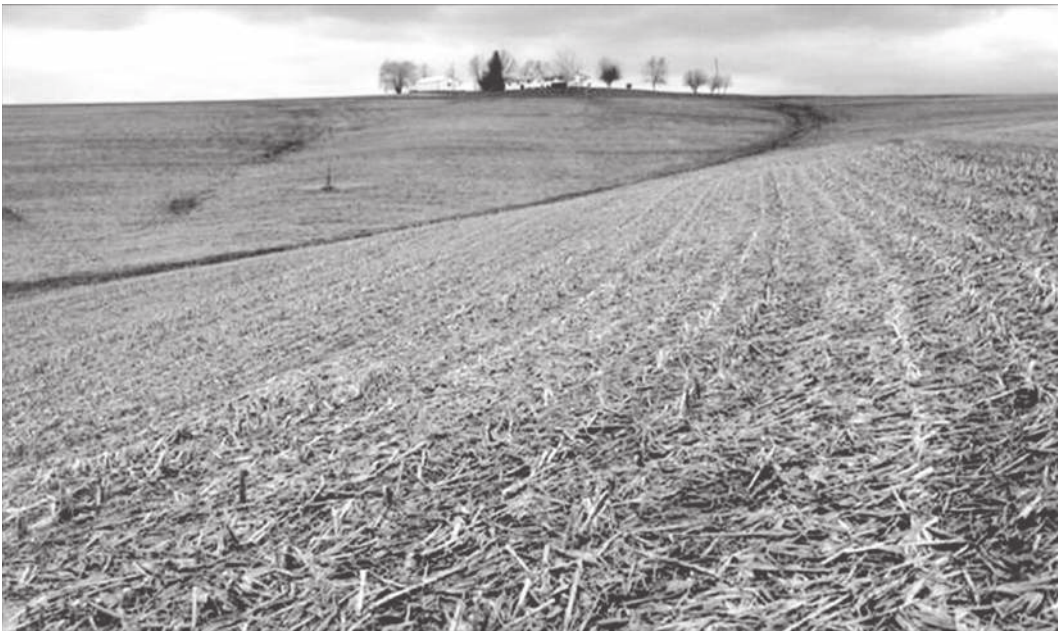
Figure 8.3 No-till fields after crops had been removed, April 2008. Note slopes > 10% and several hundred feet long with no evident erosion, P = 12+ in. (30 cm). (Continued)

Indeed, this is the most startling finding from the 2007 storm. I was able to find no visible erosion (rill or gullies) on no-till land, even under the areas of greatest precipitation with 10% slopes 1000 ft (300 m) long (Figure 8.3)! Not only was I looking but, at my request, NRCS agents were also looking on my behalf as they went about their duties. Two minor exceptions were found. One was where excessive water flowed off a paved road and onto a no-till field (Figure 8.3). The other was in Minnesota, where a small rill formed on a newly planted field in the follow-up storm of June 2008. I note again that the effectiveness of no-till is directly related to productivity: healthier plants grow faster and larger, and produce more residues to leave on the field after harvest.

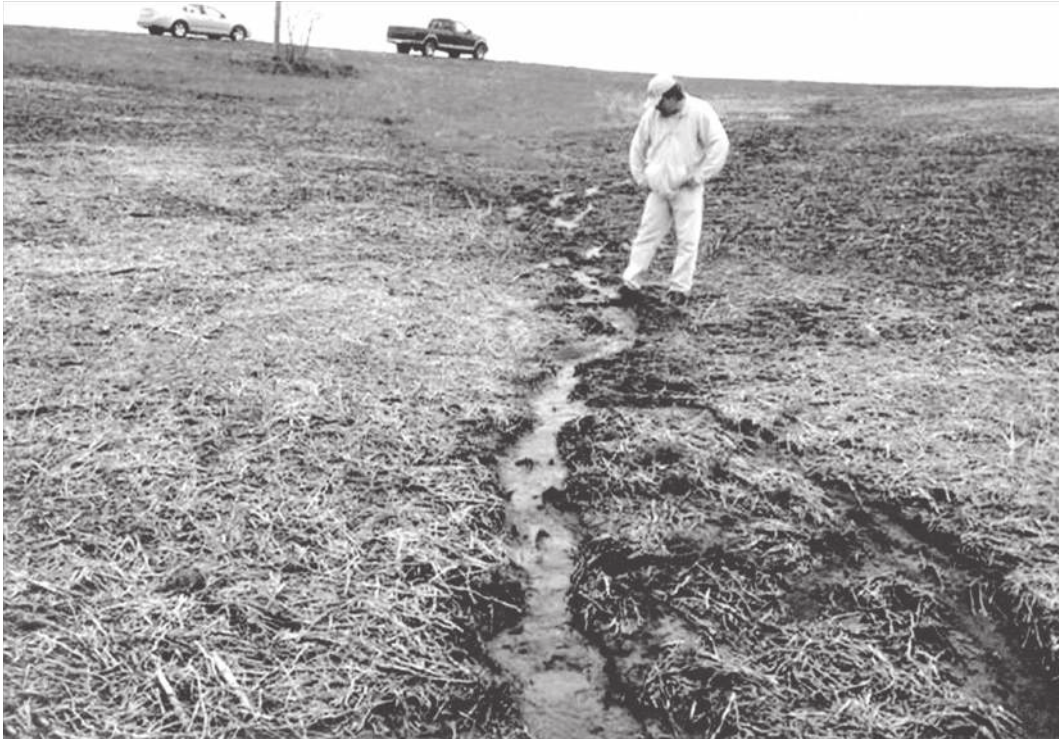
Figure 8.3 (Continued) No-till fields after crops had been removed, April 2008. Rill caused by runoff from road. All 3 scenes in this figure are on Brinkman Ridge Road, about 4 mi (7 km) north of Chaseburg, WI. Secs 4&9, T14N, R6W.
