**HISTORICAL AGRICULTURE
AND SOIL EROSION IN THE
UPPER MISSISSIPPI
VALLEY
HILL COUNTRY**

STANLEY W. TRIMBLE

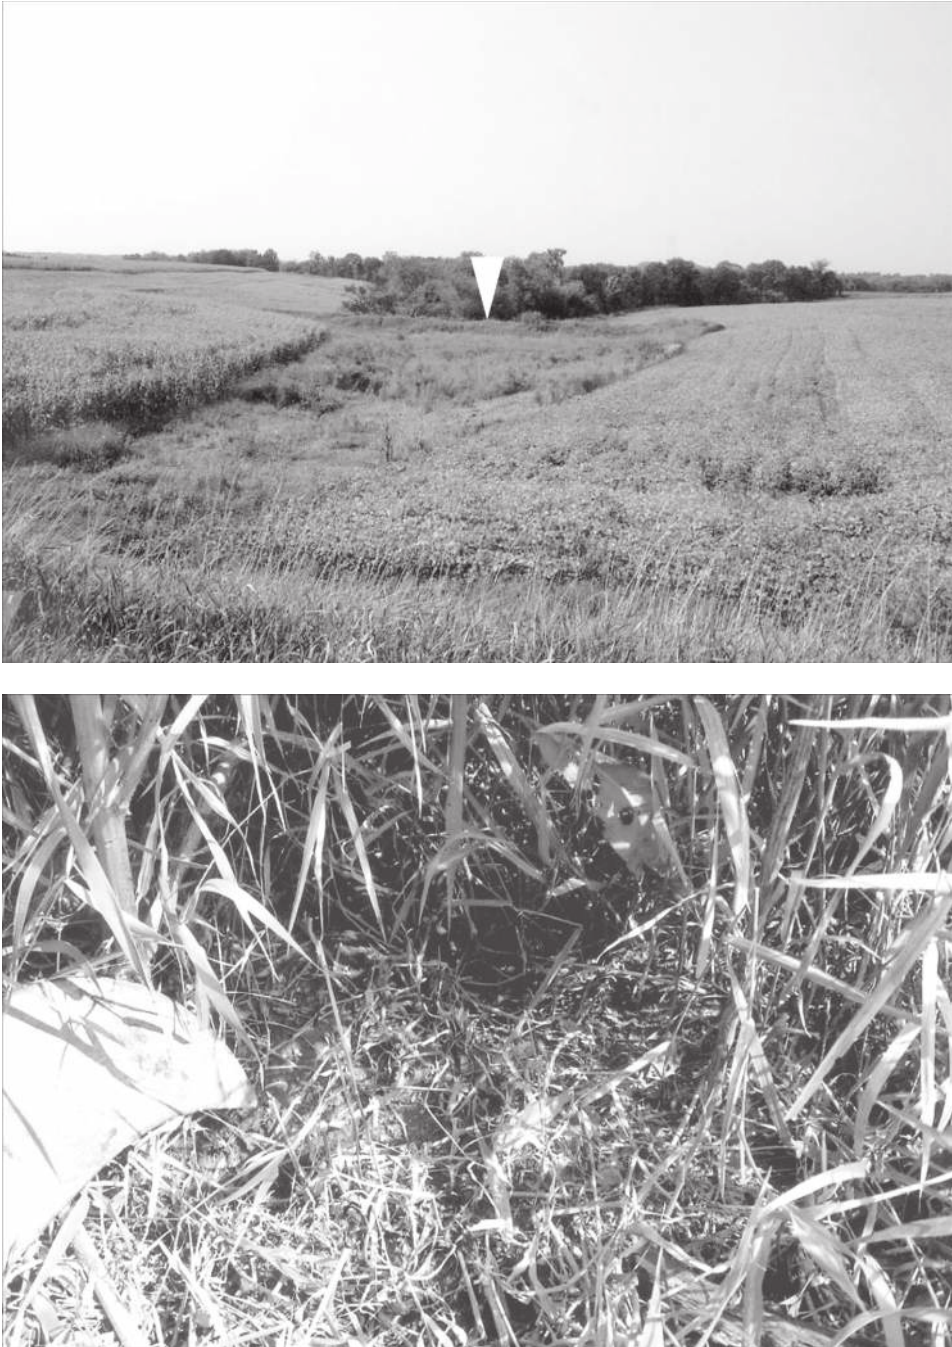
Figure 8.4 A sediment trap after the 2007 storm. Top: A “dry” floodwater retarding dam (arrow) controlling about 8–10 acres (3–4 ha) of mostly no-till crops, 5 mi (8 km) north of Altura, MN, on Beaver-Altura Road looking west. $P = 10$ in. (25 cm). Corn is to the left and soybeans are to the right. Bottom: Bottom of dry pond. Note lack of any sediment accumulation. NW1/4, Sec. 19, T18N, R9W, Winona County, MN. Photos made Sept. 2–9, 2007.

One might well ask about “sheet” erosion from this storm. While there were effectively no rills or gullies found on no-till fields, how much, if any, soil was eroded by rainfall detachment and so-called “sheet” flow? We have no after-the-fact way to measure this for most fields but, again fortuitously, an opportunity presented itself. About 5 mi (8 km) north of Altura, Minnesota, the outflow from a small watershed in no-till corn and soybeans was caught in a floodwater-retention basin. This location received almost 10 in. (25 cm) of rain in the storm. Considering just the general appearance, and using the root crowns of weeds as a benchmark, I could find no evidence of any deposition in the basin (Figure 8.4).

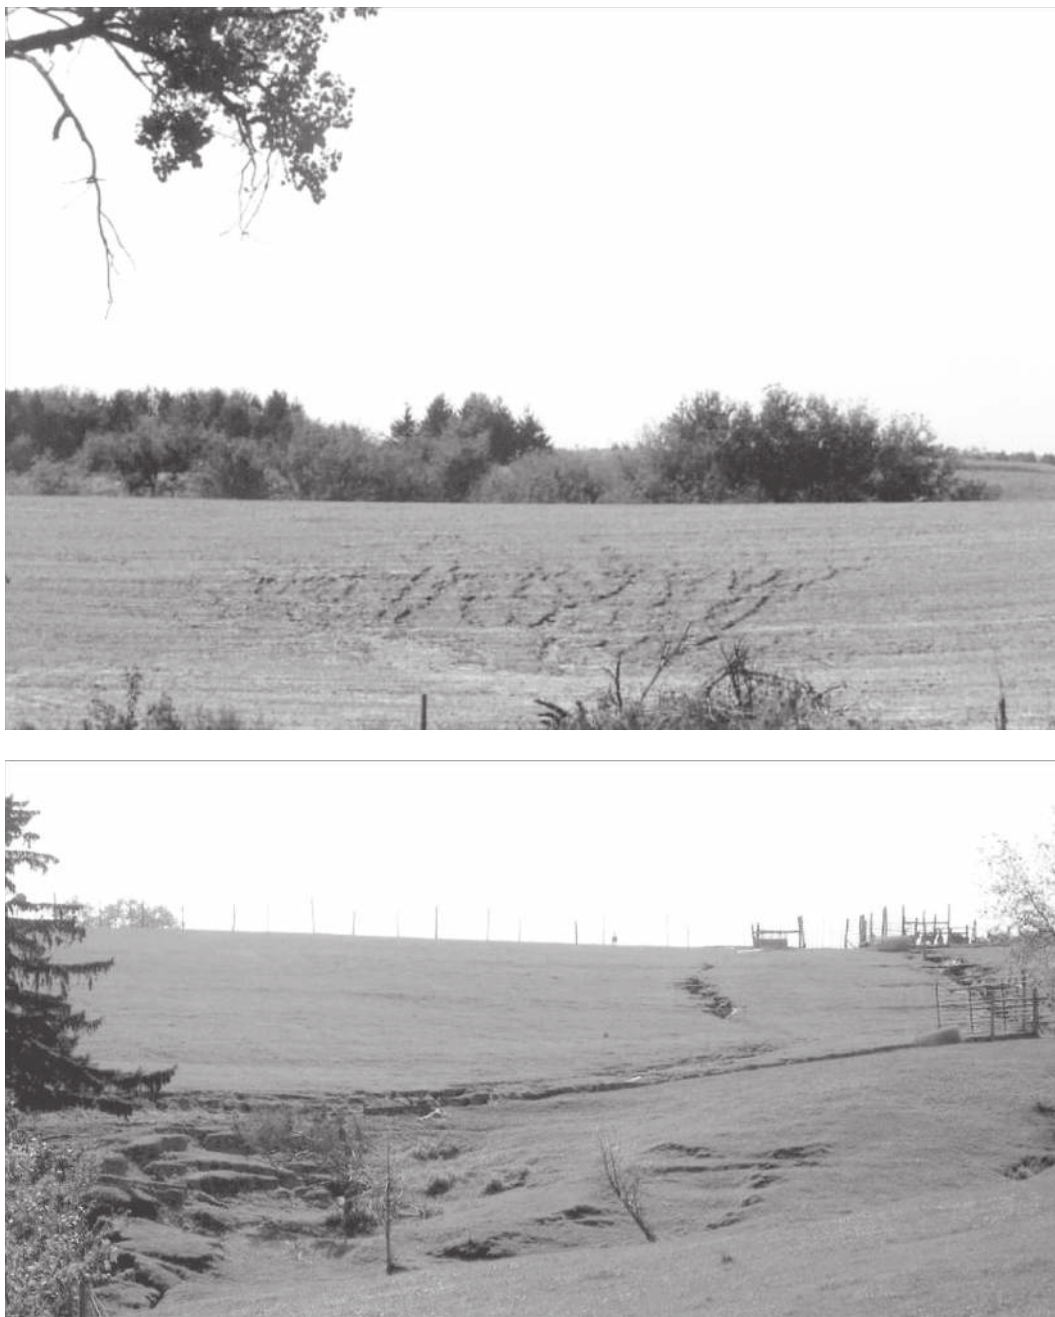
Figure 8.5 Severe soil erosion with lesser levels of conservation management, storm of August 2007. Top: Newly planted field with no apparent conservation measures, Beaver-Altura Road about 4 mi (7 km) north of Altura looking west. P = 10 in. (25 cm). Sec 25, T108N, R10W, Winona Co. Bottom: Gullying on animal trails, heavily grazed area 2 mi (3 km) south of Stoddard, WI, on County O, NW $\frac{1}{4}$ Sec 3, T13N, R7W. Vernon Co. P = 12 inches (30cm). (All photos made September 2–9, 2007 by Edyta Zygmunt.) (Continued)

Of course, there was highly evident soil erosion from the 2007 storm under less effective forms of conservation management, but these were not common and I had to look for them. Some newly planted fields using conventional agriculture with no evident conservation measures resulted in severe rill erosion (Figure 8.5). Likewise, poor grazing management (by modern standards) allowed rills and gullies to form along animal trails (Figure 8.5). Even some contour strips were overpowered and allowed severe rills (Figure 8.5), but such failures were extremely rare and found only in the areas of greatest rainfall. Indeed, one could drive through Bohemian Coulee of Coon Creek, which received only 4–7 in., or 10–18 cm (Figure 8.1), and hardly know that anything had happened at all. Recalling that 5–6 in., or 12.5–15 cm/24 hr is a 100-year storm, one can readily see the significance.

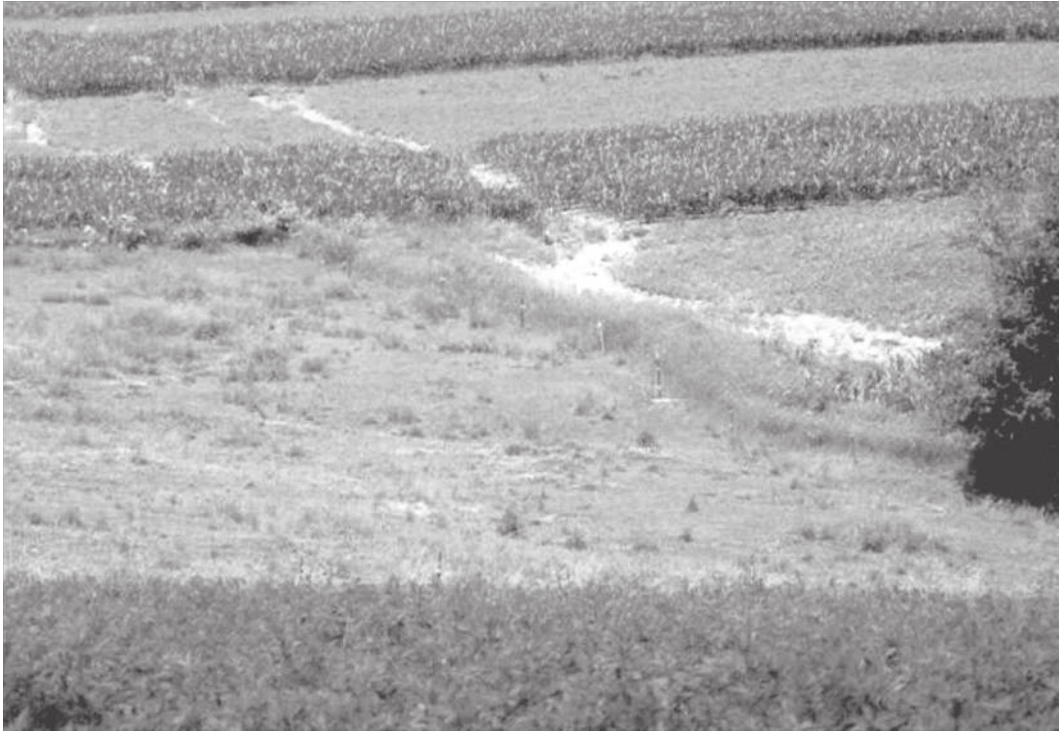
Figure 8.5 (Continued) Severe soil erosion with lesser levels of conservation management, storm of August 2007. Severe rills in contour strip cropping, about 5 mi (8 km) SE of Stoddard. P = 12 in. (30 cm). (All photos made September 2–9, 2007 by Edyta Zygmont.)

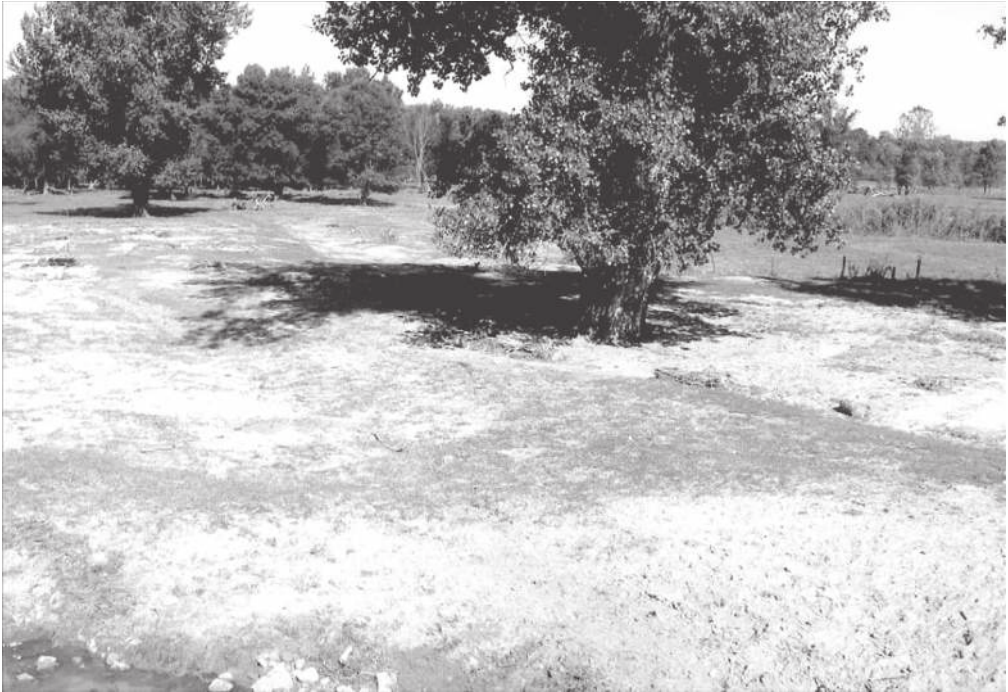
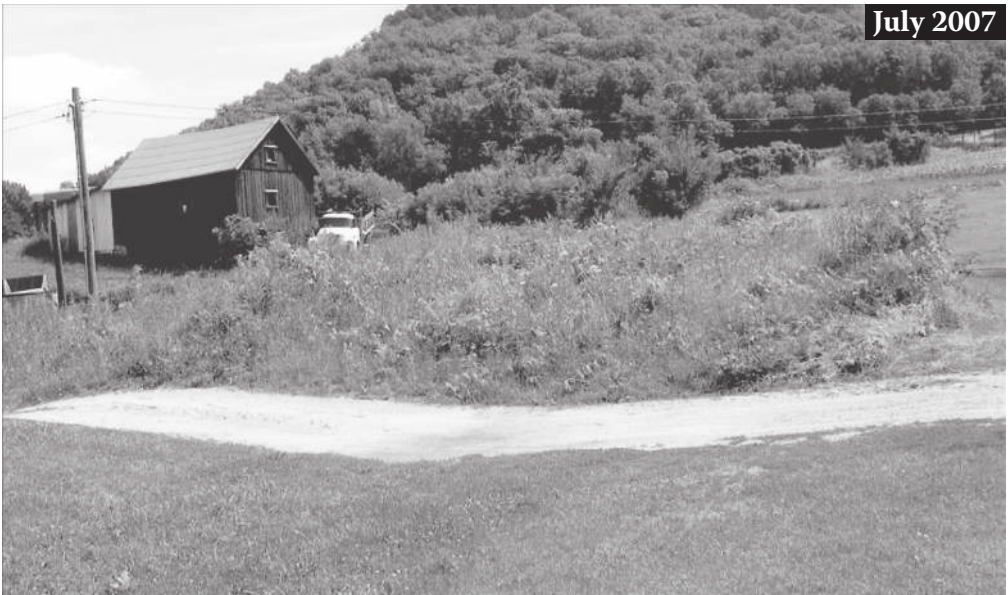
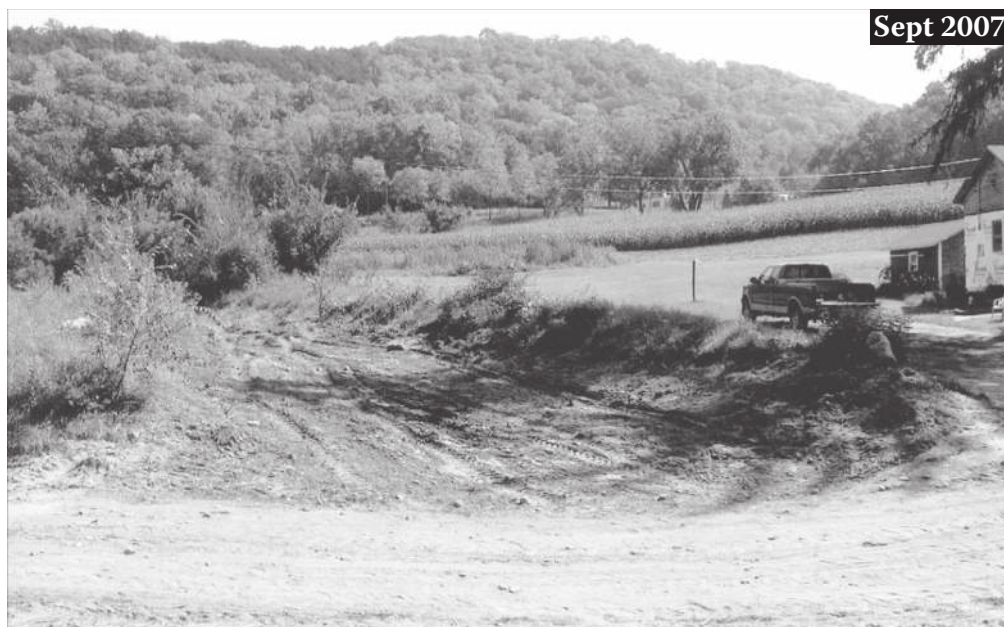
Figure 8.6 Damage to Zink farm from 2007 storm, 1 mi (1.6 km) SW of Stoddard (see Chapter 4, $P > 12$ in., or 30 cm). Top: View of fan across Coon Creek floodplain from bridge on County O looking west, September 2007. Fresh deposits of mostly coarse material, 1–5 in. (2.5–7.5 cm) thick. Cottonwood tree in right foreground is the one with buried trunk mentioned in Chapter 4. Bottom: between house and barn, looking north up dormant flume formed from rock fan in 1930s to protect house and farmyard. Photo made July 2007. (Photos credit: Edyta Zygmunt.) (Continued)

Figure 8.6 (Continued) Damage to Zink farm from 2007 storm, 1 mi (1.6 km) SW of Stoddard (see Chapter 4, P > 12 in., or 30 cm). The same flume September 2007, looking northeast. Accumulated debris from the August 2007 storm has been cleaned out. (Photos credit: Edyta Zygmunt.)

depth (Figure 3.10). Thus, some old gullies were reactivated, and a few new ones, mostly small, were initiated. For example, both gullies at the Zink Farm (>12 in., or 30 cm) were reactivated, and much of the fan extending westward from the bridge out 500 ft (150 m) onto the Coon Creek floodplain received 0–5 in. (0–13 cm) of material ranging mostly from sand to cobbles (Figure 8.6). Upstream in Timber Coulee (7–8 in. or 19 cm), another rock fan (*cum* rock flume) formed in a farmyard over historical time was reactivated (Figure 8.7).

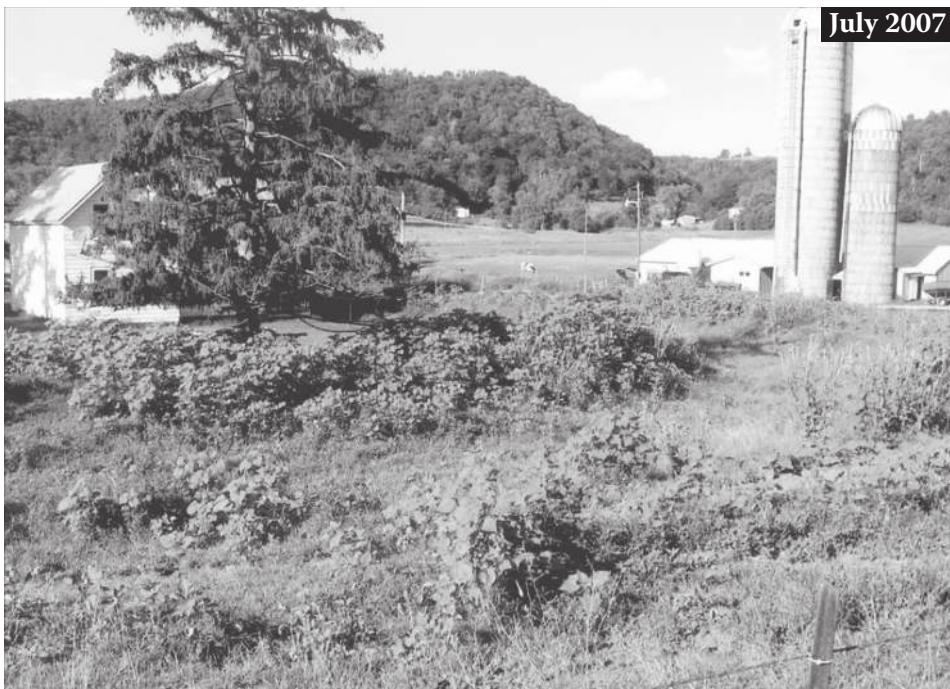
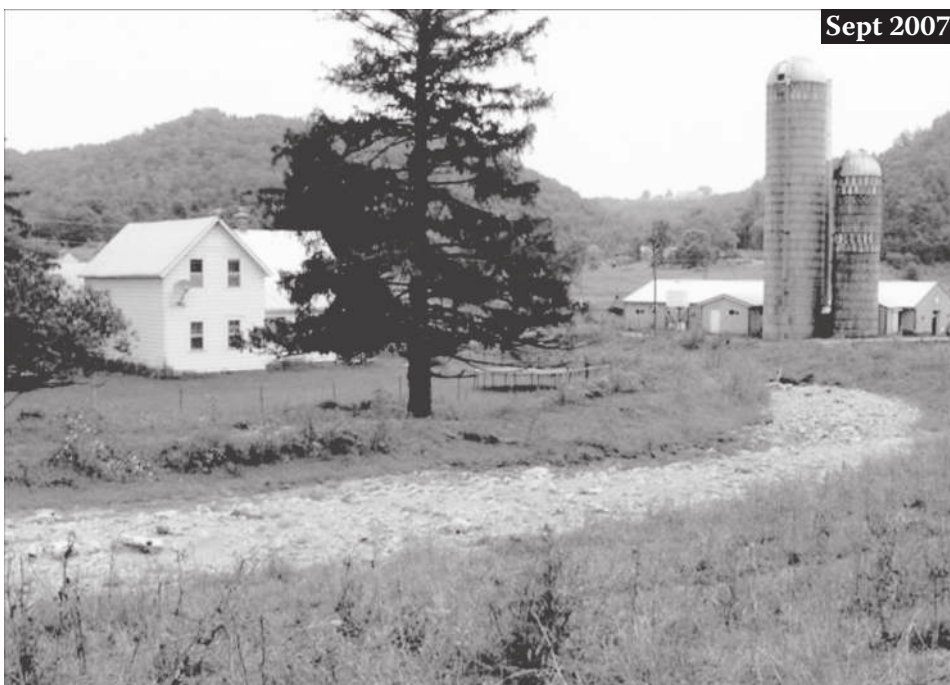
Figure 8.7 Flume formed from rock fan to protect farm, similar to that at Zink farm (see Figure 8.6), photo made from County P looking north, Timber Coulee, NW1/4, Sec 8, T14N, R4W, Vernon Co. P = 7–8 in. (20 cm). Top: July 2007, dormant flume. Bottom: September 2007. Note “gravel road” appearance. (Photo credit: Edyta Zygmunt.)

I have identified perhaps three dozen valley farmsteads in the Hill Country with a history similar to that of the Zink farm (see Chapter 8, Figure 8.7). However, the total number was doubtlessly much larger, numbering perhaps in the hundreds. The irony is that the problem was rarely the fault of the victim. Rather, the water was coming from the land of neighbors on the uplands, sometimes at some distance.

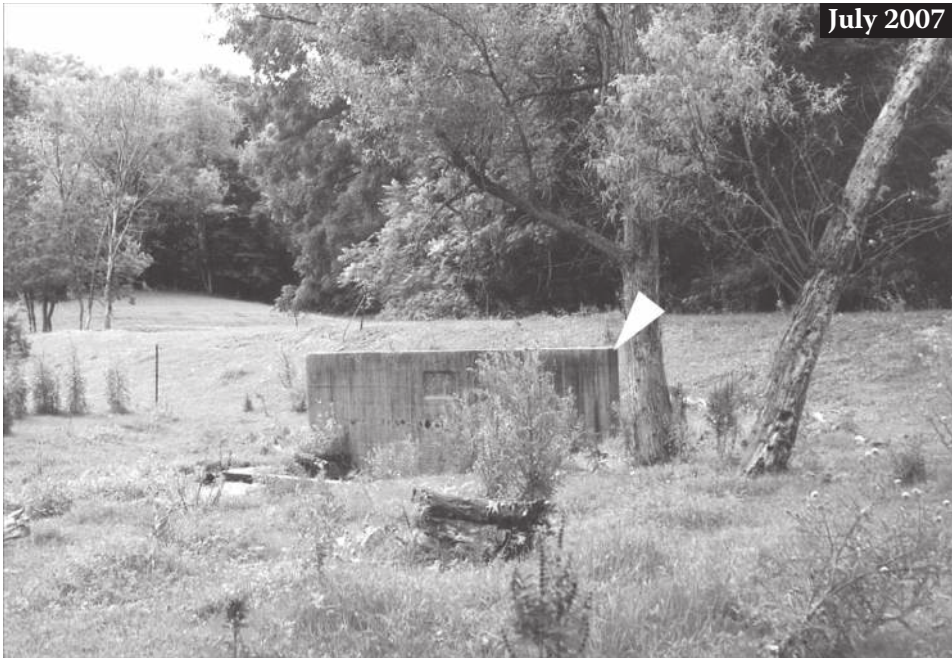
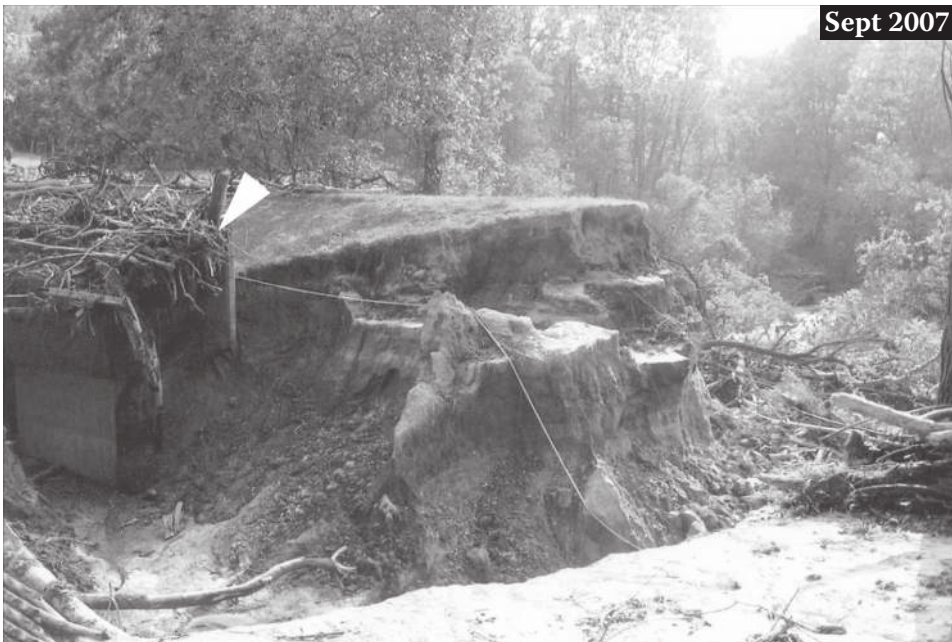
Figure 8.8 Proksch Coulee Trench, looking downstream at the dam and drop structure built in 1936 by Soil Conservation Service to stabilize gully, 2 mi (3 km) east of Stoddard WI ($P > 12$ in., or 30 cm). Viewer stands on reservoir fill. Top: Dam and drop inlet, looking downstream, July 2007. Arrows point to top-right corner of drop structure. Note sediment filled to level of drop inlet (see Figure 4.10). Bottom: Breached dam, September 2007. Note drop inlet to left covered and blocked with woody debris. Gully in foreground extends about 200 ft (60 m) upstream in accumulated sediment. Bottom of gully visible in right background is about 30 ft (9 m) lower than dam. (Photos credit: Edyta Zygumunt.)

In Proksch Coulee trench ($P > 12$ in. or 30 cm), the gully was only mildly and intermittently reactivated, but the 71-year-old dam was overtopped and breached. Huge piles of timber slash and debris left upstream were transported to the dam, where they blocked the drop inlet. Since the dam had no emergency spillway, the huge flow then overtopped the dam and breached it (Figure 8.8). This event is strong evidence that no dam of any size should be built in the eastern United States without an emergency spillway (Trimble, 2011).

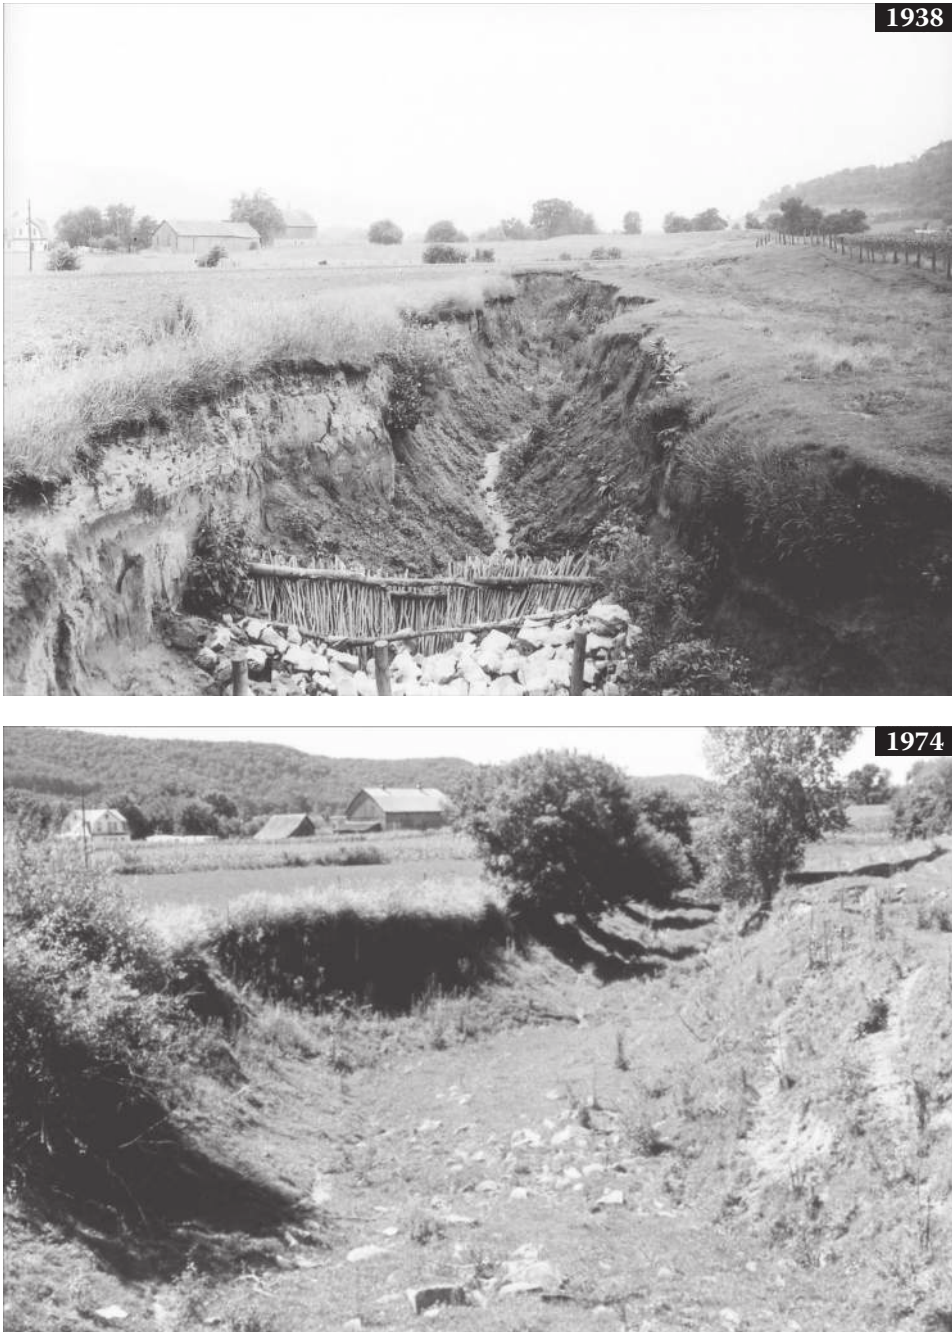
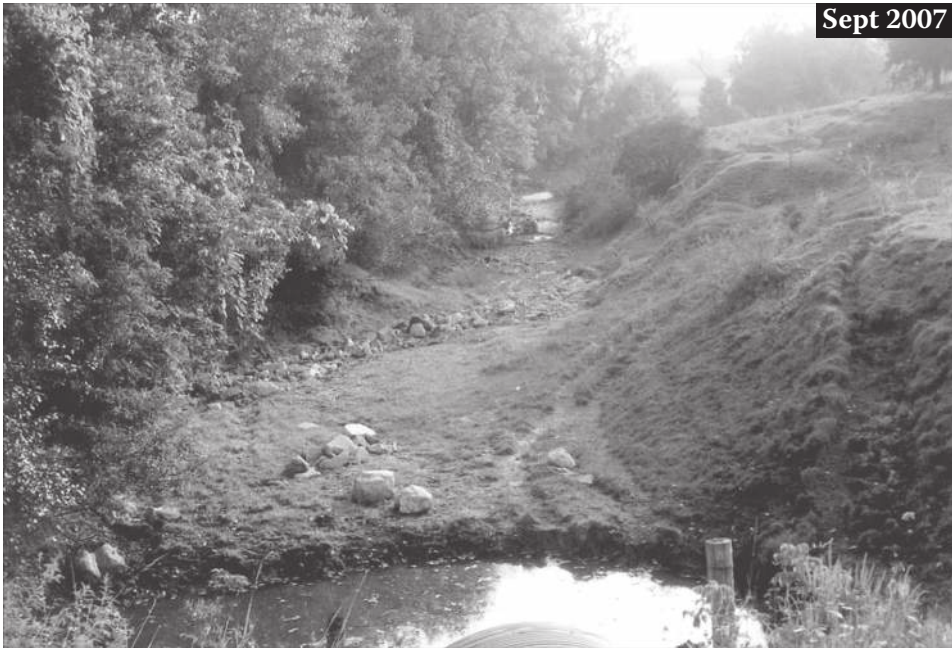
Figure 8.9 Gully 1 mi (1.6 km) north of Chaseburg, WI, looking downstream from bridge on County K, P > 12 in. or 30 cm (SW1/4 Sec21 T14N R6W, Vernon Co.). Top: July 1, 1938. Note about 3 ft (1 m) of light-colored, historical sediment accretion on bank and apparent recentness of gully incision. A storm the next day destroyed the timber and rock revetment. Photo by S.C. Happ. Bottom: 1974. Note that gully more than doubled in size after 1938 but was stable by 1974. (Continued)

Figure 8.9 (Continued) Gully 1 mi (1.6 km) north of Chaseburg, WI, looking downstream from bridge on County K, P > 12 in. or 30 cm (SW1/4 Sec21 T14N R6W, Vernon Co.). September 2007 after flood. Note line of rock following thalweg, perhaps rip-rap from plunge pool in foreground, but gully is otherwise stable. (Photo credit: Edyta Zygmunt.)

Other old gullies fared somewhat better, even when located in the area of maximum rainfall. Certainly, the best documented is a gully about 1 mi (1.6 km) north of Chaseburg, Wisconsin ($P > 12$ in., or 30 cm; Figure 8.9). In the first photo, made in July 1938, the recentness of the gully is evident. The next photo, made in July 1974, shows a greatly enlarged, but then-stable drainage way, and it has been that way during the entire period that I have been working there. The last photo is after the 2007 flood, and one can hardly tell a flood had passed through (Figure 8.9). Another once-rampant gully, only slightly reactivated, furnished enough debris in the 1930s to continually close Wisconsin State Highway 56 ($P = 10$ –12 in., or 28 cm). To control it, a debris basin was built in 1941, and it filled in four years

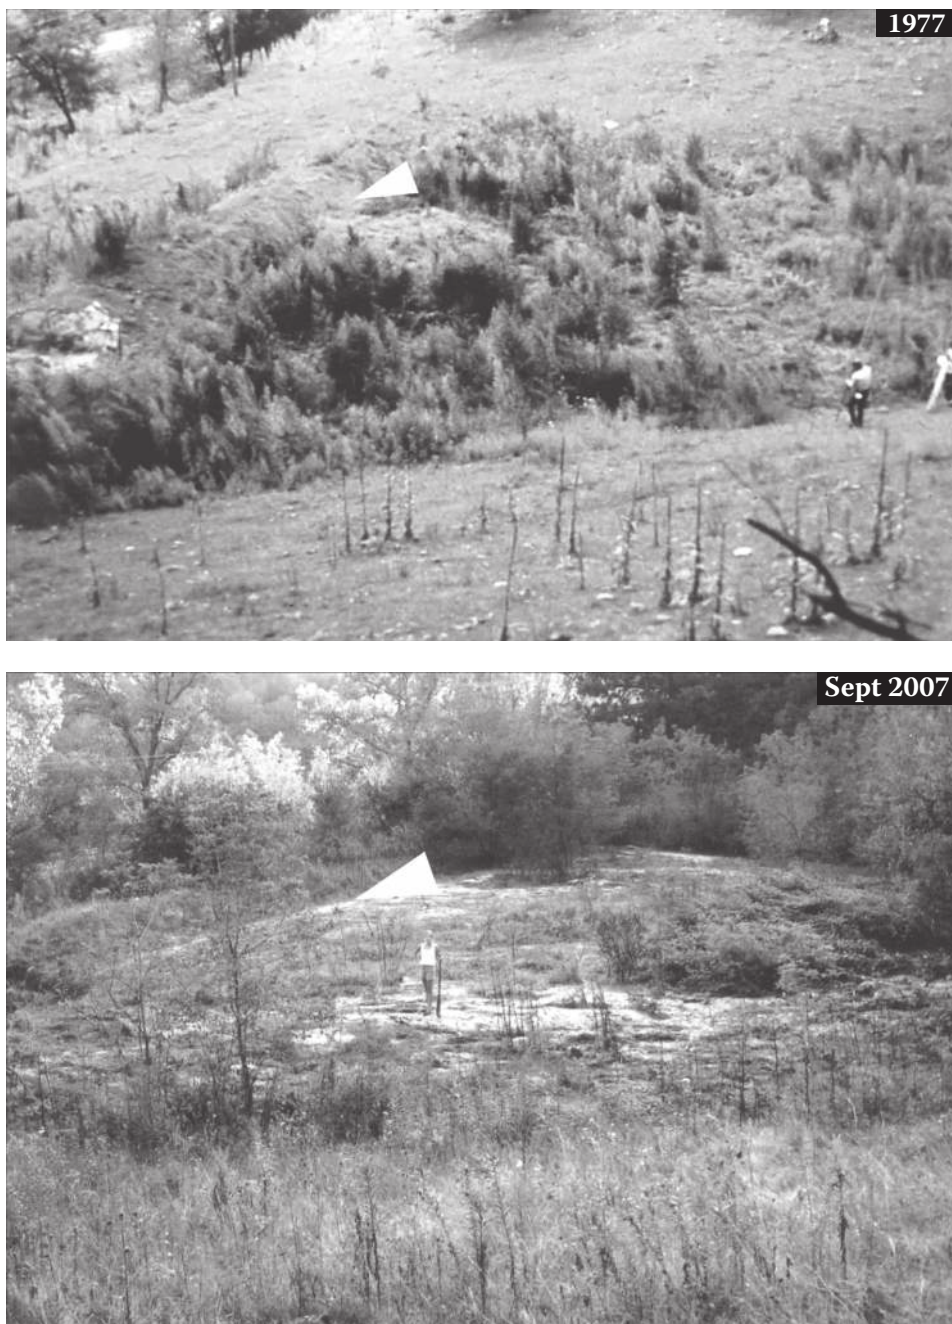
Figure 8.10 Upper Mitchell debris basin, built in 1941 to protect WI Hwy 56 from gully debris, 4 mi (7 km) SE of Genoa ($P = 10\text{--}12$ in. or 30 cm, Sec 36, T13 N R6W). Top: Surveying the basin, 1977. Basin filled in 4 years (1941–1945). Dam to left, sediment basin outlined by dark vegetation, Hwy 56 to top left. Arrow marks edge of fill against dam. Bottom, September 2007. Light material is 1–5 in. (2.5–7.5 cm) of sediment delivered by August 2007 storm. Note that level of fill by dam is hardly higher than in 1977.

reforested, and the more level upland areas were planted to alfalfa. When we surveyed it in 1976 and 1977, the gully from the upland had become relict from the infrequent flows and had grown up in forest (Trimble and Lund, 1982). The effects of an extreme storm on this debris dam are discussed in Chapter 8 (see Fig. 8.10).

(Upper Mitchell Debris Dam, Chapter 4, see Trimble and Lund, 1982). Dormant for years and densely vegetated, the gully was reactivated by the 2007 storm but only slightly as evidenced by the 0–4 in. (0–10 cm) deep deposits on the old surface of the basin (Figure 8.10).

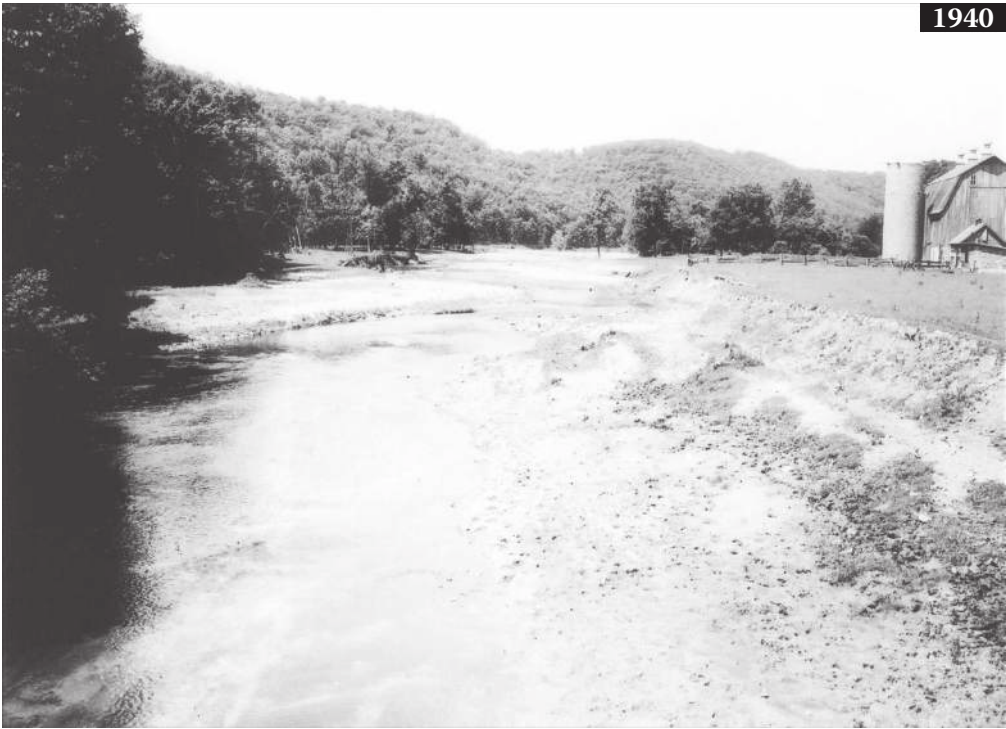
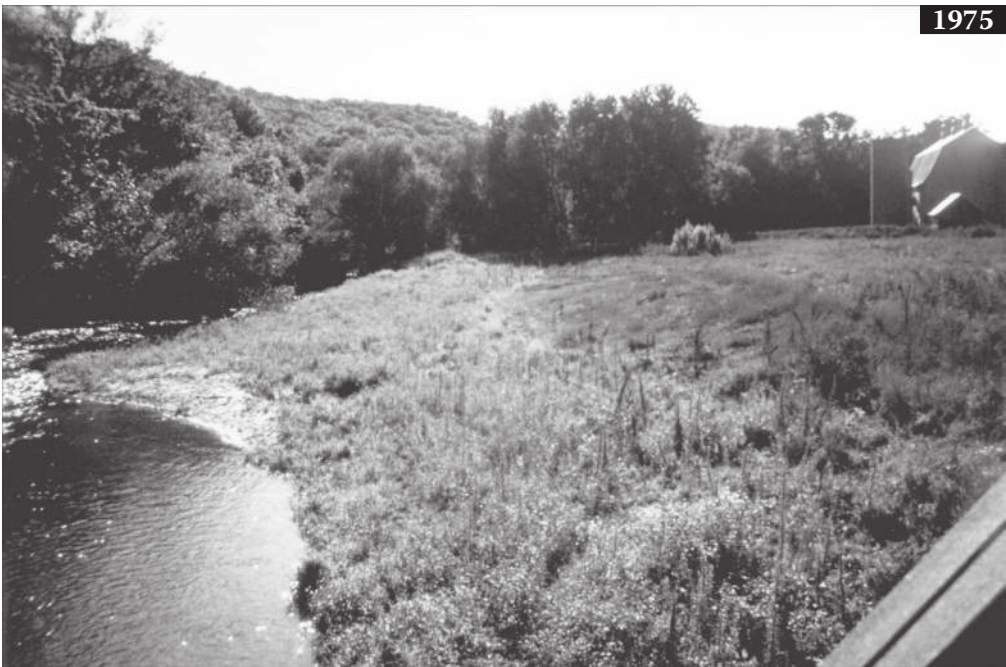
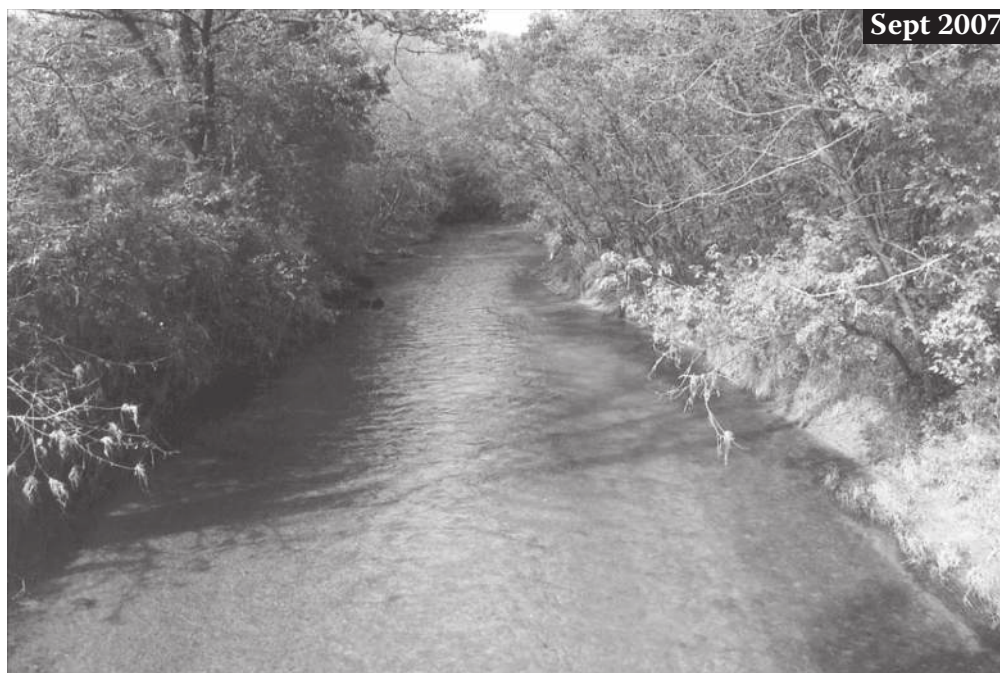
Figure 8.11 North Fork of Whitewater River 1 mi (1.6 km) west of Elba, looking upstream from bridge as seen in Figure 3.12; note barn for reference. Top: 1940. Note disturbed condition of channel. Bottom: 1975, condition was stable, and this has continued to the present. (Continued)

Figure 8.11 (Continued) September 2007, P = 9–11 in. (22–27 cm). (Photo credit: Edyta Zygmunt.)

Even in areas having the same rainfall from this storm, there was a great disparity in the amount of change in stream channels. Some channels were ripped up, and others were hardly changed. Some looked as damaged as those of the 1930s, while others changed little. For example, the north Fork of the Whitewater River (P = 9–11 in., or 25 cm), a disaster in the 1930s (see Figure 3.12), was hardly changed (Figure 8.11). While it did not get the maximum amount of precipitation, it is of interest to see what happened at the “benchmark” tributary reach on Bohemian Creek about 4 mi (7 km) northeast of Coon Valley. It will be seen that a 100-year storm (4–7 in., or 10–17 cm) there had little impact (Figure 8.12).

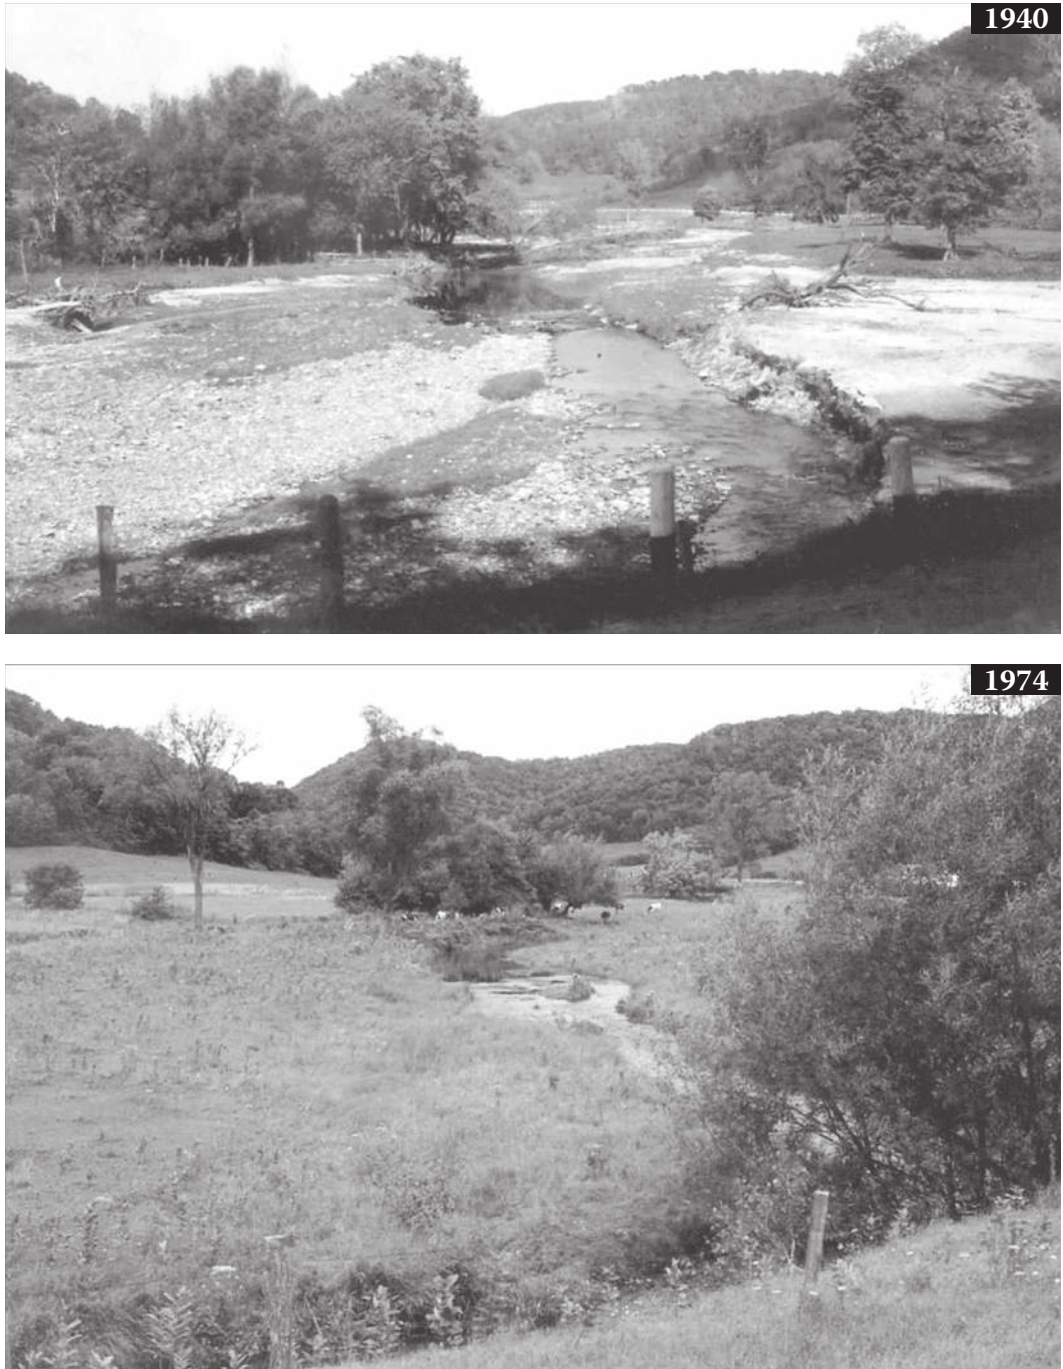
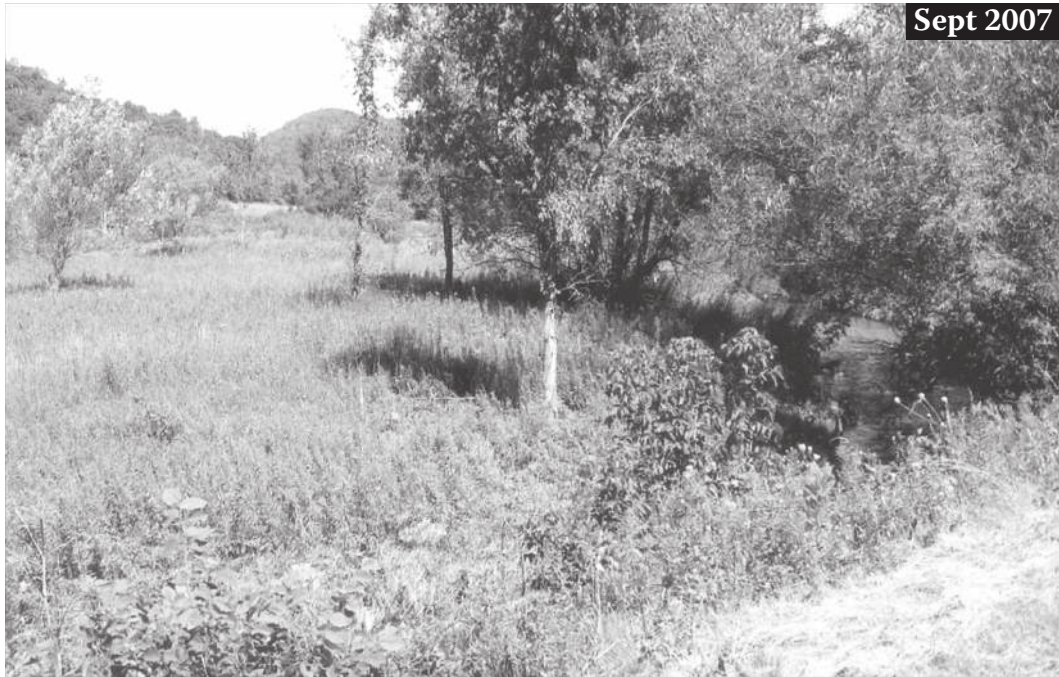
Figure 8.12 Bohemian Creek about 3 mi (5 km) NW of Coon Valley, WI, looking upstream from County G (SW1/4 Sec 34T15NR5W, La Crosse Co.). Top: Photo made 1940 by S.C. Happ as the “typical” tributary in the Hill Country. Bottom: 1974, note stable, grassed floodplain and narrow stream. (Continued)

Figure 8.12 (Continued) Bohemian Creek about 3 mi (5 km) NW of Coon Valley, WI, looking upstream from County G (SW1/4 Sec 34T15NR5W, La Crosse Co.). September 2007, completely stable after storm of 4–7 in. (10–18 cm), which is greater than the 100-year storm. Bohemian Creek had only scattered bank erosion from this storm, and I found no mass movements or visible soil erosion of any kind on agricultural fields.

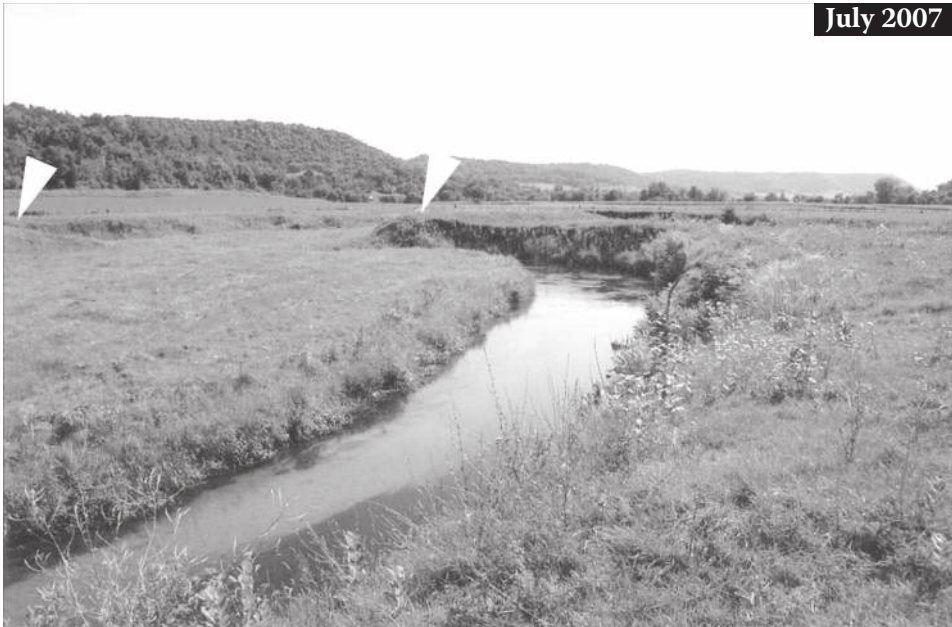
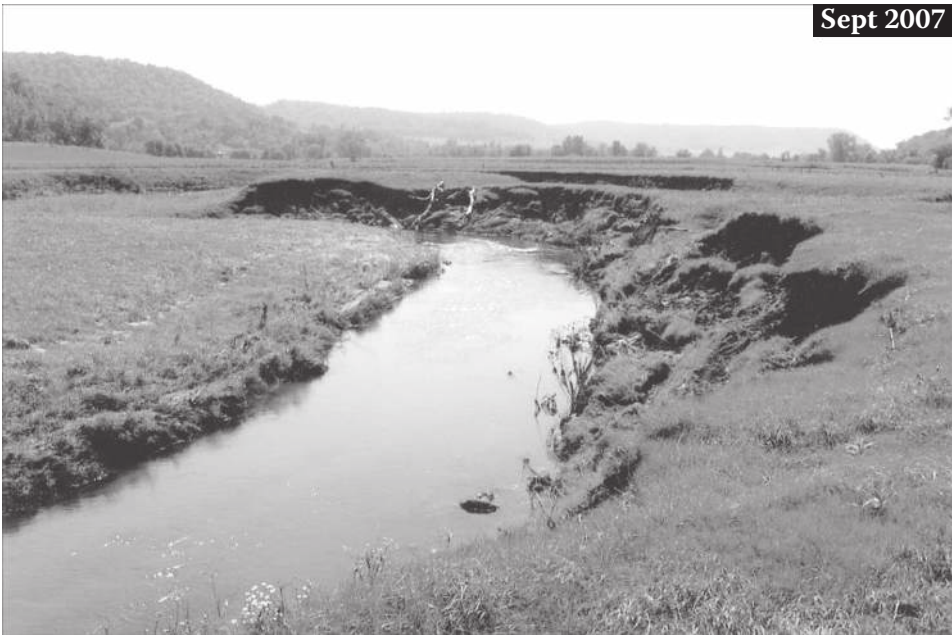
Figure 8.13 Collapse of high stream banks 2 weeks after the flood of August 2007, looking downstream Upper Main Valley, Coon Creek, 2 mi (3 km) east of Coon Valley WI, R = 4–10 in. (10–25 cm). For exact location, see photo site in Figure 6.7. Top: July, 2007. Range C from Pleistocene terrace (hump on floodplain in distance) to distant high bank seen in Figure 6.7 is noted by arrows. Bottom: About 10–14 days after the flood. Note logs in background on old floodplain suggesting inundation of the old floodplain (now a terrace). Some erosion of the high bank in the foreground was evident. However, inundation plus the rainfall saturated the normally dry bank, increasing pore pressure and weakening the bank, thus allowing it to collapse and be more susceptible to erosion. (Photos credit: Edyta Zygmunt.)

Because of the greater rainfall in the headwaters of the Whitewater, there was far more bank erosion in the UMV there than in Coon Creek. Indeed, a bridge was severely damaged about 2 mi (3 km) south of Elba and there was severe bank erosion. In Coon Creek, there was only moderate bank erosion during the storm, but the prolonged bankfull flow saturated the high banks, which are normally dry and extremely stable during the summer. The prolonged saturation and higher pore pressure allowed many similar banks to slump or even collapse after the event (Figure 8.13). The deposition of sediment on floodplains was similar to that of the tributaries.

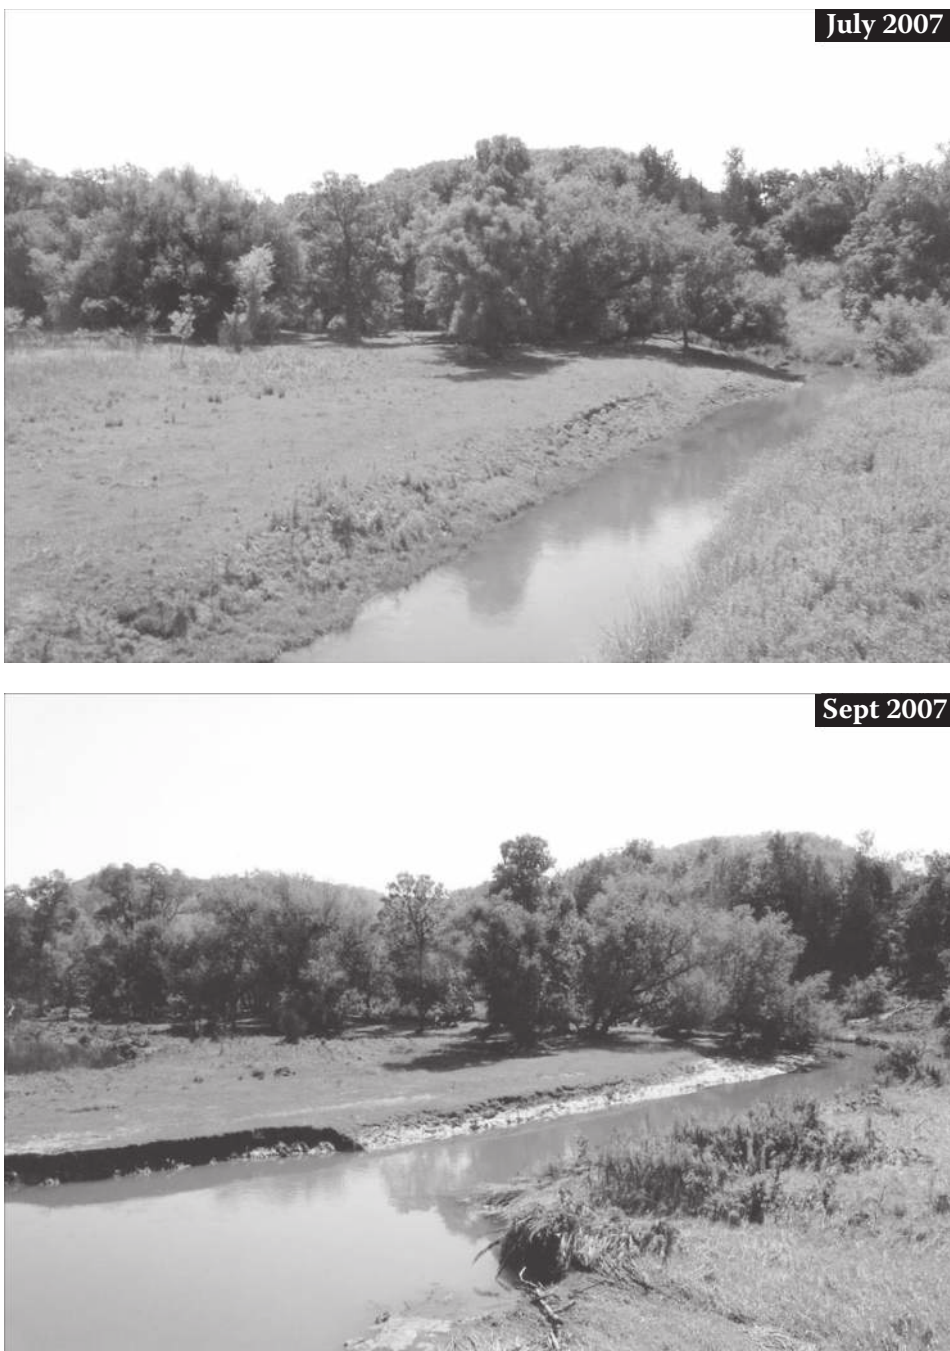
Figure 8.14 Erosion of grazed Lower Main Valley streambanks by August 2007 flood, looking upstream from bridge over Coon Creek, 3 mi (5 km) west of Chaseburg, WI (NW1/4 Sec 30 T14N R6W). High bank and terrace in background is shown in Figure 3.17. Top: July 2007; note trampled banks from grazing. Bottom: September 2007. Note severe erosion in left foreground, but far bank in middle ground appears to have accretion. (Photos credit: Edyta Zygmunt.)

Figure 3.17 Destabilization of stream reach by collapse of undercut high terrace, showing natural and human factors. This reach may be observed by looking upstream (south) from WI State Highway 162 bridge over Coon Creek (see Fig. 8.14).

In both basins, the LMV experienced high flows, but the bank and channel erosion again appeared more severe in the Whitewater. In Coon Creek, most LMV bank erosion appeared to be correlated with streams having trees or grazed grass as riparian vegetation (Figure 8.14). Ungrazed grass did not appear to have much erosion (Figure 8.15). This observation also seemed to be correct in the Bad Axe River and accords with published work on the subject (Trimble, 1997, 2004; Lyons et al., 2000). In parts of the Whitewater, however, bank vegetation seemed to make little difference. Indeed, bank erosion observed there from banks having ungrazed grass was just as great as from forested banks (Figure 8.16). This greater bank erosion might result from greater rainfall in headwaters, or it might be from the high sand content of floodplains in the Whitewater. This sand came from the erosion of high terraces such as those seen at Ratz Gully (Chapter 4) and Fairwater (Chapter 5) and would serve to make LMV streambanks more erodible.
