**HISTORICAL AGRICULTURE
AND SOIL EROSION IN THE
UPPER MISSISSIPPI
VALLEY
HILL COUNTRY**

STANLEY W. TRIMBLE

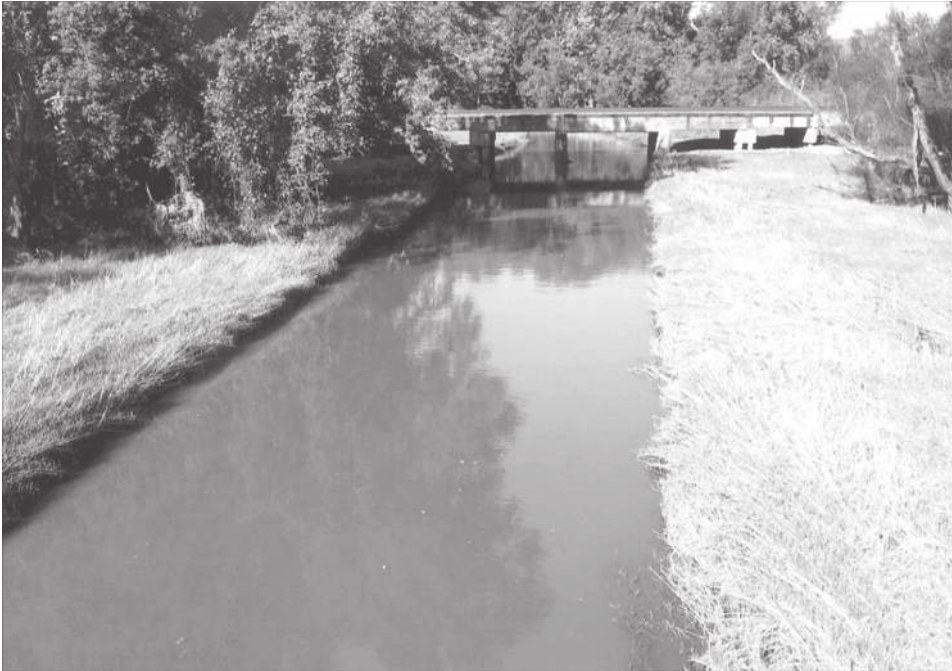
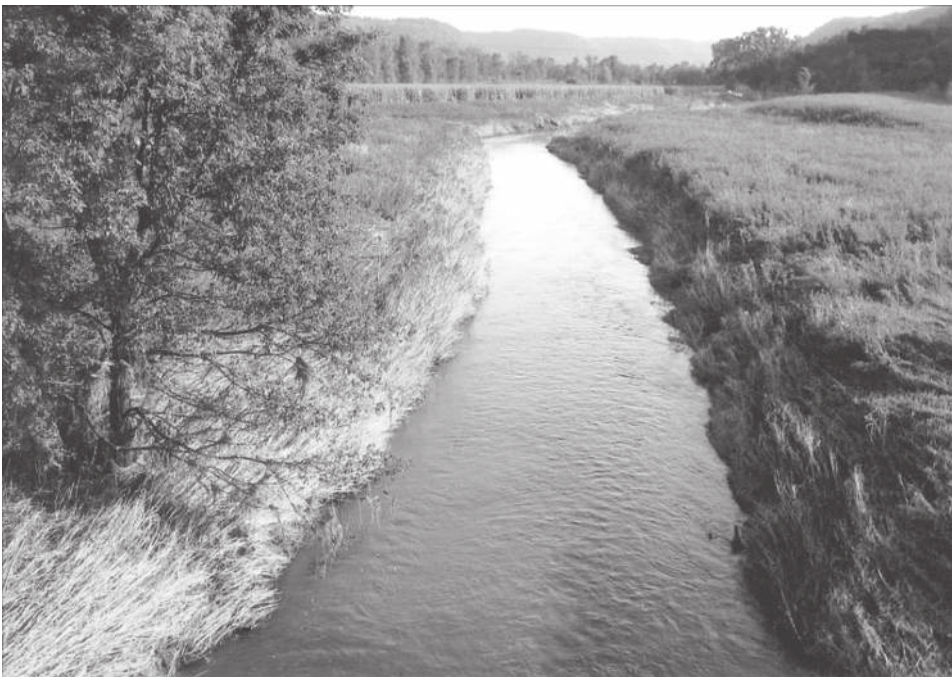
Figure 8.15 Stable ungrazed grass banks in the Lower Main Valley after 2007 flood. Top: Lower Coon Creek looking downstream from Hwy 35 bridge 1 mi (1.6 km) south of Stoddard WI. Bottom: North Fork, Bad Axe River looking downstream from Hwy 56 bridge at Romance WI (SE1/4 Sec 36 T13N R&W. Vernon Co.). (Photos credit: Edyta Zygmunt.)

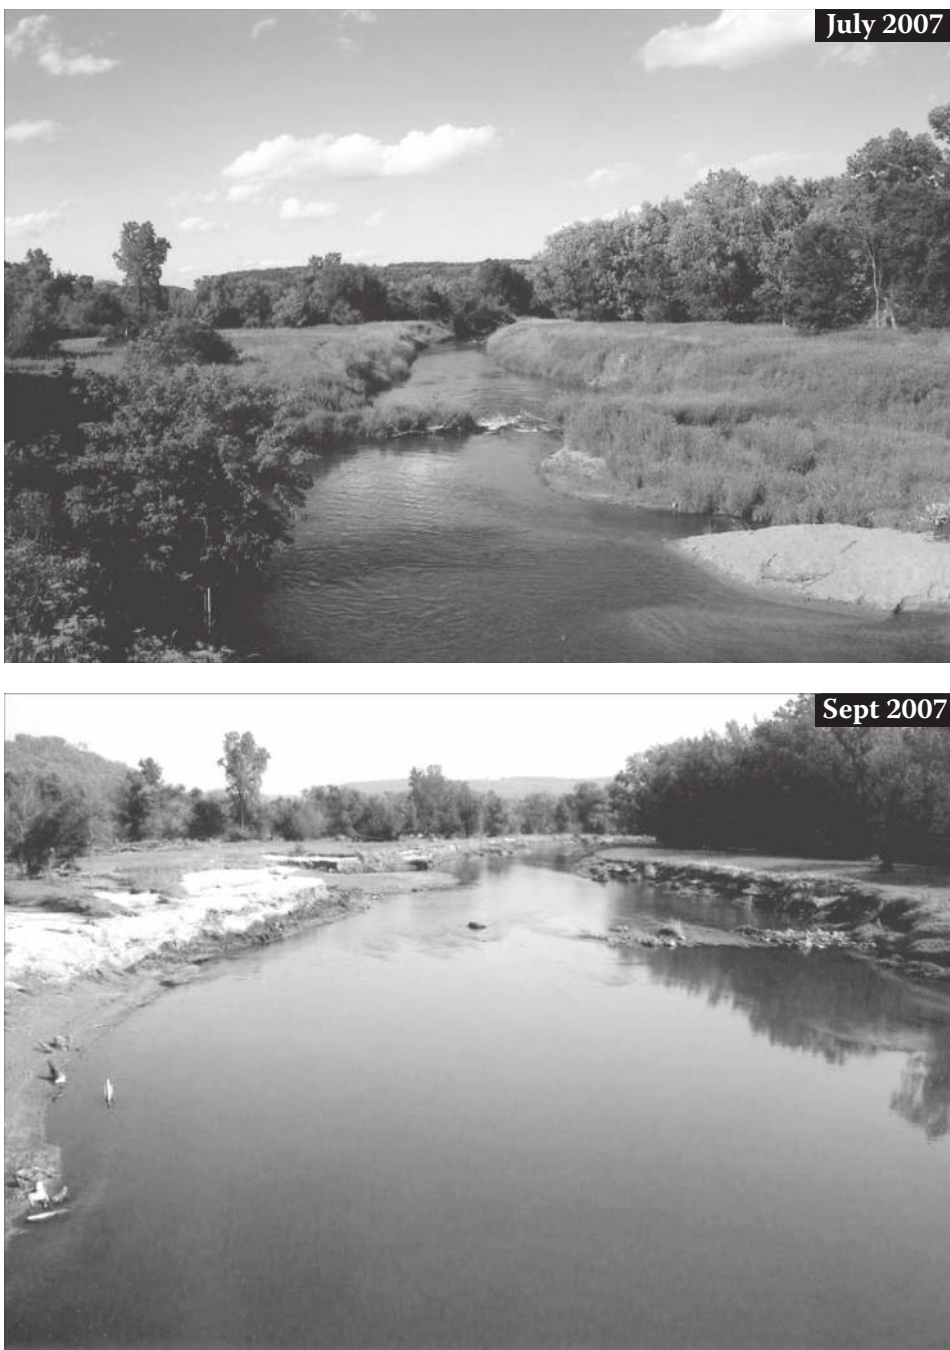
Figure 8.16 Extremely severe erosion of ungrazed grass streambanks, looking downstream from bridge over Whitewater River at Beaver MN, 6 mi (10 km) north of Elba, $R = 10\text{--}14$ in. (25–35 cm). Top: July 2007. Bottom: September 2007. (Photos credit: Edyta Zygmunt.)

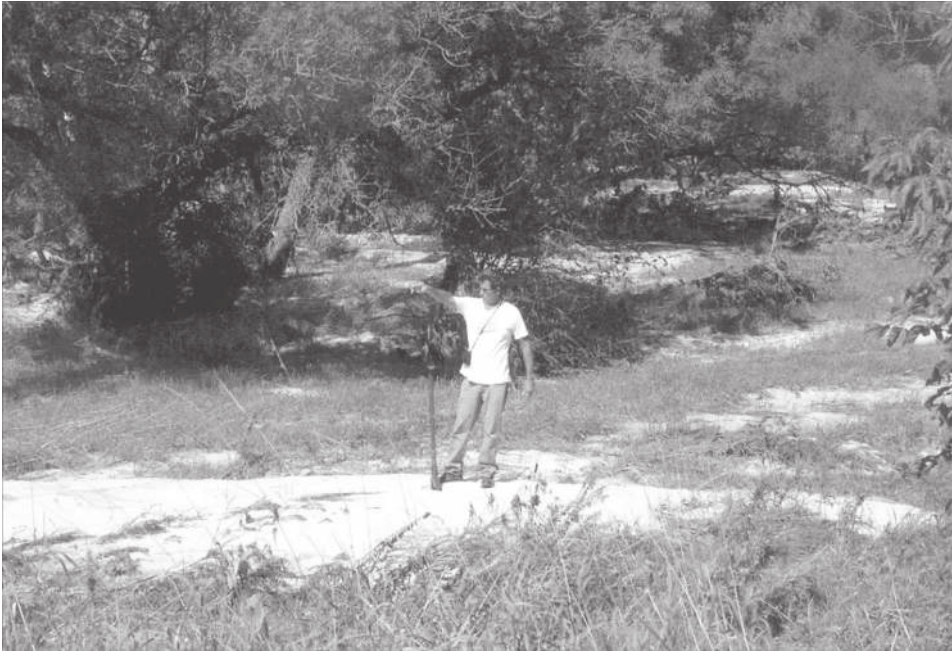
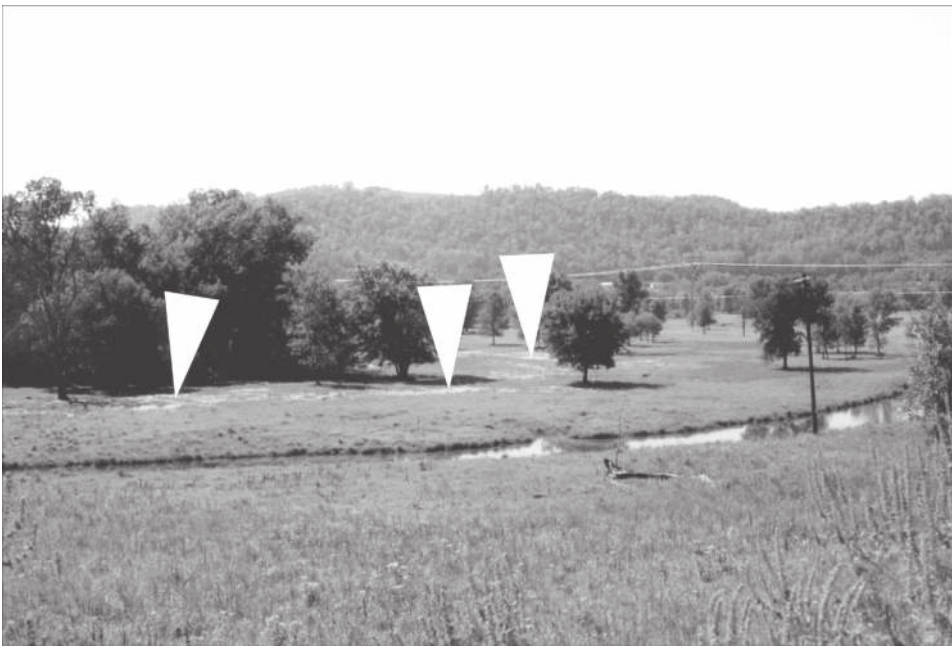
Figure 8.17 Sediment deposition on Lower Main Valley floodplains from August 2007 flood, highly variable in distribution and thickness, Top: Splays of sand ranging up to almost 2 ft (60 cm) thick just downstream of bridge in Figure 8.14. Bottom: Splays of sediment on Coon Creek floodplain looking southwest from Cedar Valley Drive, 2 mi (3 km) east of Stoddard, WI (E1/2 Sec 26 T14N R7W, Vernon Co.). (Photos credit: Edyta Zygmunt.)

Deposition on the floodplain was very noticeable and of significant volume. Most visible deposition was generally sandy in nature with a highly irregular distribution (Figure 8.17). Most occurred in scattered splays with usual thicknesses of 1 to 5 in. (2.5–7.5 cm), but some small splays almost 2 ft (60 cm) thick were measured (Figure 8.17). It generally appeared that there was more sediment deposition just downstream of severe bank cutting, which suggested that a significant proportion of the deposited sediment was coming from local bank and channel erosion. Indeed, it appeared that material was simply transferred by the turbulent water from steambanks to floodplains immediately downstream.

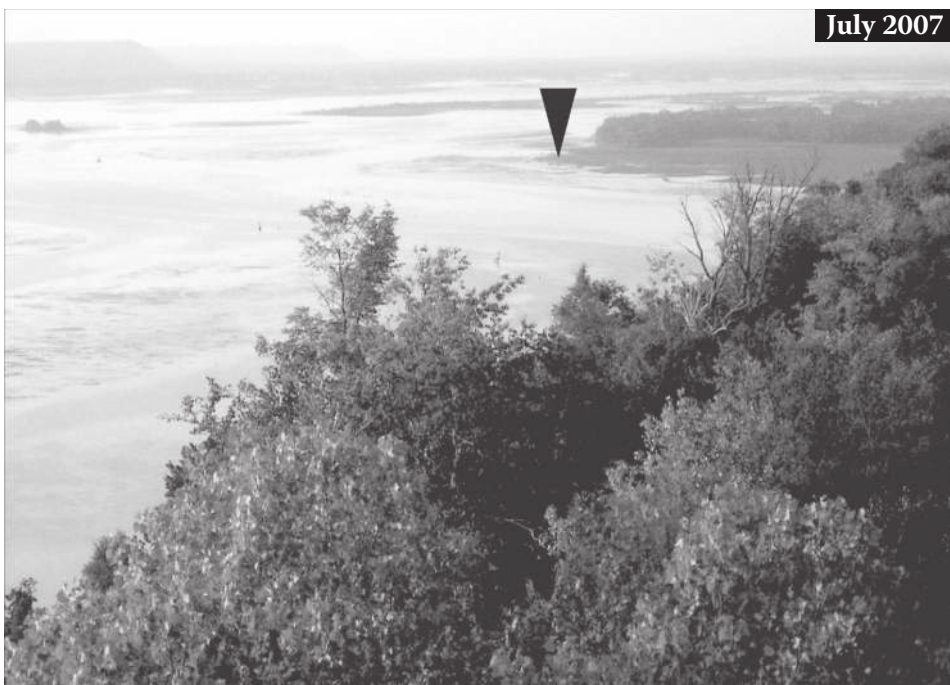
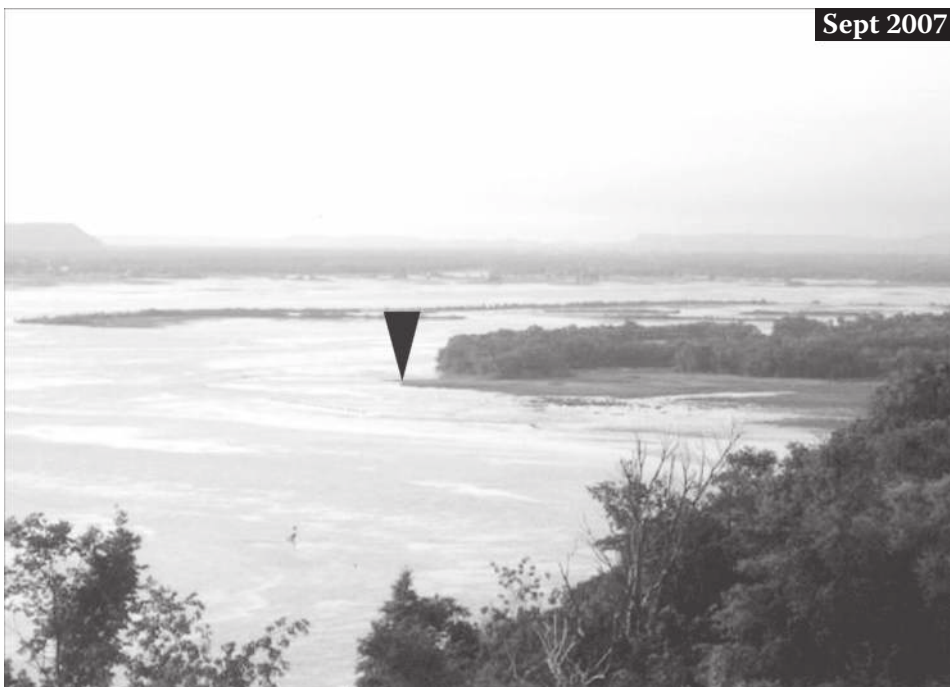
Figure 8.18 Repeat views of Coon Creek delta front in Pool 8 of Mississippi River, looking northeast from scenic overlook on bluff, off Hwy 35, 3 mi (5 km) north of Genoa, WI. Top: July 2007, arrow indicates westernmost growth of vegetation on delta front. Bottom: Sept 2007. There was no discernible change. A photo in July 2008 also showed no change, and there was no change from July 2006. (Photos credit: Edyta Zygmunt.)

The first approach was to compare the Coon Creek delta front at successive dates by oblique ground photography (Figure 8.18). I had such photographs for many dates because my research crews often had late afternoon picnics on a bluff overlooking Navigation Pool 8 and the Coon Creek delta. The view is so beautiful that one cannot resist making several photographs at each visit. In Figure 8.18, I compare the extent of the delta in July 2007 to that of September 2007; there is little difference. What we are actually seeing, however, is the plant growth on the delta. The comparison is not perfect because of probable slight differences in pool level and seasonal stage of vegetation growth. July 2008 and summer 2006 were also available (not shown), but all are essentially identical. Indeed, the only way one can tell them apart is by the recorded date. Certainly, we can conclude from these photographs that there was no huge burst of sediment brought to the Mississippi River by the big flood.

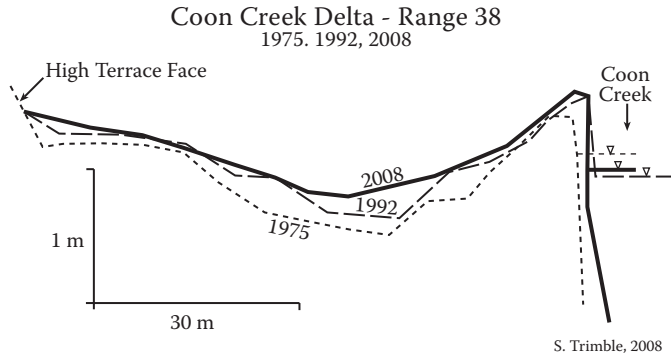
Figure 8.19 Instrumented cross-sectional survey of north bank of the Coon Creek delta extending into navigation Pool 8 of the Mississippi River, 1975, 1992, and July 2008. The profile is located 500 ft (160 m) downstream of the railroad bridge seen in Figure 8.15 and off to the right and out of sight in Figure 8.18. The period 1975–1992 included one basin-wide, 100-year storm, and the period 1992–2008 included the August 2007 flood and another large storm in June 2008. The average rate of accretion for the earlier period was *greater* than for the later period including the extreme storms of August 2007 and June 2008. These data do not support the concept that extreme floods necessarily scour out legacy sediment, at least in humid area streams with broad floodplains.

The harder line of evidence is a surveyed profile across the delta dating from 1938 (Figure 8.19). The profile is just downstream from the railroad bridge crossing the mouth

of Coon Creek (Figure 8.15) and is not visible in Figure 8.18, being just out of view to the right (upstream). For clarity, only the profiles for 1975, 1992, and July 2008 are shown. Not only is there no deluge of sediment from the 2007 and 2008 floods, the rate of accretion for 1992–2008 is slightly *less* than that of 1975–1992! As pointed out in Chapter 3, the rate of accretion at the mouth of Coon Creek has been remarkably uniform since the late 1930s. Here, we see that an extreme flood seems to have made little difference.
