Experimental Fatigue Test for Pre-Qualification of Repair Mortars Applied to Historical Masonry

Alessandro Grazzini

Keywords: strengthening mortars, historical masonry, durability, fatigue test, plaster detachment

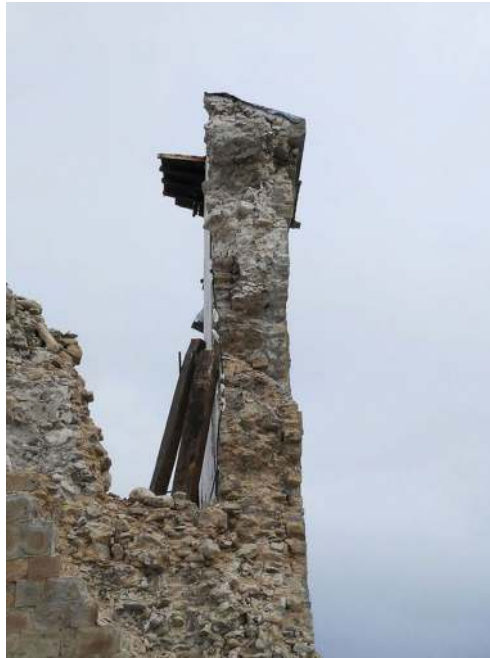
Figure 1. Collapse of the St. Agostino church in Amatrice after the Central Italy earthquake 2016 (image courtesy of the Curia of Rieti).

Recent earthquakes have shown the clear failure of restoration work performed with the use of concrete materials, the excessive stiffness of which has completely distorted the original characteristics of historical masonry buildings. **Figure 1** shows the ineffectiveness of the cementitious insertion materials inside historical walls of the St. Agostino church, collapsed during the last great Italian earthquake of Amatrice, just in correspondence with the previous stitching made by cement injections.

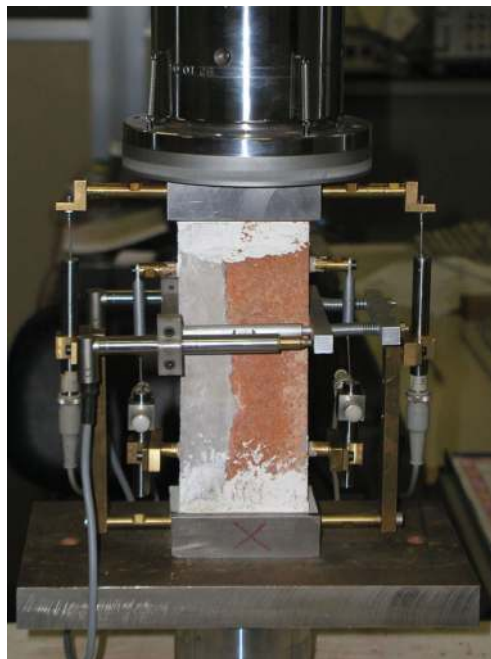
Figure 4. Mixed brick-mortar test pieces.

The next step of this experimental procedure was the manufacturing of particular mixed brick-mortar specimens measuring $223 \times 57 \times 83$ mm (Figure 4). The mixed specimens were made from historical cut on which a 30 mm thick layer of strengthening mortar was applied. The brick surface was treated by means of a drill to facilitate the mortar’s adhesion. The treatments simulate roughness and irregularity of the masonry surface that in the real executive

Each mixed test piece was labeled with “XL” where “X” stands for the code of the relative mortar (A–D).

Altogether eight mixed pieces were manufactured for each “XL” series: two for preliminary static tests, three for freezing-thawing tests and three for cyclic loading tests. The vertical and horizontal displacements were recorded respectively by means of a couple of vertical transducers and a horizontal transducer (**Figure 4**). The horizontal transducer served to measure the displacements due to bulging. The mixed specimens were instrumented also with a pair of electrical strain gauges on the opposing vertical faces measured transverse strains. In this manner, it is possible to measure the axial deformations (in vertical, horizontal and transverse directions), whose algebraic sum yields the volumetric deformation.

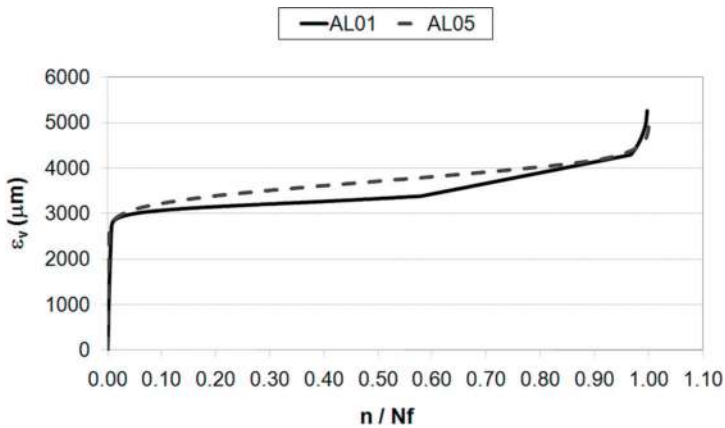
Figure 6. AL series cyclic tests: max vertical deformation.

Fatigue life of a material subjected to cyclic loading tests is linked to the evolution of the deformations during stage II [4–7]. By analogy with the method suggested for concrete [8], the evolution of vertical deformations over time was recorded for evaluating fatigue strength of material. The goal is to ascertain whether fatigue life of the mixed brick-mortar system also depends on the rate of increase of vertical deformations during stage II (termed secondary creep rate). **Figures 6–9** shows that the broken test pieces (before 1,00,000 cycles, as shown in **Table 7**) displayed a steeper slant in the stage II section of the curve, followed, at ca 80–90% of test piece life, by a sudden increase at stage III (failure). Conversely, the diagrams of the mixed specimens that passed 1,00,000 cycles mark displayed a lesser slant, reflecting an effective behavior still far from failure. From these results of cyclic tests, through linear interpolation between 20 and 80% of secondary creep values (**Figure 10**), derivatives $\partial \epsilon_v / \partial n$ (i.e., the

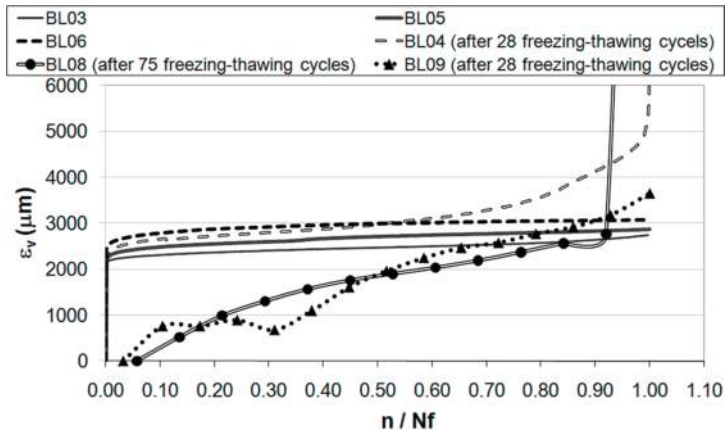
Figure 7. BL series cyclic tests: max vertical deformation.

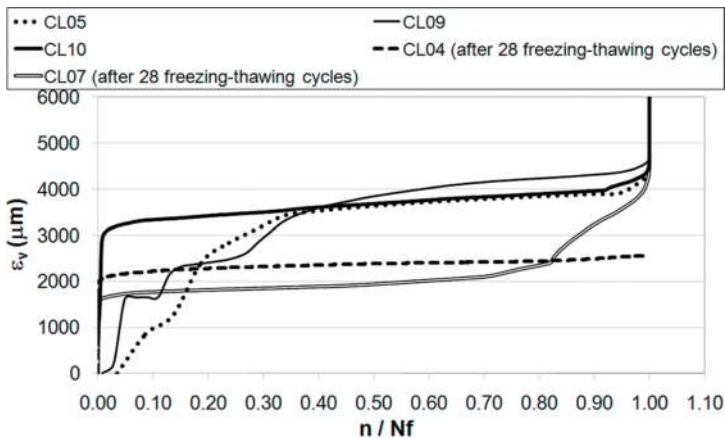
Figure 8. CL series cyclic tests: max vertical deformation.

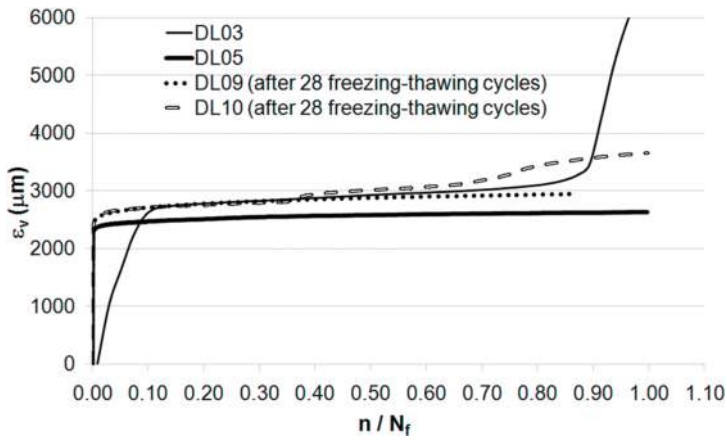
Figure 9. DL series cyclic tests: max vertical deformation.

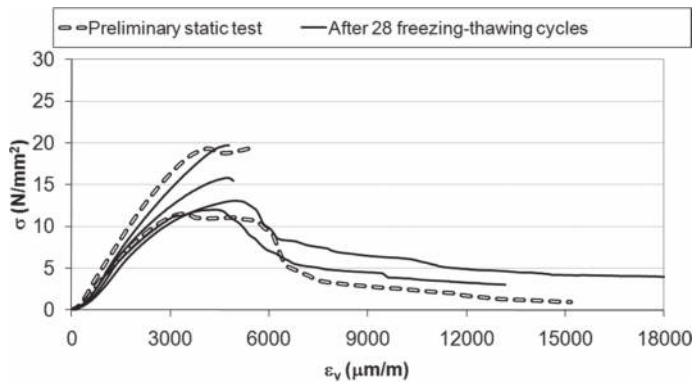
Figure 11. AL series static tests.

In some samples, the theoretical value of cycles to failure N_{the} was found to be lower than that obtained from laboratory tests (Table 7). After the final value of cyclic test, the relationship (Eq. (1)) was useful to predict the failure on the detachment surface between brick and repair mortar. The measure of the volumetric deformations is in agreement with the theoretical value obtained from Eq. (1): the time when the volumetric deformations shifted to negative sign (propensity to bulge due to poor vertical collaboration or detachment at the interface between the two materials) was the failure time of the mixed brick-mortar specimen. The methodology and the numerical analysis proved very sensitive to the initial signs of weakening in the brick-mortar system, indicating clearly the onset of a crisis due to fatigue. Figures 11–14 illustrate the static tests performed on mixed test pieces.

The values obtained for a majority of the series remained within the average of the two preliminary tests, save for the series DL (Figure 14), which displayed a considerable increase in strength. In most cases, static curves after freezing-thawing revealed a more brittle behavior. Test pieces of BL and DL series that passed 1,000,000 cycles mark were tested to failure: the DL series displayed a noticeable increase of their mechanical properties. Some CL and DL test pieces were subjected both to freezing-thawing test and to cyclic loading: CL maintained a static behavior similar to the weakest preliminary test result; instead in the DL series, an appreciable increase of strength was mated to a lesser degree of brittleness compared to the test pieces subjected to cyclic loading only.

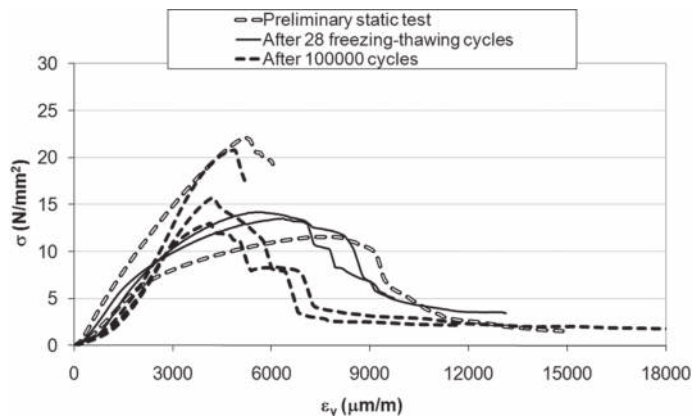
Figure 12. BL series static tests.

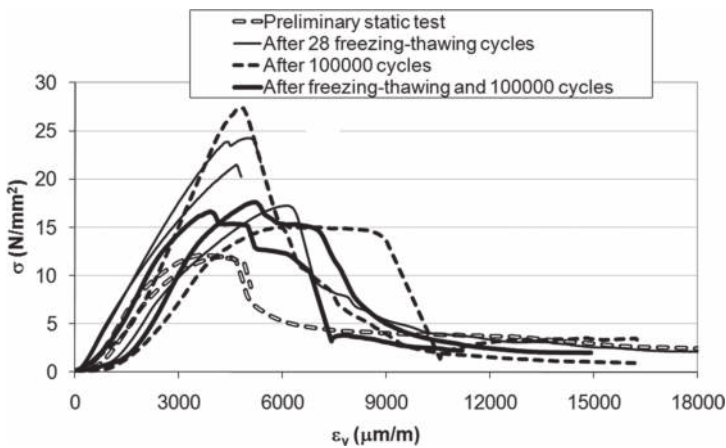
Figure 14. DL series static tests.

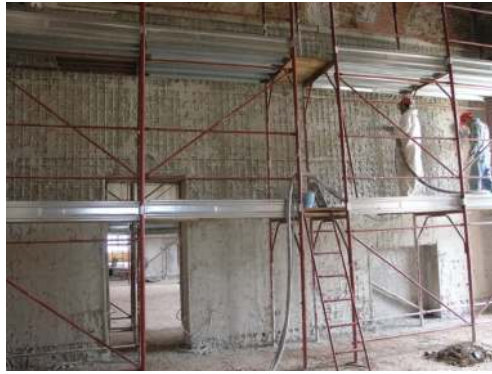
Figure 15. Application of mortar D as the reinforced plaster to Venaria's masonries.

came from the real application of mortar D as reinforced plaster retrofitting of some walls of the Royal Palace of Venaria (**Figure 15**). After 10 years, this plaster does not present any pathology of incompatibility.

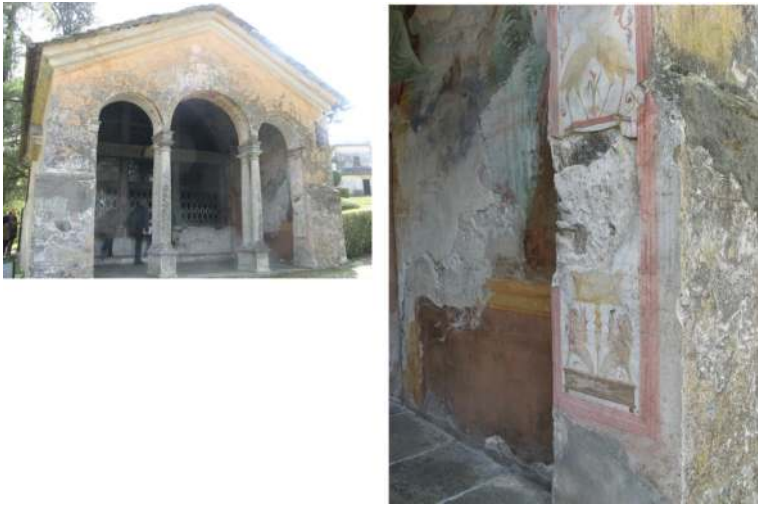
Figure 16. Decay of historical plasters because of the rain infiltrations (Sacro Monte of Varallo).

An innovative laboratory procedure, developed at the Non-Destructive Testing Laboratory of the Politecnico di Torino, is described for test mechanical adhesion of new repair mortars. Compression static tests were carried out on composite specimen stone block-repair mortar, which specific geometry can test the de-bonding process of mortar in adherence with a stone masonry structure. The methodology is being used at Sacro Monte di Varallo Special Natural Reserve. Situated at the top of the hill above the town of Varallo in Piedmont (Italy), Sacro Monte is an artistic-religious complex consisting of 45 chapels, which contain with frescoes and sculptures that tell the story of the life of Christ (**Figure 16**).

The main problem of historical plasters' preservation is linked to the rain infiltrations and to the freezing-thawing cycles that compromise their adhesion to stone masonries. Through compression static tests on stone-mortar composite specimens, it was possible to prequalify the dehumidified mortar with greater durability guarantees. Sometimes the long-term detachment determined the failure of the restoration work. The test validates the mechanical

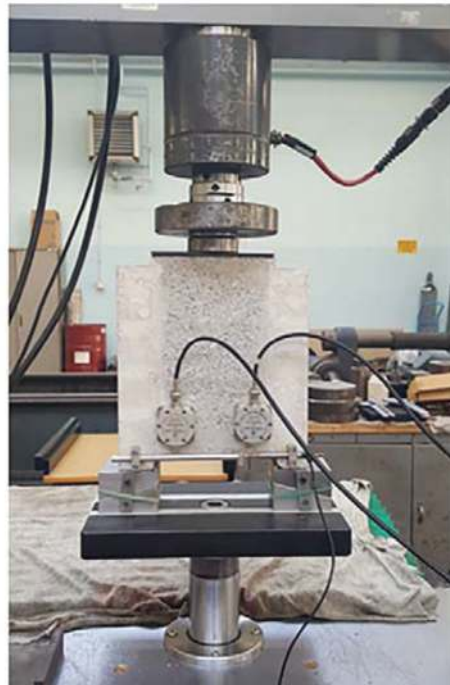
Figure 17. Geometry of composite specimen and test setup.

For carrying out tests, a particular geometry of the composite specimen has been proposed. Four mixed specimens were made, applying a 40 mm mortar layer to both shorter faces of the stone brick suitably cut with the dimensions shown in **Figure 17**. The mechanical characteristics of the repair mortar and the stone brick were chosen equivalent to those of the stone masonry at the Sacro Monte di Varallo. The experimental test can carry out also by masonry brick, if the historical walls were made by bricks. The hydraulic lime mortar was a pre-blended transpiring product, for dehumidifying repair work on historical masonry

The surface of the stone block has been treated specifically by means of a drill to facilitate the mortar's adhesion. This treatment aimed to simulate the real discontinuities on the wall surface that favor the adhesion of the plaster. The application of the dehumidified mortar took place leaving specific and surface symmetrical discontinuities at the top and bottom of the specimen, as shown in **Figure 17**. These notches favored the trigger and propagation of multiple cracks, in order to test the adhesion of two linked materials. An inductive horizontal displacement transducer was applied at the bottom of the specimen for the bulging displacements. The vertical displacements were recorded by the piston's translation of the 250 kN servo controlled test machine. The composite specimens were tested by monotonous compression load by horizontal controlled opening (0.0001 mm/s). Static tests have been performed after 28 days of maturation. The composite specimen rested, through the side layers mortar, on a double system of steel wedges (**Figure 18**). The wedges were coupled by a 1 mm thick Teflon layer for reducing the horizontal friction during the plaster's expansion. The "SM" (Stone brick-Mortar) label has been associated with each specimen with its sequence number.
