Cultural Heritage of a Three Centuries Old Wooden Church

Patricia Săsăran, Ancuța Țenter and Lorelay-Diana Jianu

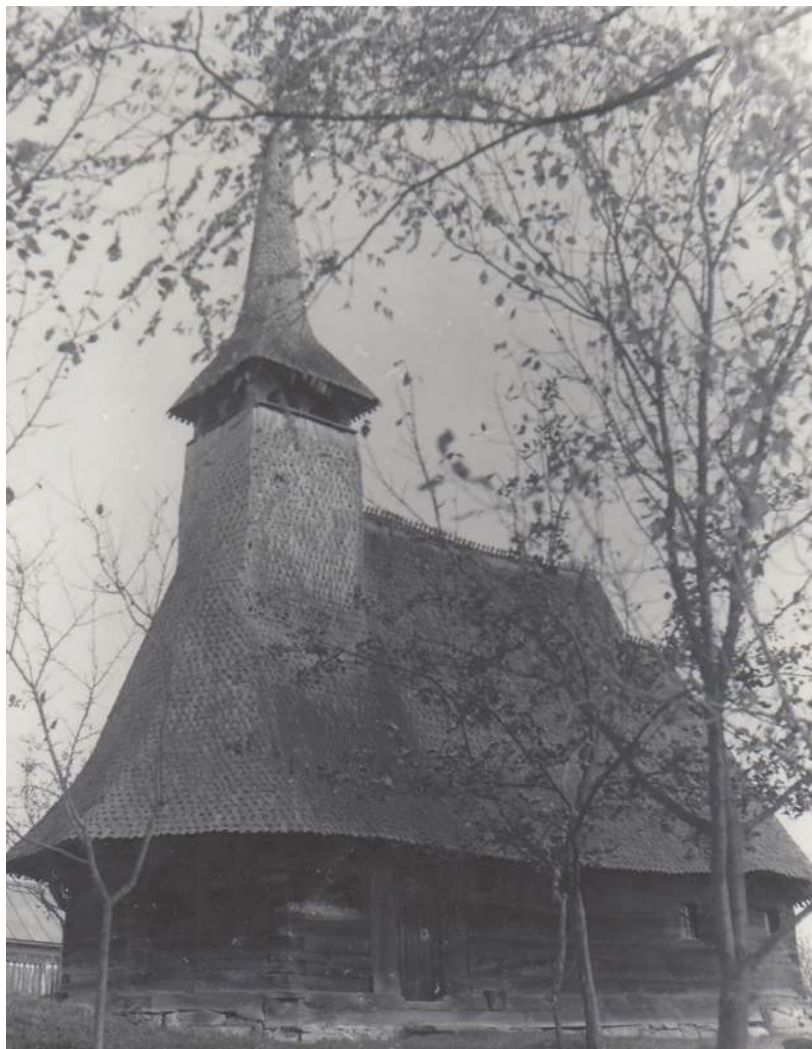
Figure 1.
Holy Archangels Church, Drăghia.

The village is remarked by the presence of a wooden church (**Figure 1**) built in 1706, as testified to this day by the Latin inscription found left of the entrance: *Anno 1706 D. 14 obrys*. It is under the patronage of the Holy Archangels Michael and Gabriel, and today, it is part of the Lăpuș Deanery, belonging to the Orthodox Episcopate of Maramureș and Sătmar. It is made of oak wood, harvested from the oak forest found higher up from the church, and was paid for using donations from the villagers.

The church is 12.40 m long, 4.45 m wide, 7.50 m high at the ridge and 15.50 m high at the tower's spire. The base and the walls are all made of oak beams placed on a dry-laid stone foundation [6].

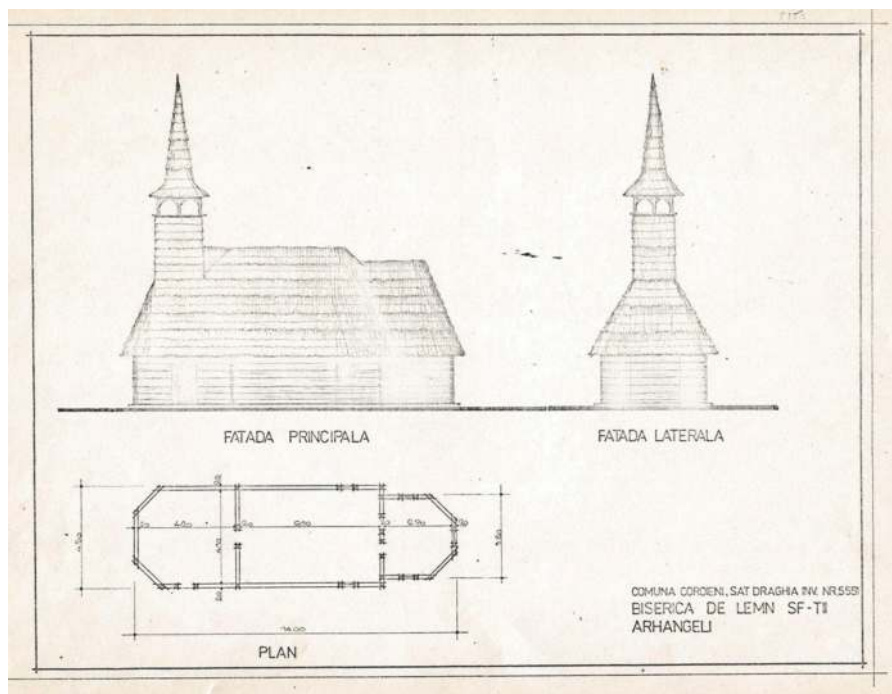
Figure 2.
The building plan of the Holy Archangels Church, Drăghia.

The building plan (**Figure 2**) [7] is found throughout the area, the church being divided into a narthex, nave and altar. The narthex has a polygonal shape, covered with a straight ceiling, above which the bell tower is situated. The ceiling is painted with cherubs, and the walls are painted with images of the Myrrhbearers and of wise and foolish virgins from the Gospel of Mathew. The narthex was where the women would attend the mass [8].

The nave is rectangular, with a dome, and is separated from the narthex by a wall with an opening and a door. The door is painted with two saints and, in the lower part, the tree of life in a pot. The door frame is engraved with symbols such as

the six-petaled rosette, honeycomb and wolf's teeth. The opening is fitted with small turned columns of various forms that were painted white [9]. Between the nave and the altar is the iconostasis. The altar is in a domed polygonal apse.

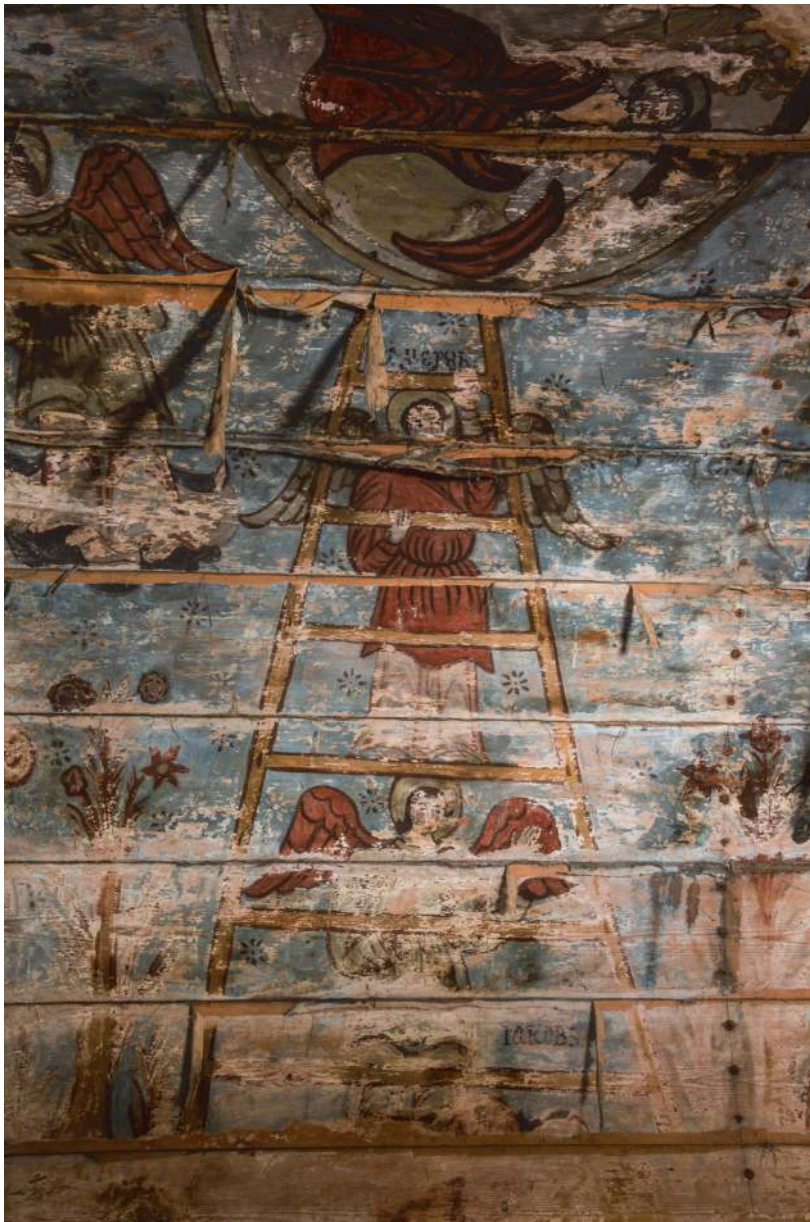
Figure 3.
Painting of angels climbing Jacob's ladder.

The painting in the nave is badly damaged, many scenes being unrecognisable, with only some spots of colour left. Among the visible images, there are Jacob's ladder (Figure 3), the Holy Trinity, Elijah riding to the heavens in his fire chariot

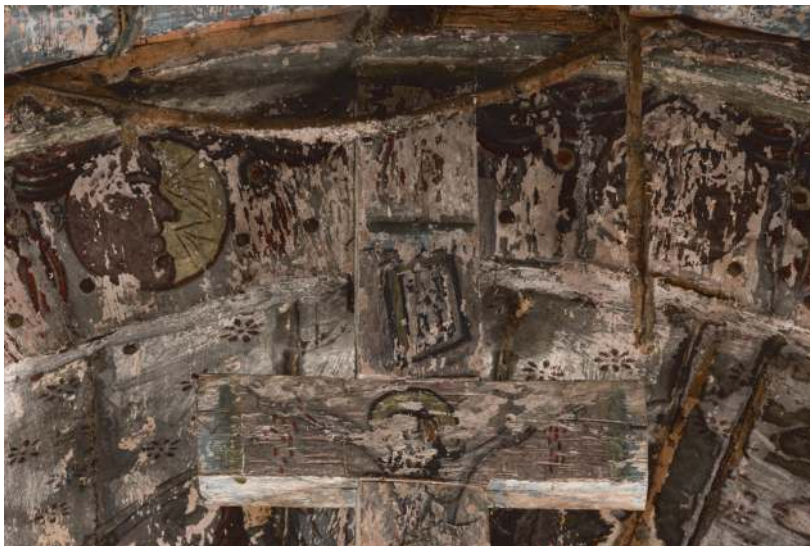
Figure 4.
Detached canvas strips.

The partial detachment of the canvas strips (**Figure 4**), stuck to cover the gaps between the planks, led to the exfoliation and loss of the paint layer found on them. Numerous bands detached completely of the support and led to the permanent loss of the paint layer. Furthermore, there are hints of a moderate xylophagous attack that affected the support and led to small losses of paint layers. In some places one can see flight holes caused by xylophagous insects.

The painting is tempera on canvas and wood and covers the entirety of the church interior. In order to make a continuous painting medium, the painters applied bands of hemp canvas stuck with animal glue to the gaps between the beams and planks. In the altar there is a part of the wall that is entirely covered with canvas, not just the gaps.

1. Removal of non-adherent deposits
2. Removal of the nails from the support
3. Restoration of the cohesion and adhesion of the paint layer to the support
4. Filling in with new wood
5. Cleaning the back end of the canvas strips
6. Consolidation of the painting on the canvas
7. Application of the canvas strips to the support
8. Removal of the restoration canvas and glue surplus from the surface
9. Insurance of the fish glue and micronised chalk from the edge of the paint layer
10. Gradual removal of the adherent and non-adherent deposits off the surface of the paint
11. Selective grouting
12. Chromatic integration

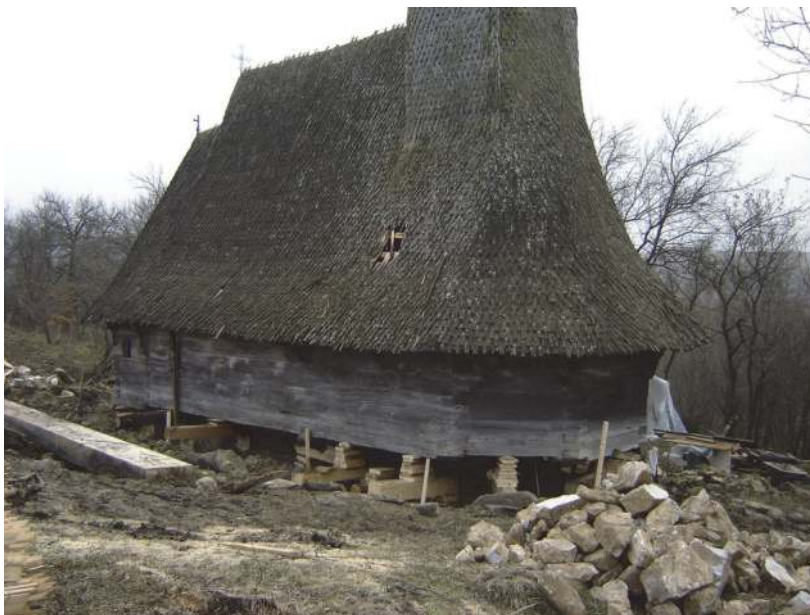
Figure 5.
The lifting of the church.

The restoration and consolidation work required numerous interventions. Since the church interior was painted, a protective tent was needed to protect it during the works. The entire roof framework was removed, since it was badly damaged, leaving only the frame of the tower. Then, the entire church was lifted (**Figure 5**), using a jack and wedges, to a height that permitted the foundation work to be carried out.

Once lifted, the existing stone foundation was dismantled, and a new foundation made of reinforced concrete was poured on the entire base of the church, as well as two crossbeams that would sustain the dividing walls between the three rooms. The stone foundation was rebuilt over the concrete one, keeping the old architecture. The wooden base was replaced with oak beams that were treated to protect them from rot and fire. Some of the beams were dismantled and either restored or replaced. The building was placed on the new base and the new foundation, and then the new roof framework was built. A scaffold was built in order for the workers and materials to easily reach the roof. The old wooden shingle covering was badly damaged by the weather and had many holes made by green woodpeckers, so it had to be replaced, and the birds' access to the tower was hindered using fine-mesh netting. The cross from the tip of the tower was restored as well and placed back in its place. The finishing work was also performed, on the floors and wood-work. The work ended with the installation of the lightning rod.

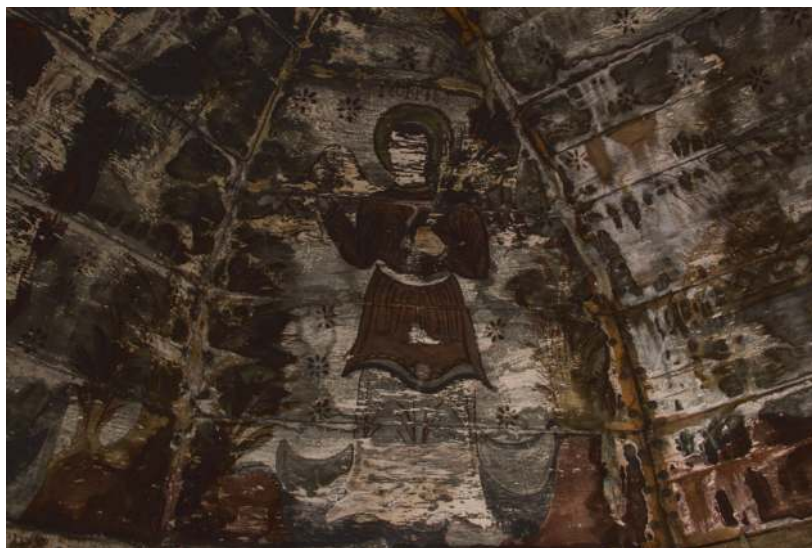
Figure 6.
The sequence in the ceiling.

Unfortunately the funds were exhausted; the mural painting had no chance to be restored. The age of the church and the current climatic conditions lead to an advanced degradation of the painting from the interior of the wooden church (**Figures 6 and 7**).

consequence of rainwater seeping in, the wood and the painting on it were badly damaged. Another cause of damage were the temperature fluctuations between night and day, which led to volumetric changes of the wooden structure that resulted in the chipping and fissure of the paint layer, leading to a complete loss of painting in some large areas. This phenomenon is particularly intense on the southern side of the church, which receives more sunlight during the day than the other sides.

Following the degradation of the binder and the volumetric changes suffered by the wooden support under moisture gain and loss, the paint layer lost its adhesion to the wood, leading to chipping. Significant losses of paint layer are ascertained, even all the way to the wooden support, caused by dusting or involuntary rubbing and hitting on the surface. For example, the areas that were protected by the pews of the cantors hold more paint than those next to them. Still, these areas and the iconostasis have more damage caused by the metal nails driven in the wood.
