# Quality Impairments in Flexible Road Pavements

## Abstract

The purpose of this chapter is to present the reader with the physical processes of how flexible road pavements progressively fail and impair the quality of finished roads arising from non-adherence to roads construction quality outlines and requirements. This was achieved by investigating eight (8) roads from a sample of nineteen (19) roads based on purposive sampling. Using instruments of steel tapes, paints for failed sections, rolling rule and pictures, measurement of length, width and depth of various failed sections were taken for five (5) daily measurements at three (3) monthly visit intervals for Four Hundred and Thirty Five (435) days to show the rate of deterioration. Data obtained were analyzed for reliability of pavements using Weibull distribution statistics on Reliasoft Weibull<sup>++</sup> to extrapolate pavement reliability from bathtub function. Findings showed that roads failed progressively within six (6) months after finished construction and deteriorated fast with increased failures on length, depth and width of pavements. The practical implications of this is that the process of construction did no

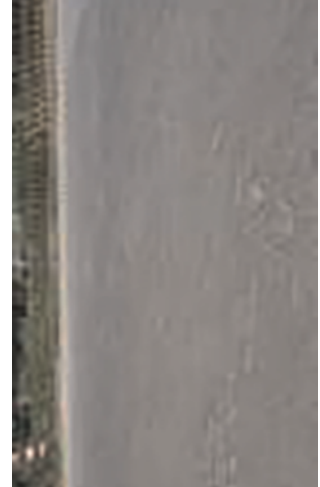
<p>This form of crack failure originate from unstable wearing course and poor drainage</p>
2. Depression	 	<p>This form of road failure is very visible with creter form of depression. Its occurrence is traceable to heavy rainfall and improper side drainage</p>

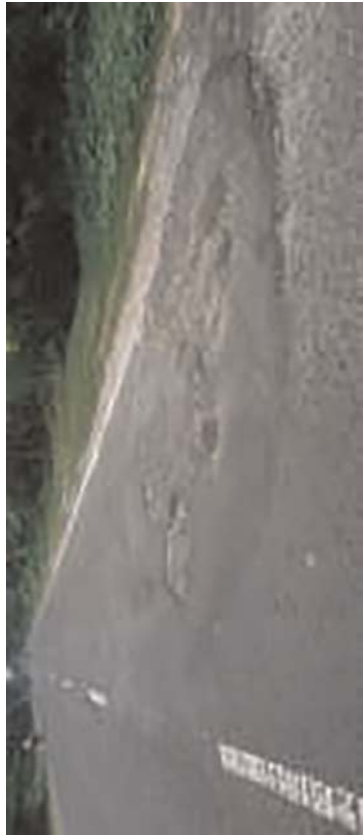
<b>Failure Type</b>	<b>Figure</b>	<b>Description</b>
6. Corrugation and Shoving

Failure is often associated with roughness and elevated sections of the pavement. Poor materials mix design, high traffic loads and unstable binders are most the causes of this failure

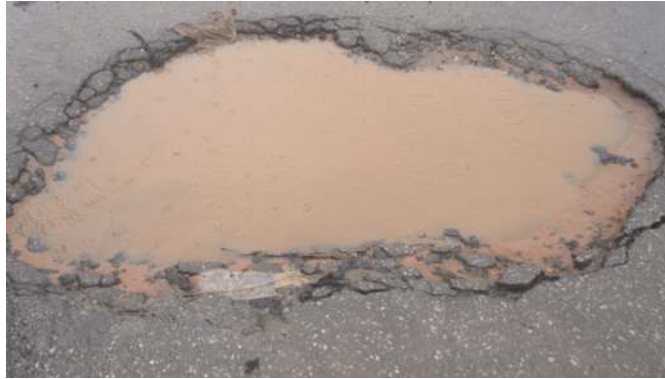
**Figure 3.**  
*Showing how water aids road failure.*

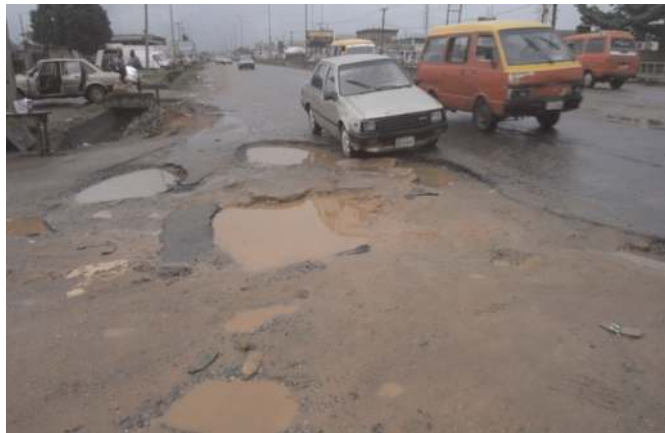
**Figure 4.**  
*Showing how water aids road failure.*

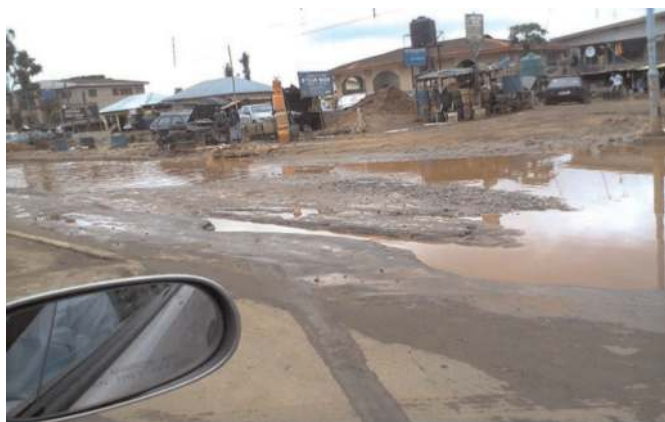
**Figure 5.**  
*Showing how failed portion of roads affects or increase journey time.*
