Chapter

Implications of Land Use and Cover Changes on Upper River Rwizi Macro-Watershed Health in South Western Uganda

Abstract

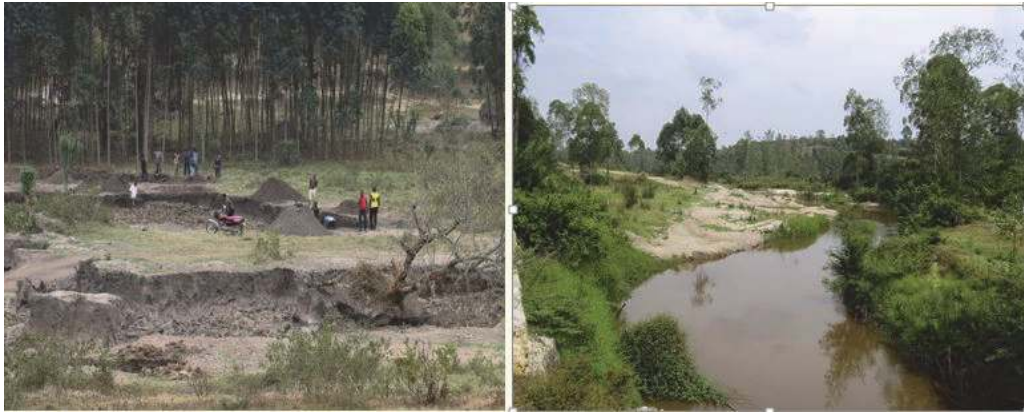
Figure 10.
Sand mining close to river Rwizi near Mbarara City and Rwizi's buffer zone in Nyakayojo. Photo credit, Nseka, December 2020.

Due to rapid urban development in the region, there has been an increase in demand for construction materials including sand and bricks. In order to meet the demand for construction materials, local communities have embarked on sand mining (**Figure 10**) and brick making (**Figure 11**) along the riverbanks, wetlands and buffer zones.

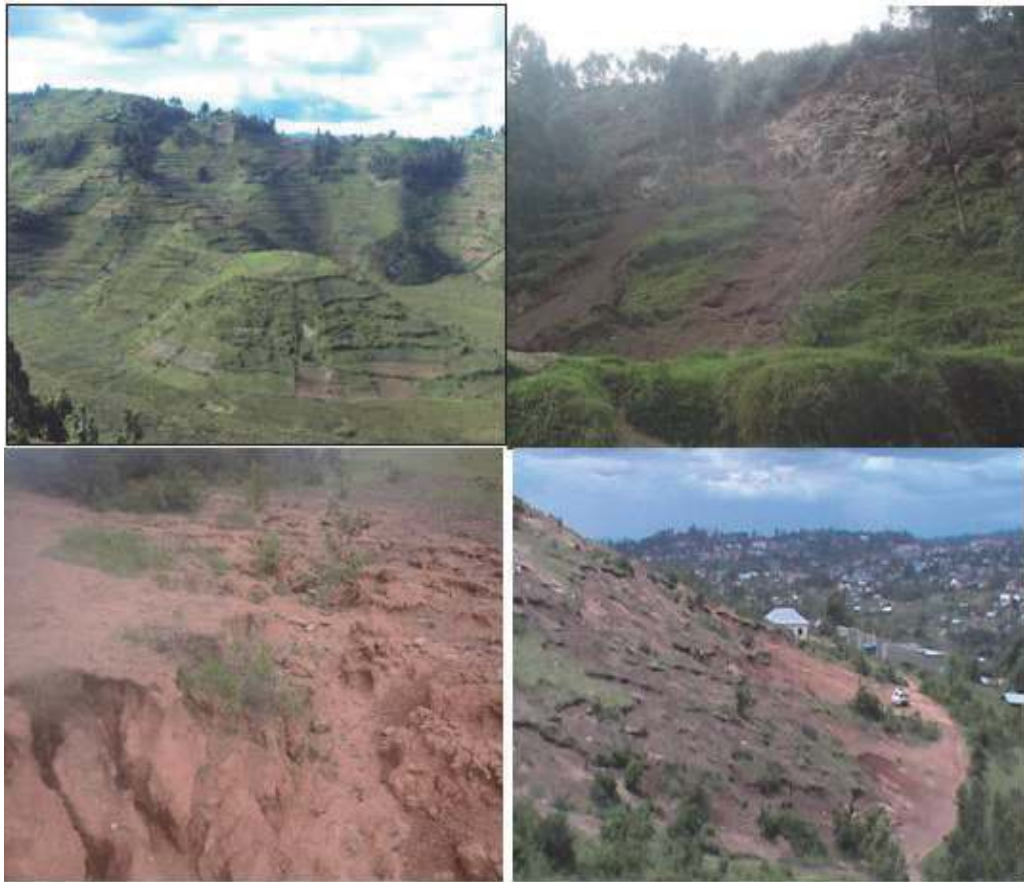
Figure 12.
Intensively cultivated slopes which appear to be degraded. Photo credit: Nseka, July 2020.

Changes in the land use and cover characteristics associated with increasing human activities have adversely affected the watershed properties. As already noted, there has been unprecedented conversion of natural land covers into human induced types. Following field investigations, it was established that many slopes flanking the river valley appear to be intensively cultivated leading to the emergence of many bare surfaces (**Figure 12**). Increased farming activities have affected

hillslope hydrological properties. This has resulted into increased runoff due to reduced infiltration as evidenced by many gullies and other erosion features on the landscape (**Figure 12**).

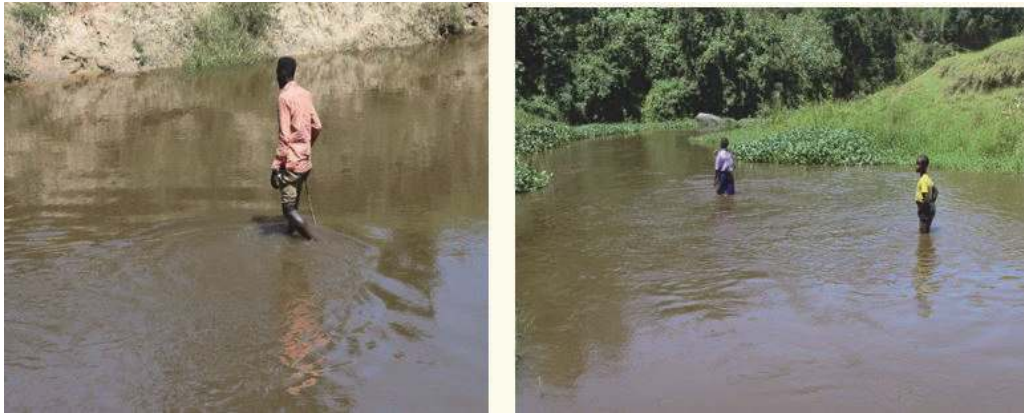
Figure 14. Shallow section of the river channel where local communities cross without bridges. Photo credit, Ayesiga, September 2020.

(**Figure 15**). Communities living in the watershed revealed that memories of the river with its ample clean water, thick vegetation, wild animals and birds are quickly fading. A close observation of the river channel indicates higher levels of turbidity, with the channel water turning to brown (**Figures 14–16**).

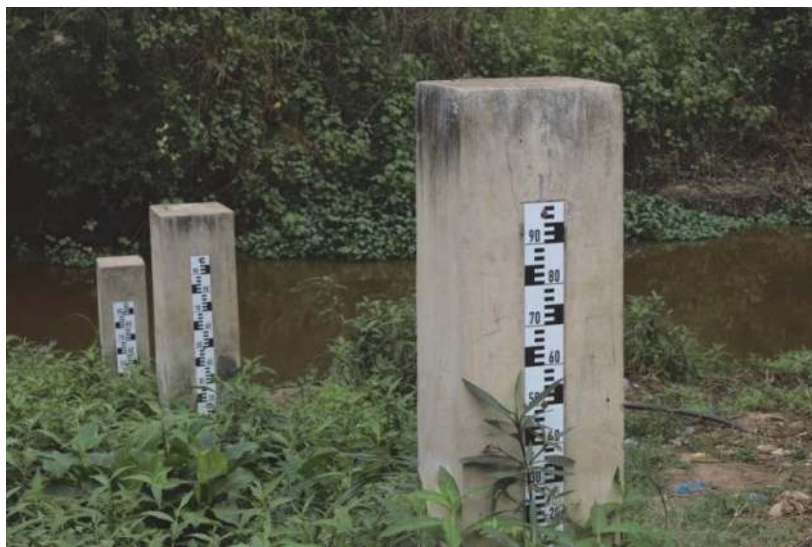
Figure 15. The river’s water flow gauging station near Nyamitanga in Mbarara town has been rendered useless. Photo credit, Ayesiga patience, October 2020.

coming years if nothing is done to save it. During interactions with local communities, it was further reported that “the formerly wider river is narrowing”. Sometimes, during the dry season, since there is hardly any water flowing from the hills, the water levels reduce into a small stream and, if one is not keen enough, they would think it is not a major river. Local communities indicated that sand mining and brick making along the riverbanks and its buffer zone have almost changed its course. Farming and sand mining are among the most destructive activities choking river Rwizi to extinction. Due to increased human activities along the river valley, compounded with wetland and swamp destruction, the water levels in the river channel and its tributaries have drastically reduced. This is vividly evidenced by the river’s water flow gauging station that is no longer used to monitor flow dynamics (**Figure 15**).

Following field investigations as well as interaction with local communities and key informants, it was established that the water levels of river Rwizi has dwindled by two and a half meters from the highest level where it used to be as indicated by the original gauging pillars at Nyamitanga which were established in 1970

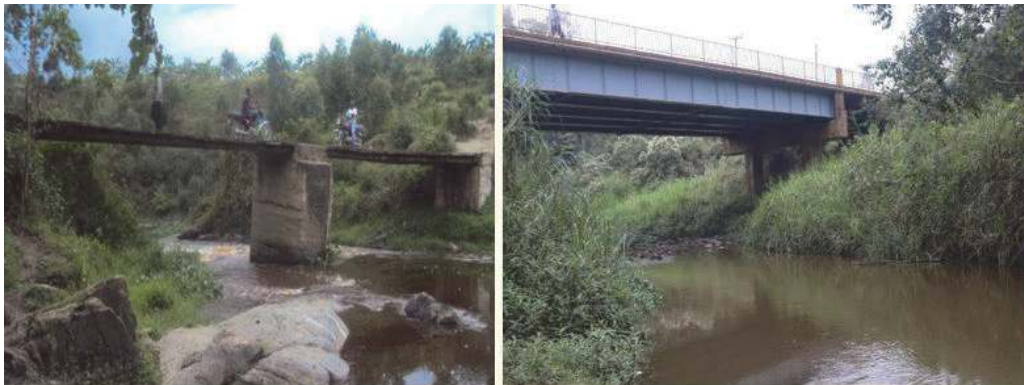
Figure 16.
Dropped water levels along sections of the river Rwizi. Photo credit, Ayesiga patience, December, 2020.

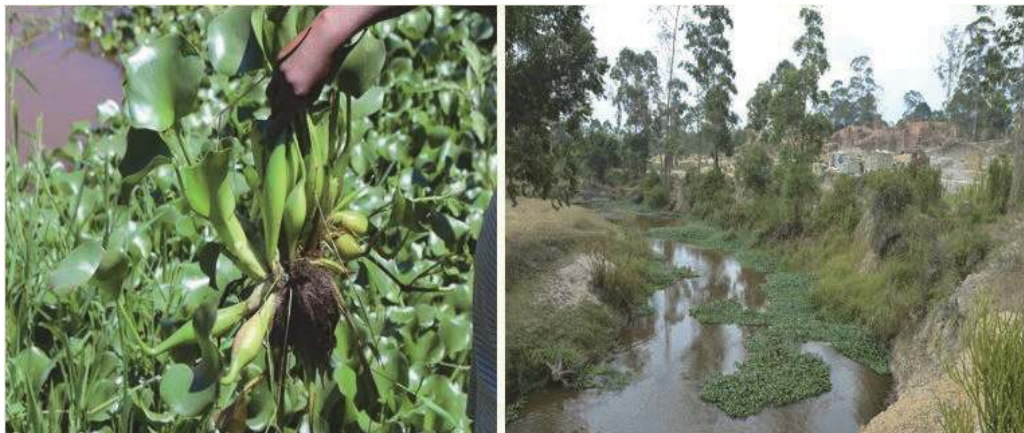
Figure 17.
Sections of the river invaded and covered by water hyacinth near Mbarara City. Photo credit, Nseka, December 2020.

Due to continuous watershed degradation, many sections of the river channel have been invaded by the waterweed (**Figure 17**). The invasive water hyacinth has congested the river, right from Ndeija sub-county in Rwampara District up to Sango bay in Rakai and the problem has been exacerbated by destructive agricultural practices within the watershed.

The water hyacinth is an indicator of polluted water with many nutrients from the surrounding gardens. Following an interaction with communities, it was revealed that the river's deterioration is due to widespread illegal land grabbing along the fragile riverbanks and buffer zone.
