# SEGEDUNUM

Excavations by Charles Daniels in the Roman Fort  
at Wallsend (1975–1984)

VOLUME 1: The Structural Remains

Alan Rushworth and Alexandra Croom

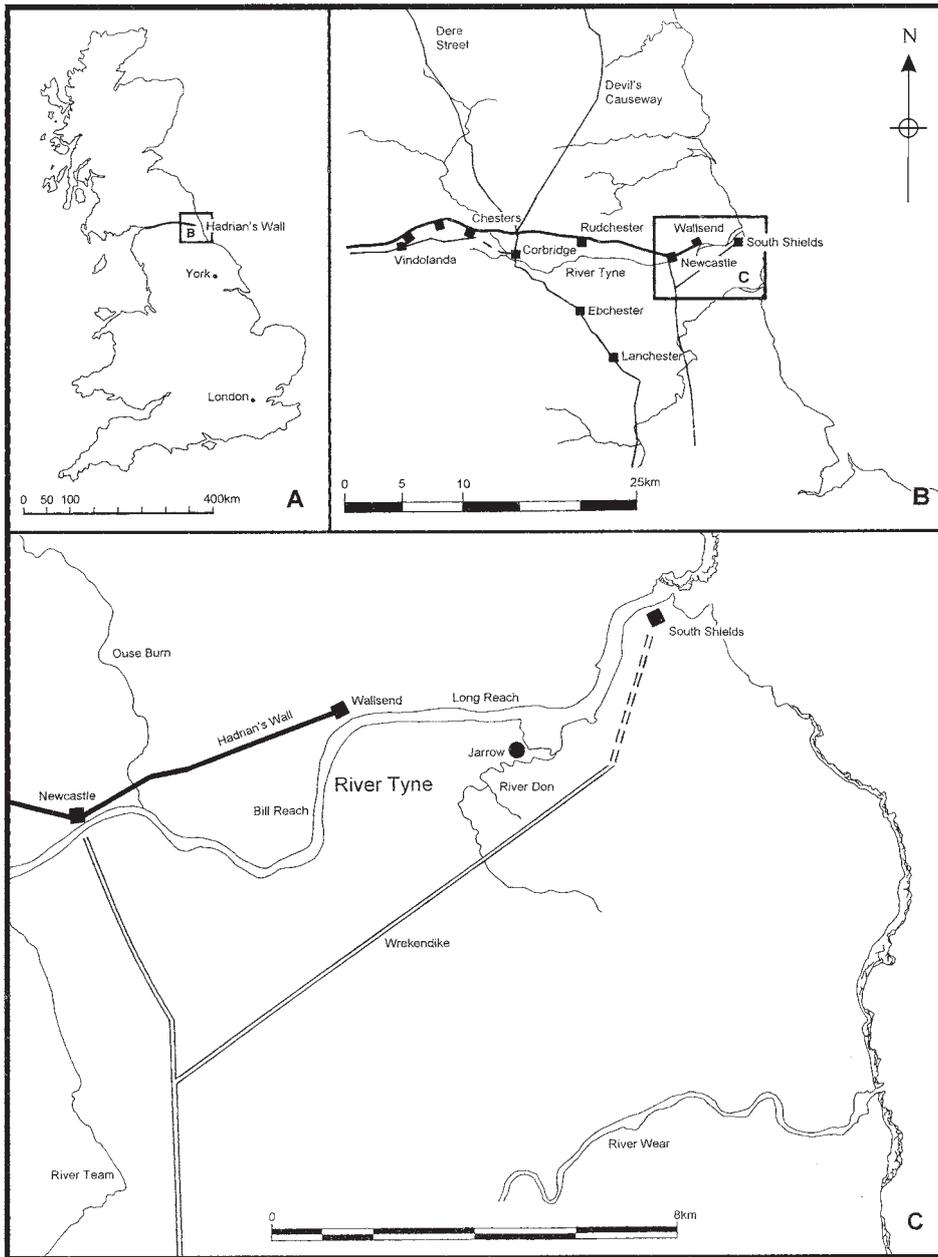
Figure 1.01: The location of Wallsend fort (taken from Hodgson 2003, fig. 7, with kind permission).

The Roman fort of Segedunum stood in a strong position at the eastern terminal of Hadrian's Wall (Fig. 1.01), and indeed its Roman name is thought to mean 'Strong Fort' or 'Victory Fort' (Rivet and Smith 1981, 452–3). Its location on a spur overlooking a bend of the River Tyne provided commanding views in every direction, but particularly up and down the stretches of river to the east and south. The river was wider in antiquity (prior to the reclamation of land for shipyards as part of the Tyne Improvement works in the nineteenth century) and the ground dropped away fairly steeply from the south side of the fort

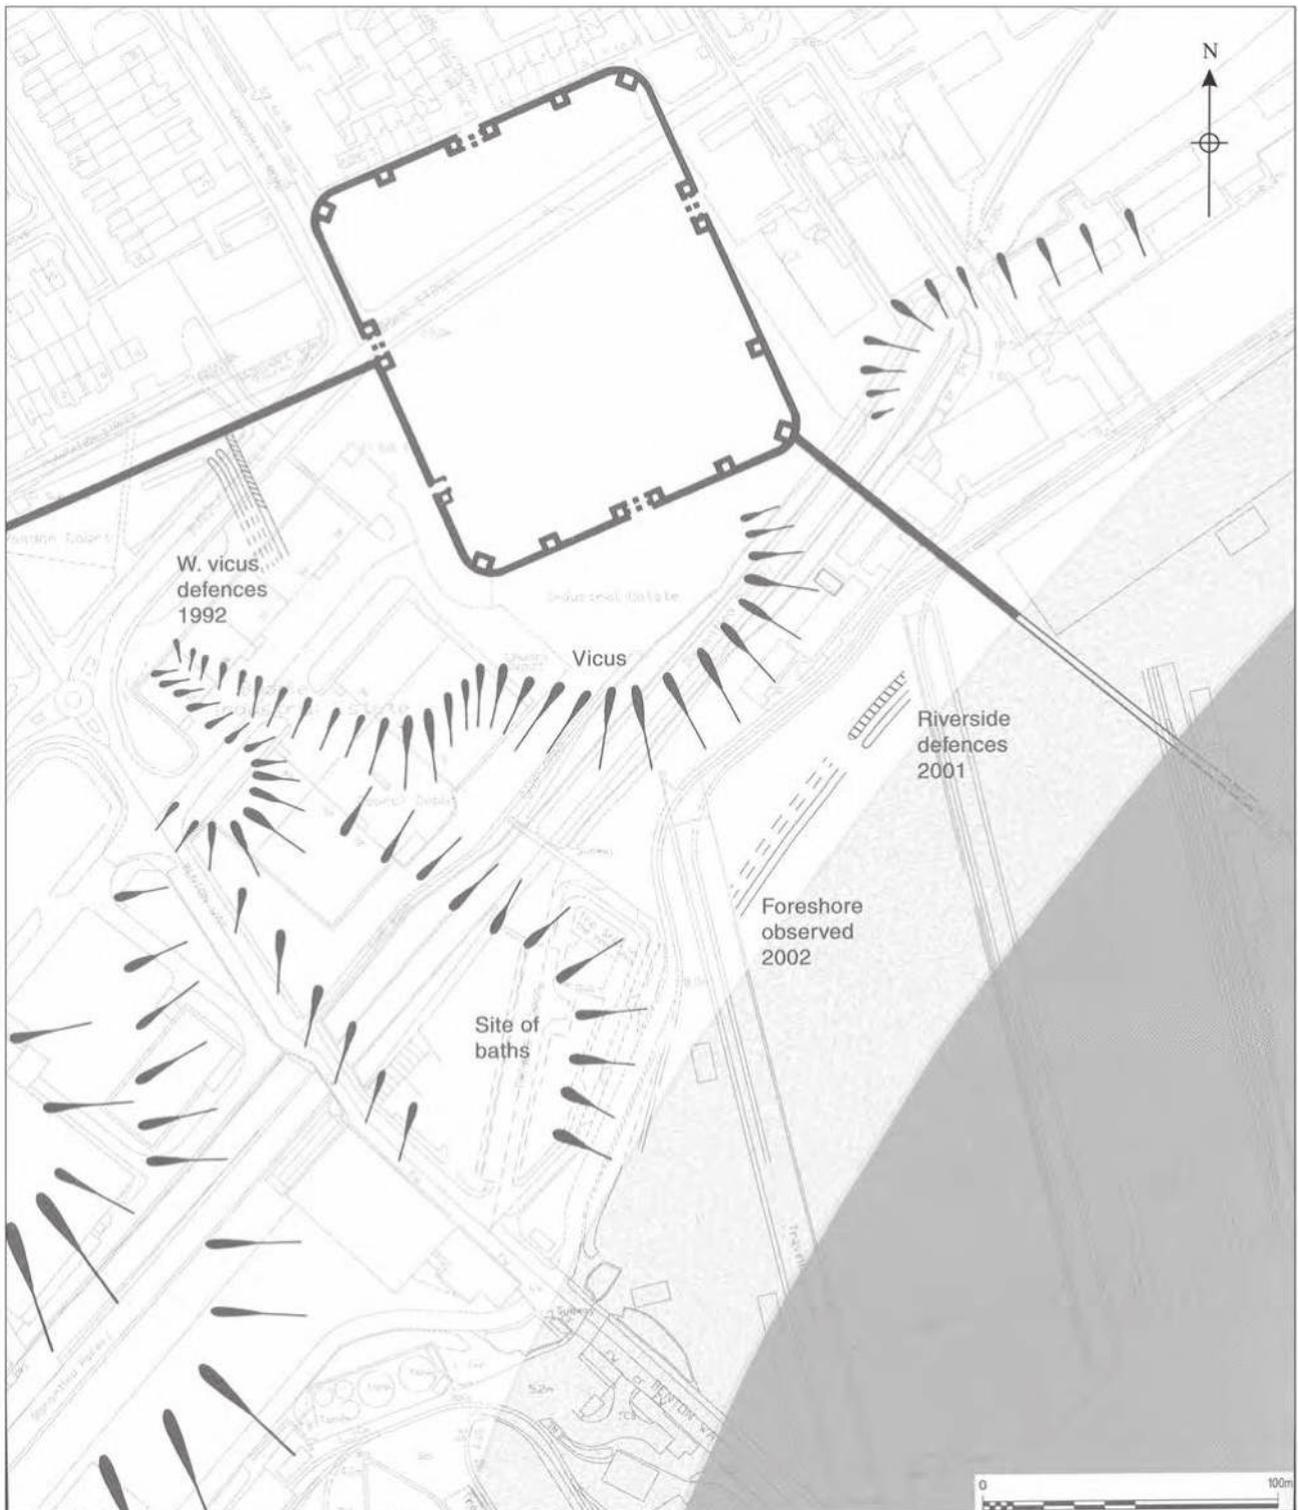
Figure 1.02: The site of Wallsend Fort (taken from Hodgson 2003, fig 8, with kind permission).

down to the river bank (Fig. 1.02).

A civil settlement extended in the angle between the Wall and the Fort, stretching down to the river-bank (Fig. 1.02). A bath-house, temple or shrine, two burials, two or three roads and a potter's kiln have so far been recorded. The eighteenth-century antiquary, Wallis, also noted the remains of a possible quay at the shore of the river (cf. Snape and Bidwell, 1994). The ultimate stretch of Hadrian's Wall running from the south-east corner of the fort down to the river was partially uncovered in 1903, whilst recent excavation of the Wall along Buddle Street to the west of the fort has revealed post holes and a ditch system, thought to be part of the *vicus* defences (Snape 1992).

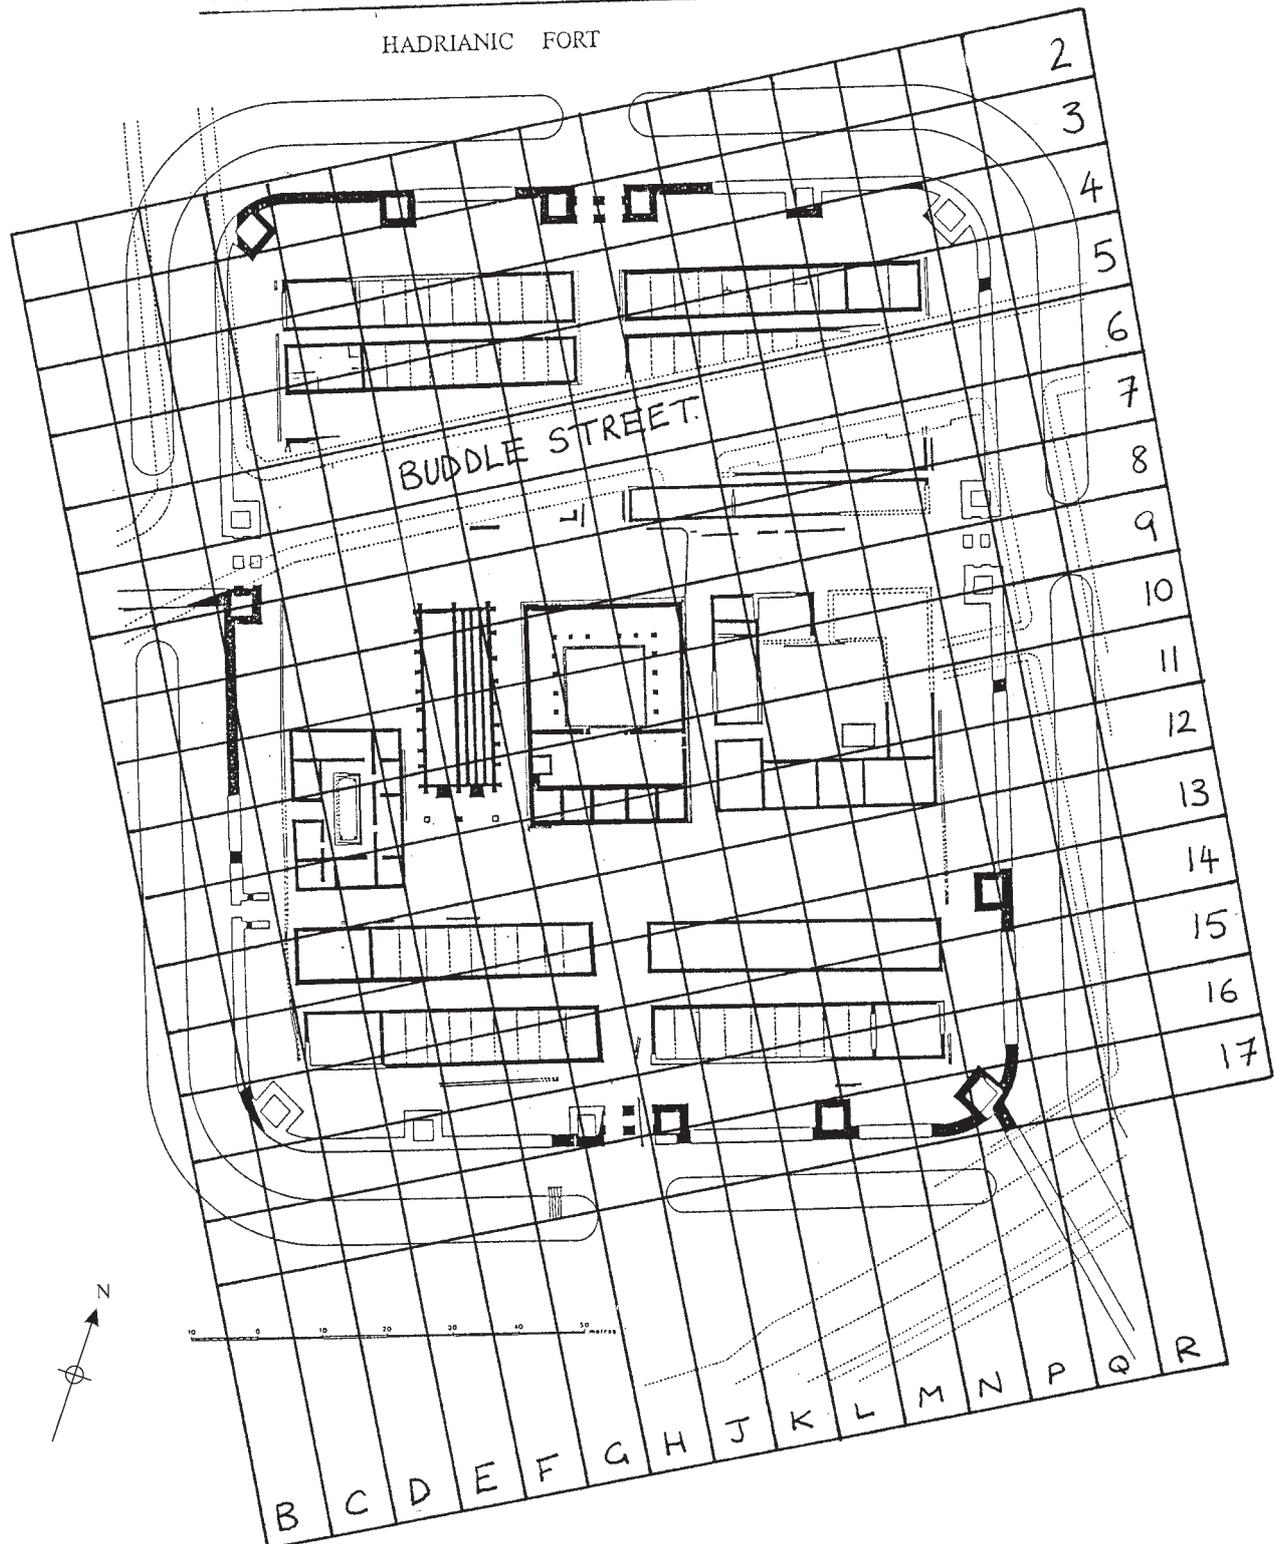
Figure 1.03: Wallsend Fort. Plan of the grid system used during the 1975–84 excavations.

The whole fort was divided up into 10 × 10 metre grids, which were ordered alphabetically and numerically, running from B–R and 2–17 (Fig. 1.03). Each grid reference provided the recording and location of contexts and features across the fort. In total 18 sites were excavated in the ten years of work at Wallsend, each site covering a number of grids (Fig. 1.04; and see Table 1.01 for a listing of the grid squares in each site).

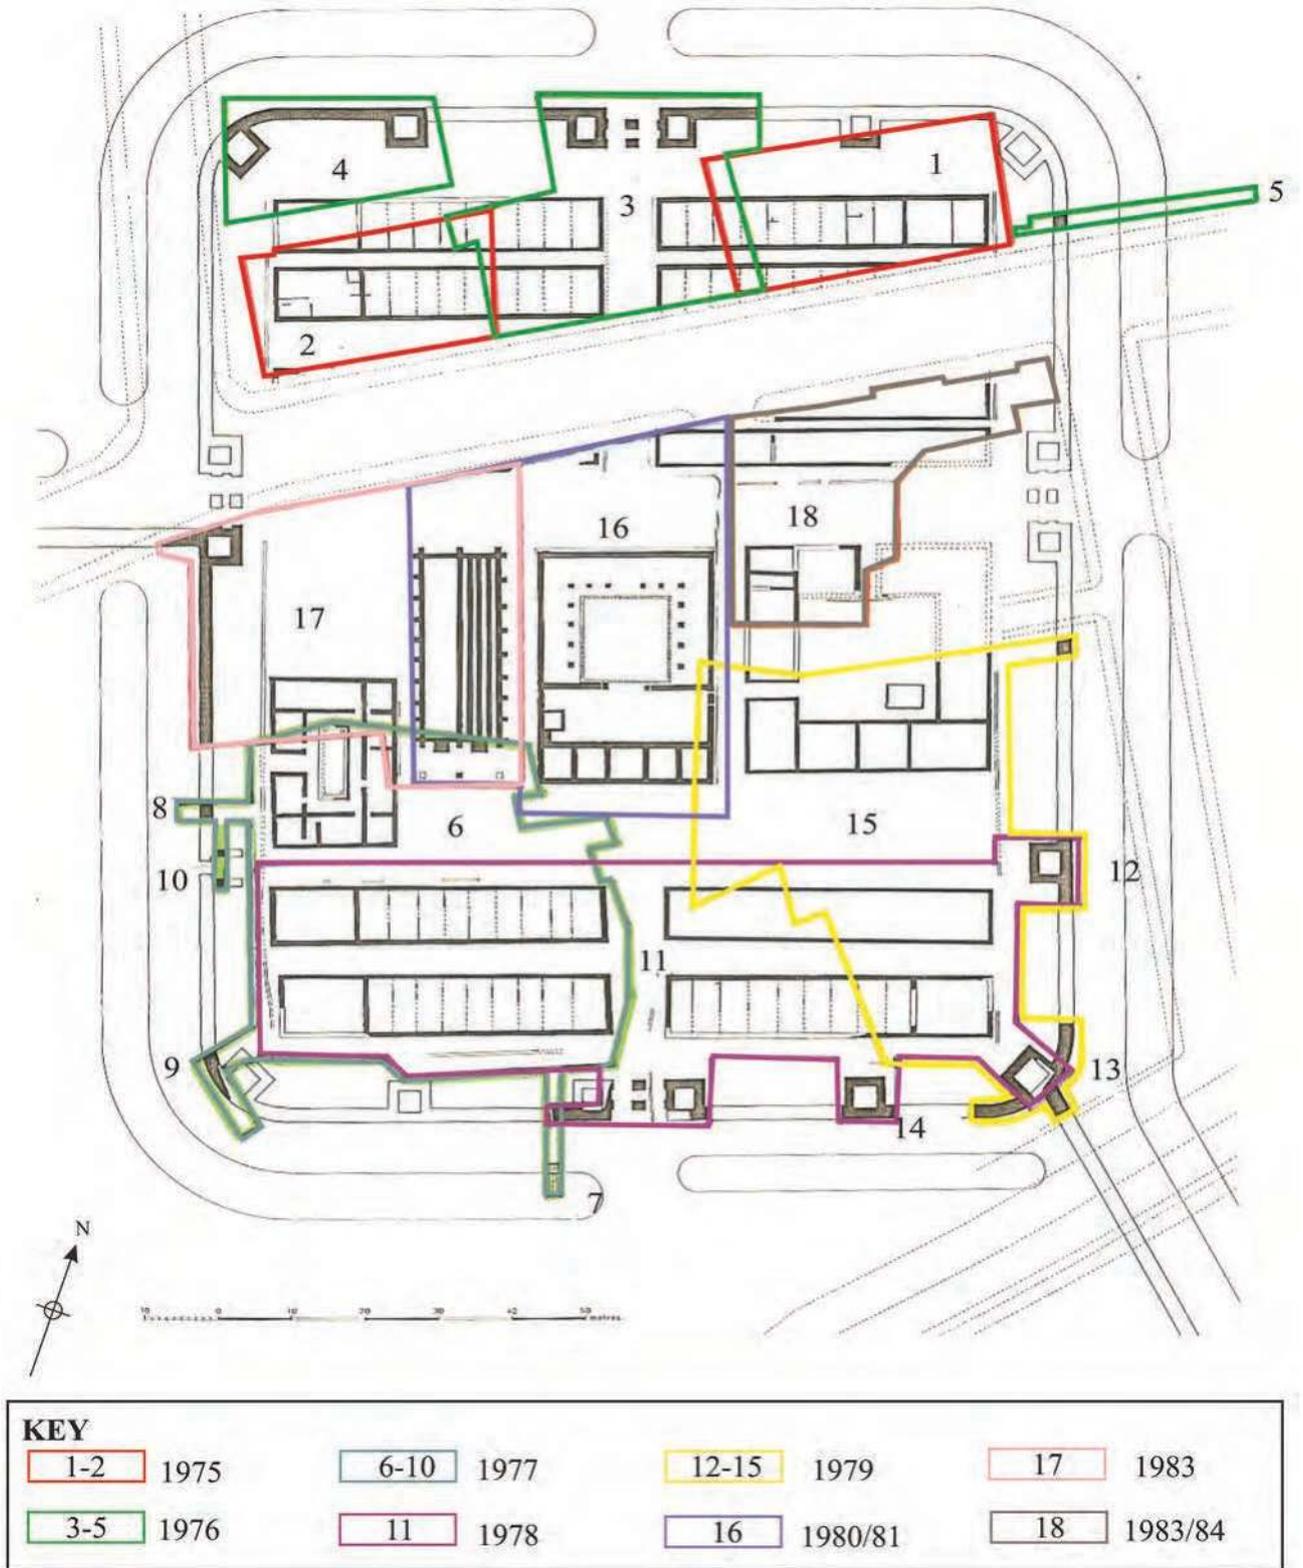
Figure 1.04: Wallsend Fort. Plan of the yearly stages and constituent site numbers of the Daniels excavations.

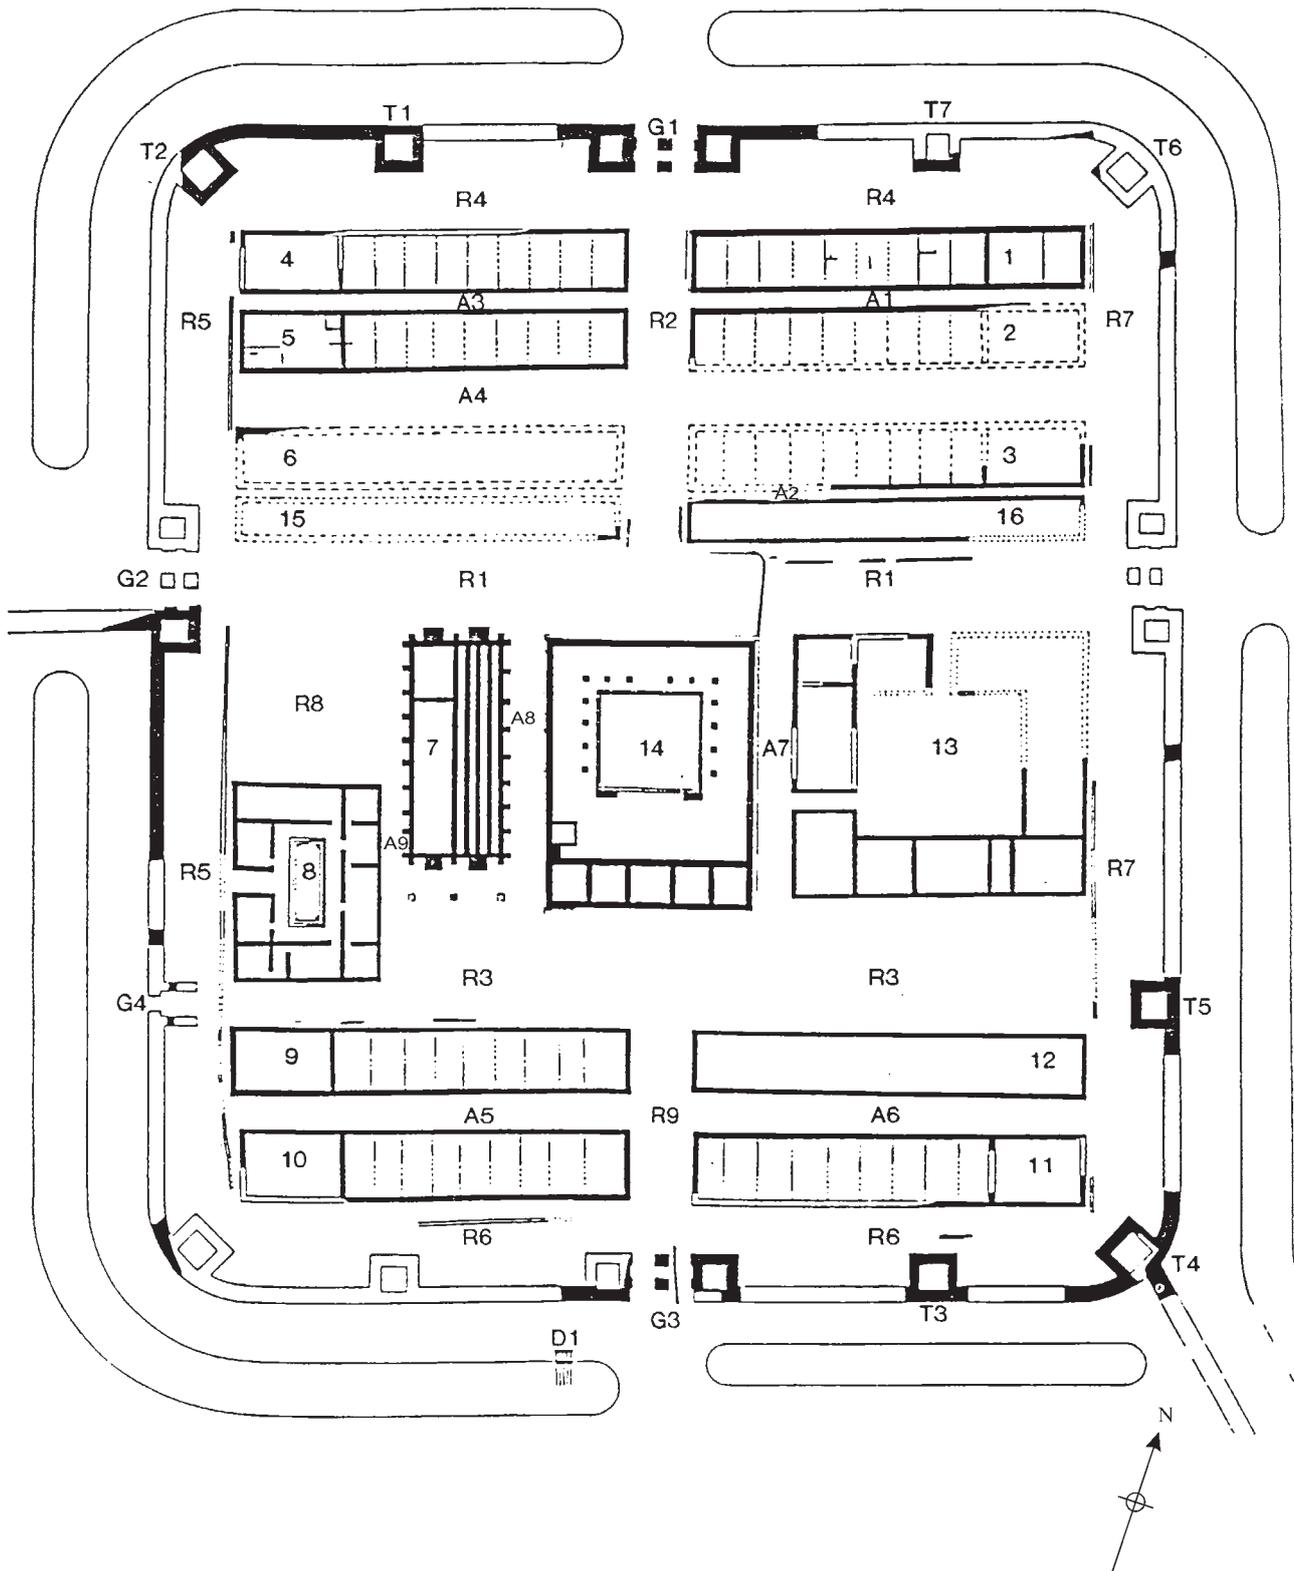
Figure 1.05: The Hadrianic fort as shown in Daniels 1989, 78, fig 39.

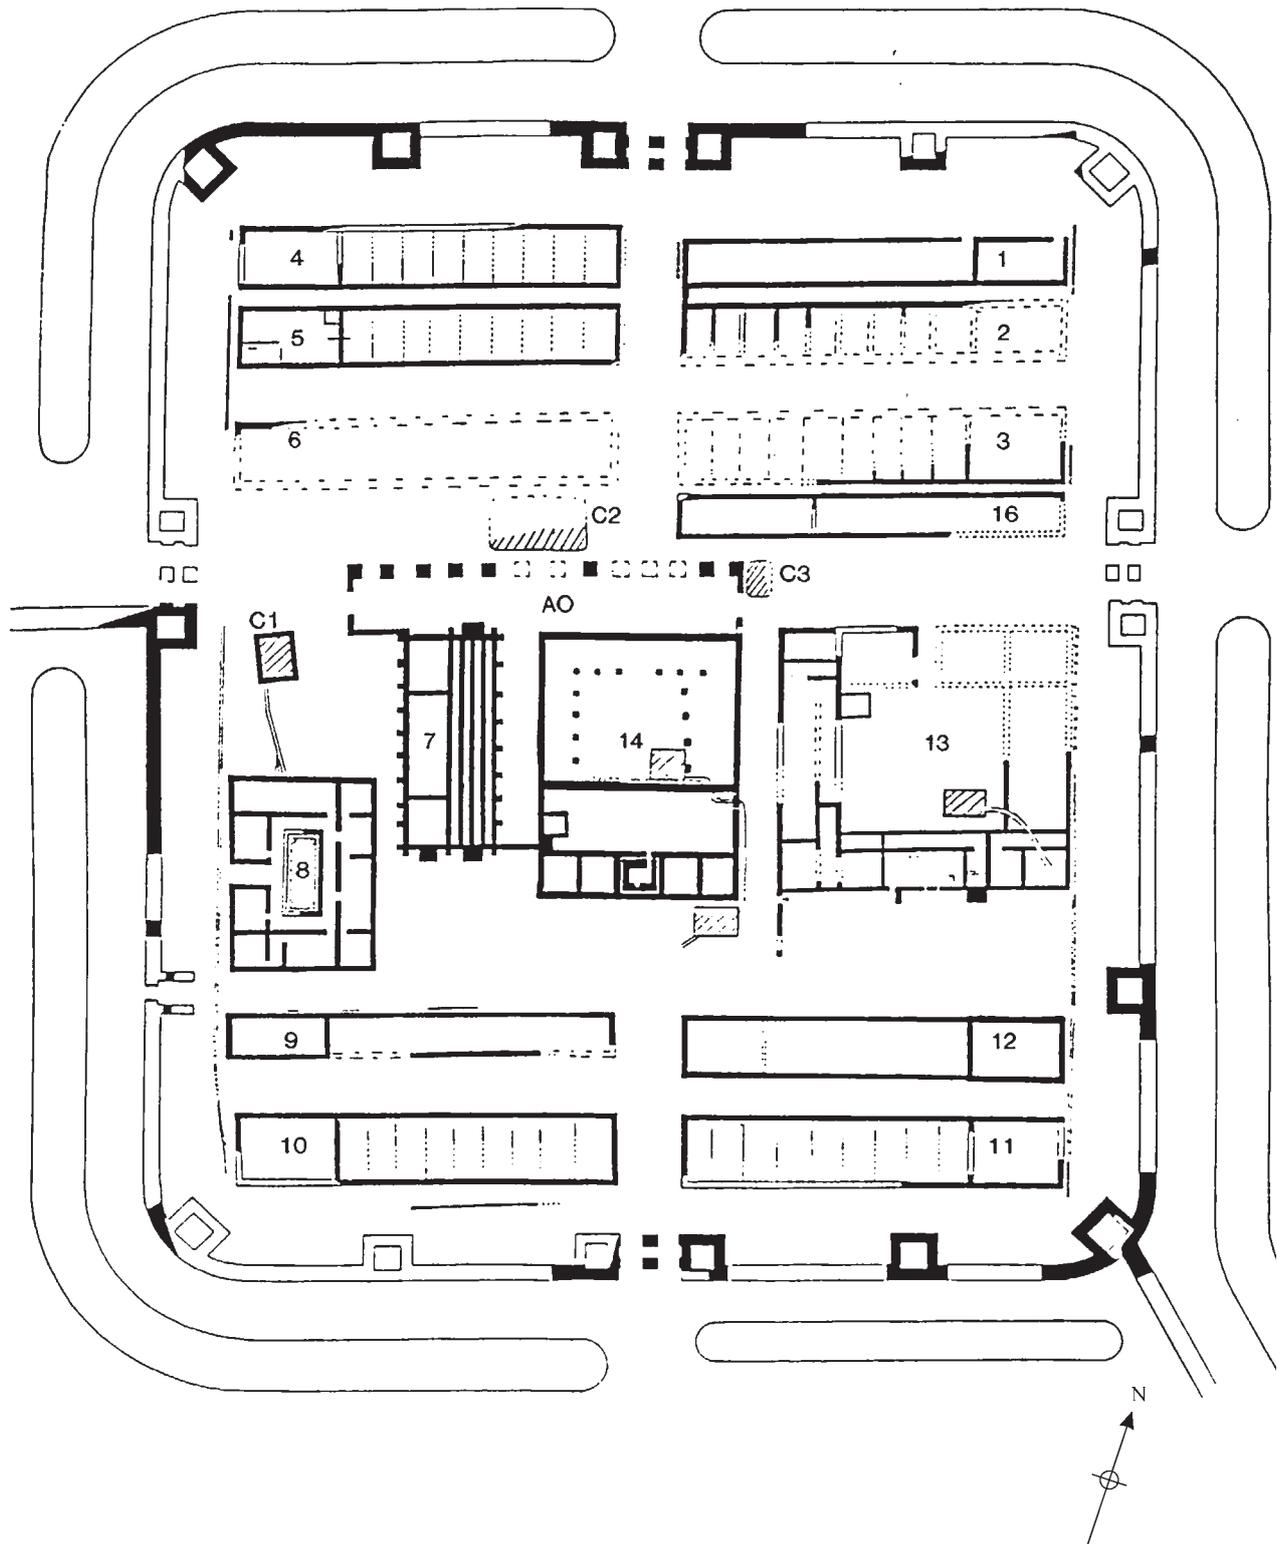
Figure 1.06: The early 3rd-century fort as shown in Daniels 1989, 80, fig 40.

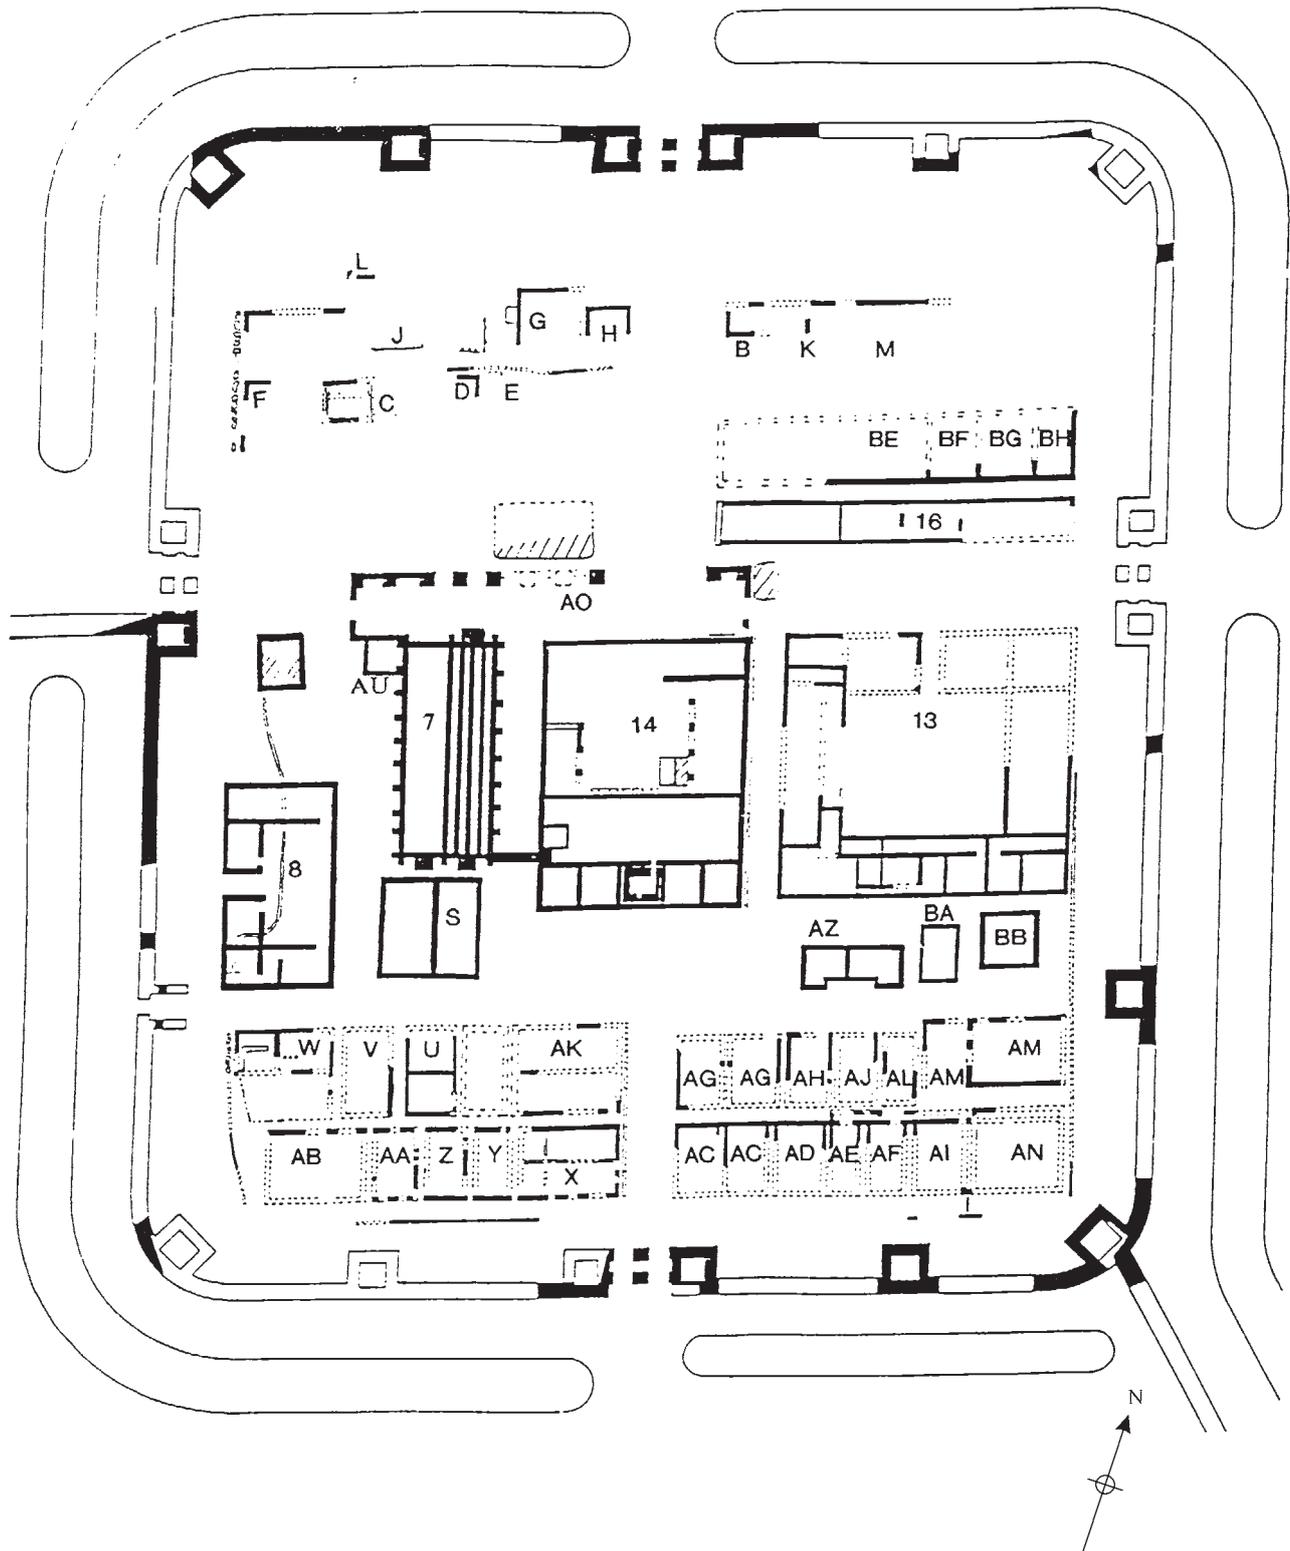
Figure 1.07: The early 4th-century fort as shown in Daniels 1989, 81, fig 41.

The excavators in 1975–6 had interpreted these alterations in a very different fashion, as constituting a distinct phase involving the demolition of most of Building 2 and the erection of three small, irregular 'shack'-like buildings over the site (See Chapter 1: Figs 1.07, 1.08). These 'shacks', labelled 'Buildings B, K and M', were thought to re-use the north wall and the former *contubernia* dividing walls of Building 2, whilst the west wall of Building 2 was demolished to the level of the lowest course and incorporated into the new road surface. Three phases in the occupation of these structures were defined by the excavators on the basis of floor types, which in turn were attributed to Periods 3 and 4 of the fort, corresponding to the early and mid-late fourth century respectively.

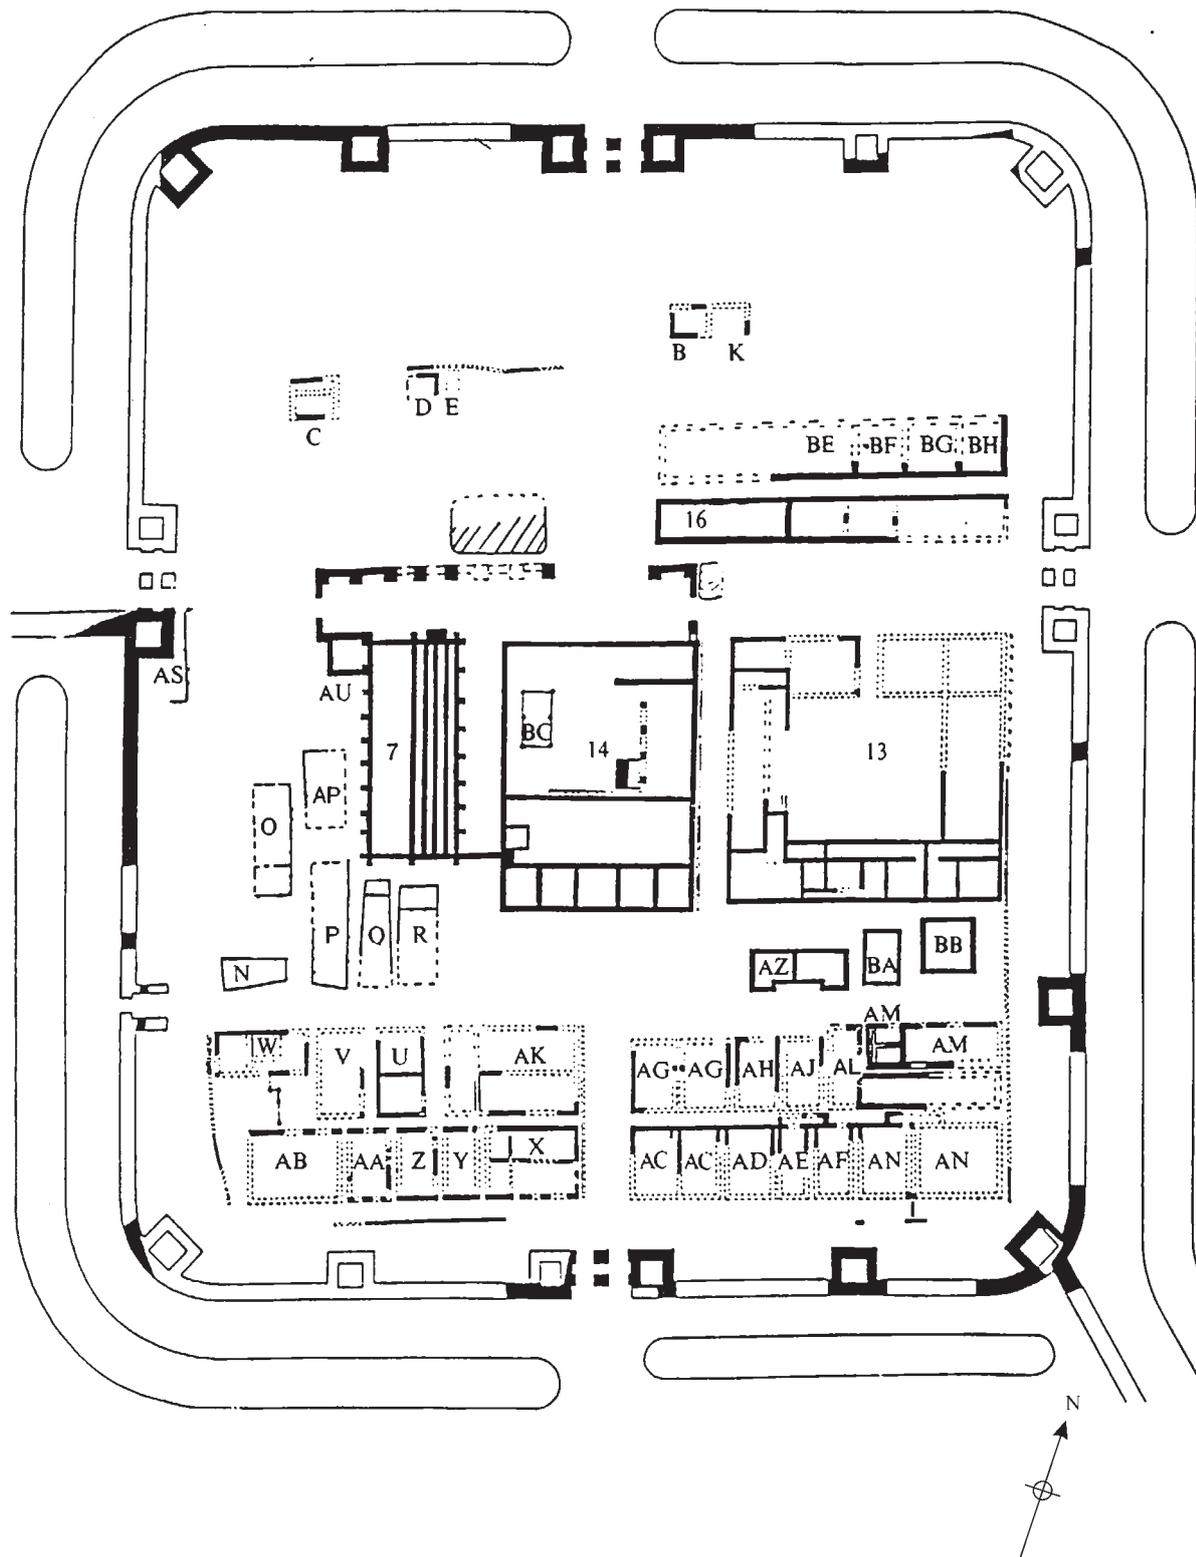
Figure 1.08: The late 4th-century fort as shown in Daniels 1989, 82, fig 42.

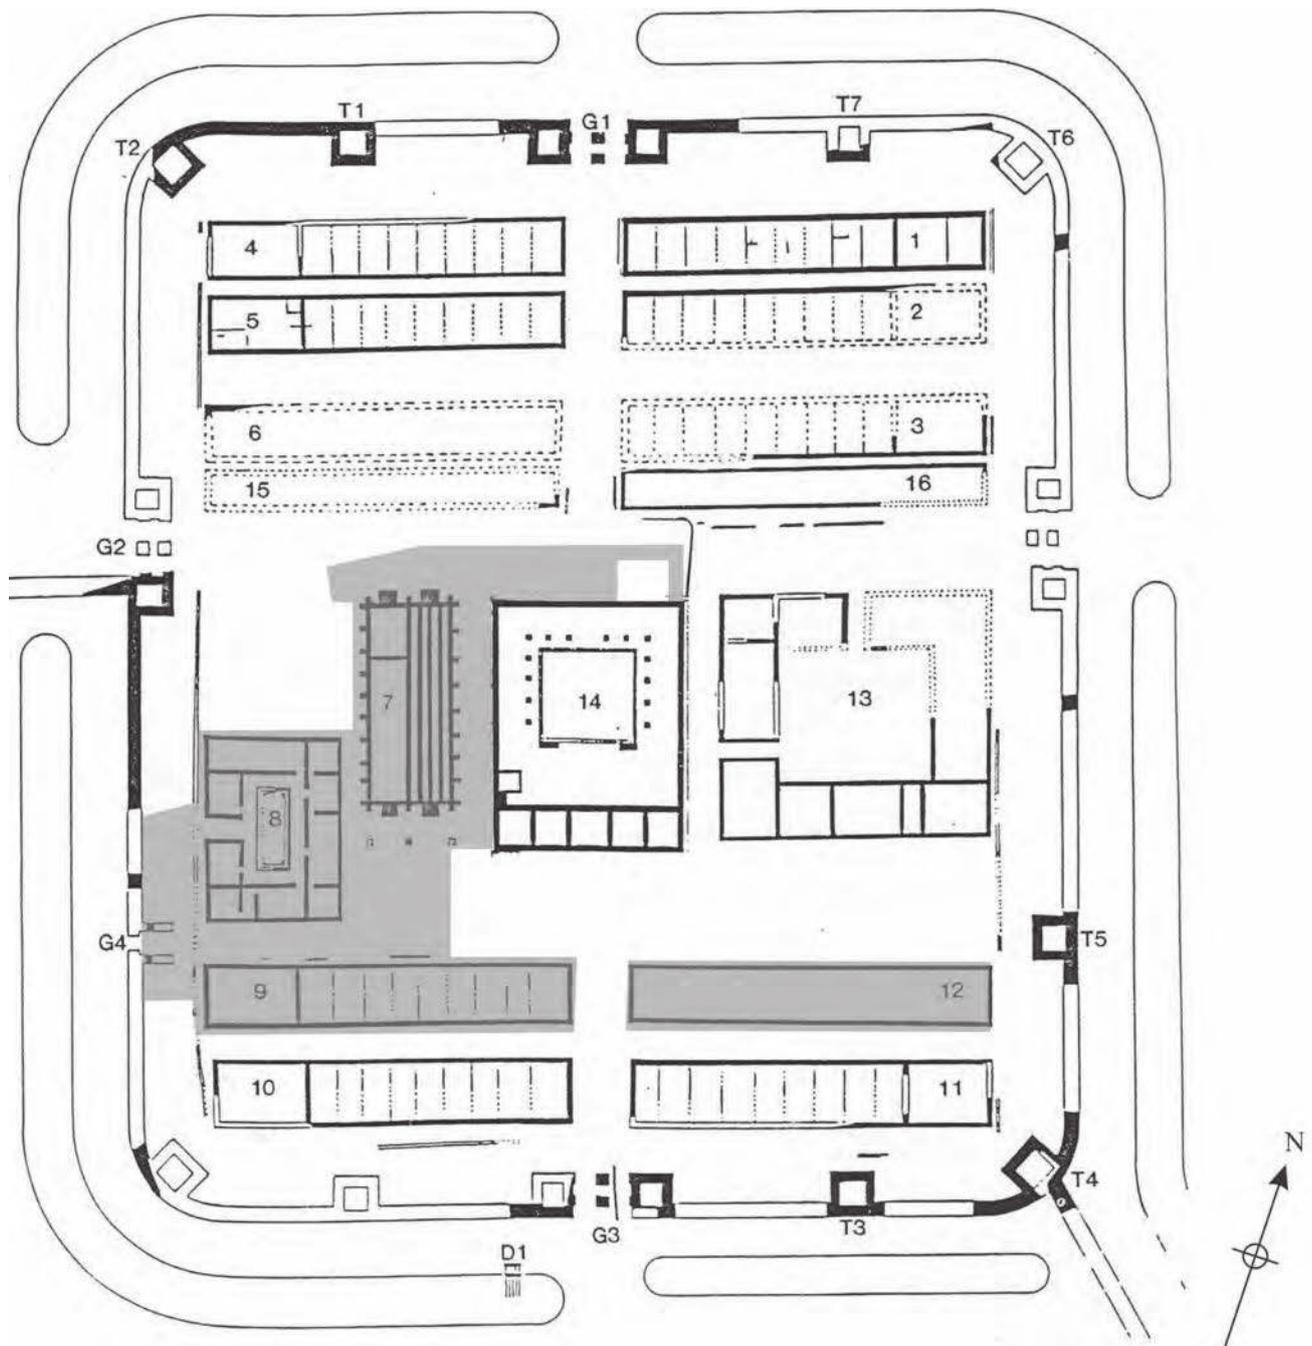
Figure 1.09: Areas of the fort re-excavated in 1997–8 (taken from Hodgson 2003, fig. 6, with kind permission).

fully exposed in 1975–84. The Project involved, *inter alia*, the re-excavation and display of the hospital, granary, forehall and Buildings 9 and 12 with their overlying chalets (Fig 1.09). The excavation results, published by Tyne and Wear Museums (Hodgson 2003), had implications far beyond these areas,

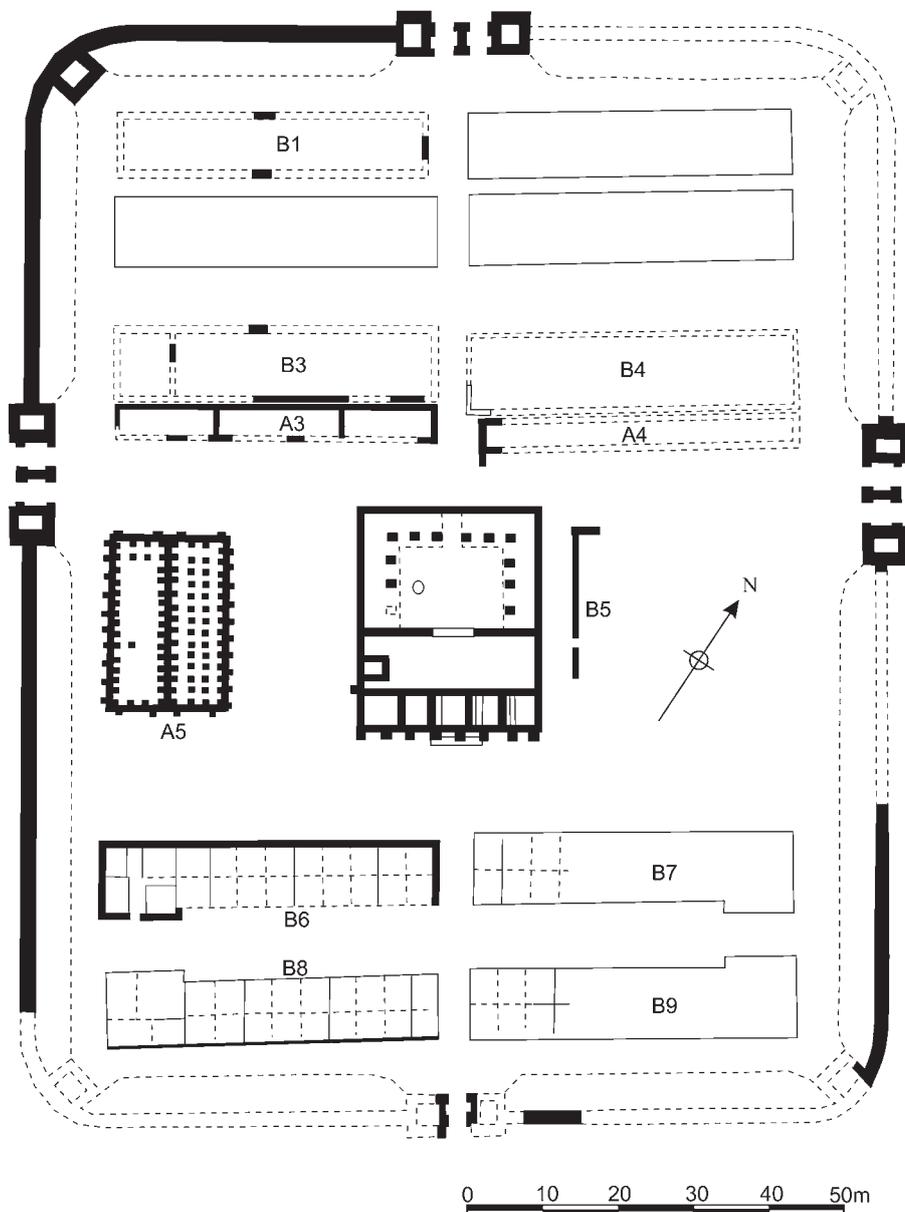
Figure 2.02: The later second-century fort at South Shields (Period 4) with barracks rebuilt in stone (after Hodgson 2009, fig 5)

The striking resemblance of the Hadrianic fort's layout to that of the mid-Antonine stone fort at South Shields has previously been highlighted by Bidwell and Speak (1994, 18; cf. Hodgson 2009, 62–63, fig 5 for most up to date outline of the South Shields Period 4 fort plan; see Fig. 2.02 here). Like Wallsend, South Shields appears to have been laid out for an equitate cohort, with definite evidence for four cavalry stable-barracks (B6–B9) in the *retentura*. These were initially constructed in timber then rebuilt in stone, as were those at Wallsend in Period 2, and correspondingly positioned. In the *praetentura* a pair of long narrow

buildings (A3 and A4), which have been identified as workshops, can be seen lining the north side of the *via principalis*, facing the central range, like 15 and 16. The more westerly of the two, A3, was subdivided into three chambers, the central one being somewhat longer than the end rooms, but too little is known of A4 to determine whether it was similarly treated. However a projecting stub wall prolonging the line of its west wall southward might imply A4 was fronted by a portico of some kind. Only three buildings (B1, B3, B4) have so far been located in the remainder of the *praetentura*, and very little is known of their internal layout, but their positioning, outline and proportions are consistent with their identification as three of the required six infantry barracks (corresponding to Buildings 4, 6 and 3 respectively at Wallsend).

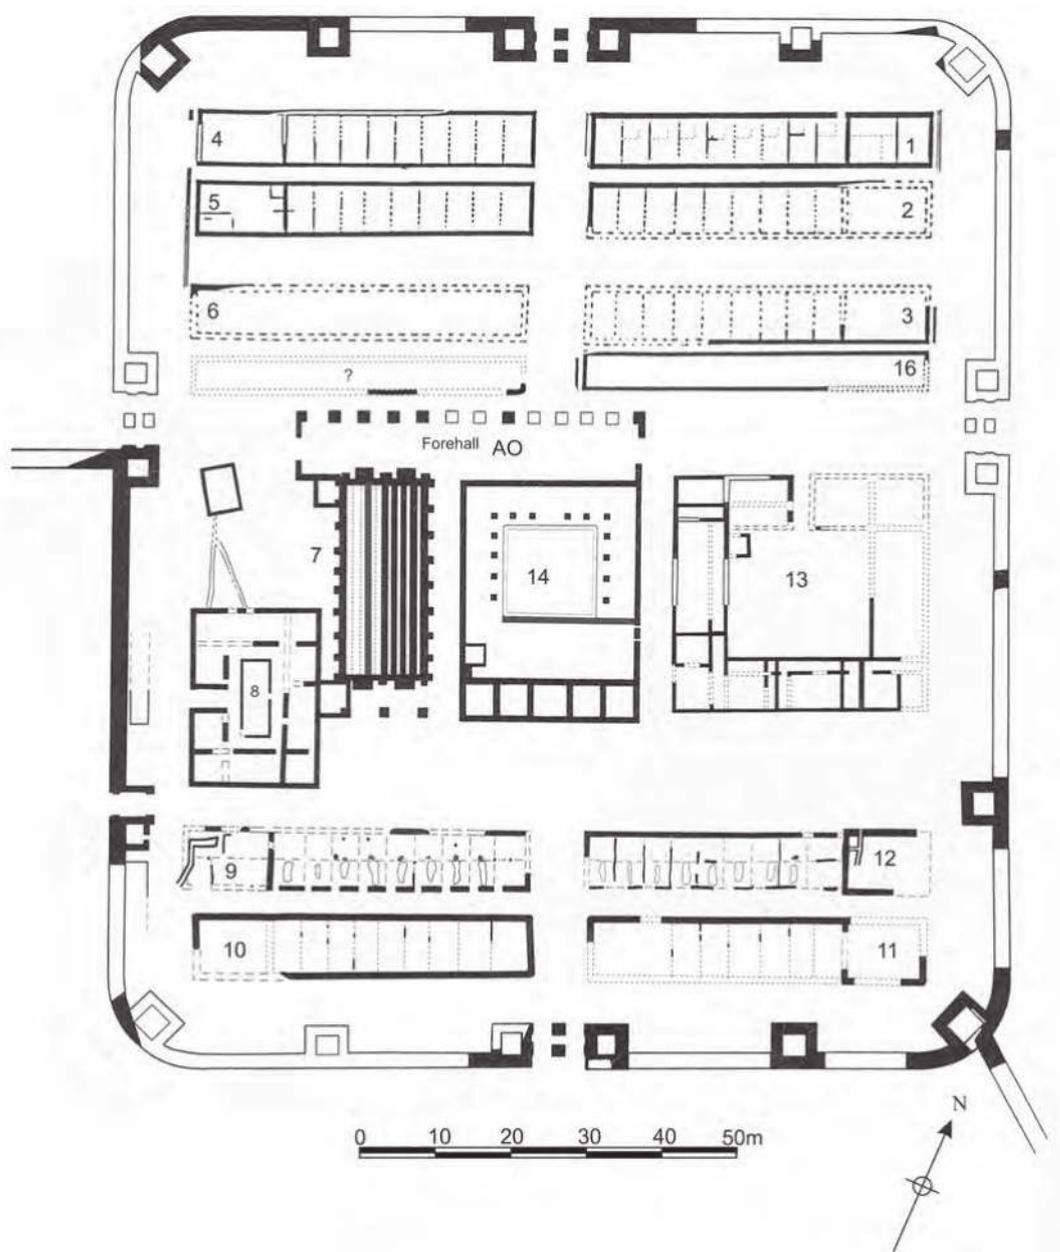
Fig. 2.03 Period 2 The mid-Antonine or later second-century fort, 0

### The central range

offices with a regimental shrine in the middle of the row in the normal manner. A definite addition of this period, extending right along the frontage of the *principia* and the neighbouring granary, and straddling the *via principalis*, was a large forehall (Daniels' Building AO). This was furnished with wide, arched entrances at the east and west ends and an arched façade along the north side supported by a row of 13 square piers and infilled by panel walls which perhaps carried window openings above. The forehall was probably roofed covering the northern approaches to both the *principia* and the granary, and its construction entailed the demolition of the granary's north portico which had been rendered redundant. The forehall would have sheltered loading and unloading of provisions at the north end of the granary and perhaps helped to control access to that building. It probably also served as a covered assembly point in front of the headquarters building where troops could be marshalled for ceremonial purposes. It did not, however, in all probability, function as a drill hall (*basilica exercitatoria*) of the kind mentioned on an inscription from Netherby (RIB 978), a role more plausibly performed by the type of structure revealed by recent excavations at Birdoswald (Wilmott 1997, 75–82, 95–8; 2001, 70–2; Wilmott *et al* 2009, 216–19; cf. Hodgson 2003, 181–2). Small square buildings, possibly associated with the administration of the granary – monitoring the receipt and disbursement of supplies to the garrison for example, were attached to the south-west (AV) and north-west (AU) corners of the granary at some point during this period. Building AU was tucked into the angle formed by the west wall of the granary and the south wall of the forehall and clearly post-dated the latter's construction.

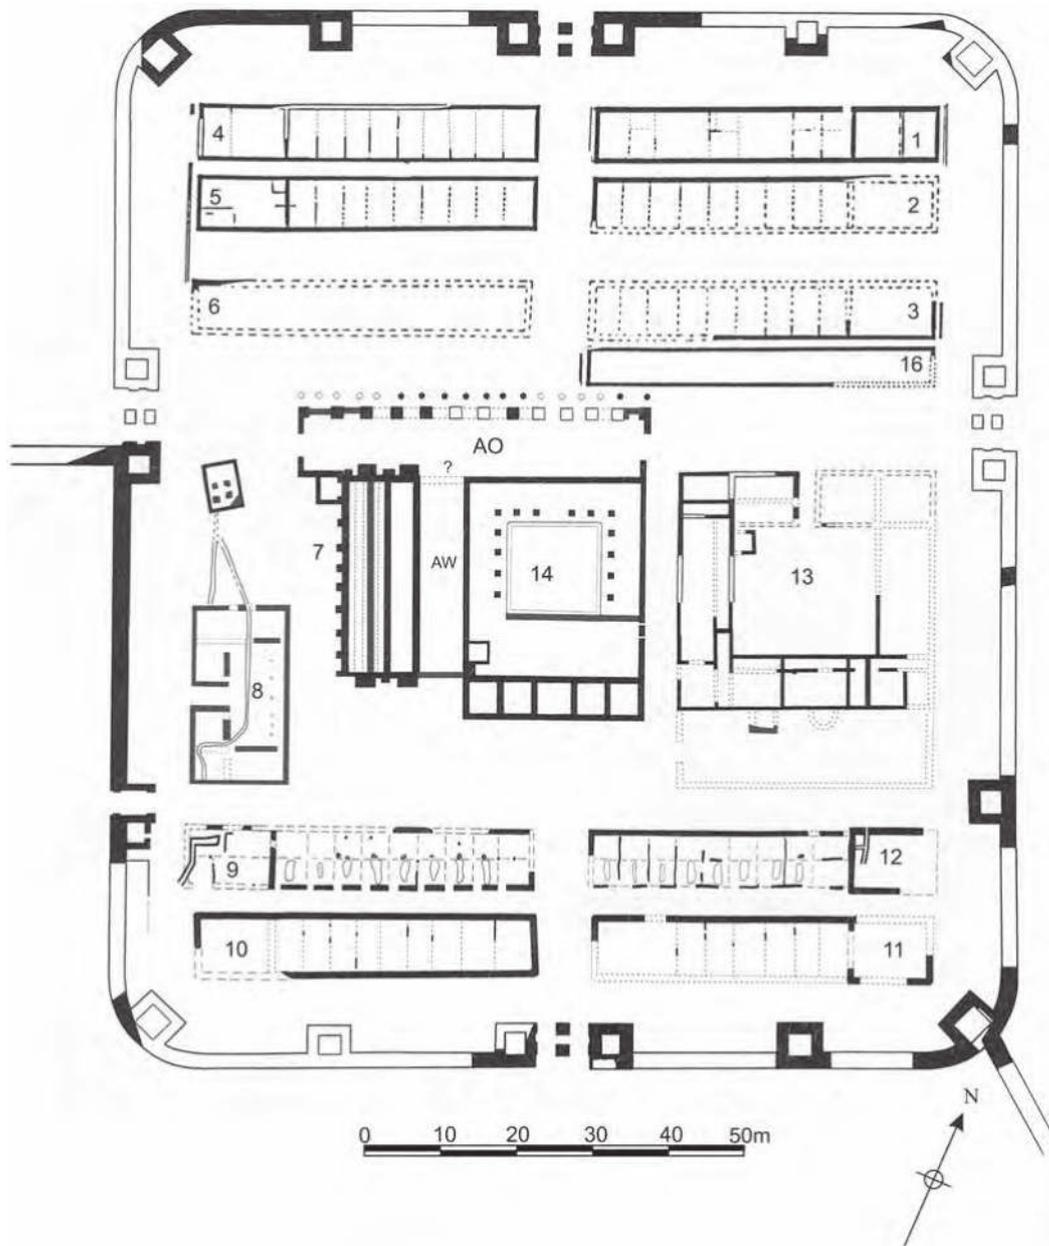
Fig. 10. Period 3. The fort in the late second/early third century.
