# SEGEDUNUM

Excavations by Charles Daniels in the Roman Fort  
at Wallsend (1975–1984)

VOLUME 1: The Structural Remains

Alan Rushworth and Alexandra Croom

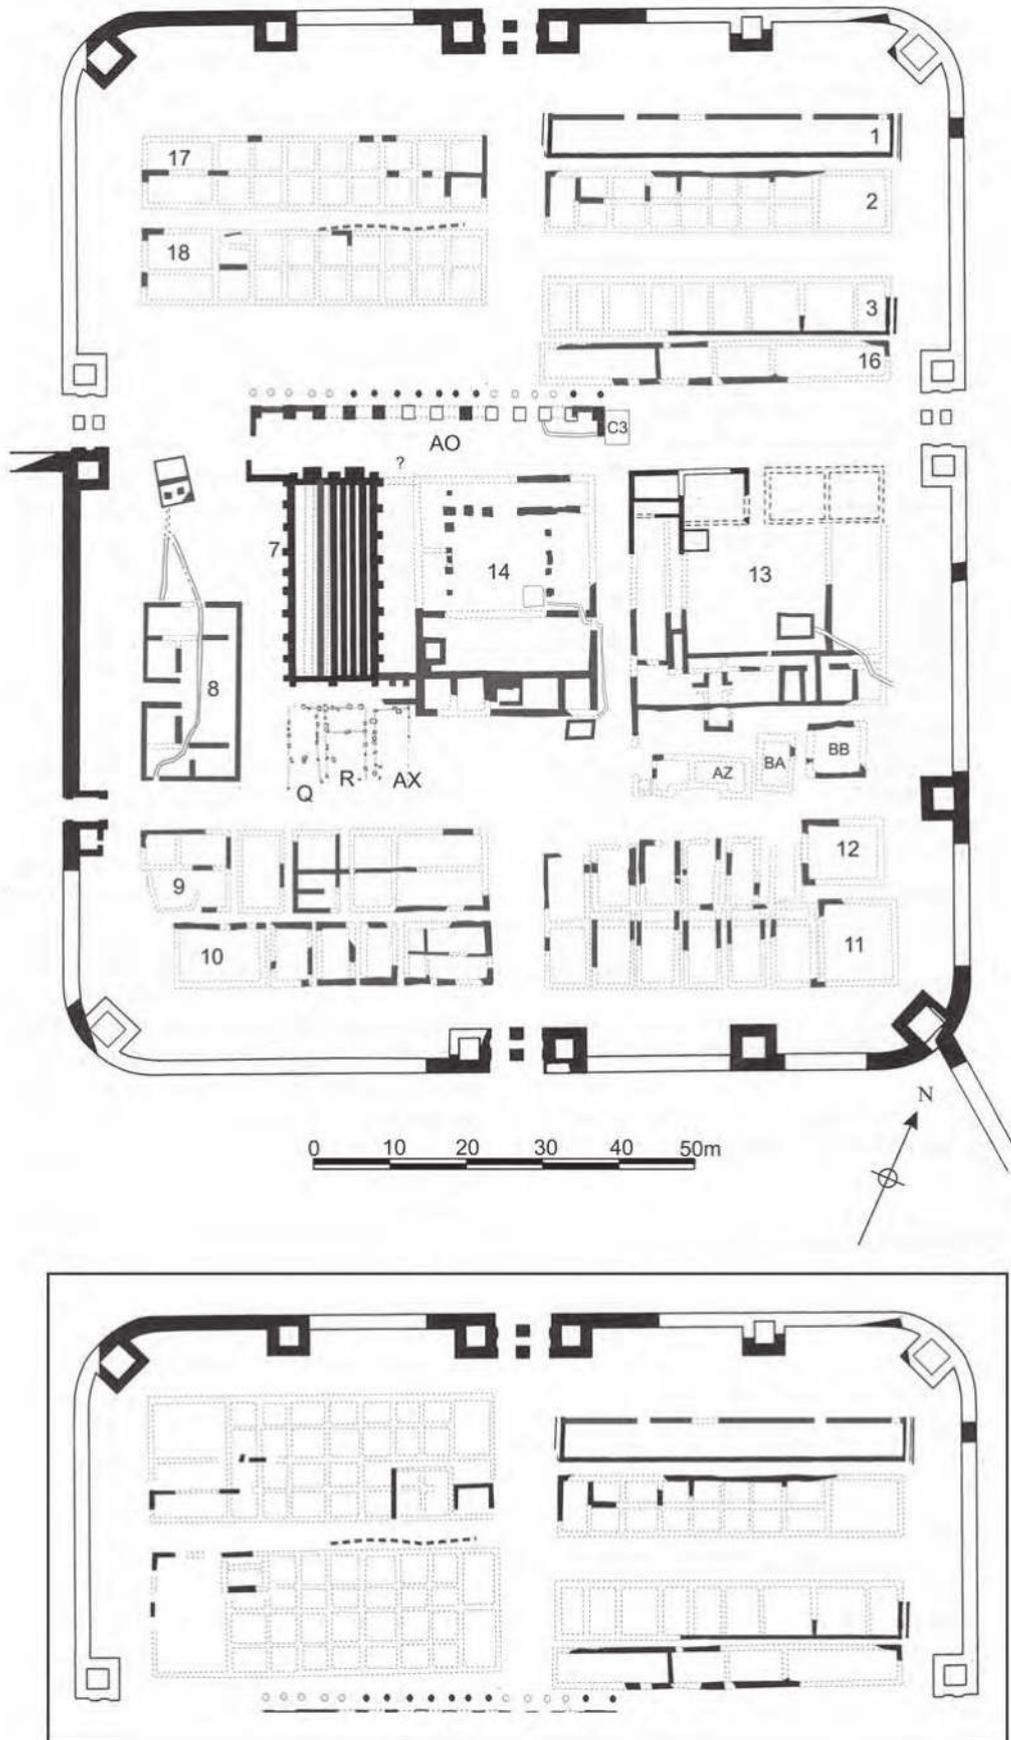
Figure 8 Period 4 The fort between ca 3 and the mid-third century with inset showing an alternative possible layout of the praetentura barracks.

Less clear was the number and overall pattern of the blocks. It does appear certain that the footprint of the new blocks was different from that of the three blocks which previously occupied this part of the fort (Buildings 4, 5 and 6). In marked contrast to the situation pertaining in the east *praetentura*, Buildings 4–6 were evidently superseded, although individual structural elements may have been incorporated in the new layout. This would imply that the number of blocks erected in west *praetentura* in the new scheme was different from that applying previously. This could conceivably reflect the need to squeeze in an extra block to make up for the shortfall in barrack accommodation resulting from the conversion of Building 1 into a stable. The only way to retain the previous number of six barrack blocks in the north part of the fort would have been to insert four in the west half of the *praetentura*, laid out in pairs of back-to-back blocks in order to fit the available space there (see Fig. 2.05 inset). Even so the most northerly block would have to encroach on the north *intervallum* road.

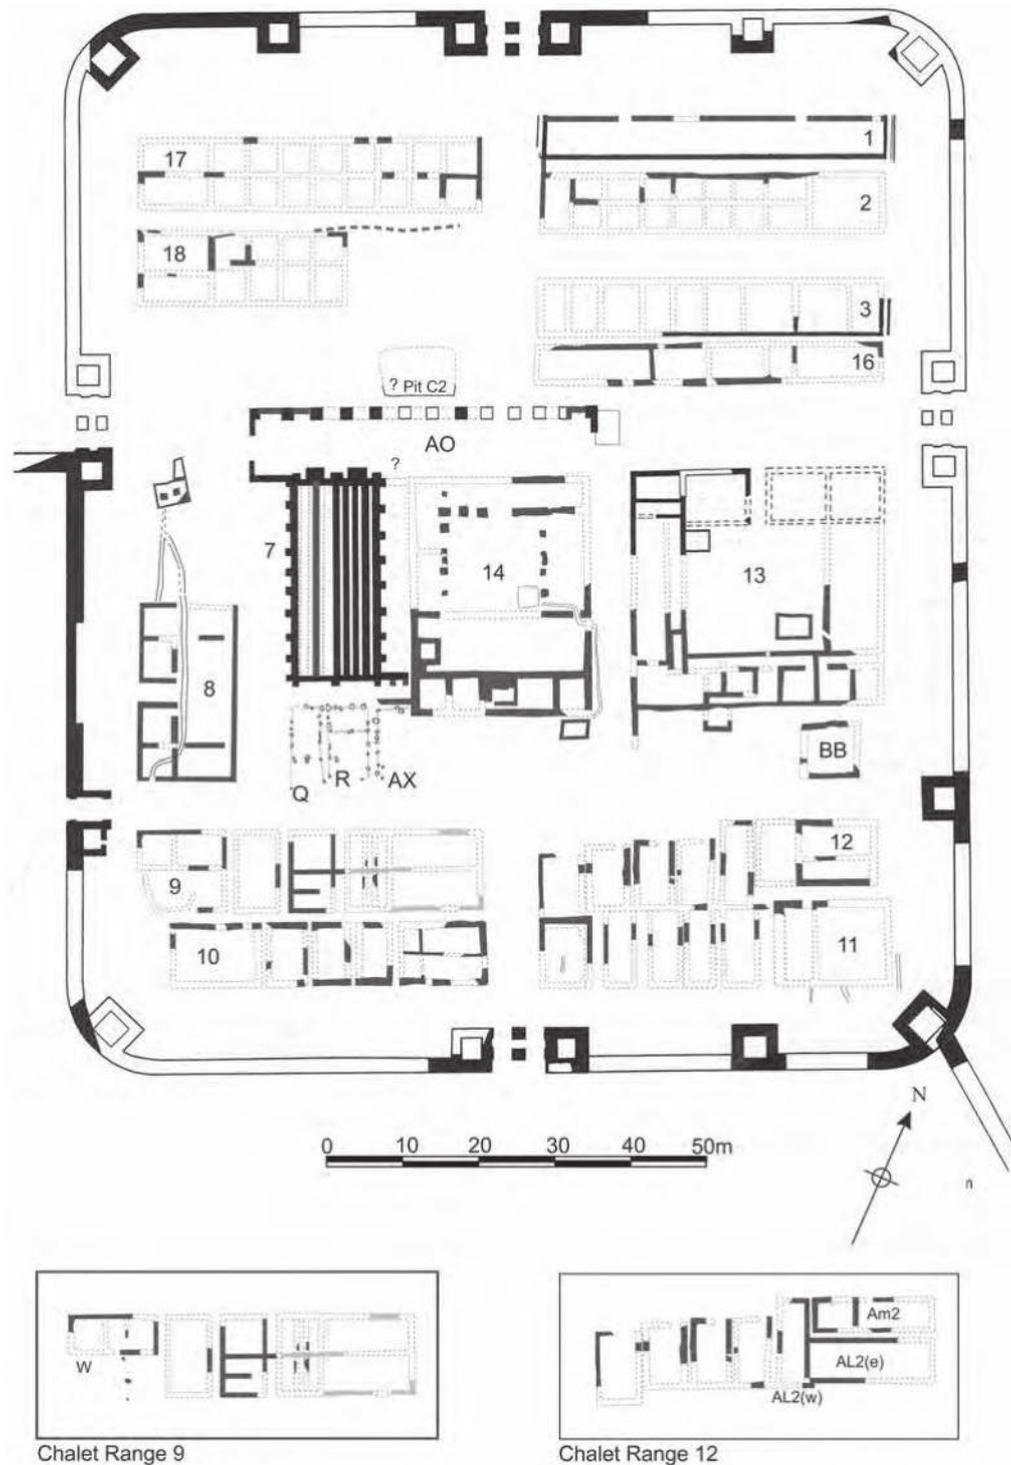
Figure 2.06: The fort in the mid- to late third century with insets showing the latest alteration to the officers quarters at the ends of Chalet Ranges 9 (W) and 12 (AL2 AM2).

#### **The mid-late third century (Fig. 2.06)**

Most of the buildings associated with the Period 4 fort probably continued in use up until the end of the third century, in one form or another, though potentially with many alterations. In the cavalry chalet-barracks in the southern part of the fort, remodelling can be glimpsed, though the pattern can rarely be plotted out in full so the implications of and reasoning behind the alterations can rarely be understood. Examples include work in the eastern half of Range 9 (over ET), which might be fragment of a fairly extensive replanning, apparent reshuffling of chalet footprints in part of Range 11 and successive alterations to the decurion's quarters at the west ends of Ranges 9 and 10 (W and AB). Indeed the officer's quarters generally appear to have been a focus for continual attention with evidence for remodelling of those associated with Ranges 11 and 12 as well (AN and AM respectively). The sequence relating to the latter, involving a series of inter-related alterations to the decurion's quarters and the adjoining chalet (AM and AL) at the east end of the range, is particularly complex and eventually resulted in wholesale replanning of this area. This is one of the rare instances where the plan is relatively complete and, although areas of uncertainty remain, it certainly serves to underline just how radical some of the chalet-barrack remodelling could be.

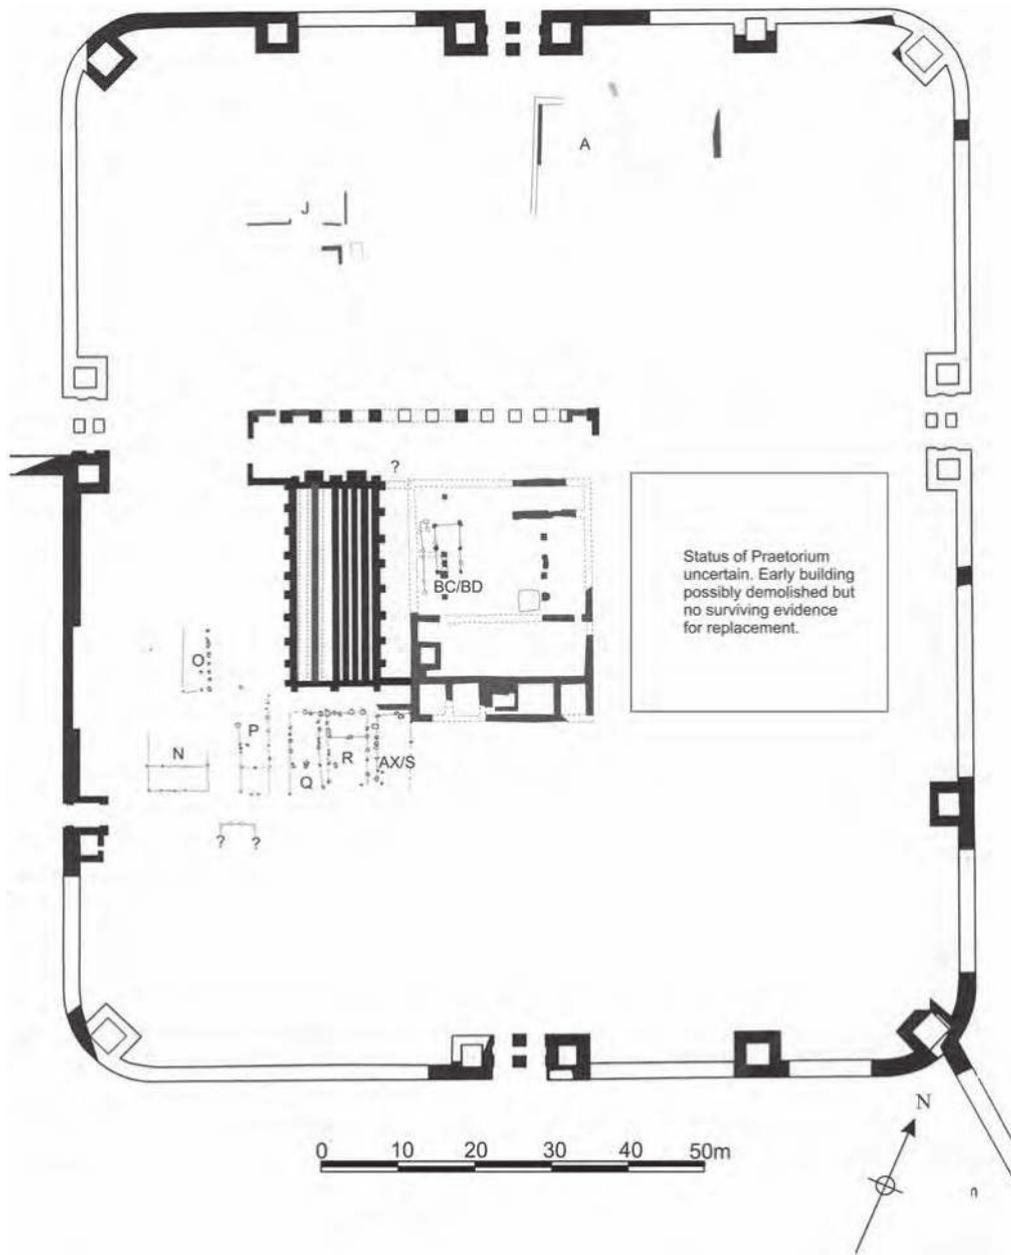
Figure 10 Surviving evidence for the fort in the fourth century

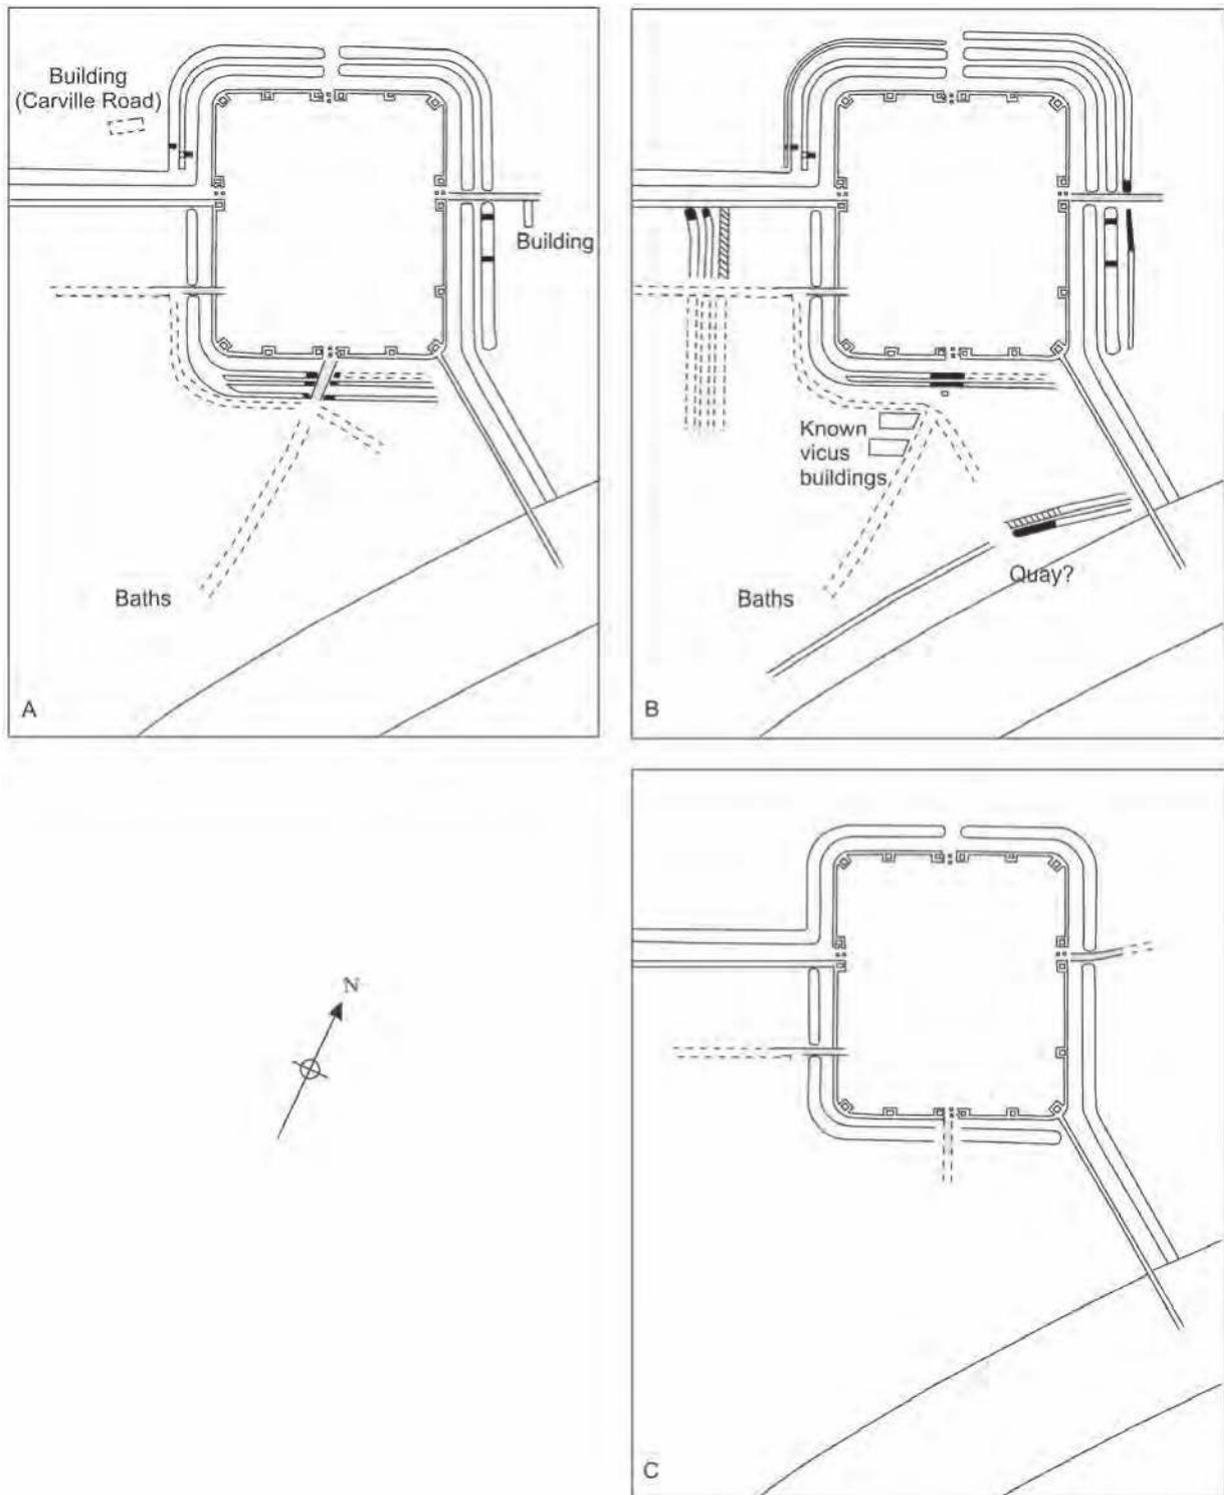
Figure 8 Plans to illustrate the development of the defensive ditch system, access roads and known vicus remains around the fort. Approximate scale 1:4000 (based on Hodgson 2003, fig.13, with additions). A: Second century; B: Third century; C: Fourth century

The fort was surrounded by a series of defensive ditches, the number and disposition of which changed over time. Excavations by Tyne and Wear Museums have greatly improved our understanding of this changing pattern of defensive ditches (see Hodgson 2003, 18–21 with fig. 13, adapted as Fig. 2.08 here; cf. Archaeological Practice 2006), but the restored pattern is based on relatively limited sampling and may change when further evidence emerges. Originally there were two ditches on the west side of the fort to the north of Hadrian's Wall. A narrower gully or trench was added beyond these, probably in the third century, which may have represented a defensive feature other than a ditch. It is uncertain whether

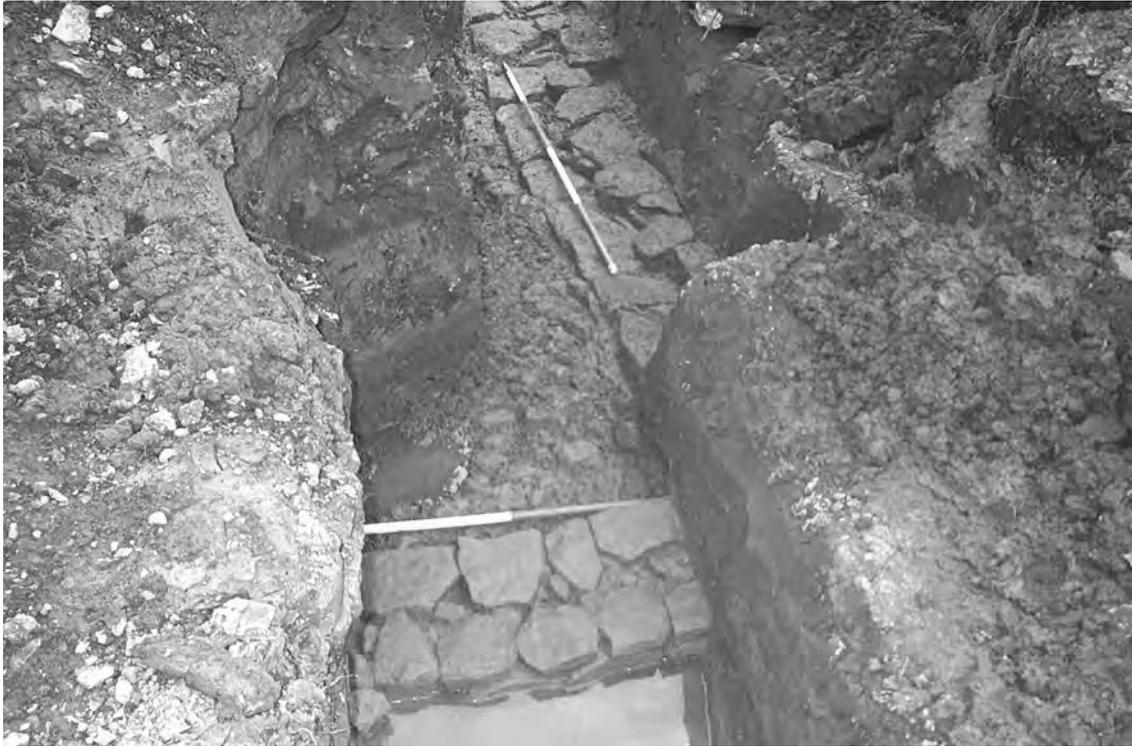
Figure 2 View from the east of the walls of the building uncovered beside Carville Road, north of Hadrian's Wall, in 2006

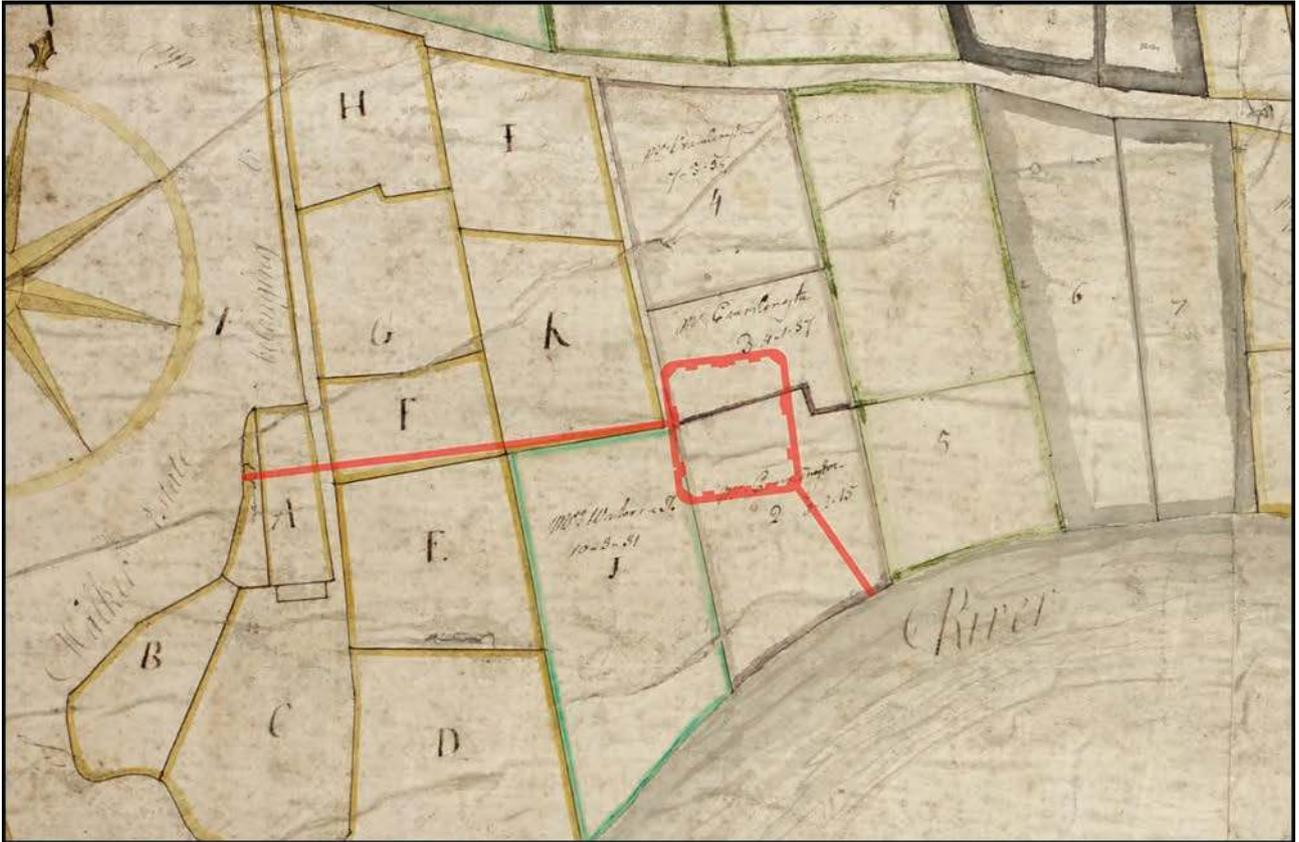
Figure 20 Extract from the Richard Hornsby's 1790 survey of the Dean and Chapter of Durham's estate in Wallsend (DCD E/AA/3) showing the fort site before colliery development, with the positions of the Roman fort, Hadrian's Wall and Branch Wall outlined in red. Reproduced by permission of Durham University Library

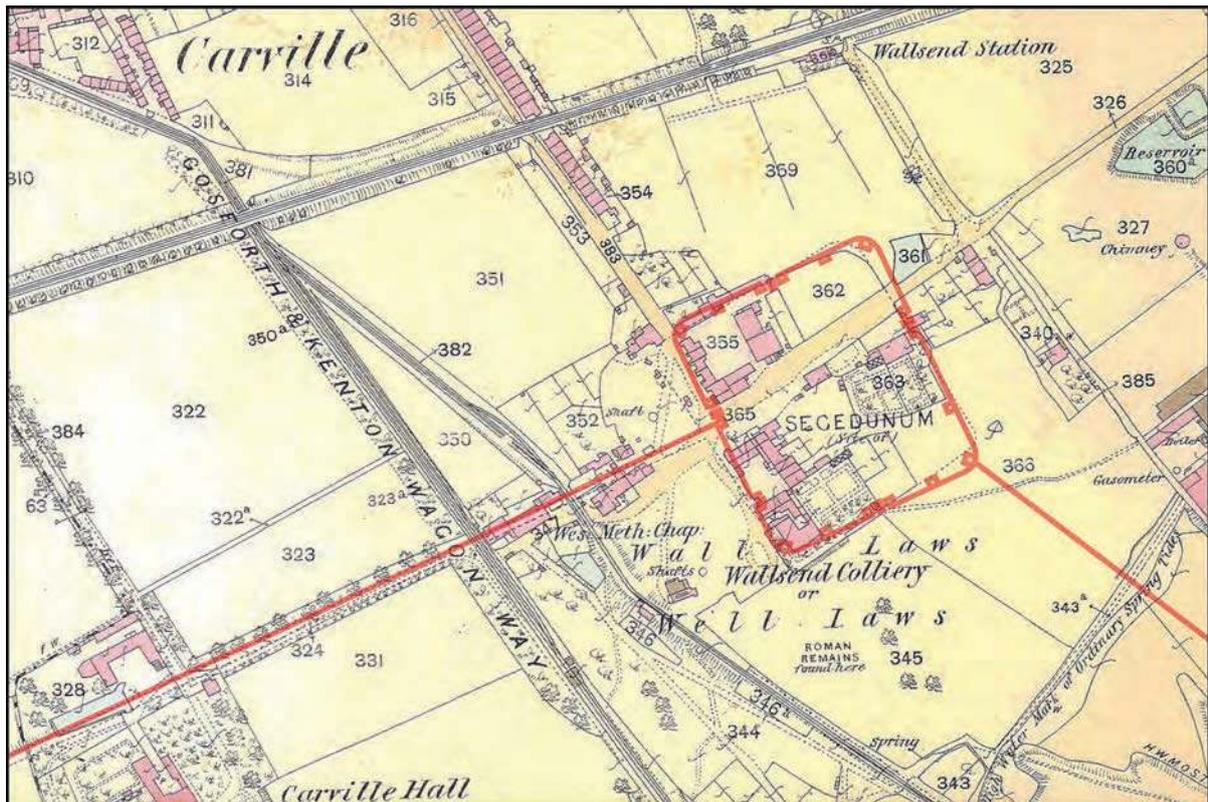
Figure 22 Extract from the 1st edition Ordnance Survey map showing Wallsend following closure of the colliery with the fort and Hadrian's Wall outlined in red.

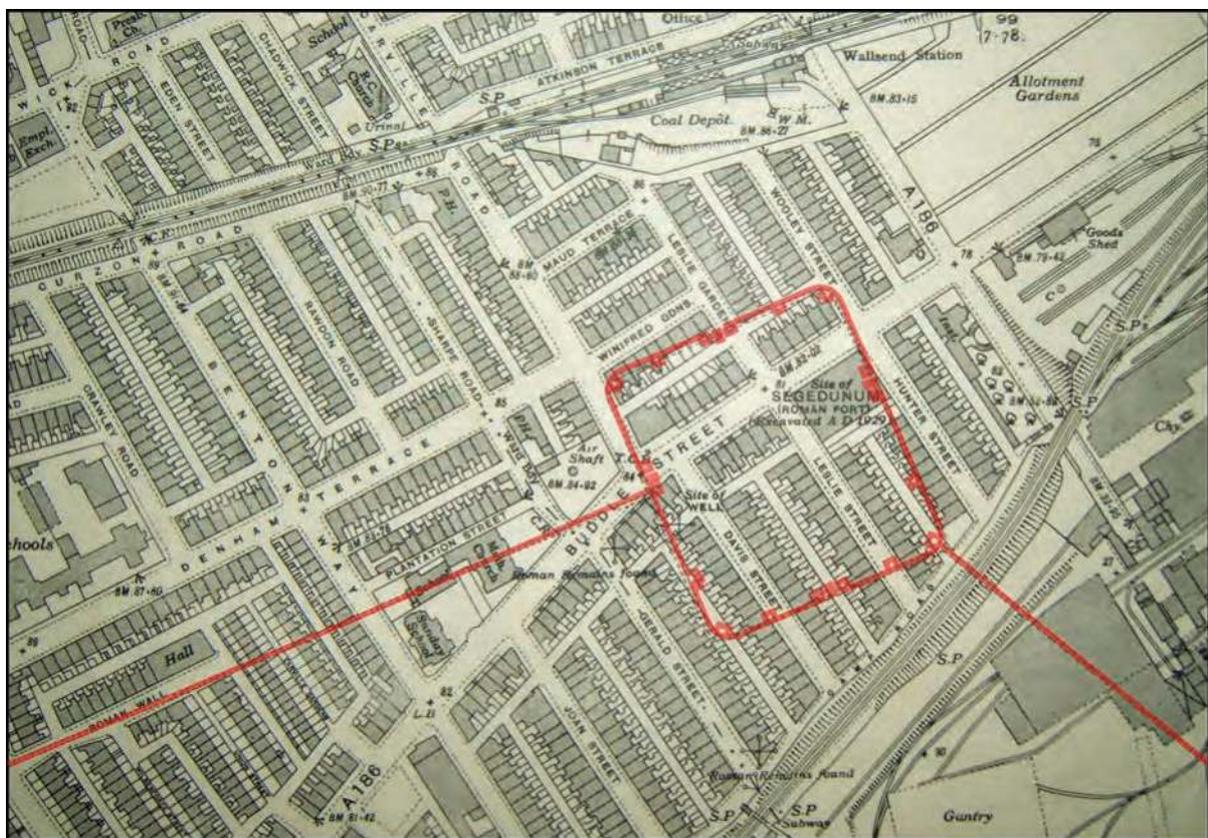
Figure 23 Extract from the 10th edition Ordnance Survey map showing Wallsend following the erection of terraced housing across the site, with the fort and Hadrian's Wall outlined in red.

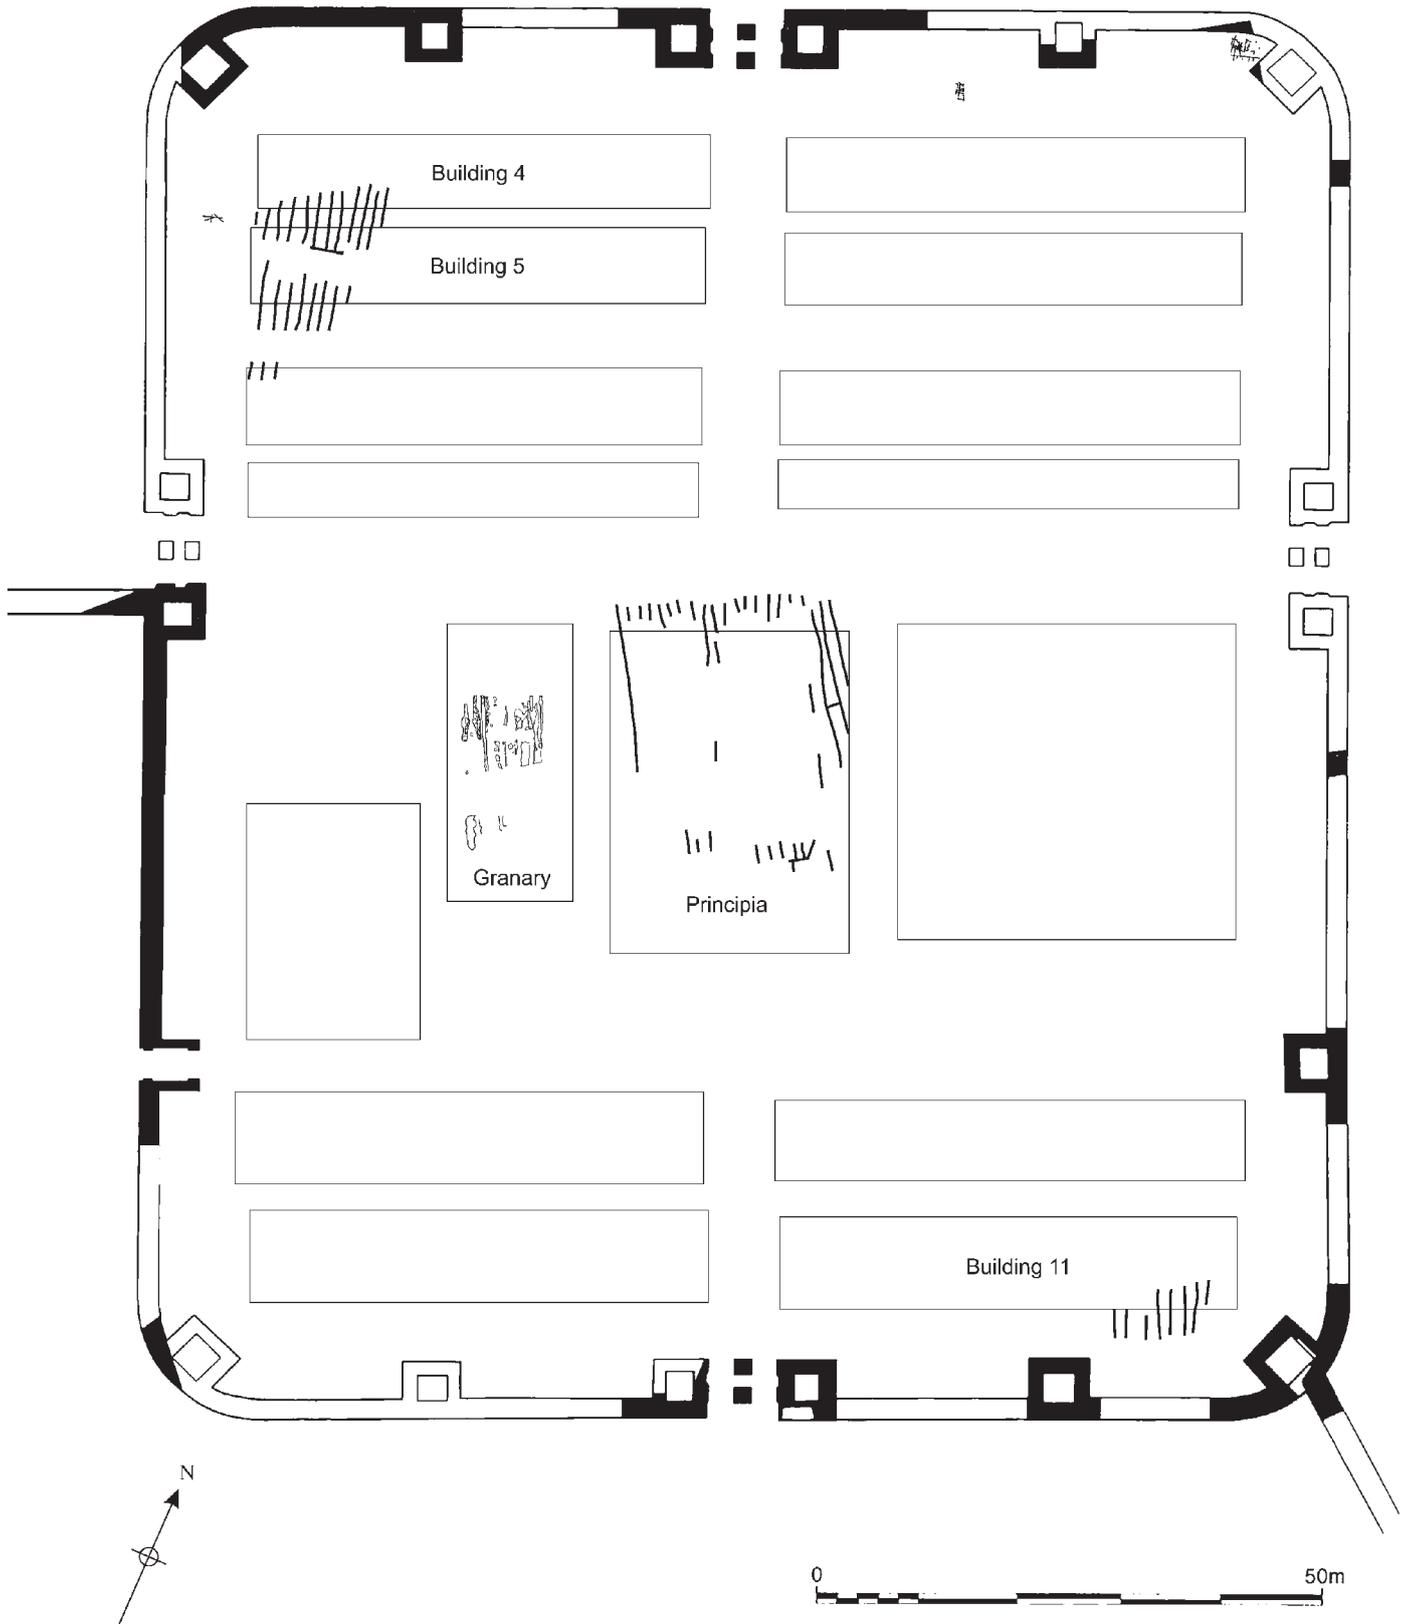
Figure 10 Evidence for pre-Roman cultivation beneath the fort, uncovered by the Daniels excavations, 1971-72.

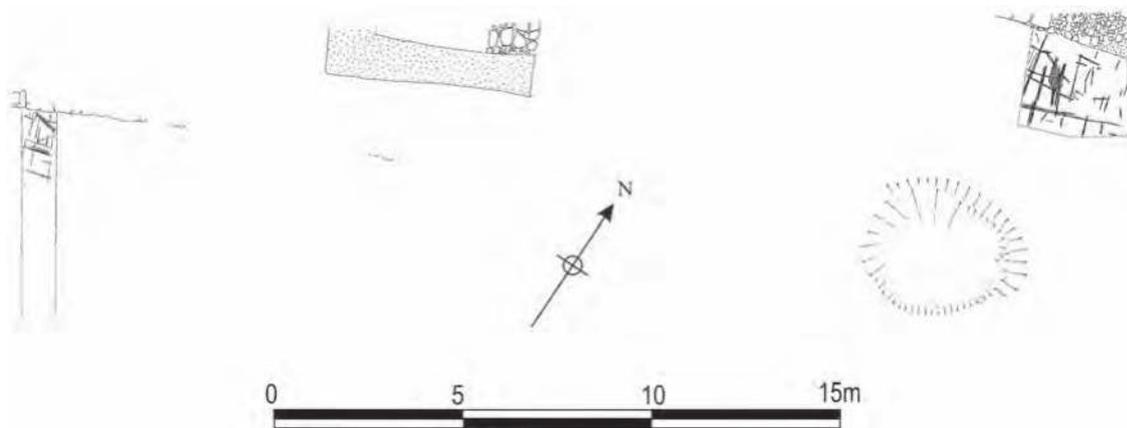
Figure 3.03: Plough marks exposed next to the north east defences. Scale 0

In the north rampart, west of the north-east angle tower and immediately south of the section of fort wall (Q04:03, 04), a small area 2.00m square was excavated down to the level of the subsoil. This revealed a series of irregular plough marks cut mainly in two directions, but on a similar alignment to the fort. They varied in width from 0.05m to 0.15m and contained a dirty greyish-brown loam which was quite distinct from the dark yellow loam of the natural subsoil. Several were cut by the foundation trench for the fort north wall. A further area of ploughmarks (N04:17) cut into brownish greyish clay and extending up to 1.50m the south of secondary rampart revetment N04:02, was exposed in a 0.70m wide strip excavated through the *intervallum* road levels some 5.5m west of the interval tower.

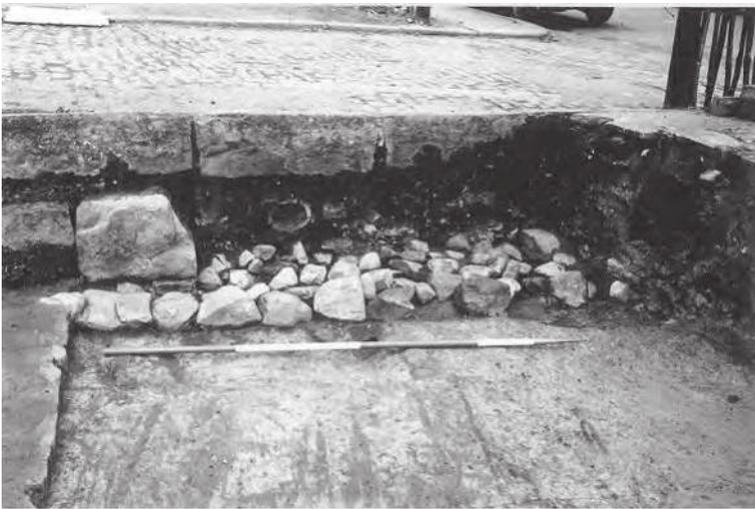
Figure 3.04: Ardmarks below the ramp next to the foundations of the north curtain wall in the north east corner of the fort, from the south

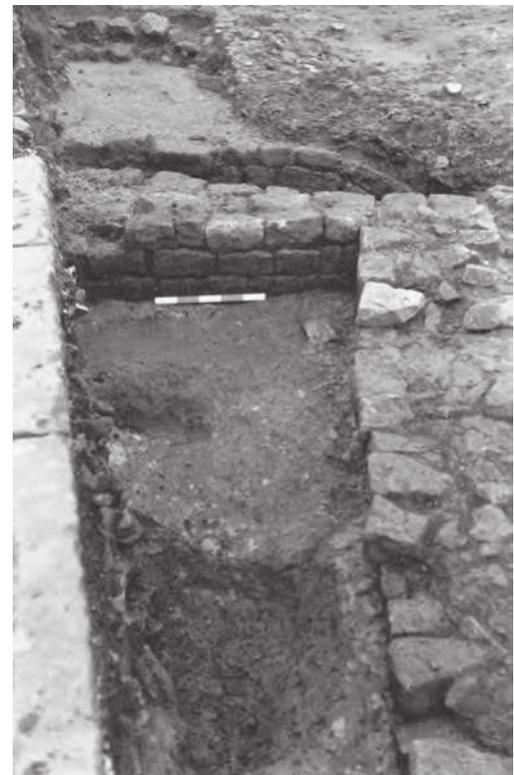
Figure 3.04: Cultivation remains excavated beneath the Roman levels in the north-west corner of Building 4 with the intervallum drain and ramp revetment wall also evident beyond the building looking west.

Two of furrows or gulleys (E03:16, F03:32) were recorded beneath the northern end of the east intervallum road and the north-west corner of Building 4, together with part of an oval pit (E03:17). These two lay on a slightly more north-westerly alignment than the main system beneath Buildings 4 and 5. A little

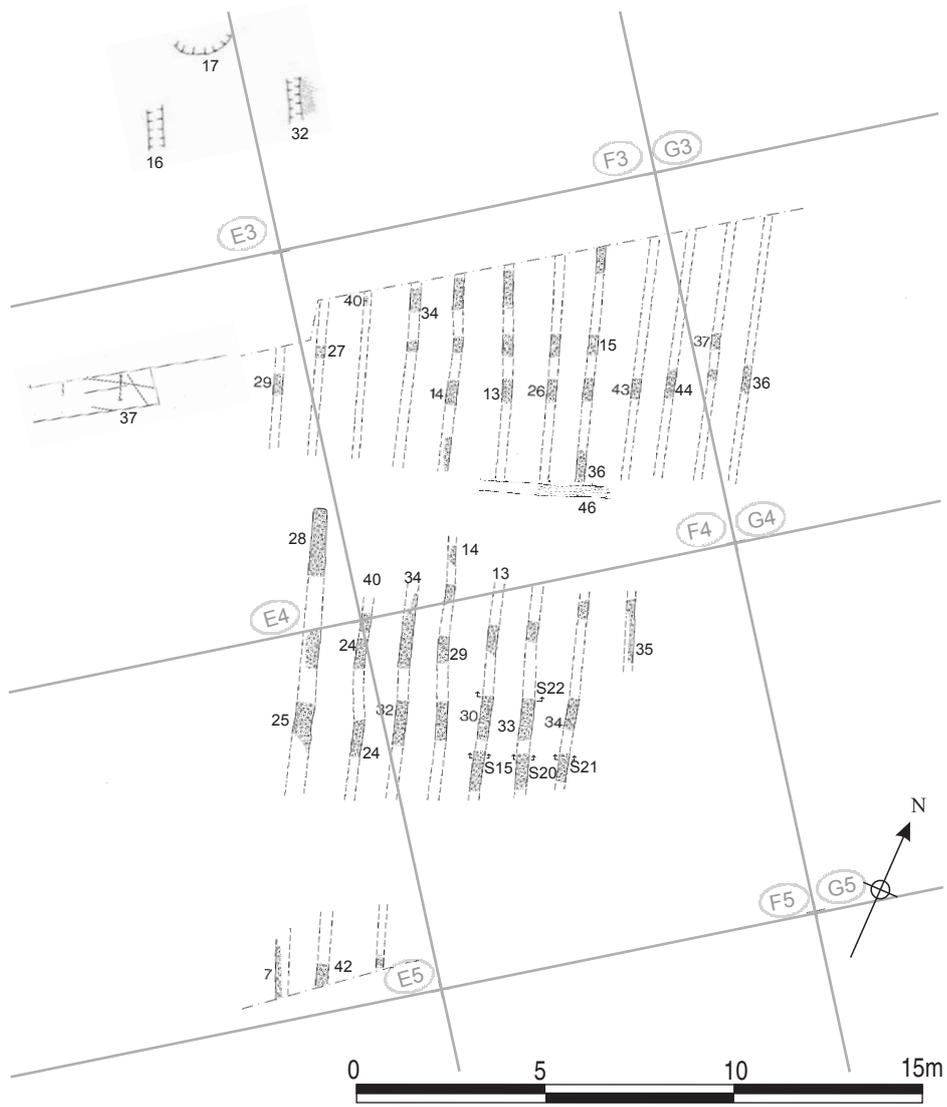
Fig re 8 Pre-Roman cultivation in the north west area of the fort, 8

Buildings 4, 5 and 6 and the roads between them. These were cut with the north-south axis slightly more to the north-east than the buildings. Traces of east-west trenches, probably of the same series, were uncovered under Building 5 and the street between Buildings 5 and 6 (F04:46, perhaps E05:16). It was not possible to say whether this was cross-ploughing or trenches marking the limits of the field system. The trenches consisted of shallow cuts on average 0.25m wide and up to 0.05m deep with dish-shaped profiles and usually spaced between 0.75m and 1.00m apart. The fill was a mixture of sand, clay and grit. These trenches were not like the room dividing slots in the officer's quarters of Building 5 which were on a slightly different alignment, had bowl-shaped profiles and contained a fill of dirty yellow clay and fragments of sandstone.

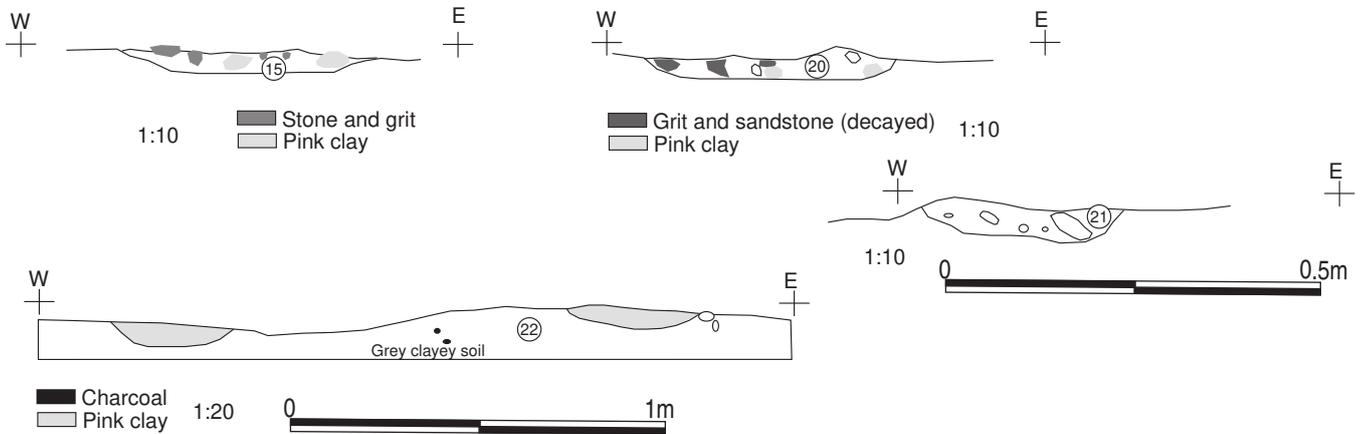
Fig re 8 Sections across cultivation furrows in grid square F5 south of Building 5

The pre-fort ploughsoil beneath Building 5 was composed of very clayey, medium grey or olive coloured loam (E04:26, E05:26, F04:22, F05:31, G04:20, G05:23) which contained charcoal and was heavily stained with orange iron pan in places.

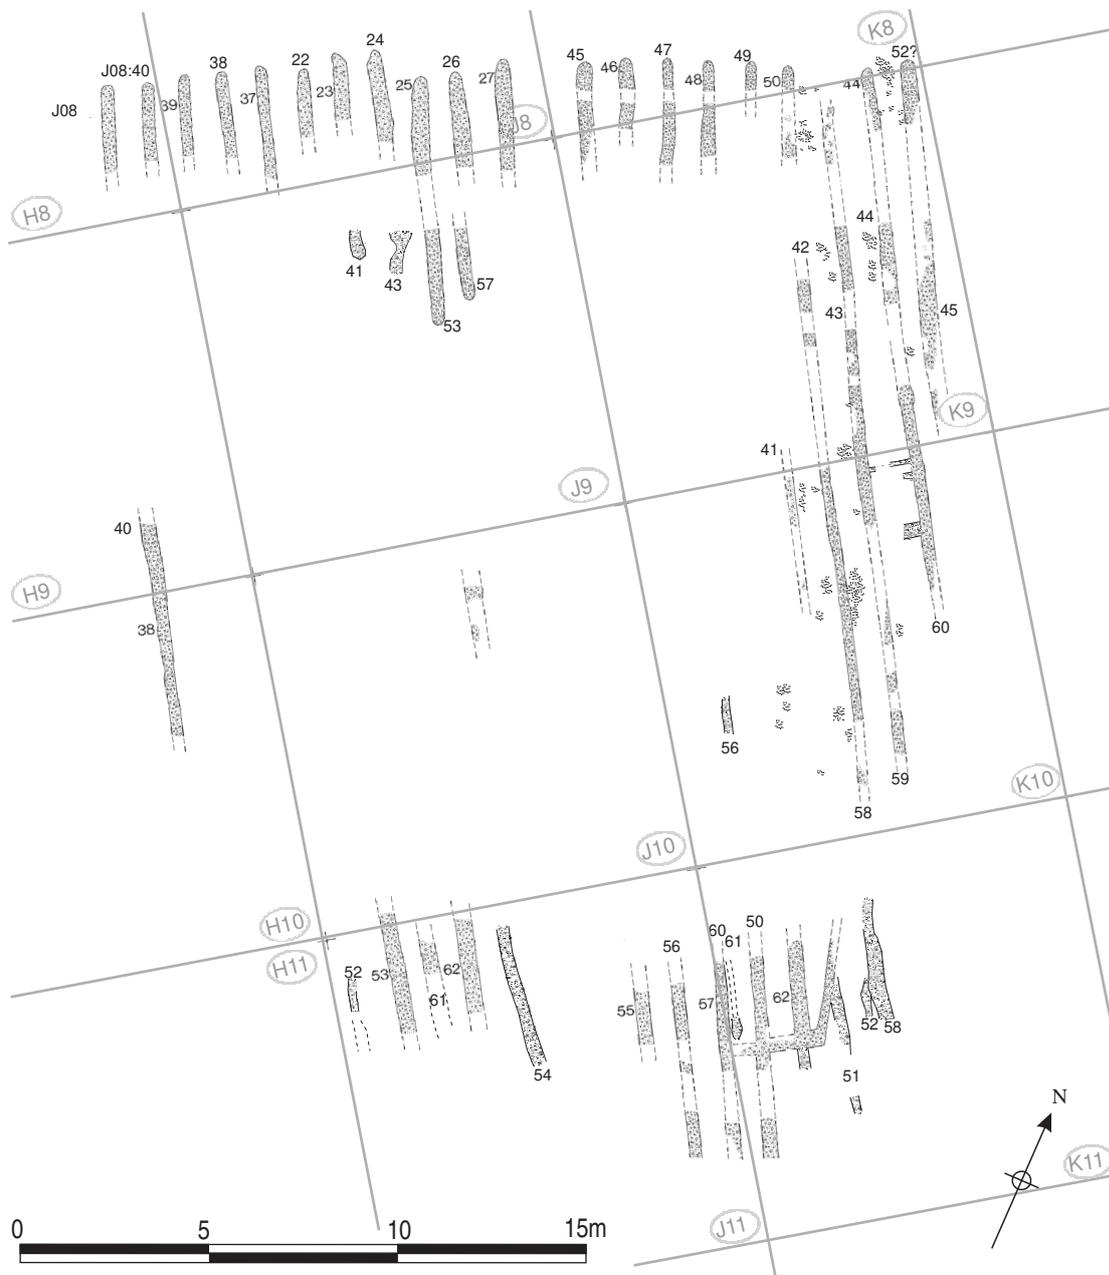
Fig re 8 Pre-Roman cultivation furrows beneath the principia and via principalis, 8

The most extensive area of furrows was revealed beneath the *principia* forecourt and crosshall and the area of the *via principalis* immediately to the north in 1980–81. These were on a more north-westerly orientation than the fort buildings. Only one example, recorded just by site plan, appeared to cut across the main orientation on an east-west alignment and then appeared to turn north following a more north-

easterly orientation than the rest. The surviving depth of the furrows was 50–100mm and their width was 0.20–0.40m. Those extending along the southern edge of the *via principalis* were generally filled with sandstone fragments and yellow sand. Further south in the area of the forecourt and crosshall the fills were predominantly described as orange clay, often qualified as ‘dirty’.

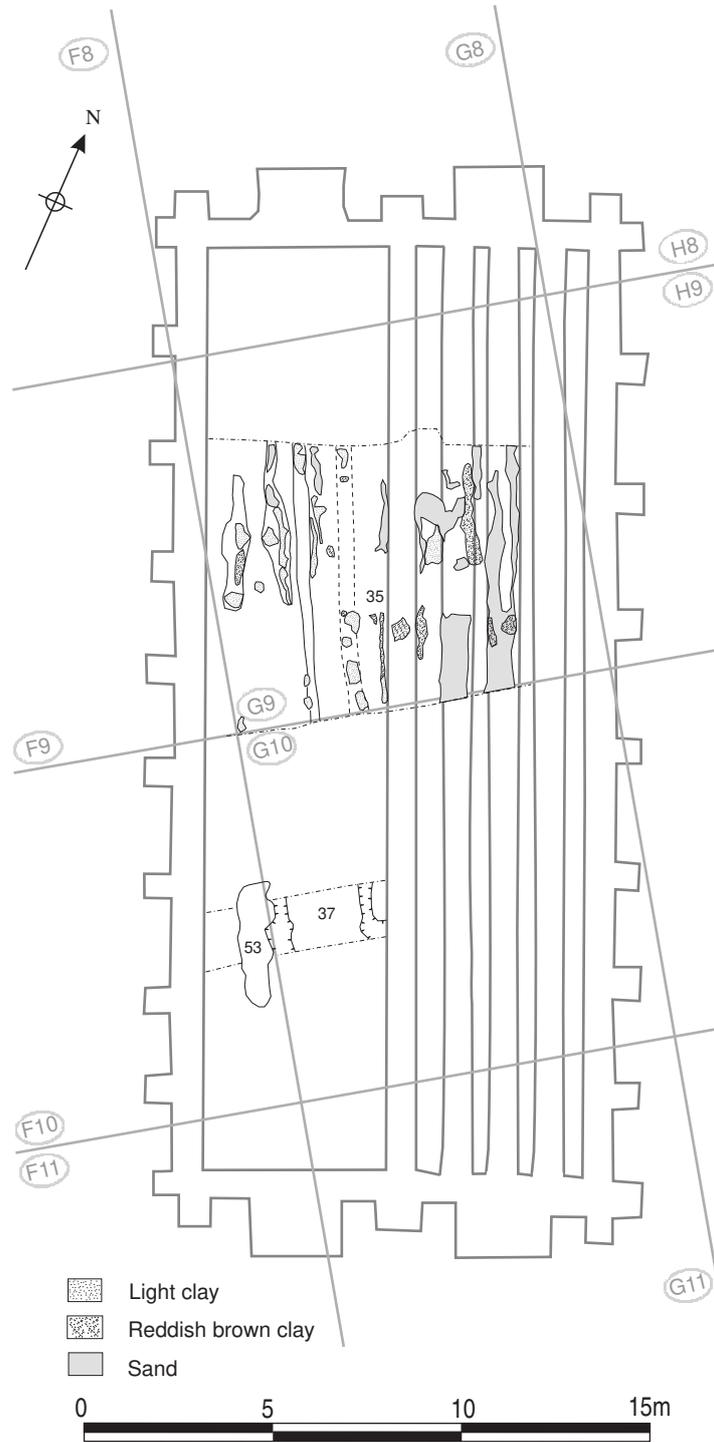
Figure 8 Evidence for pre-Roman cultivation beneath the granary at D

Two areas in the interior of the granary were excavated to sufficient depth to expose traces of pre-Roman agriculture in 1983.

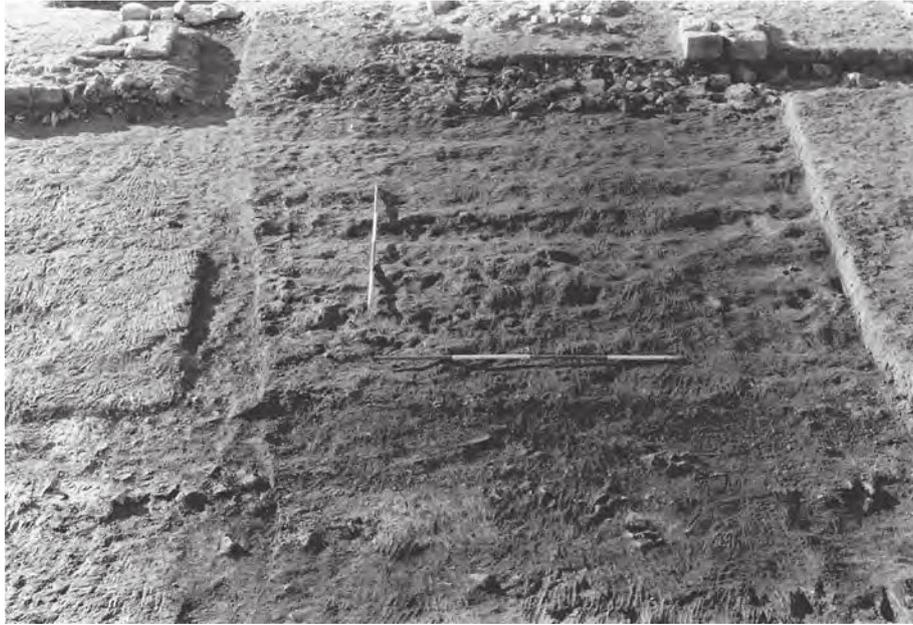
Figure 3.09 Cultivation furrows exposed during excavation of a slot beneath the granary in grid square G9

In the northern half of the building a 6–8m wide strip was excavated across the virtually its entire width in grid square G09 (see Fig 3.09). A series of apparent furrows (G09:35) were recorded on the site

plan (but only summarily described), distinguished by fills of reddish-brown and lighter clay and sand. Their orientation was slightly to the north-west of the main axis of the granary itself.

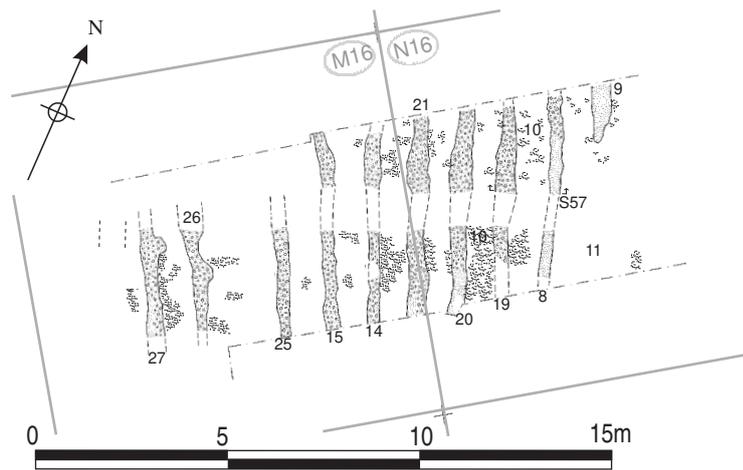
Figure 3.10 Cultivation furrows in the south east corner of the fort beneath Building 1 and the south intervallum road, 10

Extensive areas of burning were noted around these furrows and these may be comparable with the burning noted in the 1997–8 excavations and at Denton on Hadrian's Wall. Analysis suggested this was deliberately undertaken, probably on a regular basis, to destroy all the weeds and shoots of weeds and increase the latent fertility of the soil (Hodgson 2003, 31–2).

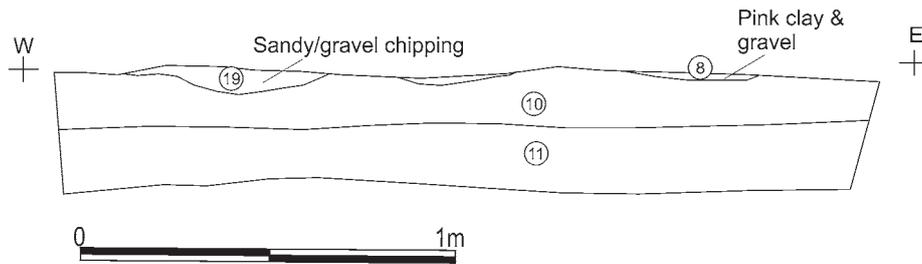
Figure 3 Section S3 across N0 and N0 in the south east corner of the fort, at 0
