# SEGEDUNUM

Excavations by Charles Daniels in the Roman Fort  
at Wallsend (1975–1984)

VOLUME 1: The Structural Remains

Alan Rushworth and Alexandra Croom

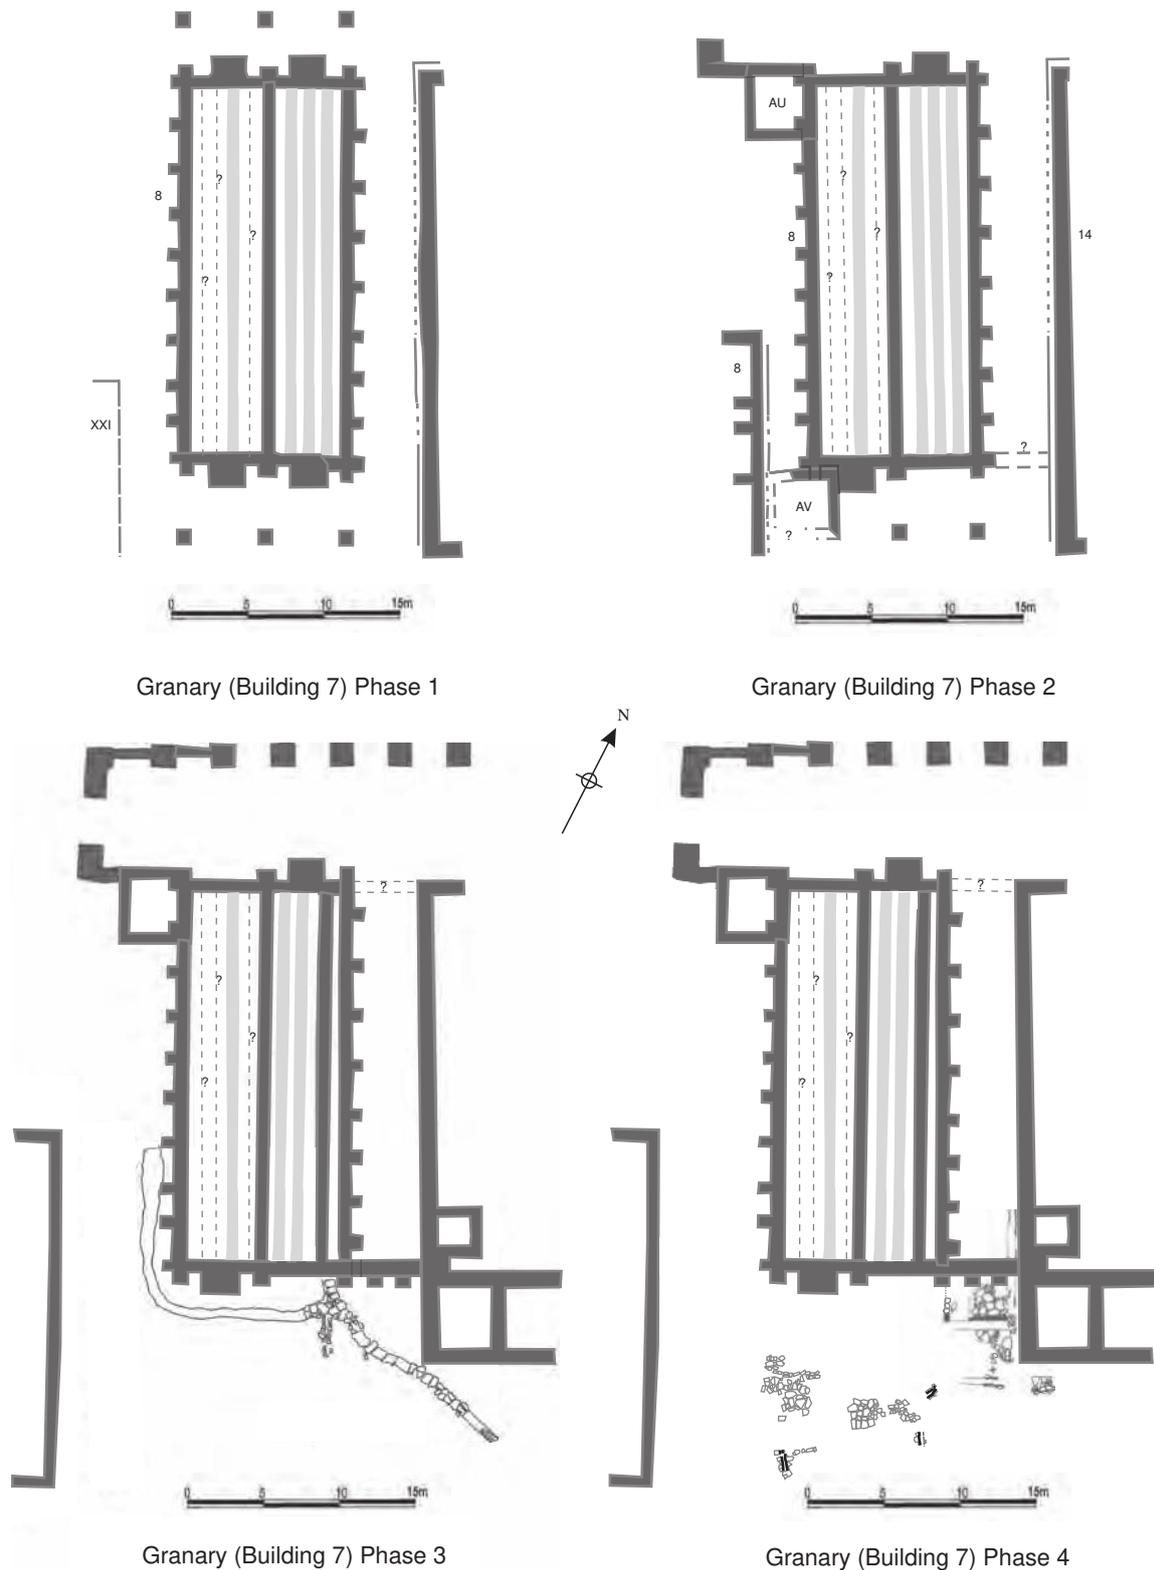
Figure 4 Phase plans of the granary building at 4

In its primary phase, Building 7 comprised a rectangular, double granary measuring 26m × 11.40m. The structure was orientated north-south. The floor of the east granary was supported by three longitudinal sleeper walls. The west granary had a solid base composed of several layers of clay and stone. This again supported a series of longitudinal sleeper walls of which only a small fragment of one wall survived when uncovered in 1981. The two halves of the granary were separated by a north-south spine wall, which has been entirely removed by later robbing (G08:29, G09:15, G10:32, G11:64). The outer walls, too, were heavily robbed down to their foundations after the Roman period, the outline of the building being defined by robber trenches, with only two short stretches of actual masonry surviving on the north and west sides (G08:12, F09:14). These were constructed of roughly squared sandstone facing stones with a rubble core and varied in thickness between 0.80m and 0.65m. They were set on

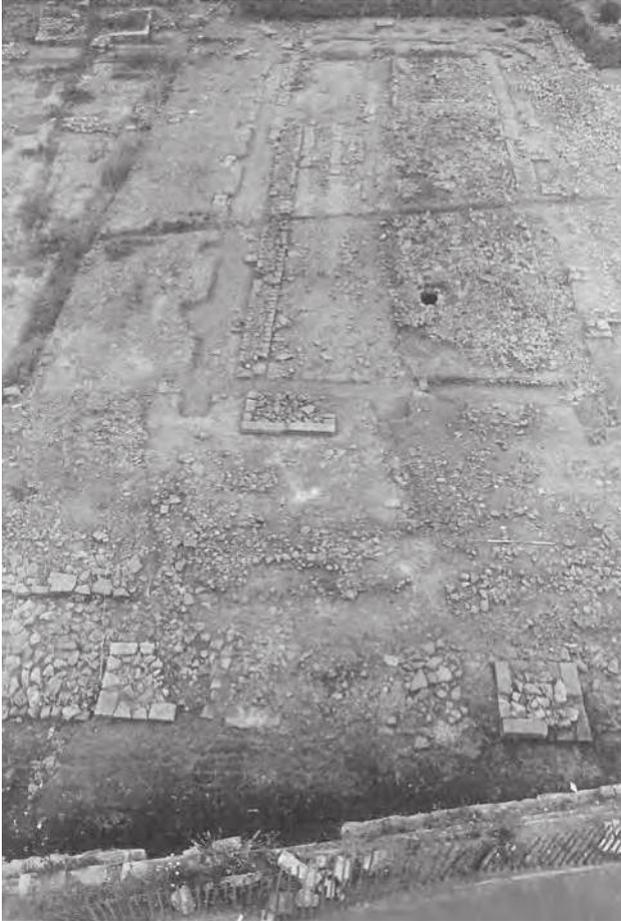
Figure 4.01 Granary and Alley 8 from the north. Note the robbed outer walls, the NW loading steps and the well preserved sleeper wall G8.

flags (as at Corbridge) or timber joists and planking. Raising the floor in this way was designed to reduce problems of damp and vermin. The easternmost of the sleeper walls (H08:24, H09:19, G08:30, G09:05, G10:24, G11:57) was relatively well-preserved, surviving to two courses for much of its length, but the others were severely robbed (G08:25, G09:11, G11:59; G08:27, G09:13, G11:61) with only short stretches of surviving masonry remaining near the centre of the building (G10:19, G10:22). Flags were laid on the ground surface in the 0.50m wide channels between the walls and measured up to 0.50 by 0.50m in size. Again these survived only in a central strip across the width of this half of the granary and at the southern end of the easternmost channel (G10:20, 21; G10:18, G11:56). (See Hodgson 2003, 173–4 for re-excavation of the flagging in 1997–8.)

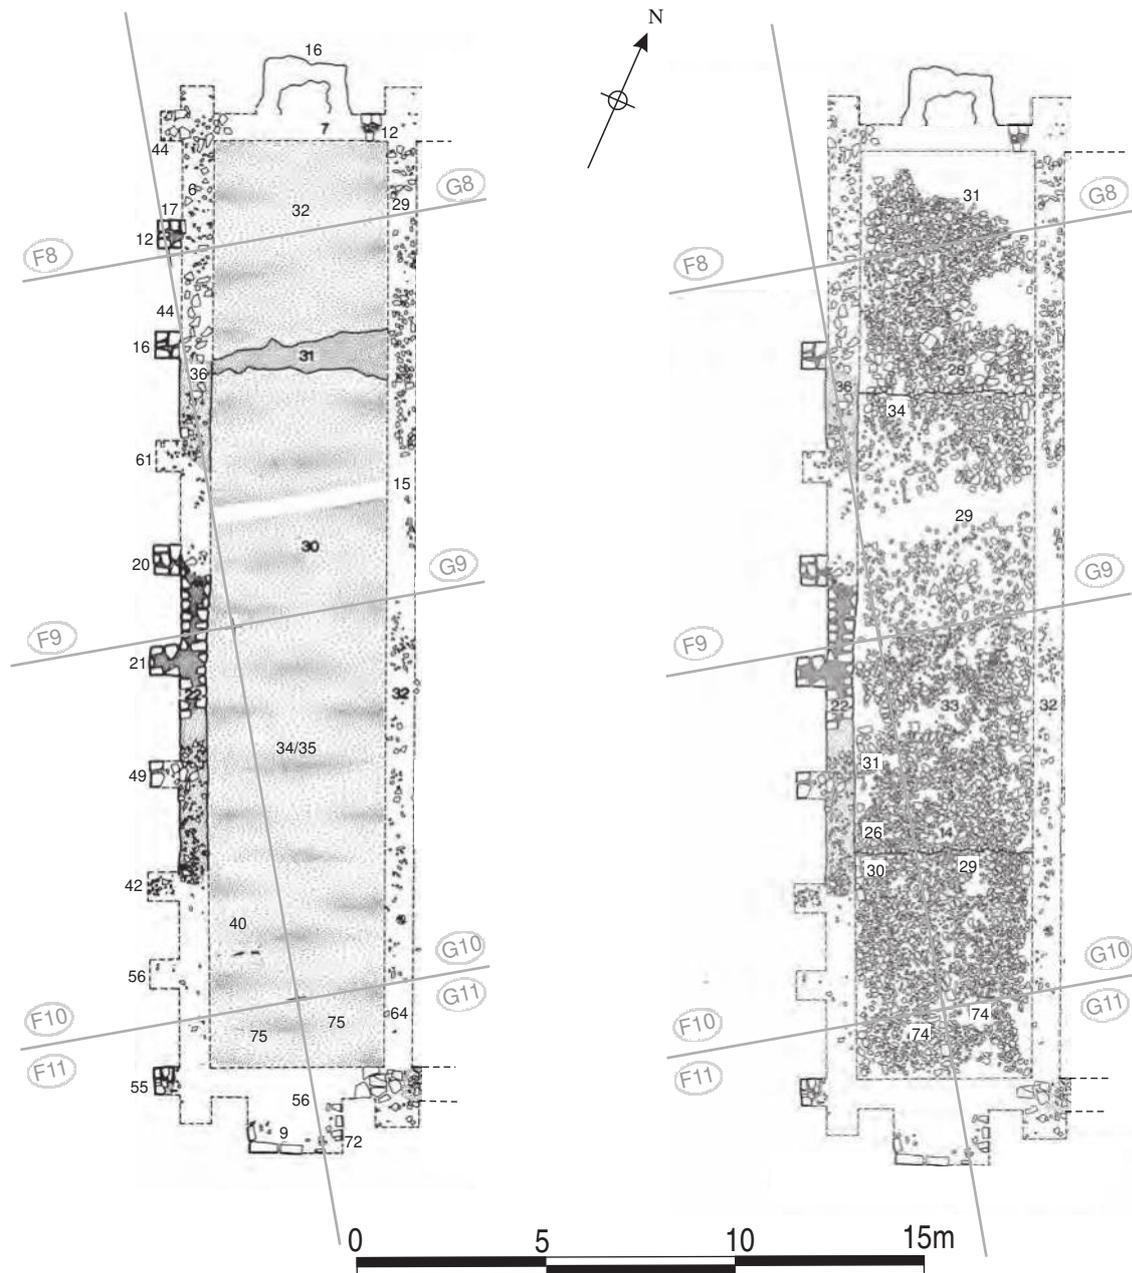
Figure 4.04: Clay base and cobble and flag makeup layers of the west granary at 1:200.

The arrangements in the west granary differed quite markedly from those in the east granary. A series of distinct makeup layers, composed of clay or rubble, cobbles and flags, were identified when the building was fully excavated in 1983 (see Table 4.01; Fig. 4.04). These were interpreted by the excavators as successive floor levels, each representing a different structural phase, which were integrated into the overall four-period framework envisaged at that stage. In actuality these layers of clay and stone provided a base or raft on top of which were constructed a set of sleeper walls and flagging. Only a fragment portion of one sleeper wall (G10:07) and a small area of flags (G10:02) survived when these features were recorded in 1981 (see Fig. 4.03). These were broadly similar in form to, but differed in detail from, those recorded in the east granary. No equivalent levelling deposits were reported in the east granary, though the likely existence of some kind of clay construction deposit

Next a clay and cobble level (F10:31, F11:74, G08:31, G09:29, G10:33, G11:74), which incorporated areas of flagging within it, was deposited over the clay level (Figs 4.04 right; 4.06–4.08). Slight traces indicating the presence of two 'partitions' (neither of which was visible in the levels above or beneath) were noted in this layer, dividing it into unequal thirds, with the smaller areas situated at the north and south ends of the Granary and a larger undivided area in the

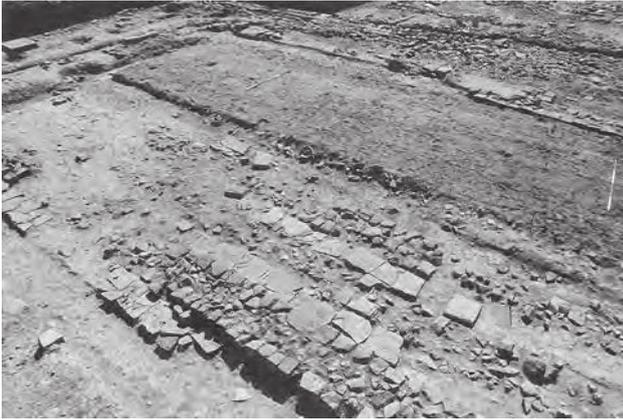
Figure 4.05: The clay base layer in the west granary in 1983, looking south-west.

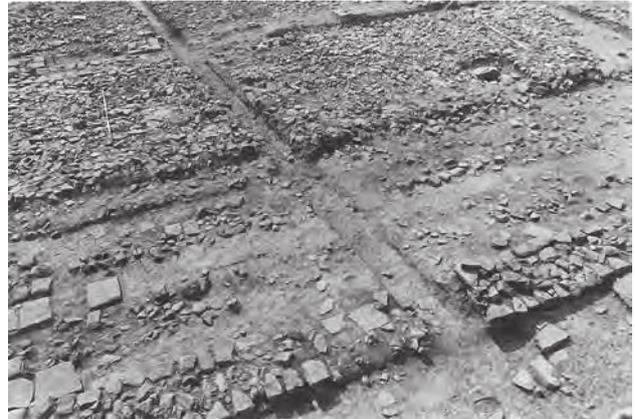
Figure 4.06: As 4.05. A modern drain trench has cut a section through the make up. The large posthole towards the north end of the structure is a colliery era intrusion.

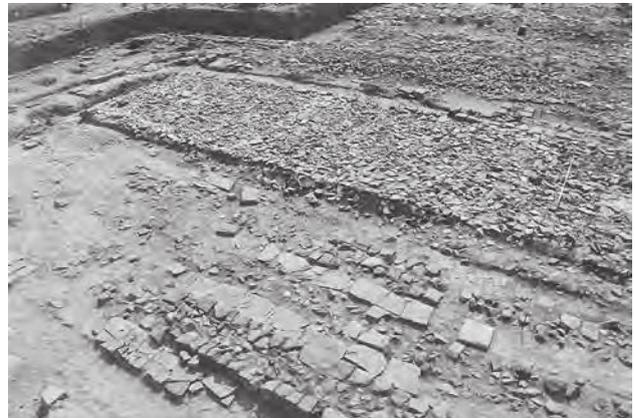
Figure 4.08: As 4.07. Compare Fig. 4.05 from the same view point.

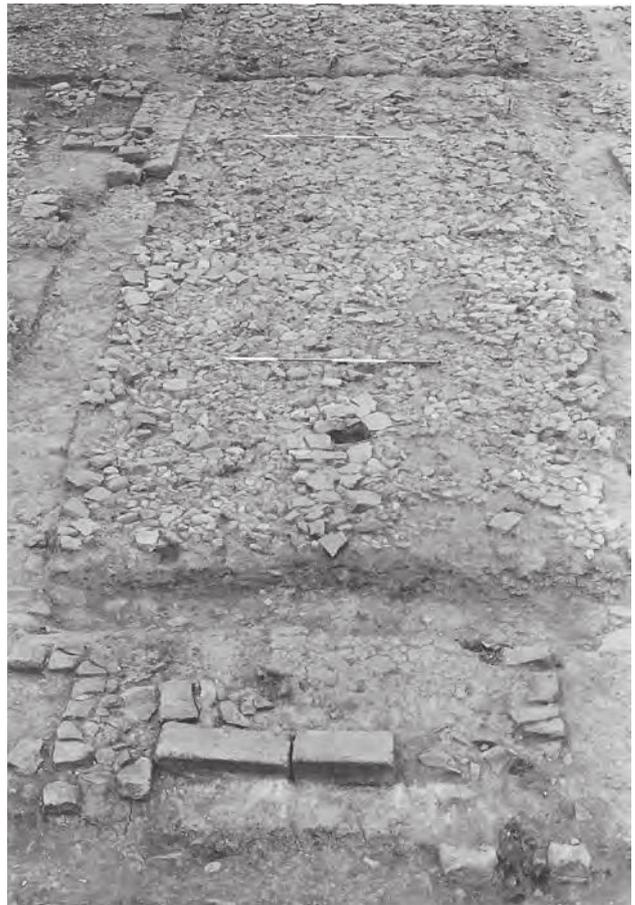
Fig. 4.09 Close up of the SW loading step serving the west granary. The NE corner of Building AV is also visible.

slabs on the outer (southern) edge of the platform but neither was as long as the north-east pair and there was a gap where at least one additional slab had been removed. The inner edge of the surviving slabs was rebated, exactly like their counterparts on the north-east platform, and presumably similarly once held the slabs which formed the next tread of the steps. Parts of the side walls of the platform also remained. The south-east and north-west platforms had been virtually totally robbed away or demolished, the former only being represented by a spread of small-medium sized stones set in dark brown silty clay (G11:81) in the corresponding position. A similar platform-shaped stone scatter (G08:16) represented the robbing residue of the north-west platform, but here, beneath the spread, the trench (G08:39) cut to rob out the facing stones were recognised, enclosing the clay base of the platform.

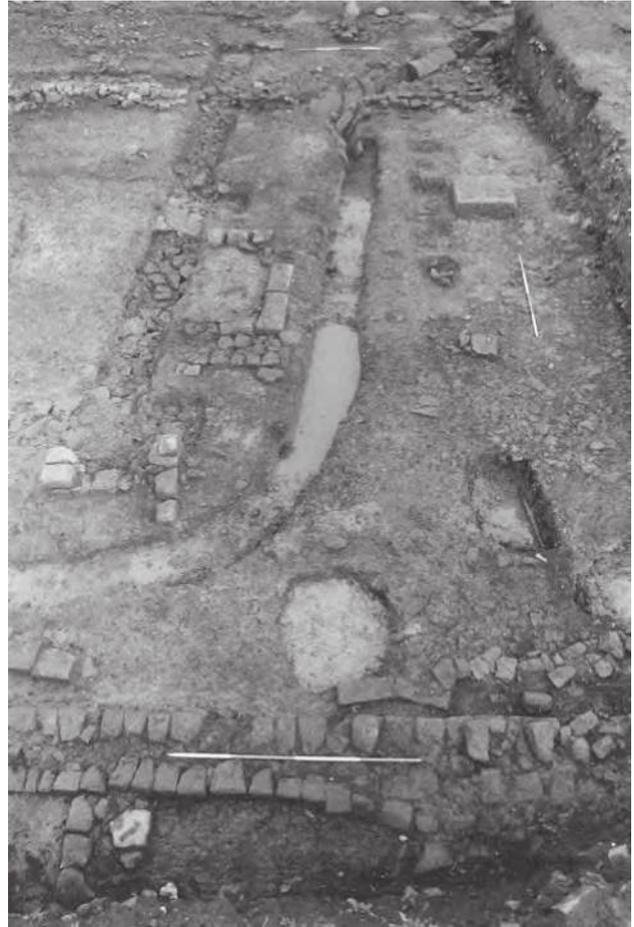
Figure 4 The south end of the granary viewed in plan. Note the SW loading step, the central pier base of the portico, the remains of Building AV and drain F11:53. In the background sleeper wall G11:57, drains G11:07 and G11:79 and the crosswall foundation trench of AW can also be seen.

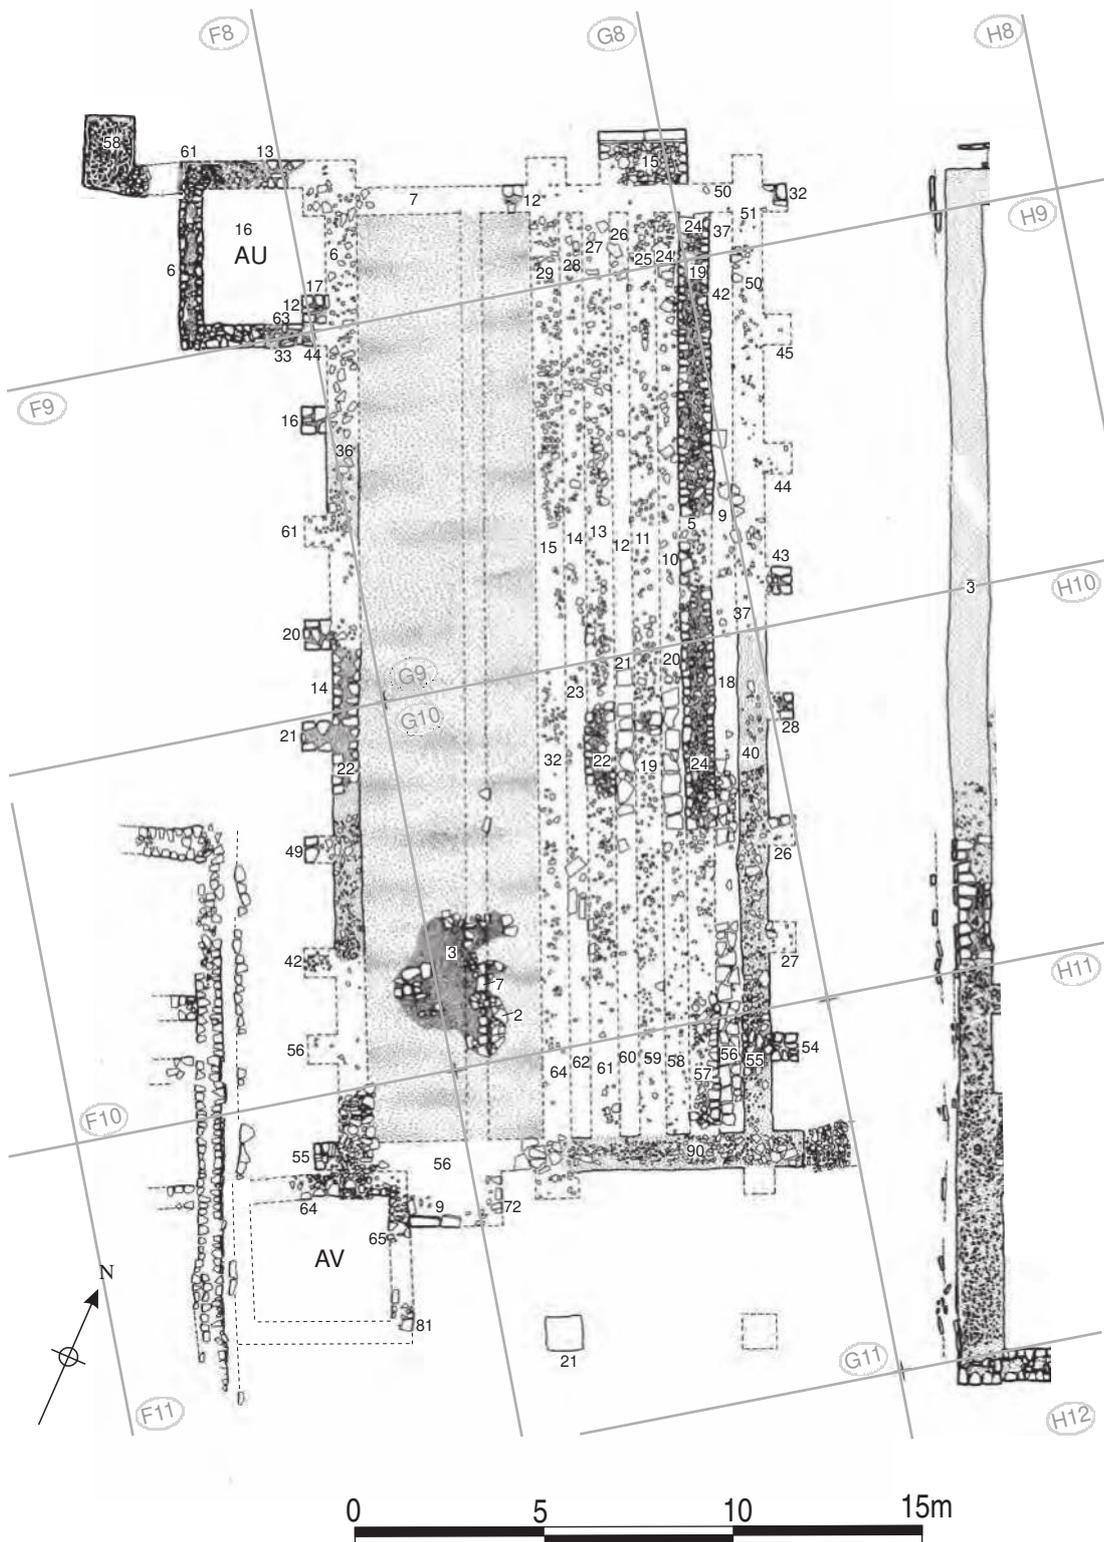
Fig re 1 Granary (Building 7, Phase 2 at 0

Building AU took the form of a small, rectangular room, measuring 5.20m north-south by 3.90m east-west, and was tacked onto the north-western end of the granary (Figs 4.11, 4.16). Its floor (F08:17) was composed of small packed stones which showed some signs of wear. This was overlain by a rubble spread (F08:16) which may relate to the period after the building had gone out of use and reflect post-Roman disturbance. The excavation revealed the full length of the south and west walls, which survived up to two courses high and were evidently of one build (F08:06, 63, F09:33). The walls were 0.60m wide with no trace of foundations and may simply have been sleeper walls supporting a half-timbered superstructure. The south wall of Building AU (F08:63, F09:33) clearly butted up against the south face of granary buttress F08:12/G08:17 and presumably, therefore, also against the west wall of the granary (which served as the east wall of AU), although the exact relationship between these two walls has been obscured by robbing. The north wall of the building was shared with Forehall AO, forming the southern wall of that part of the forehall extending to the west of the granary. Only

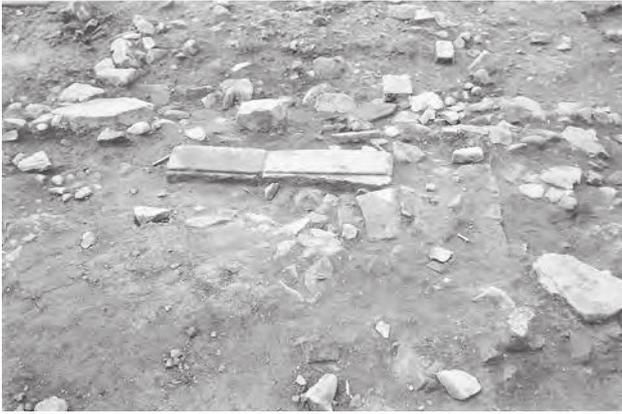
Figure 4.12: Granary SW loading steps, seen from the north in plan view. The rebate for the next step clearly. Fragments of the west wall of Building AV can be discerned but are not yet fully exposed.

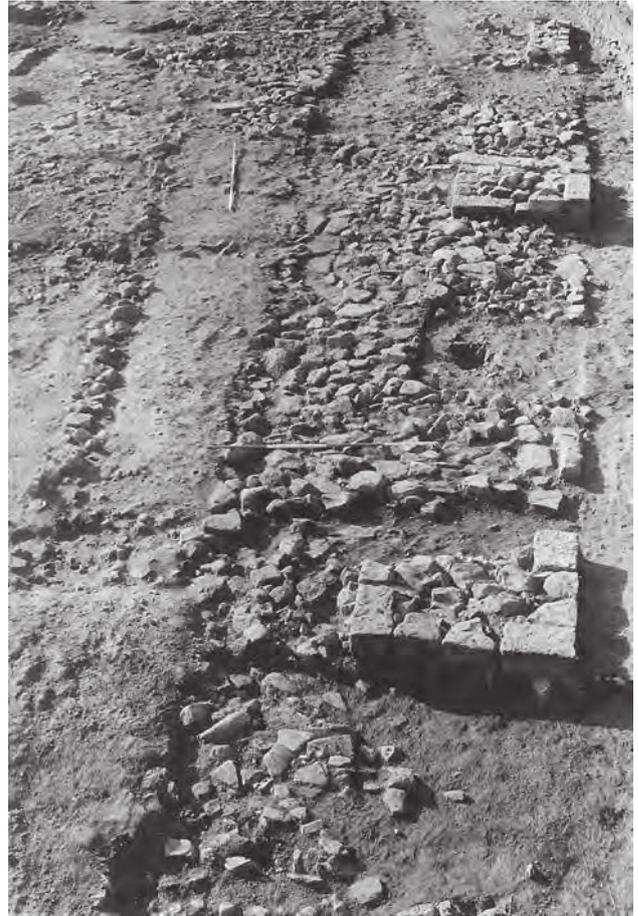
Figure 4.13: The piers of the forehall (AO) from the east, in plan view. Note the location of the robbed out pier (G07:12) and the long blocks, incorporated in the pier (G07:03), in the background which may have been reused from the NW loading steps of the granary.

The granary entrances may have undergone a secondary remodelling, occasioned by the erection of the stone forehall (Building AO) along the north front of the *principia* and granary. Construction of this massive piers structure over the *via principalis* must have entailed the demolition of granary's northern portico. From the surviving remains of the loading platforms it may also be inferred that both halves of the *horrea* were modified to become single-ended structures, with the east granary now being entered from the north end only, whilst the west granary retained its south entrance, but lost its north one. Thus, whilst substantial elements of the base course of the north-east and south-west platforms remained (Fig. 4.12), their south-east and north-west counterparts were only represented by stone spreads of robbing residue (G11:81; G08:16) in the appropriate positions and, in the case of the north-west platform, the trench (G08:39) cut to remove the facing stones enclosing the clay base of the platform (Fig. 4.13). Five, large, well-cut blocks, measuring 0.65–0.80m × 0.25–0.35m (height not recorded, but c.0.20 to judge from photographs) and very similar in form to those used for the granary steps, were incorporated in the masonry of one of the piers (G07:03) of the forehall

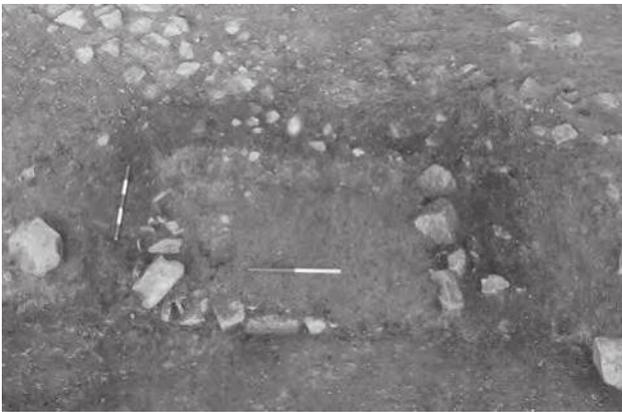
Figure 4.14: Close up of the robbed remains of the NW loading step.

(Fig. 4.14). It is tempting to interpret these blocks as representing the reuse of material from the north-west steps, only 6.00m from pier G07:03 (which was the nearest of any of the AO piers to that platform – Fig. 4.15). If correct this would not only imply that the removal of at least one of loading platforms occurred during the Roman period, rather than simply representing post-Roman robbing, but would also indicate that the demolition of the two loading platforms and the construction of the forehall were essentially contemporaneous, linked structural events. It should be noted however that if this is the case some means of entering the west granary at its north end must have been re-established later on when all access to the southern end of the building was blocked off by a row of timber buildings (see Chapter 6). Perhaps the original doorway was reopened and a simple set of wooden steps resting directly on the ground surface were installed at that point. Doorways may also have been inserted between the two halves of the building, if none existed previously.

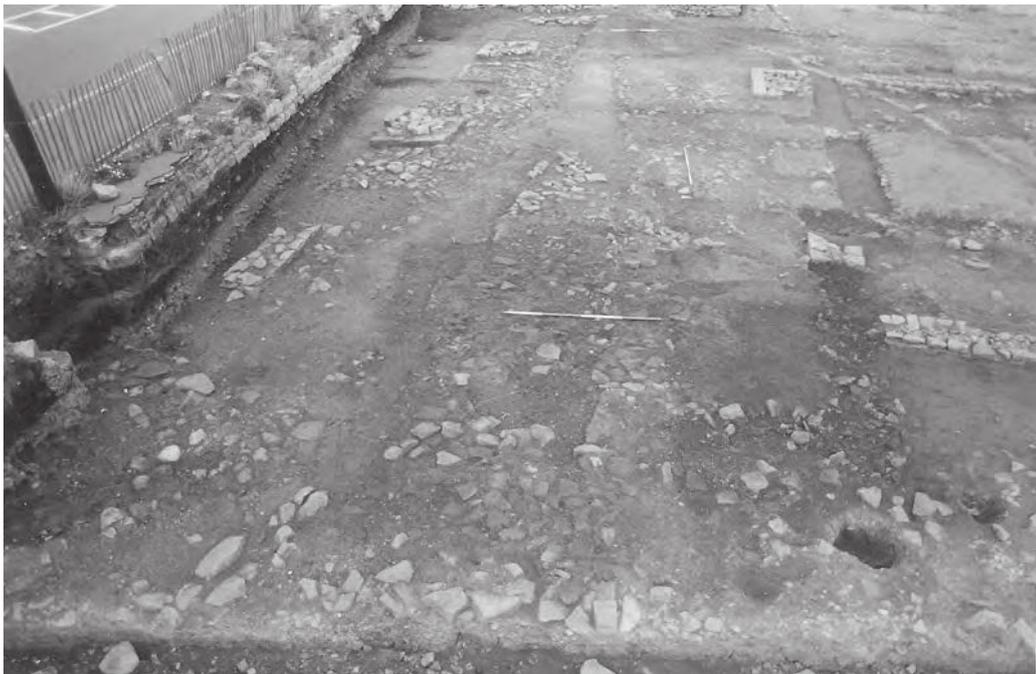
Figure 4.15: The north end of the granary and the forehall seen in plan view. Note the proximity to forehall pier (G07:03) to the robbed out NW loading step.

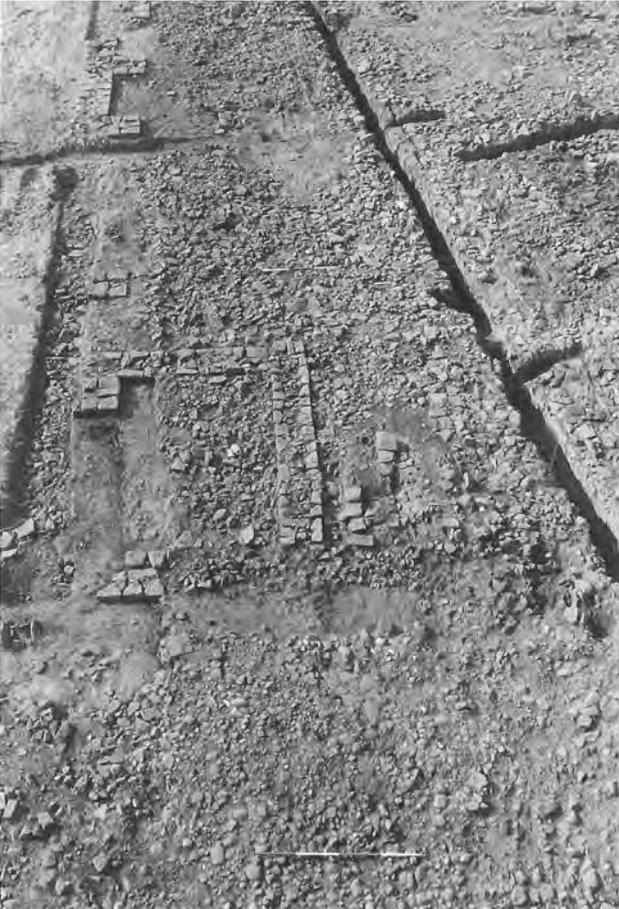
Figure 4 Building AU at the NW corner of the granary viewed from the north in 1977. The remains of the drying malting kiln are also visible.

a one metre length of this wall's masonry survived (F08:13), the remainder having been robbed out (F08:51), but, at 0.75m broad and set on rubble foundations 1.00m wide (F08:61, G08:43), it was clearly more substantially built than the south and west walls of AU. Wall F08:13 was probably therefore

integral to Building AO rather than AU, implying the construction of AU was subsequent to that of the forehall. In effect Building AU was created simply by building its western and southern walls in the pre-existing corner formed by the junction of the granary and the forehall.

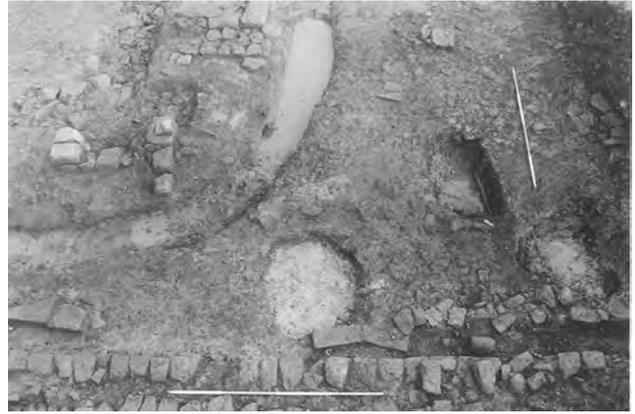
Figure 7 The remains of Building AV viewed from the west in 1981, comprising fragments of the building's north and east walls next to the SW corner of the granary. Note the gutter alongside the east wall of the hospital.

A second small rectangular building, labelled AV, was built at the south-west corner of the granary (Figs 4.11, 4.17). Slight traces of the north (F11:64) and east (F11:65, 81) walls of this building run across and appear to be set on a layer of cobbling which was identified by the excavators as the primary road surface (F11:73), immediately to the south and west of the granary. The north-east corner of AV sat in the angle formed by the granary's south wall and the west face of the south-west loading platform, butting up against these pre-existing structures. The north wall of AV must have incorporated the westernmost buttress on the granary south wall. There was no trace of the south wall of AV, which had presumably been entirely removed by later activity. However, AV clearly extended southwards beyond the steps of the south-western entrance, though probably no further than the line of the existing granary portico. Similarly, no evidence for a western wall was recovered. It is possible that the east wall of the hospital was used for the purpose, with the north and south walls of AV butting directly up against it. If that was the case, the positioning of Building AV would have interrupted the line of the gutter (F10:50,

F11:77), which ran alongside the hospital wall, and the building's construction would therefore have to have been secondary to the erection of the stone hospital (Building 8 Phase 1). This would represent a useful piece of relative chronology, even though the two structural events need not have been separated by any great interval of time. However it is not certain that Building AV did extend right up to the hospital wall. It may conceivably have stopped short of the hospital east wall leaving sufficient space for the gutter to pass between. The west wall of AV could conceivably have been robbed in its entirety, like the south wall. Judging from the photographic record (Fig. 4.17) the gutter lining incorporated a couple of large, neatly-squared oblong blocks which resemble those used in the granary loading platforms. It is conceivable that these blocks derived from the redundant south-east loading platform and were reused to line the gutter alongside the hospital wall at this time. However they appear to lack the distinctive rebates present on the surviving *in situ* blocks so it is impossible to verify now whether this was their original purpose.

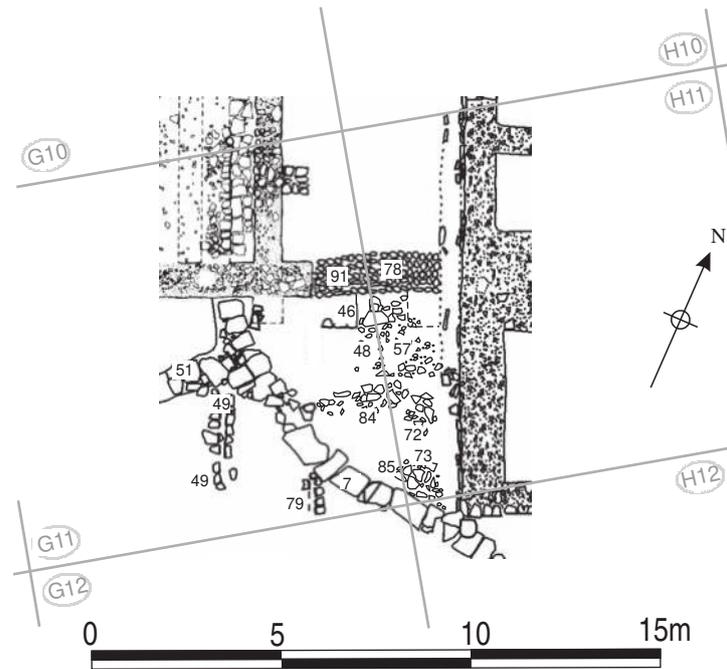
Figure 4.18: The remains of the wall closing off the south end of Alley 8 (Building AW), plus the drains and surfaces in the area to the south at 0

The southern end of the alley was blocked off by a wall which continued the line of the granary south wall (Figs 4.18, 4.19). This blocking wall was represented by a pitched, rubble foundation (G11:91, H11:78), up to 1.3m wide, overlain by yellow clay, which abutted the most southerly buttress of the granary east wall. The superstructure of this wall has been entirely removed by robber trench H11:71, which, in so doing, has also obscured the original relationship between the wall and the adjacent surfaces. However, in the 'Building notes' compiled following the 1983–1984 seasons it is stated that the foundation was clearly added against the most southerly buttress of the granary east wall, and was therefore a secondary feature. On the south side of

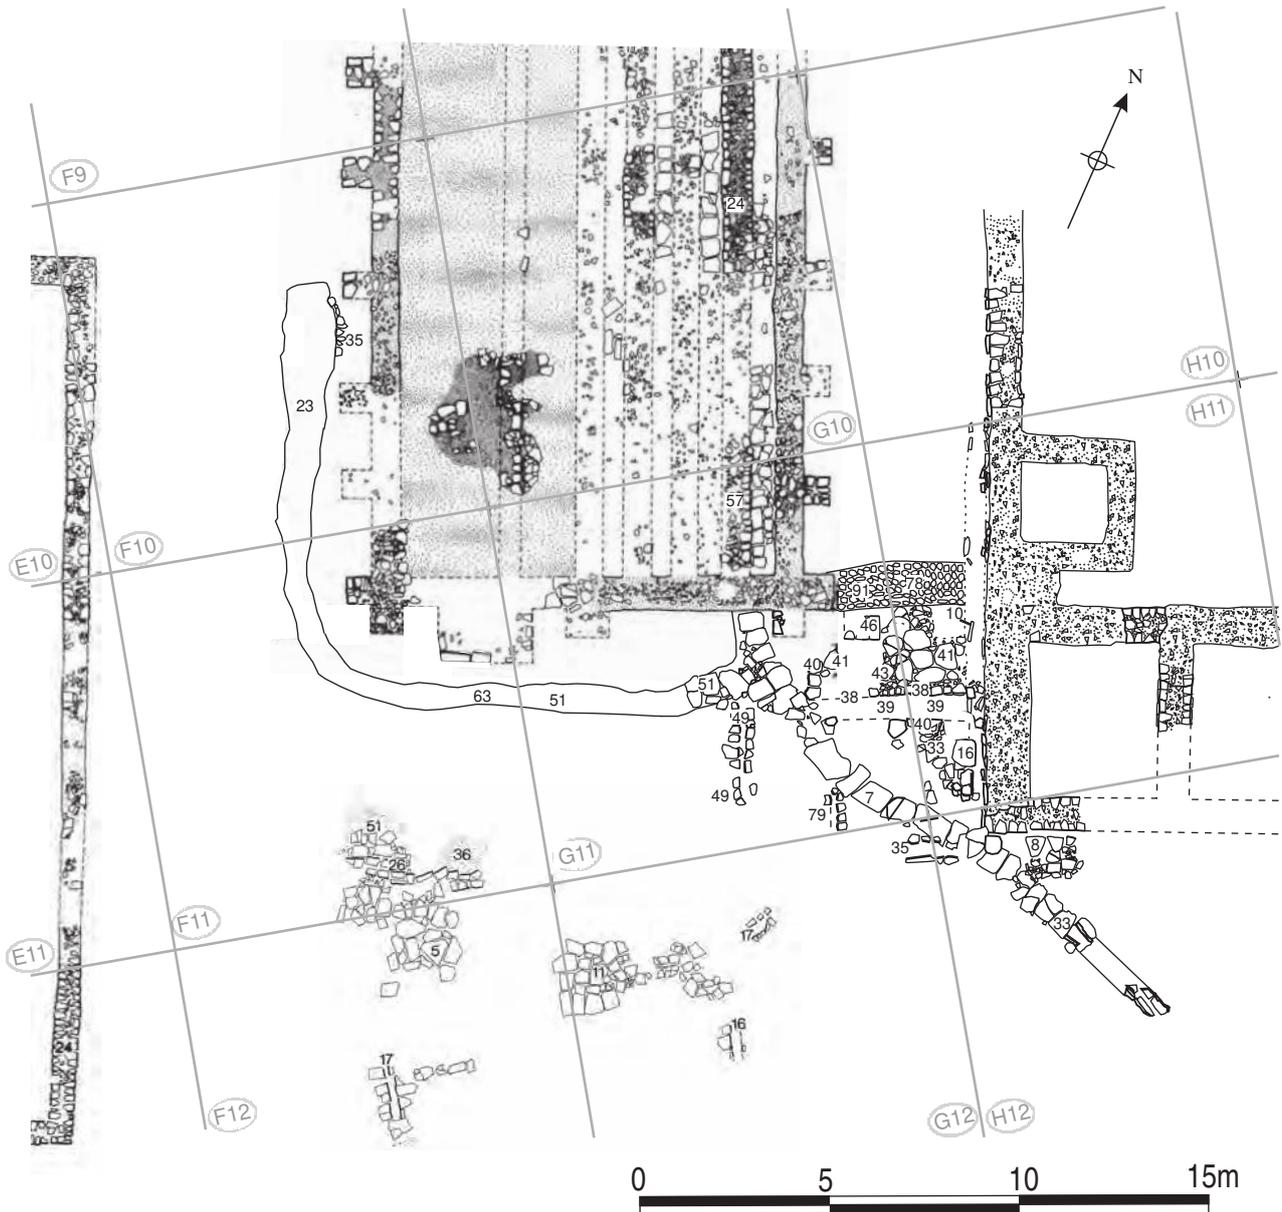
Figure 4.9 The south end of the granary (Phases 3 and 4 showing the south wall of AW and the surrounding storm drains F10:23/F11:63/G11:51 and G11:07/H12:33, at 1:200. Also shown for reference are the flagged floors of the third-century timber building in this area.

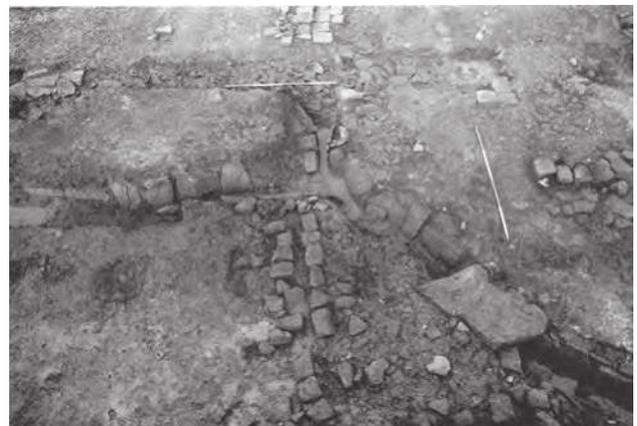
Figure 4.20: Drains G11:49 (foreground) and G11:07/51 (mid left to bottom right) at the south-east corner of the granary, viewed in 9

Further evidence is provided by presence of a series of drains to the south of the granary. Most intriguing was a very substantial drain (G11:07, H12:33; TWM 7687), as much as 1.0m wide at the top, which was constructed using thin sloping slabs to form the side walls and covered by similar flat slabs. This appeared to run from the southern end of the east granary past the south west corner of the *principia* and thence down the *via decumana* and perhaps exited the fort through the south gate where a similarly constructed drain was encountered. It appeared to cut another drain (G11:49; TWM 7215), which was only 0.15m wide and some 2.50m in length, its side walls being composed of small stone blocks, of which only a single course survived (Figs 4.19, 4.20). A further branch of the main

drain joined the previously described section just south of the granary. This branch extended around the south end of the granary, starting from a point not quite half way along the length of the building (F10:23, F11:63, G11:51). Virtually all its side walling and cover slabs had been robbed out at some point. The position of drain G11:07 in relation to the granary is puzzling. It certainly ran right up to the south end of the building. However the drain could not easily have collected rainwater falling from the roof of the primary granary. It terminates at a point immediately west of the granary's east wall, opposite the line of flagging (G11:56) which separates that wall and the most easterly of the sleeper walls (G08:30, G09:05, G10:24, G11:57, H08:24, H09:19) in the east granary. The position of the drain instead suggests that there was a roof valley between the two walls and further implies that the internal wall was rebuilt to form a partition wall supporting one side of the roof valley.

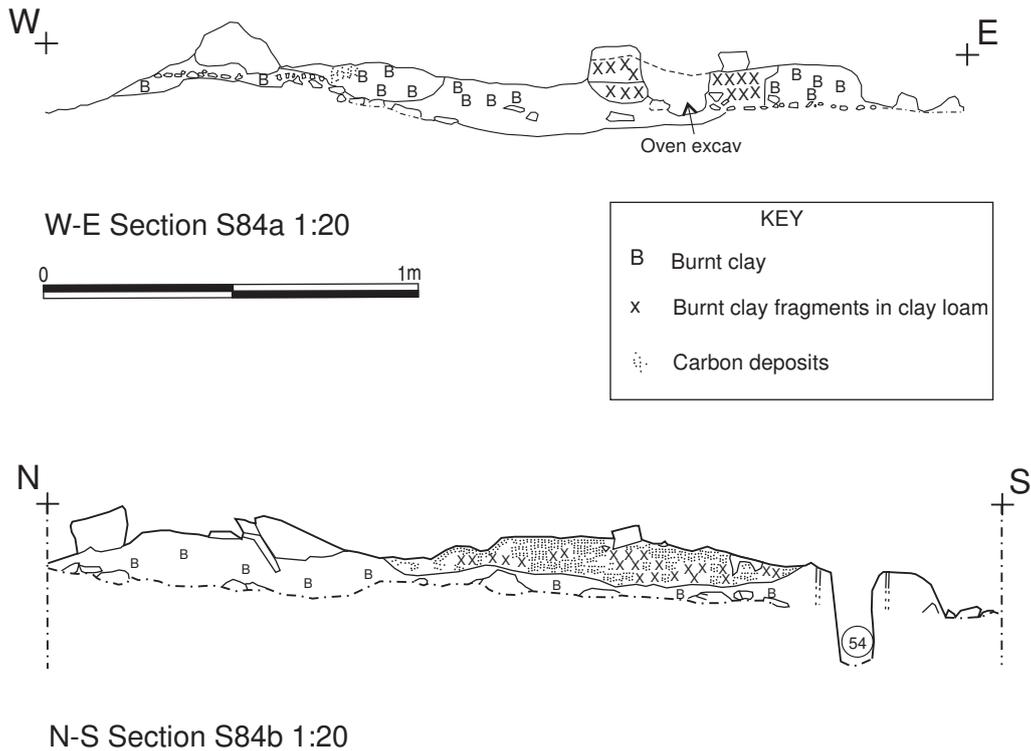
Figure 4.22: Sections 84a and b across drying kiln F08:05, at 1:20.

The traces of a possible corn-drying or -malting kiln (F08:05) were identified tucked in the angle created by the west side of AU and south-west corner of AO (Figs 4.21, 4.22). The kiln took the form of a squarish, clay platform, with two parallel flue channels, orientated roughly north-south, set in it. The easterly of the two flues was the better preserved, comprising two facing lines of flat, roughly worked stones, roughly parallel to the west wall of AU (F08:06) to the east. The two walls were c.0.40m apart and 2.20m long, although only seven facing blocks remained *in situ*, three belonging to the western 'wall', at the southern end of the kiln, and four at the northern end belonging to the east wall (B91/2a–4a, B93/36–37). The north end of the structure, where the two walls may originally have joined, must have abutted the south wall of the forehall AO (F08:13/58). The structure sat on a layer of dark-brown clay with traces of burning (F08:39). The strip of clay and tile between the two walls was heavily burnt, with traces of coal also present, particularly towards the north end. In the case of the western flue, masonry side walls did not survive, but

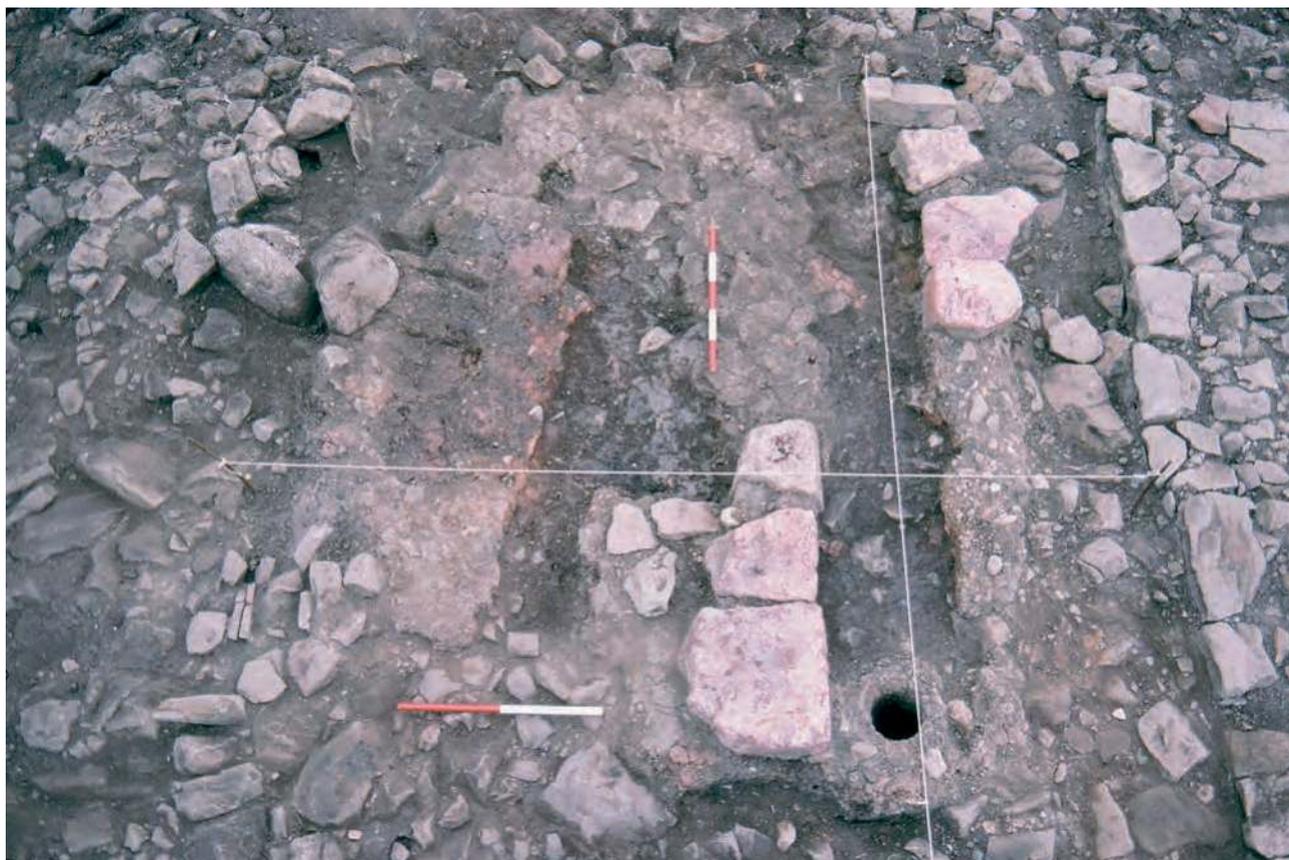
Figure 4.23: Drying/malting kiln F08:05.

The kiln superstructure produced only 0.024kg of pottery, mostly BB2 cooking pot sherds (F08:05). The

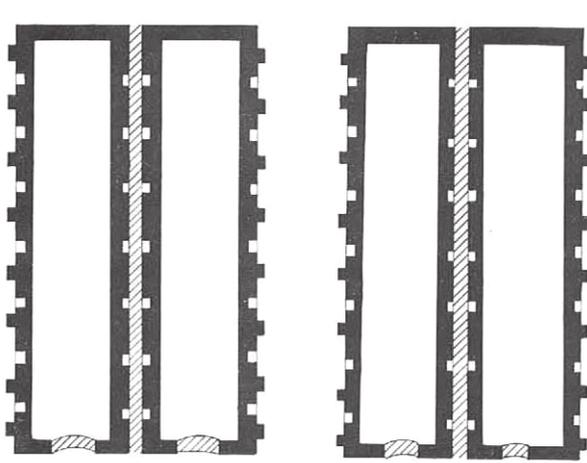
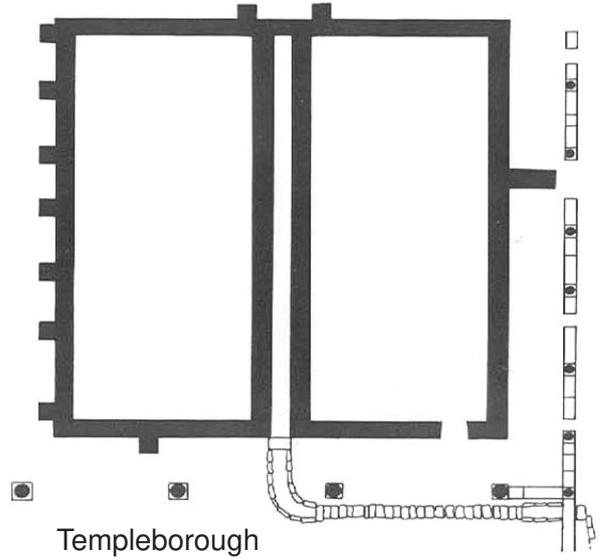
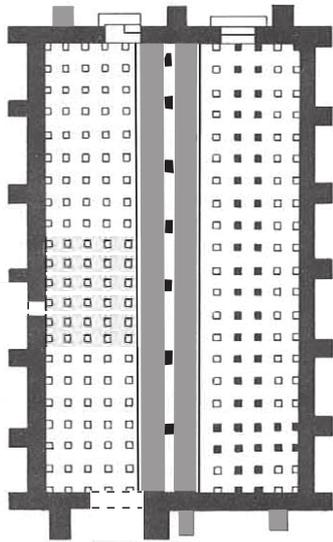
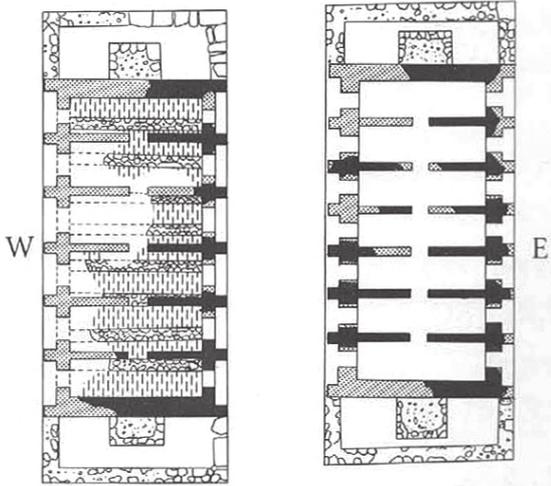
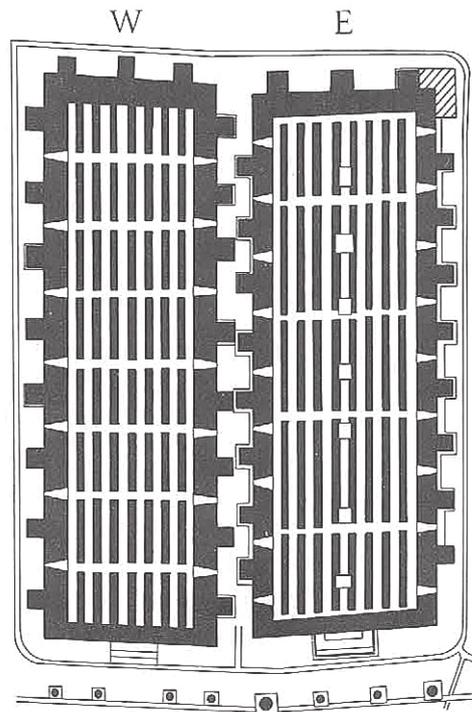
Figure 4.24: Granary comparison plan, showing examples of paired and double-ended granaries, 1:400.

The provision of granaries in auxiliary forts typically conformed to three basic patterns, a single granary, a pair of separate single granaries (Fig. 4.24) or a conjoined double granary (Fig. 4.25), with Wallsend falling into the last category. Double granaries were less prevalent than pairs of separate *horrea*, but they were not uncommon. In some cases these structures were divided midway along by a wall running across the width of the building, as at Birrens, for example, which was also furnished with two single granaries (cf. Gentry 1976, 60–62, fig. 6; Christison 1896). More often the partition wall ran down the length of the building, as was the case at Bar Hill, Brecon Gaer, Hardknott, Lyne and Slack, as well as Wallsend itself

less common than single-ended version, but it is paralleled at Gelligaer (see Fig. 4.24), for example, where both *horrea* were double-ended (cf. Gentry 1976, 78–79, fig. 10). The apparent rarity of this type may be overstated however. Whilst some granaries definitely were single-ended – notably the two late second/third-century examples at Corbridge, the Housesteads granary in both its primary Hadrianic and secondary remodelled forms, and the double *horreum* at Hardknott – many have not been fully exposed and have simply been assumed to be single-ended. The double granary at Benwell is a case in

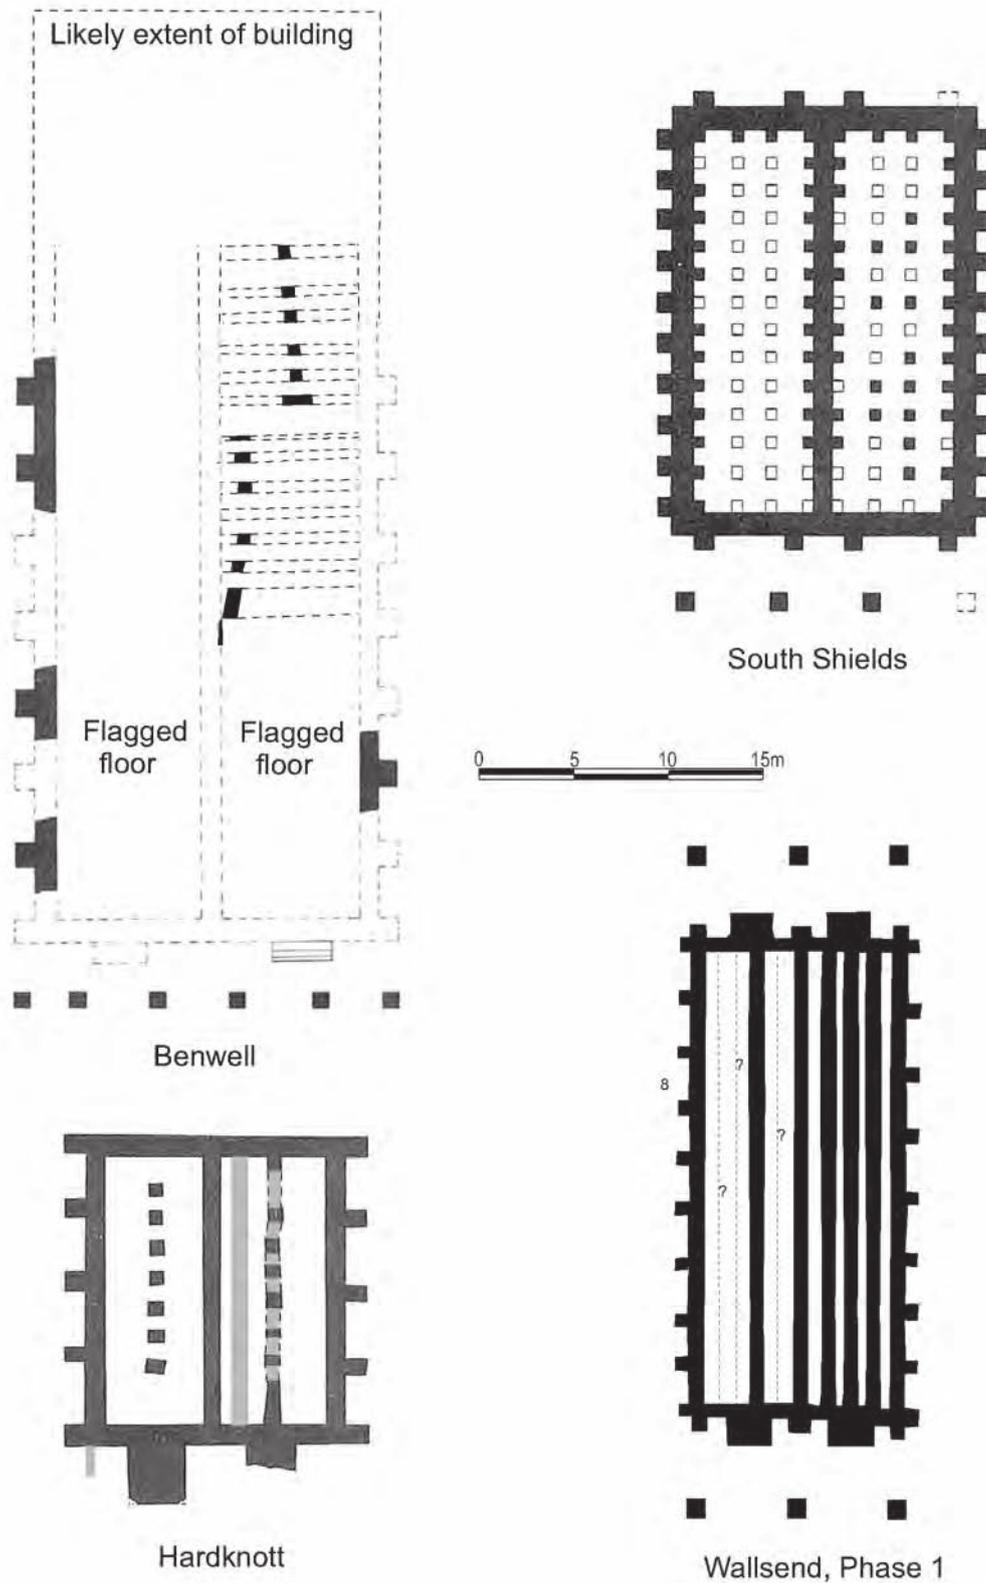
Figure 2 Granary comparison plan, showing examples of double granaries, ①
