# SEGEDUNUM

Excavations by Charles Daniels in the Roman Fort  
at Wallsend (1975–1984)

VOLUME 1: The Structural Remains

Alan Rushworth and Alexandra Croom

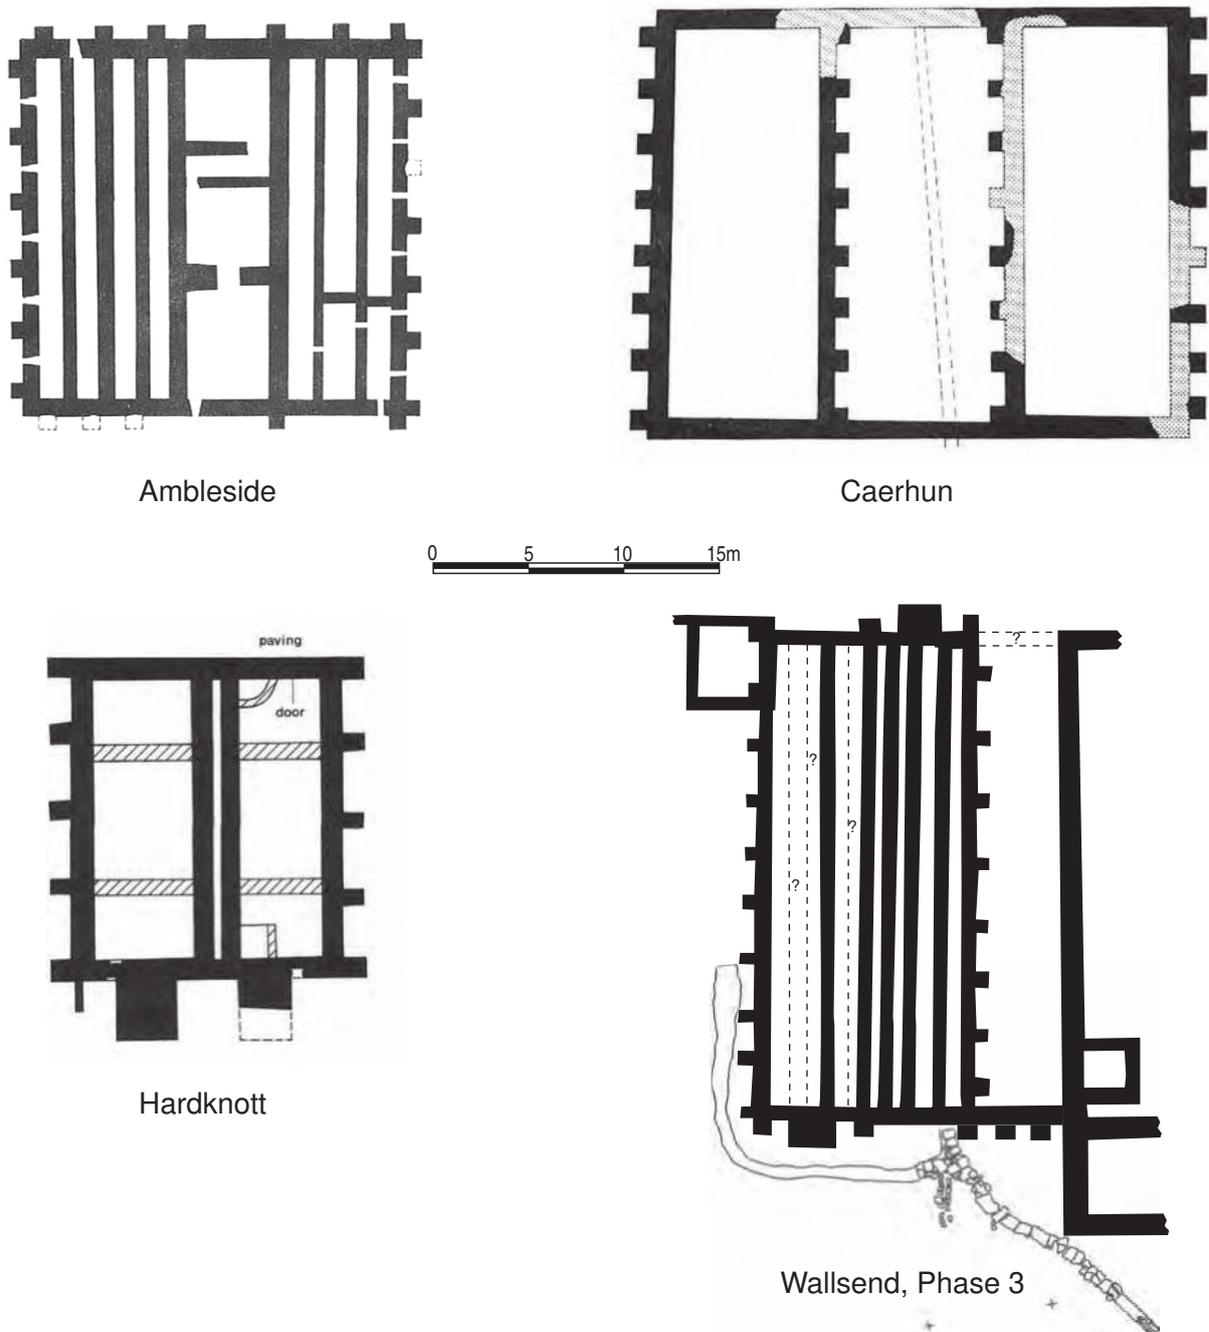
Fig. 4.24 Granary comparison plan, showing examples of granaries with enclosed yards or covered extensions, ①

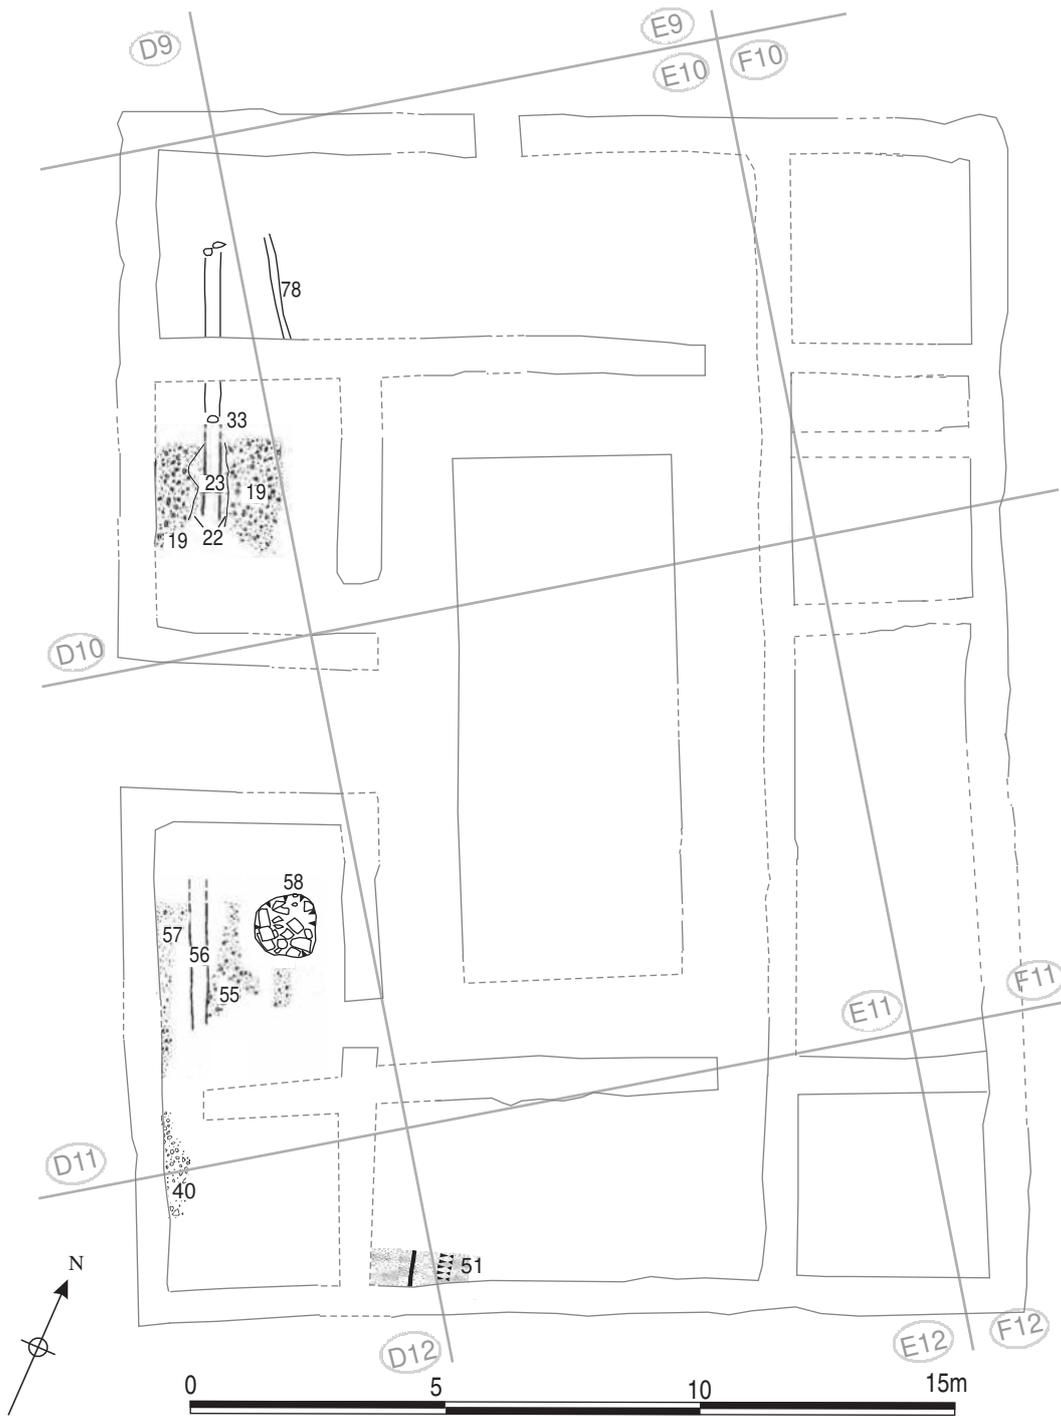
Figure 5.03 Evidence for the timber hospital (Building 21) (at 1:100 scale) with the outline of Building 8 shown for reference.

The construction slot appeared to either cut or be respected by cobbled surfaces revealed within Rooms 1 and 9 of the stone hospital. These surfaces were attributed to Building Phase 1 by Daniels, but their relationship to the construction slot suggests they must be associated with Building 21. In Room 9 the pink clay-filled slot was overlain by a wider strip of grey, clayey loam and smallish cobbles (D10:22) which apparently cut a surface composed of small, well-packed stones (D10:19) and might be associated with the dismantling of the timber building. The presence

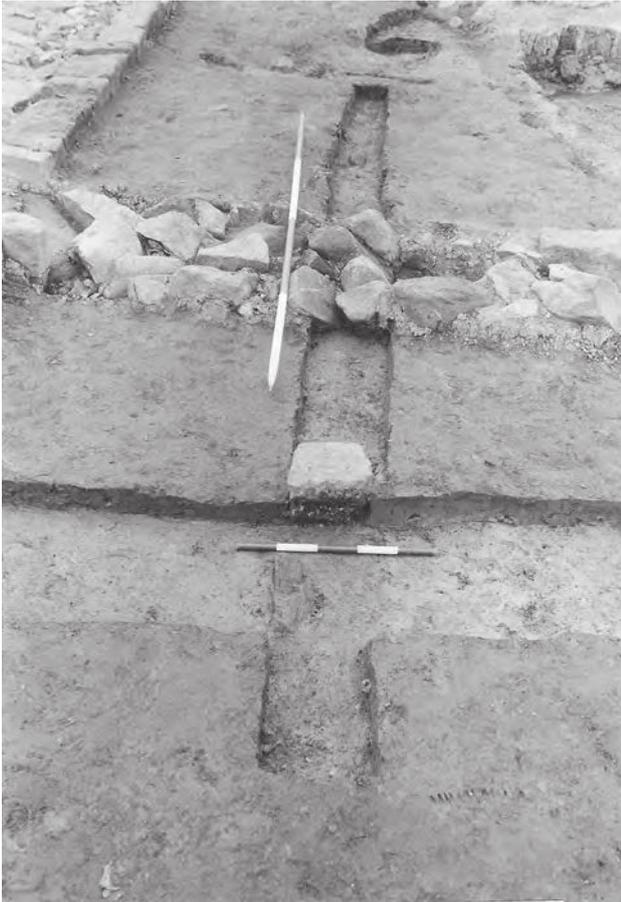
Figure 5.02: The construction trench for the west wall of timber building 21 (D10:33), from the south. The slot is cut by the internal wall foundations D10:33 of Building 8 Phase 1

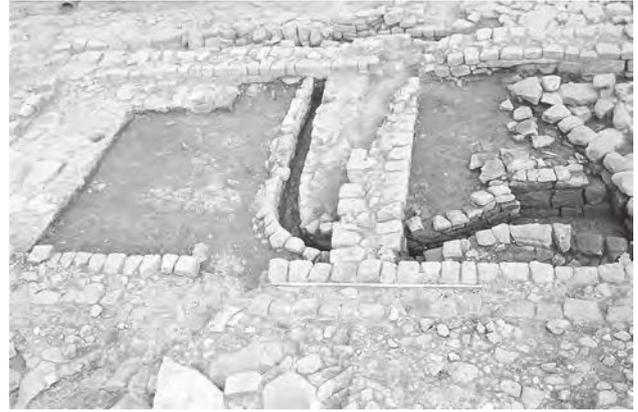
Figure 5.03: Gravel surfaces D12:40 visible beneath the later floor of Building 8, Room 1 (to left), viewed from the west.

To the south of Building 21, a well-packed, worn surface of small cobbles (D12:40) revealed in Room 2 of the stone hospital, immediately to the west of the latrine drain (D12:38), may have formed part of the *intervallum* road surface contemporary with the timber building (probably equivalent to TWM context 5533). It thus might correspond to cobbling D11:57 and D10 19, laid on the west side of the slot further north. Daniels on the other hand considered D12:40 was a later internal floor surface, assigning it to Building 8 Phase 2 (TWM Period 3). The surface was actually level with the bottom of the west wall of the hospital (Fig. 5.03 and cf. Fig. 5.16 below), so it seems unlikely that it was laid as late as Daniels supposed. However the resilient road cobbling may have remained in use as part of the internal floor of Room 2 during Phases 1 and even 2 of that building (no other surface which could be confidently attributed to either Phase 1 or 2 was recognised in the area to the west of drain D12:38).

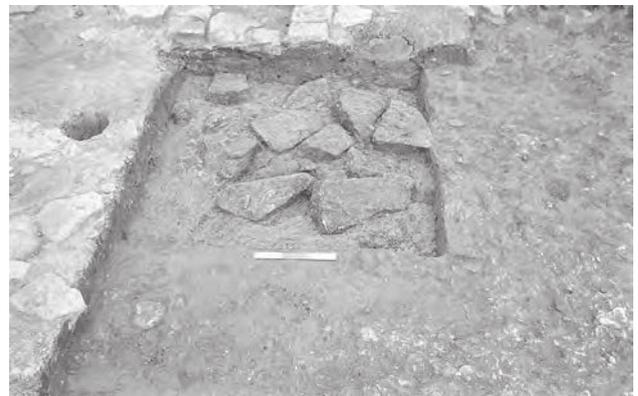
Figure 5.04: The stone filled pit D11:58 exposed beneath the floor of Building 8 Room 1.

orange gravel and grit (D11:57, perhaps equivalent to TWM 5634) was apparent, though here too the odd patch of cobbling was recorded. These layers were covered by clayey, grey loam (D11:53), perhaps associated with the end of the timber hospital. In the centre of Room 1 the cobbled surface was cut by a large pit (D11:58), c. 1.10m in diameter, backfilled by large stones, some of them apparently dressed facing blocks, but no finds. The stone fill was covered by and intermixed with clayey loam (D11:54), like that

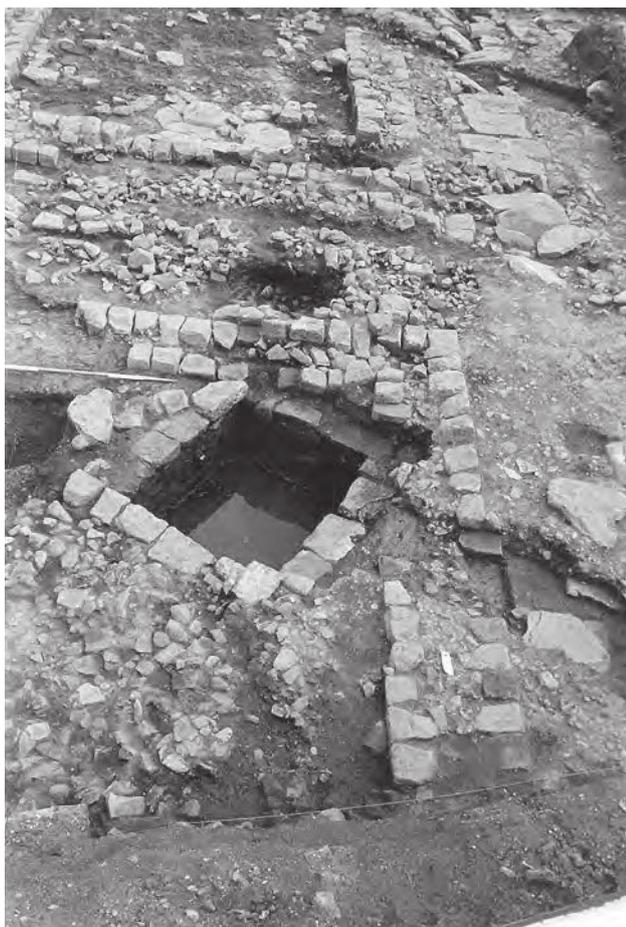
Figure 5.06: The west range and intervallum drain. The section exposed by a modern pipe trench shows the flags of drain side wall D10:11 butting neatly up against the offset course of the west wall (2).

On the west side of the building a line of flags (D10:11), c.0.70m wide, abutted the offset course of the northern half of the west wall and formed part of the *intervallum* surface. The cover slabs of the *intervallum* road drain (D10:27) rested on top of these flags, which served as the uppermost course of the east wall of the drain (Figs 5.06–5.07). This substantial drain was traced from the southern edge of the *via principalis* (and may have originated in the north-west *praetentura* where a comparable drain was recorded running on the same line alongside the

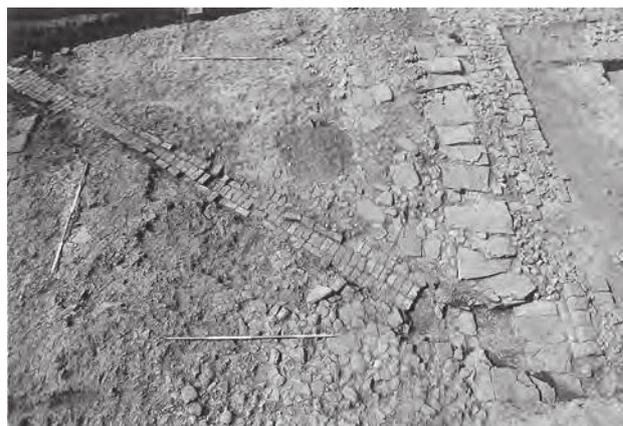
Figure 5.07: The intervallum road and drain beside the west wall of the hospital. Note the way in which the flags belonging to the east side wall (D10:11) of the drain neatly abut the offset course of the hospital wall (3).

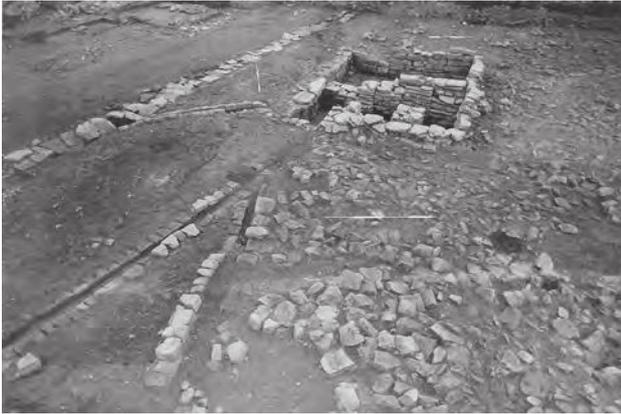
Figure 5.08 The junction of the Phase 1 water conduit south of Cistern 1

The hospital was supplied with water from the large cistern situated in the open area to the north of the building, via a network of stone conduits. Two of the channels leading off the cistern may be associated with Building 8 Phase 1. The first, which took the form of a stone-walled, flag-bottomed conduit (E08:60, E09:06/29), 0.20m wide, ran from the south-west corner of the cistern across the 'assembly area', reaching the north wall of the hospital only 2.60m from the north-west angle of the building. It was well-

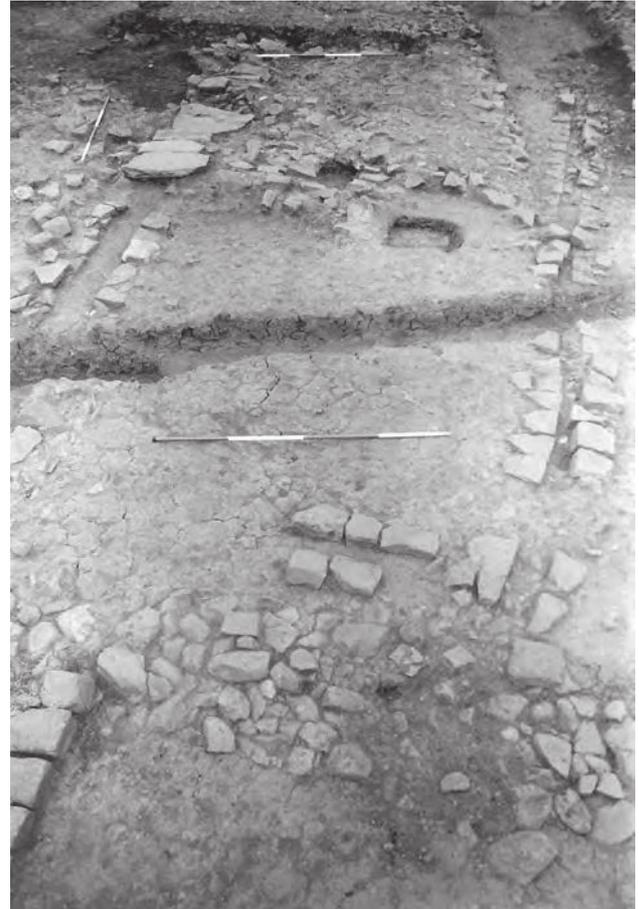
Figure 5.09: Conduit E09:6/29 intersecting gutter D09:15 near the north west corner of the hospital.

An external gutter was recorded running along the north and east sides of the building. Near the north-west corner a very short length (0.85m) of the northern gutter survived (D09:15, E09:50), immediately west of the point where the water conduit (E08:60, E09:06/29) leading from the cistern entered the building. The gutter was perpendicular to the water conduit and

similar in form, comprising a pair of single faced walls, neither more than a single course high, and 0.15m apart. However the conduit walls appeared to cut through the line of the gutter, interrupting latter's channel suggesting that construction of the conduit occurred later than that of the gutter. The east gutter (F10:50, F11:77) was constructed with a single line of

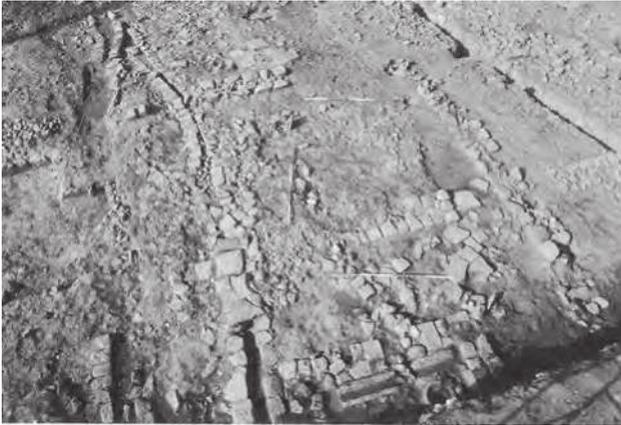
Figure 10 Successive phases of water conduit crossing the north range, from right to left: Phase 1 channel approaching the gap in the courtyard stylobate, centre: Phase 2-3 channel. Left: Phase 4 channel.

The second channel (E09:34, E10:62), which branched off the first conduit 3.00m south of the cistern, entered the hospital through the doorway not quite midway along the north wall (Fig. 5.10). This was certainly used to flush the latrine during Building 8 Phase 2, when it continued directly across Room 8 and down the west side of the courtyard to the south-east corner of the building. However the conduit must have originated during Phase 1. A line of small stone blocks, which can be seen on Figs 5.10 and 5.11, extending across the north portico, evidently represented one side wall of this conduit in its first phase. Having passed through Room 8, the channel veered in a south-easterly direction across the portico and fed water into the courtyard gutter (which was only in use during Phase 1). Another sluice, perhaps following the line of the Phase 2 conduit via Room 1, may have connected the lowest point of the gutter in the south-west corner of the courtyard to the latrine pit in Room 2. This rather elaborate network of conduits and gutters would thus have enabled water to flow all the way from the cistern to the latrine, though it

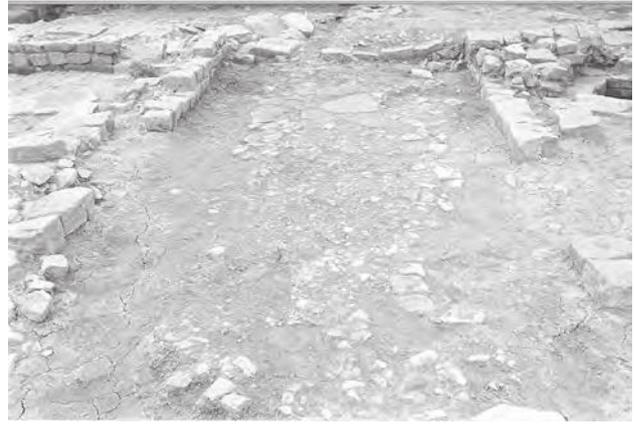
Figure 11 Phase 1 surfaces in the entranceway

The principal entrance into the building was via a passageway 2.40m wide and 5.00m long, surfaced with gravel and flags (D11:43). The door opened inwards and was probably double-leafed, although only the southern door pivot (D11:48) was found. The small extant pivot hole, D11:48, could scarcely have housed a shaft capable of sustaining the weight of a door large enough to close the entire entrance (Fig. 5.13). The leaves were checked by a threshold consisting of a row of seven neatly-cut blocks set on edge (D11:44 – comprising one short stone and six long, of which one had been removed by modern pipe D11:05). Inside, bands of unmetalled clay on the south and north sides of the passageway (D11:45–46), 0.50 and 0.35–40 m wide respectively, were tentatively interpreted as evidence for benches (visible on Fig. 5.12). The fact that the gravel and flagged passage surface did not extend over these clay bands, which were simply extensions of the underlying pink clay foundation of the passage walls, was thought to reflect the presence of superimposed structures – wooden

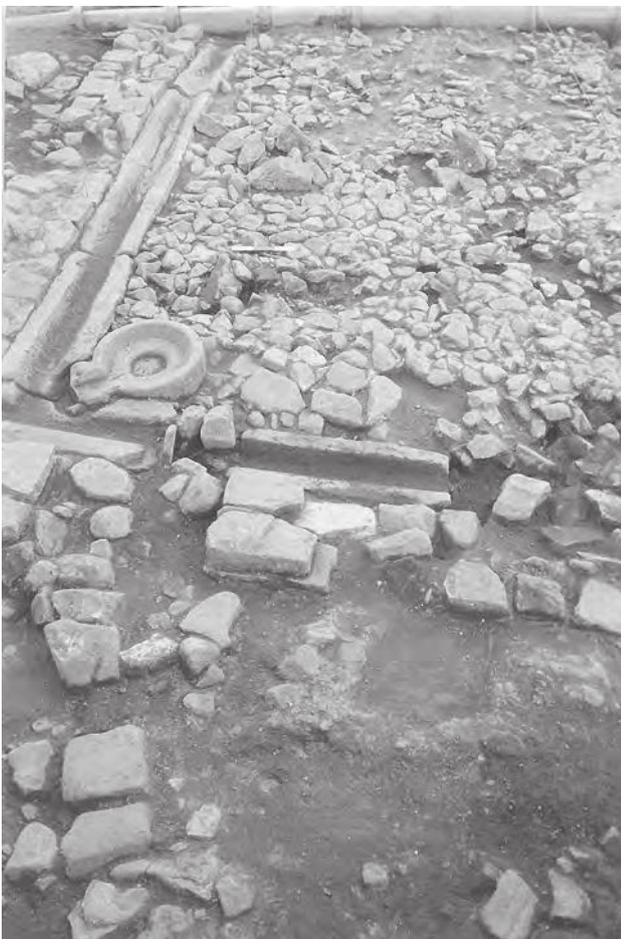
Figure 12 The north east corner of the Phase 1 courtyard showing the surviving side wall of the water conduit passing through the gap in the stylobate.

in the northern stylobate near its north-east corner, where the water channel, which crossed Room 8 and the north portico, was connected to the courtyard gutter, as evinced by the surviving remains of one the channel's side walls (see above, Fig 5.11). The central part of the courtyard (which measured 9.25m by 3.00m) was surfaced by small cobbles showing hardly any wear (E10:27, E11:53). In two of the corners, the north-east and south-east (and presumably originally in all four) were circular, carved stone water basins (E10:22, E11:36), with external and internal diameters of 0.49m and 0.36m respectively. The basins were 0.06m deep, with a central area in each basin, 0.19m in diameter, recessed a further 0.035m. The basins were connected by spouts to carved stone gutters running alongside the stylobates (Fig. 5.15). The surviving 14 gutter stones from the eastern half of the courtyard were c. 0.30m wide and varied markedly in length from 0.66m–1.10m (north: E10:24; south: E11:44 east: E10:23, E11:41). The system was doubtless designed to collect rainwater running off the roof. The gutter on the west side, like the adjacent stylobate, plus the north-west and south-west basins had been entirely obliterated by the later conduit (E10:25). Around the courtyard the colonnade walkway, 1.60m wide, was surfaced with a mixture of cobbles and flags, all well-worn (north: E10:31; east: E10:21, E11:34; west: E11:52). A patch of sandy gravel (E10:26) towards the western end of the north walkway may represent part of the bedding layer for this surface. A large BB1 cooking pot (E11:45) 'found *in situ*' towards the south end of the west walkway and abutting the west stylobate foundation was probably set into the walkway surface.

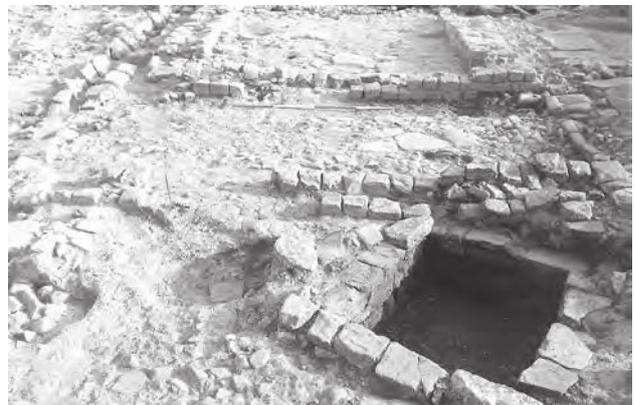
Figure 13 The entranceway from the north with the Phase 1 surfaces exposed and south pivot stone and threshold blocks visible.

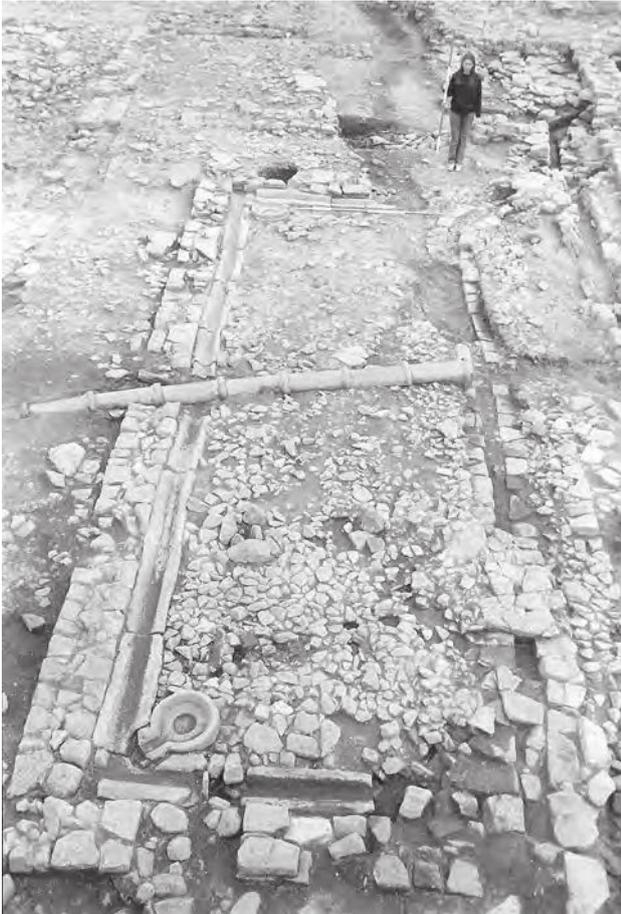
Fig re 54 The courtyard from the north.

The courtyard had a stylobate, 0.45m wide, on all four sides, which presumably provided a low base for columns supporting a lean-to roof over the surrounding walkway, though no trace of the colonnaded superstructure survived. The stylobate took the form of a low wall, composed of thin, fairly neatly cut stones with little core (north: E10:20; south: E11:28, with foundation E11:49; east: E10:21, E11:18; west: E11:51). It nowhere survived to more than two courses and perhaps never originally stood any higher, as the few extant stones of the upper course which were present appeared to form a cap of interlocking flat slabs leaving scarcely any of the core exposed. The western stylobate had been largely removed by the later water conduits, but the rubble foundation remained (E10:29, E11:50). There was a neat break

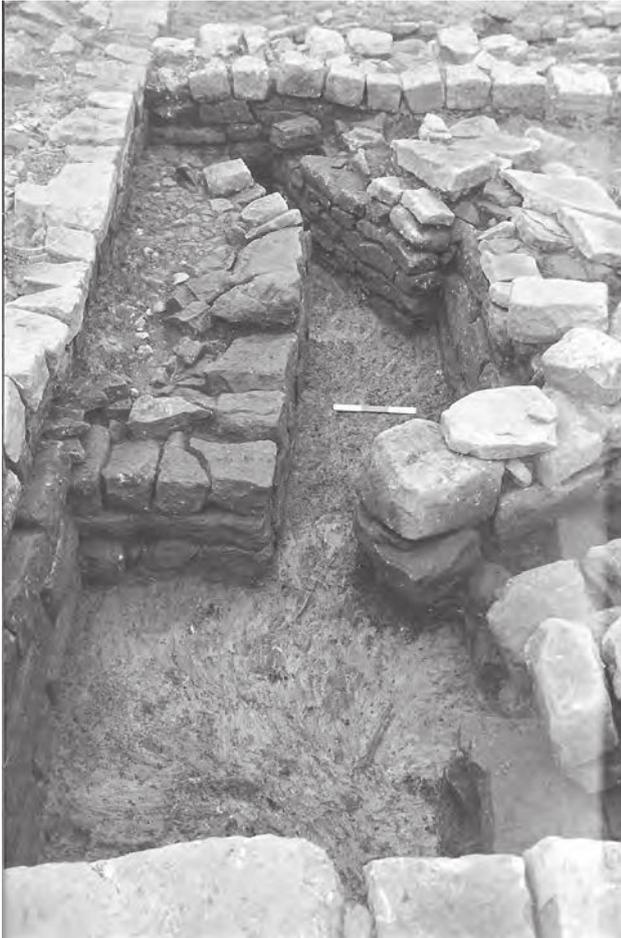
Fig re 6 The latrine pit and Phase 1 channel to the north

A stone-lined cesspit (D12:36), measuring 1.50 east-west by 1.30m north-south, was located in the south-west corner of the room (Figs 5.16, 5.17). This was probably the very first part of the building to be constructed. The sides of the latrine were built of large blocks up to 0.45m long and 0.20m high, this stonework being noticeably more substantial than the south and west walls of the hospital, which were set on the corresponding walls of the latrine with a careful offset c. 0.10m wide. The east side was largely removed by subsequent reconstruction, but a few of the original facing blocks were recognised beneath the later water channels. A stone-lined drain (D12:38) fed into it from the north. The drain was 0.60m wide and 0.50m deep and stood three-four courses high. To the west of the drain, a well-packed, worn surface of small cobbles (D12:40) may have formed part of the earlier *intervallum* road surface reused as part of the internal floor surface in Room 2 during this phase. No trace of the cobbling was recognised on the east side of the drain, where a patch of flags overlying a mixed clay layer (D12:45) might have been primary, but could also have belonged to the building's second phase. The outlet, which was 0.65m wide and rose the full height of the cesspit walls, lay on the south side. Two 0.80–0.85m long rectangular slabs (D12:13) formed the lintel over the outlet. The base of the pit was formed by the natural clay partially covered by a deposit of light grey silt between the water channel inlet and sewer outlet. Overlying this silt was the main fill of the pit, a very dirty, tacky, dark-brown clayey soil (D12:34), which was exceedingly moist. Assuming the cesspit was cleaned out periodically, the bulk of this fill will have built up late in the life of the latrine, or even upon its disuse, but the lowest part of the fill might have been deposited at a much earlier stage, depending on how thorough the cleaning was. The course of the outlet channel beneath the *via quintana* was not exposed in 1977, but was revealed in 1997–8 (see Hodgson 2003, 130, 158–61, fig 90) and was shown to be of one build with the cesspit south and west walls.

rainfall was certainly collected from the courtyard roof into a system of shallow basins and guttering around the edge of the central cobbled area. This source was apparently supplemented by water from Cistern 1, which was channelled through a stone conduit across the north range and portico to feed into the courtyard gutter near the latter's north-east corner. The gutter in turn conducted all the water to the south-west corner of the courtyard, its lowest point. From there the water may have been channelled to the latrine pit through the southern part of Room 1, following the same route that was employed in Phase 2. This entered the Room 1 through a doorway in the south-east corner, ran westwards to the south-west corner of the room where it curved sharply round and entered the latrine chamber through another doorway. However the early arrangements in the south-west corner of the courtyard have been obscured by later alterations. Finally, it is also possible that the pit was sluiced out manually on a regular basis (Hodgson 2003, 129).

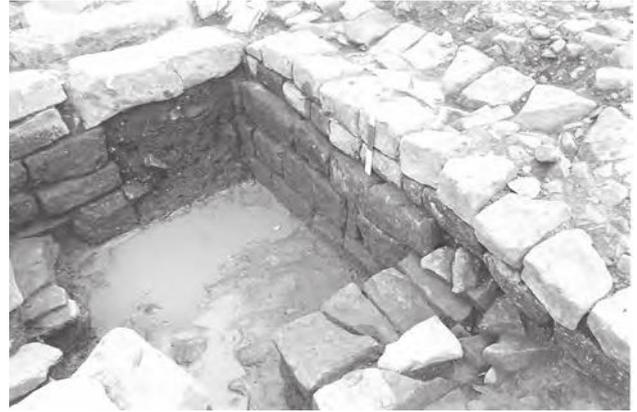
Fig re 7 The latrine cess pit from the north east side wing the outlet opening the large masonry of the pit side walls and offset for the hospital walls.

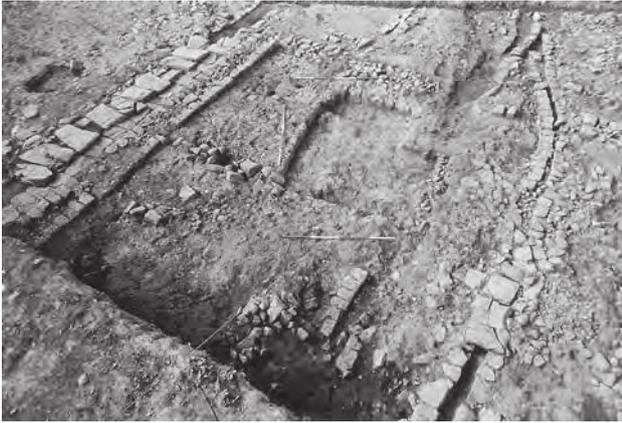
Figure 5.20: The intervallum drain along the west wall of the hospital plus the phases of water conduit entering the hospital.

A major alteration was also made to the course of the water channel (E09:34, E10:62), which entered the hospital through a doorway almost midway along the north face. This originally fed water from Cistern 1 into the peristyle gutter in the north-east corner of the courtyard (see above Phase 1). The channel was now realigned to run directly to the latrine in the south-west corner of the building, diverging from the earlier course – which must have become redundant and had largely been robbed out – in Room 8 and following a north-south course across the courtyard (E10:25, E11:42), where some of its cover slabs still remained *in situ* (Fig. 5.20). It then turned westward to enter Room 1 through the pre-existing doorway, running along the south side of the room into the south-west corner where it turned sharply southward to pass through the doorway connecting Rooms 1 and 2 (D11:33 – see Fig. 5.21). In the north-west part of Room 2, a junction was made between the new channel and the earlier stone channel (D12:38) leading into the cesspit in the southern part of the room. The secondary conduit was significantly narrower than primary channel in Room 2, which resulted in a slightly awkward junction where the two eastern side walls met (Fig. 5.22; cf. Fig. 5.16 above). It is likely that the channel was originally covered by capstones, though none survived in Rooms 1 and 2, having probably been removed for use elsewhere when the conduit went out of use and was backfilled.

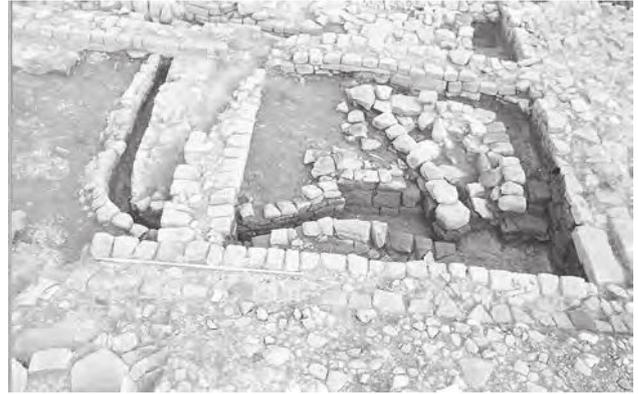
Figure 5.21: The latrine in Room 2 and the Phase 2 and possible Phase 1 conduit in Room 1.

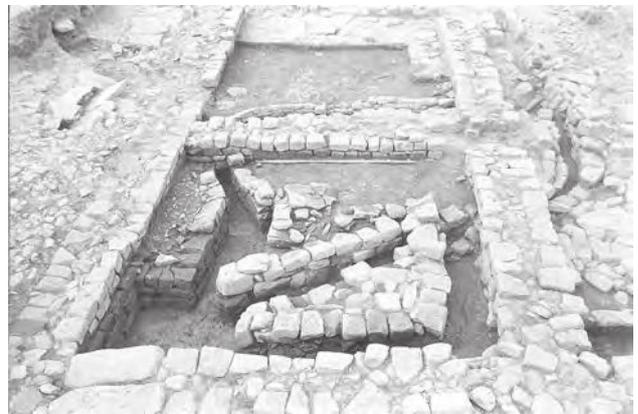
Figure 5.22: The latrine in the south-west corner of the hospital (Room 2) showing successive phases of water channel.

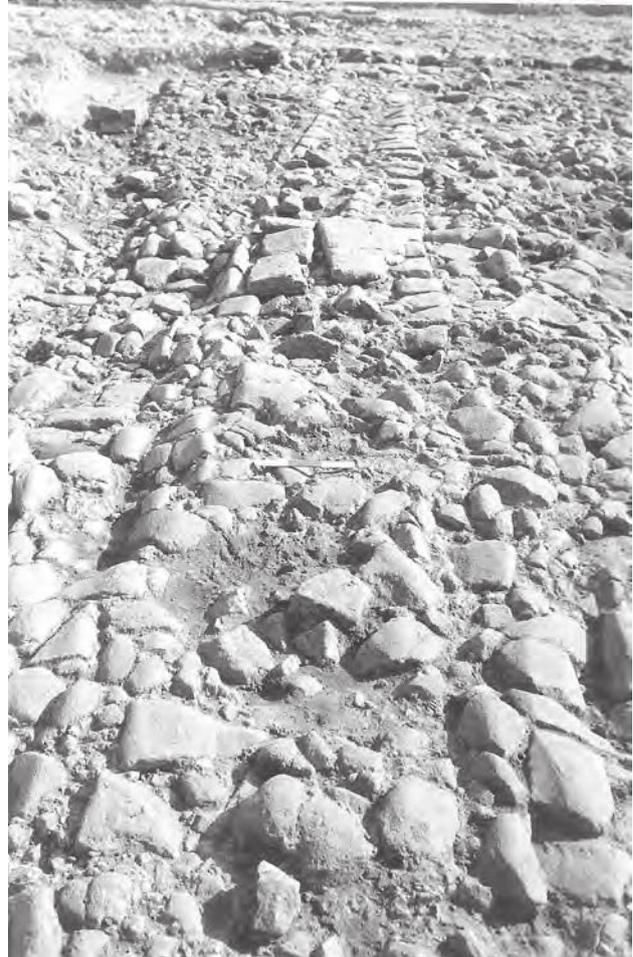
Figure 5.23 Phase 2–3 road surfaces overlying the east wing of the hospital.

This Phase 2 roadway showed signs of heavy wear, with deep rutting on the surface and areas of patching on the north-south carriageway (contexts F11:38–39; see Figs 5.23–5.24; cf. Fig 6.21 below). The ruts were also particularly pronounced on the north-south carriageway and seemed to run past the south-west steps of the granary. The former east wall of the building had been demolished down to its bottom two or three courses, and these surviving remains too were heavily rutted with the stones knocked out of alignment. This rutting was probably caused by the movement of laden supply carts towards the granary and is a common characteristic of roads which have reinforced surfaces in them, like kerbs that have been incorporated into the surface, or, as in this case, where a building has been demolished and the lower courses of the walls used in the road surface. The carts probably entered via the *p rta quintana*, continued along the *v a quintana* and turned north at the south-east corner of the Phase 2 hospital. They were probably unloaded beside the south-west steps of the granary.

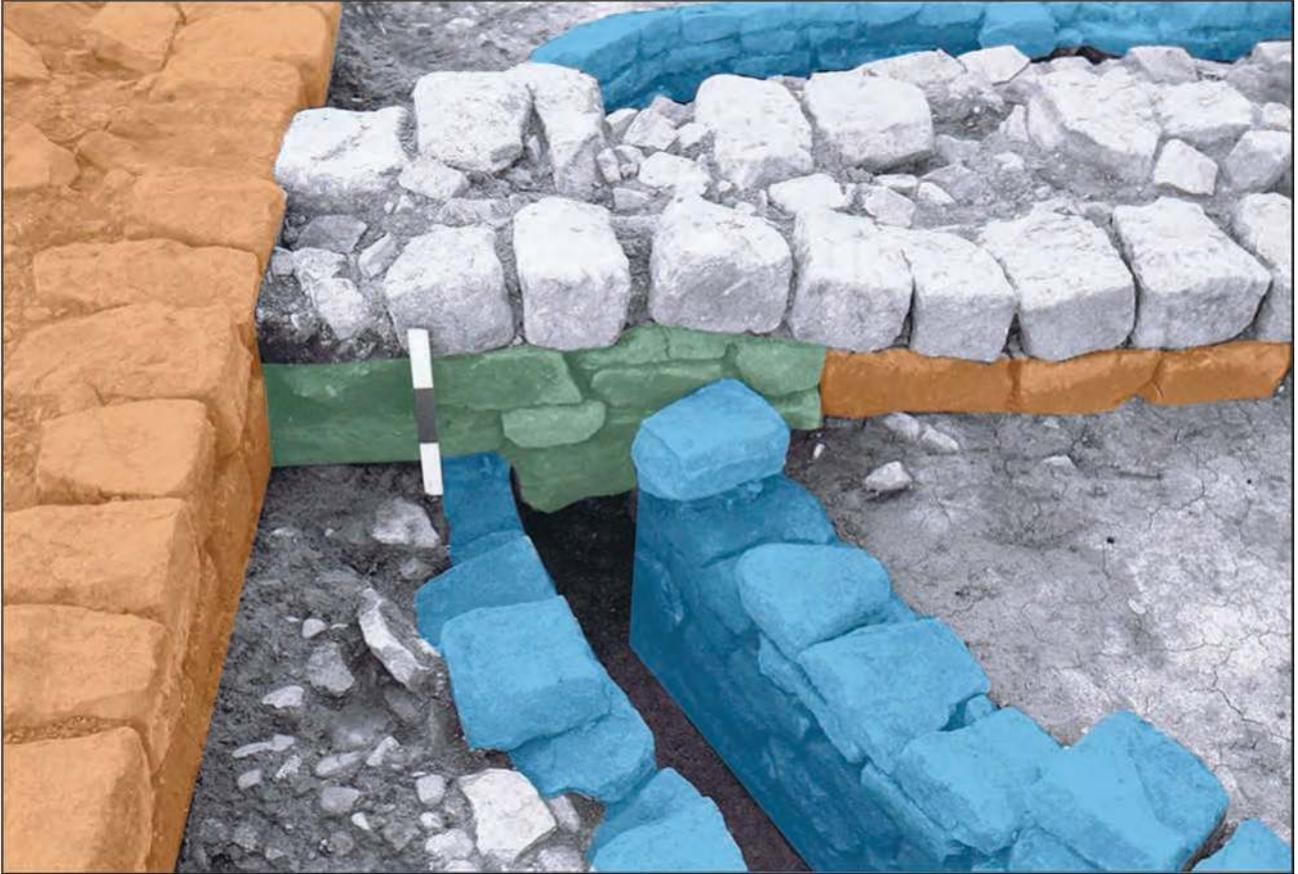
Figure 5:26: The passage of the Phase 2 (possibly Phase 1) conduit between Rooms 1 and 2. Pink represents Phase 1 walls. Blue: the stone conduit. Green: blocking of the doorway (Phase 3) with the wall later being rebuilt over the top.

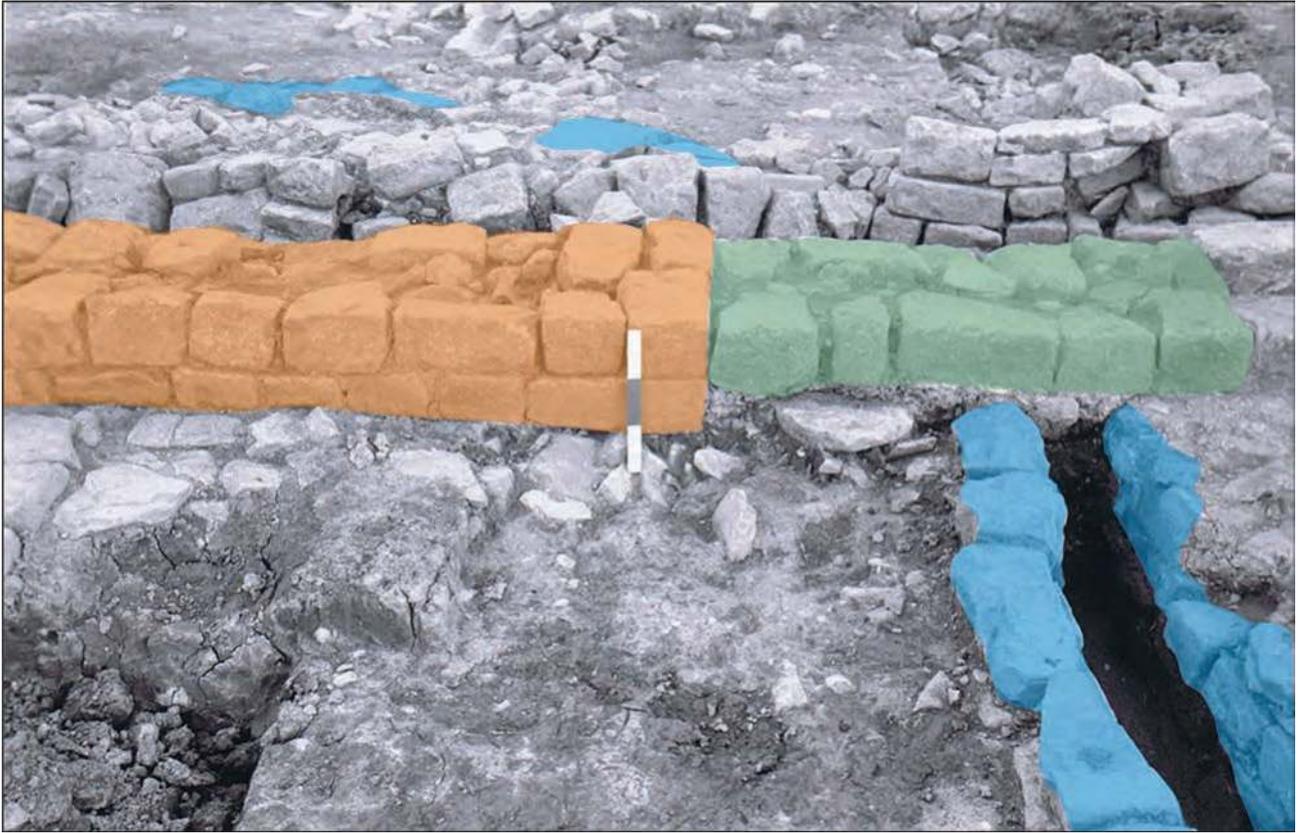
Figure 5:27: The passage of the Phase 2 conduit from the courtyard through the doorway into Room 1 (foreground). Pink: primary east wall of Room 1. Blue: the conduit. Green: the Phase 3 blocking of the doorway, after this conduit had been replaced.

doorway, opening onto the courtyard, was situated at the south end of this wall. A later blocking of this doorway clearly butted up against the primary north jamb (see Fig. 5.28 below). The width of this doorway was uncertain as the southern jamb was more difficult to identify than its northern counterpart due to later rebuilding and the obliteration of the masonry at the junction between Rooms 1, 2 and 3 by a modern earthenware pipe (E11:20), but was probably between 0.90–1.10m. The south wall (D11:10), which was shared with the south-west corner latrine room, displayed evidence of later rebuilding. Although this wall survived to a height of two courses and more at the west end, only the lowest course was original and was actually narrower than the course above, which must belong to a later rebuild. There was a neat break in the masonry of the lower course towards the west end of the wall, indicating the presence of a doorway connecting Room 1 with the latrine (see Fig. 5.28 below). This doorway, like that in the east wall, was certainly utilised during Phase 2 of the stone hospital to enable a water conduit (D11:33) to reach the latrine cesspit and, like the other doorway, was subsequently blocked, probably when the conduit was taken out of use. Thereafter the wall was totally rebuilt. The east end of the wall had been destroyed by the modern pipe (E11:20), which made it impossible to determine conclusively the sequential relationships between this wall, with its later rebuild, and the adjoining north-south walls, D11:20 and D12:05 (the east wall of the latrine), which themselves must have incorporated at least partially rebuilt elements.

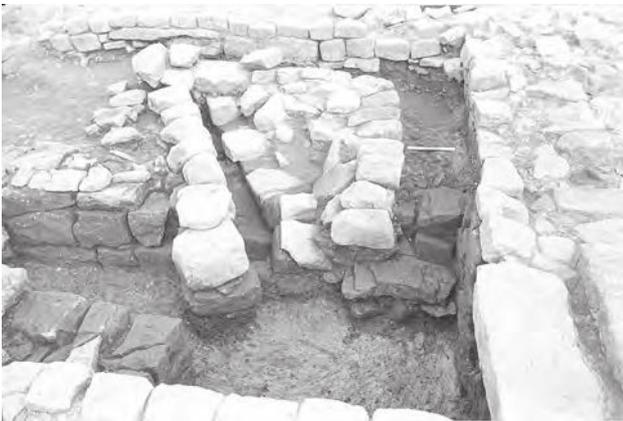
Figure 5:28: The latrine, from the west, showing the Phase 3 and 4 channels.

between the upper courses. The side walls were built of small, neat stonework. Larger stonework was employed in the stretch approaching the cesspit, where the north-west wall (D12:23) of the channel survived up to three courses (0.40m) high and two courses of its south-eastern counterpart (D12:35) remained (cf. Fig. 5.28). The terminal of the conduit cut through the

former east wall of the cesspit and projected into the pit, virtually closing off the southern end of the primary and now backfilled channel. Thus, by straightening out the course of the channel to a considerable degree, the new arrangement was presumably intended to improve the flow of water into the cesspit.

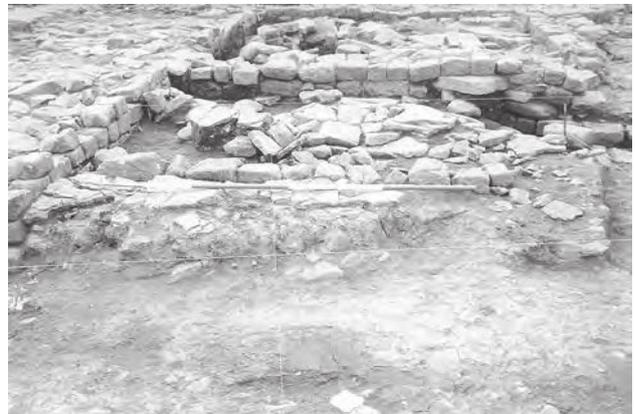
Figure 5:29: Room 3: remains of Phase 3 wall E12:35 separating Room 3 (foreground) from an enlarged Room 2. The Phase 4 wall with capstone over the drain is visible in the background. Also visible beyond wall E12:35 are the fragmentary remains of flagged floor E12:04, dark clay makeup E12:03 and V-shaped drain E12:02 associated with timber building N, overlying the flagged floors of the hospital.

In what remained of Room 3, now reduced to an internal length of 5.40m–5.85m, there was a flagged floor (E12:36) butting up against the east face of wall E12:35. Only a narrow area of this flagging survived, noticeably cracked with wear, right beside the wall, the remainder having been removed by nineteenth-century conduits (E11:07; E11:04/16; E10:07), but it was once probably an angular floor surface of evenly-cut squarish slabs. In the eastern part of the room a fragmentary floor surface, consisting mostly of small slabs and very shattered flags (E12:20), may belong to this phase and may indeed form the continuation of flagging E12:36, though much damaged. In addition a line of three stones (E12:29), was interpreted as possibly forming part of a north south dividing wall. This may, however, be a misleading impression created by the destruction of the deposits immediately to the west and partial dislocation of the three stones by the post-Roman conduit and disturbance

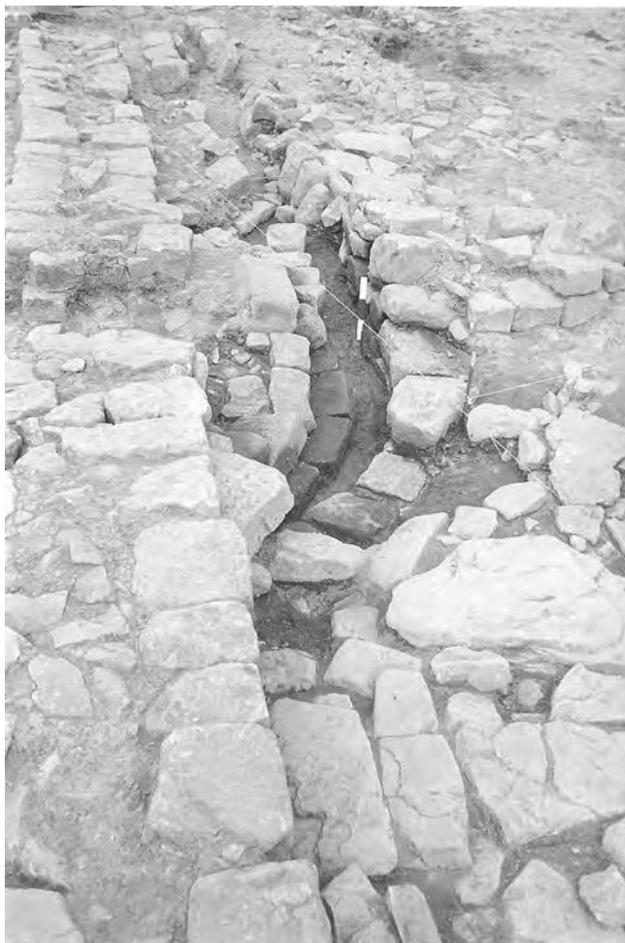
Figure 5:30: Phase 3 and 4 conduits entering Room 3 from the courtyard.

The defining feature of this phase was the re-routing of the water channel from the south-west corner of the courtyard to run southward into Room 3 and then diagonally across Room 2 to empty into the north-east angle of the cesspit. This meant the earlier, circuitous channel through Rooms 1 and 2, with the pronounced and conceivably problematic bend where it negotiated the doorway between the two rooms, could now be taken out of service and backfilled. The doorway between Rooms 1 and 2 was blocked. The blocking wall, between three and four courses of which survived, cut the uppermost courses of the drain walls, one course of blocking actually sitting in the channel, D11:33, with some fill beneath, demonstrating that this occurred whilst the conduit was being taken out of service (see Fig. 5.26). The backfill in the redundant channel overlying a 30mm thick deposit of yellow-grey drain silt (D11:50, E11:40) was similar throughout, consisting of a mixed, dark greenish-grey, clayey loam, siltier with much charcoal flecking and coal towards the bottom (D11:49, E11:39), and with a lot of pink clay and stone in the upper packing (D11:40, E11:38). Several capstones were found in the fill in Room 2 (D12:37). The doorway between the courtyard and Room 1 was also blocked and a new entrance provided at the north end of the east wall. In this case the blocking (D11:31) was simply carried over the drain fill (see Fig. 5.27), indicating that this operation was accomplished after the modifications to the water channels had been completed, though not necessarily long after. The new, 0.75m wide threshold (E11:24), in the north-east corner of the room, was composed of small, flat sandstone slabs and a flagstone with a peck hole, presumably to hold the door pivot, and now, if not earlier, the room was floored with flagging D11:16 (see above Phase 2).

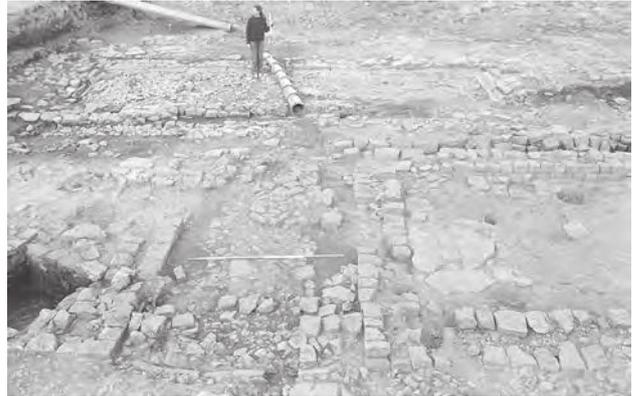
Fig re 5 Th Ph se 4 entranceway

The doorway into the building was narrowed by the construction of short responds on either side (D10:08, D11:12). The responds were 0.58m wide and

their respective lengths were 0.40m–0.45m (north) and 0.60m–0.65m (south), reducing the width of the doorway to 1.50m. The south respond sealed a deposit of light yellow-grey clay loam (D11:47) which in turn lay on top of the stone pack on the south side of the entrance (D11:42).

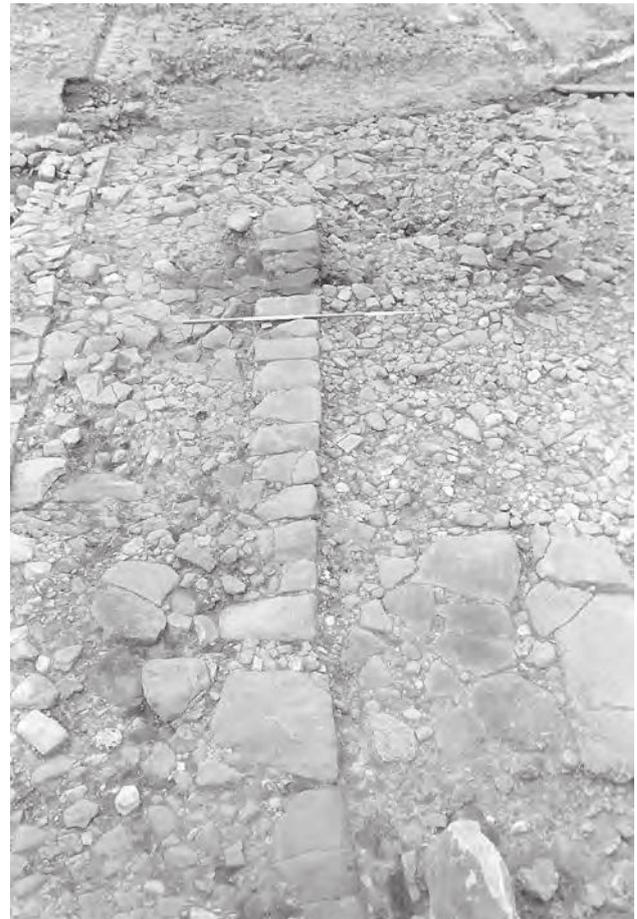
Figure 5.6 The *via quintana* south of the hospital with the late Roman level exposed including the kerb line.

The surface incorporated a line of worn flagstones (in D12:12) which ran for 7.00m along the centre of the carriageway, parallel to the south wall of the hospital (Fig. 5.36). The flags varied in width from 0.20m–0.60m and were interpreted as the cover slabs of a central drain, though no attempt was made to lift them and the fact that they were all flush on the south edge with tails laid towards the north is more characteristic of road kerbstones than drain cover slabs (and this is how they were interpreted in 1997–8: see Hodgson 2003, 160–1). The line of flags changed direction slightly at the west end of the excavated area and were in line with slabs forming the northern side of the central drain which led through the *porta quintana*. These formed part of the penultimate road surface revealed in the *porta quintana* (TWM 7044, probably equivalent to Daniels' C12:04). The metalling to the north of the line of slabs was largely removed

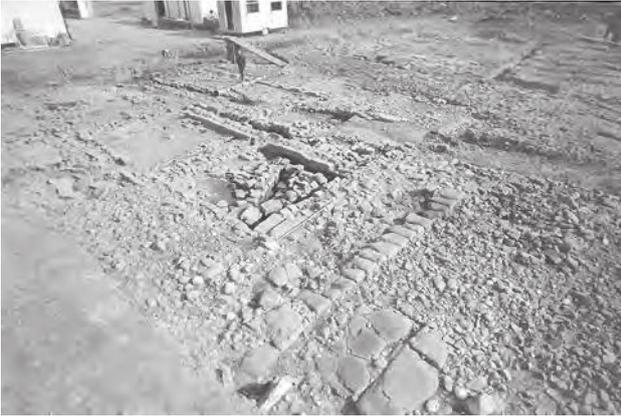
Fig re 5 37 The *via quintana* beside the south west corner of the hospital with predominately late Roman surfaces exposed. The flags to the south of the kerb may be a relic of an earlier road surface (early 3rd century – TWM Period 3).

Like those in the gate passageway, all the *via quintana* slabs were heavily worn with wheel ruts running the full length of the kerb, being especially pronounced on the five most easterly stones. These ruts were similar to those observed on the Phase 2 road surface east of the hospital, and were presumably caused by heavy cart traffic.

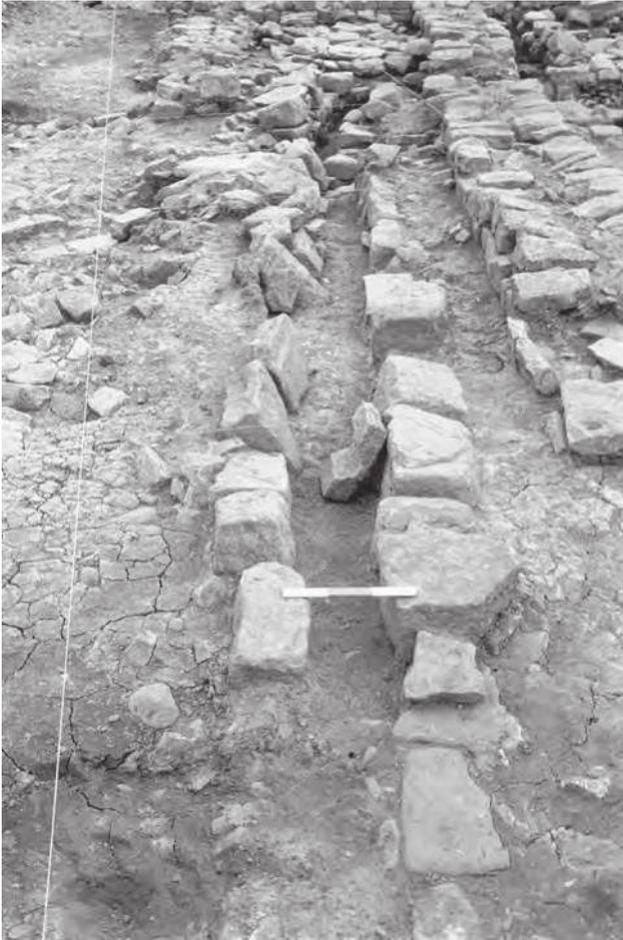
Figure 5 8 Phase 4 water conduit with one of the original gutter stones sitting in the channel having formed part of its fill. View looking south.
