# SEGEDUNUM

Excavations by Charles Daniels in the Roman Fort  
at Wallsend (1975–1984)

VOLUME 1: The Structural Remains

Alan Rushworth and Alexandra Croom

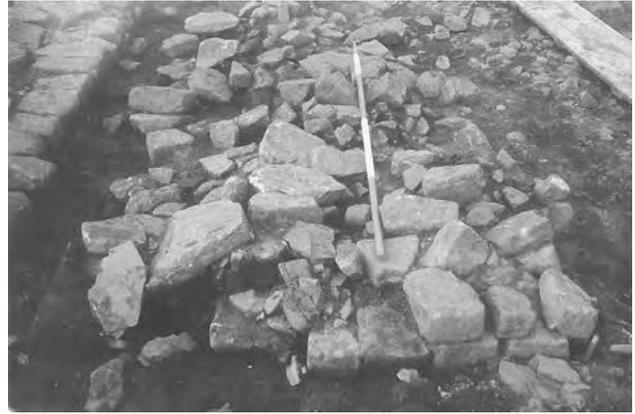
Figure 9 Hospital demolition rubble E11:09 (from south).

from four mortaria, including an incomplete Mancetter-Hartshill mortarium rim that was probably third century in date. There was also the rim sherd from a Nene Valley funnel-necked beaker, and a sherd of Central Campanian amphora. The beaker type was made from the second quarter of the third century, but may not have reached the north in any numbers until after 250, while the amphora dates to the mid-third century or later. Overall the assemblage was mainly composed of third century material, including Yorkshire grey ware and BB1 with a groove above the lattice decoration (250+), but no Crambeck reduced ware and no calcite gritted ware, pointing to a date after *c.* 250 but before *c.* 270 for the demolition of the hospital.

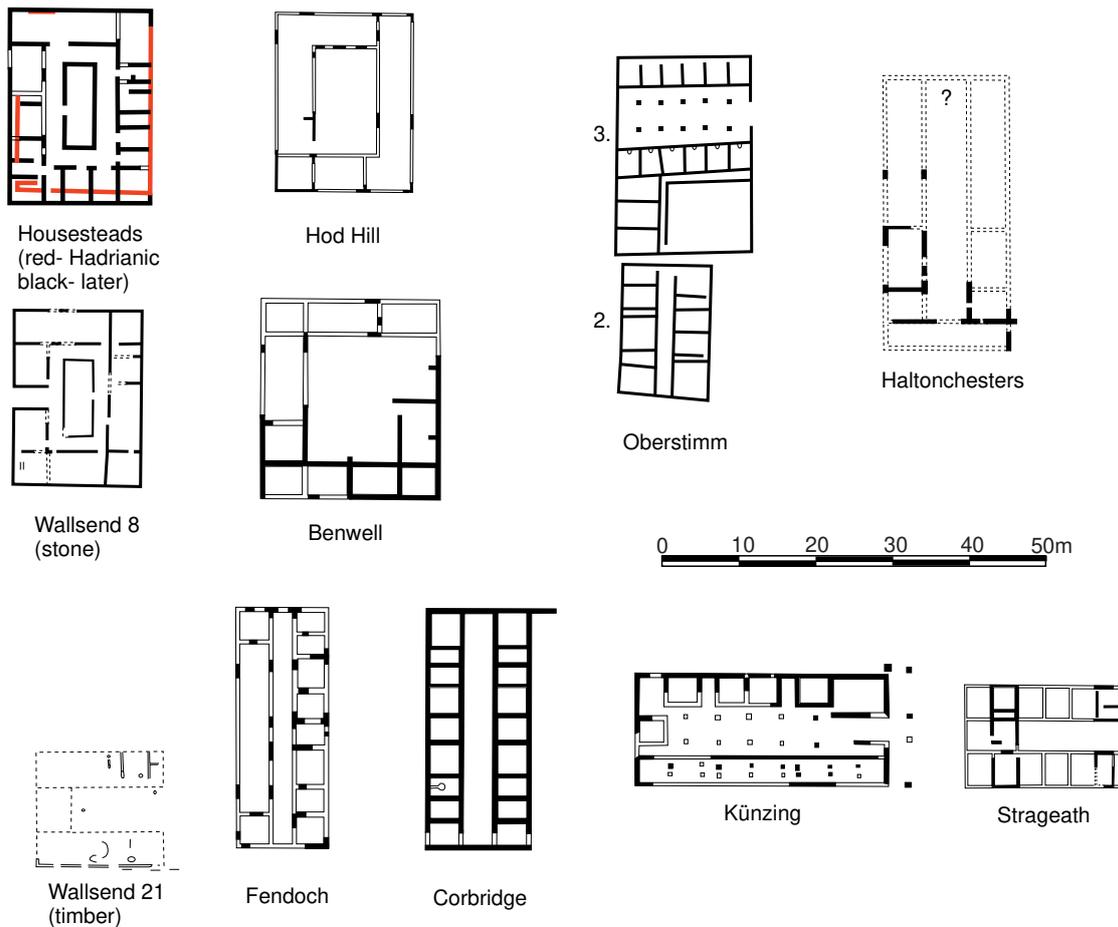
Figure 5.40: Comparative plans of a range of possible hospital buildings based on Hodgson 2003, fig. 88, with additions. Scale 1 0

The second type of building consists of two rows of rooms laid out on either side of a broad corridor or central space. It is this type which Building 21 most closely resembles. Other possible examples are known at Strageath, at Kunzing and Oberstimm (Building 3) on the German frontier, and perhaps at Corbridge. The suggested courtyard building on the west side of the granary at Haltonchesters might also fall into this category, if the plan of those complex remains has been correctly interpreted (cf. Dore 2010, 15–24).

A number of other buildings previously grouped with the second type, characterised by rows of rooms on either side of a narrower corridor were discarded by Hodgson because of their similarity to a workshop building at Corbridge Red House (2003, 126–7). These included examples at Fendoch, Oberstimm (Building 2) and perhaps the Corbridge building noted above. It is also worth noting that at least some of the buildings with a central space, notably Haltonchesters, Strageath, and Künzing, appear to have been furnished with a third range, closing off at least one of the narrower ends. This suggests that these two types were not so very different in their form and were distinguished principally by the change in the character of the central space from a central lightwell to a fully fledged courtyard.

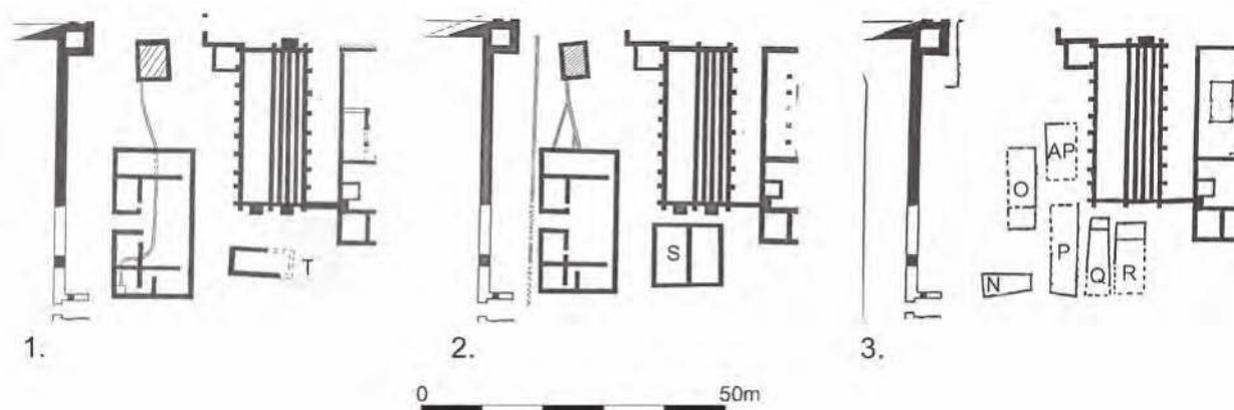
Fig. 6.01 Daniels’ interpretation of the later structured phases in the eastern part of the central range. 1. Late third/early fourth century 2. Early fourth century 3. Later fourth century Scale 0 50m

The structural sequence which Charles Daniels’ team proposed began with a stone building (labelled Building T), erected in the area to the south of the

granary and immediately to the east of the north-south road which covered the former east wing of the hospital. This was ascribed to Daniels' Fort Phase 3 (i.e. the late third/early fourth century) and considered to be contemporary with Phase 2 of the hospital. However the remains of the structure, as restored, were very fragmentary. The most substantial surviving components comprised areas of flagged flooring. The building was interpreted by the excavators as a rectangular structure, aligned roughly east-west with overall dimensions of approximately 11.5m east-west by 5m north-south (internally). The long side was roughly parallel to the *via quintana* and a small, east-facing porch was restored. This interpretation was essentially arrived at by considering a rough line of stones (F11:26) within the flagging (F11:10) as the disturbed base of the north wall and the north edge (G12:24) of a large, rectangular, hearth base (G12:13), composed of pitched stones, which lay on the same general alignment, as another fragment of the same wall. Hypothetical lines for the other walls were then simply traced around the two main surviving areas of flagging to the south (F11:10; G12:11). Effectively this restored the building as a single, open-fronted chalet, though it clearly did not share the same alignment as any other chalets or neighbouring buildings.

Building T, was subsequently replaced by a new structure, labelled Building S. This again was assigned to Fort Phase 3, and judged to be contemporary with Phase 3 and 4 of the adjacent hospital. Like its predecessor, Building S was defined by the surviving remains of the floors, in this case spreads of pink-brown clay (F11:11, G11:13), rather than firm evidence of external walls. On the basis of the distribution of the clay spreads, the new building was interpreted as a rectangular structure with dimensions of approximately 9m (north-south) by 11m–12m (east-west). It was not considered entirely certain whether the walls were of stone or timber, but the balance was felt to be in favour of stone. A line of sandstone rubble (F12:06) including occasional faced blocks, which ran north-south between the two main spreads of clay and was continued to the north by a robber trench (F11:18), was thought to represent the partially robbed foundations of an internal, north-south partition dividing the building into two. Surrounding and delineating the extent of the clay spreads were areas of disturbance which the excavators interpreted as robber trenches although the outer edges of these trenches were difficult to define.

Building S, in turn, was replaced by two post-hole constructed buildings, labelled Q and R. These were orientated roughly north-south, on the same alignment as the two halves of S. Other post hole buildings, designated P, N, O, and AP were recognised to the west and north-west, overlying the remains of the hospital, which must have been demolished by this stage, and the north-south street. However no

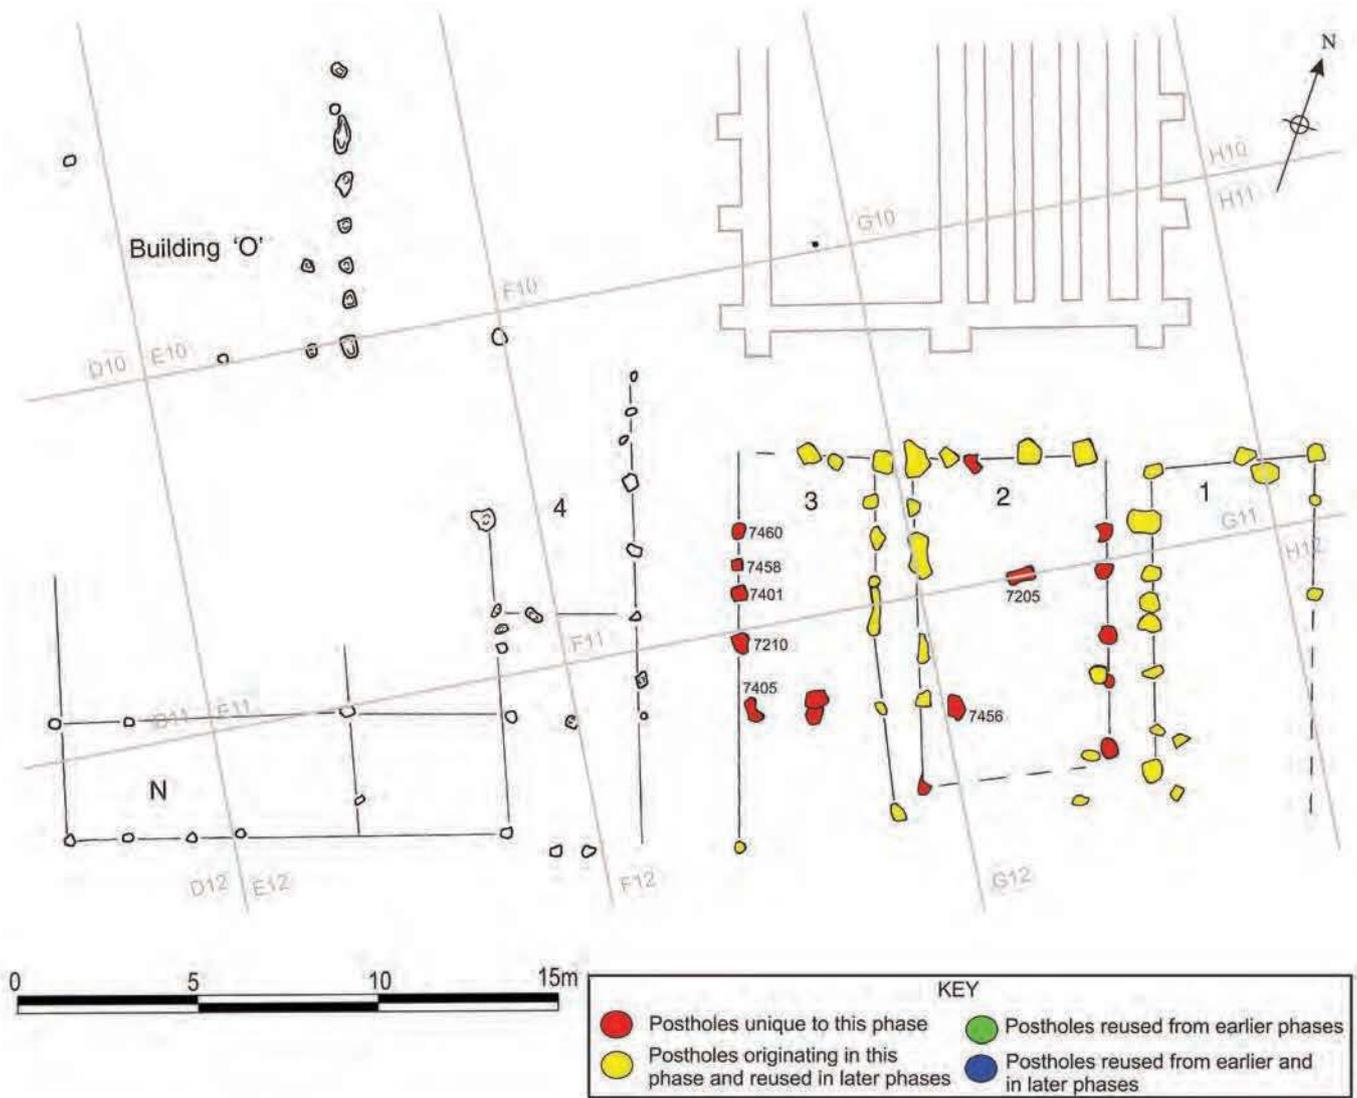
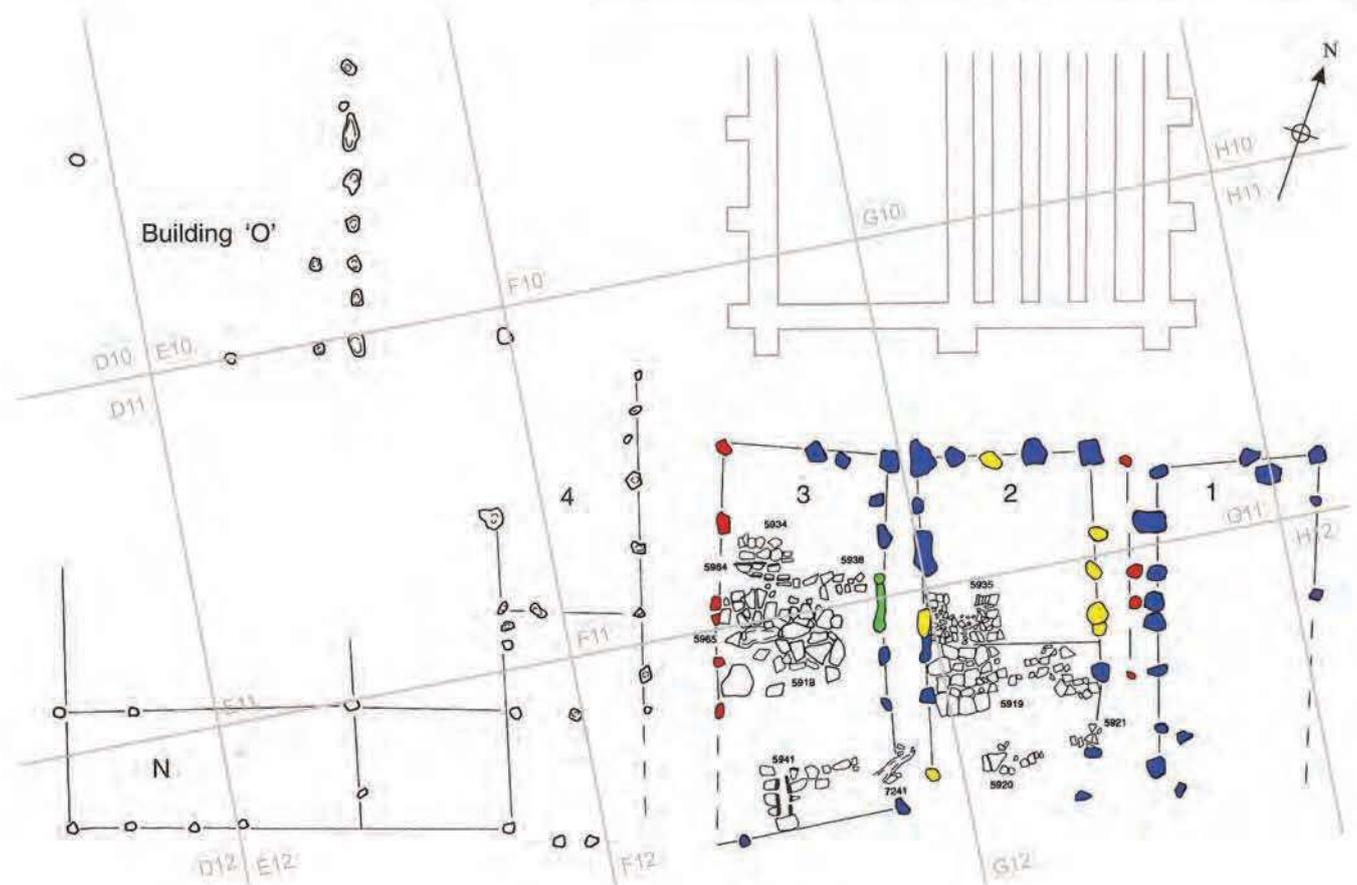
Figure 6.02: 1997–8 excavation phases A (top) and B (bottom) (based on Hodgson 2003, 144 figs. 99–100). Scale 1:250.

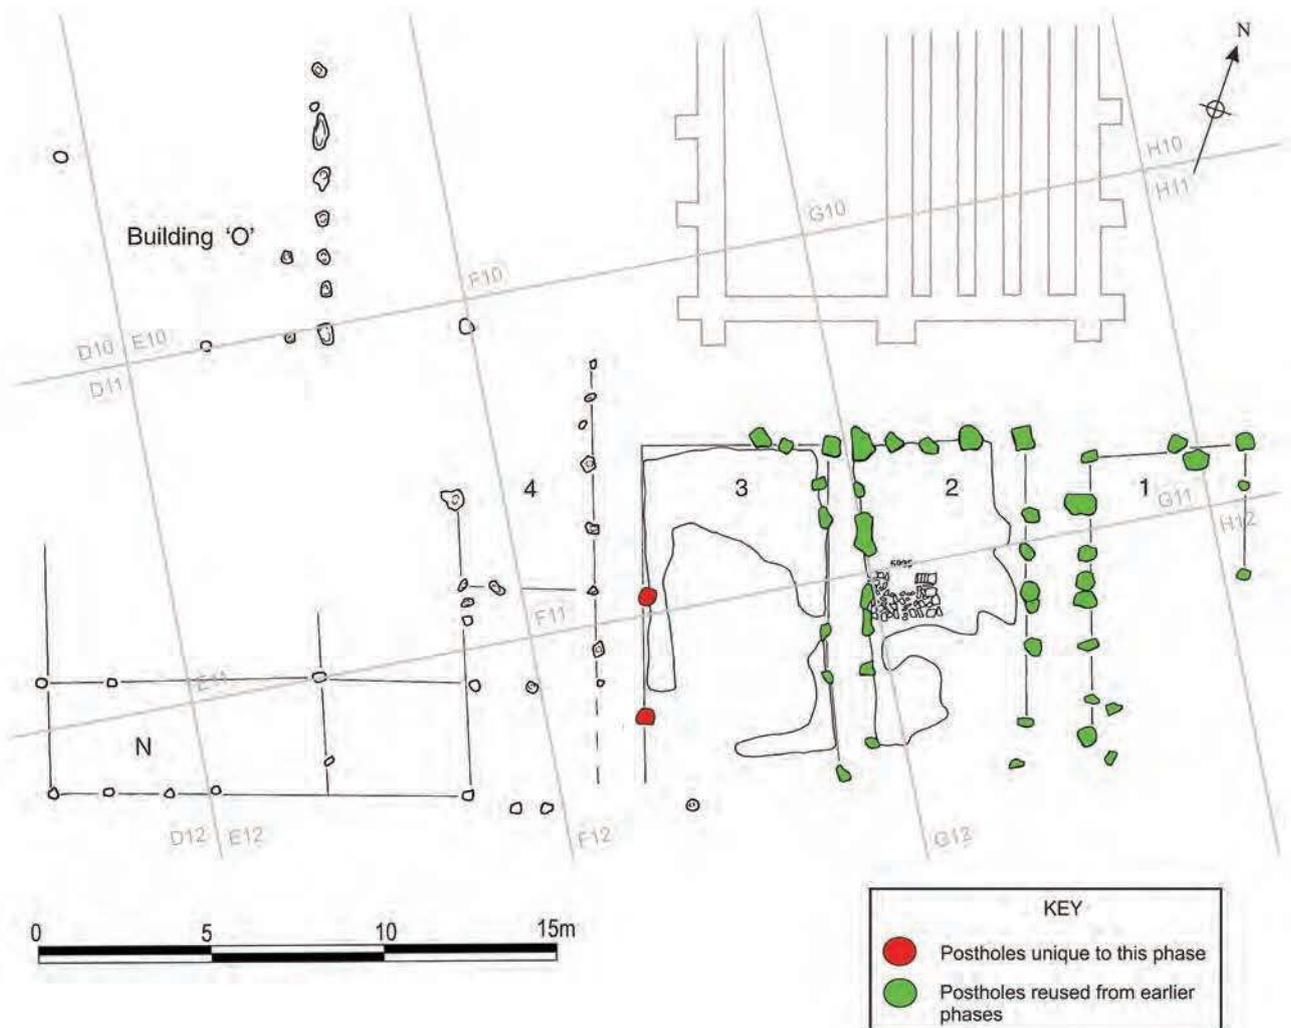
Figure 6.03: 1997 excavation Phase C (based on Hodgson 2003, 145 fig 101). Scale 1:250.

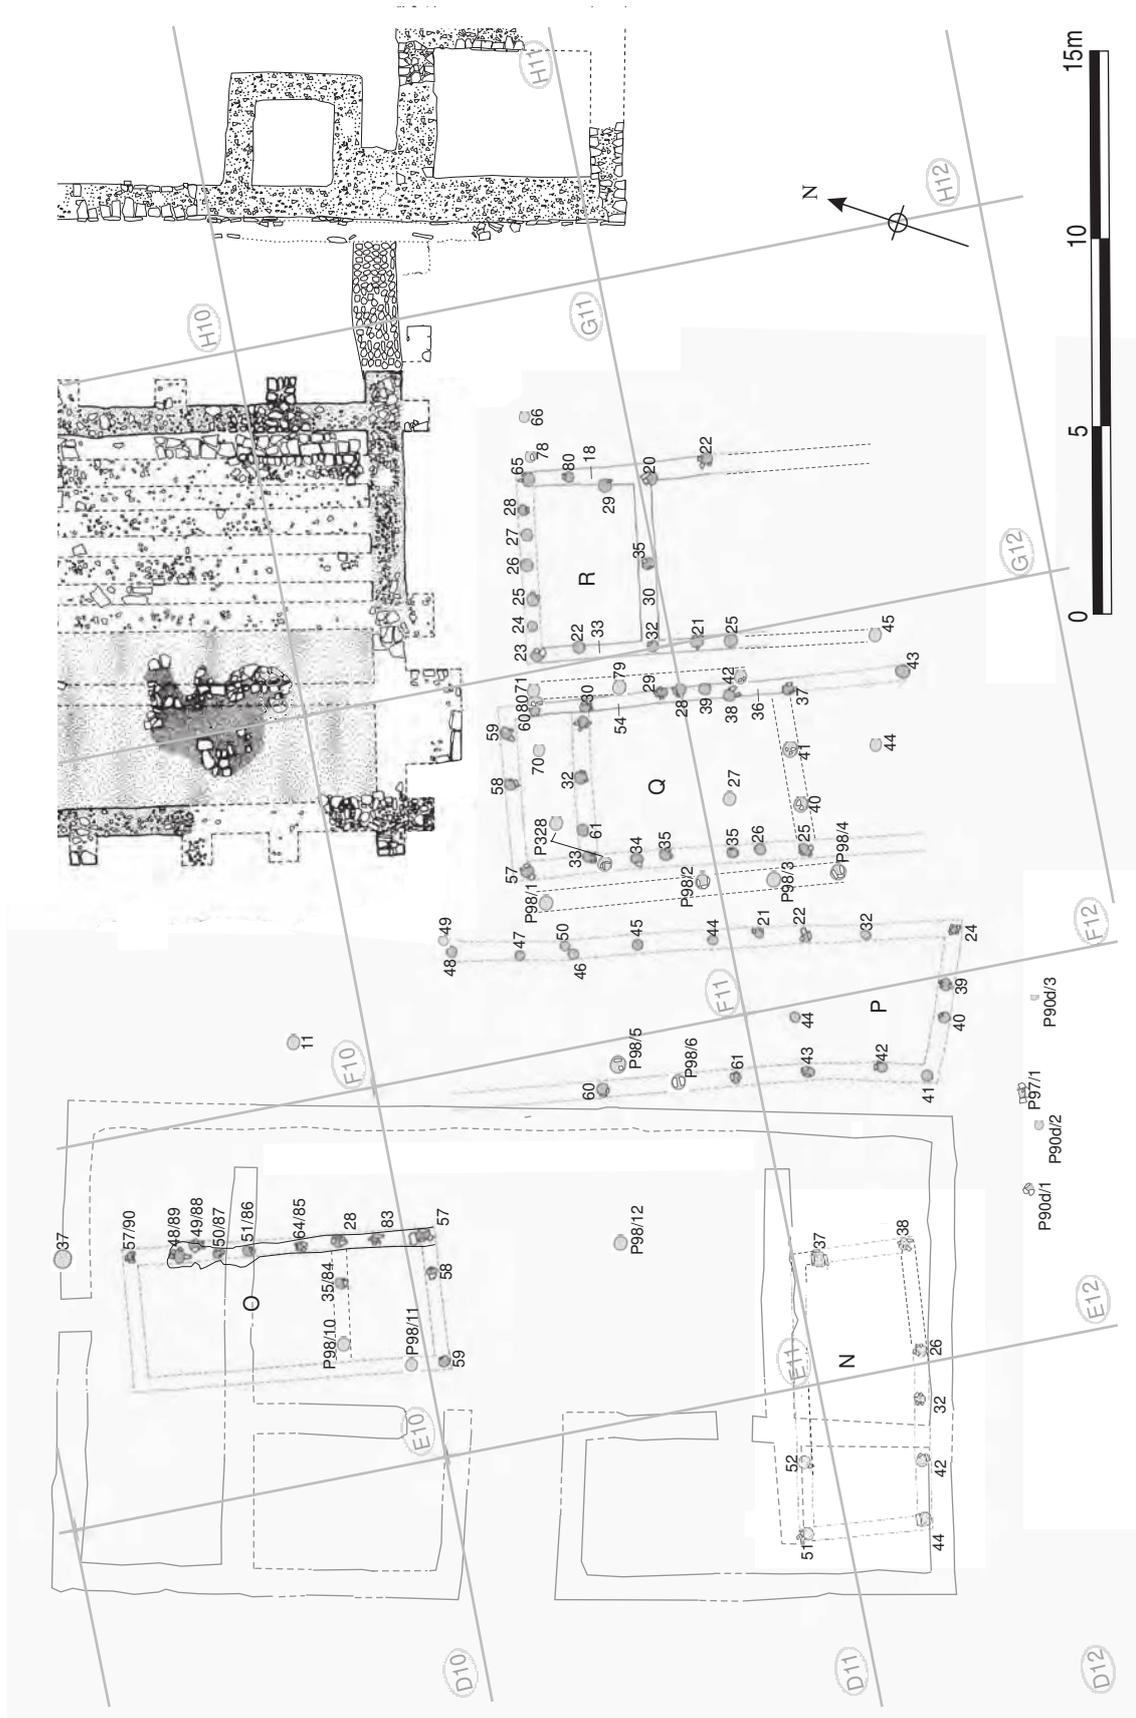
Figure 6.04: Plan of all the postholes associated with Buildings N, O, P, Q, B and AX identified during the Daniels excavation. Scale 1:200

All the post holes identified during the 1975–84 excavations are shown on Figure 6.04, including a number which were shown on the site plans relating to the 1977 and 1983 seasons but never allocated context numbers. Figure 6.05 attempts to correlate the 1977/81/83 record with that of 1997–8, allocating the appropriate Daniels context numbers to those post holes re-excavated by Tyne and Wear Museums and adding supplementary examples not recorded

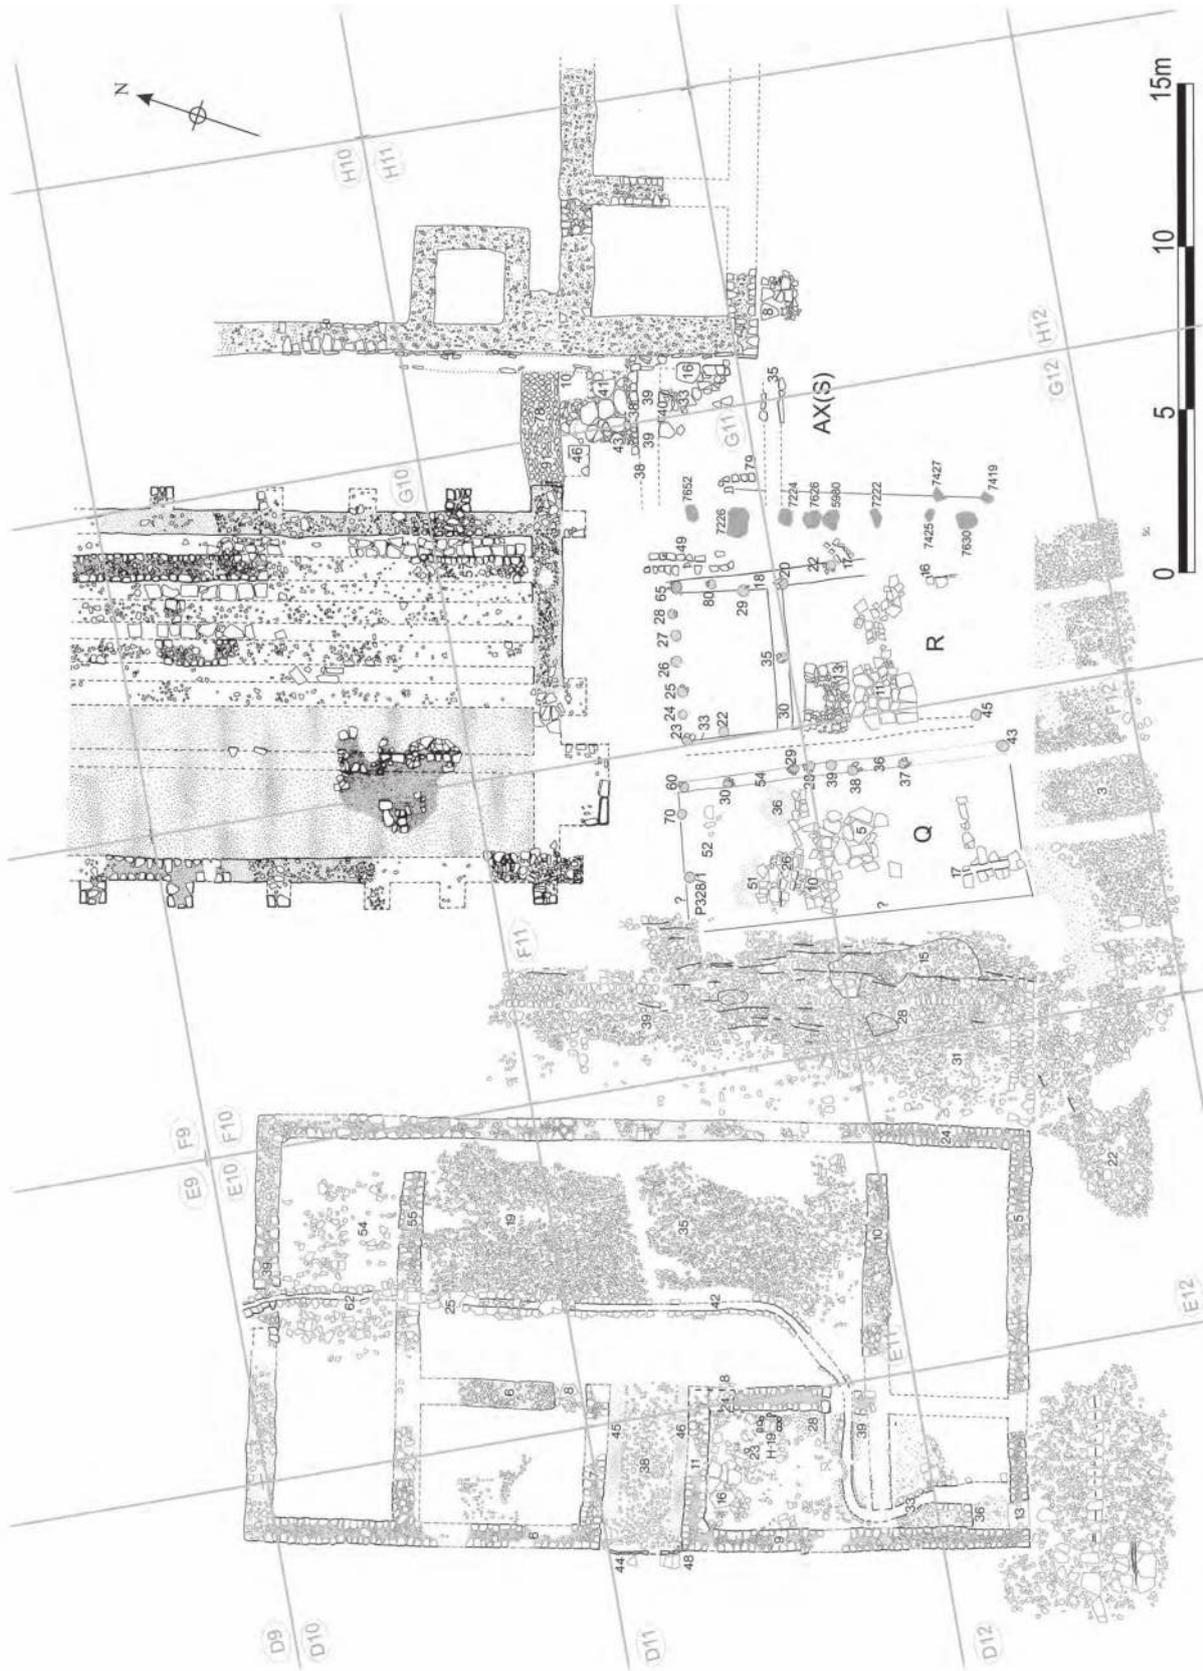
Figure 6.06: South West Central Range, Period 3 showing Building Q, R and AX (S) Phase B (building T phase). More than one phase of AX(S) is displayed. Scale 1:200.

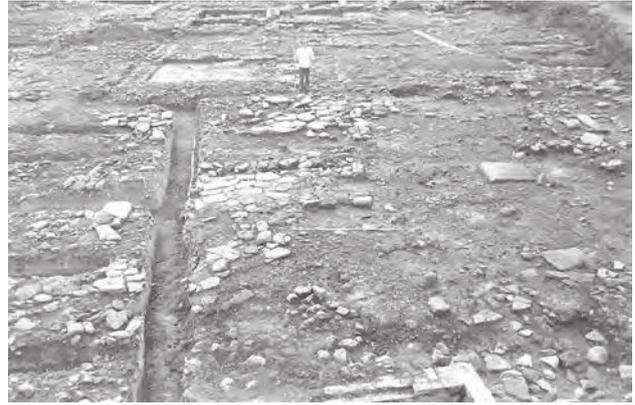
Figure 6.07: Buildings R and Q from the east showing the flagged surfaces and other features of Phase B.

The floor of Building Q was represented by a 3.5m wide area of substantial stone flagging (F11:10, F12:05), which extended across the centre of the building (Fig. 6.07). Towards the northern edge of the flags lay a crudely-built, east-west aligned wall composed of two lines of roughly faced sandstone blocks (F11:26, TWM 5964). Daniels interpreted this as part of the north wall of 'Building T', but it can now clearly be seen to have been an internal feature. The 1997–8 excavators suggested this was most probably a low screen wall associated with a hearth immediately to the north (Hodgson 2003, 143–5), noting that the flagstones on that side (F11:51; TWM 5934) were worn, fire-reddened and shattered. An alternative possible interpretation as the base of an internal timber partition was dismissed in the 1997–8 excavation report on the basis that the wall was only present in the western half of the building and did not appear to continue further eastwards (those stones which Daniels considered formed the rest of the wall were probably simply a fortuitous linear scatter of surviving flagstones – part of F11:10 – as the 1997–8 excavators noted). However there was clear evidence for a partition line in the equivalent position in Building R and in AX (S) so it is possible the remainder of the wall had simply have been robbed away.

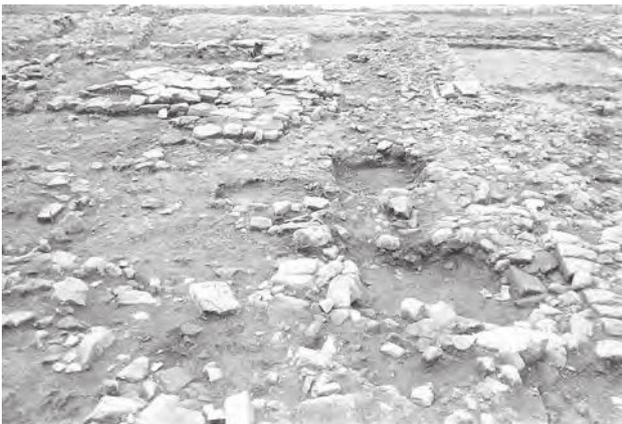
Figure 6.08: The flagged floor of Building R from the north with the north-south road over the east wing of the Period 2 *h sp tal.*

FLOOR SURFACES AND INTERNAL FEATURES (Figs 6.08–6.09)  
The internal arrangements associated with this phase of Building R were very similar to those uncovered in Q. The floor was likewise represented by substantial stone flagging (G12:11), which again survived best in

the central third of the structure where it stretched 4.60m from east to west, probably representing the building's full internal width. The 1977 excavators recorded this as directly overlying the earlier gravel road surface, but in 1997–8 it was noted that the flagged surface was bedded in places upon a 0.08m deep spread of pink clay (TWM 5943; cf. Hodgson 2003, 142). The flagging extended furthest south on the east side, where the edge of flagging was initially interpreted as the side wall of a drain (G12:16), like that in Building Q. The few stones identified as the opposite side wall of this supposed drain are unconvincing, however.

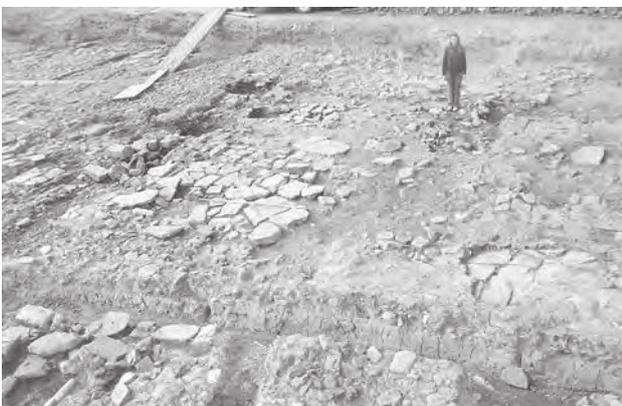
Figure 6.09: The flagged floors of Building Q (left) and clay floor of R (right) viewed from the south.

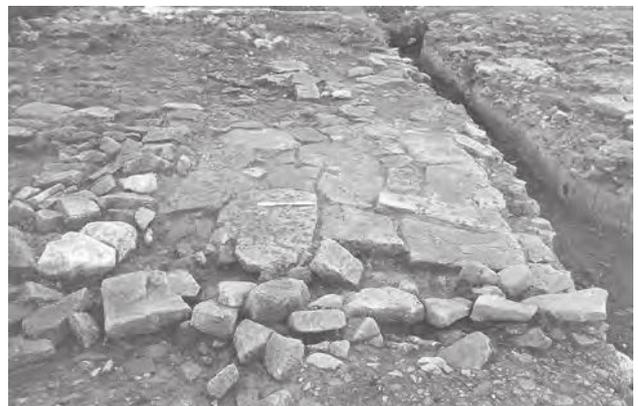
Figure 6.10: Phase B flagged floor and pitched stone base (G12:13) of Building R with stone packing F12:06 in the foreground.

Immediately north of the main area of flagging, a rectangular pack of pitched stones (G12:13, G12:24), was interpreted as the foundation for a large hearth (see Figs 6.10, 6.11). Measuring 2.20m × 1.30m at its widest points, the eastern and western edges of the feature were formed of sandstone and limestone rubble laid flat whilst the intervening infill consisted of sandstone fragments pitched at an angle of 40 degrees to create a rough herring bone foundation. This was apparently packed with pink clay, patches of which were burnt to a red-orange colouration. A large modern intrusion (G12:18) had cut through the northern side of the feature midway along its length.

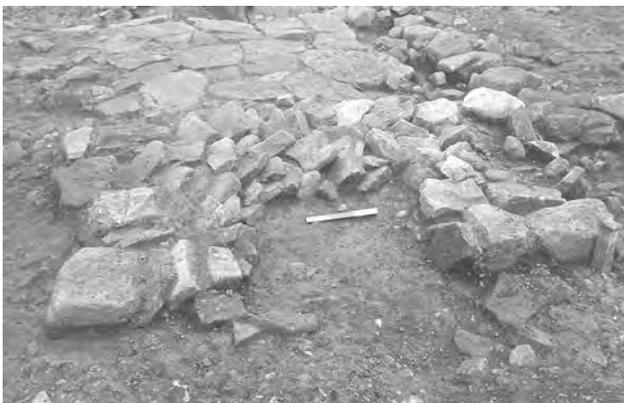
Figure 6.11: View of stone foundation G12:13 from the north showing the pitched stone techniques used and the gap left by a modern intrusion (G12:25).

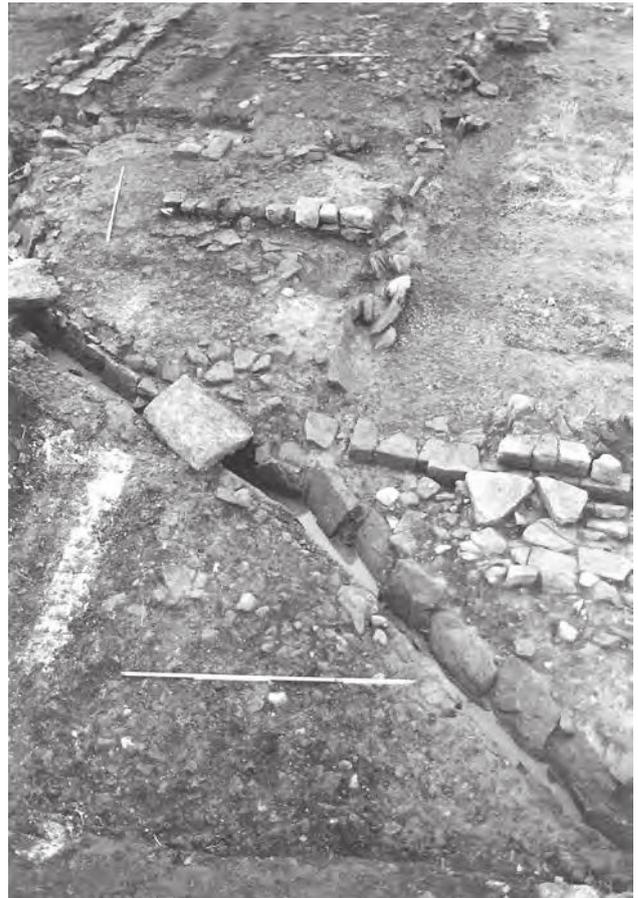
Figure 6.12: Drain G11:07/H12:33 and flagging H12:08 at the south-west corner of the *principia*, viewed in 1983. Wall G3 of Building AX (N), and the foundation trench and buttress for the crosswall of AW can be seen in the background. The flagging of Building AX (S), excavated in 1981, has been removed.

The northern building was defined by a short east-west aligned wall (G11:38, H11:38), attached to the west face of the *principia*. This stood on the remains of the earlier cobble and flagstone surface (G11:48, H11:57) and formed the southern kerb of a new flagged floor (G11:43, H11:41), which extended

northwards towards the granary extension wall (AW – G11:91, H11:78) that closed off the end of the former alley. Only the south face of wall G11:38/H11:38 survived, but a spread of tumbled stone blocks (G11:37, H11:37), overlying the flagged floor, evidently represented the wall's collapsed remains. The resultant structure, tucked into the angle between the headquarters and AW, was some 2.50m square. Access to this structure from the south would have been very difficult. Access from the west via the 2–3m wide alley between the south wall of the granary and the rear walls of timber buildings Q, R and AX (S) would have been possible, though somewhat constrained. However it is possible it was connected to the eastern granary extension (AW) by a doorway through wall G11:91/H11:78 which closed off the southern end of the former Alley 8. All the masonry of this wall was robbed out removing any trace of a doorway. Its function is unclear.

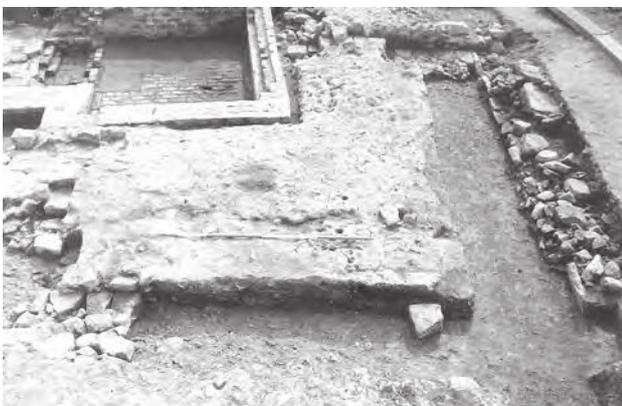
Figure 6.13: The south west corner of the *principia* from the north with the gutter alongside the west wall overlain by flagstones of AX (S) evident in the top right corner.

lined the southern edge of this slot also extended south-eastwards (H11:16, 33), overlying the earlier drain or gutter (H08:18) which ran alongside the *principia* west wall, and evidently forming the internal floor surface in this part of the building (Fig. 6.13).

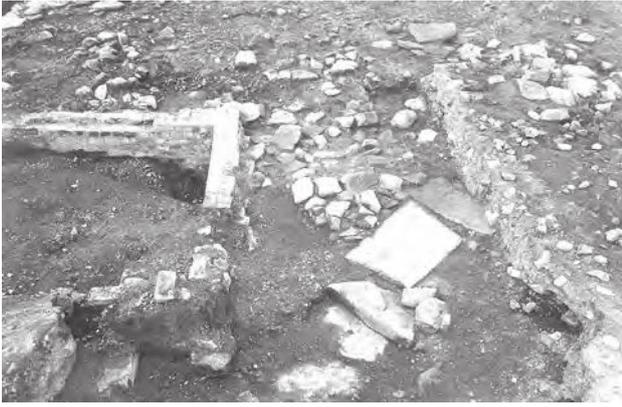
Figure 6.14: Drain G11:07 with the possible overlying surface of Building AX (G11:08).

The remainder of the building's interior arrangements, to the south of the partition slot, had largely been removed by a nineteenth-century brick cellar and the surviving flagging in the northern part of the building did not extend sufficiently far to the west to define the edge of the building on this side. Hence the overall dimensions of AX (S) in this phase are uncertain. However three lines of post holes associated with various phases of the west wall of the building, were identified in the course of the 1997–8 excavations, although only one of these, the medial of the three, survived anything like completely with eight pits being recorded (including G11:66). None of these alignments can be firmly attributed to Phase B, and indeed sleeper-beam rather than post-in-pit construction may have been employed in this phase. Nevertheless, they do give a general indication of the length of the building and the position of the west wall of AX (S) at various stages, suggesting that the building was perhaps as much as 10.50m long and between 4.00m and 5.40m wide. Furthermore, a patch of flagging (G11:79) just to the south-west of the slab-lined drain (seen most clearly in photographs taken in 1977, cf. Fig. 6.14), probably marked the western edge of the building's stone floor during one phase of its existence, though it is not clear which. The edge of this flagging was interpreted by the 1983 excavators as the east side wall of another drain, but the supposed west side wall of this 'drain' was represented by no

more than a single slab and its validity is questionable. The edge of the flagging respected the projected course of the most easterly of the three post hole alignments noted above. This consisted of only two surviving post holes (TWM 7419, 7427) at the southern end of the building, much of that row having been destroyed by the brick cellar. The building which may be restored on this basis was significantly narrower than the Phase B versions of the two neighbouring buildings, R and Q, with an internal width of only 3.50m as opposed to 4.40m. The alley between AX (S) and R would also have been significantly wider than that between Q and R, all of which implies that these particular arrangements in AX (S) belonged to a different phase when the east wall of R was also located somewhat further to the east.

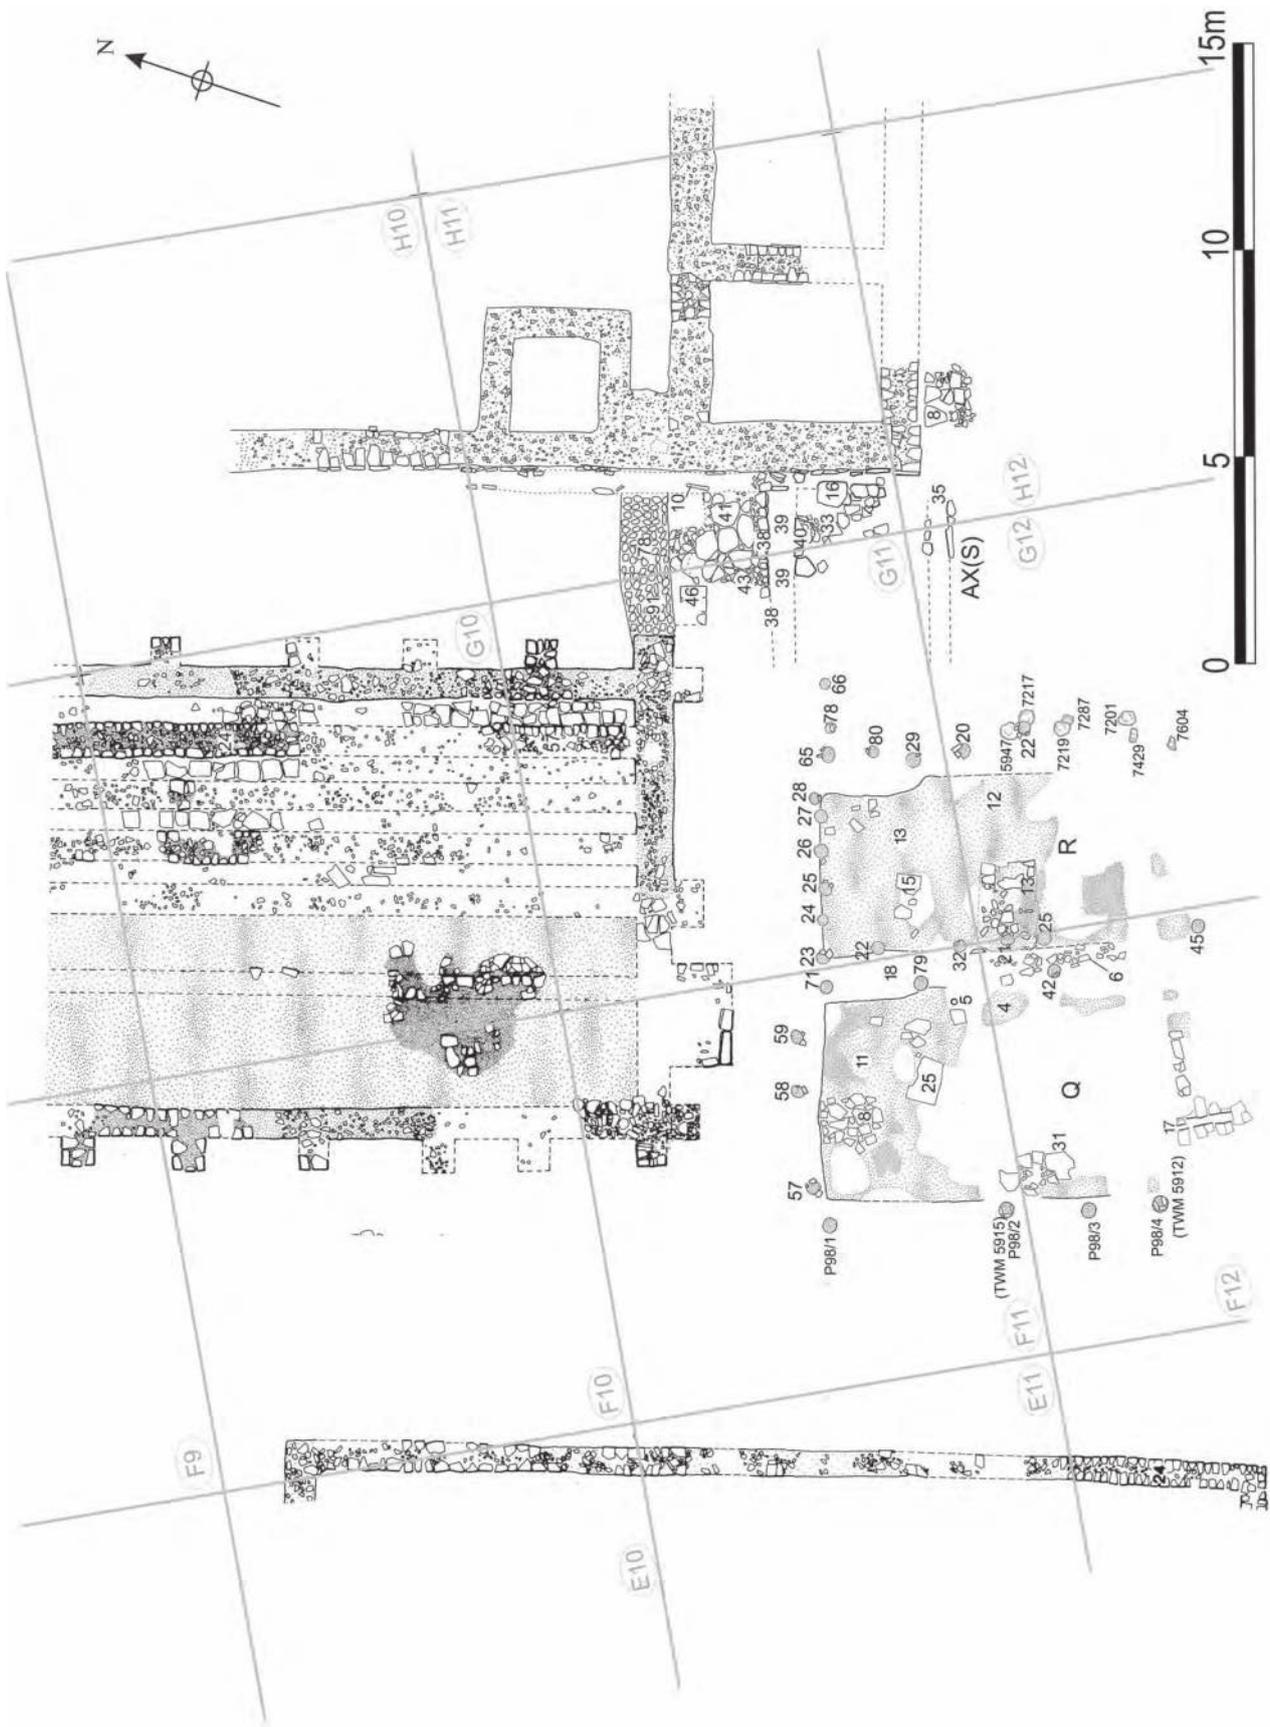
Figure 6.15: Buildings Q and R, Phase C (Building S phase) at 1:200.

### **TW** Phase C = 'Building S' phase (Fig. 6.15)

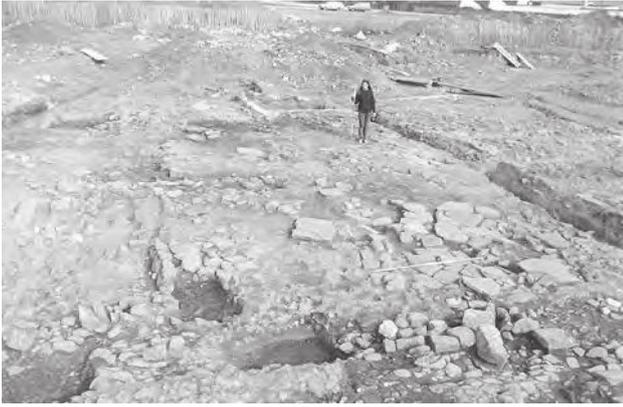
Figure 6.16: Building Q and R viewed from the west. The clay floors of Phase C are evident in both buildings. The flagstones in the right foreground belong to the underlying Phase B surface, the later flagging to the left was laid on the clay layer.

#### *Q and R: floor levels and internal features (Figs 6.16, 6.17)*

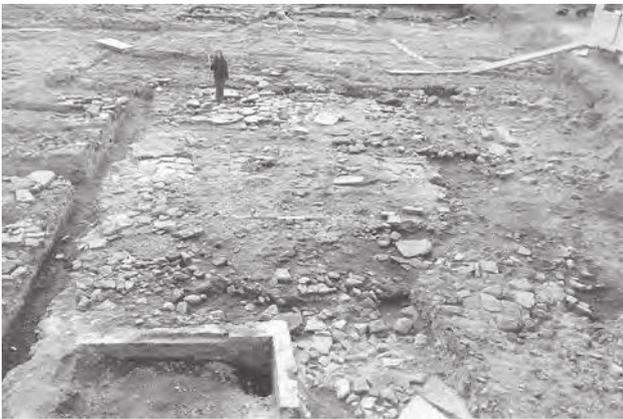
Figure 6.17: Building R Phase C clay floor with Building Q Phase B flagging and C clay/flags in the background. Fragments of AX(S) are visible in the foreground. Compare to Figure 6.10

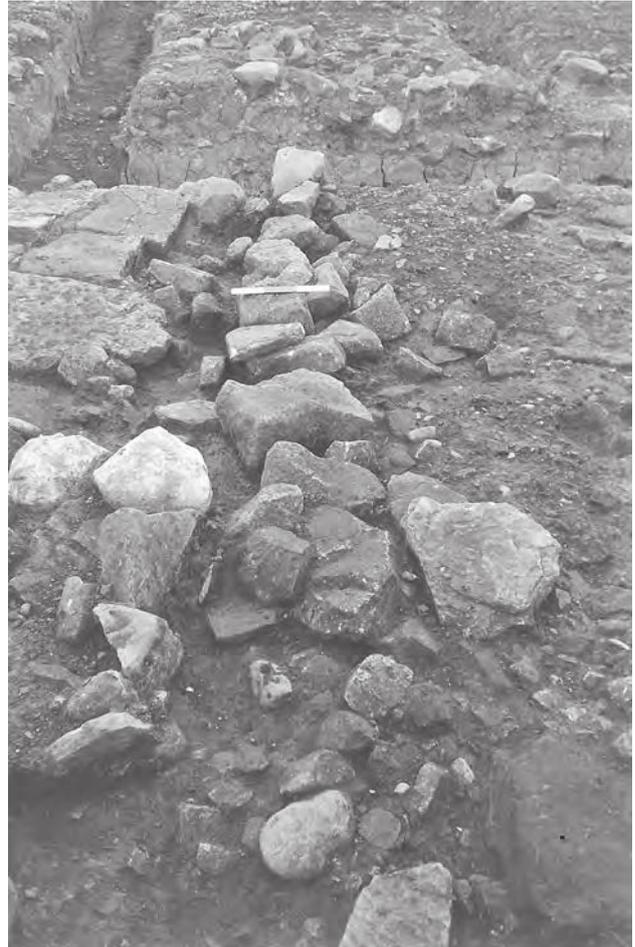
Figure 6.18: Stone packing F12:06 viewed from the north.

dismantled and therefore be associated with Phase C. The west wall of the building included one post hole (G12:21 = TWM 5978) which cut through the western edge of the large stone base (G12:13) associated with the previous phase. A 2.50m long line of sandstone rubble (F12:06; TWM 5939, cf. Hodgson 2003, 143), including occasional faced blocks, ran north-south along the west side of R. The site photographs (Fig. 6.18, cf. Fig. 6.10 above) make it clear that this was a deliberately constructed alignment rather than a random accumulation of rubble in the alley between Q and R. It may represent the packing of a drain in the eavesdrip between Q and R, as suggested by the 1997–8 excavators, or the packing for a post trench associated with the west wall of R. The east wall of R was probably represented by the westerly of the two post hole alignments recorded on this side of the building, which was clearly shown by the 1997–8 evidence to cut the other line (see Figs 6.06 and 6.16: note the relationship between post holes TWM 7228 = G11:29 and 7234, 5947, 7284=G12:22 and 7217, and 7219 and 7287).

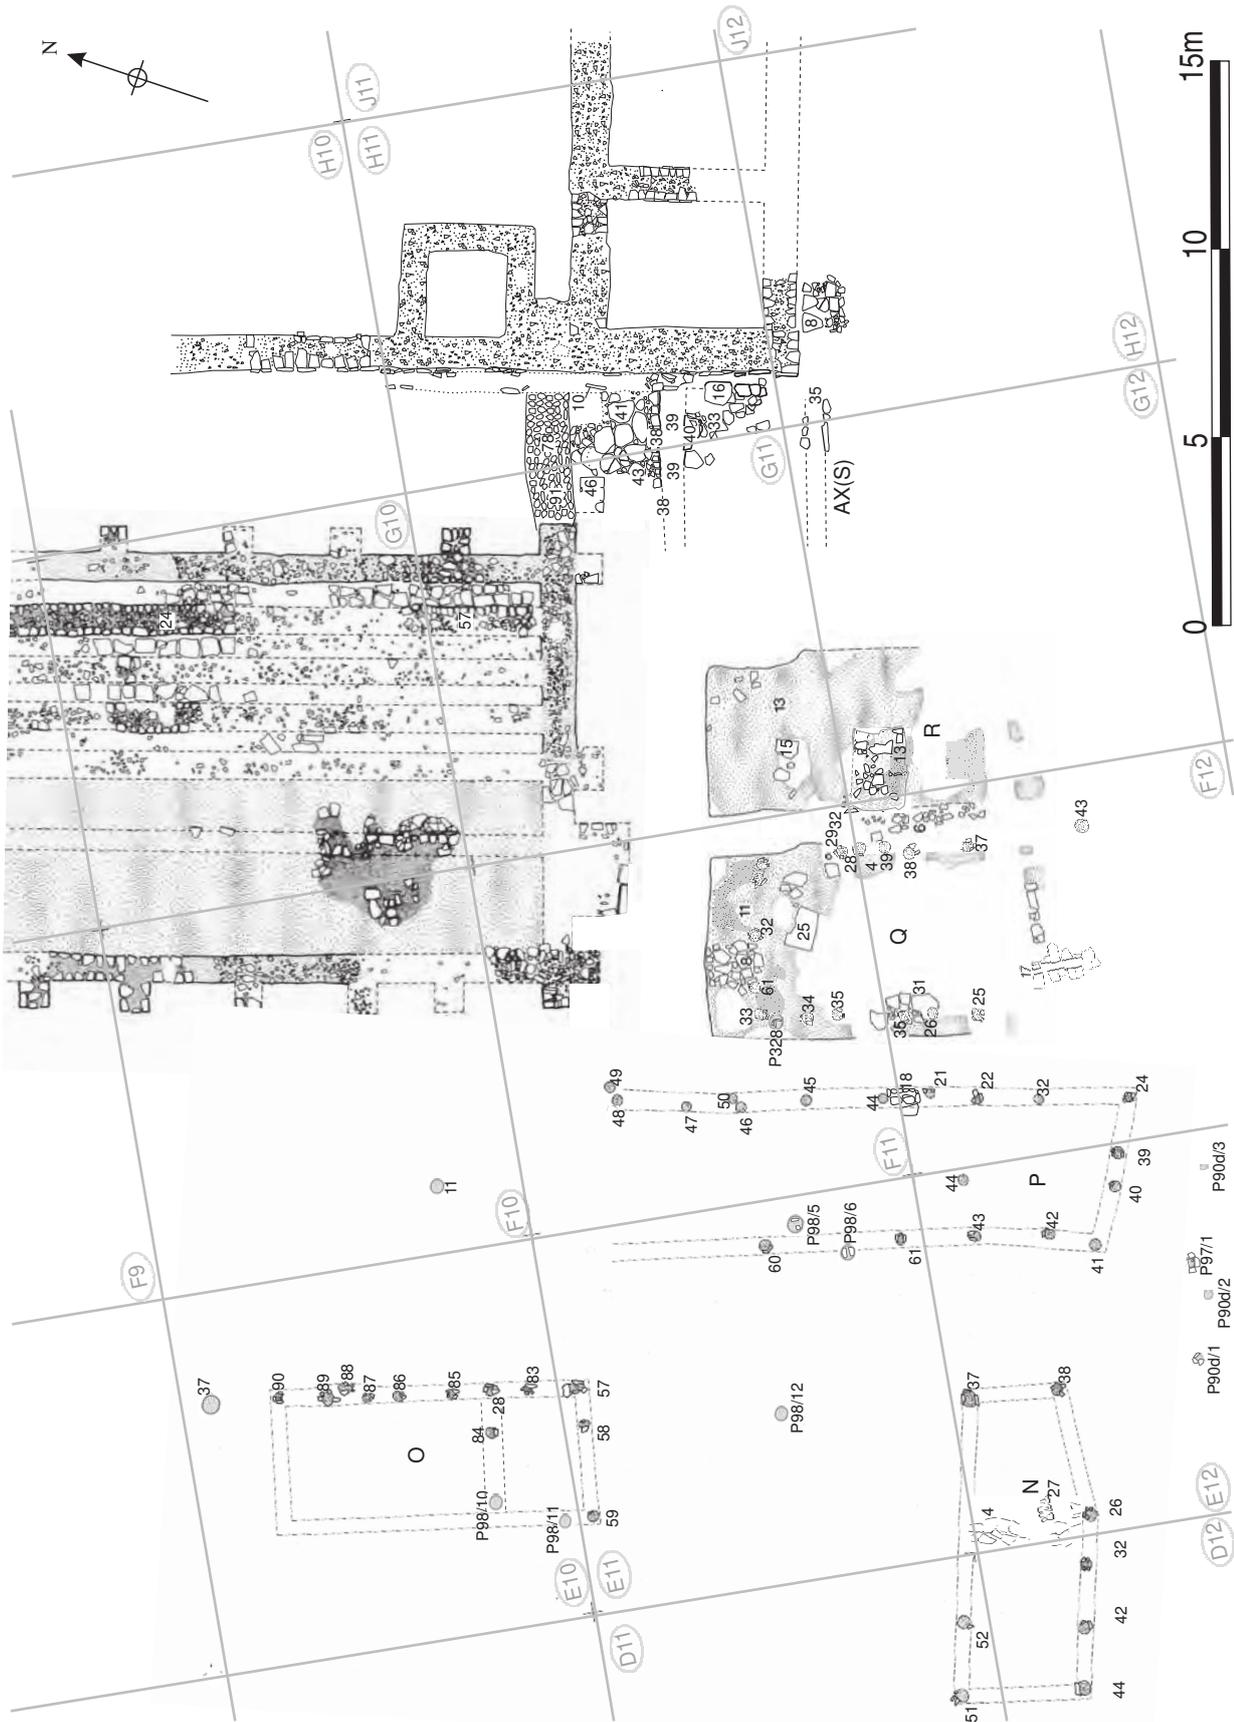
Figure 6.19: Building N, O and P, and Q and R, Phase D at 1:200.

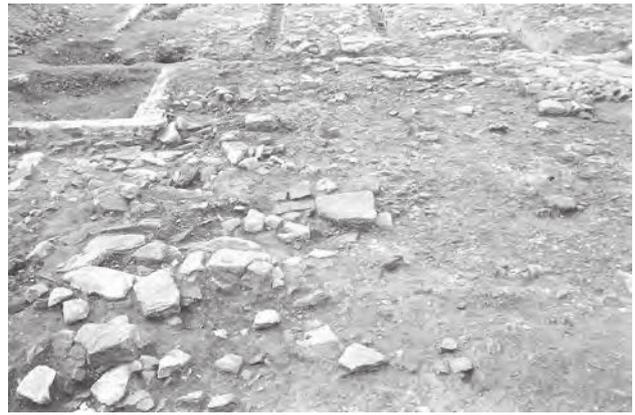
Figure 6.20: Possible later drain (G11:40/41) viewed from the north in 1977 (left foreground).

have sat at a higher level than the clay floors of Buildings Q and R. It presumably therefore belongs to a period later than Phase C, and perhaps even postdated Phase D.
