# SEGEDUNUM

Excavations by Charles Daniels in the Roman Fort  
at Wallsend (1975–1984)

VOLUME 1: The Structural Remains

Alan Rushworth and Alexandra Croom

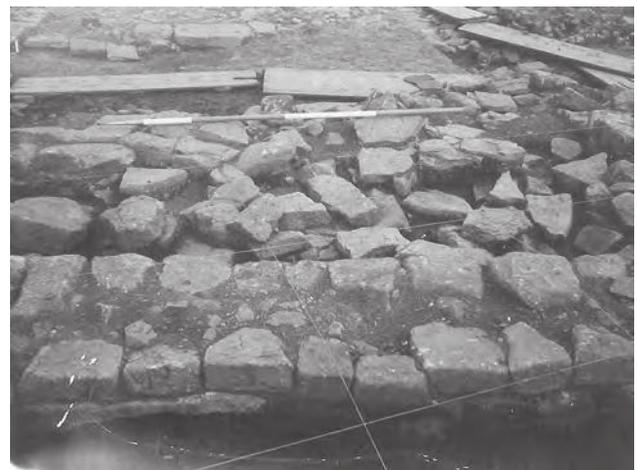
Figure 6.21: Flagging E12:04 and dark clay E12:03 overlying demolition rubble of hospital (from west).

A small area of surviving flagged flooring (E12:04) was revealed in the centre of the building (see Fig.6.21), overlying a layer of dark loam (D12:08, E12:03), which in turn covered the Phase 4 flagged floor (E12:02) in the western half of Hospital Room 3. To the east, the flagging incorporated a shallow drain or gutter (E12:28), V-shaped section and composed of pitched slabs (see above Fig. 5.29), which was subsequently rebuilt in a very similar form though of inferior construction (E12:27). The dark loam was seen to extend further northward (E11:06) covering the mass of collapsed rubble (E11:09) in the south-east corner of the former hospital courtyard which evidently derived from the demolition of Building 8 (see above Fig. 5.39).

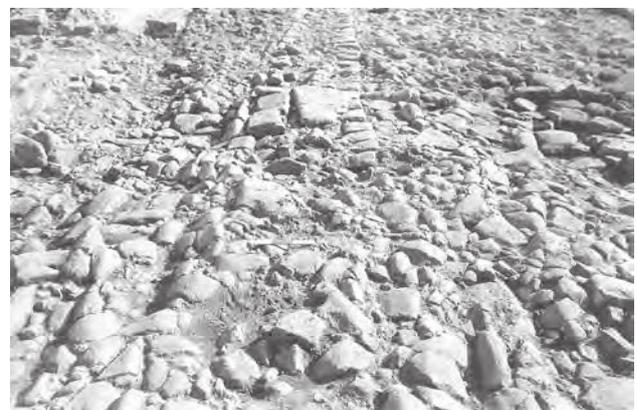
Figure 6.22: Small patch of flagstones possibly associated with Building P overlying the east wall of the Period 2 hospital and the later road surfaces.

(see Fig. 6.22). In addition, there was evidence for alterations or repairs to Building P in the form of two pairs of closely spaced postholes (F11:46/50, and F11:48/49), towards the northern end of the east wall, indicating replacement of one post by another at these two points. Another possible post hole (P98/5), positioned close to west wall post hole E11:60, but a little further to the east, may signify that the west side of the building was similarly reconstructed at some stage.

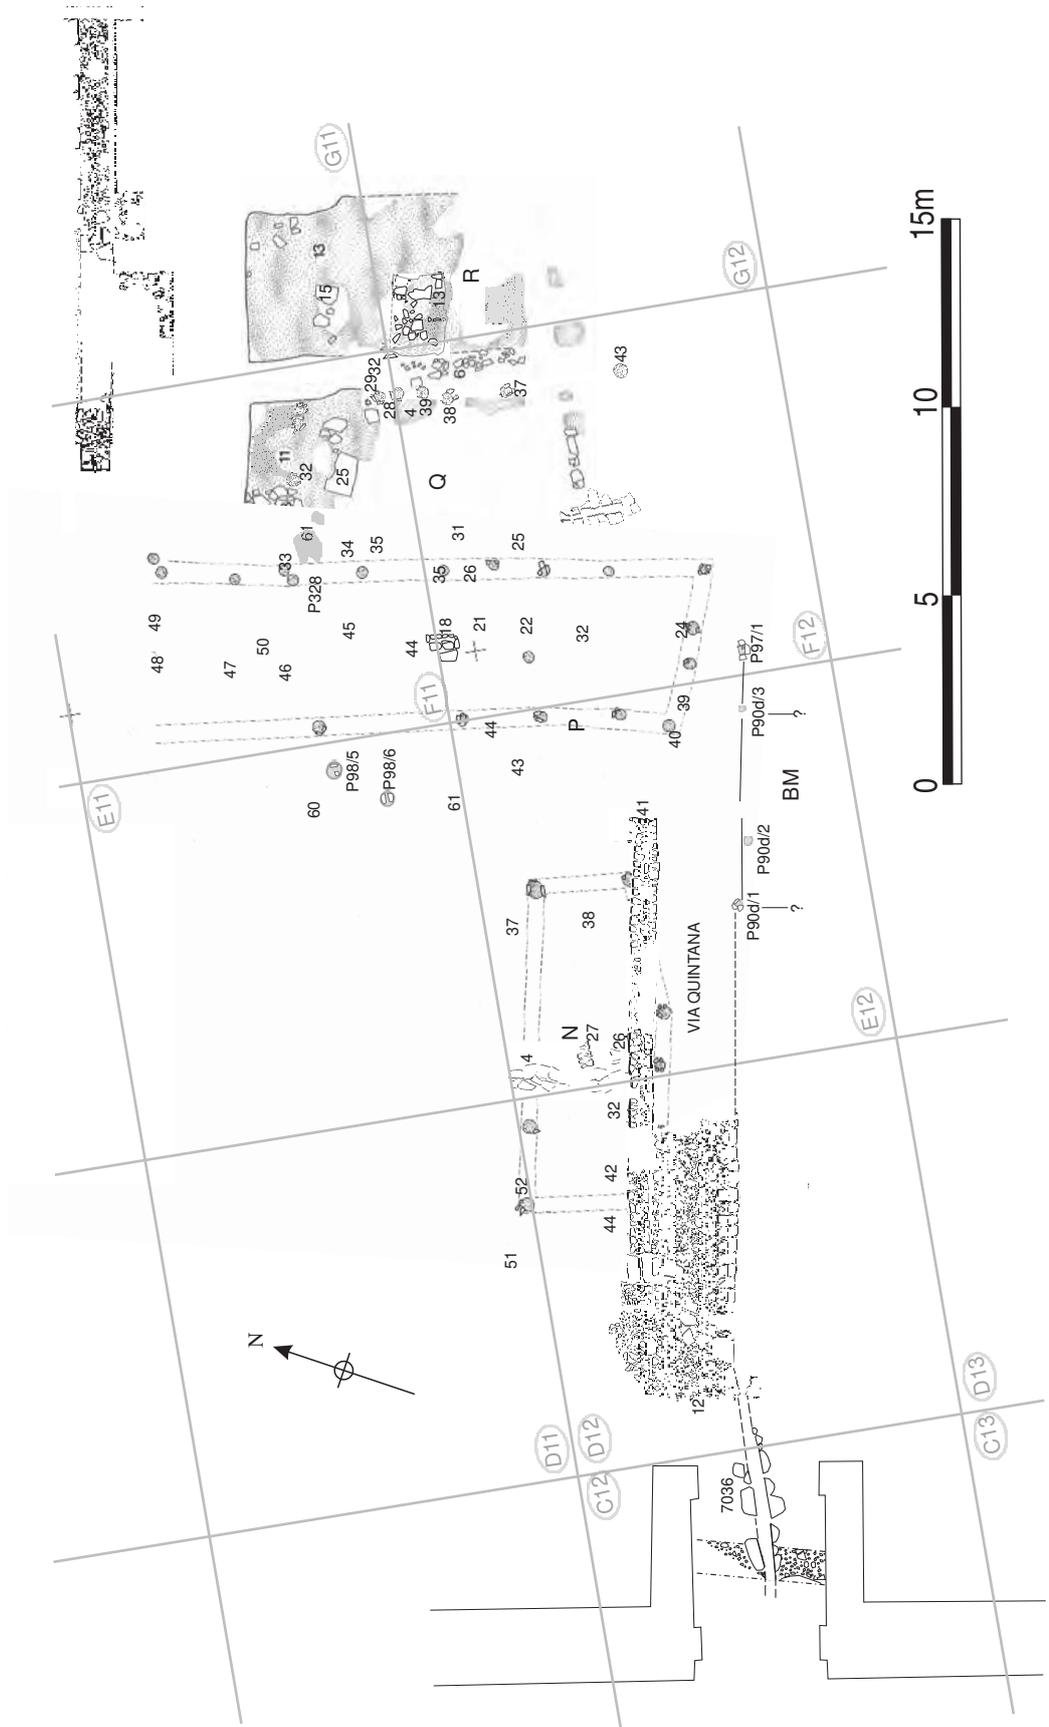
Figure 6.23: The relationship of the final phase of posthole buildings to the narrowed via quintana carriage way. Scale 1:200.

A line of four post holes was recorded on site plans P90d and P97, cut into the uppermost surviving surface of the *via quintana* carriageway, roughly opposite the south end of Building P (see Fig. 6.23). Although these post holes were never allocated context numbers or otherwise described they can be seen to lie on the same alignment as the southern edge of a line of substantial kerbstones which lay 5m to the west (interpreted as part of road surface D12:12/E12:11; TWM 7911, cf. Hodgson 2003, 164–5 fig. 115). The postholes extended over a distance of 7.20m. The kerbstones may define the southern limit of the fourth-century *via quintana*, which had evidently been reduced to a narrow street or alley no more than 3m wide. The line of post holes may have formed the north wall of a late building, designated Building BM here, located on the south side of this narrower carriageway. No comparable remains were identified directly to the south, in grid squares E13 and F13, over the western part of Chalet-barrack range 9, but these may have affected by the truncation of later levels of the fort. It may however be relevant that lines of substantial timber post holes did feature as structural components in the final phases of the officer's quarters (Building W), at the west end of Chalet range 9, to the south-west of BM. These fenced off an apparent flagged yard on the south side of W, with a further cluster of post holes being identified immediately to the west of the yard in 1998 (Hodgson 2003, 96 fig. 68, 101), though no coherent building could be restored.

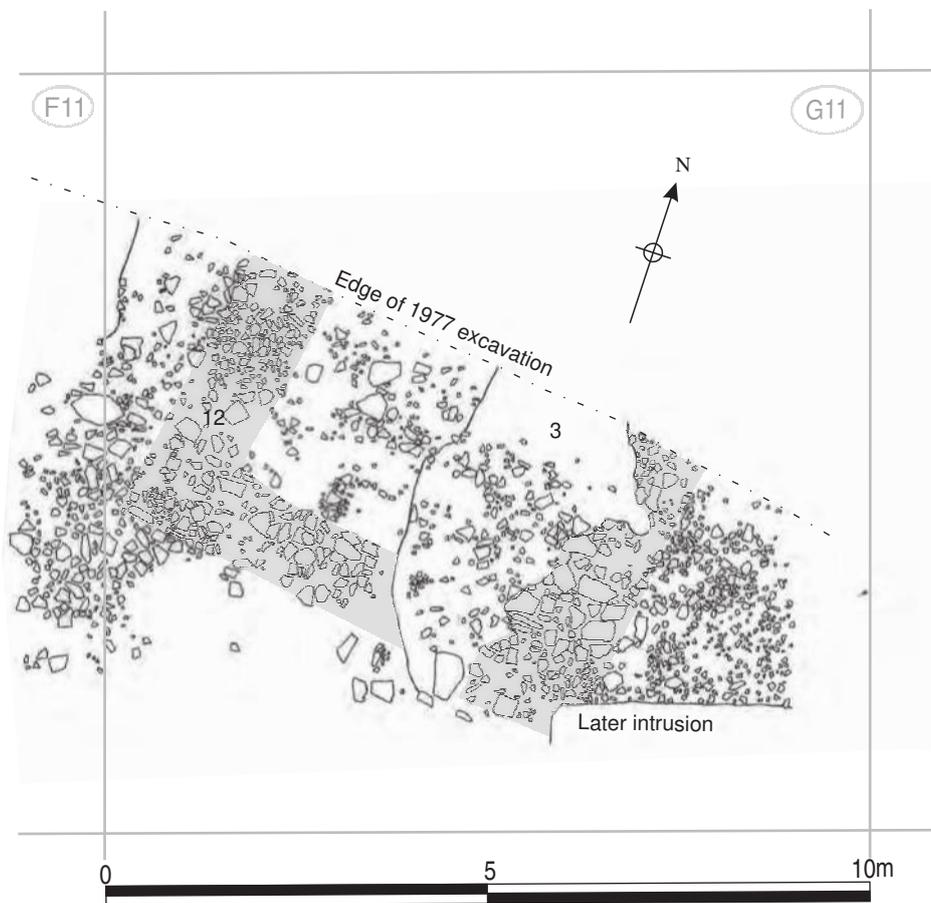
Figure 6.24: The stone foundations of Building BJ as exposed in 1977, at 1:100.

### Building BJ: The post-Roman structure (Fig. 6.24)

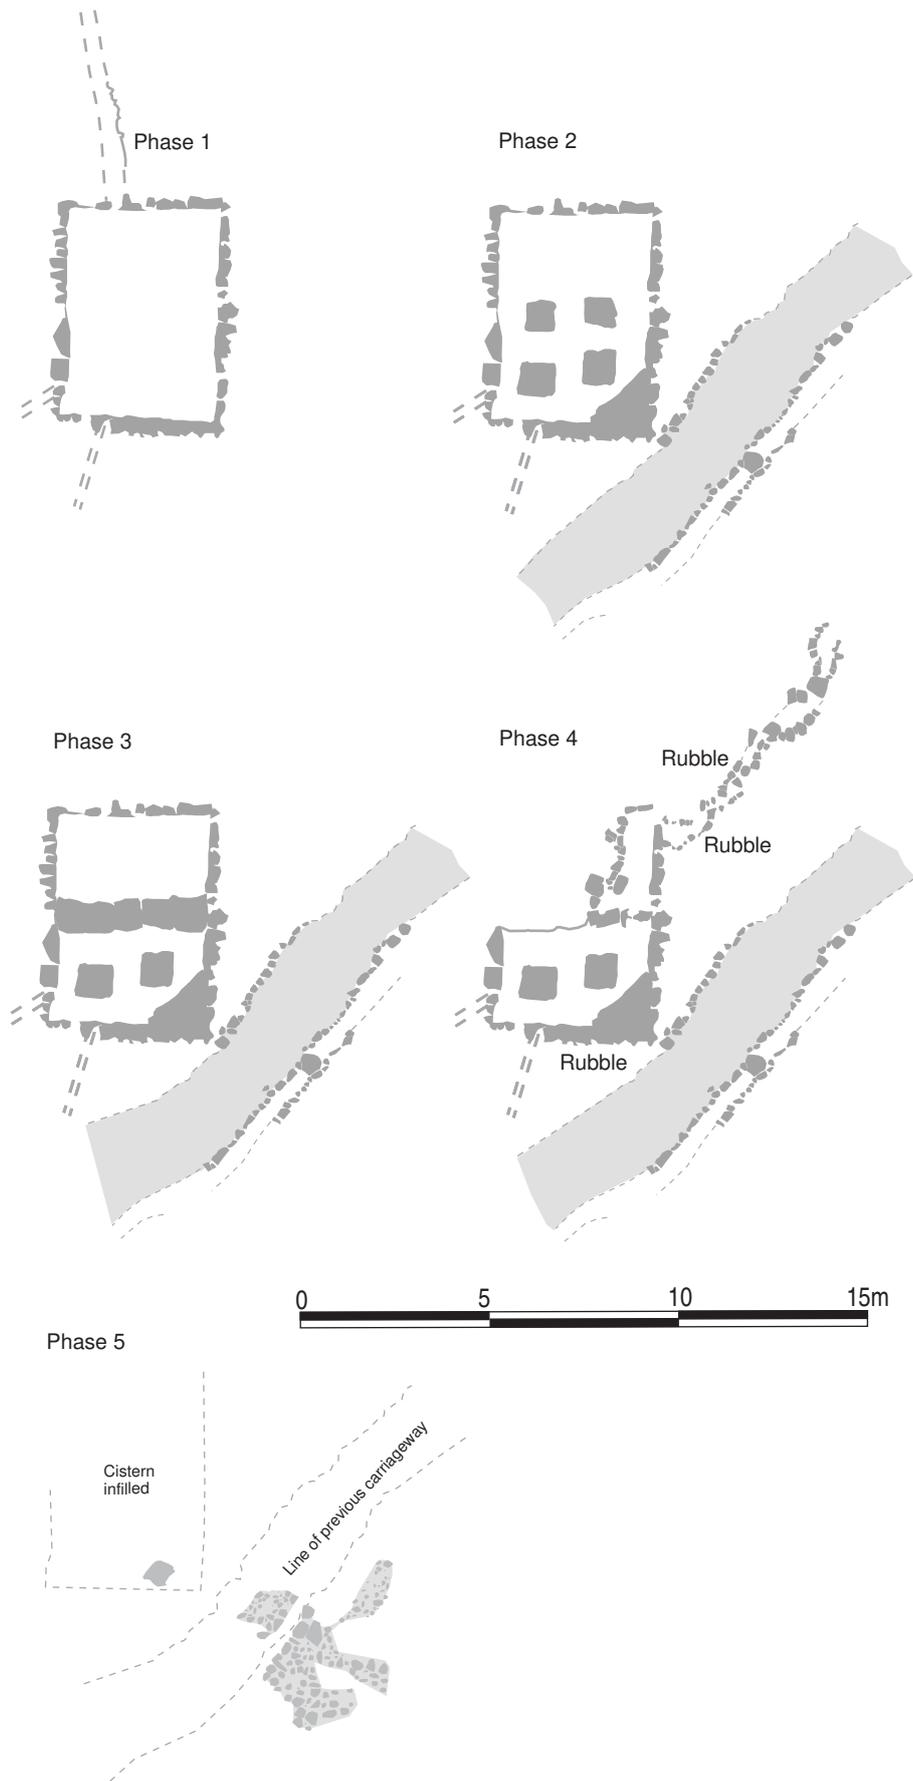
Fig. 10 Cistern 1 and adjacent road surfaces – phases. Scale 1:100

corner, the lowest point. The primary inlet channel (E08:65) ran from the north and fed into the cistern at its north-west corner (see Fig. 7.01: Phase 1). Its point of origin lay beyond the northern limit of the 1983 excavation site and could not be identified, but the channel may have represented a diversion from the main *intervallum* drain (E07:44, E08:66/67, D08:67, D09:05, D10:11 etc.), which passed some 2m to 3m to the west of the cistern. Stretches of the conduit's east side wall survived (E07:10, E07:42, E08:61). The west side had presumably been robbed when the channel was taken out of use and backfilled with a dark grey-brown clay-silt (E07:43, E08:73). The post-Roman destruction, noted above, meant it was uncertain how long this drain remained in use, as any later levels had largely been removed, but it was clear that it was in use at the same time as the earliest cobbled surface on the north side of the water tank (E08:58 – see below). It may have been replaced by a more direct diversion from the *intervallum* drain, which is represented by

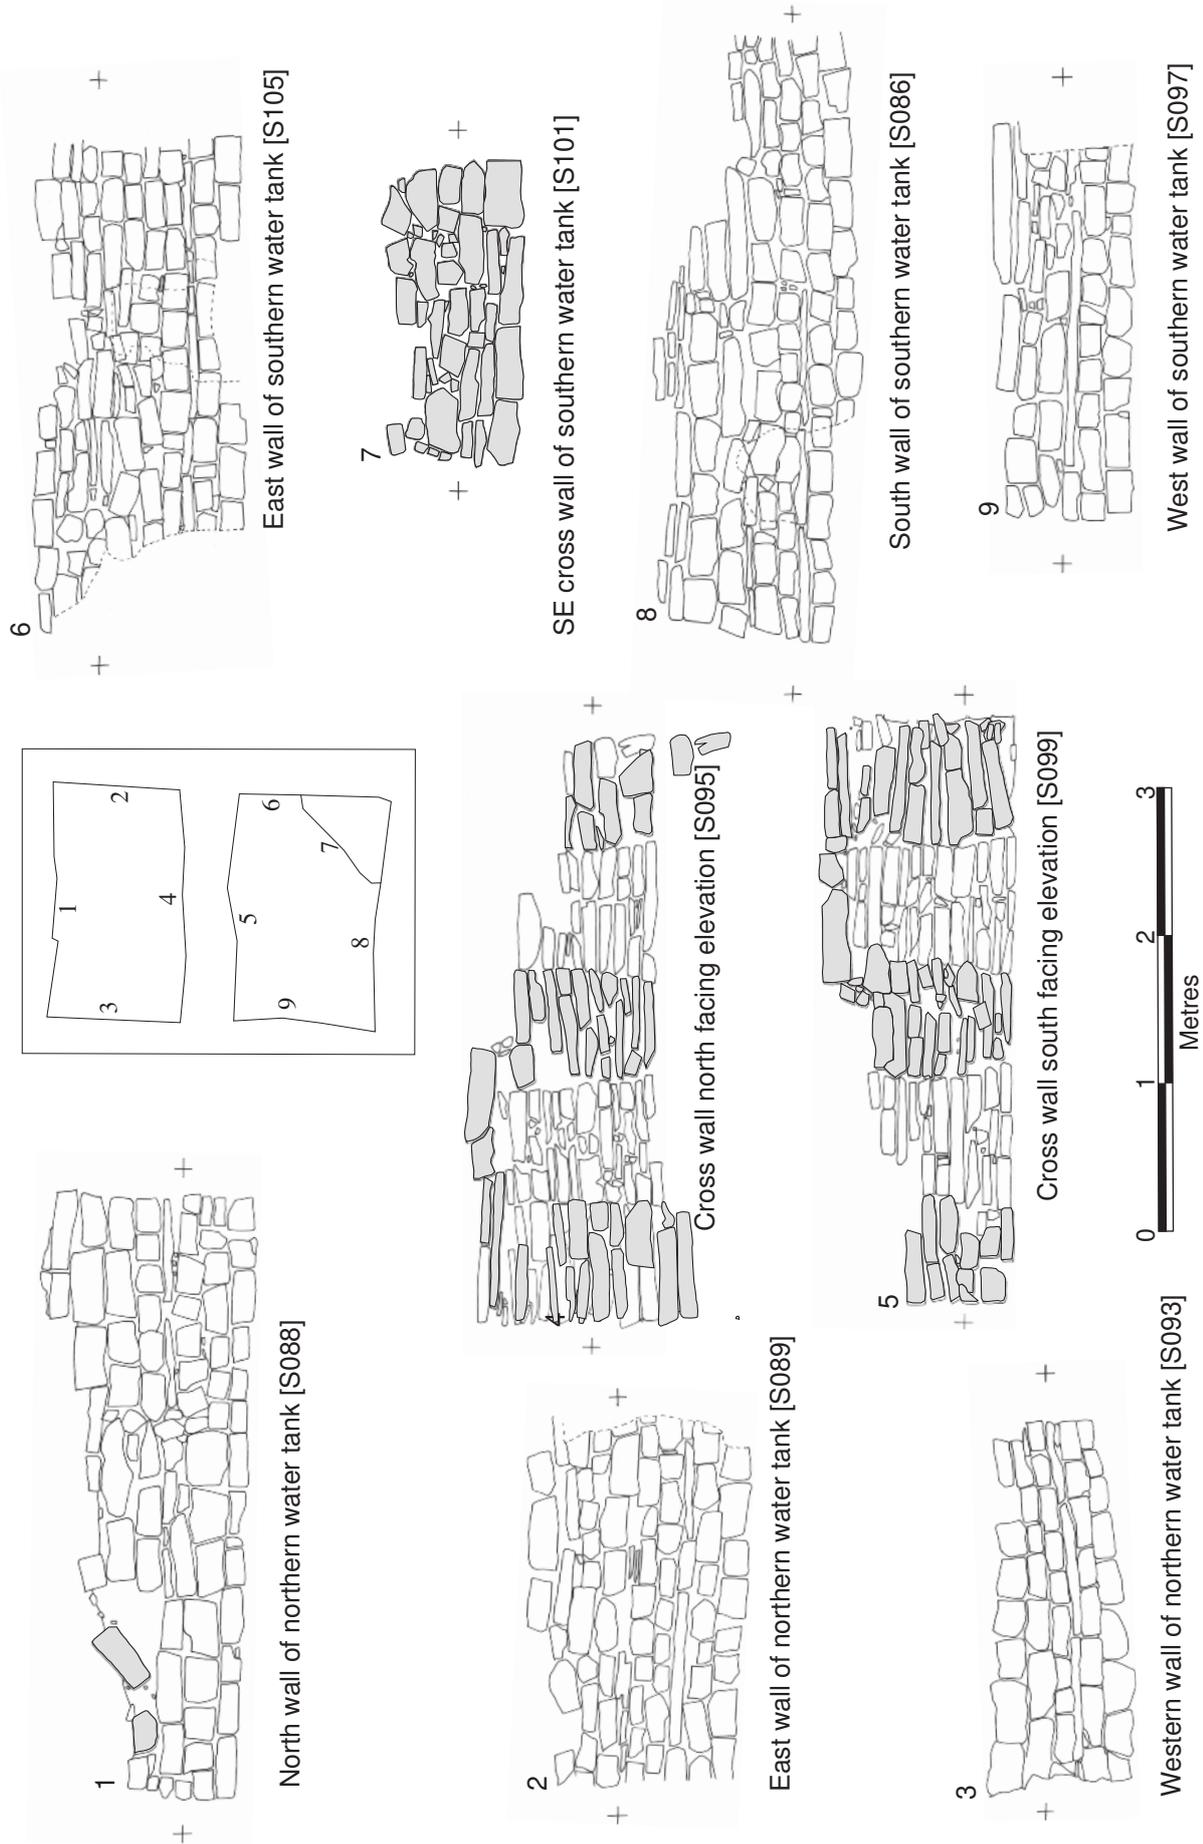
Figure 7.03: Elevation drawings of cistern wall faces. The shaded areas indicate secondary masonry and infilling. Scale 1:50.

was constructed across the south-east corner of the south cistern, the space in the corner being backfilled with soil and stone (Figs 7.03: S 101, 7.08–7.09). This was probably designed to buttress that corner because of the proximity of the re-routed *via principalis* levels (see below). There is no direct evidence that any of the late road levels actually clipped this corner of the cistern and consequently overlaid the buttress, which was only covered by the material later used to fill the southern half of the cistern (E08:29), but the vibration caused by passing traffic may have suggested reinforcement was needed.

A wall (E08:28) was constructed across the middle of the tank dividing it into northern and southern halves incorporating the two central pillars in its line (Figs 7.03: S95, S99, 7.10). This may have been intended to convert the northern half of the cistern into a settling tank, presumably to improve the quality of the water issuing from it and perhaps prevent the outlet conduits and the channel in the hospital from becoming clogged with silt. A 0.90m long rectangular stone block with an inset socket sat on top of the medial wall. The northern tank was then apparently allowed to gradually fill with silt. The bottom silt consisted of a dark brown sticky soil (E08:44), incorporating a large number of finds, predominantly bone, whilst the upper fill was composed of a rich black silty soil (E08:41), which was subsequently covered by a level of deliberately laid flags and large stones (E08:27). The bones formed an unusual assemblage, containing a lot of cow cheeks, rather than normal kitchen waste. At any rate this appears to indicate deliberate deposition of waste from butchery or some other process rather than the accidental washing of rubbish into the tank. The overlying flagging appeared to define a channel along the east edge of the infilled northern tank (Figs

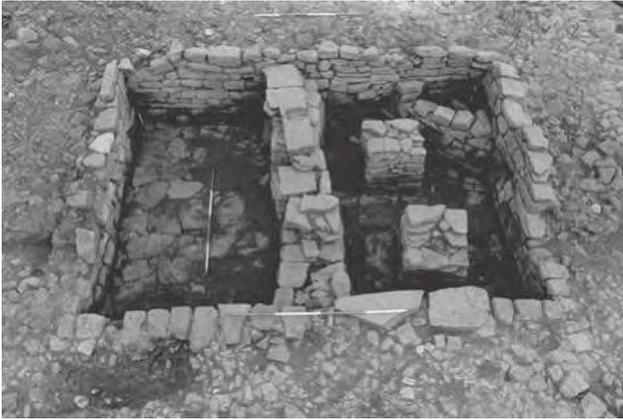
Figure 7.06 Overall view of Cistern 1 from the west.

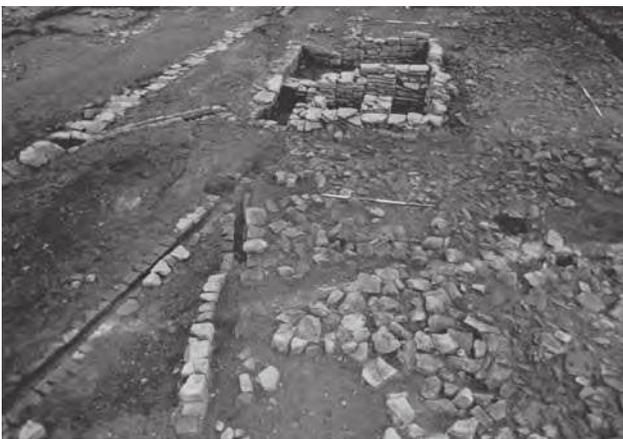
Figure 7.07 Water channels leading from Cistern 1 towards the intervallum drain and the hospital, looking north

been removed by later activity although its course could still be traced, but further south up to two courses of the conduit side walls and the flagged base survived. The width of the channel ranged between 0.20m and 0.30m. A similarly constructed overflow channel (D08:61, E08:55), which fed into the main *intervallum* road drain to the west, was probably broadly contemporary with the south conduit. The channel was c. 0.25m wide and would have helped to regulate the level of water in the cistern.

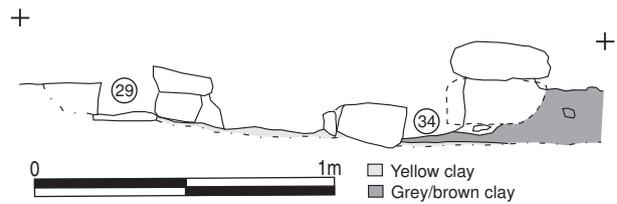
Figure 7.06: Section S120 across Phase 1 water channel E08:29 and Phase 2 conduit E08:34 Scale 1:1

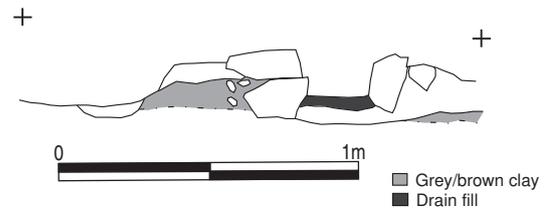
Figure 7.07 Section S2 across water conduit in E9 Scale 1:1

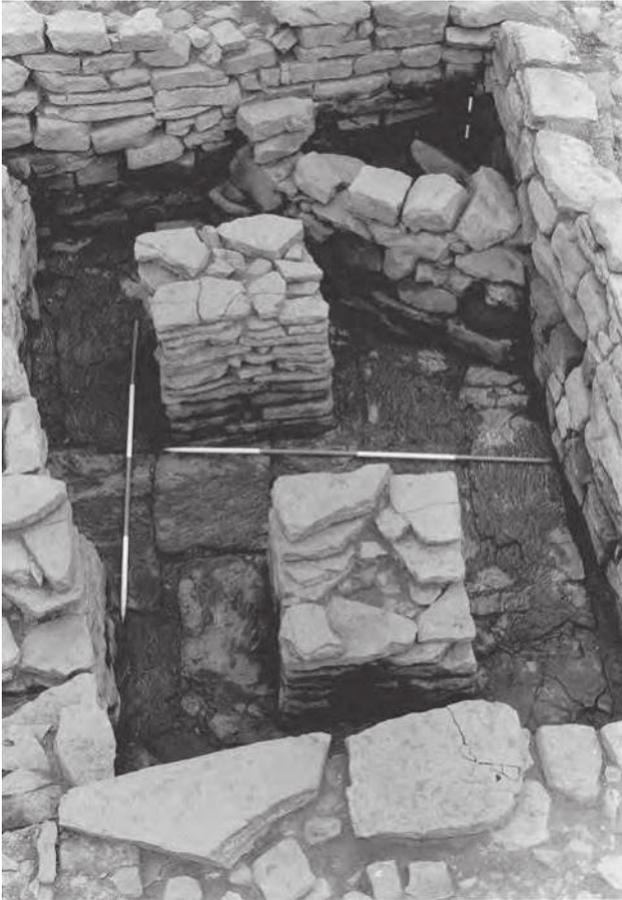
Figure 7.08 The southern half of Cistern 1 from the west showing the two pillars and corner reinforcing wall.

Four stone pillars, square in plan and constructed of flat slabs, were inserted in the tank (Figs 7.08, 7.10). Two of these were positioned in the centre of the tank, where they were incorporated in a later cross-wall (E08:28) dividing the tank in two, and the remaining pair in the southern half of the cistern (E08:39, 43). The south-east pillar was positioned eccentrically with regard to its south-west counterpart, appearing to respect the south-east corner buttress. This would

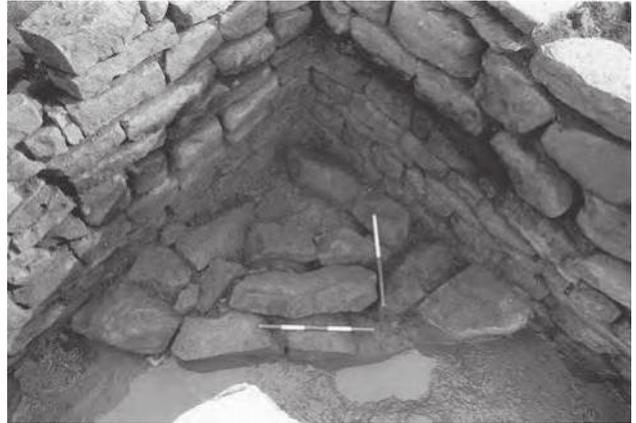
Figure 7.09: Base of the corner buttress, from the north-west.

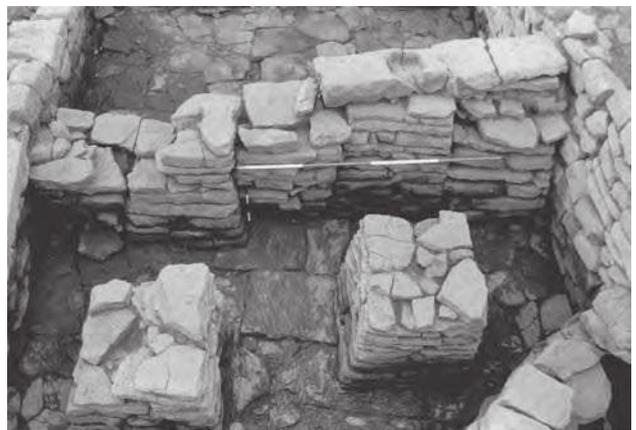
Figure 7.10 The cistern dividing wall from the south showing the two earlier pillars incorporated.

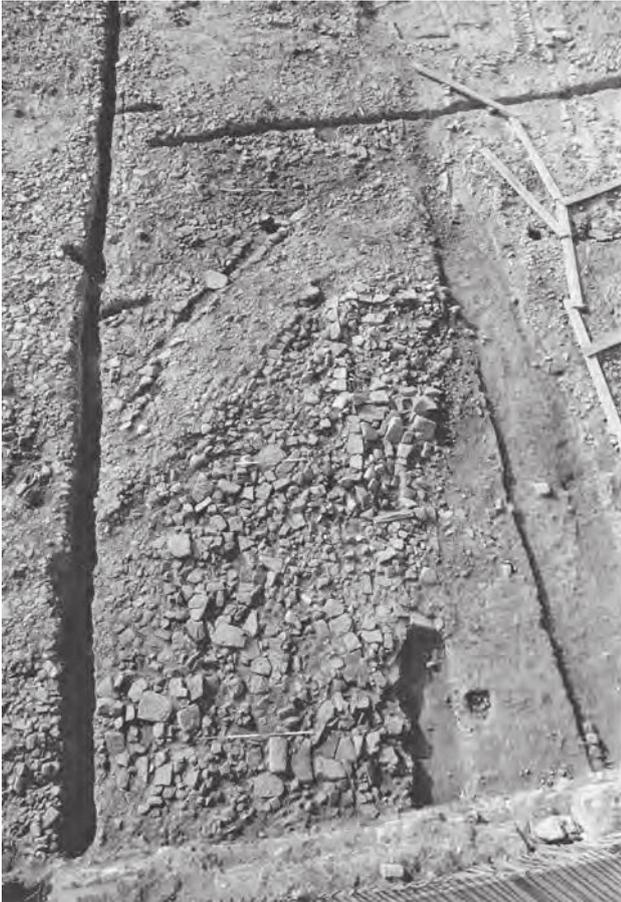
Figure 7 View of the assembly area from the north with the rerouted *via principalis* running diagonally from lower left to upper right, the infilled cistern in the centre and the intervallum drain at top right.

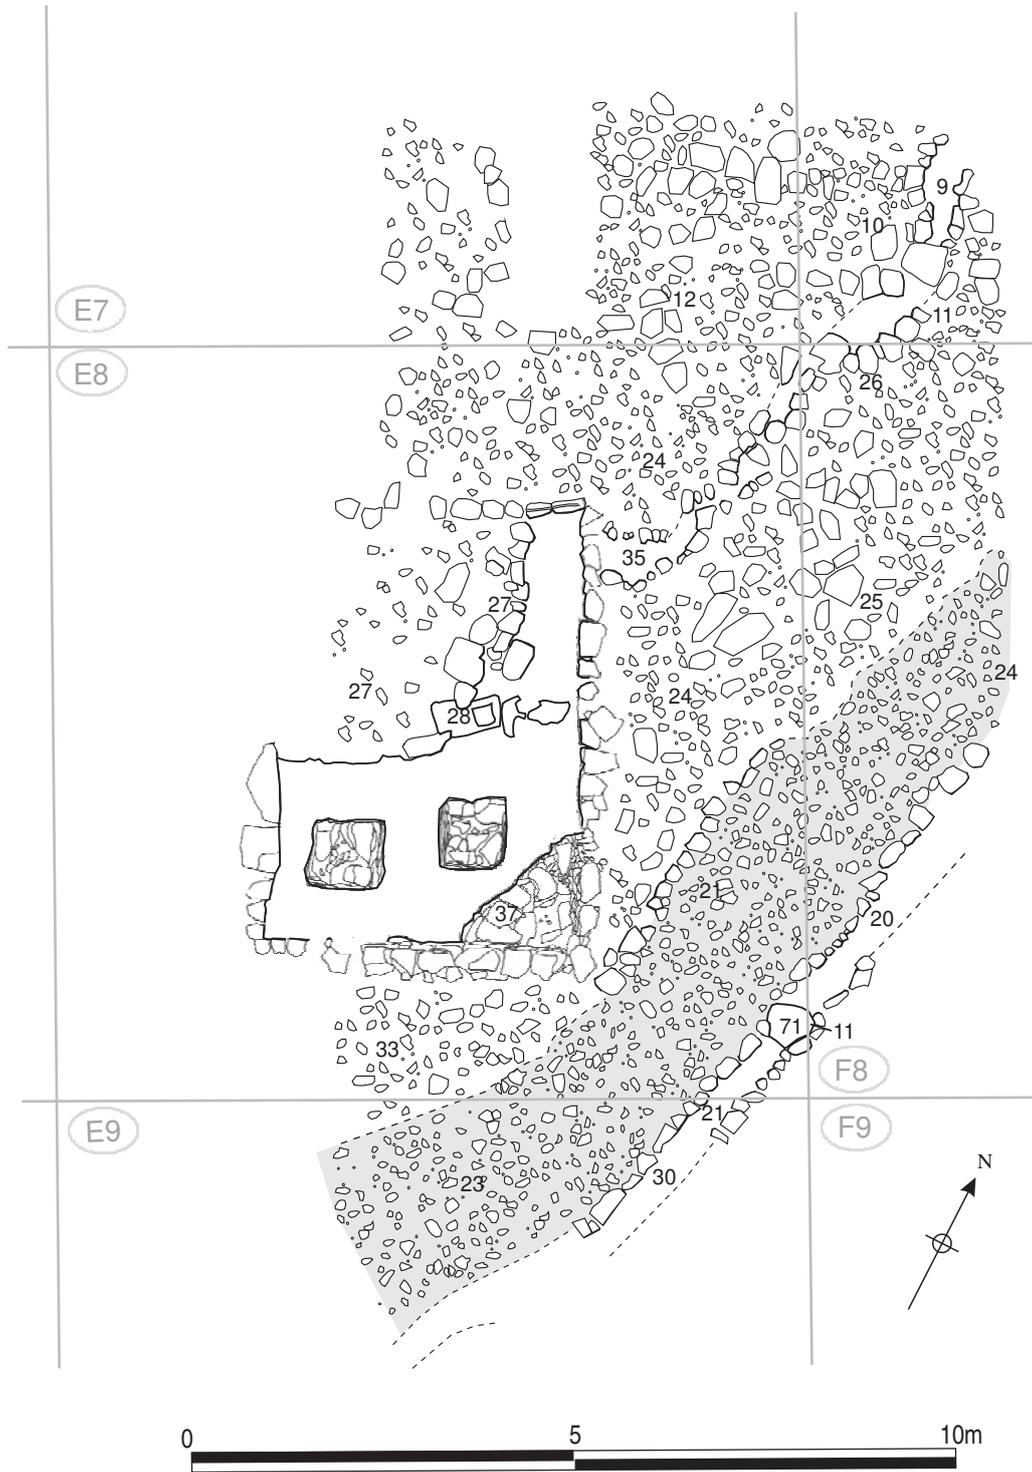
Figure 7.12: Cistern Phase 4, showing the partial infilling and the surrounding rubble spreads. The earlier re-routed via principalis road carriageway is highlighted in grey tone. Scale 0

7.11–7.13, that was presumably intended to enable the water from conduit E08:35 (see below) to flow into the southern tank, which remained in use. The socket stone was situated at the southern end of the channel revetment perhaps hinting at some form of superstructure associated with this remodelling.

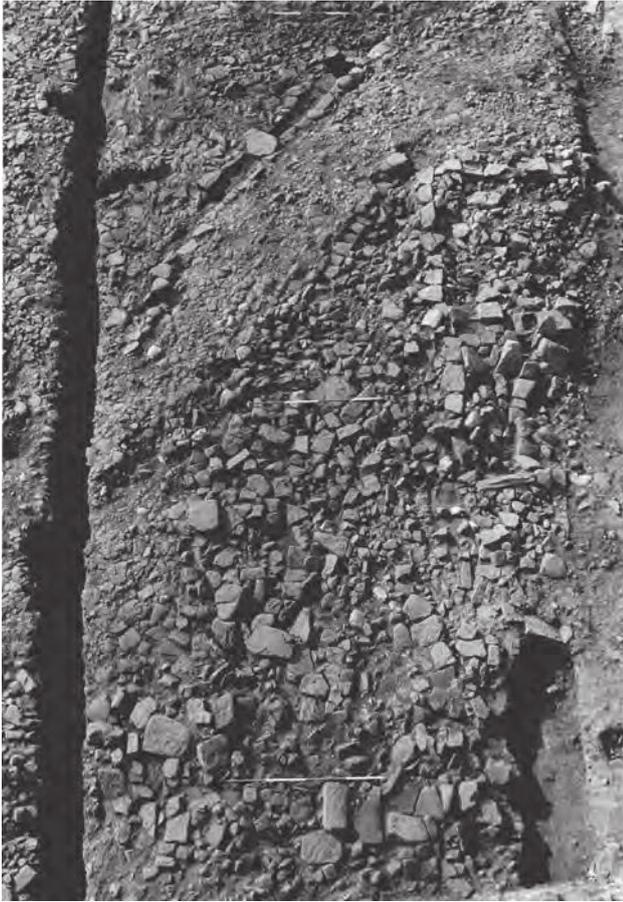
Figure 7.13: Closer view of the infilled cistern with channel in the north infilling, the re-routed via principalis, running from mid left to top right corner of the view, and surrounding rubble spread, from the north

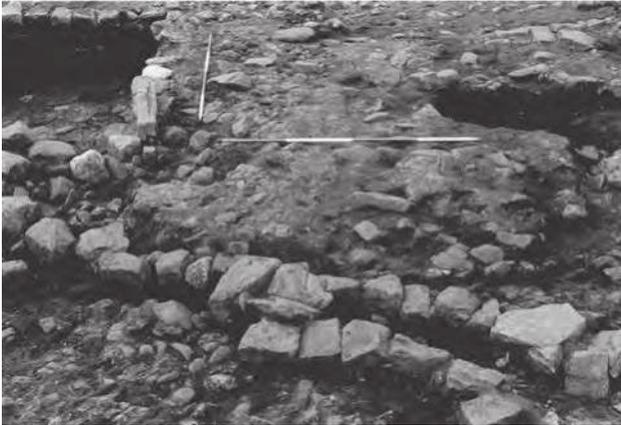
Figure 7.14: Drain E08:35 feeding into the north east corner of the cistern, from the east.

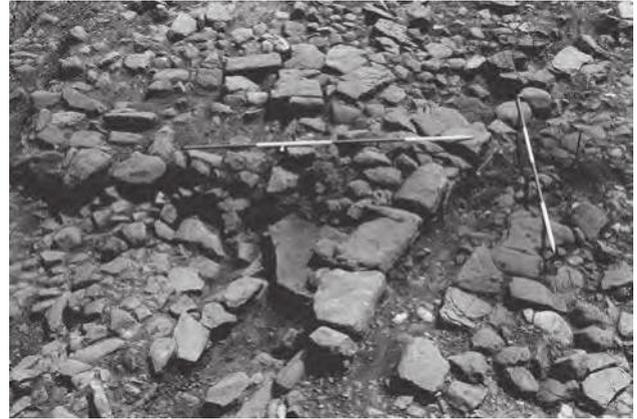
Figure 7.15: The latest surviving road surface on the re-routed *via principalis*.

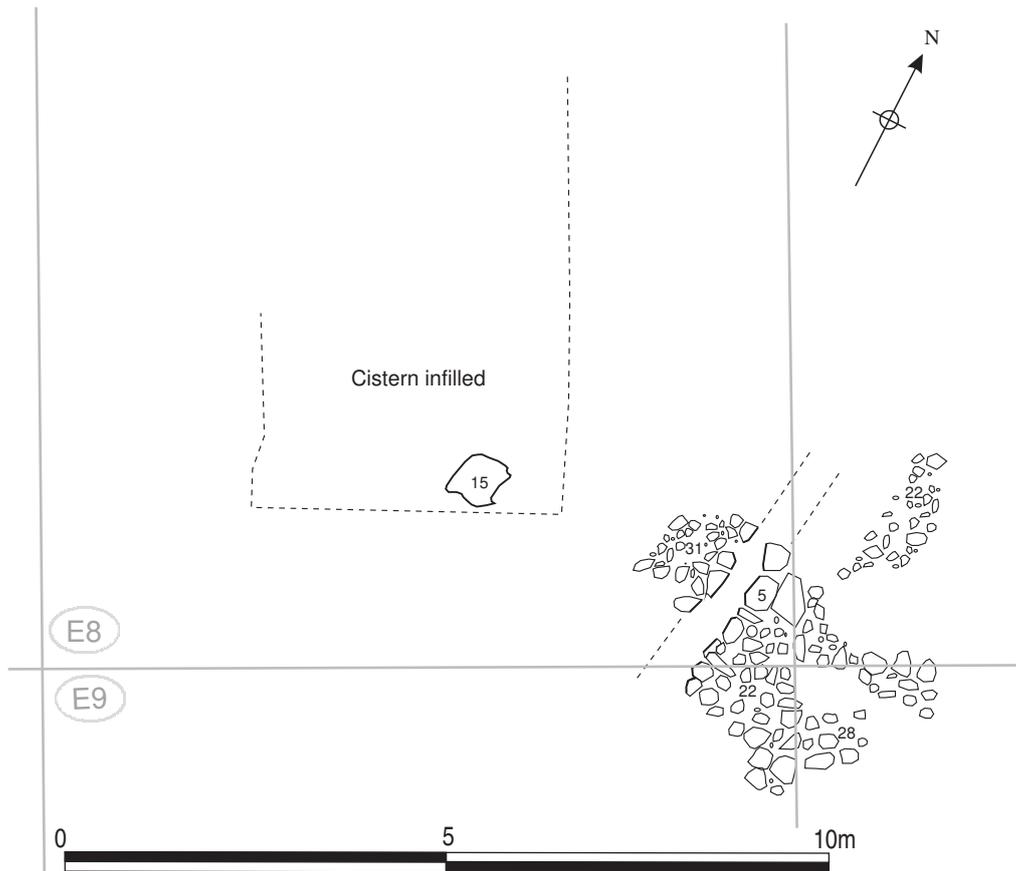
Figure 7.16: Plan of the latest surviving road surface in the vicinity of Cistern 1 (post-dating the cistern's infilling), 1:100.

A further road level (E08:31, E09:22, F09:28), which survived only fragmentarily, was subsequently laid over the carriageway. This was composed of somewhat larger cobbles and stone blocks than the previous surface and was not confined within the same limits, extending eastward over the line of the earlier side gutter (see Figs 7.15, 7.16). This surface, too, incorporated a drain (E08:05), positioned slightly to the west of the previous gutter, but the road surface extended on both sides of it.

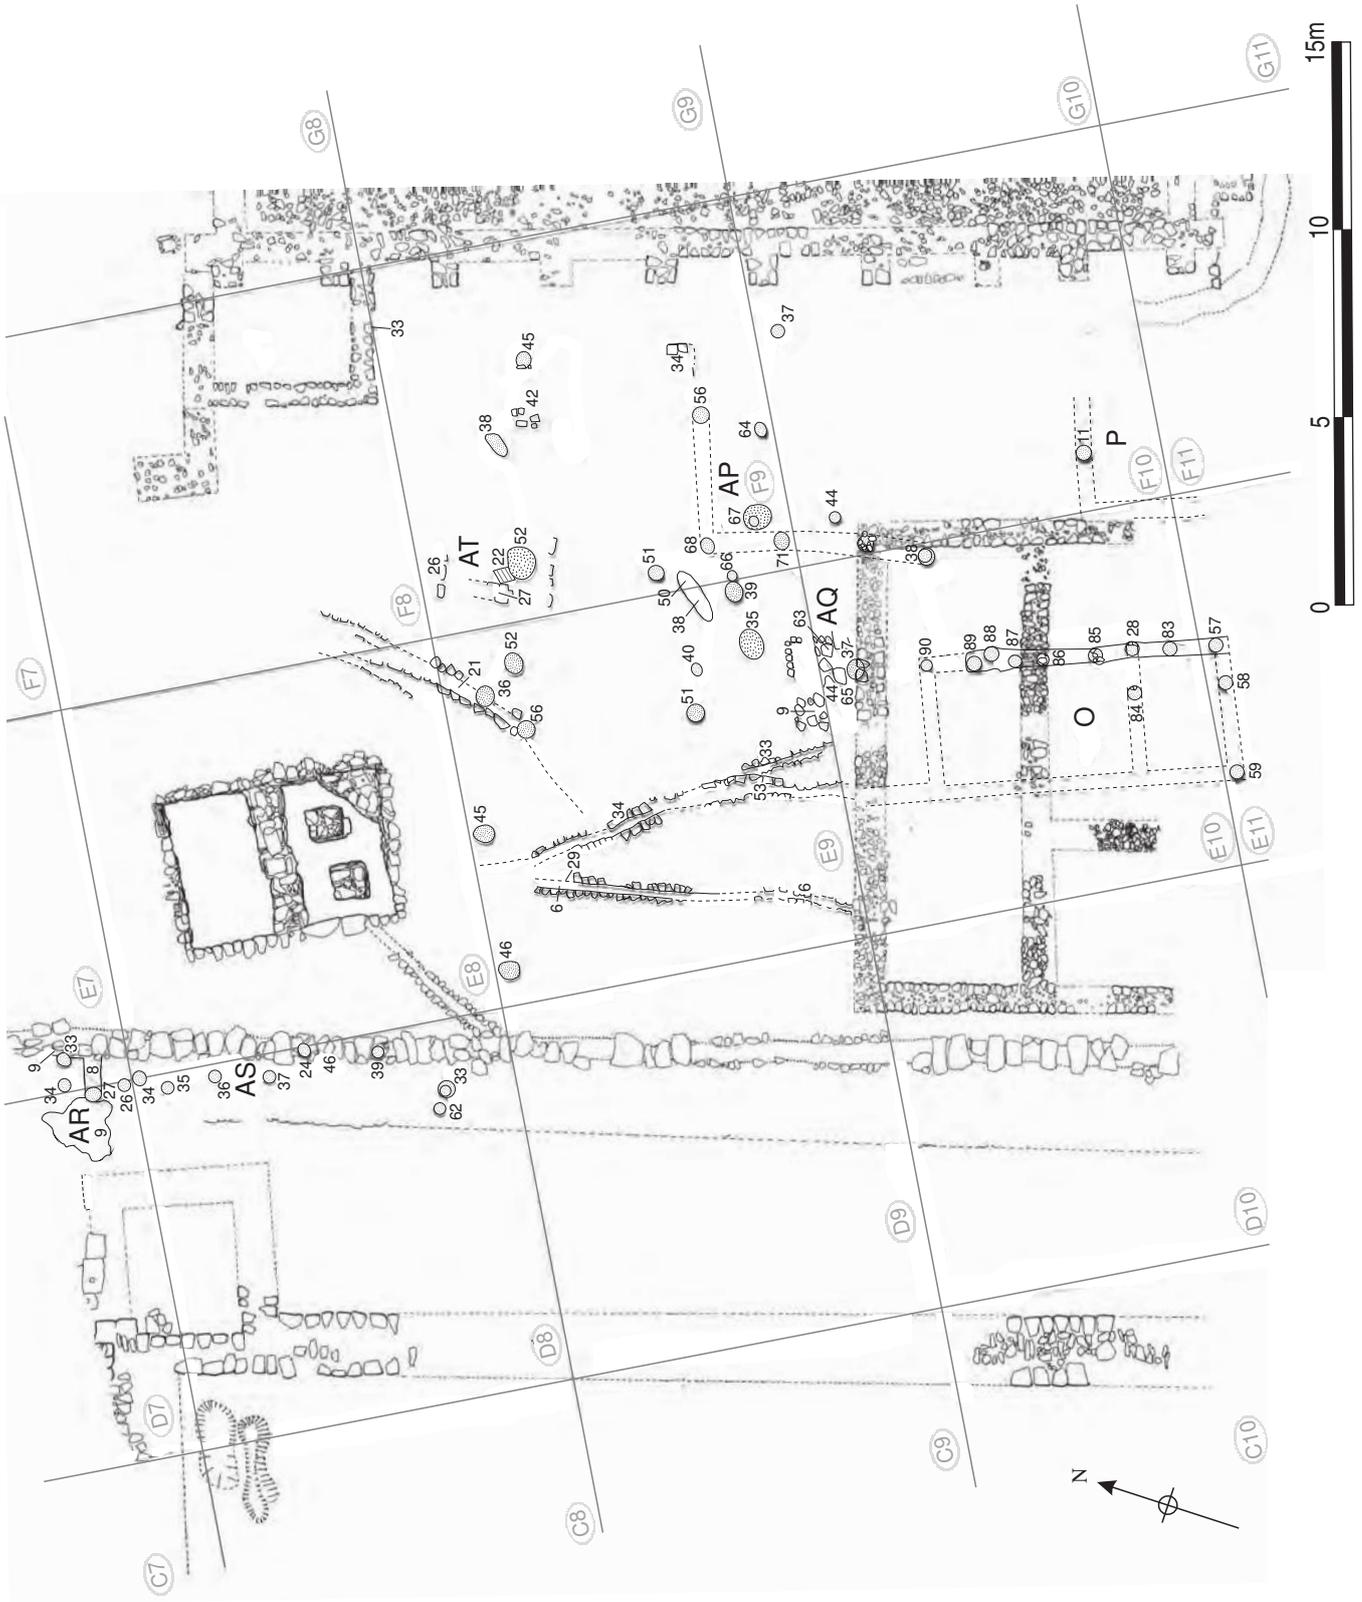
Figure 7.17: Plan showing the late timber-built structures identified in the assembly area. The cistern, hospital and other earlier stone structures are shown for reference. Scale 1:200.

A number of additional structures, mostly consisting of groups of post holes, were identified in the assembly area, between Cistern 1 to the north and the north wall of the hospital to the south (Fig. 7.17). None of the structures could be interpreted as coherent building plans, however. Furthermore it was difficult to integrate them into a clear sequential phasing due to widespread inconsistencies and contradictions in the excavation archive. Nevertheless it is clear that these structures were generally relatively late in the surviving structural sequence and can be assigned to Period 4 or later.

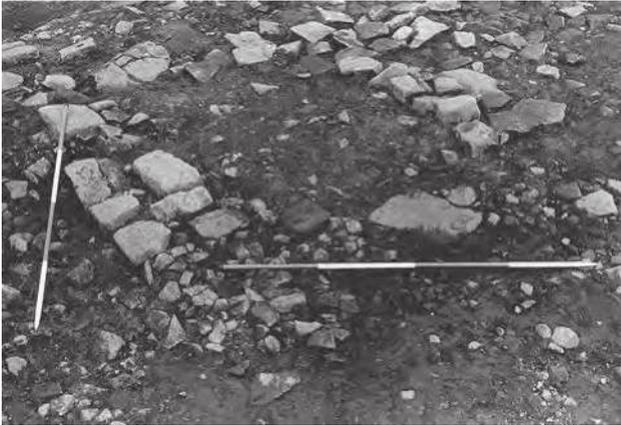
Figure 7.18: The remains of the structure labeled AQ immediately north of the hospital's north wall (shown in the left foreground), looking NW. Perhaps associated with Building O.

### Building AQ (Fig. 7.18)

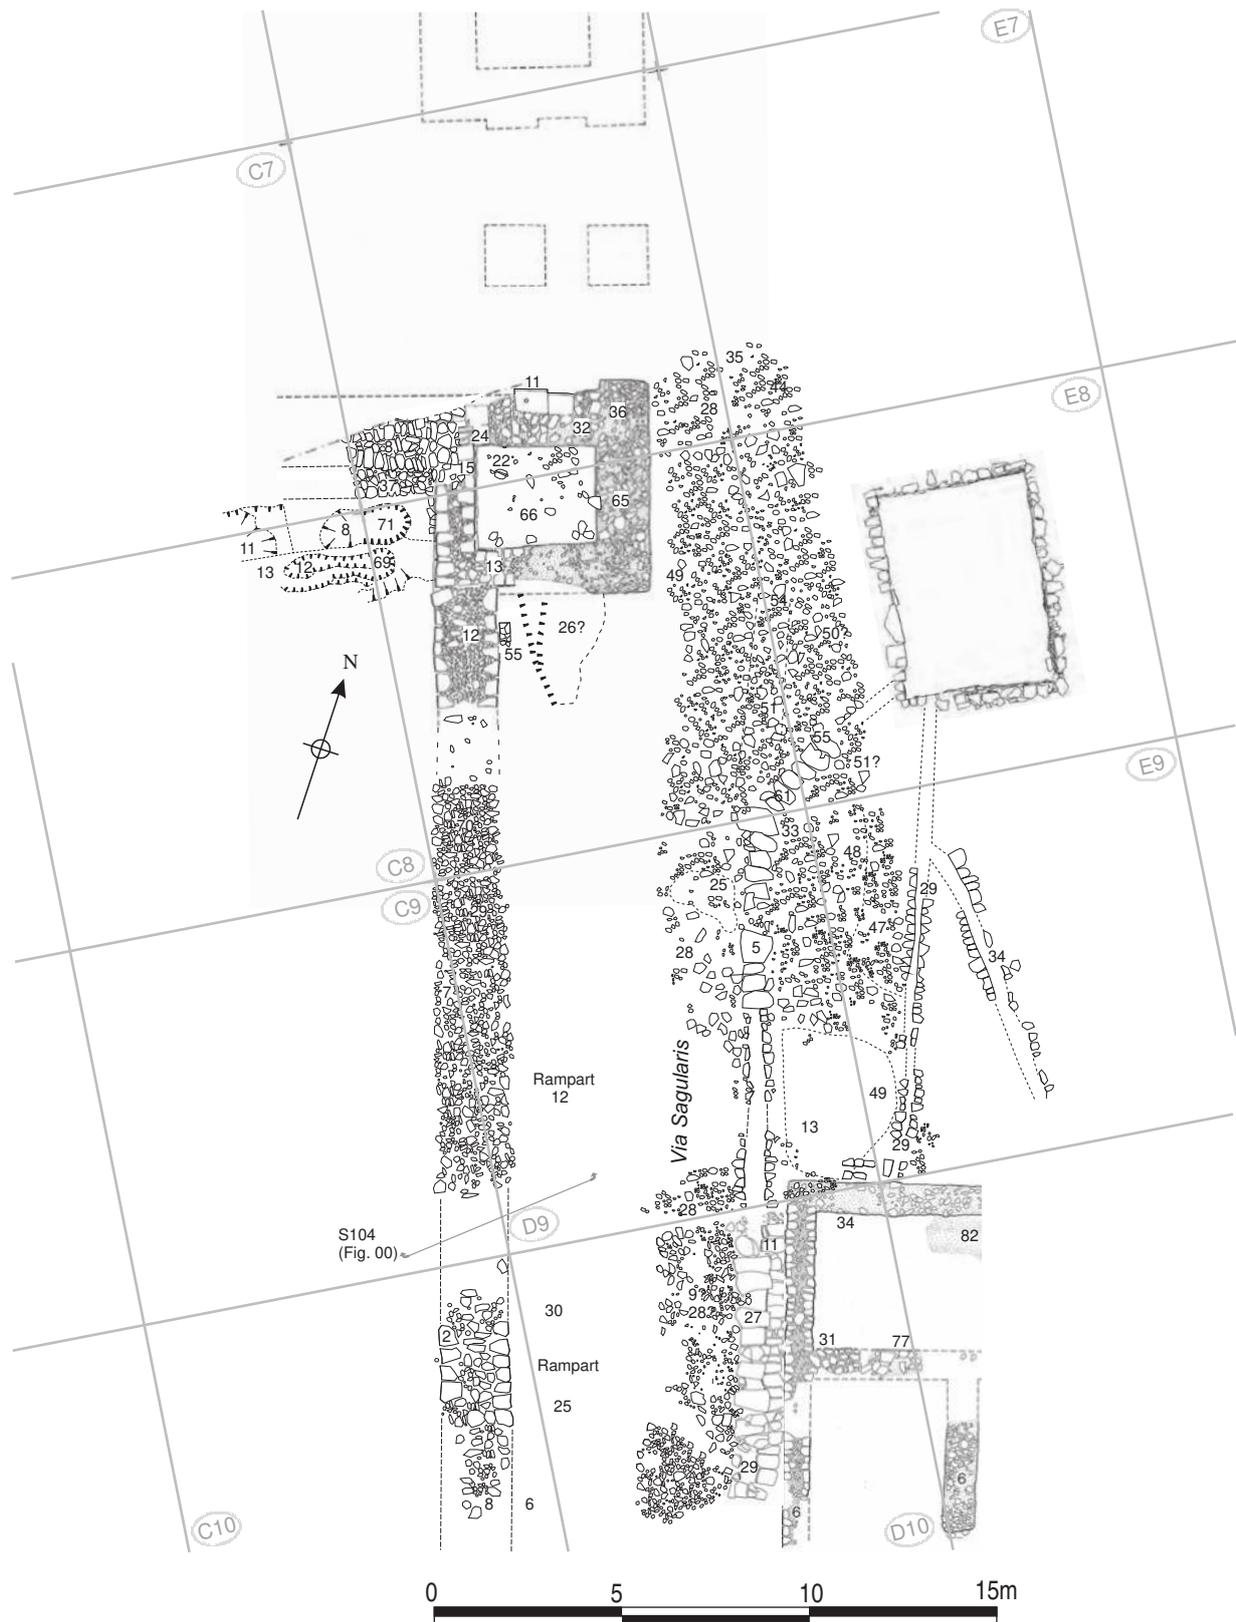
Figure 7.19: The western defences showing the earliest surviving intervallum road surfaces identified in 1983. (N.B. Excavation was not taken down to the pre-fort level in D10). Scale 1:200.

#### Road Level 1 (Fig. 7.19–7.21)

At the northern end of the *intervallum* road, next to the west gate, excavation was taken down to the lowest layer of street metalling which sat directly on top of the loamy layer intermixed with sand and silt designated 'old ground surface' (D07:34, D08:68, E08:68 – but site plan P392 indicates the latter incorporated quite a few cobbles, to the east of the *intervallum* drain). This initial road surface was composed of tightly packed pebbles, smoothed by wear, intermixed with larger stones 0.10–0.30m in diameter, set in a matrix of light brown to grey silt and fine dark brown loam (D07:28, D08:49, E07:35). On the evidence of site plan P375, E08:50, to the east, and E08:51 (to south of feeder channel D08:61/E08:55), also corresponded to this level but different equivalences were proposed on the context sheets).

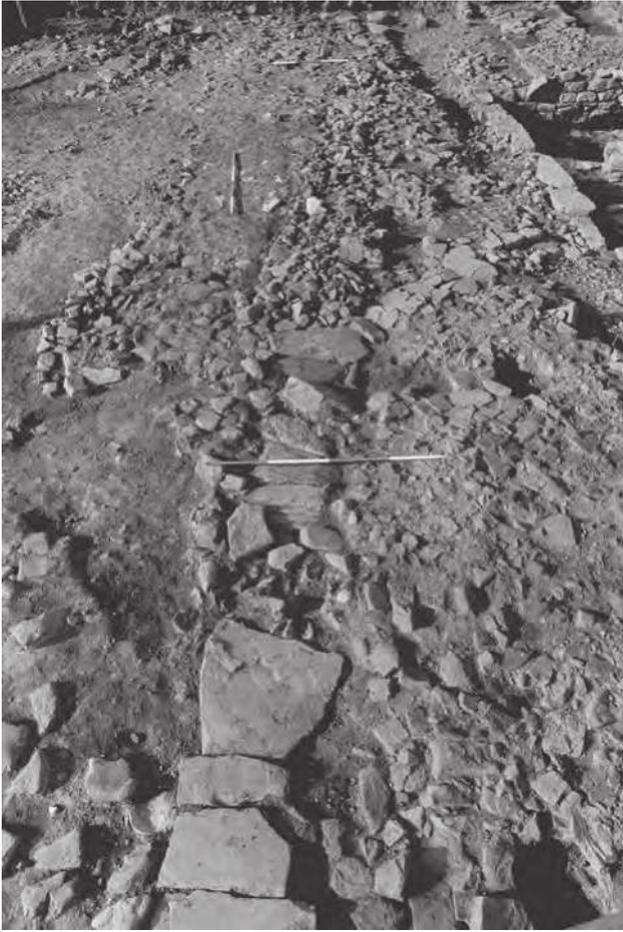
Figure 7.20: The earliest surviving metalled surface and stone-capped drain on the west *intervallum* road, looking north. The diversion of the drain via Cistern 1 and the rubble infilling over the redundant stretch are visible.

drain side wall E07:27. This would probably have flowed into the west side of the cistern near its north-west corner (for more discussion of this diversion see below: The West *Intervallum* Road and Figs 7.18–7.20).

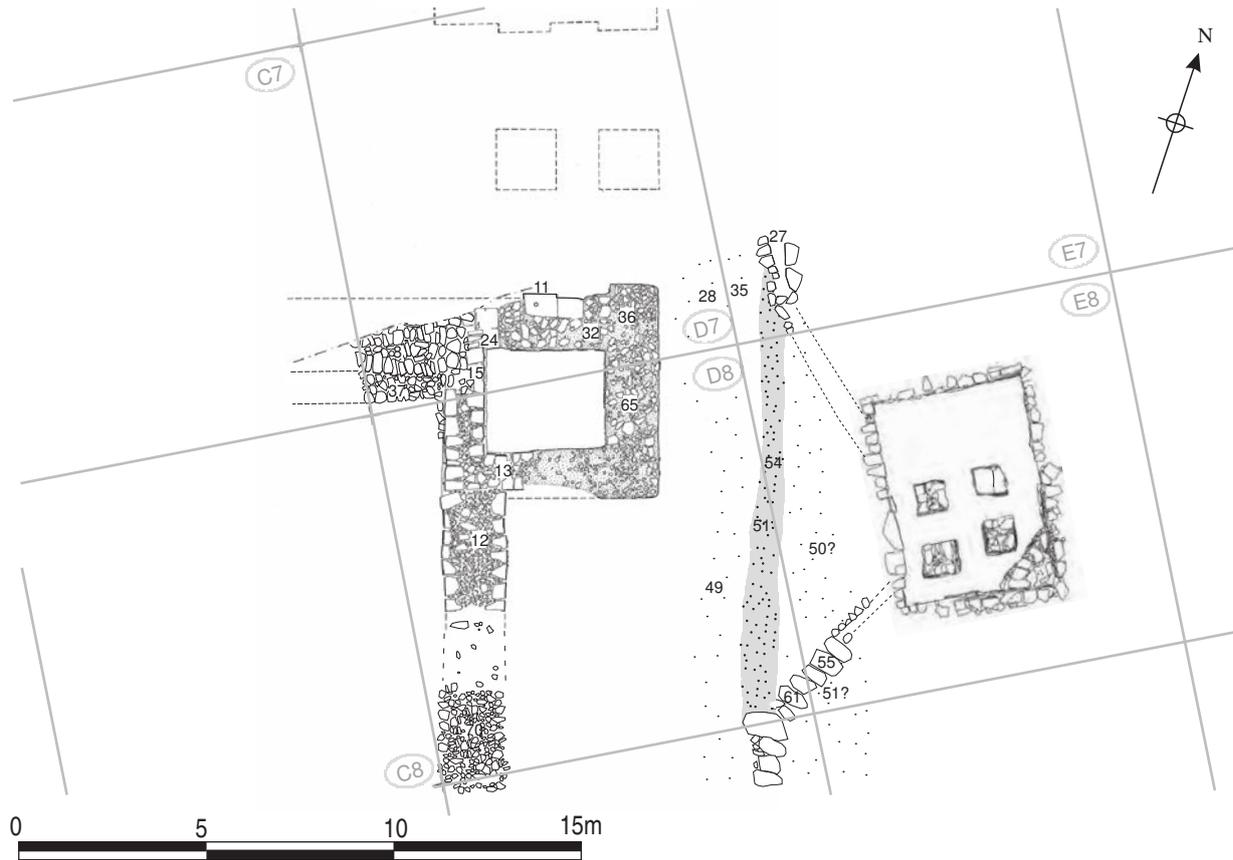
Figure 7.21: Schematic plan showing the recorded contexts associated with the earliest level of intervallum road metalling based on site plan P3 Scale 0

The relationship of the *intervallum* drain to Road Level 1 appears somewhat complex. When the street surface was first exposed the drain was not apparent. It was not covered by the metalling itself, however, but instead by a deposit of irregular stones, averaging 0.30m in diameter, in dark brown soil (D08:51, E08:54), which filled the 1m wide linear depression in the surface, over the drain capstones. The capstones were
