# SEGEDUNUM

Excavations by Charles Daniels in the Roman Fort  
at Wallsend (1975–1984)

VOLUME 1: The Structural Remains

Alan Rushworth and Alexandra Croom

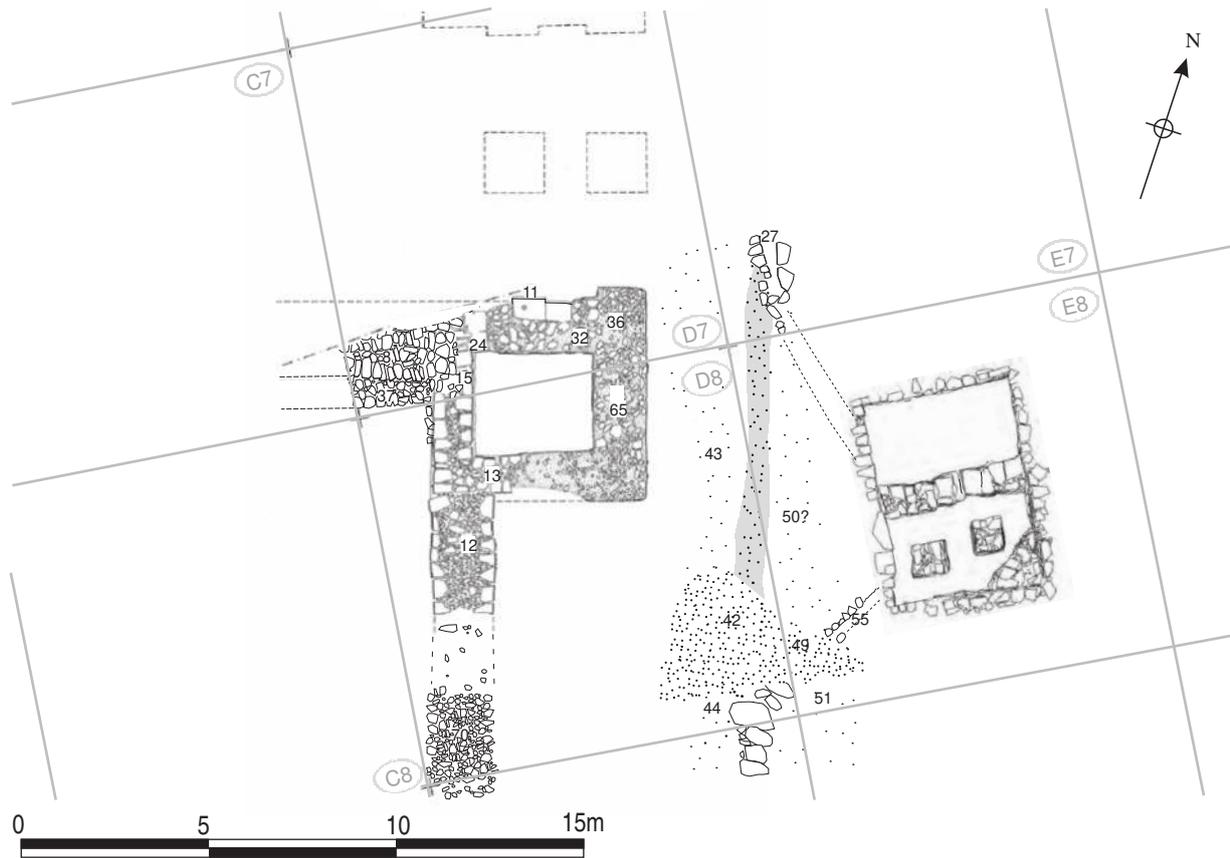
Figure 7.22: Schematic plan showing the recorded contexts associated with the second recorded level of intervallum road metalling next to the west gate, based on sketch plan D08/Fig 7, at 1:200.

#### Road Levels 2 and 3 (Fig. 7.22)

The initial street surface was overlain by a layer of worn pebbly gravel and loosely packed worn cobbles in matrices of gritty soil and fine brown soil respectively (D08:43, E08:50) perhaps roughly equivalent to the surface of tightly packed, well-worn cobbles (D08:44, E08:51) on the south side of the feeder channel leading from Cistern 1 to the *intervallum* drain. At the southern end of D08 this level was reportedly partially covered in turn by another layer of stones, worn smooth by wear, set in a matrix described as in crushed gravel (D08:42) and powdery grey-brown gravelly soil (E08:49). This level was not planned in detail, the extent of its various layers of cobbling only being plotted on one of the sketch plans (D8: fig 7).

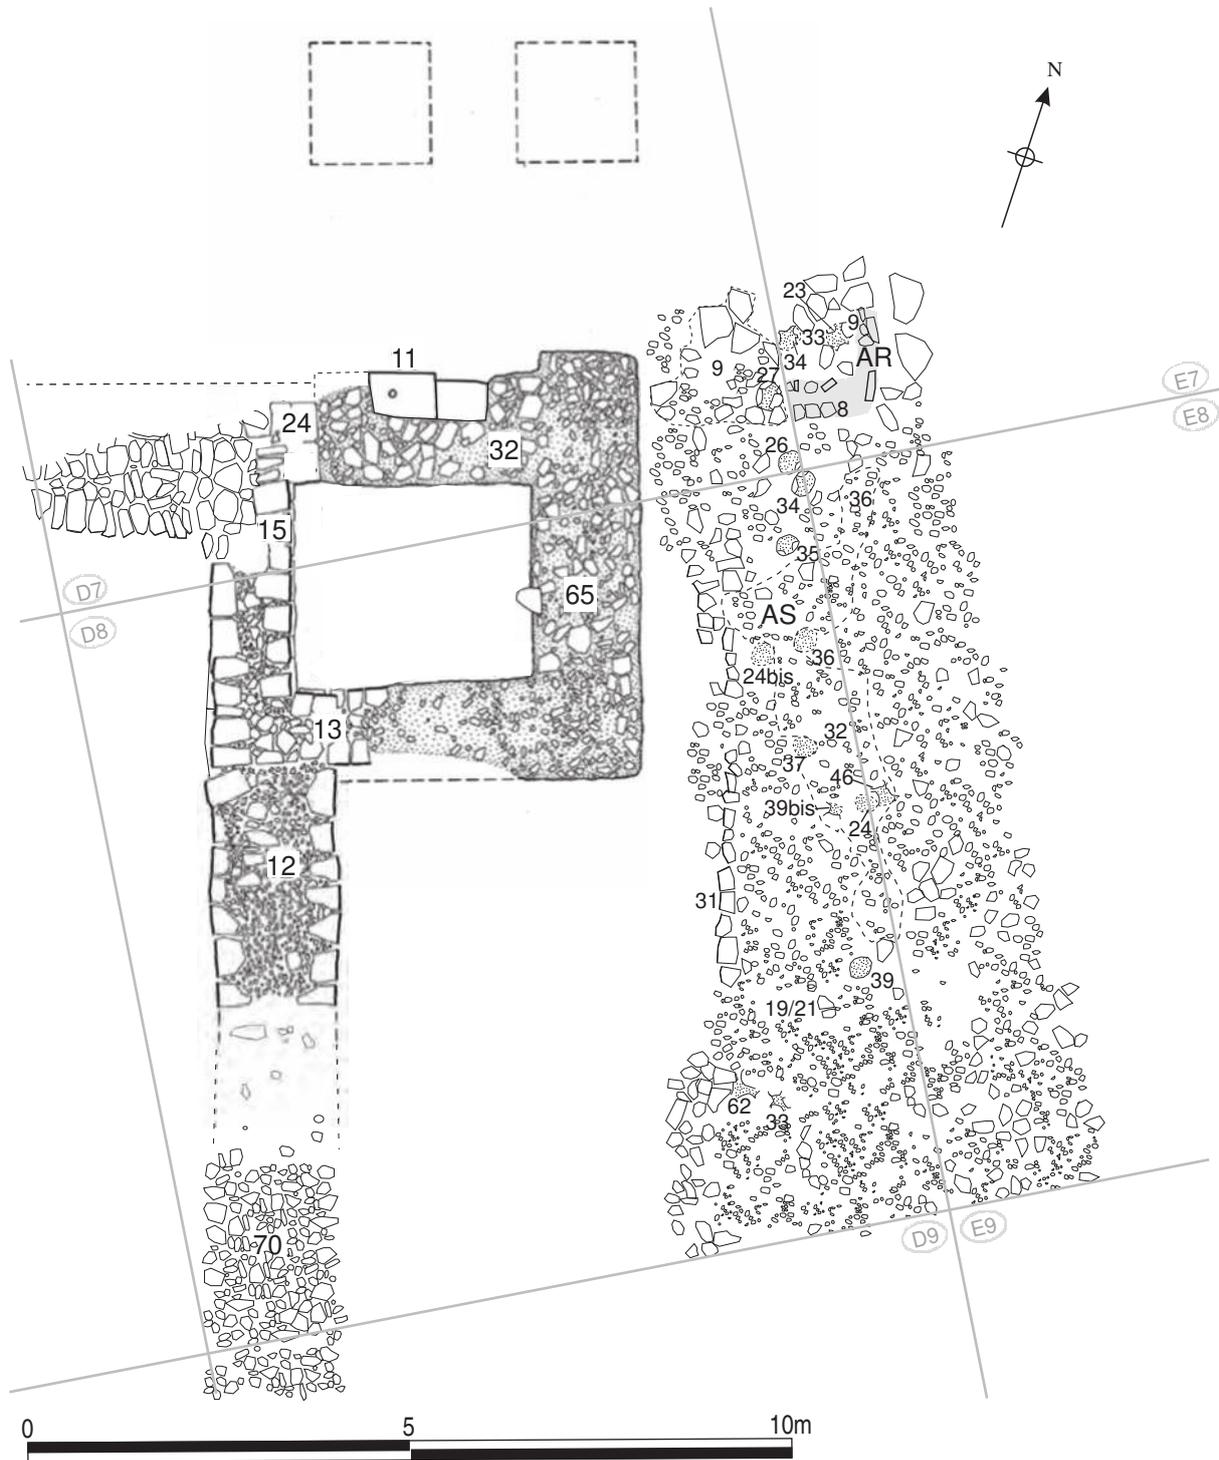
Fig re 3 The Level 4 intervallum road surfaces next to the west gate with the postholes of Building AS and the remains of AR (suggested wall lines highlighted with tone), 1:100.

#### Road Level 4 (Fig. 7.23–7.25)

#### Building AS (Figs 7.23–7.26)

Over the north end of AS very fragmentary traces of stone walling were interpreted by the excavators as the remains of a second possible structure, which they labelled Building AR (see Fig. 7.23). These

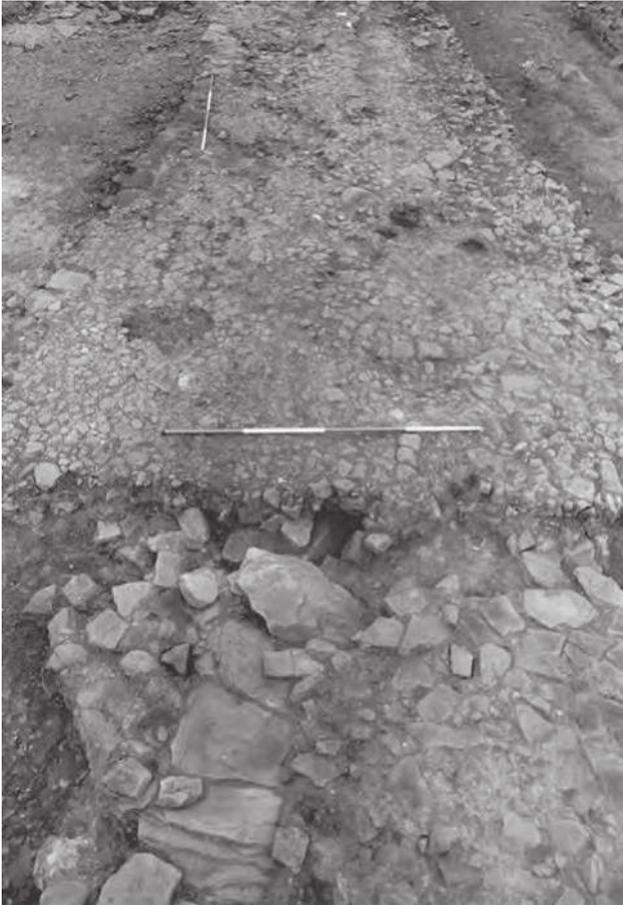
Figure 7.24: The Level 4 road surface (D08:19/21) cut by the postholes of Building AS, looking north.

A further cobbled road surface, or perhaps two successive surfaces, was identified in D08 and D07, made up of stones averaging 0.10–0.15m in diameter, intermixed with crushed gravel and worn pebbles (D07:09, D08:19, 21). The west side of carriageway was bounded by a stone kerb (D08:31). In places, particularly towards the north, a second kerb line, immediately to the west of the main one, is recorded on plan P355. There was no trace of a corresponding

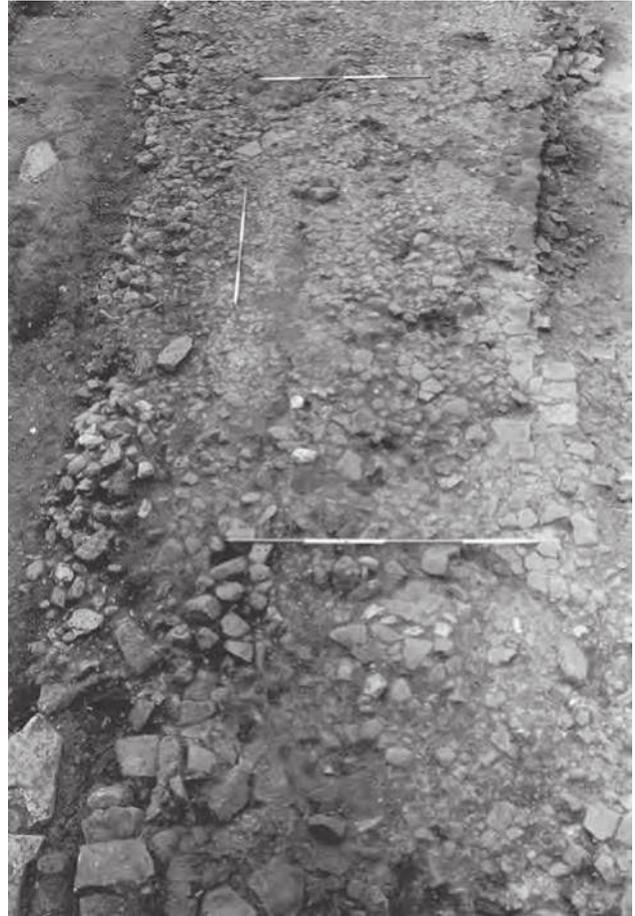
Figure 7.25: The Level 4 intervallum road surface, looking south. The postholes of AS are apparent as is the north end of the earlier intervallum drain realignment (E07:08) in the bottom left corner.

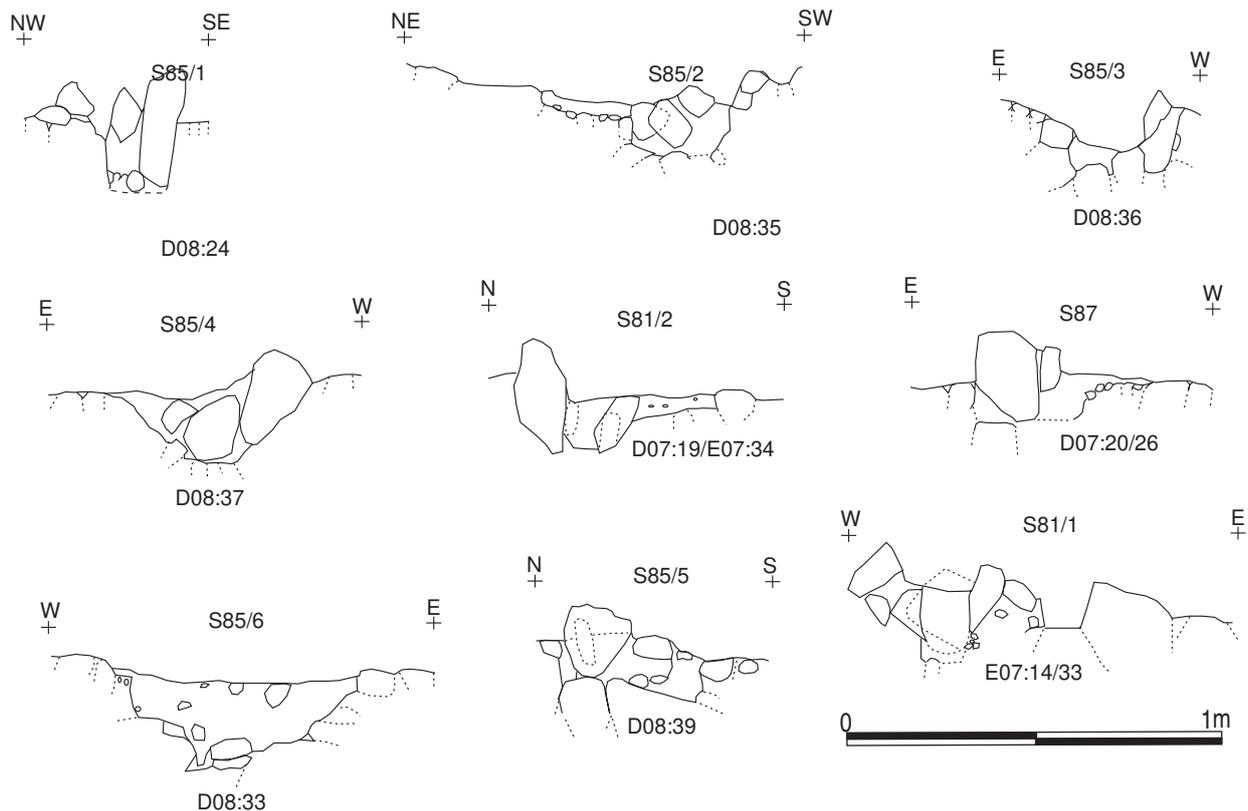
Figure 8 Section drawings of post holes associated with Building AS, at D

D08:24 is likewise located at different spots on plans P330 and P355 (the sketch plan and P355 duplicate post holes are numbered D08:39bis and D08:24bis here, for convenience). The post holes were revealed by groups of packing stones protruding into the road surfaces (Fig. 7.26). They were arranged roughly in a line, some 10.30m in length, oriented north-south, and lay some 2.0–3.0m east of the gatetower and 5.5m

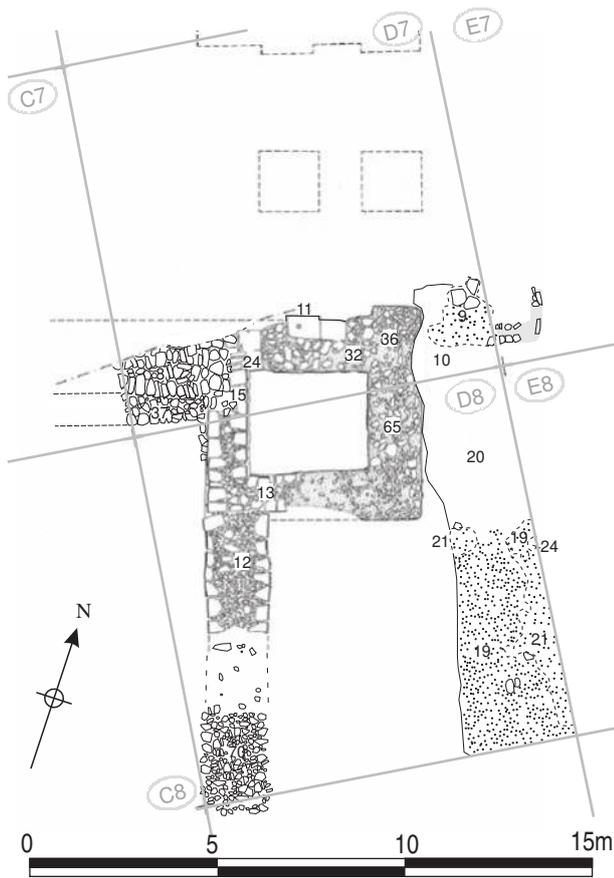
Figure 7 Latest surviving levels of the west intervallum road next to the west gate (based on site plan P330), 1:200.

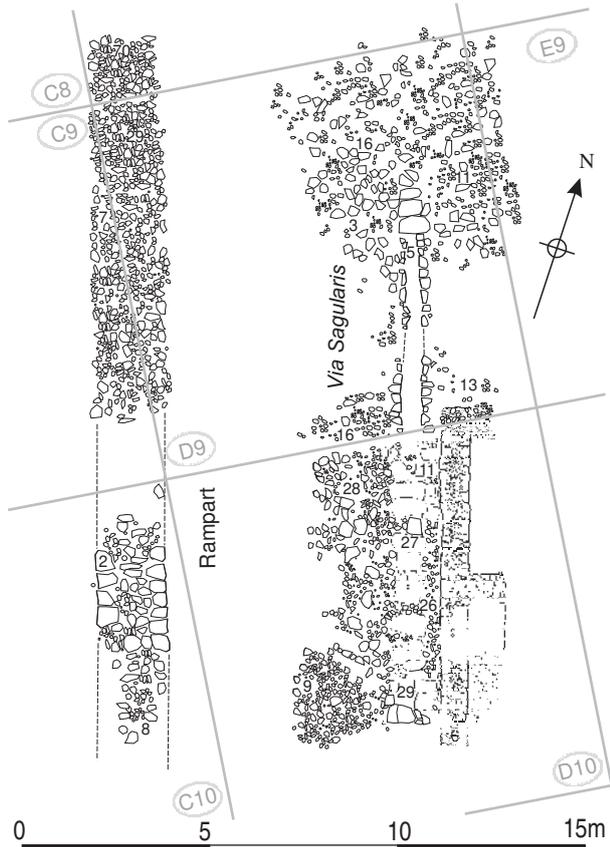
Fig re 2 8 Later west intervallum road surfaces in grid squares D9 and D10 (based on site plans P331 and P332),

The lower road surface to the west of the drain was overlain by D09:03 and D09:16 which, stratigraphically, seem to have formed different parts of the same secondary level. D09:03 was described as a worn cobble and flagstone surface on the relevant context sheet. On site plan P331, however, it is shown as comprising discrete patches of scattered flagging, whilst only one patch of D09:16 resembled its context

sheet description – uneven broken flagstones – the remainder of that layer apparently consisting of much smaller cobbling, which surrounded the scattered patches of D09:03. This was 2.0–2.5m wide from the edge of the *intervallum* drain. To the east of the drain (and overlapping it towards the north), an extensive area of worn stones (D09:11) on the edge of the assembly area was interpreted as another possible road surface, which was perhaps equivalent to the stone surface in orange/brown soil (E09:12) in grid square E09, these layers together overlying the earlier ‘road foundation’ D09:33/E09:48. Overlapping the eastern margin of E09:12 and overlying sub-base E09:47, was a further patch of worn stone surfacing (E09:11), measuring 5m (N–S) by 2m (E–W).

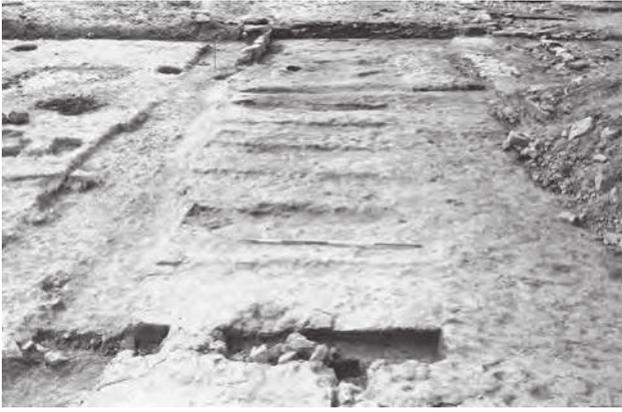
Figure 8 The north end of Building BI construction slots in the foreground beneath the *via principalis* with pre-Roman cultivation furrows evident beyond, looking west.

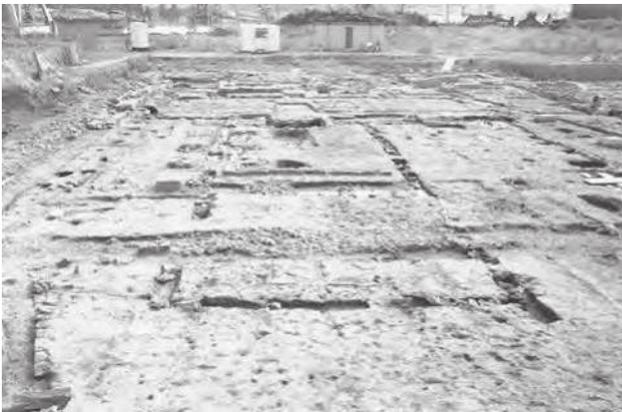
Figure 8 The main construction slots of timber building BI, looking south

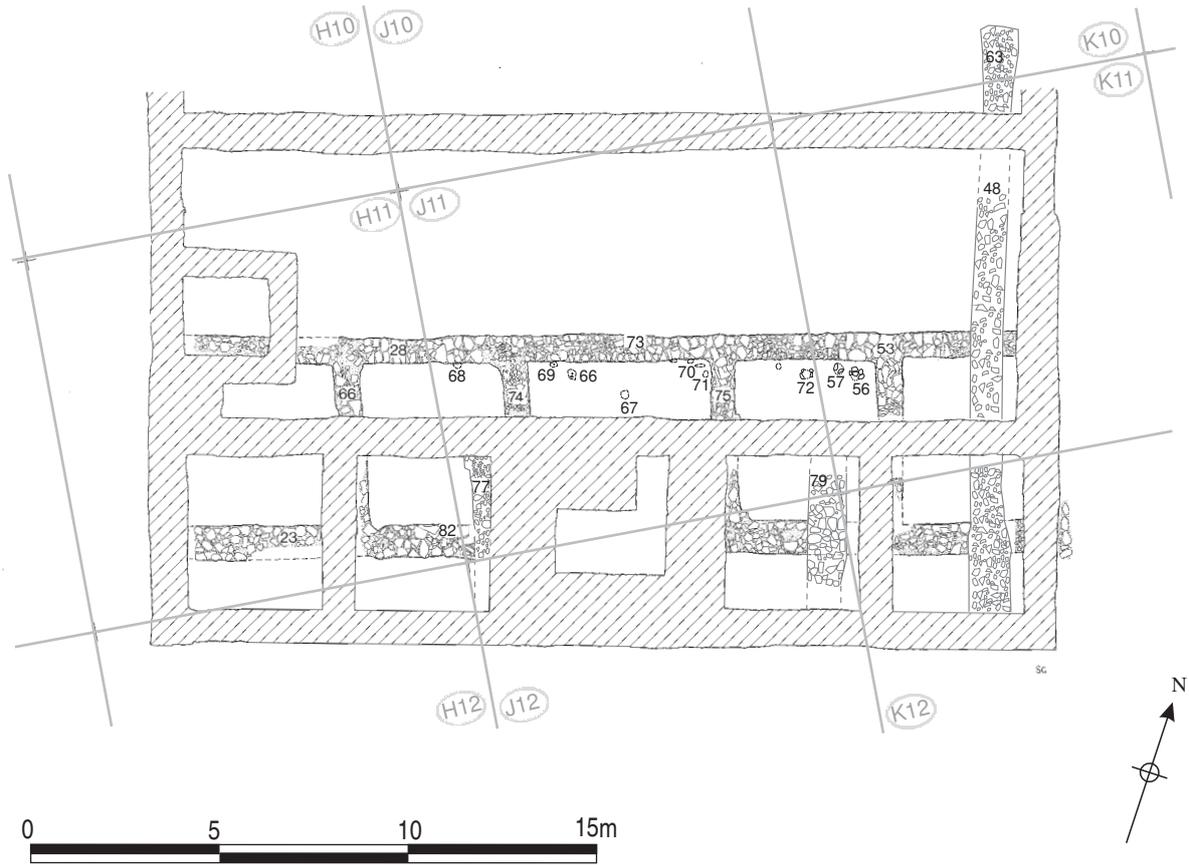
Figure 8.05: First and second phase of aborted foundations for the principia south range, with outline of definitive layout of crosshall and south range shown in red for reference (at 1:50).

As originally designed the headquarters was laid out on a slightly more northerly footprint than the definitive Phase 1 building. Thus, in the case of the building's south wall, the southern edge of the original foundations lay some 2.40m to the north of the south face of the offset course in the final building. Similarly the north edge of the foundations of the south range lay anything between 2.10m and 2.40m to the north of the north face of the equivalent wall as finally erected. The original south wall would have been in line with the portico on the south side of the granary. The footprint was also offset slightly to the east by comparison with the definitive Phase 1 plan. Thus, the eastern edges of the original side wall foundations in the south range lay c. 0.10–0.25m beyond the eastern edges of the corresponding Phase 1 side walls. At the eastern end of the range's south wall, a short stretch of the foundations of the main east wall (K12 no number assigned) projected 0.25m beyond the Phase 1 east wall, extending over a distance of 1.50m, from north to south. All other trace of the east and west walls had evidently been removed during construction of the definitive Phase 1 building.

#### *Intermediate foundation plan* (Figs 8.04–8.06)

A second layout appears to have been begun which entailed shifting the east wall of the building c. 1.20m westward, with respect to both the original foundations and those of the definitive version. The east wall foundations of the cross-hall and south range (K11:48) were traced and were observed to continue a further 3.0m beyond the north wall of the cross-hall, along the east side of the courtyard before coming to a stop (K10:63). The foundations were generally c. 0.80m wide (though broadening to as much as 1.0m wide in places) and were composed of large pieces of sandstone rubble set in orange clay. No east-west walls associated with this phase were conclusively identified, that is to say the south wall of the building or the north and south walls of the cross-hall, but these were all assumed to lie on the same line as their later counterparts. It is likely that the building's west wall would have lain to the west of that finally built, but the levels in the alley (Alley 8) to the west were not removed to a sufficient extent to confirm this.

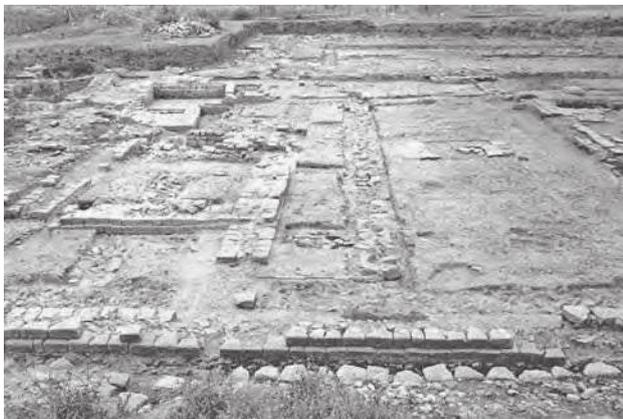
Figure 8.06: General view of the principia south range and crosshall looking west with the earlier unfinished foundations apparent in the centre and the intermediate foundations running from left to right just beyond the east wall in the foreground.

The foundations were uniformly composed of substantial, roughly cut blocks of sandstone rubble set in grey-orange or pink-grey clay (see Fig. 8.06). Their width varied, those belonging to the south wall (H11:23, J11:82 (also present in grid squares J12 and K12 but no context numbers assigned)) being the broadest, at 0.70–0.90m. The north wall foundations (H11:28, J11:73, K11:53) and foundations between the various rooms of the south range (separating Rooms A and B: H11:66, B/C: J11:74, C/D: J11:75, D/E: also K11:53) were similar in width, generally varying between c. 0.55m and 0.70m.

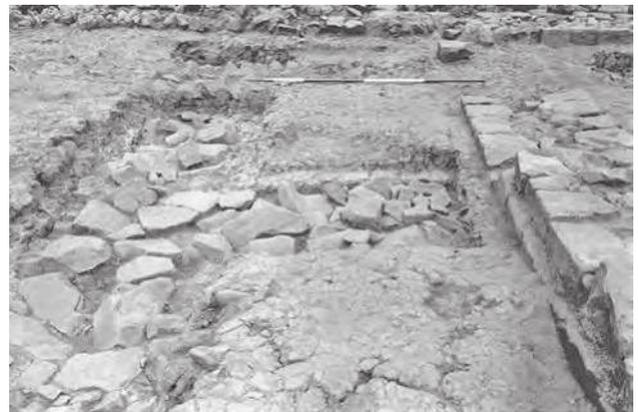
Figure 8.06: Detail showing the original south range foundations cut by the north wall of the range as built, looking east.

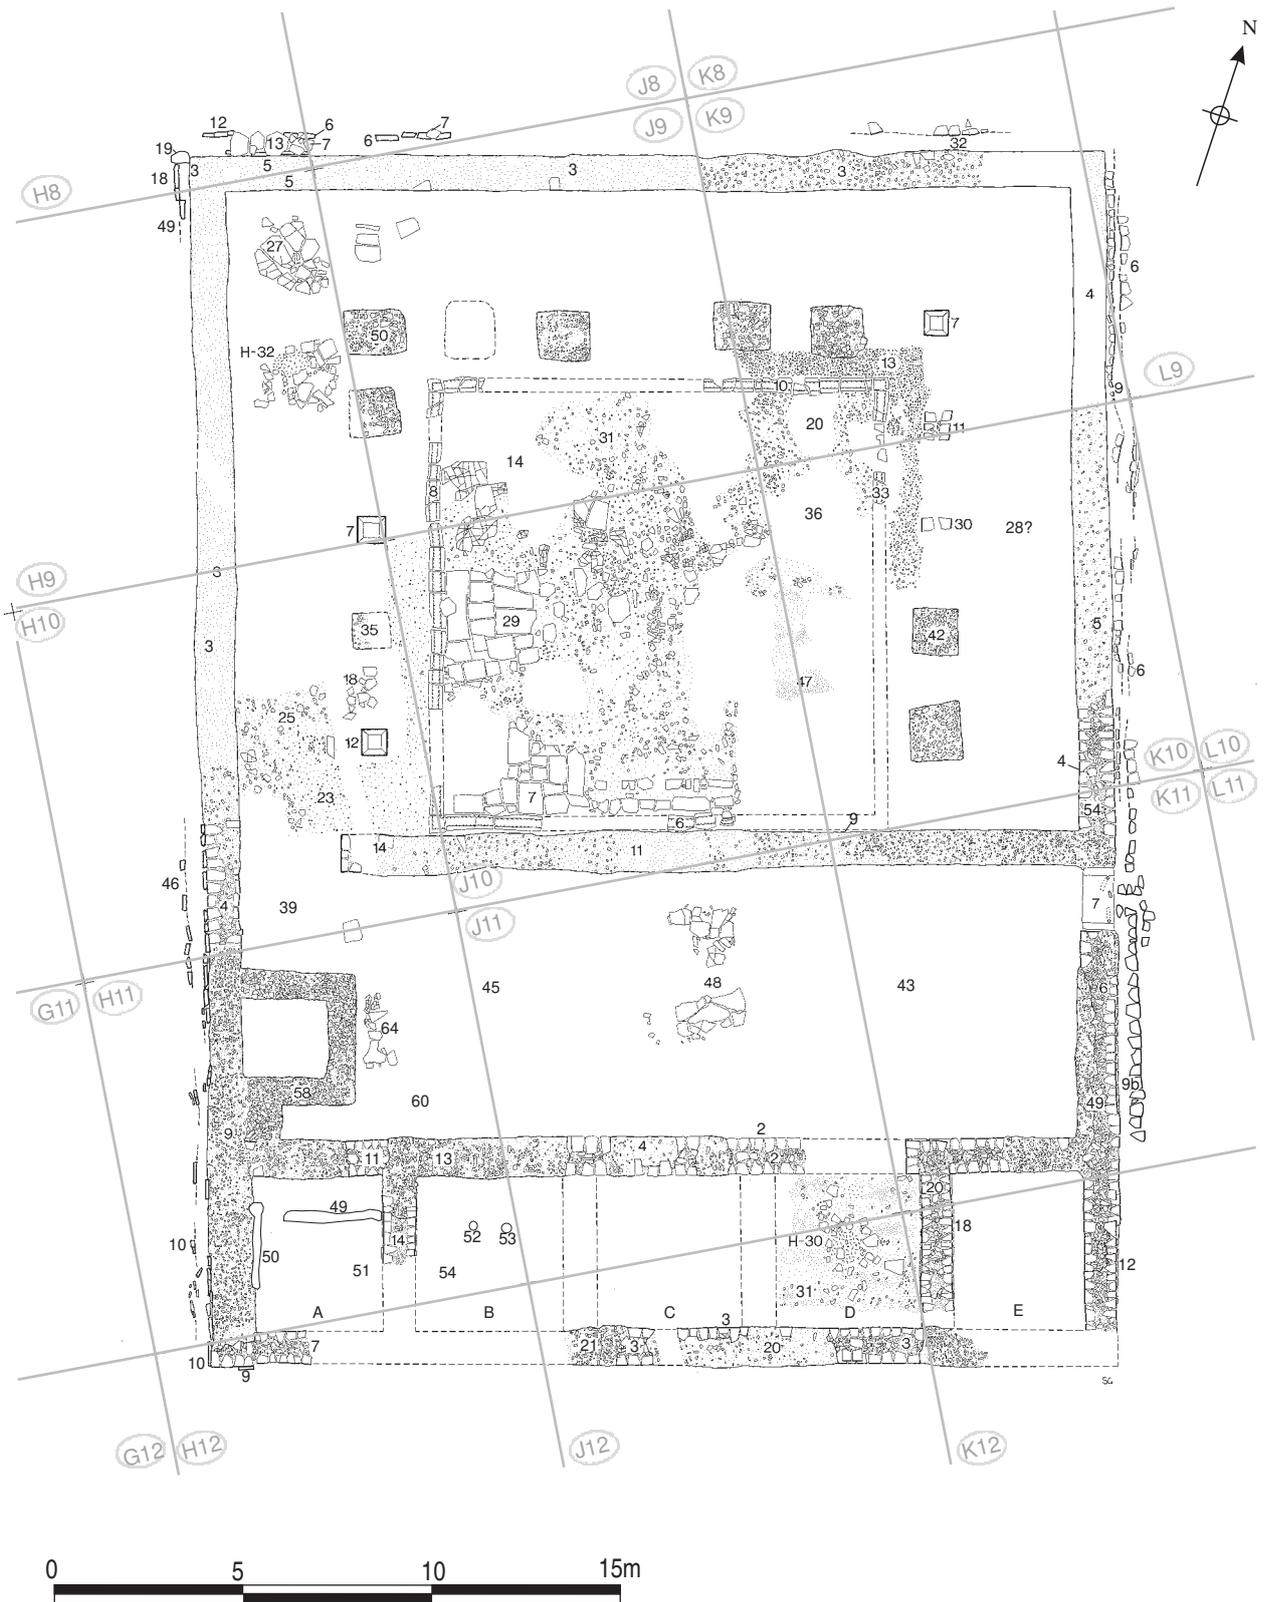
Fig re 0 7 Building 4 Ph se 1 at 0

Stone-lined drains or gutter channels ran along the outer face of the building on all four sides. The drain alongside the west wall (H08:18, H09:49, H10:46, H11:10, H12:10) was composed of upright slabs set vertically on either side of the drain channel. This form of construction continued around the north-west corner of the building and was traced alongside the north wall for 6.50m (as H08:12, J08:06), surviving particularly well next to the corner, where several capstones remained *in situ* (H08:13, J08:07; also H08:19 at the north end of the western drain). The fill (H08:20, J08:05) was described as a silty grey-brown soil. Further east this drain had largely been destroyed by a modern drain channel, but, towards the building's north-east corner, the fragmentary remains of side-walling again survived (K09:32). Here, however, ordinary sandstone facing stones had been used to form the drain sidewalls and the same form of construction was recorded alongside the east wall (K09:09, K10:06, L09:06), although upright slabs were also noted in the channel in places (K10:07) perhaps signifying the drain was relined at some stage. Further south, the drain (K11:09b) may have been later adapted later on (in Phase 3?), to take the overflow channel from a cistern in the south-east corner of the courtyard, which emerged beneath the east end doorway of the cross-hall. Here the drain diverged away from the east wall of the *principia* slightly, and for most of its length only the west side wall was exposed. The excavators seem to have been uncertain whether this part of the drain was primary, or perhaps a secondary realignment. It was not included on their inked plans of Phase 1 and 2 of the building, but the manner of its construction

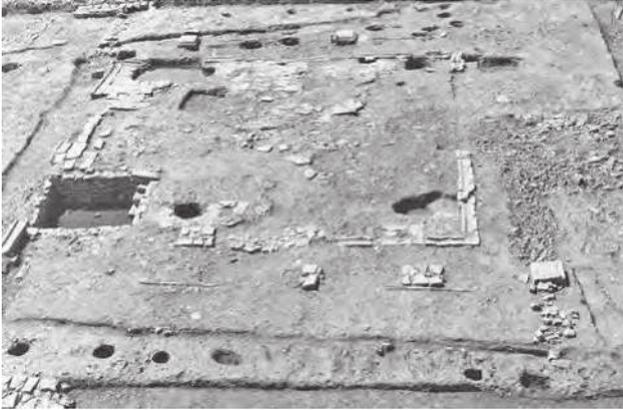
Figure 8.08 General view of the courtyard, looking west.

The northern half of the *principia* took the form of a flagged courtyard with a colonnaded covered walkway around its north, west and east sides plus an eaves-drip on all four sides (Figs 8.08–8.10). The entire area formed a rectangular space with dimensions of 22m east-west by 17m north-south, whilst the open central yard delimited by the eaves drip gutter was just over 11m square. The surface of flagging within the central yard bounded by the eaves drip was very worn and shattered and had

been replaced in many places, having obviously seen a great deal of use, probably over a long period (Figs 8.08, 8.09). It survived best to the west (J09:14, J10:29) and south (J10:07, 14), there consisting of fairly regular sandstone slabs measuring on average c. 0.70m × 0.55m. Elsewhere the surface was so badly worn that only the odd flag remained relatively intact, the remainder being so fractured and disturbed that individual slabs could not be distinguished within the degraded layer of crushed sandstone fragments intermixed with medium brown or grey clay (J09:31, J10:42, K09:20, K10:36). The courtyard flagging was set on a layer of mottled yellow and brown silty soil (J09:38, J10:49, K10:44) which was interpreted as a make up material. A patch of orange clay with some stone inclusions (K10:47) was also noted beneath the south-western part of the courtyard, although it is not altogether clear that this deposit was distinct from the underlying clay fills (J10:55, K10:52) of the beam slots (J10:60, K10:53) for the earlier timber building (BI).

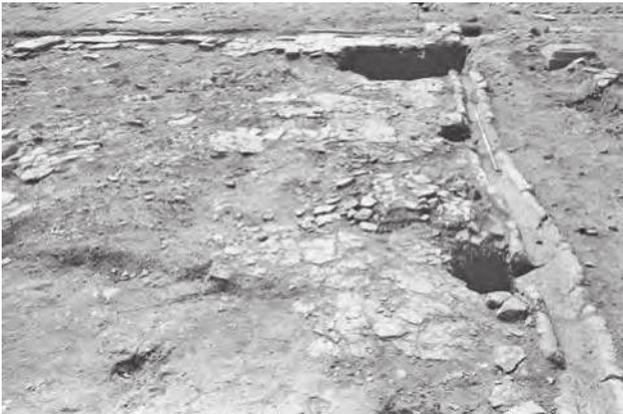
Figure 8.09: The very worn, fragmentary flagging of the primary courtyard surface looking south with the west eaves drip gutter visible on the right.

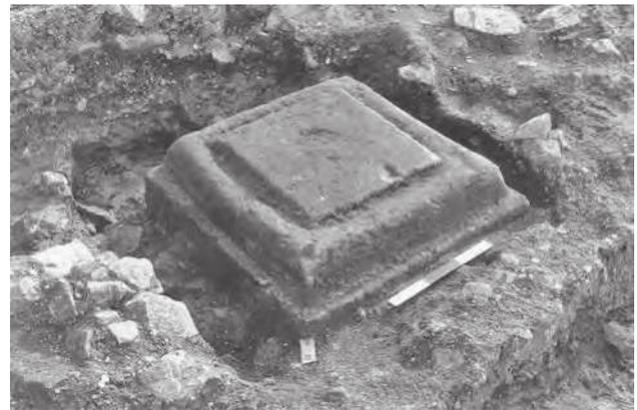
Figure 8.11 North portico column base, K10 after Simpson 1930, fig 3

The colonnade was composed of four columns along each side (north, west and east) plus one at each of the north-east and north-west corners. There was a wider gap in the middle of the north side (3.5m between the edges of the foundation pits), forming a central entrance which presumably lay opposite the main gate in the north wall of the *principia* (although no trace of that gate remained). In most cases all that survived were the square foundation pits which supported the columns (west side: H09:41, H10:22/35, 44, J09:51; north-west corner: J09:50; north side: J09:37, 52, and two unnumbered foundation pits in K09; east side: K10:42, 43, 55, 66). These took the form of shallow, steep-sided pits, generally around 1.3m square, though dimensions varied considerably, and packed with medium-sized, angular sandstone fragments in an orange clay matrix. In some cases rounded cobbles were also recorded in the packing (H10:35, J09:37). However, three column bases survived *in situ* along the west side (H09:07, H10:12, set on foundation deposits H09:41 and H10:44 respectively) and in the north-east corner (K09:07) of the colonnade (Figs 8.11, 8.12). These measured c. 0.65–0.8m square and were rounded along their upper margins with a smaller 0.4m square area marked out with an incised groove along the upper surface where the column would have been positioned. The western pair had previously been uncovered by the Wallsend borough engineers working with F. G. Simpson in 1929, the earlier excavation trench (H10:13) being rediscovered in 1980 (cf. Spain and Simpson 1930, fig. 3). There were also two bases made up of faced stone forming part of the east colonnade (K09:11/K10:27, K10:30), the more northerly of the two being the better preserved (K09:11/K10:27), measuring 0.7m by 0.8m. The excavators were uncertain whether these belonged to the same primary phase given their very different character. However, even if they

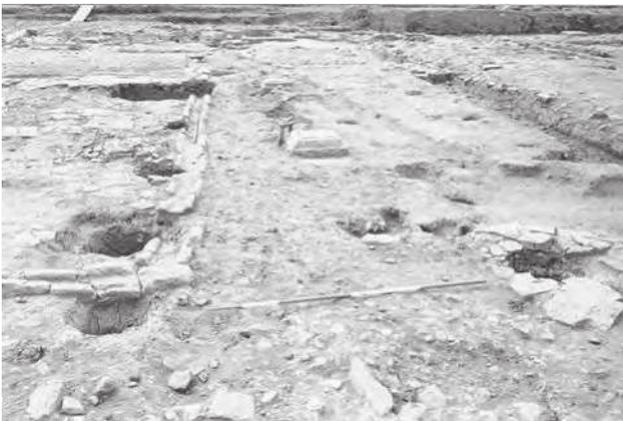
Figure 8.10 The west portico from the north with primary column bases and eaves drip gutter visible.

The eaves drip channel itself survived best along on the west side of the courtyard (J09:08, J10:28) where both the north-west (J09:10) and south-west corners (J10:04, 05) were present and only a couple of relatively short sections were missing. The north-east corner also survived (J09:12, K09:10, 33, K10:37), but most of the remainder of the east side was destroyed and long sections of the north and south sides were lost (surviving fragments of the south eaves drip: J10:04, 05, 06). The eaves drip was made up of oblong sandstone blocks up to 1.20m in length, though most had been cracked and broken over time, and 0.35–0.40m wide. They varied in thickness between 0.12m and 0.20m, whilst the channel cut in the upper surface ranged between 30mm and 100mm in depth. Some blocks were repositioned and re-used in later phases (K10:10).

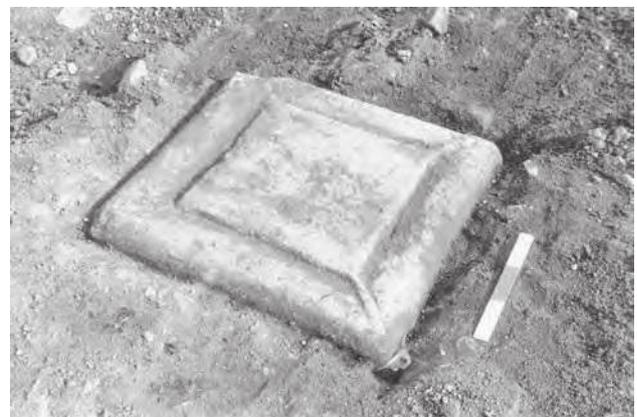
Figure 8.12 West portico column base, H10 after Simpson 1930, fig 3

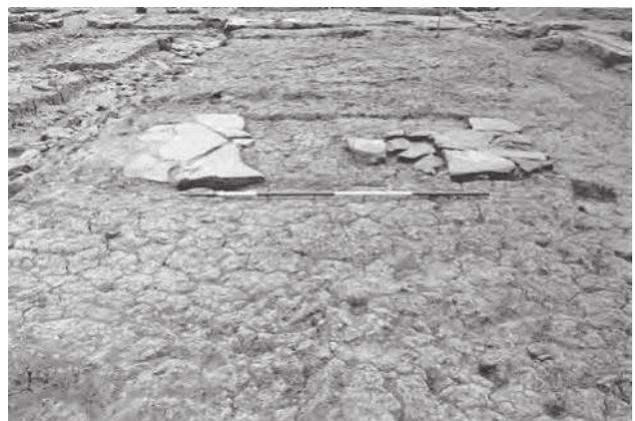
Figure 8.13: Early flagging J11:48 in the crosshall associated with *principia Ph se 1* viewed from the east.

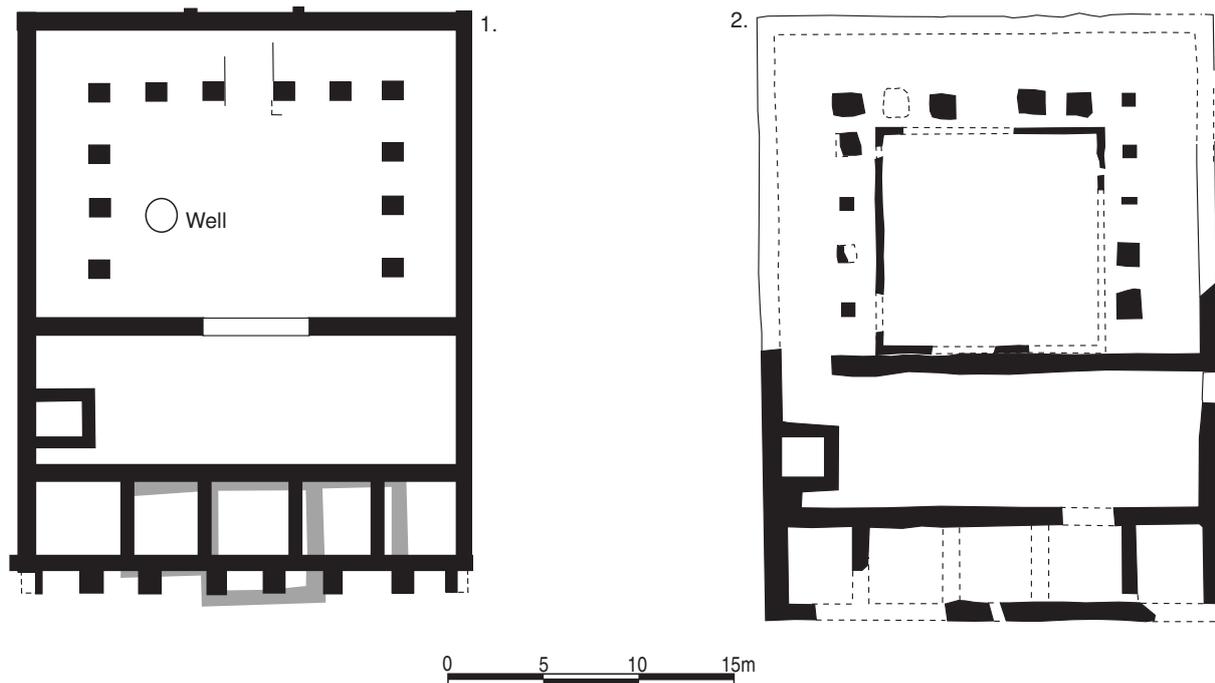
Figure 8.14 The Phase 1 principia at Wallsend shown alongside the mid-Antonine principia at South Shields for comparison. Scale 0

Certain features of Building 14 Phase 1 recur in the mid-Antonine *principia* at South Shields (Period 4B; see Bidwell and Speak 1994, 58–75), a site which provides so many parallels for Wallsend (see Fig. 8.14). These included the lack of a north aisle in the cross-hall which is a very common feature elsewhere. Curiously the tribunal in both buildings is still offset to the south of the cross-hall's centreline as though there was a north aisle in place. The steps up to the tribunal were clearly located on the south side at Wallsend and the same was probably true at South Shields. Both buildings had a doorway in their east wall opening into the north-east corner of the cross-hall from the adjoining alley and probably designed to give the commanding officer convenient access from the *paetorium*. Nevertheless there are also many significant differences and these buildings cannot be regarded as carbon copies of one another. The external buttresses provided along the south-east wall of the South Shields headquarters have no parallel at Wallsend. These were presumably intended to support a two-storey rear range, similar to that which

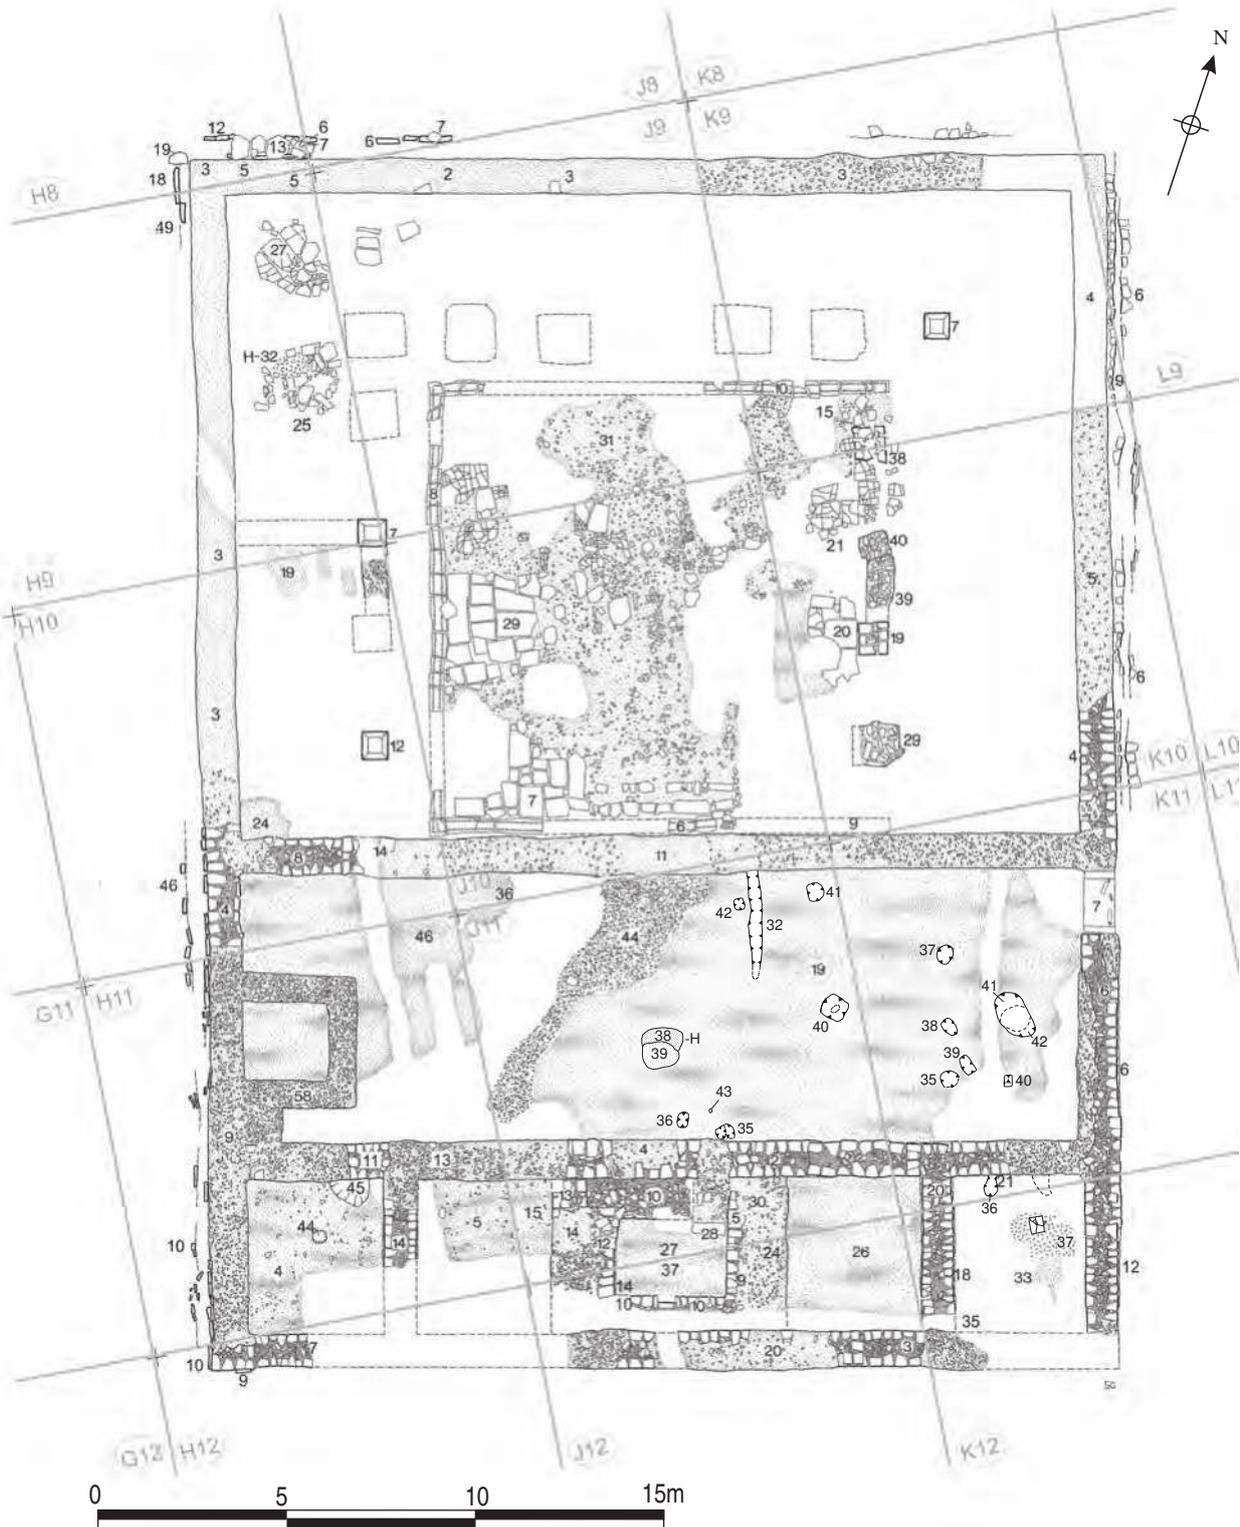
Figure 8 Building 14 Phase 2 at 0

The four columns of the east colonnade were demolished and a new colonnade erected 1.0m to the west, over the line of the eastern eaves drip channel which went out of use (Fig. 8.16). The new colonnade was represented by three roughly square pillar bases made from facing stones (K10:19, 38, 40) and one foundation deposit (K10:29). The form of the bases was similar to K09:11 and K10:30 belonging to the Phase 1 east colonnade. The best preserved of the pillar bases was K10:19, which was neatly constructed and measured 0.85m × 0.75m, whilst the dimensions of K10:38 were c. 1.00m × 0.90m, though its stones may have spread slightly. The foundations were composed of deposits of tightly packed, angular sandstone rubble set in orange pink clay (K10:29, K10:54 for base K10:19, K10:67 for base K10:38). The site plans suggest these deposits were set in squarish pits (dimensions: K10:29, 1.40m × 1.10m; K10:54, 1.25m × 1.15m), but there is no reference to such pits in the context records and no record of the depth or thickness of the foundation deposits either.

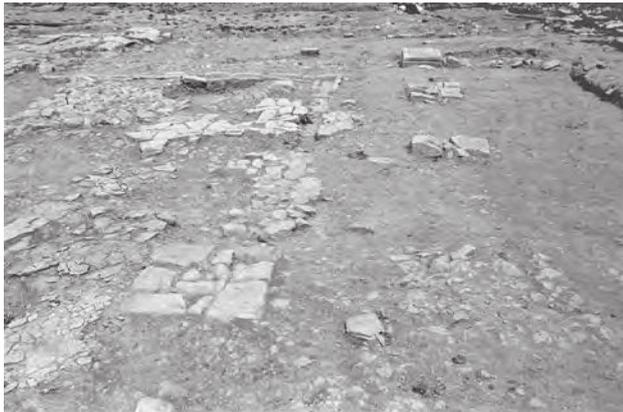
Figure 8 The east portico with Phase 1 (to right) and Phase 2 (centre) column/pillar bases apparent, looking north

The similarity of Phase 1 bases K09:11 and K10:30 to those of the new east colonnade led the excavators

to speculate that K09:11 and K10:30 might actually have formed part of the same secondary remodelling. However the latter cannot readily be integrated into any coherent scheme with the rest of the Phase 2 courtyard. It was suggested they might form a pillared doorway, but the Phase 2 bases did not lie directly in line with them so it is difficult to envisage how this would have worked.

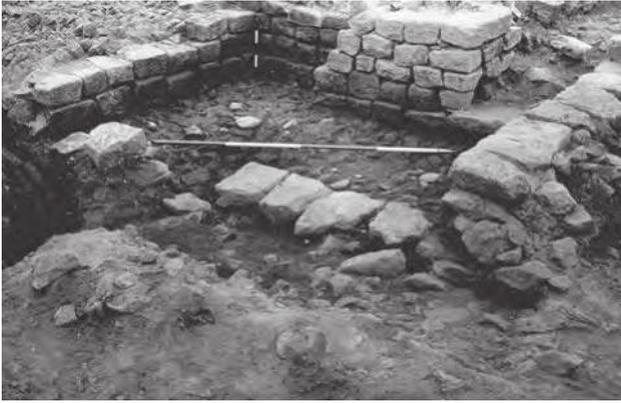
Figure 7 View showing the two successive phases of the strong room north wall, from the south east.

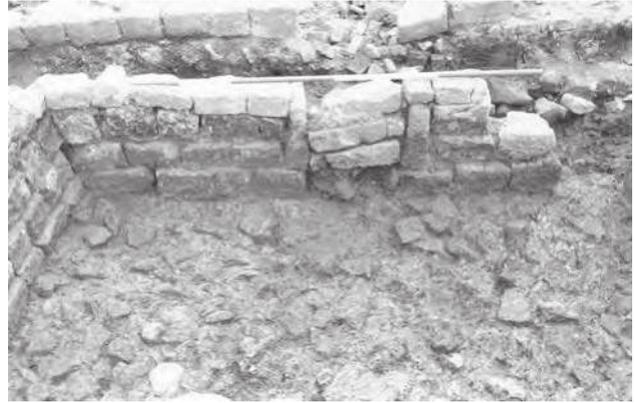
Figure 8 The niche in the strong room south wall, later blocked up

courses high, the west wall standing the highest. Although it did not survive completely intact, the north wall (J11:10) appeared to continue westward to butt up against the external west wall (J11:13). The inner south wall (J12:10) may have done the same, but its west end was cut away by a modern drain (J12:04). The north wall was as much as 1.10m thick from its face to the inner face of the north wall of the range (J11:02), whilst the corresponding width of the south wall was rather less, though still substantial at c. 0.90m. The facing stones in all four walls were bonded together with mortar, but whereas the north (J11:10) and east (J11:05, J12:09) walls were backed by a mortar and rough stone core, the west wall (J11:12, J12:14) appeared to have clay and cobble backing. In the case of the south inner wall (J12:10), its backing had largely been destroyed by a modern drain (J12:04), perhaps belonging to the colliery period, but slight remains of dirty pink bonding clay (J12:22), which it was suggested may have formed part of a similar clay and cobble core, did survive beneath the drain. The excavators considered these apparent differences in construction technique – the use of mortared or clay wall backing – might reflect alterations to the strong room, which would not therefore represent a single construction event in the form revealed. However, elsewhere it was noted that the suggested clay backing might simply represent make up material below or for the original floor of Room C, which was then cut into when the inner walls of the strong room were inserted, in which case these differences might be more apparent than real. The facing of the south wall displayed less regular construction than the other walls, incorporating a variety of differently shaped facing stones – some flat and wide and some with long narrow proportions. A niche (J12:19) was located in the centre of the south wall (Fig. 8.18). This was some 0.60m wide and used large, thin blocks stood on their ends to form its east and west sides, but its depth could not be accurately estimated as the back of the niche had been cut away by the modern drain.

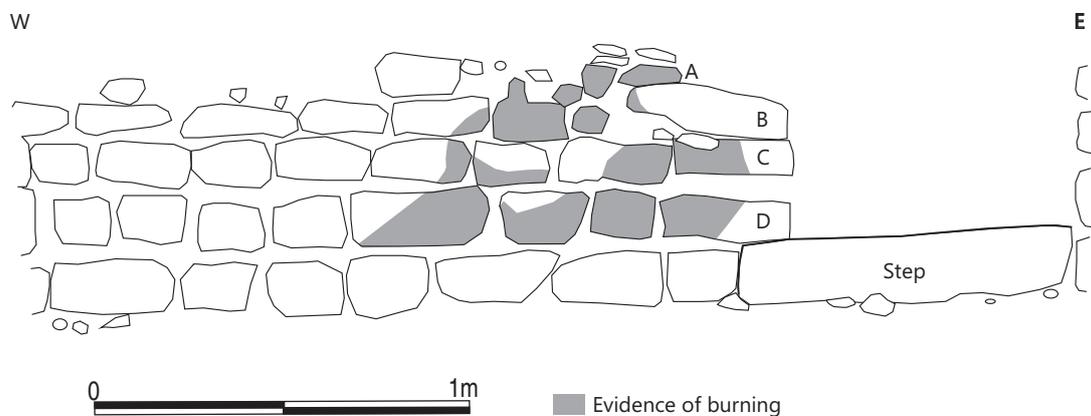
Figure 9 Elevation of the north wall of the strong room, at the phase at 10

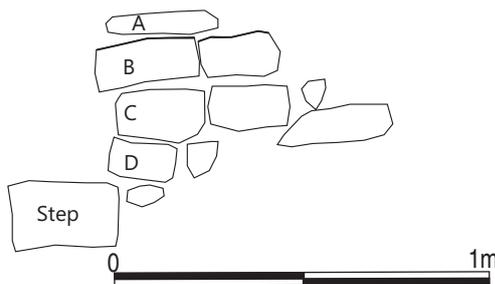
Figure 10 West elevation of entrance to strong room, at the phase at 10

The entrance was in the north-east corner of the room, the passage descending from the cross-hall being 2.10m long and 0.80m wide. The passageway would originally have been furnished with steps, a total of five treads being estimated by Daniels (see *Britannia* 12, (1981), 322), but all had been robbed except for bottom one (J11:28). This step projected forward of the line of the north wall and was 0.90m long (E-W), 0.44m wide (N-S) and 0.16m high. The upper surface of the block was chamfered along its north and east sides, with traces of *opus signinum* surviving along the lower edge, and the excavators considered that it might have formed part of a reused base, perhaps a pillar base or column base. To the north of the surviving step, the passageway floor was covered by a deposit of mortar, clay and cobbles (J11:29), which represented the foundation

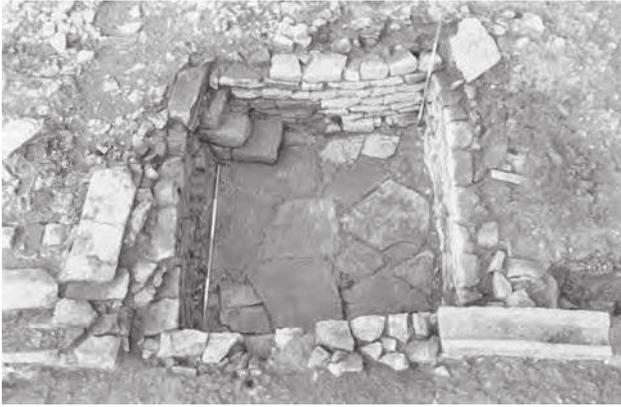
Figure 8.2 Courtyard cistern fully emptied, viewed from the south

Water tanks were cut into the south east and south west corners of the courtyard. The one in the south east (J10:22, K10:16) was substantial, stone built, with a flagged bottom (Fig. 8.22). The dimensions of the tank were 2.86m (N-S) by 2.65m (E-W). The single-faced side walls stood between 0.94m and 1.16m high, with seven or eight courses preserved (north: J10:16, K10:13; south: J10:21, K10:12; east: K10:11; west: J10:15). They were constructed of irregular sandstone blocks and shallow flags, bonded with mortar and sealed by clay behind the wall faces, and were 0.30–0.50m wide. The uppermost stones were level with flagged surface of courtyard (J10:14). The bottom of the cistern was floored with large irregular flags (J10:24, 52, K10:15), up to 1.40m in length and 1.10m wide in the case of the largest example, these being set in pink puddled clay, with orange clay infilling the gaps between the flags (J10:53). A set of steps (J10:54) descended into the cistern at its north-west corner, with a total of three treads below the courtyard level, incorporating re-used *spolia* (Fig. 8.23). The uppermost of the three was an eaves drip corner stone whilst the bottom step was formed by an upturned column base (which could imply that part of the colonnade and associated eaves drip only went out of use when the water tank was inserted). The east side wall apparently cut into the foundation of the Phase 2 column base on the east side (K10–29), whilst the south wall intruded across the line of the eaves drip channel, which may have been the origin of the stone used at the top of the steps. Another displaced gutter stone from the eaves drip channel (K10:10) was revealed at the south-west corner of the tank. This was some 1.30m long, 0.34m wide and 0.14m deep and was clearly *ex situ* as it partially overlay the tank's south wall, its west end indeed forming the wall's uppermost course, even though it was still on the exact line of the eaves drip.
