# SEGEDUNUM

Excavations by Charles Daniels in the Roman Fort  
at Wallsend (1975–1984)

VOLUME 1: The Structural Remains

Alan Rushworth and Alexandra Croom

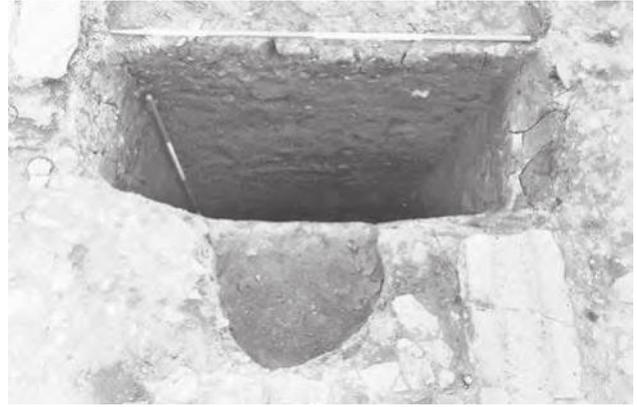
Figure 8.25: The south-west courtyard pit, half sectioned, viewed from the north

The south-west pit is a rather perplexing feature. Although assigned to Phase 3, as outlined above, it should be noted that no courtyard surfaces or deposits were recorded overlying the fill deposits, just topsoil. Furthermore, the pit appeared to cut through the line of the Phase 4 wall footing H10:11/J10:03, which was set on the line of the western eaves drip and probably provided the base for a row of timber uprights (cf.

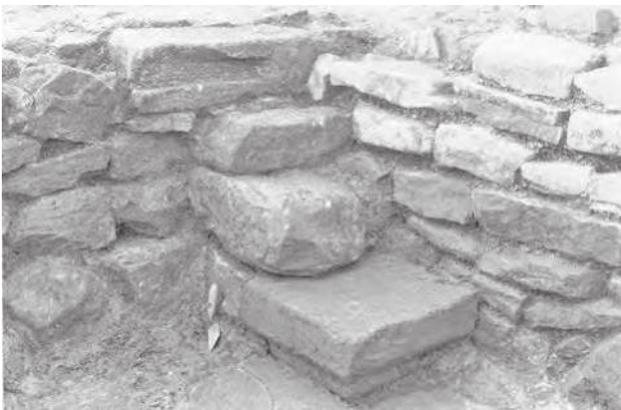
Figure 8.3 The steps down to the courtyard water tank with the reused eaves drip corner stone at the top and an upturned column or pier base at the bottom.

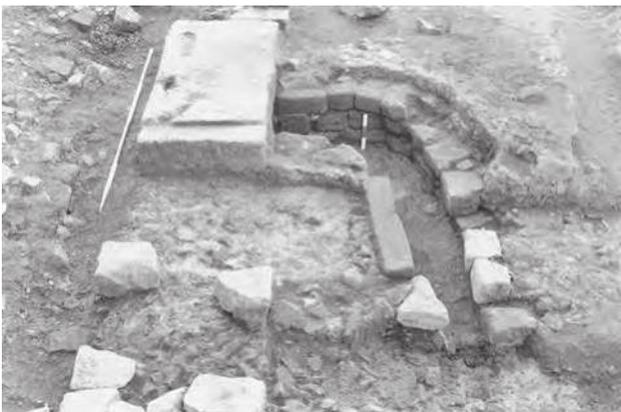
Figure 8.4 The water conduit from the courtyard cistern cutting through the crosshall north wall foundation then turning to pass beneath the threshold slab of the east doorway

An overflow drain with stone side walls (K10:18) headed eastward from the south-east corner of the cistern, running parallel with the north wall of the

cross-hall, before tracing a sharp dogleg, involving a turn of almost 90 degrees to enter the north-east corner of the cross hall (as K11:24), perhaps via an existing doorway, then another 90 degree turn to the

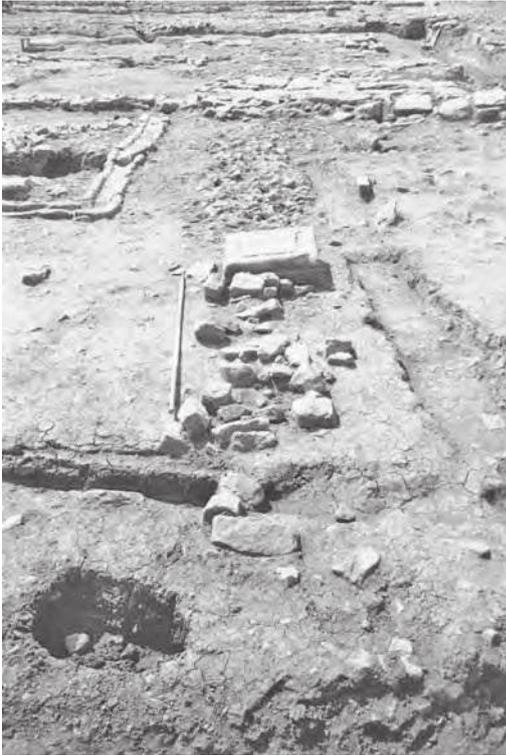
Figure 8.26 The north portico, looking west with the column base K09:07 and wall foundations K09:39 visible.

The north-east portico was blocked off at this stage. The evidence is provided by a substantial foundation deposit consisting of a 1.0m wide band of compacted river cobbles in a medium brown loam (J09:21, K09:08) with some pink clay bonding. The rounded cobbles averaged 100mm in length. The foundation deposit followed an east-west alignment on the same line as the colonnade of the north portico. The west end of the foundation was obscured by the later flagged entrance (J09:04). At its east end, the deposit ran up towards the sole surviving column base of the north portico (K09:07), falling just short according to the context record and an earlier site plan (P232), but continuing, on the evidence of site plan P269, which appears to show it narrowing where it abutted the column base. In fact the full width deposit appears to terminate roughly in line with the pillar/column bases of the repositioned (Phase 2) east colonnade. Abutting the east side of base K09:07 was a rough alignment of jumbled stone blocks (K09:39), perhaps disturbed, which continued the alignment of J09:21/K09:08 up to the east wall of the headquarters (Fig. 8.26). In

plan, K09:39 appears to be similar to the foundations associated with the walling in of various sections of the east and west portico in Phase 2 – H10:21 and K10:39 – and quite different from J09:21/K09:08. It is, however, similar in width to the narrowed eastern terminal of J09:21/K09:08, abutting the west side of column base K09:07. As noted previously, in connection with the Phase 2 courtyard, it is possible that H10:21, K10:39 and K09:39 could all belong to the earlier phase, with K09:39 originally continuing further westwards, only to be replaced there by J09:21/K09:08 in Phase 3. The latter's broader width suggests it might represent the foundations for a stone wall, which would have been built over the stone base for timber-panelled walling of Phase 2. Alternatively J09:21/K09:08 and K09:39 might both be contemporary, with the former representing the exterior stone wall closing up the eastern half of the north portico, whilst K09:39 (and the very eastern end of K09:08) merely supported an internal wall, either a timber partition or a much less substantial stone wall, with the area of the east portico to the south having already been closed off, at least partially, in Phase 2.

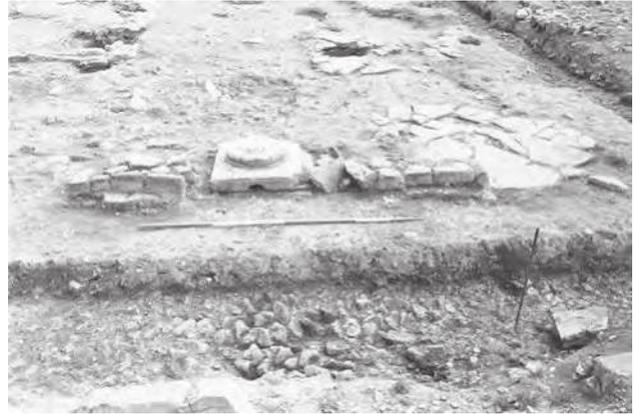
Figure 8.27: The Phase 3 wall, H09:26/J09:15 incorporating column base J09:06, viewed from the north, with primary portico flagging H09:27, visible to the right.

A rather puzzling group of structures in the north-west portico can also be attributed to this phase. A column base (J09:06) was set on top of the portico's primary flagging (J09:30), only 1.0m from the north wall of the building, and in line with the original columns of the west portico, to the south. On either side of the base, short stretches of narrow walling (J09:15, H09:26) were preserved which may have formed part of a single east-west aligned wall running parallel to the north wall (Fig. 8.27). The 0.80m length to the east (J09:15) was in the better condition, consisting of a single course of walling, 0.50m wide, faced on both sides with a rubble core. On the west side a 1.45m long survived, but was much more disturbed with individual stones being displaced, although the wall's north face was apparent. The base was unlike any other found in the headquarters,

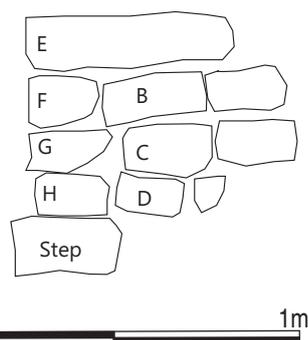
Figure 8 West elevation of entrance to strong room, and detail at 10

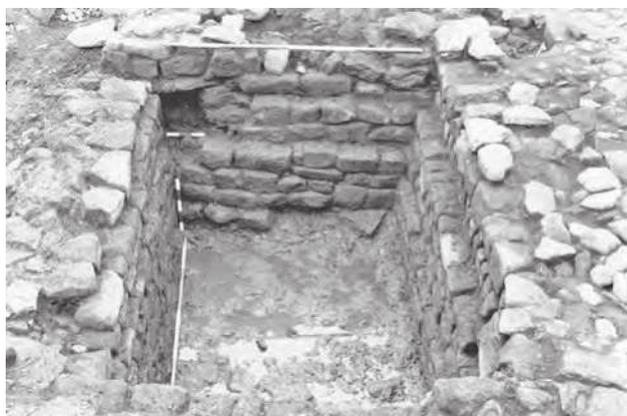
Figure 8 The cistern next to the south east corner of the principia with the inlet for the channel from the principia cistern visible in the north east corner. View looking east.

The precise details as to how the water tank was supplied are unclear as the various water channels and surrounding road levels only underwent limited investigation. The tank was fed by an inlet at the north-east corner with a stone-capped channel passing through the perimeter wall (Fig. 8.31). This probably connected to the conduit (K11:09b) which ran down the southern end of Alley 7, leading from the tank in the south-east corner of the courtyard via the east entrance to the crosshall, although this could not be confirmed because the connecting section was not exposed beneath the later road surfaces and was in any case interrupted by a broad modern drain cut (K12:03). An overflow channel (J12:35) ran from a stone-capped outlet at the south-west corner of the tank and was traced heading in a south-westerly direction for a distance of 4m (Figs 8.32, 8.33). It perhaps led towards a major slab-sided drain which headed diagonally across the *via quintana* from just outside the south-west corner of the headquarters (G11:07/H12:33). The channel ranged in width from 0.15m to 0.40m, with side walls composed of up to two courses of roughly dressed facing stones, and was capped at its south-west end by a substantial block of stone, 1.35m long, 0.60m wide and perhaps c. 0.20–0.25m thick, which was cracked diagonally across the middle and probably reused. At its north-east end a triangular slab, 0.70m long on each side and 0.10m thick, was wedged point down in the channel. The slab was perforated by three holes 100–110mm in diameter and was interpreted as a filter stone, perhaps a reused drain cover. A filter stone would be more appropriate for an inlet channel, perhaps, and in any case it is not clear how well the stone would have functioned since it largely blocked the channel, so it may simply have formed part of the later stone backfill in the channel (J12:34). The bottom of drain channel J12:35 was filled by a medium brown sandy silt and few stones (J12:36).

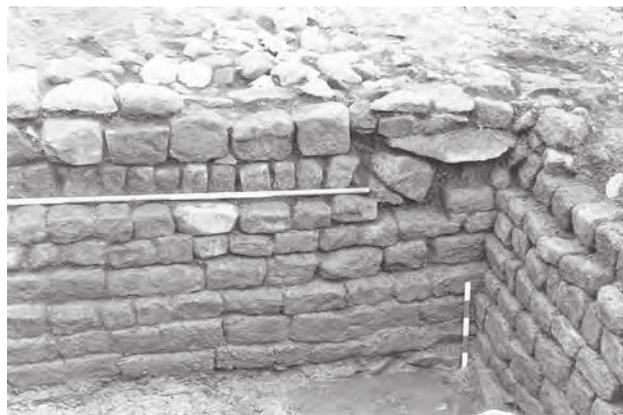
Figure 8 South west corner of the cistern south of the principia, showing the outlet prior to the exposure of the channel.

the same, perhaps with a gap to allow the gutter or drain channel which ran along the south side of the building to feed into the cistern. It is not clear whether the surrounding wall ever rose substantially higher, perhaps forming a low parapet around the cistern. Including the surrounding wall, the tank measured 4.50m (E-W) by 3.00m (N-S) and was c. 1.50m deep. The revetment walling lining the south, east and west sides of the cistern stepped inward once or twice (see Figs 8.31, 8.32), with the result that the internal dimensions of the tank were significantly greater at the top (3.50m E-W × 2.20m N-S) than at the bottom (3.00m E-W × 1.80m N-S).

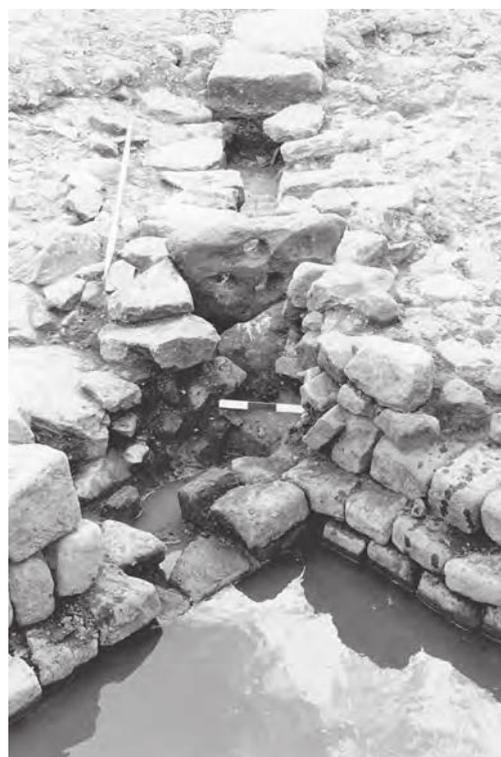
Figure 8 The water channel at the south west corner of the cistern south of the principia with the filter stone apparent in the channel.

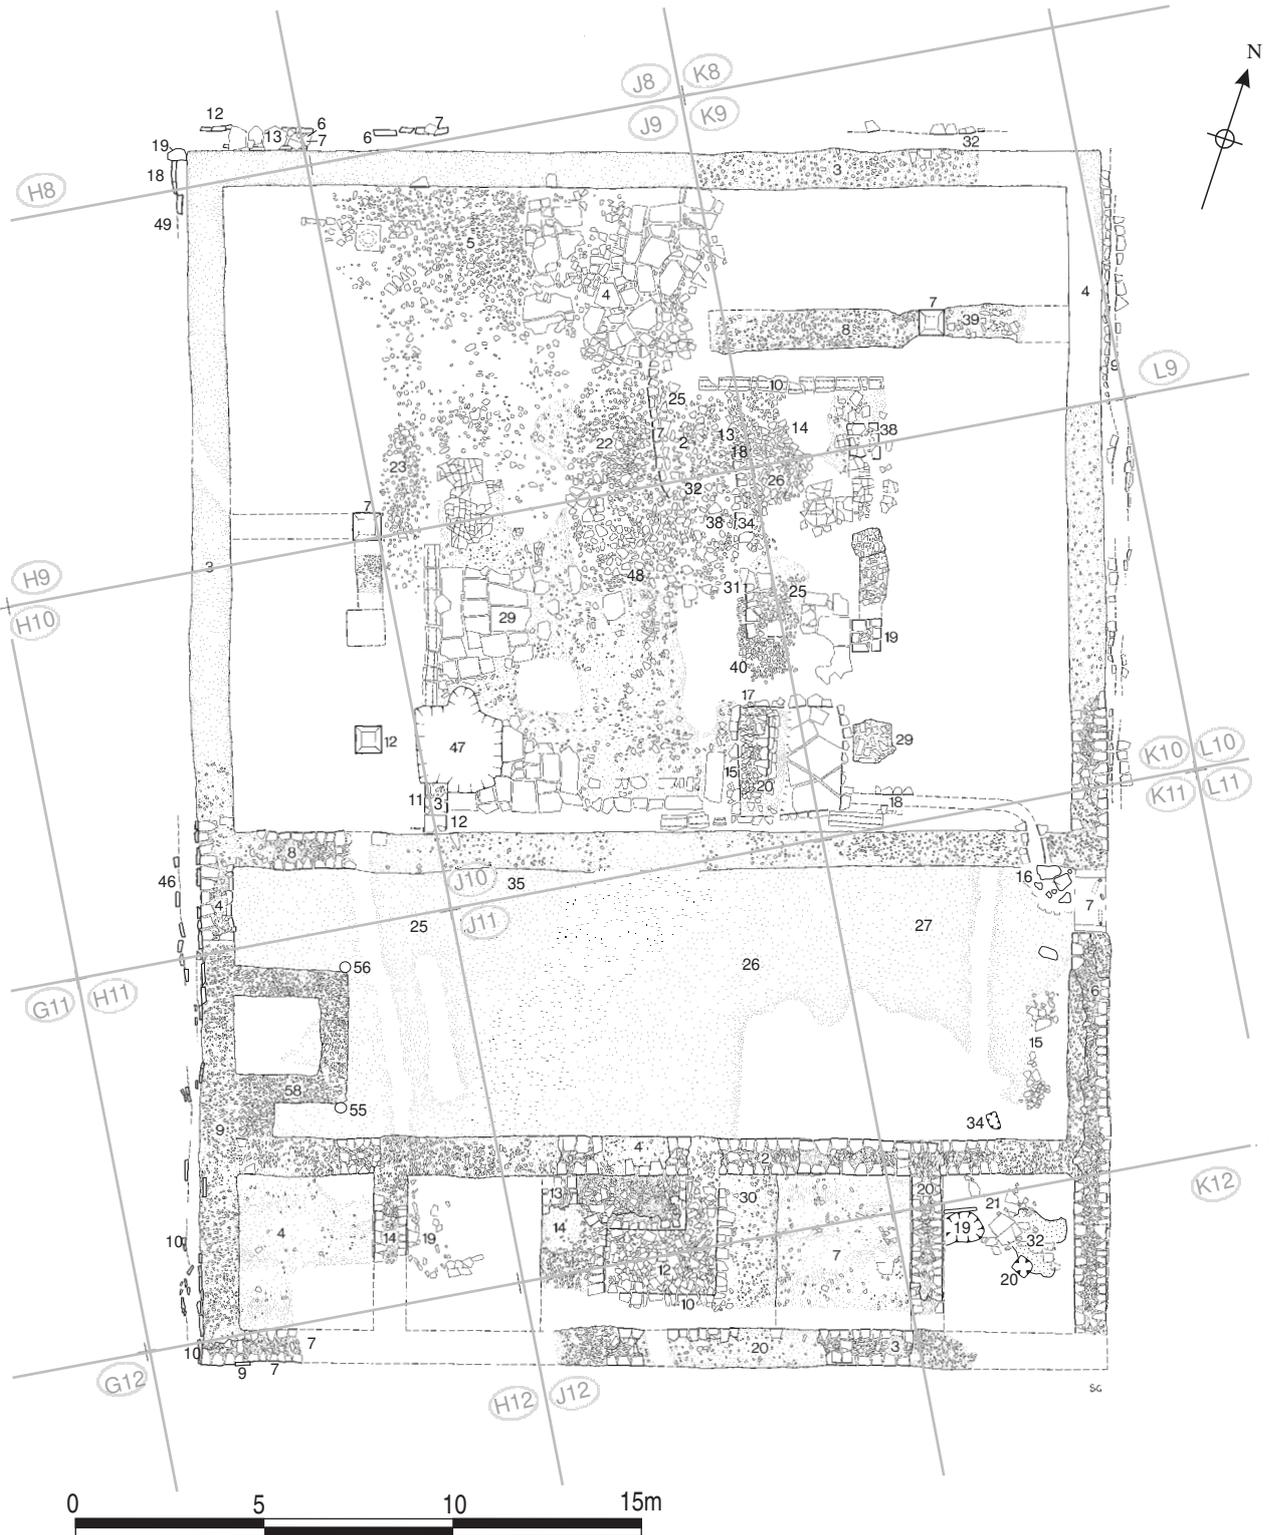
Fig re 8 Building 1 showing the Phase 4 courtyard and the latest recorded Phase 3 activity in the cross hall and south range where the Phase 4 levels were truncated, plus the rubble demolition fill in the strong room. Scale 1:200.

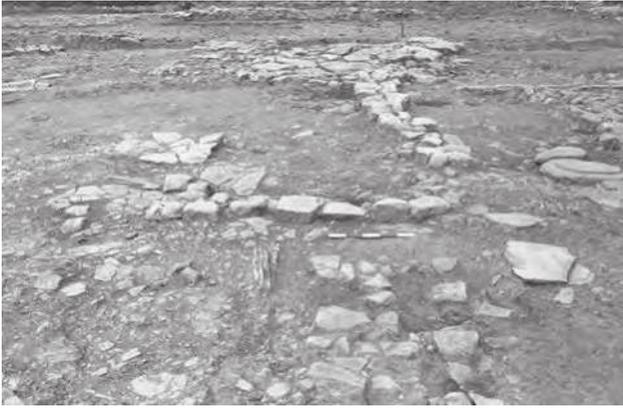
Figure 8 Late surfaces and features in the centre of the courtyard, looking north towards the entrance flagging (J09:04). East-west kerb J10:48 is in the foreground with north-south kerb J09:07/J10:32 beyond.

courtyard, though areas of cobbling and even kerbing (J10:48) also spread into the centre of the yard and into the west and north-west portico (J09:23, J09:05). Various interpretations suggested by individual members of the excavation team were noted in the

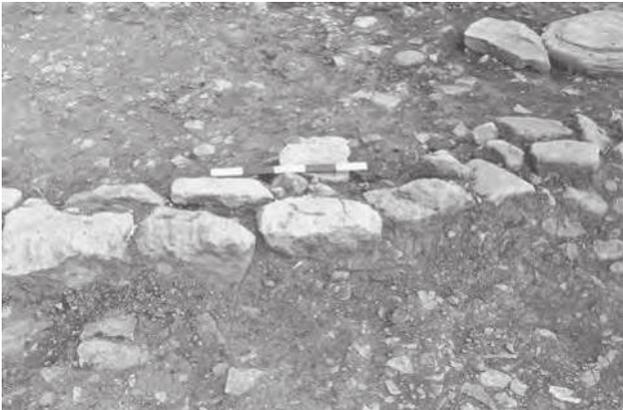
Figure 8.36: Phase 4 'kerb' J09:07/J10:32, from the west.

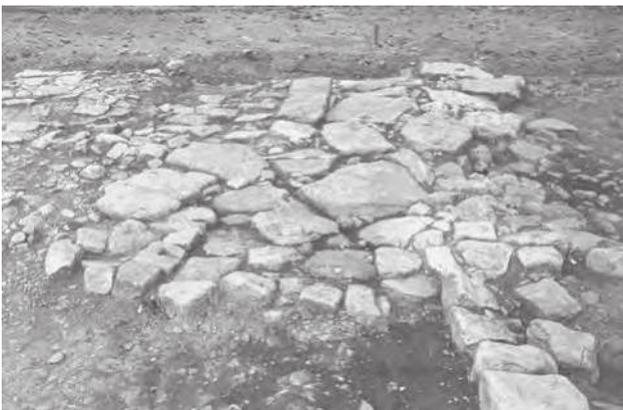
Figure 8.37: Phase 4 flagging J09:04 in the area of the courtyard entrance, looking north

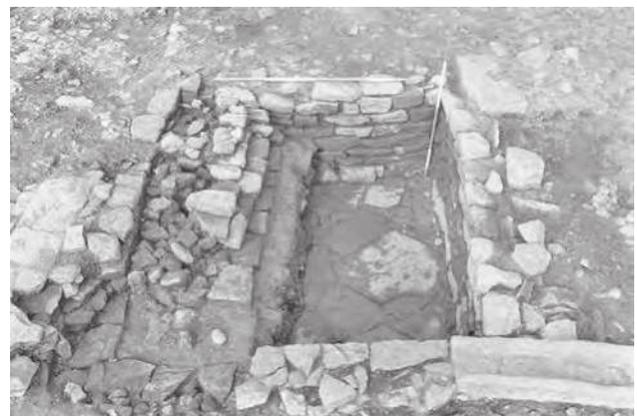
Figure 8.38: The partial infilling of the courtyard south-east cistern, from the south

The western side of the south-east water tank (J10:22, K10:16) was deliberately infilled. The infilling was carefully constructed, beginning with a 0.40–0.50m deep base of burnt and soot-stained sandstone rubble (J10:25), including large irregular flags but no facing stones. This was sealed by a cap of pink/grey sandy clay (J10:19), some 0.42m deep. A stepped revetment wall (J10:20), 0.46m high, was set this clay foundation and comprised four courses of single-faced walling, each course stepped back behind the line of the one below, the lowest course lying 0.93m east of the original west wall of the cistern. The revetment facing stones were bonded with mortar, but rather irregular, and revetted a core of mortared rubble. The uppermost course (J10:17) was composed of quite small stones. Although the infill walling clearly stood to its full height, just below the lip of the original west wall of the tank, it was not preserved intact. The southern end of the stone infilling had been removed

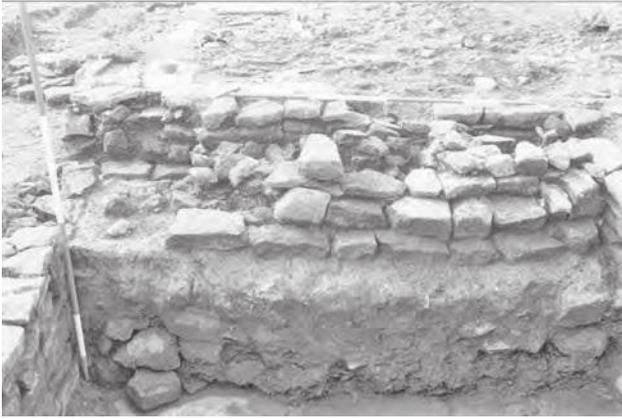
Fig re 9 Rubble, clay cap and stepped revetment wall of the courtyard cistern infilling.

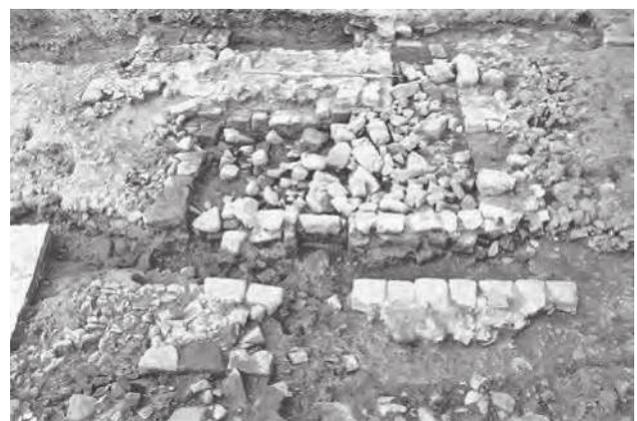
Figure 8.40: Rubble collapse(?) filling the strong room, looking north

The rubble filling the strong room was interpreted, albeit very tentatively, as deliberate packing, and it was suggested that this might have been intended to provide a stronger foundation for the *aedes* above. The fact that all of the stone appeared to have fallen within the confines of the room was regarded as too neat to simply represent general dereliction and collapse. Even so the post-excavation notes do

contain significant expressions of doubt regarding this interpretation, with the looseness of the rubble fill being noted, for example. Moreover the descriptions contained in the actual context records indicate a process of abandonment and natural collapse was envisaged during the excavation itself, and the sequence described therein does appear more plausible. Whilst the robbing of the steps and the presumed flooring (perhaps flagstones) was clearly deliberate, this could simply signify the removal of certain useful components for reuse elsewhere when the structure was abandoned. Thereafter the building may have been left to decay naturally, ultimately resulting in the collapse of the barrel-vaulted ceiling and the floor of the *aedes* above into the interior of the strong room. The structures excavated in 1980–81 represent what remained after a long process of medieval and modern destruction, which, in effect, stripped off the later Roman levels in this area down to the current level and explains why the only surviving rubble collapse was that preserved within the confines of the sunken strong room.

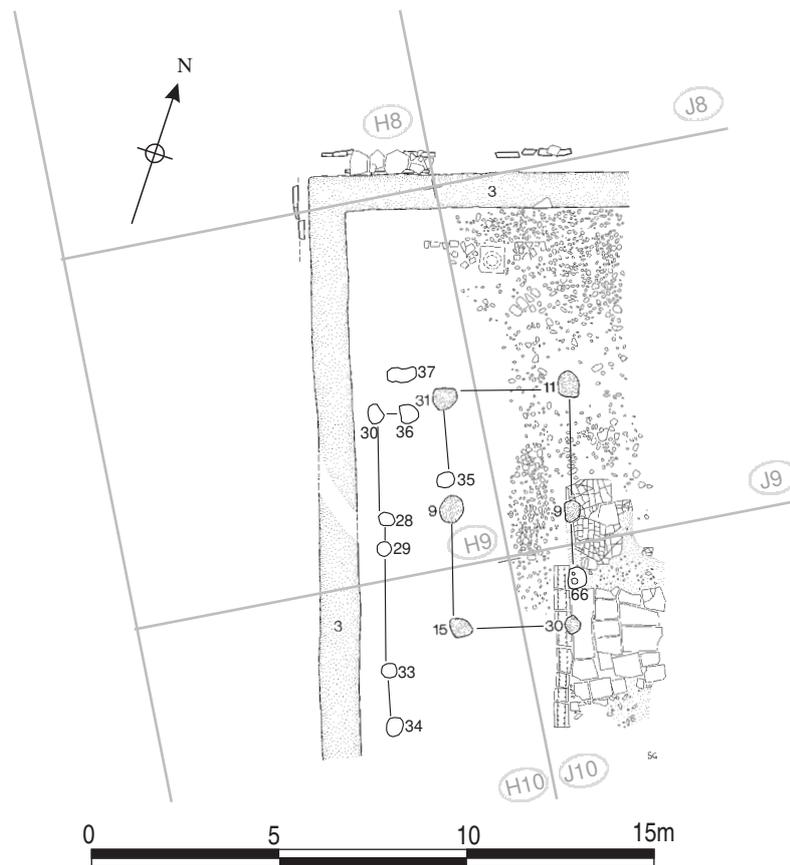
Fig re 8 : Building BCB D, at 0

The post holes designated BD (H09:28–30, 35–37, H10:33–34) were not dissimilar in form or dimensions to those of BC, but, at c. 0.25–0.35m in depth, they were generally shallower. They all contained packing stones in a medium brown silty soil. Much charcoal was also present in the fill of H09:36, whilst H09:37 reportedly contained only charcoal and one dressed stone. These last two postholes may conceivably have belonged to an earlier stage as they were reported to lie beneath earlier portico flagging H09:25, but that surface was so fragmentary that this relationship is not conclusive. A further post hole (J10:66, filled with dark brown loam, grit and stone J10:65), may be added to this group since its position appeared to correspond to a gap in courtyard flagging J10:29 and was probably obscured by a patch of trampled excavation debris when the underlying silty and sandy makeup layer (J10:49) was first exposed. Six of the post pits appeared to be grouped close together in pairs (H09:28 and 29, H09:30 and 36, and H10:33 and 34) whilst five of

these also appeared to form a possible north-south alignment positioned only c. 0.50m from the west wall of the *principia* and 1.20m west of BC (from north to south: H09:30, 28, 29, H10:33, 34). This 8.70m long alignment extended beyond the south end of BC and may have turned to the east at its north end where H09:36 lay very close to H09:30.

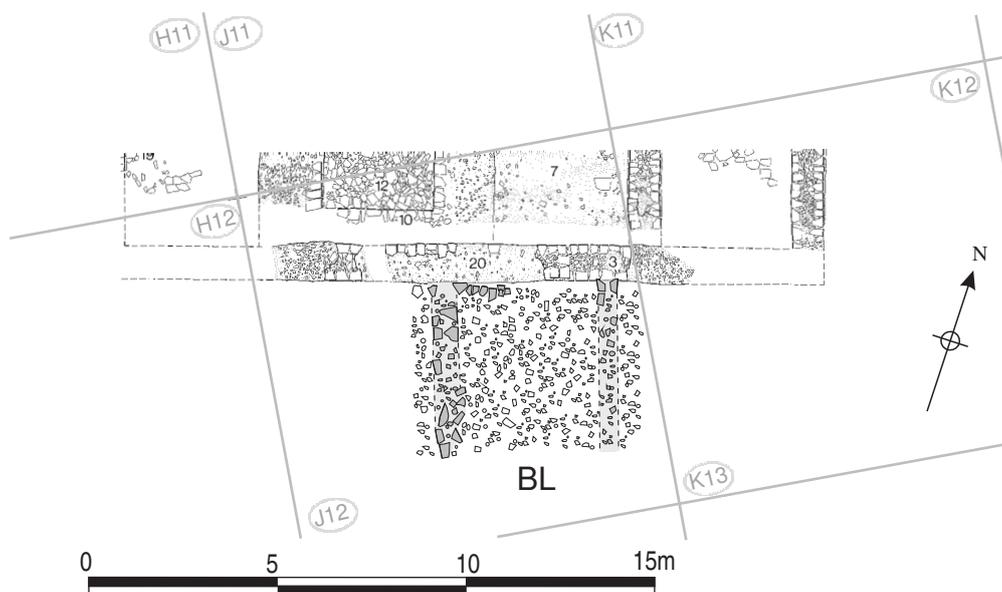
Fig. 2 Building BL south of Building 4 at 0

The mixed rubble and cobble surface next to the south wall of the *principia*, did not display the same degree of wear as the cobbled surfaces in the alley, implying it saw less traffic, and was noticeably less built up. It was composed of medium-sized sandstone fragments and river cobbles, partially worn in places (J12:05), overlying a possible makeup layer composed of varyingly sized rubble set in orange-brown clay (J12:33).

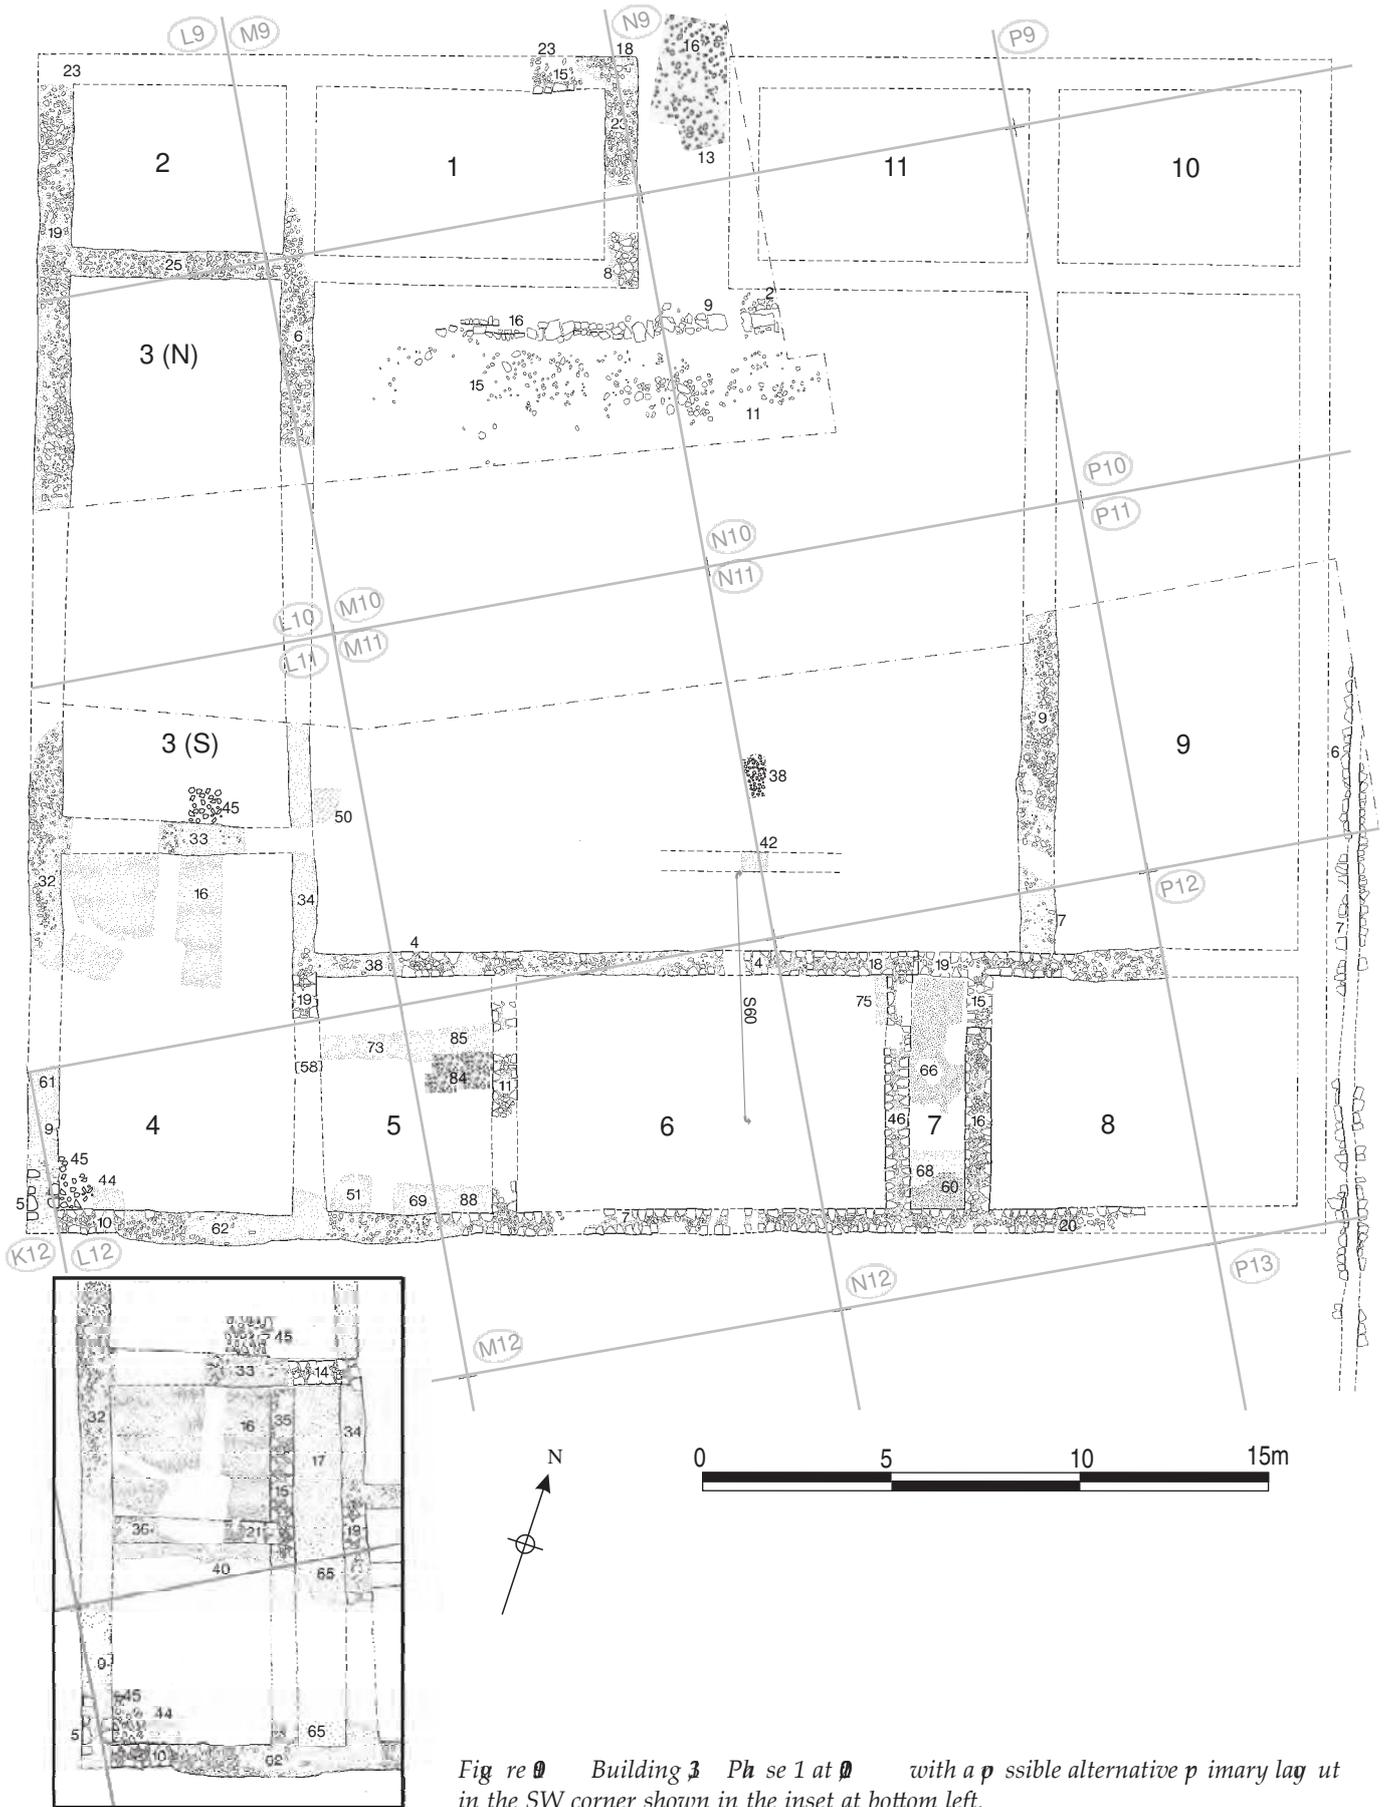
Fig re 10 Building 3 Phase 1 at 10 with a possible alternative primary layout in the SW corner shown in the inset at bottom left.

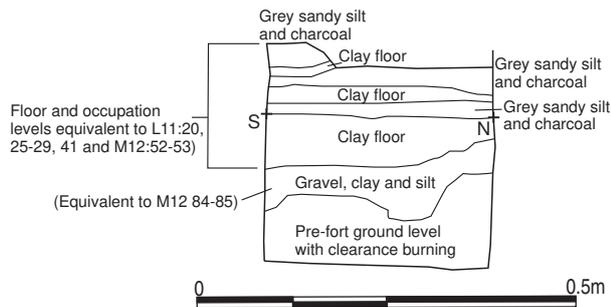
Figure 9.03: Section S58 on the west side of colliery era posthole (M12:30) in the south corridor, at 1:20.

through the Roman levels on the west side of the pit (site drawing S58 – Fig 9.03 here). The pre-fort ground surface showed signs of clearance burning and also appeared to feature one and perhaps two narrow furrows, 0.12m wide at the top (0.05m at the bottom) and 0.09m apart. This was overlain and levelled by a layer of yellow-orange gravel clay and silt evidently equivalent to M12:84–85.

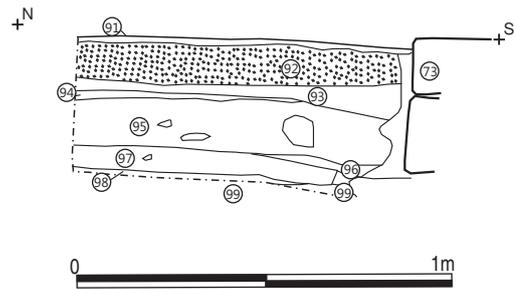
Figure 9.04: West facing section (S62) of a sondage through the floor levels in the south corridor in M12, at 1:20.

Two small sondages through the full sequence of floor levels in the northern part of the room revealed the composition of the room's earliest surfaces. One 0.70m square trial trench was excavated roughly mid-way along the length of the room, towards its north edge, in the area of the Phase 2 corridor (see section S62 – Fig 9.04 here). The lowest level revealed here was a mixed yellow sand-clay floor (M12:99). This was overlain by a thin mortar level (M12:98) – thickest at its southern end where it reached 25mm, decreasing to as little as 10mm elsewhere – which perhaps represented another floor surface. A further deposit, up to c. 55mm deep, composed of dark grey silt and charcoal in equal measure (M12:97) covered the floor levels and might represent occupation debris. In the north-east corner of the room, a series of floor levels and occupation deposits were uncovered up against the east wall (N12:46). The lowest floor was composed of a mixture of stone and sandy clay (N12:75), which was overlaid by dark grey silty clay loam flecked with charcoal (N12:74), probably representing occupation silt/debris. This in turn was covered by a hard mortar floor surface (N12:72), pinkish-white in colour, changing to buff/white lower down where its composition was more mixed and included some stone. This surface was level with the top of the lowest course of the east wall and was overlain by a thin layer of charcoal and silt occupation debris (N12:73).

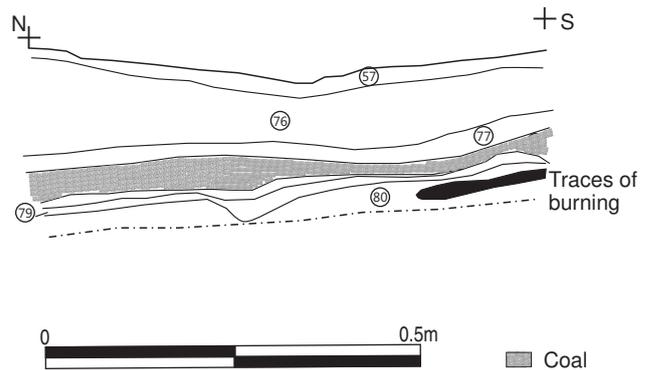
Figure 9.05: Section S59 through unexcavated layers of Room 6 seen in the east side of later intrusion N12:28, at 1:10.

Further south, advantage was taken of a later intrusion (N12:28) in the eastern part of the room to record the full sequence of early layers (the west-facing section recorded as S59 – Fig 9.05 here). The pre-fort ground surface (N12:80) was drawn but not described, though it evidently displayed patches of burning, presumably reflecting clearance of vegetation. Directly overlying this was a thin layer of yellow/

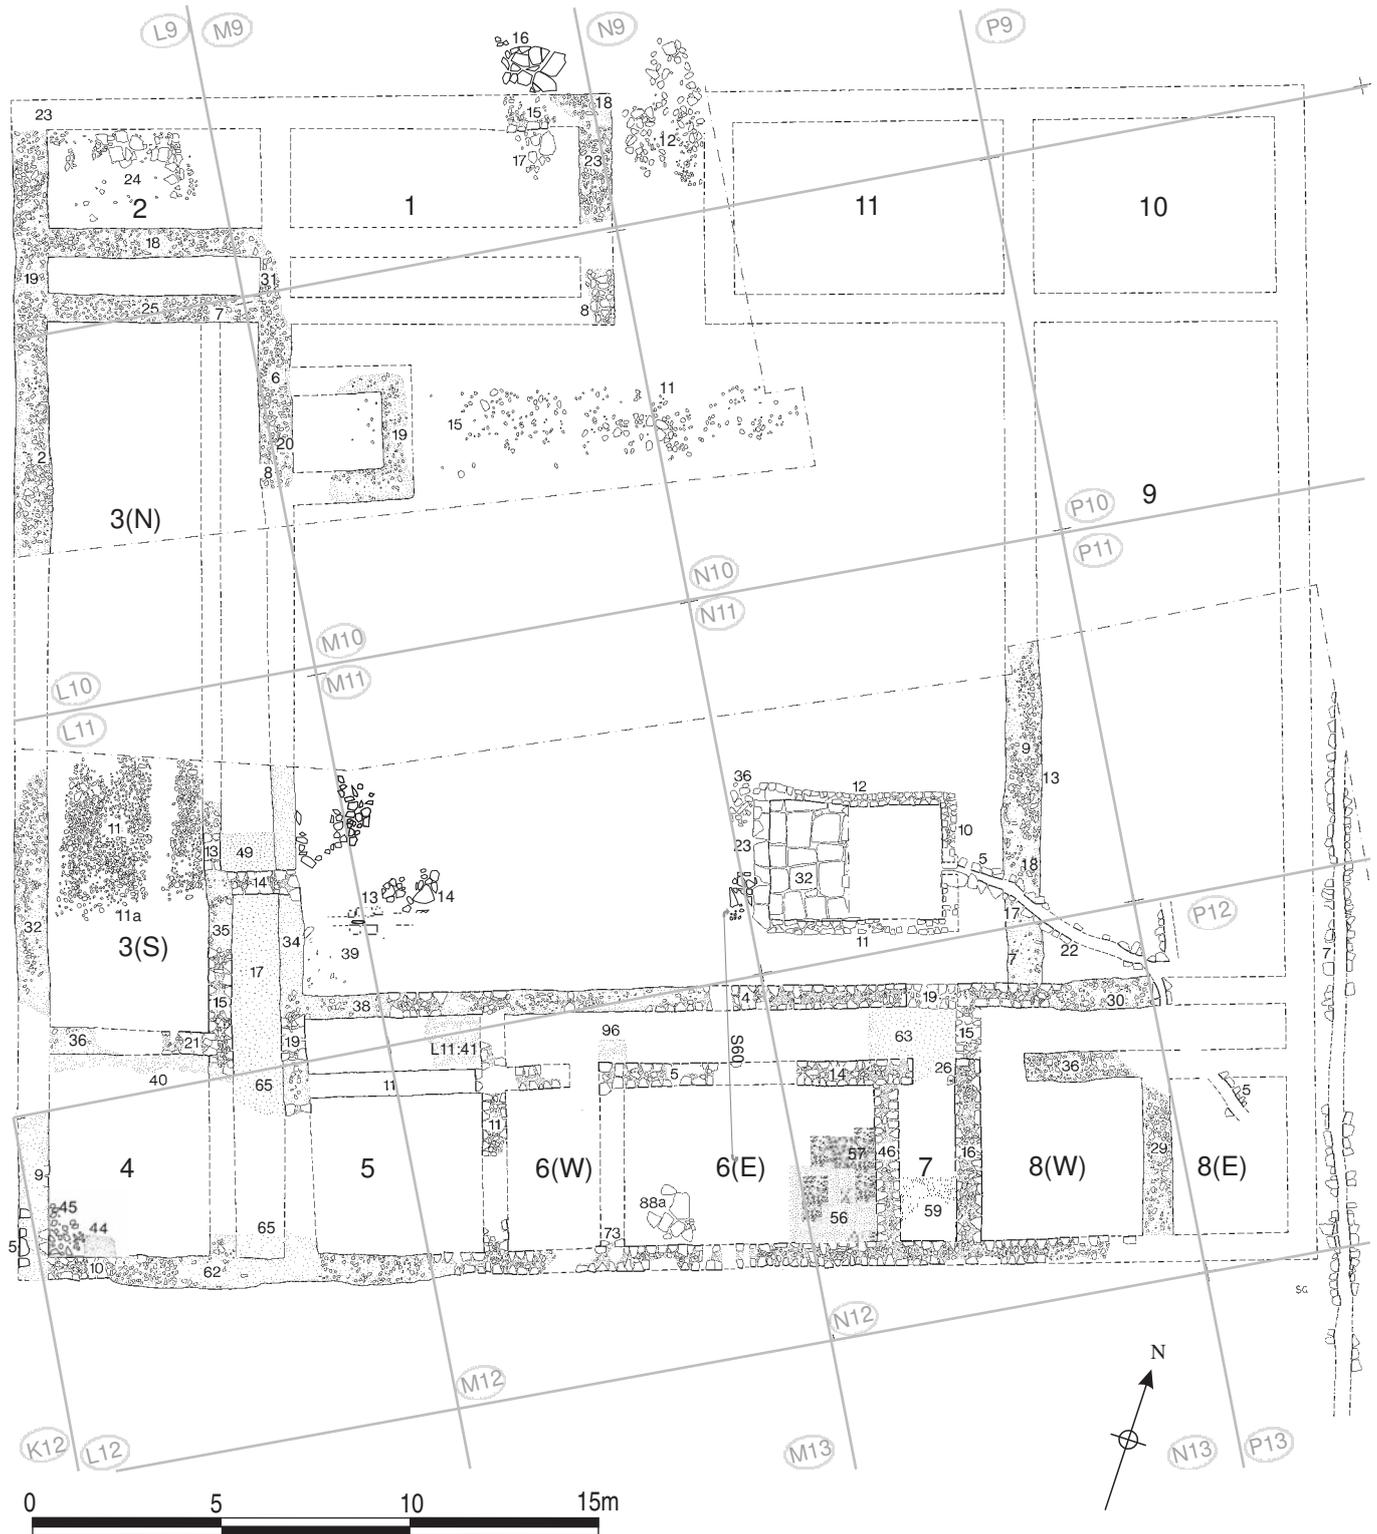
Figure 9.06: Building 13, Phase 2 at 1:200.

By contrast with the south side of the building, the east range was very poorly preserved, with only the most deeply cut features surviving – that is to say essentially certain drain channels. Virtually all trace of the building's east wall had been removed, leaving only a linear spread of rubble (P12:16) – presumably disturbed foundation material – and one short trench (P11:10), measuring 1.40m by 0.35m, interpreted as a remnant of the foundation trench, though it might equally represent a robbing cut which had gone a little deeper than elsewhere. The wall's position can, however, be gauged by reference to the stone-lined drain (P11:06, P12:07) which ran alongside the wall, on the western margin of the *intervallum* road (P11:11, P12:13). The foundations of the west wall of the range did survive, however, taking the form of a line of closely distributed sandstone rubble (N11:13) overlain by pink plastic clay (N11:09, 17–18, N12:07), in places set in a distinct trench varying between 0.90m and 1.15m in width.

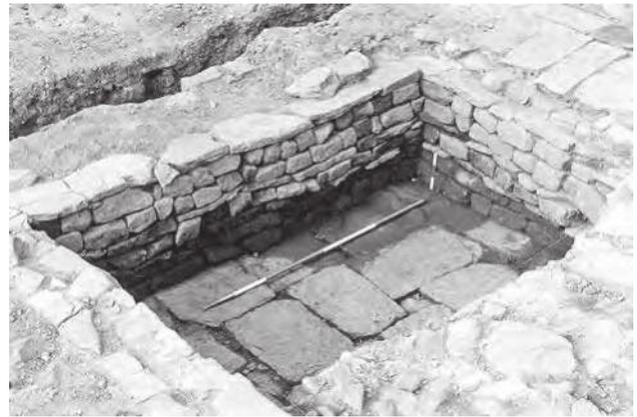
Figure 9.07: The west half of the courtyard cistern emptied out.

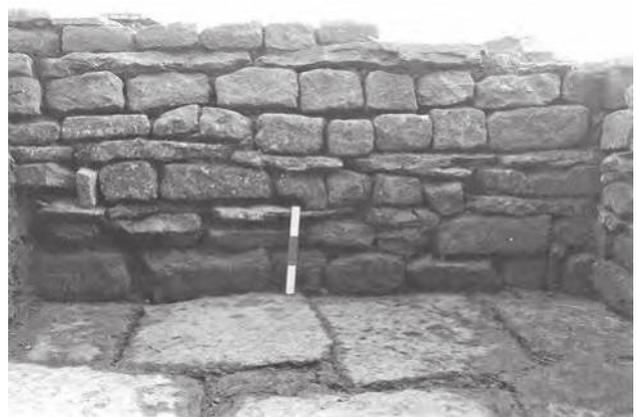
Figure 9.08: South wall of the courtyard cistern (N11:11).

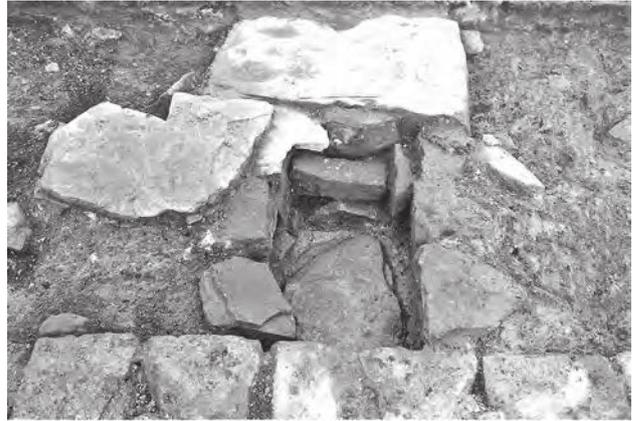
Figure 9.10: 'Drain/soakaway' N12:58 from the west.

In the passage, a rather patchy flagged floor was laid (N12:48), of which two large slabs survived in the centre of the room (one overlying 'drain' N12:58) with smaller flags along the southern edge of the doorway, including a threshold pivot stone (N12:26) positioned right beside east wall. Elsewhere all that remained was a scatter of small stones and patches of pink/grey streaky clay to judge from site plan P200. Into this flagged floor was set a 'drain' or soakaway feature (N12:58) which extended across the width of the passage, from east to west, and was composed of two lines of facing stones set on either side of a flagged base (Fig. 9.10). The side walls were placed 0.50m apart, narrowing to 0.35m at its west end. Three packing stones were wedged in towards the eastern end of the feature, which was covered by a large flagstone (part of floor N12:48) sealing a deposit of loose grey sticky silt (N12:61). The remainder of the drain/soakaway was filled by a very loose packing of stone rubble and brown loam with slight traces of charcoal (N12:55), perhaps representing the backfilling of the structure at the end of its life.

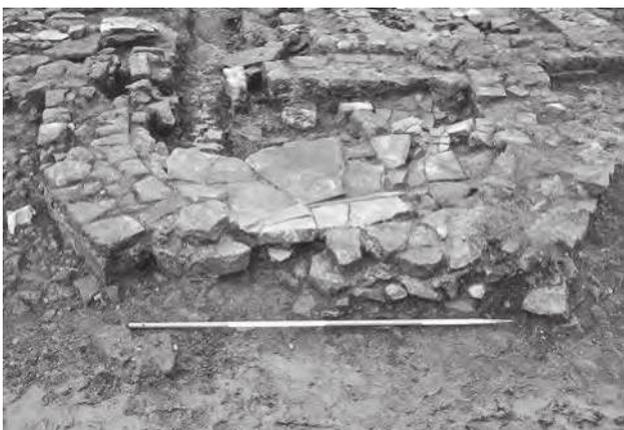
Figure 9.12: Initial flagged floor M12:51 in apse M12:08 from the south. The earlier phase cast vents in the south wall can be seen in the background.

A semi-circular apse (M12:08) was added against the outer face of the south wall (Figs 9.12, 9.13), opposite the eastern part of Room 6 and overlying the street surface of worn orange sandstone cobbles (L12:38, M12:39), which extended along the south side of the *praetorium*. The east-west width of the apse, at its broadest point next to the building's south wall, was 4.10m and its maximum extent from north to south was estimated at c. 2.80m. The enclosing wall was up to 0.57m wide and of typical mortared construction, surviving two and sometimes three courses high. Its western end blocked the westerly (M12:49) of the two narrow vents through the south wall which were inserted during the previous sub-phase.

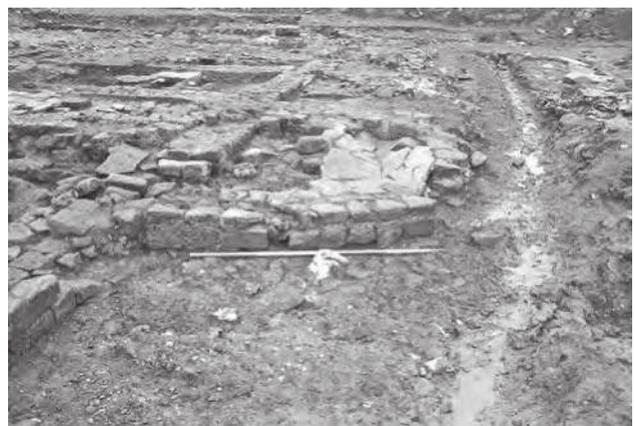
Figure 9.13: Apse M12:08 from the west.

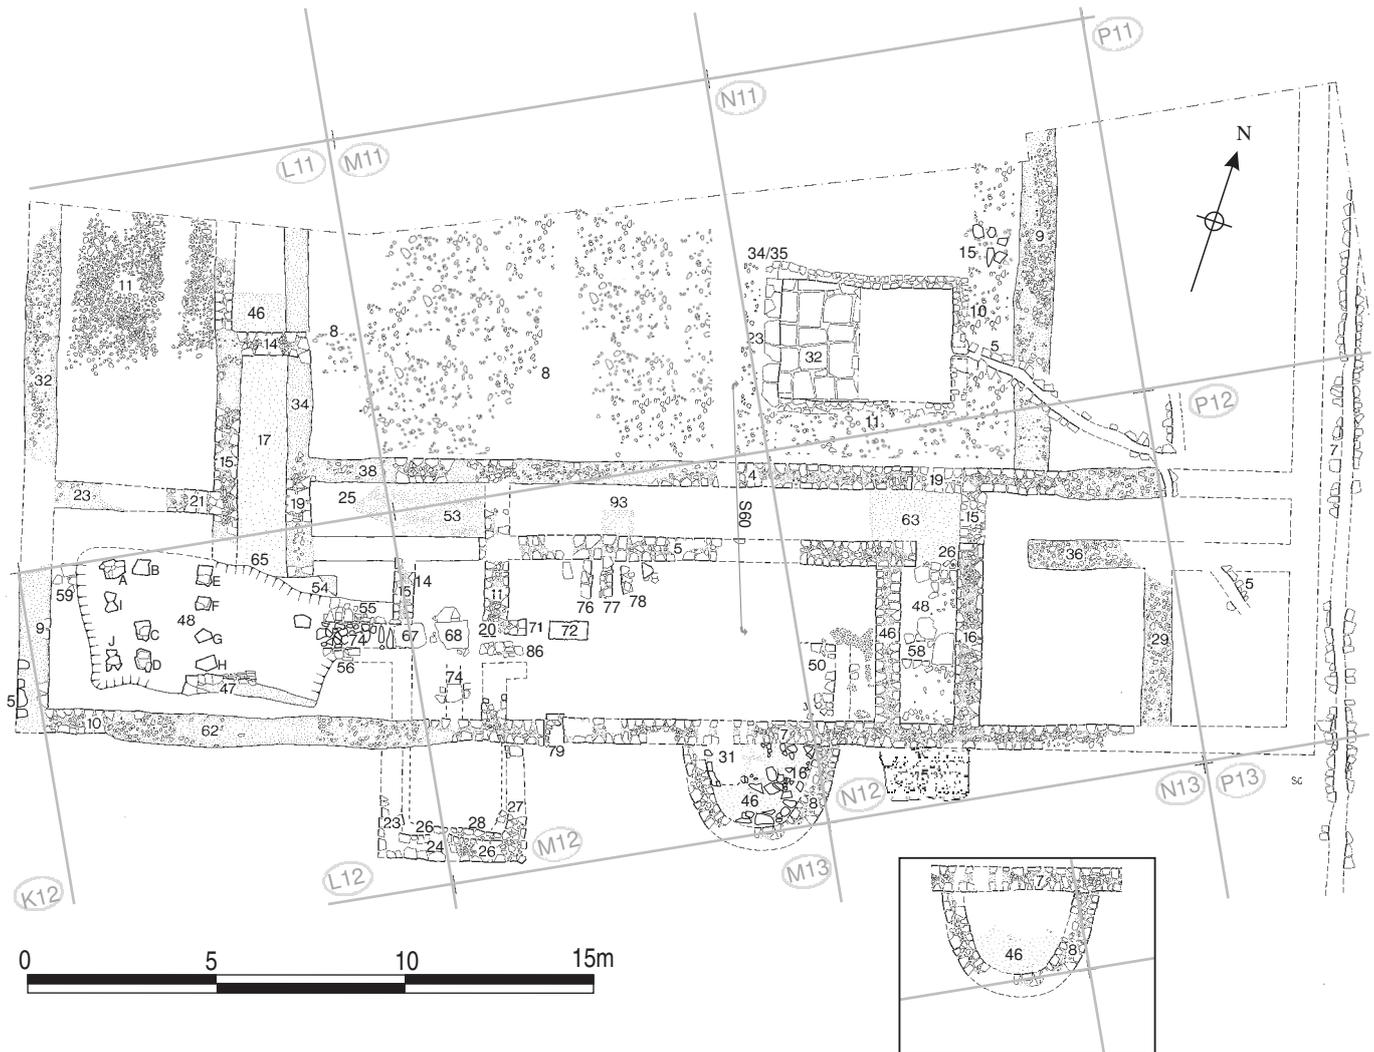
Figure 9.14: Building 13, Phases 3.iii and 3.iv with inset showing second phase of flooring in the semi-circular apse at 1:200

The apse underwent a series of alterations over the course of its life. A floor of fine grained sandstone flags (M12:51) was present in the southern half of the structure. This had settled unevenly so that it no longer formed a flat surface when excavated and

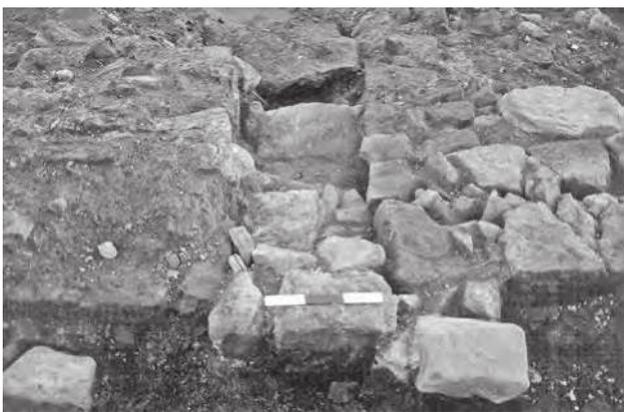
Figure 9.15: Blocking M12:79 (Phase 3iii) in the Room 6 hypocaust flue M12:70, from the north.

west corridor and the western half of Room 5. The flue for the hypocaust in Room 6 (M12:70) was blocked with a couple of large facing stones and pink clay (M12:79- see Fig. 9.15) and the excavators seem to have assumed that the semi-circular apse (M12:08) to the east was taken out of use and demolished at the same time, although no surfaces or structures attributable to this sub-phase were identified in Room 6.

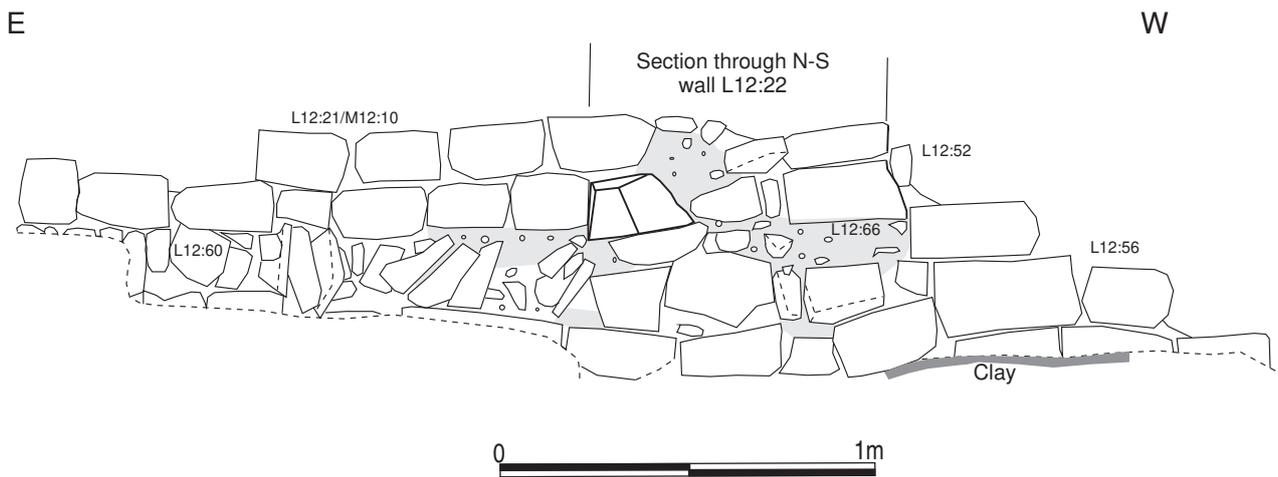
Figure 9.16: Elevation drawing (S61) of the south face of the flue at 1:20

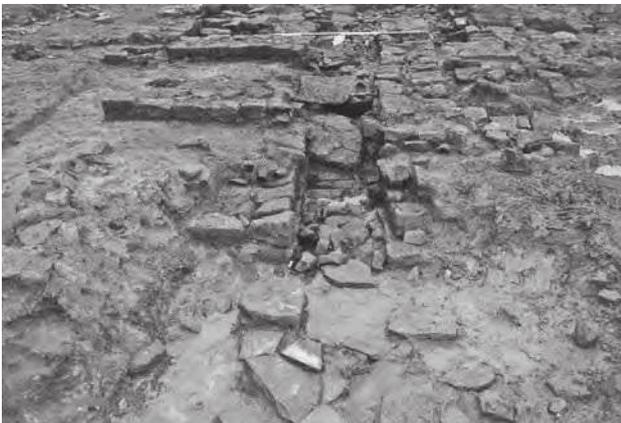
Figure 9.17: View of the stoking chamber from the west hypocaust with the west flue in the fore and the east flue in the far background. The south flue is to the right beyond the later crosswall.

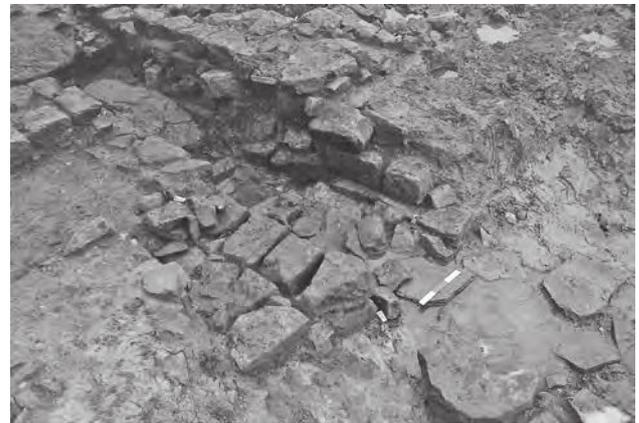
Figure 9.18: The initial (Phase 3iii-iv) form of the west flue.
