# SEGEDUNUM

Excavations by Charles Daniels in the Roman Fort  
at Wallsend (1975–1984)

VOLUME 1: The Structural Remains

Alan Rushworth and Alexandra Croom

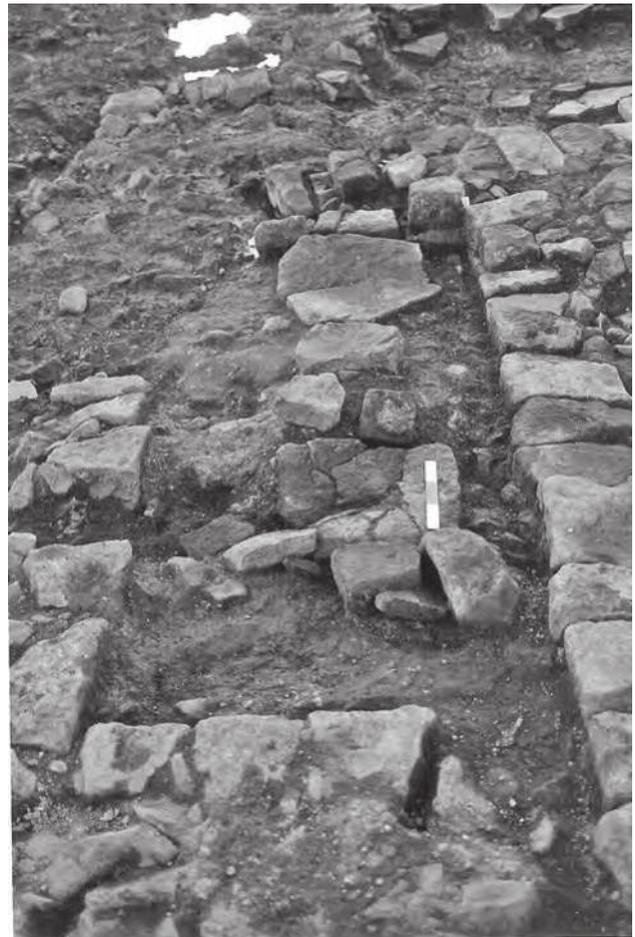
Figure 9.19: Remnants of south flue M12:74, from the east, in the southern part of the stoking chamber incorporated in later flagged floor L12:70 after the room was subdivided.

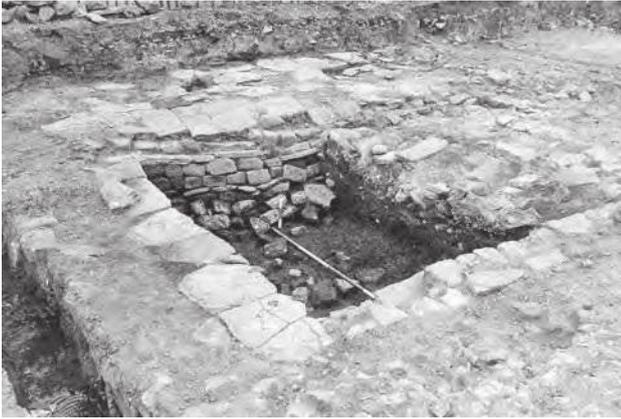
Figure 9.21: Rubble in lowest fill in the courtyard cistern (below the piers), from the south west, with the courtyard flagging in the background.

#### Courtyard (Fig. 9.21)

To the north and north-west of the cistern, extending right to the limit of 1979 excavation area, well-laid, neatly squared-off rectangular flags (M11:07, N11:14) took the place of the gravel and cobble surface. The southern edge of this flagging respected the north wall of the cistern (N11:12), demonstrating that the cistern was already in existence when the flagstones were laid (Fig. 9.21). The flags were composed of fine-grained, slightly micaceous sandstone and were a mixture of orange, off-white and greyish/green, with grey being the dominant colouring. They generally averaged c. 0.70m by 0.75m, although the largest examples were as long as 0.90–1.05m. The laying of the flagstones was attributed to Sub-Phase 3v in the Daniels/Moffat phase plans and context database, although there were no useful stratigraphic links to permit any direct equivalence between activity in the courtyard on the one hand and the interior of the south range on the other. Over the remainder of the courtyard it is presumed that the earlier gravel and cobbled surface remained in use. Indeed M11:08 was recorded as slightly overlapping the adjacent flagstones (M11:07). It is unclear why the flagging was laid only in this particular part of the courtyard. The flagstones do not appear to have stretched beyond the line of the cistern's eastern sidewall, but did extend

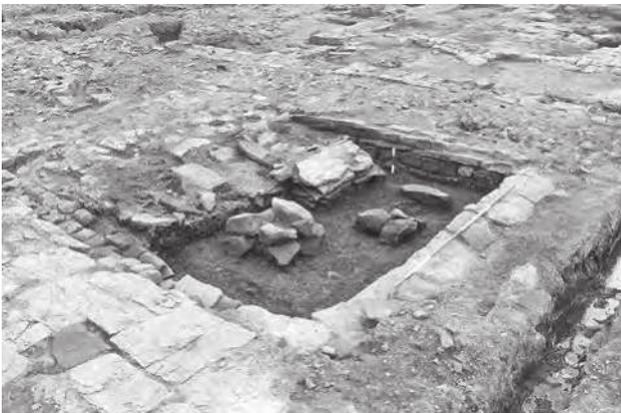
Figure 9.22: Piers N1 and N2 in the courtyard cistern.

#### Cistern (Fig. 9.22)

A thick deposit of slightly brownish-grey silty clay-loam (N11:29) flecked with coal and pink clay lumps covered the bottom of the cistern. This was some 0.40m deep in the centre of the tank, but was, respectively, as much as 0.80m and 0.87m deep further north and south, where the deposit sloped down the sides of the tank. Three stone pillars (N11:25, 26, 27) were uncovered in the western half of the tank, set on top of this layer of silt (Fig. 9.22). The pillars were constructed of roughly faced sandstone blocks or, in the case of N11:27, superimposed flat flagstones and were bonded with orange-brown sandy mortar. A similar spread of orange brown sandy mortar (N11:28) lay beneath the northernmost pillar (N11:25), but was separated from direct connection with it by a lens of silt. The northernmost pillar (N11:25) measured 0.80m by 0.70m and stood 0.40m high; the south-western example (N11:26), which measured 0.90m (N-S) by 0.60m, was somewhat damaged and only stood 0.26m high. The south-eastern pillar (N11:27) measured 0.90m × 0.60m and stood 0.40m high. Similar structures were found in southern half of Cistern 1, to the north of the hospital, and they were presumably designed to support a floor covering at least part of the tank. Other pillars may have stood in the eastern half of the cistern which was not emptied.

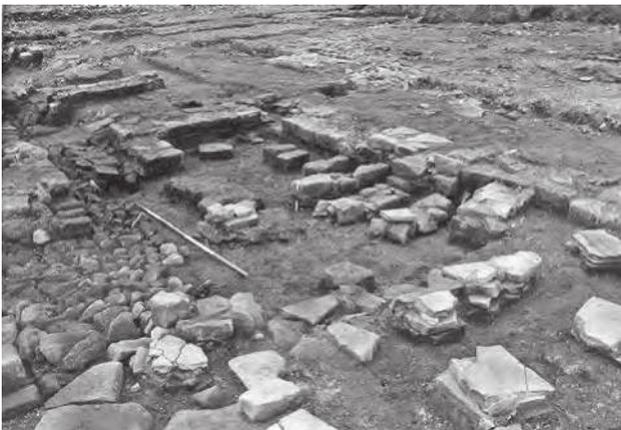
Figure 9.23: The east hypocaust viewed from the south-east (Phase 3v) with Phase 3vi east-west wall foundations M12:69 also visible to the right, reducing the area of the hypocaust.

A pillared hypocaust (M12:80) was inserted in Room 6 (Fig. 9.23), which was simultaneously truncated in length towards the east by the construction of a new dividing wall (M12:06, N12:21). This reduced the dimensions of Room 6 to 7.00m by 4.20m. The wall was up to 0.68m wide and of typical construction, featuring fine-grained sandstone facing stones bonded with gritty, off-white mortar, the core also containing several tiles. A doorway in the north-east corner of the room provided access from the corridor. A total of 16 *pilae* (A-H, J-Q) belonging to the hypocaust survived, most of which were located in the eastern half of the room. They were mainly composed of flat slabs, though some stone blocks were used, notably in A, which resembled the earlier dwarf walls immediately to the west (and might even represent another one of those, rather than a *pila* of this sub-phase). Single upright blocks were incorporated in P and Q, the one in the latter case being interpreted as a possible altar (but does not appear to have been retained as small find). Many of the *pilae* were not fully exposed so their full height could not be accurately gauged. However, *Pila C*, which was measured from its base, stood to a height of 0.55m and was composed of seven slabs. The size of the *pilae* varied considerably, with Q and O amongst the largest, measuring 0.50m

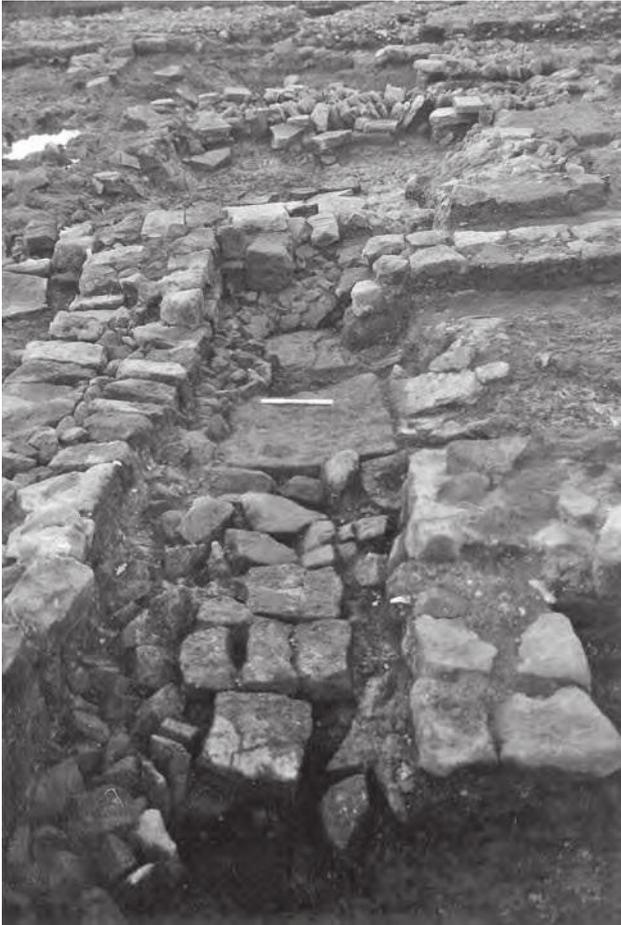
Figure 9.24: The initial (Phase 3iii–iv) form of the east flue serving the east courtyard.

The hypocaust was fired from the west end of the room using the same stoking chamber from which the west hypocaust was heated. Only the north side of the flue was preserved (Fig. 9.24). The surviving flue side wall (M12:71) was bonded to the west side wall (M12:11) of the stoking chamber, which was carefully rebuilt at that point (M12:20), and projected c. 0.50m into the hypocaust. The combined length of flue (M12:20 and 71) was 1.23m. Its width could not be gauged with certainty, but it was probably in the order of 0.70m, the bottom of the channel being floored with small flagstones (M12:86) along its full length. The projecting side wall was the width of two facing stones, splaying slightly from 0.35m at its junction with wall M12:11 to 0.43m at its eastern end. Some 0.40m further east and directly in line with the flue wall there was a stone base (M12:72), measuring 1.05m east-west by 0.50m north-south. Like the flue side wall, it was composed of two lines of facing stones with no real core. It was interpreted as the support for a bath and perhaps functioned with a corresponding base to the south so that the bath supported by these bases would have straddled the flow of heat from the flue. The side wall of the flue opening (M12:20) was heavily burnt to a pinkish red colour. The nearest stone *pila*, of the hypocaust (M12:80Q), immediately to the west of base M12:72, also showed signs of burning.

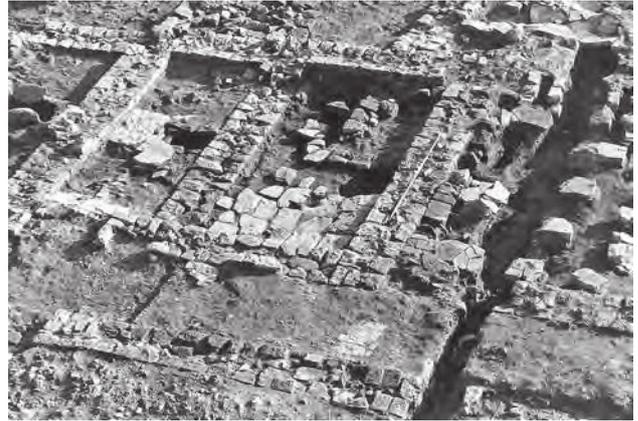
Figure 9.25: Phase 3v – flagged floor N12:47 incorporating demolished wall N12:46.

#### Room 7 (Fig. 9.25)

Contemporary with the construction of the new partition wall (M12:06, N12:21), the west wall of the north south passage (N12:46) was demolished to create an enlarged Room 7 also encompassing the former eastern end of Room 6. Thus remodelled, the room was almost square with internal dimensions of 4.15m east-west by 4.10m north-south. It is noteworthy that the new west wall (M12:06/N12:21) appeared to cut very neatly through the room's north wall (N12:14), suggesting the latter may have been rebuilt at the same time. A flagged floor composed of thick, regularly proportioned slabs, up to 0.45m

in length, was laid in the north-west corner of the room (N12:47), alongside walls N12:14 and M12:06/N12:21. The slabs extended eastwards towards the footings of demolished passage wall (N12:46), which were probably also incorporated in the floor along with the pre-existing patchy flagged surface of the passage (N12:48) and the demolished remnants of earlier (Phase 3i–ii) hypocaust walls (N12:50) in the south-west corner. A light grey-brown loam containing a lot of mortar (N12:52) covered the area between the demolished remnants of the hypocaust and the footings of the former passage wall. The doorway into the room remained unaltered. It was perhaps at this stage that the enigmatic stone-lined feature (N12:58), interpreted as a possible drain or soakaway, was backfilled with a very loose packing of stone rubble and brown loam, including slight traces of charcoal (N12:55).

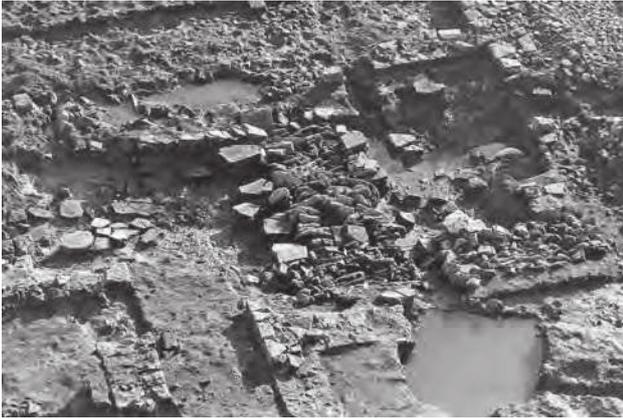
Figure 9.27: The west hypocaust from the north with Phase 3vi wall foundation L12:46 subdividing it (pitched stone packing N-S).

#### The south-west corner (Fig. 9.27)

The line of the south corridor wall (L12:11) was extended as far as the main west wall of the building, and the former west hypocaust chamber further subdivided by the construction of a north south wall (L12:46). Both the north-south and east-west aligned walls survived only in the form of very broad foundations constructed of very closely set pitched slabs. Those of the north south wall were 1.25m wide filling the space between two rows of *pilae* with a central row taken up. To the north and south the foundations extended beyond the cut for the earlier hypocaust. The slabs were almost all fine-grained sandstone, 50–80mm thick, and included two or three very smooth slabs which resembled those used in the *pilae*. The chamber in the south-west corner of the building created by these two new walls was largely filled by a dump of fairly homogenous, plastic pink grey clay (L12:13) containing relatively few impurities – a little tile, coal and some stone. The clay covered an area c. 2.70m by 3.00m and the depth of the deposit varied between a few centimetres to c. 0.30m, but its surface was very uneven with a pronounced dip in the centre where it filled the hypocaust pit. This depression, which was some 0.50m deep and measured c. 2.75m north-south by 2.00m east-west, may have been the result of gradual settling of the clay dump. The pink clay also filled the earlier (Sub-Phase 3iii?) opening (L12:50) through the west wall (which the excavators interpreted as a drain outlet), blocking it up completely.

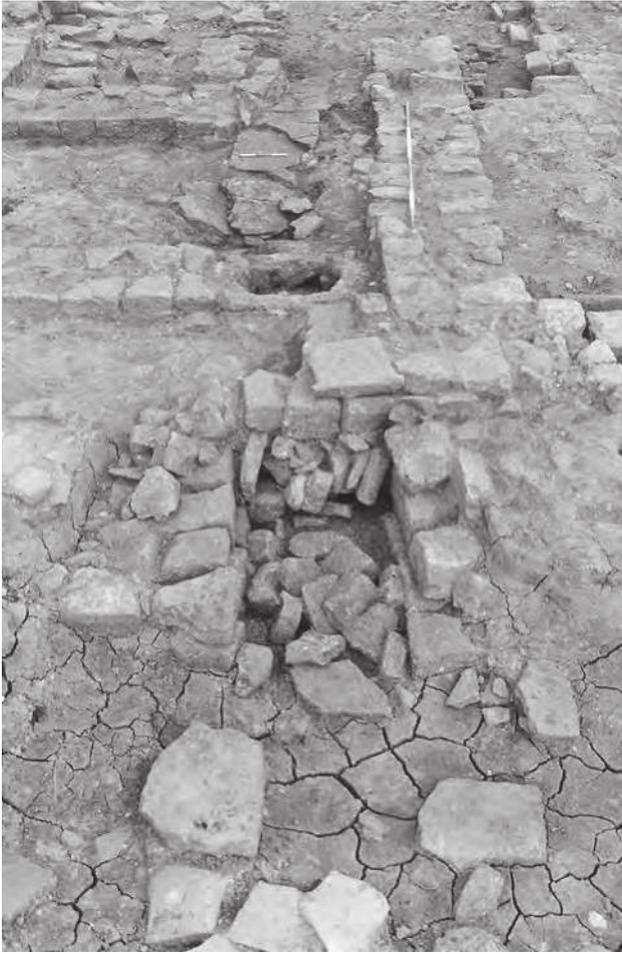
Figure 9.28: Phase 3vi blocking of the west flue.

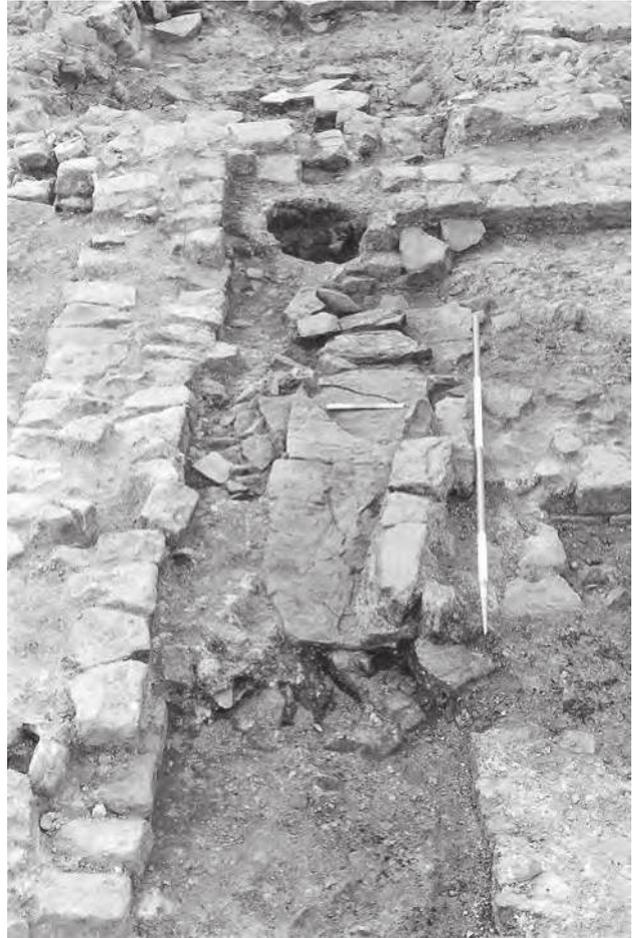
Figure 9.29: Phase 3vi east flue from the east showing flags M12:65, modified north wall M12:12 and crosswall L12:21/M12:15

The north-south wall (L12:22) was bonded to an east-west aligned wall (L12:21, M12:10) which extended east ward on a line just south of the east hypocaust flue, reducing the internal, north-south length of the firing chamber and the equivalent width of the east hypocaust chamber to c. 2.70m. This east-west wall was set on the same pitched stone foundations (L12:66, M12:69) which supported wall L12:22 over the west hypocaust flue. These foundations were as much as 1.50m broad towards their east end. The masonry of the wall survived for 4.70m, the foundations for a further 1.75m, where it joined a north-south wall, of which only the stone foundations (M12:36) survived, and which ran up to join the room's north wall (M12:05). Construction of these two walls (L12:21/M12:10 and M12:36) reduced the size of the hypocaust chamber to something of the order of 4.00m long by 2.70m wide. There were also alterations to the north side of the stokehole where a new facing of roughly worked blocks (M12:12) was laid at an oblique angle to the earlier face (Fig. 9.29). These stones were burnt to a maroon red colour on their south side. A new flagged base (M12:65) was laid in the stokehole, over a layer of makeup consisting of dark grey silty clay loam, with some charcoal and stone debris (M12:64). The flags were burnt and cracked by the heat in the stokehole and extended into the firing chamber, which was covered by a deposit of coal and ash (L12:64, M12:37). A similar layer of mixed furnace debris (M12:45, M12:57), comprising coal, ash, charcoal, silt and mortar, was also present in the stokehole flue itself, over flagging M12:65 and the foundations (L12:66, M12:69) of wall L12:21/M12:10, which formed the south side of the flue and firing chamber. In the hypocaust chamber, furnace debris consisting of charcoal and dark silt (M12:60), overlying earlier flue side wall (M12:71) and stone base (M12:72), was probably associated with the remodelled flue of this sub-phase. Its presence would imply that the earlier flue side wall and the rectangular base had been demolished by this stage.

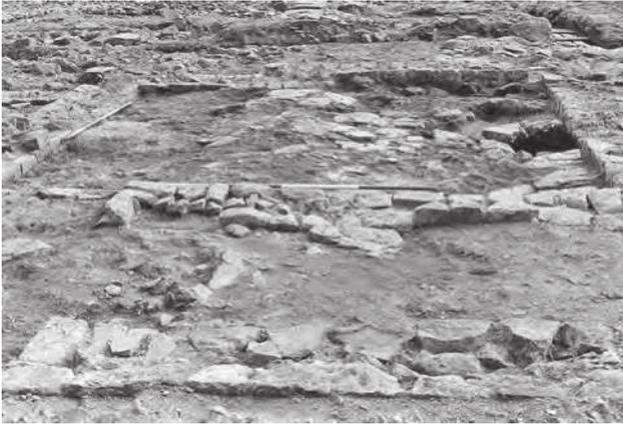
Figure 9.30: The later flagged floor with hearths in enlarged Room 7, from the north (Phase 3vi).

A new floor was laid in this room (Fig.9.30). In the area of the former passage this was composed of a 0.10m thick layer of yellow-orange sandy mortar in grey/black silty clay loam (N12:38), with much charcoal interspersed, which probably represented the remnant of a mortar floor. In the centre of the room, the flooring took the form of worn sandstone flagging interspersed with pebbles (N12:37), set on a 0.10m deposit of mortar and soil makeup or debris. Traces of burning at three points in the room (two in the south-west corner and one near the entrance in the north-east corner) may indicate the position of hearths (N12:40–42).

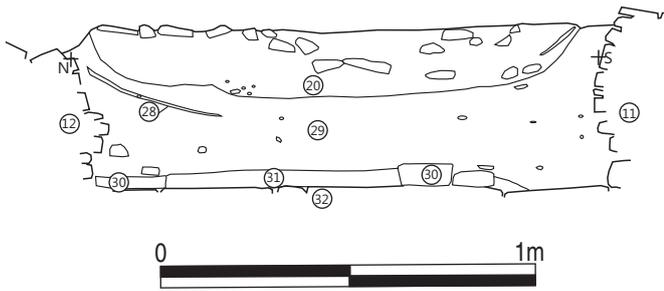
Figure 9.32: Section S56 across the fills of the courtyard cistern at **Q**

##### *Courtyard and cistern (Fig. 9.32)*

The cistern was taken out of use and backfilled with a jumbled mass of light brown/yellow mortar with broken coarse yellow sandstone flags, small stones,

pieces of brick rubble, gravel chips and off-white mortar (N11:20), the whole deposit being some 0.35m deep. There were slight indications of layering in the material, suggesting it had been tipped in from the east, this being particularly evident in regard to the flagstones, which gave the impression of sloping down from east to west.

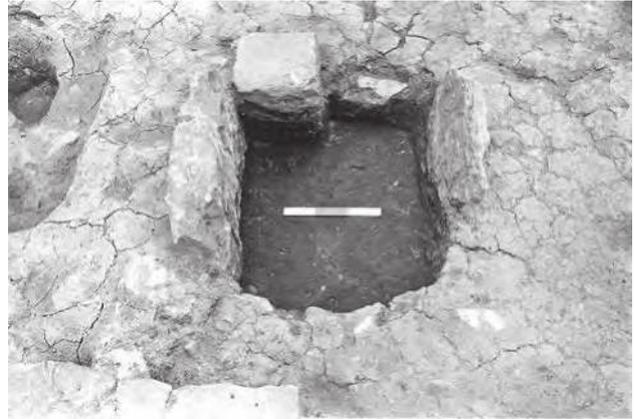
Figure 9.33: Metalworking hearth N12:24 in Room 8W (Phase 4 or later), from the west.

In Room 8W a mortar and clay surface was laid (N12:09). A possible metalworking hearth (N12:24) occupied the west side of the room near the south-west corner (Fig.9.33). This was formed by two large slabs, set vertically, 0.65m apart, on the north and south sides of a rectangular pit. The latter, which measured as much as 0.90m from east to west, was filled by a 0.35–0.40m deep deposit of burnt debris consisting of brown/black gritty and silty clay loam (N12:25), including a lot of copper-alloy fragments, ferrous material and charcoal, with ash around the edges. The two vertical slabs also showed signs of burning. In the north-east corner of the pit, a roughly square facing stone, measuring 0.25–0.30m on each side, rested on the burnt debris and was thought to have been perhaps functionally related. The copper alloy fragments were not present in the lower fill of the hearth pit. Spreads of coal (N12:33) over surface N12:09 might also have been associated with this hearth. Immediately to the south-east, there was a curious channel (N12:49), aligned north-south and c.

1.60m in length. It was up to 0.70m wide overall and lined with facing stones, often pitched at an angle. The channel was 0.20–0.25m wide and 0.13m deep, and filled by grey clay loam and small stones (N12:44), but the structure was probably damaged by later disturbance. This feature was interpreted as a drain of some sort though there was clearly no outlet through the adjoining south wall.

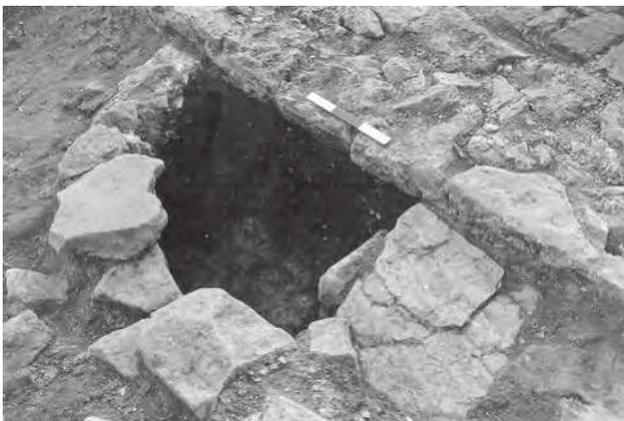
Figure 9.34: Late pit N12:28 dug at the western edge of Room 7.

A pit (N12:28), measuring 0.75m by 0.60m and c. 0.20–0.25m deep, was cut right through the floor levels at the western edge of Room 7 (Fig. 9.34).

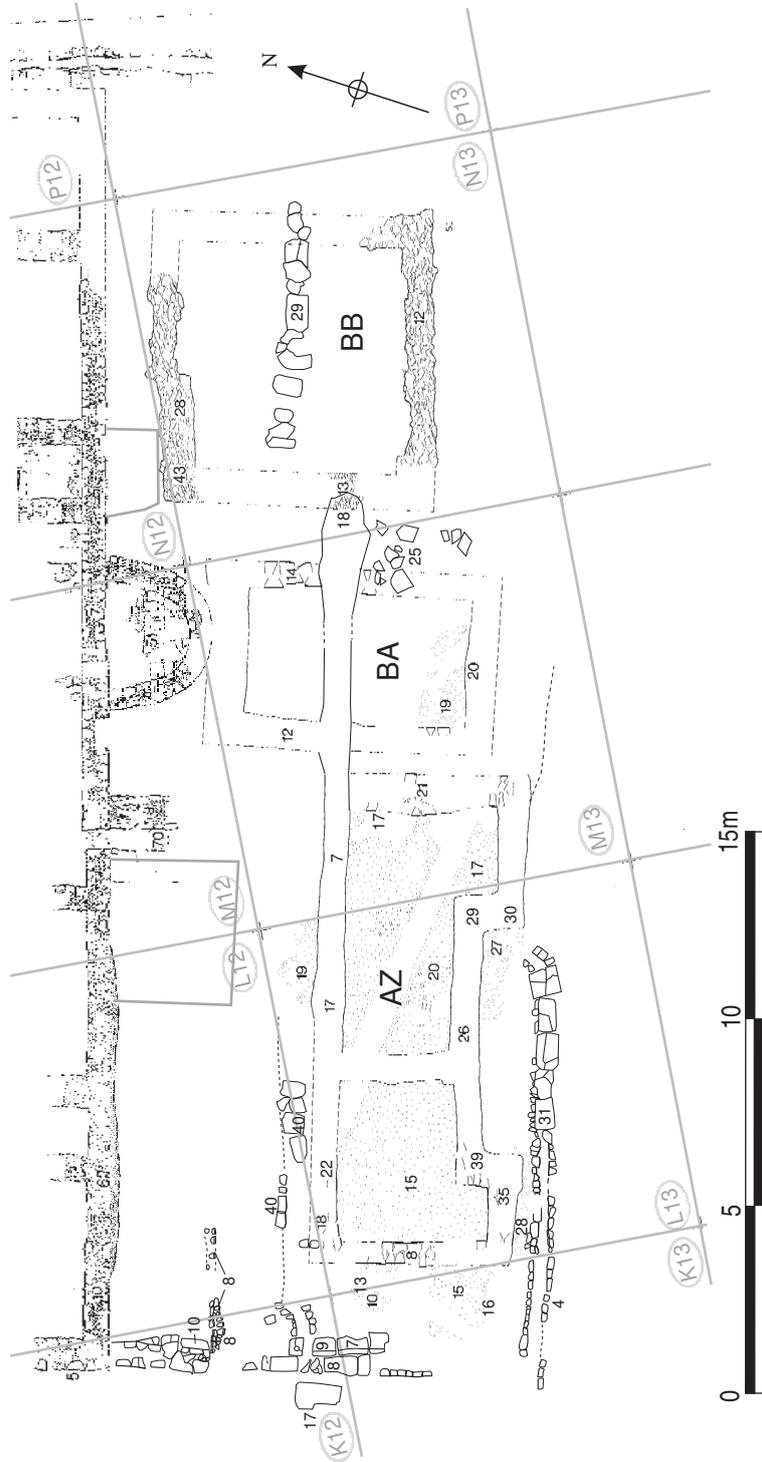
Figure 9.35: All features south of the praetorium Phases 1-5. Scale 1:200.

##### *Introduction and outline summary* (Figs 9.35, 9.36)

The next phase south of the *praetorium* was marked by the construction of three small buildings, labelled AZ, BA and BB by the excavators (Figs 9.35, 9.38).

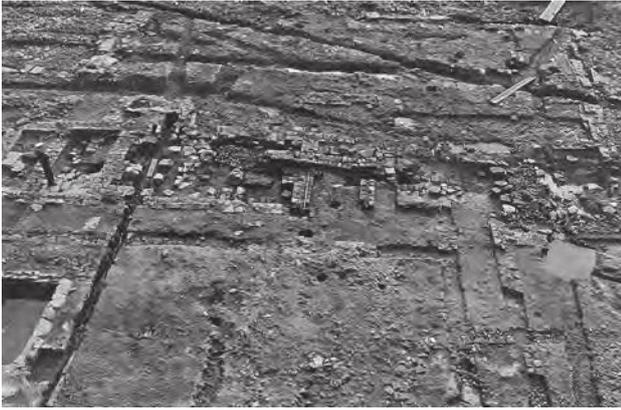
Figure 9.36: Southern part of the praetorium and the structures to the south under excavation in 1979, viewed from Simpson Hotel, looking south.

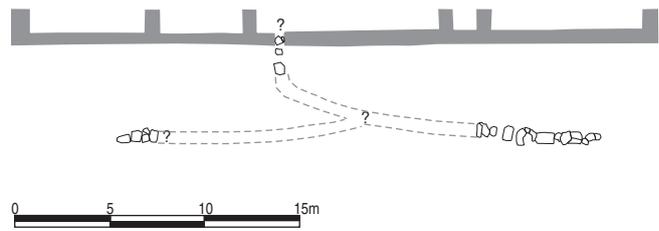
Area south of Building 13, Phase 1 (at 1:400)

Figure 9.37: Phases 1–3 in the area south of the praetorium

The lowest level exposed south of the *praetorium* was a worn surface of orange sandstone cobbles (L12:38, M12:39) alongside the south wall of the building. An area of this surface, up to 1.75m wide, was exposed, extending from the building's south-west corner as far as the semi-circular apse. This perhaps represented the primary surface of *via quintana*, although no excavation took place beneath the cobbling to confirm

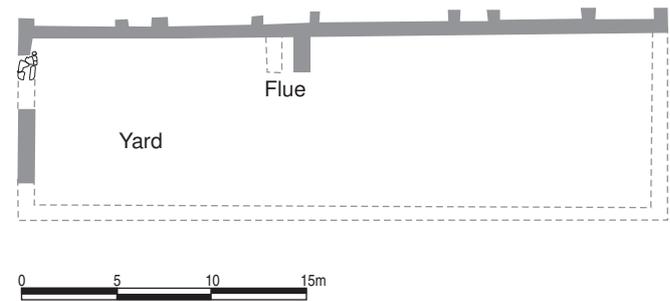
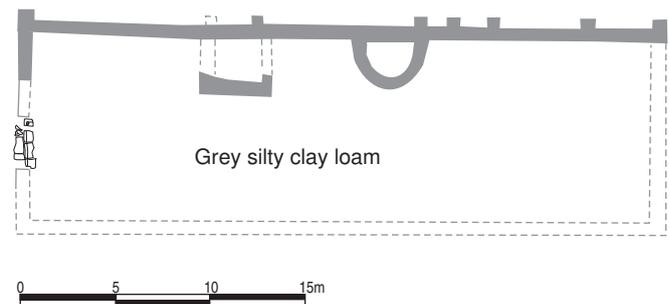
Area south of Building 13, Phase 2 (at 1:400)

Area south of Building 13, Phase 3 (at 1:400)

The next structural phase was manifested by the construction of a walled yard attached to the south side of the *praetorium*. Only the west wall (K12:05, K13:08, L12:27) of this yard survived, and formed an extension of the west wall of the *praetorium*. The junction with the south-west corner of the *praetorium* was damaged so it is not clear whether it formed a simple butt joint which would point to it being a secondary addition. (The east face of the yard wall could be seen to butt against *praetorium* south wall, but the west face was destroyed at the relevant point, so might conceivably have formed an alternate butt joint like many of the joints in this building, in which case it could have been a primary structural component.) Moffat considered the yard was secondary, belonging to Phases 3i–ii, and contemporary with the use of the external stokehole (M12:70) through the south wall of the *praetorium*. The yard wall extended at least 8.30m southward from the *praetorium* (its south-west corner did not survive) and was c. 0.65m wide. For the most part only a single course of masonry remained. Nevertheless two distinct structural phases were evident in the extant fabric. Towards the northern end of the wall, the existence of an area of 1.00m wide sandstone slabs (K12:10), beneath the surviving course of masonry, suggested that the original entrance lay here and was later blocked. This was confirmed by the survival of two stones immediately

A layer of grey silty clay loam (L12:14, L13:38, M12:38, M13:24, N12:69, N13:03) covered the entire area south of the *praetorium*. This was described as olive green-grey (N13:03) in colour or mid-grey with a slight olive tinge (L12:14), and fairly intense concentrations of charcoal were noted in places (M12:38). The clay loam was seen to ride up against the walls of both the square and the semi-circular apses (L12:23–24; M12:08) and the stoking flue wall (M12:09) and the east face of the yard wall (L12:27), as well as the south wall of the *praetorium* (L12:10, M12:07), indicating that its deposition post-dated the building of those structures. It was overlain by the floor levels (L13:15, 20) and clay packing (L12:19, 27–8) associated with Building AZ.

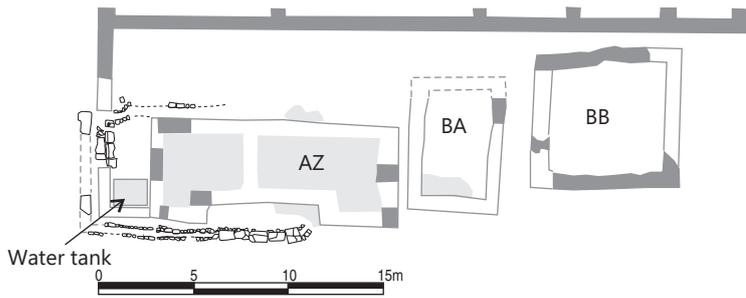
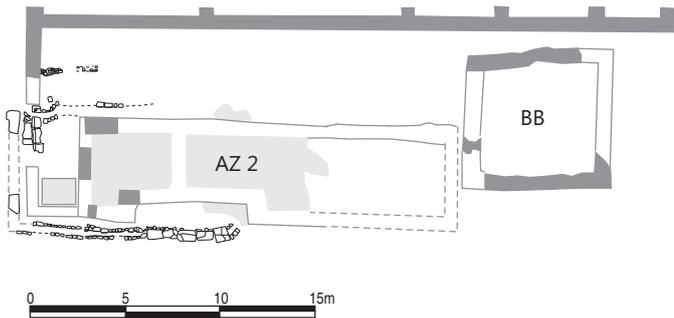
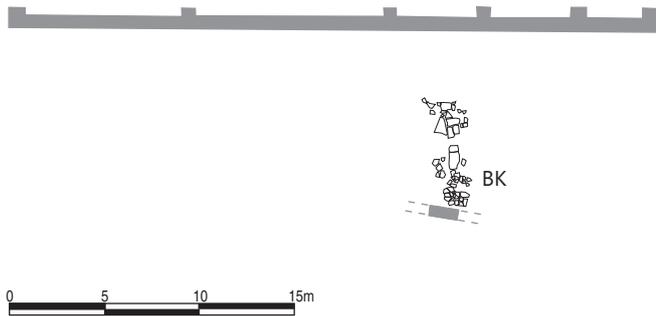
Figure 9.38: Phases 4–6 in the area south of the praetorium

Area south of the Building 13, Phase 4 (at 1:400)

Area south of the Building 13, Phase 5 (at 1:400)

Area south of the Building 13, Phase 6 (at 1:400)

The remains of a flagged floor (M13:25) associated with the extension of AZ was found to the south of the robber trench. This was equated by the excavators with the floor of the later Building BK (N13:04), immediately to the east, however the evidence of both site photography (see Fig 9.42) and site plan P172 – which marks a line of hachures between M13:25 and N13:04 – shows that flagging M13:25 was at an appreciably lower level than the stone floor of BK and this equation should be rejected. Significantly, the lower flagging did not extend north of the robber trench, but did extend across the line of the former east wall of BA, with one or two of the wall's stones being incorporated in the surface. It is unclear how the south wall was treated in the extension of AZ, i.e. whether it continued the line of the original east wing frontage or that of the recessed central section. It was noted above that the *opus signinum* floor (L13:20, M13:17) in the east room of AZ appeared to extend across the line of the building's original east wall, and it was inferred that this might mark the position of an end doorway. Alternatively, however, it might signify that there were actually two floor layers here, associated with the different phases of AZ. If the mortar layer beneath the *opus signinum* was a separate floor surface, rather than being bedding for the *opus signinum*, as suggested by the excavators, it might belong to the initial phase of AZ (AZ 1), whilst the *opus signinum* floor might have been laid after the original wall was demolished and the building extended (AZ 2). This could also explain why the suggested tile 'hearth' (L13:42) was covered by *opus signinum*, if it was associated with the initial mortar floor and went out of use when the *opus signinum* was laid.

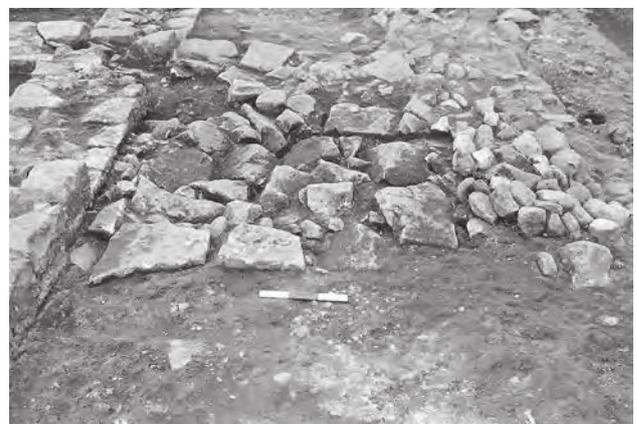
Figure 9.39: Stone base/buttress N12:45 overlapped by the foundation of the north wall Building BB, from the west.

Perhaps in Phase 3iv, a solid, roughly constructed stone platform (N12:45), consisting of large stones with an outer facing (see Fig. 9.39 below), was built against the outer face of the south wall at the end of the passageway (Room 7). One layer of stones remained. The roughly rectangular space between the stone platform and the semi circular apse, to the west, was covered by a layer of yellowish mortar (N12:65), up to c. 20mm thick, which may have been structurally related to the stone base. Alongside the south wall of

buttress or base (N12:45) which was attached to the south range of the *praetorium* and which itself probably overlay the grey clay loam deposit of Phase 3 (Fig. 9.39). Nothing survived of the interior levels, only the underlying grey clay loam being exposed, and there were no clues as to the function of the building.

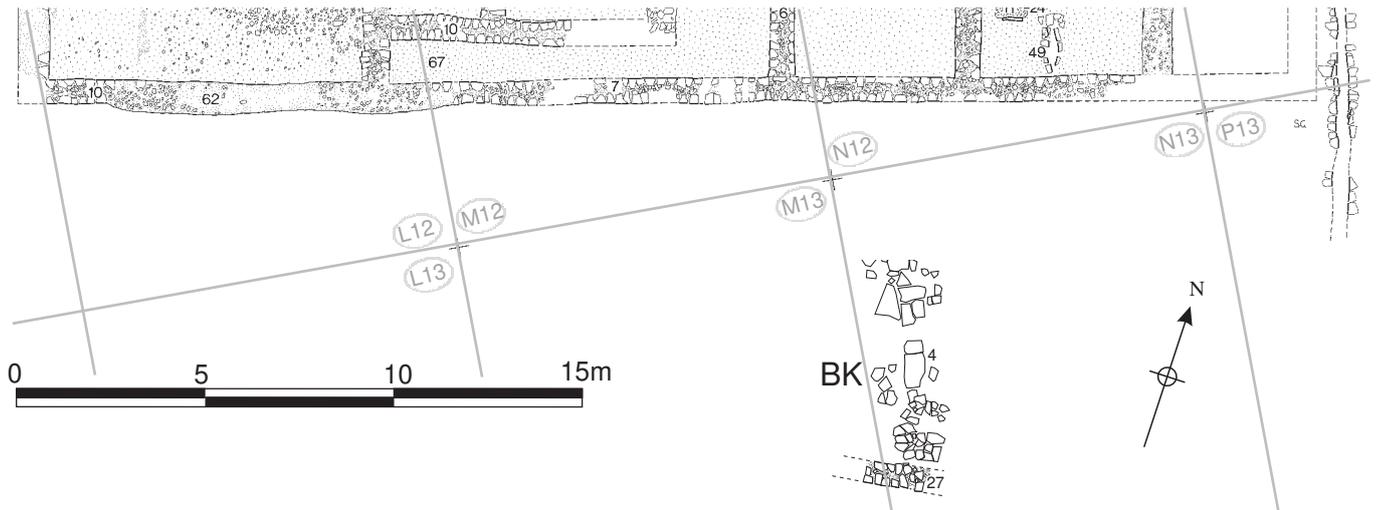
Figure 9.40: Area south of the praetorium, Phase 6 – Building BK. Scale 1:200.

The survival of a small pocket of higher stratigraphy over the western end of Building BB provided evidence for a further structural phase, the latest that could confidently be attributed to the Roman period in the area south of the *praetorium*. The phase was represented by the fragmentary remains of another building, labelled BK. The site photographs (B63/08, B64/03a) show that a significant depth of deposits separated the flagstones associated with the floor of AZ 2 (M13:25) from the surviving remains of BK. These deposit(s) included a layer of mortar and rubble debris (M13:13) which was explicitly described as overlying flagging M13:25. This was probably equivalent to the 'stone and mortar spread', N13:19,

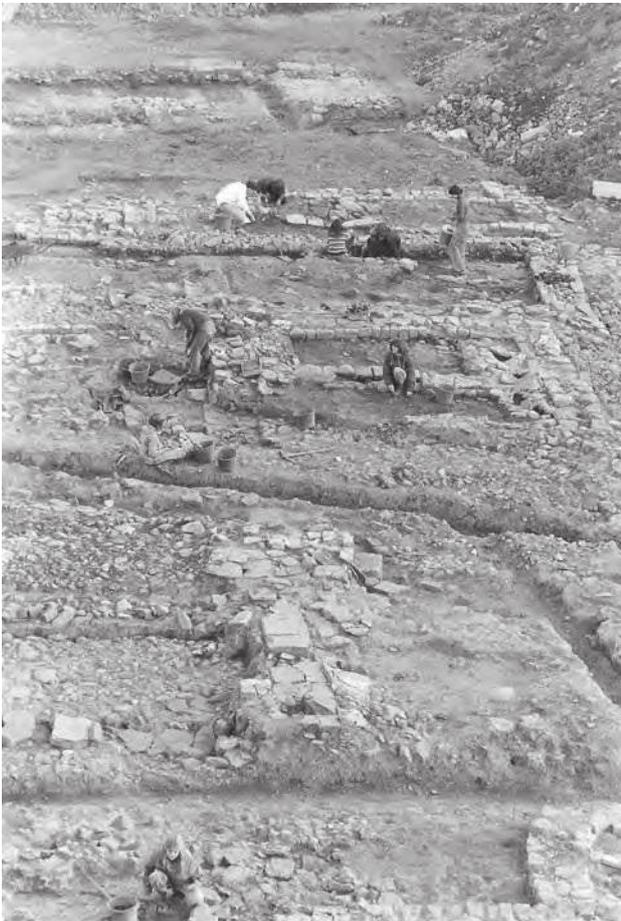
Figure 9.41: General view of the remains of Building BK south of the praetorium with cover slabs of primary (?) Drain N13:29 visible at a lower level to the left and Chalet rang 1 beg nd.

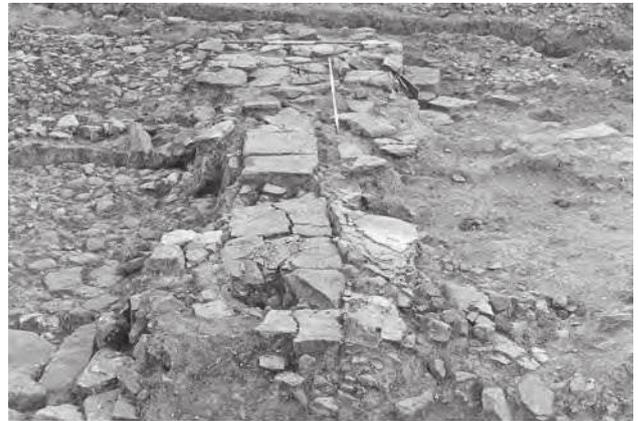
Figure 9.42: The remains of Building BK viewed from the north. The lower flags in the right background were associated with the second phase of AZ (AZ 2). Drain N13:29 cover slabs can be just seen in the left foreground.

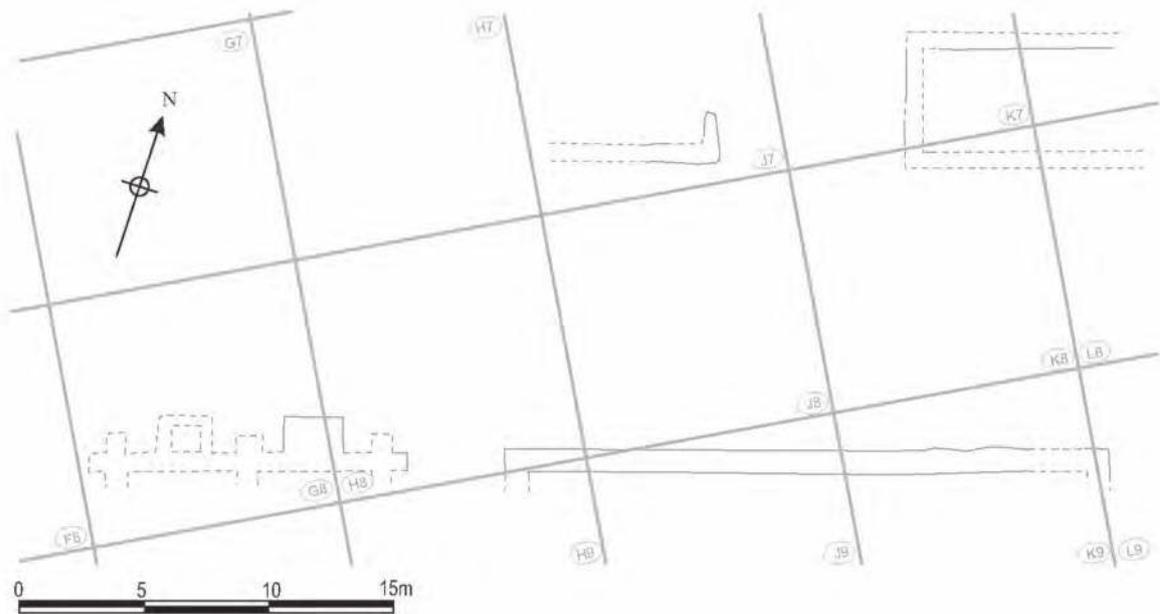
Figure 8.01 The central via principalis, Phase 1 including Building 5 Phase 1 (at 8.01).

A number of apparently early features were identified beneath layers of metalling and cobbled foundations of the *via principalis* (see Fig 8.01). These included areas of flagging (J08:12, J08:30), an L-shaped linear strip of clay (J08:15) and patches of bedding sand (J08:31). Flagging J08:30, which covered an area measuring 3.30m (N-S) by 2.80m (E-W), was probably equivalent to the smaller area of green sandstone slabs found in the same spot during 1997-8 (TWM 5255), much

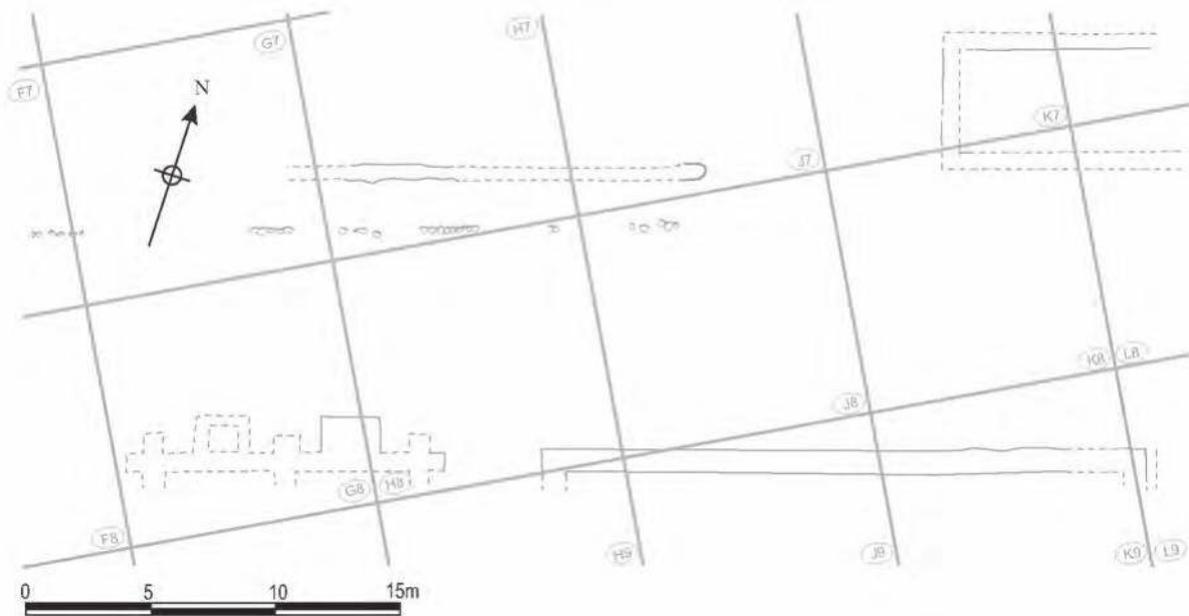
Figure 8.02 Via principalis Phase 2 showing Building 5 Phase 2 Scale 8.02.

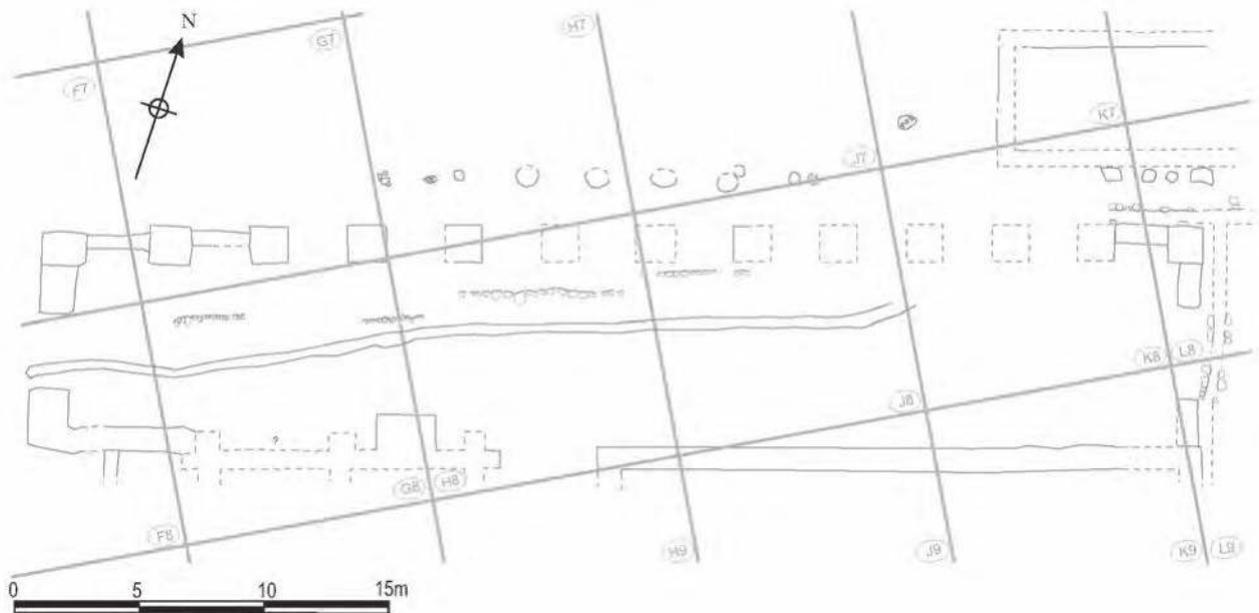
Figure 10.06 Via principalis, Phase 2 showing the forehall. Building 15 Phase 2 may be contemporary and the timber portico later. Scale 1:100.

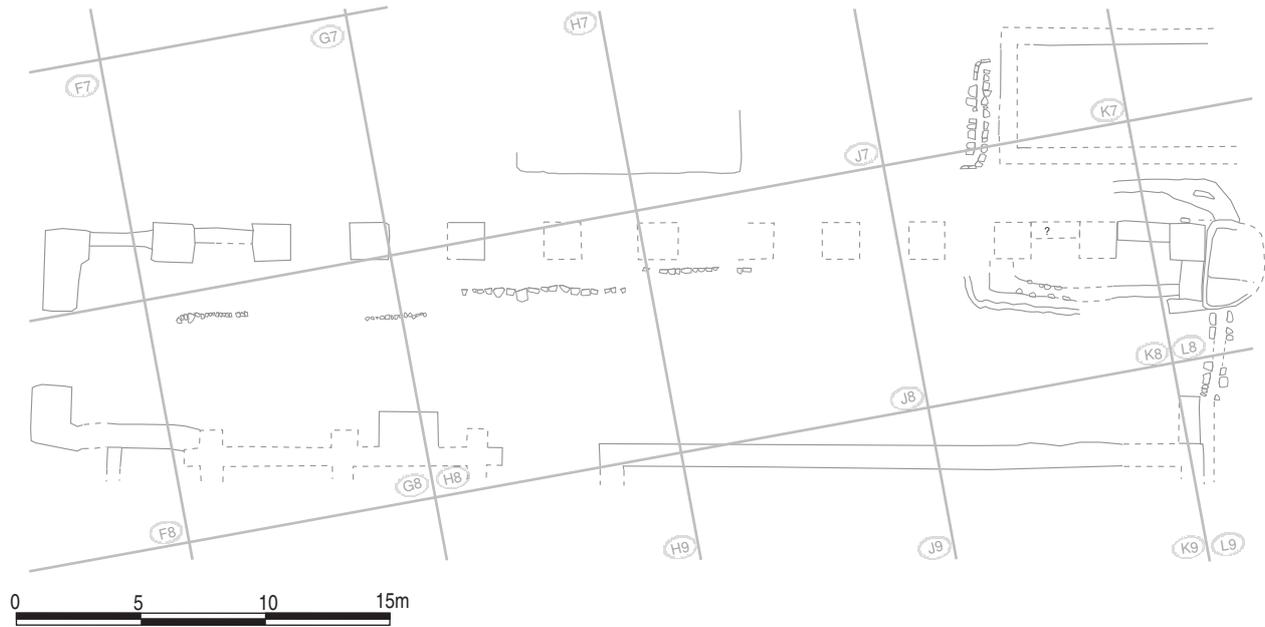
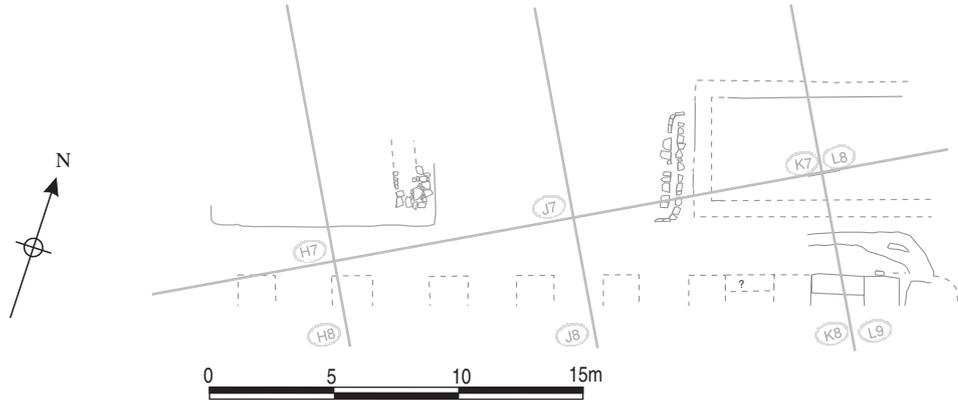
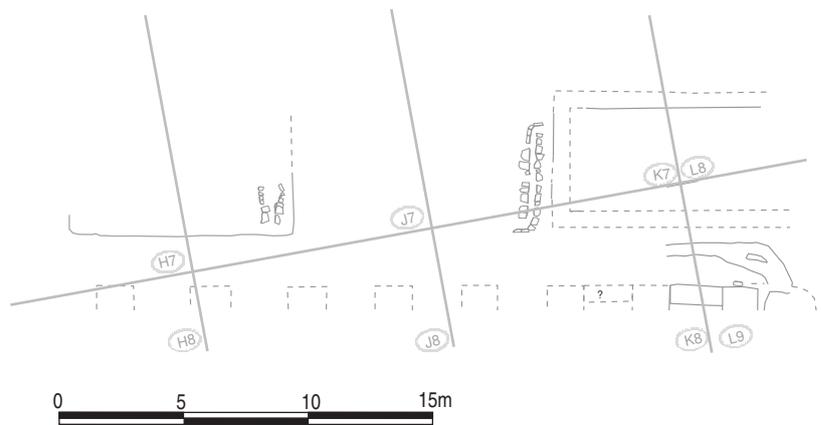
Figure 4 Forehall Phase 3 plans at 1:300

Forehall, adjoining roads and cisterns/pits, Phase 3 (at 1:300).

Phase 3 showing flagging laid over east end of infilled rectangular pit ('Cistern 2') (at 1:300).

Phase 3 revetment wall over subsided pit fill (at 1:300)

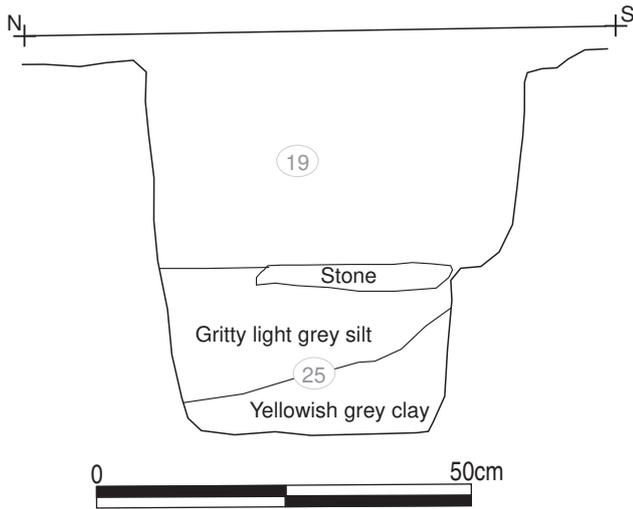
Figure 10.8 Section S4 through drain K08:12 and slot K08:12 at 10. (Context numbers relate to grid square L08.)

associated with a timber-built structure, was exposed in the bottom of a much later drain channel (K08:15, L08:19) just to the north of the Period 2 forehall's north-east corner. The form of this feature – steep-sided with a flat bottom – suggested it too represented a slot for a timber sleeper beam. It was 0.40–0.50m wide and 0.23m deep and contained a yellowish grey clay-silt overlain by a very gritty, light grey-orange silt, incorporating some coal (see Fig 10.05 – section drawing S64). The slot was traced for a distance of 2.55m, running on an east-west alignment, before appearing to turn and return southward. To the west it was cut by a nineteenth-century cellar, but the plan of the surviving remains suggested that the north-east corner of a timber building might have been exposed. It was cut by one of the post holes (L08:26) of the timber portico attached to the north face of the forehall (AO). Its walls follow the same orientations as the principal Roman stone buildings, but its position beneath the *via principalis* is difficult to correlate with the known fort plan so it may have been associated with the initial construction phase of the fort, and perhaps with Building BI, whatever the latter's function.

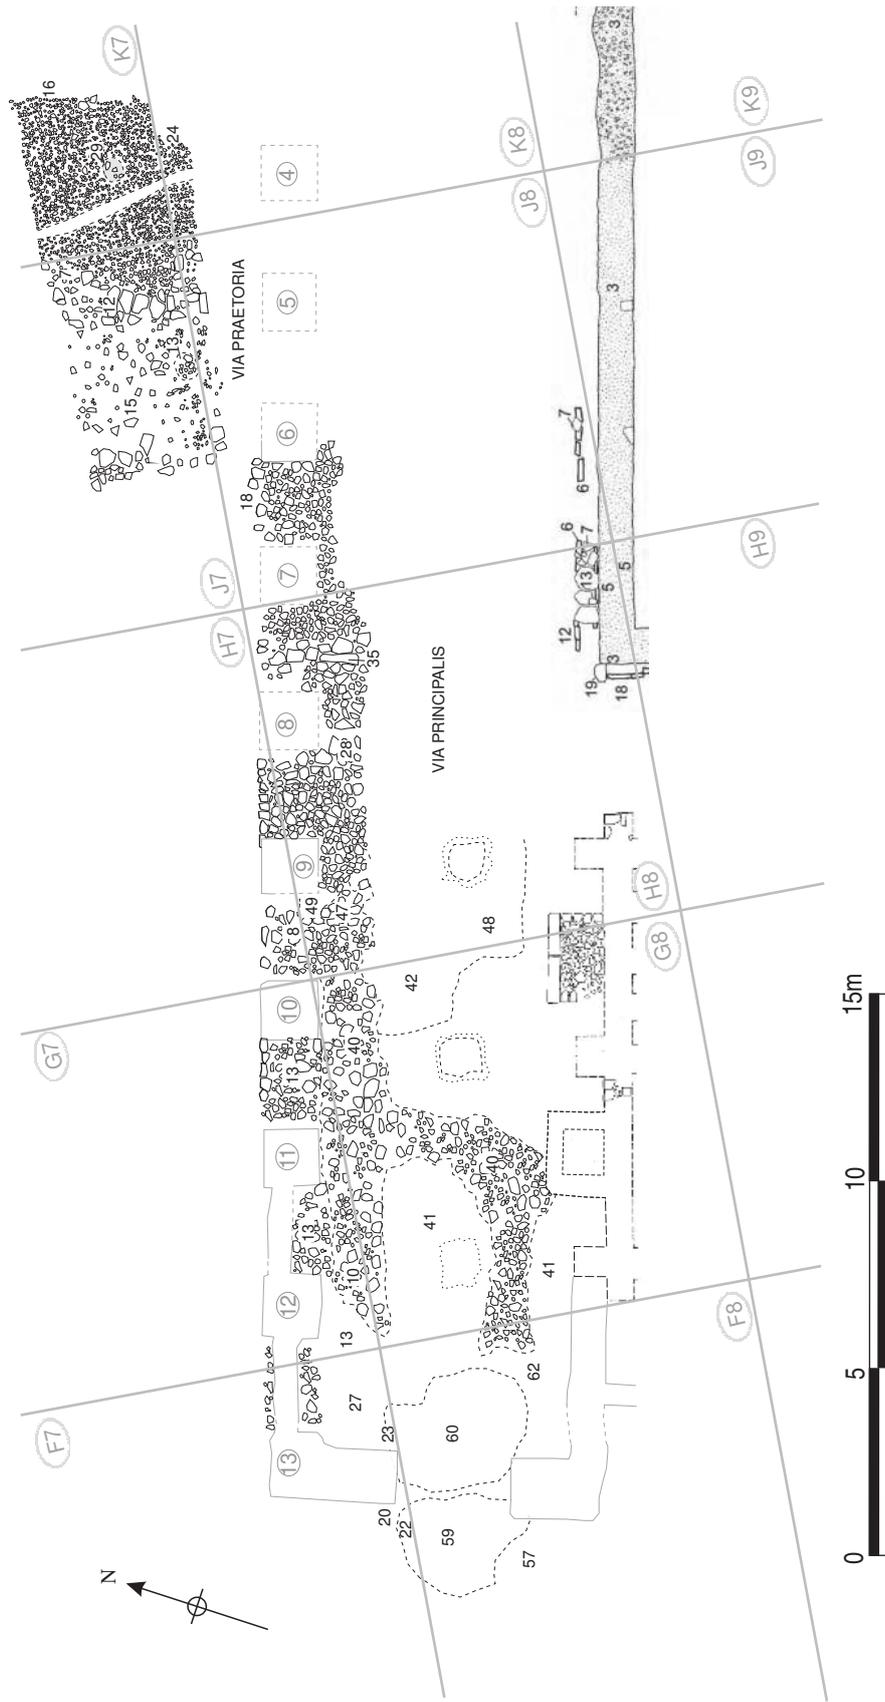
Figure 10.06: Via principalis foundations and via praetoria, Phase 1 (outline of later forehall shown for reference) at 1:200.

In the area to the west, extending towards the western entrance of the later forehall, a variety of road surfaces and foundation deposits and possible bedding layers were revealed in 1983. These included a road foundation level consisting of, from west to east, yellow gravel, smaller flags or tightly packed irregularly shaped stones in light brown to grey silt-loam (F07:20/F08:57/62/G08:41 = TWM 5219?), adjoining an expanse of large flags interspersed with large cobbles or boulders (G07:10/G08:40/H08:47, probably to be identified with the layer of angular blocks and slabs of white, green, yellow and brown sandstone uncovered in the same area in 1997–8 – TWM 5262, see Hodgson 2003, 176–7 – and perhaps also equivalent to the foundation layer of large cobbles present further north – F07:27, G07:13 etc.) and a layer of pale yellow gravel and mid-brown sandy gravel soil (G08:42/H08:48).<sup>1</sup> In the area of the later forehall entrance this foundation level was overlain by two patches of a surface composed of gravel, pebbles and angular stones (F07:22/F08:59, F07:23/F08:60). Overlying the gravel/pebble layer and extending eastwards over the foundation level was a surface made up of well-worn medium-sized cobbles, interspersed with flags, set in a silty soil matrix which varied from yellow to dark brown in colour (F08:55/G08:36, G08:37/H08:43). Further east, over G08:42/H08:48, a bedding (?) layer of brown/yellow sandy soil (H08:45) was overlain by a road surface or foundation level (H08:41, H08:42) composed of well-worn, medium-sized stones and flags, set in dark brown soil, which *might* equate to the 1980–81 Phase 1 metalling H08:30. All of these levels probably belong to the first period of the fort's occupation, although relating the road levels found in the 1983 excavation season to those previously identified further to the east in 1980–81 is problematic. Thus H08:41 and H08:42 might alternatively form part of the Phase 2 road metalling H08:23 (1981) and H08:34 (1983), in which case H08:45 could represent makeup or bedding for that phase of the road.

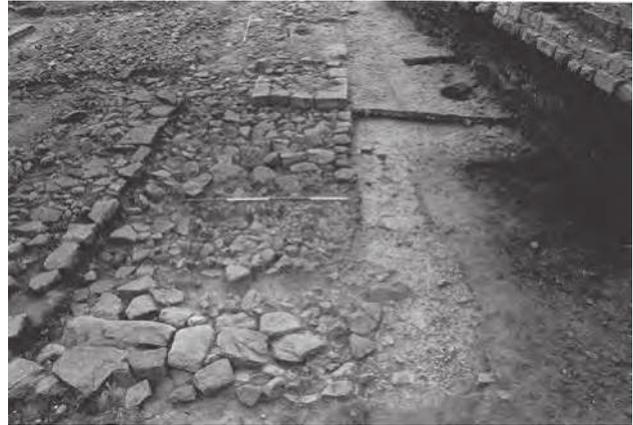
Figure 11 Phase 1 road foundation along the north edge of the *via principalis* with north-south kerb H08 in the foreground and phase 2 kerb H08:22 on the left. Looking west (2).
