# SEGEDUNUM

Excavations by Charles Daniels in the Roman Fort  
at Wallsend (1975–1984)

VOLUME 1: The Structural Remains

Alan Rushworth and Alexandra Croom

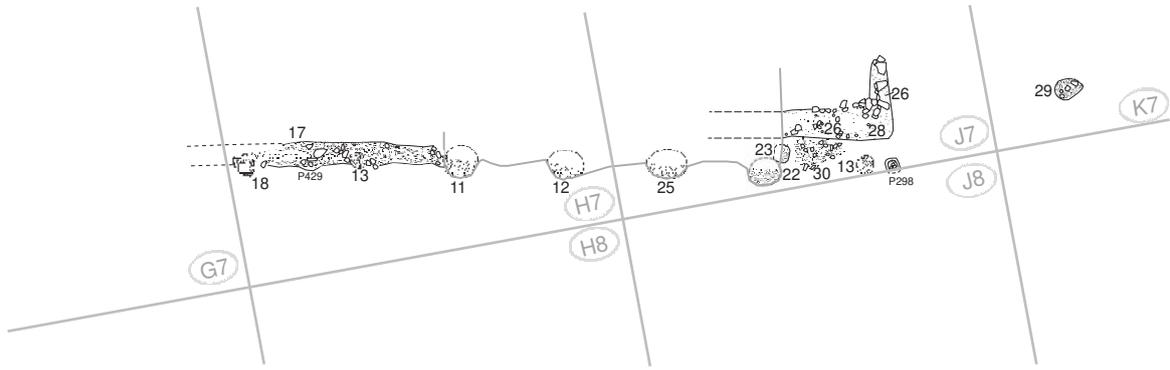
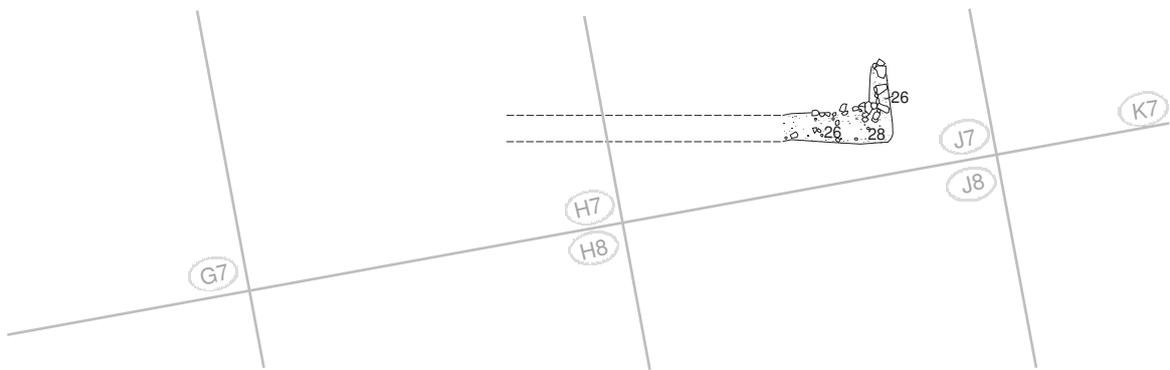
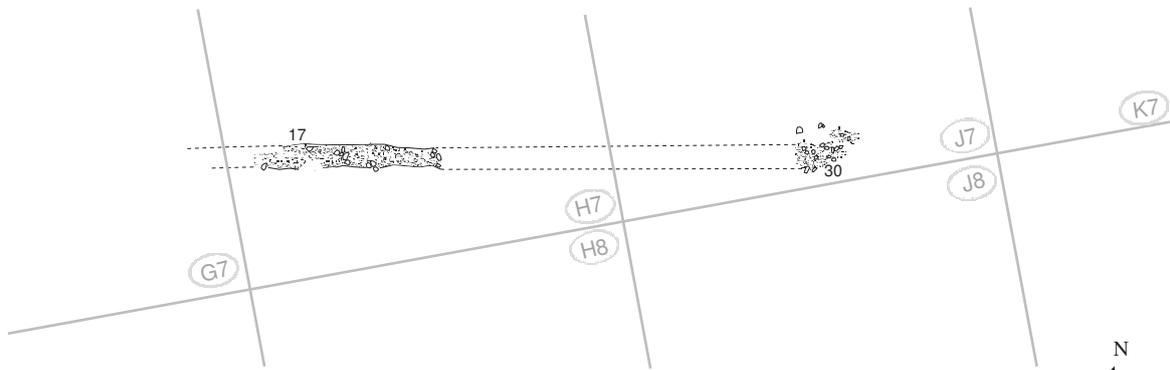
1. All features with forehall portico (AY) postholes and pit C2 shown for reference

2. Building 15, Phase 1

3. Building 15, Phase 2

On the other side of rectangular pit H07:10/J07:18, a 5m stretch of the south wall foundations was exposed in 1984. This, however, lay c. 0.70m south of the projected line of the south wall trench exposed further east and consisted of a 0.45–0.65m wide strip of rubble in yellow gravel (H07:17), which cut the pre-fort plough soil of grey clay silt (H07:19, G07:15). This foundation deposit continued westward beneath Buddle Street, whilst to the east it was cut away by the pit. No definite trace of these foundations was found on the same alignment east of the pit (but see below). A light gravel spread (G07:14) overlying the

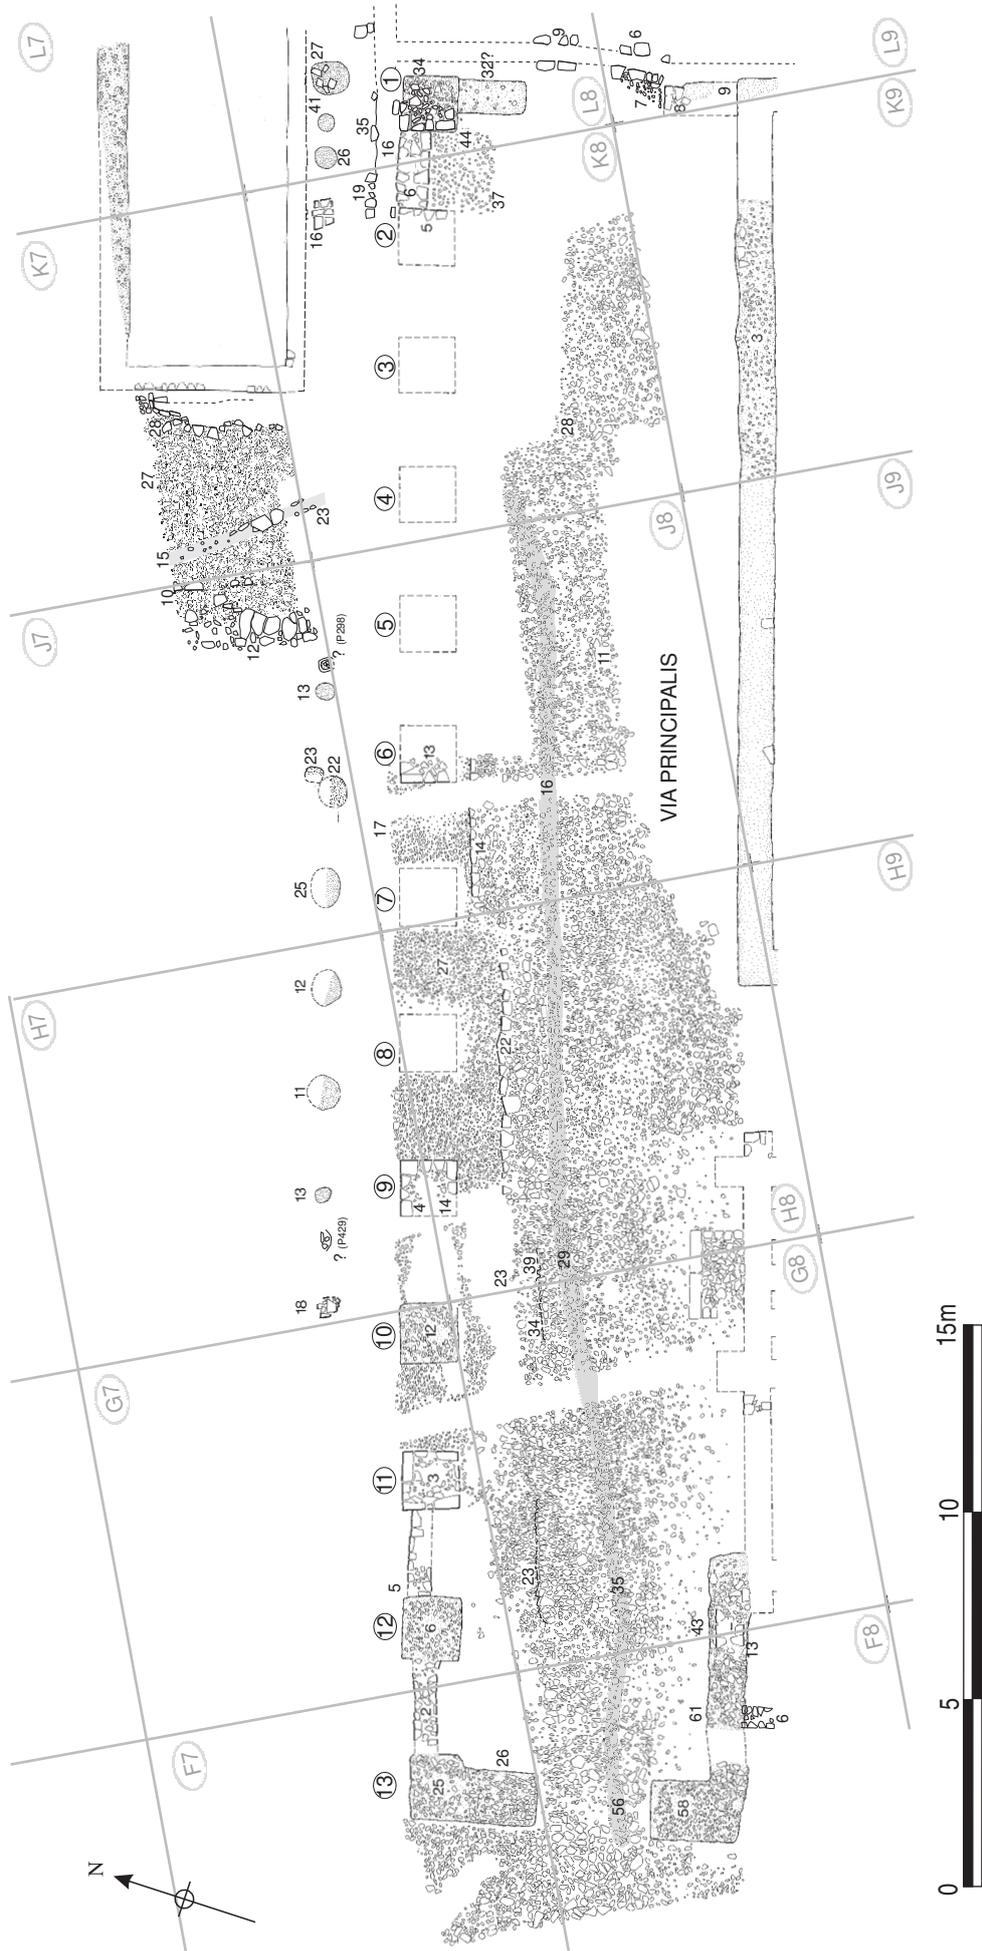
Figure 10.10: Building AO and portico AY, at 1:200.

east to west and 9m wide, north-south, was erected over the *via principalis* in Fort Phase 2 (Figs 10.11, 10.12). This structure, which was labelled Building AO by Daniels, extended along the full frontage of the *principia* and granary and indeed projected more than 6m further west beyond that. On the other side, however, it did not stretch beyond the *principia*, over the eastern third of the *via principalis*. The building was reinvestigated by TWM in 1997–8 (see Hodgson 2003, 171–82, esp. 176–182). The architectural form of the building was extensively treated in the report on the 1997–8 work (*ibid.*, 180–82) and, accordingly, will only be reviewed briefly here. This report will focus instead on the relationship of the forehall to the underlying and adjoining road levels of the *via principalis* which supplied the evidence for the dating of the structure. Most of these levels were removed in the course of the Daniels excavation and the chronology proposed in the 1997–8 excavation report could therefore only be a provisional one.

A well-set cobbled road surface (K07:27), some 25–50mm thick, was laid over the earlier layers of metalling on the *via praetoria* (see Fig. 10.10 above). It appeared to be composed of small to medium-sized cobbles, none larger than 150mm in diameter, to judge from site plan P241. The carriageway was 4.30–4.70m wide (the width increasing towards the north) and was bounded by kerbs on either side. The west kerb (J07:10) was the better preserved of the two, although it survived only partially and was composed of roughly worked slabs 0.20–0.50m in length. The east kerb (K07:28) was more disturbed, perhaps by the construction of drain K07:19, the kerbstones being inset irregularly on the west of the drain side wall. A surface of rough cobbles (described as ‘almost rubble’) extended westward from kerb J07:10 as far as flagged drain J07:12 marking the edge of the earlier road carriageway. This may represent a widening of the road, infilling this strip to bring it up to the level of the main road carriageway.

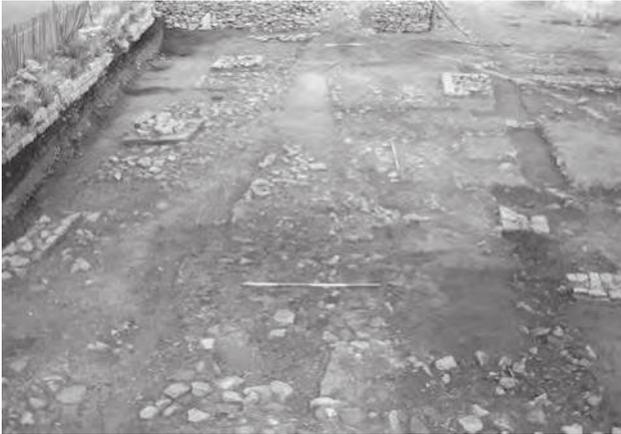
Figure 10.1 The remains of the western half of the forehall, including Piers 9 and 11, infill wall F07:02, south wall F08:13 and adjoining robber trenches looking east in 2003.

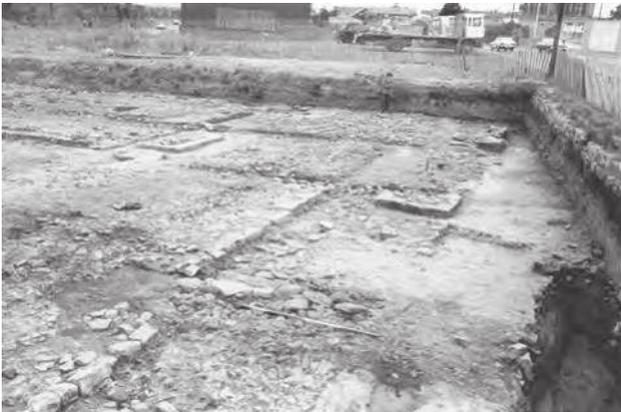
Figure 10.2 The west end of the forehall with Phase 2 via principalis kerbs J08:04 and H08:04 looking west in 2003.

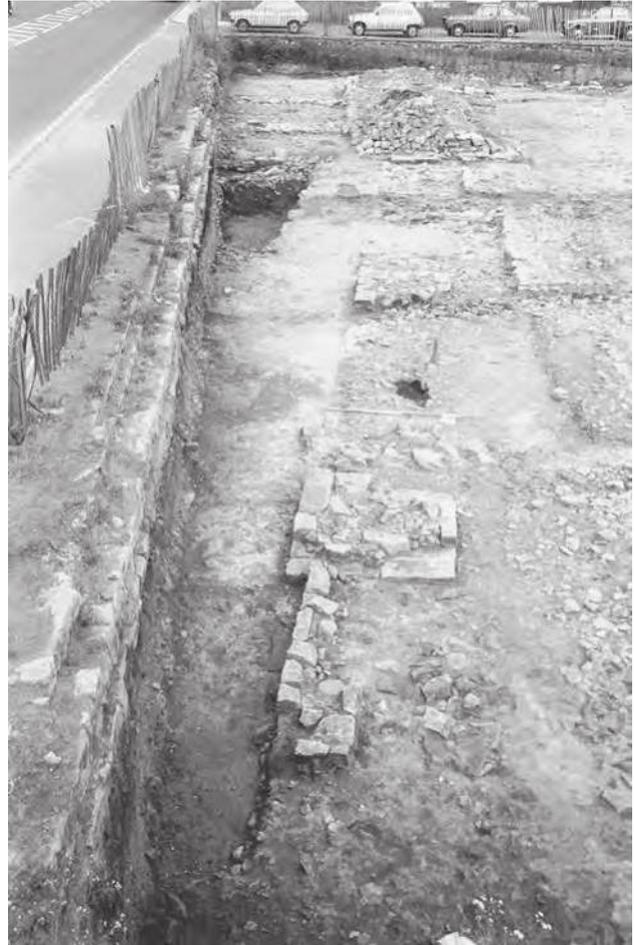
Figure 10.13: Piers 11 and 9 and infill wall G07:05 with the site of pier 11 in the foreground looking east in 2003.

square pier bases, all measuring around 1.5m square and set on the northern edge of the Phase 1 roadway, the north face of each pier base was virtually in line with the kerb of the underlying rubble road foundation. These presumably supported a series of 12 arches, which were not, however, all identical in their span, to judge from the distances between the surviving piers. Most of those which could be measured were 2.30m wide, but the span of the westernmost was greater at c. 2.45m wide, whilst the easternmost spanned as little as 2.10m. Furthermore, the arched apertures in the eastern half of the forehall, in the area destroyed by a nineteenth-century cellar, may have been even narrower, at under 2.00m, although it is possible that the arrangements were a little different here, as the *via praetoria* led up towards the entrance to the *principia*. In the case of five of the pier bases (L08:15, K08:05, J08:13, H07:04/H08:14, G07:03, representing the first, second, sixth, ninth and eleventh examples from east to west respectively), a single course of masonry survived at least partially (two courses in the case of Pier 11 – G07:03 – see Figs 10.13–10.14). Three other examples had been robbed out leaving only foundation deposits (G07:12, G07:06,

The two most westerly archways and the easternmost one were blocked up by panel walls, which abutted the piers on either side (Figs. 10.11, 10.13–10.14, 10.16). These infilling walls (F07:02, G07:05/11, K08:05/L08:15) were faced using roughly-dressed sandstone rubble blocks, enclosing cores composed of angular sandstone rubble, and were mortar-bonded, in contrast to the clay bonding employed in the piers themselves. Only a single course of masonry survived in the case, of the two westerly walls F07:02, G07:05), which were only 0.55–0.60m wide. However, re-examination of the wall infilling the easternmost archway (K08:06, L08:16), in 1983, revealed that three courses survived here and, at 0.80–0.95m, this wall was also significantly wider than those further west. The stonework of wall K08:06/L08:16 was seen to be less neatly squared than that of the adjoining piers and towards its west end actually jutted slightly beyond the north face of Pier 2. The eastern end of the wall butted up flush against pier L08:15, but did not butt quite so neatly up against pier K08:05, suggesting the wall had been constructed from east to west.

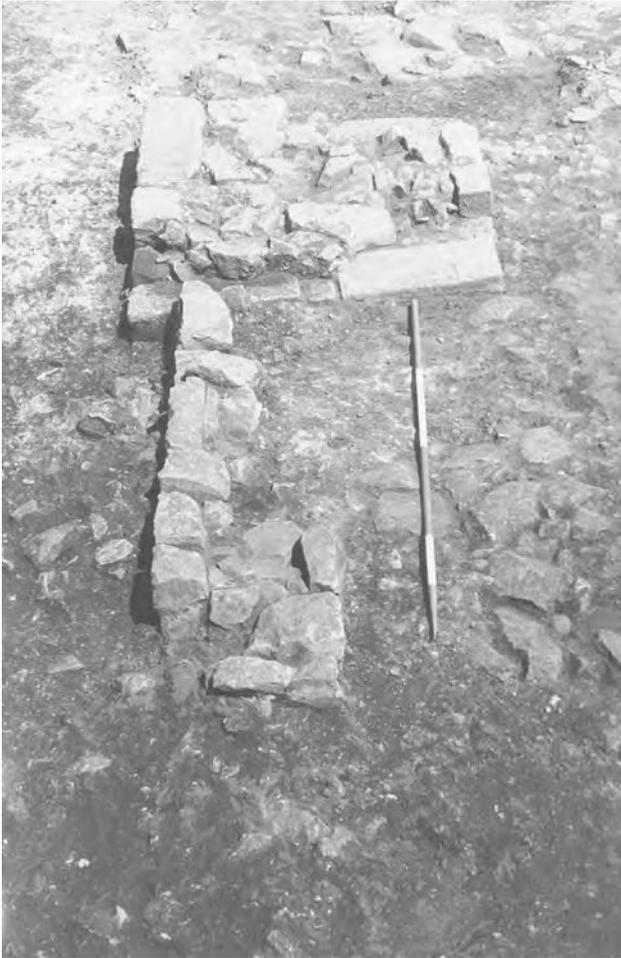
Figure 10.14: Pier 11 (G07:03) and adjoining infill wall (G07:03) from the west (N 10°).

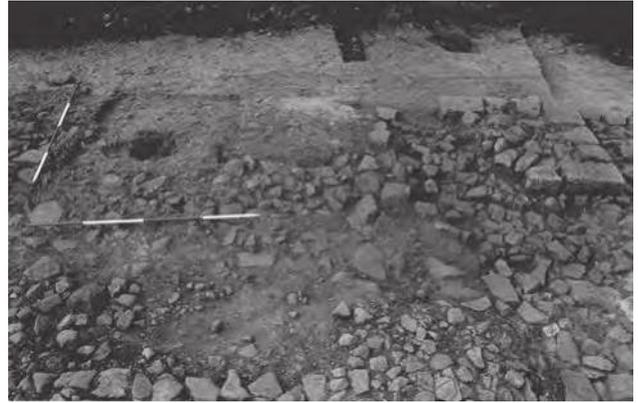
Figure 10.15: Piers 10 (site of) and 9 with road kerbs G07:03 and H08:17 in the foreground, from the south (N 10°).

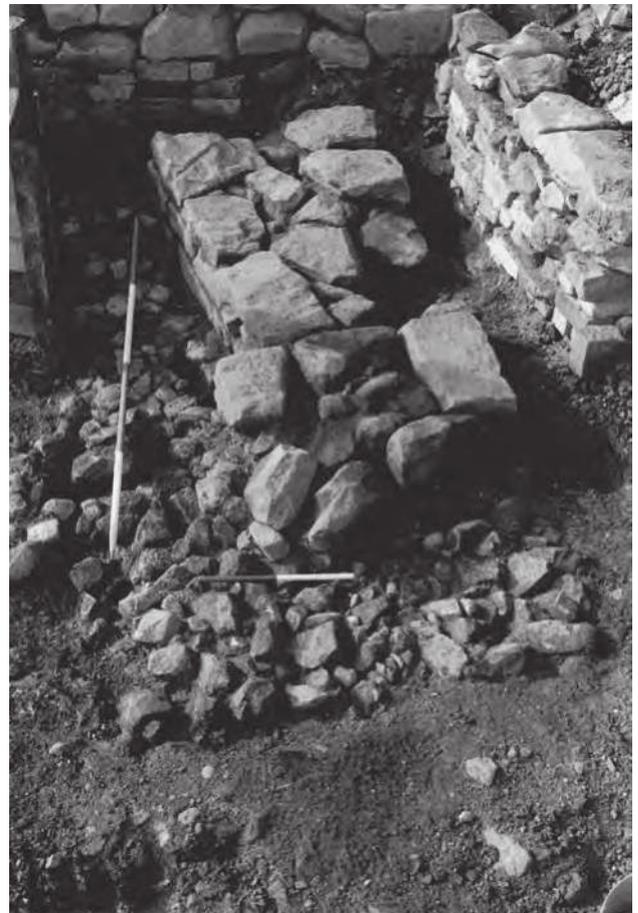
Figure 10.16: View of Pier 1 and infill wall from the east showing wing pier foundations and underlying cobble surface.

The piers were set on foundations of densely packed rubble. Those of the easternmost pier base (1) were the most thoroughly investigated (L08:34) and seen to be composed of orange-yellow clay on sandstone rubble in a 1.45m square pit, with chippings laid over the top as bedding for the masonry of the pier itself (Fig. 10.16). The pit cut right down into the clay subsoil. Other examples (e.g. pier base 2 – K08:43; 12 – G07:06; 13 – F07:25) were described in less detail, but were clearly similar in construction: rubble in a yellow-clay matrix (K08:43), sandstone fragments closely packed in medium-brown silty soil (G07:06). The foundations of base 2 (K08:43) were observed to cut the Phase 1 road cobbling (K08:42/L08:39). Similarly, Piers 6 (J08:13), 9 (H07:04/H08:14), 11 (G07:03) and 13 (F07:25), are all explicitly recorded as overlying or cutting the rubble road foundation levels along the northern edge of the primary *via principalis* carriageway (J08:18, H07:08, H08:28, G07:13, F07:27). However the relationship between the piers and the Phase 1 metalling (e.g. J08:17, H08:27) overlying the road's rubble foundations is not documented on any of the context sheets.

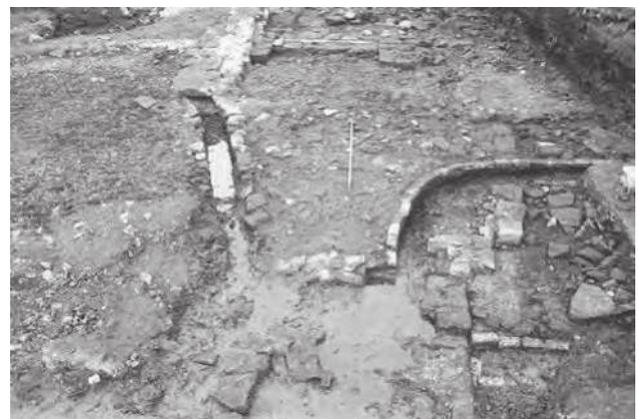
Fig. 10.17 The east end of the forehall looking north in 1980, with Piers 1 and 2 and infill wall in the background and wall L0 on the south side of the entrance. Drain L0 crosses the road carriageway on the right.

On the south side of entrance, masonry belonging to the north-east corner of an equivalent wall (L09:08) did survive. It was constructed of roughly dressed facing stones with a rubble core and, like the piers, was clay-bonded. The wall was 1.90m in length, from north to south, and was set on foundations composed of pink or red clay and sandstone rubble (L09:09), which reportedly cut the Phase 2 cobbled surface (L09:07, L08:12, K08:13) on either side of the entrance. Its full width did not survive, but could be estimated at c. 0.80m by comparison with foundation remains L08:32 on the north side of the entrance. The east portal of the forehall, thus defined, was c. 3.70m wide.

A stone-lined drain or gutter (L08:09, L09:06) ran along the east side of this wall and cut across the carriageway of the *via principalis*, in front of the

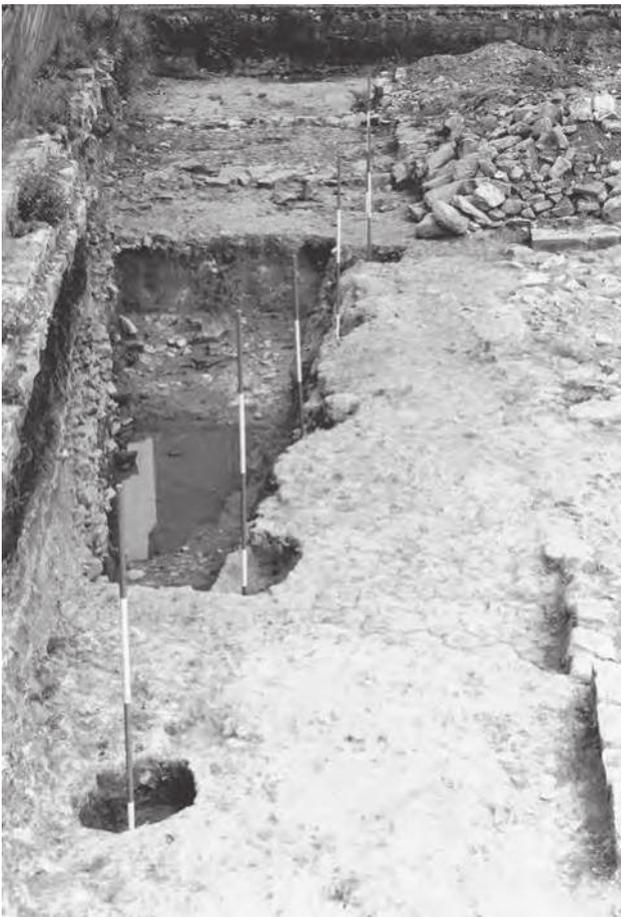
Figure 10.16 Postholes of the forehall portico cut by rectangular pit C2 (shown completely emptied) from the west (9.8).

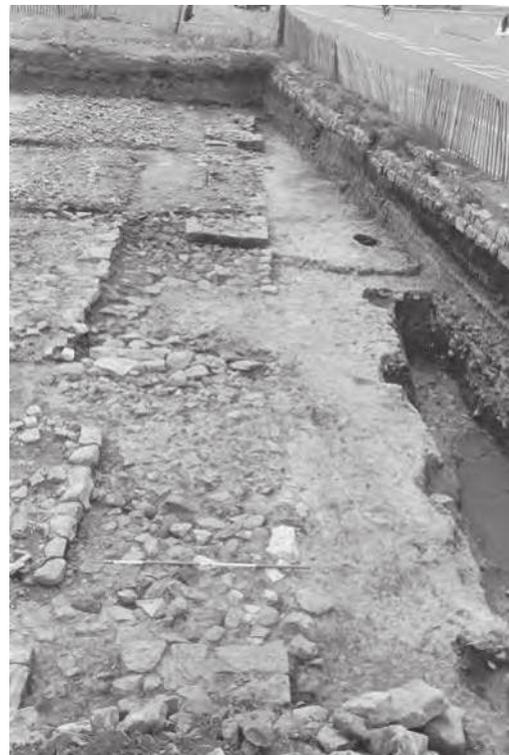
Figure 10.17 The north edge of the *via principalis* showing Phase 1 road foundations, Phase 2 kerbs J08:02 and H08:02 forehall piers 9 and 11 and portico postholes cut by rectangular pit C2 (9.8).

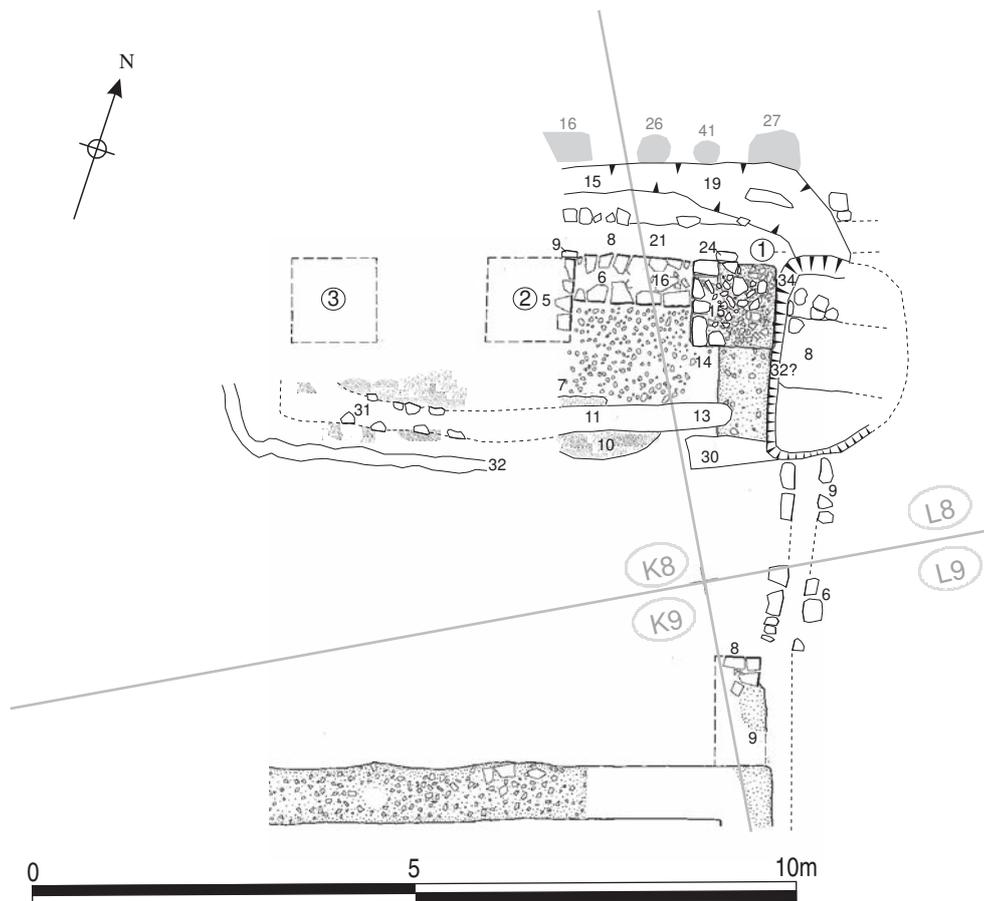
Fig re 10 North East corner of Building AO showing later features, (at 10)

**The forehall (Fig. 10.20)**

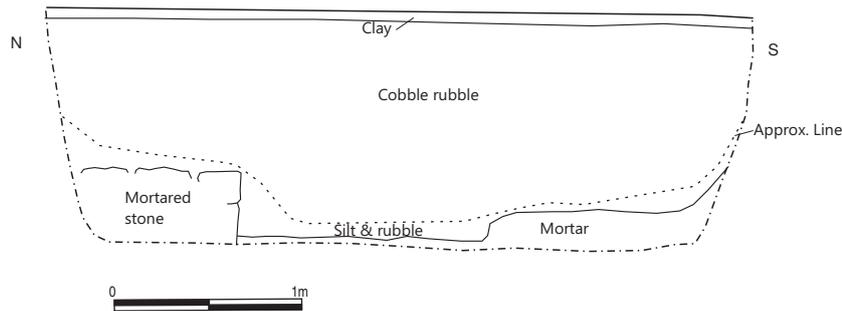
Figure 10.21: Reconstructed profile (S63) through Cistern 3 (L08:08). Scale 1:40.

Immediately to the east of the forehall, a large pit (L08:08) was dug. This was interpreted as another water tank, labelled Cistern 3. The top of the pit

measured some 3.76m along its west side (c. 3.20m at its base), next to the forehall, where it was widest, but only around 2.00m on its east side, being somewhat irregular in plan, whilst its breadth from east to west was 2.60m and its maximum depth was 1.25m. The sides were steep but not quite vertical. The north side was furnished with a step or ledge, c. 0.80m wide, 0.40m high and 0.85m below the top of the pit. The ledge was constructed of yellow, coarse-grained sandstone blocks bonded with an off-white gritty mortar. A similar stone ledge had probably existed along the south side, but had been robbed out leaving only a 0.20m high and up to 1.25m wide raised area of mortar which also extended a further 0.25m up the side of the pit. In the central section, between the two 'ledges', the base of the tank was covered by a shallow (0.03–0.04m high) deposit of mortar, similar in composition to the residue of the southern ledge. Later on, the pit had been backfilled with loose, medium sized rubble, containing many air pockets but no soil matrix, overlain by areas of mortary lumps and all sealed beneath a 0.06m thick capping of orange-yellow and grey clay. A shallow layer of light-medium grey silt and rubble was present at the bottom of the tank, also overlying the ledges and extending about halfway up its sides.

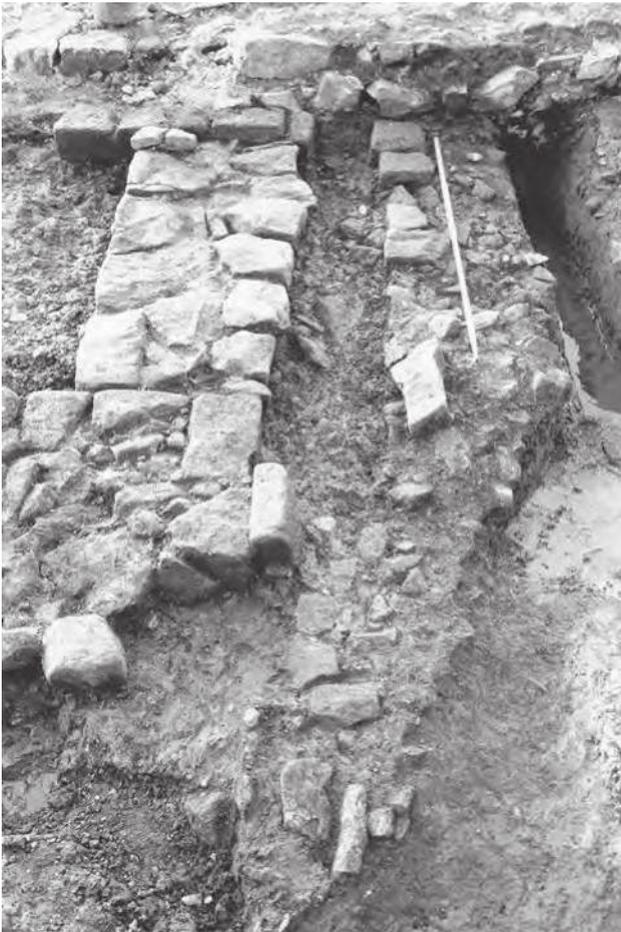
Figure 10.22: Piers 1 and 2 and infill wall K08:06/L08:16, gutter K08:19/L08:35 and later drain K08:15/L08:19 over deep r early slot K08:15/L08:19 on the right, looking west (A).

#### Drain channels (Figs 10.22, 10.23)

The course of the earlier drain L08:09/L09:06, which cut across the *via principalis* carriageway, was interrupted by the cistern and presumably now flowed into the south side of the tank. To the north, a new drain channel may have been cut along the north side of the forehall at this stage, positioned c. 1.25m beyond the north face of the piers and infill wall, and appearing to curve round the north-east corner of the building to flow into the cistern (see Fig. 10.20 above). The channel was steep-sided, with a flat bottom and was 0.5m wide. To the north of Pier 1 it appeared to split into two channels briefly (two sub-phases?), before merging again and running up to the cut for Cistern 3, where the combined channel was c. 0.95m wide. It was filled by dark grey, loose, crumbly loam flecked with charcoal (K08:15, L08:19). No trace of any stone lining or drain supports was found, but a number of stone slabs along its course were tipped in such a way as to suggest they originally formed capstones which had later broken and partially collapsed into the silt in the channel. Presumably the channel was lined with wooden planks. How far westward this drain continued beyond Pier 2 is unclear, but it may have connected with a north-south drain on the *via praetoria* (e.g. K07:15) and/or perhaps the channel which ran

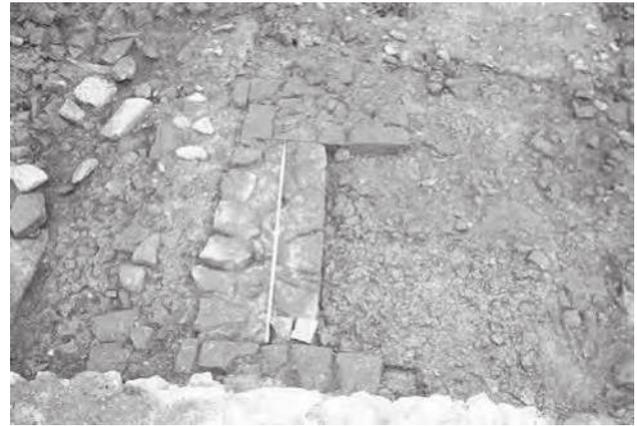
Figure 10.22: The north east corner of the forehall wing gutter K08:19/L08:35 packed with clay (K08:08/L08:21) in front (left) of Piers 1 and 2 and infill wall K08:06/L08:16, looking east (B).

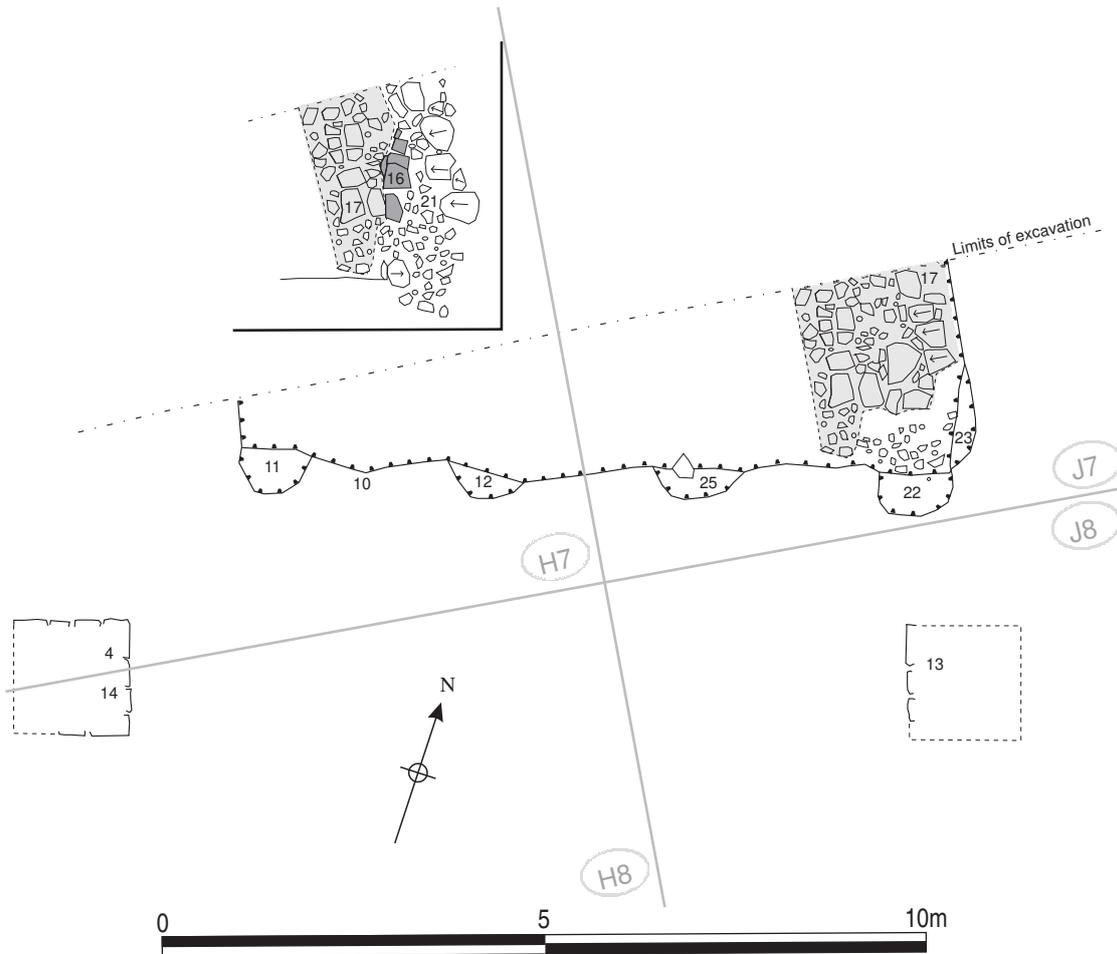
Figure 10.24: The rectangular pit (Cistern 2) north of forehall AO (at 1:100) with stone level (surface?) J07:17 over the fill also shown. The inset shows stonework of a possible side wall (J07:17).

A large rectangular pit (H07:10, J07:18) was dug through the mixed layer of sand, silty soil and sandstone chips (G07:07/H07:15) covering the demolished remains of Building 15. It was positioned along the northern edge of the timber portico (AY) fronting the forehall, but chopped away substantial portions of several post holes (H07:11, 12, J07:22, 23, 25) belonging to the timber structure, suggesting the portico had probably been dismantled by this stage (Fig. 10.24).

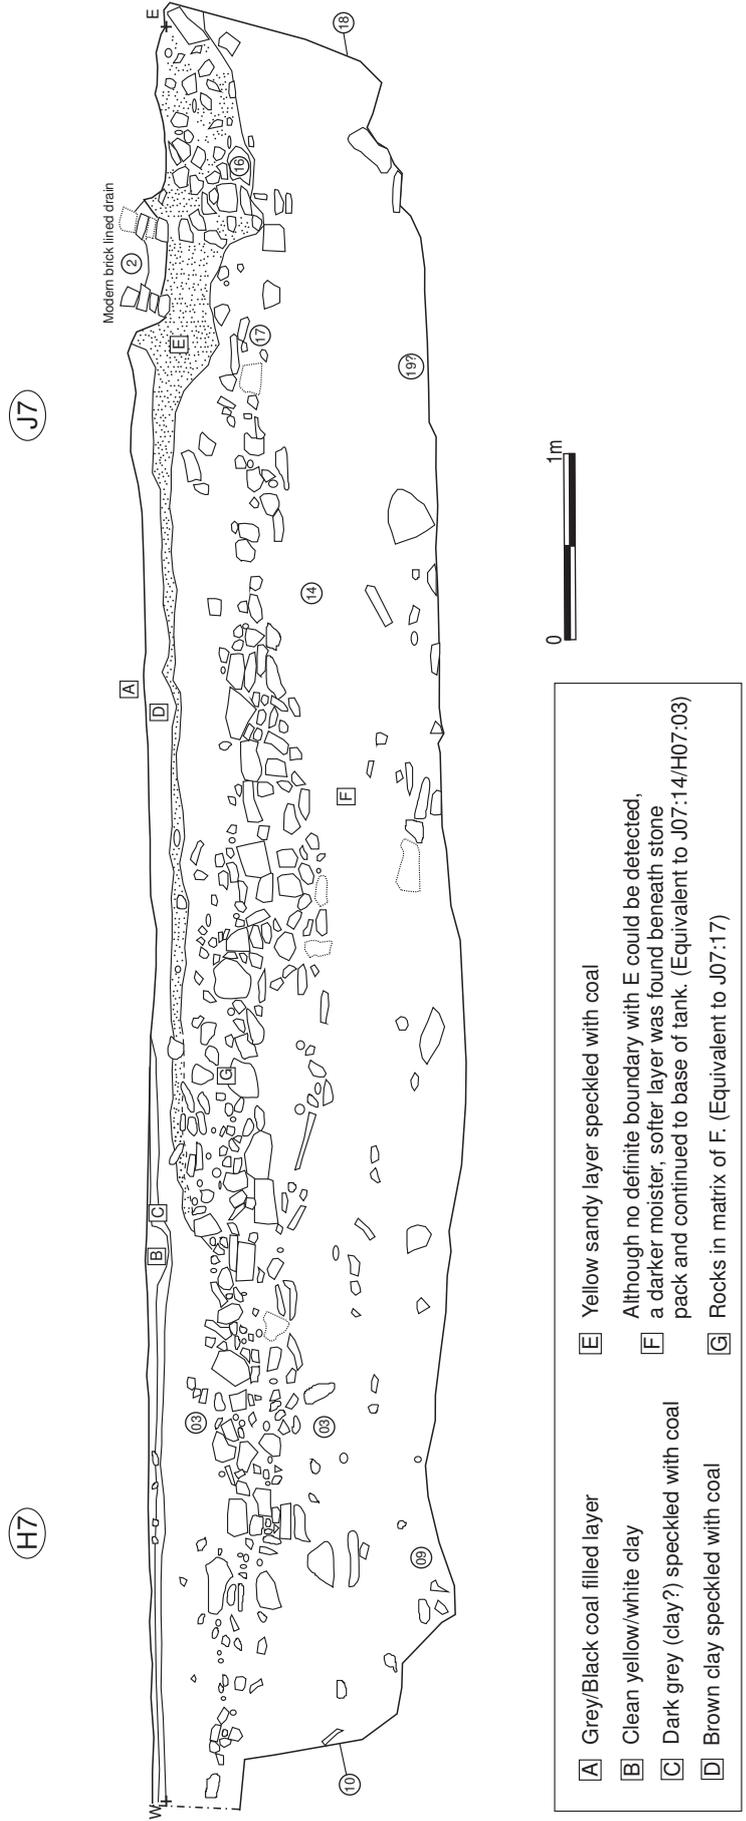
Figure 10.25: South facing section (S65) through Cistern 2 (H07:10/J07:18) along south side of Buddle Street. Scale 1:40. (Context numbers and equivalences were not shown on the original drawing and have been restored on the basis of the information on the context sheets.)

The pit measured c. 9.0m in length (east–west). Its full width from north to south could not be determined as it continued beneath Buddle Street, but it must have been at least 2.70m (on the overall plans of the fort in Phases 2–4, Daniels estimated its full width was at perhaps c. 7.0m). The pit was steep-sided with a fairly flat-bottom and was c. 1.0m deep, as can be seen in the section drawing (S65 – see Fig 10.25).

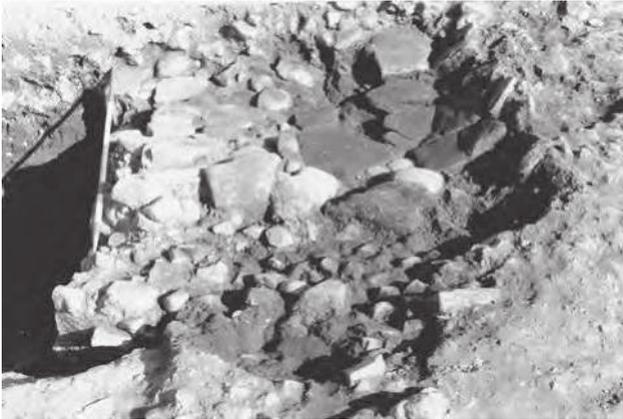
Figure 10.26 Flagging J07:17 laid over the east end of the rectangular pit C2 from the south (1981).

A 0.10–0.15m thick level of large, medium and small stones, mainly comprising rounded cobbles, but including some flags and dressed facing stones (J07:17), was laid over the silt and intermixed with it c.0.90–1.00m above the bottom of the pit (Fig. 10.26). This stone layer can be seen clearly in section, being the equivalent to two 'courses' deep. It may have been designed to form a rough surface over the back-filled pit similar to the rubble deposits laid over adjacent areas. It was covered by further dark silt which was essentially indistinguishable from that which lay beneath and formed a matrix for the stones, and was treated as the same context. Some 1.8m from the eastern lip of the pit this stone layer took on a much more definite character, being composed of larger slabs which formed a deliberately laid surface with a distinct edge or kerb along its west side (see Figs 10.24 & 10.25). When originally laid, this surface was probably flush with the ground surface surrounding the pit and may have been associated with a widening of the carriageway at southern end of the *via praetoria*, however it had evidently subsided subsequently, doubtless as a result of the gradual settling of the underlying silt. This is demonstrated by the way the slabs along the eastern edge tipped downwards from the lip of the pit to the level of the main flagging and presumably accounts for the way silt continued to accumulate over the stone layer. A single-faced wall (J07:16), which was positioned some 0.80–1.20m from the edge of the pit and survived up to three courses high, was set on top of the stone slabs,

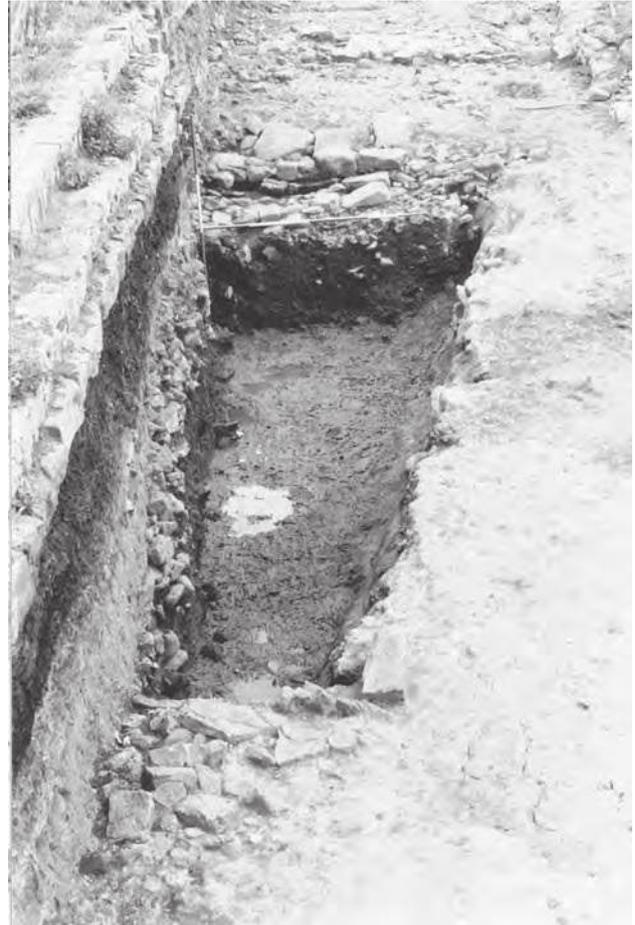
Figure 10.27: Rectangular pit C2 looking east (1981). Note the later revetment J07:17 (for the *via principalis carriageway*) overlying flagged surface J07:17 and the dark silty sill of the cistern.

presumably to counteract the subsidence, and was probably designed to retain the west side of the road carriageway (Figs 10.27–10.28). The space between the revetment wall and the edge of the pit was filled with rubble consisting of medium-sized stones in a matrix of medium brown clayey soil.

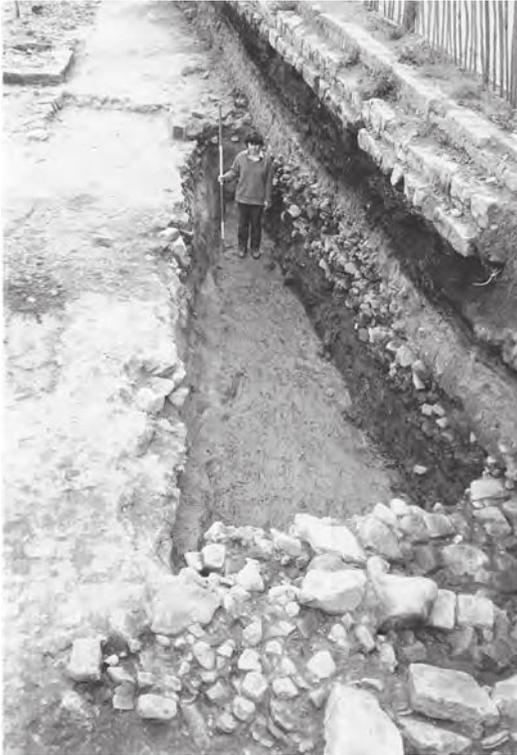
Figure 8 Rectangular pit C2 from the east (Fig 8) with revetment wall J07:16 overlying flags J07:17 in the foreground.

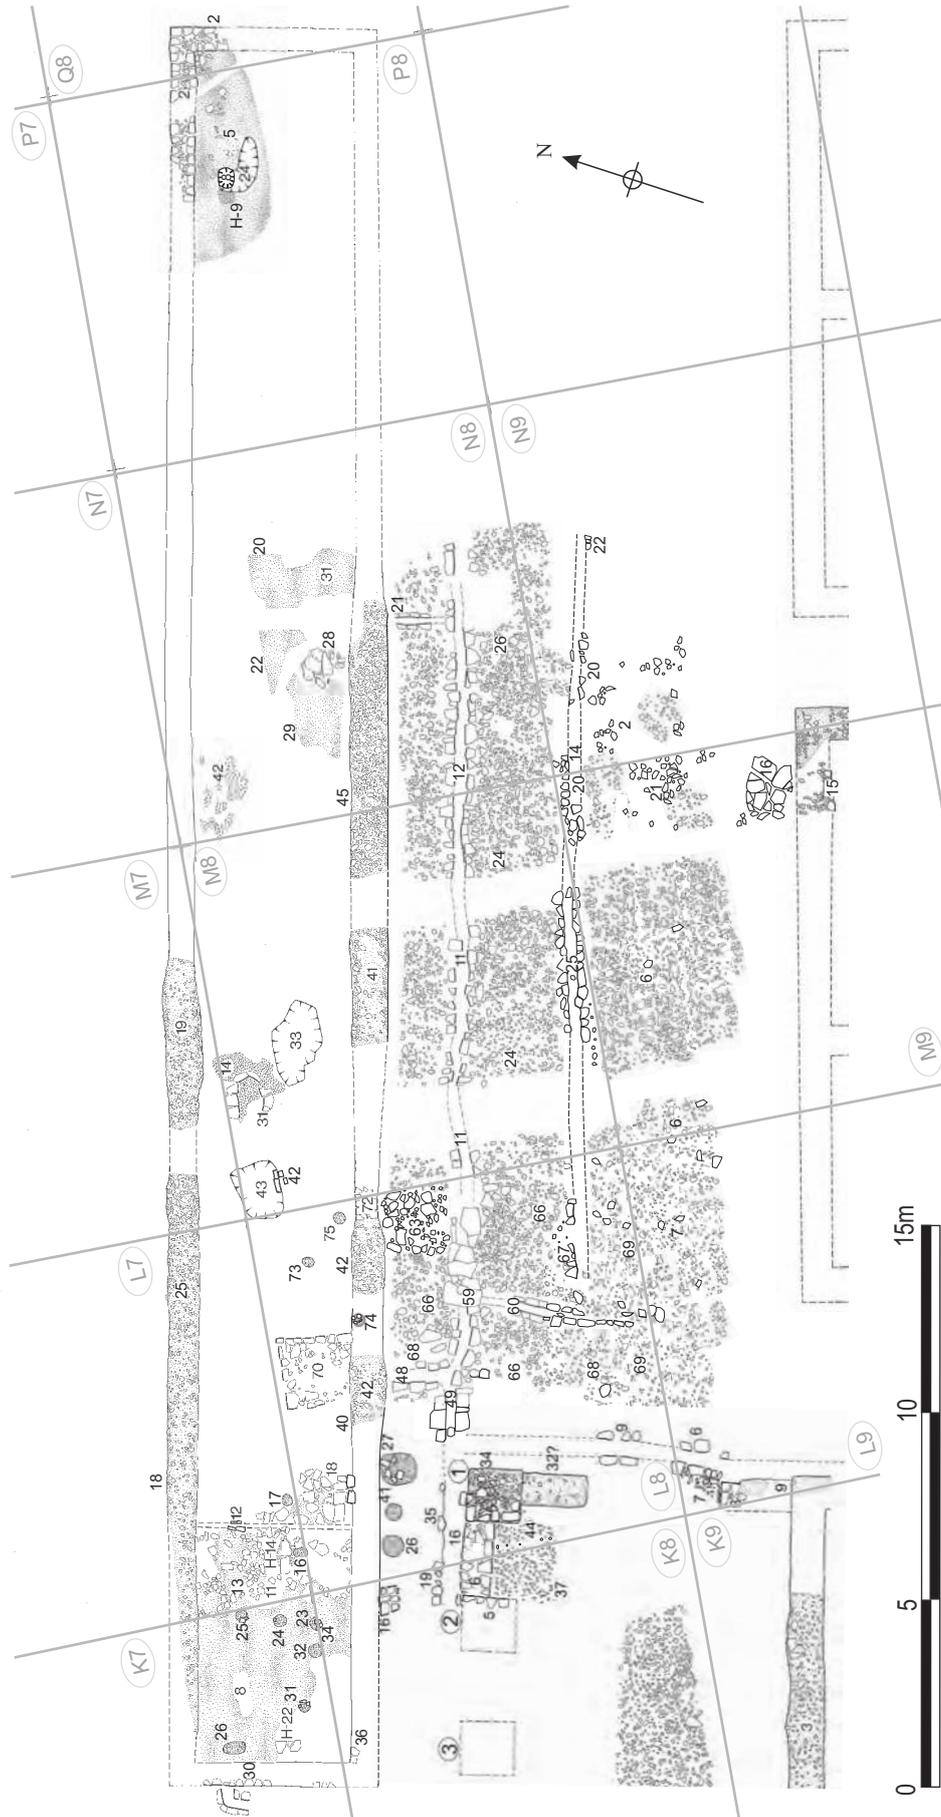
Figure 11.01: Building 16, Phase 1 and 2 features at 1:200.

## Building 16 Phases 1 and 2 (Fig. 11.01)

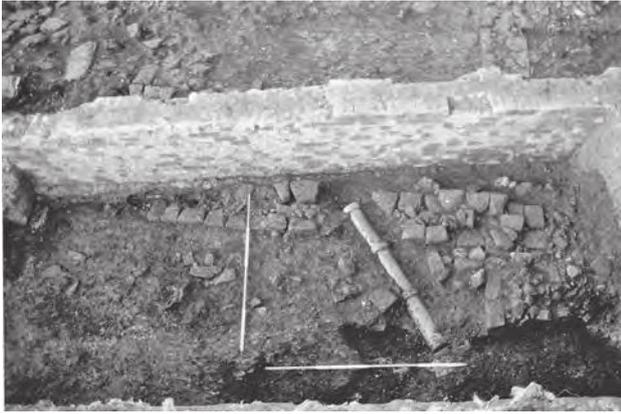
Figure 11.02: The north-west corner of Building 16, looking north.

The robbing of the primary external walls was very thorough. Only the north-east corner of the building preserved a substantial stretch of masonry (north wall: P08:02; north and east walls: Q08:02), with up to three courses of the wall surviving at the angle itself (Fig. 11.02). This section of wall was 0.60–0.70m wide and was composed of roughly dressed rubble facing stones, with a mortared rubble core. Elsewhere, all that survived were stretches of the outer facing of the west wall (K07:30 – Fig. 11.03) and the inner face at the south west corner (K08:36), and one short fragment of the south wall (L08:72), which may however form a later rebuild. Otherwise only foundation deposits were preserved – north wall (L07:18, 25, M07:12?, 19); south wall (K08:36, L08:42, M08:41, N08:33, 45); west wall (K07:35) – composed of yellow clay, packed on top of blocks of sandstone rubble, c. 0.10–0.30m in diameter. To the east, where the foundations were described as 'black and yellow claggy, silty clay' (N08:33) and 'stones . . . in black silt' (N08:45), it is possible that these black silty deposits signify a degree of contamination, perhaps as a result of the later wall robbing. The south wall foundation trench, which was the most extensively exposed, varied in width between 0.75m and 1.20m.

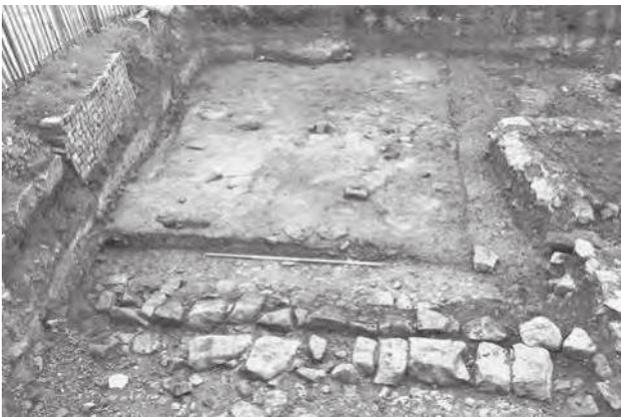
Figure 11.03: The west end of Building 16, looking east, with the wall robber trenches emptied, the Phase 1 floors and post holes apparent and *via praetoria* drain in the foreground.

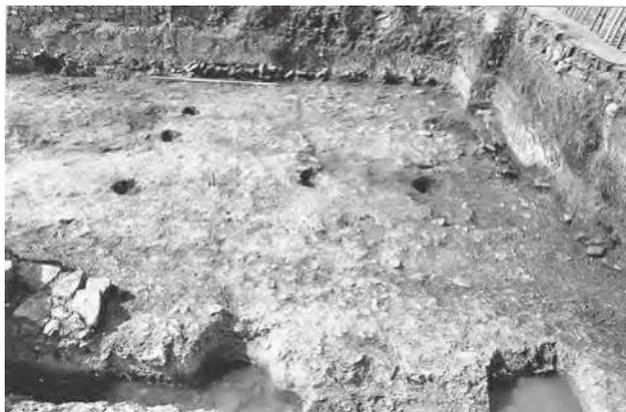
Figure 11.04: The arrangement of postholes in the western part of Building 16. The postholes (L08:26, 27) and pier base or wall (K08:16) in the foreground are probably later but note the north-south alignment of the postholes line up with K08:16.

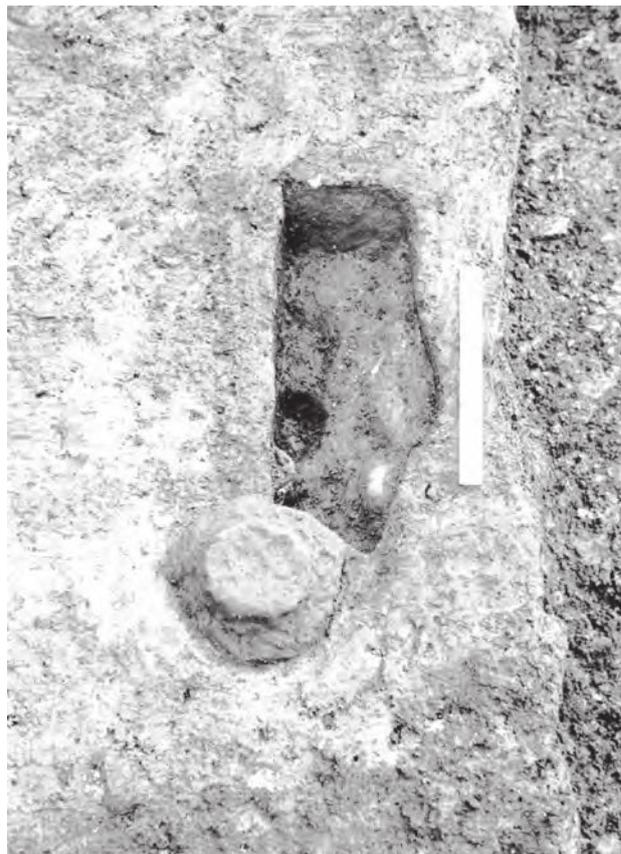
Figure 11.05: Small oblong pit K07:26 with socket hole in the base and a cylindrical stone set at its northern end.

capital and upper section of shaft – was set into the ground on the northern edge of the pit. Intriguingly, the pit was positioned only 0.10m from the west wall of the building, directly opposite the point where one branch of the external drain running down the side of the *via praetoria* (K07:19) appeared to emerge from Building 16, hinting that there might have been some functional link between the two features. Despite their proximity, no direct physical link between the pit and the drain was apparent and it is not clear what the functional association between the two features might have been. In its definitive form, moreover, the drain channel belongs to a later period (Phase 3 of the *via praetoria*).

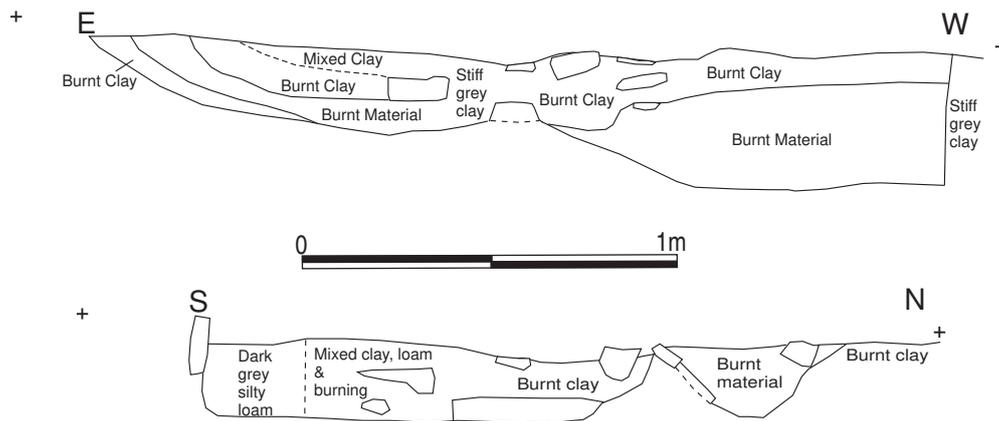
Figure 11.06: North (top) and east (bottom) facing sections through furnace M08:31 (S115) at 1:20.

Towards the centre of the building two large pits cut into the clay floor/makeup were revealed (M08:43, M08:31), one of which was interpreted as a kiln (M08:31). The latter took the form of a narrow oval pit, some 1.10m long (E-W) and up to 0.60m wide (N-S), filled by burnt clay and charcoal (M08:14) and surrounded by flags, which gave the feature respective overall dimensions of 1.20m by 1.25m (Figs 11.06, 11.07). The flagstones were laid flat around the lip of the pit and were absent on the west side perhaps indicating the kiln (if such it was) was worked from this end. A second pit (M08:43), sub-rectangular in plan and measuring 1.00–1.30m (N-S) by 1.40–1.60m (E-W), lay 1m west of the suggested kiln and directly in line with it, implying that the pit might have been functionally related to the kiln in some way, although this could not be confirmed. The pit was filled by yellow sandy material (M08:34), which, on the evidence of site plan P413, also extended beyond the lip of the pit over clay M08:35/N08:43 and was equivalent to the sandy spread (L07:24/L08:64/M07:14) to the north and west. On site plan P426 a couple of large upright stones are shown set in the southern side of the pit and might be associated with an adjoining setting of three smaller upright stone slabs (M08:42) shown on an earlier plan (P413), which were aligned east-west and positioned on the lip of the pit, close to its south-east corner. These slabs resemble packing post-pit stones, but they were not identified as a post-setting. The feature was recorded as cutting makeup M08:35, but its relationship to sandy fill and overlying spread M08:34 is unclear ('?butted by 34', 'contemporary with pit fill 34'). However, its positioning on the very edge of the pit appears too precise to be coincidental and implies that the stone setting must have been associated with the pit in some way. Rather than cutting through the sandy fill or spread, the stones perhaps protruded up through that material which was deposited over them at a later stage without fully covering them. A third pit (M08:33) was located just to the south-east of the suggested kiln. This was cut into the dark red-brown
