# SEGEDUNUM

Excavations by Charles Daniels in the Roman Fort  
at Wallsend (1975–1984)

VOLUME 1: The Structural Remains

Alan Rushworth and Alexandra Croom

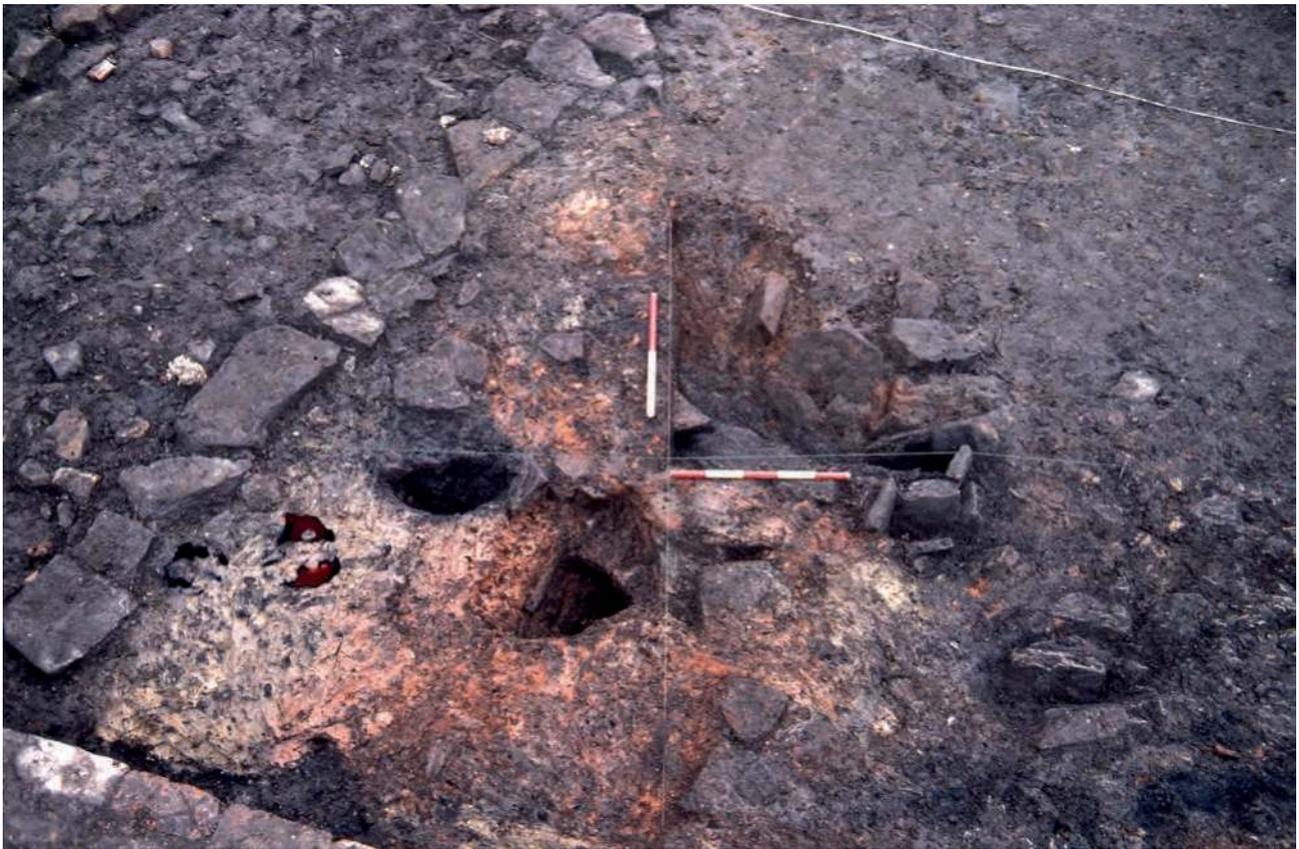
Figure 11.07: Kiln M08:31 under excavation, looking north-east.

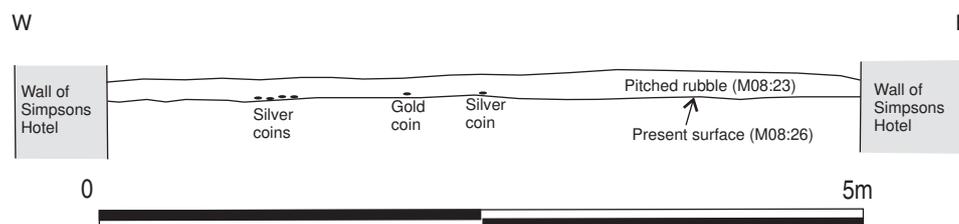
Figure 11.08: Schematic measured sketch showing positions of coins, projected in a single section, at 1:50.

The gold and silver coin hoard was assigned to context M08:26 on the relevant context sheet and in research archive records compiled subsequently. However it should be noted that a sketch plan and section (reproduced here as Figs 11.08, 11.09), drawn and annotated by the site supervisor (NG) when the find was reported the police, provide a much more detailed record which indicates that the coins were found at the base of the overlying pitched rubble layer (M08:23), on or over the surface of burnt clay M08:26. The clear implication is that the coin hoard could be associated more properly with M08:23 and certainly cannot provide a *terminus post quem* for burnt clay layer M08:26.

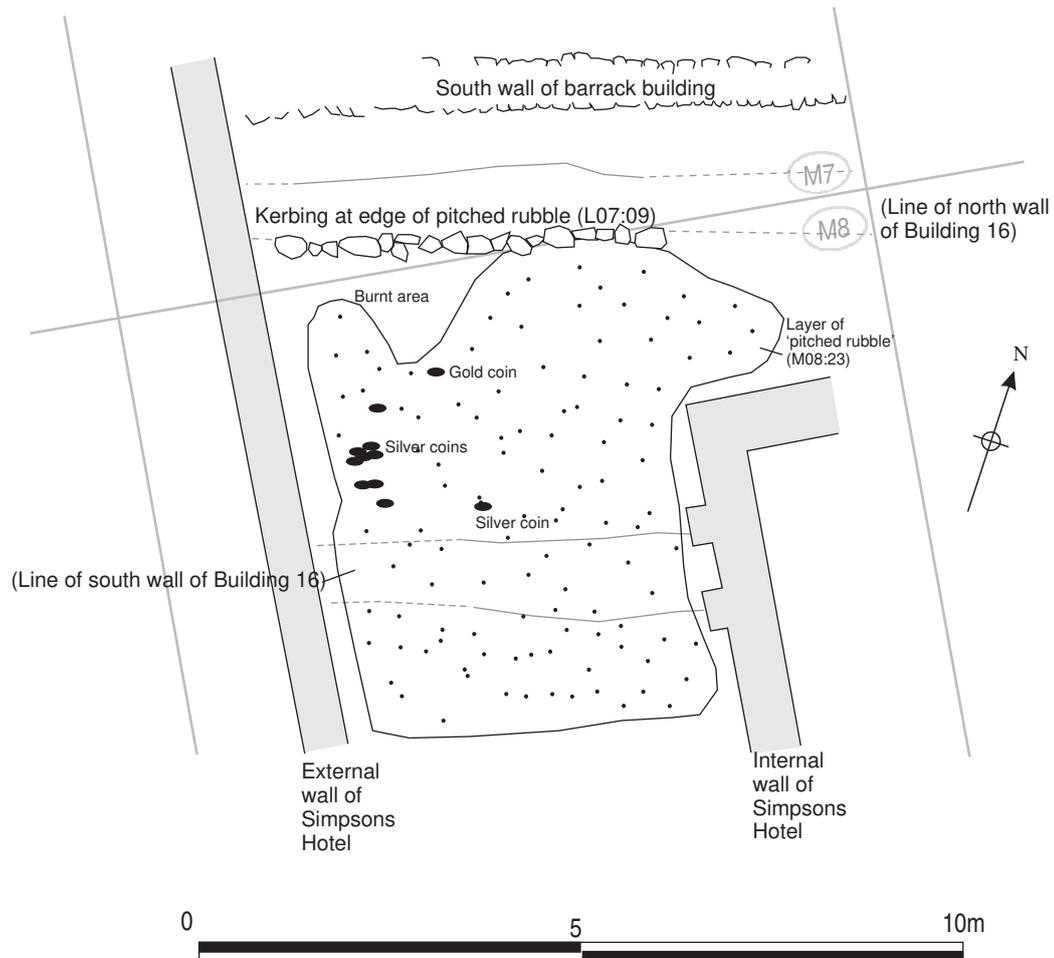
Figure 11.09: Measured sketch plan showing the findspots of the coins. Context numbers added and the position of the north and south walls of Building 16 shown for reference though not recognized at the time of excavation, at 1:100.

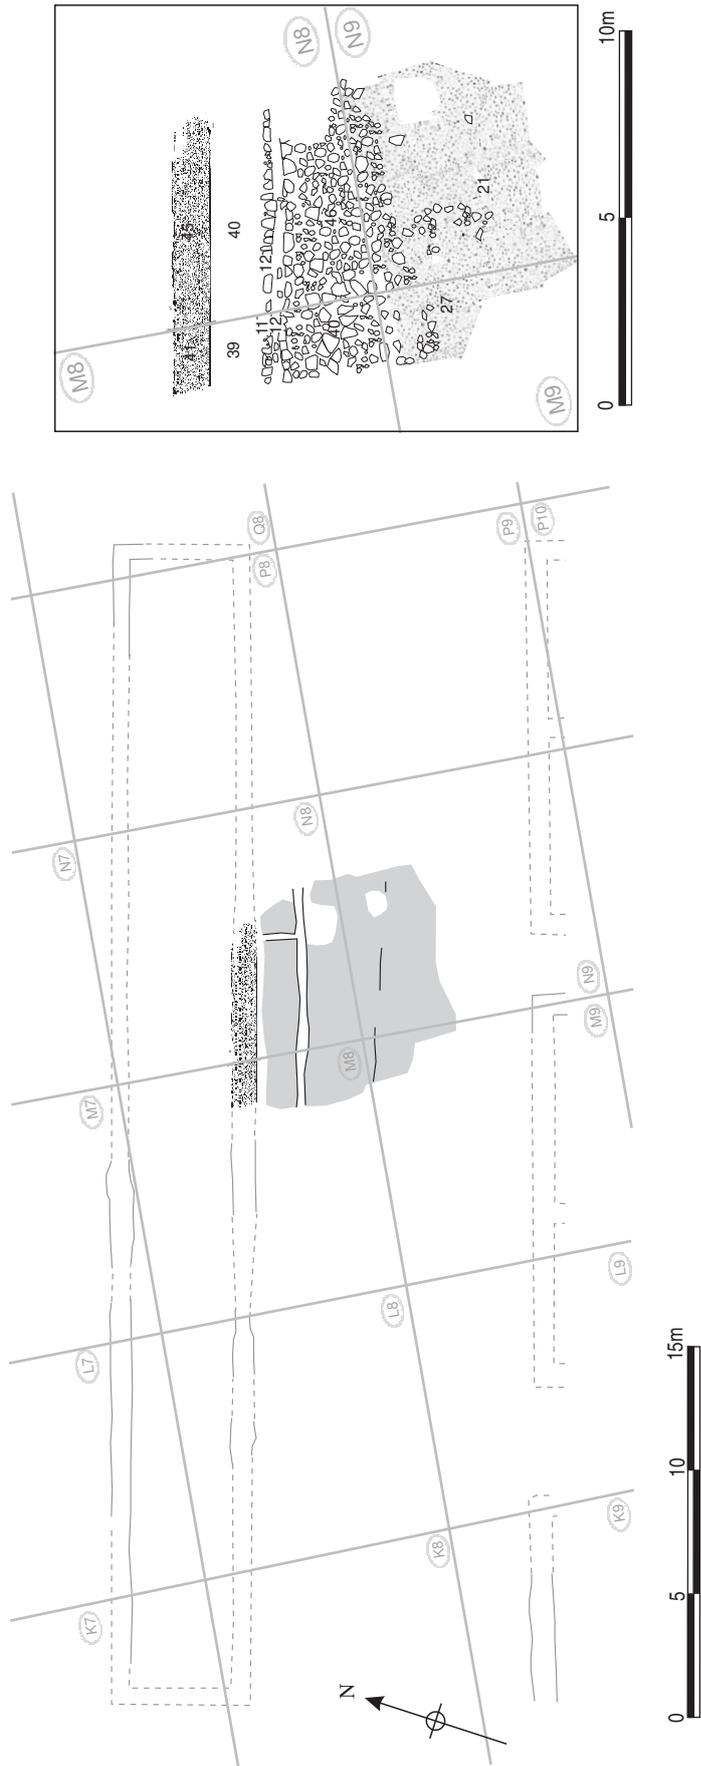
Figure 11.10: Plan showing the location of the earliest road levels exposed on the eastern via principalis at 1:300, with a more detailed plan of the surface at 1:200 in the inset box.

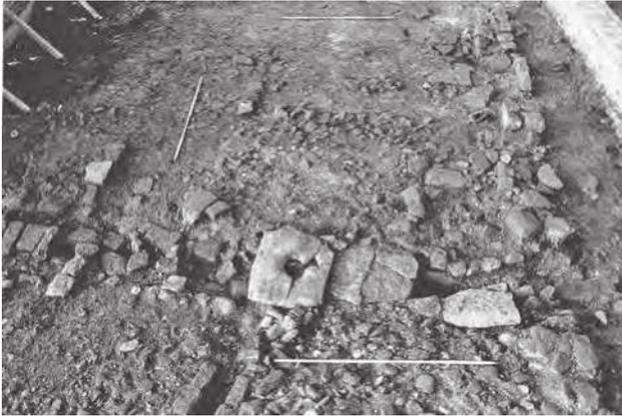
Figure 11.11: Perforated drain cover at the junction of drain L08:59 (E-W) and L08:60 (N-S), looking north.

carrying away industrial effluent of some kind. It lay directly opposite the roughly square platform (L08:70) abutting the south wall. The excavators suggested that this branch cut and was therefore stratigraphically later than L08:49. Two stones on the south side of L08:59 appeared to form the east side of a possible southward continuation of L08:48 which perhaps connected the drain with the north-east corner of Cistern 3. Certainly, if its construction preceded that of Cistern 3 (L08:08), the drain's course must later have been interrupted by the cistern.

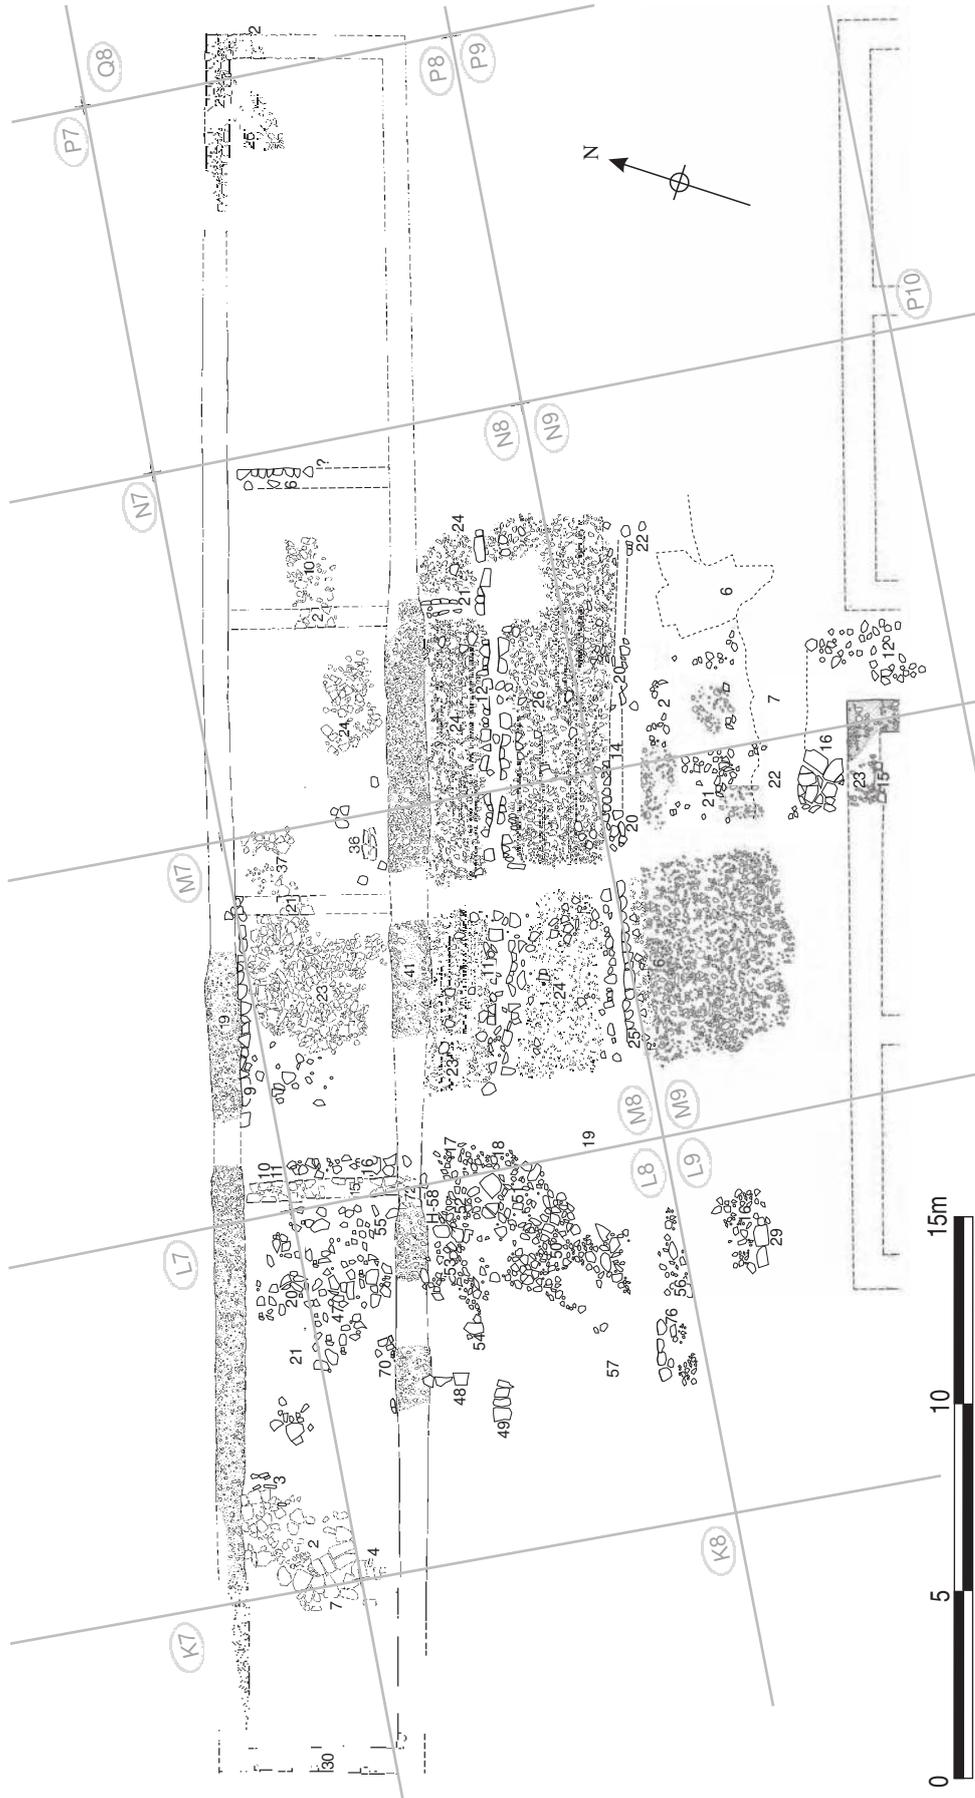
Figure 11.12: Building 16, Phase 3 at 1:200.

### *Building 16* (Fig. 11.12)

The third phase of Building 16, as defined by the excavators, was marked by substantial alterations to the internal arrangements (Fig. 11.12). The building was divided by a series of north-south cross-walls (M07:10/M08:15, M08:21, N08:02, N08:06) into at least four and perhaps five rooms. The cross-walls were constructed with a narrow rubble core between faces of roughly dressed sandstone rubble blocks and were probably bonded with clay, although this is not described, whilst the rooms appear to have had floors constructed of stone – composed of either flagging or pitched rubble – rather than the clay floors which predominantly characterised the earlier phases. Preservation of these levels was very patchy, however, and the surviving features provided far less indication regarding the purpose of the building in this phase. In addition, the record of the various features and deposits associated with this phase contained in the site archive presents a number of significant problems with regard to its interpretation.

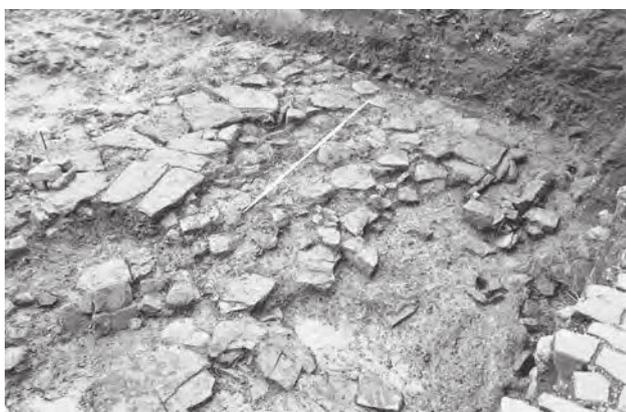
Figure 11.13: Phase 3 stone floor K07:07/L07:02/L08:04, with the short drain channel (L07:03) to the right, looking north-west.

overlying floor surface clearly associated with the suggested rebuild may simply reflect the generally limited surviving extent of the later stone surfaces (K07:07/L07:02/L08:04 and K07:06/L07:09) in this area, a result of the considerable post-Roman disturbance affecting that part of the site. However there remain more substantial objections to the theory that the south wall was rebuilt in the manner described, which cannot be so readily dismissed. Principal amongst these was the obvious manner in which the postholes coincided with the extent of the forehall frontage, with none being found on the same line further to the east, in 1983–4, which would be consistent with their interpretation as part of an associated portico. Moreover, if the stratigraphic relationships set out in the relevant context records are all accepted as valid, post pad/wall masonry K08:16 should be later than the three post holes, L08:26, 27 and 41, and cannot have formed part of the same structure, whether rebuilt workshop frontage or forehall portico.

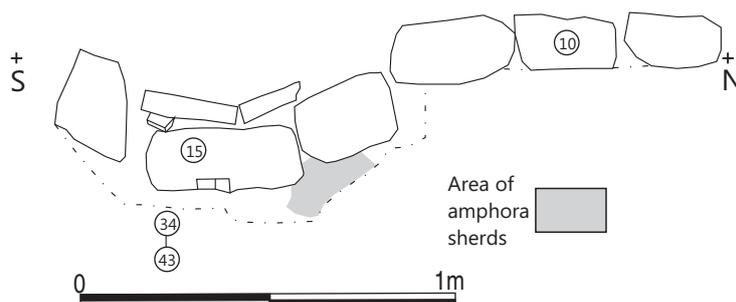
Figure 11.14: Section S122 at 1:20 showing the north end of partition wall M07:10/M08:15 in Building 16.

The partition wall (M07:10, M08:15) which separated Rooms 1 and 2 was 0.50m wide and was preserved over its entire length, although only a single course survived. The wall was erected over the site of the earlier backfilled pit (M08:43) and as a result its central section had partially subsided into the pit (see section drawing S122 – Fig 11.14 here). Here it was also seen to sit on top of a group of amphora sherds, perhaps the remains of a vessel associated with the pit infill. Elsewhere the wall reportedly sat directly on the ‘floor makeup’ (probably M08:35) with no trace of any foundations. At its southern end the partition wall butted up against the sole surviving masonry fragment of the building’s south wall (L08:72). Stone surfaces were identified in various parts of Room 2. A spread of rubble perhaps forming a flagged surface

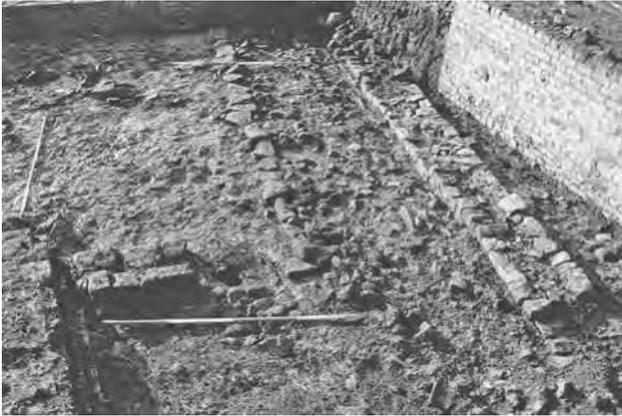
Figure 11.15: Phase 3 stone kerb M07:08 (marking the north edge of stone floor M08:23 already excavated), with crosswall M08:21 in the left foreground, looking west. The north wall against which the kerb butted has been robbed out but the south wall of Building 3 is visible to the right on the other side of Alley 2.

Much less survived of the next cross wall (M08:21), which divided Room 2 from Room 3, the southern half having been destroyed by the brick cellar wall of Simpson’s Hotel. All that remained was a metre long section, plus a further couple of facing stones abutting the presumed line of the building’s north wall. The partition wall was 0.50–0.60m wide and the site photographs suggest that two courses survived, with, again, no evidence for any foundations. On the east side of the cross-wall in the north-west corner of Room 3 a somewhat patchy stone surface (M08:37) which was not described further was shown on plan P407. It appeared to consist of a mixture of flagstones and cobbles. The south-east quarter of the room was covered by a spread of rubble blocks which were 0.10–0.50m long set in a matrix of black silt (N08:24). This was considered equivalent to pitched rubble M08:23 in Room 2 and like the latter was recorded on site plan P405 as extending across the line of the south wall and over the northern part of the *via principalis* as far as drain M08:11/N08:12. In the south-west corner, a linear stone setting (M08:36) was uncovered, consisting of two lines of steeply pitched slabs forming a V-shaped channel 1m in length. At the western end of the pitched stone setting, and laid perpendicular to it, was a line of three flags which might have been associated in some way.

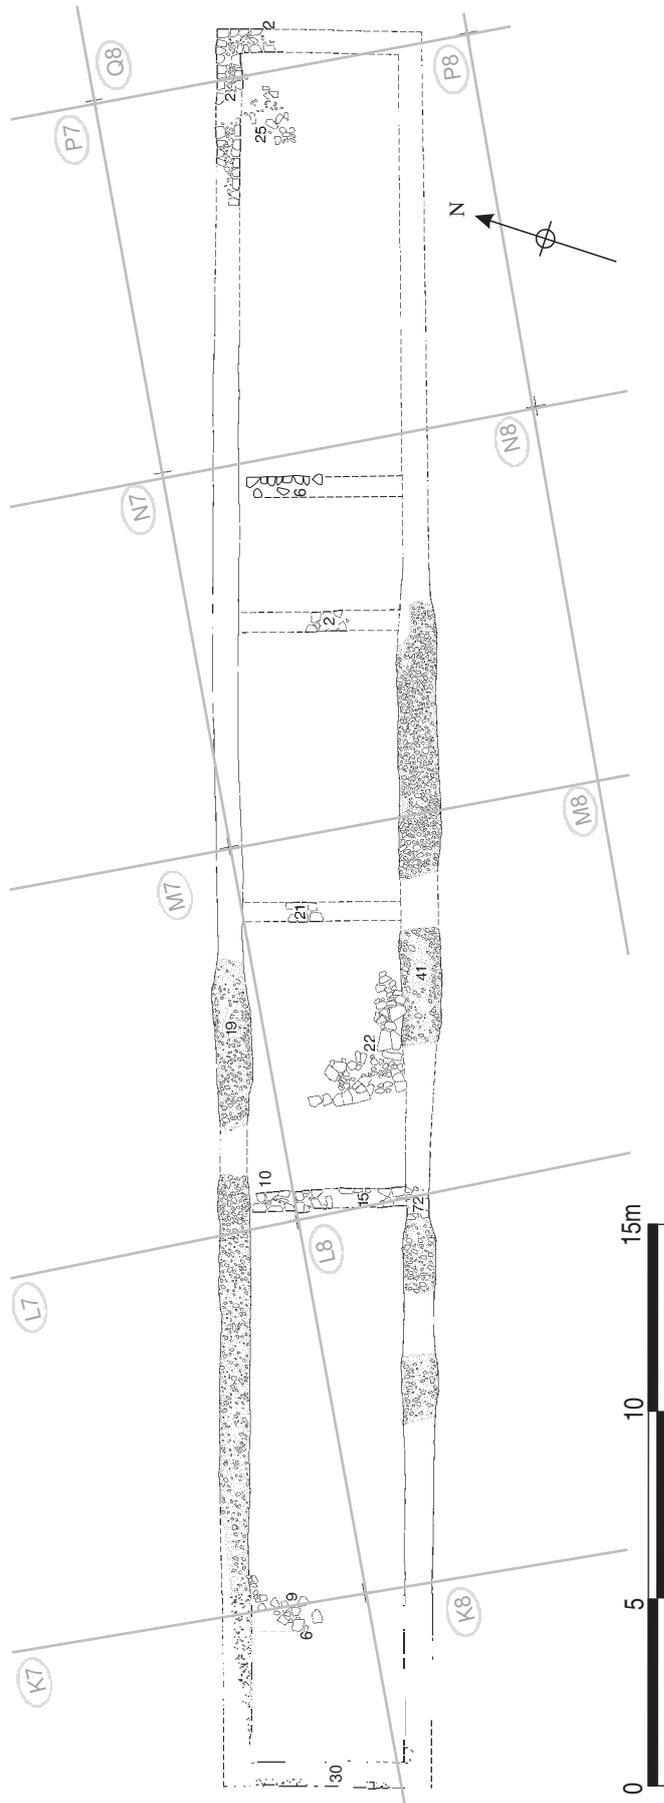
Figure 11.16: Building 16, Phase 4 at 1:200.

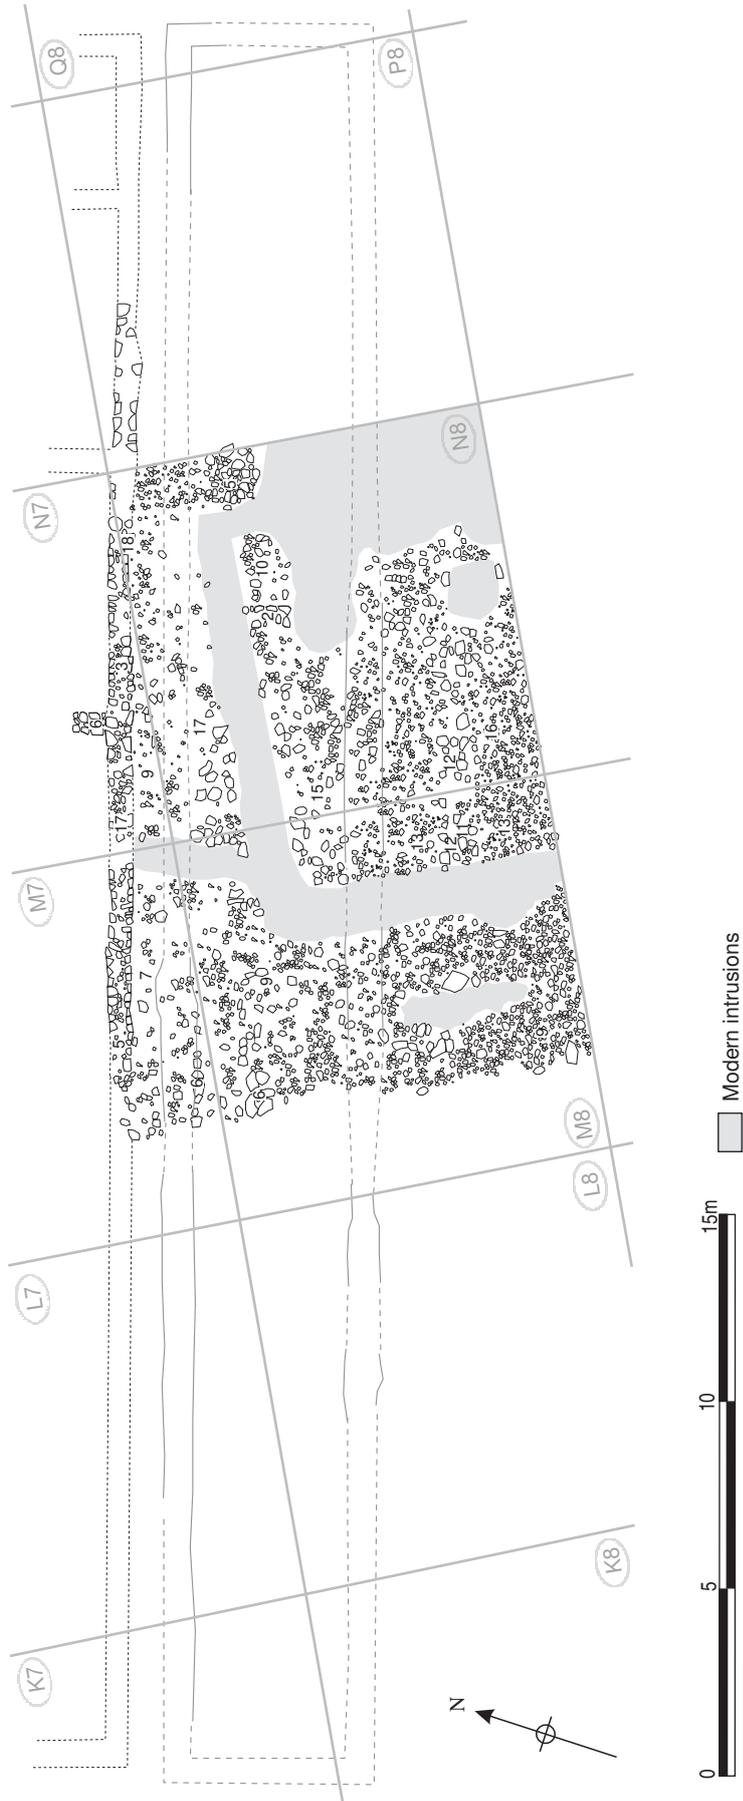
Figure 11.17: Rubble deposits recorded over the centre of Building 16 and the via principalis (at 1:200).

Across grid squares M7, M8, N7, N8 and parts of M9, the remains of Building 16 and the *via principalis* were covered by a general spread of rubble in dark grey/brown silt (M07:07, M08:09, 13, M09:05, N07:09, N08:15/17, P08:21, Q08:17). A similar layer consisting of fairly small pieces of rubble was noted over the western end of the building and the road (K08:04, L08:06). It is uncertain whether this rubble, which was revealed immediately upon the clearance of the modern overburden, represents the bottom of modern disturbance or dereliction following the demolition of the building. The former appears most likely, but traces of later Roman structures could conceivably survive amidst this disturbance, perhaps, for example, the patch of large, cracked flagstones (M08:06) covering an area measuring 1.20m by 0.70m over the northern part of the building, although a more recent date for this feature cannot be ruled out. Further consideration is given to the problems associated with the rubble layers overlying the site and the robber trenches relating to Building 16 in the next section.

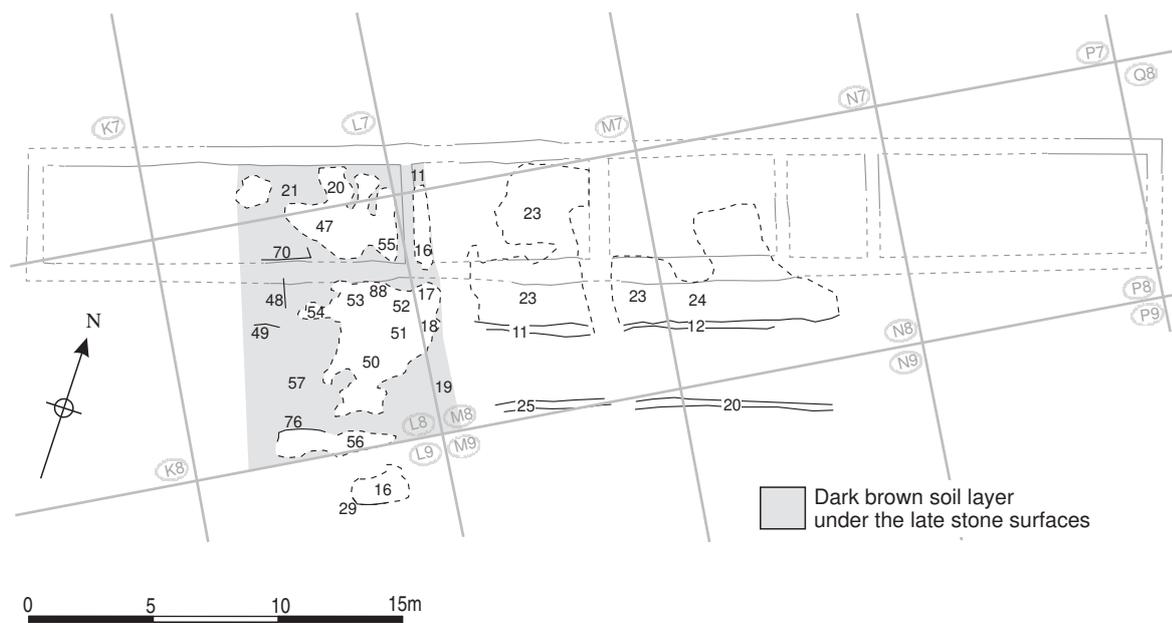
Figure 11.18: Plan to show the extent of later surfaces over Building 16 and the east *via principalis* (at 1:300).

It is very difficult to correlate the uppermost levels exposed on the west side of the outer brick wall of Simpson's Hotel (M07:04/M08:04) with those on the east side. To the west, all the Phase 3–4 surfaces or stone spreads, both inside the building and over the road carriageway, were recorded as overlying a dark brown soil layer (L07:21/L08:57/M07:11/M08:19) which appeared to form a horizon over the entire area. There is no parallel for this dark soil to the east of wall M07:04/M08:04 unless it is the general spread of rubble in dark grey/brown silt revealed across the entire area immediately upon the clearance of the modern overburden and recorded on the initial plan of this part of the site, P398 (cf. e.g. M07:07, M08:09, 13, M09:05, N07:09, N08:15/17, P08:21). If this is the case, however, the underlying stone surfaces M08:23 and N08:24, east of wall M07:04/M08:04, would have no parallel to the west. One possibility is that the dark soil matrix should be seen as surrounding and intermixed with the cobbles, flagging and other stone spreads west of the brick wall, rather than underlying them. In that case the soil might constitute the residue left after the robbing of much of the Phase 3 surface material, and partially equate to the deposits shown to the east on P398, with more of that material, however, having perhaps been cleaned off in the western area to expose the Phase 3 surfaces. The rather convoluted and speculative nature of such an explanation needs no emphasis. Furthermore there remain significant differences between the two areas notably the continued appearance of the earlier longitudinal drain channels to the east of wall M07:04/M08:04, not only in the Phase 3 road surfaces but even in the overlying rubble deposits, whereas the channels were for the most part obscured to the west of Simpson's Hotel.

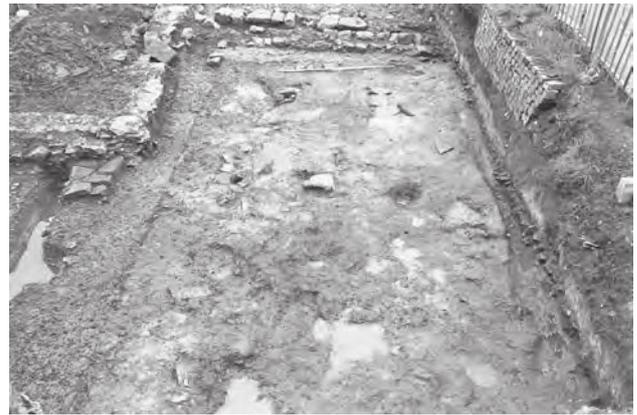
Figure 11.19: View of the west end of Building 16, looking west, showing the proximity of stone masonry K08:16 and L08:26 to the primary south wall of the building.

There are further issues concerning the south wall of Building 16, notably its relationship to the structural features associated with the suggested forehall portico (AY) and the tentative evidence that the wall underwent at least partial rebuilding at some stage. The context record for the sole surviving fragment of the south wall (L08:72) explicitly states that it sat over the robbing debris in trench L08:65, implying that the wall had been demolished, robbed and rebuilt. In addition, 2m to the west of masonry fragment L08:72, robber trench L08:65 was cut by a post setting (L08:74) which did not appear to be modern and was treated as a Roman period feature (tentatively assigned to Building 16 Phase 2). The uncertainty regarding the function of the three post holes (L08:27, 28, 41) and the post pad (K08:16), positioned directly alongside Building 16's south wall, has already been noted in the discussion of the forehall portico (see Chapter 10). If these features formed part of a forehall portico, like the post holes further west, this would have resulted in rainwater runoff pouring off the forehall roof and portico on to the south side of the adjacent Building 16. The difficulties inherent in this interpretation would be resolved if the post holes were instead associated with the rebuilding of part of the south wall of Building 16 on a slightly different line. Although interpreted as a post pad, K08:16 might actually represent the eastern end of a stretch of repositioned south wall. The remainder of that wall to the west would have been cut away by a nineteenth century cellar (J08:02/K08:02). Its south face was clipped by drain channel K08:15, which made its original form less obvious, but it appears fairly convincing as a wall fragment on site photographs (e.g. B70/19–22, 25–6; see Fig 11.19 here, cf. Fig. 11.04 above) and it was explicitly recorded as overlying and post-dating robber trench K08:17 (the stonework does not appear to impinge on the line of the robber trench

on site plans P237 or P238 but it may have appeared to sit at a higher level). Immediately to the east, the building would either have been open-fronted or perhaps have had a timber wall marked by the three post holes L08:26, 27 and 41. Post hole L08:74, cutting the line of the old robbed-out south wall, might also form part of this timber section whilst the surviving fragment of wall masonry nearby (L08:72) would mark the resumption of the stone wall (this latter may or may not have been rebuilt depending on how much credence is attached to the context descriptions of the relationship between wall masonry L08:72 and robber trench and fill L08:65). In addition, it might also be significant that suggested terminal K08:16 was roughly in line with the north–south row of three postholes (K07:23–5) which cut the earlier clay floor of Building 16 (see Fig. 11.04 above). This row of posts could conceivably have been associated with a partition separating off the west end of the building, although the posts were assigned to Phase 2 and may be too early to be associated with the suggested rebuild.

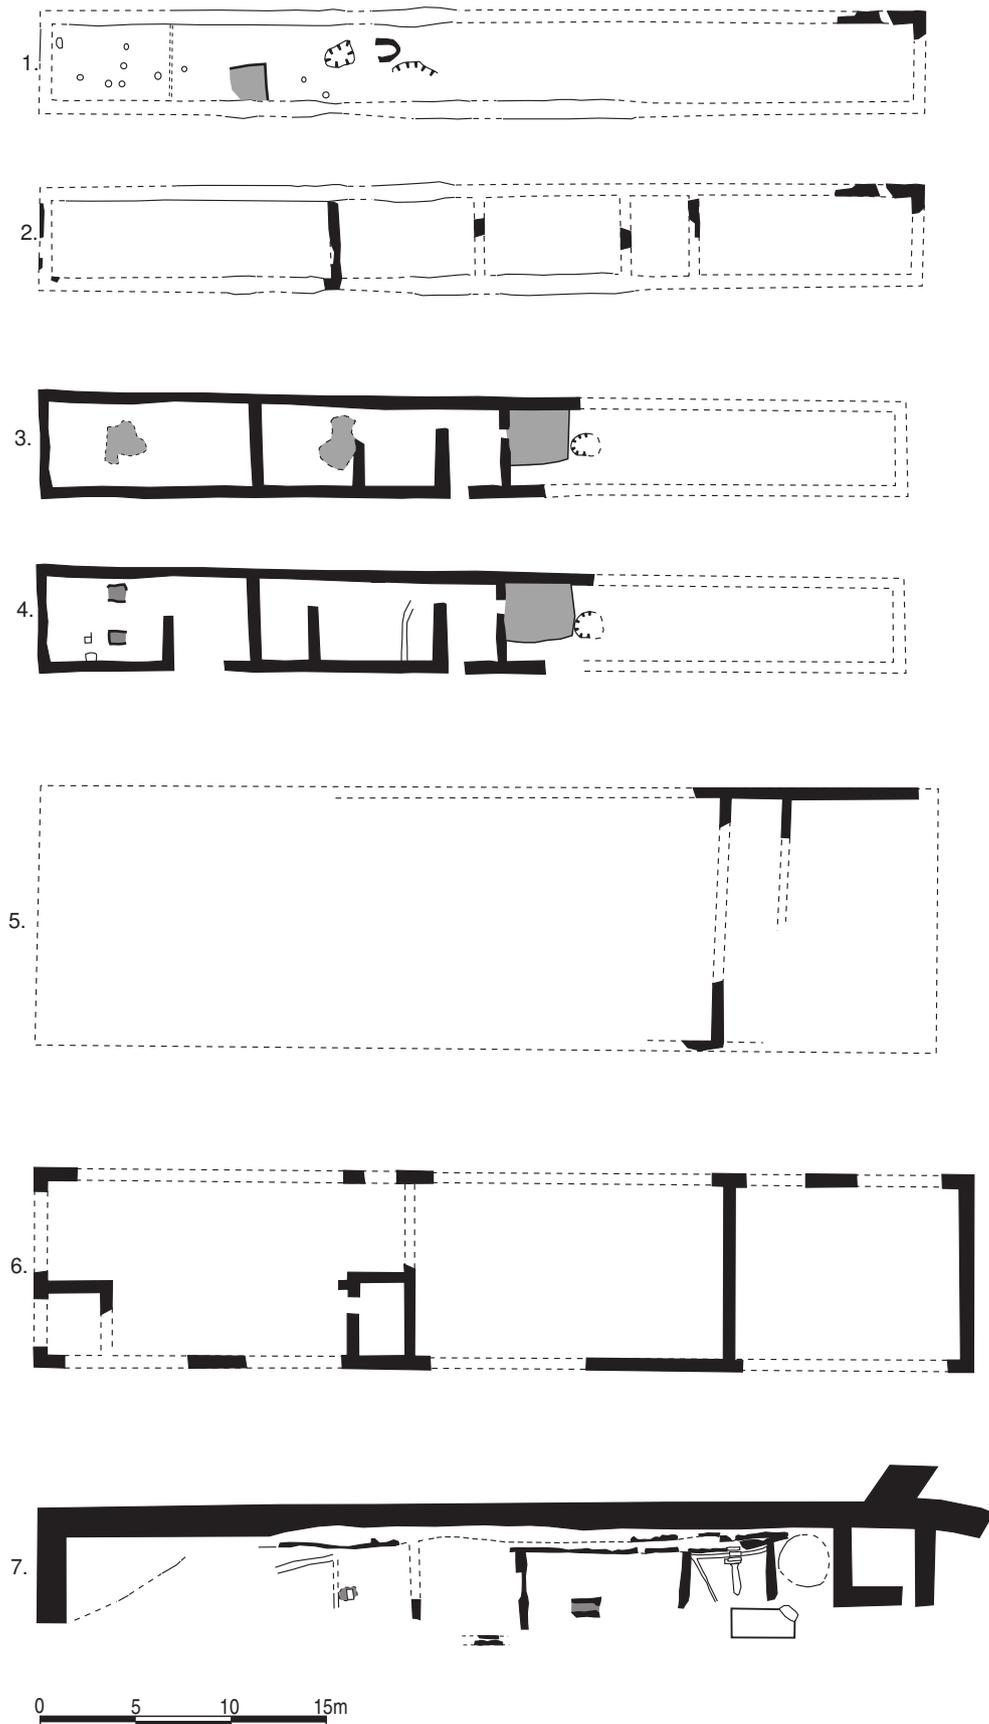
Figure 11.20: Workshops on Hadrian's Wall: 1. Wallsend Building 16 Phase 1–2, 2. Building 16 Phases 3–4, 3. Birdoswald Building 4400 Period 2b, 4. Birdoswald 4401 and 4402 Period 4a. 5. Benwell, 6. Housesteads Building IV, 7. Housesteads north rampart early third century. Scale 1:400

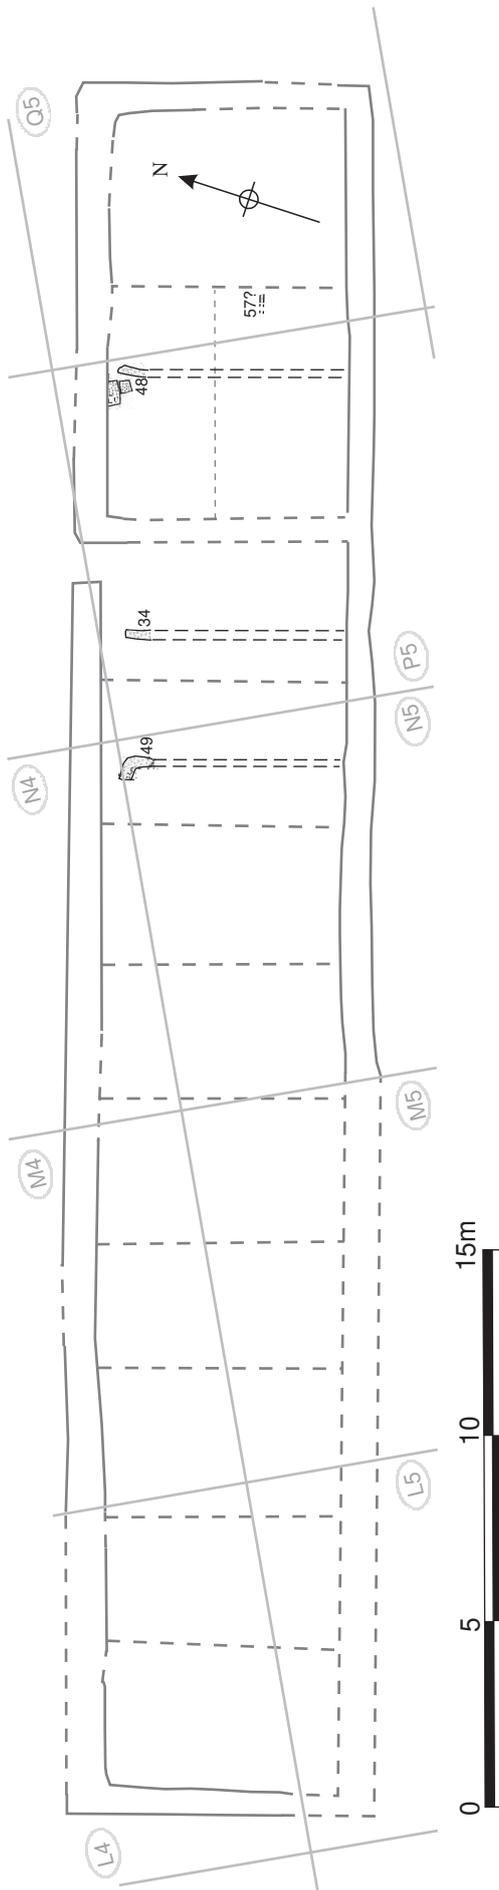
Figure 12.01: Building 1. Features associated with a possible timber barrack phase, with plan of later stone barrack shown in outline at 1:200

short of the south wall (see Fig. 13.10). Moreover, the three anomalous slots in Building 1 were completely at variance with the positioning of the other slots defining the *contubernium* layout of the Phase 1 stone barrack (see Fig 12.01). The slots ranged in width from 0.20m in the case of P05:34 to up to 0.30m in the case of N05:49. None was observed to extend the south of the secondary north wall of Building 1 and hence the recorded surviving lengths of these slots from north to south nowhere exceeded 0.80m. N05:49, the longest of the slots, as revealed, also featured a dogleg at its northern end giving it an inverted L-shape.

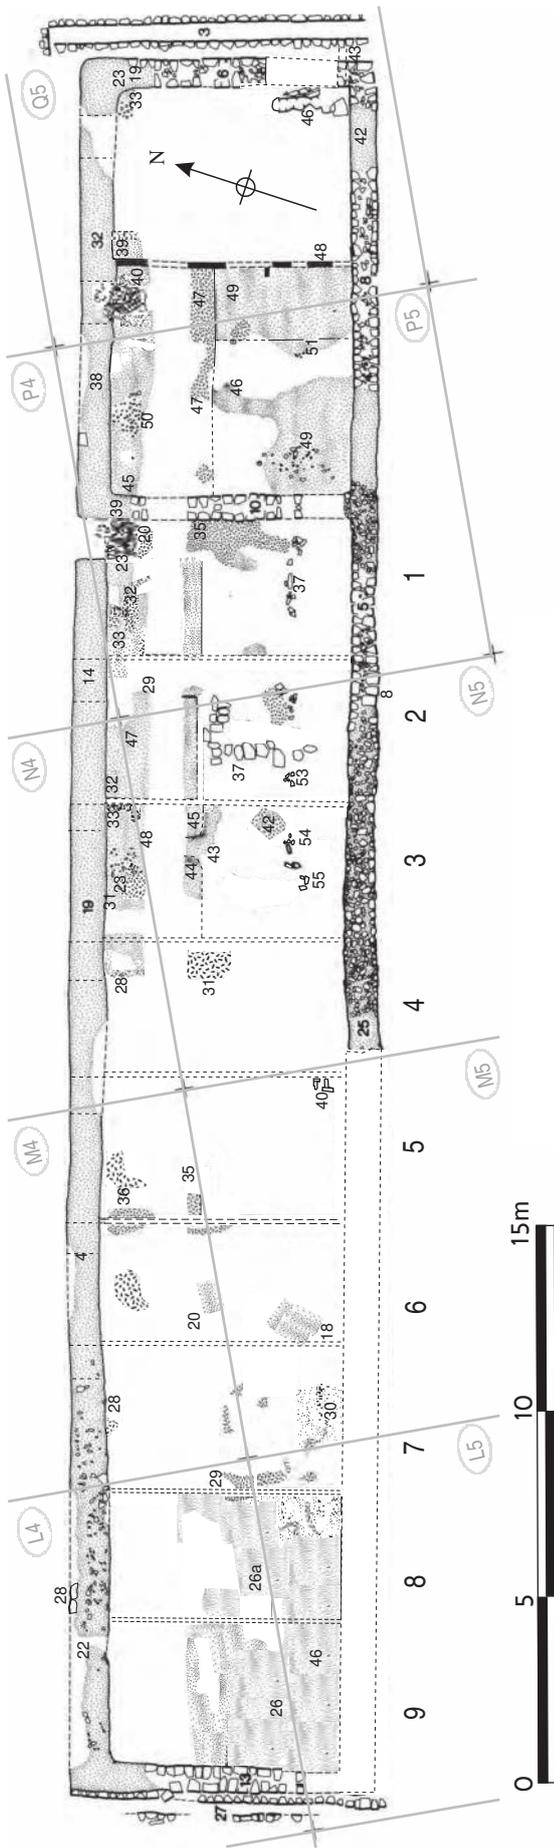
Figure 13.01: Building 1, Phase 1, Sub-Phase 1 at 1:200.

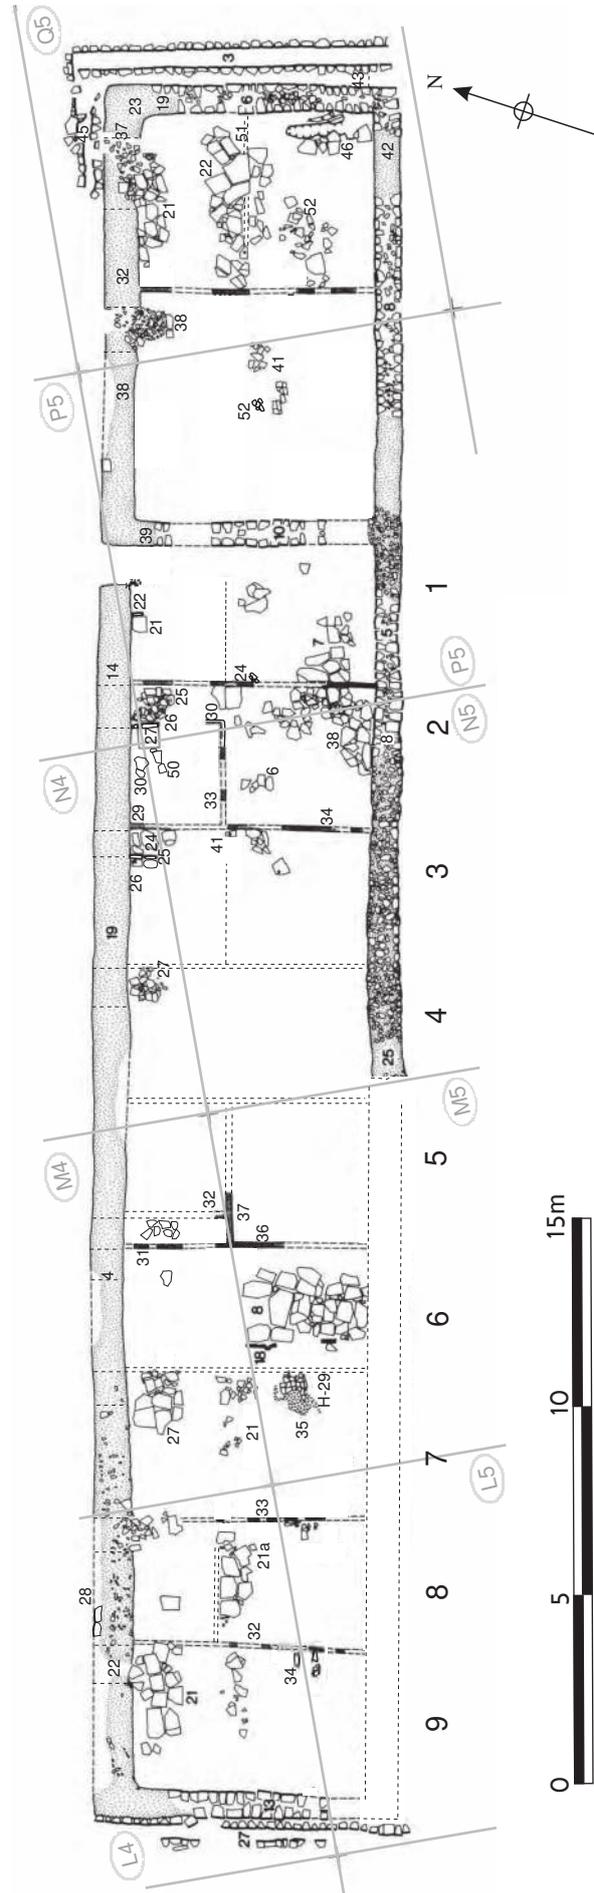
Figure 13.02: Building 1, Phase 1, Sub-Phase 2 at 1:200.

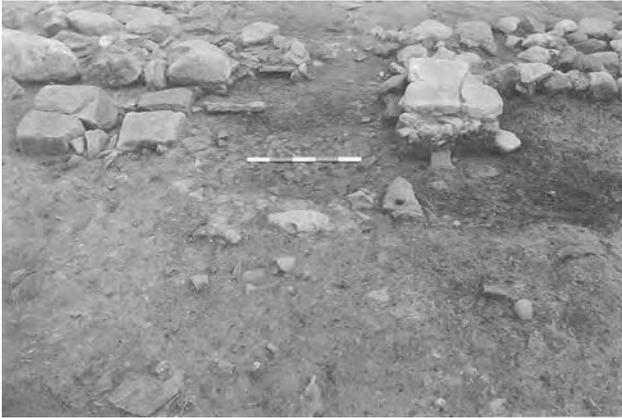
Figure 8 Pivot stone P05:21 associated with the Sub-Phase 1 doorway into the side passage of Contubernium 1 from the north.

The foundation of the north wall of Building 1 ended 1.00m west of the west wall of the officer's quarters, allowing for an entrance in the north-east corner of *Contubernium* 1. A surface of worn, broken sandstone (P05:20) lay over the area immediately south of the entrance. In the south-west corner of the doorway was a pivot stone (P05:23) which, with the surface P05:20, suggested that the door opened towards the interior (Fig. 13.03).

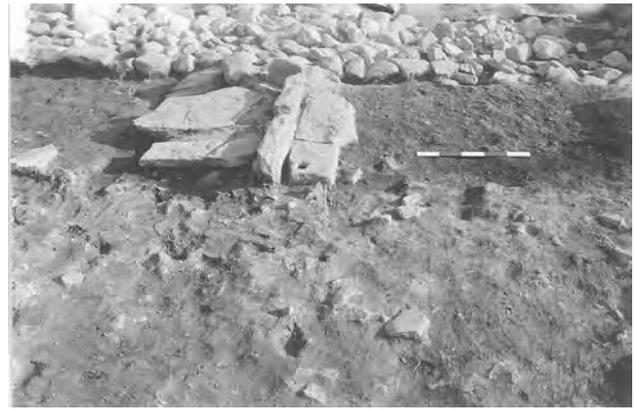
Fig. 13.04 Flagging inside the side passage (left) and the doorway threshold (right) into the north room of *Contubernium* 3 (N04:27), from the north

Very little of this sub-phase survived in *Contubernium* 3. Virtually all of the floor surfaces had been removed. Over the north-east corner were several worn irregular flags (N04:24), possibly the remains of the Sub-Phase 2 stone entrance. Abutting the west side of these was a threshold composed of two upright stones (N04:25) which were laid end to end and stood 0.20m above the stone surfaces on either side. Immediately to the west of these was a small worn flag (N04:26) containing a pivot-hole in the north-east corner. The threshold probably belonged to a doorway leading from the north end of a side passage into the front room of the *contubernium*, an arrangement paralleled in *Contubernium* 2 (Fig. 13.04).

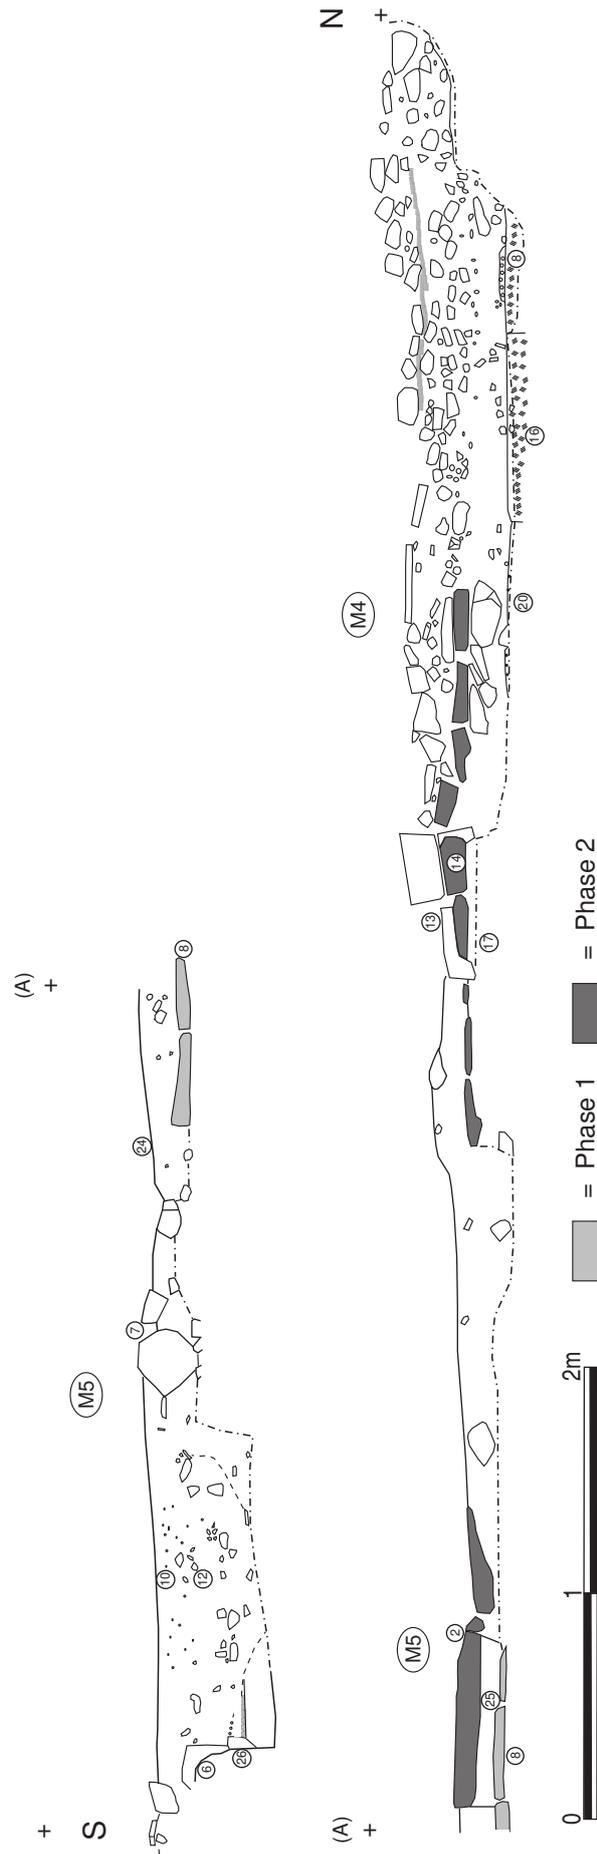
Figure 13.05: East-facing section (S43) across Building 1 in grid squares M04 and M05, at 1:30

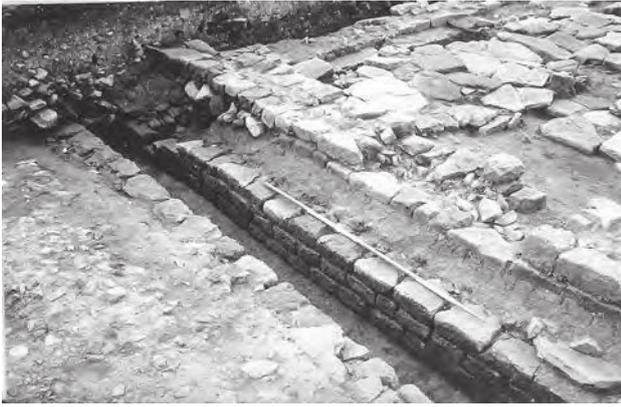
Figure 13.06: Drain Q05:03 alongside the east end of Building 1 with the Phase 2 flagging exposed in the SE corner of the building

Drains were uncovered to the north, east and west of the building. The drain immediately east of the officer's quarters was very well preserved (Q05:03). In its original form it was composed of two sides of well dressed facers on average 0.25m wide by 0.13m high, three courses deep (Figs 13.06, 13.07). The channel was 0.40m wide. There were traces of broken cover slabs in situ on the west side of the drain. It extended beyond the north wall of the building for 1.00m where it was joined by the east–west drain (Q05:45). The bottom of the channel was covered with a layer of yellowish-green silt (Q05:29) which lay below a layer of soil and rubble (Q05:28), probably backfill from when the drain went out of use at the end of Building 1.

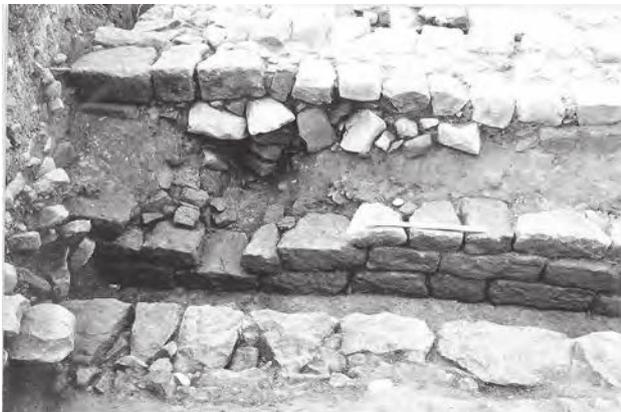
Figure 13.07: Drain Q05:03 with outflow channel Q05:43 leading from the latrine and drain in Building 1 excavated.

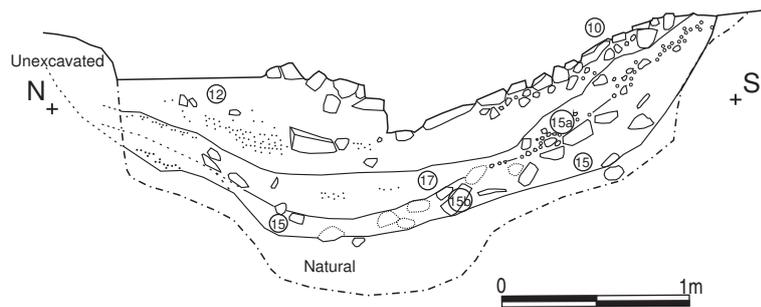
Figure 13 Section (S16) across pit Q04:10 in the north intervallum. Scale 1:10

The surface of the north *intervallum* road revealed a large, roughly oval shaped pit (Q04:10<sup>1</sup>). This was cut through the primary road and the southern part of the north rampart. It was situated in the area between the angle tower and the north-east corner of Building 1 and lay on a south-east to north-west alignment. It measured 4.00m (across the main axis) by 3.20m.
