# SEGEDUNUM

Excavations by Charles Daniels in the Roman Fort  
at Wallsend (1975–1984)

VOLUME 1: The Structural Remains

Alan Rushworth and Alexandra Croom

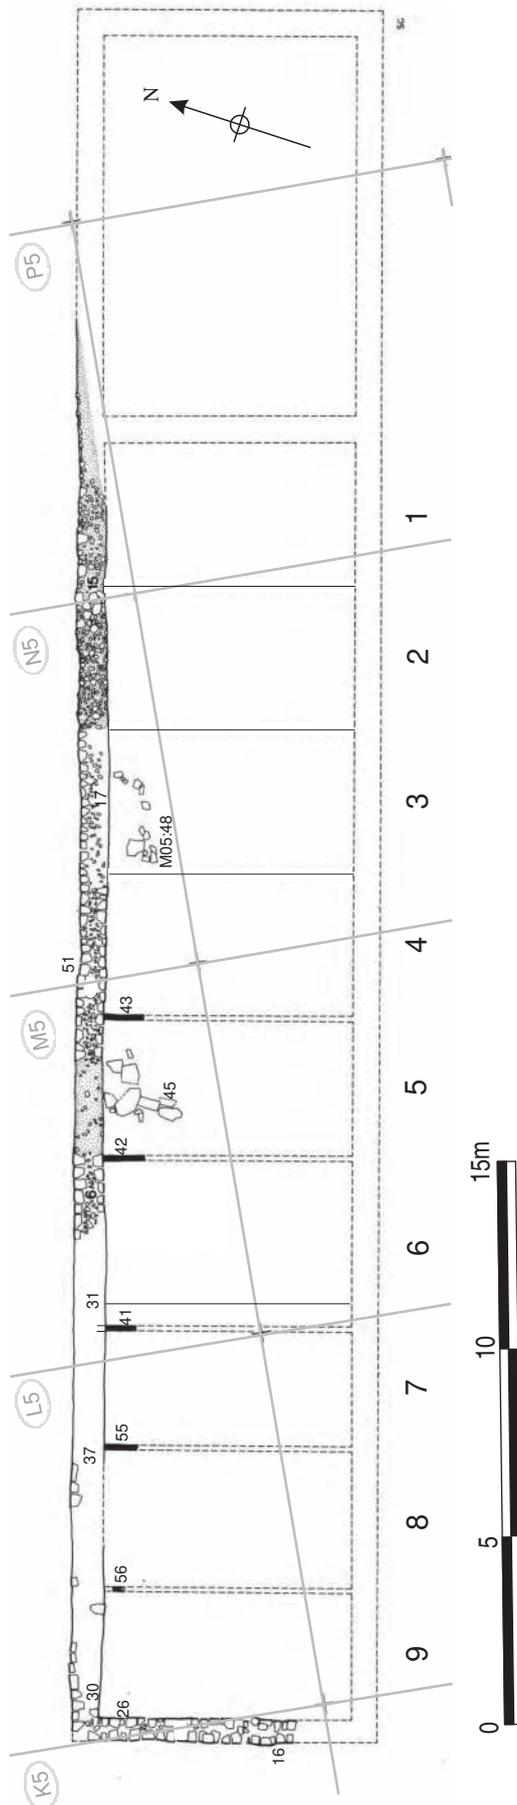
Figure 13.09: Building 2, Phase 1, including partition slot M05:41 possibly belonging to a Period 1 timber barrack. Scale 1:200.

Only one partition (M05:41) was identified in Building 2 which may have belonged to a timber phase preceding the stone-walled barrack (see Fig 13.09). Not only did it appear to be out of step with the other timber *contubernia* partitions associated with the stone building (too close to L05:55 to the west and too distant from M05:42 to the east – 3.10m and 4.50m respectively), but also site plan P216 suggests that this partition continued northwards under the line of the north wall of the building, being visible at the base of robber trench M05:31, and cannot therefore have formed part of the stone barrack (see below Chapter 13, Building 2, *Contubernium* 6). Although no evidence was recovered for timber outer walls which might have been associated with partition M05:41, the analogy with the Period 1 barracks revealed in the *retentura* in 1997–8, suggests that Building 2 may similarly have been constructed entirely of timber in its primary phase.

(M05:41) between *Contubernia* 6 and 7. The line was very clear when the area was taken down to the natural sub-soil. It measured 0.14m wide and had a fill of dirty grey silt. Four small stake-holes were also found, two on either side of the trench, touching the sides. These were 0.06m in diameter and contained the same grey fill. The slot was situated 4.50m from partition M05:42, far more than the usual *contubernium* width, and probably therefore did not form part of the same sequence as the others uncovered in Building 2. Moreover plan P216 suggests that this partition continued northwards under the line of the north wall of the building, being visible at the base of robber trench M05:31. This would imply that it was not associated with the stone barrack building at all, but rather may represent one surviving element of a Hadrianic timber barrack building.

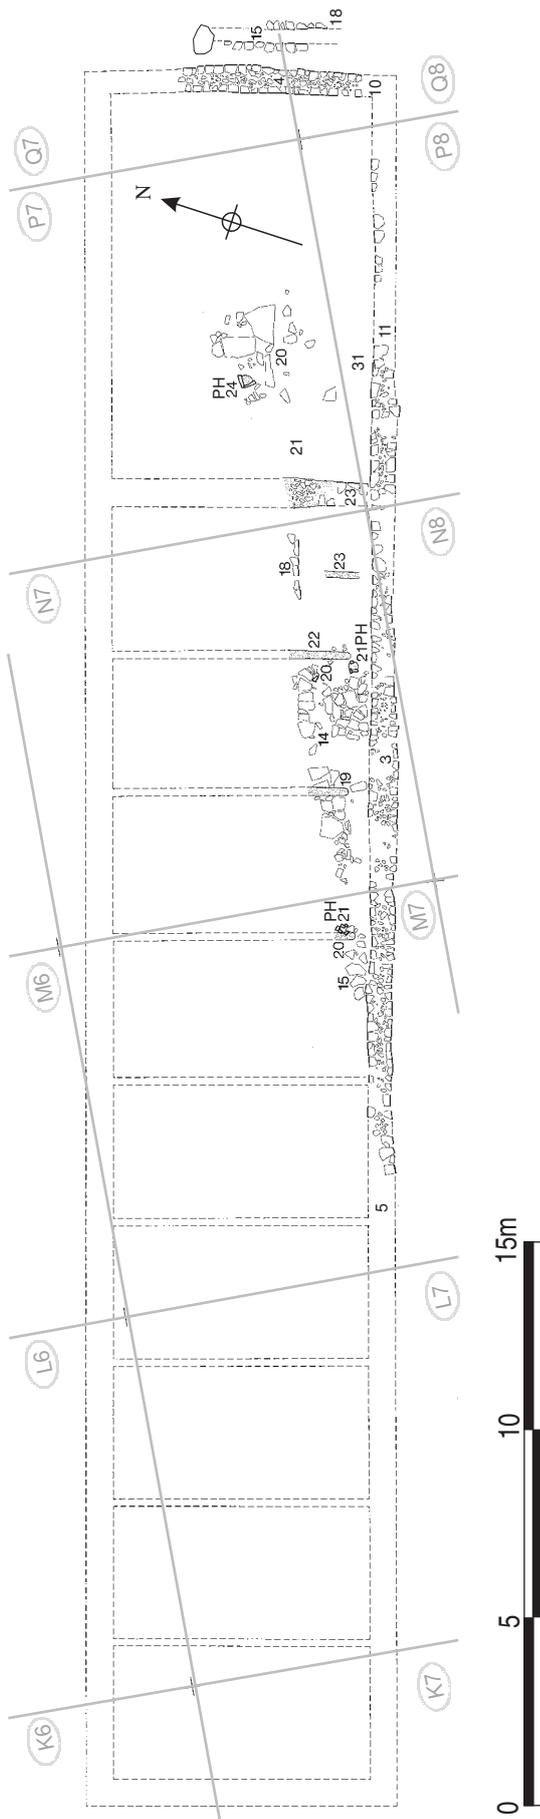
Figure 13.10: North Barracks, Building 3, Phase 1–2. Scale 1:200.

Evidence for two phases of timber partition walling can also be identified in Building 3, although once again the earlier phase, which might be associated with a timber barrack, is represented by only by a single slot, N07:23 (see Fig 13.10). This was 0.15m wide and filled with stone chippings. It was traced over a distance of 1.50m, being cut by the rubble foundations of the south wall of the stone barrack (N07:24) at one end and overlain to the north by a 1.70m long stone alignment (N07:18), which ran parallel to the south wall and probably also represented a feature of the early stone barrack. The slot was located 1.70m from the west wall of the centurion's quarters (P07:23) and 1.90m from the next partition (N07:22). It clearly did not fall into the same pattern as the three other partition slots (M07:20, N07:19, 22), which were fairly evenly spaced, 3.40–3.60m apart, and convincingly define the four easternmost *contubernia* of a subsequent stone barrack block.

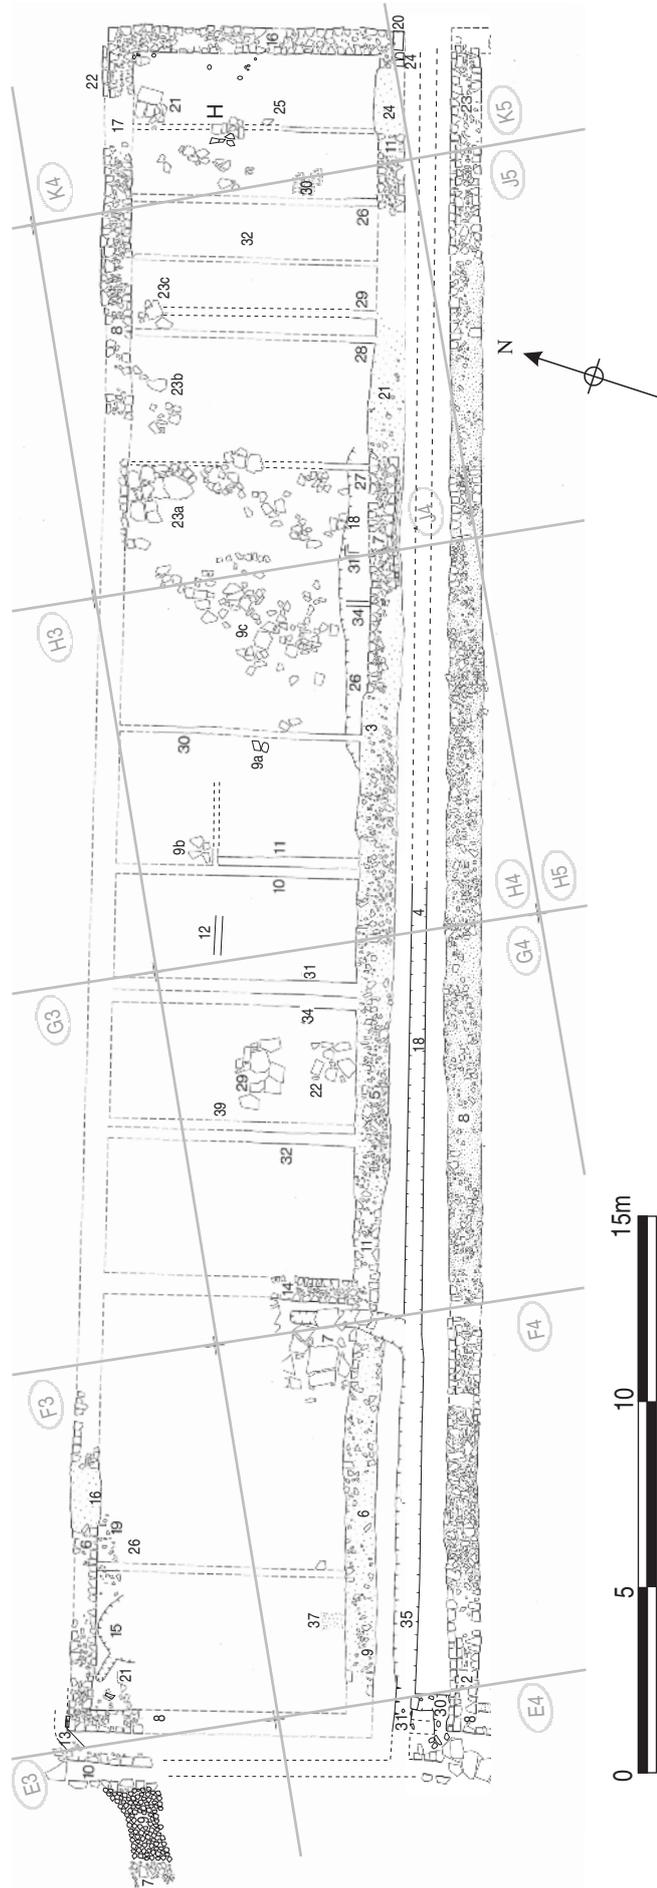
Figure 13.11: Building 4, all features. Scale 1:200.

There was clear evidence for the existence of two phases or sub-phases of partition slot in Building 4. As was the case in Building 1, both sets of partitions were attributed to the stone barrack in Daniels' initial post-excavation analysis. The two successive phases are clearest towards the west, with the Phase 1 and Phase 2 slots lying alongside one another, separating *Contubernia* 1–4, and in this part of the block it is certainly the case that both phases of partition can be fitted comfortably into the plan of the stone barrack. Further east, however, only a single set of partitions formed a coherent pattern within the stone block. Four additional partitions (J04:29, 31, 32, K04:25) at this end of the building were more difficult to fit into the standard layout of a north-facing barrack *contubernia*, with the two easternmost (J04:32 and K04:25) being spaced one *contubernium* width apart, along the central north-south axes of *Contubernia* 8 and 9 respectively (see Fig 13.11).

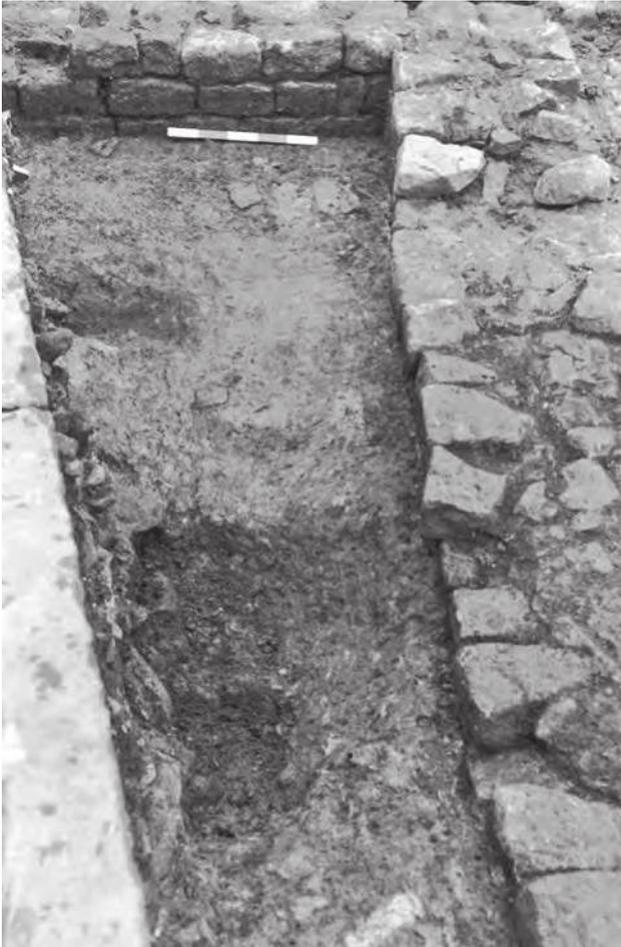
Figure 13.12: The north-west corner of Building 4 showing the north and west walls surviving up to three courses high looking west.

The building measured 45.60m by 8.00m externally. The best surviving fragment of wall occurred at the north-west corner of the building, where both the north and west walls stood two courses high above an offset which projected outwards to the north and west (see Fig. 13.12). The wall measured 0.65m wide while the offset extended an additional 0.10m. It was constructed with squared, keyed blocks on average 0.12m high × 0.22m wide × 0.20m deep. The core consisted of small sandstone fragments and the bonding material was grey clay. This lay on a foundation of hard pink puddled clay 0.20m deep and 0.80m wide.

Only 2.00m of the northern end of the west wall (F03:08) remained to the north of the lane. Forming the north-east corner with wall F03:06, a total of three courses still stood there (Fig. 13.12). The whole length of the east wall (K04:16) of Building 4 survived up to three courses high (Fig. 13.13). The north-east corner of the building was intact, with three courses remaining there, but the junction of the east and south walls had been damaged by post-Roman activity, so that only the inner corner survived.

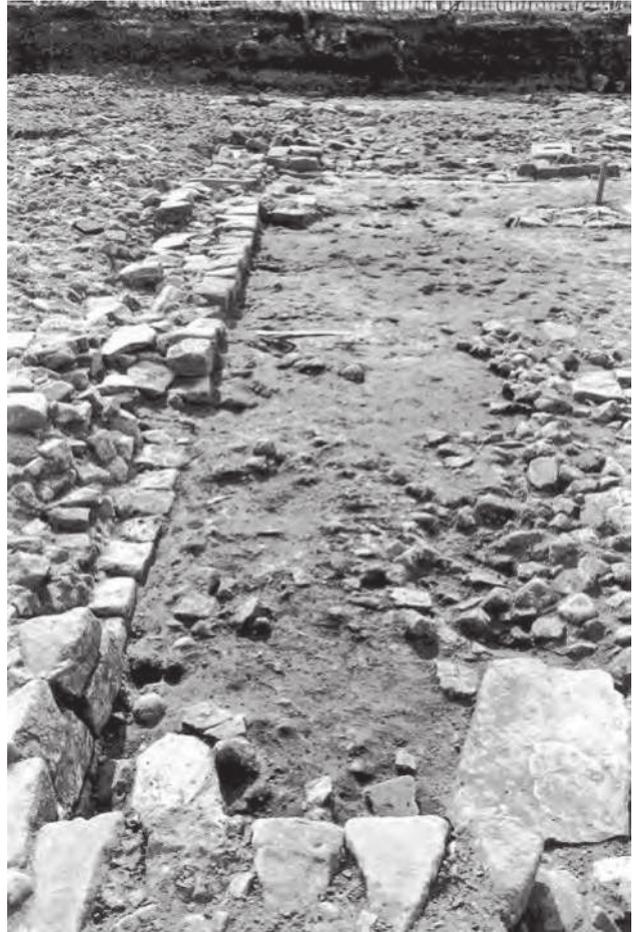
Figure 13.13: The east end of Building 4, looking south. Note the survival of three courses at the NE corner in the foreground.

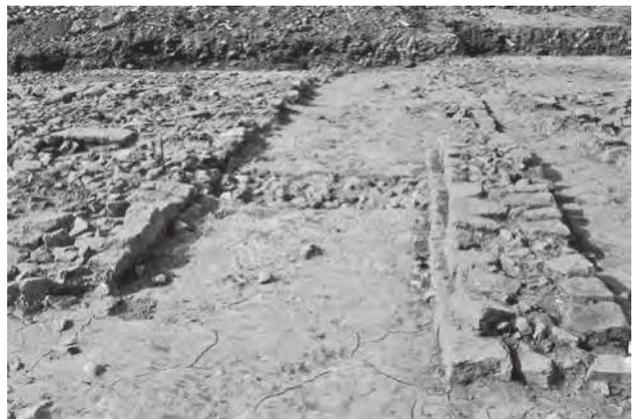
Figure 13.14: The south wall of Building 4 (right) showing the surviving stonework including the offset course, with the north wall of Building 5 to the left, looking west.

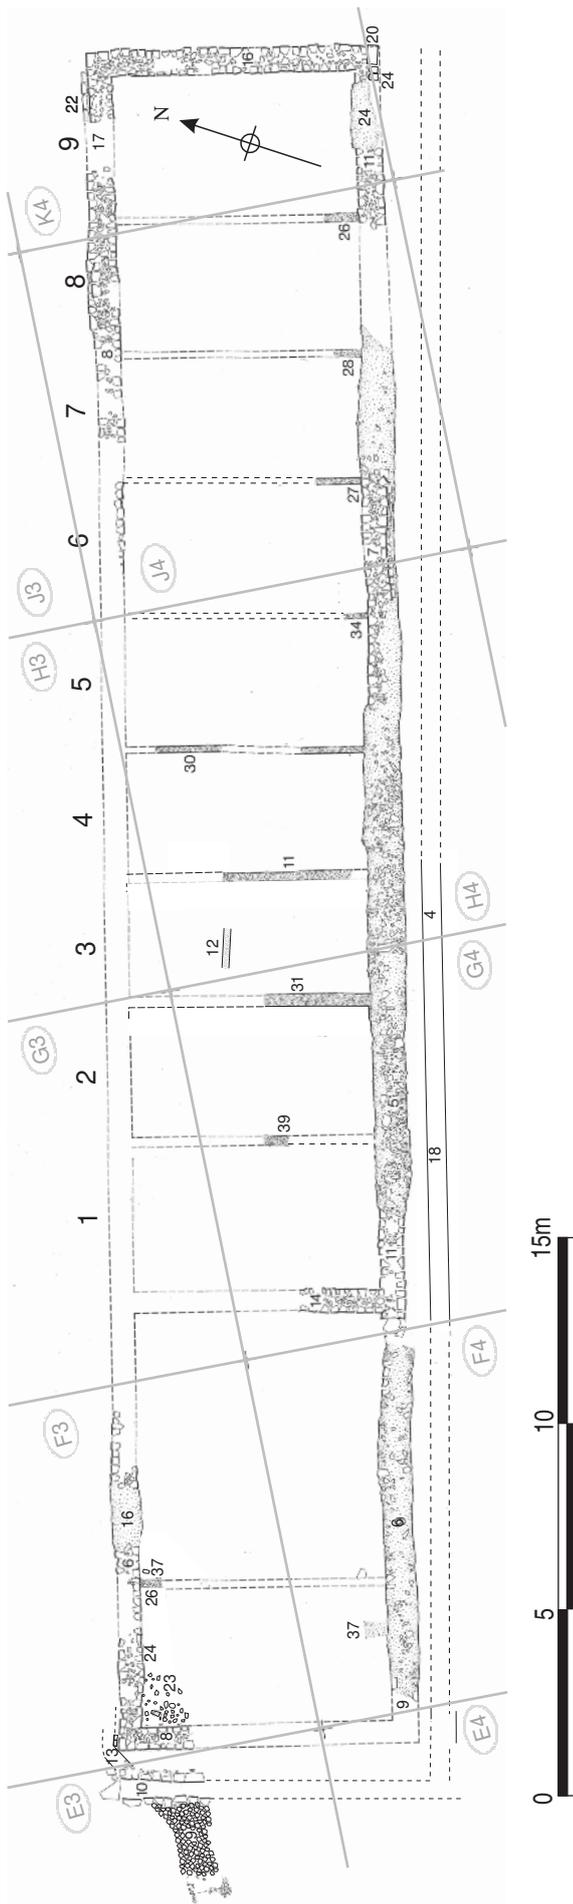
Figure 13.15: Building 4, Stone Phase 1 at 1:200.

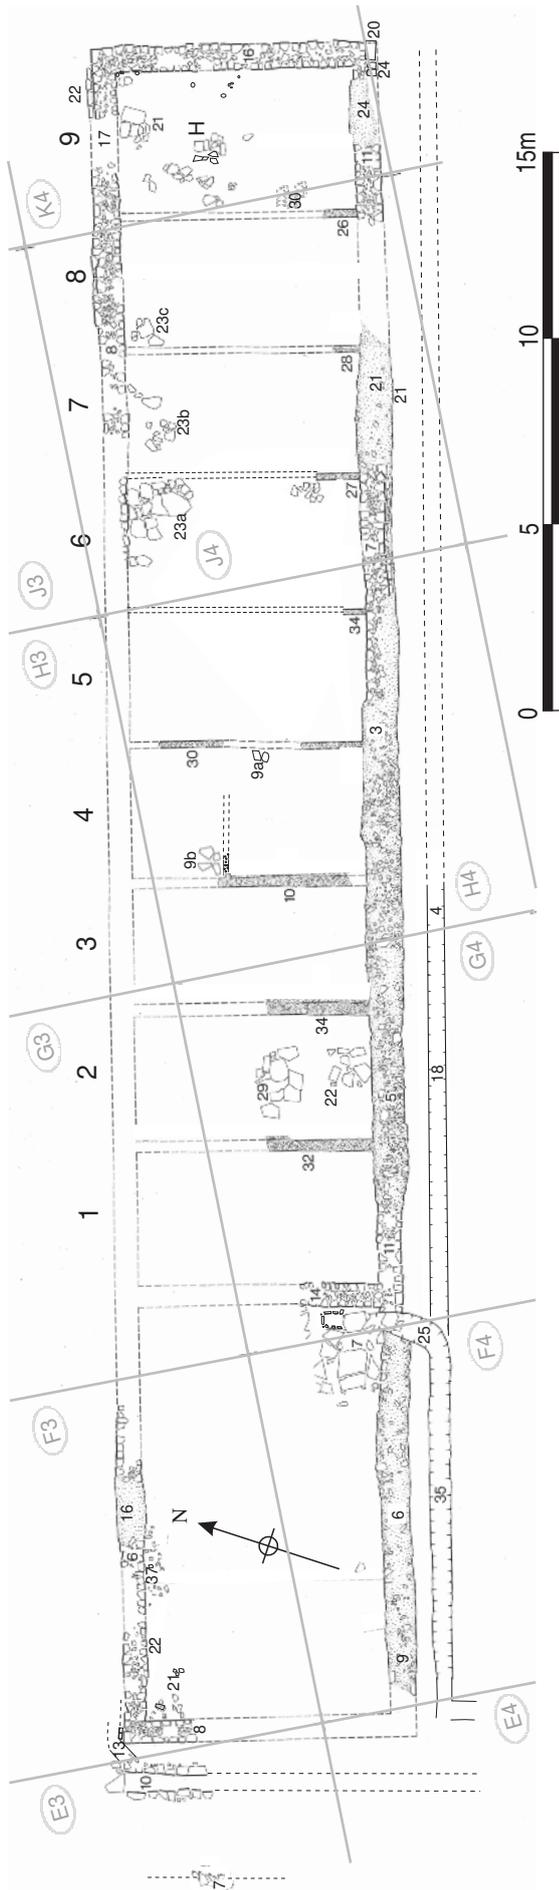
Figure 13.16: Building 4, Stone Phase 2 at 1:200.

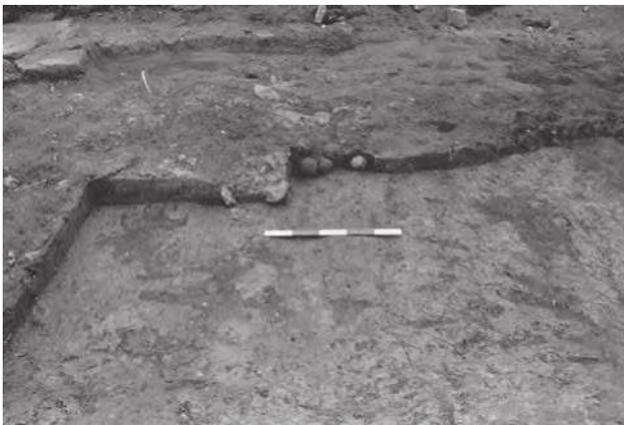
Figure 13.17: *Ballista* balls filling partition slot G04:31 in Building 4 *Contubernium* 2

*Contubernia* 2 and 3 were divided by a slot (G04:31) for a partition 3.40m from the line (G04:39) of the west wall of the room. Over 2.50m of the southern end of the slot was uncovered. This measured 0.45m wide × 0.15m deep and had a rounded, dish-shaped profile. The trench first appeared on the surface of the clay make-up (G04:07) as a smear of pink clay. Further investigations revealed a slot containing redeposited clay, grey loam and sixteen throwing stones or *ballista* balls (SF 458–473 – lost). The occurrence of *ballista* balls in the fill of partition slots was not uncommon on the site, but this was by far the largest number recovered from any one slot (Fig. 13.17).

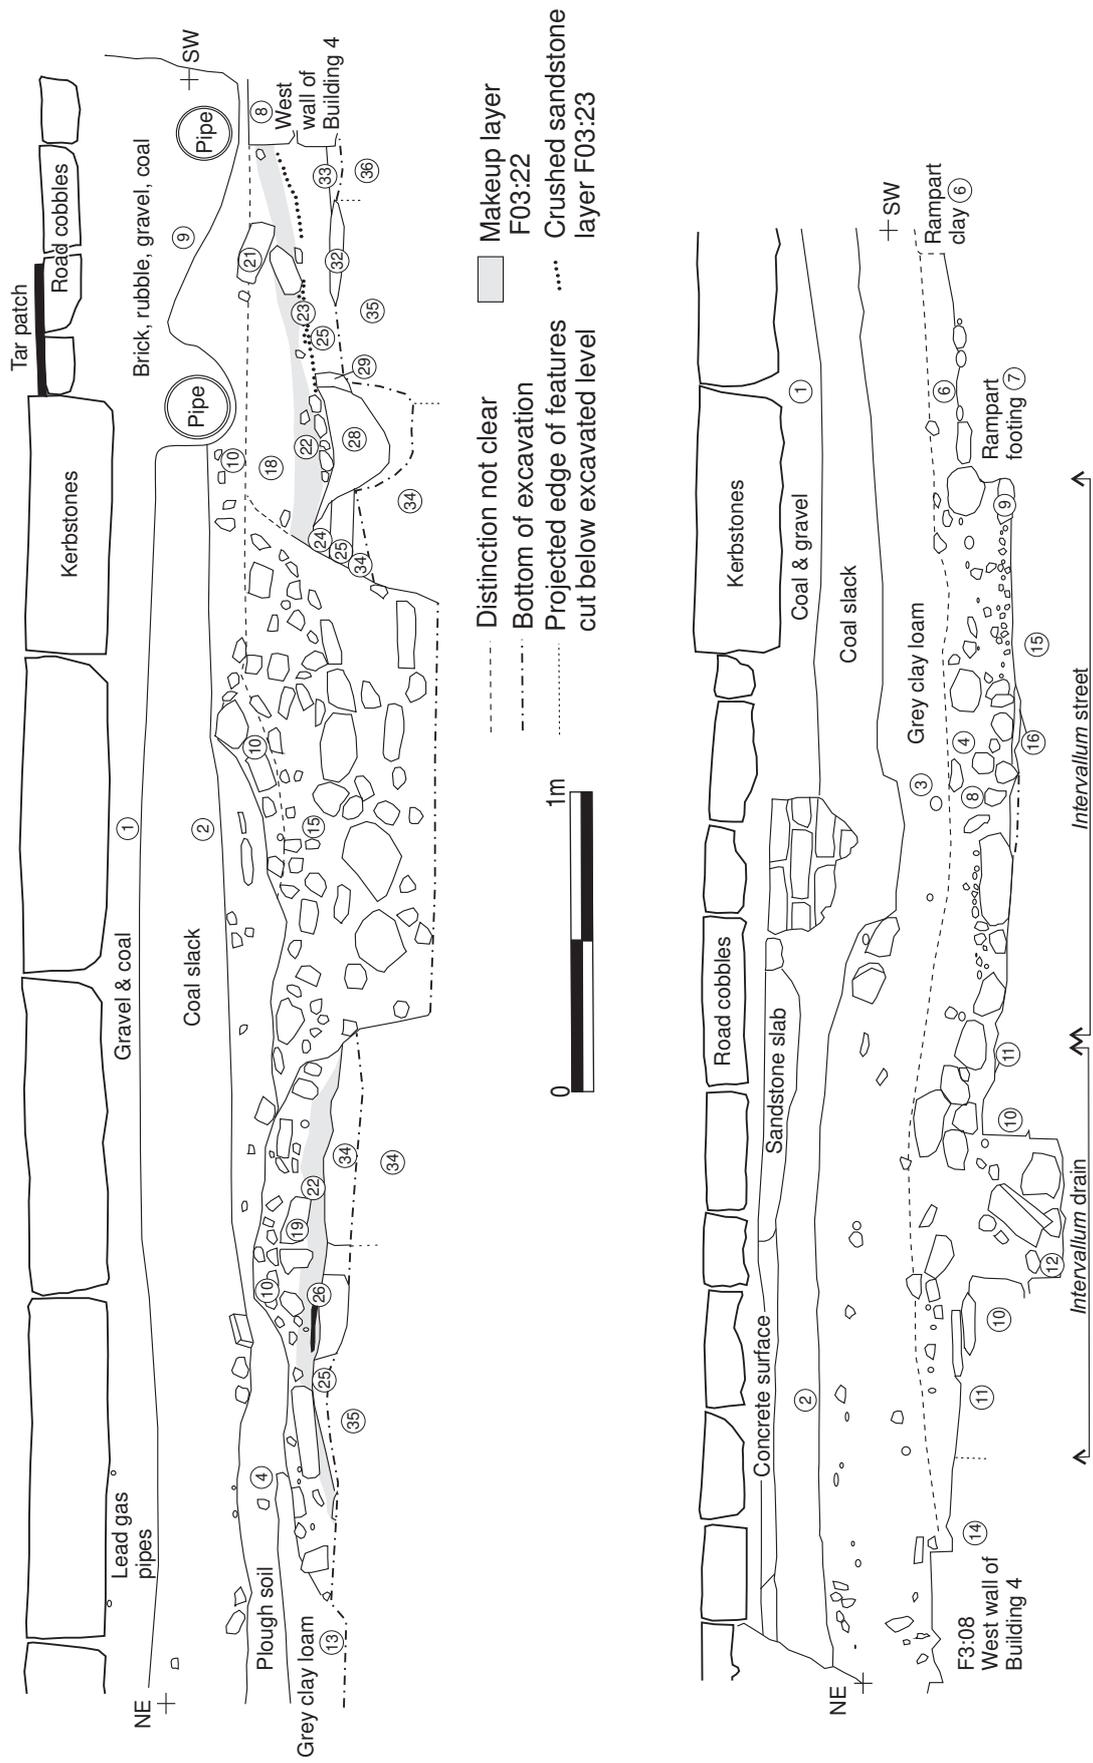
Figure 13.18: Section drawing S49 (E), across NW corner of Building 4 (grid square F03) and Section S49 (W) across the intervallic road and rampart (grid square E03) at 1:25.

#### North-west corner of the building (Figs 13.18, 13.19)

A large pit (F03:15), which perhaps functioned as a soakaway, had been dug right through to the natural in the north-east corner of the room during the later occupation of the officer's quarters. This removed a substantial amount of the stratigraphy in an area already limited by the modern lane and created problems in tracing the true extent of the floors. Most of the following description is taken from the section which lay under the north side of the lane (see Fig 13.18: section S49).

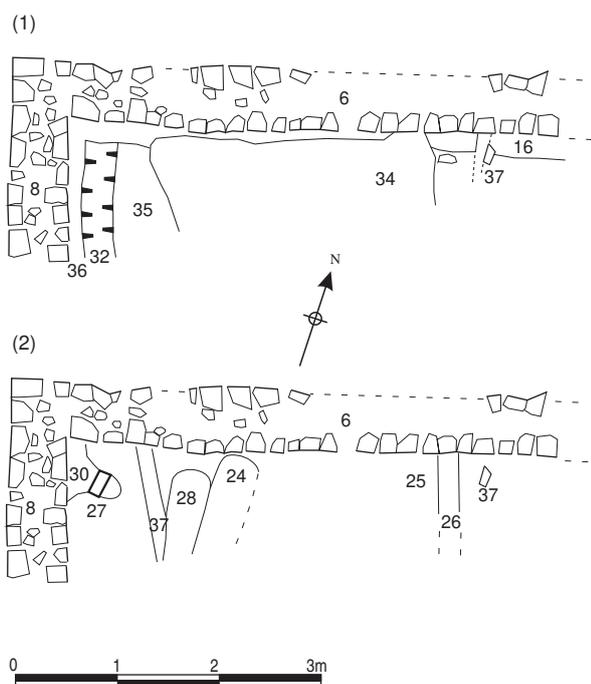
Figure 9 The north west corner of Building 4 sub wing 1 The earliest features cut into natural clay subsoil including cultivation furrow including leveling deposits at

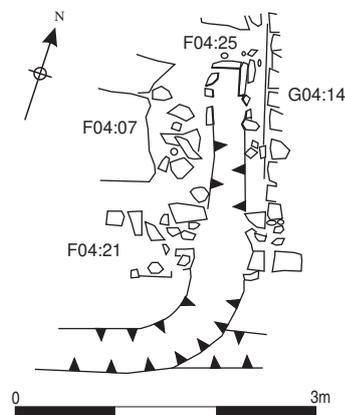
Fig. 10 Plan of latrine F04:25 in the south east corner of the Building 4 officer's quarters. Scale 1:75.

The trench was later re-dug (F04:33) in the direction of the flow west from the point where the channel from the Building 4 officer's quarters latrine (F04:25) entered it. This measure was presumably associated with the construction of the latrine. The new trench was the same width but 0.50m deep. Alterations were made to the course of the channel at its west end which may also be linked to this recutting. A 0.90m long branch (E04:30) was dug at a right angle to the original course to meet the north wall of Building 5. It then turned sharply again to run around the north-west corner of the barrack to connect with the *intervallum* drain a little to the south. The rerouted channel thus took the L-shaped dogleg (Figs 13.28, 13.29). The original channel to the west of the new branch may now have gone out of use, but there is no definite evidence.

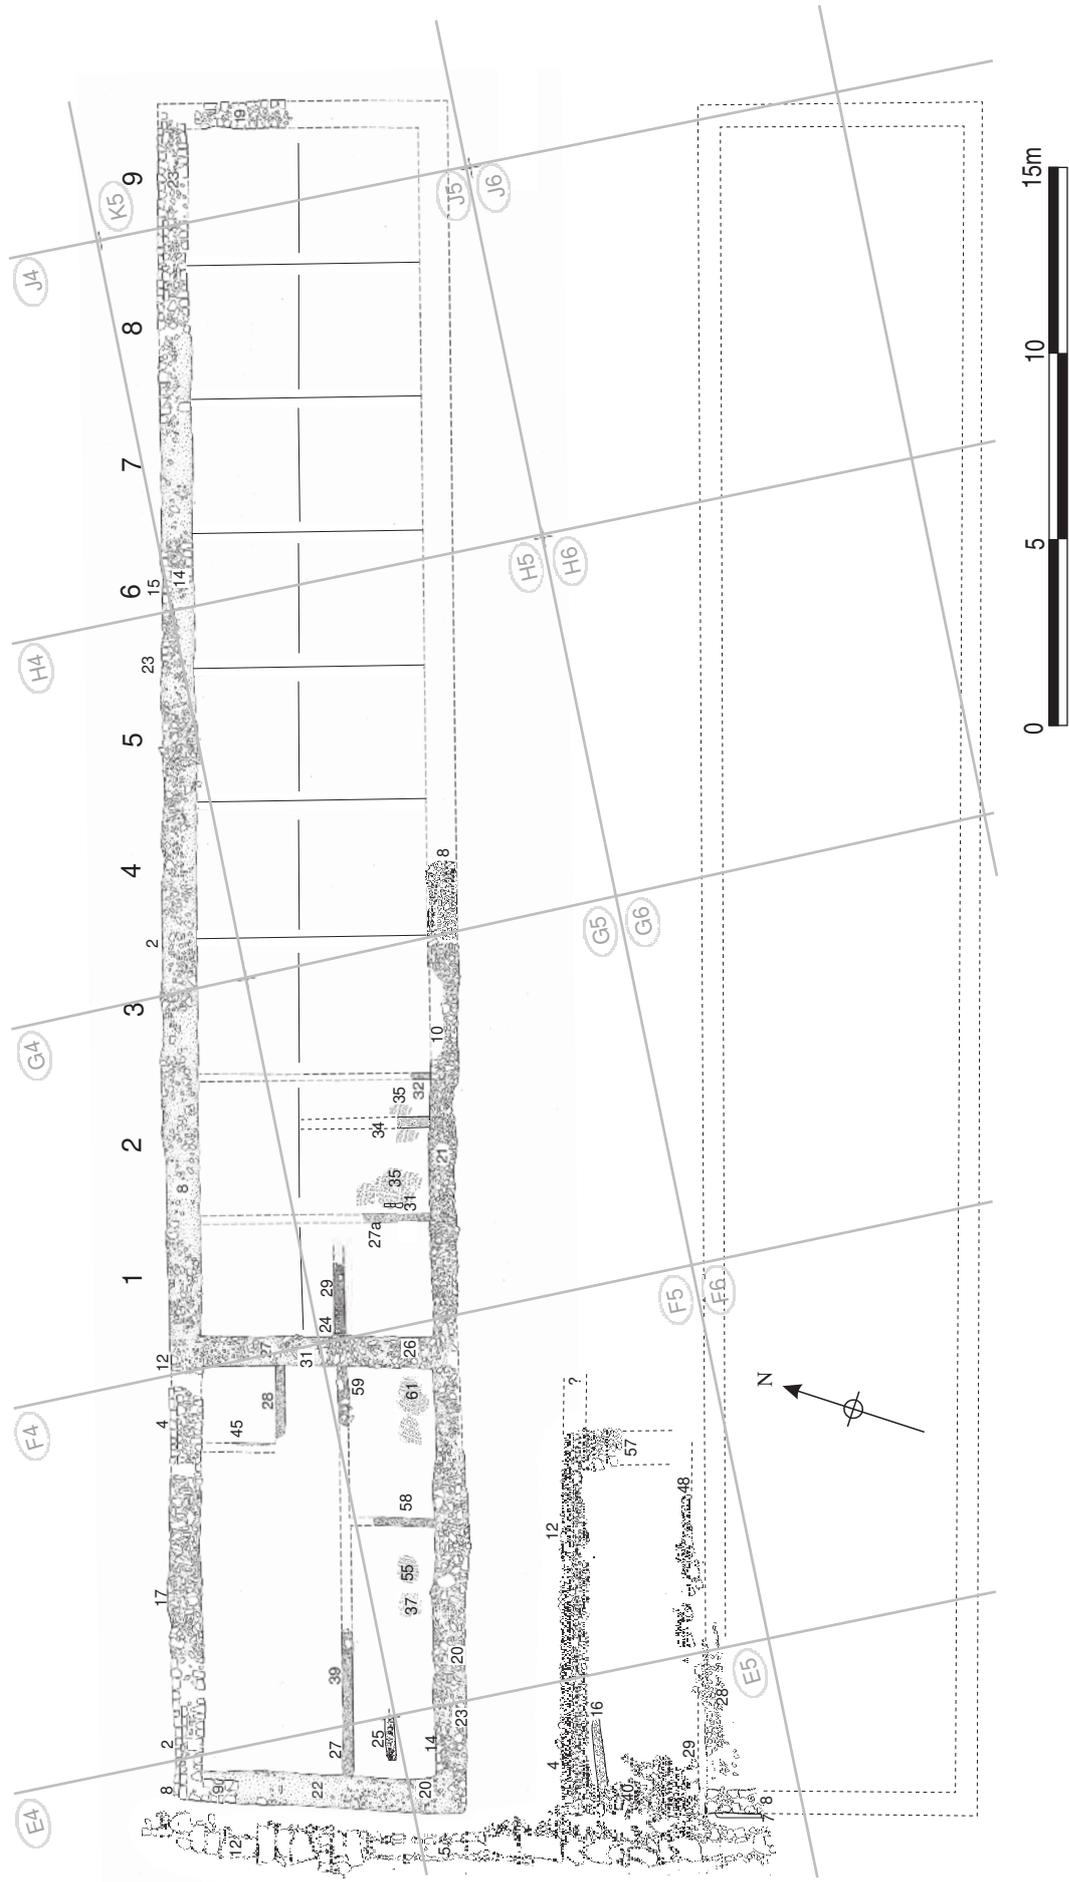
Figure 13.21: Buildings 5 and 6, Phase 1, all features. Scale 1:200

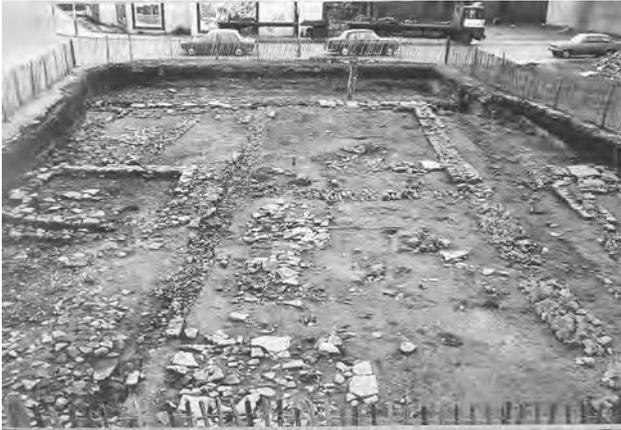
Figure 13.22: 1975 excavation Site 2 looking west mainly showing the west end of Building 5 – foundations and wall footing of Stone Phase 1 (Period 2). Fragments of the third-century barrack phase can be seen surviving over the former street to the south (left).

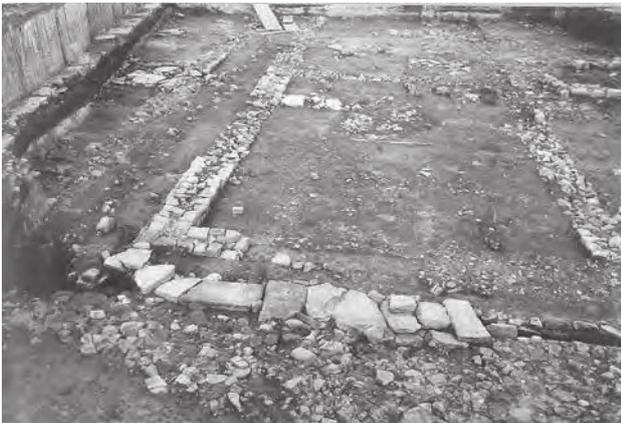
Figure 3 West end of Building 5 with the stone-capped intervallum street drain in the foreground and the north-west corner of the building visible behind.

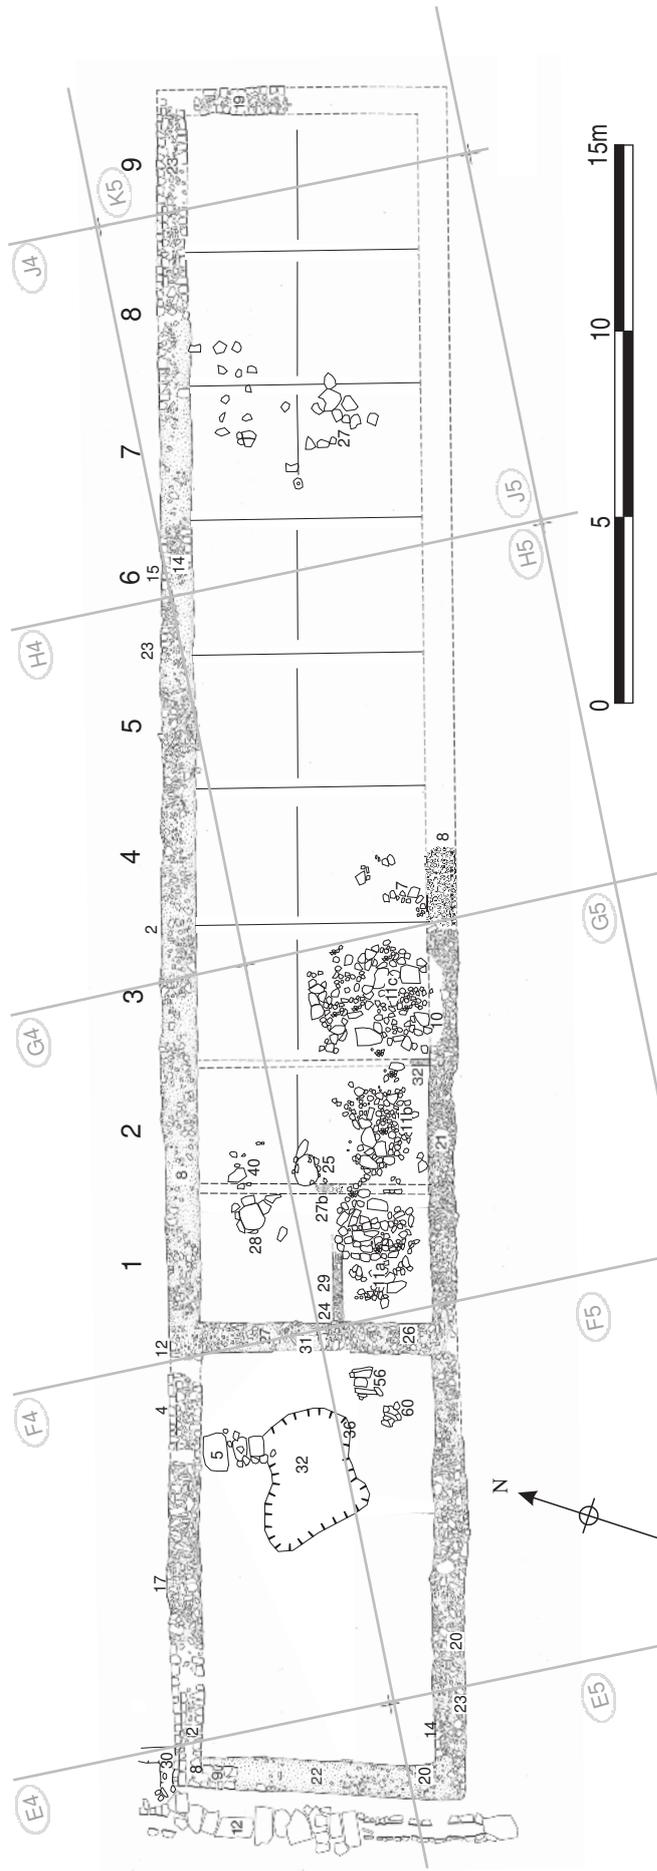
Figure 13.24: Building 5, Phase 2 and possible later features. Scale 1:200.

### The contubernia (Fig. 13.24)

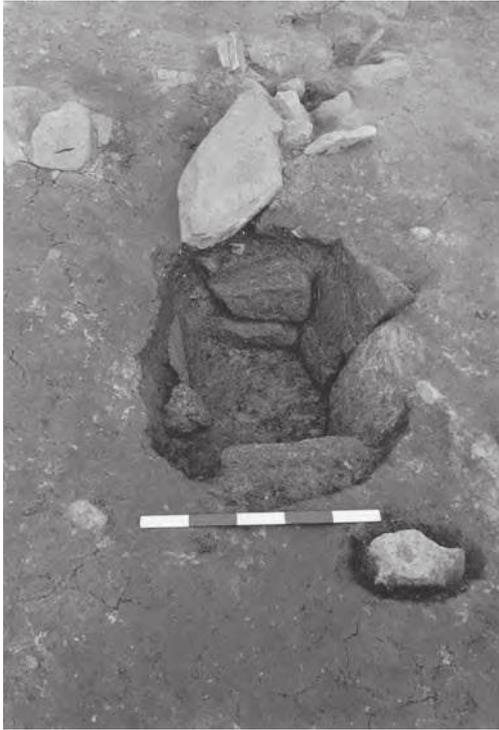
Figure 13.25: Stone box G05:25 in Building 5.

three Gillam 151 rims dating to the third century (G04:28). There was a single sherd of samian, from a Curle 21 dating from the late second or first half of the third century. The cist in *Contubernium* 2 produced only a body sherd of BB2 and two sherds from a Form 30 dated 150–80 (G05:25). These assemblages may reflect the backfilling of the stone boxes, perhaps at the end of the barrack's life.

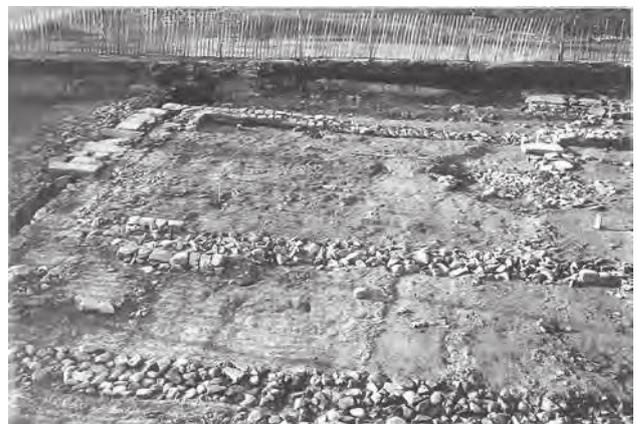
Figure 13.27: The unfinished foundation of Building 6 in the foreground with Barrack 5 beyond, looking north.

### Earlier wall foundations (Fig. 13.27)

in width from 0.80m–0.85m, these comprised a west foundation (E05:40) corresponding to the western end of the building, a north foundation (E05:11, F05:12), which ran 10.10m eastwards to join up with another north–south aligned foundation trench (F05:57). There was no trace of the north foundation to the east of E05:57, giving the assemblage the appearance of a wing, projecting north of Building 6. The foundations were clearly overlain by the lower (E05:12) of the two metallised surfaces covering the street between Buildings 5 and 6 (Alley 4) and must therefore be early in the life of the fort.

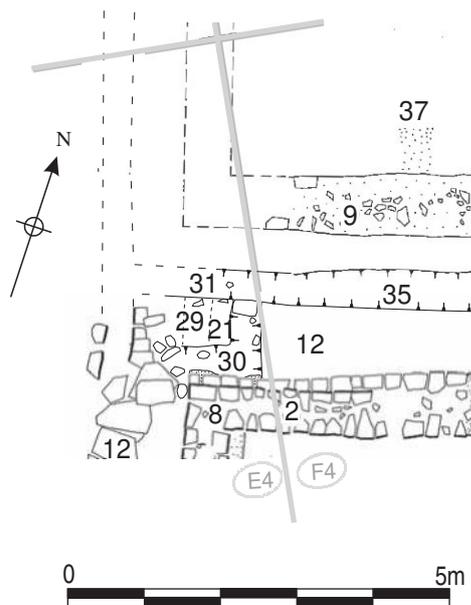
Figure 13.28: Plan showing arrangement of eaves drip channels and intervallum drain at the west end of Alley 3 between Building 4 and 5. Scale 0

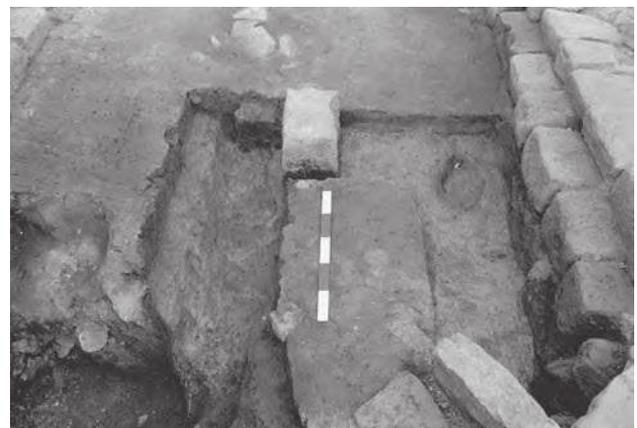
Figure 13.29: Eaves drip and gutter channels at west end of Alley 3

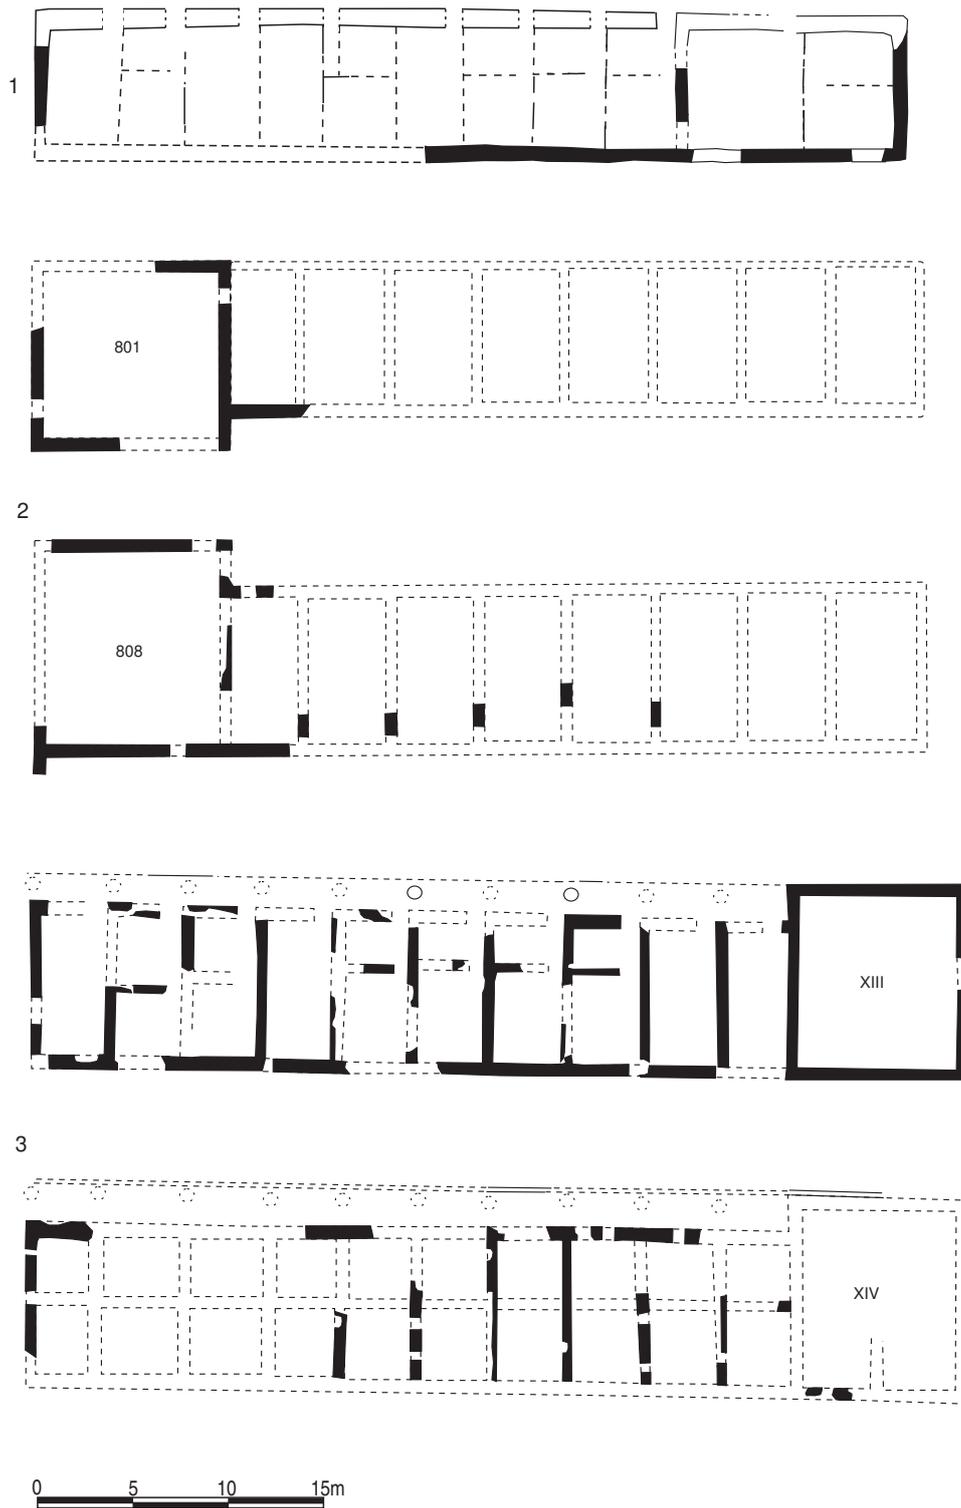
Figure 13.30: Second-century infantry barracks: 1. Wallsend Building 1 Phase 1.2, 2. Birdoswald Buildings 801 and 808, 3. Housesteads Building XIII and XIV (©)

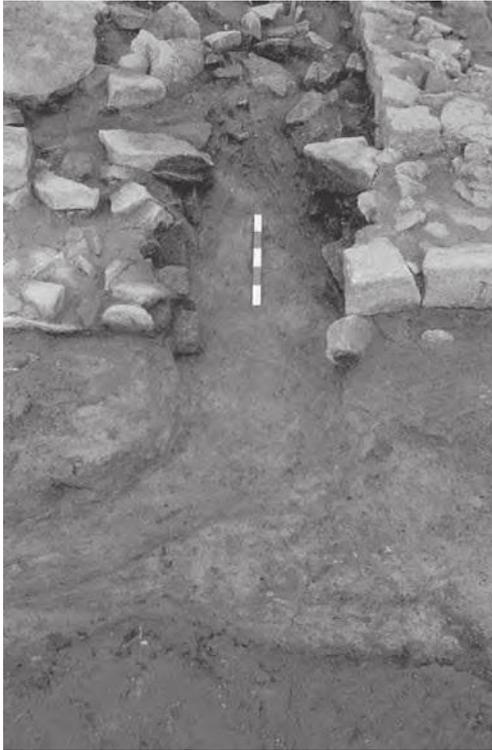
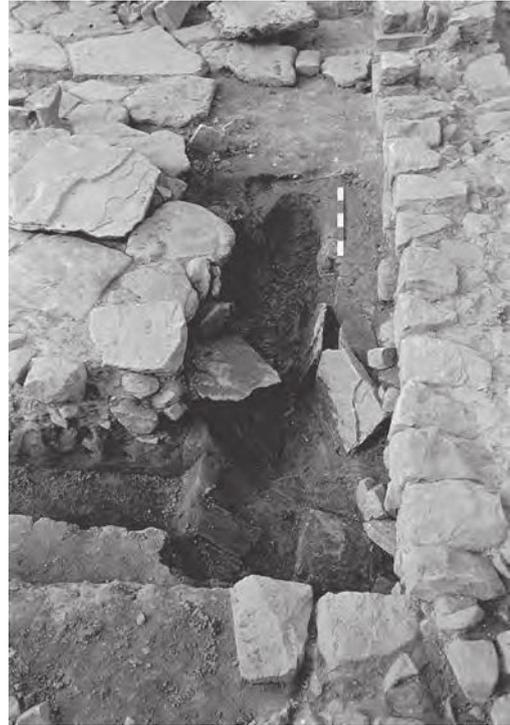
Figure 3 Latrines in the corner of the centurion's quarters: left – Building 4 right – Building 1

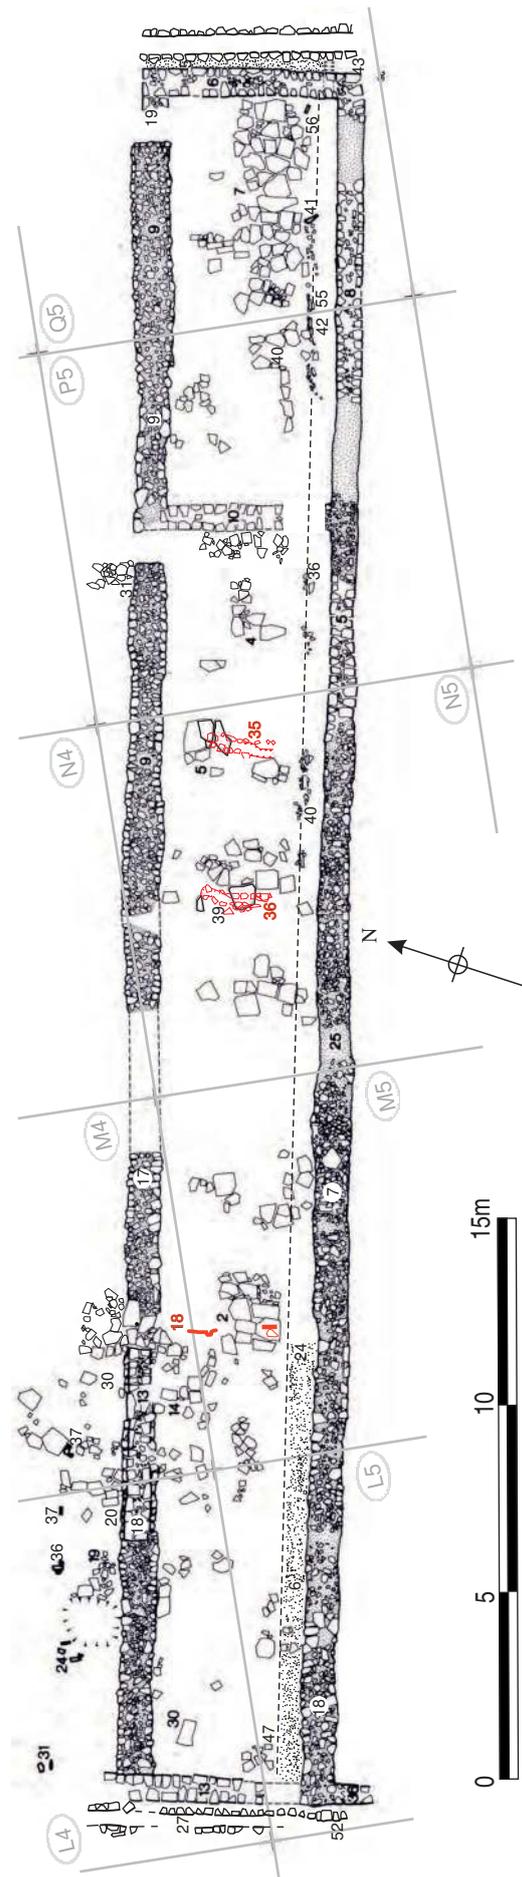
Figure 14.01: Building 1, Phase 2 stable at 1:200.

The second, main, stone-built phase in Building 1 involved the demolition of the former barrack block and the erection of a narrower building over the site. The new building appears to have formed one, long, open building or hall, with no obvious partitions or dividing walls (Fig. 14.01). A new flagged floor replaced that of Sub-Phase 2, in some areas directly overlying the former slots of the dividing partitions. A drain ran along the south side of the interior for the complete length of the building, probably using the former flagged floor as the drain bottom. To the north of the building a timber supported verandah

was constructed over the demolition deposits of the barracks. The combination of stone flooring, internal drain and an absence of internal partitions suggested the building may have functioned as a stable.

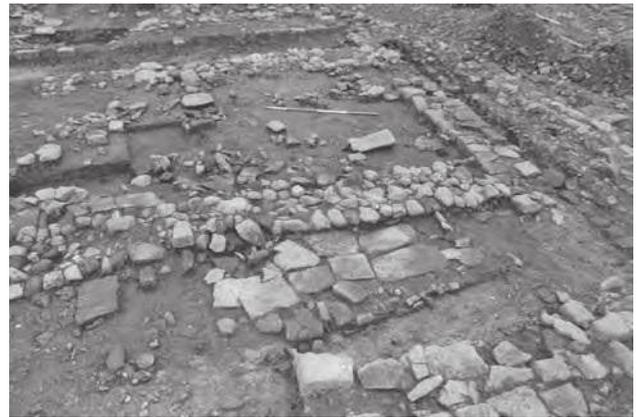
Figure 14.02: The Phase 2 stable foundations overlying barrack period flagging.

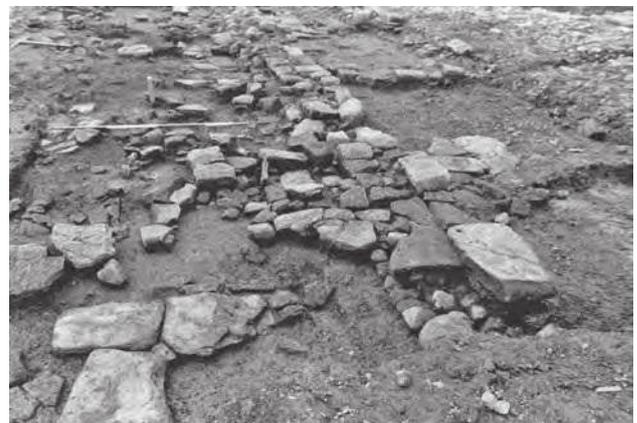
Figure 14.03: The north wall of the third-century stable, looking west with successive levels of flagged flooring evident, including an earlier barrack floor (Stone Phase 1) in the foreground. A threshold stone with pivot hole, belonging to a doorway in the stable wall is visible in the foreground.

abruptly ended 1.00m short of the east wall. The west side of the new section of north wall (Q05:19) had been damaged or robbed so the width of the doorway could only be estimated. Another could be seen 11.00m from the west end of the building, immediately east of the section of north wall (M04:13) which had survived. The east end of the wall had been squared off at this point and several large flags, a continuation of the floor (M04:14) over the interior, extended across the cobble foundation east of this, giving a doorway 1.30m wide. A possible pivot hole visible in surface of the largest slab (Fig. 14.03) might, however, imply a doorway no more than 0.60m wide, but the slab may have been recycled from an earlier *contubernium* doorway. A third entrance was suggested immediately west of the former dividing wall where a 0.90m gap had been left between the foundation and the fragment of new north wall.

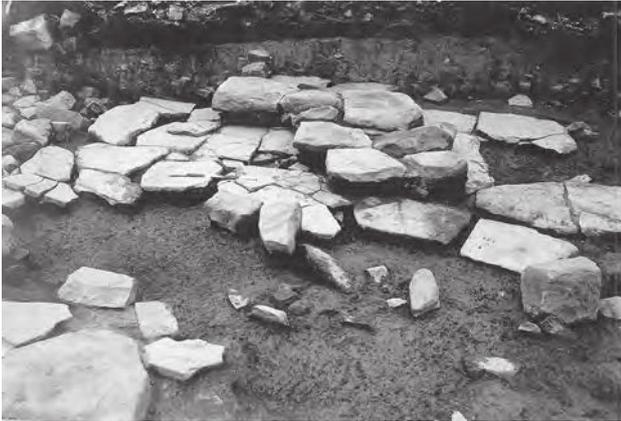
Figure 14.04: Phase 2 stable flagging (M05:02) overlying the Phase 1.2 flagged floor (M05:08) in the south room of Contubernium 6 from the east

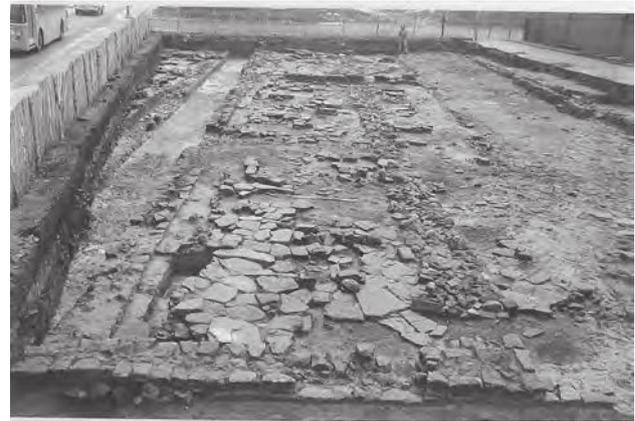
Figure 14.05: Building 1 looking west in the SE corner. The Phase 2 stable flagging is exposed in the SE corner with the Phase 1.2 flagging of the centurion's quarters visible to the right, cut by the cobble foundation of the Phase 2 building's north wall.
