# SEGEDUNUM

Excavations by Charles Daniels in the Roman Fort  
at Wallsend (1975–1984)

VOLUME 1: The Structural Remains

Alan Rushworth and Alexandra Croom

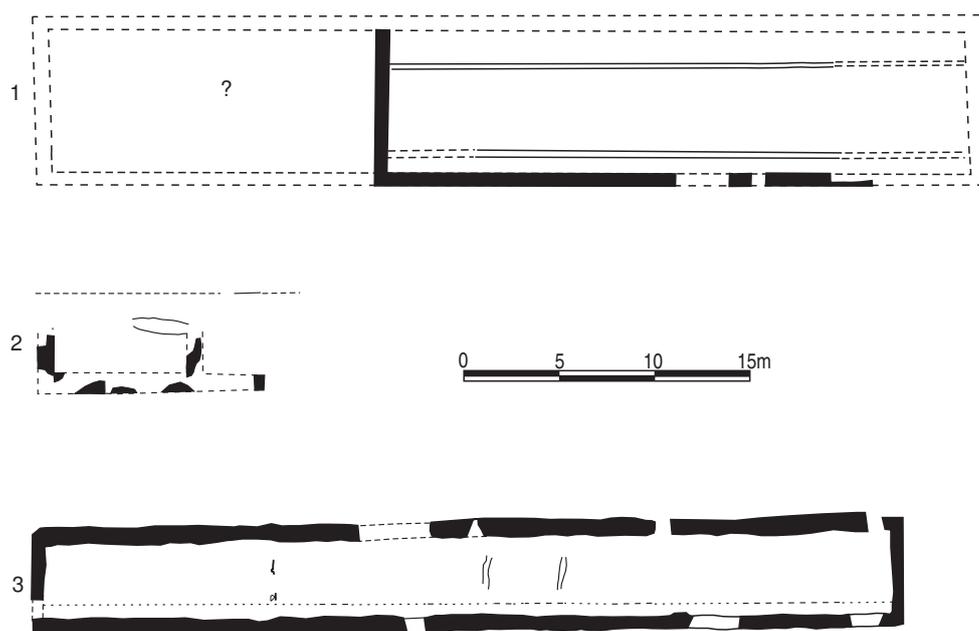
Figure 14.06: Stables at 1. Housesteads Building XV Phase 3, 2. Vindolanda, 3. Wallsend Building 1 Stone Phase 2. Scale 1:400

if these were not stabled in the centurions' houses. Building 1 was probably intended to perform such a role. A useful comparison is provided by the stable identified at Housesteads, Building XV Phase 3 (also a third-century building), which was located in a fort housing a peditate infantry cohort (though reinforced by a unit of Frisians which may have included cavalry). This was a broadly similar structure – a rectangular, undivided hall with a flagged floor, but featuring two parallel, capped drains running along its full length (Fig. 14.06). Building XV was double the width of Wallsend Building 1 and could probably accommodate two facing rows of animals. Another building furnished with a lateral drain which has been interpreted as a possible stable was located in the east rampart space at Vindolanda (Bidwell 1985, 72–4). It took the form of a rectangular building, 4.15m wide internally and in excess of 11.7m in length, set against the inner face of the curtain wall and this too was probably intended as general provision for pack animals rather than specifically for the cavalry mounts of the equitate cohort stationed there (Hodgson and Bidwell 2004, 128).

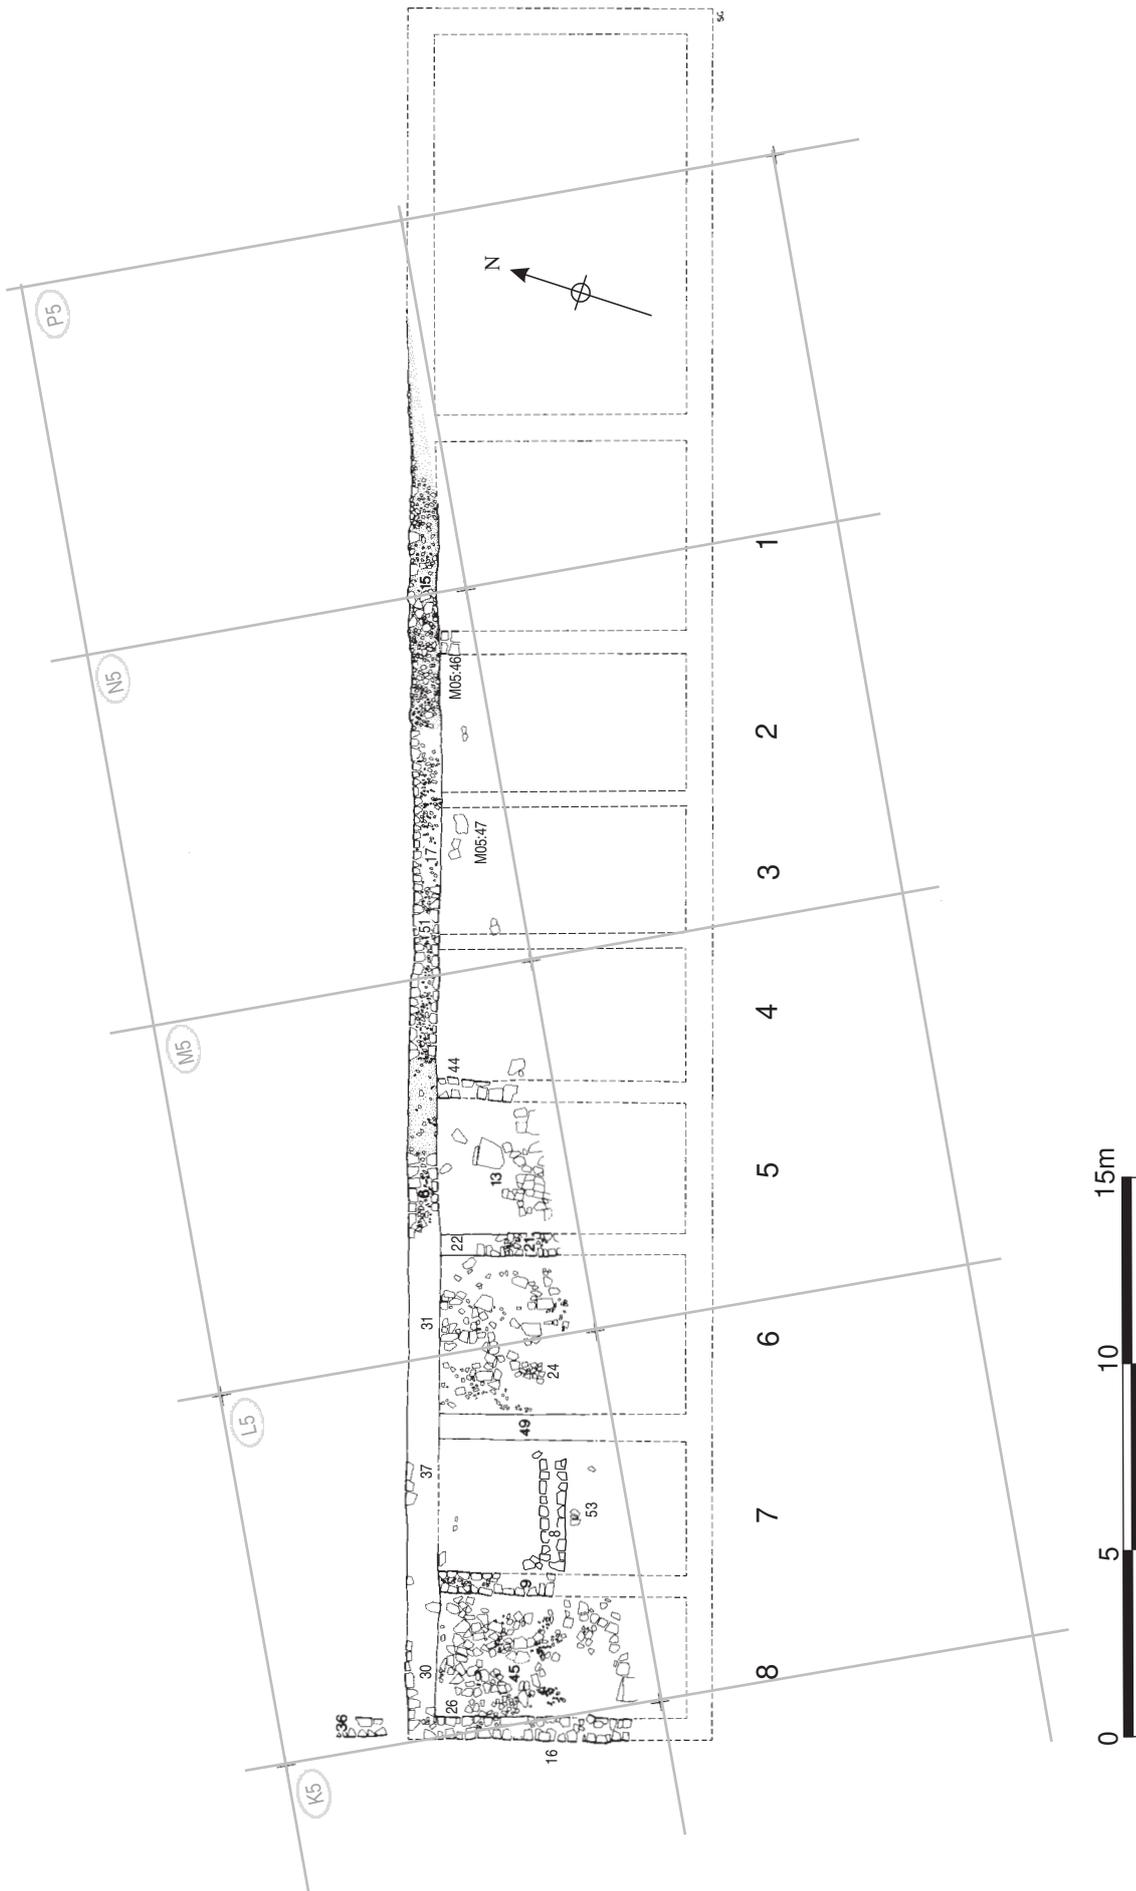
Figure 14.07: Building 2, Phase 2 at 1:200.

A substantial remodelling, evident right across the interior of Barrack 2, represented Stone Phase 2 in that building. This involved the demolition of the wooden partitions between the *contubernia* and the construction of stone walls instead, which probably

separated one fewer *contubernia* than previously, whilst the floors were covered with a further level of stone flagging. The spacing of the walls was not very regular, varying between 3.30m and 4.30m. Considering the extra space taken up by the stone walls, by comparison with timber partitions, and even using the minimum *contubernium* width as an average for those *contubernia* which were not uncovered, the maximum possible number of *contubernia* that could be fitted into the estimated space in Phase 2 would be eight. The lack of a cross-wall in the most westerly *contubernium* might imply that this performed a specialised function – equipment storage for instance – which would further reduce the potential size of the *centuria* occupying the Phase 2 barrack block.

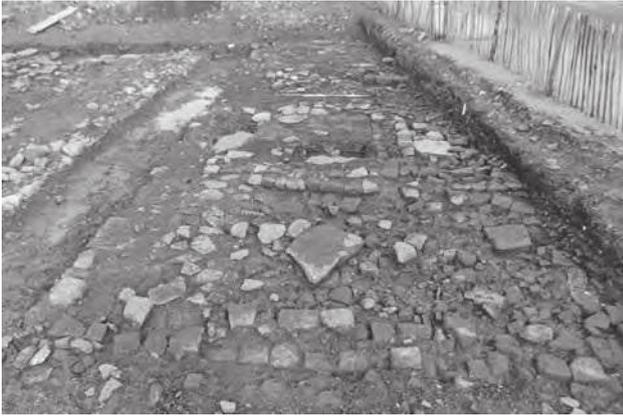
Figure 14.08: Building 2, looking from the west end of the block showing the third-century barrack levels.

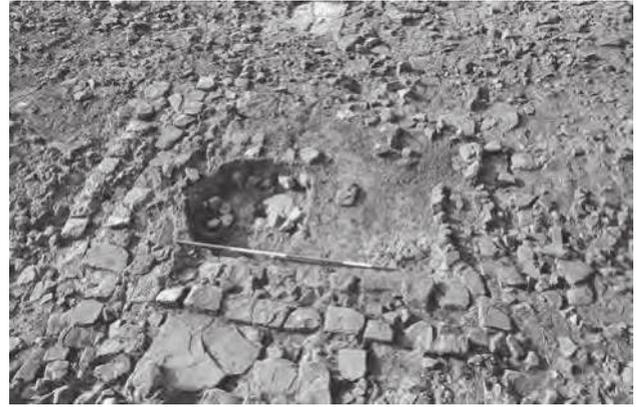
Figure 10 The latest surviving levels in the rear room of the 3rd-century Barrack 2 Contubernium 7 (Daniels Building B), looking north.

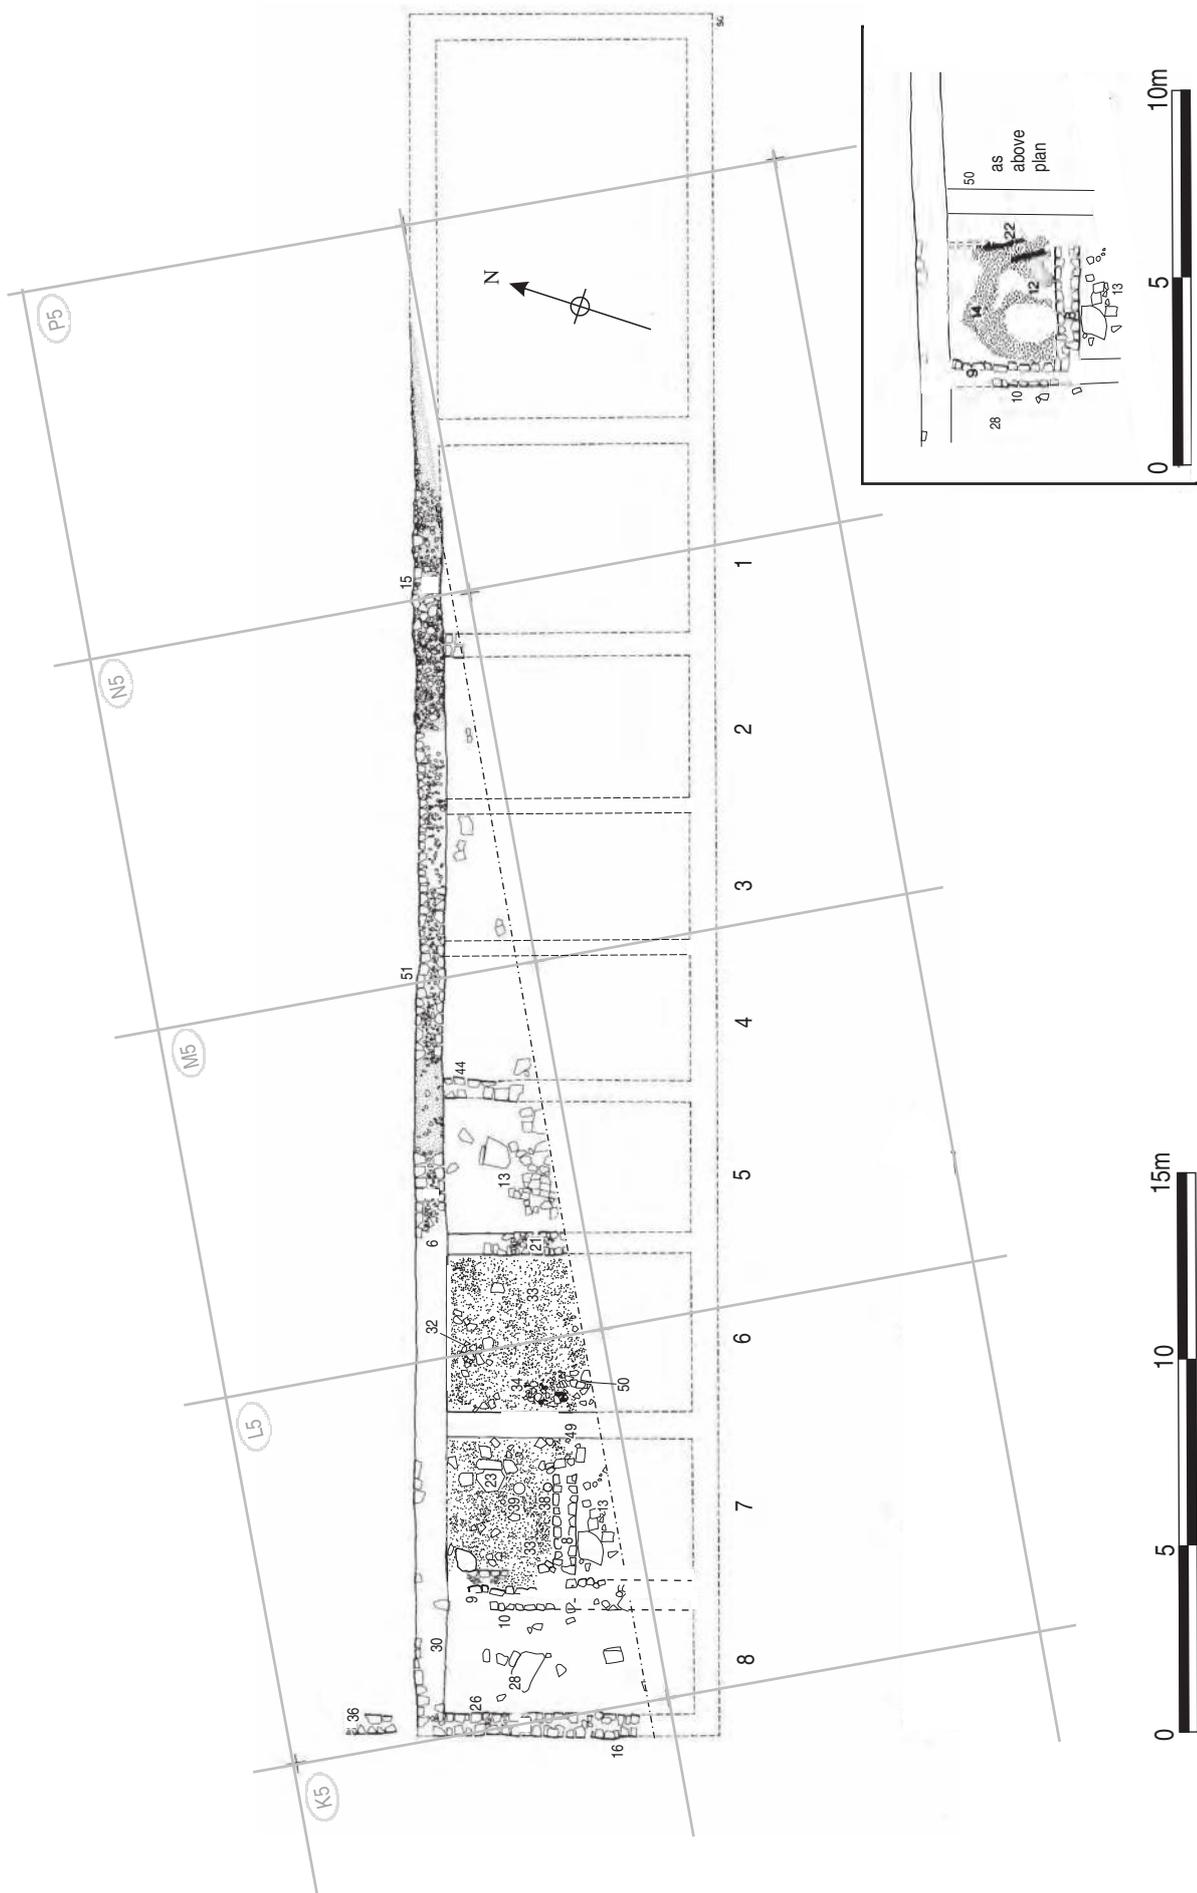
Figure 14.10: Building 2, later modifications to the Phase 2 barrack at 1:200.

The excavators in 1975–6 had interpreted these alterations in a very different fashion, as constituting a distinct phase involving the demolition of most of Building 2 and the erection of three small, irregular 'shack'-like buildings over the site (See Chapter 1: Figs 1.07, 1.08). These 'shacks', labelled 'Buildings B, K and M', were thought to re-use the north wall and the former *contubernia* dividing walls of Building 2, whilst the west wall of Building 2 was demolished to the level of the lowest course and incorporated into the new road surface. Three phases in the occupation of these structures were defined by the excavators on the basis of floor types, which in turn were attributed to Periods 3 and 4 of the fort, corresponding to the early and mid-late fourth century respectively.

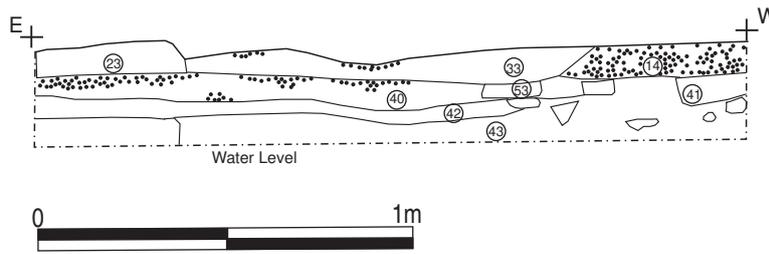
Figure 14.11: Section (S47) across the south face of modern pit L05:27 in Building 2, Contubernium 7, Scale 1:20.

Modern pits (L05:05, 27) had damaged the interior of the *contubernium*, but a layer of grey-buff clay (L05:33), on average 0.08m deep, was uncovered over most of the room (Fig. 14.11). Lenses of coal were found in the upper surface of the clay (L05:14). The clay respected the edges of the south and west walls and extended across the entrance in the south east corner of the room. It overlay the earlier flagging (L05:53) and loam floors (L05:40) of Building 2 and also the former east face of the dividing wall (L05:09). This was interpreted as a floor surface in its own right but may simply represent make up for the flagged floor laid on top (L05:23). Fragmentary remains of this flagging (L05:23) were found over the clay layer and extended over the south-east entrance into the room. One large shattered flagstone on the east side of the room may have been used as

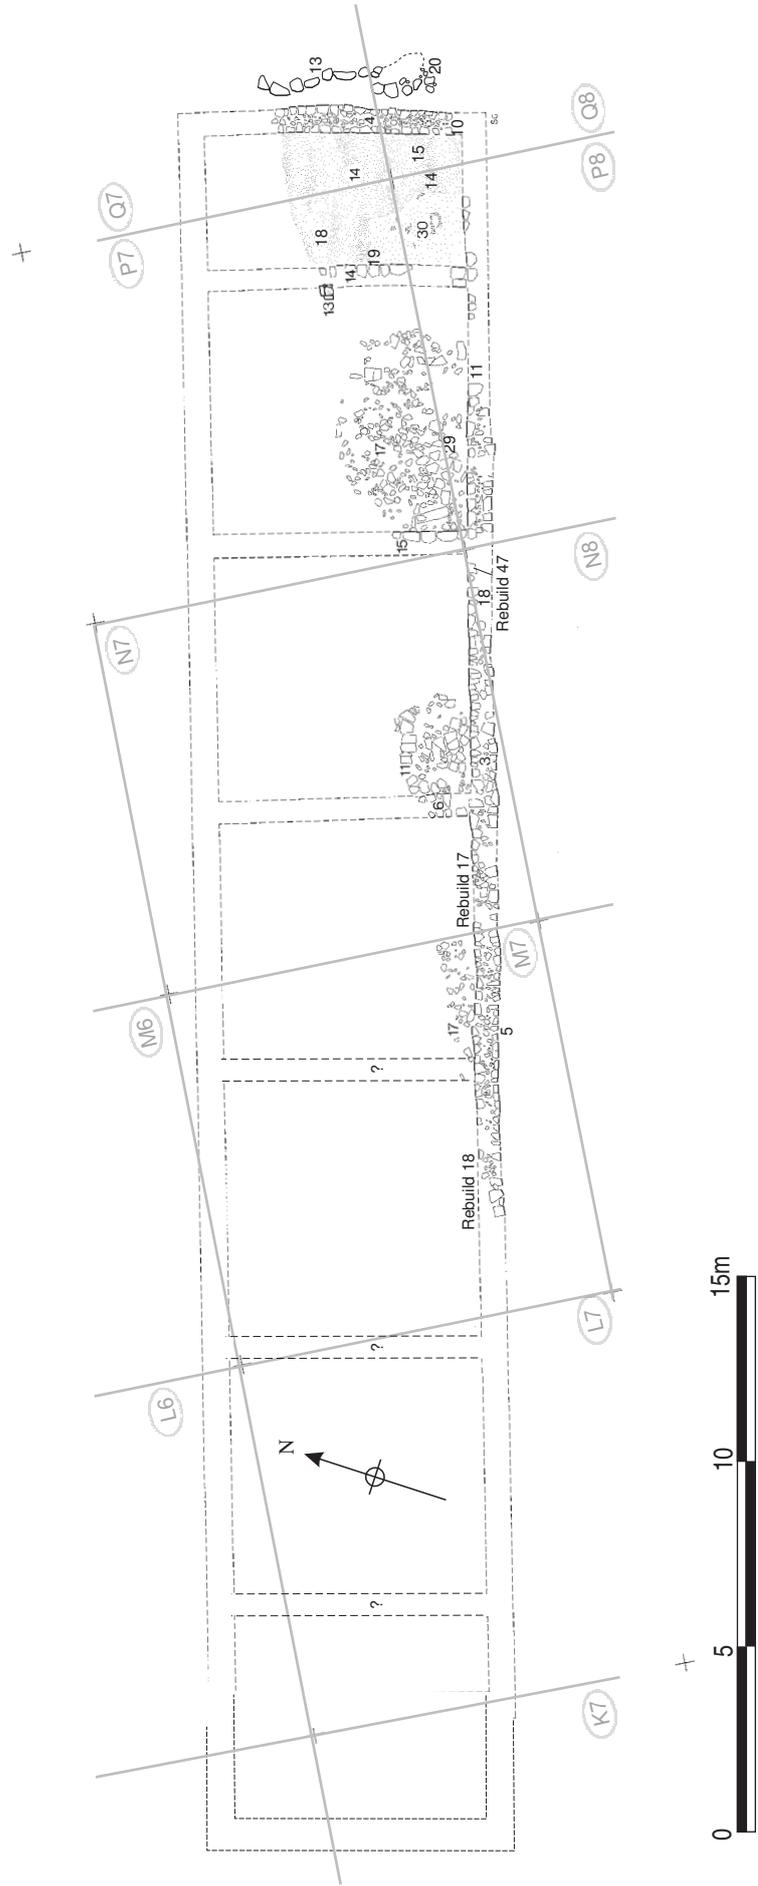
Figure 14.12: North Barracks, Building 3, Phase 3 at 1:200.

Instead of a range of chalets what was actually revealed were two rooms of the rebuilt centurion's house (BG and BH), plus a narrow tapering slice at the rear of several *contubernia* (BE and BF), all forming part of a conjoined barrack block (Fig.14.12). Only one partition wall was identified in the exposed area of the *contubernia*. Others may have been removed by later robbing. This, together with the very limited area uncovered, made it more difficult to understand the layout of the stone *contubernia*. The surviving partition wall was located c. 6.30m from the west wall of the officer's quarters. This would appear abnormally wide for a single *contubernium*, by comparison with those recorded in the better preserved of the third-century *praetentura* barracks such as Building 2 and parts of Building 18, although this is how it was interpreted in the final stage of Daniels post-excavation work, with BF being relabelled *Contubernium* 1 and BE *Contubernium* 2. Based on that spacing, five of these enlarged *contubernia* would fit into the available length of the barrack, allowing for a little minor variation. Alternatively it is possible that an intervening partition wall had been removed leaving no trace. 'Building BF' would then equate to the two easternmost *contubernia*. However these would be uncharacteristically narrow with internal widths of perhaps 2.85m each. If that spacing was replicated in the rest of the block a total of ten *contubernia* could have been squeezed into the available length, one more than in the preceding Phase 1/2 stone barrack, whereas the arrangements exhibited in the better preserved of the rebuilt stone barracks generally seem to imply a reduction in the number of *contubernia* to no more than eight. This contradiction might be resolved if there were smaller rooms at either end of the range which performed functions other than accommodating troops, such as storage or a service area for the officer's house. The Daniels scheme would

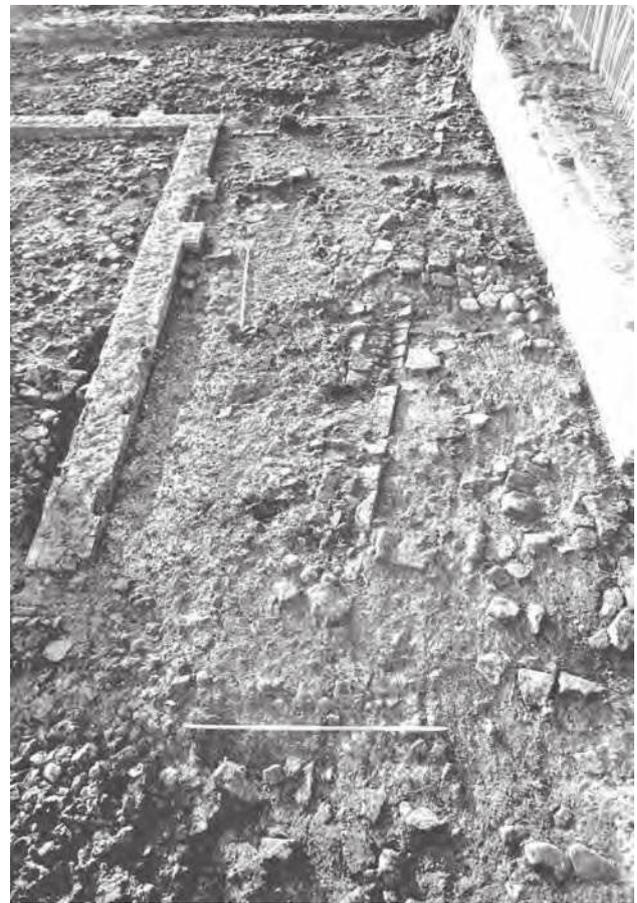
Figure 14.13: South wall of Barrack 3 in grid square M07.

The south wall of the building may have been partially rebuilt as part of this remodelling (Fig. 14.13). Certainly there is clear evidence that the wall underwent at least partial reconstruction at some stage. At four points the wall had been demolished down to its foundations or lowest course and then rebuilt using cobbles and boulders set in yellow clay (M07:18, N07:17, N08:47 and *see* unnumbered stretch on P421). These sections were respectively at least 2.25–3.00m, 3.50m, 1.00m and 1.25m in length and appeared too wide and too ragged to represent doorways, created and then later blocked up, which in any case would only have given access to the narrow alley between the barrack block and Workshop Building 16. The character of the rebuild admittedly does appear rather crude by comparison with the new partition walls (see Fig. 14.14) so might represent a later repair, unless the surviving repair fabric was only the equivalent of a foundation level – perhaps similar to the cobble footing of the rebuilt south wall of Building 1 – with better quality masonry erected above which has not survived.

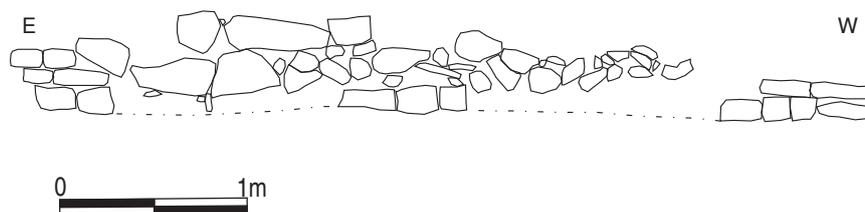
Figure 14.14: Elevation showing the north face of the blocking N07:17 in the south wall of Building 3 (N7:03). Scale 1:40.

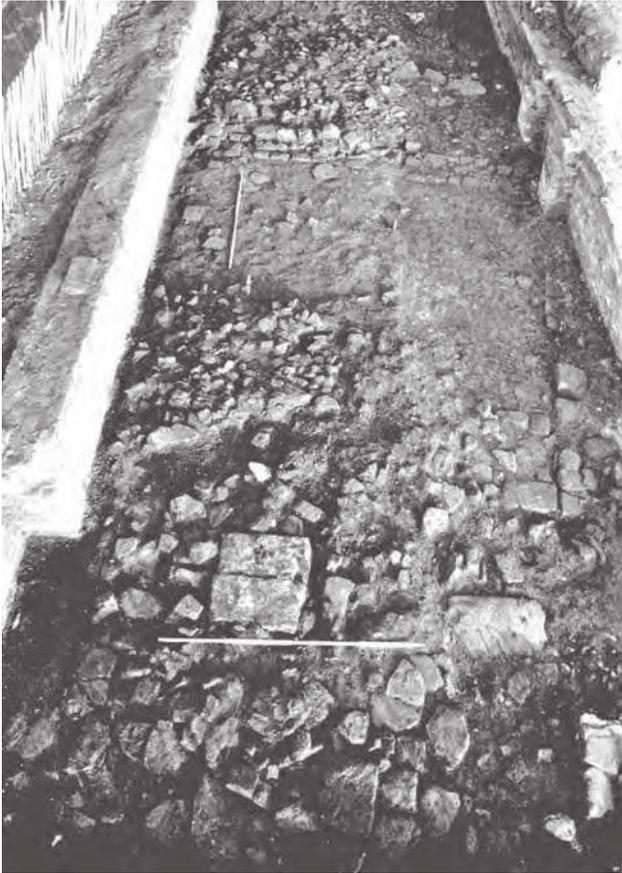
Figure 3 The south east corner of Building 3, the area of the centurion's quarters, looking east.

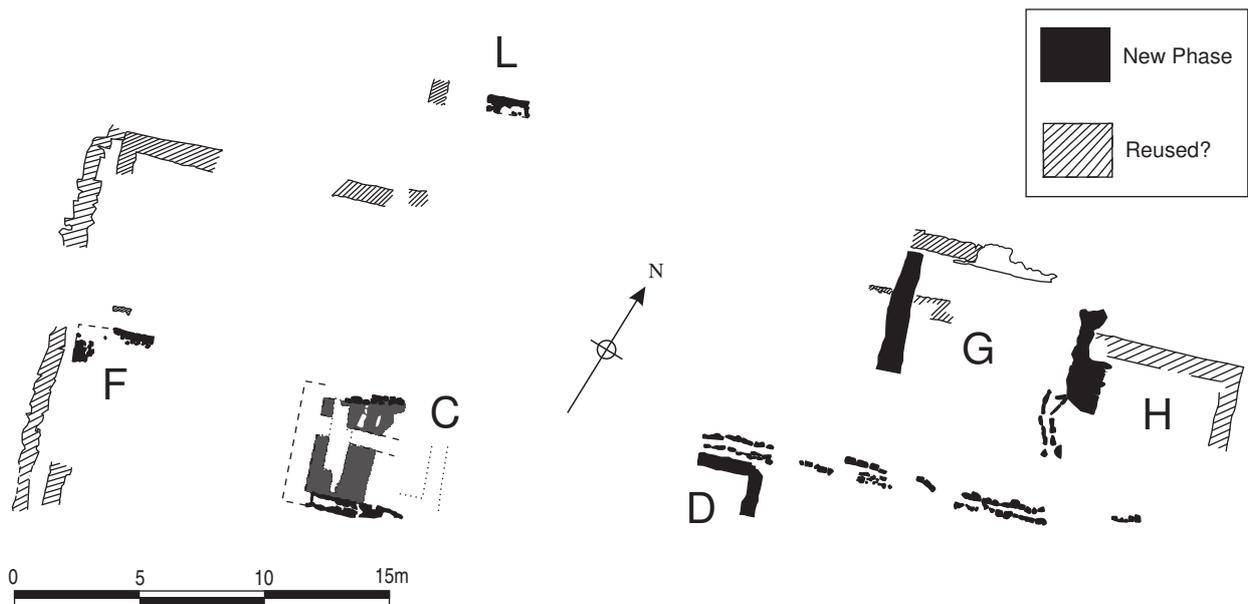
Figure 14.17: Surviving third-century structures in the north-west praetentura, showing walling possibly retained from the previous phase and newly built. Scale 1:300.

### *Introduction* (Figs 14.17, 14.18)

The remains of Building 17 were regarded by Daniels as forming three small distinct structures, which he labelled, from east to west, H, G and L (see Fig. 14.17 above; cf. Fig. 1.07). As restored by Daniels, Building H was a rectangular structure, measuring 4m by 5.5m, which reused the east and north walls of Building 5, along with a newly constructed west wall of which only the external face survived, and was open-fronted to the south. Directly adjoining H on its west side, G was envisaged as a larger structure, some 8.5m (E-W) by 6.7m (N-S), again rectangular and open-fronted, which reused the south wall of Building 4 as its north wall and featured newly constructed east and west walls represented only by strips of rubble marking the position of their foundations. To the north-west, L lay on the edge of the excavated area, with a fragmentary length of newly constructed walling forming its south wall (G04:10) whilst its west wall was apparently represented by the wall which had separated the *contubernia* and officer's quarters of Building 4 (G04:14). A cobbled floor surface was identified inside the building (G04:23), but most of the putative structure would have lain beyond the northern edge of the excavated area, beneath the back alley of Buddle Street and Winifred Gardens, whilst to the east it was destroyed by a broad plough furrow, and hence no clear estimate of its overall size or form was advanced. Some 3m to the west of G, lines of post holes were interpreted as forming the remains of an east-west aligned, rectangular timber building (J), measuring perhaps 14m by 6m. The south and east walls of this structure were well-represented, the north wall less so and the west wall not at all. Daniels suggested this building was a secondary addition to the stone structures in this area.

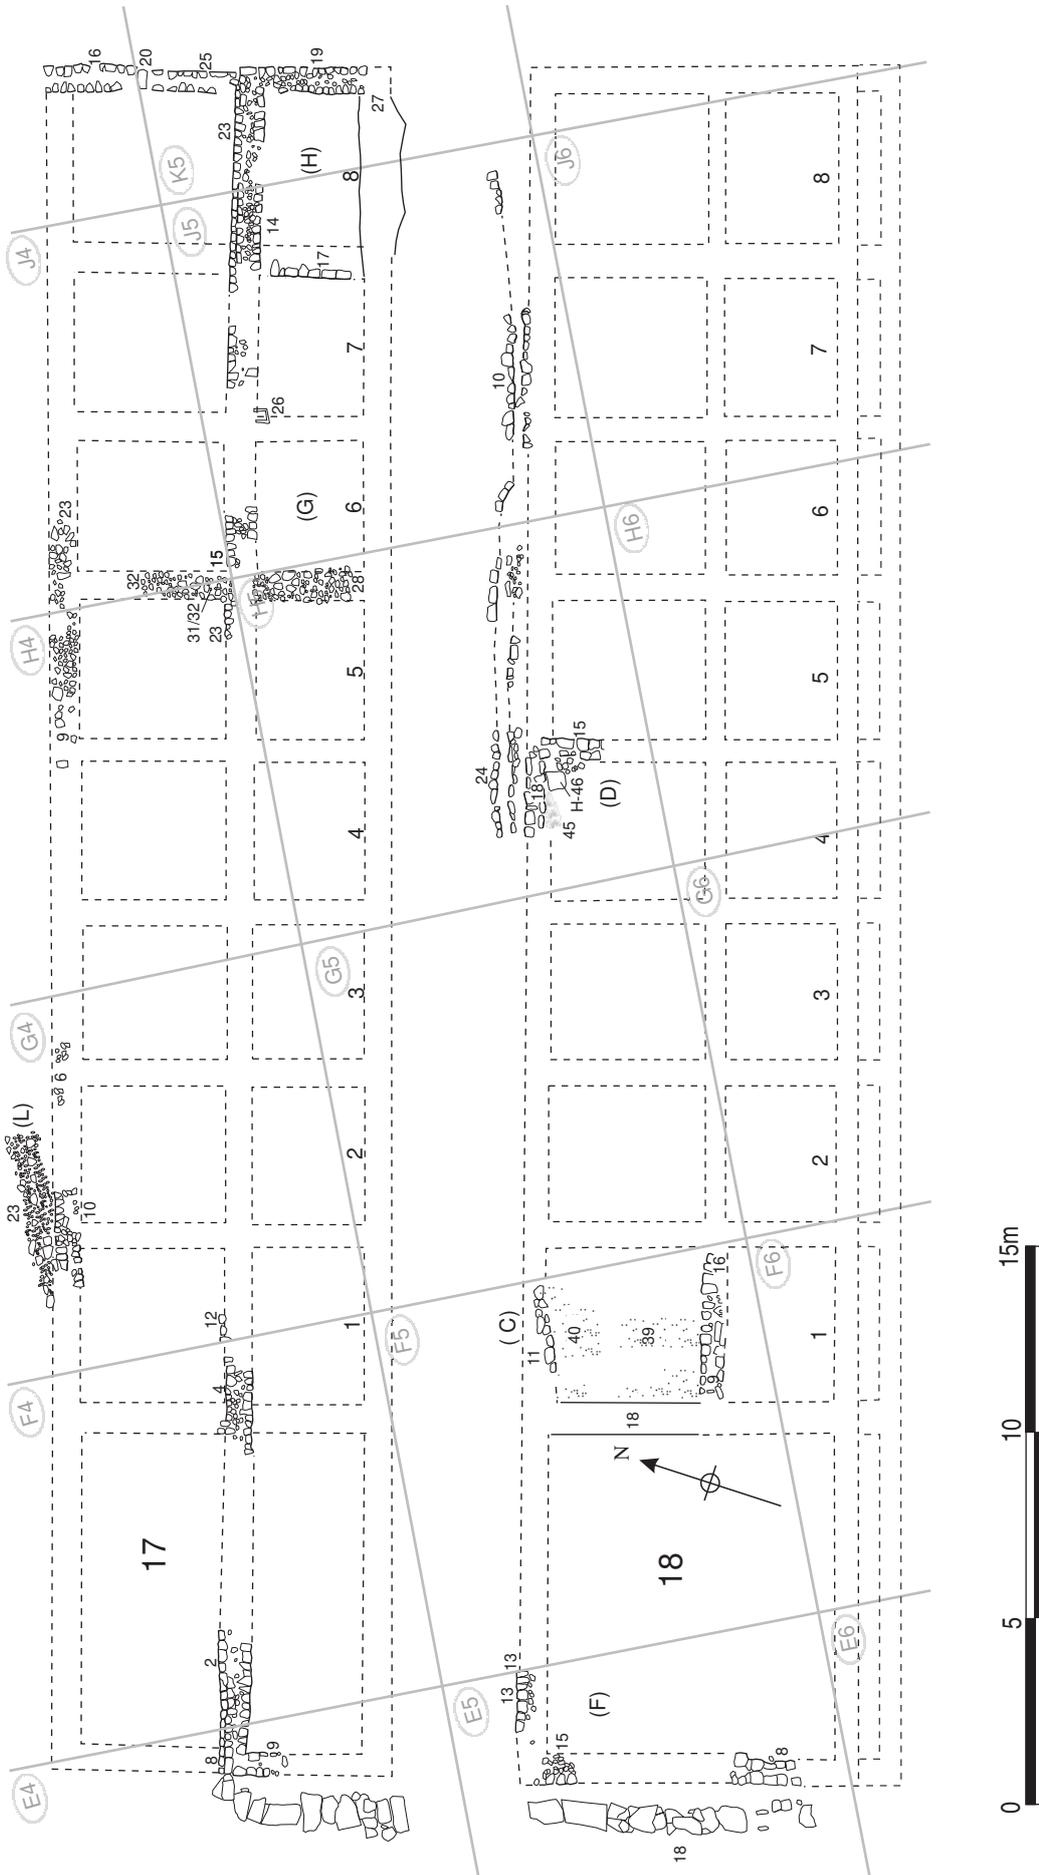
Figure 14.18: Third-century Barracks 17 and 18, with two alternative restorations of the contubernia of 18 with smaller southern front rooms like 17, and with front and rear rooms of equal dimensions. The Daniels building codes are shown in brackets. Scale 1:200

However Fig 14.18 also highlights how small was the proportion of the barrack plan which actually survived, meaning that the remains could quite

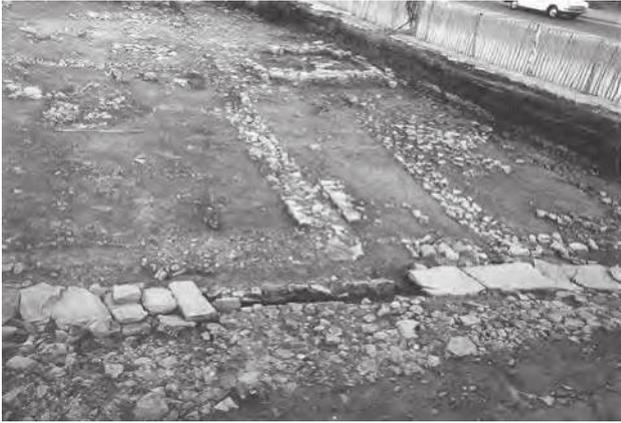
Figure 14.19: The intervallum drain, fragments of the third-century barracks next to the south wall of Building 5 and overlying the unfinished foundations of Building 6 (right), looking east.

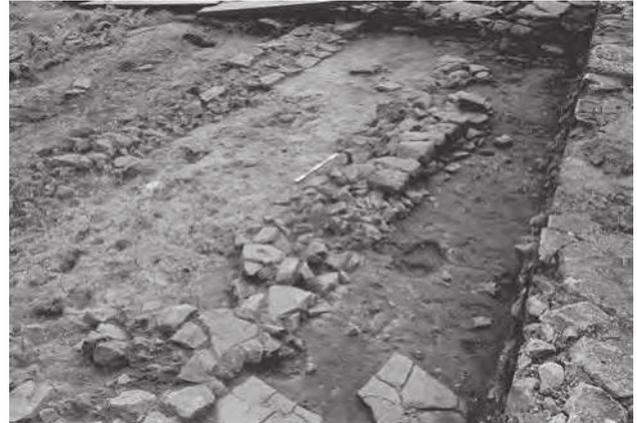
Figure 14.21: North wall of Building 17 (G04:10) from the north east.

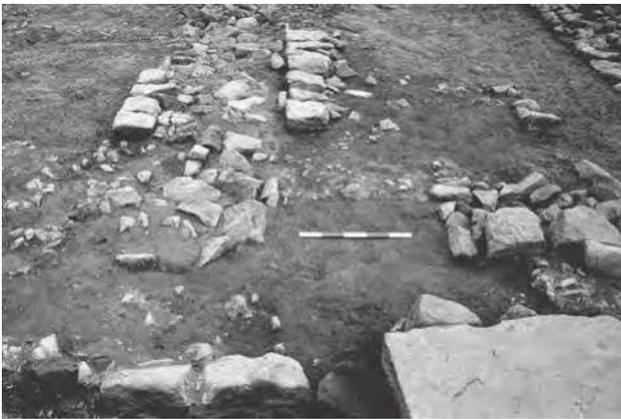
Figure 14.20: Detail showing the north wall (E05:13) of third-century Barrack 18 (right) next to the south wall of second-century Barrack 5 (E05:14) at a lower level.

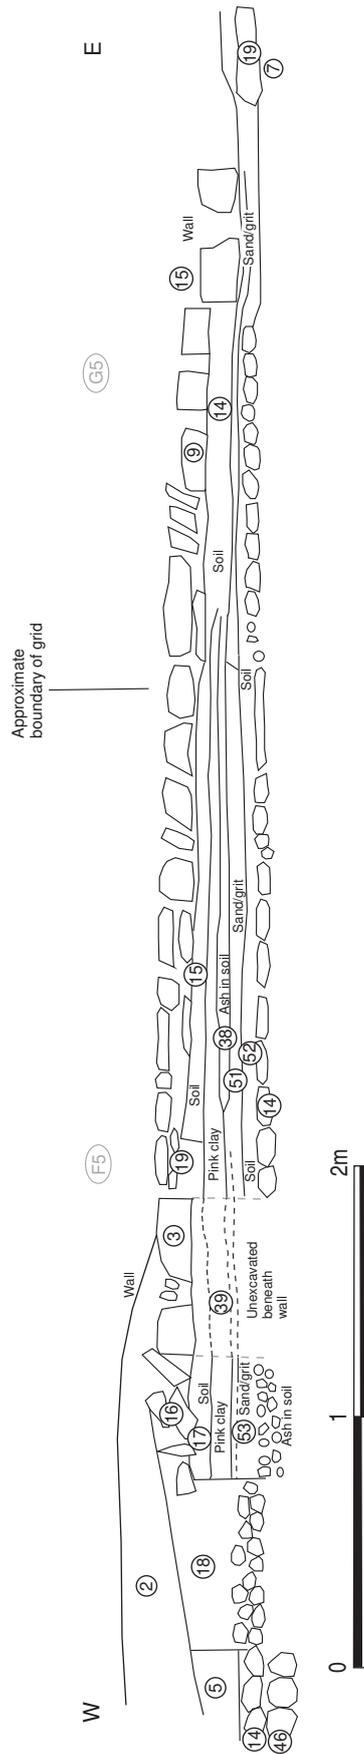
Figure 14.22: Section Drawing S11: Reconstruction of the SW-NE section through Building 18 Contubernium 1 (Daniels 'Building C'). Scale 1:30.

### **Contubernium 1 (Building C)** (Fig. 14.22)

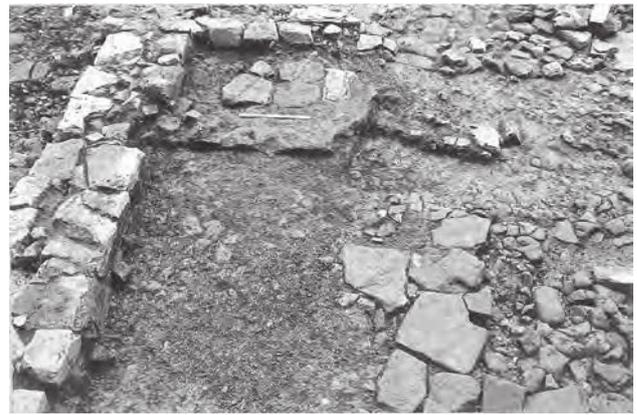
Figure 14.23: Phase 1 hearth F05:50 (the flagged setting at the top of the view) in Building 18 Contubernium 1 looking north

#### *Phase 1* (Figs 14.23, 14.24)

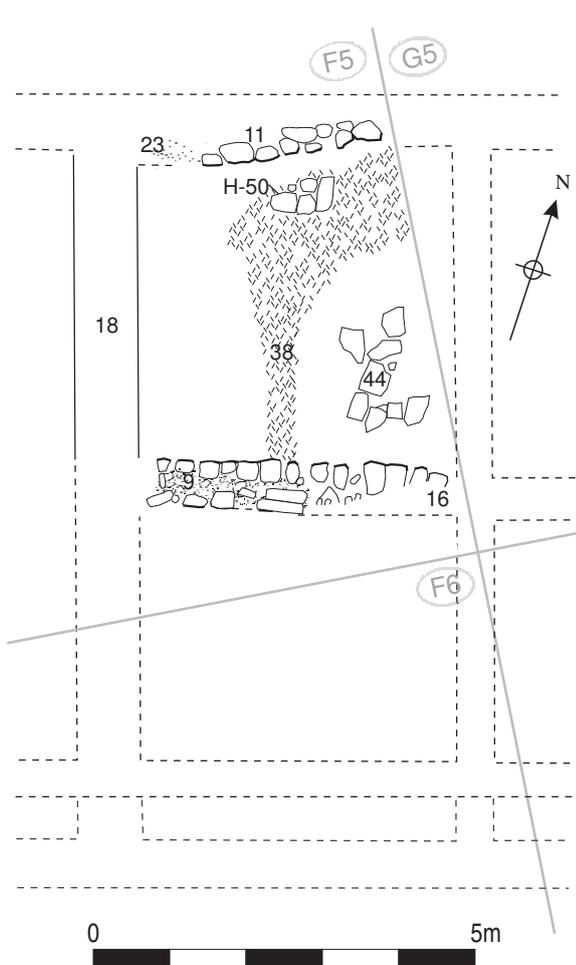
Figure 14.24: Building 18, Contubernium 1 (Daniels 'Building C') Phase 1, Sub-Phase 1, 1:100.

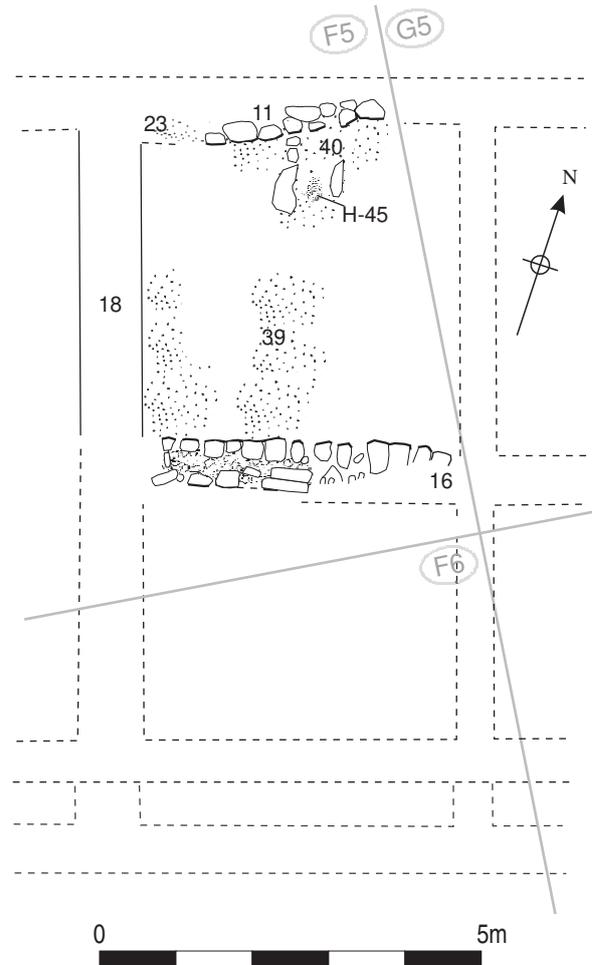
Figure 14.25: Building 18, Contubernium 1 (Daniels 'Building C') Phase 1, Sub-Phase 2, 1:100.

A second sub-phase in the *contubernium* was marked by a pink clay floor (F05:39, 40) which survived over an area 4m × 3m (Figs 14.25, 14.26). The earlier hearth (F05:50) was replaced by another occupying the same position (F05:45). This was represented by an oval patch of fire reddened clay and dull yellow sand, 0.45m × 0.35m in extent and surrounded by a ring of blue charcoal. A row of three small flagstones, 1m long in total, was present on the west side of the

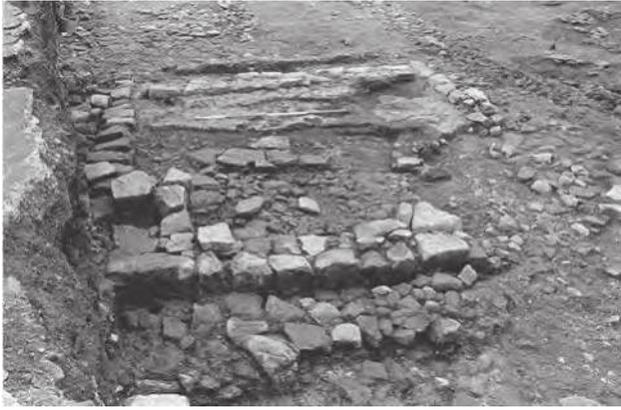
Figure 14.27 Views of successive phases of the north room of Building 18 Contubernium 1 from the east. 1 Phase 1 Sub-phase 2 (with later east wall G05:15 visible); 2. Phase 2; 3. Phase 3.

form of platform or conceivably a replacement stone floor. Some of the smaller, flatter stones were pitched vertically, as is evident in the site photographs, which might imply they simply represented structural collapse, but these may have overlain the main pack or had conceivably been dislodged by post-Roman ploughing.

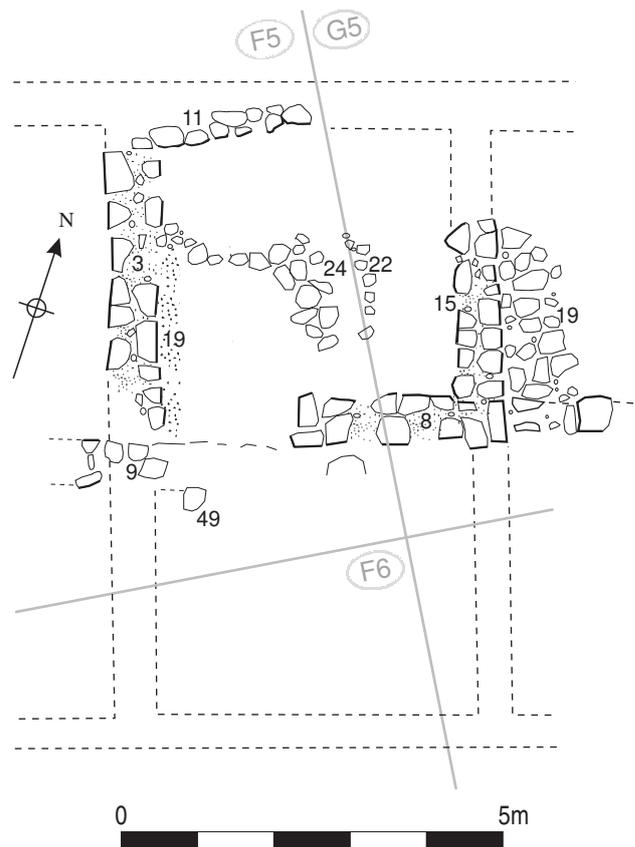
Figure 14.27: Building 18, Contubernium 1 Phase 2

The second phase of Building 18 involved a substantial remodelling of *Contubernium 1* which was shifted 1.20m to the east with the construction of new west (F05:03) and east (G05:15) walls. These walls were c. 0.65m wide and were constructed with two lines of roughly dressed, sandstone facing stones with a thin rubble core. They survived only course high, with the exception of one block apparently belonging

to a second course at the southern end of east wall G05:15. A 0.20m wide and 0.10 thick deposit of fairly clean and firm orange-pink clay (F05:19) was packed along the east side of wall F05:03, the purpose of which was unclear. The north wall (F05:11) may have been rebuilt at this stage as well, as supposed by the excavators, since the surviving remains were reported to lie over the edge of the deposit of grey-green soil (F05:15) marking the end of Phase 1. The original medial partition wall, F05:09, was also replaced by a new one, some 0.7m wide, located immediately to the north (F05:10, G5:08). This reduced the size of the north room, which now measured 4m × 3.5m internally. An entrance through the medial wall was apparent in the south-west corner of the room and was some 1.35m wide (assuming the full length of the wall was preserved). In the interior, a floor surface (F05:24, G05:22), composed of small flagstones and flat stones, and including a tile and an amphora sherd, was present, though it survived only sparsely, mainly in the centre of the room. A few flagstones (F05:49) overlying earlier medial wall F05:09 may represent the sparse remnants of a floor in the south room.

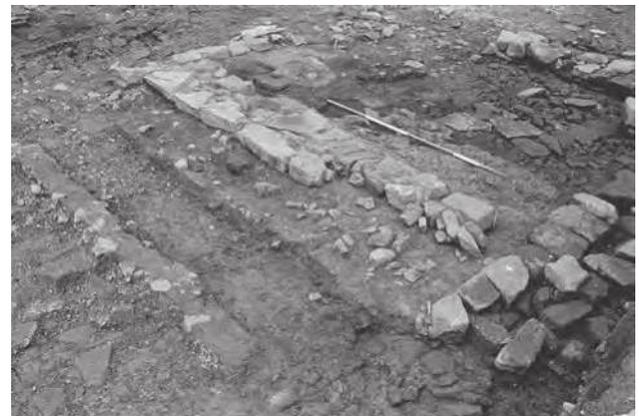
Figure 14.28: The robber trench for Phase 1 west wall F05:18 Contubernium 1 with later wall F05:03 beyond, from the SW.

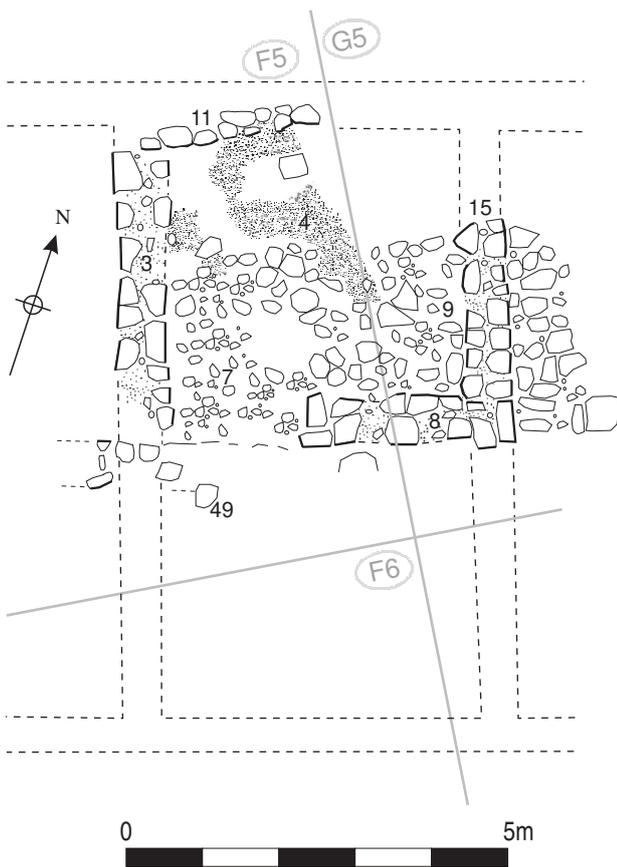
Figure 14.29: Building 18, Contubernium 1 *Ph se 3* ∅

The final activity recognised within the north room of *Contubernium* 1 was represented by stone packing (F05:07, G05:09), some 0.10–0.15m deep, composed of a mixture of smallish stones, large cobbles and building rubble in a matrix of dark clayey soil, which filled most of the interior. In the north-west corner of the room a layer of yellow sand mixed with brown soil (F05:04), 0.05m thick, was present instead and overlay the edge of the stone packing. The stone layer was also present on the east side of wall G05:15, overlying the cobble surface (G05:19) in *Contubernium* 2. The excavators considered this stone layer to be a deliberate pack perhaps to create some

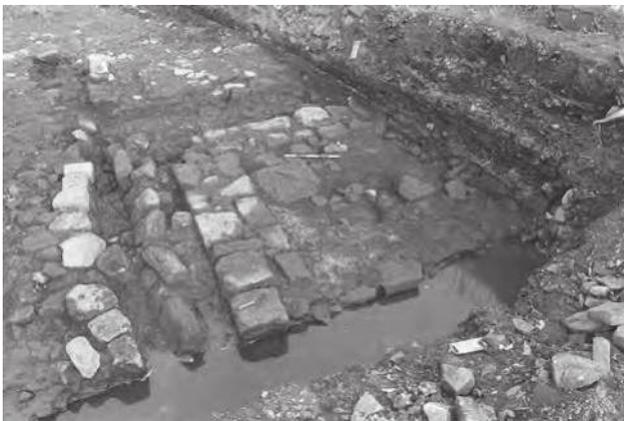
Figure 14.30: NE corner of 18 Contubernium 4 (Daniels Building D) from the west with the street drain to left and Building E beyond.

The north-east corner of Contubernium 4 also survived the widespread destruction of the third-century levels (Figs 14.30, 14.31) and was interpreted by Daniels as part of another freestanding stone structure (Building D). In addition to a 2m long stretch of the north wall (H05:18 – see above), a 1.6m length of the east wall (H05:15) survived here. This wall was 0.60m wide and was bonded with the north wall. The excavators regarded this junction as marking the intact corner

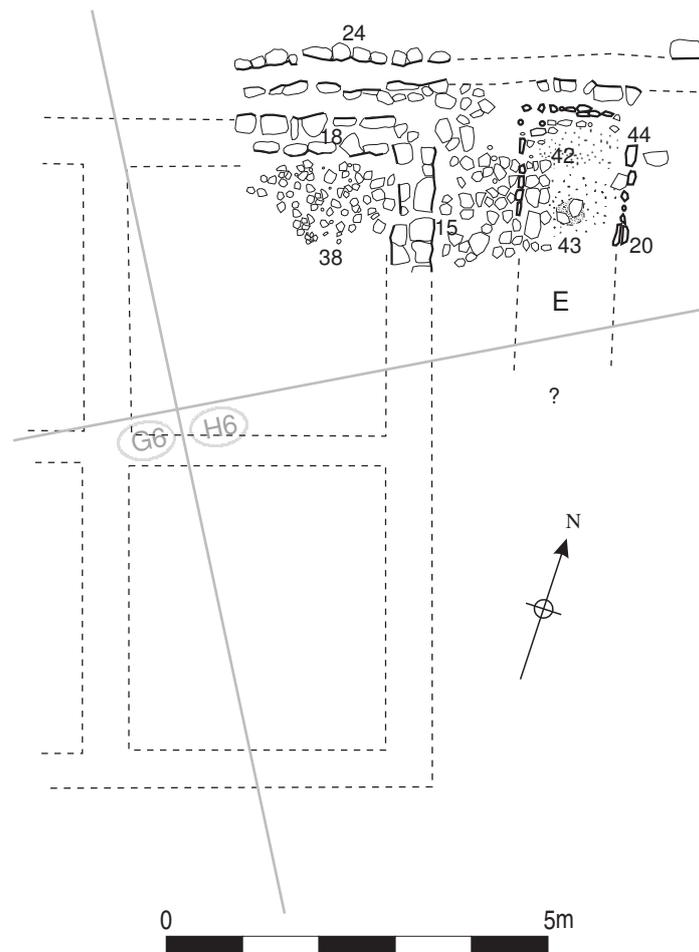
Figure 14.31: Building 18, Contubernium 4 (Daniels 'Building D') Phase 2 and adjacent Building E, 1:100

The laying of a stone floor (H05:22) in the interior represented a second phase of Building E. This was composed of small shattered flagging, including several large pieces of tile, laid on top of a 50mm deep layer of fine, dirty grey soil (H05:23, 41) which covered the earlier clay floor.

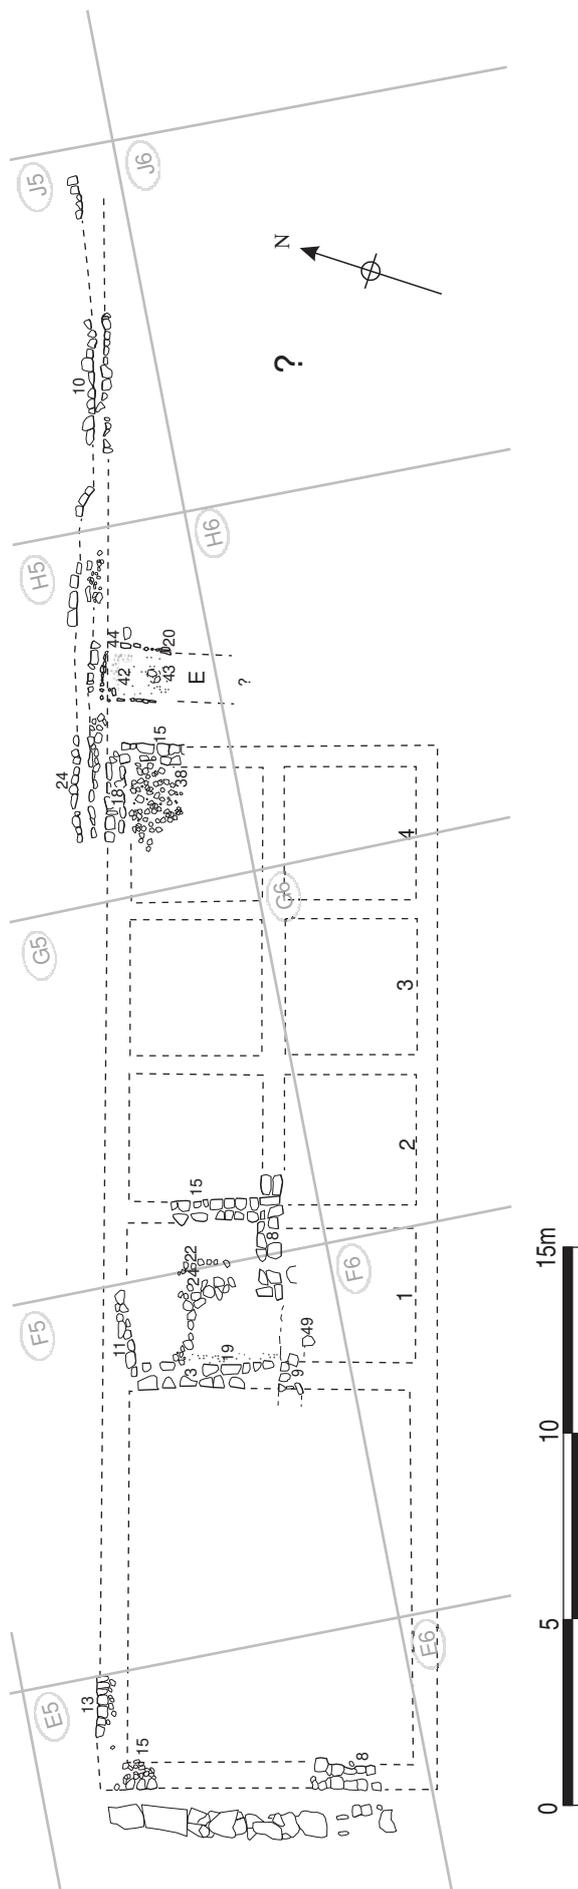
Figure 14.32: Secondary phase of third-century Barrack 18, showing possible reduction in length of block, 1:200.

Only a small area of Building 18 was excavated to the east of *Contubernium* 4, but it is clear that no definite traces of further *contubernia* were exposed there. Instead the remains of a small timber structure labelled Building E by Daniels were exposed. This may relate to a later phase of the building and perhaps reflects the replacement of the block's four easternmost *contubernia* by a series of timber buildings, the remainder of which lay beyond the edge of the excavation (Fig. 14.32).
