# SEGEDUNUM

Excavations by Charles Daniels in the Roman Fort  
at Wallsend (1975–1984)

VOLUME 1: The Structural Remains

Alan Rushworth and Alexandra Croom

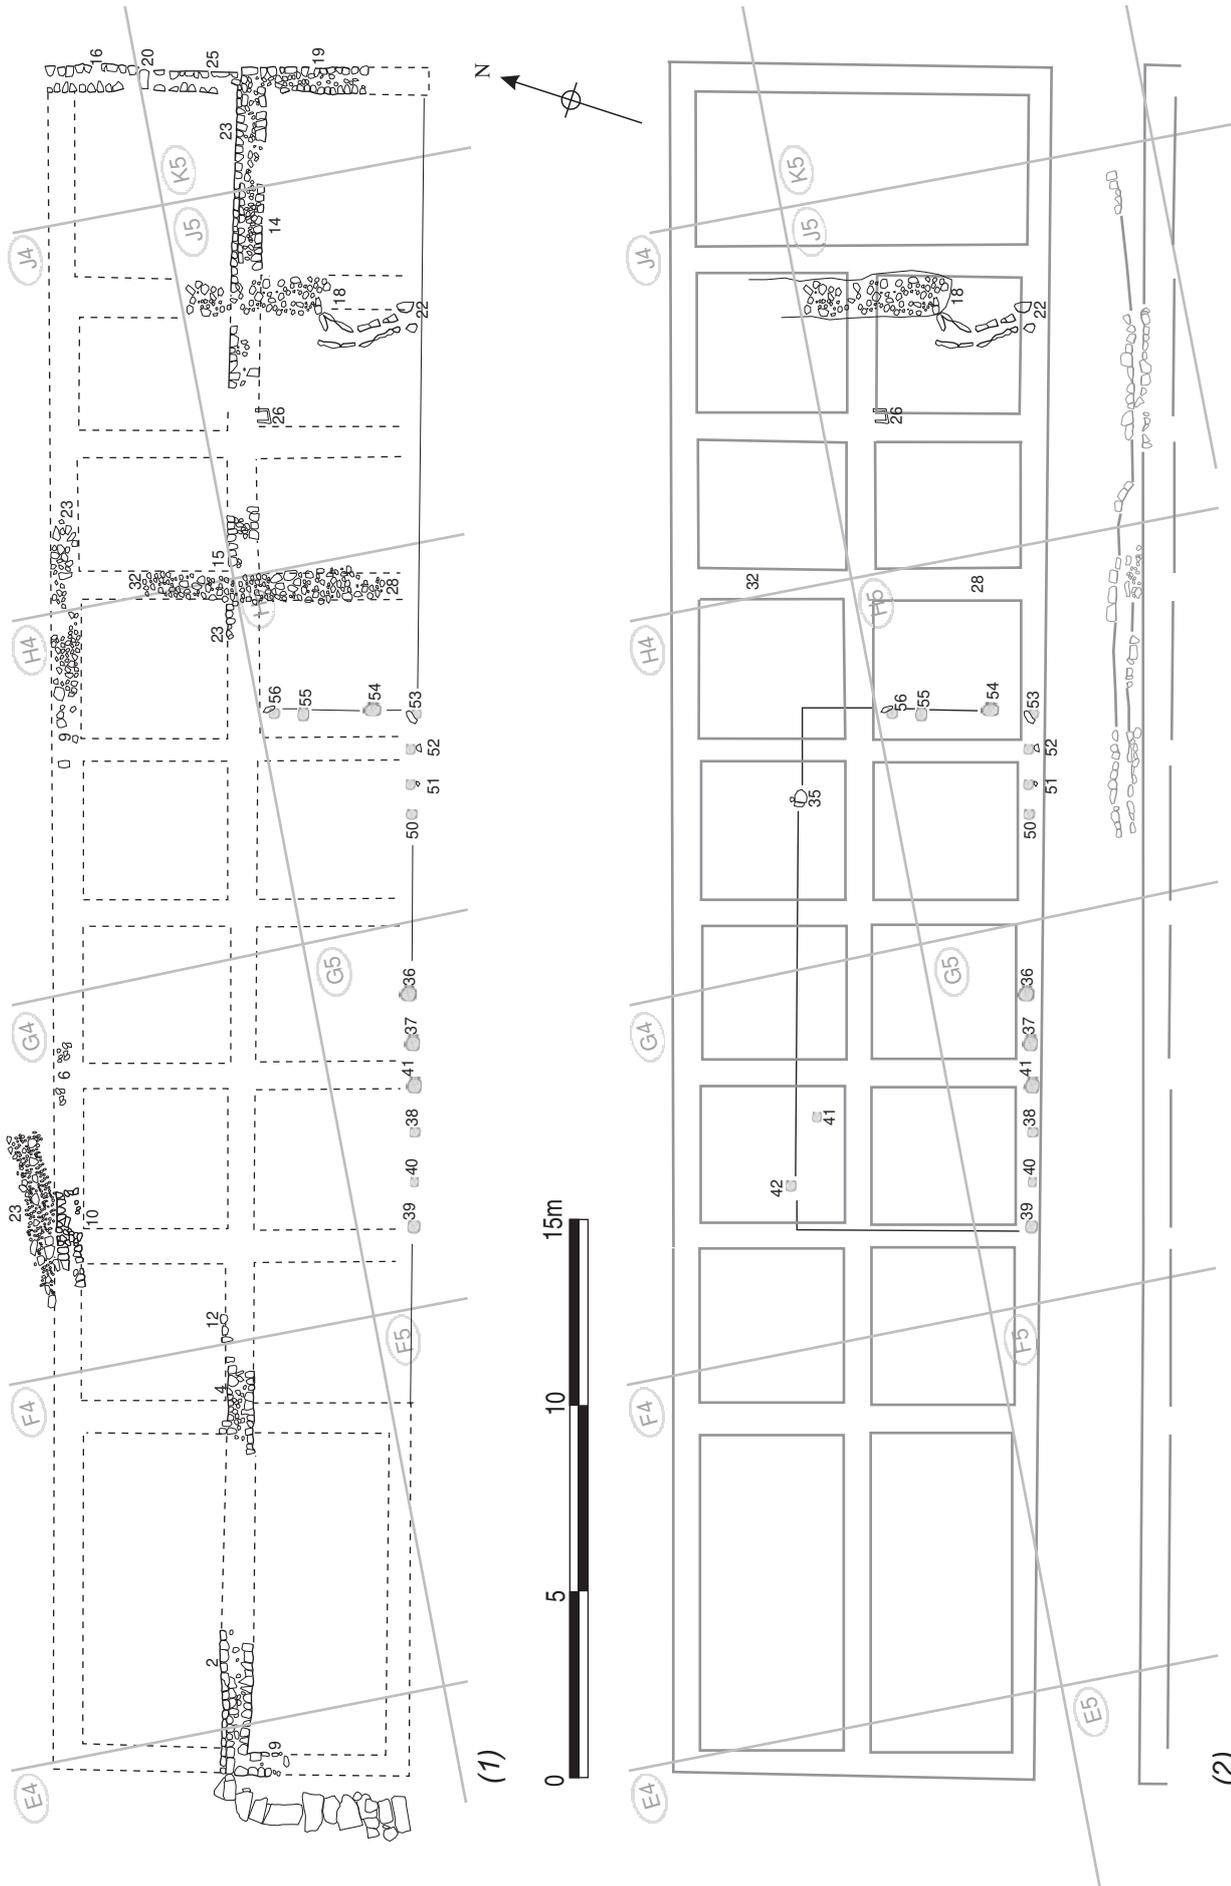
Figure 14.33: Two alternative restorations of the latest features in Building 17, (1) with the posts of 'Building J' interpreted as part of the south façade of Barrack 17, (2) with Building J restored as a separate rectangular timber building, replacing part of 17. Scale 1:200.

Daniels interpreted these post holes as forming a rectangular timber building around 14m in length (E-W) and 6m wide (N-S), regarding it as a secondary feature of the late Roman layout in the west *praetentura*. This remains the most straightforward interpretation of the evidence – a post-in-pit building erected over the central third of Building 17 (perhaps in the fourth century?) after that structure had gone out of use and been demolished. Any floor levels and occupation deposits associated with the timber building would presumably have been destroyed by later activity.

Nevertheless there is an alternative possibility, namely that the post holes marked the remodelling of Building 17 as a hybrid timber and stone-built barrack block. Such hybrid construction is apparent in the case of Building 12, one of the earlier cavalry barracks in the *retentura*, where the frontage of the *contubernia* range as well as its internal partitions was built of timber (see Chapter 16 below). A similar mixture of stone and timber construction was also encountered in some of third-century phases of barrack block at South Shields (cf. Hodgson and Bidwell 2004, 125–8), extending so far as to include the end wall of the *contubernia* in some instances. It could be argued that something similar obtained in the case of Building 17, with the main east-west row of posts which Daniels assigned to Building J potentially forming part of a timber frontage and the east wall representing an internal partition. It seems unlikely that any such arrangement formed part of

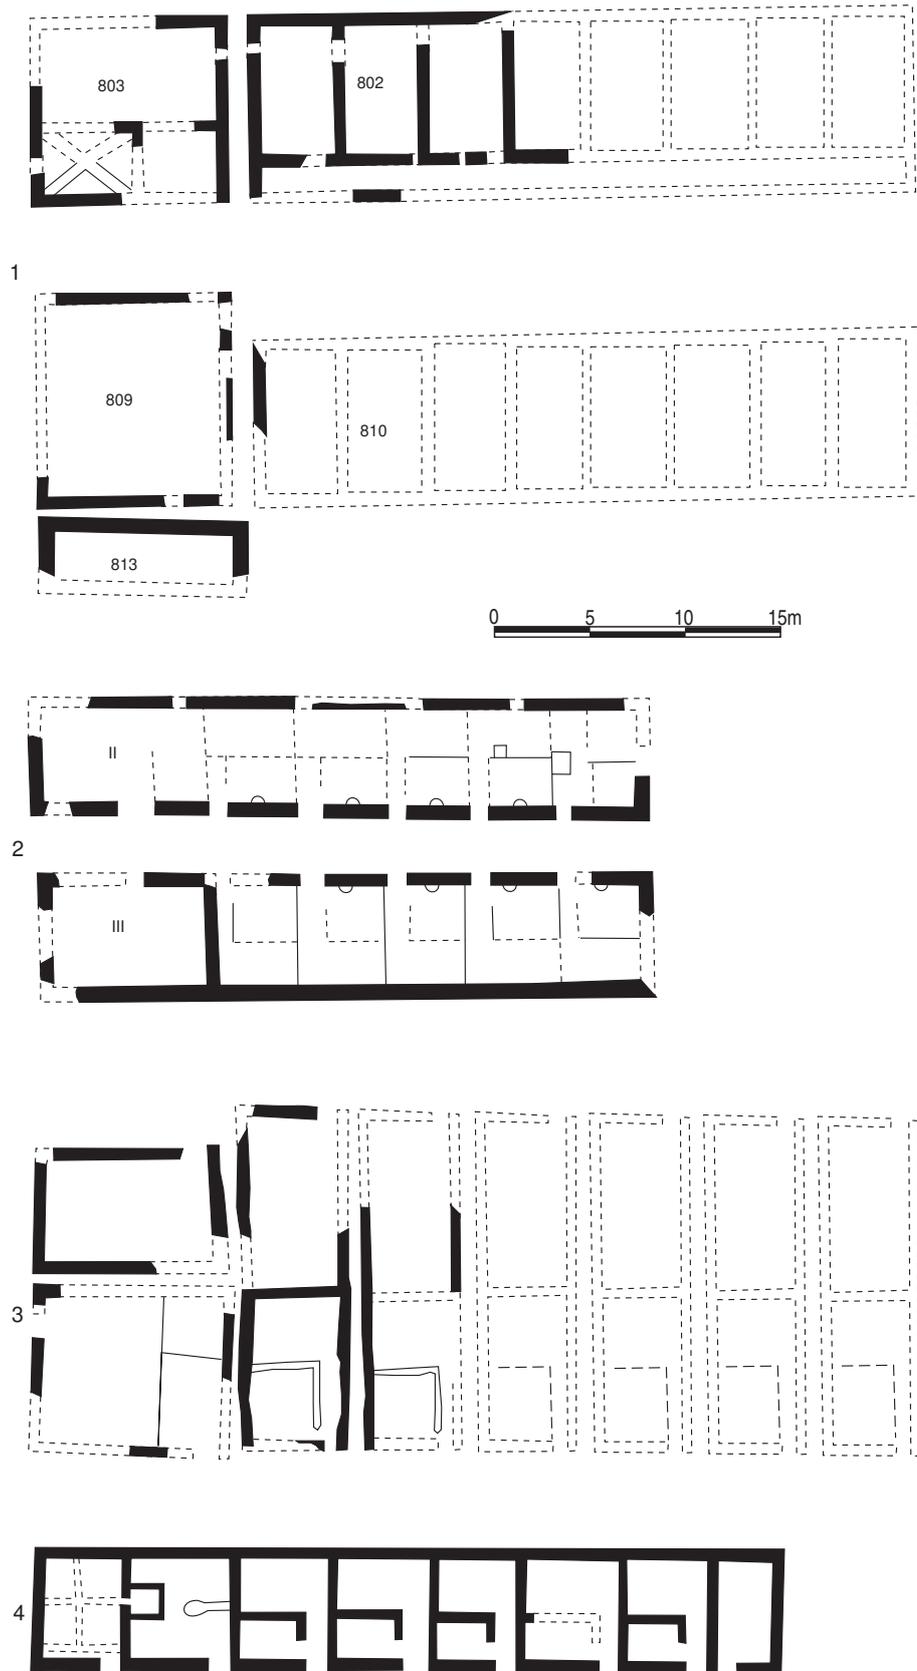
Figure 14.35: Third-century infantry barracks: 1. Birdoswald (after Wilmott et al 2009), 2. South Shields Barracks II and III c. AD 225/35–300 (after Hodgson and Bidwell 2003), 3. Vindolanda (after Bidwell 1985), 4. South Shields Period 7 barrack c. AD 286/312–c. 350 (after Hodgson and Bidwell 2003). Scale 1:400.

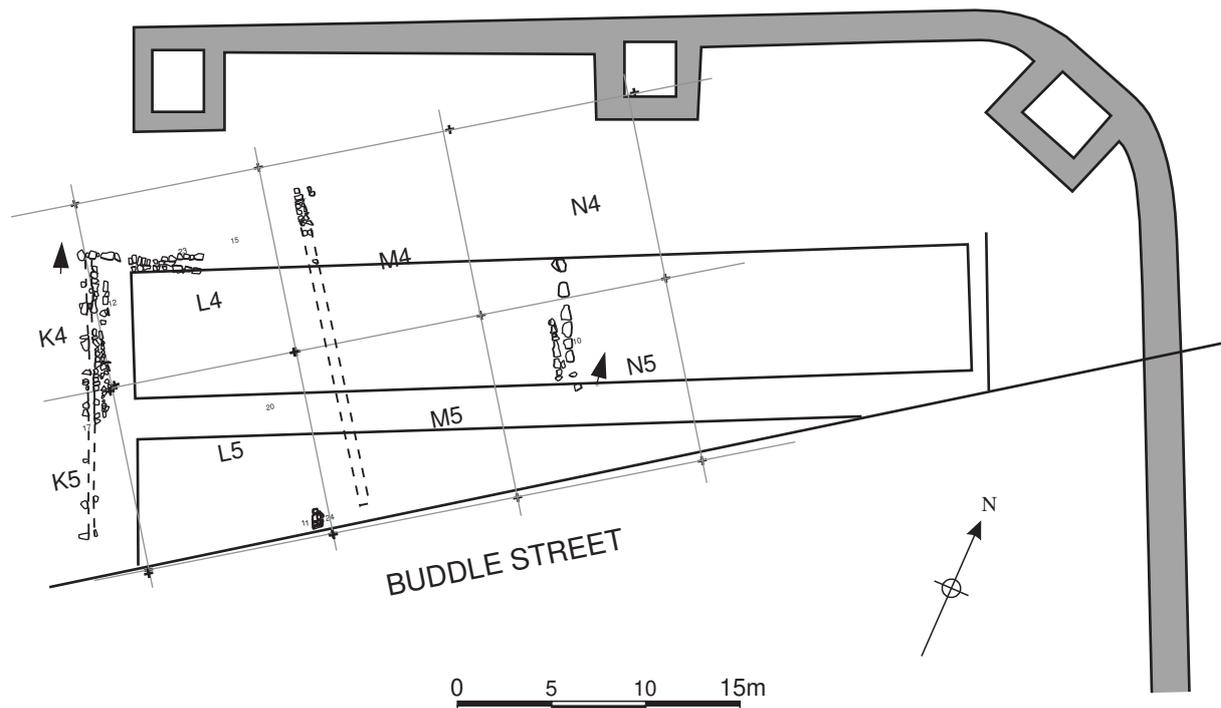
Figure 14.36: Late structures in the north-east part of the fort shown in relation to the earlier buildings. Scale 1:400.

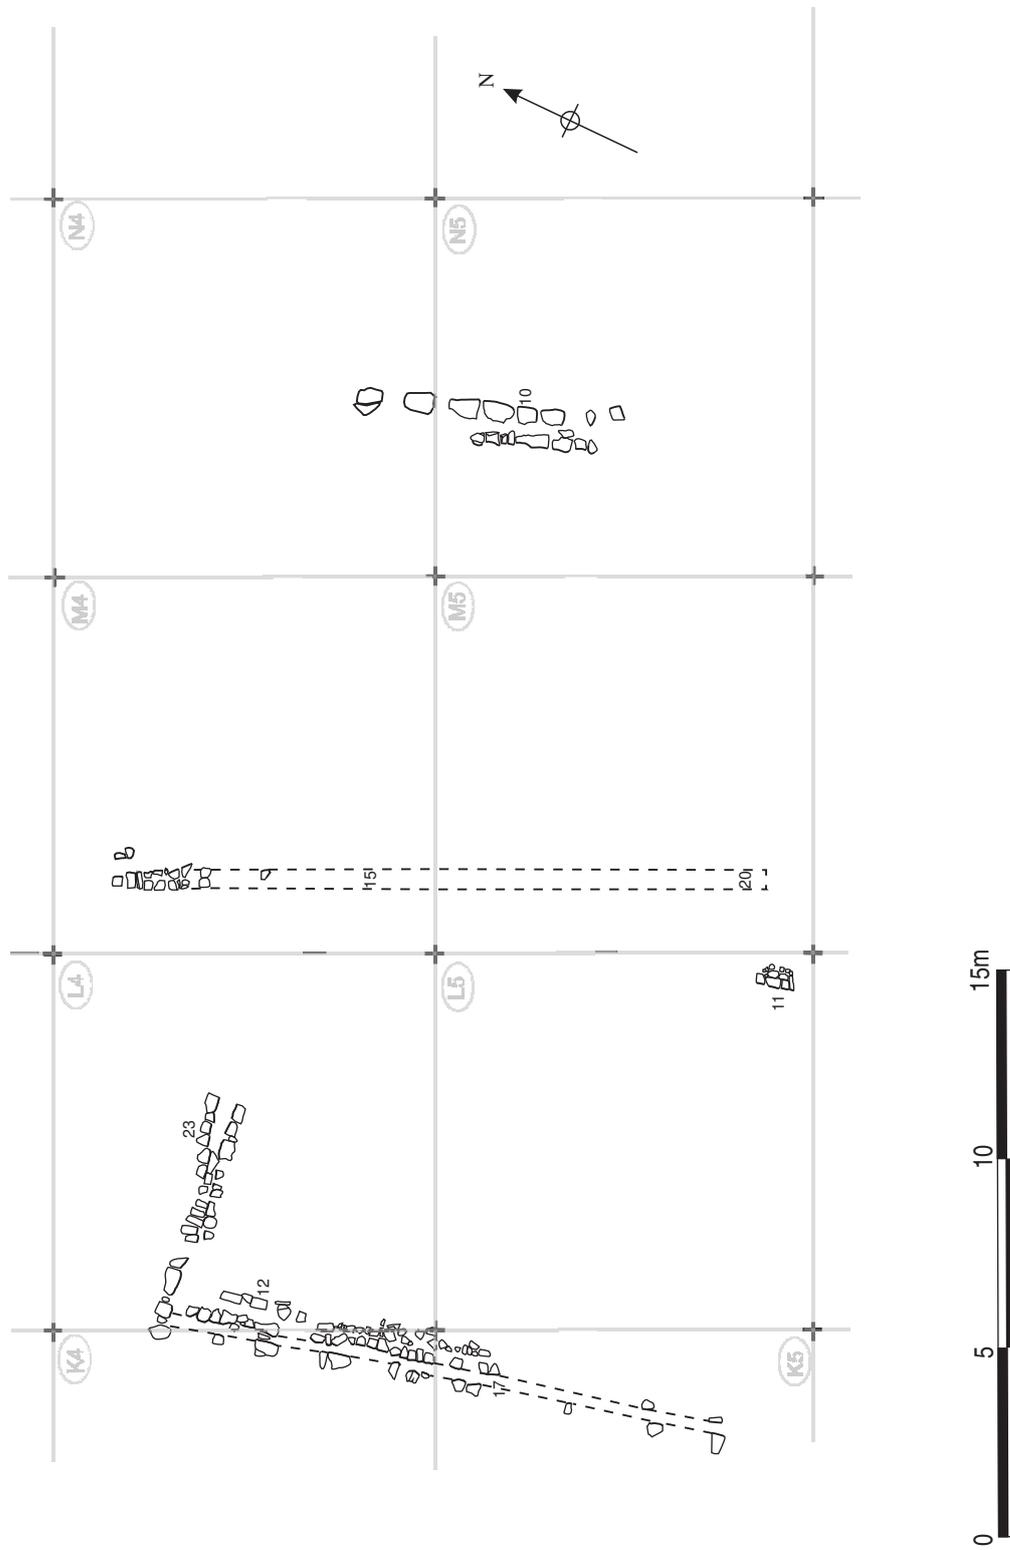
Figure 14.37: Later Roman structures in the north-east part of the fort at 1:200.

Four stretches of walling were identified, each aligned roughly north-south and surviving no more than a single course in height (see Fig. 14.37). The most westerly of these (K05:17, L04:12) was *c.* 7.0m in

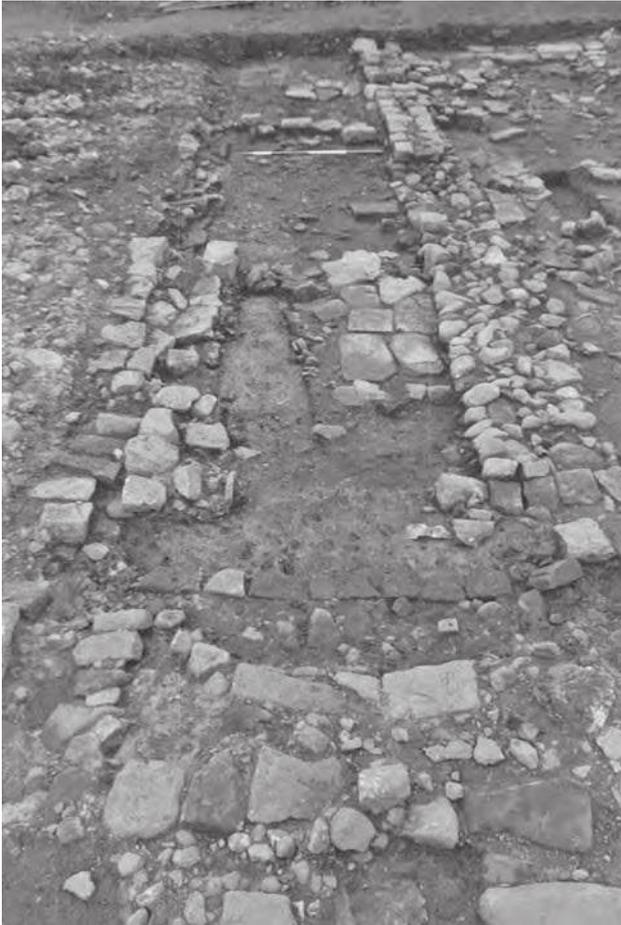
Figure 14.38: The north-west corner of Building 1 showing the later north-south wall (L04:12) and east-west gutter and possible walls (L04:23), looking east.

length and was composed of very large, roughly-faced blocks which may have been reused. It was located just beyond the west end of the former Building 1 and was lined on its west side by a stone-faced drain or gutter, again one course deep, which was traced over a distance of 15m along the east edge of the *via praetoria*. The gutter made a 90 degree turn towards the east (L04:23) at the north end of the wall, suggesting this represented the northern limit of any building associated with the wall, but there was no firm evidence for any walling running alongside this stretch of guttering, which extended for a further 5.0m. Although the alignment of the new wall did not correspond exactly with that of the west gable wall of Building 1, the two were broadly similar and K05:17/L04:12 could therefore represent the end wall of a building or range of buildings occupying broadly the same plot as the earlier Building 1 (see Fig. 14.38).

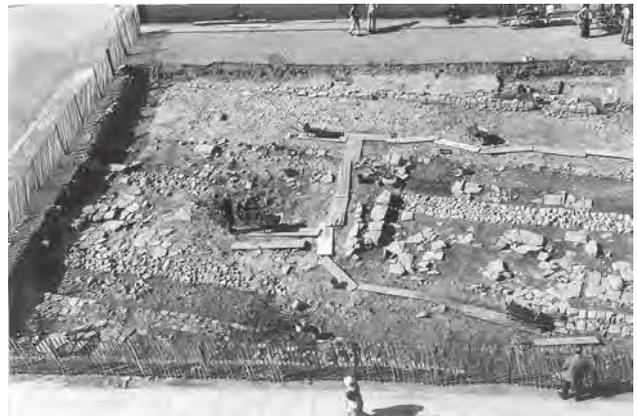
Figure 14.40: Central section of Building 1 viewed from Simpson's Hotel in 1975. Late wall N05:10 can be seen in the centre of the photograph.

A much shorter stretch (L05:11), no more than 1.0m long and 0.40m wide, survived some 12m to the south-east of K05:17/L04:12. It sat on a layer of loose, dark grey-blue loam which in turn extended westward over the line of the robbed out wall (L05:49) which had separated *Contubernia* 7 and 8 of the previous Building 2, implying that particular partition wall had been robbed out at some point prior to the erection of the later Roman structures. No detailed plan exists for the third of these walls (M04:15, M05:20), apart from its northern end, though its approximate position can be estimated. The fourth and final stretch of walling (N05:10) was more substantial at 7.0m long and 1.0m wide, and was located 24.0m to the east of west wall, K05:17/L04:12. The easternmost wall comprised large, roughly faced blocks with a rubble core (Figs 14.39, 14.40). A dark earth layer (N05:20) formed a matrix between and beneath the wall's stones.

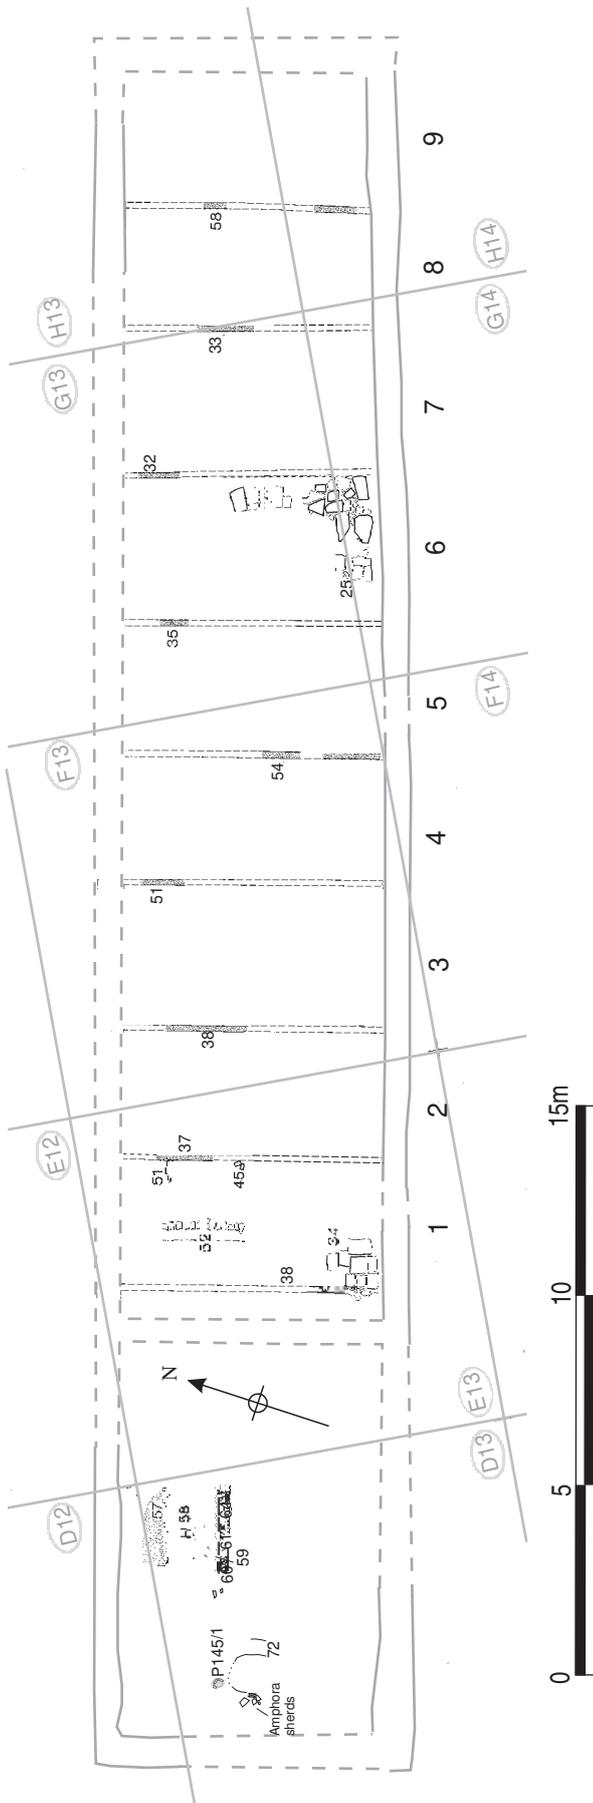
Figure 15.01: Building 9, Period 1 at 1:200.

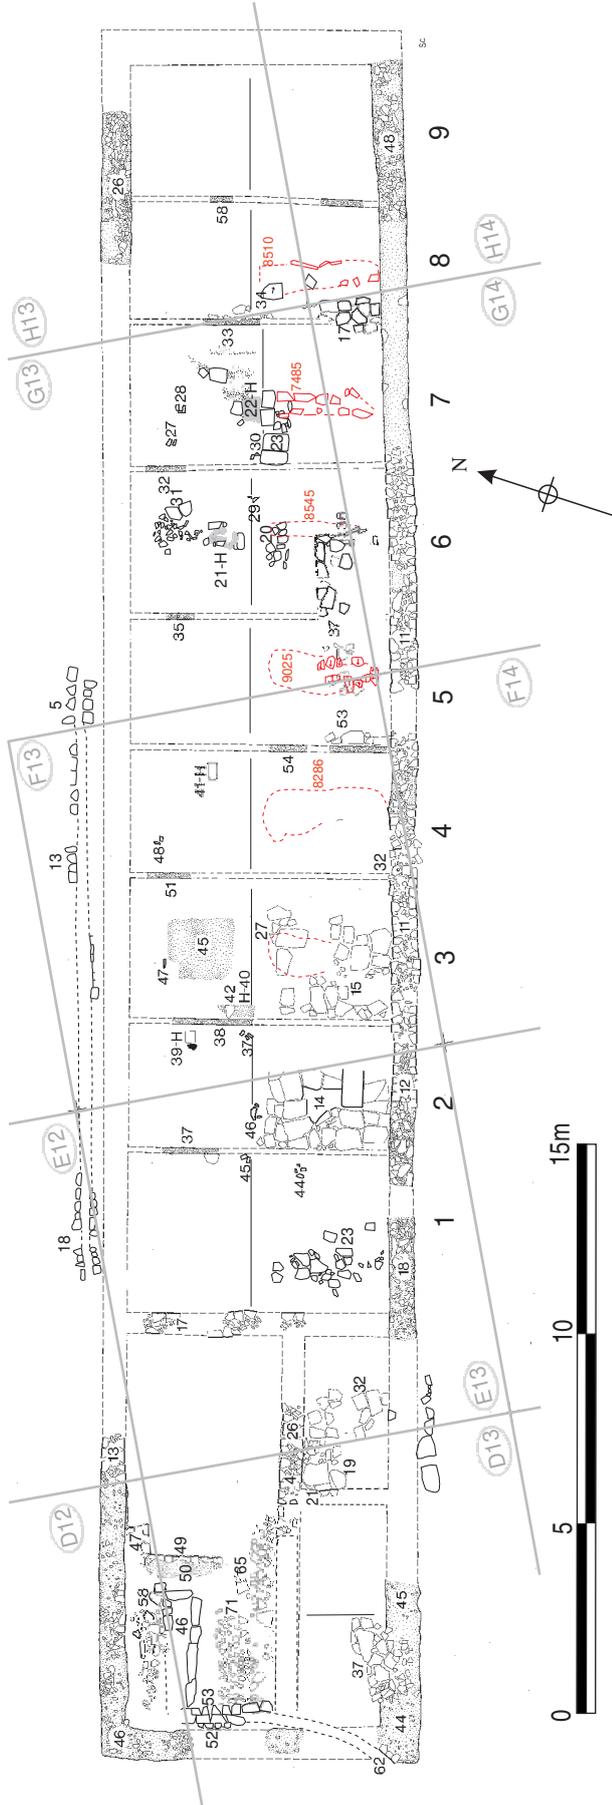
Figure 15.02: Building 9, Period 2/3 at 1:200

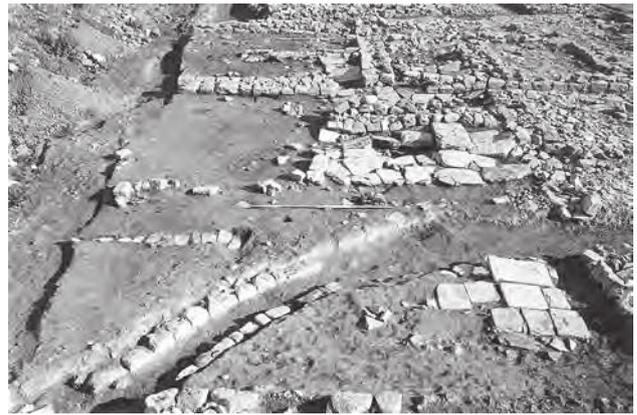
Figure 15.03: Building 9 viewed from the west showing flagged floors – E13:34 in *Contubernium* 1 (Period 1), E13:35 in 2 and F13:37 in 3 (Period 2 & 3).

In *Contubernia* 1, 2, 3 and 6, the floor levels which were associated with the stone barrack could be identified on the basis of their relative position in the sequences of floors revealed here (Figs 15.03, 15.04). The upper flagging in the south half of *Contubernium* 1 (E13:23), ran over the top of the earlier flagging (E13:34) and the slot which formed the west wall of

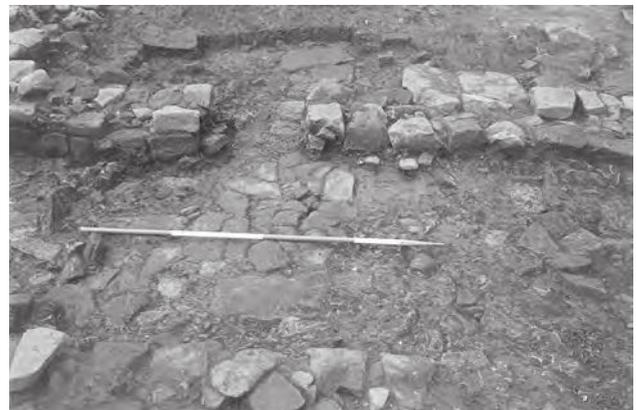
Figure 15.04: View from the south of Period 1 flagged floor G13:25 in the south room of *Contubernium* 6 and the protruding slab wall of the Period 2/3 urine sump (G13:21) at the extreme left foreground. In the background, beyond the Period 4 spine wall, can be seen at top left hearth flag G13:21 sitting on Period 2/3 clay floor, with flags G13:23 belonging to the Period 2/3 floor of *Contubernium* 7 to the right.

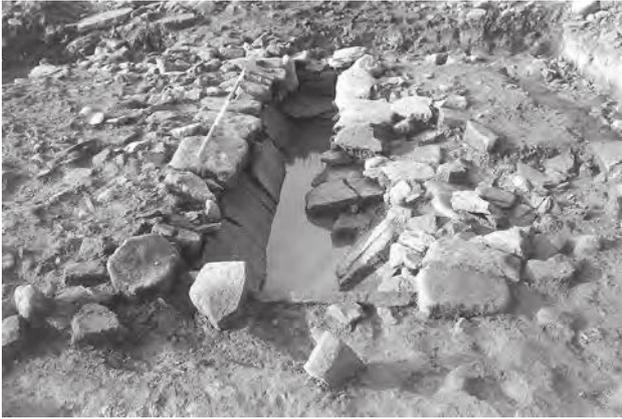
Figure 15.05: The flag lined urine sump (D13:46) in the officer's quarters from the east.

A large stone-lined urine-pit (D13:46), measuring internally 2.45m by 0.45m–0.50m, was constructed in the north-west room. This pit is probably a more elaborate version of those recently found in the front rooms of the *contubernia*, appropriate to an officer's accommodation, and was presumably designed to hold the waste from the decurion's horses. The sides consisted of large slabs set on edge sloping down into the bottom of the pit (see Fig. 15.05), giving an overall depth of 0.50m–0.60m. The pit's construction trench (D12:59) was observed on its north side, cutting into a grey clay spread (D12:60, D13:66 – a timber barrack level?), which in turn covered a grey clayey silt layer (D12:61) interpreted as the 'old ground surface' (pre-barrack?), overlying the natural subsoil. An overflow drain (D13:52/53) ran from the west end of the latrine southward along the inner face of the west wall (see Fig. 15.06), exiting at the south-west angle of the building (D13:62). This was found to contain a green-grey sandy silt (D13:70) including much pottery and glass. The remains of a stone surface survived to the

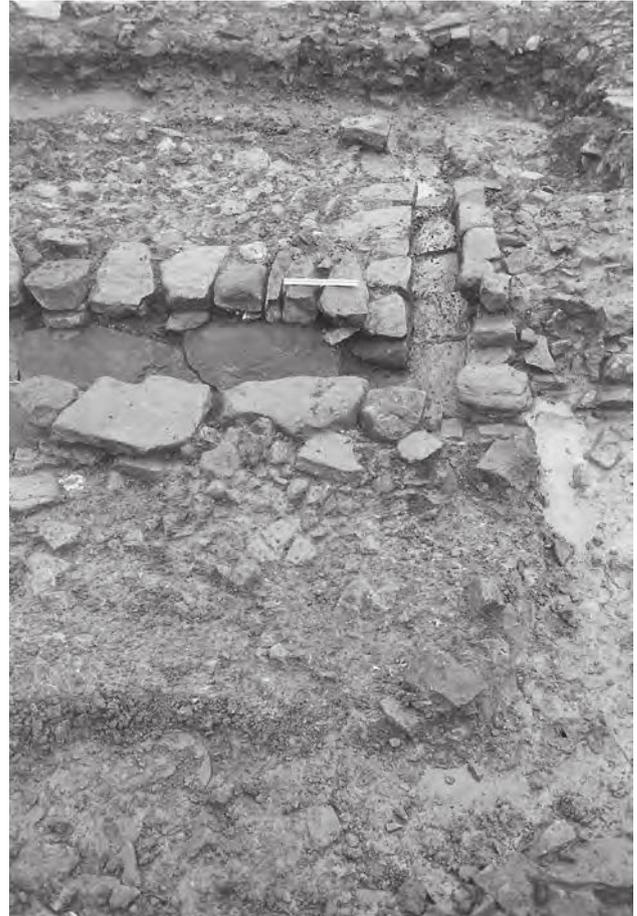
Figure 15.06: Stone channel D13:52/53 leading away from the west end of the urine sump from the north

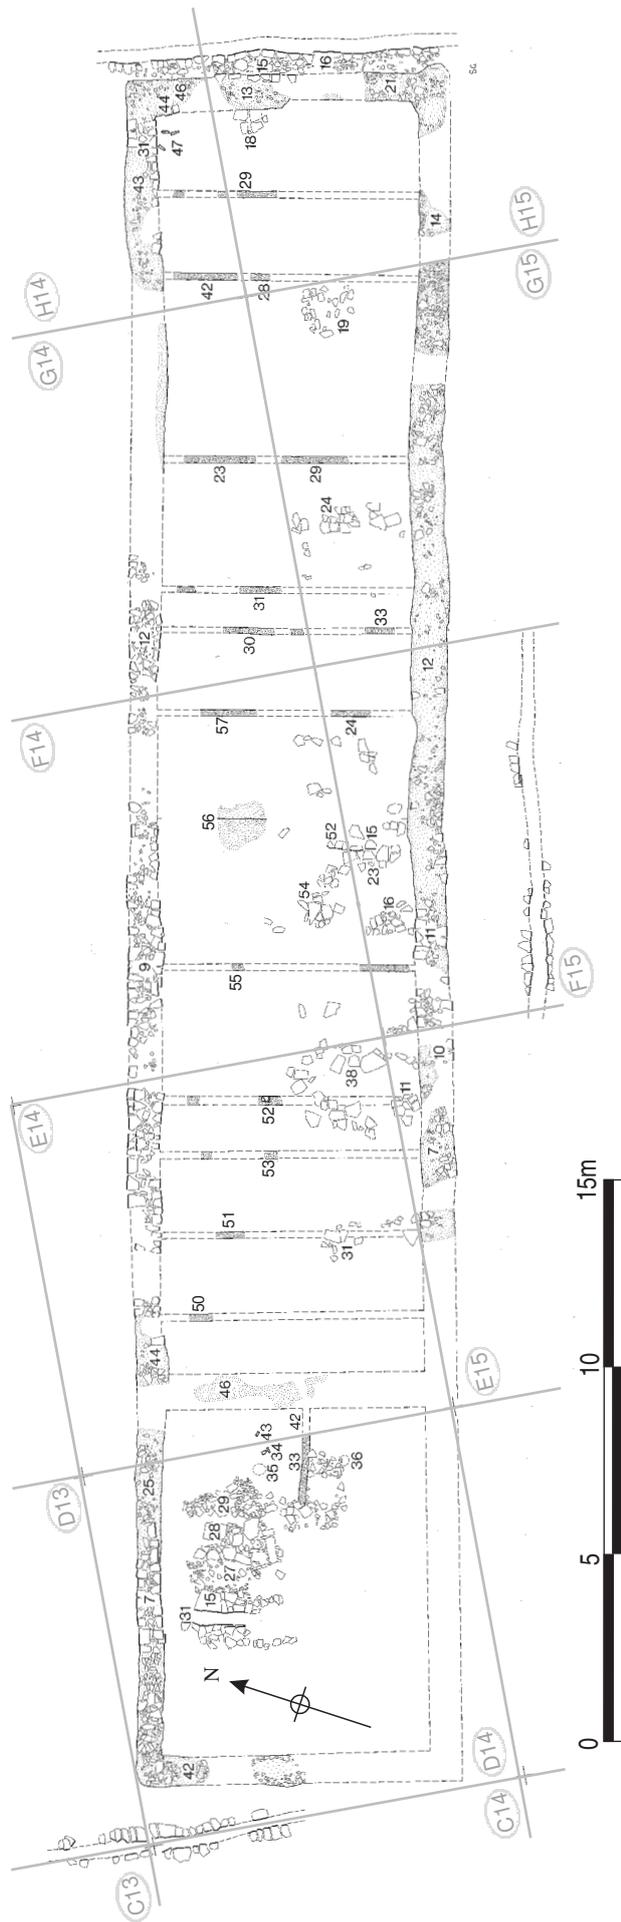
Figure 15.07: Building 10, All features associated with the Period 1 and 2 barracks at 1:200.

Very little of Building 10 survived (see Fig. 15.07), even by comparison with Building 9 its neighbour to the north, when it was excavated by Daniels in 1978 (as with Building 9, initial clearance of overburden took place in 1977). The south-west corner in particular, including much of the officer's quarters, had been entirely removed by modern cellars. Of the outer walls not more than two courses of the

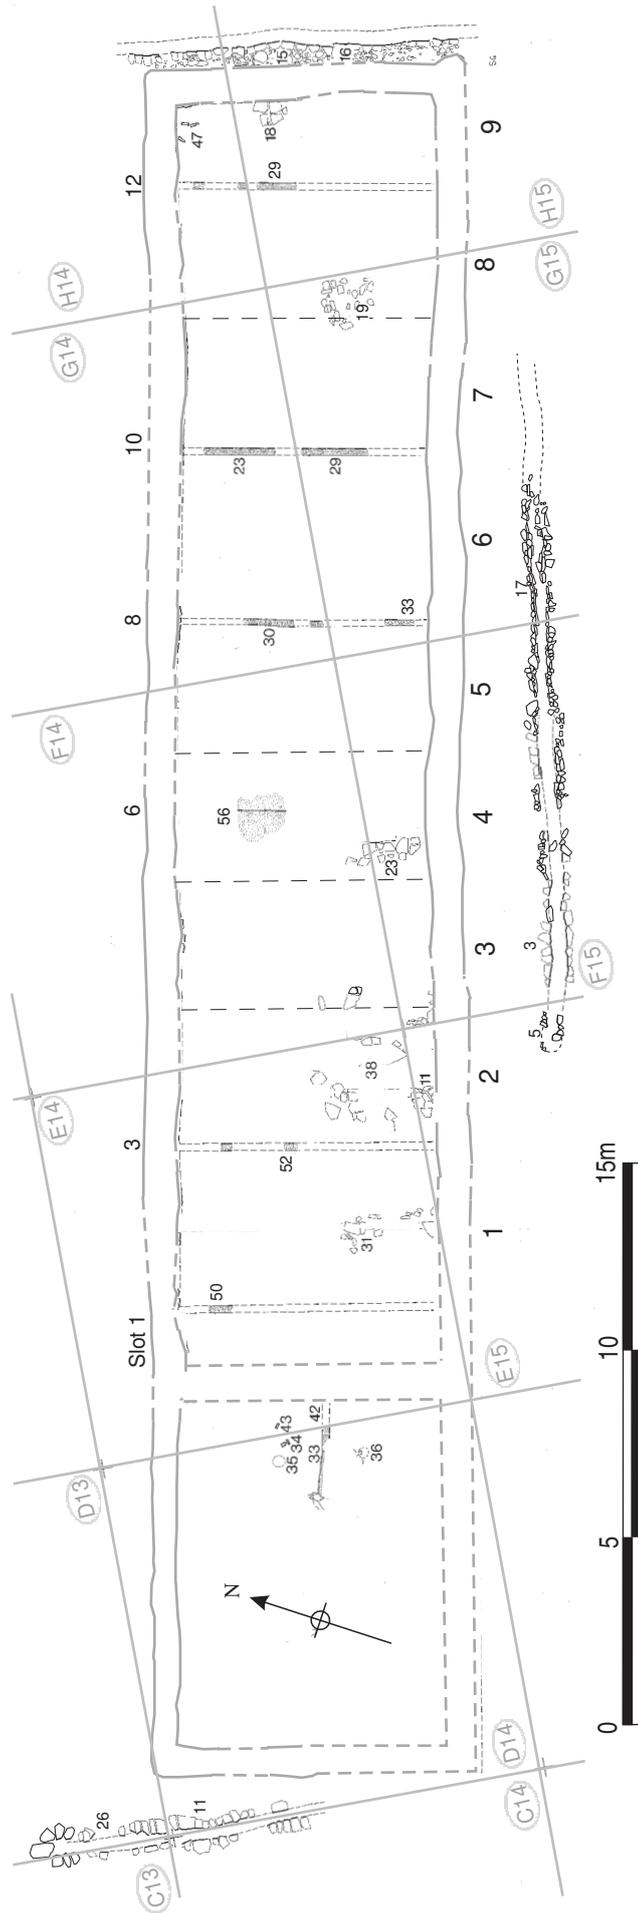
Figure 15.08: Building 10, Period 1 with the outline of the later stone barrack shown for reference at 1:200.

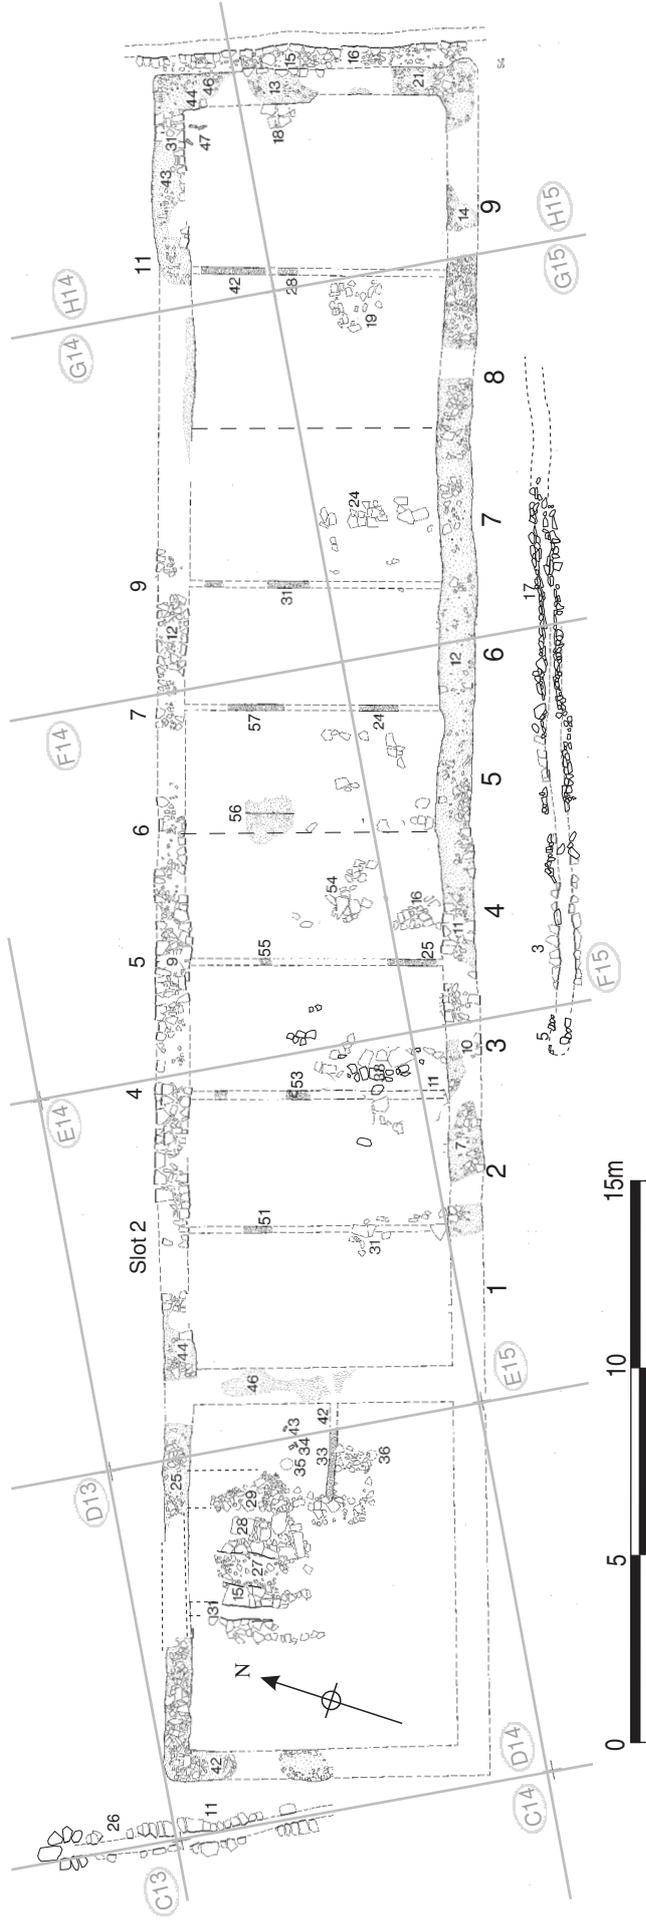
Figure 15.09: Building 10, Period 2 at 1:200.

The fullest sequence of floors was encountered in E14 and E15, where the lowest level comprised areas of flagging (E14:31, 38, E15:11) in the southern part of the barrack block (see Figs 15.09, 15.12), as noted above, and corresponding clay floors to the north (E14:48, 49, overlain by a layer of possible occupation material E14:47). Both the clay and flagstone layers were covered by another clay level which was subdivided into many separate contexts, but appeared to extend the full length of the block. In F14 and F15 areas of flagging were noted to the south, but the corresponding clay floor in the north was not identified. The same overlying clay level was present, however. No relationships were noted between either of these clay levels and the partition slots in E14 and F14/15, with the exception of slot F15:24 (no. 7) which was recorded as being underneath clay level F15:17.

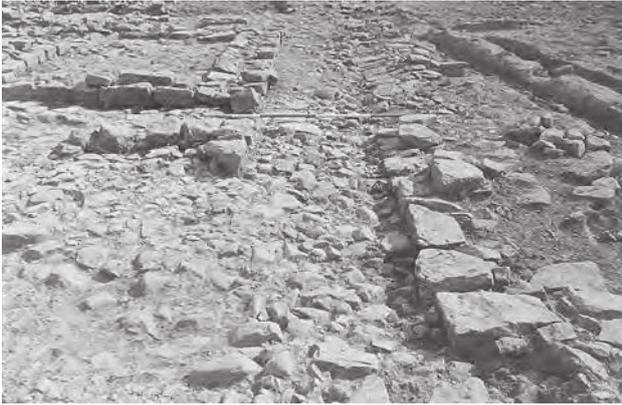
Figure 2 View along the north wall of Barrack 10 from the west.

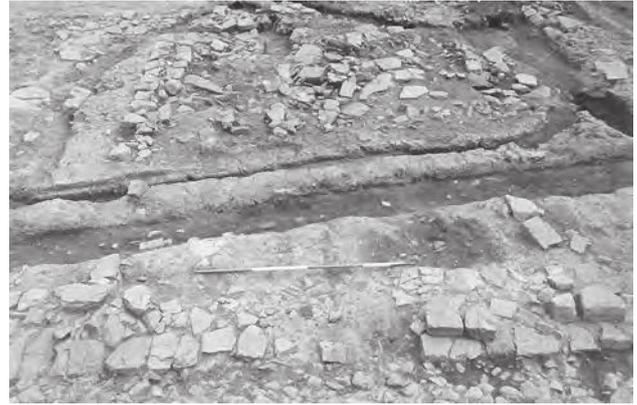
Figure 3 View of the north wall of Barrack 10 looking south, showing the pronounced offset.

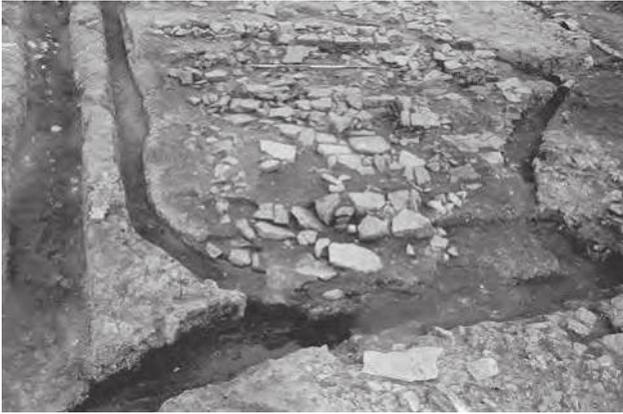
Figure 15.12: Successive phases of flagging in the southern ends of Contubernia 1, 2 and 3 overlain by chalet walling

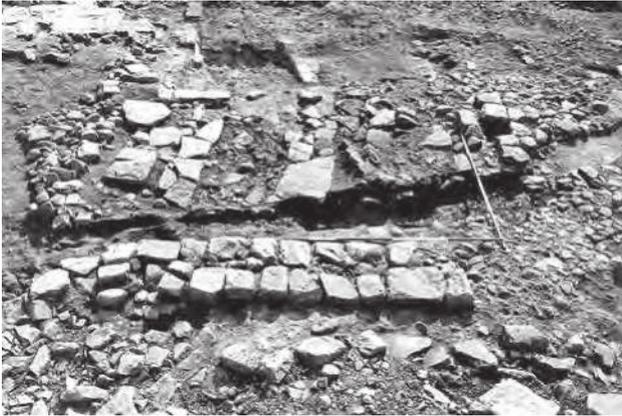
Figure 15.13: The stone-lined drain in the decurion's quarters of Barrack 0 (Stone Phase 1, from the north)

As a result of the limited extent of the area examined, no clear impression of the overall development of the house could be gained, though a number of features were identified. Within the officer's quarters, a drain (D14:15/31) and parts of the flagged floor (D14:15, 28) were revealed and assigned to the stone barrack by the excavators (Figs 15.13, 15.14). All these features overlaid or cut into a layer of orange silty clay (D14:32, E14:37). The drain was 0.33–0.35m wide, with side walls constructed of neatly coursed stone blocks (Fig. 15.13), and was filled with a mid-grey silty soil with small stone and coal inclusions (D14:26). A 1.30m length of the drain survived, but could be seen, in the bottom of a modern drain cut (D14:03), to extend further northward and may have continued via an outlet through the north wall of the building, though this was not traced. The flagged floor was separated into two distinct areas by a 0.80m wide spread of small, close-set stones (D14:27), mostly consisting of

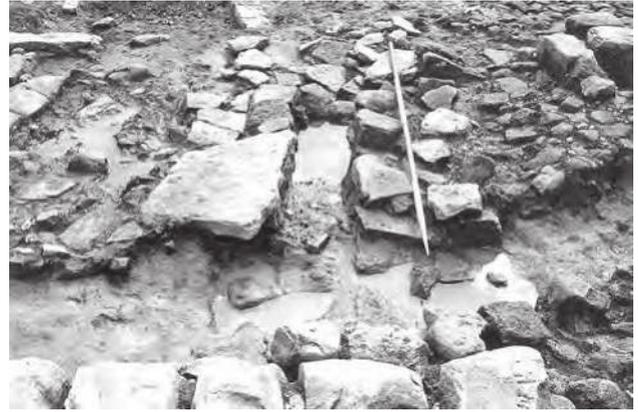
Figure 15.14: Period 2 stone surfaces in the decurion's quarters of Barrack 0 partially reused in the chalet barrack.

rubble, but with a few small flags. The flagstones on either side formed a clear edge (Fig. 15.14). In plan, the feature is reminiscent of the urine sumps found in Building 9 and 12, but analysis of the site photographs demonstrates that no pitched stones defining such a pit were evident in section, and nor was any staining apparent in the bottom of the modern drain cut to the north. It seems likely that flagging was respecting the edges of an internal structure, perhaps of timber construction, which sat on the stone spread. Such a structure may have been associated with the stabling of the officer's horses. To the east of the flagging an area of rounded cobbles stones (D14:29) was recorded, running north-south, though evidently partially removed by later activity so its full extent could not be determined. Some of the stones appeared to be worn so the feature was interpreted by the excavators as a possible surface. However the site photographs suggest the band of was of some depth and it might therefore represent the foundations for a north-south partition wall, perhaps defining a passageway at the eastern end of the house. At its south end some of the flagstones of D14:28 apparently extended across the wall's line.

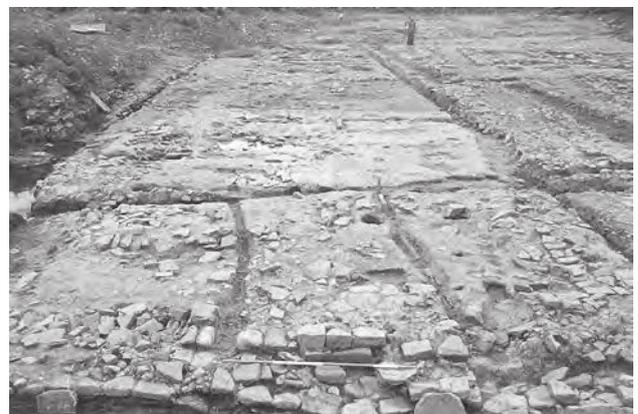
Figure 15.15 View of Building 10 from the east showing the east wall. The drain side-wall and the flagstones of the secondary drain lining can just be seen along side.

ends of several barracks, e.g. Buildings 1, 3, 4, 5 and 11. Only the west side of this drain remained, with up to three courses surviving (Fig. 15.15). The east side had been removed by a modern drain trench. The gap between the north-south drain and the east wall of the building was packed with rubble including some facing stones (H15:15). This was thought to be secondary to the drain, but to pre-date Chalet X. It may therefore have been packed in when the barrack was rebuilt in stone. In a subsequent phase the drain was reconstructed using upright slabs to reline the sides (Fig.15.15). Elements of both of the slab side-walls survived, though several stones were displaced by the modern drain. This method of construction is typical of some of the later drains in the fort, notably that running south eastward from the south end of the granary past the south-west corner of the *principia* (G11:04). It may even form another stretch of the latter drain, perhaps connecting up with the similarly constructed length observed in the east carriageway of the south gate (H16:06). This latter phase of the

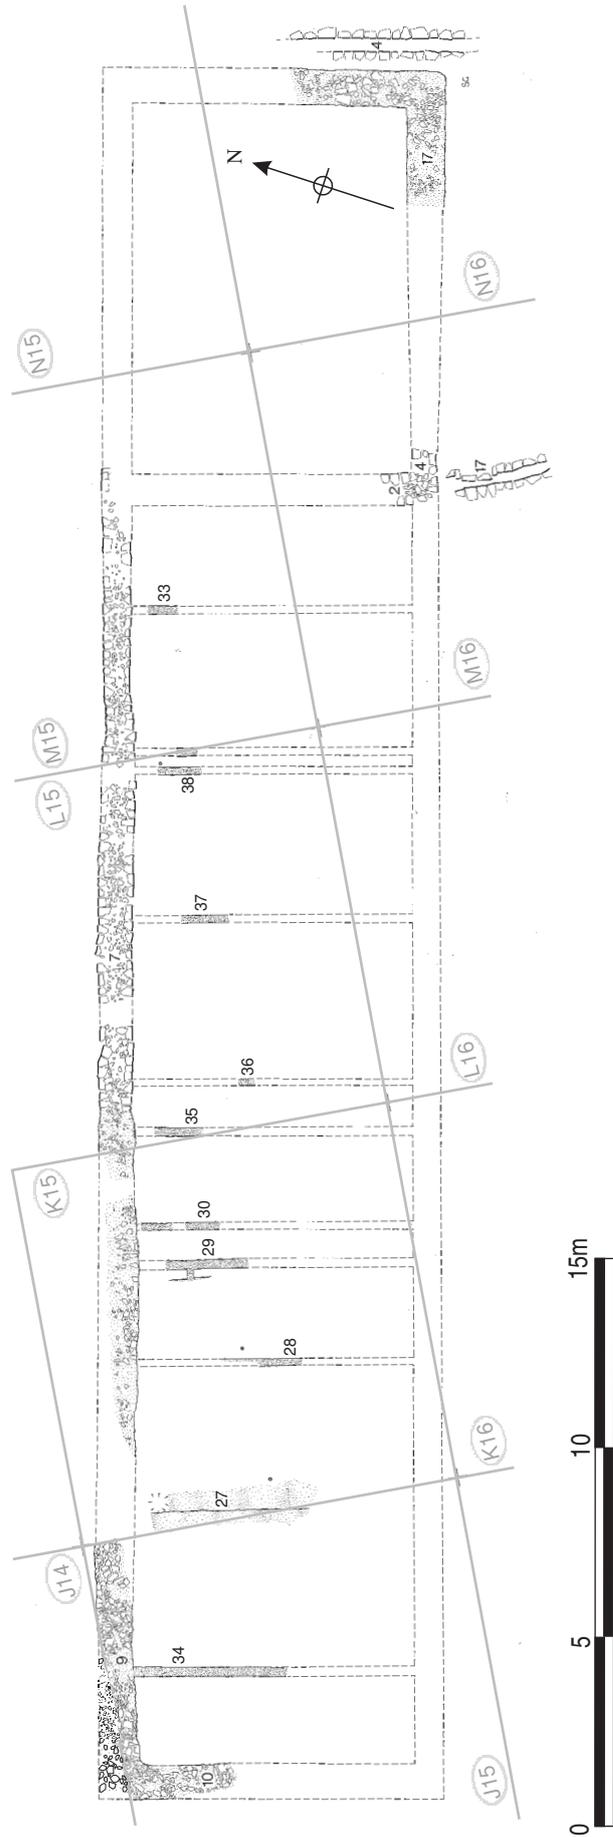
Figure 15.16: Building 11, all partitions at 1:200.

Certain evidence recovered in 1978 would support this reconstruction. A total of 12 narrow, gravel- and clay-filled slots, running north south, were identified (see Fig. 15.16), representing the remains of timber and wattle-and-daub partitions which divided the barrack internally into a series of *contubernia*. All but one of the slots (J15:28) was located at the very end of the 1978 excavation season in digging specifically aimed at locating such features and they were principally recorded, with accompanying annotations by Charles Daniels, on one site plan (P161). Context numbers were assigned, but these context records provide no additional description nor any indication of stratigraphic relationships.

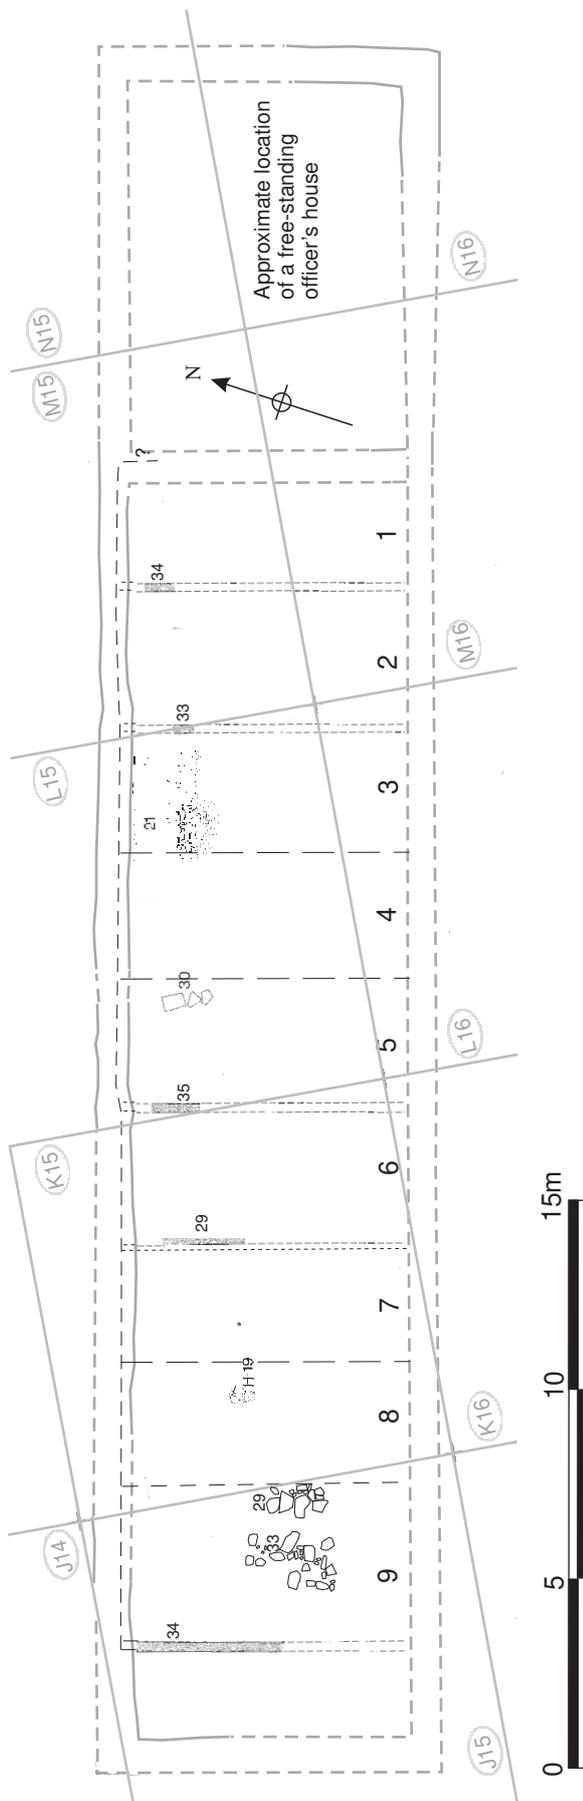
Figure 15.17: Building 11, Period 1 at 1:200.

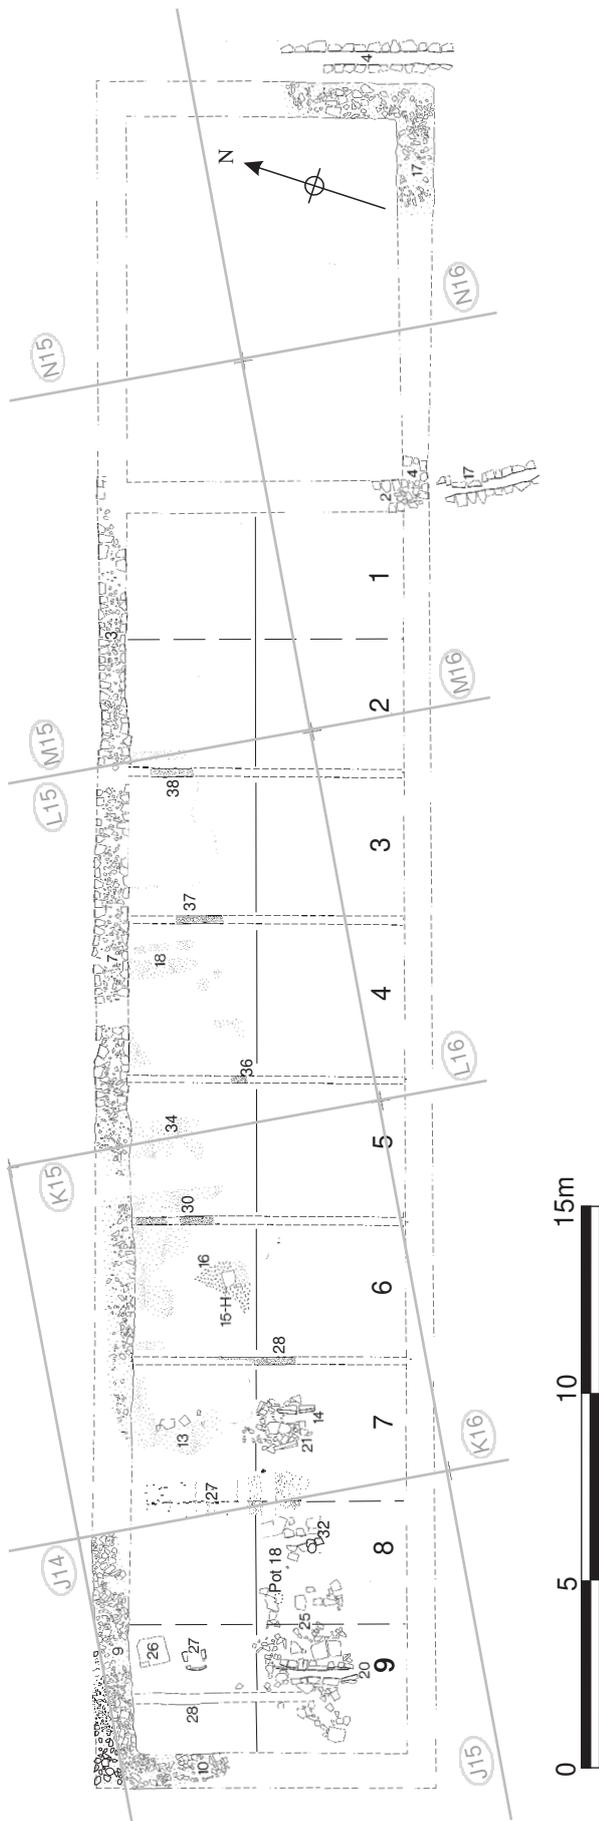
Figure 15.18: Building 11, Period 2 at 1:200.
