# SEGEDUNUM

Excavations by Charles Daniels in the Roman Fort  
at Wallsend (1975–1984)

VOLUME 1: The Structural Remains

Alan Rushworth and Alexandra Croom

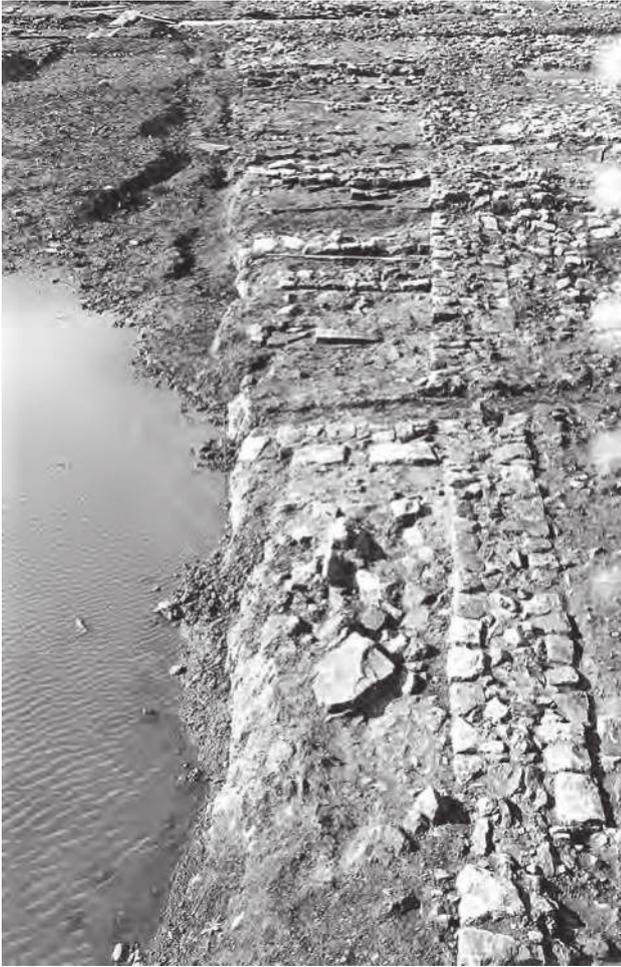
Figure 9 North wall of Barrack 1 with the later chert side walls butting up against it to the south, looking west.

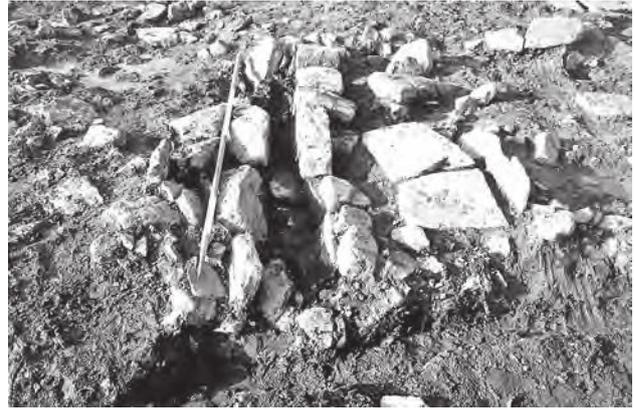
Figure 15.20: Stone drain J15:20 in Contubernium 9, looking north

The south room of *Contubernium* 9 contained a drain (J15:20), which was offset slightly to the east of the room's central axis. It comprised a double line of faced and squared sandstone blocks, which survived over a length of 2.20m (Fig. 15.20). Its channel was 0.12m wide with slabs on the bottom and cut the underlying clay makeup (J15:19). It was filled by a clean, sticky grey clay covered by small rubble which probably formed part of the overall layer of demolition disturbance. The drain was associated with flagging (J15:25), which represented the floor

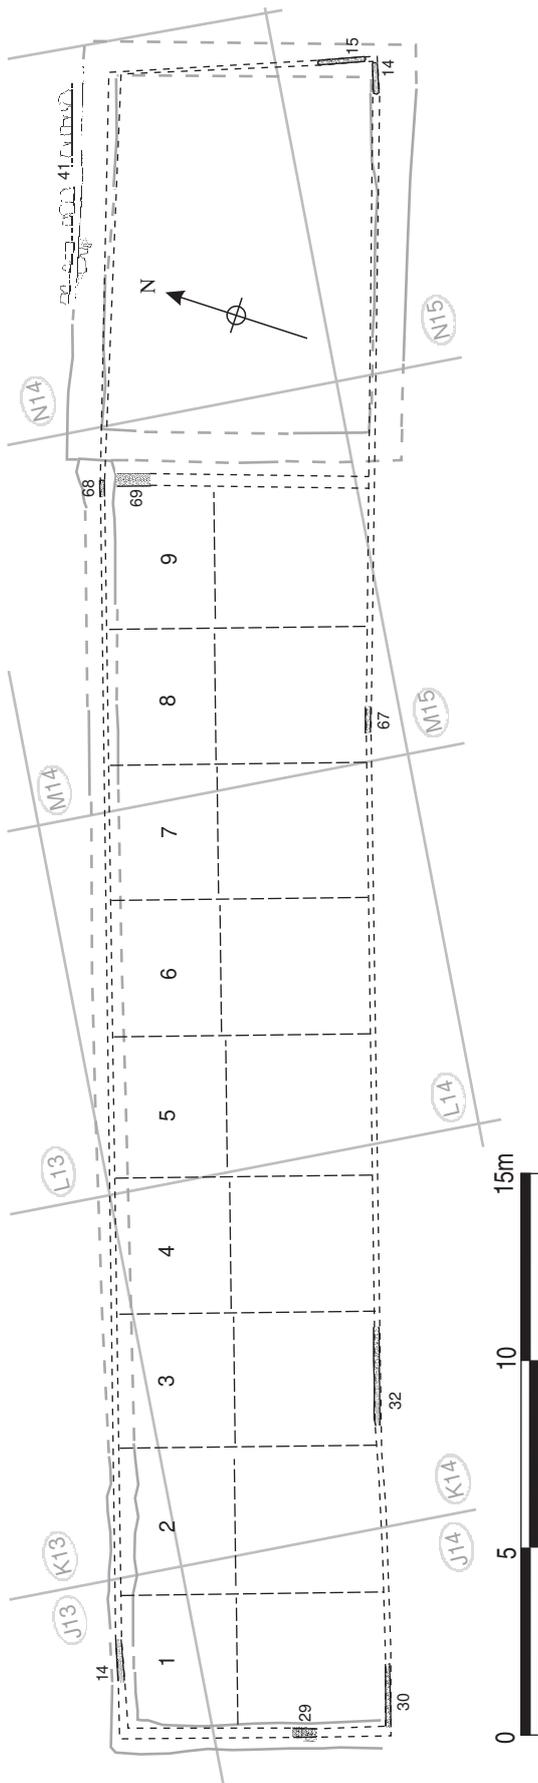
Figure 15.21: Building 12, Phase 1 with the outline of the later stone barrack shown for reference (at 1:200).

Relatively few features revealed by Daniels could be firmly attributed to the primary timber phase of the stable-barrack block. Construction slots, which had probably held sleeper beams supporting the outer walls of the block (or conceivably individual post holes though none were recognised), were revealed under all the stone walls of the later barrack. The excavated lengths of slot ranged from 0.15m to 0.35m in width and were filled with material variously described as grey silt and pink clay (J14:29 – west wall), pink clay (K14:32 – south wall), patchy pink and grey clayey loam (alternatively described as a narrow band of yellow clay) (M14:67 – south wall), grey loamy clay (M14:68 – north wall) and 'grey sticky material with odd stones, tile' (J13:14 – north wall – see Figs 15.22, 15.23). All this material presumably related to the backfilling of the wall trenches when the timber building was demolished. At its western end the south wall trench (J14:30) was seen to cut a layer of grey clayey silt interpreted as the former ground surface (J14:31) and the natural clay subsoil. Packing stones were recorded in some of the slots (M14:68 – north wall; N15:14 – south wall). Although the lengths of slot uncovered were all relatively short (the longest extended no more than 2.60m), they included the south-east angle (N15:14–15) and stretches of all three external walls at the west end of the block (slots J13:14, J14:29–30), which were sufficient to establish the overall length of the building as 44.50m, whilst its maximum width at its west end was 7.50m, narrowing to only c. 7.00m further east.

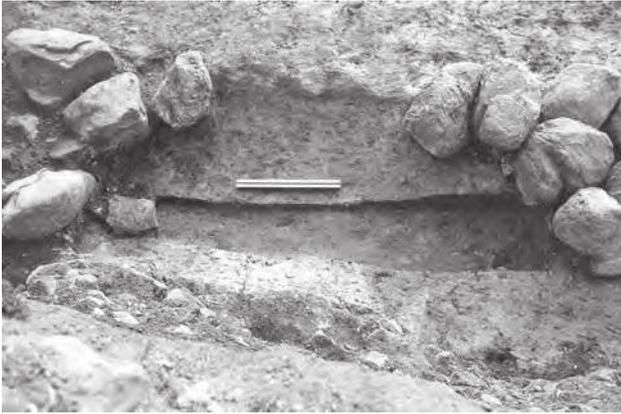
Fig re 1 Slot (J1) for north wall of timber barrack 2 looking south

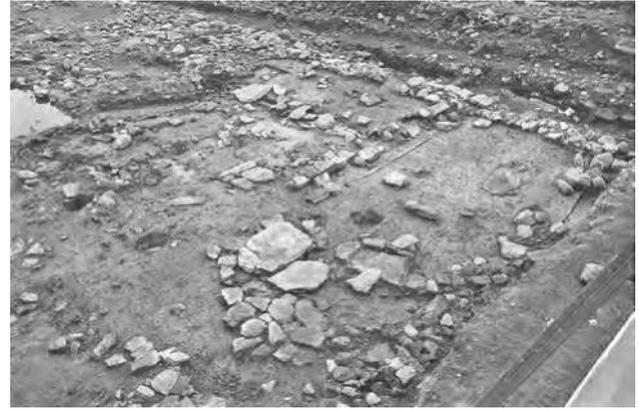
Fig re 2 The west end of Building 2 looking south west with drain J1 visible and slot J2 at extreme right.

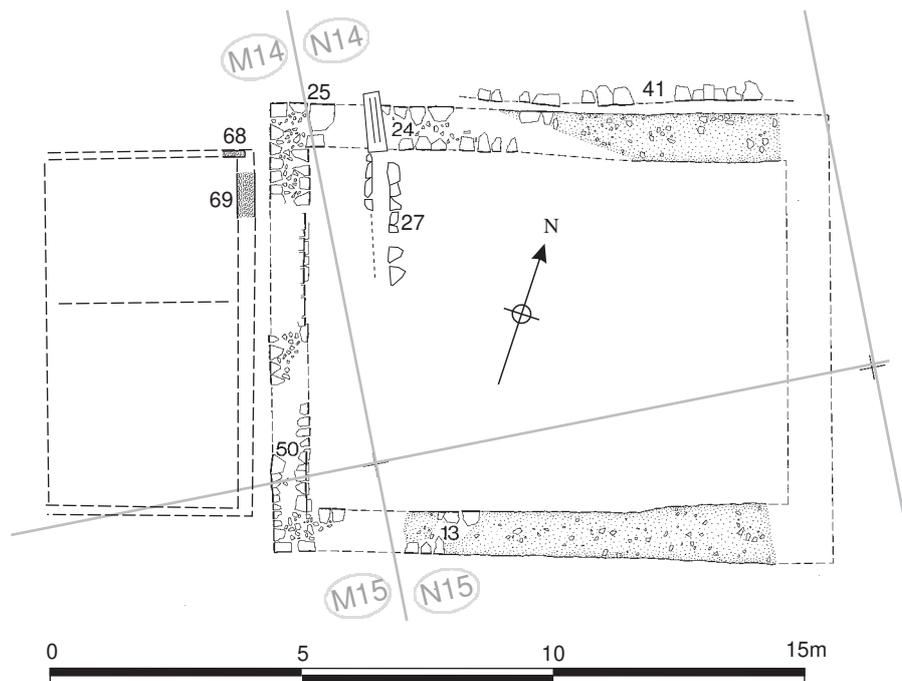
Figure 15.24: Building 12, Phase 2 plan showing the addition of the officer's stone house at 1:150.

The second phase of Building 12 is marked by the replacement of the original timber-built decurion's quarters by a stone house (Fig. 15.24). This was erected on the same site as its predecessor, at the east end of the barrack. The full length of the west wall (N14:25, M14:50) and fragments of the north (N14:24) and south (N15:13) walls remained and measured 0.80–0.85m in width. Where the masonry of the north and south walls had been robbed away the clay foundations still survived. No trace of the east wall was found owing to the modern disturbance at that end of the building. The surviving walls showed that the officer's house was 8.90m wide externally (from north to south) and over 10m long. Although its full external length could not be determined conclusively, but it can be estimated based on the presumed course

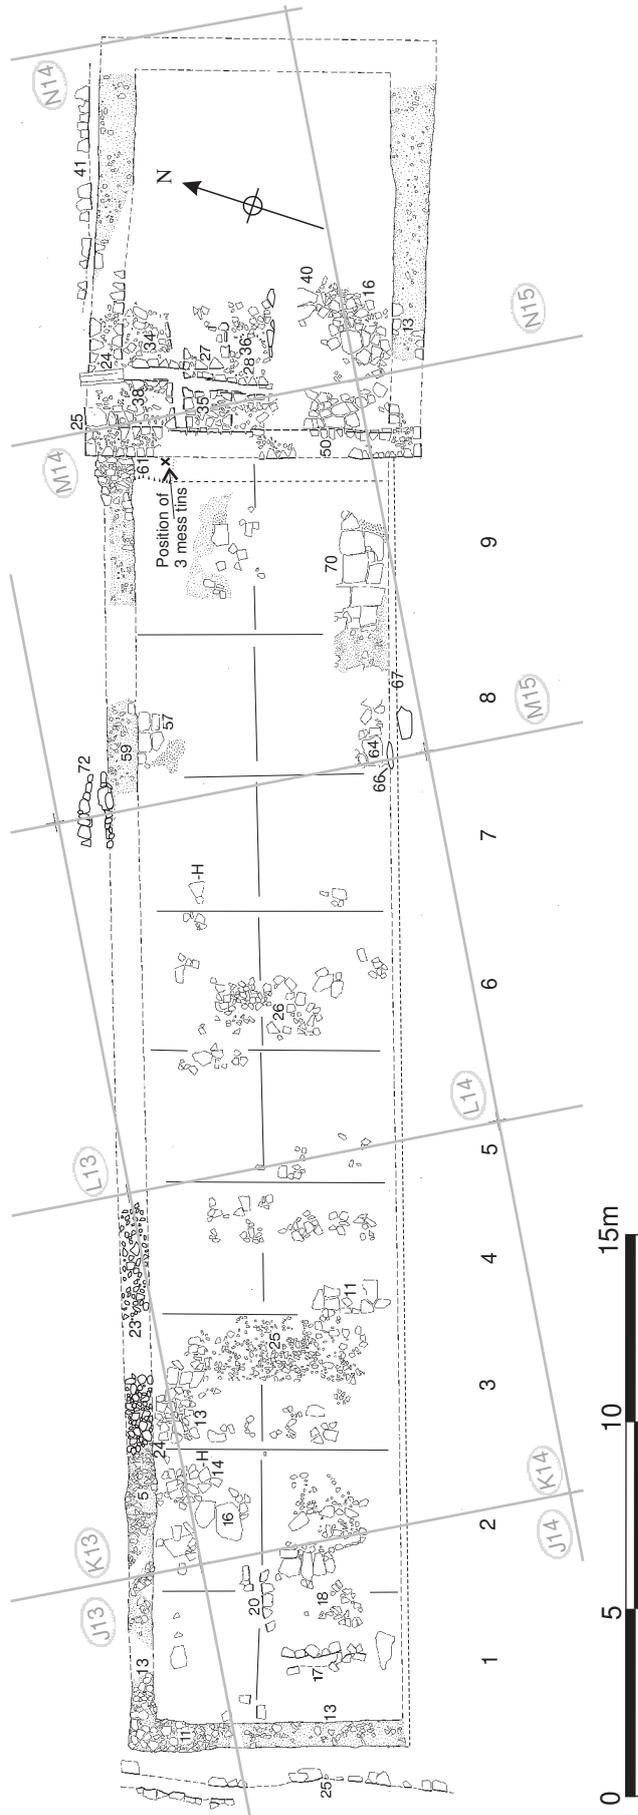
Figure 15.25: Building 12, Phase 3 at 1:200.

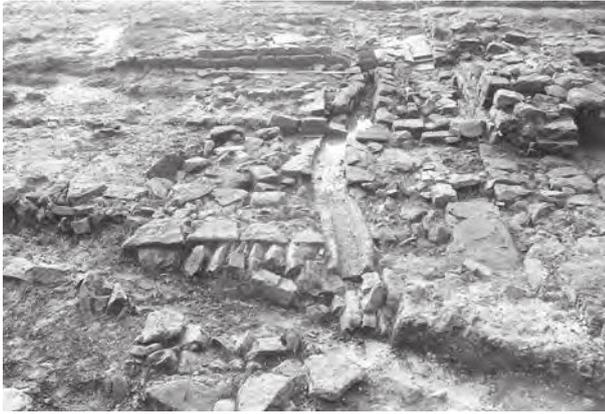
Figure 15.26: Cruciform arrangement of channels in the officer's quarters.

In north-west corner of the house a complex of latrine channels was evident. This was initially interpreted as a channel hypocaust by the excavators and, in its ultimate cruciform layout, the complex of channels does indeed resemble such a structure, in plan at least. However there was no sign of burning on any of the stones and this preliminary interpretation, which is reflected in the context records, had already been abandoned by the time the draft structural summary was compiled. The latrine underwent later modification which has partially obscured its original form. Daniels believed that initially it had a T-shaped arrangement, comprising a main north-south channel (N14:27) with an offshoot to the west (N14:26). A subsequent phase involved the extension of the west channel towards the east and the realignment and southwards extension of the southern part of the

north-south channel, the combined changes resulting in an overall cruciform arrangement of channels, all of which were surrounded by a packing of clay and stone (N14:33–36) which extended as far as the earlier flagging in the south-west part of the the house. Re-excavation in 1997–8 has suggested that the initial form of the latrine was simpler than proposed by Daniels with just the north-south channel belonging to this phase. One stone forming part this channel can be seen in the bottom of the western offshoot channel, implying that the latter must have been a later construction which interrupted the original line of the north-south channel, rather than a contemporary element as Daniels believed. Daniels also considered that some of the stones incorporated in the clay and stone packing defined the southern and eastern limits of the initial latrine and were presumably earlier than the main packing. On site plan P199 three or four stones do appear to mark a straight edge on the same alignment as the southern end of the north-south drain. However, no differentiation was evident in the stone/clay to the north and south of this line, which was recorded as two single contexts on either side of the drain (N14:35 (west), 36 (east)). The eastern edge is even less clear on the site plan (P199) and the overall evidence is not conclusive.

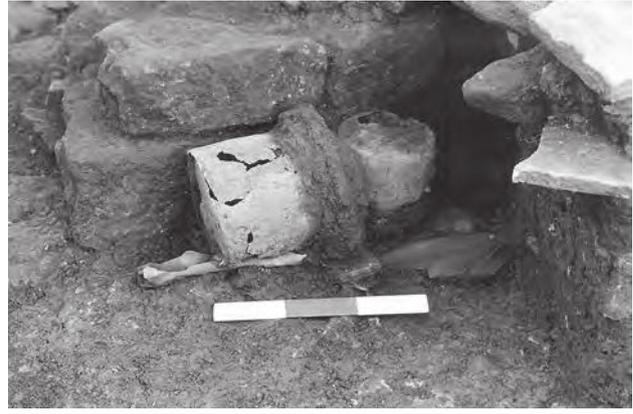
Figure 15.27: Barrack 2 mess tins next to west wall of the officer's quarters.

Copper alloy: buckets (nos 79–81, M14:61 – see Fig. 15.27)

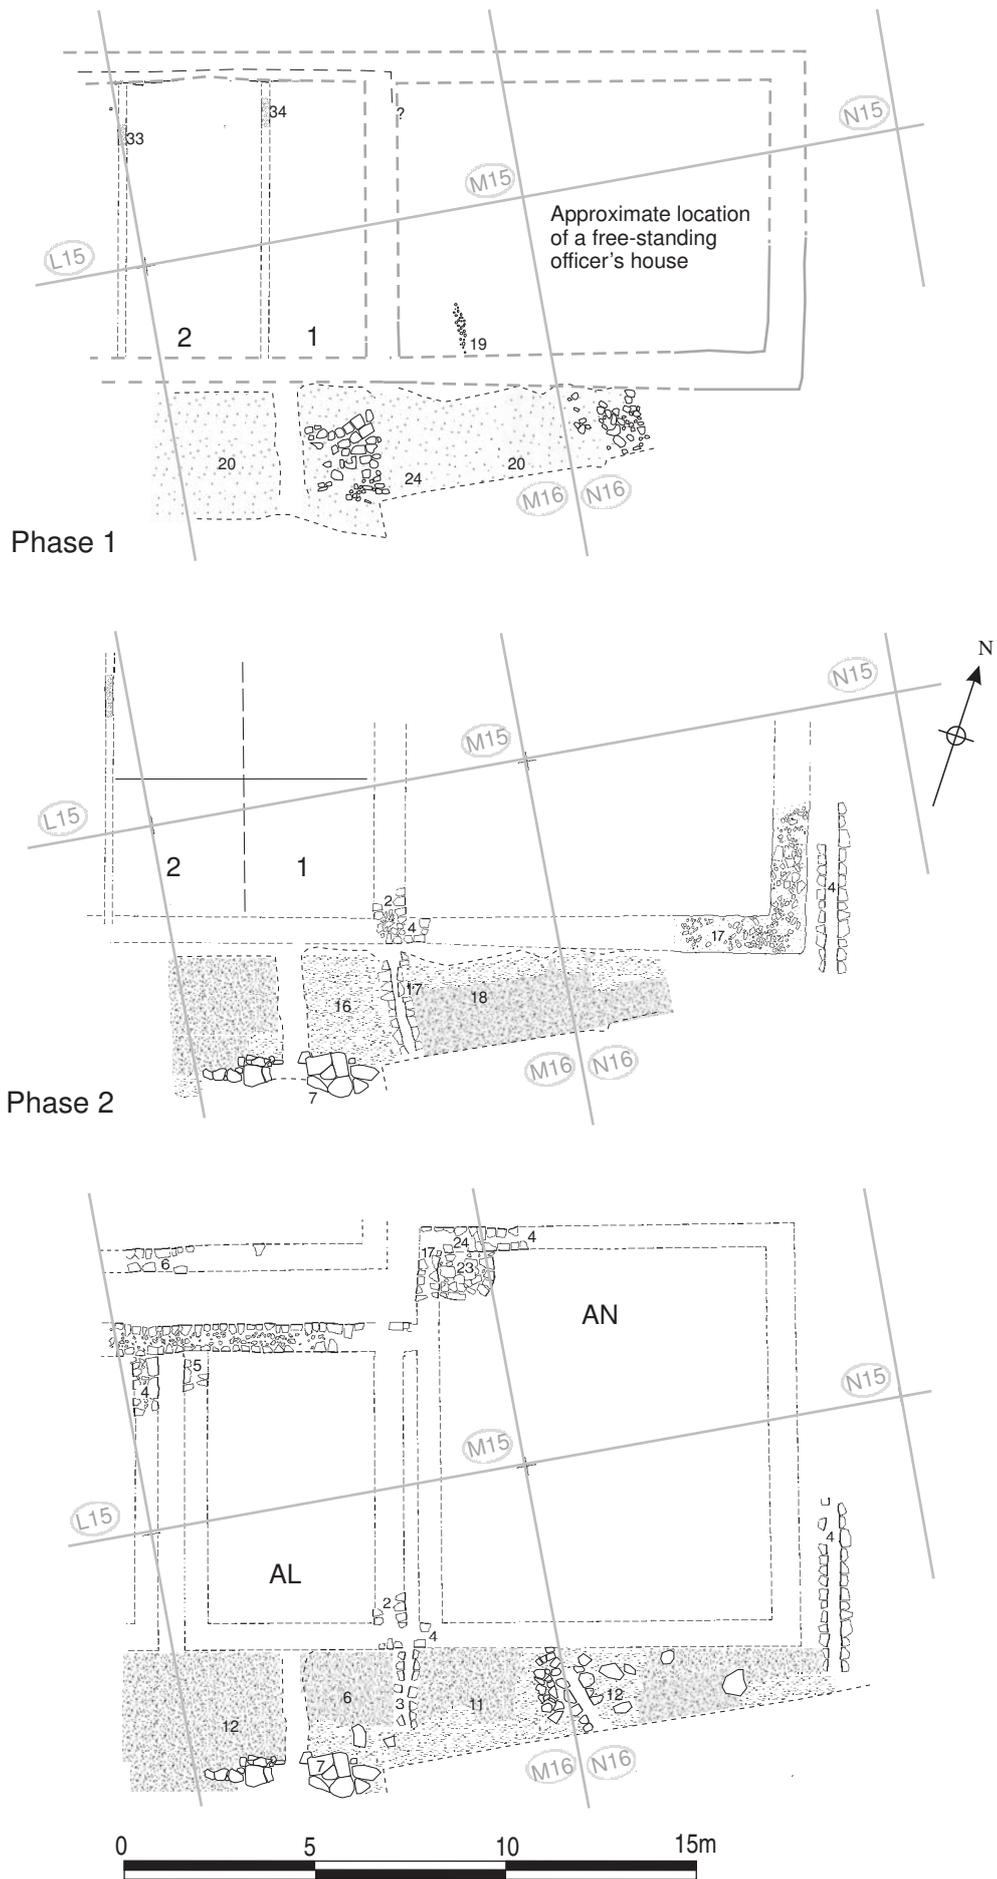
Figure 8 Location of the intervallum road surfaces south of Building 1 and Ch let Rang 1 (AL & AN) at 0

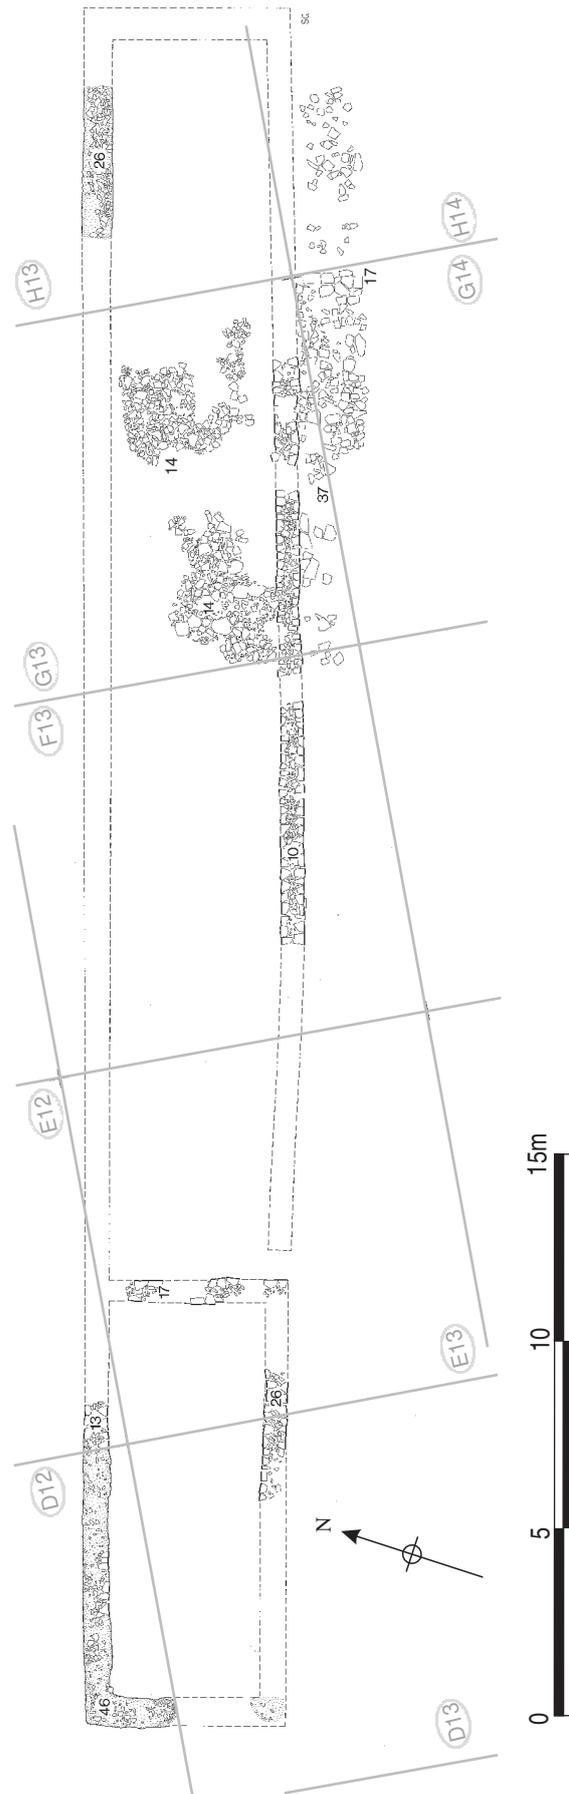
Figure 16.03: Building 9, Phase 2, final Daniels interpretation at 1:200.

*Daniels' Building 9 Phase 2 (revised version)*  
(Fig.16.03)

A reassessment of Phase 2 was prompted by the recognition that cross wall F13–10 almost lines up with the medial wall, D13:04, constructed across the officer's quarters at some stage (see above). It was suggested that this medial wall might have been designed from the outset to serve along with cross wall F13:10/G13:10 as the south wall of the building, rather than forming a medial east-west partition, with the whole building being foreshortened on the south side, possibly to function as a stable, paralleling the change which takes place in Building 1 in Phase 2. Although the interim structural report stated that the stratigraphic evidence in Building 9 did not support this interpretation (but without any further explanation), it was ultimately adopted as the favoured version, incorporated in interim summary reports (cf. Daniels 1989, 79–80), in the context phasing and depicted amongst the most recent series of inked plans, catalogued when post-excavation analysis resumed in 1997–8. As reconstructed, the building comprised a long, narrow, open room, measuring 33.10m by 4.10m–4.50m internally and stretching the full length of the former *contubernia*. The room was somewhat irregular, being wider in the middle (5.85m externally) than at either end (5.40m–5.50m). Only the area of the former officer's quarters at the

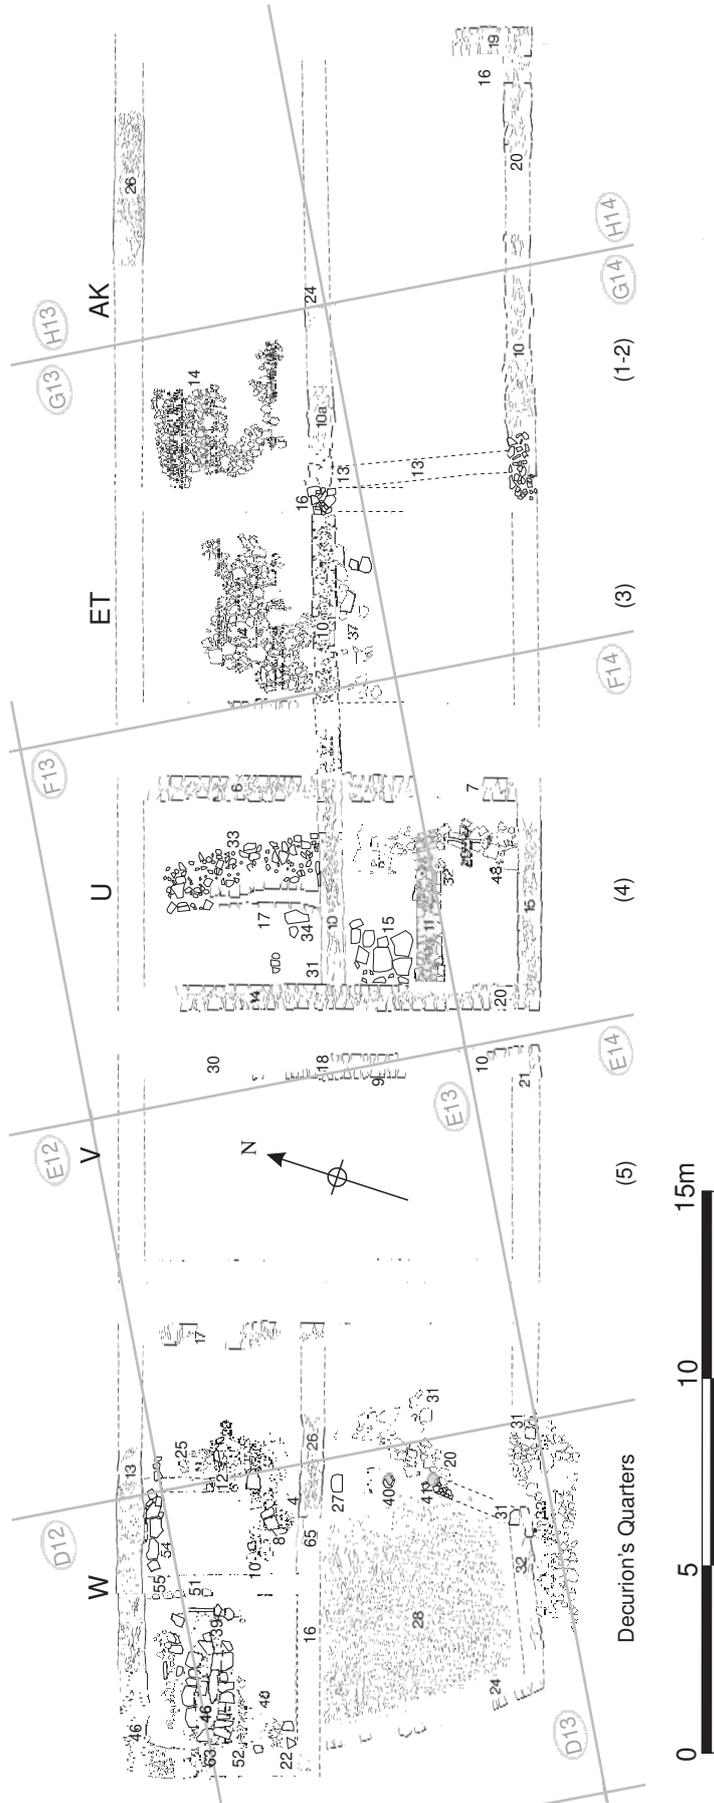
Figure 16.04: Chalet Range 9 at 1:200.

#### *The overall layout of barrack rang* (Fig. 16.04)

The 1997–8 excavations resulted in a much improved understanding of the third-century arrangements in Building 9. Daniels' Phase 2 has essentially been eliminated, key elements being combined with the chalet phase layout (Daniels' overall Phase 3, dated to c. 300, but now shifted considerably earlier to correspond to TWM Period 4). This interpretation is largely followed here. Where the Daniels' excavation record suggests an alternative interpretation this is highlighted below.

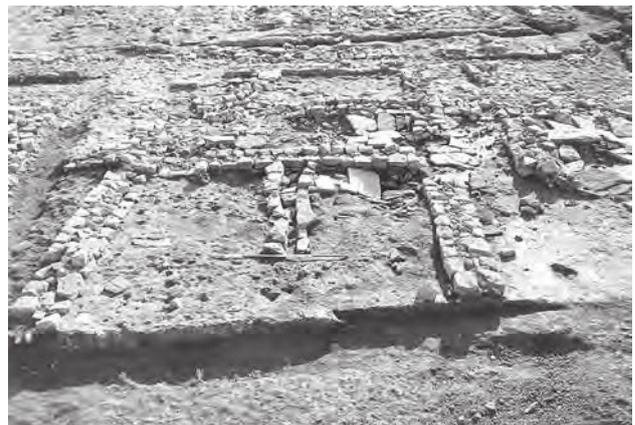
Figure 16.05 Rang 9 Chalet U from the north with the central drain and both east and west walls visible and the west wall of ET just in shadow on left.

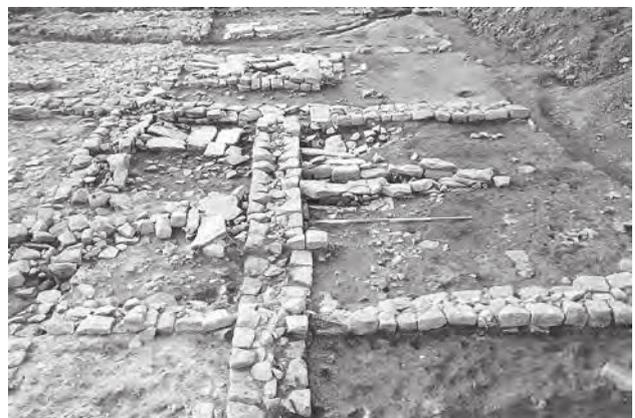
Figure 16.06 Chalet U from the east. Note the earlier south wall of Building 9 (left) probably incorporated in the floor along with flagging, but perhaps still used here as a room divider.

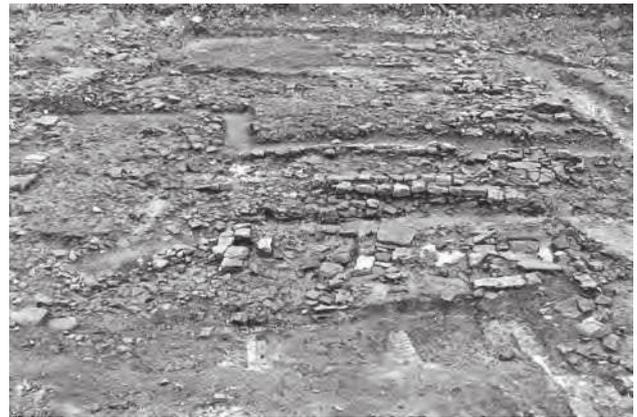
Figure 16.07: General view of chalet phase (Period 4 levels in the decurion's quarters (W and AB) of Rang 9 and 10 viewed from the south

### **Building W (the officer's house) (Figs 16.07-16.09)**

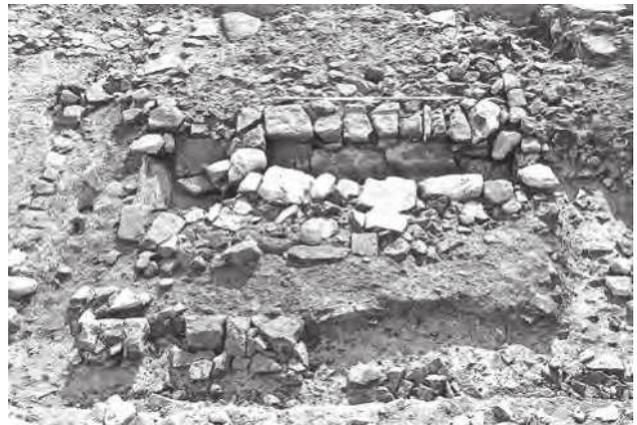
Figure 16.08: The shortened urine pit in the decurion's quarters (Chalet W) of Chalet Rang 9 viewed from the north

The north range was divided into three rooms. In the western room, which measured 4.00m by 4.00m internally, the urine sump (D12:49, D13:46) continued in use, but was reduced in length to 2.35m and narrowed to a width of 0.60m (Fig. 16.08). The outlet drain (D13:52/53) was also taken out of use and backfilled (D13:69). The side walls of the sump were raised by the addition of an extra course of stone blocks, bring the top of the sump up to the level of a new stone floor (D12:50, D13:39, 48) which was laid in the room. The west side wall of the outlet drain was incorporated in this surface and the fill of this drain (D13:69) was identical in composition to the overlying surface (D13:48). There may have been an entrance in the middle of the west wall of this room, the evidence for which was a pivot setting (D13:63, recorded in a site notebook sketch plan) and an apparent gap (D13:54) in the robber trenches (D13:22) of the west wall. The central room was separated from the western room by a north-south wall, one face of which survived (D12:55, D13:51), and which probably occupied a similar position to the Phase 2 partition. To the east the room was closed off by another stone wall (D13:12, E13:25), giving it internal dimensions of 4.00m (north-south) by c. 2.20m (east-west). The relatively narrow proportions of this chamber suggest that this room functioned as an entrance passageway, with opposing doorways in the south and north walls. This supposition was supported by the pronounced pattern of wear identified by the 1997–8 excavators over a 1m wide area of the *via quintana* street surface immediately outside the north wall (TWM 7973, cf. Hodgson 2003, 99). A line of flagstones (D12:54) in the corresponding position just inside the north wall, at the north end of the passageway, may have formed part of the threshold with the flagging having presumably continued through the doorway before the north wall was robbed out. The only possible floor recorded in the passageway was a rubble level (D13:11) over a layer of soil and stone (D13:55). This was bounded to the south by a distinct line of flagstones (D13:10), that appeared to mark the edge of a flagged surface (D13:08) extending between the entrances to the east and west rooms and through the pre-existing doorway in the south wall, which lay directly opposite the doorway at the north end of the passageway. The east room had internal dimensions of 4.00m north-south by 3.45m and was furnished with a flagged floor (E13:29). Access to the room from the central passageway was in the south-west corner. The entrance to the western room occupied the corresponding position on the west side of the passageway.

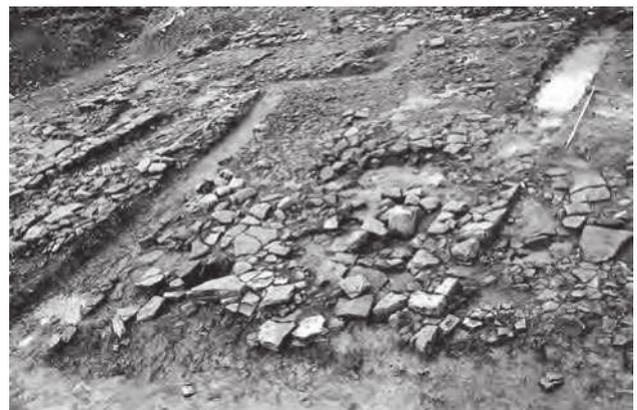
Figure 16.09: Flagged access and cobbled yard south of Rang 9 decurion's quarters (Chalet W) extending towards the north wall of Rang 10 (AK), looking west.

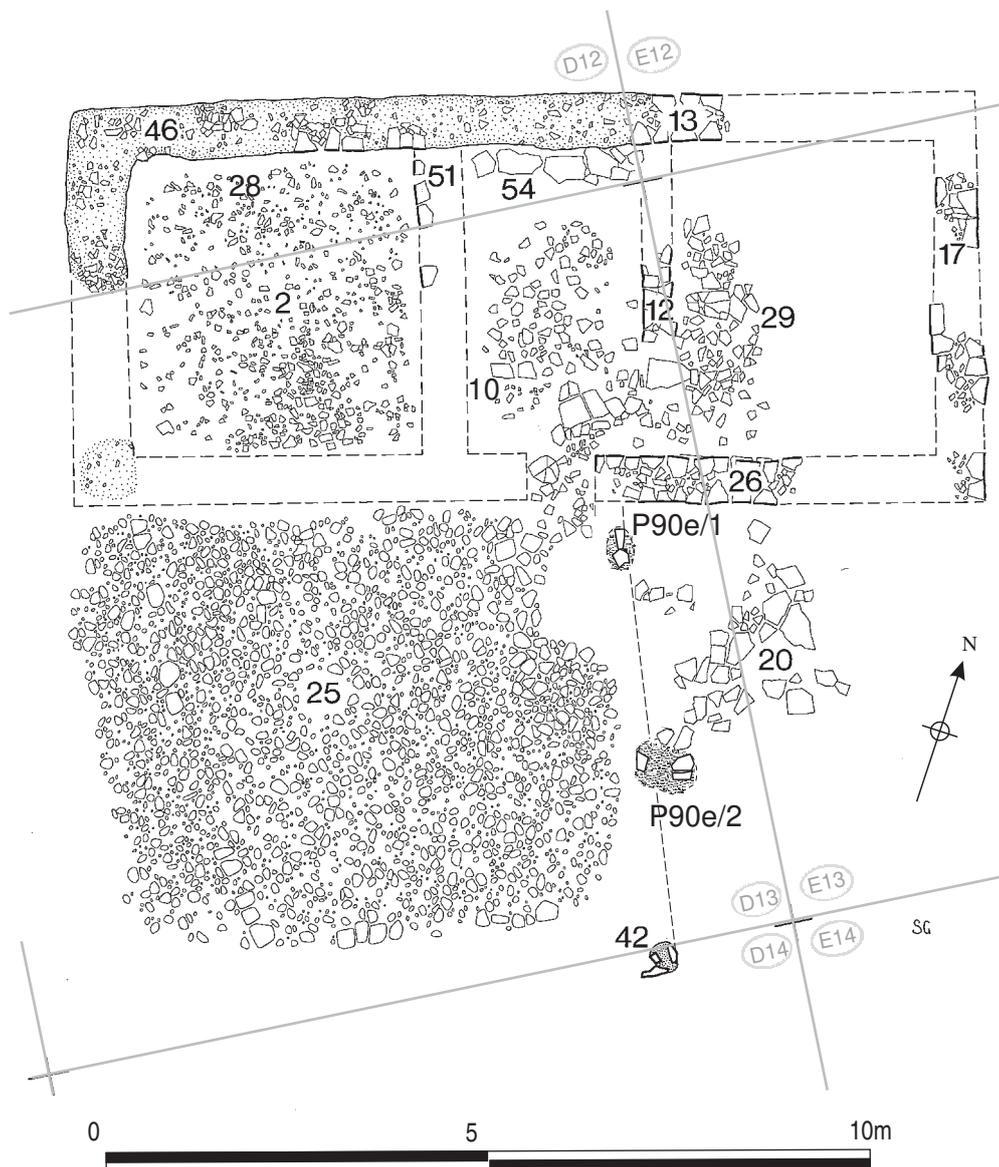
Figure 16.10: Chalet Range 9: later modifications to the officer's quarters (W) at 1:100.

#### *Later alterations* (Fig. 16.10)

The yard walls were subsequently demolished and the remains incorporated in a new cobbled surface (D13:25) laid over the south-west corner. These cobbles were close set and noticeably worn.

Four post holes (D13:40, 41, 42, 67) were identified in 1978, three of which followed a north-south alignment. Several more were revealed when the area was re-excavated in 1997–8. Unfortunately the relationship of these post holes to the latest levels was

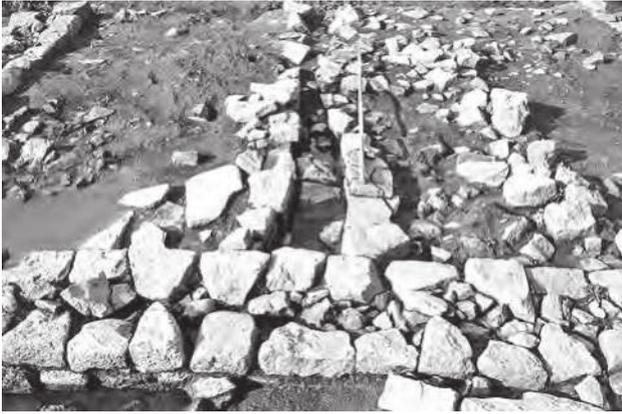
Figure 16.11: The stone-lined drain in the north (stable) half of Chalet U from the south, with the spine wall in the foreground.

A possible doorway through the spine wall into the south room was identified hard by the west wall (F13:31) on the basis of the wear on the surface of the spine wall's surviving masonry. This doorway was about 0.65m wide and to the east was a facing stone with a socket 0.06 by 0.07 m. A stone-lined drain (F13:17) ran down the centreline of the north room (Fig. 16.11). This feature was c. 0.90m wide overall, the channel being wider at its southern end (c. 0.40m) where it was best preserved. There the drain was 0.20m deep, with a rough stone bottom,

edged on either side by one or two courses of facing stones. To the north it narrowed to about half the width and its side walls were badly disturbed. To the east of this drain a very disturbed stone floor level (F13:33) was evident, which contained quite a lot of reused building stones. This had been cut away by a modern drain channel along the east side of the room. A deposit of stone and clay loam (F13:34) edged by a line of stones, filled the depression where the earlier flagged floor had subsided into the urine sump, on the north side of the spine wall immediately in front of the suggested doorway (F13:31). Internally, the room measured at least 4.50m north-south by 4.90m east-west.

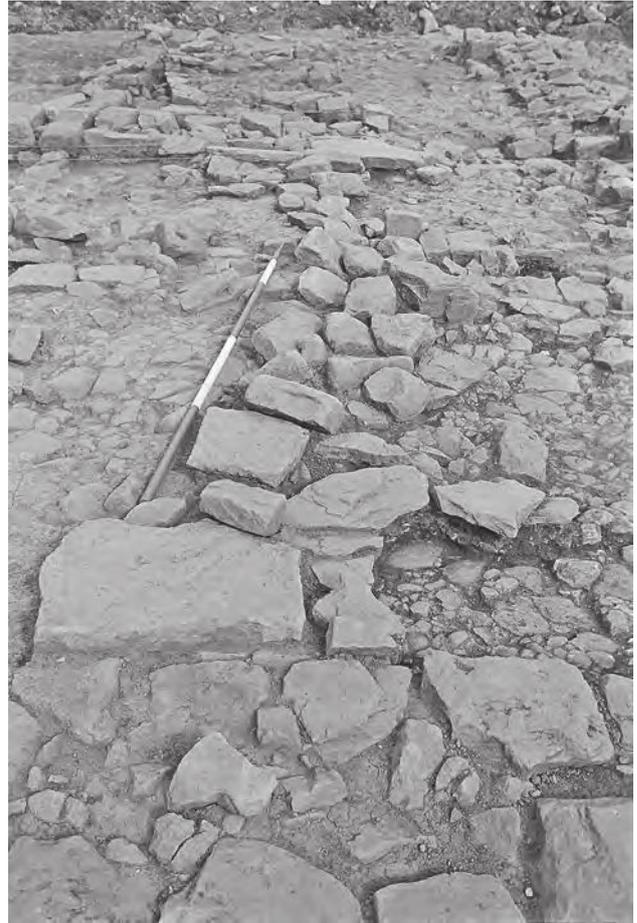
Figure 16.12: The possible stone-packed partition slot (F14:29) running north-south in the rear room of Chalet U, looking north.

The south room was at least 4.60m north-south by 4.90m east-west and may have been further partitioned into two smaller chambers. Traces of a timber partition were identified, which divided off a passageway along the east side of this room (Fig. 16.12). The evidence took the form of a line of packing stones (F14:29), with what appeared to be flagged thresholds at both the northern and southern (F14:48) ends. The presence of two such possible thresholds suggested that the remainder of the south room may have been divided into two smaller chambers, each with its own entrance. The demolished remains of the earlier south wall of Building 9 (F13:11/F14:08) perhaps served as the base of an east-west partition separating these two smaller chambers. At the north end of the passageway, right next to the east wall, the 1997–8 excavators identified a possible blocked doorway (TWM 8554) through the spine wall which probably provided access from the north room. Here, a 0.90m long section of the spine wall comprised just a single course, worn on its upper surface. Where the second course began it presented a neatly dressed face, whilst a single sandstone block prolonged the alignment of that face into the north room, perhaps acting as a jamb of some kind (Hodgson 2003, 98).

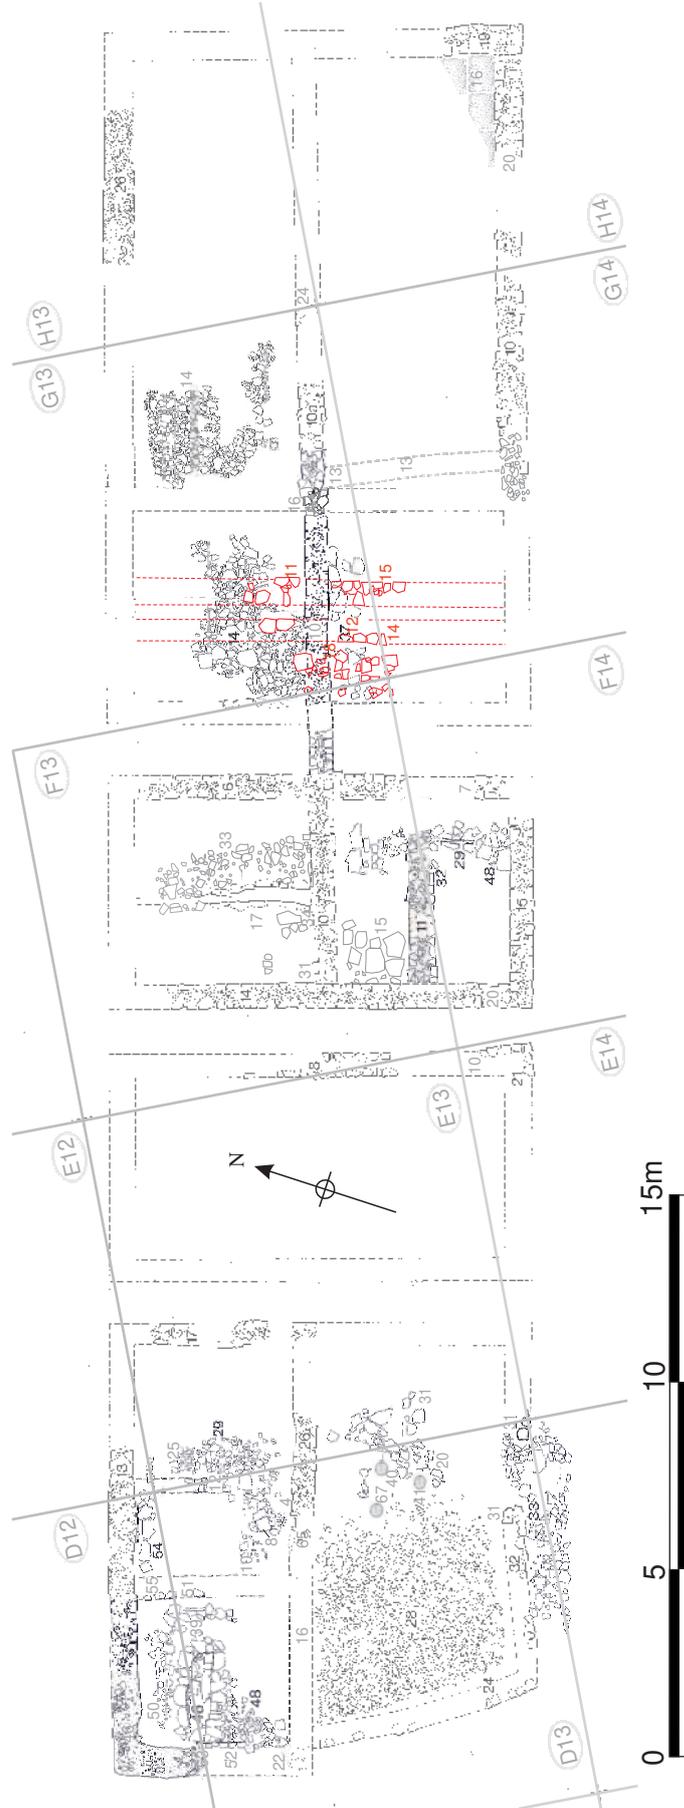
Figure 16.13: Chalet Range 9 later modifications (shown in red) at 1:200.

#### *Later alterations* (Figs 16.13, 16.14)

A group of structures overlying ET provided evidence that the layout of this part of Barrack Range 9 was later substantially remodelled. The remains of two parallel walls were noted, set on the earlier cobble and flagstone floor (G13:14, G13:37). Both survived fragmentarily on either side of the spine wall, implying that they extended across the full width of the barrack range, and followed the same, roughly north-south orientation as the side walls of *contubernium* (see Fig. 16.14, cf. Hodgson 2003, 97, fig. 70). The more westerly wall (G13:12, G14:14) had a heavily worn surface. Its stones were very large and irregular and it did not survive well enough to measure its width. Just to the east was a second wall (G13:11, G14:15) about 0.70m wide. It butted on to G13:10 on both sides. To the west of G13:11 a new surface of flagstones (G13:18) was laid, mainly on the south side of the spine wall G13:10, but also extending over the surviving remains of that wall, which exhibited similar wear on the surface of its uppermost course, demonstrating it had

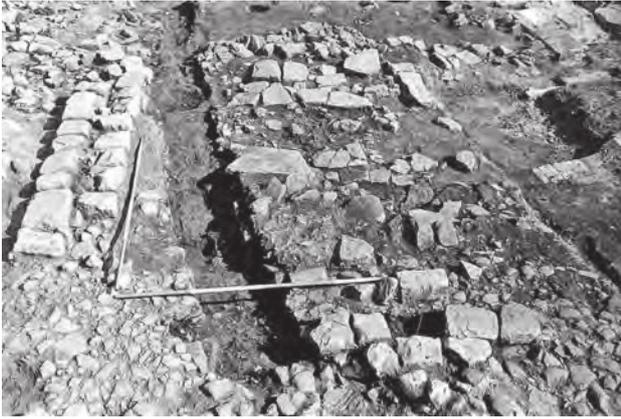
Figure 16.16: Range 10, the north-west corner of the decurion's quarters (Chalet AK), showing the rebuilt stretch of north wall (left) and successive west frontages, looking east.

The north wall of AB was the old north wall of Building 10 which survived mainly as a flagged base course over the foundation. At the north-west corner the early wall had been shortened and the old west wall completely demolished (Fig. 16.16). Some of the north wall actually survived (D14:07), and showed evidence of having been rebuilt, being very different in character to the rest of the Building 10 north wall. The 3.50m surviving stretch of walling was composed of large, roughly square or oblong blocks, with relatively little wall core, and lacked the flat plinth course, which characterised the north wall of Building 10 to the east. In addition it sat on a distinct secondary foundation layer of angular rubble (D14:21), over the original clay and rubble foundations (D14:25). The position of the new west wall was marked by the sharp edge to the new *intervallum* street cobbling (D14:13), and a line of dark grey soil 0.10m-0.15m wide (D14:37) between the street and the flagged floor of the interior. This would be consistent with the slot for some kind of timber wall or shuttering, rather than a robber trench for a stone wall. The use of timber frontage was a common feature of chalet barracks and suggests that the officer's house now faced westwards onto the *intervallum* road. The east wall of the officer's quarters was removed presumably in conjunction with the erection of the new building and the clay loam filling of the trench provided a valuable group of pottery (E14:39). The east wall of AB itself was seen in a short length of robber trench up to 0.65m wide where the impressions of four or five stones survived (E14:35) towards its north end. The rest was lost in modern disturbances, as was the whole of the south wall. As with the other chalets of the range, X, Y, Z and AA, it was assumed that the south wall of Building 10 was re-used to form the south wall of AB.

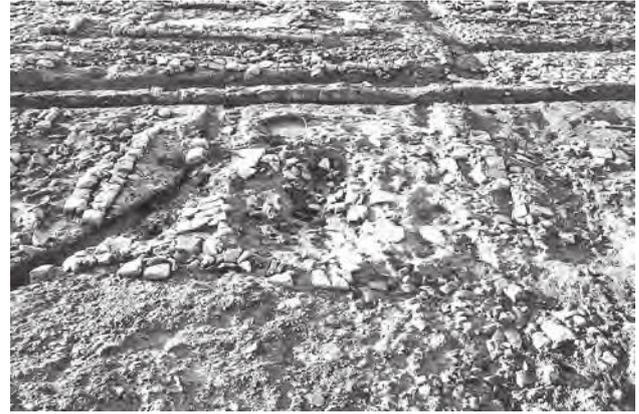
Figure 16.17: Chalet Z in Range 10 from the south with the east wall of AA (F14:43) to the left and the robbed west wall of Y on the right.

#### Chalet Z (*Contubernium* 2) (Fig. 16.17)

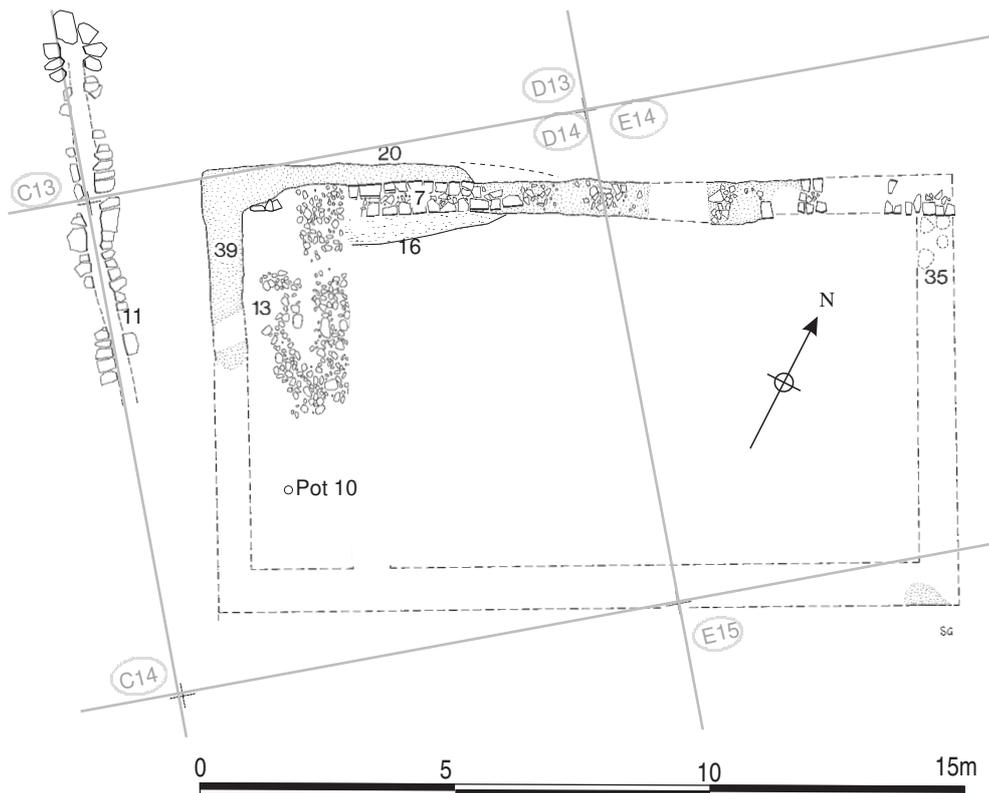
Fig. 16.18 Chalet AB (Rang 0) decurion's quarters) Phase 2 at 10

### Chalet AB – Phase 2 (Fig. 16.18)

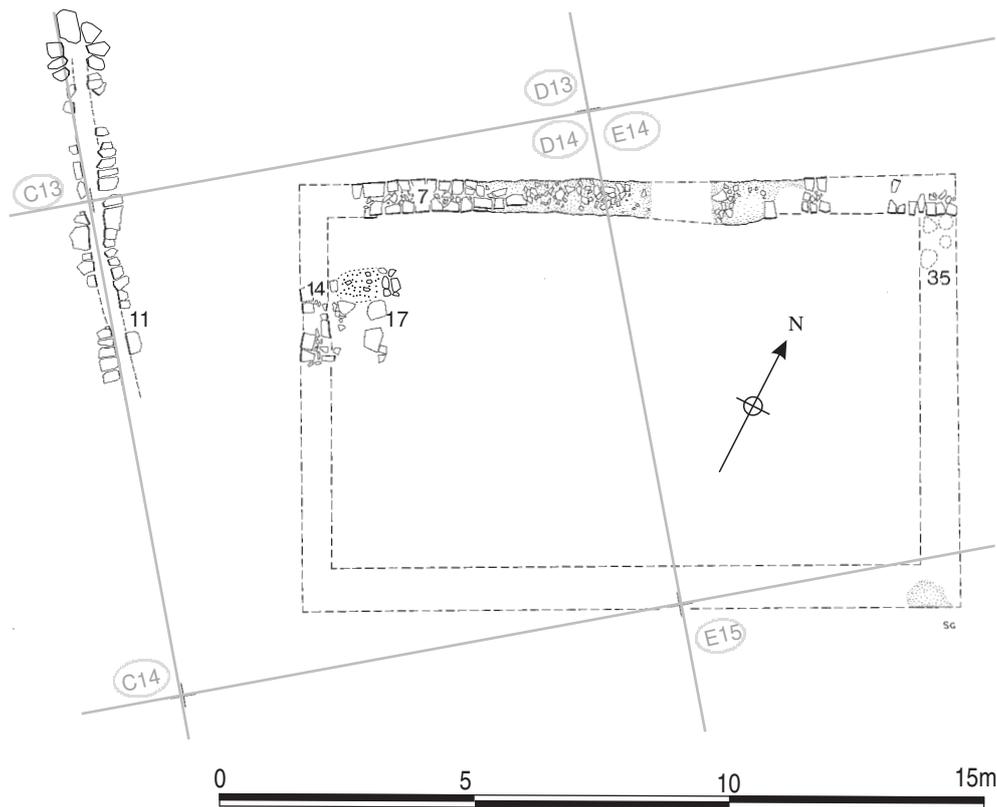
Figure 16.19 Chalet AB Phase 3 at Daniels' Fort

### Chalet AB – Phase 3 (Fig. 16.19)
