# SEGEDUNUM

Excavations by Charles Daniels in the Roman Fort  
at Wallsend (1975–1984)

VOLUME 1: The Structural Remains

Alan Rushworth and Alexandra Croom

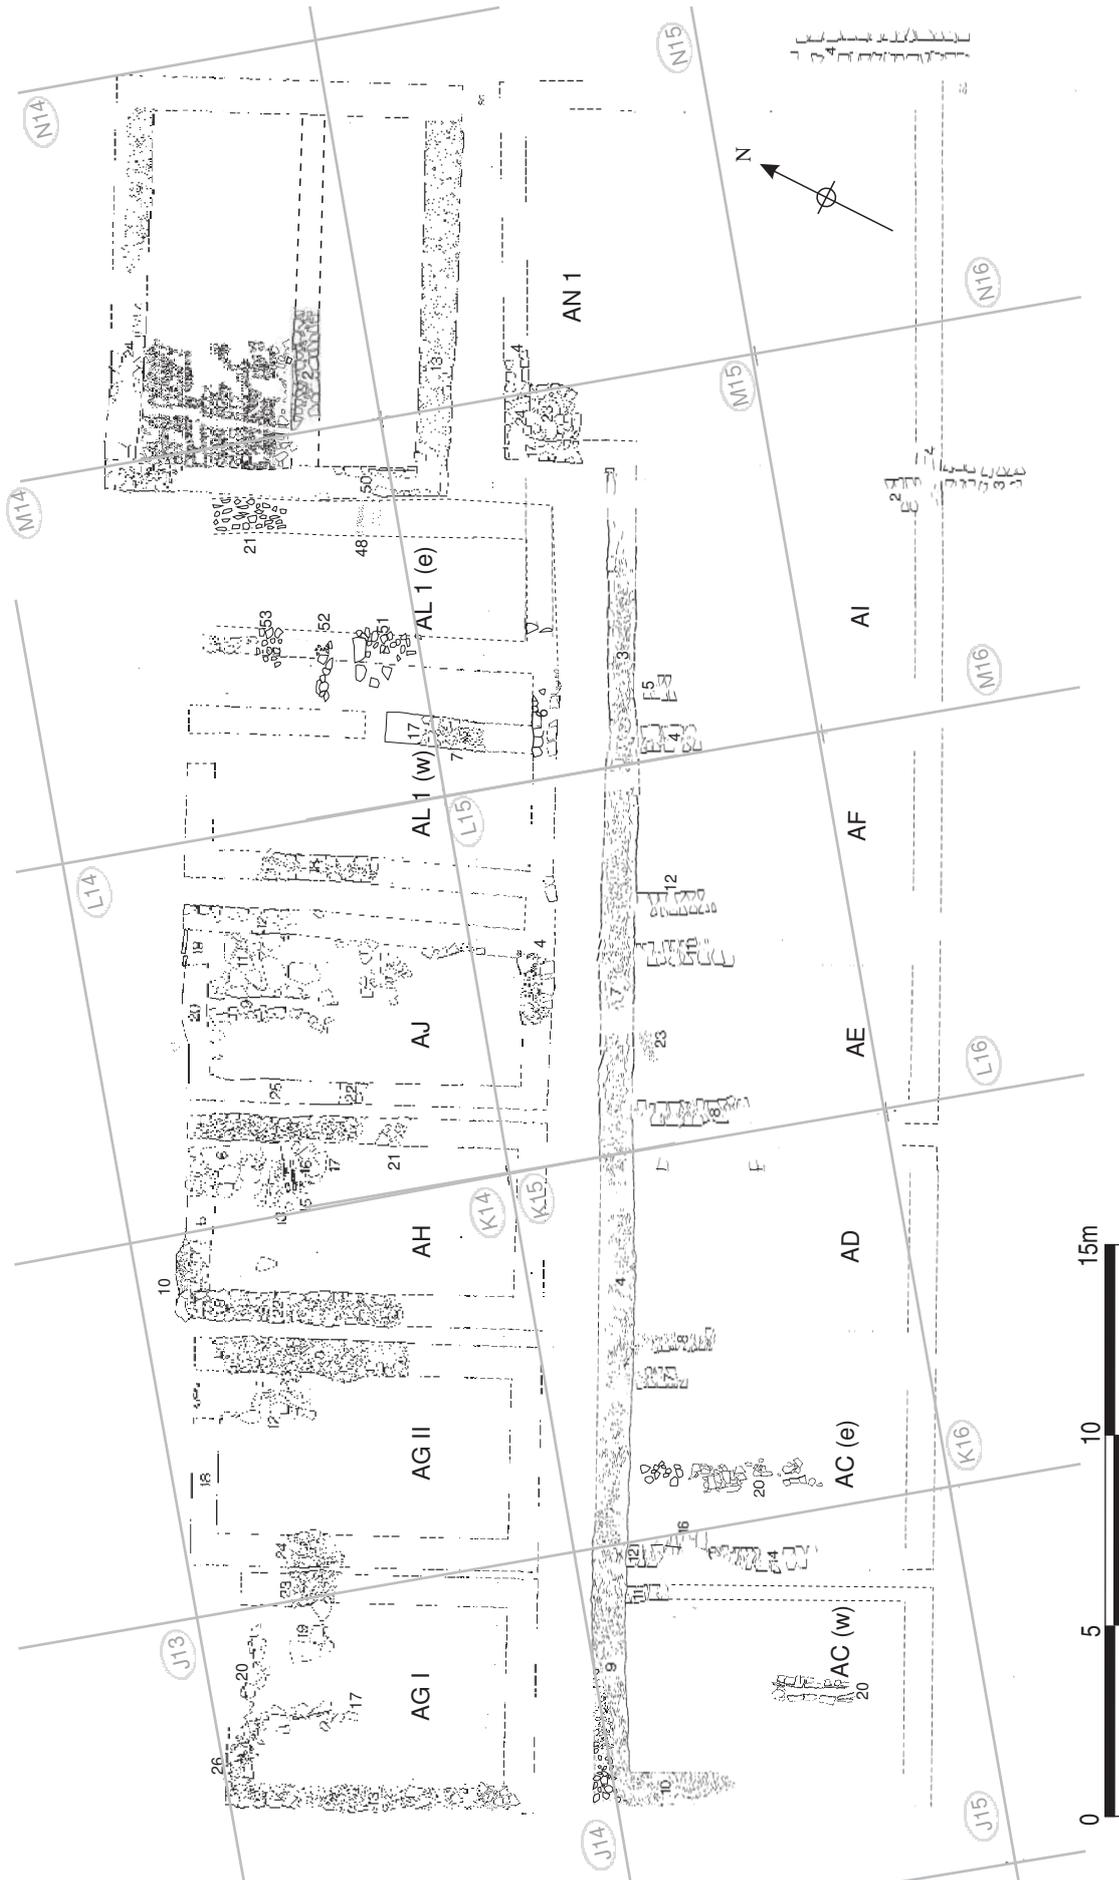
Figure 16.20: Chalet Range 11 and 12 initial layout at 1:20.

### *Introduction* (Fig. 16.20)

Chalet Range 12 was the only one of the late barracks in the *retentura* to preserve significant details regarding the front (north) walls and doorways of its constituent chalet-*contubernia* (Fig. 16.20, cf. Figs 16.27–16.29 below). The staggered nature of this combined frontage, with each individual *contubernium* recessed slightly in relation to its neighbour to the east, would suggest that the course of the eastern *v a quintana* had been altered slightly, making it an easier turn for traffic between that street and the *v a decumana*. There is no indication that a similar pattern prevailed in the western *retentura*. The frontage of Chalet Range 9 had

### **Chalet Range 12 (AG, AH, AJ, AL, AM)** (Fig. 16.20)

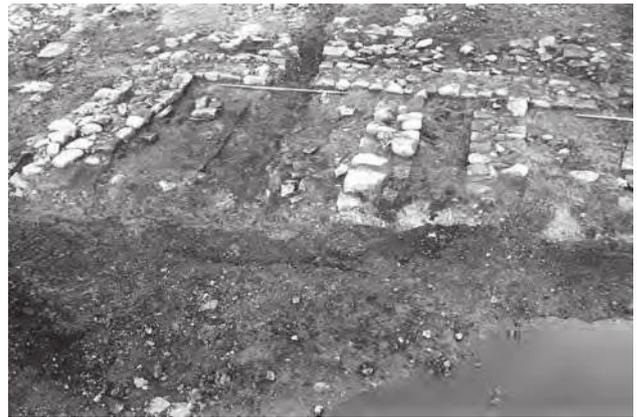
Figure 11 Chalet Rang 1 th side walls of Ch lets AE and AF running up to th north wall of earlier Barrack 1

In fact Daniels' assumption that the north wall of Building 11 was retained in use as part of the succeeding chalet range was not unreasonable, given the state of the remains as they appeared when uncovered in 1978, and is paralleled in the similar reuse of the south wall of Barrack XIII at Housesteads as the rear wall of the subsequent chalet range around the end of the third or beginning of the fourth century (Rushworth 2009a). The north wall of Building 11 survived best towards the east, where a 17.70m length of masonry was revealed standing up to two courses high (L15:07, M15:03), although the easternmost stretch, in the area of Chalet AN – the putative officer's house – had been destroyed by the course of the waggonway. The lowest courses of the chalet side walls – all that remained of these walls – butted up against the masonry footings of the north wall L15:07/M15:03 and the state of preservation of all these structures appeared to be very similar (Figs 16.21, 16.22). Further west, only foundations of the north (J15:09, K15:04) and west (J15:10) walls remained. These were composed of angular rubble set in orange clay and were 0.95m wide. The excavators' observations with regard to these less well-preserved

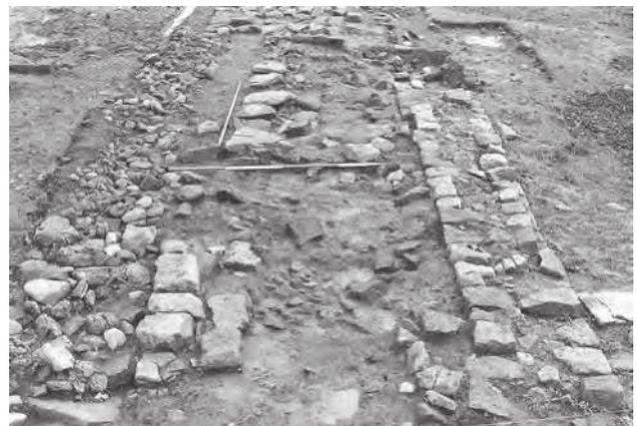
Figure 12 Th south wall of Ch let Rang 2 (p ssible ch let sp ne wall) to th left and Barrack 1 north wall to th right with later alterations beg nd, looking east.

stretches, set out in the context records for J15:09 and J15:10, seem to provide explicit evidence that these walls were rebuilt as part of the chalet phase remodelling (which at that stage was considered to be fourth-century in date). The foundations appeared to cut the clay floor associated with the Phase 2 barrack block (J15:19), sat at a relatively high level in relation to the internal flagging of the early barrack and the street to the north (J14:09), and were abutted by the lowest courses of chalet side walls (J15:11, 12). Fragmentary surfaces survived in the north-east and north-west corners of Chalets AC (w) and AC (e), respectively, apparently associated with the secondary phases of these structures. These not only abutted the chalet side walls but also appeared to sit at the same level as the north wall foundations J15:09/K15:04, suggesting the latter wall was still functioning.

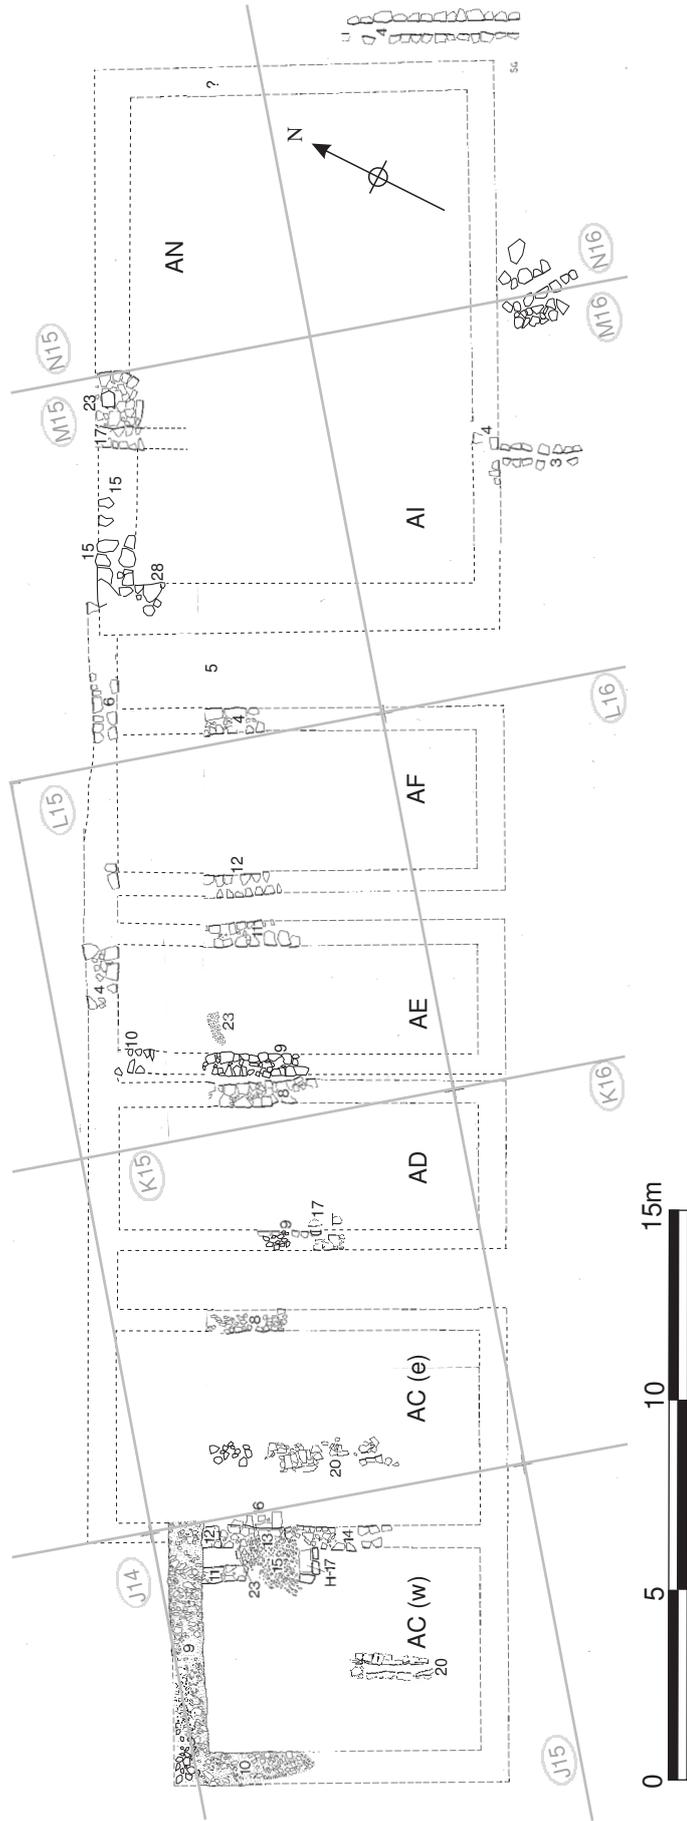
Figure 16.23: Secondary alteration to Châlet Range 11 at 1:200.

#### **Later remodelling of Chalet Range 11** (Fig. 16.23)

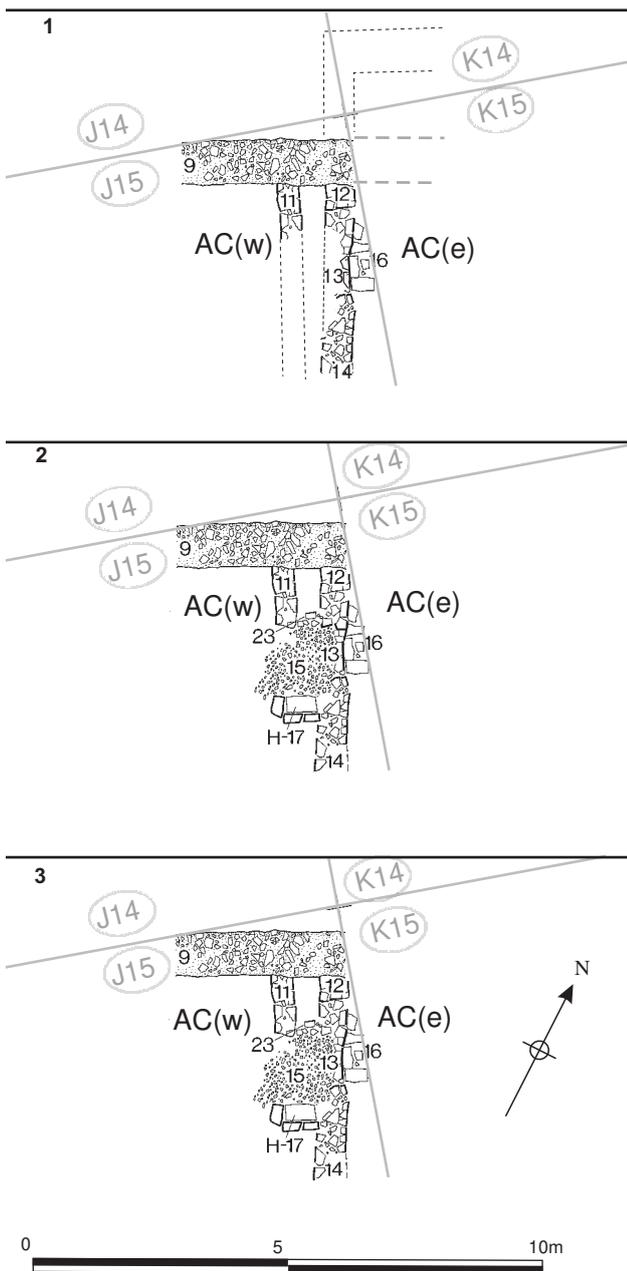
Figure 16 2 Plan showing successive phases in the area of the doorway between AC (w) and AC (e). Scale 1:100

course of the wall's east face was retained to serve as a threshold (J15:13), the upper surfaces of these stones being heavily worn. The remaining stub of east wall of AC (w) (J15:11) appeared to form a sort of alcove with wall J15:12. South of the alcove and west of the new doorway was a small area of gravel flooring (J15:31), bounded to the north by a stone kerb (J15:23) which extended between walls J15:11 and J15:12 forming the southern limit of the alcove. On the south edge of the gravel a hearth with a large stone base and upright stones on two or three sides (J15:17) was constructed, abutting the west side of wall J15:14. The alcove was filled with a layer of grey and orange clay-loam which contained a lot of,

The doorway between the east and west rooms was subsequently widened by shortening the north portion of the dividing wall (J15:12). The new door passage was 1.70m wide. A protruding stone from the south-west corner of foreshortened J15:12 may represent part of a door jamb or a door stop. The threshold between the reveals of the doorway comprised a line of small facing stones which were heavily worn on their upper surface (J15:13). To the west a second gravel surface (J15:15) was laid, which came right up to the threshold and was revetted on the north side by some of the stones of kerb J15:23 like the preceding gravel surface (see Phase 2). The alcove to the north of the kerb contained a level of grey and orange clay loam with coal, charcoal and tile flecks (J15:24). The hearth (J15:17) probably continued to function.

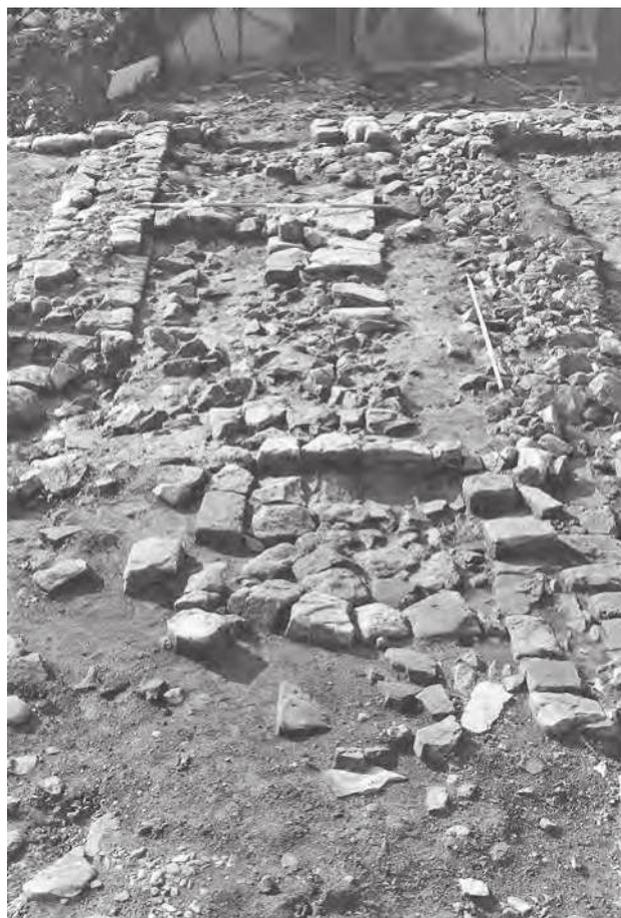
Figure 16.25: Later modifications to the north end of Chalet AI.

The clearest evidence for remodelling of the chalet range derived from Chalet AI which was completely rebuilt in this phase, shifting its footprint some 1.50m eastward. Only the northern end the new building remained (Fig. 16.25). The north (M15:15) and west (M15:28) walls were constructed similarly, consisting of a foundation deposit of small rubble on which were set footing courses, as much as 1.00m broad, composed predominantly of flat sandstone slabs or flags dressed to form a flat face along the outer edges, although more conventionally proportioned facing stones were also incorporated. The surviving fabric of the west wall (M15:28) extended only 0.85m southwards to butt up against the remains of the former north wall of Stable Barrack 11 (M15:03). In places two courses of the north wall's inner face survived, the second course being inset some 0.08m. Only one course of the north face remained, but this was level with upper course of the south face and sat on the line of the largely robbed-out south face of the rear wall of Range 12 (M15:06). The latter must have been demolished along this particular stretch during the secondary chalet phase. Although the masonry of the north wall footings had been partially robbed, the rubble foundations extended as far as the former west wall (M15:17) of the decurion's quarters (AN) which was probably reused as the chalet's new east wall. This would give the chalet an internal width of c. 3.60m (c. 5.20m overall).

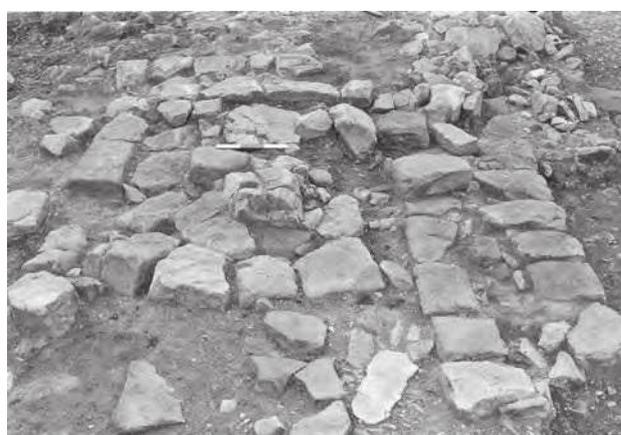
Figure 16.26: The north-west corner of the decurion's quarters (AN 1 in Rang 1) looking west.

Overlying hearth/oven M15:23 in the former north-west corner of the decurion's house was a small fragment of a possible floor (M15:22) composed of flagstones and rubble (see Fig. 16.26). This might represent part of a secondary floor associated

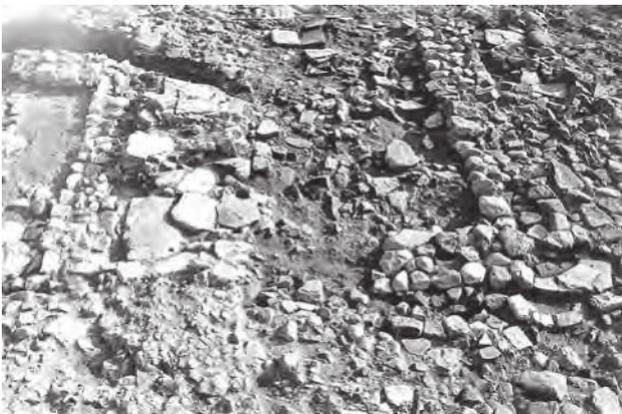
Fig re 2 Ch let AH frontag , looking south

#### *Chalet AH – Contubernium 3* (Figs 16.27, 16.28)

On this evidence the internal width of AH was c. 3.85m and its length 7.80m (measured from the inner edge of the foundations), and its overall dimensions,

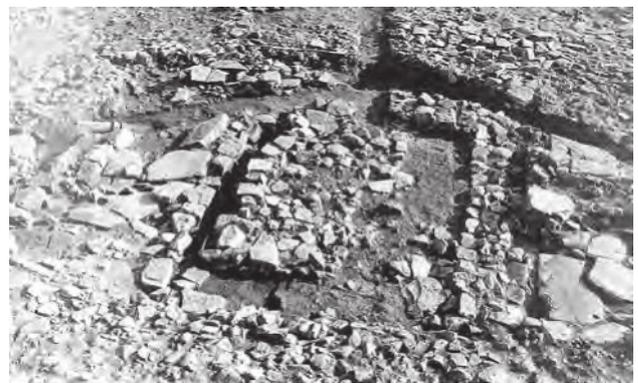
Fig re 3 Ch let AJ frontag looking south with drain L v sible in th centre.

#### *Chalet AJ – Contubernium 4* (Figs 16.27, 16.29)

The walls of AJ varied between 0.60m and 0.90m wide and their construction differed from those of Chalets AG I and II and AH to the west, lacking the river cobble and rubble foundations which distinguished the walls of those chalet-*contubernia*. Instead the footings were built of large faced sandstone blocks. The northernmost 3.60m of the east wall was partially intact (L14:12), along with a 1.30m section of the wall's west face, further south, which had been slightly displaced. One small fragment of the west wall was found (L14:22), its line being continued northward by a robber trench (L14:25), whilst the course of the north wall was indicated by its robber trench alone (L14:20).

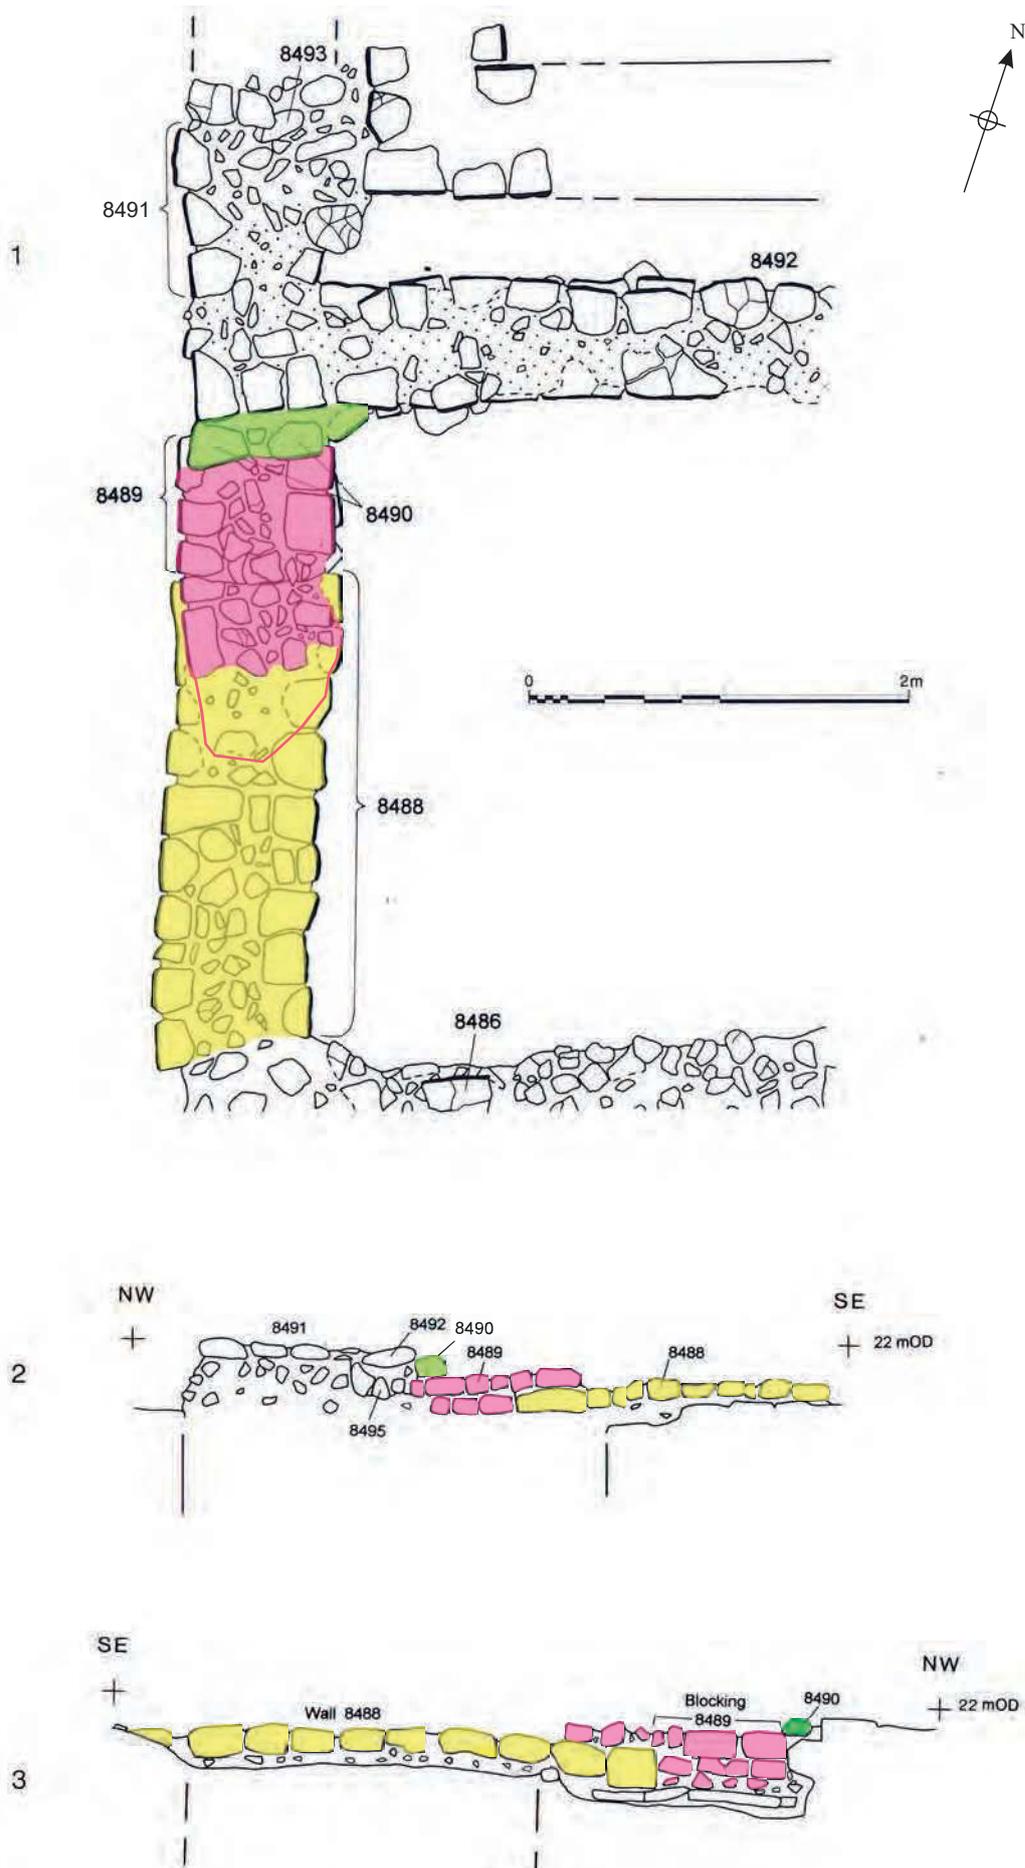
Figure 16.30: Details of east wall of Room AL II of the modified officer's house of Period 4 Barrack XII at 1:40 (adapting Hodgson 2003, 111, fig. 81, with additional colour coding to distinguish the different phases – see Fig. 16.31 for key): 1. Plan; 2. West-facing elevation; 3. East-facing elevation. The red outline marks the portion of masonry seen in the 1979 excavation but not *surviving* in the 2003 excavation.

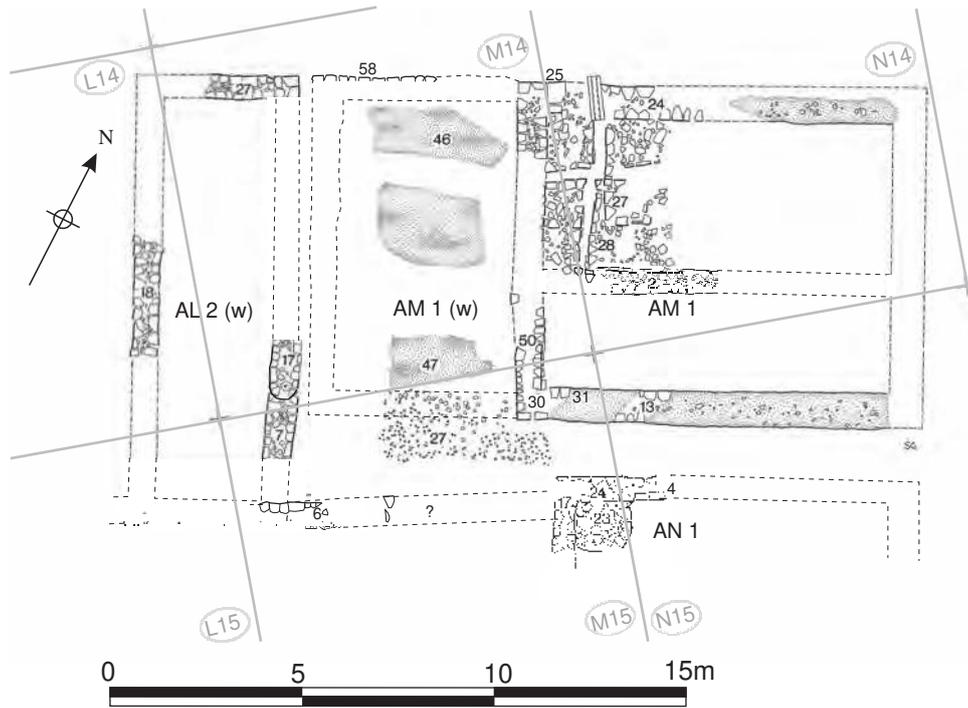
Figure 16.33 Interim remodeling of Building AL (w) and AM, Phase 1 (at 0)

The relationship between the clay floors and the rubble wall footings associated with AL1 (e) is problematic. Daniels interpreted the rubble as debris deriving from the demolition of the west wall of AM1 (w), though not with any great conviction as the doubts expressed in the structural *Notes* demonstrate. Indeed the rubble deposits, M14:51, 53, were reported to cut the clay floors rather than lying on the floor surfaces, as might be expected if they simply represented demolition debris. If the foundations were in fact cut into the clay floor it would imply that they belonged to a later phase, but there was a significant degree of uncertainty in the context records as to whether this was the actual stratigraphic relationship. The structural sequence presented above, involving the replacement of a chalet-*contubernium* (AL1 (e)) by an extension to the

decurion's house (AM1 (w)), would suggest that the clay floors of AM1 (w) must instead have been laid up against pre-existing cobble and rubble wall footings of AL1 (e). In such circumstances the foundations might appear to cut the floor level, and this could perhaps explain the apparently contradictory record.

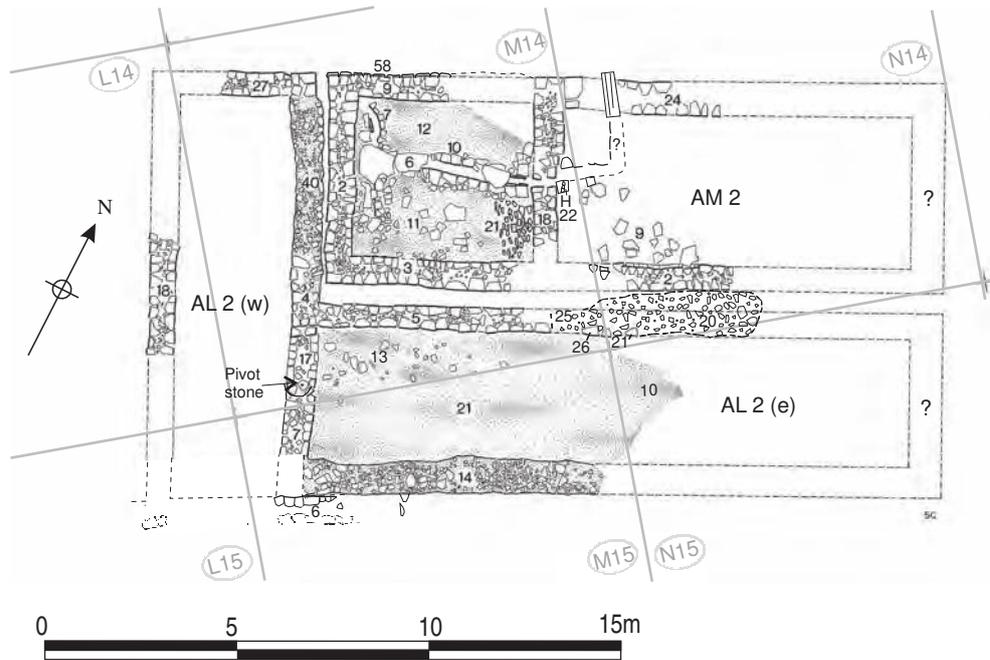
Fig. 8 Final remodeling of east end of Chalet Rang 2 (AL and AM Phase 2 (at 0 0))

east wall was now demolished and its northern half replaced by a mortar-bonded wall (M14:04). Only a short stretch of actual wall masonry (1.80m) survived, but its line was continued northwards by the remains of its associated rough cobble foundation (M14:40). The latter clearly belonged to this phase since the context records indicate that it was not present further south, beneath the stretch of the east wall (M14:17) which was retained from the preceding sub-phase to serve as an internal partition. Attached to the southern half of the AL2 (w) was an east-west aligned chalet (labelled AL2 (e)). The north wall (M14:05) of this east wing featured a mortar-bonded core and was of one build with wall M14:04, both being 0.65m wide. Further east, only fragments of the south face survived (M14:26, N14:21), but the wall's line was prolonged by the remains of its foundations (M14:25, N14:20). These consisted of a compact packing of small angular sandstone rubble fragments and cobbles, each averaging 0.10–0.15m across and incorporating a lot of bone and pottery, including an entire gritty ware vessel (N14:19). The overall width of the foundations was up to 1.25m, though they may have been spread by later disturbance. The resultant surviving length of the wall was 12.50m, extending across the southern part of the former decurion's house (AM1). The parallel south wall was represented by a 0.80–0.90m wide rubble foundation (M15:14) and a couple of stones belonging to the north face. The foundations were composed of pieces of sandstone rubble and large river cobbles in a dark grey clay soil matrix. They extended 8.50m from the east wall of the west room across the former alley surface overlapping the remains of the north wall of Building AN, which

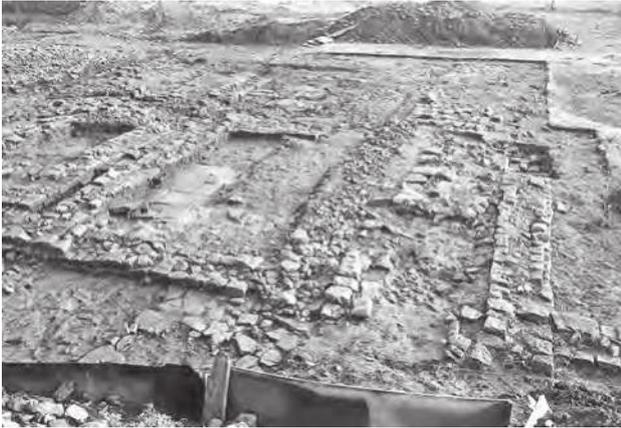
Figure 16.34: The east ends of Chalet Ranges 11 and 12 showing later chalet remodeling (AL2 (e) and AII/AN).

width as its north wall. The eastward extent of both the north and south walls was limited by modern disturbance and no trace of an eastern frontage was uncovered. Nevertheless the maximum surviving length of 12.30m, recorded in relation to AL2 (e), is a perfectly respectable overall length for any chalet, comparable to that from north to south of AL2 (w) (11.85m overall, 10.65m internally) or the east-west length of Building W at the west end of Range 9 (c. 12.00m overall, 10.60m internally), which functioned as the decurion's house in that chalet-barrack. This could signify that AL2 (e) did not extend much if any further east. If the building continued eastwards as far as the estimated east wall of the former decurion's quarters, AM1, its east-west length would have been as much as 16–17m and in excess of 20m when the width of AL2 (w) is added. A reduction of the footprint of Range 12 in this phase would certainly make the east room of AL 2 a more reasonable size, but given the uncertainty over the function of the structures at this end of the range and very extensive post-Roman disturbance the possibility that AL2 and AM2 did stretch further eastwards cannot be excluded.

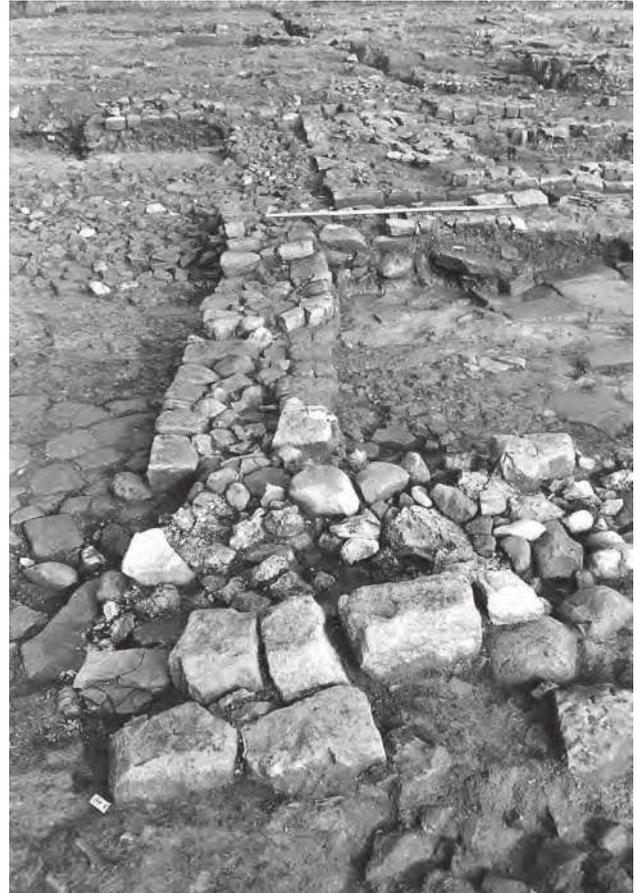
Figure 16.35: Spine wall M14:02 (foreground) north-south wall M14:03 separating AL2 (w and e) and rubble foundation of AL2 (e) south wall M14:04 looking east.

### Later remodelling of Chalet-Range 12 (Figs 16.33–16.35)

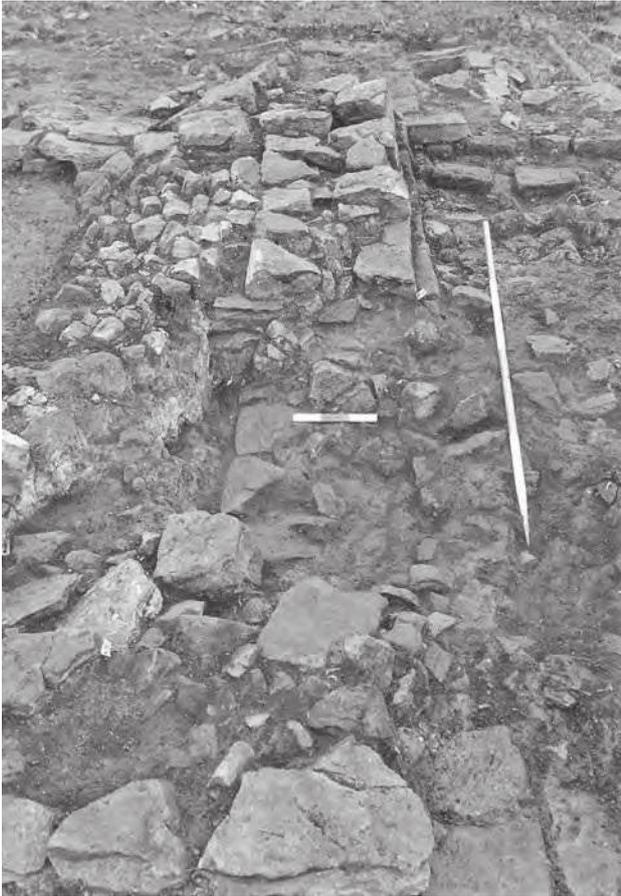
Figure 16.36: Successive phases of the west wall of the officer's quarters with final chalet period rebuilding evident (AM2), looking south

The north wall of AM1 (w) was dismantled down to its lowest course (M14:58) and rebuilt on the same line (M14:09). Up to two courses of the rebuilt wall survived and clearly belonged to a later phase than the footing course, M14:58, since their south face overlapped the corresponding face of the M14:58, rather than being flush with it or inset like their north face, the whole wall being some 0.55–0.65m wide. Although only a 3.15m length was still standing when excavated in 1979, the wall may have been rebuilt further east as well, but only the original footing course of the north wall of the decurion's house (N14:24) remained here, as a result of the damage caused by the colliery trackway. The west wall (M14:02) was bonded to the north wall and survived over its full 5.50m length. It was 0.70–0.75m wide and was probably erected on the same line as the west wall of AM1 (w), although no trace of the earlier wall was preserved. The adjoining south wall (M14:03, N14:02) followed a new course some 2.50m north of the line of the south wall of AM1 and was traced over a total distance of 10.65m, which gives a minimum length for the building. The new wall was of similar width to the west wall with two courses surviving in places,

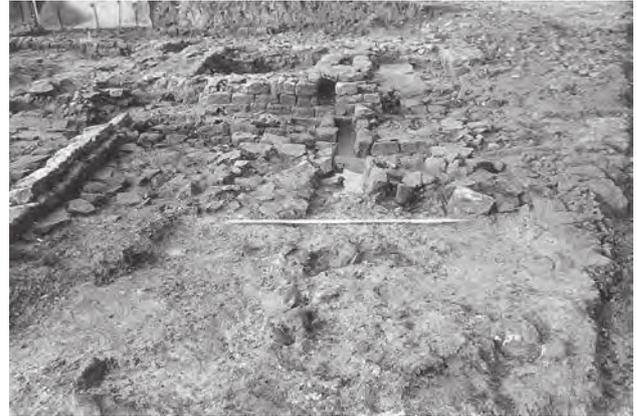
Figure 16.37: Chalet Range 12 officer's quarters (AM2) with the opening for the hypocaust flue visible in rebuilt wall M14:18

Most compelling of all, however, is the position of hearth M14:22/N14:07 right beside the opening in wall M14:18. This would appear to be incompatible with the interpretation of the opening as a drain outlet and it was presumably this which convinced Moffat that the various stone-lined channels in AM and the earlier Building 12 decurion's quarters were actually components of a channel hypocaust rather than a system of stable drains or latrines. In this case the outlet would actually represent a stokehole and flue for the hypocaust and the hearth and other traces of burning could be explained as the residue

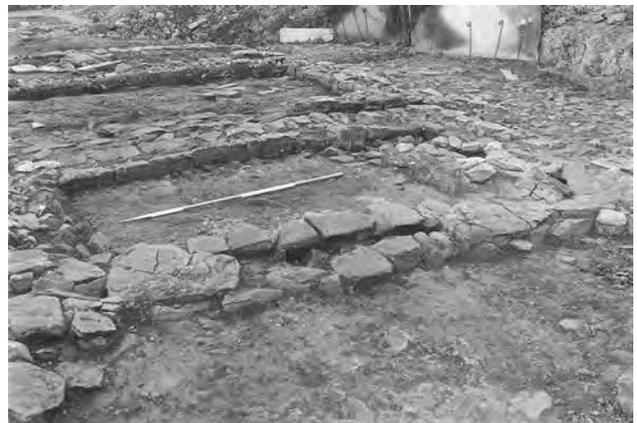
Figure 16.38: The T-shaped channel hypocaust in the western half of AM2 looking south west.

The T-shaped arrangement of channels in the west room of AM2 was initially interpreted in the context record as a network of drains, however Moffat considered that they represented the remains of a channel hypocaust. This debate persisted in the written summary in 1984–9 research archive. Interpretation as a system of drains would be consistent with the general pattern in the *retentura* cavalry barracks, with a sump being retained in the decurion's quarters of the Chalet barrack 9 (Chalet W), for example, but there are a number of strong objections to its acceptance in this case. The only outlet for a system of drains is the opening midway along partition wall M14:18 which would have discharged the effluent from the west room into the east room. It is unclear how the effluent would have been dealt with thereafter. The most logical course would have been to release it

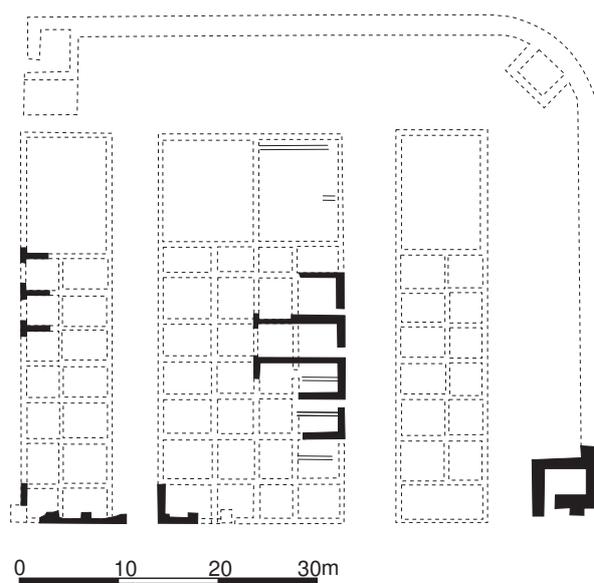
Figure 16.39: Third-century stable-barracks at Haltonchesters (1:750), as interpreted by Hodgson 2003, fig 84.2, revising Simpson and Richard 1937, fig 5.

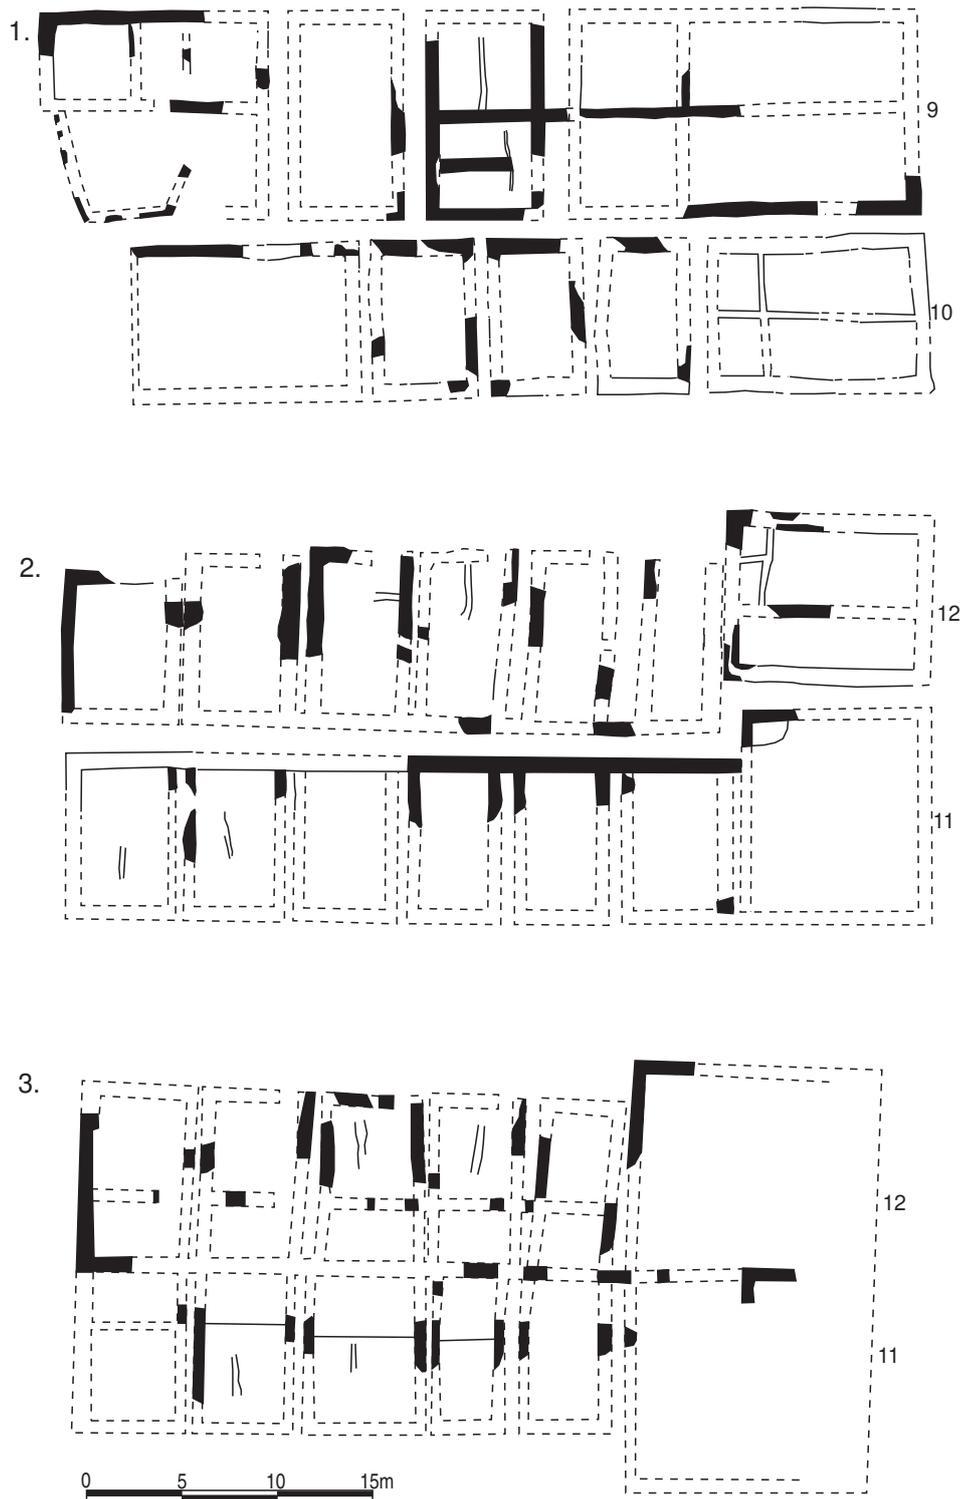
Figure 16.40: Third-century barracks at Wallsend: 1. Chalet-barracks 9 and 10; 2. Chalet-barracks 11 and 12 as restored here; 3. 11 and 12 as restored in Hodgson 2003, fig 77.1. Scale 1:400.

Differences of interpretation regarding the detailed layout of the Wallsend chalet ranges, particularly in relation to 11 and 12, were proposed in the foregoing description and analysis of the remains (Fig. 16.40). However these don't materially affect the overall interpretation of the structures as cavalry barracks,

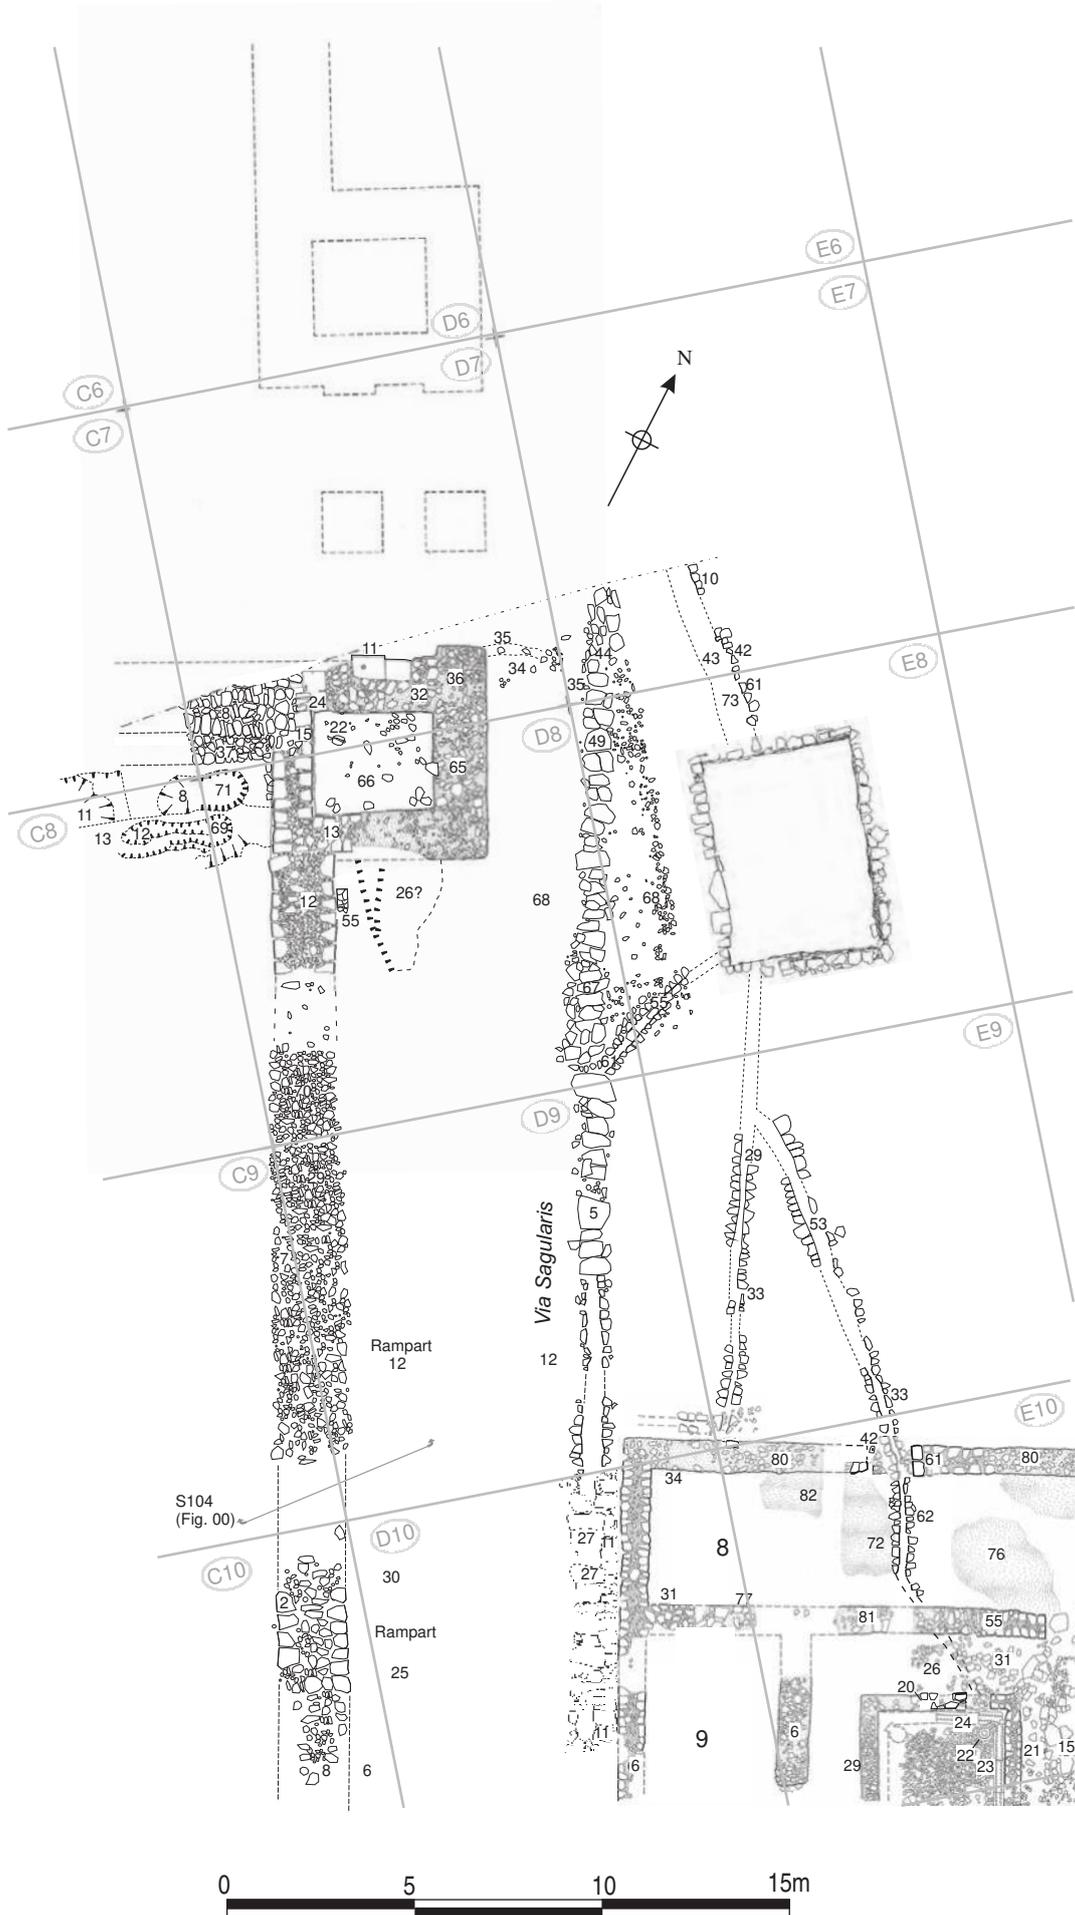
Figure 10. Period 1 and 2 features associated with Hadrian's Wall, the west gate, western defences, and the intervallum at 10. The third-century pits are also shown.

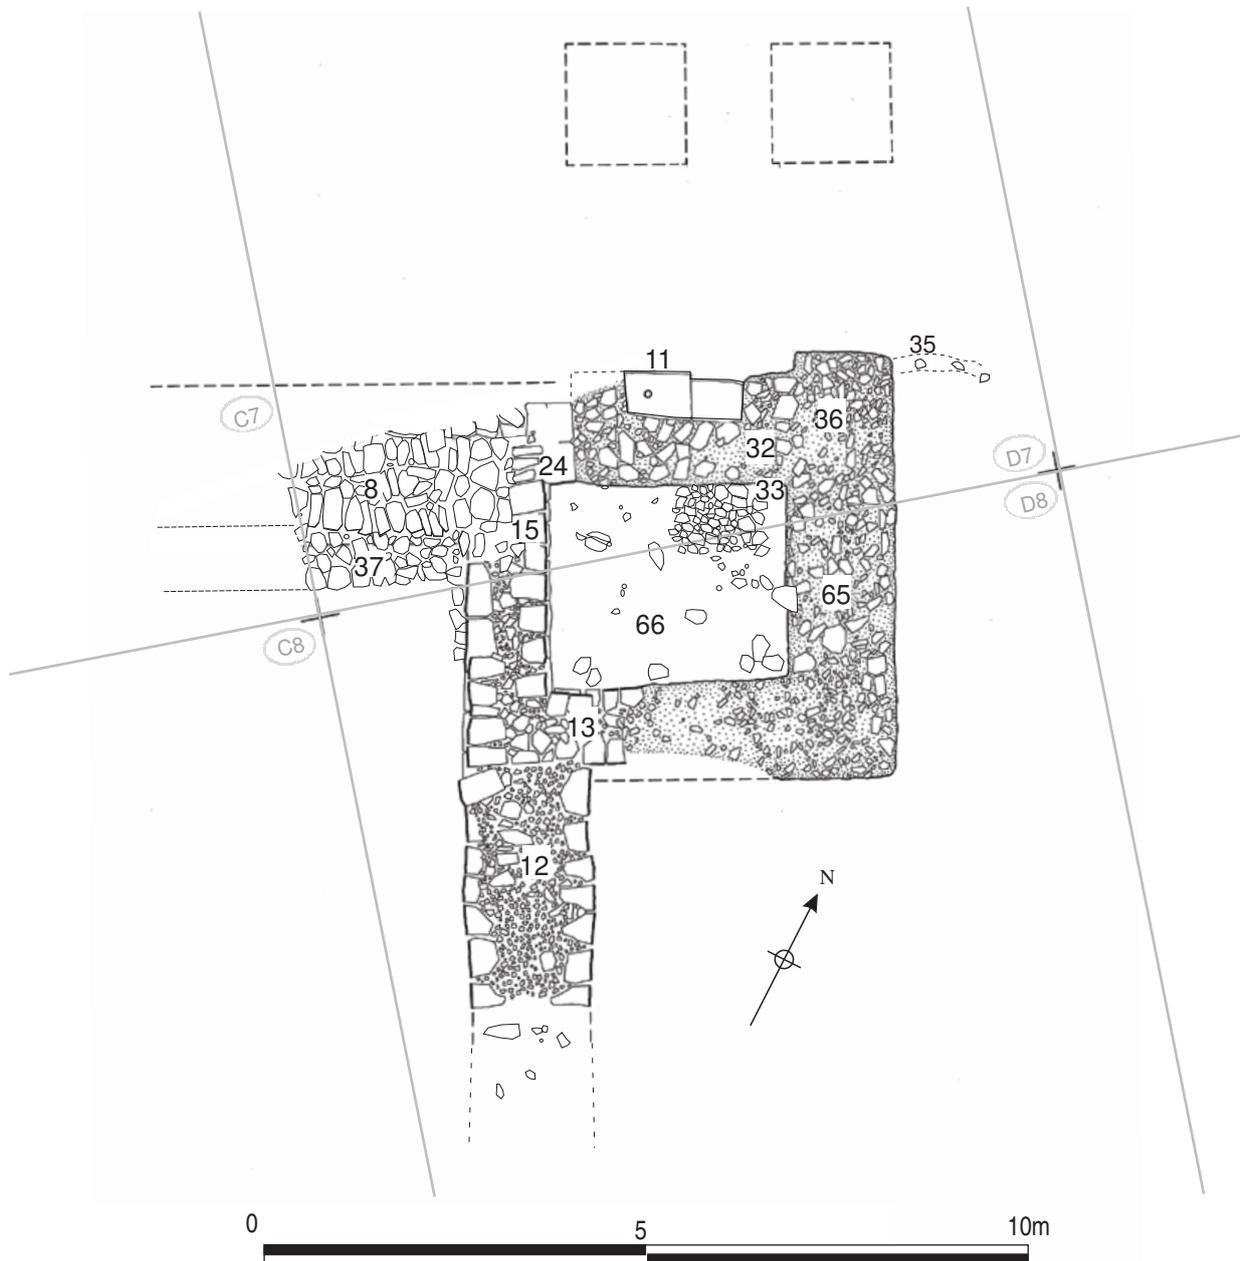
Figure 17.02: West gate south guardchamber primary floor foundation levels at 1:100.

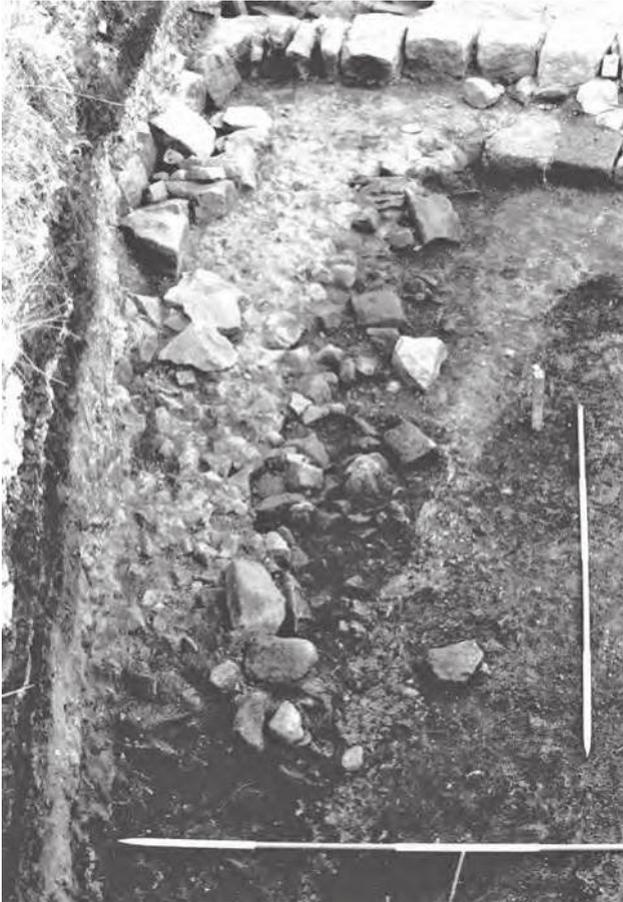
Figure 17.03: The line of Hadrian's Wall joining the west gate, from the west. The clay cap is visible over the foundations which are not yet properly exposed.

into the wall core and at least some of which may have been pitched (perhaps implied by the reference in the 1983–4 summary notes to 'pitching of big stones on clay and cobble (big) foundation'). Some stones are clearly shown overlapping others on site plan P422. Moreover the footing layer was deeply offset along its southern side. This offset was some 0.50m wide next to the gatetower, increasing to as much as 0.80m to the west, where the underlying foundations appeared to spread out further towards the south. The normal width of the footing course, from its north face to the extant southern edge can be estimated at 1.85–2.00m. This layer in turn was capped by firmly packed clay (see Fig. 17.03).
