# SEGEDUNUM

Excavations by Charles Daniels in the Roman Fort  
at Wallsend (1975–1984)

VOLUME 1: The Structural Remains

Alan Rushworth and Alexandra Croom

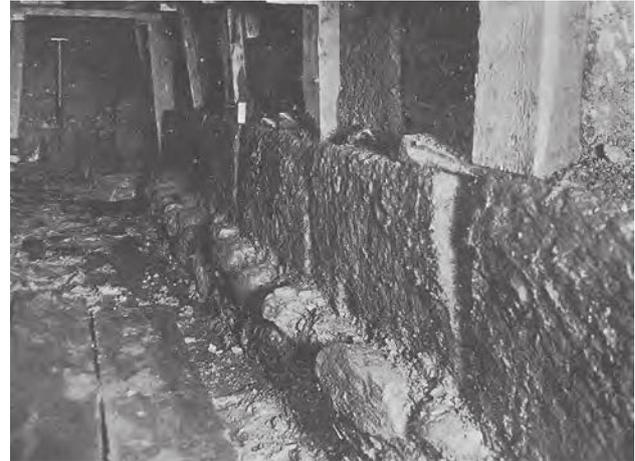
Figure 17.04: Hadrian's Wall curtain at the point where it joins the west gate, looking east. Seen in the tunnel beneath Buddle Street excavated by F. G. Simpson in 1929 (Simpson et al. 1930, fig. 7).

as Fig. 17.04). The unusual nature of this arrangement was noted, it being more normal for the Wall to meet fort gate facades at about the middle of the south tower. Also noteworthy was the 'exceptionally massive masonry', consisting of very large, neatly squared stone blocks, standing two courses high, which made up the surviving north face of the Wall at this point.

The stretch of Wall directly adjoining the west gate, revealed in the 1929 and 1983–4 excavations, displays certain unusual features which require further consideration. The footing course on the south side was characterised by a very wide offset over the cobbled foundations and was only roughly faced, whereas the north side was faced with very substantial, neatly dressed blocks, set on a rubble/cobble footing or foundation which can be seen protruding northward perhaps 0.10–0.15m in F. G. Simpson's photograph of the tunnel excavated beneath Buddle Street (Fig. 17.04). Two courses of the stone blocks survived, the upper being set back slightly. The dimensions of the stone blocks are not recorded in the published description, but the height of each course can be roughly estimated at perhaps 0.45m–0.50m by reference to the shovel appearing in the background of the photograph.

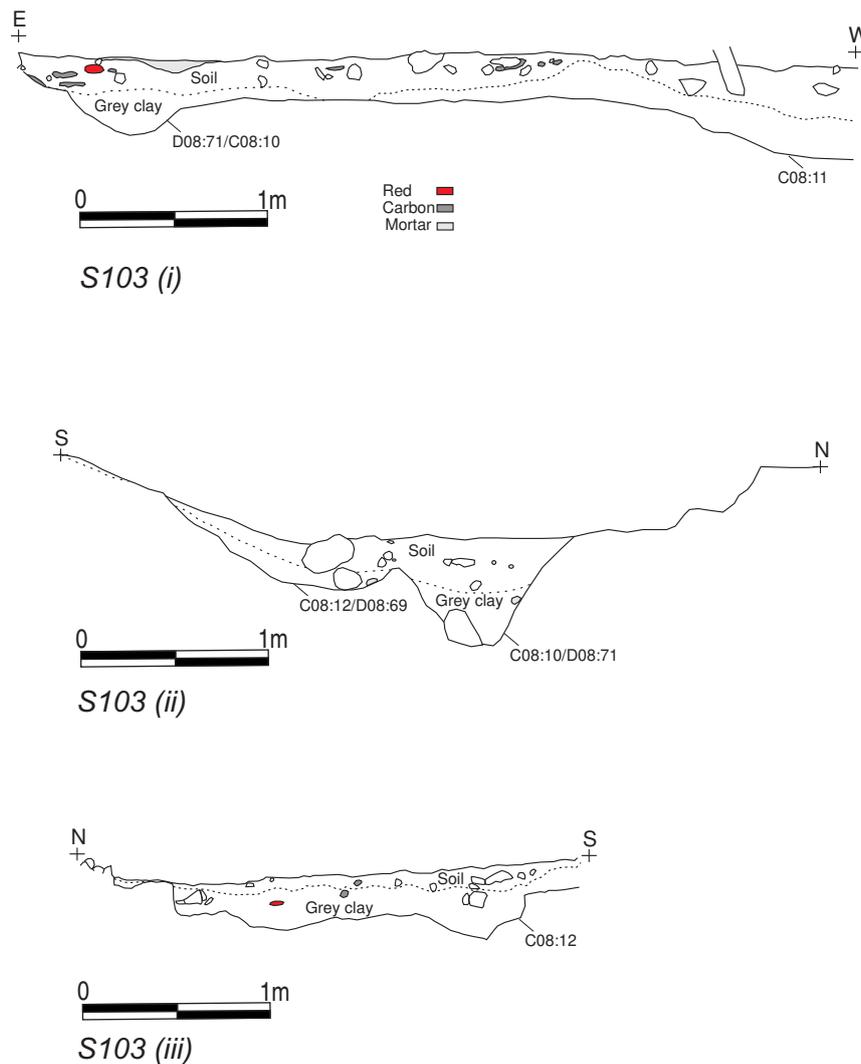
Figure 17.05: Section 103 (i-iii) across the pits outside the fort, in the angle between Hadrian's Wall and the fort curtain, (grid squares C7, C8, D7 and D8). Scale 1:40.

narrowing very slightly midway along its length. Its long axis was aligned east-west, parallel with Hadrian's Wall and perpendicular to the fort wall. The pit was 0.60m deep, with a V-shaped profile (see Fig. 17.05 – Section 103/2), and was filled by a series of deposits: two large stones, c. 0.25m in diameter, lay at the bottom of the pit in a grey-brown silt with traces of coal (C08:10/D08:59). This was overlain by a layer of redeposited brownish grey clay (C08:09/D08:58), containing scattered stones and small amounts of bone, which in its turn was completely covered by a spread of 'black carbon' (charcoal/coal?) some 40mm thick, with pottery and a few bones intermixed (C08:08/D08:57). The uppermost fill consisted of grey silty clay (C08:07/D08:56) incorporating shell remnants and a few bones.

to 0.75m towards the eastern end, where it was some 0.3m deep, and 1.0m in width at the western end, where the depth of the feature was 0.4m (see Fig. 17.05 – Section 103/2–3). On its south side, the ground level was higher, sloping up as much as 0.7m from the base of the slot. The base was lined with yellow clay and the fill, which may have been the same as layer C08:06/D08:45, contained Black Burnished Ware pottery and bones.

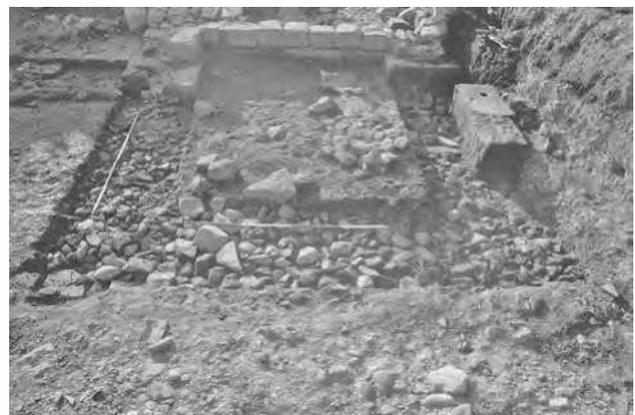
Figure 17.06: The primary floor base and foundations of the west gate's south guard chamber.

The chamber formed the base of a tower flanking the double passageway and measured c. 5.50m (E-W) by 5.0m (N-S) externally and 3.20m (E-W) by 2.80m (N-S) internally (Figs 17.02, 17.06). The guardchamber had been badly affected by later robbing and disturbance. The internal levels along its east side and particularly in the south-east corner had been cut away by a broad modern intrusion (D08:11), whilst the north, east and south walls had been robbed down to their foundations along most of their length.

The earliest level was represented by a layer of yellow-brown patchy clay, crushed mortar and sand (D08:66). Set on this was a pack of small-medium sized stones in the north-east part of the chamber, plus a few, scattered flags (D07:33 – see Figs 17.02, 17.06). The pack was roughly 1m square and was overlain by a deposit of yellow crushed mortar, gravel and small stones (D07:22, D08:53), which extended further westward in a band across the northern part of the chamber, but also projected southward into the centre of the room (Figs 17.07, 17.08). This was interpreted as the foundation of a structure of some kind, perhaps an oven (an interpretation influenced by the presence of a

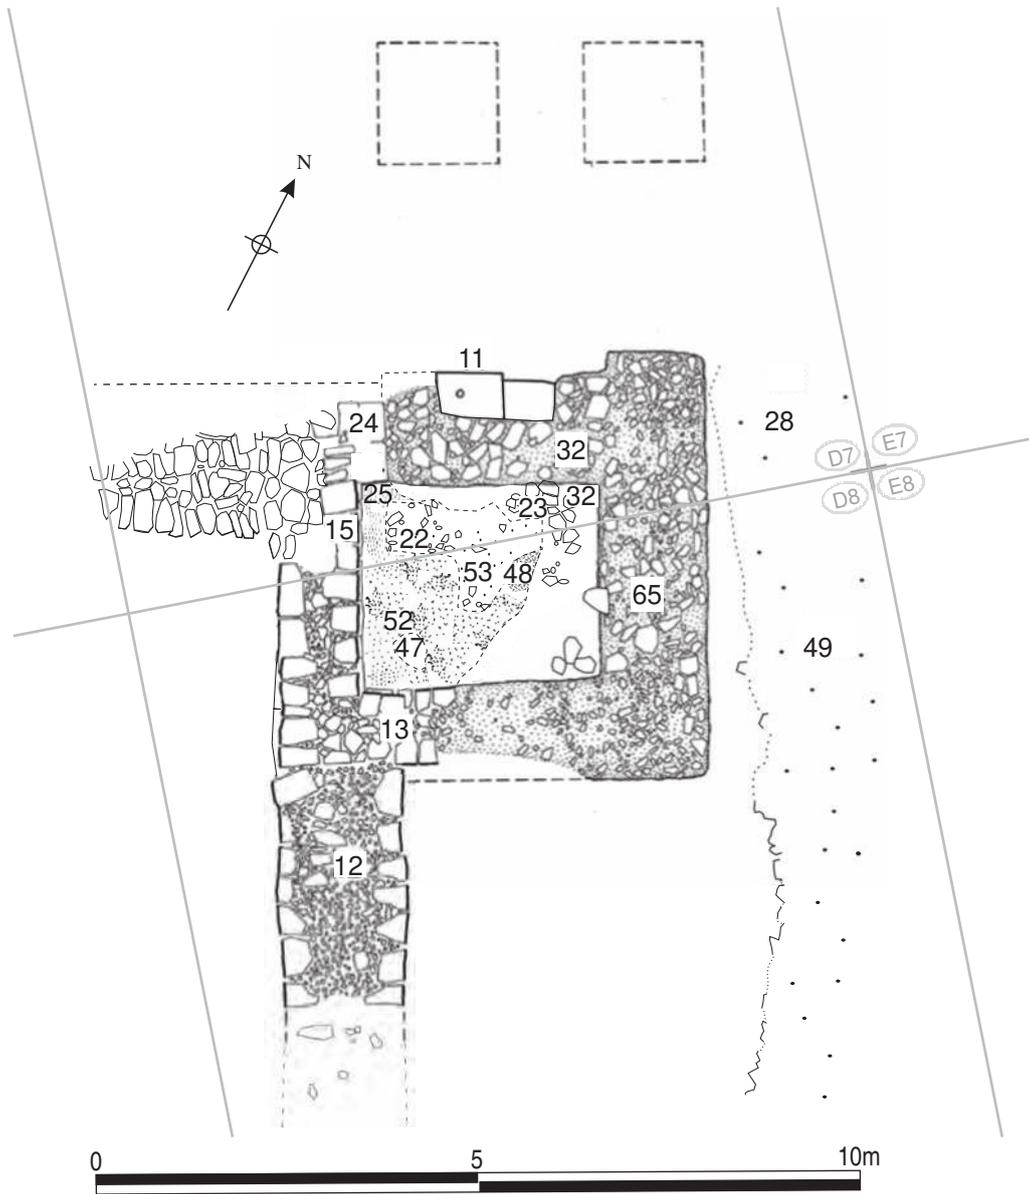
Figure 17.07: West gate, south guardchamber, the second internal level (perhaps the initial floor surface) at 1:100

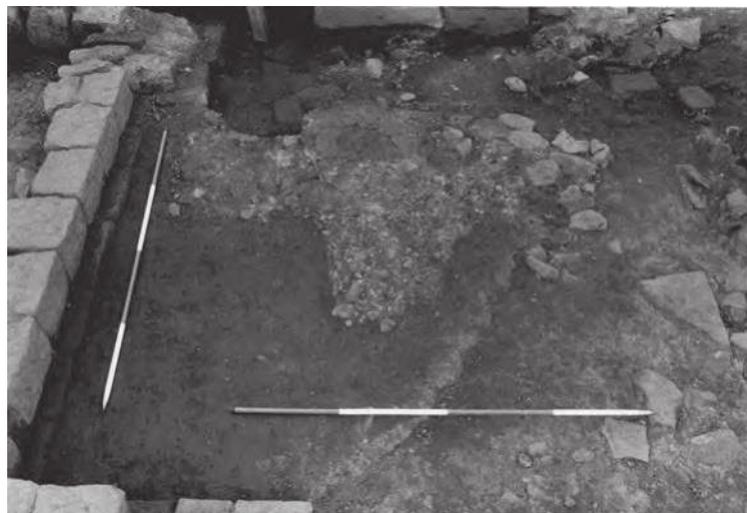
Figure 17.08: The second level in the guardchamber interior showing the crushed mortar, gravel and stone deposit (D08:53) to the north and dark silty clay (D07:25/D08:52), to the south.

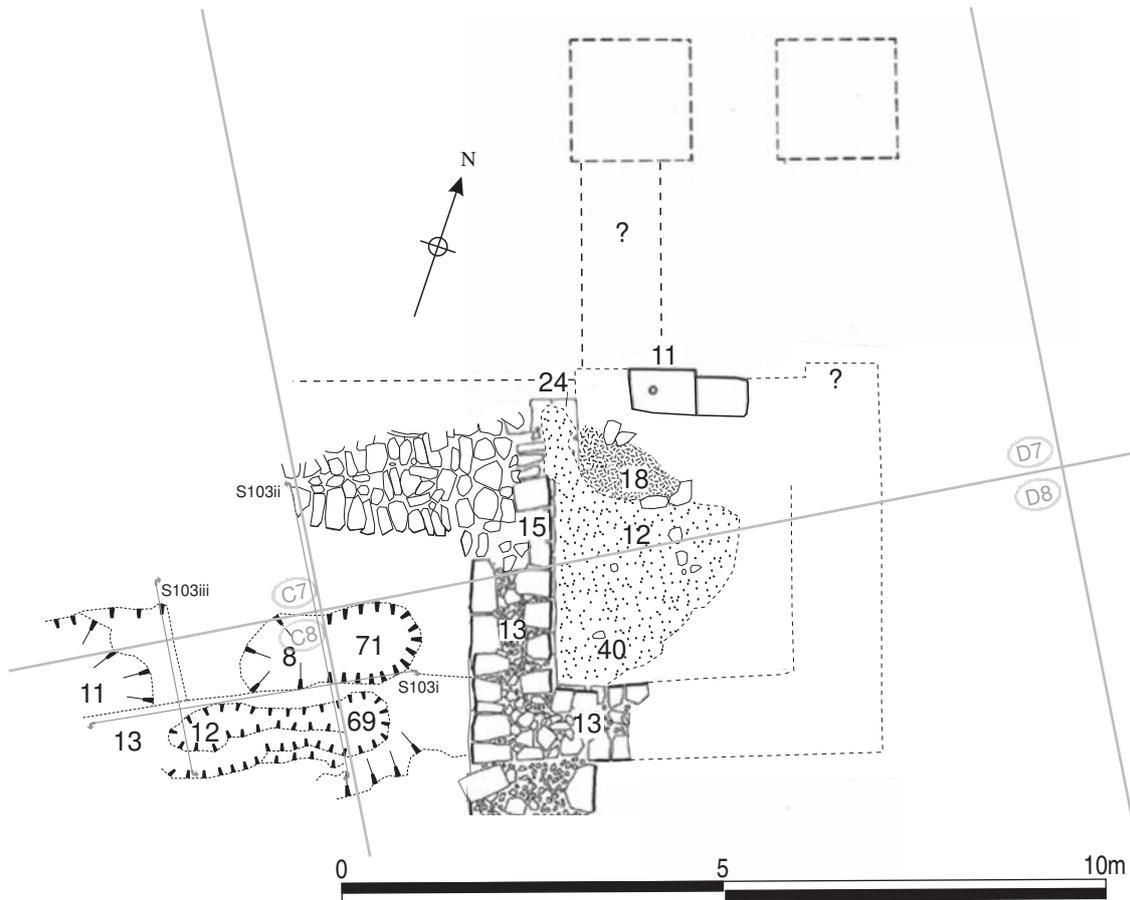
Figure 17.09: West gate, south guardchamber, secondary floor levels (third century, Period 3–4?) at 1:100.

Clay deposits D08:41 and D07:17 were in turn covered by a very gritty, well-packed light brown soil (D07:12, D08:40) which probably constituted the third floor level of the guardchamber (Figs 17.09, 17.10). This was present across the full extent of the interval tower interior in so far as it survived at this level. Intriguingly, a narrow strip of this gritty soil (surviving width: 0.20–0.40m) is also shown on site

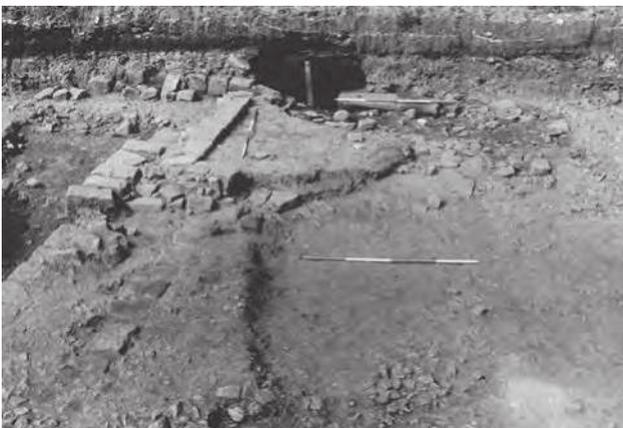
Figure 17.10: The third (third-century?) floor level (gritty soil D07:12/D08:40) in the south guard chamber and reinstated ramp levels to the south

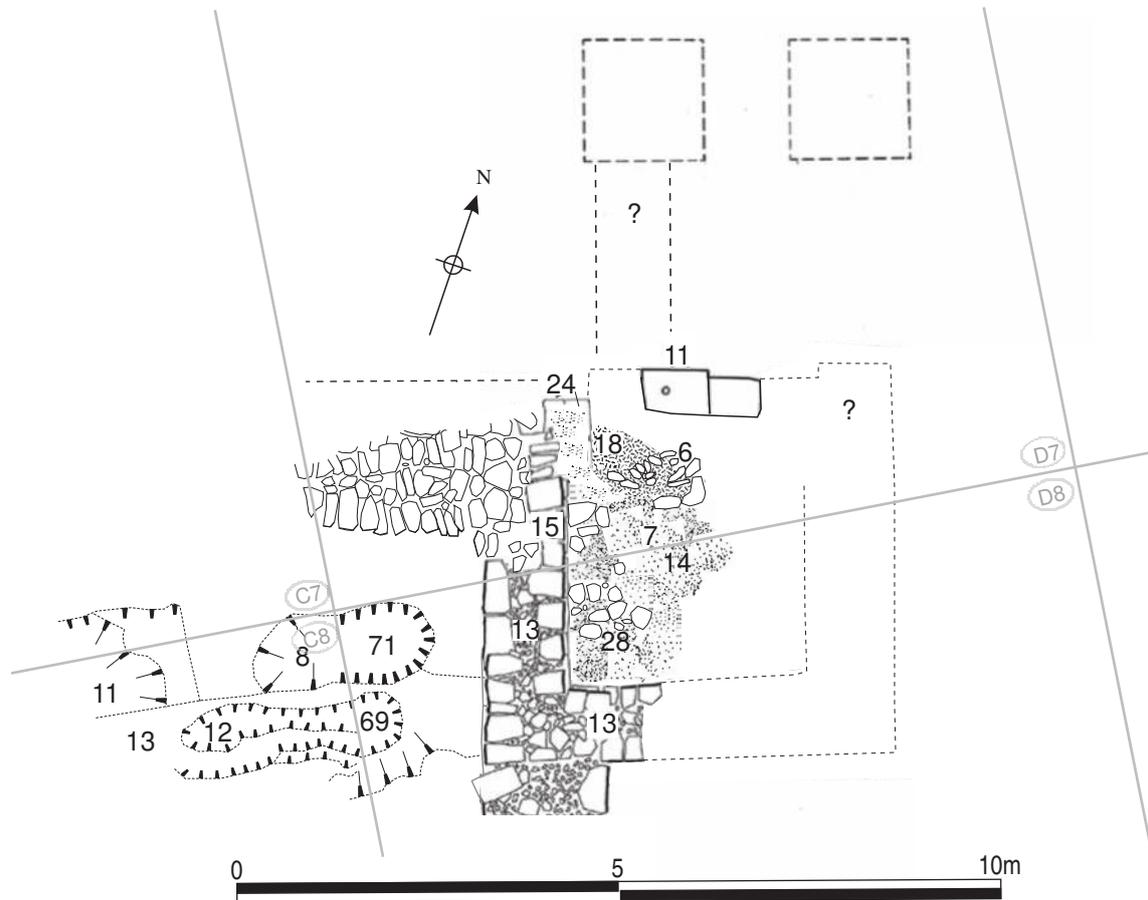
Figure 17.11: West Gate, south guardchamber, latest surface (late third/early fourth century?) at 1:100.

The uppermost surviving floor level consisted of a spread of yellow-pink clay (D07:07, D08:14) containing numerous small stones (Fig 17.11). Resting on or set into the surface of this clay were the possible remains of a very rough flagged floor made up of stones with dimensions of up to 0.40m by 0.60m. These flags may be the same as the 12 stones allocated the context number D08:28, which were described as laid flat and forming part of a possible stone floor and were shown adjoining the west wall of the tower on site plan P330. The northern edge of the yellow-pink clay D07:07/D08:14 is not clearly defined on the relevant site plan (P330), but the corresponding sketch plan for grid square D7 (D7 fig 1) might imply that the yellow-pink clay D07:07/D08:14 had a similar extent to gritty soil D07:12/D08:40 and likewise extended northward over stone blocks D07:24.

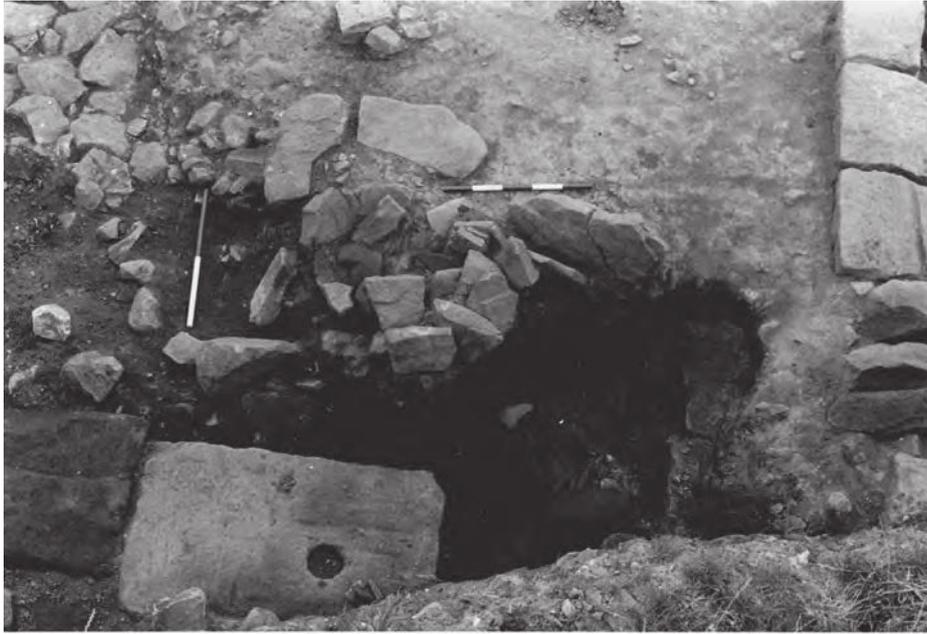
Figure 17.12: Robber trench for the north wall of the guardchamber viewed from the north. Note the mass of flat stones pitched on edge, the extant pivot stone and the floor level extending across the line of the north wall in the bottom right corner.

robbed north wall, where it was overlain by a mass of flat stones (D07:06), pitched on edge, burnt red and set in a pink clay matrix (see Figs 17.12, 17.13). The burnt pink spread was reddy brown in colour, with traces of red scorching, and was roughly oval in plan, attaining a maximum extent of 1.65m (E-W) by 0.80m (N-S), its western edge butting up against the surviving stone blocks of the north wall D07:24. The overlying pitched stones were generally relatively small – no more than 0.30m long and 0.10m wide – and covered an area some 1.25m by 0.50m.

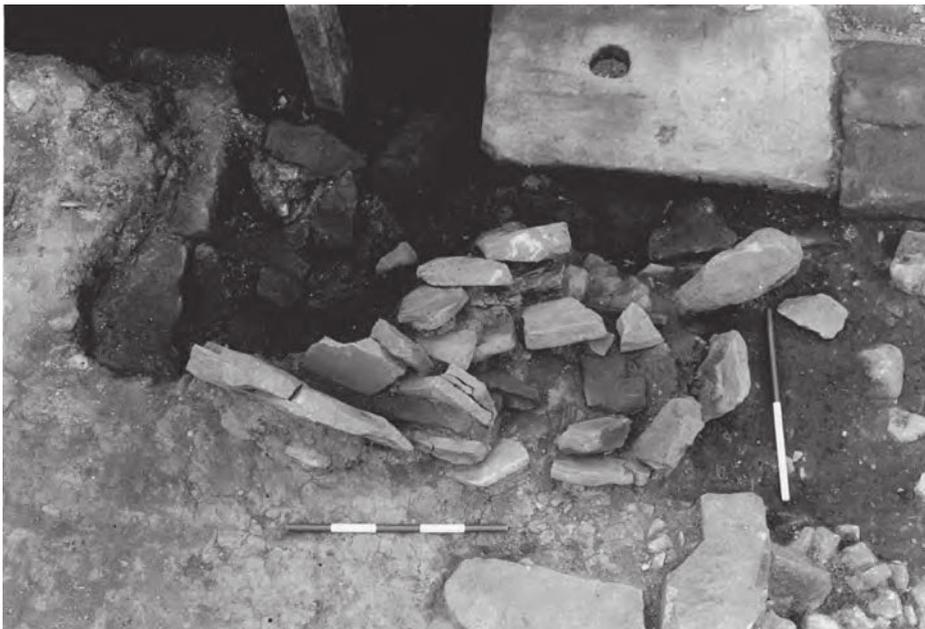
Figure 17.13: Close up view of the pitched flat stones overlying the burnt clay in the robber trench for the north wall of the guardchamber, from the south

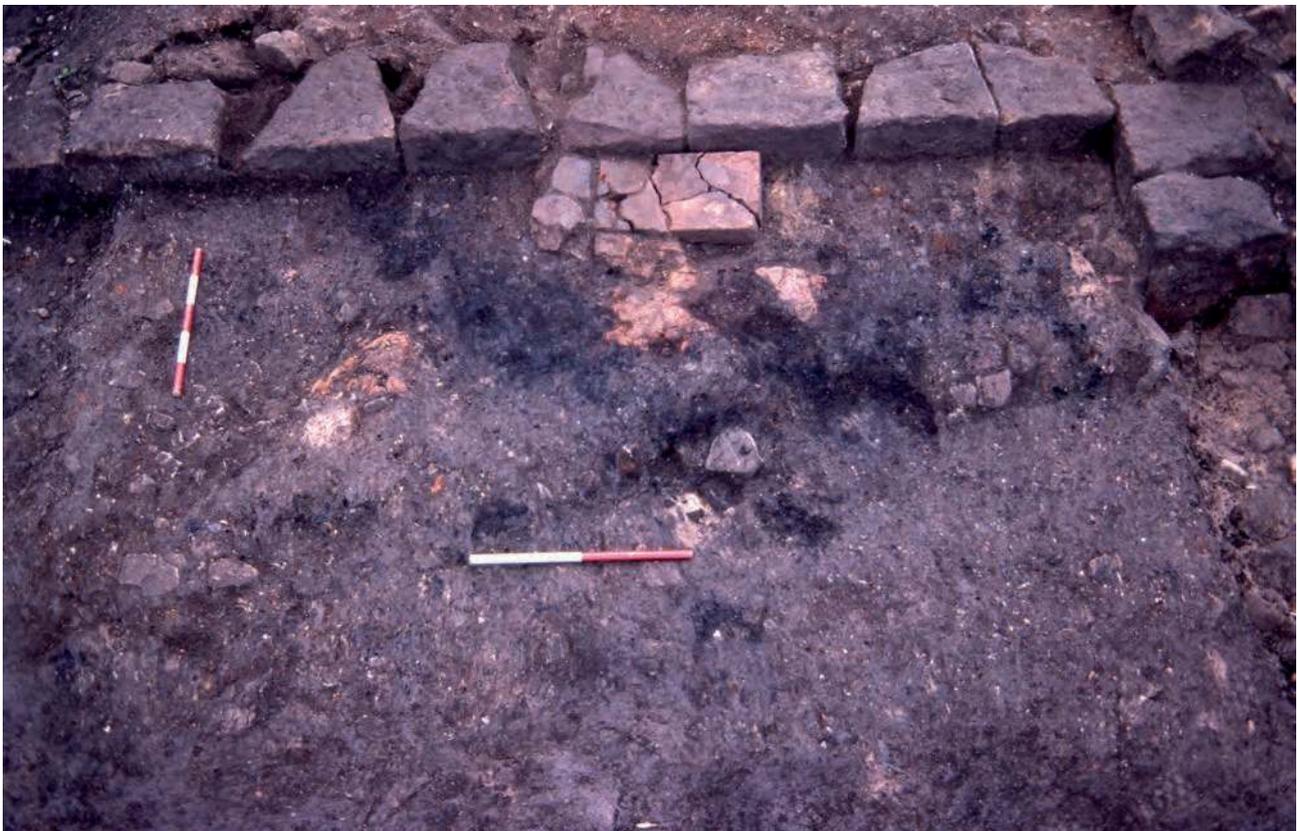
Figure 17.14 Burnt tile D08 set against the curtain wall on the leveled rampart bank.

Another 2.85m length of the footing course (C10:02), survived 16m to the south in grid square C10, to the west of the hospital (Fig. 17.14). This stretch was

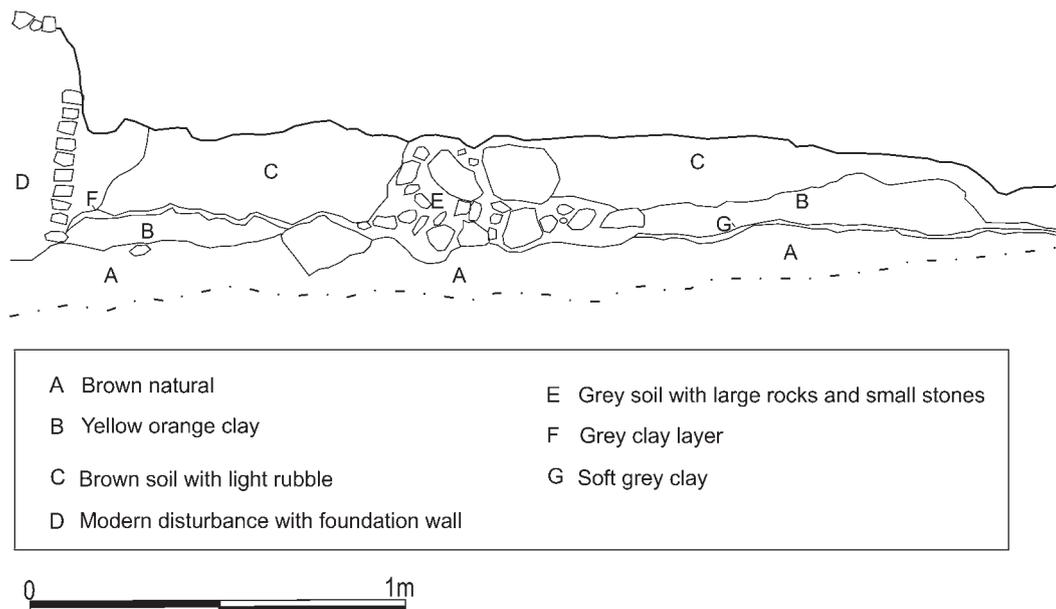
Figure 17.17: S104 across the west rampart in grid squares C9 and D9, at 1:20 (see Fig.17.01) for location).

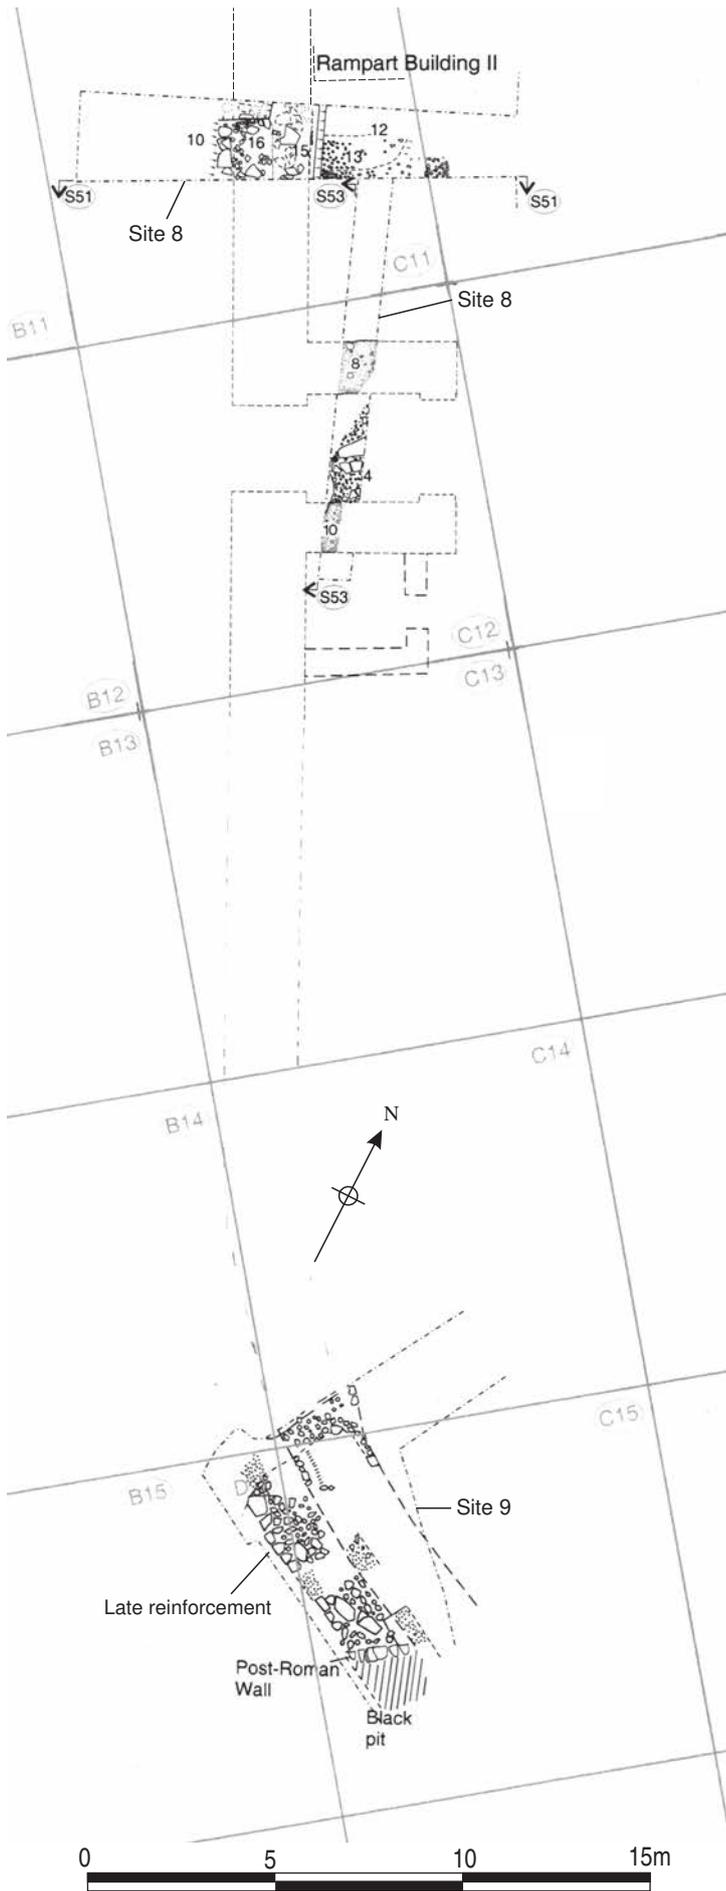
Fig. 1. Plan showing the trench locations (Sites 8–10) in the western defences, examining the porta quintana, curtain wall and rampart, and the SW angle. Scale 0

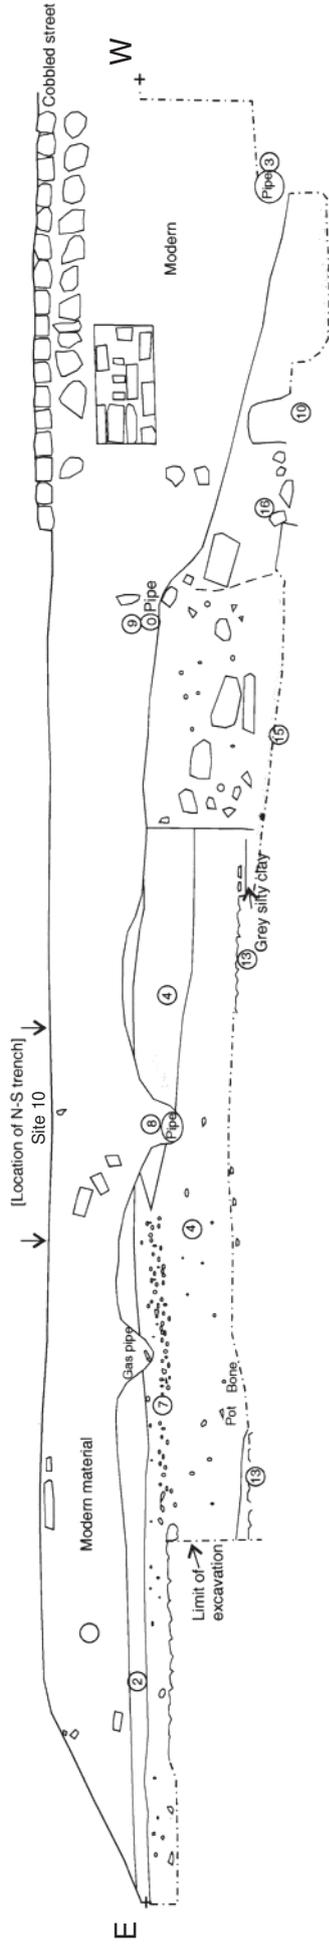
Figure 17.19: Section S51, south section in Site 8 trench across the west rampart and curtain wall, at 1:40.

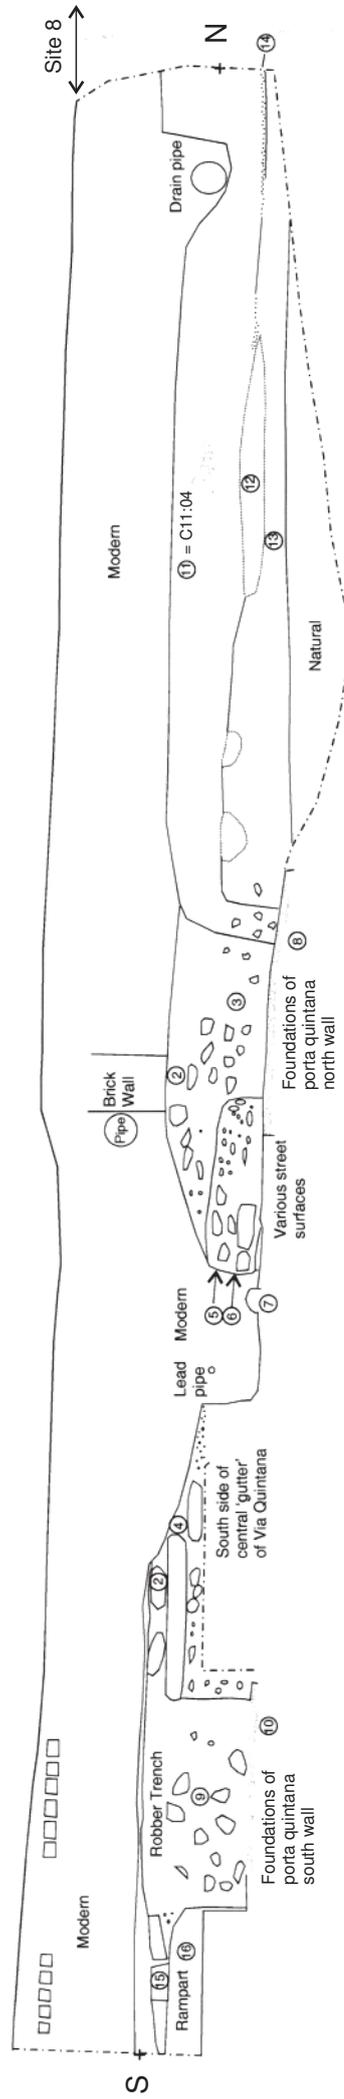
Figure 17.20: Section S53, east-facing section in Site 10 trench across the porta quintana and adjoining rampart, at 1:40.

In the area north of the gateway, a layer of grey, clay loam (C12:13) was recognised over the natural yellow clay subsoil. This was interpreted by the excavators as a buried ground surface, although comparison with the results obtained in 1997–8 might imply that it was actually a primary rampart layer, in which case the original ground surface had presumably been truncated. At one spot, the grey clay was overlain by a spread of pink/yellow clay (C12:12 – see Fig. 17.20: Section S53; Fig. 17.22: plan).

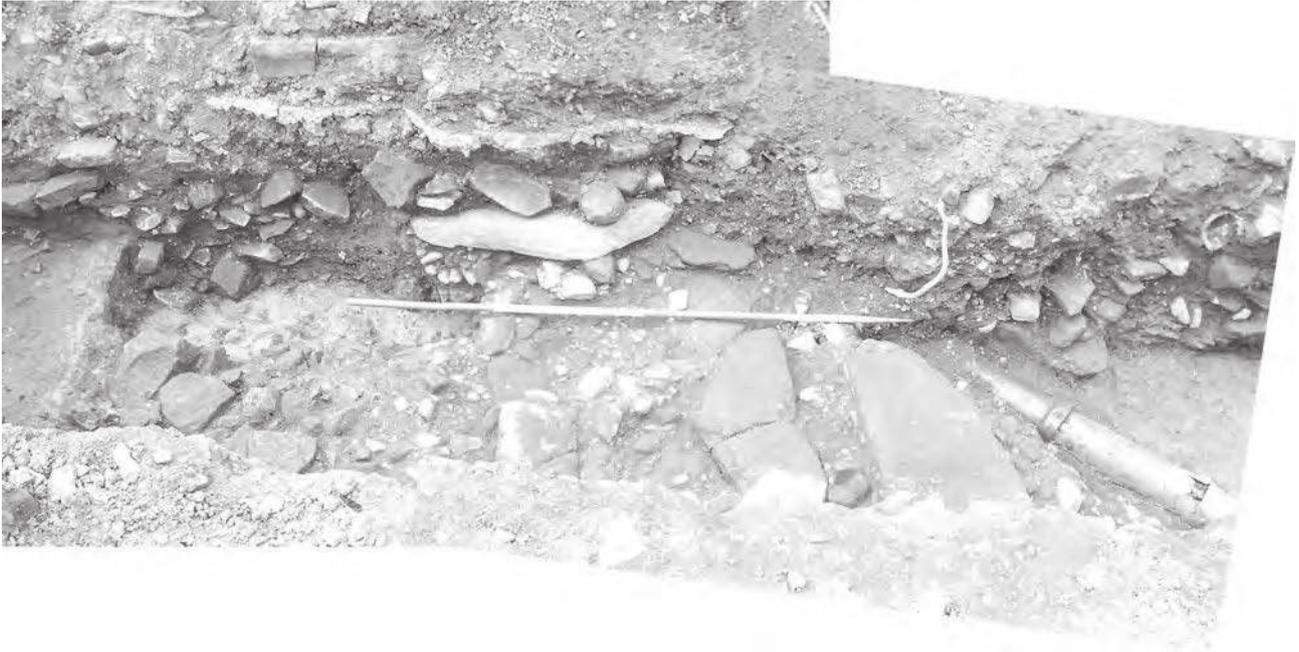
Figure 17 Via quintana road surfaces and clay foundations of the gate passages walls in the Site 10 trench.

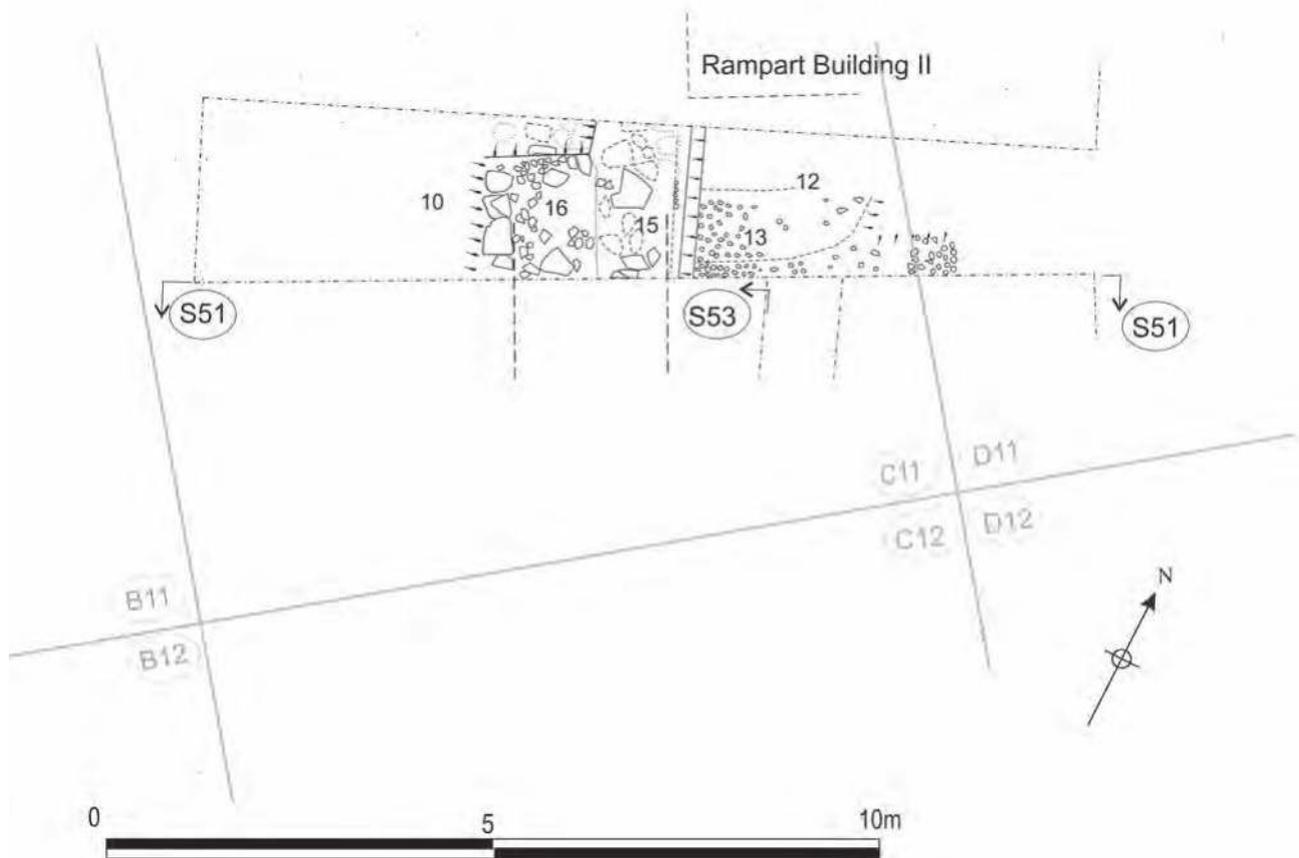
Fig. 17.21 Trench across the west defences north of the porta quintana at Segedunum

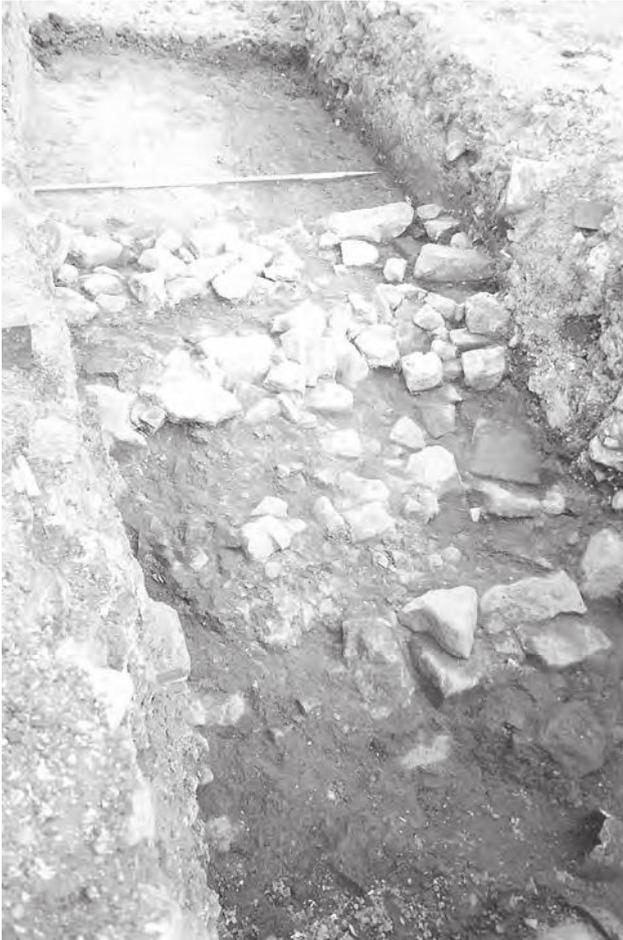
Figure 17.23: Remains of the west curtain with the late refurbishment along the outer face in the foreground, in grid square C11 (Site 8 trench).

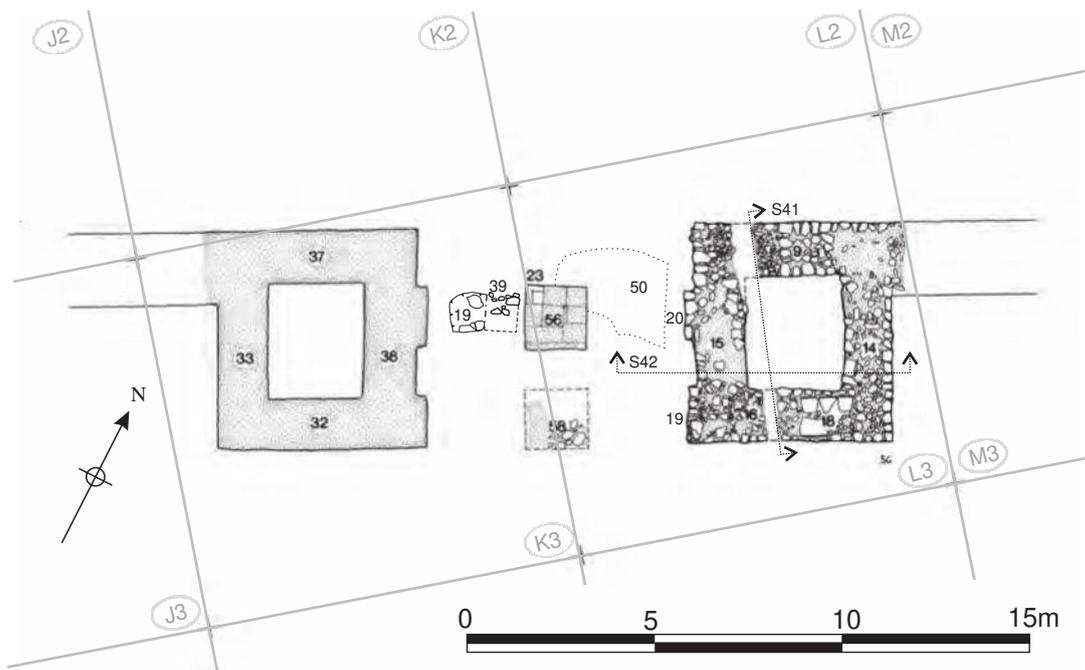
Figure 18.01 The north gate, at 0

the guardchambers. The northern pier (L03:56), which measured 1.7m × 1.5m, still retained one stone (L03:23) at its north-western corner, scored to assist with the positioning of the courses above it. The outlines of the other eight blocks could be made out in the pink foundation clay. The remainder of the stonework had been robbed away (K03:13, L03:52, 53). The position of the southern pier (L03:58), just over 1m to the south of its northern partner, was also marked by traces of pink foundation clay, but less well-preserved.

### Introduction (Fig. 18.01)

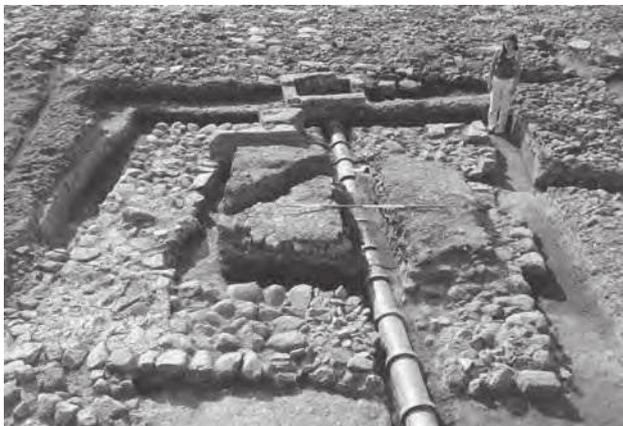
Figure 18.02: The east guardchamber of the north gate showing the tower foundations, looking south

Within the tower the original level of masons' chippings (L03:28, 45–47) was uncovered overlying grey-brown clay (L03:29), possibly a levelling layer, which in turn sat on light buff sandy soil and orange clay, both interpreted as natural subsoils (L03:30i–ii). The construction debris included a patch of coal dust

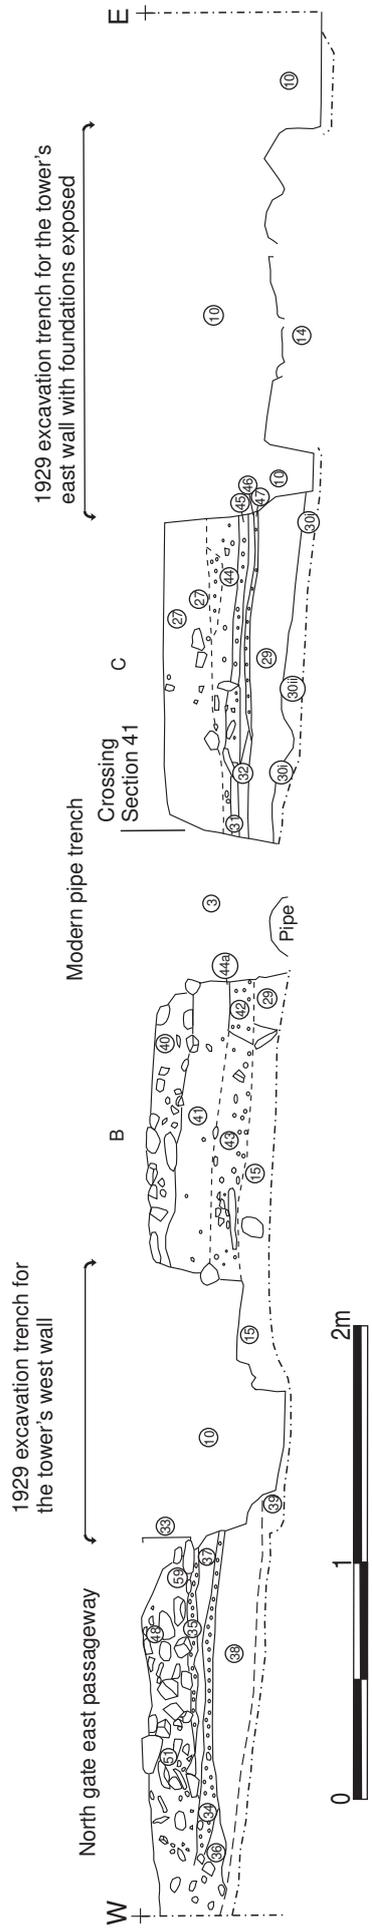
Figure 18.03: Section 42, east-west section across east tower of the north gate, 1:30 (Grid L03).

Traces of a gravel surface for an entrance passage through the tower's west wall were also seen in section (L03:42; see S42, Fig. 18.03).

A series of possible road surfaces were recognised in the gateway. The fullest sequence was recorded in the east passageway where a full section was cut through these levels (S42; cf. Fig 18.03). The lowest consisted of small stones (L03:34), mostly sandstone and gravel, over layers of grey-brown clay (L03:36, 38) which could represent levelling up. This was overlain by orange-brown clay (L03:37) surfaced by a layer of sand and gravel (L03:35), which presumably formed a second road level in the east carriageway. Overlying level L03:35, in turn, was a further road surface of small cobbles (K03:12, L03:59, 61), which was observed in plan to extend across the full width of the gateway.

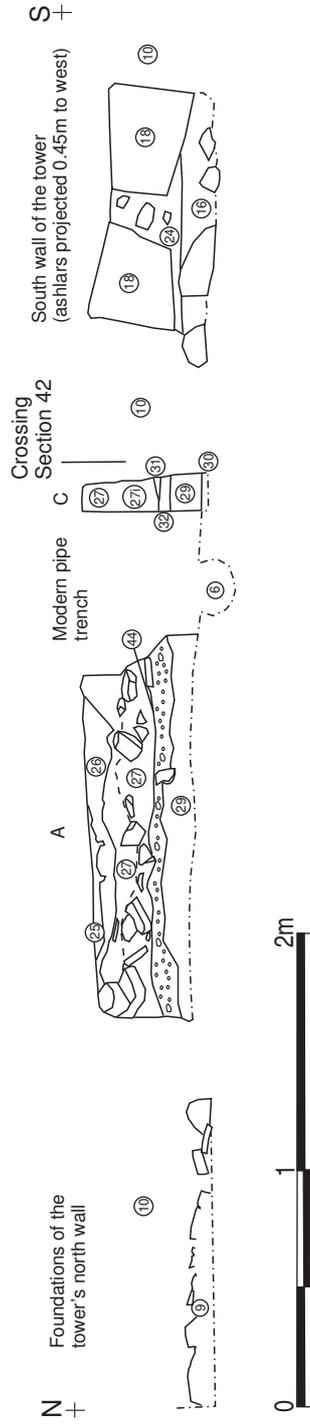
Figure 18.04: Section 41, north-south section across the east tower of the north gate, 1:30 (Grid L03).

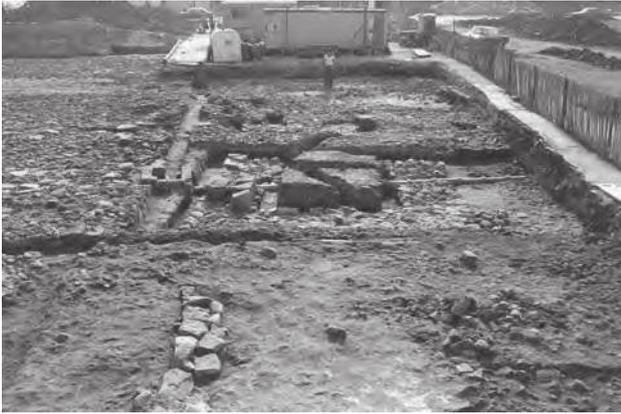
Fig. 10 View of the north ramp and north gate from the east with the ramp revetment wall in the foreground.

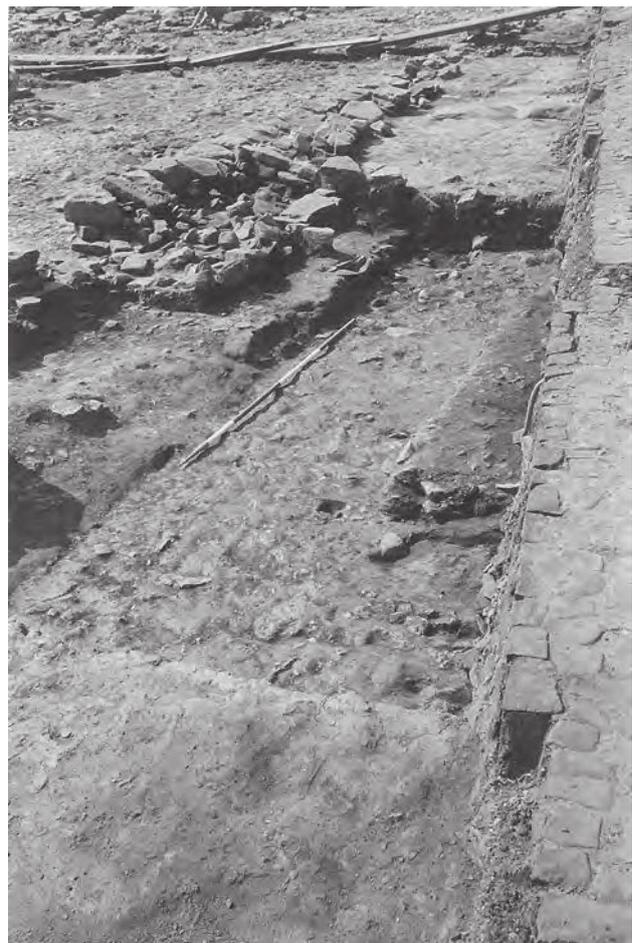
Fig. 18.07 The foundations of the interval tower east of the north gate, looking west. The rampart revetment wall extended across the front of the tower after its demolition; it can be seen across the top left.

Only the southern end of the interval tower was available for investigation (Fig. 18.07). It was situated 20.25m from the east tower of the north gate and 15.50m from the north-east angle tower. The line of south wall (P04:15) and parts of the east (P04:16) and west walls (N04:35) were indicated by the foundation of thick, pink, puddled clay. This foundation measured 1.00–1.10m wide and survived to a depth of 0.07m. It lay on a base of large river cobbles (P04:16) in a trench which cut the natural sub-soil. The width of the tower across the foundations was 6.00m. Only a narrow strip of the interior of the tower was uncovered. A thin layer of masons chippings and mortar lay on the surface (P04:18). No occupation levels survived. The walls of the tower were obviously narrower than the width of the clay foundations, as construction material over the interior and the clay of the north rampart both extended a little way across the edges of the foundations.

A new rampart kerb (N04:02, P04:03) was constructed immediately south of the original and extended across the approach to the tower, blocking off the access (Fig. 18.07; cf. Fig 20.03). It was composed of large faced sandstone blocks up to 0.40m × 0.25m × 0.35m set in a slight clay pack. Fragments of the kerb survived as a single course for 26.00m, most of this occurring west of the tower. This sat on a thin bedding of light-brown loam over the demolition rubble from the tower and the earlier road surface. In some places the kerb was keyed into the rampart with brown loam and small fragments of sandstone.

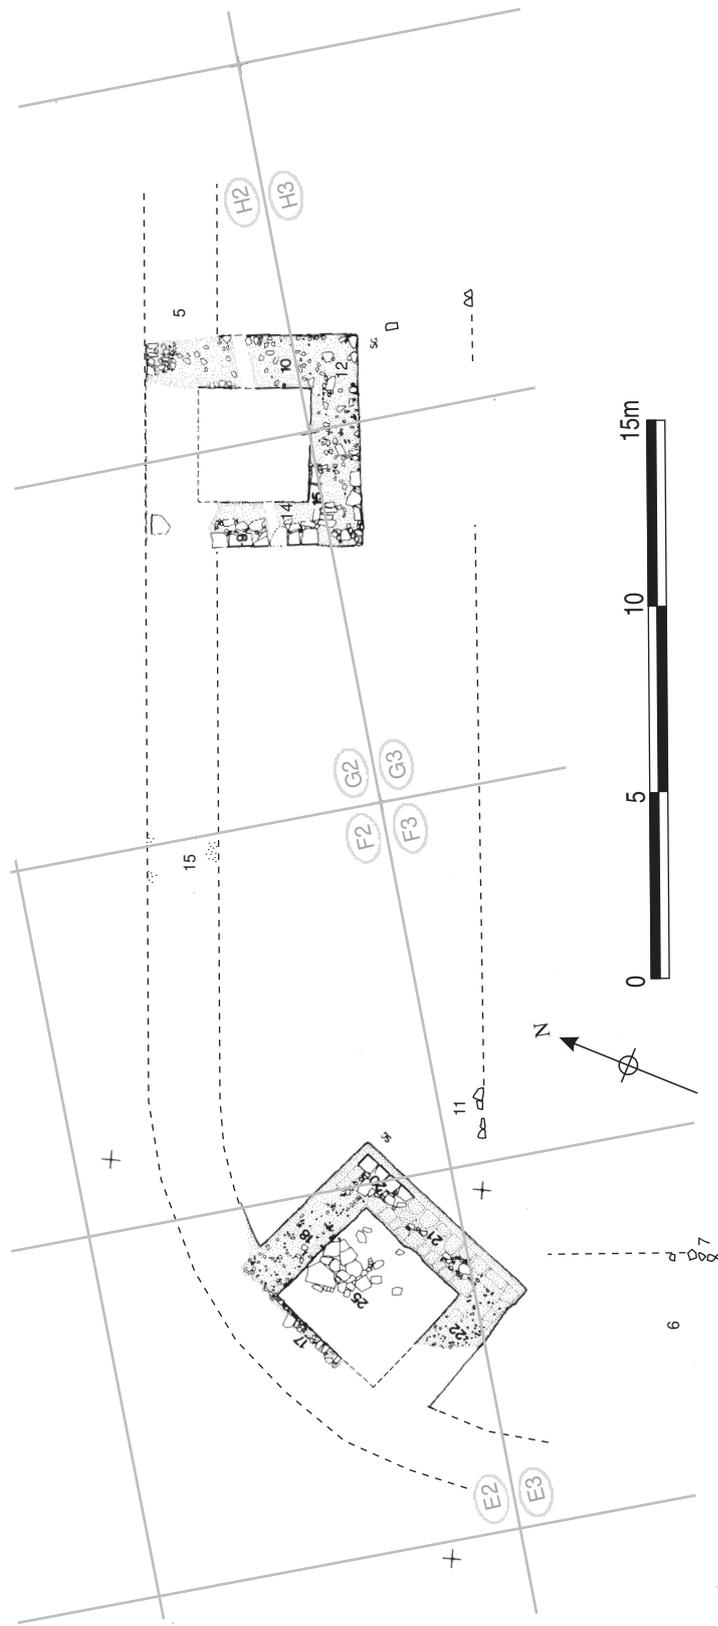
Figure 18.08: Plan of the north-west defences comprising the north west angle tower (2) and north interval tower (1) and surviving stretches of rampart revetment. Scale 1:200

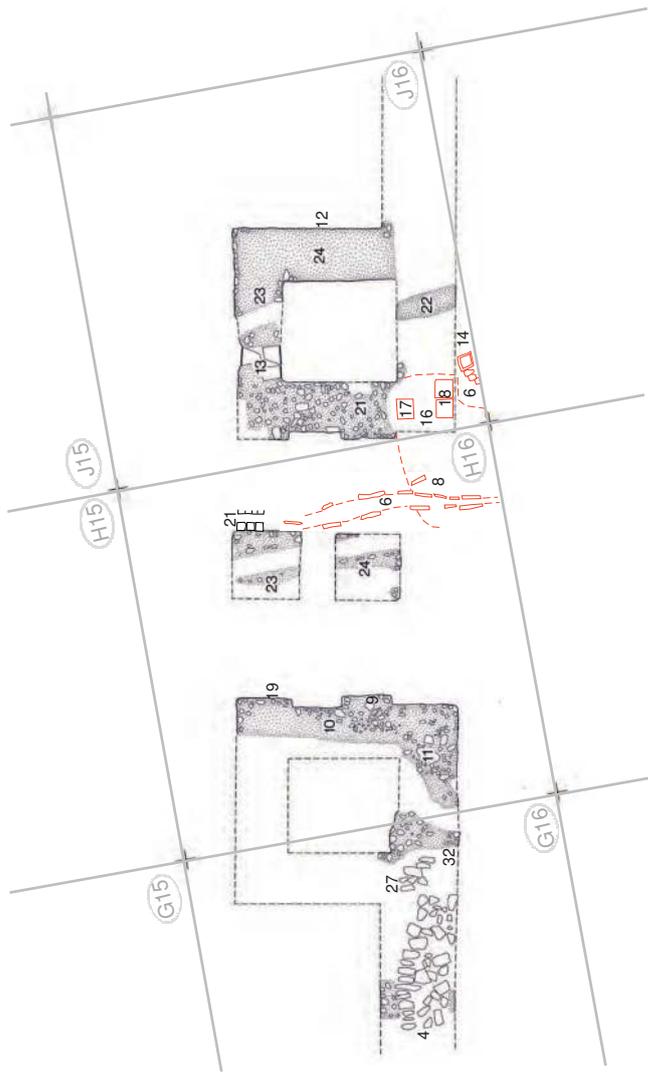
The south gate, at 1:200, with later Roman or post-Roman features marked in red.

Figure 19.01: South and east defences at 1:200.

#### *Later features and modifications* (see Fig. 19.01)

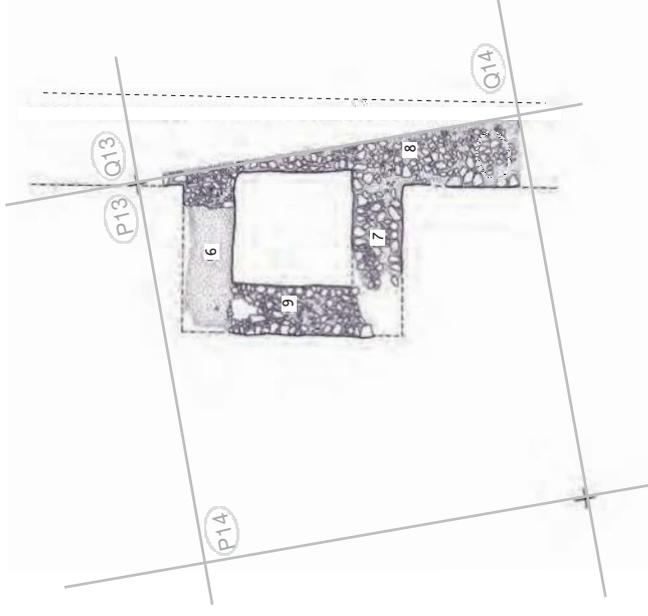
East defences: the interval tower north of the south-east angle, at 1:200

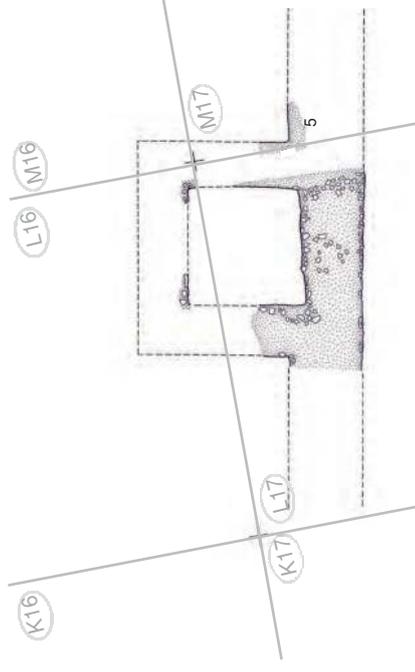
South defences: the interval tower east of the south gate, at 1:200
