# SEGEDUNUM

Excavations by Charles Daniels in the Roman Fort  
at Wallsend (1975–1984)

VOLUME 1: The Structural Remains

Alan Rushworth and Alexandra Croom

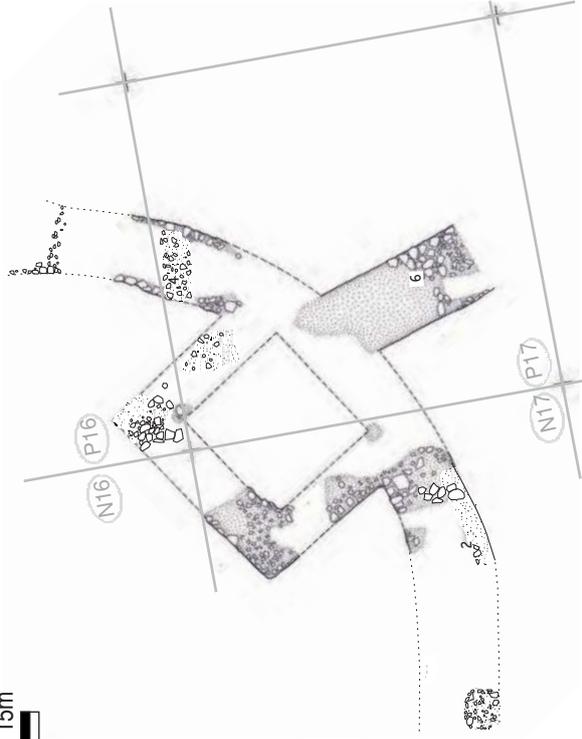
The south-east angle tower, at 1:200

The south east angle tower could only be partially exposed and traced due to the number of modern intrusions (Fig. 19.01). It survived best along its south-west side and particularly at the west corner where the pink clay and river-washed cobble foundations remained *in situ* and were planned in 1978 (P129). The outer edges of the north-west and south-west wall foundations were both still traceable at these points, round the corner and as far as the junction with the south curtain wall. Some pink clay and cobble deposits were also recorded in the area of the north corner and extending a little way down the northern east side of the tower, where a couple of sizeable stones and the imprints of others may have belonged to the external kerb. In the interior the west corner was correspondingly well-defined, plus to a much lesser extent the north and, even less certainly, south corners. The north-west wall foundations – which alone could be measured accurately – were 1.40–1.55m wide. No internal floor levels survived, however, with the natural yellow clay subsoil being exposed on all sides. On the basis of this data the external dimensions of the tower were estimated at 6.40m from the outer face of the south-east angle curtain to the rear of the tower and 6.00m from east to west. The tower appear to project inwards 4m from the inner face of the curtain. Internally it probably measured 3.50m (E–W) by 3.35m (N–S), though there was a degree of uncertainty with this estimate, and like the other towers was probably recessed c. 0.30–0.40m into the curtain wall.

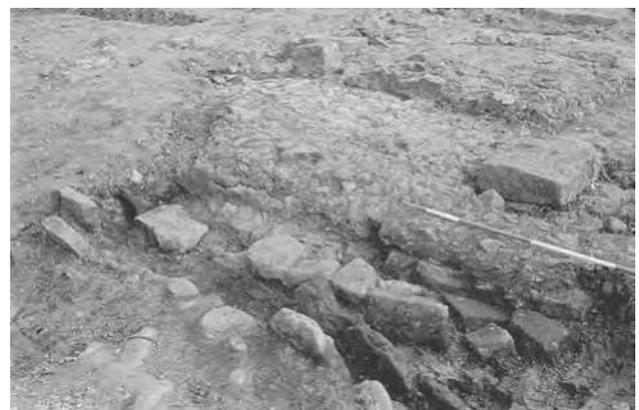
Figure 19.02 The east passageway and east gateway member of the porta decumana, looking north west.

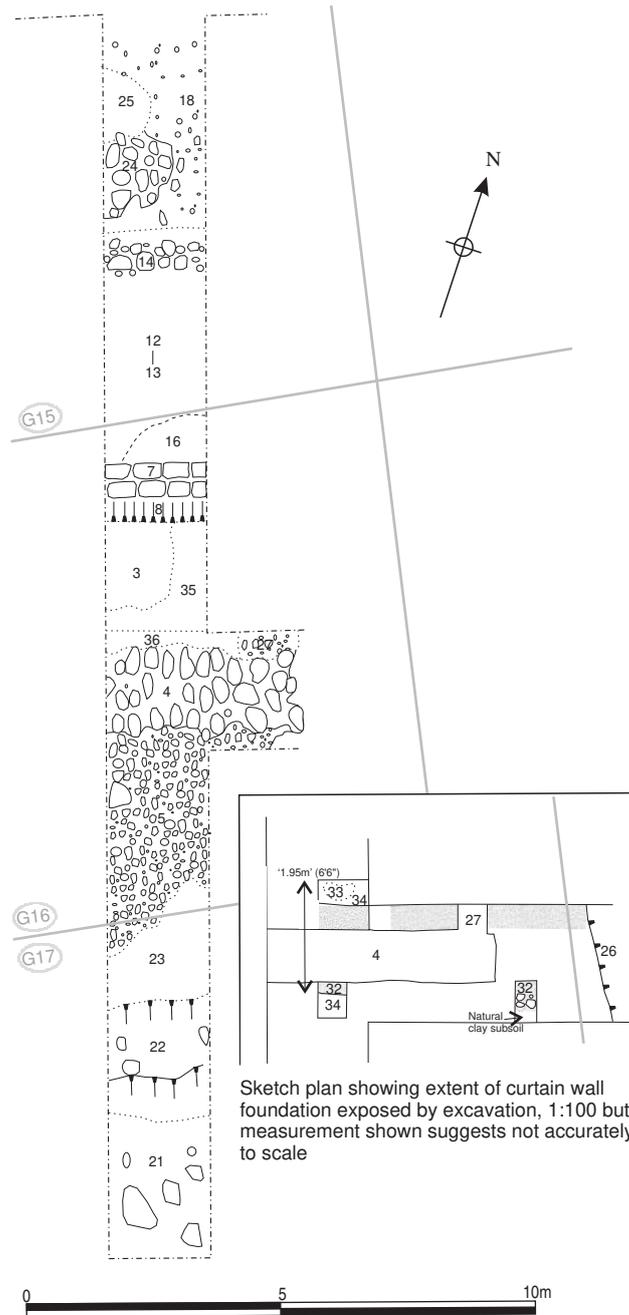
Figure 19.03 Trench across the south defences in grid squares G15-G17 Scale 1:100

A trench was excavated across the southern defences a little to the west of the *porta decumana* in 1977. In the same season a branch trench, 6.40m long and 2.35m wide, was extended eastwards from the first trench, along the line of the curtain wall, to reach the nearest tower of the gate (Fig. 19.03). The main, north-south aligned trench was 24.50m in length and 2m wide, and extended southward from the *intervallum* road, traversing the rampart, curtain wall and berm to terminate part way across the innermost

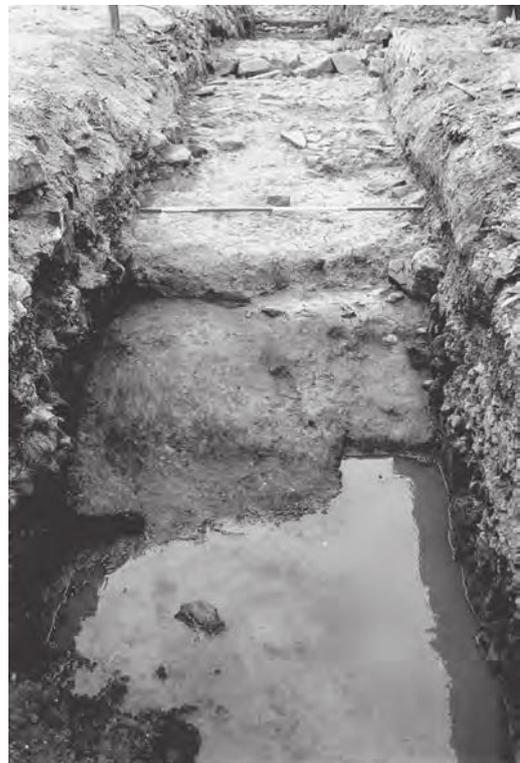
Fig. 19.04 North lip of the south ditch looking north with pitched stone foundation G16:04 visible on the line of the curtain wall in the background.

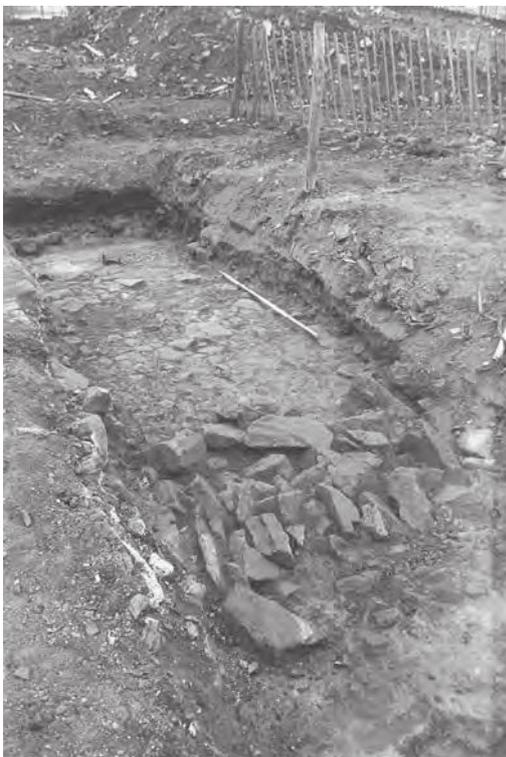
Figure 19.05: Pitched stone foundation G16:04, from the south west

The most significant of the later features identified in the Site 7 trenches was a substantial, pitched stone foundation (G16:04; cf. H16:14), 1.20m in width, overlying the clay and cobble foundation of the primary curtain wall (Fig. 19.05). The sandstone blocks used were up to 0.50m in length but averaged 0.35m long by 0.20m wide and 0.30m high. They were traced over a total distance of 4.50m running from the western edge of the main trench eastwards towards the south gate as far as the surviving fragment of masonry interpreted as belonging to the west wall of the west guardchamber (G16:27) where they petered out. Masonry G16:27 appeared to adjoin the north side of the foundations, suggesting that they were associated, though they need not have been contemporary. On the south side of foundations G16:04 the berm was covered by a surface of worn cobble stones set in in grey clay (G16:05), up to 3.70m in width (N–S), with a further 1m of more scattered metalling to the south beyond that. This cobbling appeared contemporary with the pitched foundations. Abutting the foundations on the north side was a layer of orange gravel and clay (G16:03), with coarse sand and scraps of sandstone. This

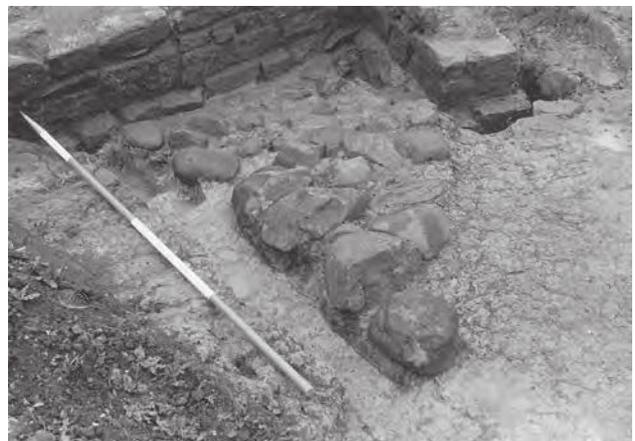
Fig. 19.06 The foundation of Branch Wall next to the south east angle of the fort, looking south west.

With the exception of a spread of pink clay, up to 2.50m wide, all trace of the Branch Wall foundations had been removed at the point where it joined the south-east angle of the fort (P177). However, 2m south of the curtain wall, the remains of the foundations survived in better condition (P17:06). These were constructed of river-washed cobbles set in pink clay, in the usual fashion, and continued right to the south end of the trench, marked by a modern stone founded garden wall (P17:08) lining the pavement of Camp Road, some 4m from the fort wall. At 2m (6ft 8in) in width, the Branch Wall foundations were relatively narrow, whilst the edges were defined by the use of larger boulders which were c. 0.25–0.30m broad across the face and tapered inward 0.25m–0.35m (Fig. 19.06).

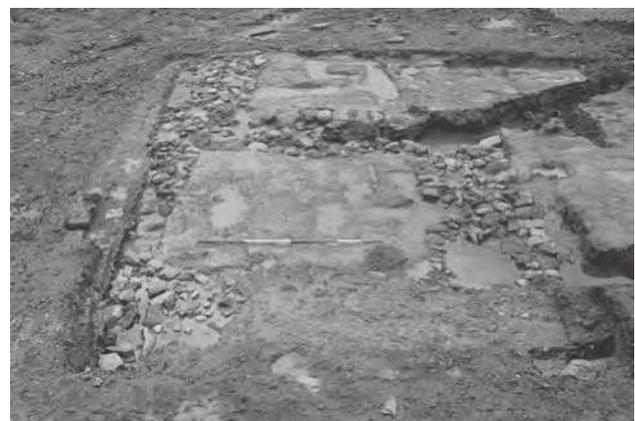
Fig. 19.08 The interval tower between the south east angle and east gate (Tower 5, looking south)

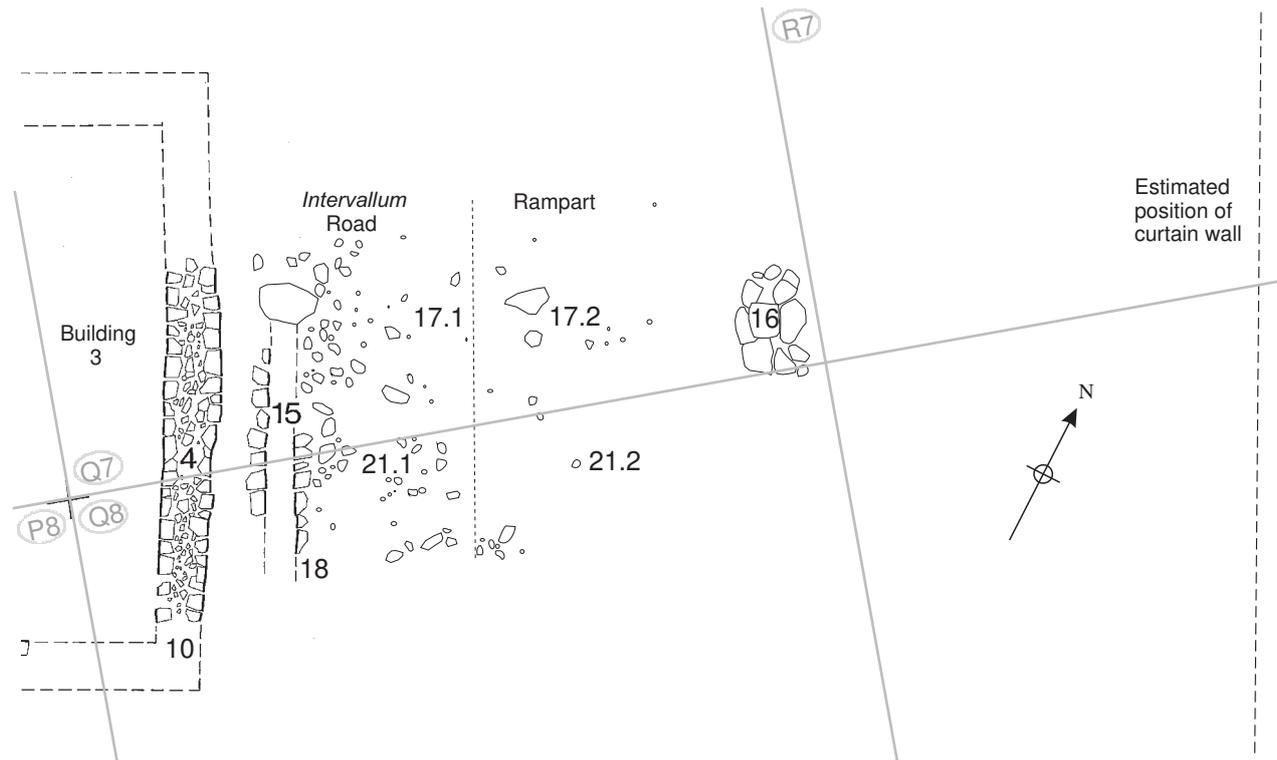
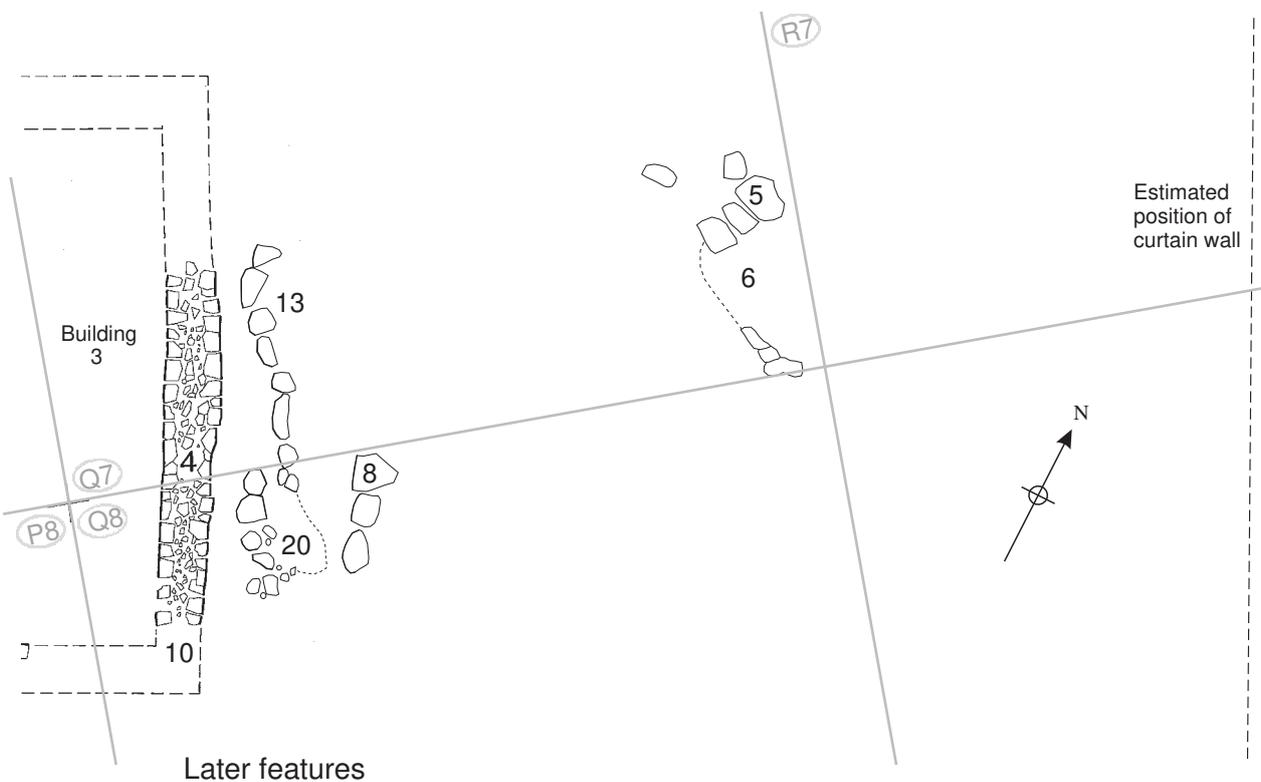
Fig re 8 Eastern intervallum road and defences in Q0 and Q8 showing earlier and later features. Scale 10

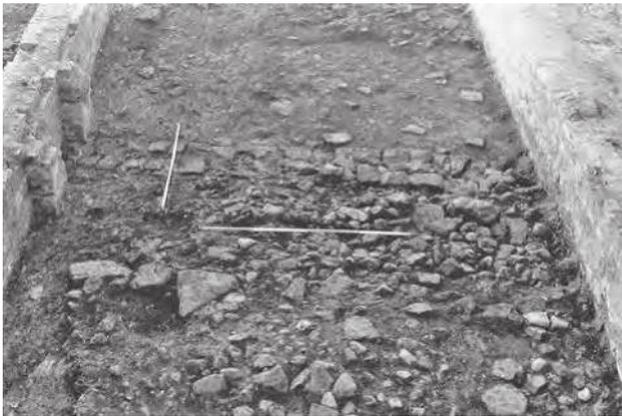
Figure 19.9 Building 3 east wall Q07:07 with the side wall stones of street drain Q07:17 in the foreground, looking west.

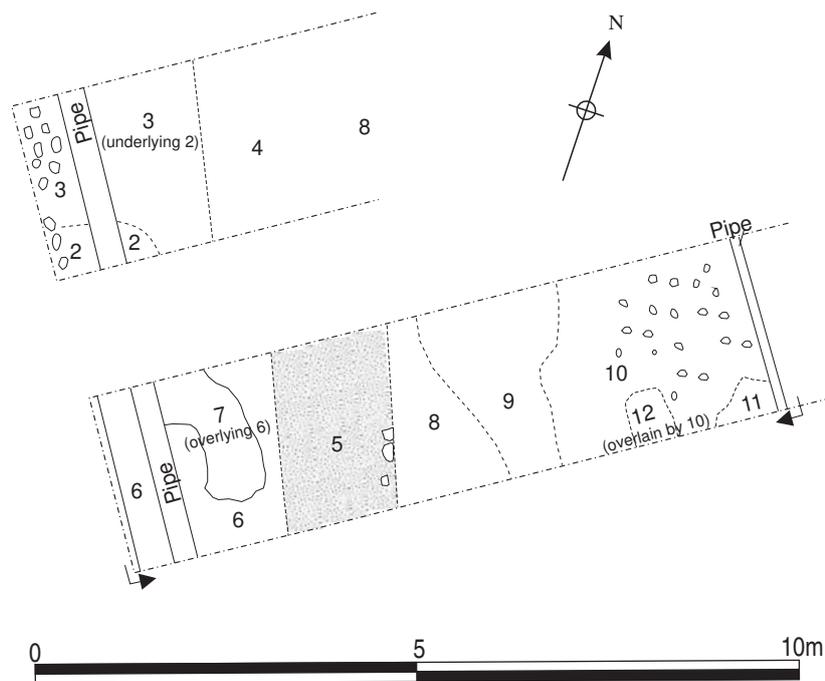
Figure 19.10: The 1976 trench across the east defences in grid square R5, at 1:100, showing upper (top) and lower (bottom) levels of excavation at the east end of the trench

The eastern edge of the curtain wall foundations and robber trench cut through a deposit of light brown sandy clay (R05:08), containing relatively few stones, which was interpreted as the original Roman ground surface. This extended for 0.40–1.50m further east at which point it was cut away by a modern, north-south aligned, linear intrusion (R05:09), perhaps a former drain trench, with vertical sides and a flat bottom, and substantially wider to the north (1.90m) than the south (0.70m/0.85m). Beyond, a thick deposit of clay (R05:12) extended eastwards and was perhaps equivalent to R05:08, though not identified as such by the excavators. In section, its surface was seen to dip down from the level of R08:08, before levelling out, and the deposit appeared to fill a 0.50–0.60m deep depression extending 0.70m from the south side of the trench, perhaps a gully, whilst reportedly overlying a greyish sand/clay. The latter may be essentially the same as the yellow sand seen at the bottom of modern drain trench R05:09, perhaps bands of natural which presumably also extended beneath R05:08.

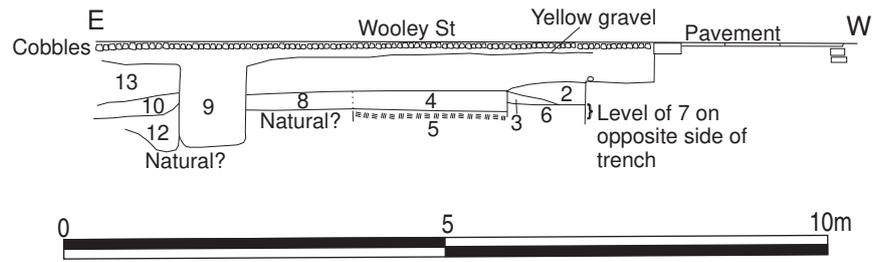
Figure 9 Section across the east defences in grid square R5 at Segedunum

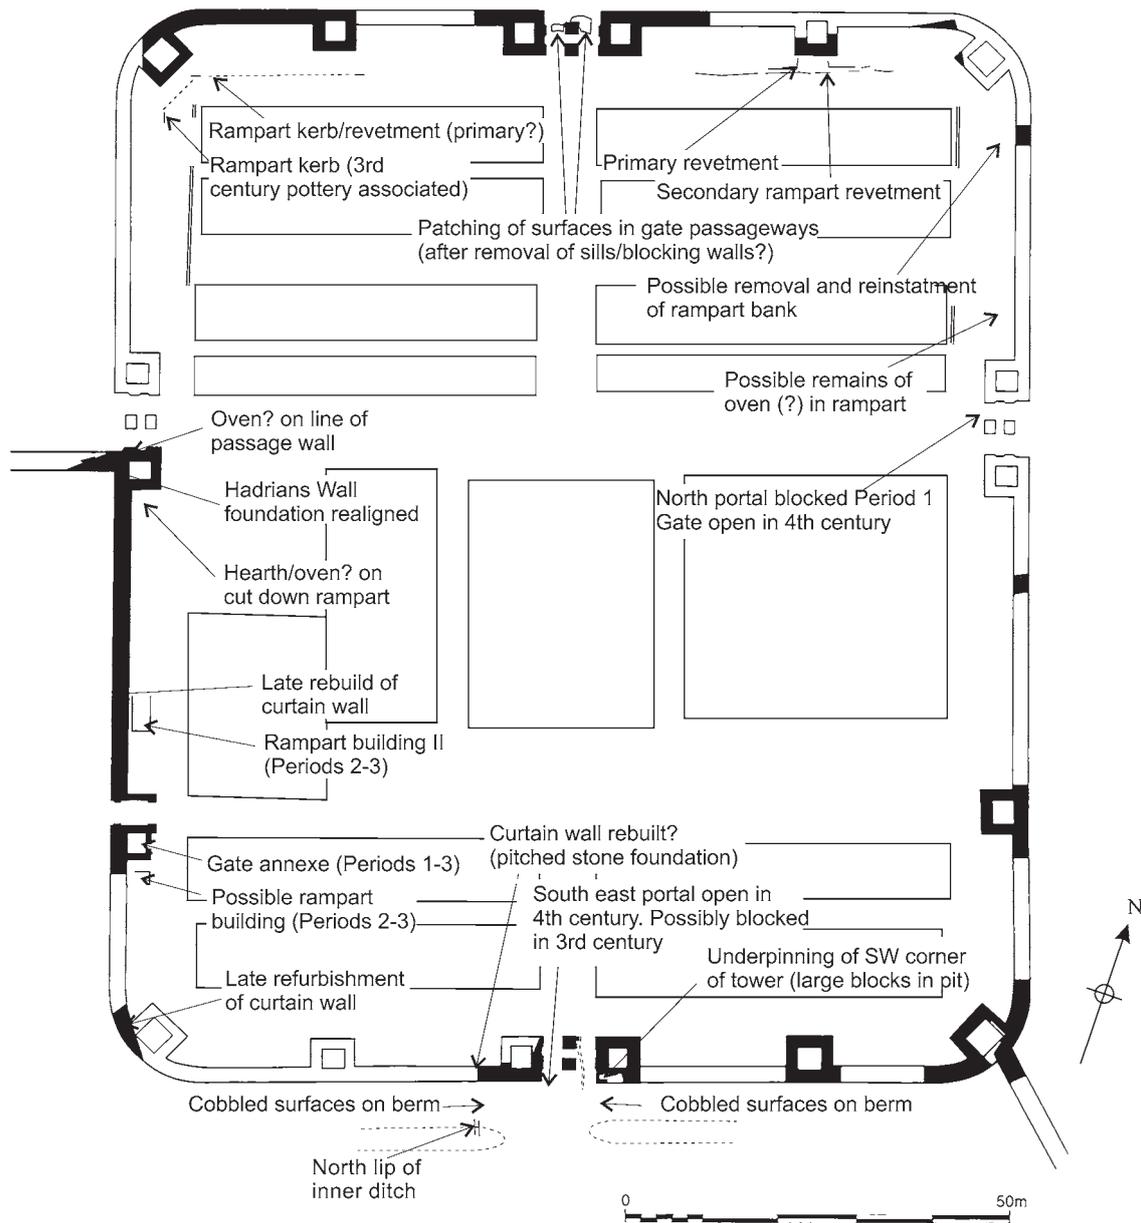
Figure 20.1: Summary plan showing the features and modifications identified in the area of the defences, 1:1000.

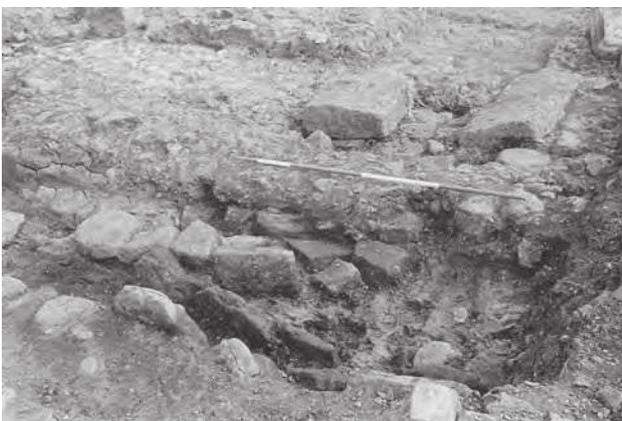
Figure 20.2: Possible modifications to the south gate. Stone filled pit H16:08/J16:09 at the south-west corner of the east guardchamber and east passage, overlain by later cobbled surfaces and cut by drain H16:06.

south-west corner of the east tower may have been underpinned at some stage using three large squared blocks set in a pit (Fig. 20.02), though it should be noted that the excavators again considered this to be a colliery-era feature of some kind. The clay and stone-packed pit appeared to extend across the front of the gate portal, though its full extent here was not traced as it was overlain by two layers of cobbling, also regarded as post-Roman, which were not removed. It might therefore conceivably have formed the foundations of a blocking wall, perhaps tied into a repair of the east tower, though it appeared very broad.

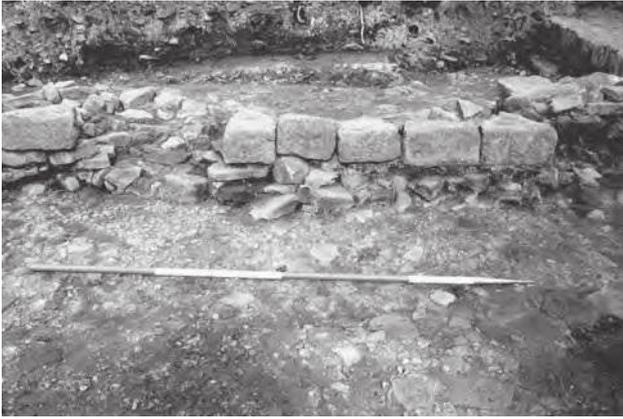
Figure 20.03: The secondary north rampart revetment N04:02/ P08 extending across the front of Interval Tower 7 closing off access.

A new rampart kerb (N04:02, P04:03) was constructed immediately south of the original and extended across the approach to the tower, blocking off the access (Fig. 18.07; cf. Fig 20.03). It was composed of large faced sandstone blocks up to 0.40m × 0.25m × 0.35m set in a slight clay pack. Fragments of the kerb survived as a single course for 26.00m, most of this occurring west of the tower. This sat on a thin bedding of light-brown loam over the demolition rubble from the tower and the earlier road surface. In some places the kerb was keyed into the rampart with brown loam and small fragments of sandstone.

described above (Figs 20.03, 20.04). No trace of successive phases of revetment was found elsewhere by Daniels, although the small quantity of third-century pottery associated with the west rampart revetment next to the north-west angle tower might hint that this was not the primary kerb.

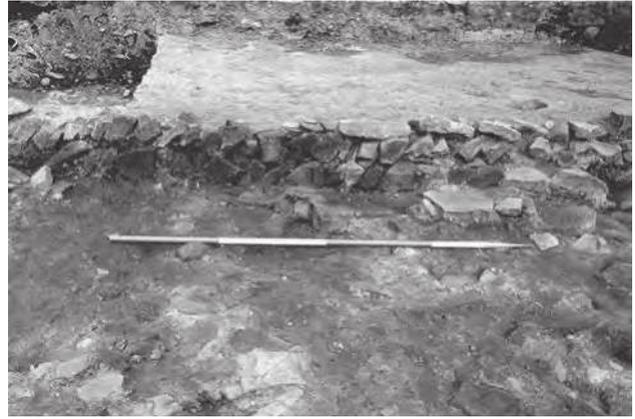
Figure 20.04: The primary north rampart with revetment wall P08 in front.

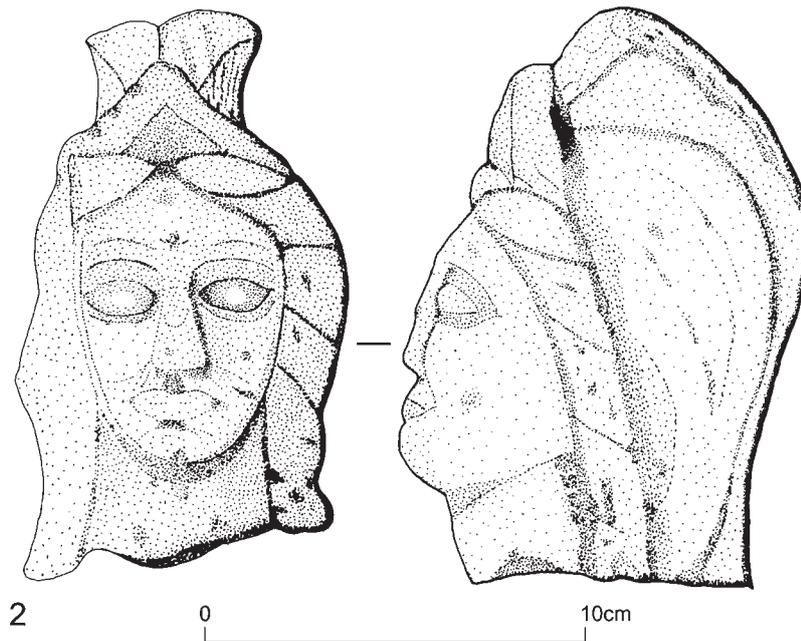
Figure 21.04 Sculpture of female head. Scale 1

#### Altar (Fig. 21.04)

6. Altar (H:240mm W:290mm B:150mm). Building 3, south wall, Period 2, P08:11, 2515, WSS5. Incomplete sandstone altar base, showing signs of burning, with a complete width or breadth of 290mm (both of the other measurements are incomplete). This was built into the wall of an Antonine building, and is therefore likely to be Hadrianic in date. The simple base with a moulding wider at the top than the bottom is also found on Antonine altars at Birrens (*CSIR I.4*, nos 3, 15).

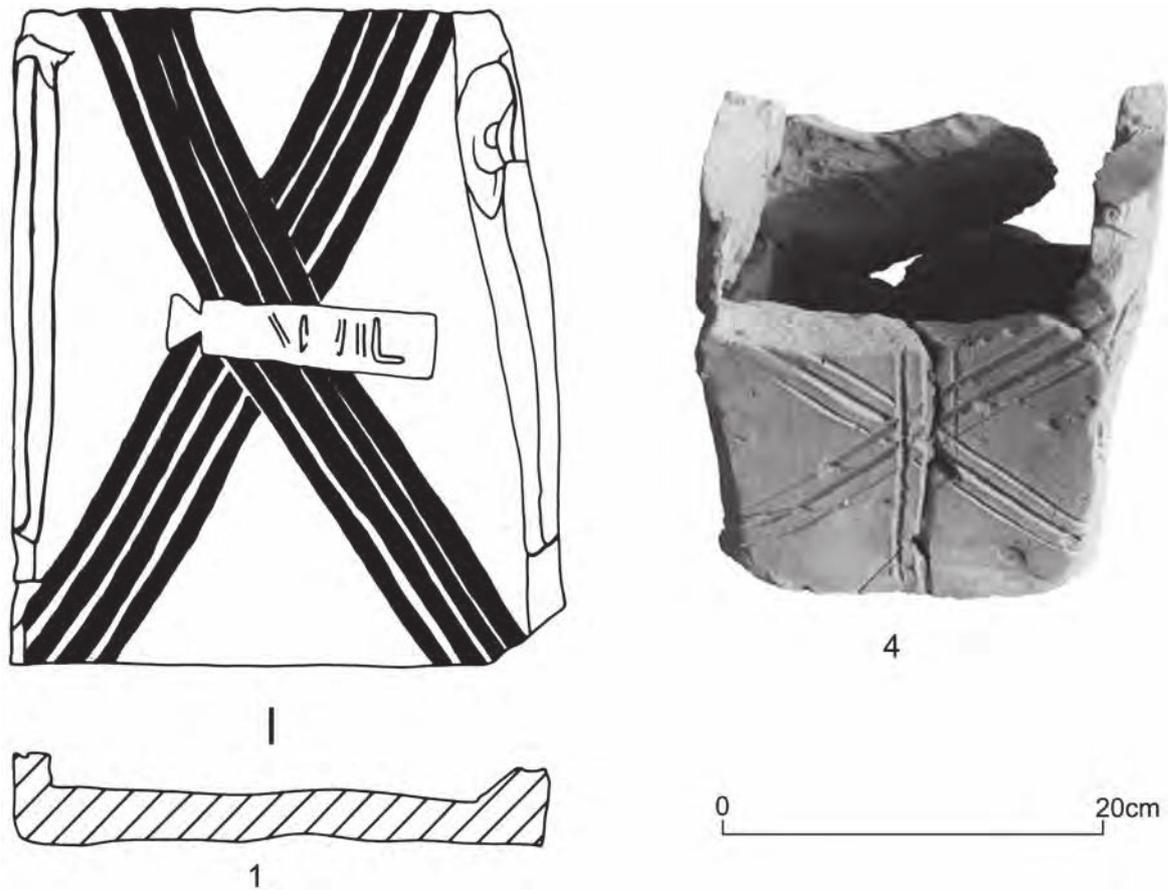
Fig. 21.08 Complete tegula, scale 1 and box tile, not to scale.

flanges *c.*15mm thick, that are often also low in height (for example, 12mm tall: H05:12). The typical dimension of a flange on a normal tile is approximately 25mm wide with an overall height of flange and base of 40mm.

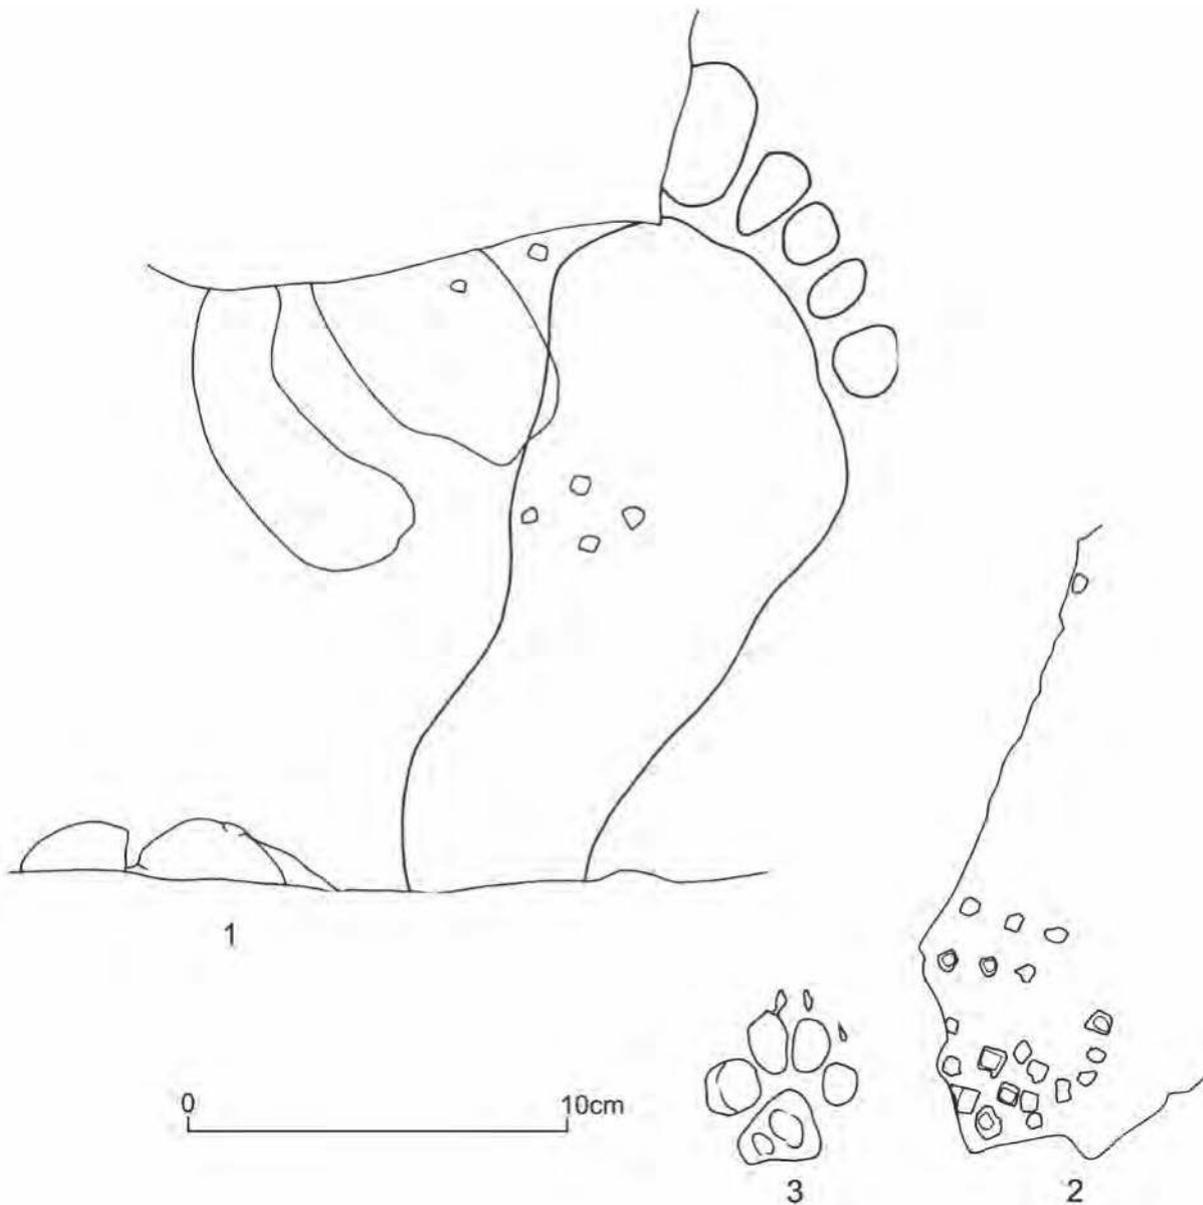
Figure 2 : Impressions on tile. Scale 1

The sherds show a range of different surface treatments for keying; from leaving the surface deliberately rough, incised lattice (Fabrics 1 and 3), comb, and one example of wavy finger grooves (M05:13). The combing takes the form of lattice, star, along the edges with a central cross, diagonal and wavy lines.

The combs can have up to seven teeth, but there is one example of a two-teethed comb lattice (E14:06). One fragment has keying on two adjoining sides, with spaced wavy finger decoration on one face, and incised lattice decoration on the other (F04:19).

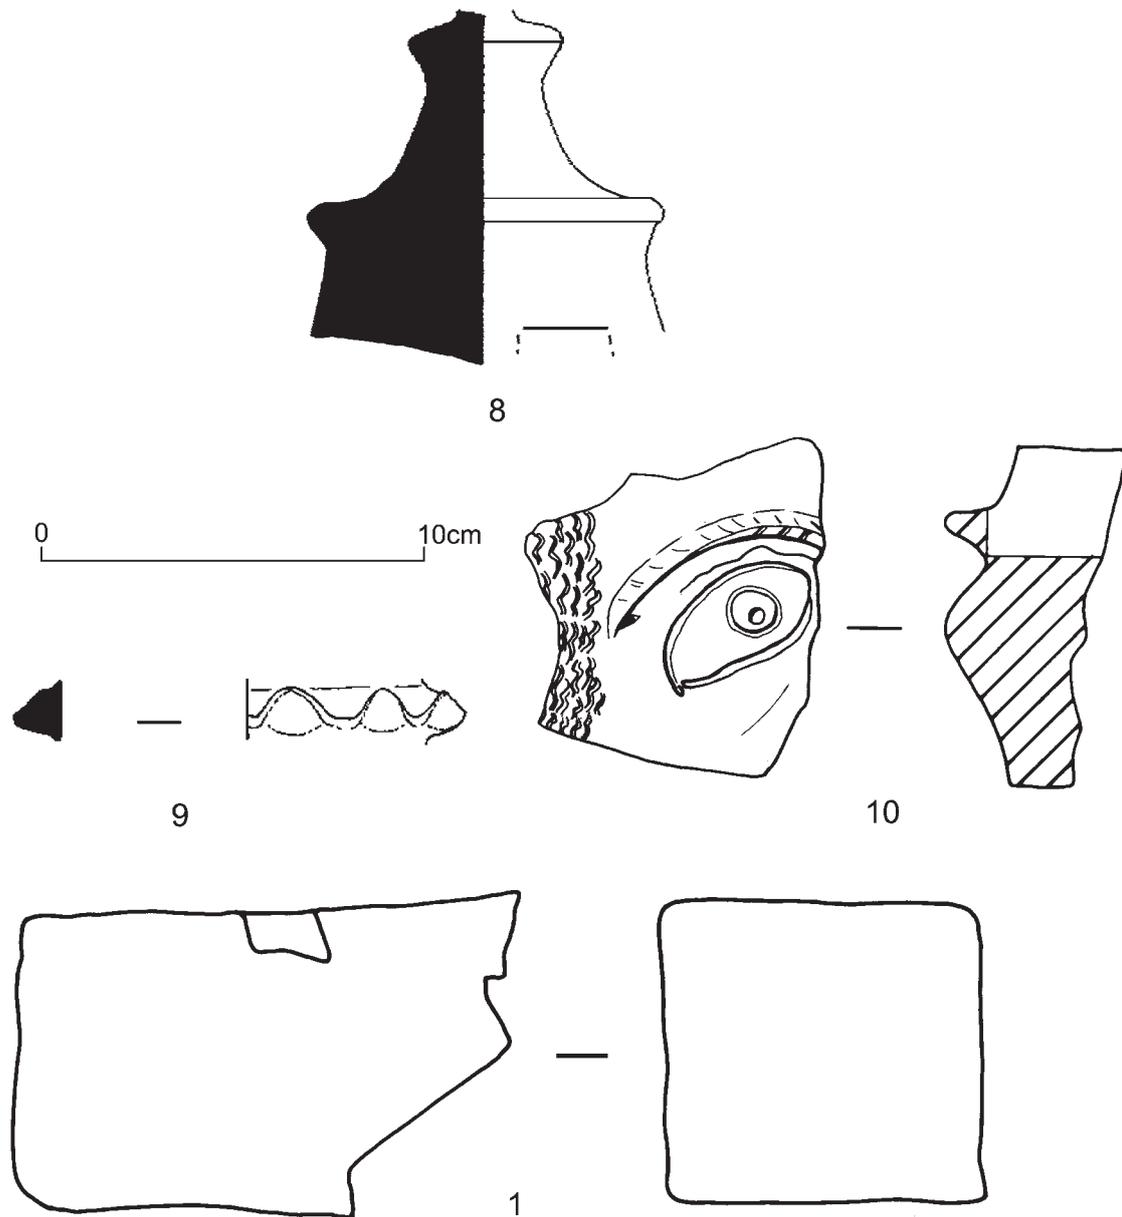
Figure 21.12: Chimney pots, tile face, and fired clay no. 1. Scale 1.2

Sherd from near the pot of the chimney pot, missing the very top of the terminal. The body expands into a ridge which is very battered, but appears to be plain. There are traces of two vents.

Incomplete rectangular block of fired clay, tapering slightly. Roughly made with grass impressions on the surfaces and a patchy and uneven colouring; along the edge of one side there is an inscribed alphabet (Graffito no. 29). The appearance of the clay is very similar to the fragments of burnt daub from the site, and some pieces which have identified as daub but which have apparently straight external edges may come from similar blocks. Tapering rectangular blocks were used to support the containers used in salt production over the source of heat (Morris 2007, fig. 5, no. 17), but similar supports were probably used elsewhere round hearths for other industrial or domestic purposes.

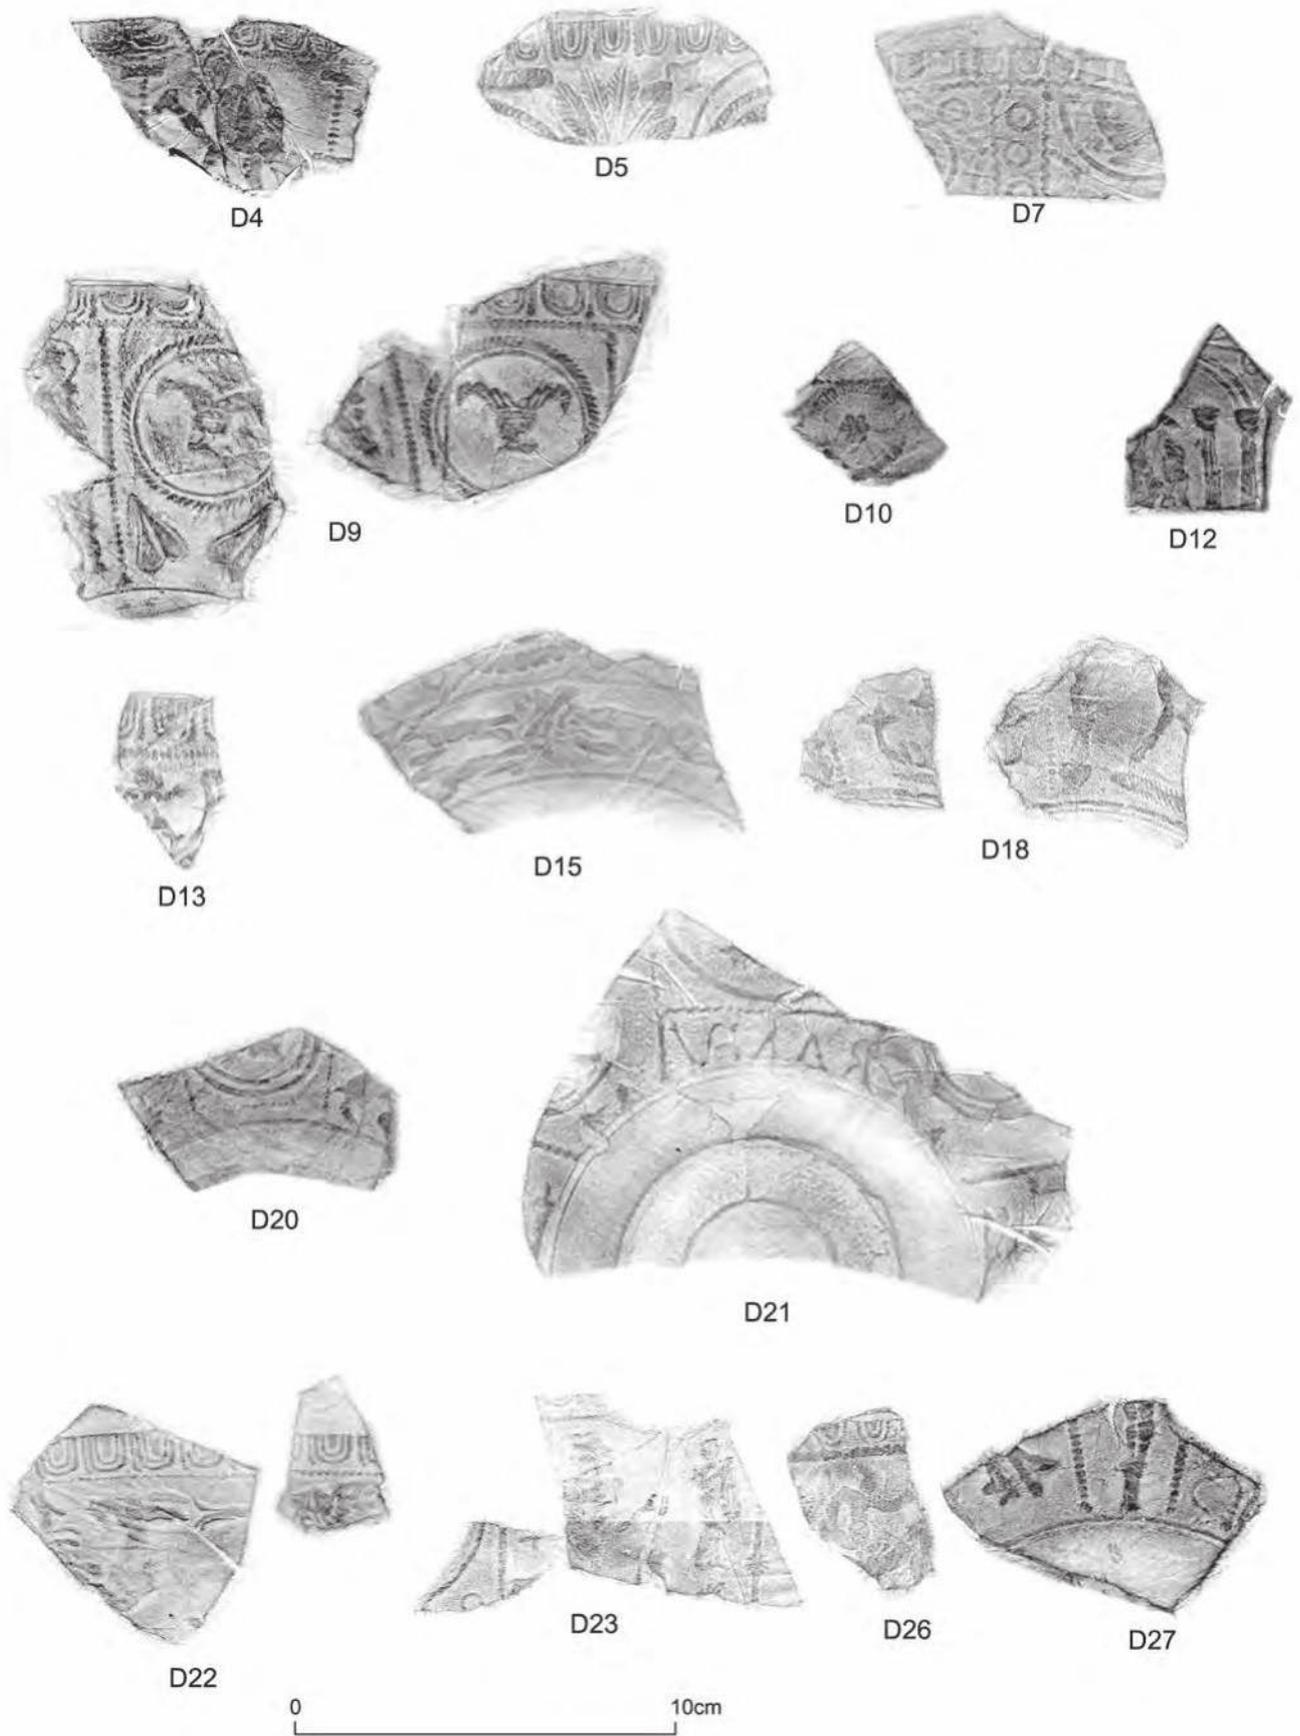
Figure 22.01: Decorated samian nos D4–D27. Scale 1:2.

- D4. Form 37, Central Gaulish. The ovolo (Rogers 208), large beads and Bacchus (O.768) were all used by Casurius ii, but the astragali across the borders and inaccurately placed at the top are more typical of Docilis i, who also used the ovolo. Nevertheless, the bowl is more likely to be by Casurius. c.AD 160–190 (Chalet 9, Building W, D13:55; joining D13:03 (area over Building 9, unstratified)).

- D5. Form 37, East Gaulish, with mould-stamp of Belsus of Rheinzabern ([BE]LSVSF retr., see no. S16 below). The scroll has a striated double medallion (a more complete version of Ricken-Fischer, KB136), leaf (*ibid.*, P61) and bird (*ibid.*, T250) in the upper concavity and the same medallion in the lower concavity. c.AD175–200 (area over Building 10, unstratified, D14:01).

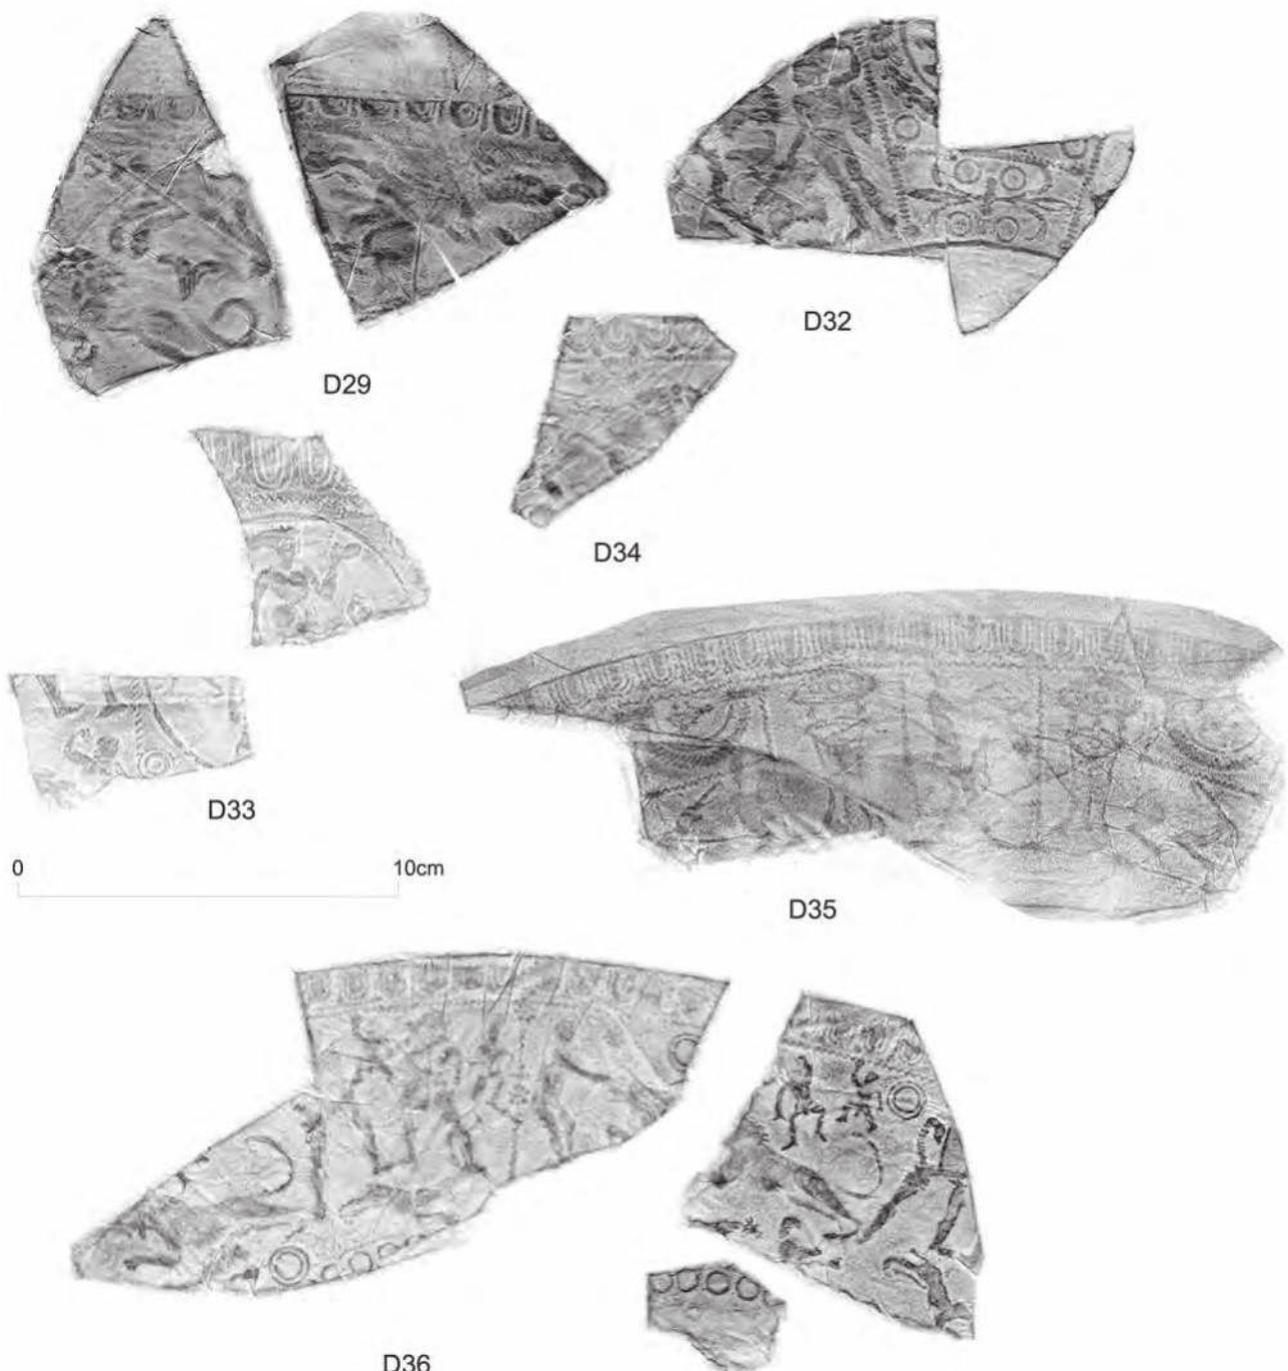
Figure 22.02: Decorated samian nos D29–D36. Scale 1:2.

- D32. Form 37, Central Gaulish, with panels: 1) a vine (Rogers N1, with a variant of the leaf H119), bird (D.1019 = O.2252?) and Bacchus (O.566, without boots). 2A) Festoon (Rogers F16), probably containing a sea-cow (D.29 = O.42?); 2B) trifid motifs (Rogers G56) stem-to-stem, joined by a vertical astragalus. The Bacchus and vine are on a stamped mould of Sacer i from Lezoux (Simpson 1977, pl. 1) and the rosette junction-masks are on bowl with the same stamp from Vienne (*ibid.*, pl. II). The trifid motif is on a signed bowl from Corbridge (S. & S. 1958, pl. 83, 13) and the same arrangement as in 2B, but with a different trifid motif, occurs on a signed bowl from Holt (*ibid.*, 12). *c.*AD125–145 (Area over Building 9, unstratified, E14:01, with joining sherd in F14:01 (area over Building 10 and Alley 5, unstratified)).

- D33. Form 37, East Gaulish (Rheinzabern). The ovolo is probably Ricken-Fischer 1963, E39. The decoration includes one panel with warriors (*ibid.*, M207–8) and a bush (*ibid.*, P9) and another with a large

roundel and a single medallion containing a Venus (*ibid.*, M44), between two figures to left (*ibid.*, M260). The use of wavy-line and corded borders is common in Cobnertus iv's work and they and many of the motifs appear on a stamped bowl from Osterburken (Ricken 1948, Taf. 31, 1). *c.* AD160–180 (area over Building 10 and Alley 5, unstratified, E14:01).

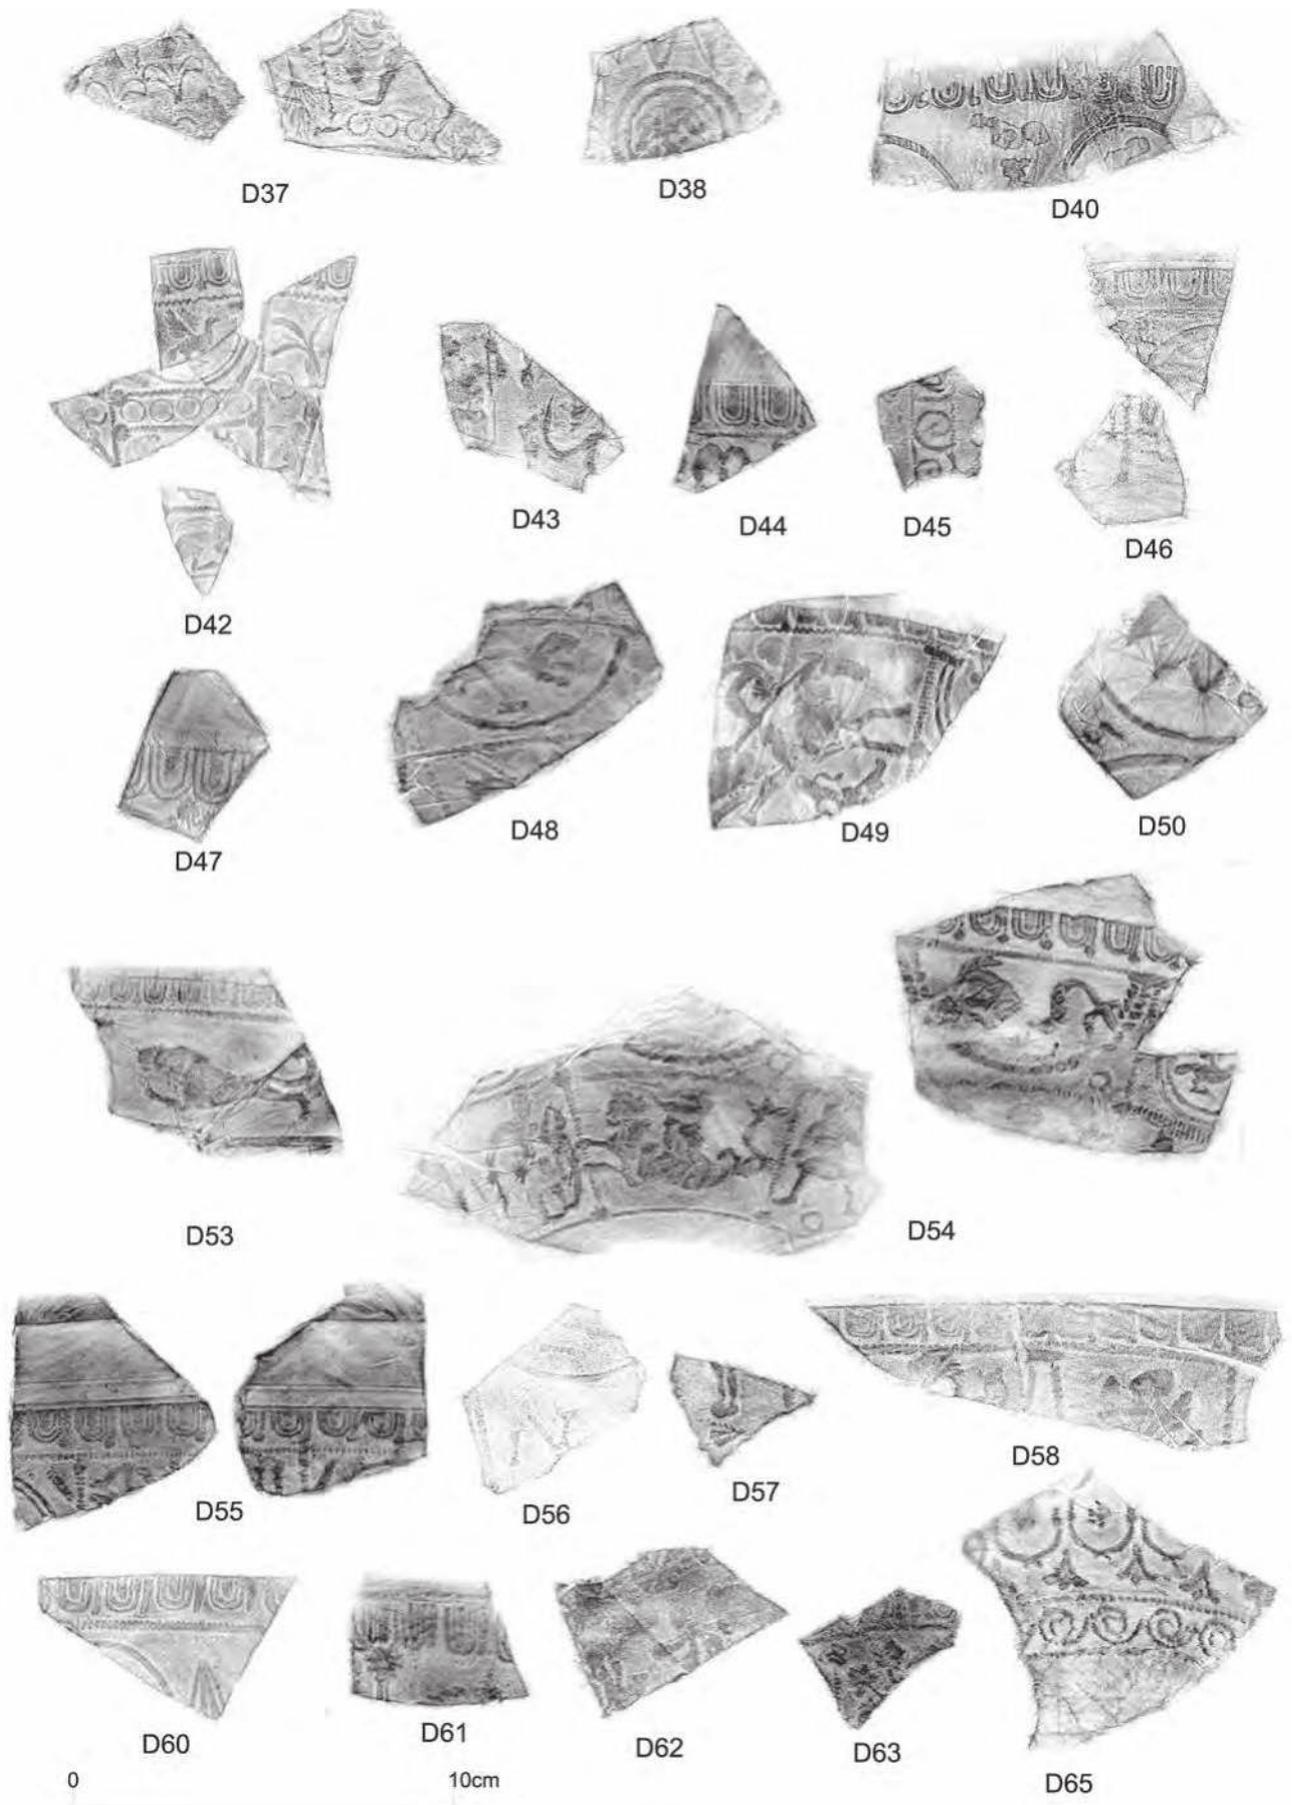
Figure 22.03: Decorated samian nos D37–D65. Scale 1:2.

- D63. Form 37, Central Gaulish. The single-bordered ovolo (Rogers B12), tree (Rogers N7) and rosette at the top of a panel border (Rogers C23) were all used by Attianus ii. c. AD 125–145 (area over Road 3, unstratified, G12:15, and area over Building 9 and Road 3, unstratified, G13:01).

- D64. Form 37, South Gaulish. The lower zone includes a panel containing rows of leaf-tips and a saltire with a five-bladed plant with striated outer petals in the bottom, over a basal wreath. The plant is on

- a stamped form 37 of Frontinus from Canterbury. c. AD 70–85 (Chalet 9, robbing and post-Roman dereliction, G13:03). (Not illustrated.)
- D65. Form 37, from the East Gaulish factory of La Madeleine. The decoration includes at least two rows of festoons (Ricken 1934, Taf .VII, 51), the lower containing seven-beaded rosettes (*ibid.*, 1), and a row of pendant trifid motifs (*ibid.*, 11). The basal wreath consists of spirals (*ibid.*, 33). The wreath, festoon and rosette are on a bowl from Corbridge and the wreath also occurs on a bowl from Camelon. c. AD 130–160 (Chalet 9, robbing and post-Roman dereliction, G13:03).
