# SEGEDUNUM

Excavations by Charles Daniels in the Roman Fort  
at Wallsend (1975–1984)

VOLUME 1: The Structural Remains

Alan Rushworth and Alexandra Croom

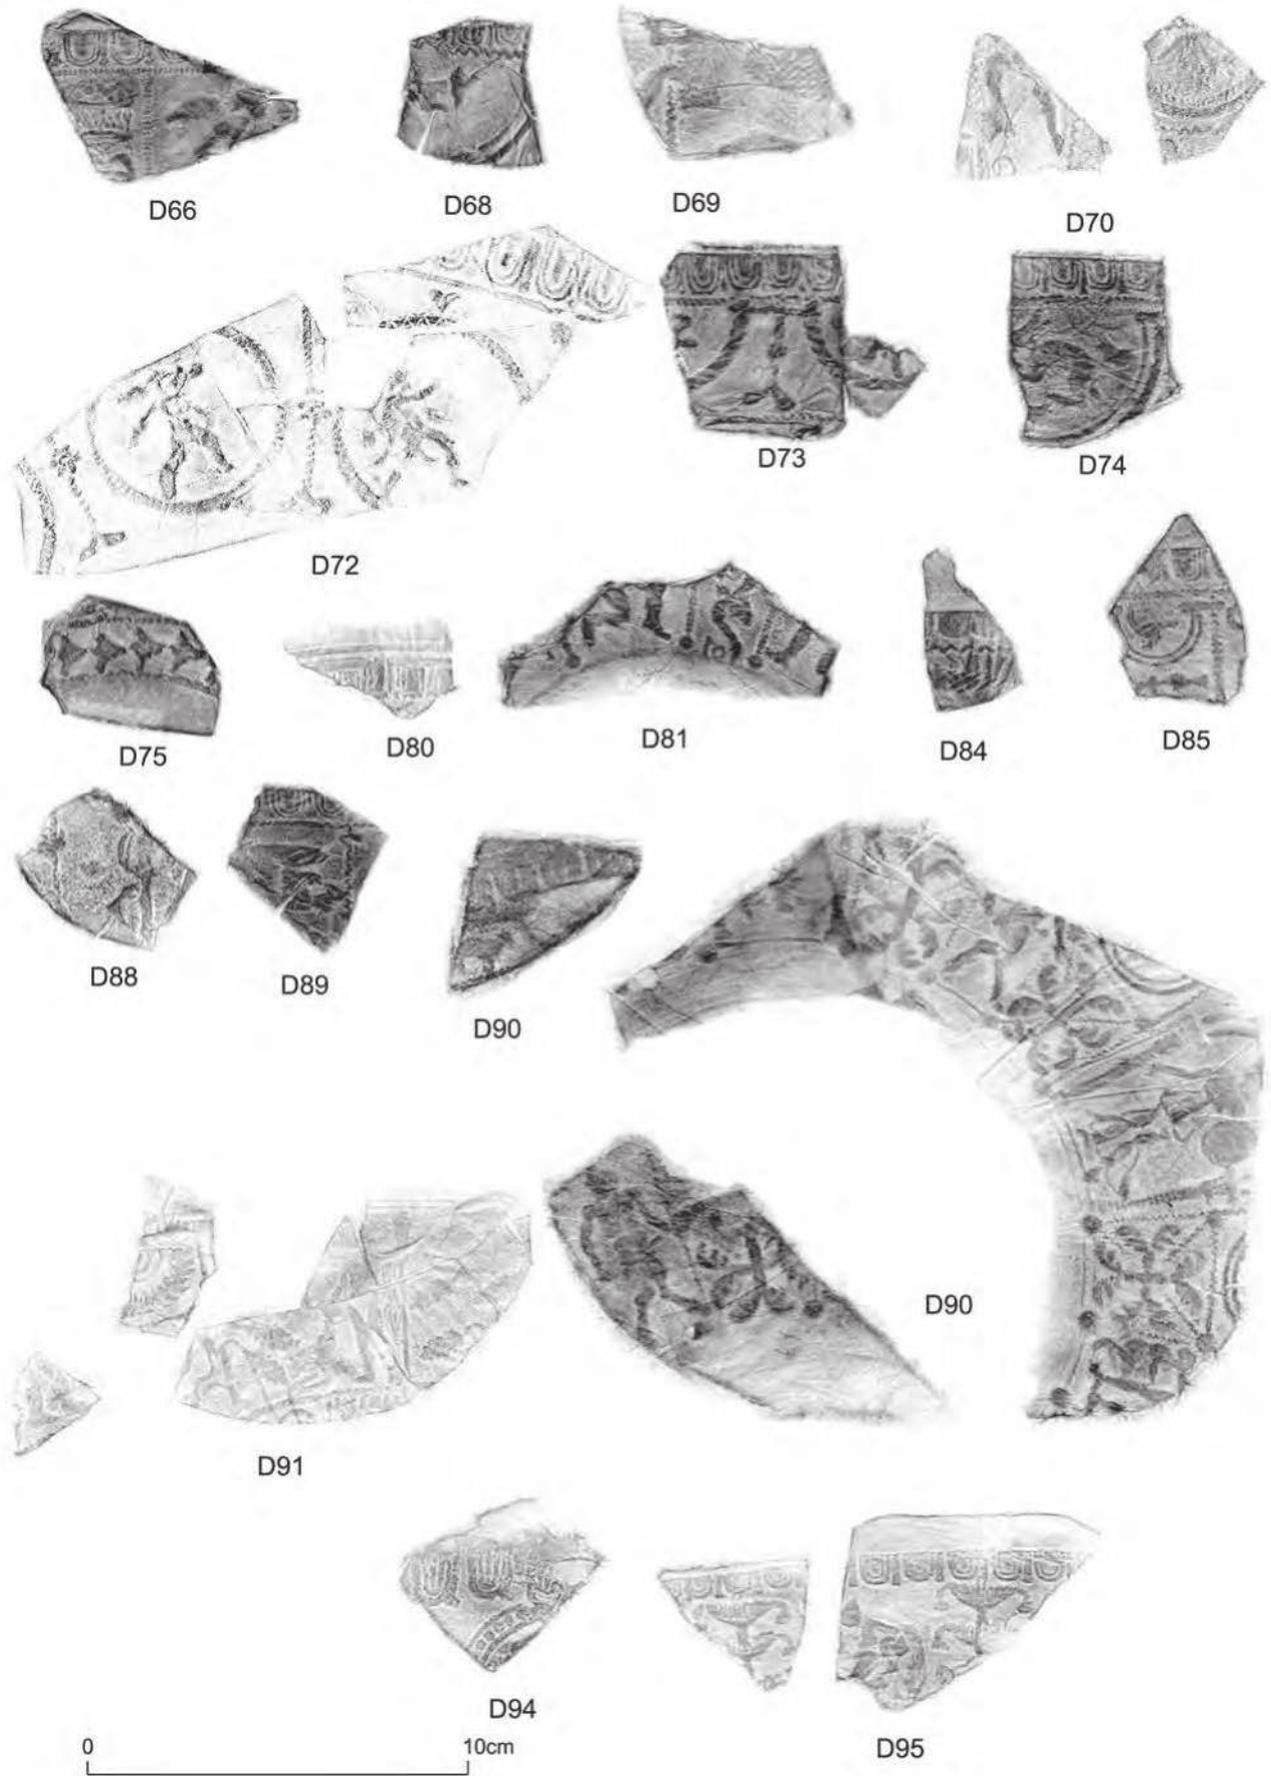
Figure 22.04: Decorated samian nos D66–D95. Scale 1:2.

- D79. Form 37, Central Gaulish, with a saltire panel with diagonals of large, square beads, cut through by a basal groove. Perhaps by Marcus v. Cf. D103.

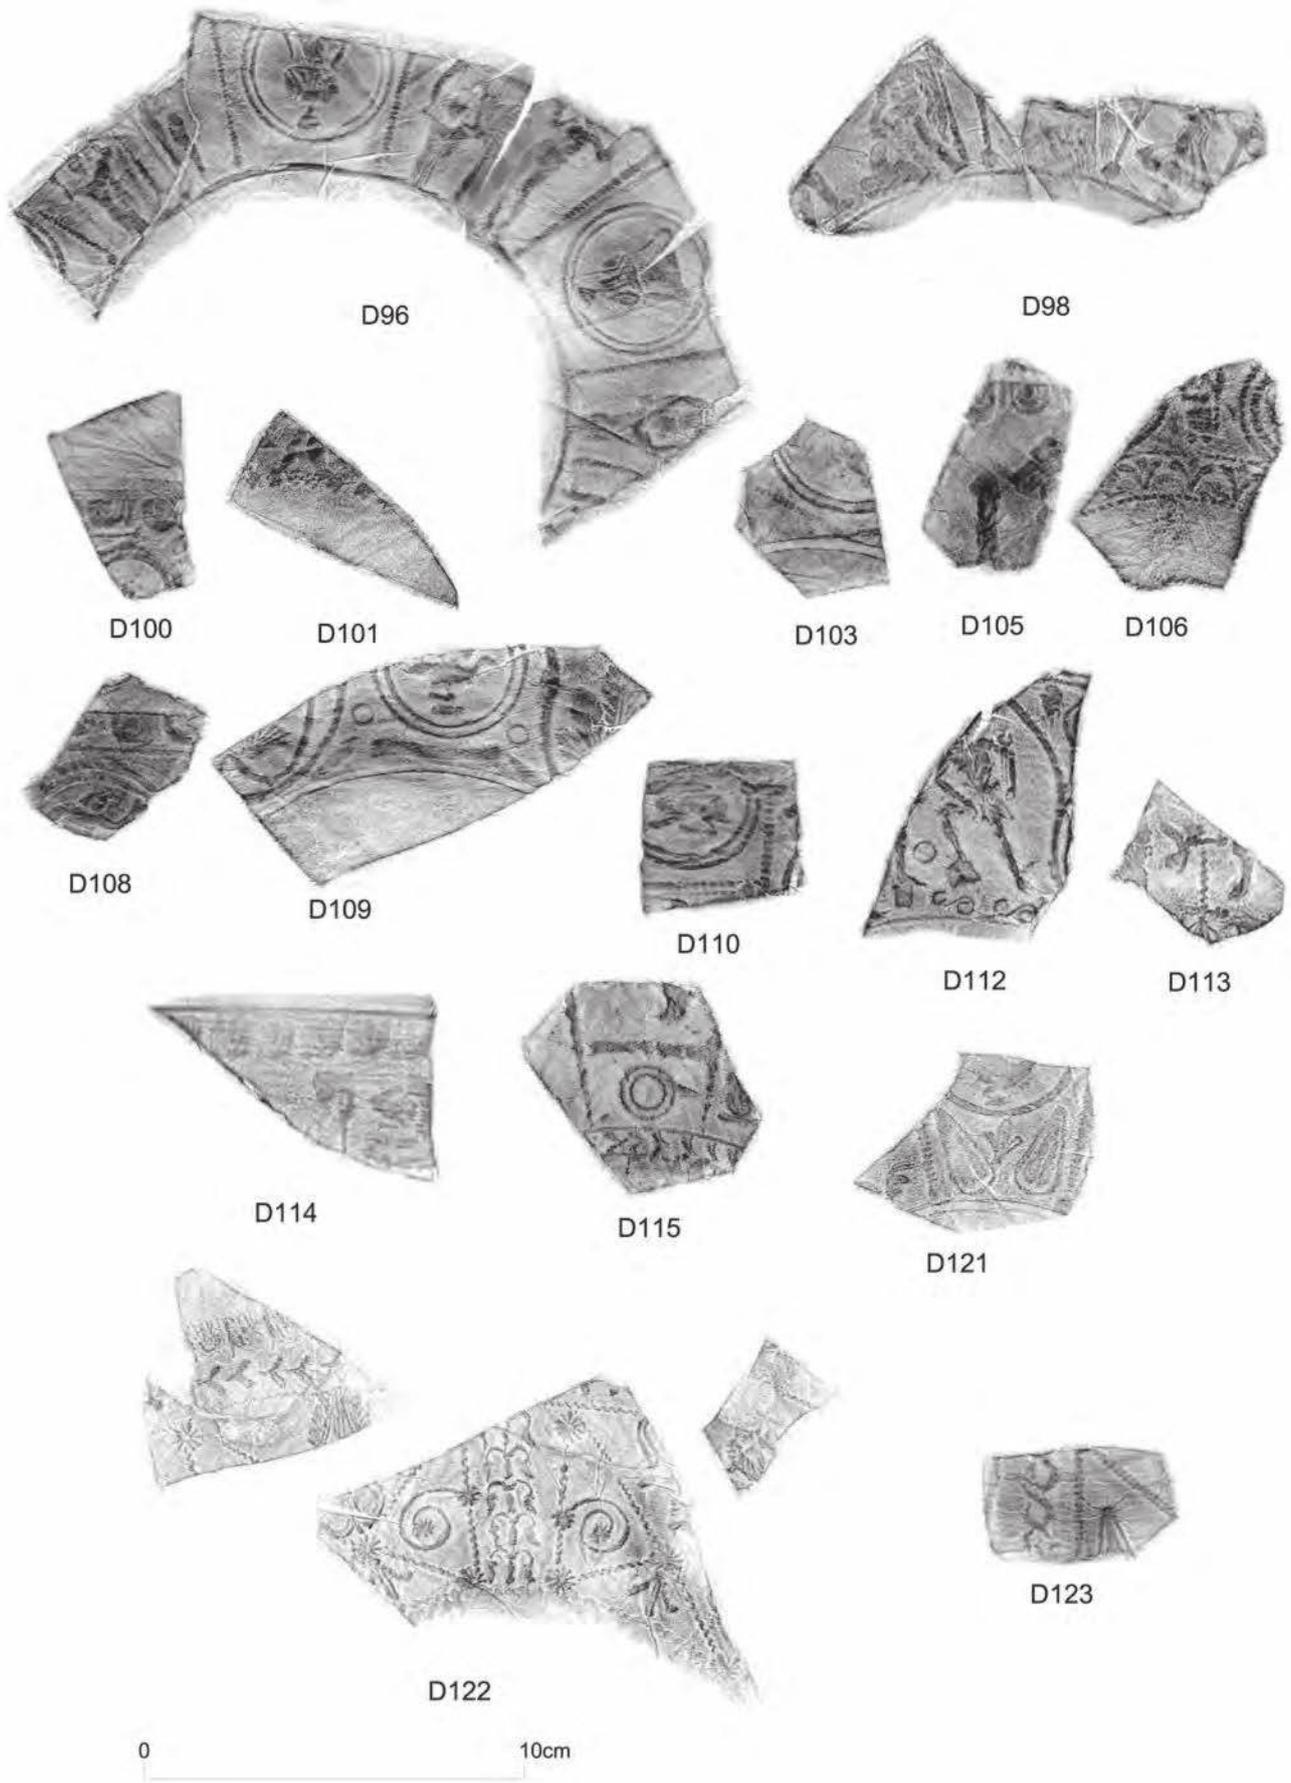
Figure 22.05: Decorated samian nos D96–D123. Scale 1:2.

- D109. Form 37, Central Gaulish. The upper concavity of the scroll contains a leaf (Rogers H35?); the lower concavity has double medallion containing a bird (D.1010 = O.2316) hovering over an astragalus (Rogers R60), a horizontal column (Rogers P3), striated spindles and small rings. A bowl in the style of Paternus v (Rogers's Paternus II), with his characteristic spindles, but with a leaf apparently not attested for him, unless it is Rogers H29. A

- stamped Paternus bowl from Wels, with a rim-stamp of Sextus v, has a similar, if not identical, scroll (Karnitsch 1955, Taf. 4, 8). *c.* AD 160–195 (Building 11, *contubernium* 3/4, L15:18).

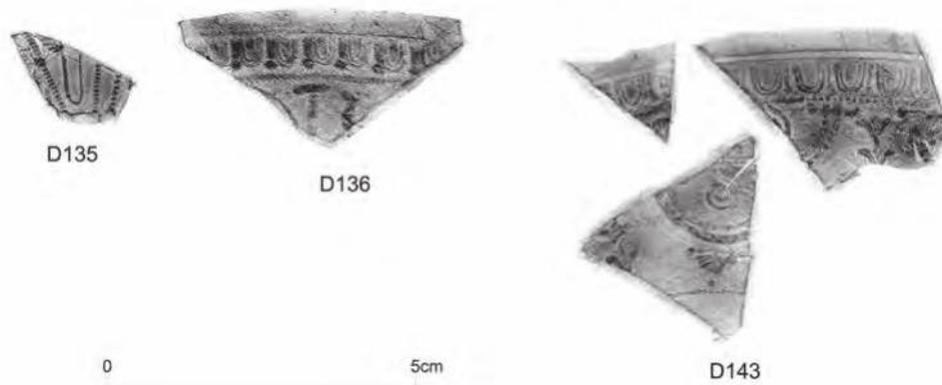
Figure 22.07: Decorated samian nos D135–D143. Scale 1:2.

- D134. Form 37, South Gaulish, with sherds in Q04:01 (joining) and N05:04 (Building 1, demolition). The trident-tongued ovolo was used at La Graufesenque by Albanus iii, G. At- Pas--, Bassinus i, Litugenus i and a potter whose name begins in Mas--. The panels include: 1A) a hare to right (D.941 = O.2056); 1B) probably = 3B). 2) An erotic group (Oswald, pl. XC, A, with the female figure using a pillar as a support) and a dagger-like motif, attached to the top of the border by a rosette. 3A) A hare to left (D.949 = O.2114); 3B) a fan-shaped plant (three impressions of a smaller version of the motif Hermet 1934, pl. 14, 49) over a wavy line. 4B) = 3B. 5) = 1). The erotic group and the hares are on a

bowl from the Bregenz Cellar hoard (Jacobs 1912, no. 11) and the hares recur on a stamped bowl of Biragillus i from Riegel (Knorr 1907, Taf. XV, 5). c. AD 90–110 (Rampart building (F2), unsealed rampart material, Q04:05).

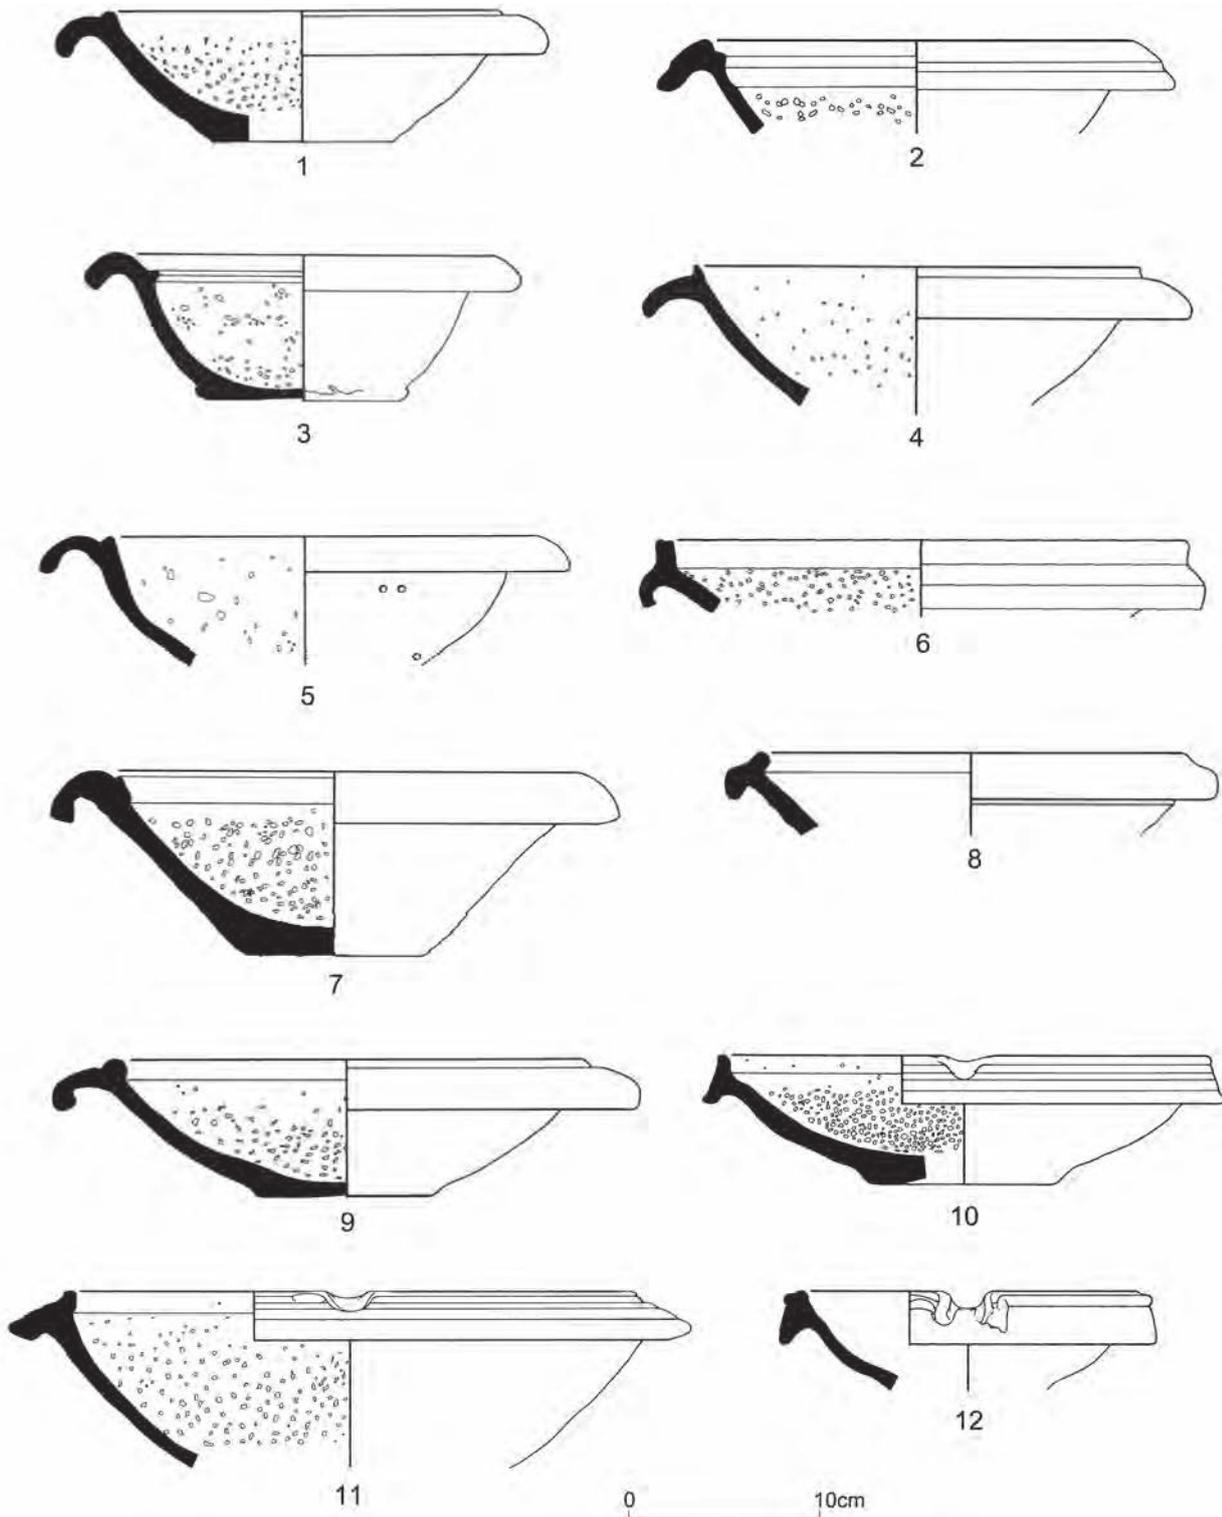
Figure 22.08: Mortaria nos 1-12. Scale 1:4.

Postholes associated with AP (E09:40, F09:66) contained some BB2 of the late second or third century, but there was also a mortarium rim, possibly from Norfolk, dated 240–300 in context F09:66 (Fig. 22.08, no. 12).

1. Road 8, E09:41, 2368, WSP239 (12K).  
Wt:0.020kg. Orange-brown fabric throughout except for 2mm of pale grey near underside of flange; ?cream slip. The fairly frequent, tiny to smallish, ill-sorted inclusions are mostly quartz with rare red-brown and black.

See also mortarium Fig. 22.08, no. 4.

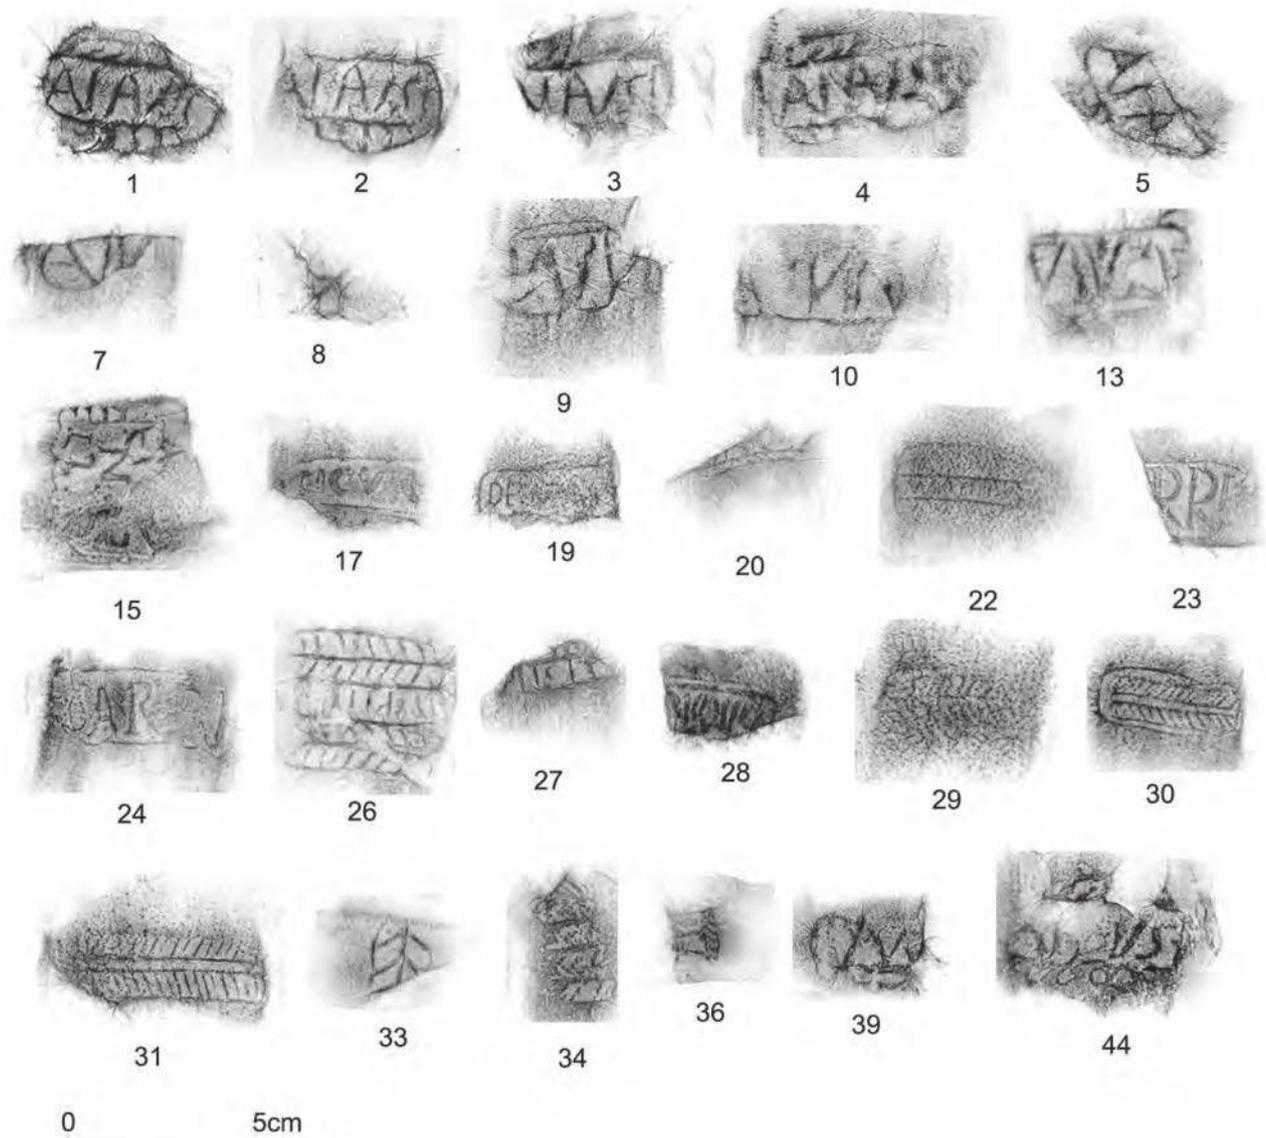
Figure 22.09: Mortarium stamps nos 1–44. Scale 1:2.

A left-facing stamp from die 1A of Anaus survives (Birley and Gillam 1948, fig. 1).

The broken stamp is from die 1A of Anaus (Birley and Gillam 1948, fig. 1).

The broken and poorly impressed stamp is from die 1A of Anaus (Birley and Gillam 1948, fig. 1). AD120–160

The broken stamp is from die 1B of Anaus (Birley and Gillam 1948, fig. 1). AD120–160. Anaus had a range of fabrics and this is the easiest one to recognize.

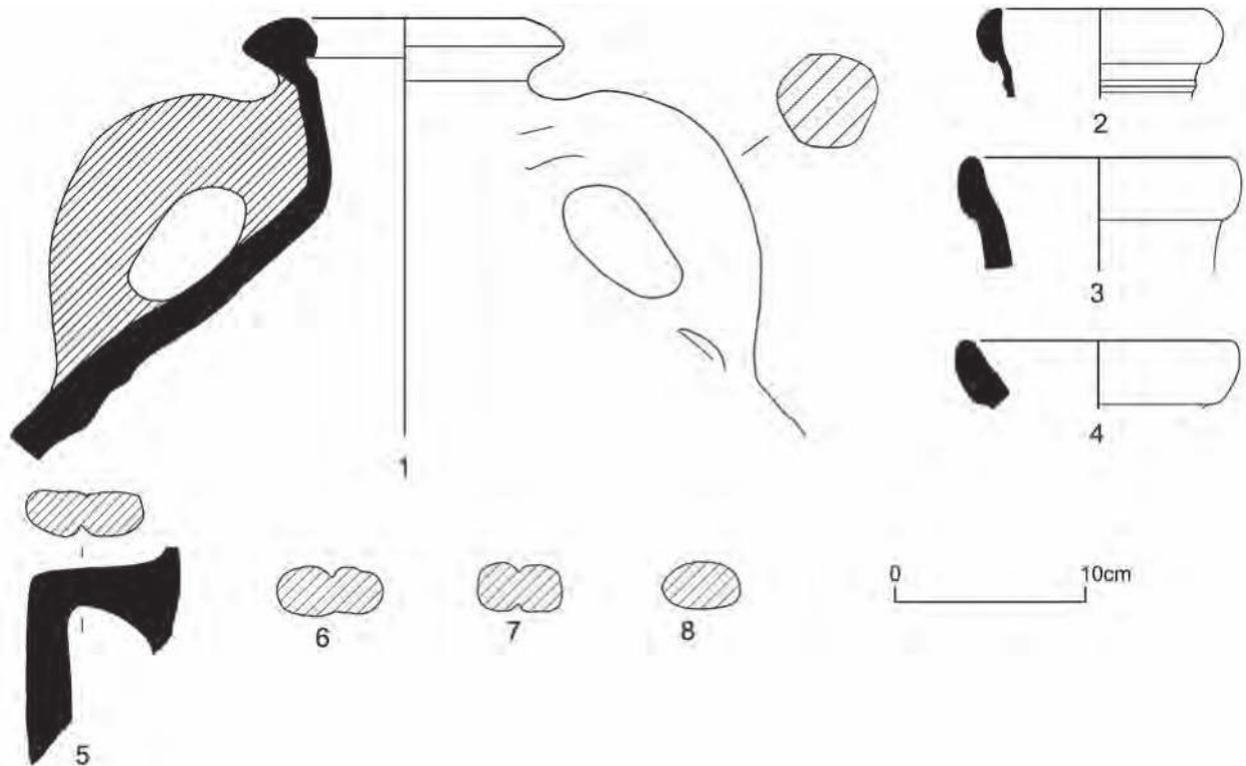
Figure 22.10: Amphorae nos 1–8. Scale 1:4.

See also amphora Fig. 22.10, no. 5.

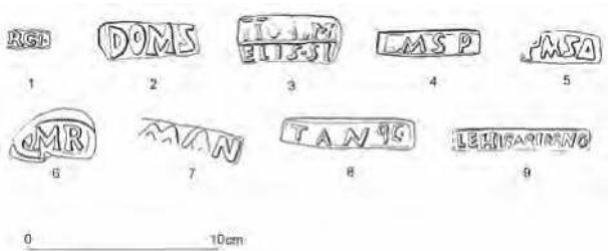
Figure 22.11: Amphora stamps nos 1–9. Scale 1:4.

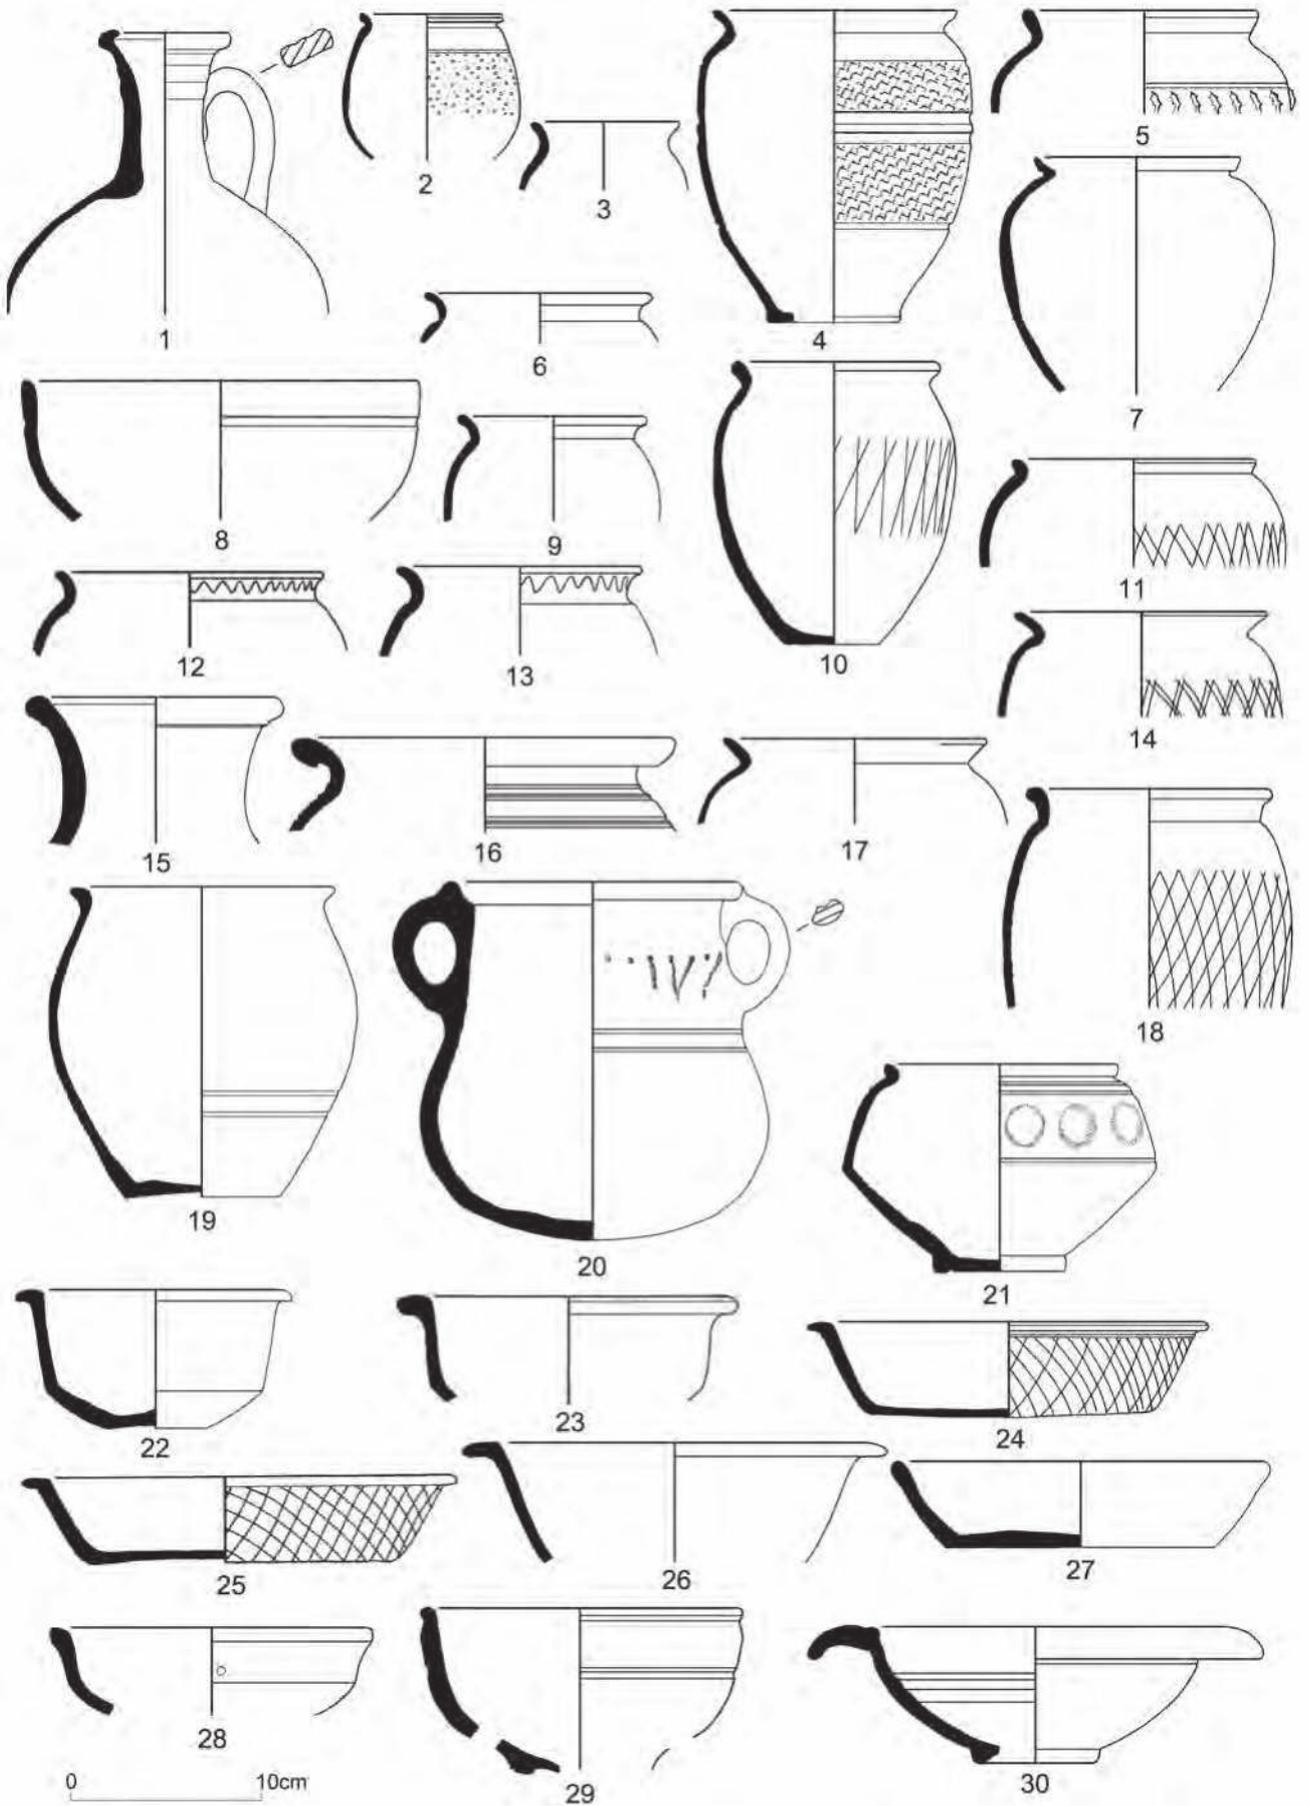
Figure 22.12: Coarse wares nos 1–30. Scale 1:4.

of the alley (N05:23, N05:24). This contained a number of substantially complete locally-produced second-century vessels that had not been much disturbed after deposition. There were four oxidised vessels, consisting of a handled cauldron (Fig. 22.12, no. 20), a biconical bowl (no. 21), a flat-rimmed carinated bowl imitating BB1 (no. 22) and a plain-rimmed bowl (no. 27), and most of an Anaus mortarium (Fig. 22.13, no. 33; mortarium stamp no. 4; with four sherds from the lower fill). Another substantial part of a worn Anaus mortarium came from the upper fill, with a single joining sherd from the daub deposit (Fig. 22.13, no. 42; mortarium stamp no. 9). There was also a grey ware cooking-pot (Fig. 22.12, no. 19) in the daub deposit, a sherd of which also came from the lower fill. The lower fill produced a second nearly complete grey ware cooking-pot (Fig. 22.12, no. 10), with joining sherds from the upper fill. There was one further vessel in the upper layers which was presumably part of the same group, a grey ware flat-rimmed bowl (Fig. 22.13, no. 39).

The lower fill produced the smallest amount of pottery, approximately 90% of which was made up of cooking-pots (Fig. 22.12, nos 9–14). The pottery from the dump and the upper layers were similar to each other, and had a more varied profile, with a much larger proportion of bowls and dishes and more flagons. The quantity of amphorae in the assemblage was small, at only 7% by weight, when it makes up 38% of the pottery from the site as a whole. The profile of vessel types (Table 22.13) is very similar to the average for material found inside the barracks, indicating that this was a dump for rubbish from the nearby buildings.

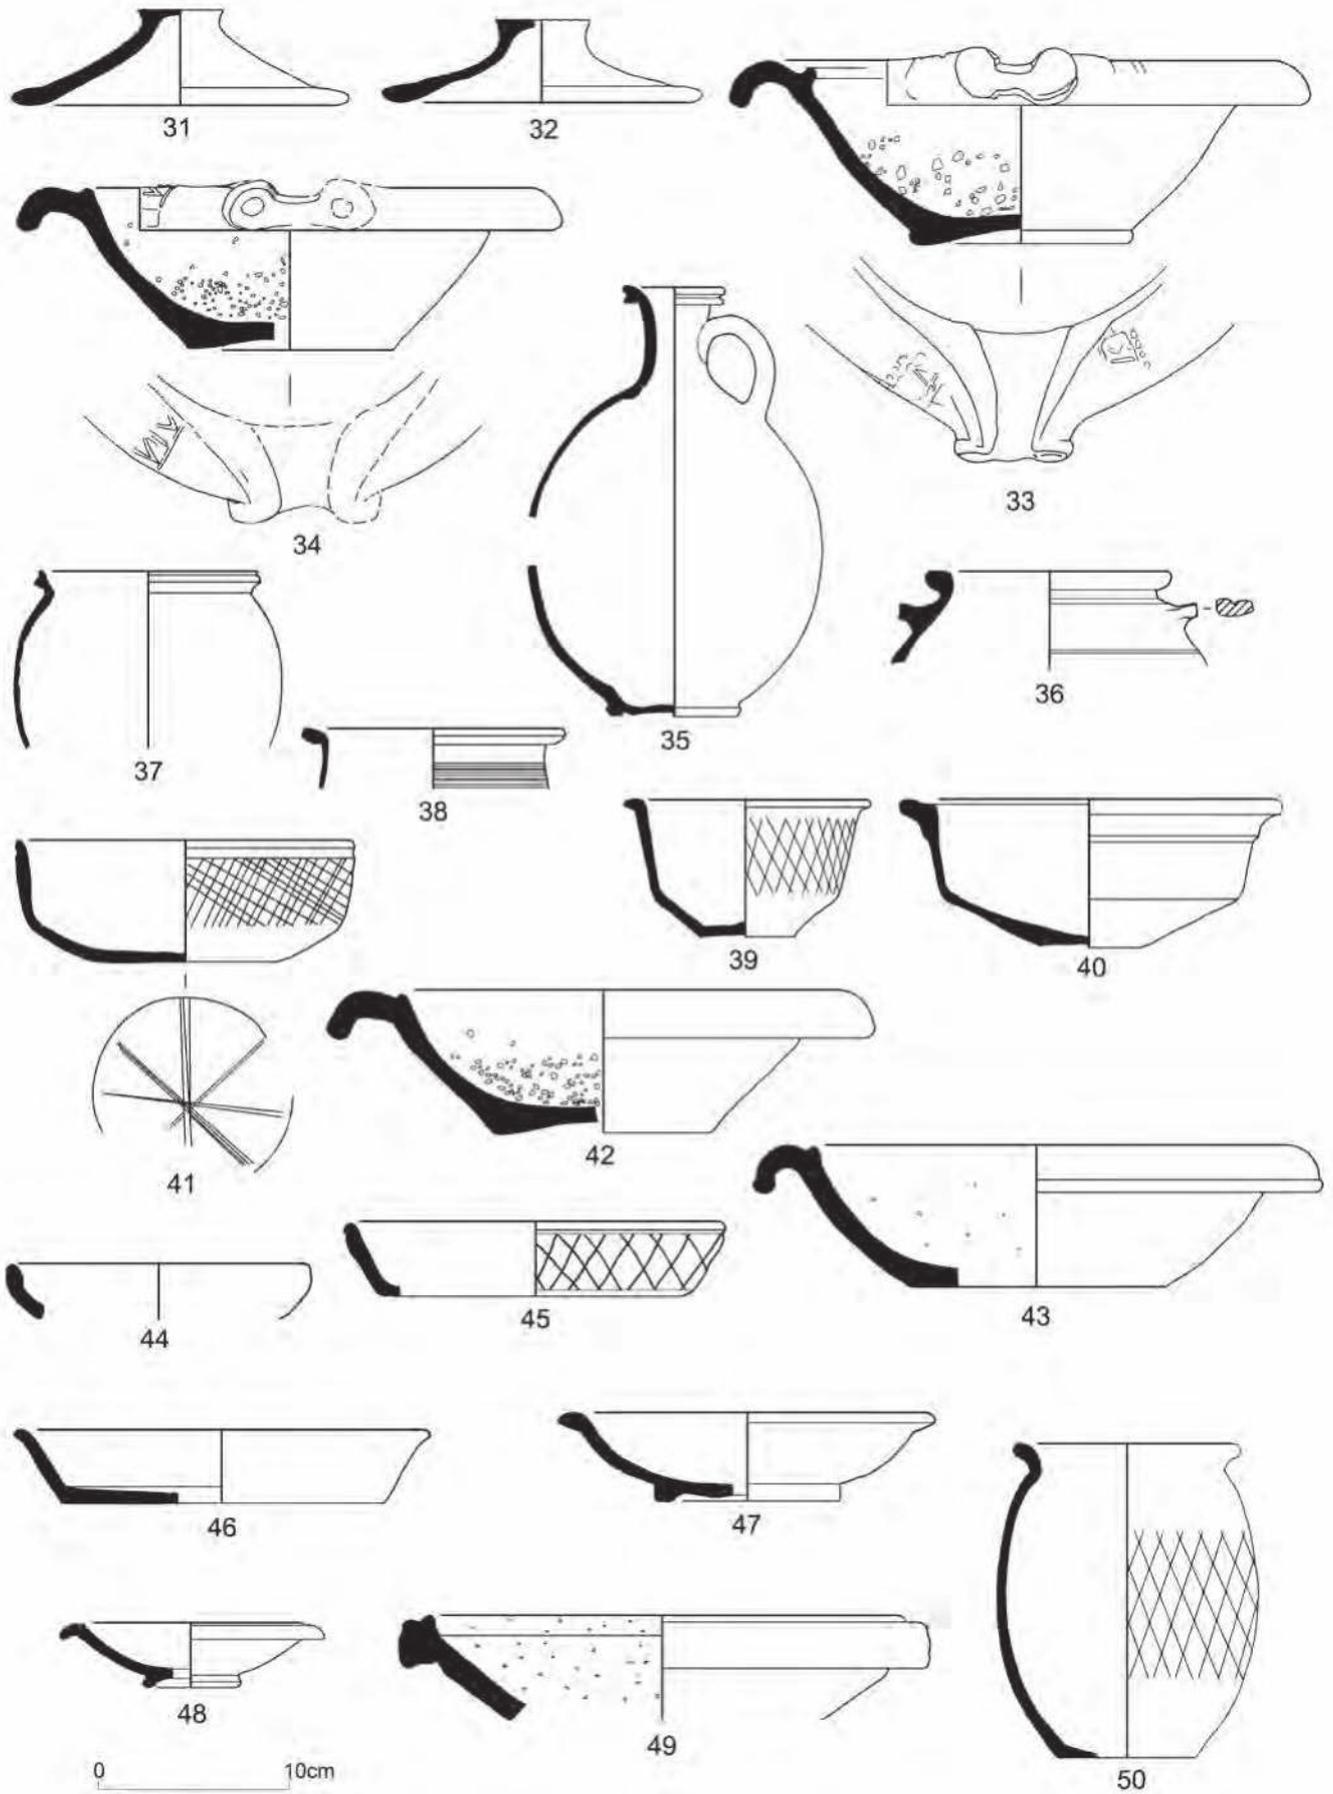
Figure 22.13: Coarse wares nos 31–50. Scale 1:4.

The fill of the alley produced 1.152kg of pottery, much of which consisted of large parts of two locally-produced second-century cooking-pots (Fig. 22.13, no. 50; Fig. 22.14, no. 51). The original drip trench produced very little pottery (0.388kg), which was made up of a mixed range of sherds from numerous vessels. Much of the material could have been mid second-century in date, but there were also a few sherds of BB2, which first appears in small quantities in the Antonine period. Most of the alley deposit came from the re-cut drip trench (F04:33) at the eastern end of the alley. This produced 6.786kg of pottery (excluding samian), much of which consisted of fairly complete vessels that had not been disturbed much after deposition. BB1 made up 41% of the coarse wares, and was the only coarse ware fabric used for the bowls, which consisted of three bead-rimmed bowls and at least four flat-rimmed bowls and dishes (Fig. 22.14, nos 56–8). The locally-produced ware made up 29% by weight, and were almost exclusively cooking-pots. The assemblage also included the lower

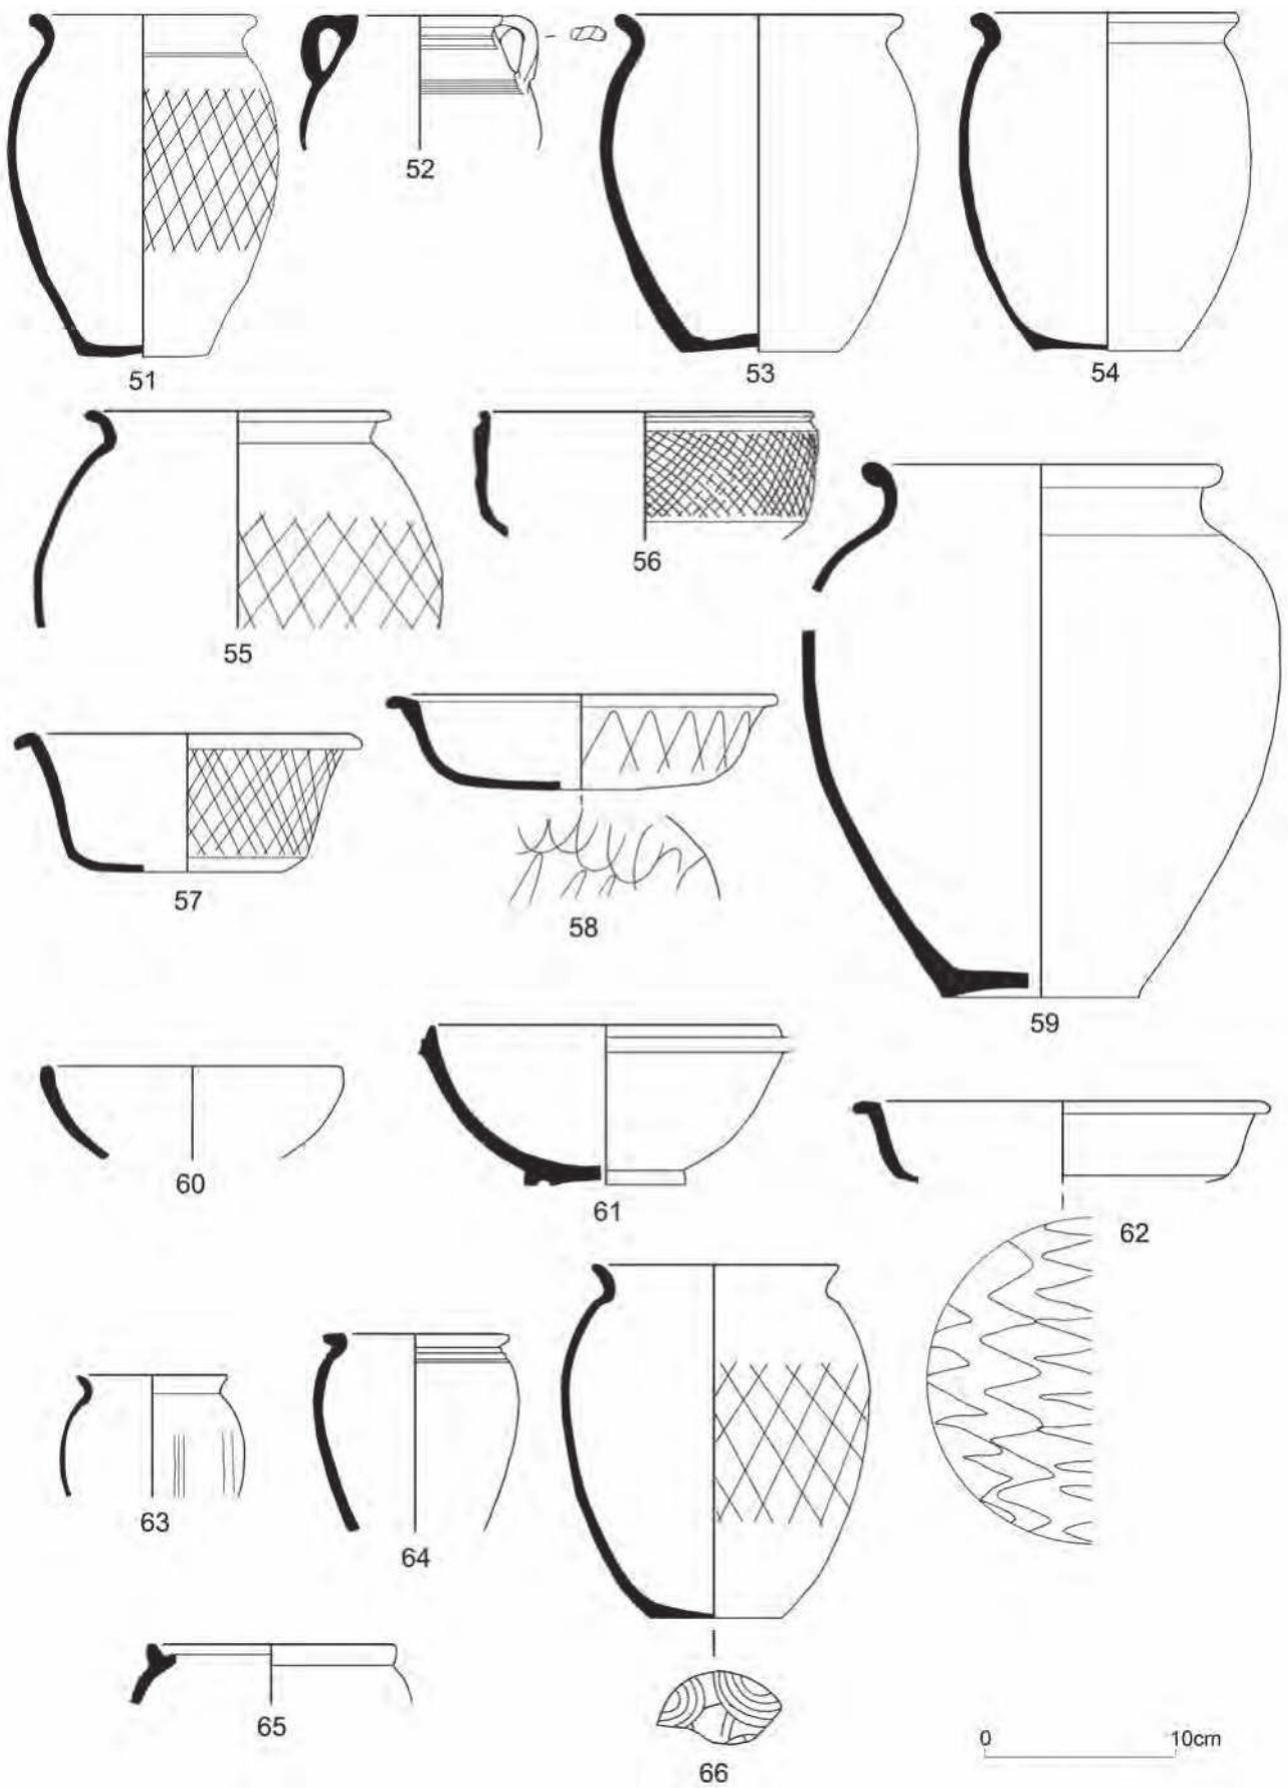
Figure 22.14: Coarse wares nos 51–66. Scale 1:4.

half of a flagon and two honey jars (Fig. 22.14, no. 52). There was one certain Antonine samian vessel, and a few sherds of BB2 (less than 1%).

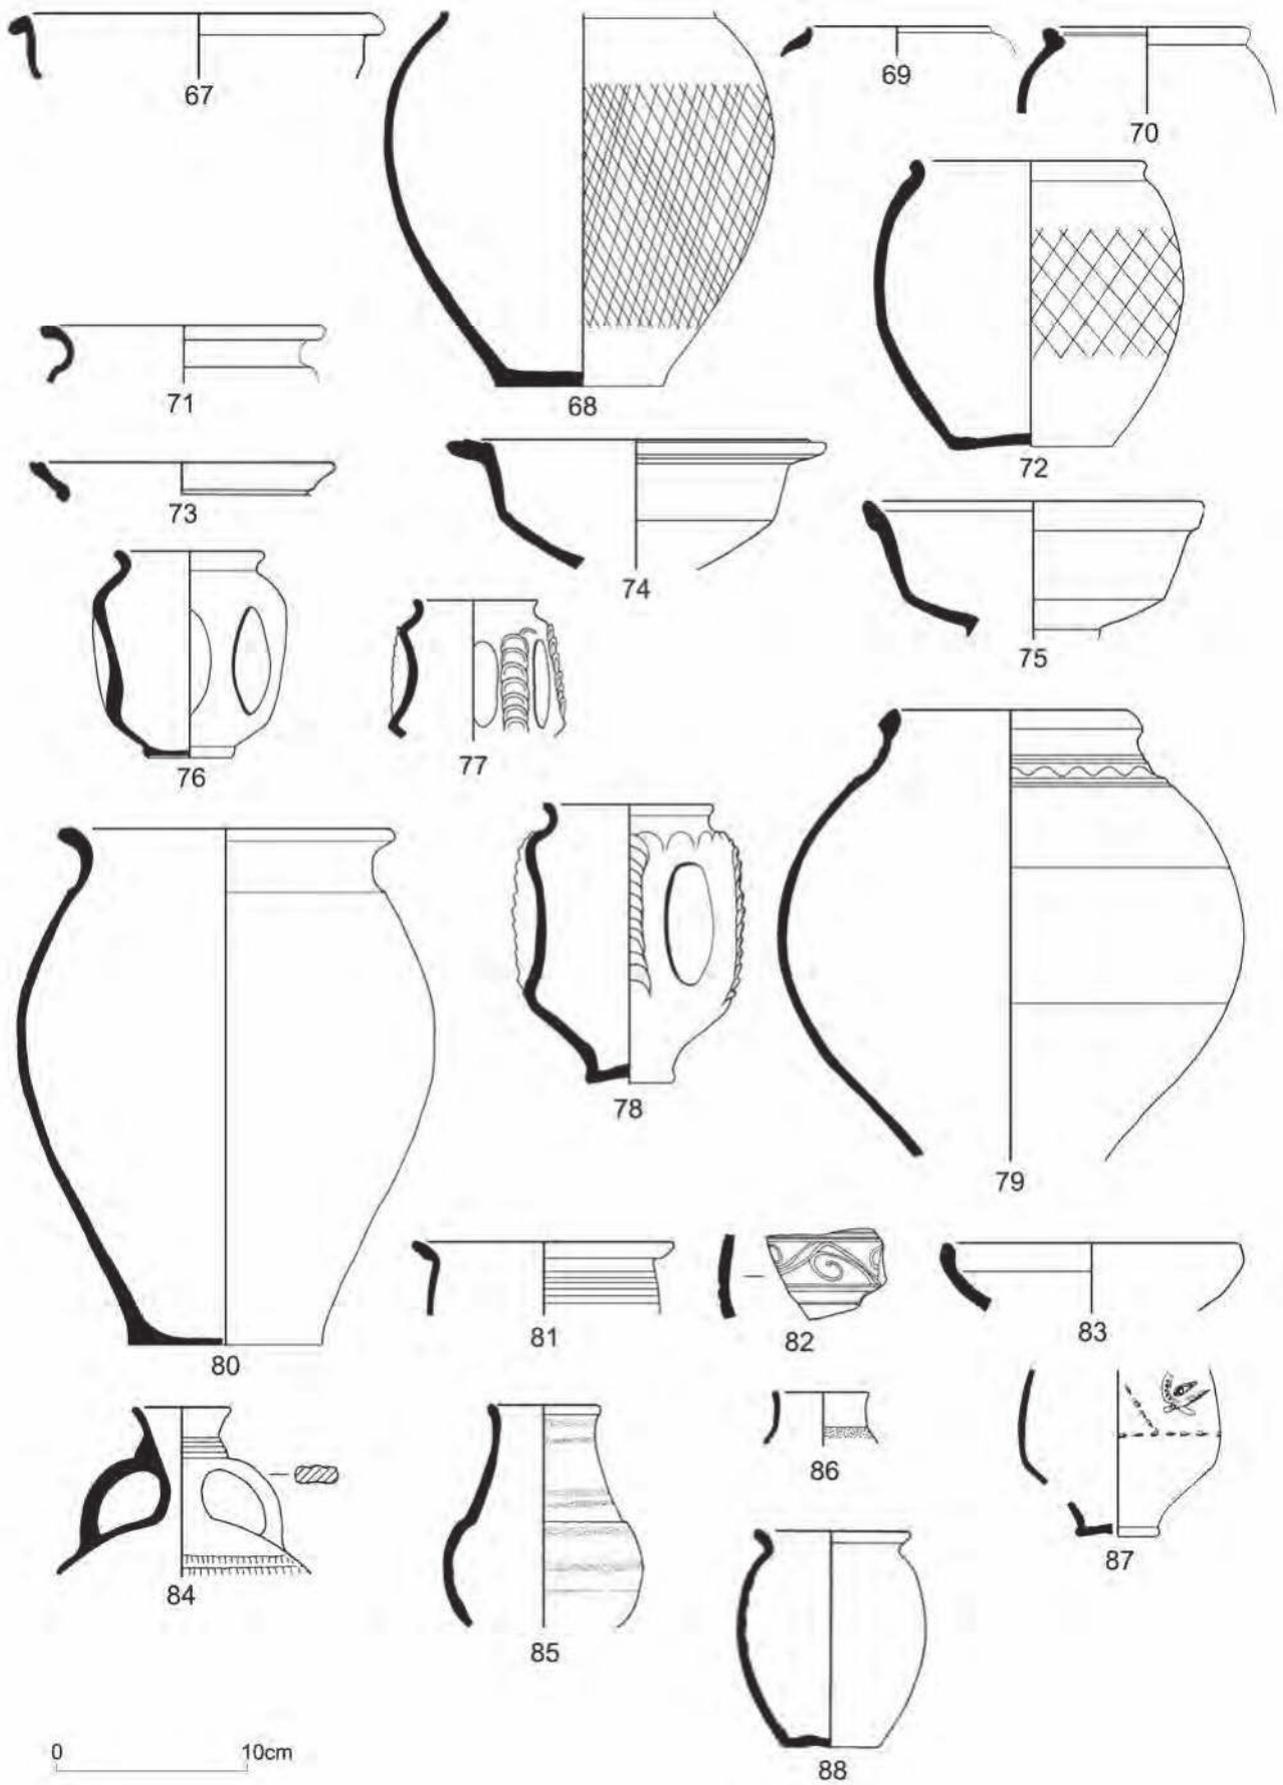
Figure 22.15: Coarse wares nos 67–88. Scale 1:4

Room 1, with a flagged floor and hearth, had a BB2 pot buried in the floor, with a stone lid flush with the floor surface (Fig. 22.15, no. 68; Fig. 25.33). This type of deliberately buried pot is comparatively common at South Shields Roman Fort, where they are found almost entirely in barracks, suggesting that this room may have been the permanent accommodation for staff in the hospital. The hospital must also have provided accommodation for patients during treatment and recuperation, staying only on a short-term basis, but it is not known how these patients were fed, whether their *contubernia* provided cooked food for them or simply handed over their portion of the rations. A study of the animal bones has shown that the assemblage is very similar to that within the barracks although slightly more restricted in the range of species present, suggesting few luxuries were brought in (Gidney 2003, 232). The small quantities of bone recovered indicates either that the hospital was kept very clean or the occupants had less access to meat on the bone (*ibid.*, 236).

The site records suggest five possible buried pots, but only two are certain. The most complete comes from room 1 of the hospital, set in place sometime in the first half of the third century. It is a BB2 pot with the rim deliberately removed, and was found with a stone lid *in situ* (Fig. 22.15, no. 68; Fig. 25.33). It was set into the floor over 1m from the north wall and 1m from the east wall (D11:23; see Figs 5.18 and 5.25). Originally this would have put it towards the back of the room, away from the entrance, but when the room was later remodelled this placed the pot near to the new doorway and the hearth set next to the door. It is unclear to which phase the pot belongs.
