# SEGEDUNUM

Excavations by Charles Daniels in the Roman Fort  
at Wallsend (1975–1984)

VOLUME 1: The Structural Remains

Alan Rushworth and Alexandra Croom

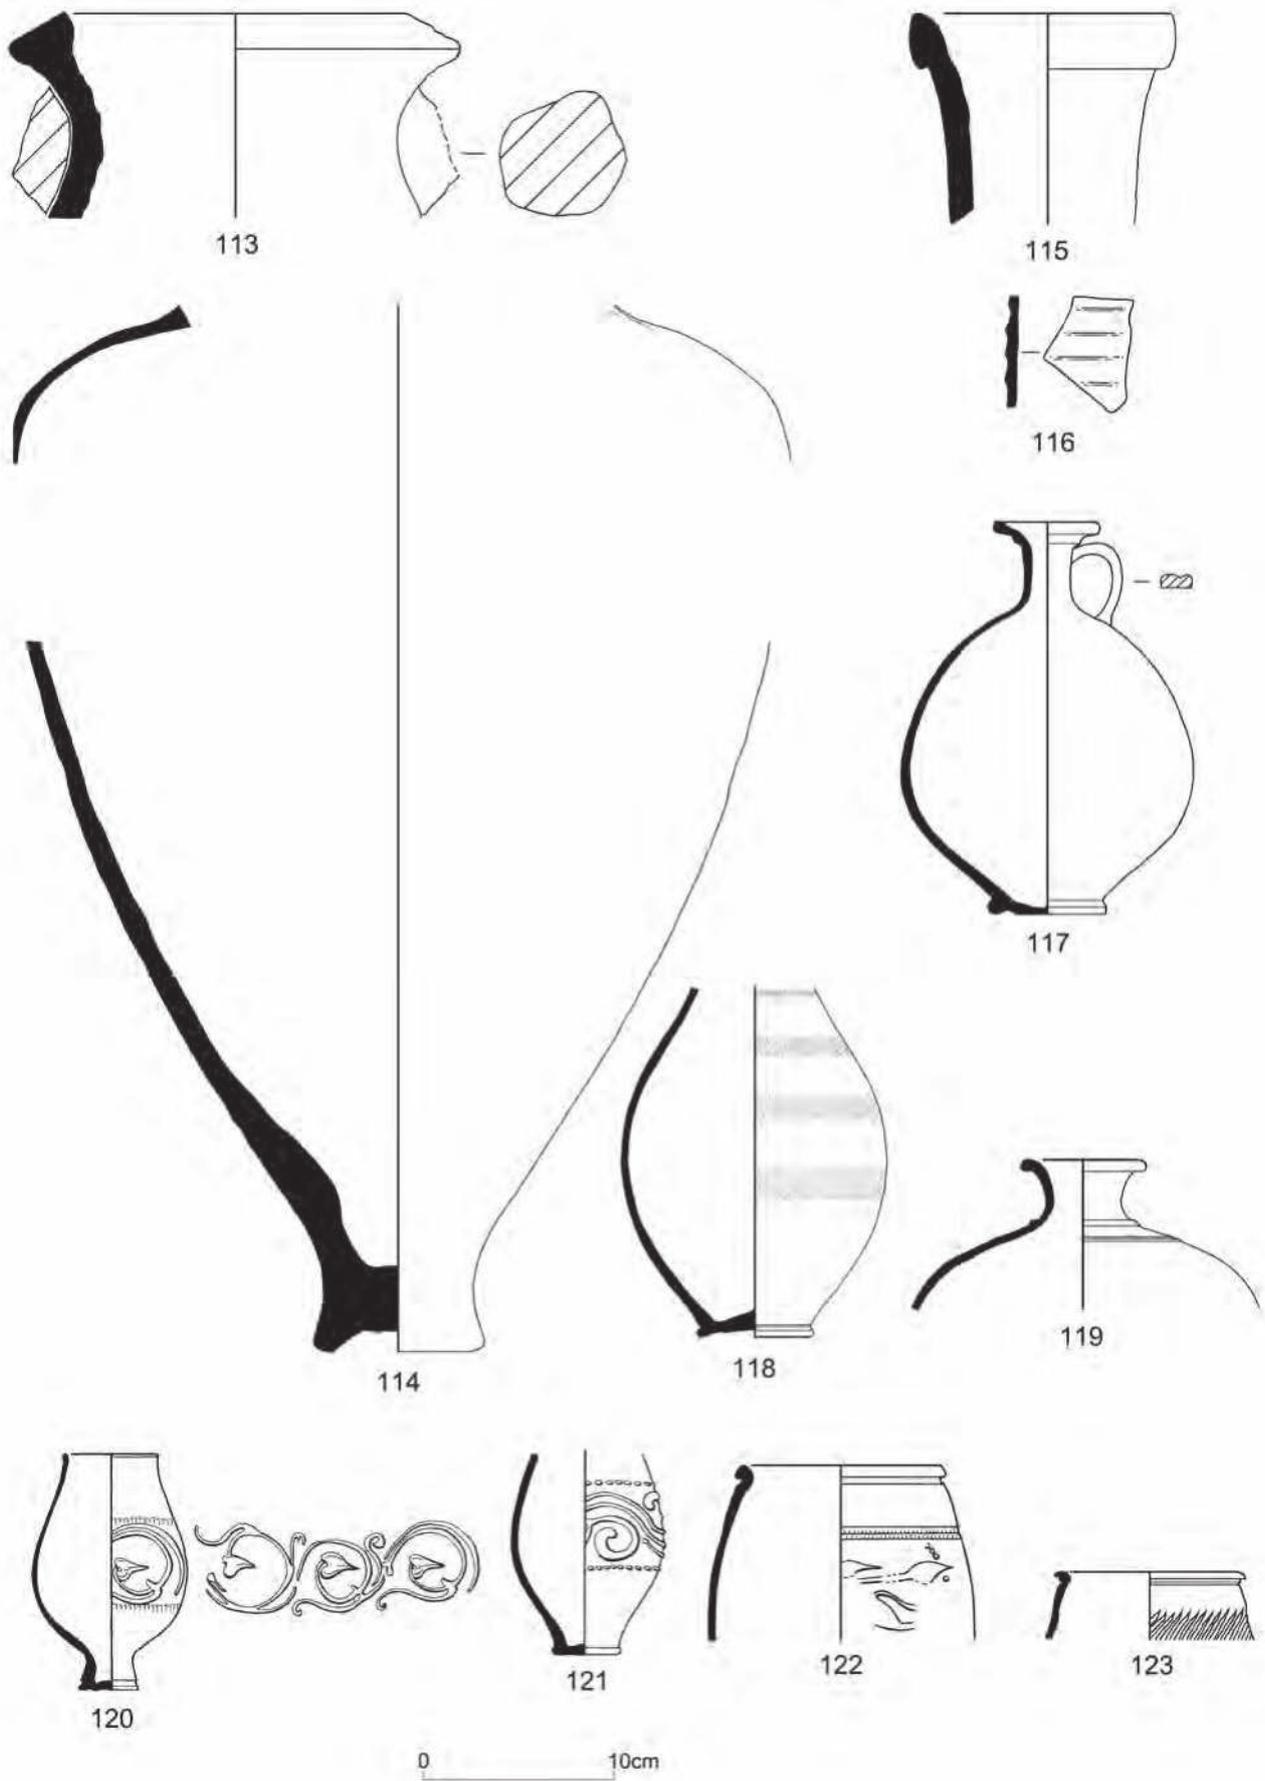
Figure 22.17: Coarse wares nos 113-123. Scale 1:4.

1. Building 1, verandah, Period 3, L04:20. See also Fig. 22.17, no. 113.

See also Fig. 22.17, no. 115

Gauloise 4: See Fig. 22.17, no. 114

Biv: see Fig. 22.17, no. 116

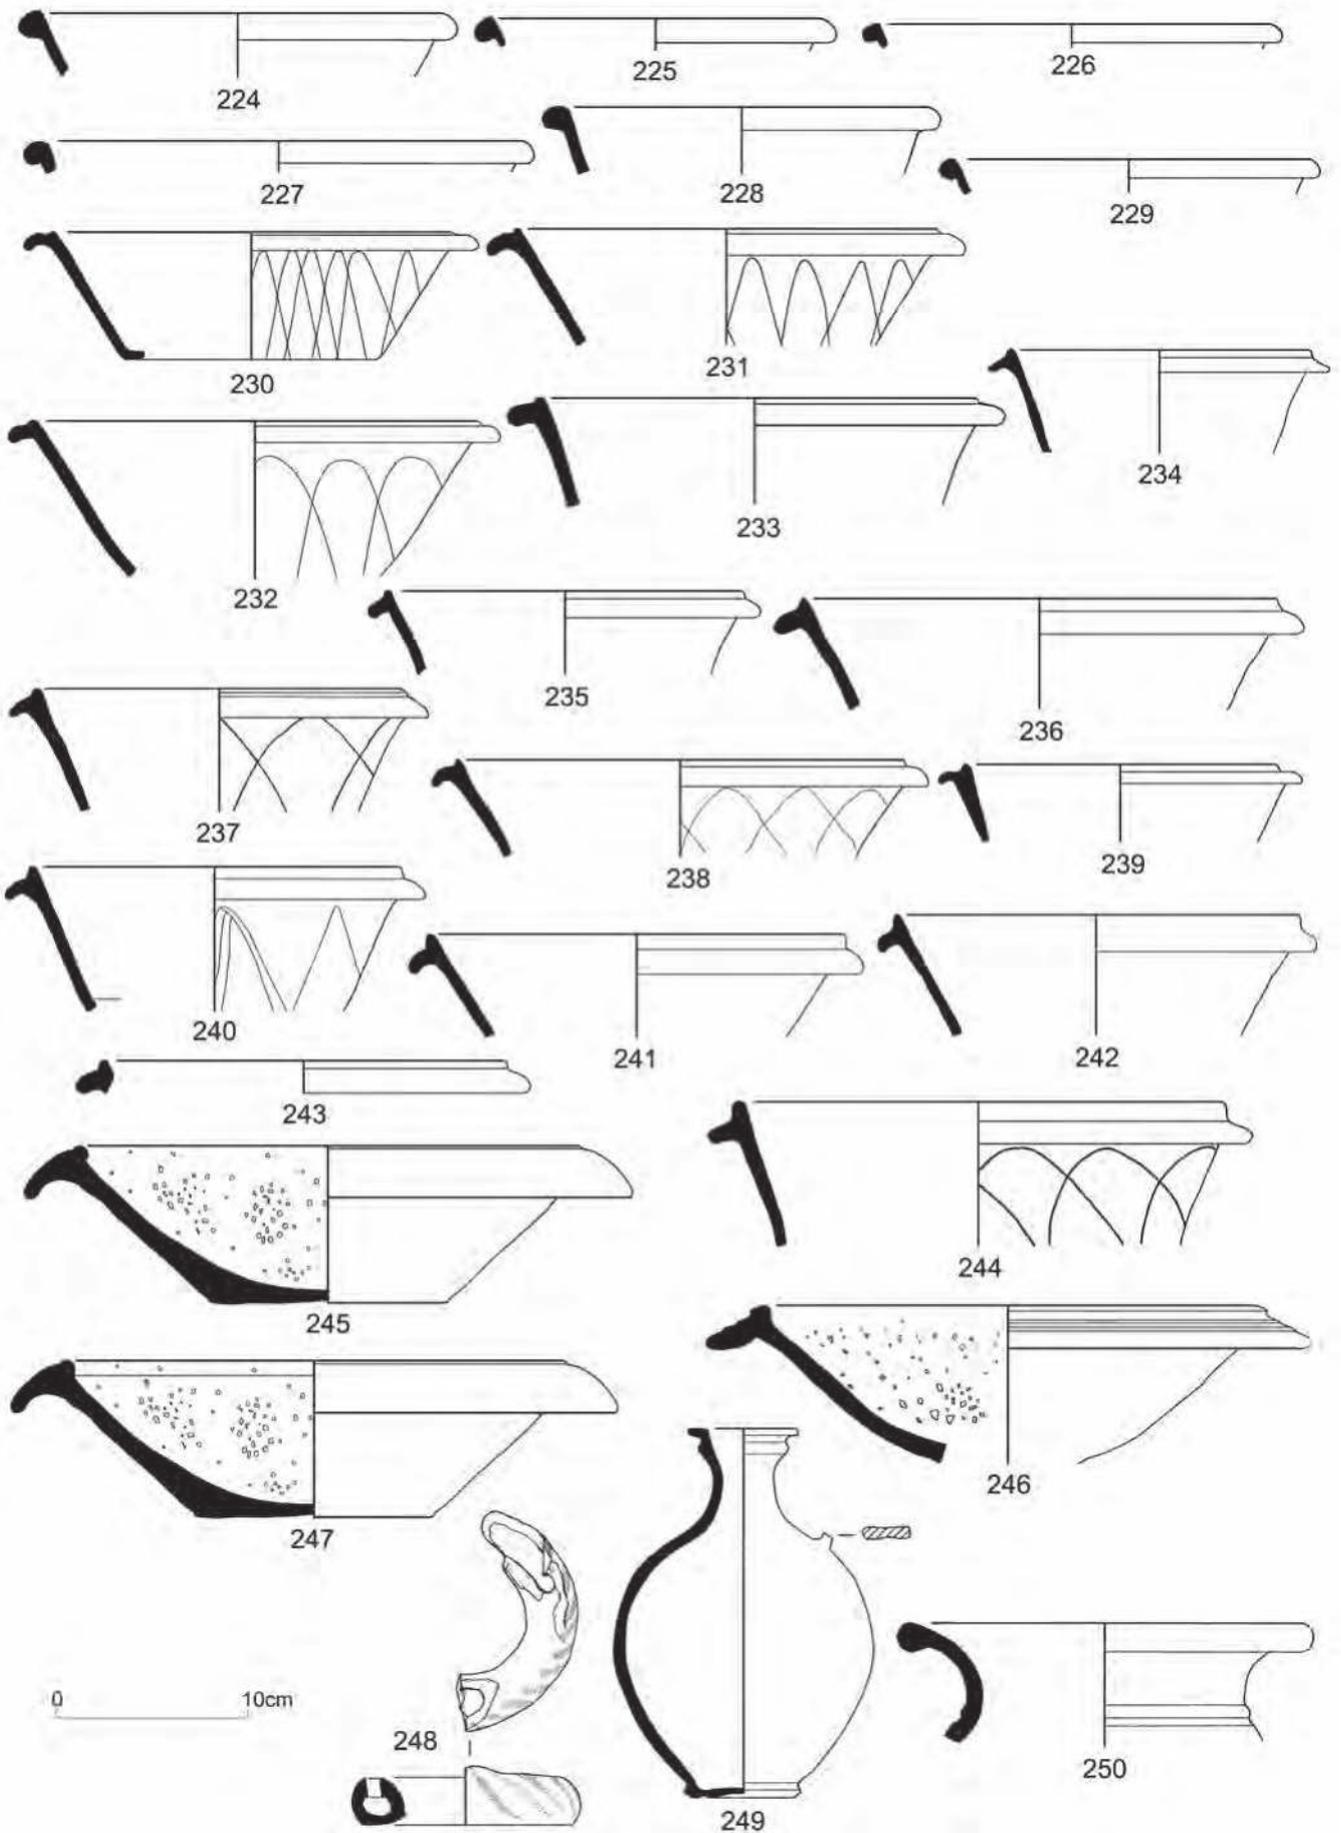
Figure 22.21: Coarse wares nos 224–250. Scale 1:4.

not subsequently disturbed (Fig. 22.22, nos 251–4, 256). This also includes a flagon which was probably in one piece when it was discarded, probably already missing its handle and much of the rim at that time (Fig. 22.21, no. 249). Many of the vessels show evidence of sooting, which is sometimes heavy.

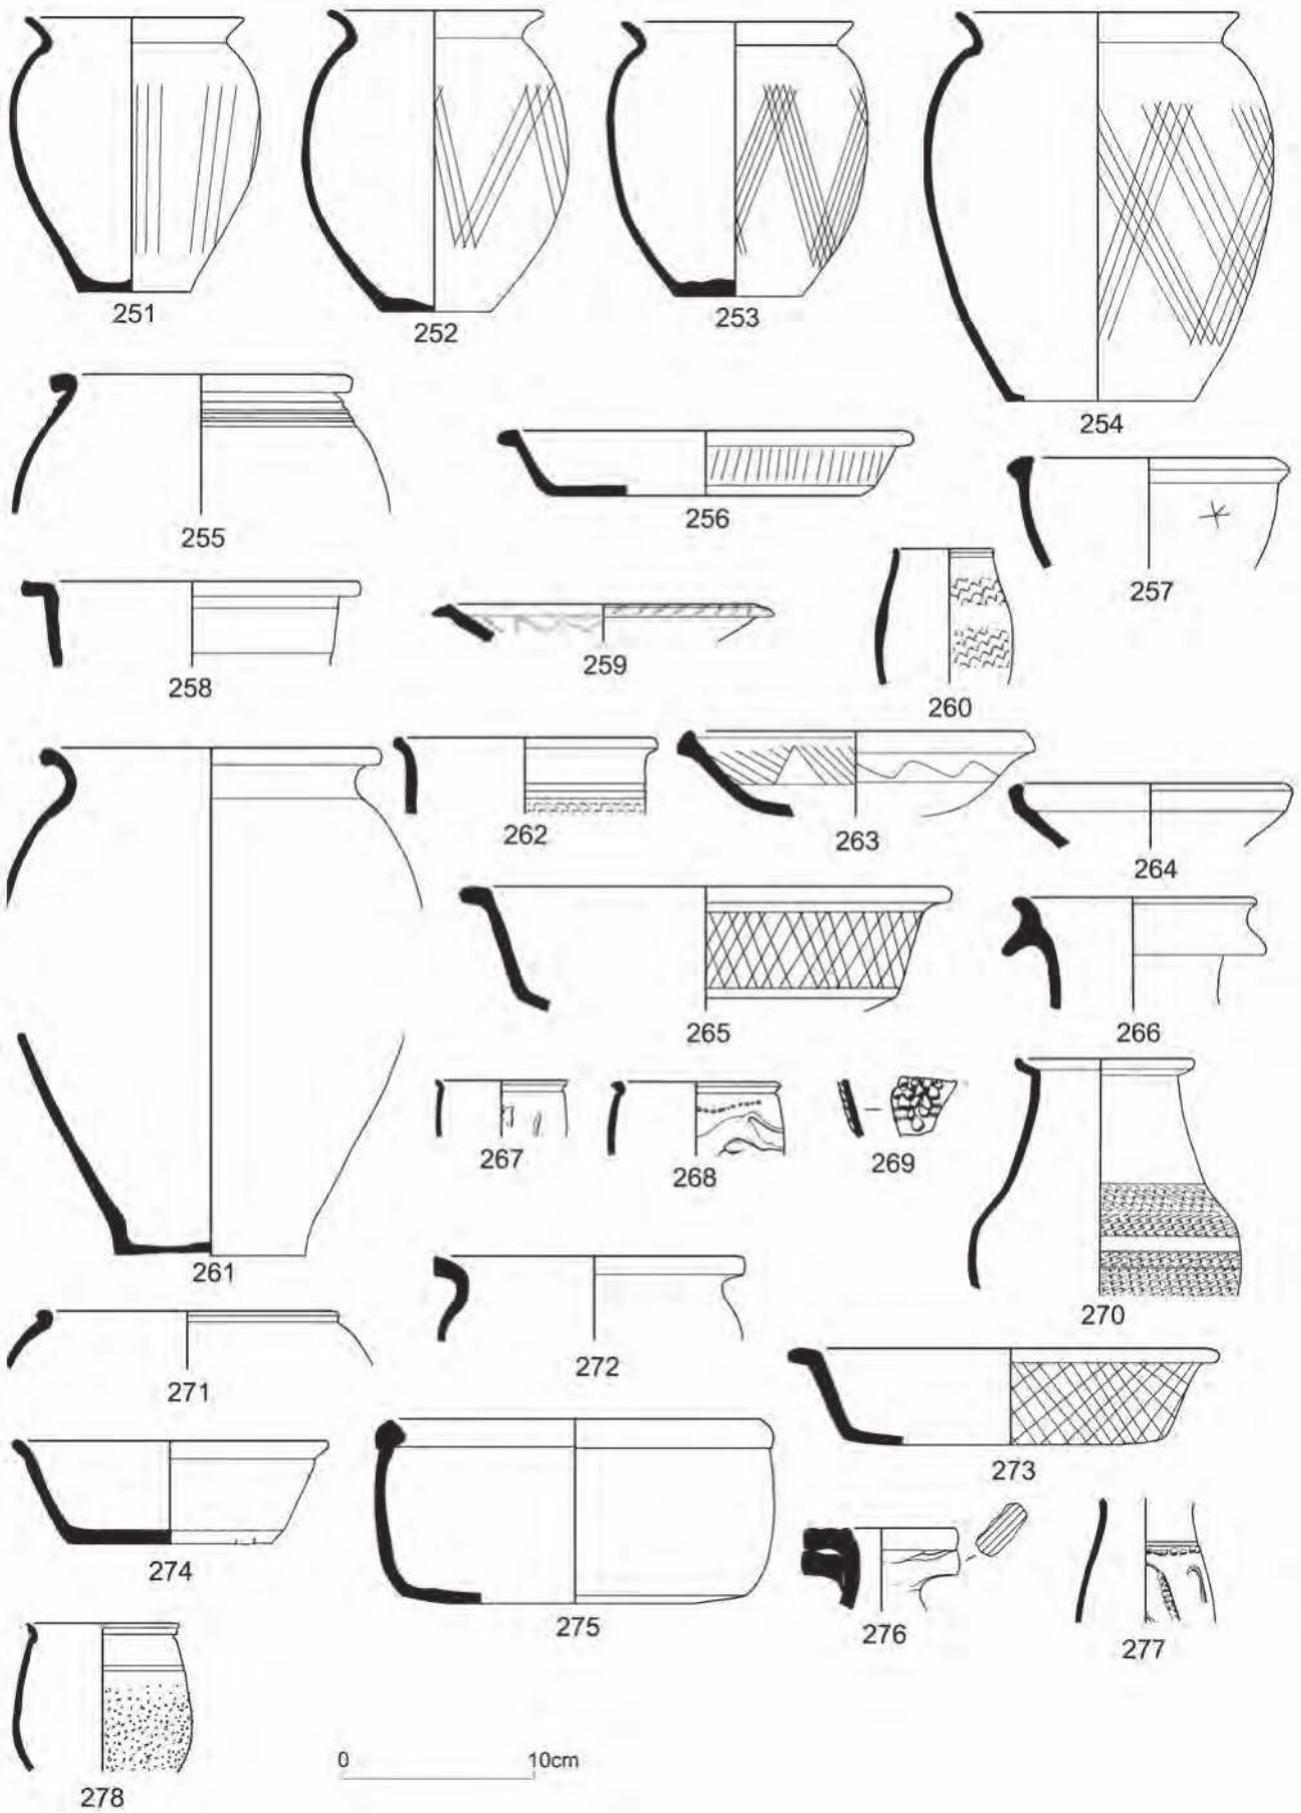
Figure 22.22: Coarse wares nos 251–278. Scale 1:4.

A number of vessels are likely to come from the South Yorkshire industries, but this was never a major source of supply. There is also a bowl with internal decoration in a South Yorkshire/Lincolnshire tradition (Fig. 22.22, no. 263). Dish: 263

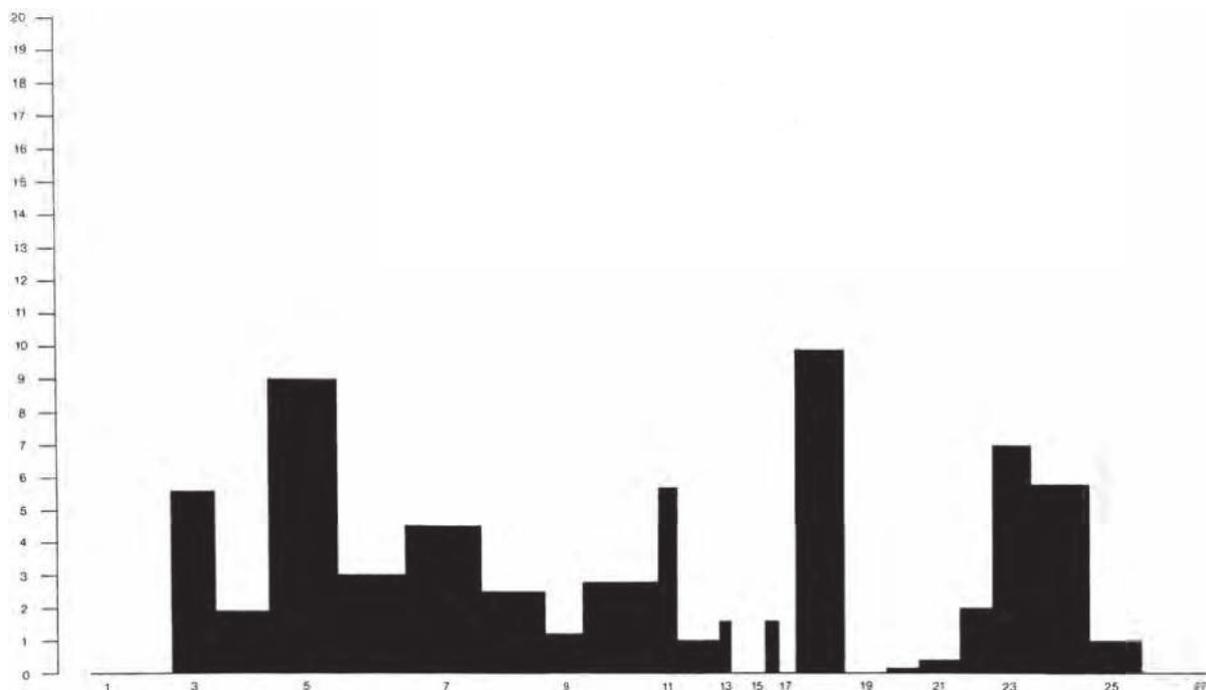
Figure 24.01 Histogram showing annual loss per 100 coins (N = 215).

In presenting the coins in a graphical form (Fig. 24.01) well-established procedures have been followed the methodology of which has been explained on a number of occasions (Casey 1986). However in the case of Wallsend the very lowest limit of the integrity of the method is reached. The total identifiable coins used in the computation, 215 items (excluding pre-

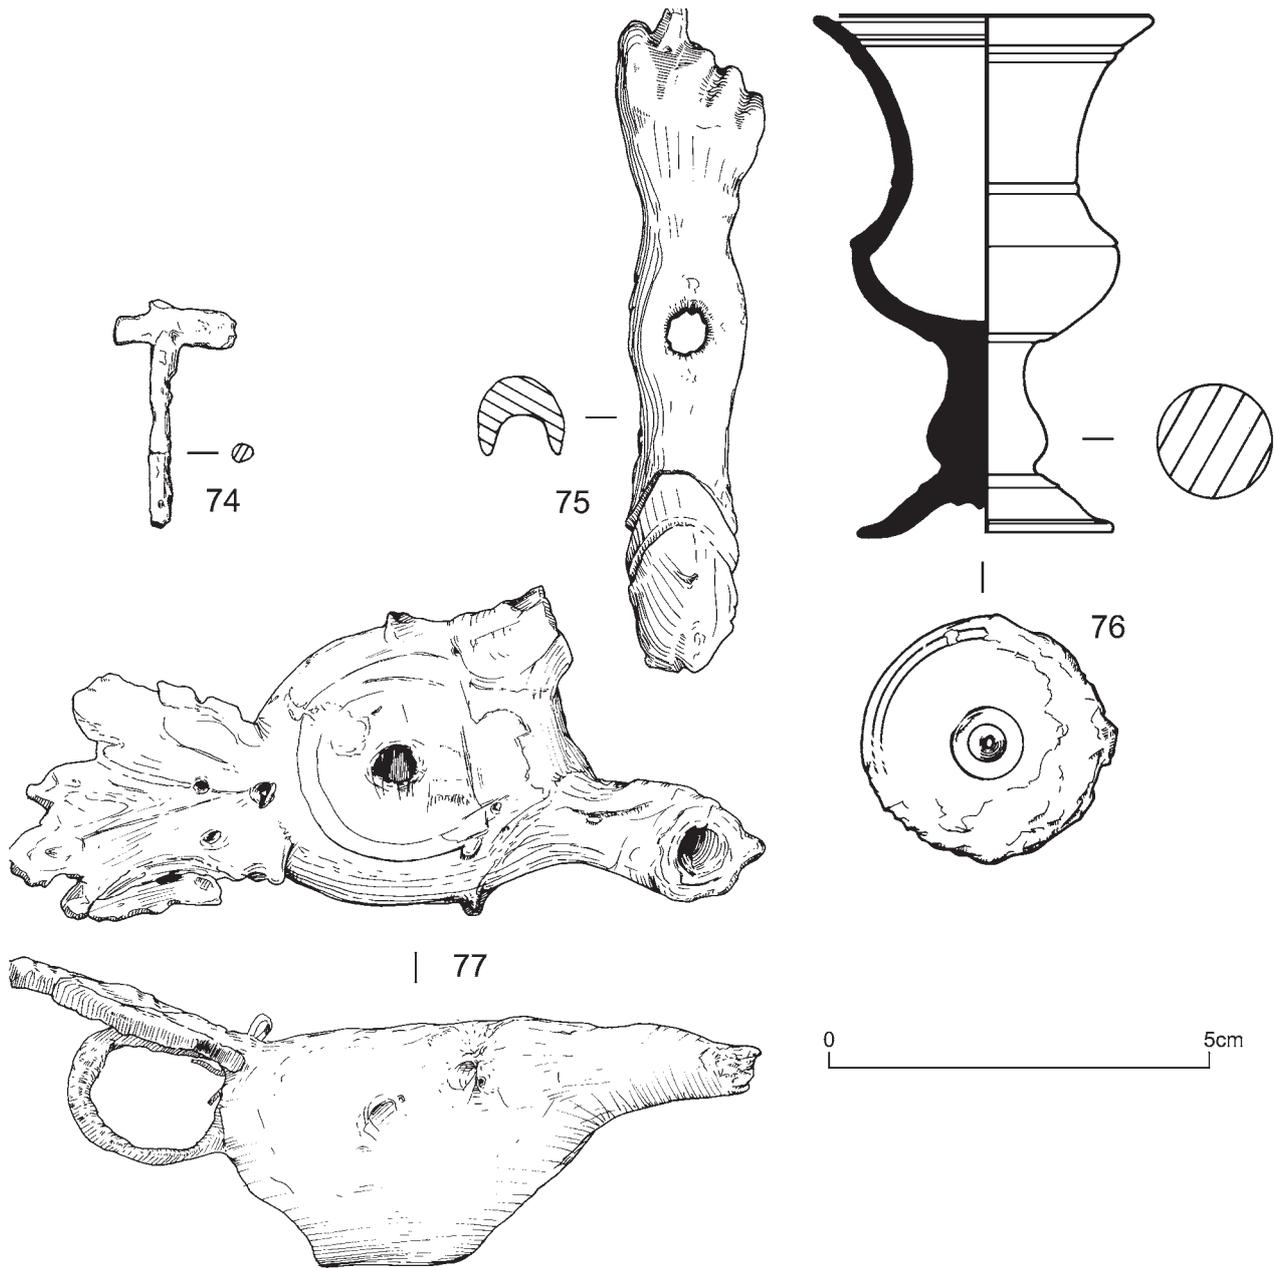
Figure 8 Copper alloy nos 74–77 Scale 1

76. Candlestick (H:69mm D of base:40mm D of rim:33mm). Building 8 abandonment/Building N make-up layer, mid-late third century, E12:03, 986, WSCA1 2001.1041  
Lathe-turned candlestick with a hollow flared lip and base and a bulging shank. Bands of incised lines decorate all three elements. There is a possible patch repair or fault in the metal on one side. A similar candlestick, now in Vienna, has a matching saucer base and has been dated to 'about the birth of Christ' (Mutz 1972, pl. 462). This example is likely to have been of some age when it reached Wallsend.

77. Hanging Lamp (H:26mm Total surv. L:85mm). Road 5, dereliction, E04:07, 150, WSCA85, 2001.1125  
Hanging lamp with a flanged counterpoise decorated to resemble a vine leaf. The filling hole is circular and surrounded by two concentric grooves. Both wick arms have broken off. A fine length of copper alloy wire runs through a circular hole in the counterpoise

and emerges underneath leaving a loop. The handle is a strip emerging from under the counterpoise and meeting the body halfway down. Two perforated lugs emerge from the side of the body to take a hanging chain. The base is missing. Similar oil lamps with single wick holes are illustrated by Mutz (1972, nos 408, 409 and 412).

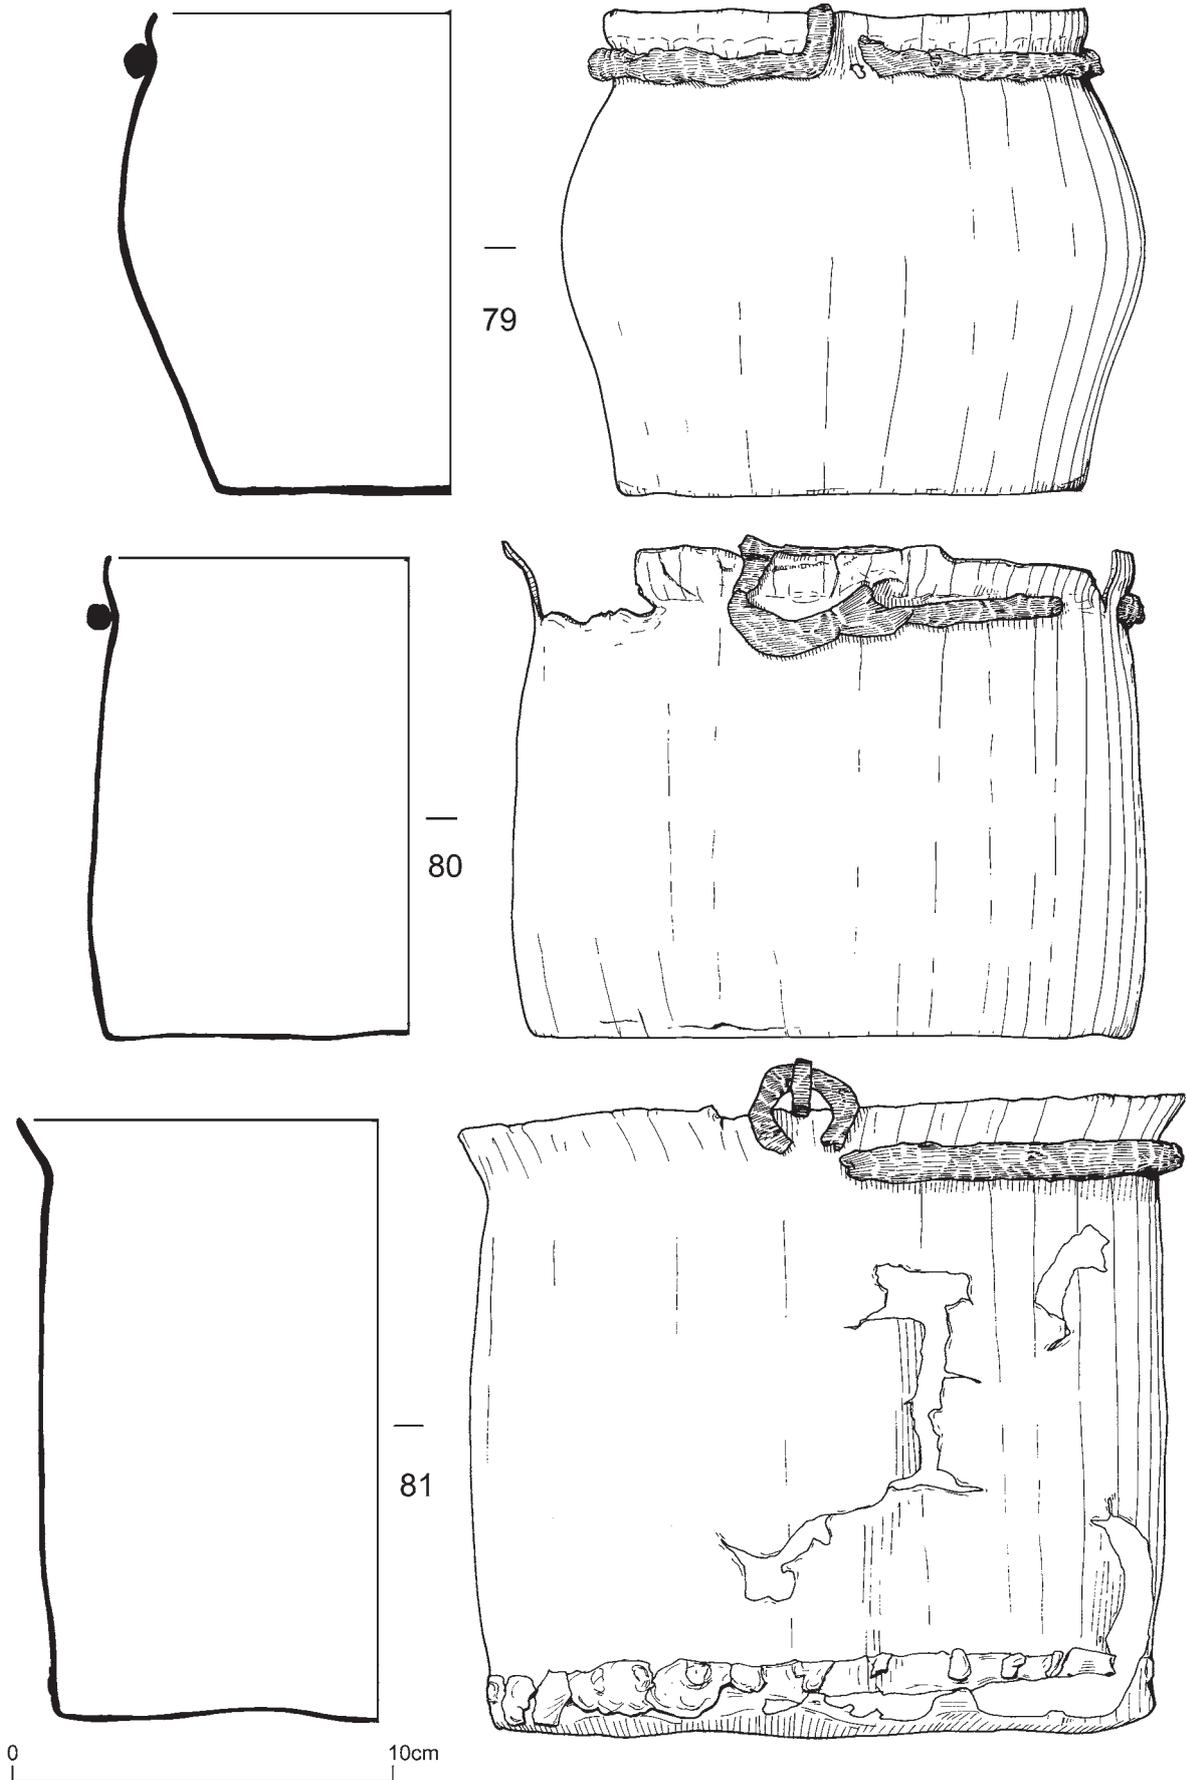
Figure 25. Copper alloy nos 79, 80, 81. Scale 1

79. Bucket (H:126mm D of base:124mm D of rim:17 × 130mm W of neck ring:10mm T of walls:1mm). Building 12, robbing *contubernium* 9/officer's quarters, Period 3, M14:61, 1895, WSCA148, 2001.1188 Vessel with a circular flat base. The thin walls belly out to curved shoulders. The rim is straight with a slightly thickened edge. The vessel is distorted so that

- the rim is now oval in shape. An iron ring of oval section fits tightly around the neck. Pieces of the iron handle are attached by corrosion to the fragmentary ring, but neither of the escutcheon loops survive. Radnóti (1938) illustrates a similar vessel from Vajta in Pannonia dated to the third century (pl. XXXVIII, no. 4, 123–4).

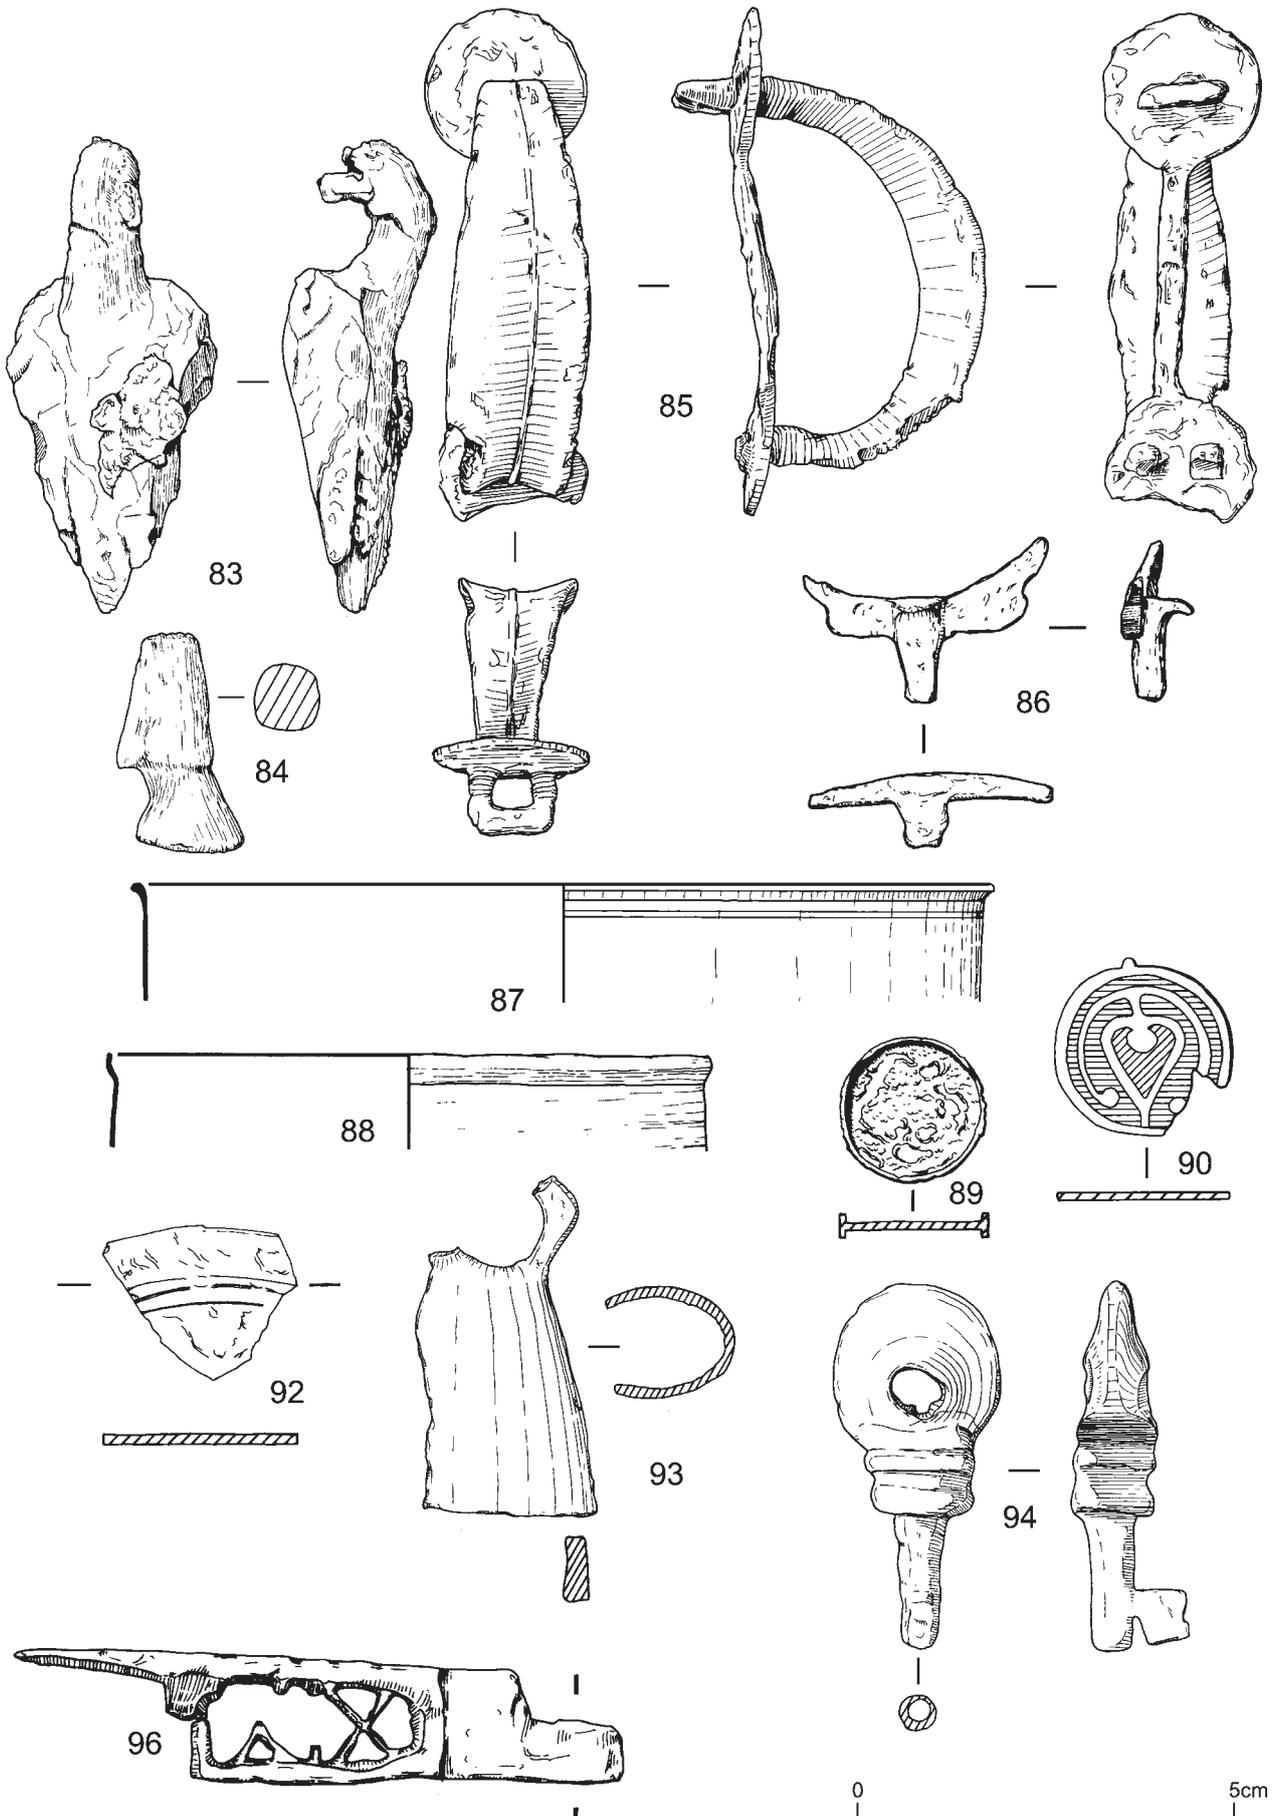
Fig. 25. Copper alloy nos. 83-96. Scale 1

93. Bell (H:46mm). Area over Building 7, unstratified, G11:01, 950, WSCA131, 2001.1171  
Incomplete bell with a long body and square mouth. The lozenge-shaped loop is pierced by a circular hole. Cf. Leicester: Kenyon 1948, fig. 87, no. 7.

94. Key (L:47mm W of head:22mm D of tube:5.5mm). Building 16, floor, Period 4, L07:02, 2024, WSCA152, 2001.1192  
Very short tubular key with a ward projecting at right-angles at the end. The ward is damaged but appears to consist of two tangs. At the top a wide, three-ribbed, rectangular-sectioned panel leads to a flattened oval head pierced by a grooved circular hole (D:6mm). The head is set at right angles to the ward.

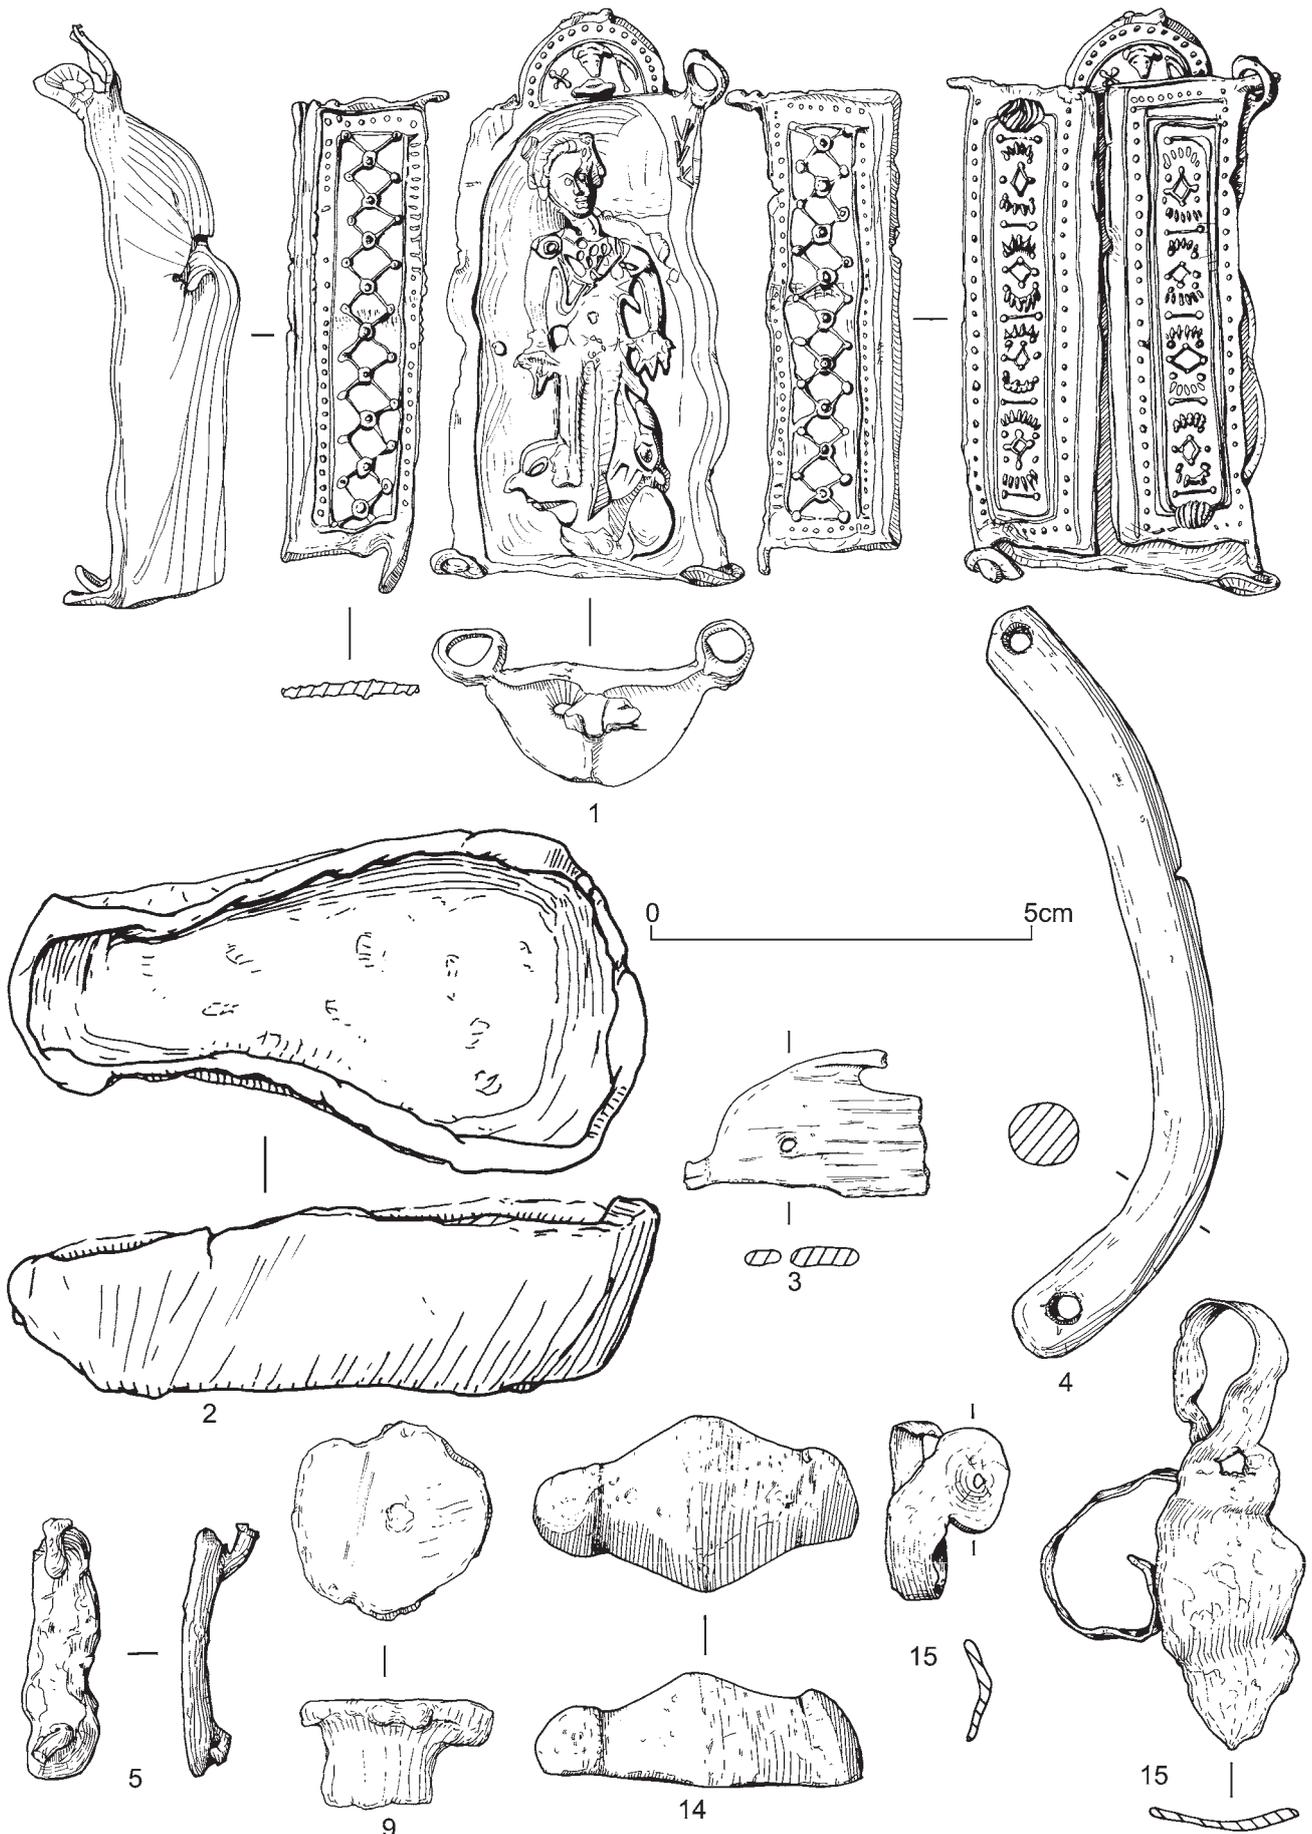
Portable shrine in the form of a cupboard with a rounded back. The two rectangular doors each have projecting spigots at two corners which fit into looped hinges at each front corner of the cupboard. The doors have raised decoration on both faces: on one face lattice work with pellets at the angles is contained in a pellet border, on

Fig re 23 Lead no. 3 Scale 1

the other a more complex rib-and-pellet border contains panels of diamond shapes and stylized shells. The pattern over-runs the border at one end of each door. There is no obvious way of fastening the doors.

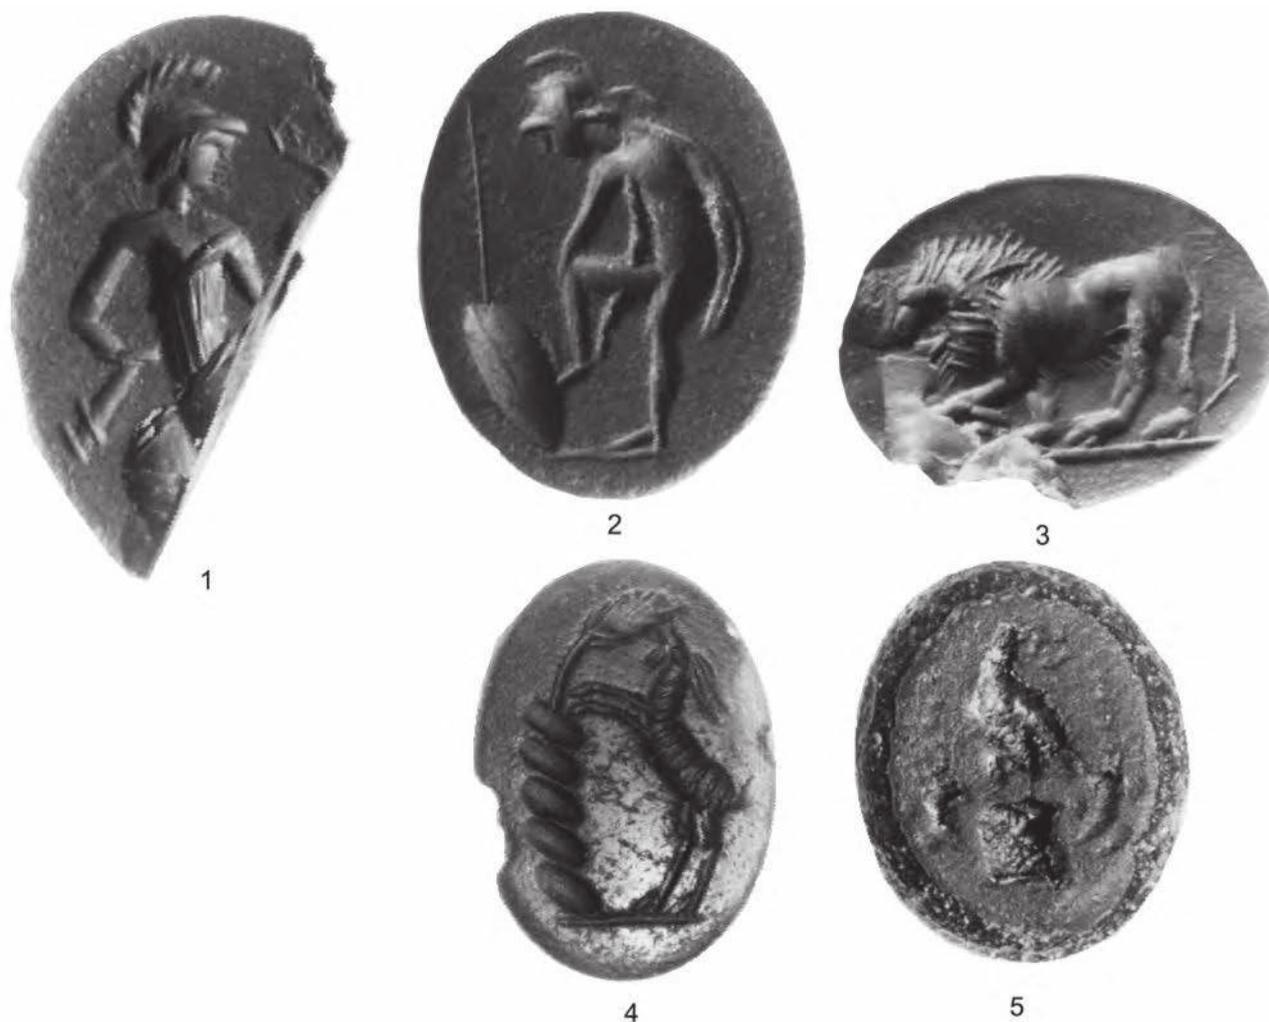
Fig. 25.26 Intaglios. Scale 1. Photos by R. Wilkins © Institute of Archaeology, University of Oxford.

### The intaglios (Fig. 25.26)

Altar and statue fragments recovered from the general area of the fort reflect the official worship of two of the three major state gods, Jupiter Best and Greatest and Minerva, the goddess of war (Snape and Bidwell 1994, 24–5). Minerva was represented in a large statue found outside the fort, but the head of a more modest statue of her was also found re-used inside the fort (Fig. 21.02). Both deities appealed to the military, as did Fortuna, represented by a copper alloy statue in the Commanding Officer's house (Fig. 25.05, no. 73), Mars, depicted on an intaglio and Dea Roma, holding both a sword and a figure of Victory, also on an intaglio (Fig 25.26, no. 1; cat. no. 6).

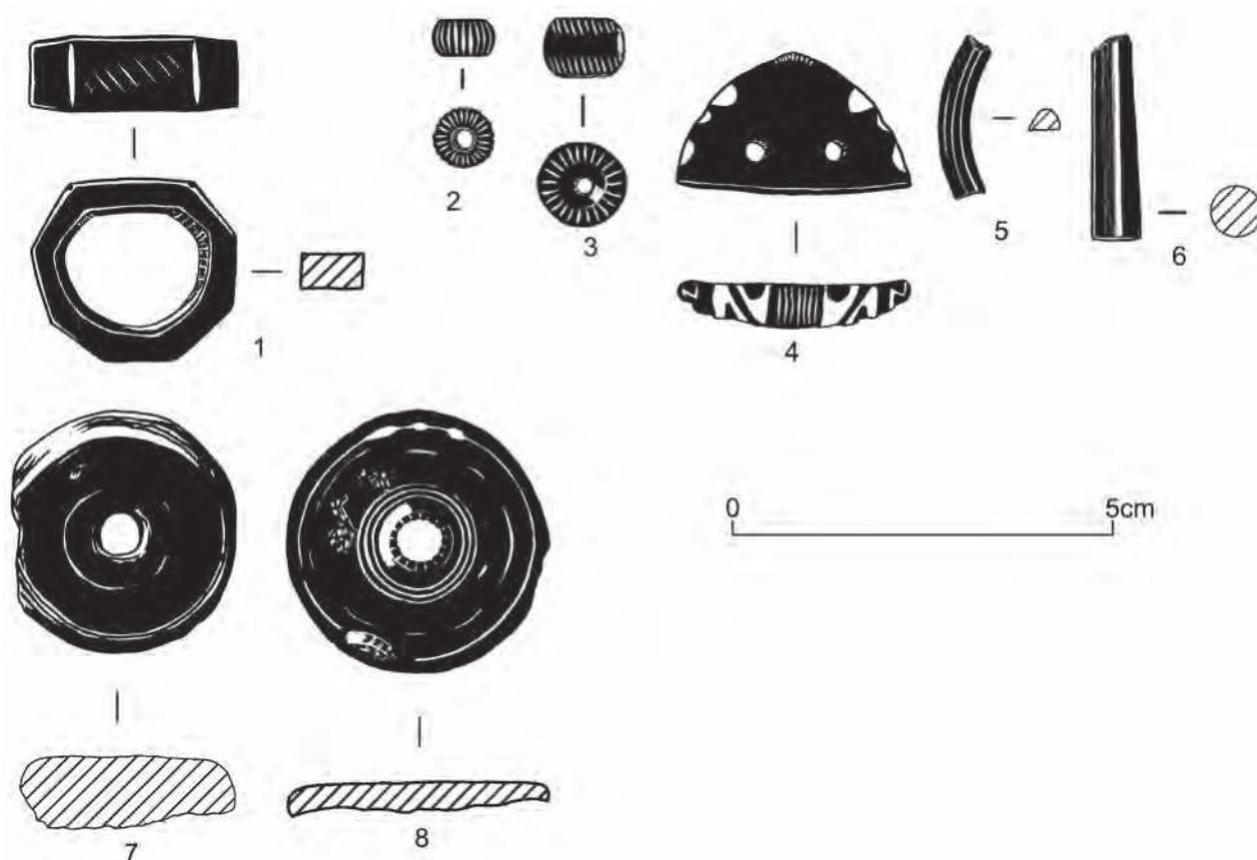
Figure 25.27 Jet and shale. Scale 1

### Jet and shale (Fig. 25.27)

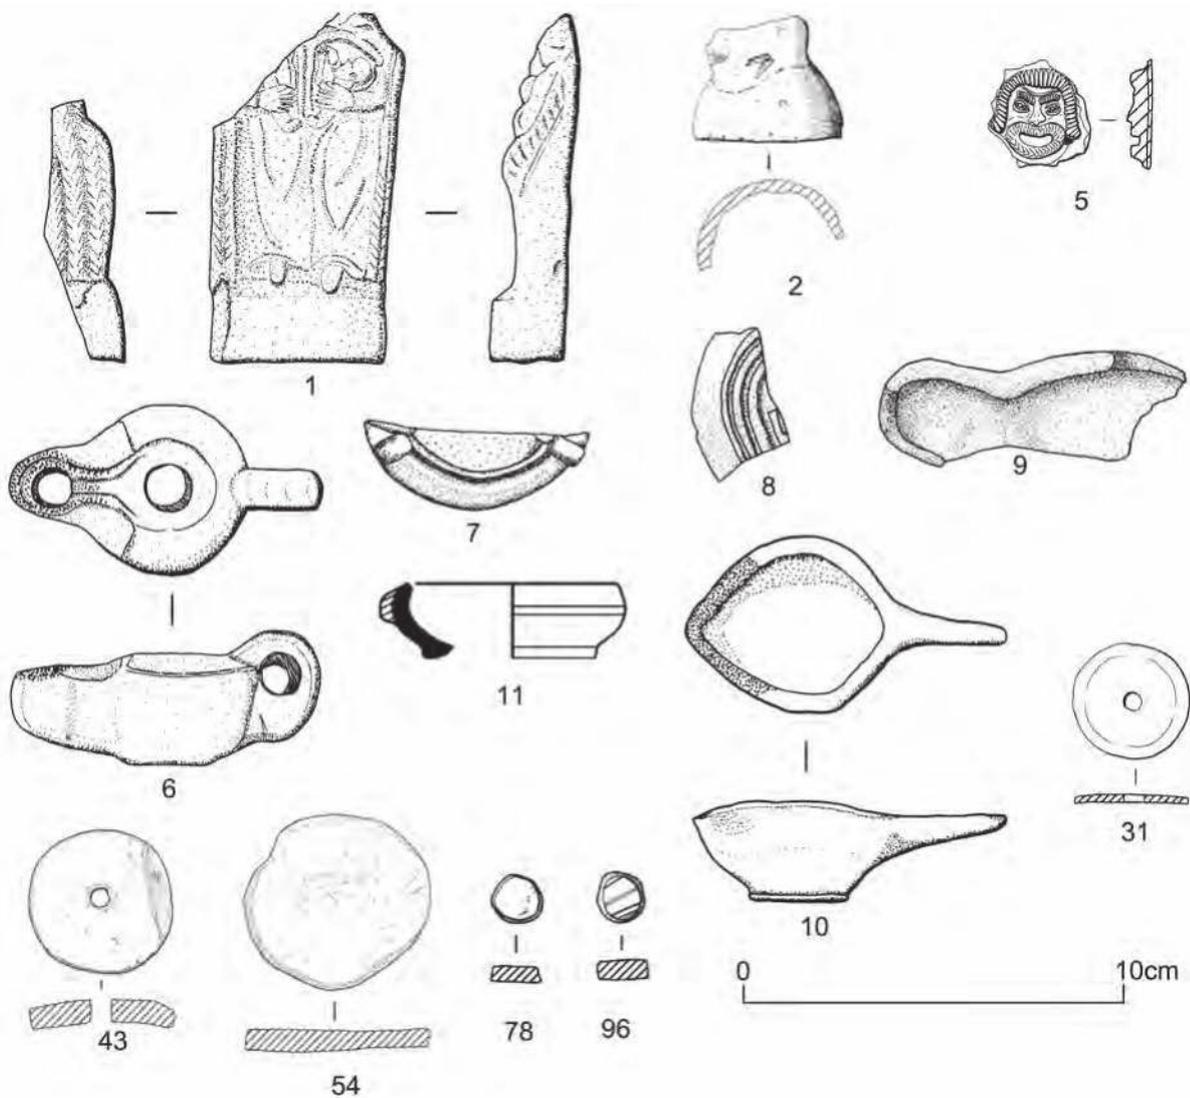
Figure 25.29: Pottery. Scale 1:2.

## Pottery (Fig. 25.29)

figurines. Five of them come from the *vicus* south of the fort, and only three from inside the fort. One of those from inside the fort, from a possible midden east of Building 3, is a nursing mother (Fig. 25.29, no. 1). The subject matter perhaps makes it more likely that this was originally owned by a woman.

The building had an interesting selection of lighting equipment. There was a complete lamp with heavy sooting round the nozzle found in a possible 'natural' layer under room 8 of the stone building, associated with Antonine samian (Fig. 25.29, no. 6). A second complete but broken lamp, which had had its filling

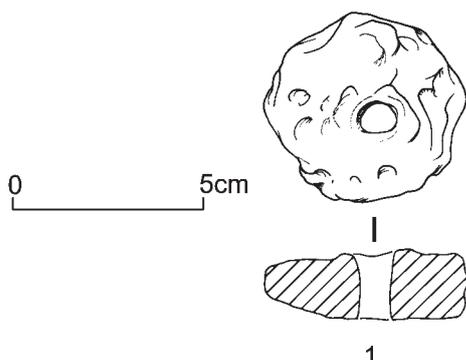
1. Disc (D: 53mm T: 15mm). Wall of medieval or modern building, N05:02, 192, WST21  
Roughly circular disc cut from the top end of a *tegula* roof tile, utilising the nail hole. Net sinker or loom weight.

Fig. 25.30 Tile. Scale 2

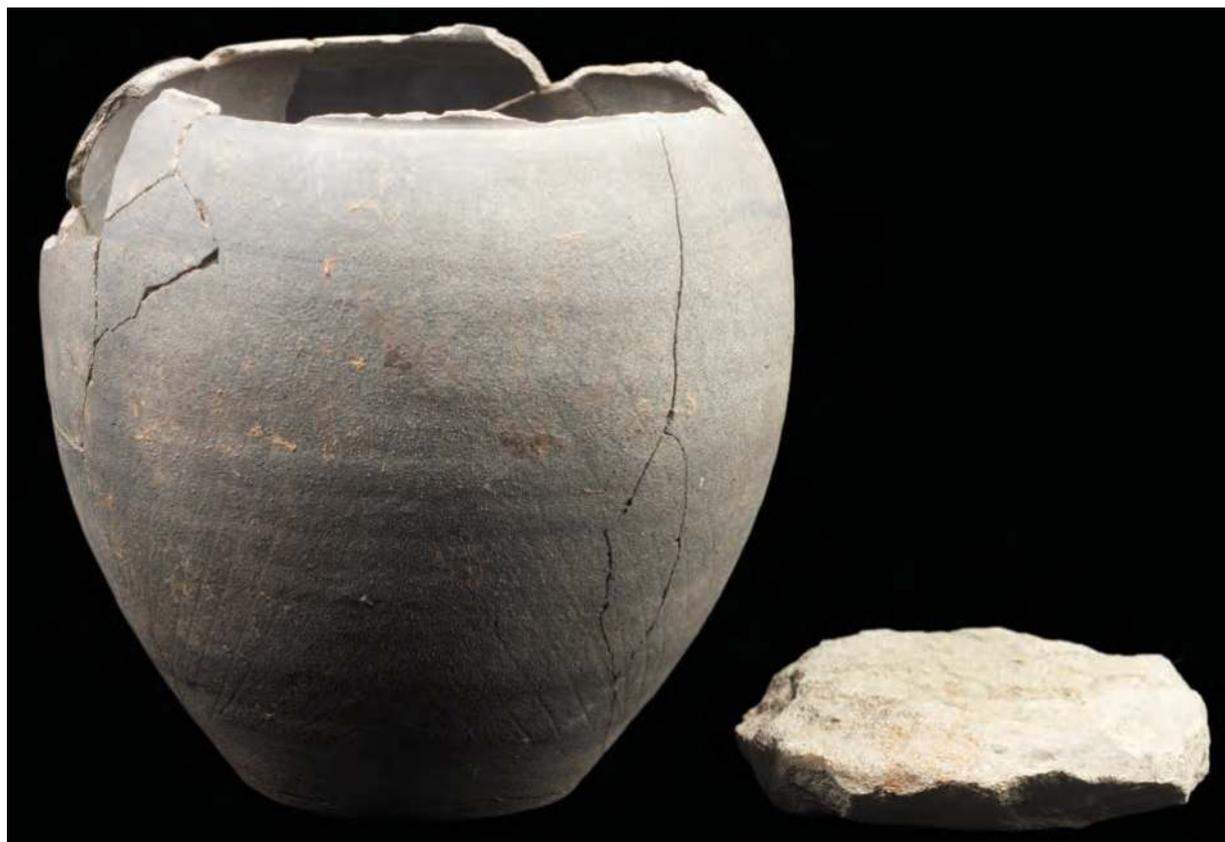
Figure 25.33: Stone lid (no. 35) used with cooking pot (coarse ware pottery cat. no. 68).

35. Pot lid (D:148mm). Building 8, room 1, Period 3, D11:23, WSS108, 2001.2965  
Roughly shaped sandstone disc, found *in situ* over a BB2 cooking pot (Fig. 22.15, no. 68) set into the floor of a room in Building 8.
