# SEGEDUNUM

Excavations by Charles Daniels in the Roman Fort  
at Wallsend (1975–1984)

VOLUME 1: The Structural Remains

Alan Rushworth and Alexandra Croom

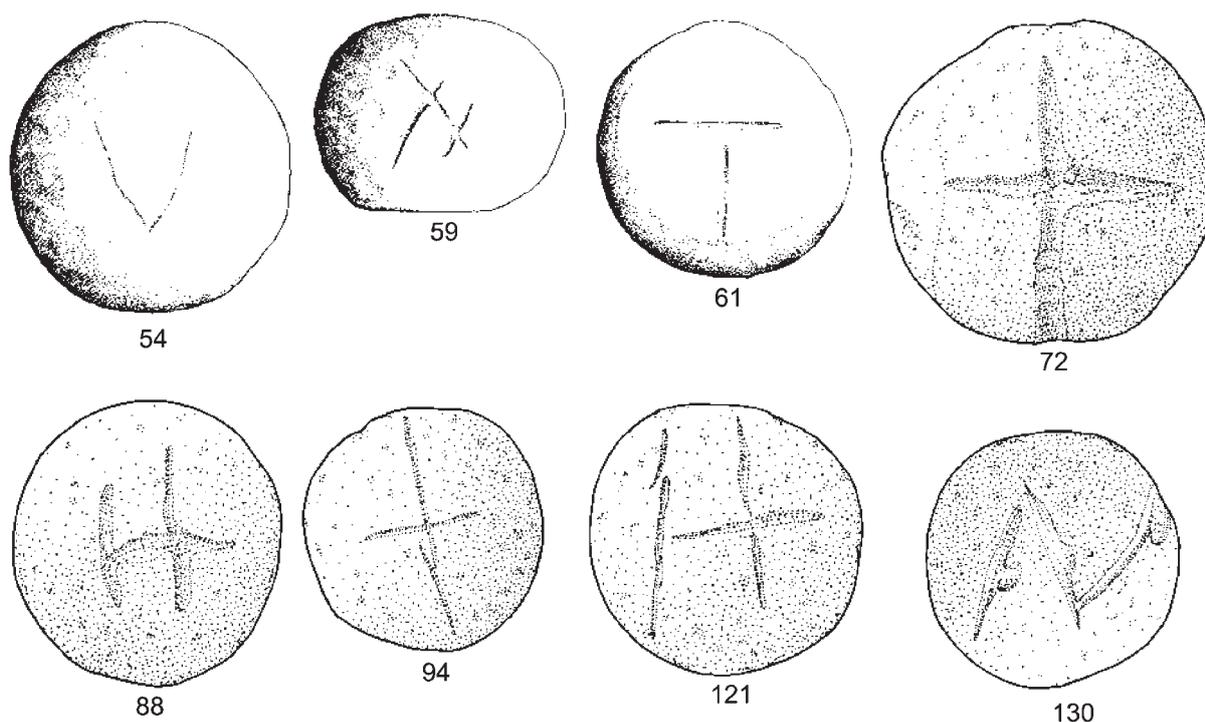
Figure 25.34: Throwing stones with graffiti. Scale 1:2.

with what appear, for the most part, to be numerals. There is no clear evidence to suggest a purpose of these numbers. Possibilities include a mason's or maker's mark, a tally mark, or markings for some form of game. Only two other stone balls from Britain have been recovered with inscriptions, *RIB II* 2451.1 from Caerleon, inscribed with an M and *RIB II* 2451.2 from Corbridge, now lost. There is some uncertainty as to the exact interpretation of the inscription of the Corbridge example. In all cases that the markings take the style of a graffito as opposed to a formal inscription. All the stones apart from no. 61 (*RIB II* 2451.3), which was unstratified, were found in the construction levels of *contubernium* 2 in Building 4 in Period 2.

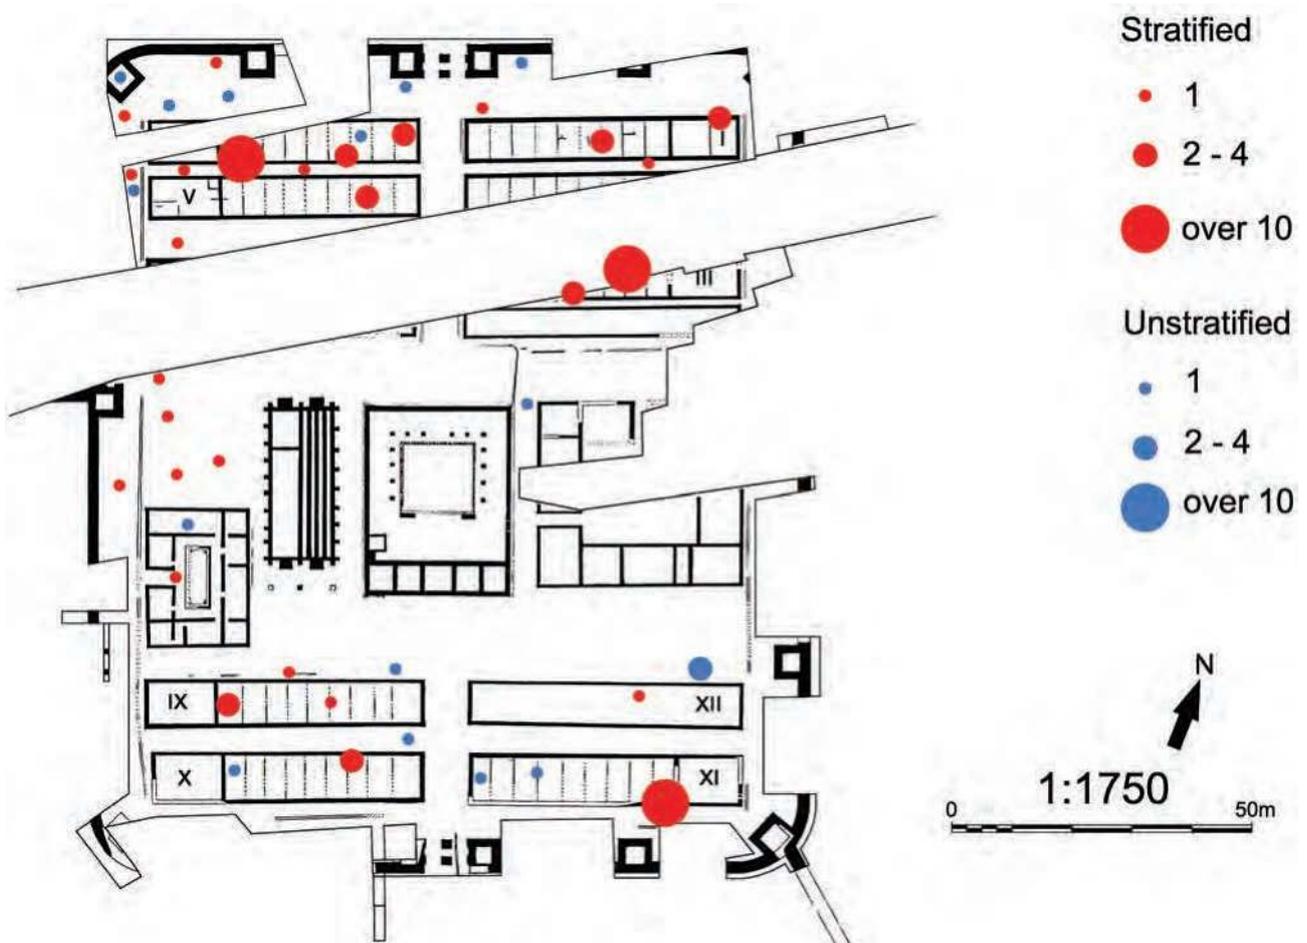
Figure 35 Distribution of the quern stones.

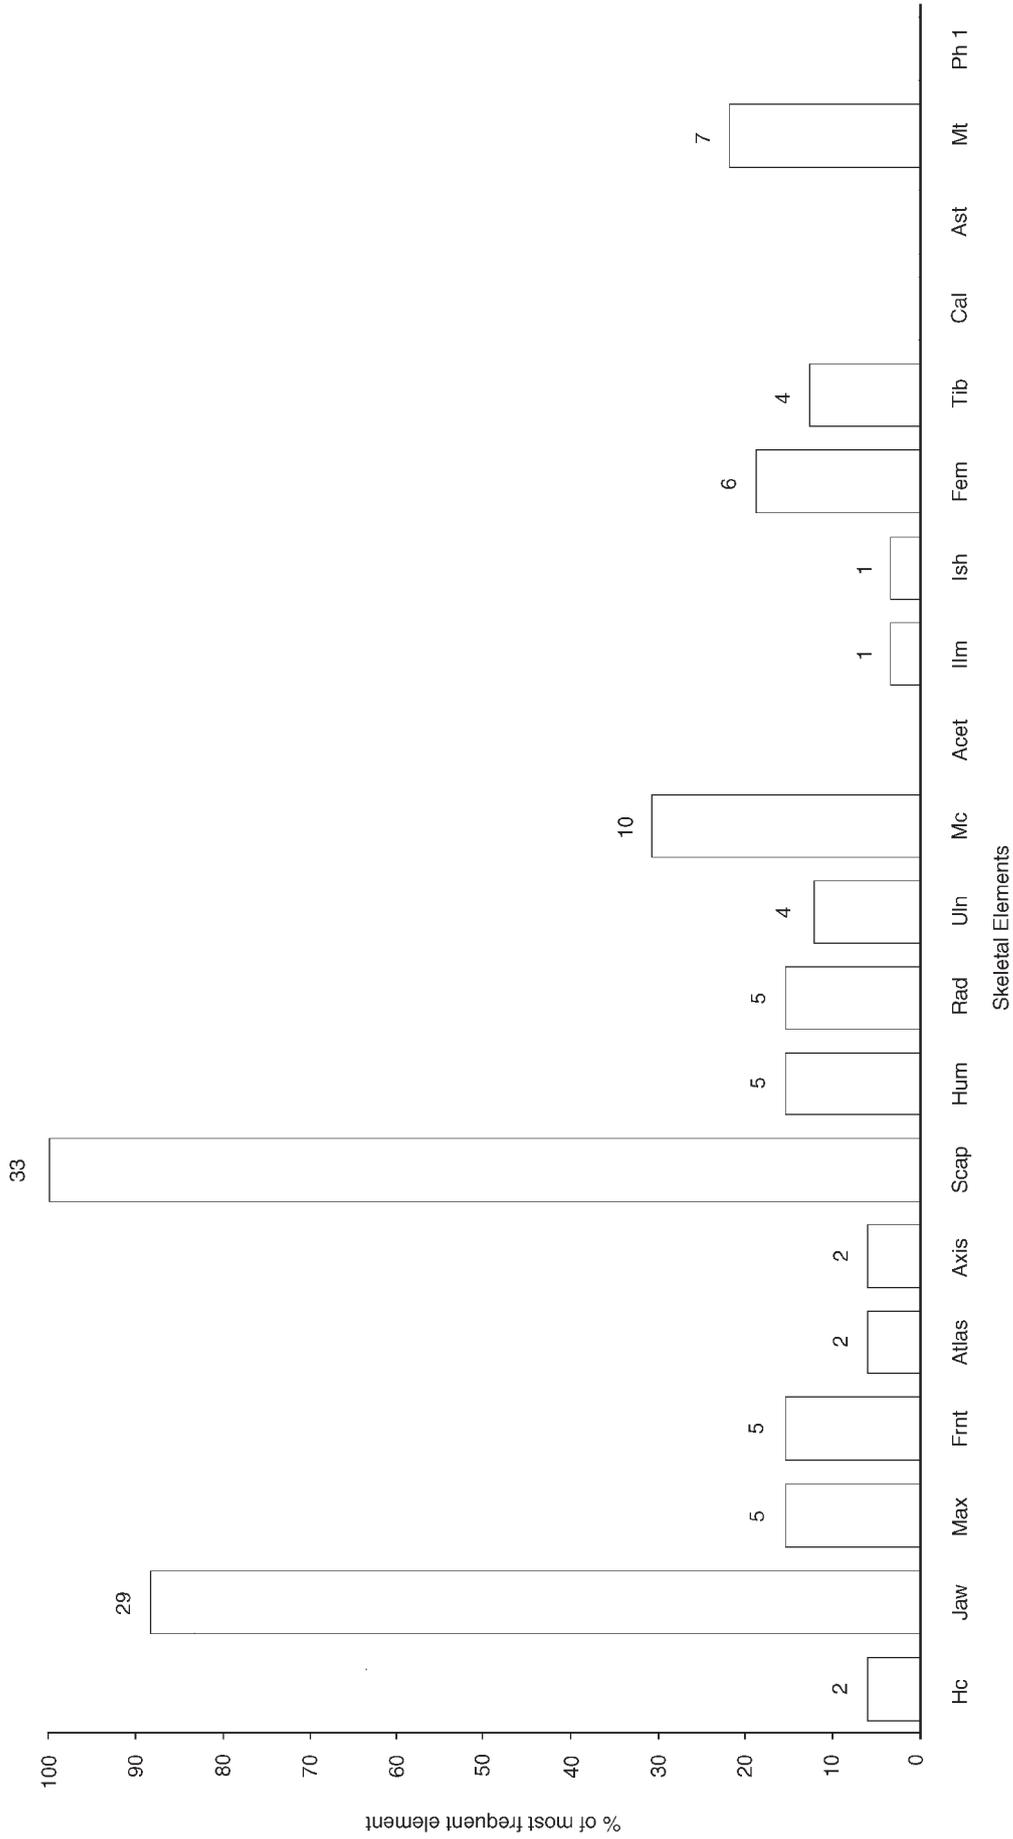
Figure 26.01: Skeletal elements of cattle bones from Cistern 1, context E08:27

The representation of the skeletal elements of cattle has been previously noted as one of the points of particular interest about this group. Figures 26.01–03 illustrate the frequency of fragments of 20 skeletal elements, chosen as being the most commonly found and representing the whole carcass. To equate with the paired elements, the number of first phalanges has been divided by four while the number of atlas and axis has been doubled.

For context E08:27, Figure 26.01 shows striking peaks of scapula and lower jaw fragments but some surprising absences that cannot be attributed to differential preservation. The calcaneum, astragalus and first phalanx are all extremely dense bones that survive well but are totally absent from the context, together with parts of the pelvis: the acetabulum. The number of maxilla fragments is extremely low compared to the abundance of lower jaw. The other skull and neck bones are also sparse, suggesting processing of the jaw bones separately from the remainder of the head and neck prior to deposition. Context E08:29 in Figure 26.02 has the same abundance of scapula fragments. The lower jaw is still the second most abundant element but the metacarpal is noticeably more abundant than in Figure 26.01. The maxilla and other skull bones are again under-represented in comparison with the lower jaw. Of the elements not seen in E08:27, none are also absent from E08:29. The information from all three contexts is summed together in Figure 26.03 to show an overall pattern of a superabundance of scapula and lower jaw fragments and a disproportionately high number of metacarpal compared to metatarsal fragments. All remaining elements are represented. Such a pattern is indicative of human selectivity in the disposal of carcass elements in this feature.

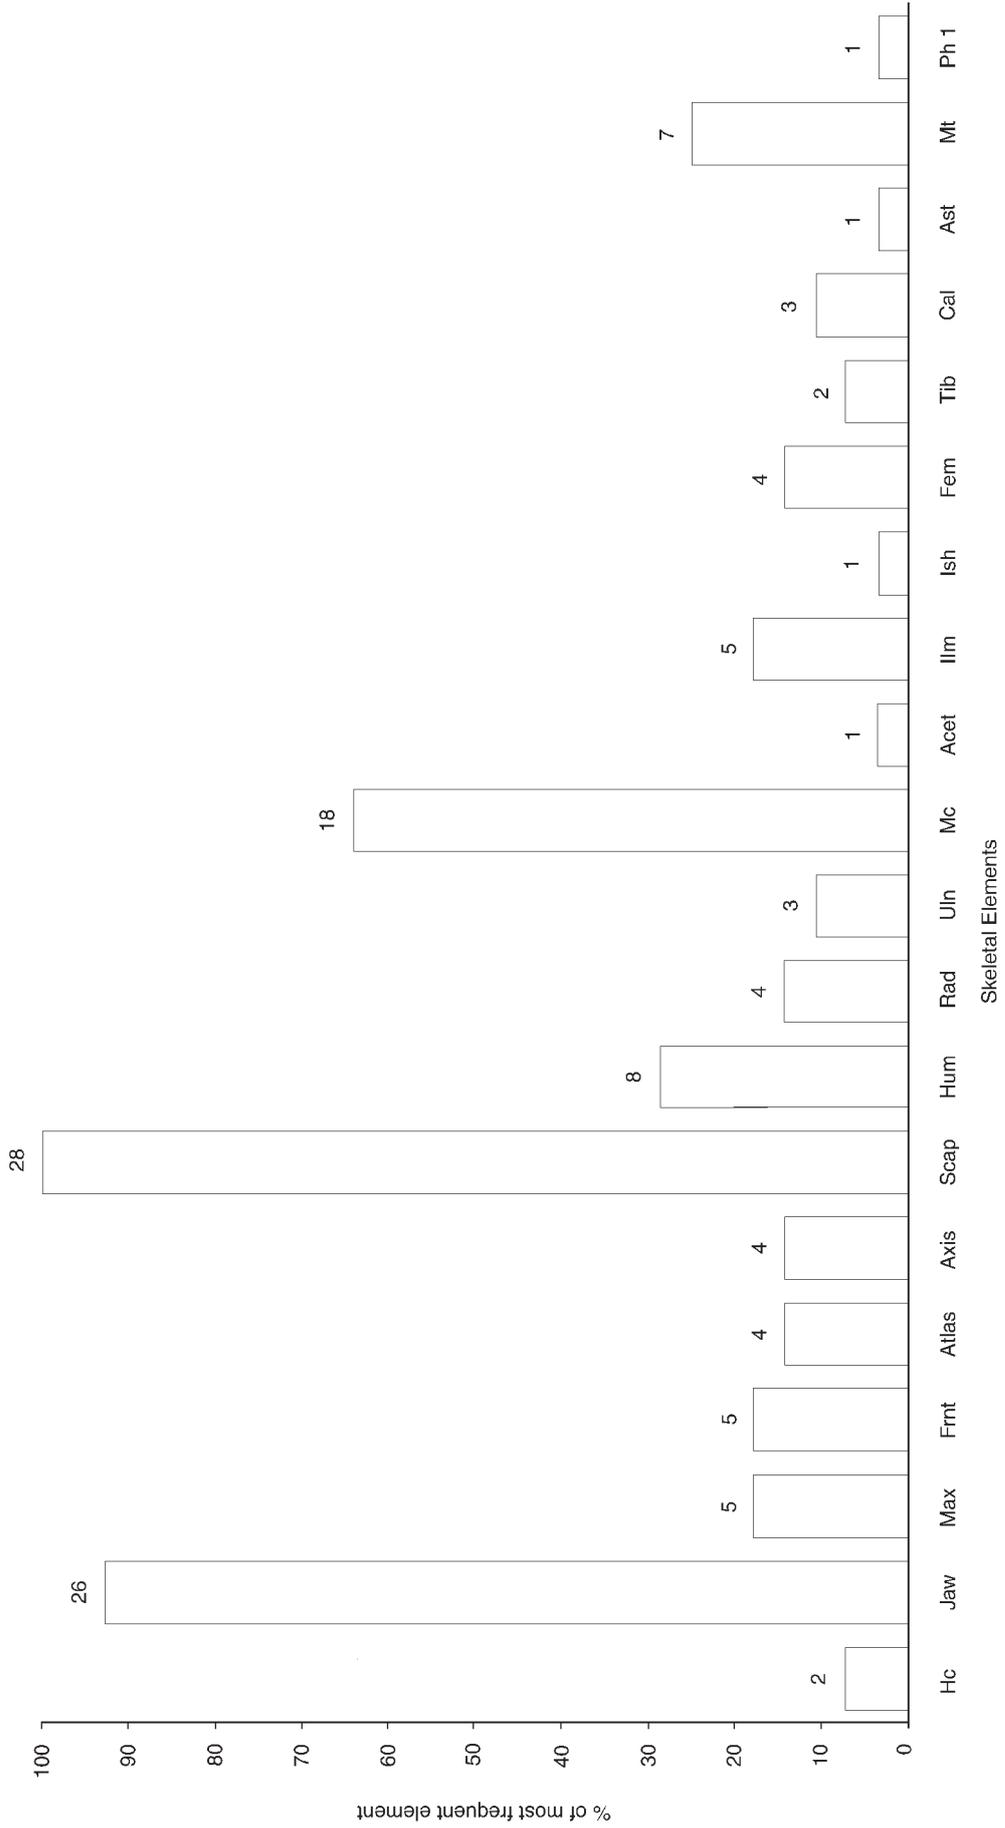
Figure 26.02: Skeletal elements of cattle bones from Cistern 1, context E09:29

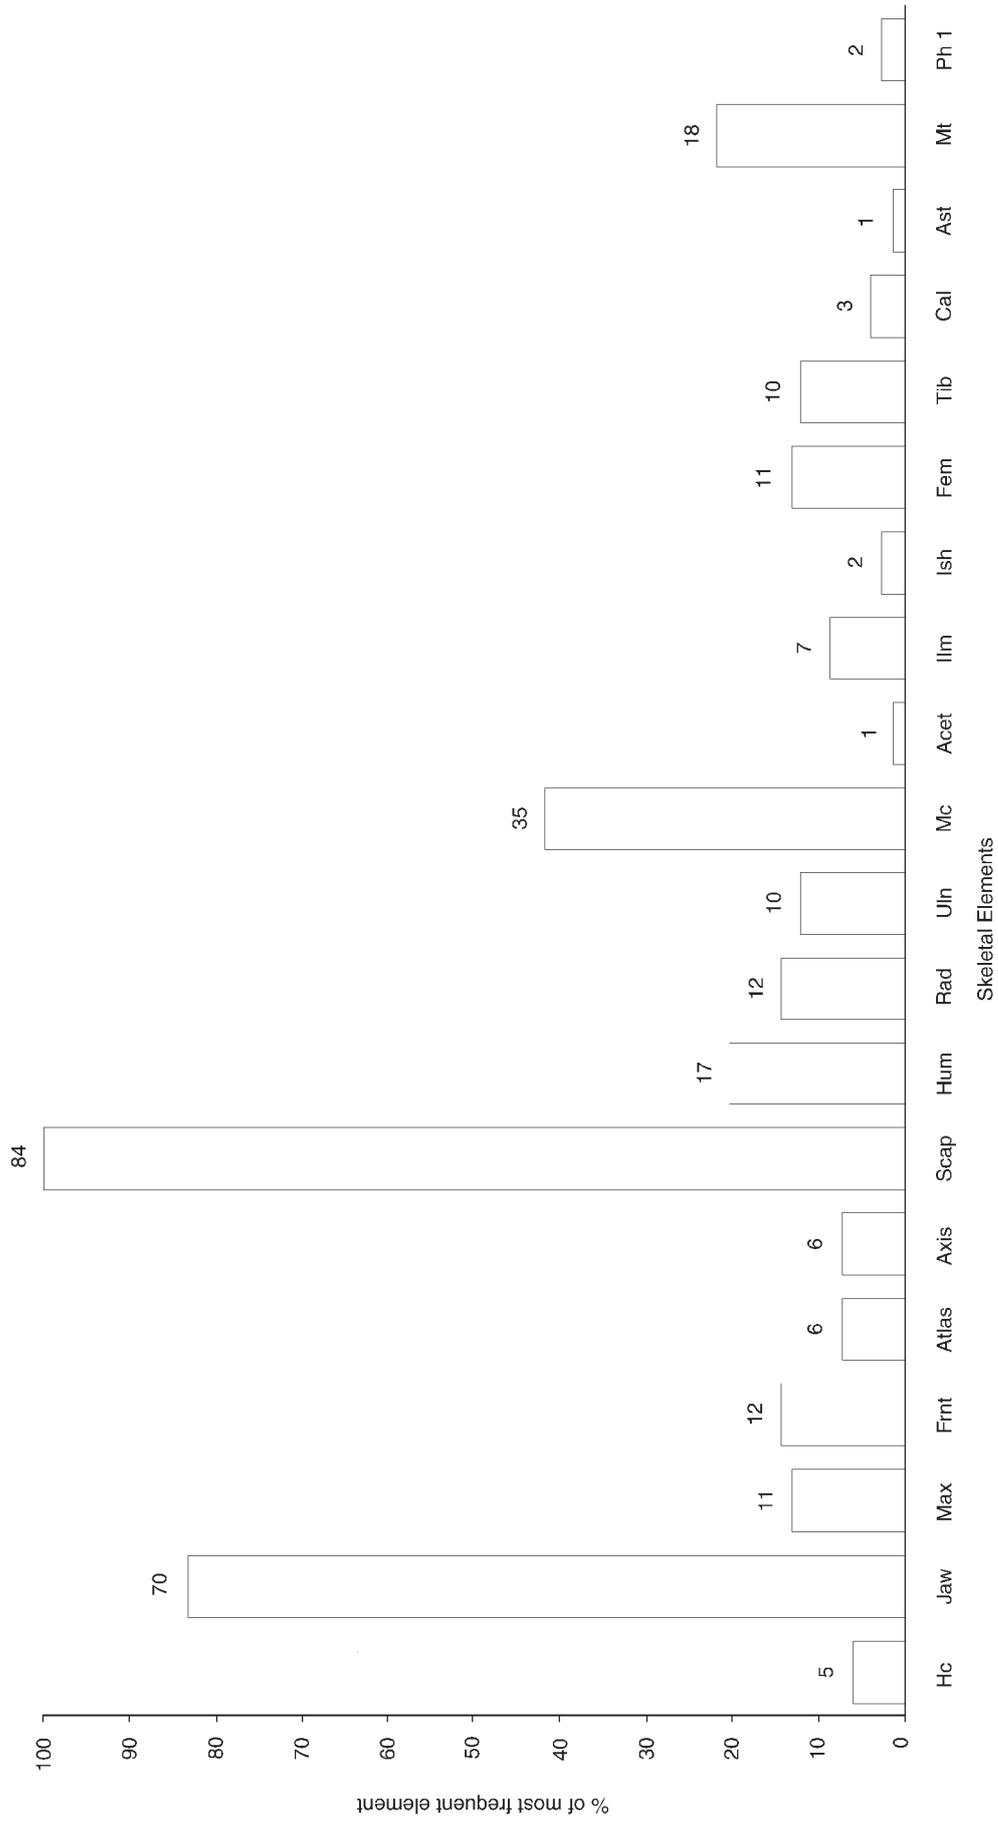
Figure 26.03: Skeletal elements of cattle bones from Cistern 1, all contexts

The zone frequencies in Figure 26.04 mirror the trends seen from the fragment frequencies in Figure 26.03. The predominance of scapula fragments is still striking. Lower jaw remains the second most common element but the zone frequencies suggest that breakage has enhanced the representation of lower jaw in the fragment counts. The frequency of metacarpal fragments is much reduced for the zone counts, approaching parity with the humerus, but still more abundant than the metatarsus. The remaining elements suggest a similar, low, level of utilisation and discard of undifferentiated parts of the carcass.

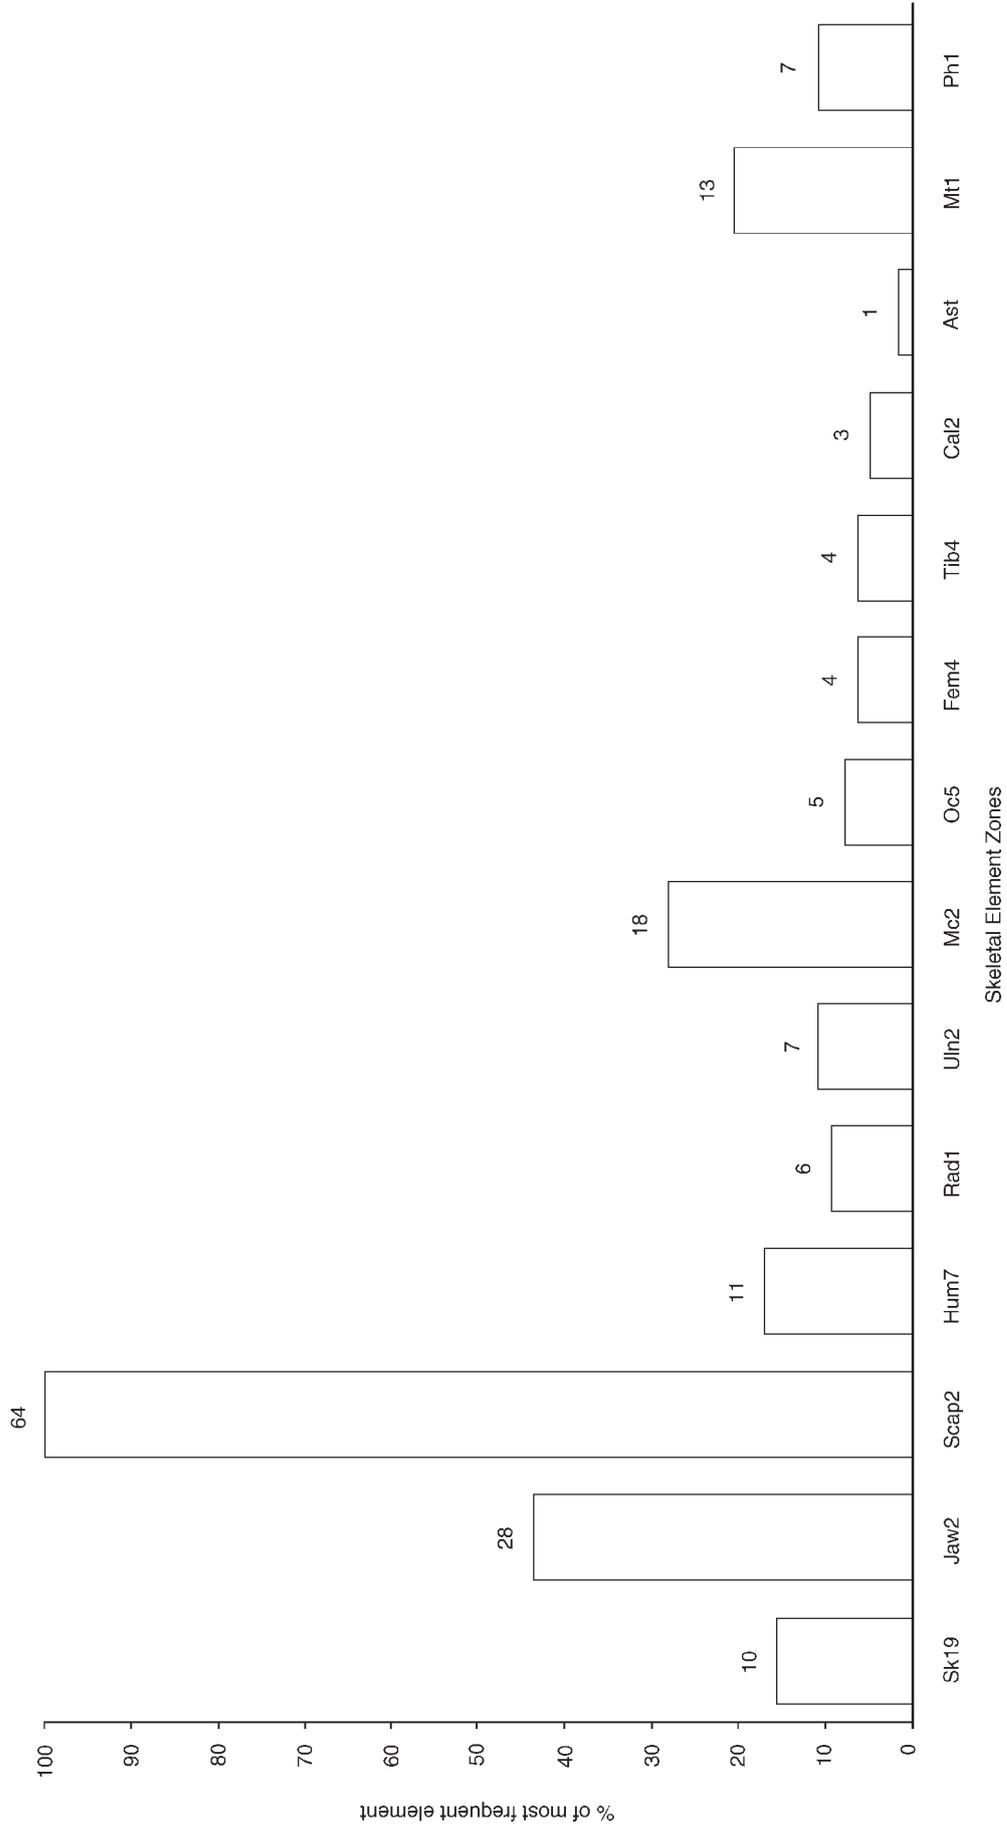
Figure 26.04: Skeletal element zones of cattle bones from Cistern 1, all contexts

Appendix 1 lists the counts of zones for each cattle element, while Figure 26.04 illustrates the frequencies of the most numerous zone for 14 of the elements considered in Figures 26.01–03. Because there are fewer individual zones than fragments, all the cistern fills are considered together in Figure 26.04. The skull and pelvis are treated as single units for the zone counts. Figure 26.04 should give an indication of the minimum number of individual elements present for

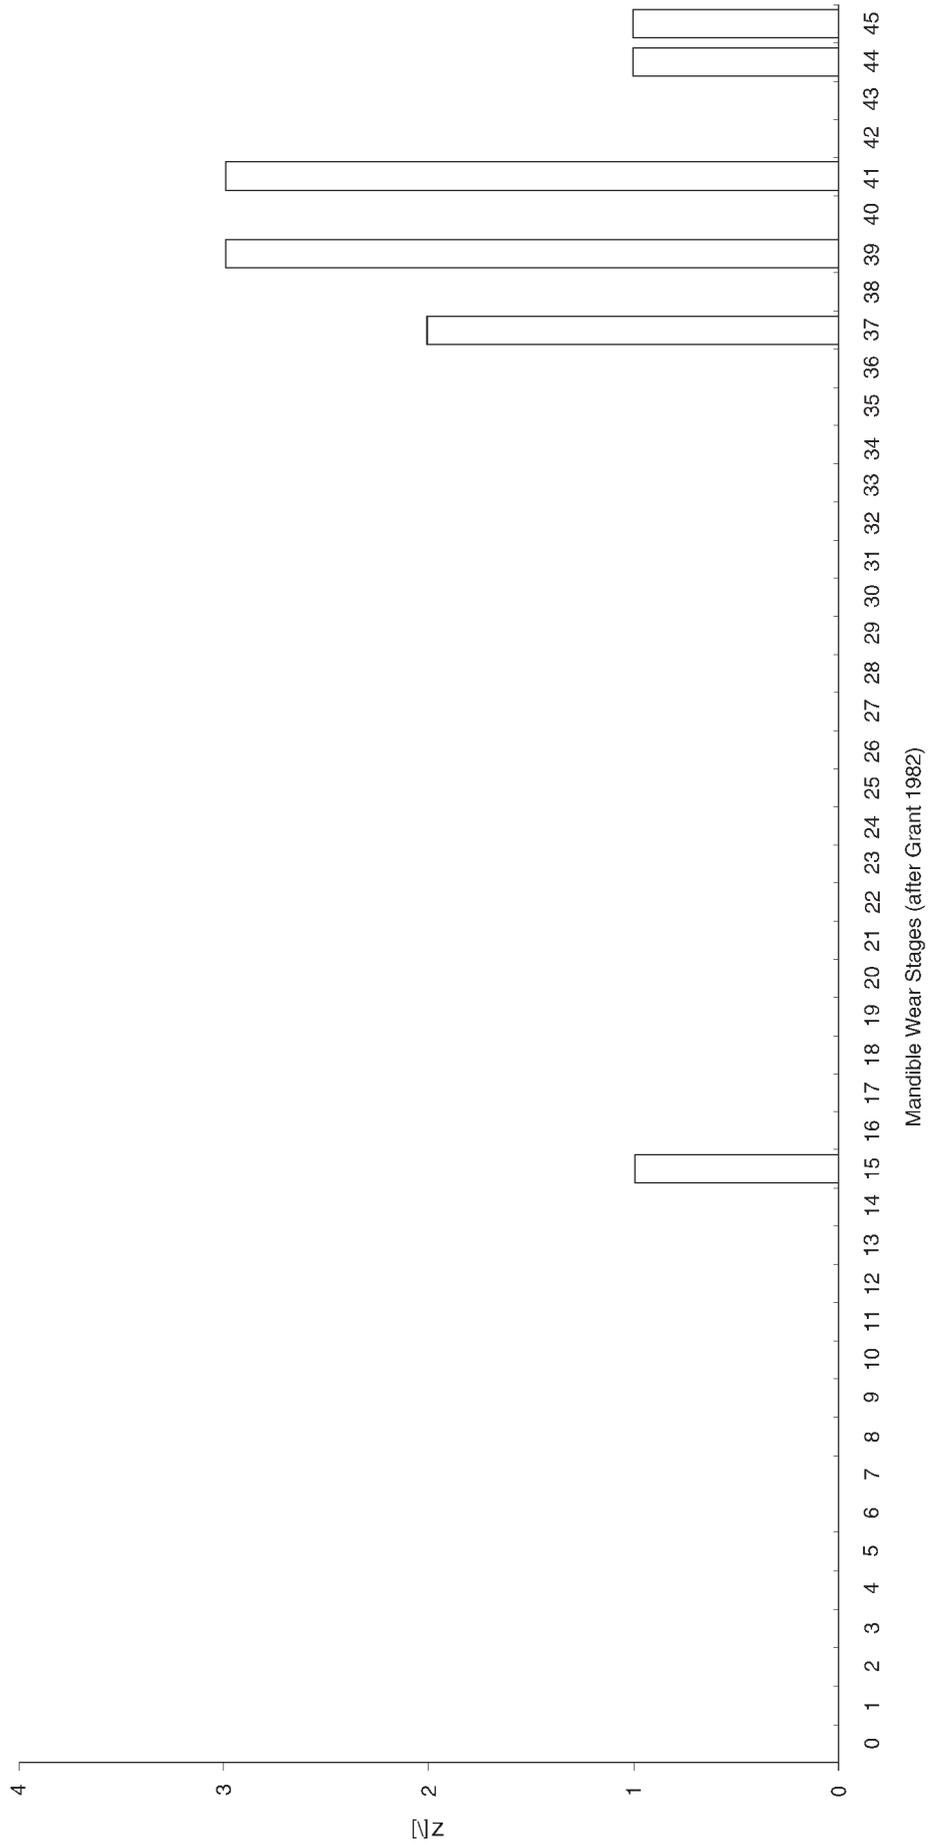
Figure 26.05: Mandible wear of cattle bones from Cistern 1, all contexts

in full wear from third-year and older animals. This is further illustrated by the Mandible Wear Scores in Figure 26.05 from the jaws with complete tooth rows surviving. Only one younger, second year, animal with molar 2 coming into wear is present at MWS 15. The remaining ten jaws span MWS 37–45. These have all molars present and in wear. By analogy with my own reference collection of Dexter cattle mandibles, those jaws at MWS 44–45 represent animals at least 10 years old and probably several years older. Breakage of the jaws has obscured the incidence of congenital absence of premolar 2 but one example was noted, as well as an example of malocclusion on molar 3.

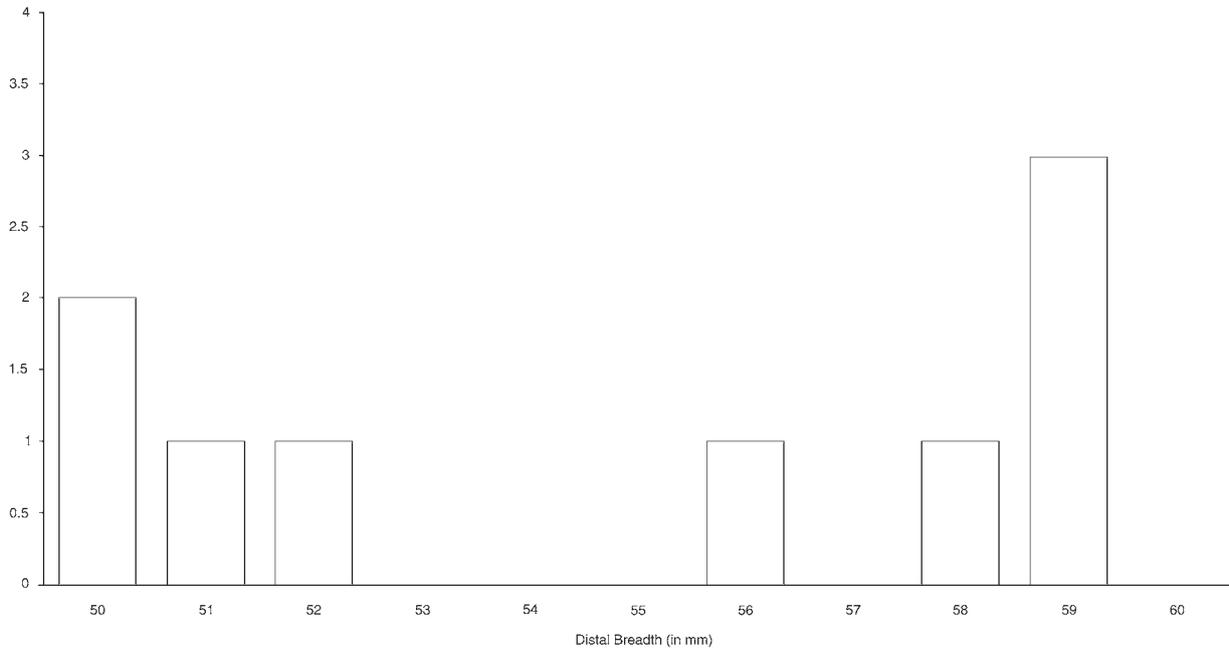
Figure 26.06: Distal breadth of cattle metacarpals from Cistern 1

metatarsals indicate heights of 1.08m and 1.14m. The distal metacarpal was the only element to provide a reasonable sample of metrical data. The nine bones in Figure 26.06 appear to fall into two groups. The smaller range from 50 to 53mm and may be female while the larger range from 56 to 59 mm and may be male. The single cattle skull with horn cores attached appeared feminine.

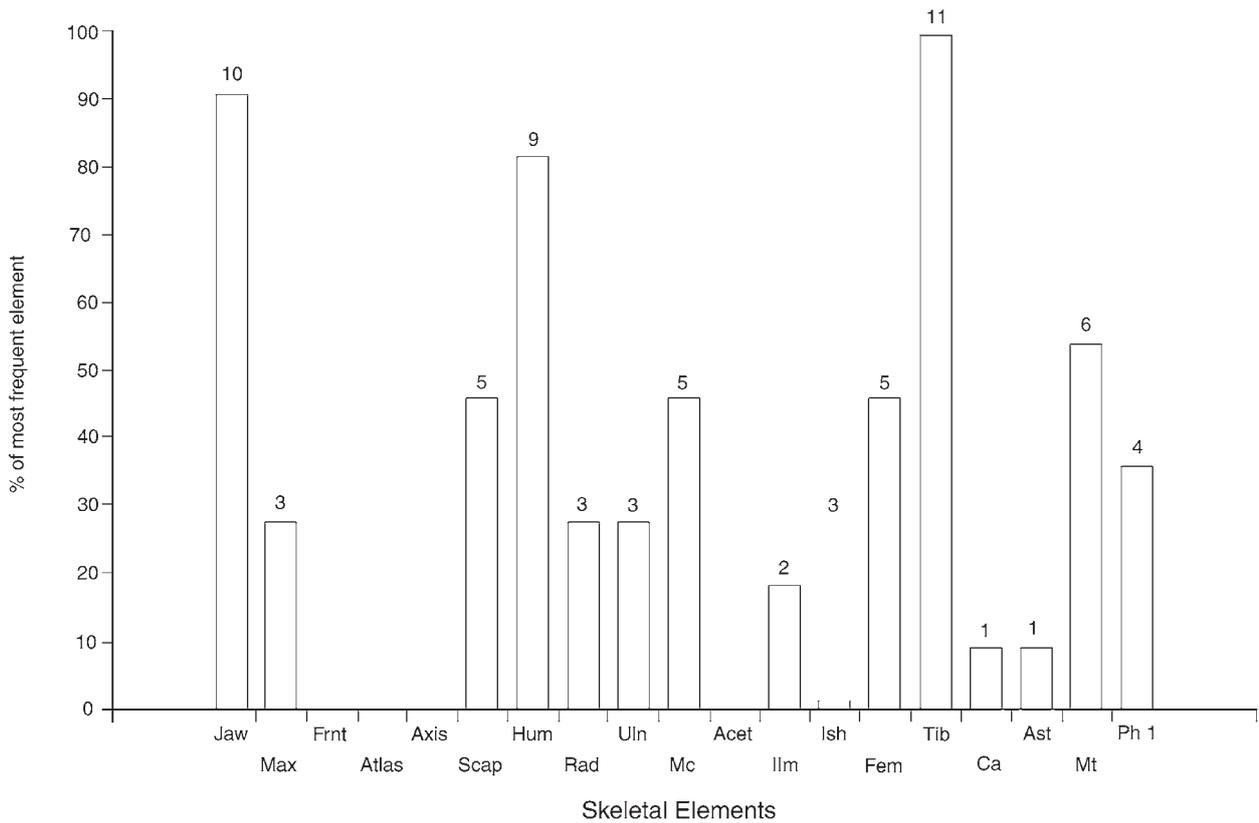
Figure 26.07: Skeletal elements of pig bones from Building 13, period 3

It is appreciated that the sample size is very small. Nonetheless Figures 26.07 and 26.08 suggest a meaningful change in body part representation between Periods 2 and 3/4. In Period 2, Figure 26.07 shows that bones of the head, forequarter and hindquarter occur in similar proportions. In Period

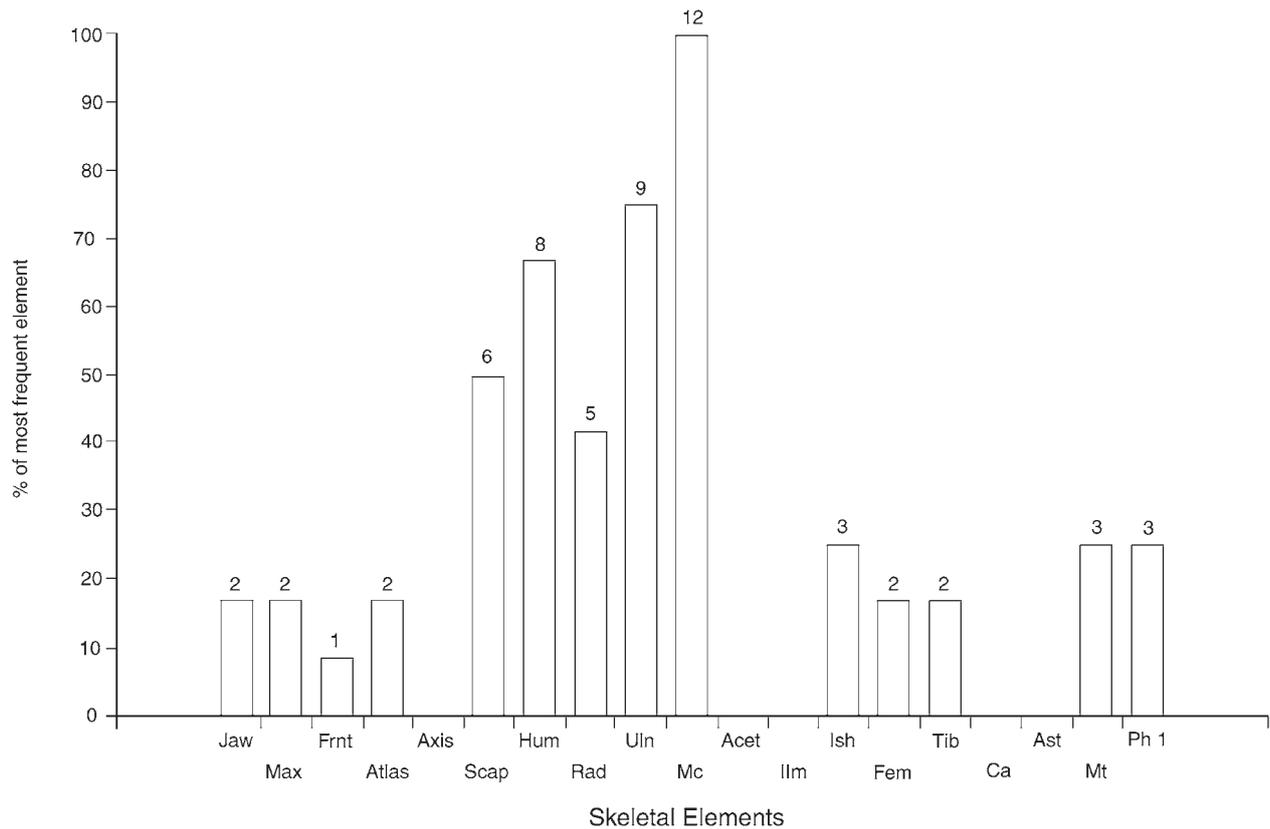
Figure 26.08: Skeletal elements of pig bones from Building 13, period 4

3, Figure 26.08 shows that bones of the forequarter are most common. The elements of the head and hindquarter occur in similar proportions but at roughly half the abundance of the forequarter.
