Chapter

A Wear Analysis Carried On Connecting Rod Bearings From Internal Combustion Engines

Abstract

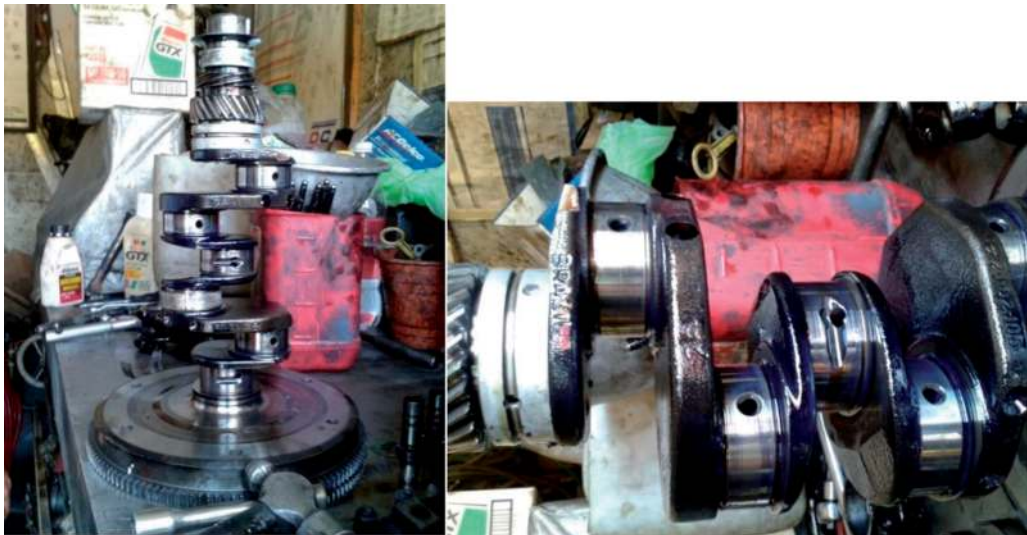
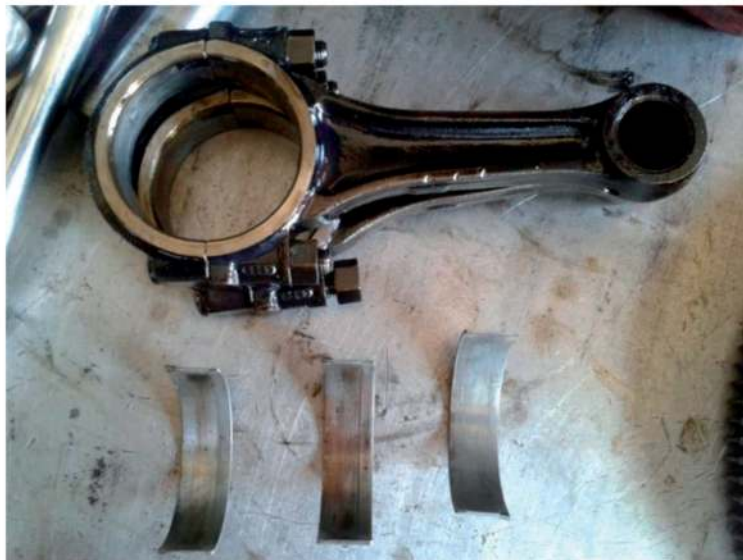
The tribological characterization of the connecting rod bearings was carried out once the worn bearings were extracted from the internal combustion engine. It was possible because the car engine was adjusted. It is important to mention that these bearings had a service life of approximately 8 years. In **Figure 2a–c**, it is possible to observe the complete crankshaft, the connecting rods, and a few worn bearings after disarming.

Figure 2.
Adjust of car engine: (a) and (b) crankshaft and (c) connecting rods and bearings.

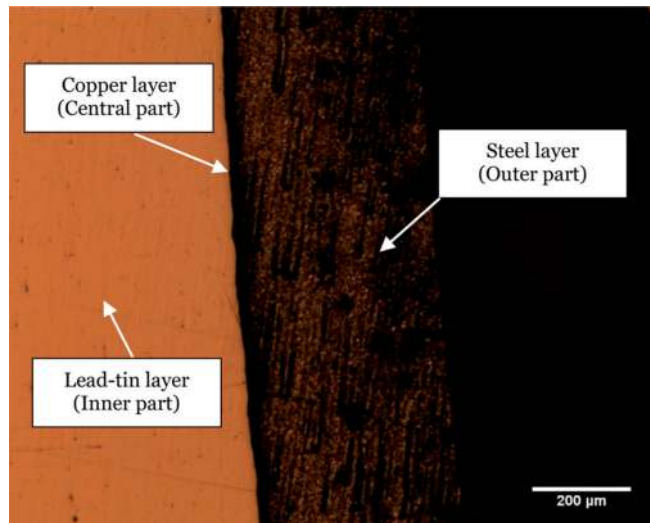
Hardness tests were carried out using a nanoindentation tester (TTX-NHT, CSM instruments). Ten hardness data from three different areas of the cross section of the bearing were calculated for each section, and an average value was obtained. The sections that were analyzed are shown in **Figure 5**. The applied load was 100 mN, the loading and unloading speed was 200 mN/min, and the duration of the measurement was 10 sec. In addition, the Young's modulus of the three different areas of the bearing was calculated as indicated in **Figure 5**. The microhardness results are presented in **Table 1** and **Figure 6**; the highest value corresponds to the outer layer of steel that is the one that makes direct contact with the rod body. In respect to the hardness of the central part, the values are very close to those of the outer layer, although this could be due to the use of copper or aluminum alloys which leads to a hardness increase. Of course, in the case of the inner layer, which is the one with the lowest hardness value, this corresponds to the Babbitt metal layer (lead-tin) that makes direct contact with the rod bearing journals from the crankshaft.

Figure 5.
 Cross section of an unworn bearing.

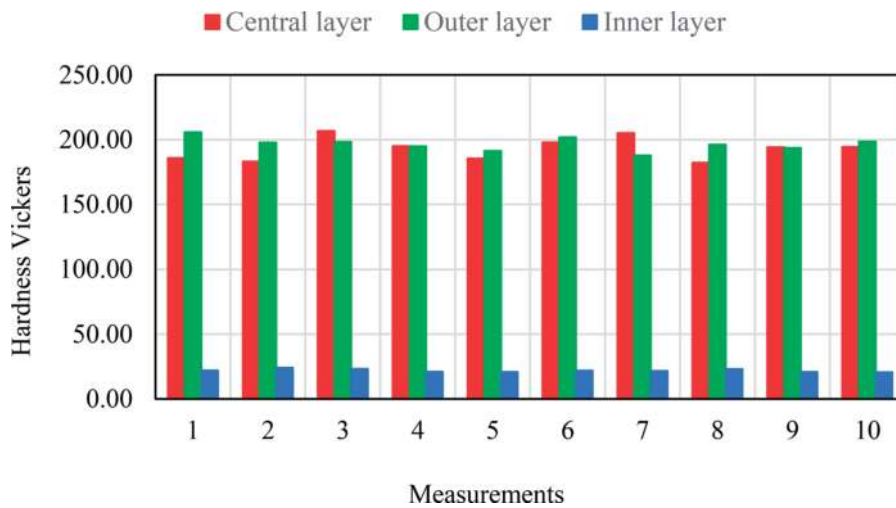
Measurements (10)	Central part (HV)	Outer part (HV)	Inner part (HV)
Average value	192.97	196.61	21.89
Standard deviation	8.75	5.11	1.20

Figure 6.
 Hardness measurements in different areas.

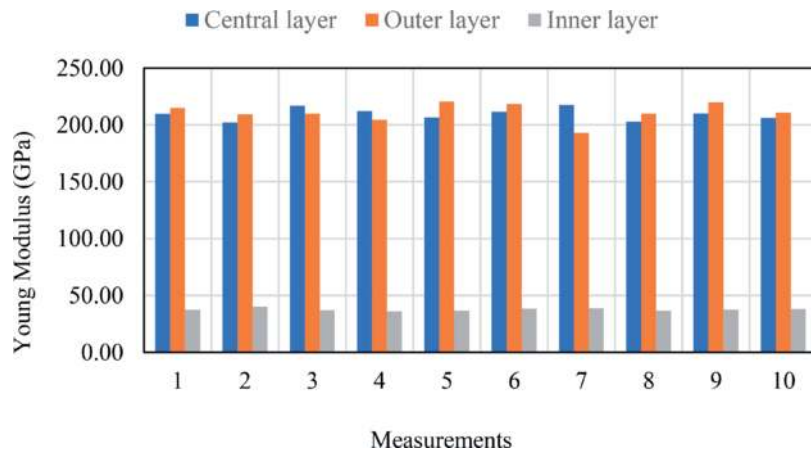
Measurements (10)	Central part (GPa)	Outer part (GPa)	Inner part (GPa)
Average value	209.56	211.19	37.67
Standard deviation	5.32	8.19	1.26

Figure 7.
Young's modulus measurements in different areas.

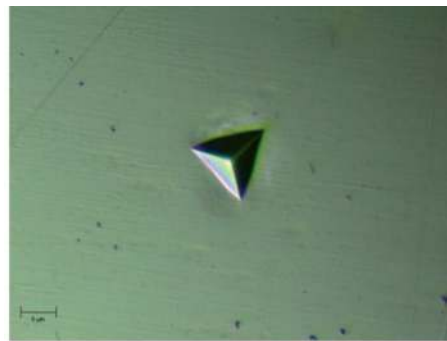
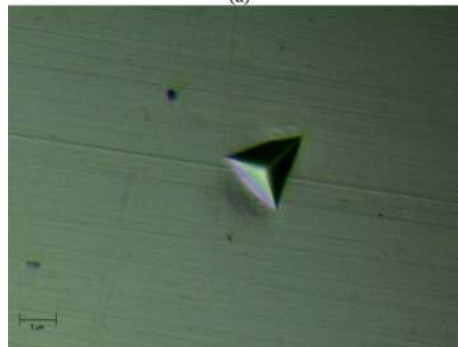
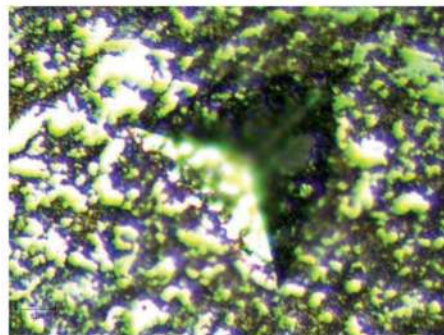
The results of the Young's modulus or modulus of elasticity (E) are shown in **Table 2** and in **Figure 7**. **Figure 8a–c** shows the traces of the pyramidal penetrator on the surface of the bearing in each of the examined areas.

Figure 8.
Hardness Vickers indentations, (a) central part, (b) outer layer, (c) inner layer.

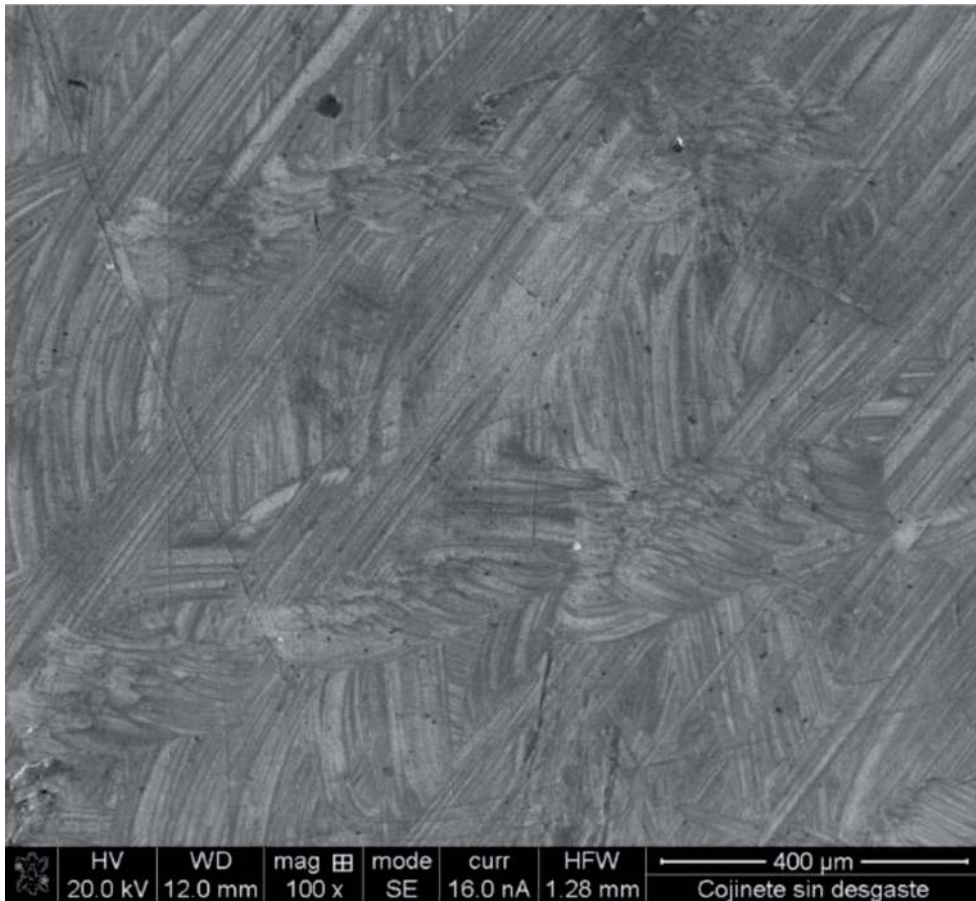
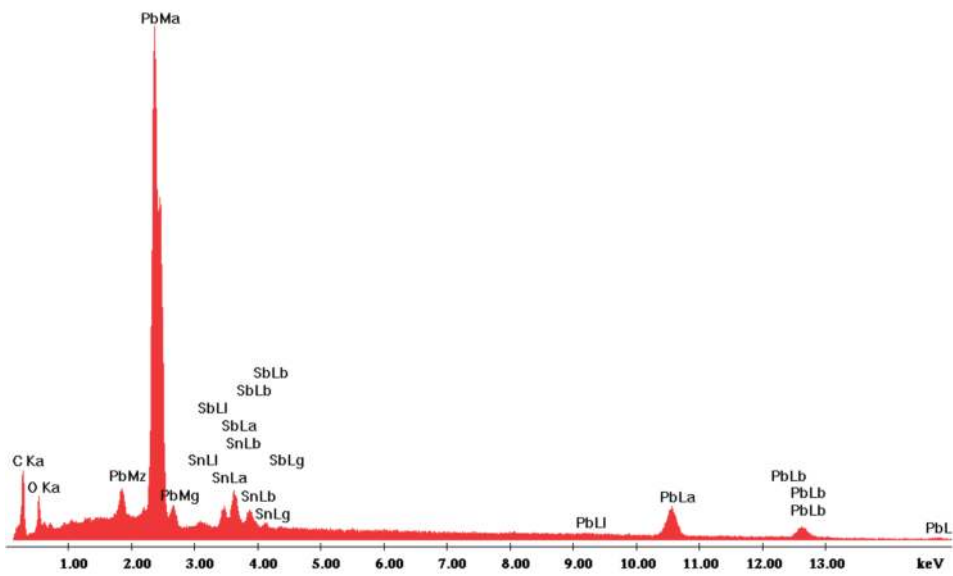
The chemical analysis was carried out using a scanning electron microscope model FE SEM JEOL JSM-7600F that can reach magnifications of 25× to 1,000,000× (see **Figure 11**). The unworn surface and the chemical analysis of the rod bearing layer that makes direct contact with the rod bearing journals from the crankshaft are shown in **Figure 12a** and **b**. Chemical elements such as C 20.86, Pb 60.05, Sn 3.89, and Sb 6.7 Wt% identified in the unworn surface.

Figure 12.
(a) Unworn rod bearing surface and (b) EDS analysis.
