# BUILT HERITAGE IN POST-DISASTER SCENARIOS

IMPROVING RESILIENCE  
AND AWARENESS TOWARDS  
PRESERVATION, RISK MITIGATION  
AND GOVERNANCE STRATEGIES

PROCEEDINGS OF THE 1ST EDITION OF THE INTERNATIONAL SUMMER SCHOOL  
“AFTER THE DAMAGES”, FERRARA, ITALY, 1-15 JULY 2020

# Built Heritage in post-Disaster Scenarios

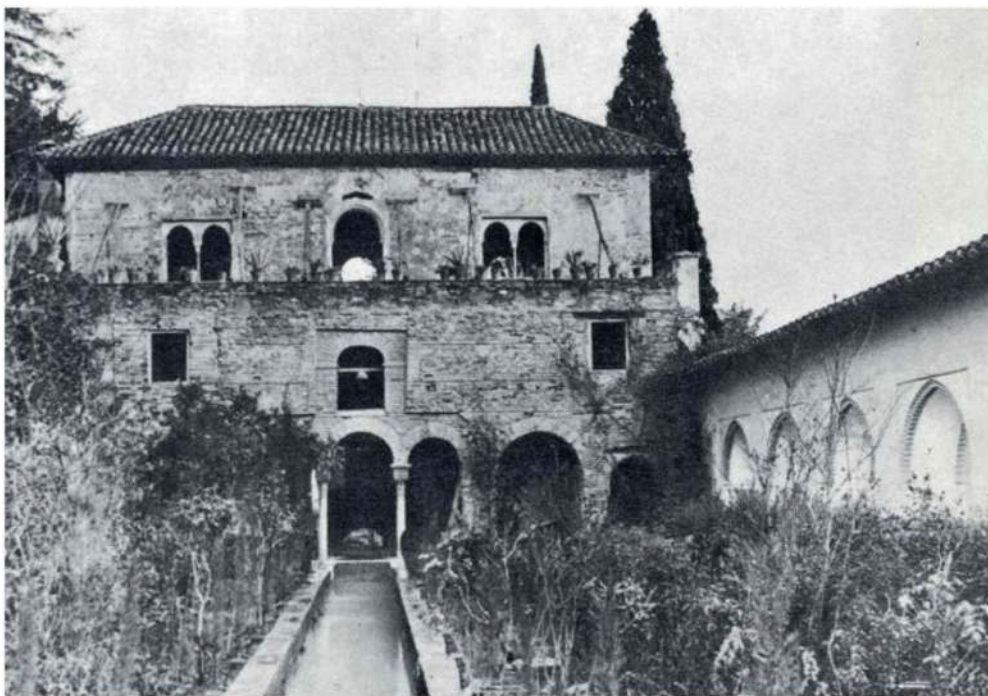
Figure 7. View of fire on december 1958 at Patio de la Acequia.

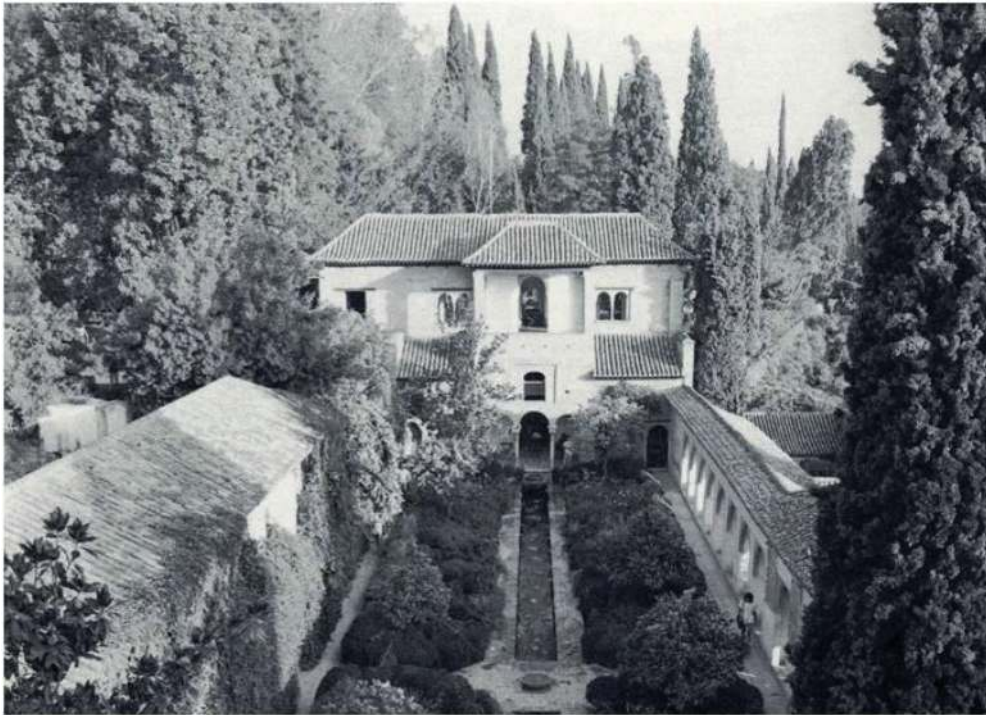
Figure 8. View of fire on december 1958 at Patio de la Acequia.

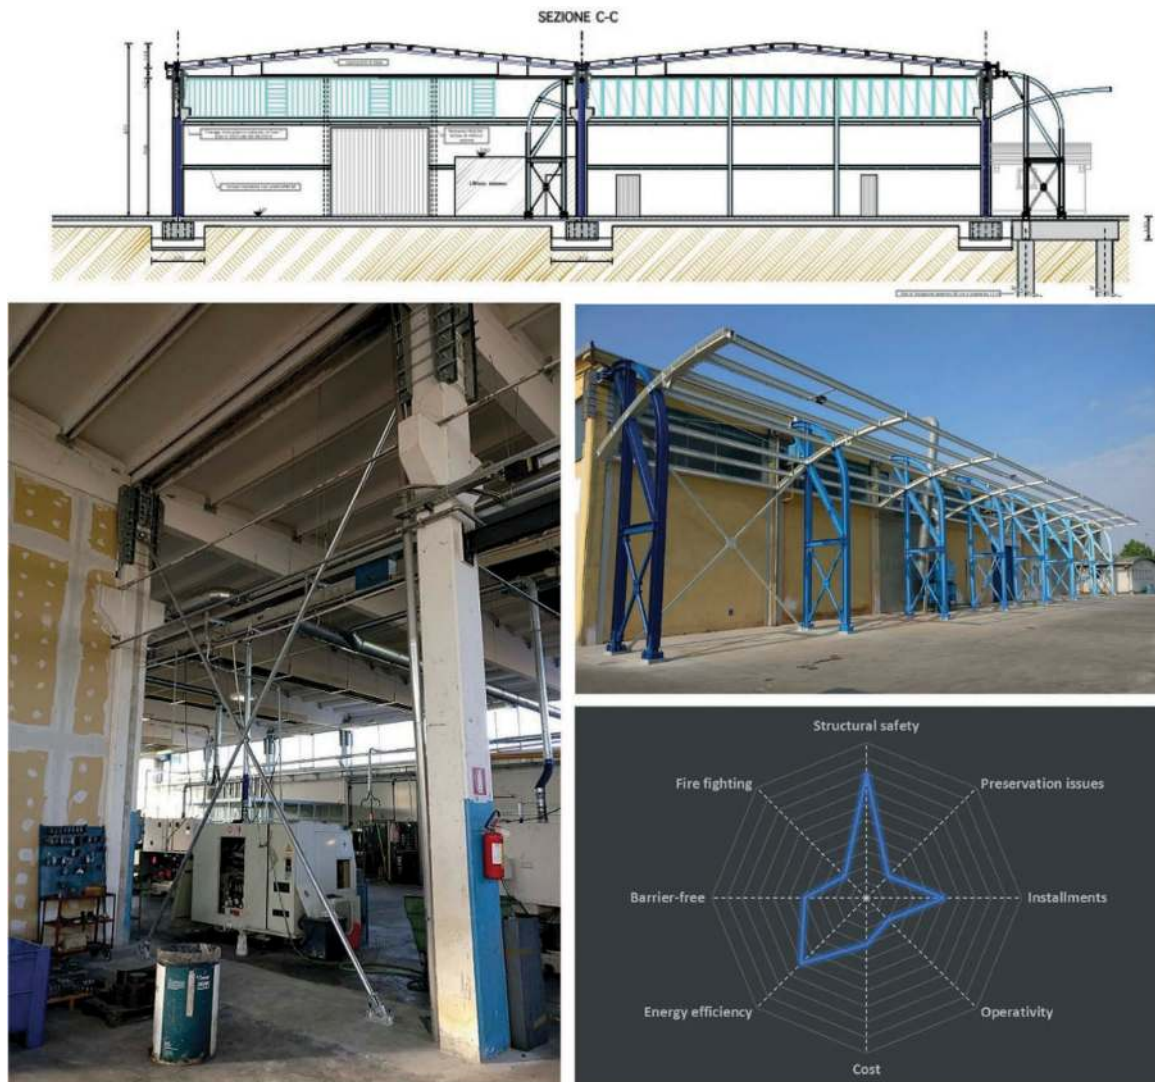
Figure 7 . Industrial prefabricated structure. The proposed seismic improvement solution can be considered optimal in terms of safety, as the creation of a system of external metal bracing system can, if properly sized, potentially allow the seismic safety of the structure to be updated, but at the price of creating thermal bridges and reducing the functionality of the building due to the size of the braces. There are also no benefits in terms of fire protection, since the material used is steel, which is very sensitive to high temperatures unless treated expensively, and there is no improvement in terms of plant, for which it may even be an obstacle, or with which it could interfere. Such a solution can therefore ideally fall on the Pareto side, which is concerned only with the costs and benefits in terms of seismic consolidation, not with other aspects.

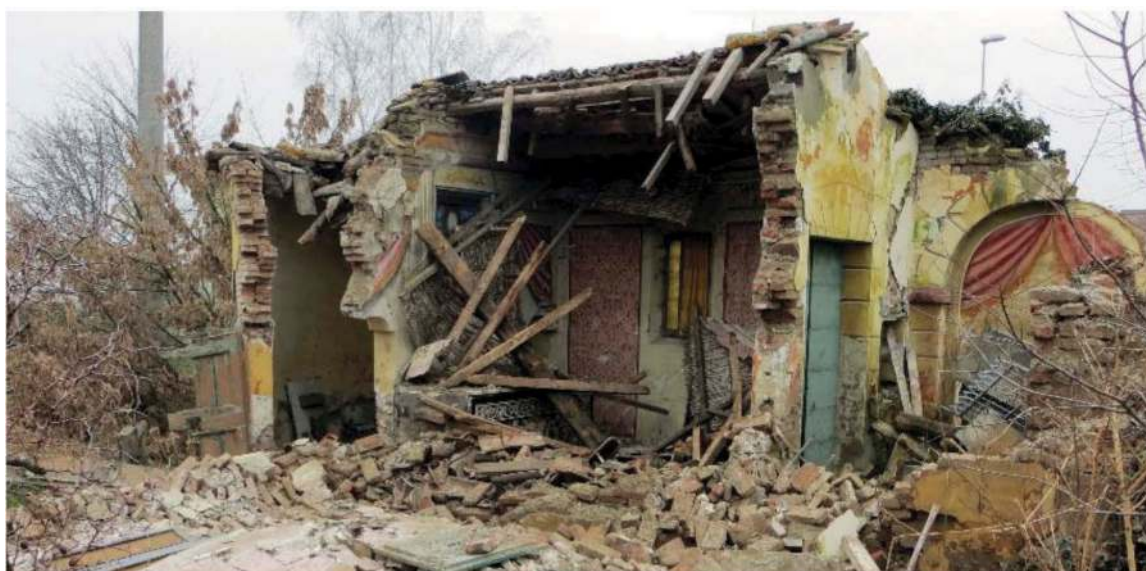
Figure 1. Mirabello, Ferrara. The Oratory of the Beata Vergine di San Luca, safety procedures and reconstruction in a single phase.

Following this phase was a phase of more extensive temporary interventions, aiming for more long-term results, based on designs by structural engineers and architects; this was a particularly delicate phase, which, despite the temporary nature of the works designed to support the wall structures, entailed attention to detail and a long-term vision for the buildings involved: as well as the walls and horizontal elements, the conservation of the remains also included decorations, existing flooring, altars, and anything else significant in terms of architecture.

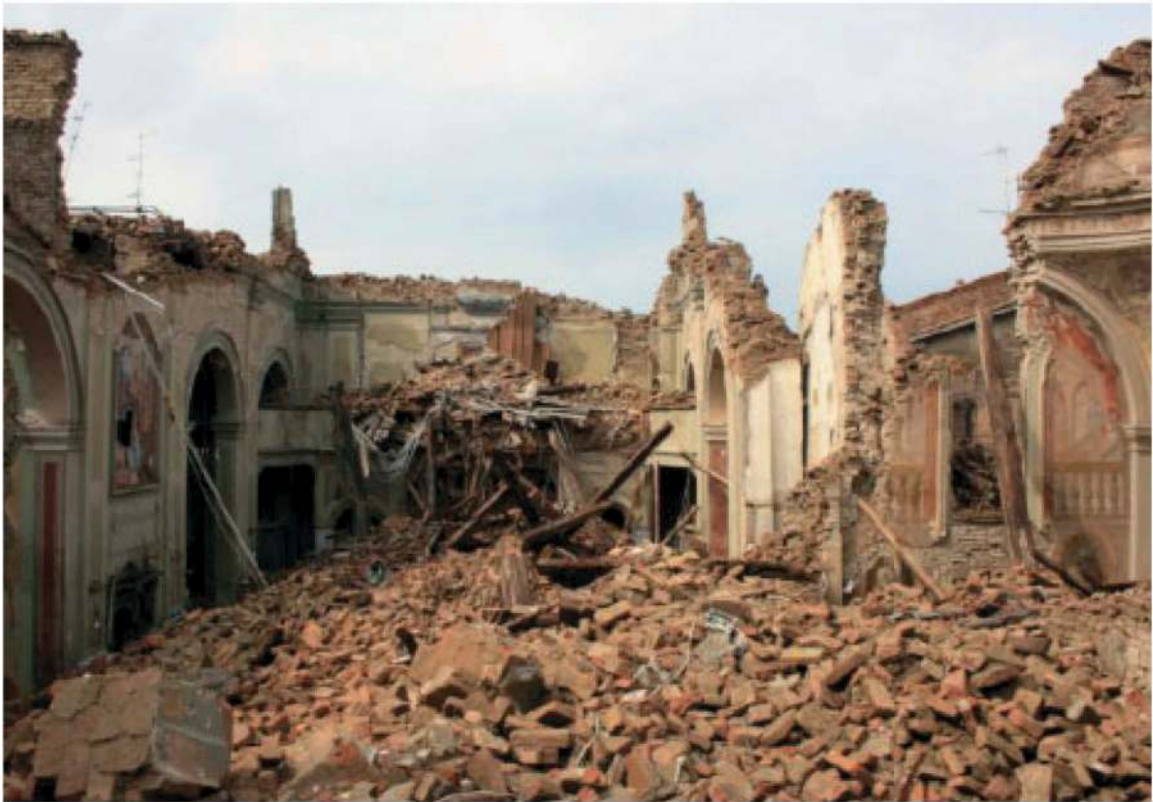
Figure 3. The parish church of San Felice sul Panaro following the 2012 earthquake.

The earthquake caused the church to collapse almost entirely, saving only the lower order of the facade, part of the side chapels and a small part of the apse, while the bell tower, entirely lost apart from a fragment at the base, collapsed into the nave. Clues to the disastrous event can be seen in photographs, which clearly show how the higher walls were built with very weak, unresistant mortar, and they lacked the correct interweaving and restraints. The enormous amount of rubble is also noticeable, measured at 1690 cu. m<sup>2</sup>.

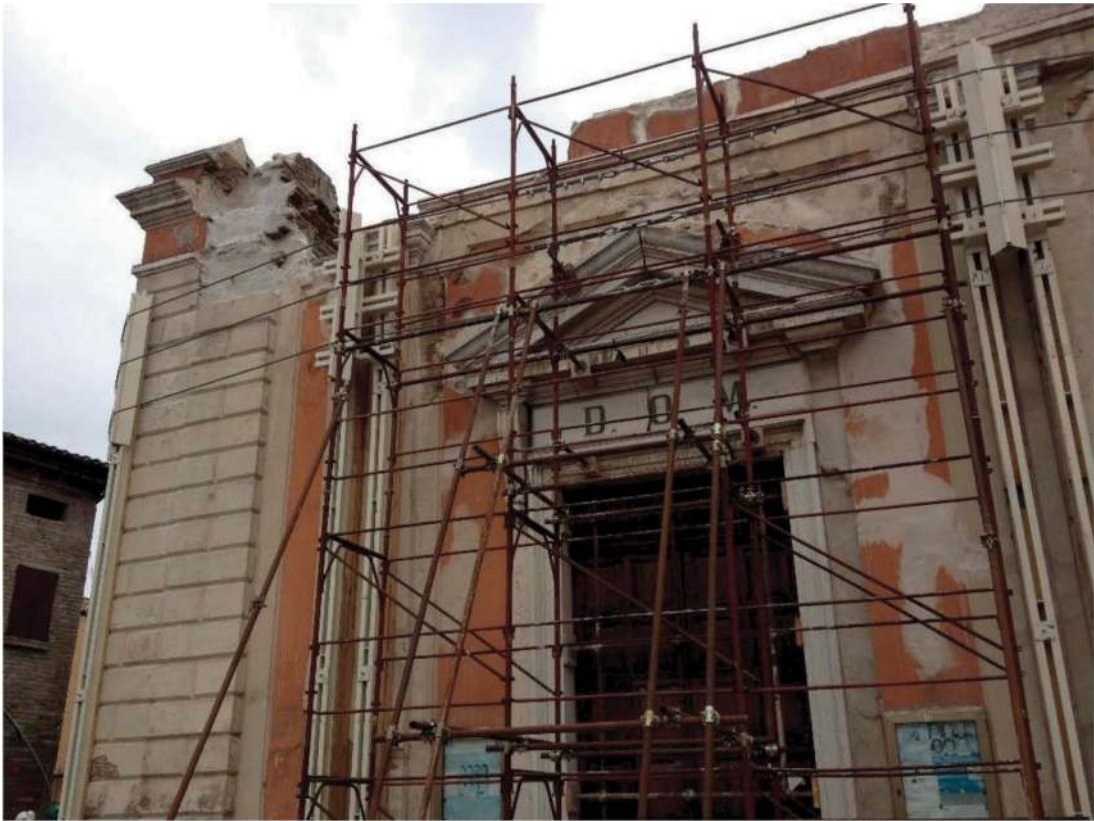
Figure 4. The first phase of securing the Church of San Felice: the scaffolding framework to prevent the overturning of the walls.

In order to secure and guarantee the possibility of reusing the little that remained of this church, for which reconstruction was planned, a strategy was prepared for coordinated, gradual interventions spread out over time. In the days immediately after the earthquake on the 29th May, actions were taken to carry out the interventions needed to prevent the right-hand chapel walls and the facade from collapsing outwards into public space.

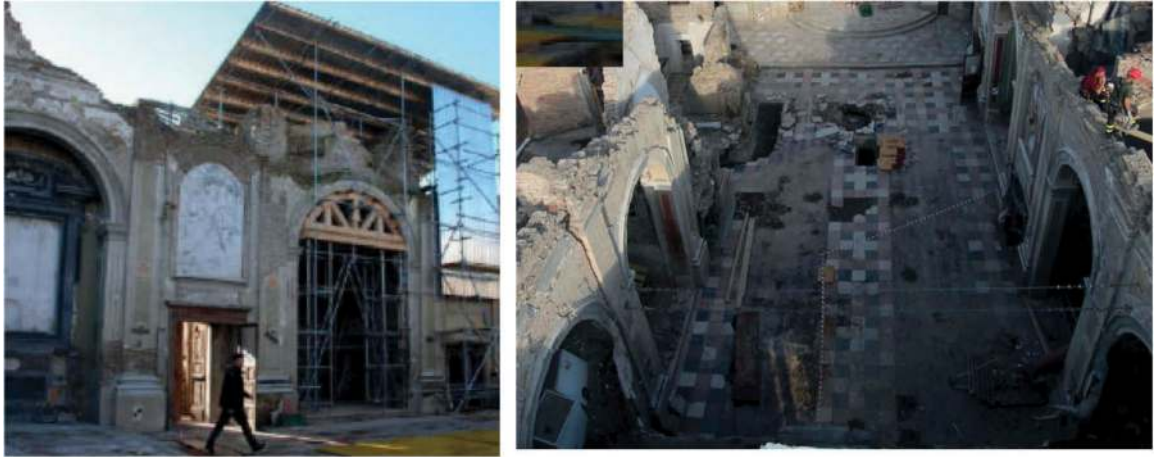
Figure 5. The second phase of the provisional works in the church of San Felice sul Panaro: removal of rubble, shoring of the collapsing walls, partial coverings to protect the decorated areas.

In order to proceed with a more structured phase of interventions, it was necessary first to address the issue of the rubble scattered around outside, especially in the piazza, where a large number of the buildings facing the church had also collapsed, and above all inside the church, where the floor was covered in layers of bricks ranging from one to three metres high. This work was carried out, partly due to the precarious state of the remaining structures, by a specialised group from the National Fire Brigade, with the assistance of archeologists to

examine the materials moved, and recover stone architectural elements and valuable parts of the altars and flooring. Gradually, as the rubble was removed, the localised protection aimed at supporting what was left of the building was carried out. Gradual work and containment measures developed with great care for each part freed from the rubble were the key concepts in this highly delicate phase of the project, which also involved temporary coverings for two chapels and the remains of the central altar, in order to protect the remains of wall decorations, stucco and elements of value.

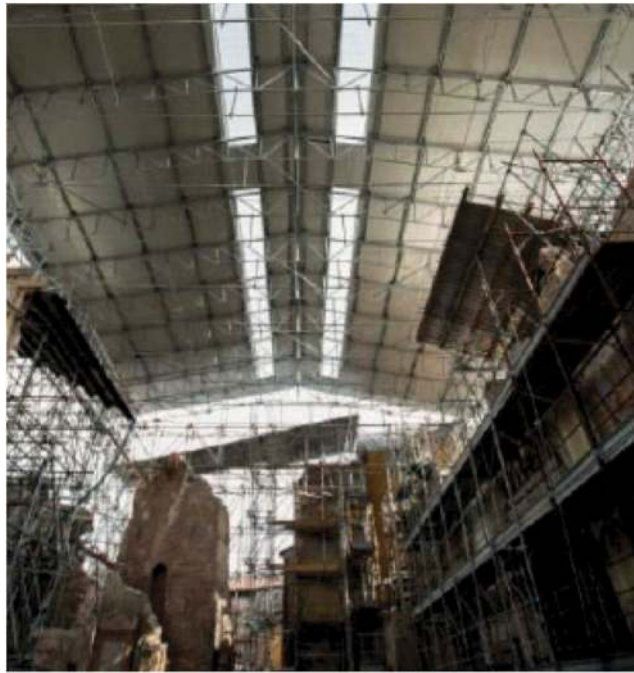
Figure 7. Third phase of the provisional works in the church of San Felice sul Panaro, project of the provision.

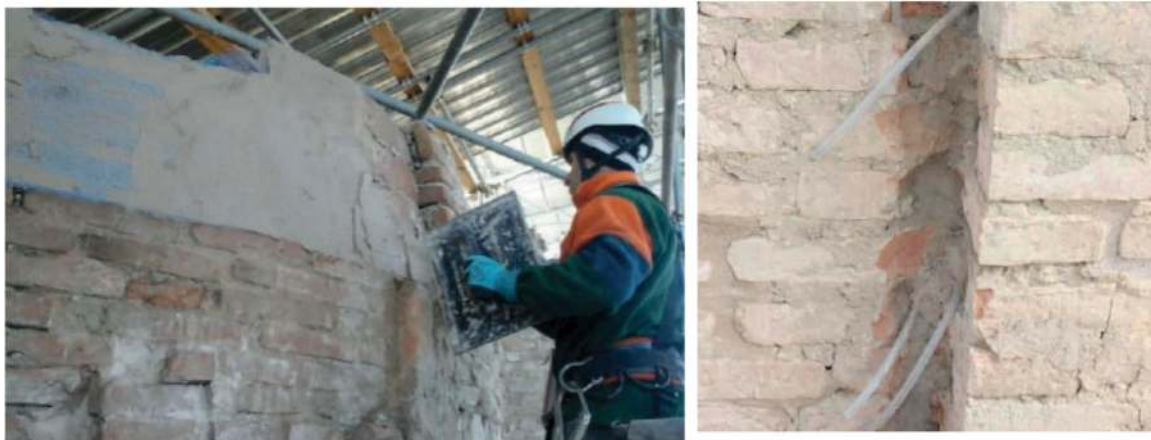
Figure 8. Church of San Felice sul Panaro: thorough operations of masonry walls consolidation.

The disastrous level of damage meant that the reconstruction of the church could not be completed in a short timeframe, so a third, final phase of temporary interventions was planned<sup>3</sup> to fully protect the remains of the hall from the elements, and at the same time consolidate the walls that were still standing. One of the purposes of the covering was to make the space visitable, so the main support structures, made from metal framework, were only placed along the sides of the nave and in the exterior spaces between the chapels, with the covering itself positioned along the slopes of the clerestories. The valuable natural stone flooring, which re-emerged from the rubble with many holes, cracks and deformities and will have to be restored, was protected with rigid panels. Meanwhile, on all the wall structures, which were in a precarious state because of both the original low construction quality and the disconnections and damage caused by the earthquake, an extensive intervention of consolidation was carried out through an integrated series of injections of liquid mortar, small wall reconstructions, and resolidification of some sections with fibre-reinforced mortar.

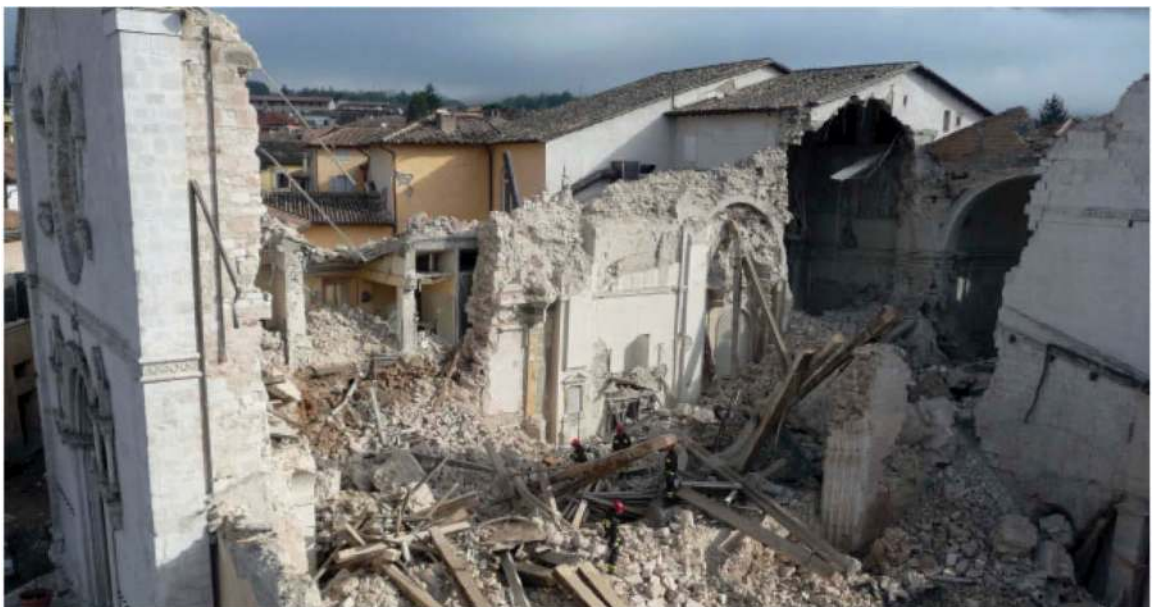
Figure 10. The Basilica of San Benedetto in Norcia following the 2016 earthquake.

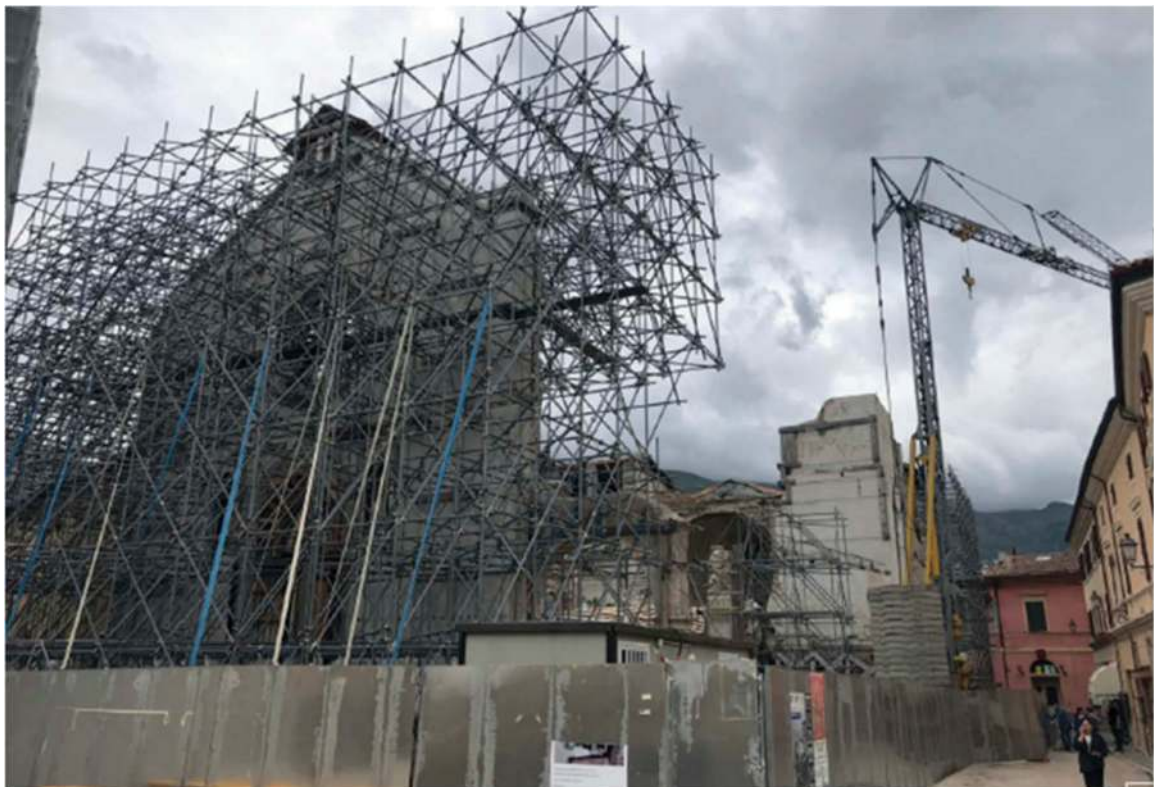
Figure 12. The metal scaffolding framework of the Basilica of San Benedetto.

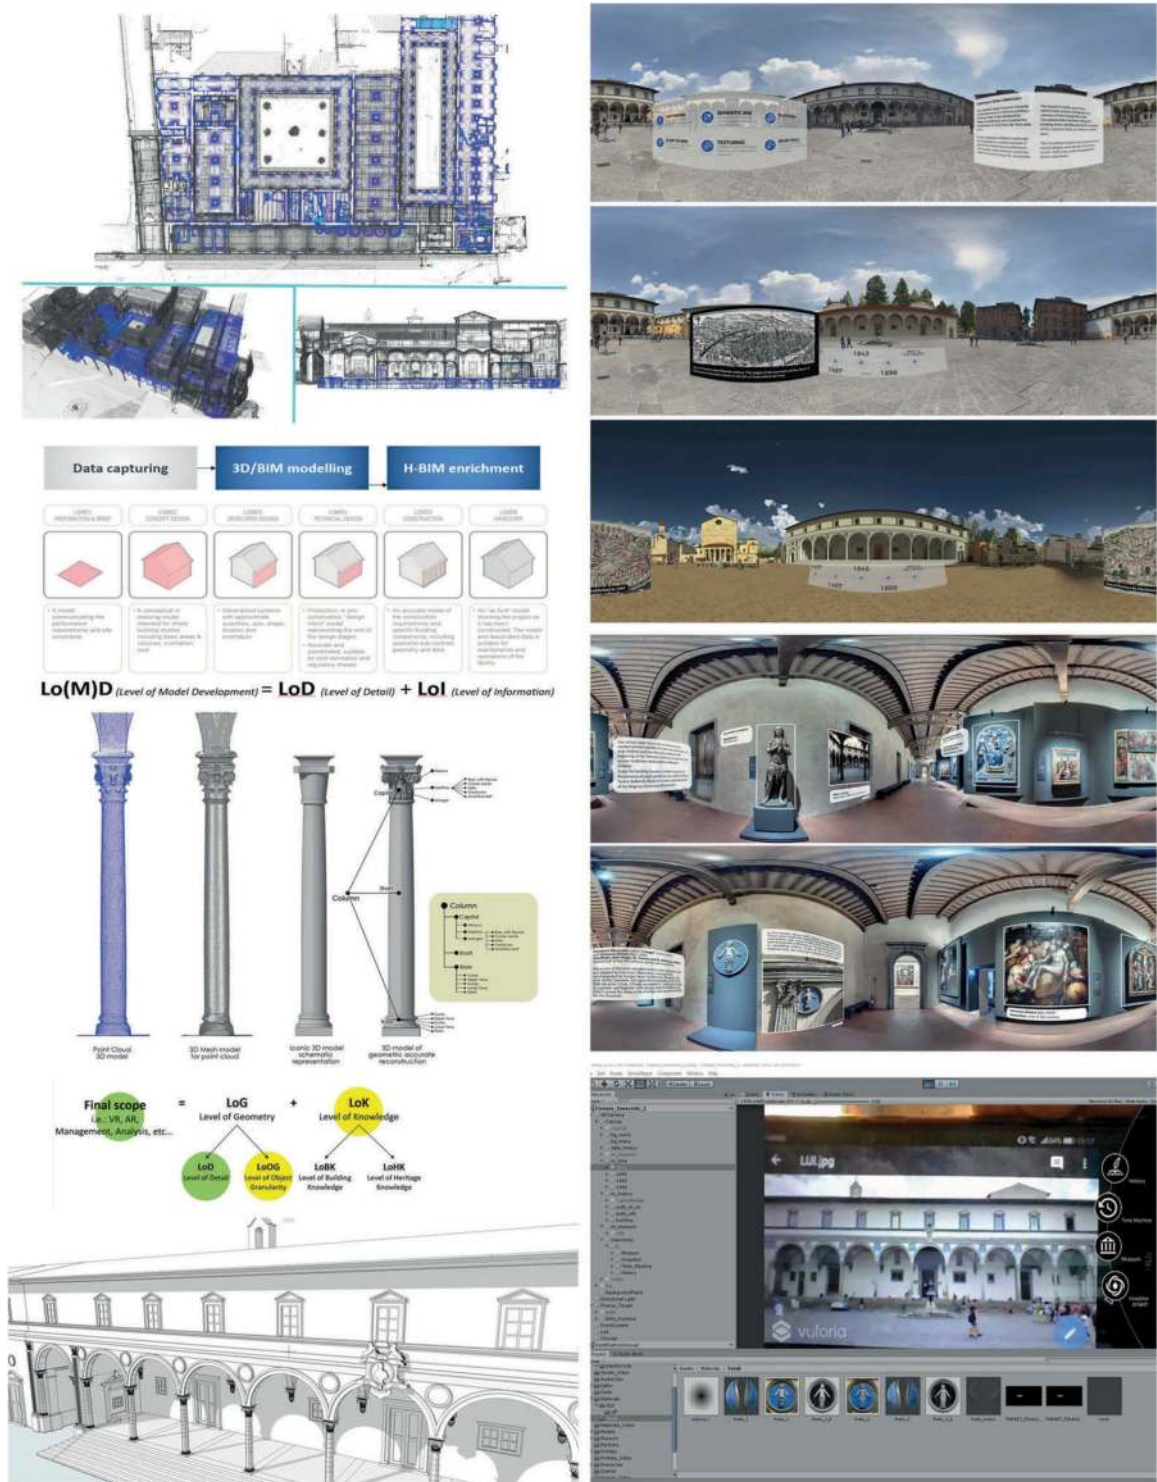
Figure 1. The overall INCEPTION approach: from the data capturing to the 3D BIM modeling and data access and re-use in VR&AR app for different users. The approach is made possible by INCEPTION semantic technologies for managing, visualizing and archiving 3D Building Information Models (BIM), together with all the related digital documents.

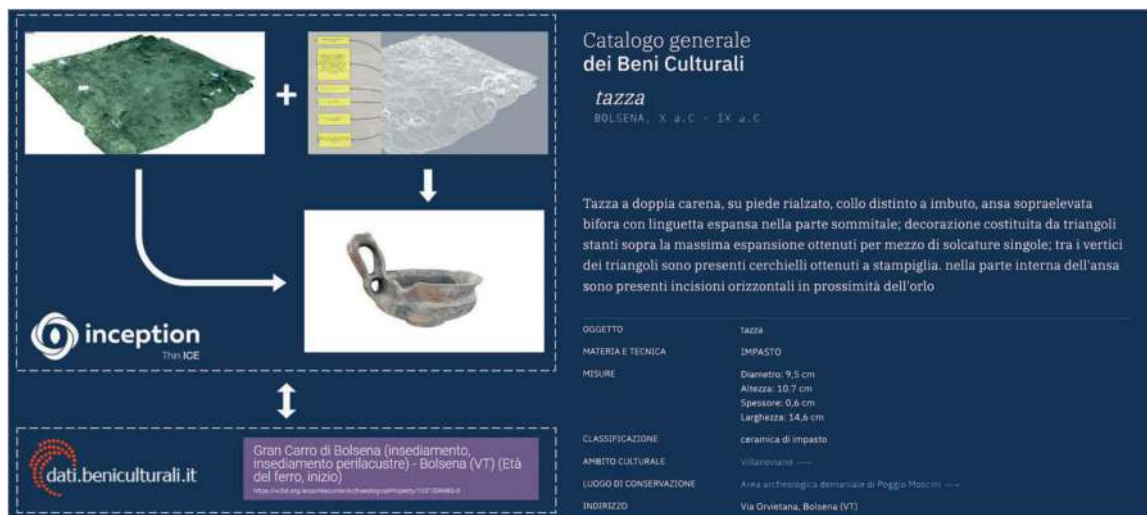
Figure 4. A schema of the re-use of INCEPTION technologies for the archaeological site of the Gran Carro at the Bolsena Lake. Textured Mesh Models and Information Models are merged together for allowing the users to access engaging 3D models while at the same time having also access to cataloguing information stored in the ICCD archive.

Furthermore, must be noticed that 3D models of the findings, as mentioned before, are themselves among the information that could be attached to a 3D model of an excavation. From the perspective of technicians or researchers, having access to such models can help you to better understand the excavation process, where artifacts were found and their value. Even in this sense INCEPTION technologies provided a solution for hosting 3D models of artifacts, directly linked to the position where they were found.

Last but not least, based on the name given to each single object of the 3D information model, a live query has been developed for retrieving all the pieces of information on the ICCD catalogue directly within the platform. This was feasible only because of the Semantic Web technologies used by both systems and opened up to a still unexplored enrichment exploiting external data source.

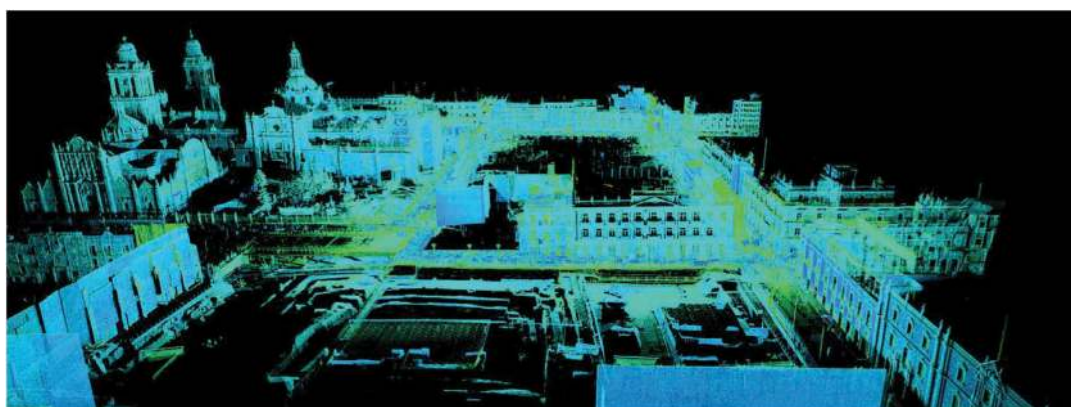
Figure 1. Point Cloud obtained from the laser scanner survey, showing both the block analyzed and the monuments surrounding it: The Cathedral and the excavation of the main Aztec Temple.

The paper analyzes the opportunities offered by integrated digital surveys, made with different methodologies, mainly 3D laser scanners and photographic shots with SFM processing, for documentation and diagnostics aimed mainly at the conservation and restoration of architectures. At the urban scale, the survey focuses on the documentation of the urban facades and pays particular attention to the analysis of the plastic deformations and of the masonry walls, in order to evaluate the misalignment value of the fronts of the buildings from the vertical plane and the interactions between the walls of different building units. Going down from the scale of detail to the architectural detail, the restitution and analysis of individual building units was also studied, closely linked to the asset value of the area; attention was focused on the survey for the documentation, the analysis of the state of structural conservation, reaching as far as the identification and classification of the lesions, the verification of the main failures of the structures and any states of risk of collapse.

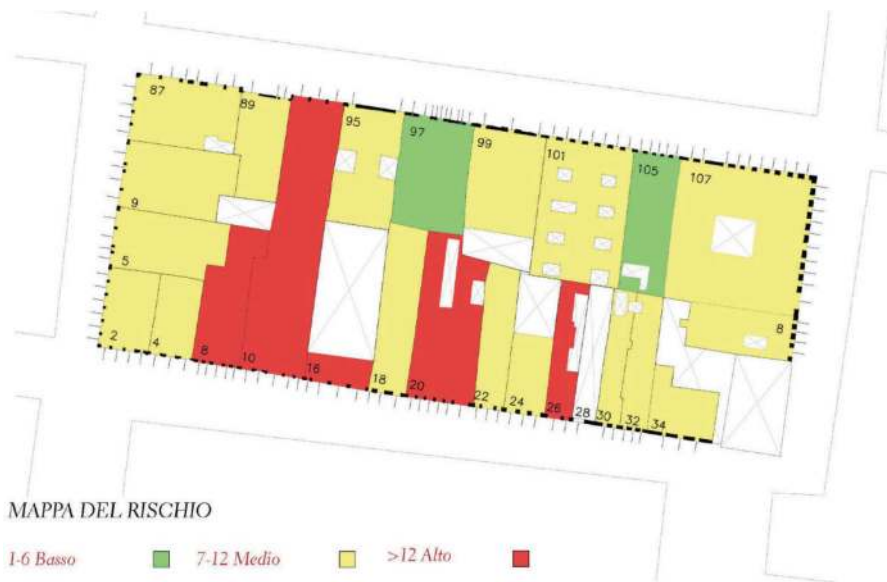
Figure 6. Final vulnerability risk scheme of all the building unit.

set of all buildings behaves (Minutoli, 2017a). It was important to take into account, in choosing the parameters useful for assessing vulnerability, a series of overall factors that put the single building in relation to the conditions it finds around it, such as the presence of internal courtyards (structural voids) within the block; the way in which the buildings flank each other (and therefore the horizontal stresses are supported and transmitted) and the ratio between the heights of the floors between the buildings. In the same way it was important to keep in mind all the data coming from the threedimensional survey and therefore the plastic deformations of the facades (the inclinations coming from the elevation maps) and the angular deformations that the elevations have accumulated in their history studded with numerous seismic events. Other data were instead deduced from the direct analysis of the buildings and were able to bring out considerations related to the materiality and the state of conservation of the facades and buildings which finally made it possible to carry out a rapid analysis but which took into consideration a sphere of aspects very different from each other. To evaluate the structural conservation status of the facades of the historic center, it was necessary to take into consideration a certain number of factors, which could be identified in all the elevations analyzed both thanks to the morphological data coming from the architectural survey and from the direct observation of the buildings. These factors were collected by fields, the values of which were categorized in order of danger; the sum of the values attributed to the fields made it possible to attribute to each card a vulnerability value which expressed the risk to which the building is subjected. The final risk value was divided into three macro-groups, which express a high, medium or low value (Minutoli, 2017b).

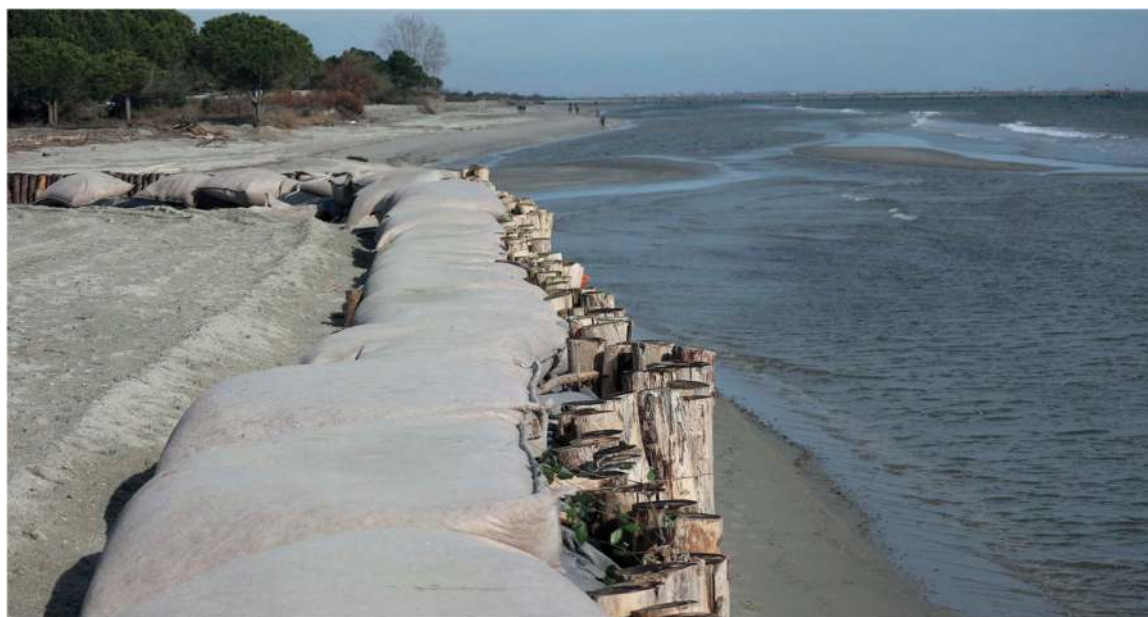
Figure 2. Coastal defense works with wooden stilts and sand bags trying to prevent beach erosion in Lido di Volano, Ferrara. In the background, dune and pine forest relicts (source: photo by R. Frainella, 2019).

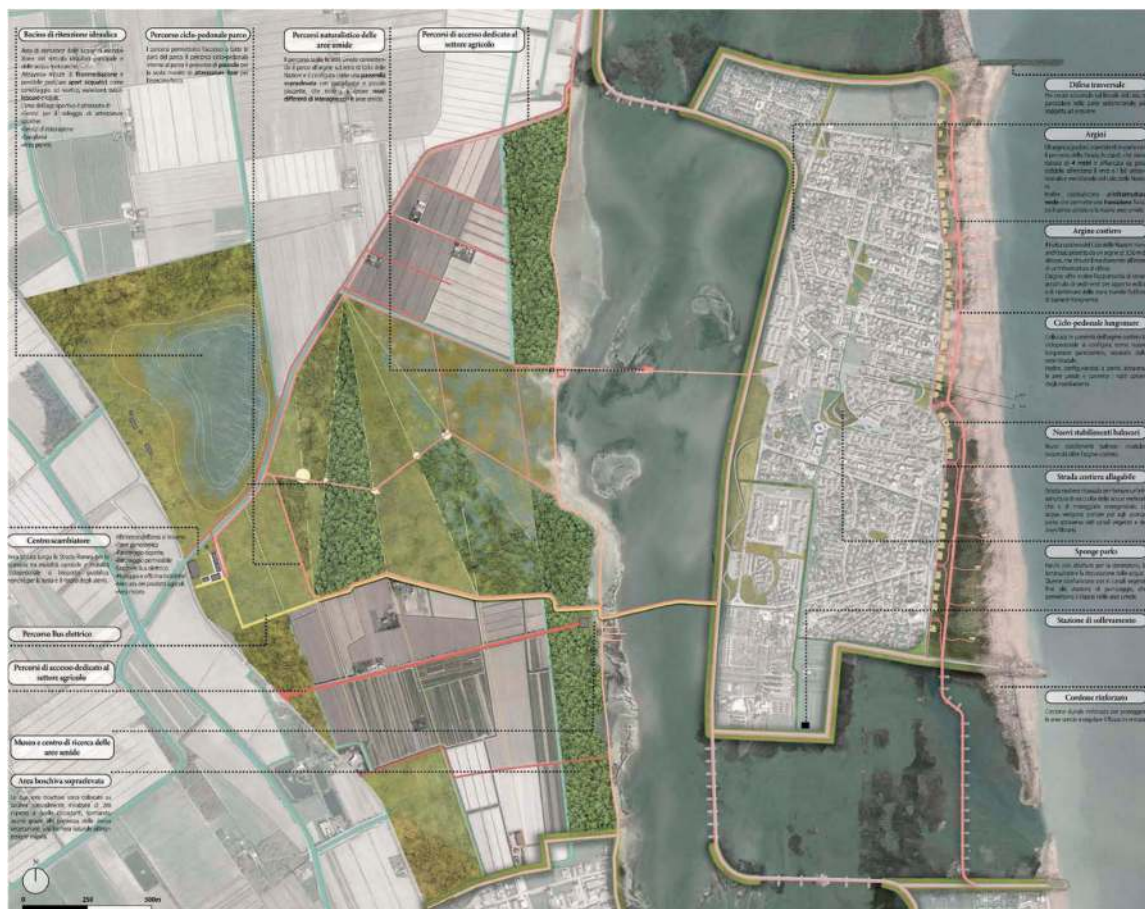
Figure 4. A vision for the selective fooding of the areas around Lido delle Nazioni, Ferrara, and the creation of a new wetland recreational park (source: Master's thesis by I. Biondi "La Città del Delta", DA UniFE a.a. 2019- 20, tutor Prof. R. Farinella and Prof. E. Dorato, co-tutor Prof. G. Lobosco).

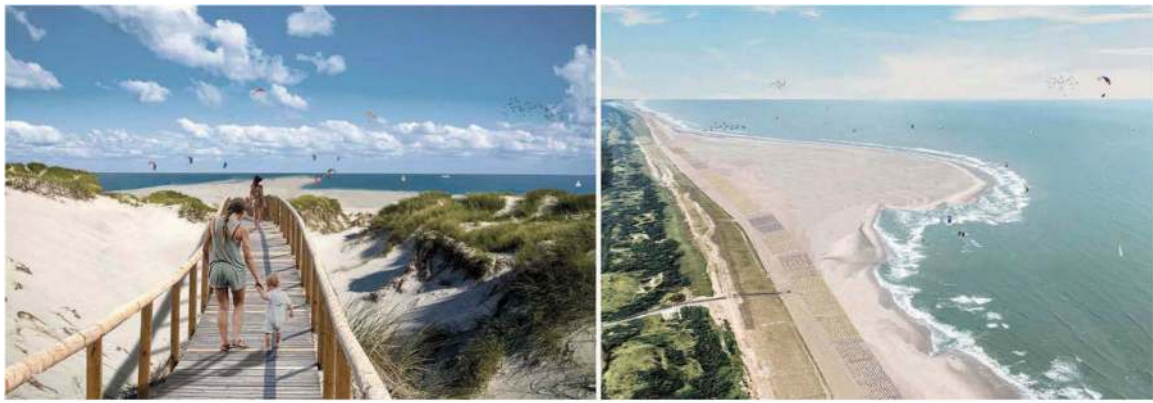
Figure 5. Possible new morphological structure for the north coast of Ravenna: reconfiguration of the protection dune system and creation of a sand motor for a dynamic conservation of the coast (source: Master's thesis by G. Lazzarini, A. Montanari "Sistemi in Evoluzione", DA UniFE a.a. 2019-20, tutor Prof. E. Dorato, co-tutor Prof. R. Farinella and B. Giambastiani).

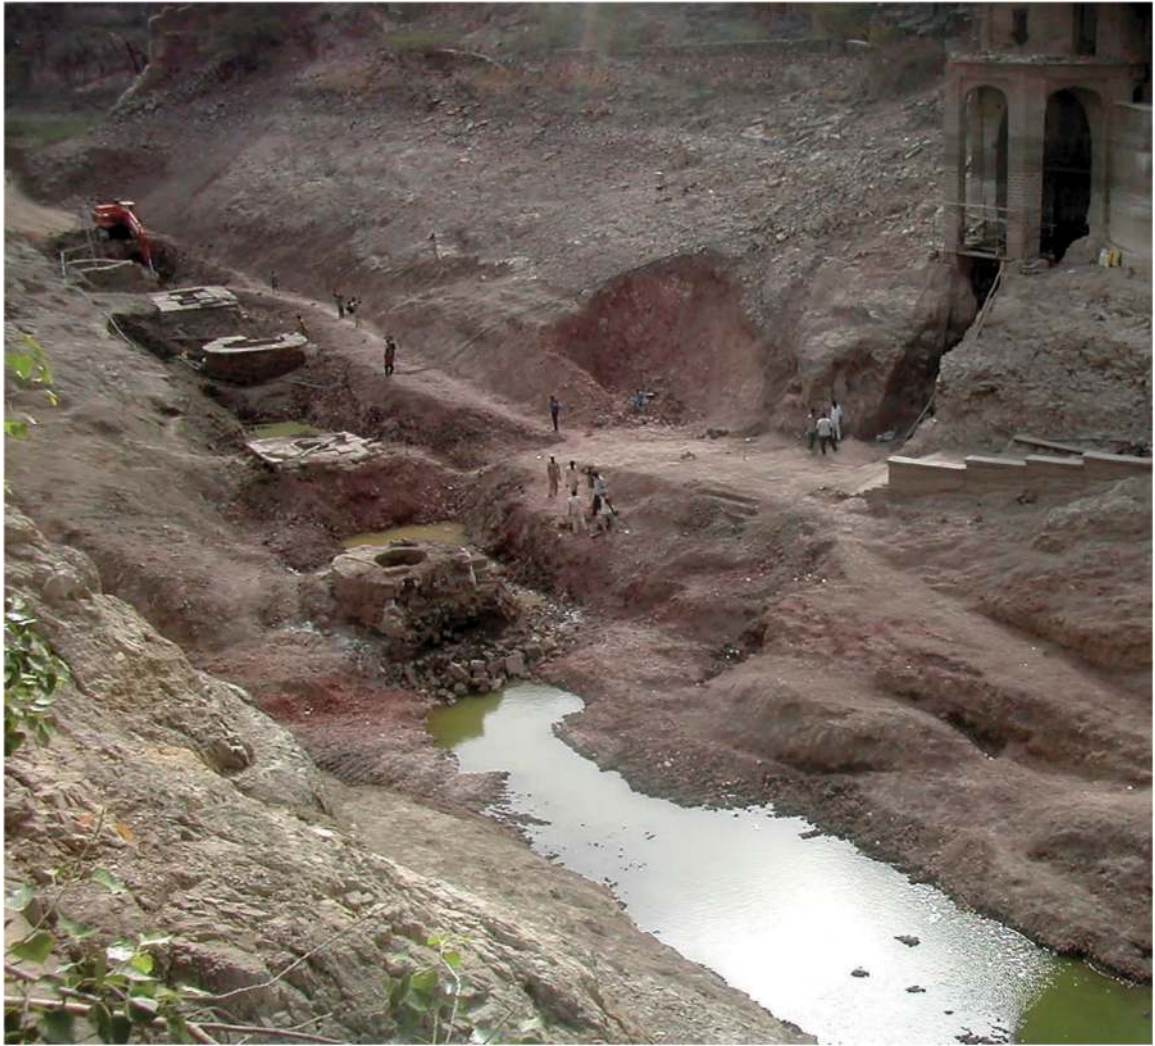
Figure 3. Ranisar beris.

number and pattern of the steps, the riser and treads, etc. were not predetermined. The transition between the natural and the humanmade is blurred, gradual and reflects the ambiguous edges resulting from varying rainfall. It was a relationship of negotiation, working with the uncertainties of nature.

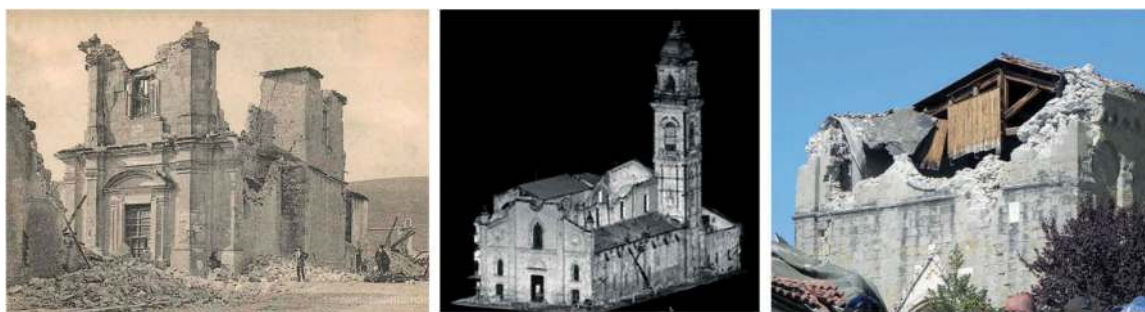
Figure 1. The overturning of the faade is one of the most recurring damage mechanisms in masonry churches: here just some examples taken from different Italian earthquakes in the last century: from left to right, 1915 San Giovanni Church in Avezzano (AQ), 2012 Santa Maria Maggiore Church in Mirandola (MO), 2016 Church in Amatrice (RI).

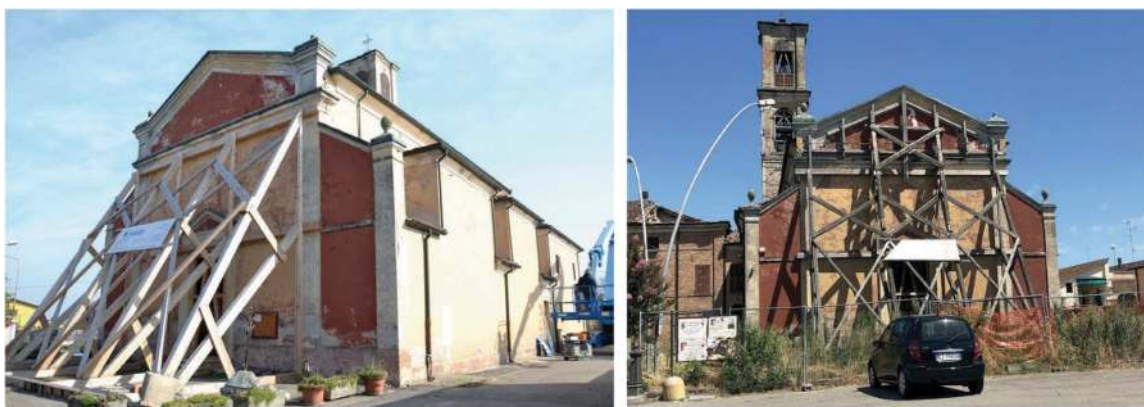
Figure 3. San Michele Arcangelo Church in Bomporto (MO): on the left the wooden rakers installed in 2012, on the right the worsened conditions of the same interventions in 2019.

shoring systems with structural scaffoldings and timber rakers or hooping systems with steel wire ropes were the most used techniques. Against shear mechanisms, the main intervention consisted in the realization of timber frames for shoring the openings, sometimes followed by the cracks refill aimed at restoring the masonry structural continuity. Anyway, no particular correlation between the securing technique and the level of damage has been detected in the 19 analysed cases. Figure 3 shows an examples of timber rakers, mostly used by the Civil Defense and Fire Brigade Teams. This technique allows to quickly secure buildings with low costs but, on the other hand, it requires large spaces in front of the building and easily deteriorate under whether conditions, losing their effectiveness against new shocks. Moreover the material can't be reused.

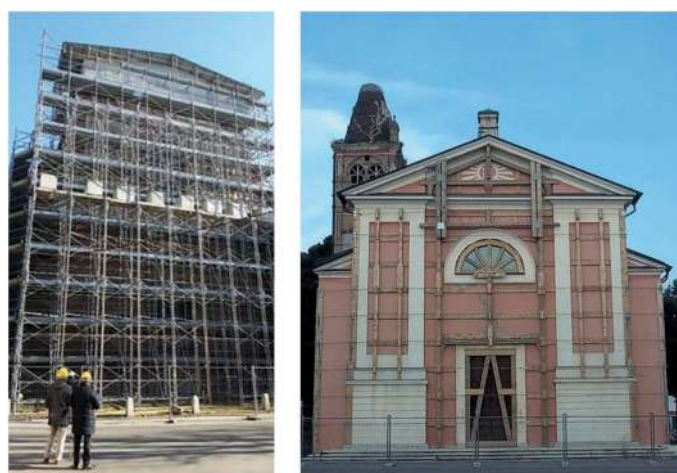
Figure 4. On the left, Jesus Church in Mirandola (MO): the structural scaffolding prevented the overturning of the façade damaged by the Emilian earthquake; on the right, Santa Caterina Church in Rovereto sulla Secchia (MO): the hooping system with steel strands prevented the overturning of perimetral walls.

Structural scaffoldings is another widespread solution for shoring damaged structures. The seventeenth-century Jesus Church, in Mirandola (MO), is an example of this kind of interventions (Figure 4, left). Immediately after the seismic event, a triple scaffolding has been installed around both the façade and the south transept. Dynamic tests carried out by the University of Venice showed the effectiveness of this system. Moreover, after 5 years, in-situ investigations was needed to design the final strengthening project: in this occasion, the scaffolding has become an useful support to investigate the building from a short distance. Anyway this structure could be very expensive. Hooping systems with steel strands, polyester bands or tie-rods are another technique frequently used in the Emilian emergency (Figure 4, right). This system is less cumbersome and less expensive with respect to the aforementioned techniques. Moreover, this devices could become definitive thanks to small adjustments (i.e. changing anchorages or re-tensioning rods

according to current stress conditions). However, precarious safety conditions which prevent to operate close to or inside the structure, or irregularities in the architectural shape may hinder the application of this system.

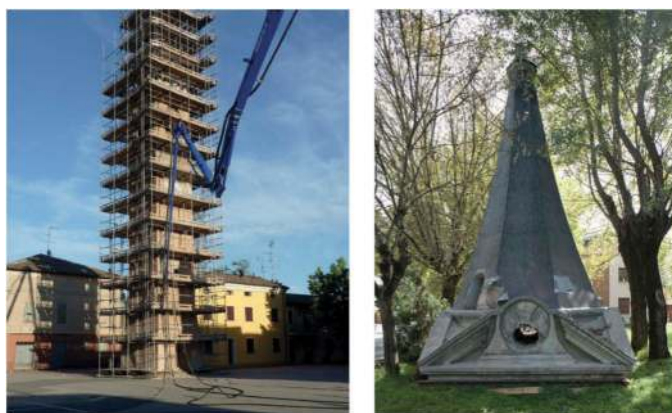
Figure 6. On the left, Sant'Anna in Reno Centese (FE): the isolated bell tower was heavily damaged by horizontal cracks and requires emergency action for restore adequate safety conditions to get close to the building. On the right, Santi Senesio e Teopompo Church in Medolla (MO): in order to prevent the overturning of the bell chamber, the macro-element was removed and conserved in a storage area.

In such a situation, preliminary interventions are usually needed in order to improve safety conditions before getting close to the structure. Then, to prevent the most dangerous collapse mechanisms, the emergency intervention consisted in hooping with steel strands whereas, shoring with structural scaffoldings was mostly used to restore the vertical masonry continuity frequently injured by the horizontal cracks due to hammering phenomena. However, the emergency solution needs to be carefully planned according to the issues of the specific case. For instance, the first aid interventions adopted for the bell-tower of Sant'Anna Church, in Reno Centese (FE), was strongly influenced by the heaviness of damages that prevented from getting close to the structure (Figure 6, left). Because of the precarious safety conditions, a preliminary securing was carried out from distance using Spritz-Beton technology. This first action allowed to get near the masonry applying fiber-reinforced strips for restoring structural stability. However, the removal of this emergency reinforcement, foreseen by the final recovery, was quite invasive for the conservation of the historical surfaces: even if this technique is not expensive, its removal required about the same cost as its application. The first aid action adopted for the trunk strongly influences the technique for securing bell chambers. Hooping systems with polyester bands or steel strands, associated with timber shores for openings and crack refill to recover the structural continuity are usually preferred. For the most dangerous cases, in which the bell chamber is completely detached from the trunk, a scaffolding could be installed to connect the upper part with the lower one or, if the severity of damage is too high, it could be necessary to remove the entire macro-element, storing it for the future restoration (Figure 6, right).

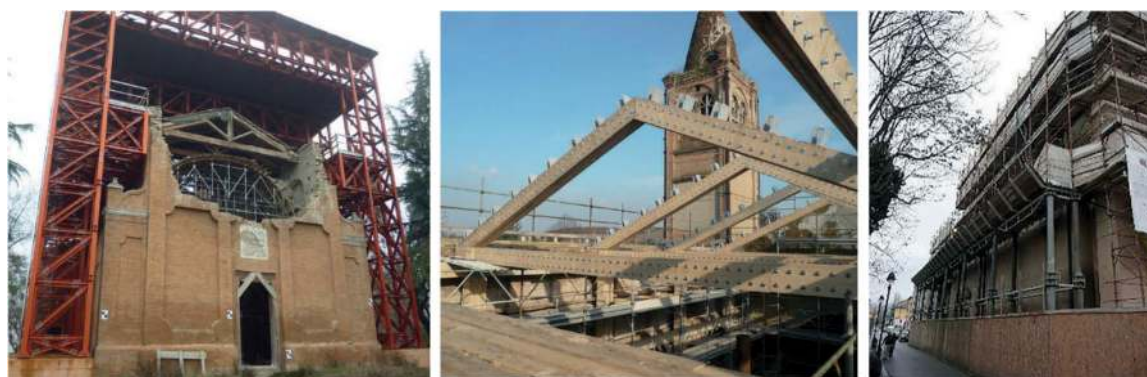
Figure 7. On the left, San Luca Church in Medolla (MO) and, in the center, Santa Caterina Church in Novi di Modena (MO): shoring systems with timber frame and metal frame respectively. On the right, Beata Vergine del Rosario Church in Finale Emilia (MO): shoring systems with metal frame and structural scaffolding.

Shoring systems with structural scaffoldings can also be optimized. This structure, made of small modular and standard elements (pipe and joints), are characterized by great easiness and speed of installation that allows to shore also the more complex architectural shapes in small operating spaces. On the other side, as previously highlighted, this shoring technique is rather expensive. It is therefore important to ascertain whether rental or purchase is more cost-effective, in consideration of the time foreseen before the final recovery. This assessment must consider different factors. First of all the maintenance costs: in general, after three years it is necessary to restore structural efficiency by integration and replacement of degraded parts. Moreover, it must be considered the possible economic advantage obtained by using the same structure to investigate the building for executive design and to realize the final works. To this aim, all the safety requirements should have been observed from the first stages (i.g. the scaffolding has to be installed at the correct distance from the building). Another aspect to consider is the possible recovery of purchasing costs obtained by selling the scaffolding. This structures indeed can be totally reused in other interventions ensuring the almost complete recovery of the material. Anyway, structural scaffoldings could have significant encumbrance that could prevent access or usability of spaces. Consequently, in order to ensure the passage, it could be convenient the integration with a metal frame, as shown in Figure 7c. In this case, the lower part is made of metal frame in order to reduce the dimensions, whereas the upper part is made of scaffoldings to encircle the building, becoming a useful support for subsequent operations.

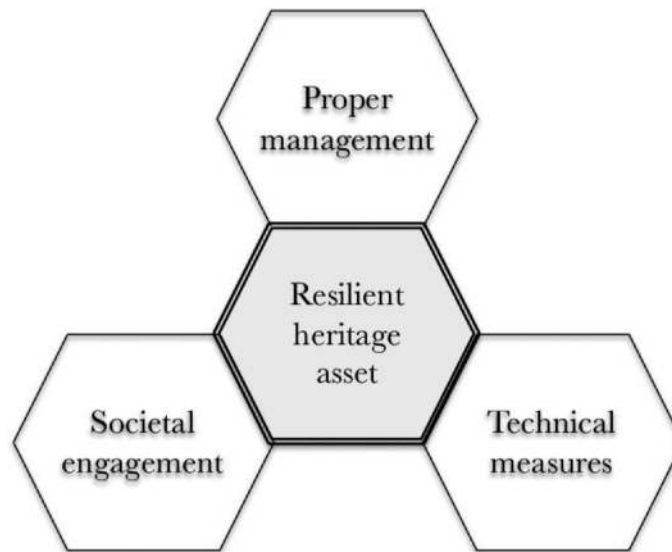
Figure 1. Components of establishing of resilience of cultural heritage asset.
