# BUILT HERITAGE IN POST-DISASTER SCENARIOS

IMPROVING RESILIENCE  
AND AWARENESS TOWARDS  
PRESERVATION, RISK MITIGATION  
AND GOVERNANCE STRATEGIES

PROCEEDINGS OF THE 1ST EDITION OF THE INTERNATIONAL SUMMER SCHOOL  
“AFTER THE DAMAGES”, FERRARA, ITALY, 1-15 JULY 2020

# Built Heritage in post-Disaster Scenarios

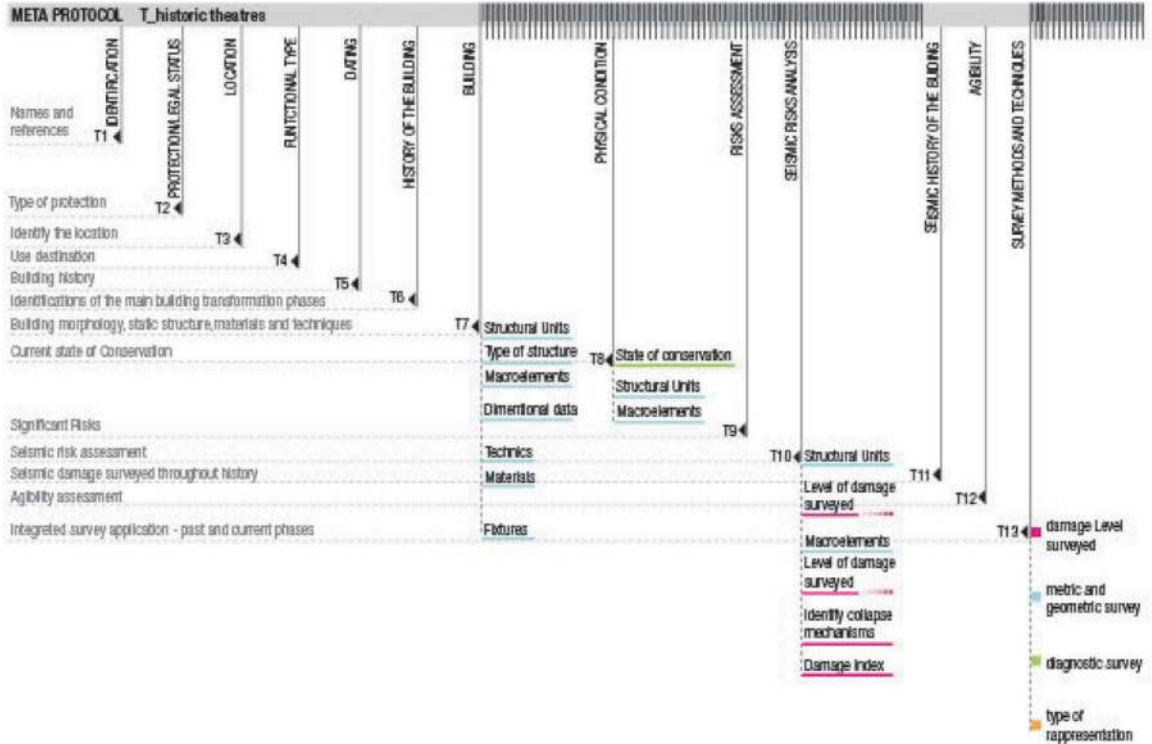
Figure 5. Structure of the meta-protocol for the expeditious survey of seismic damage for historic theatres. It’ is a proposed implementation of the MIC sheet on the specific theatres typology -T.

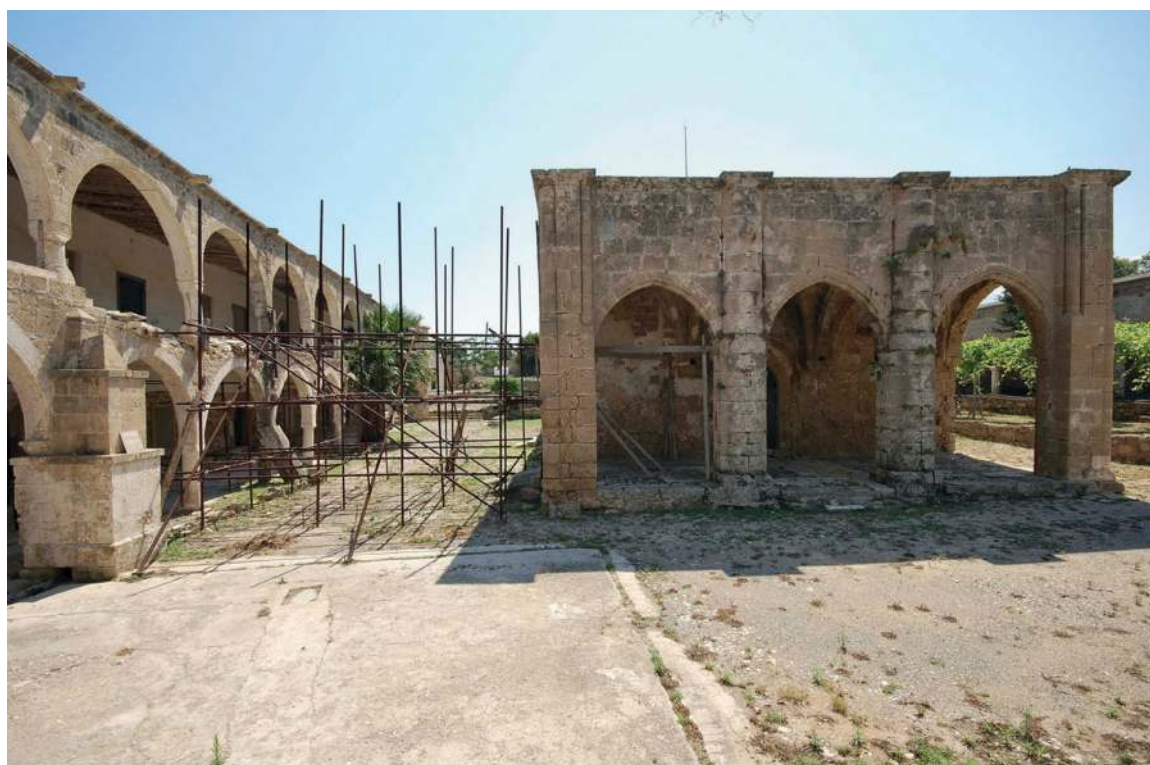
Figure 4. The scaffolding is holding in place the leaning column, urgent intervention is required (photo: A. Camiz, 2014).

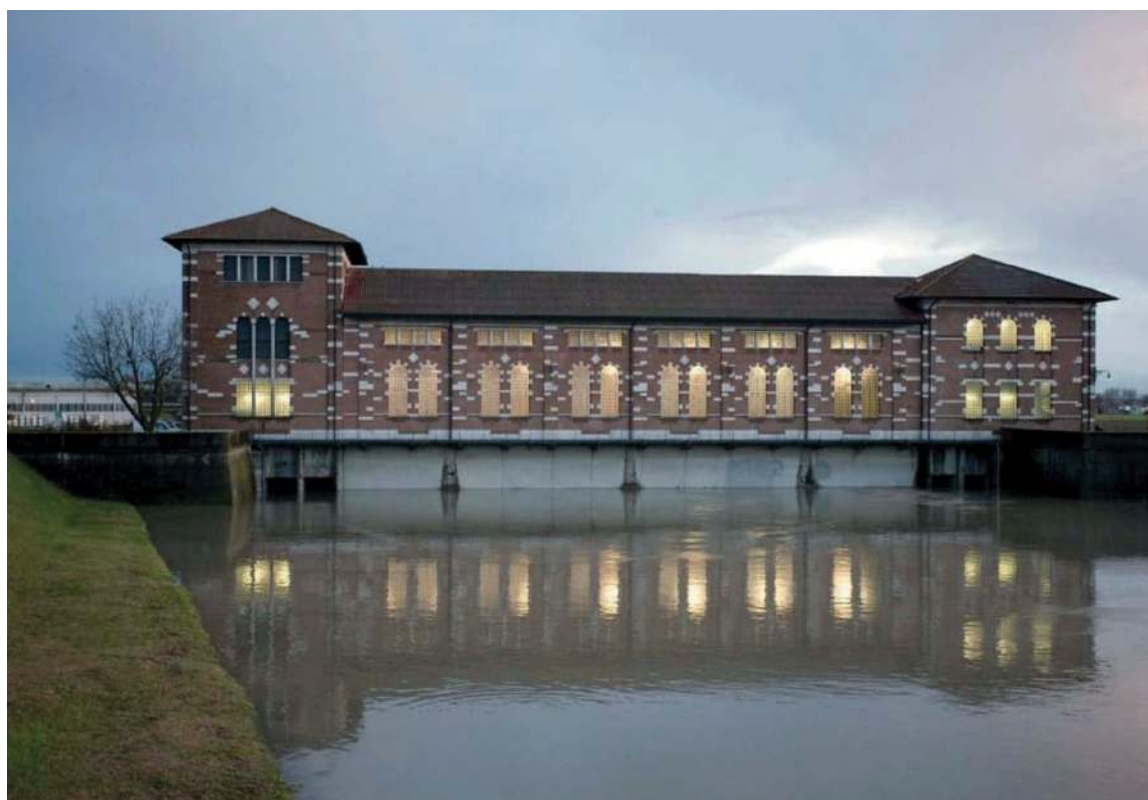
Figure 1. Lifting plant of Bondeno Palata built in 1925 (Burana Reclamation Consortium).

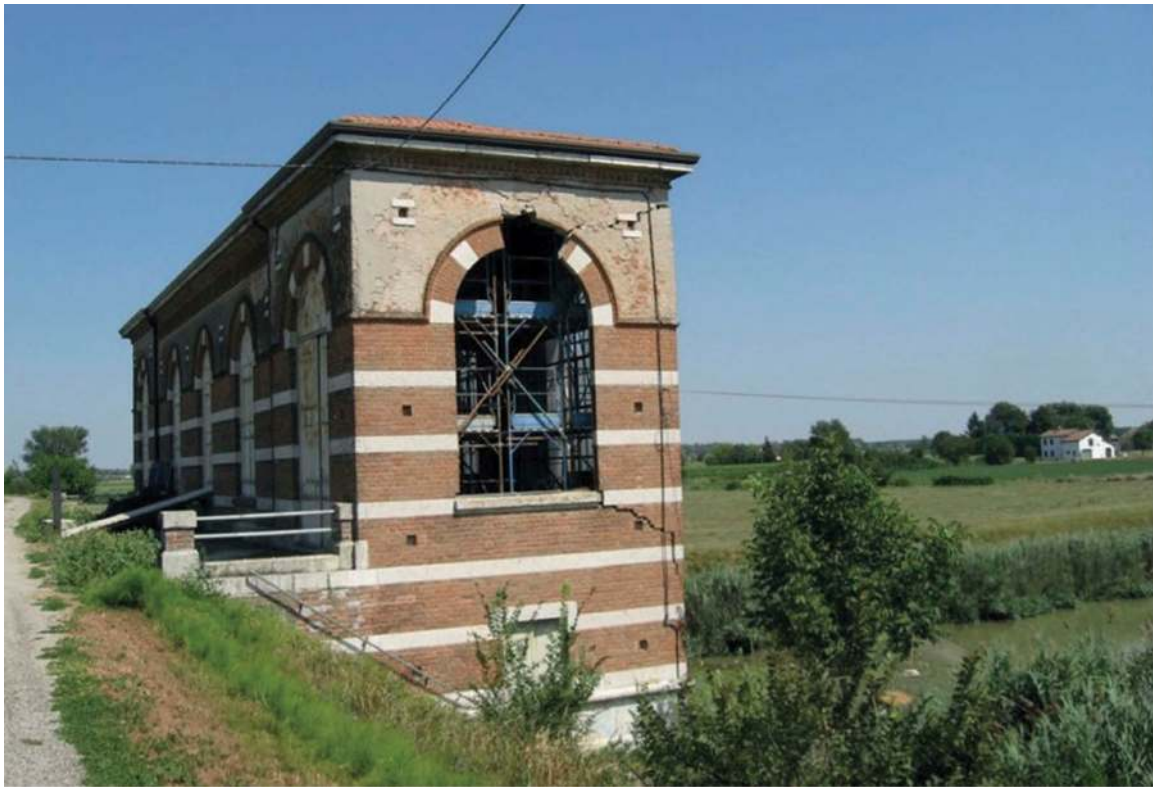
Figure 2. “Botti of San Prospero” near Moglia (Central Emilia Reclamation Consortium).

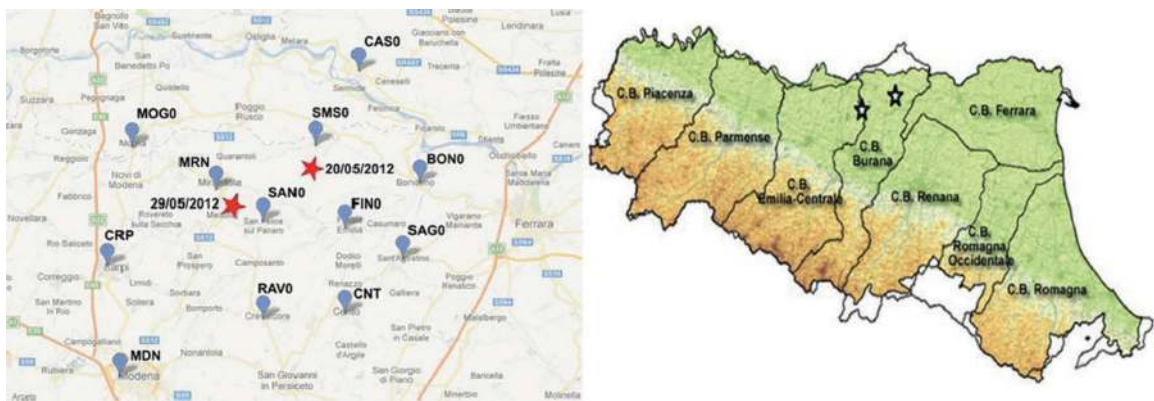
Figure 4. The area hit by seismic sequence in 2012 with localization of the epicenters of the two main events and of the accelerometric stations of the RAN network, on the left. MOG0 and BON0 denote the position of the towns of Moglia and Bondeno (Cattari et. al. 2012). The Consortia of reclamation in Emilia-Romagna on the right.

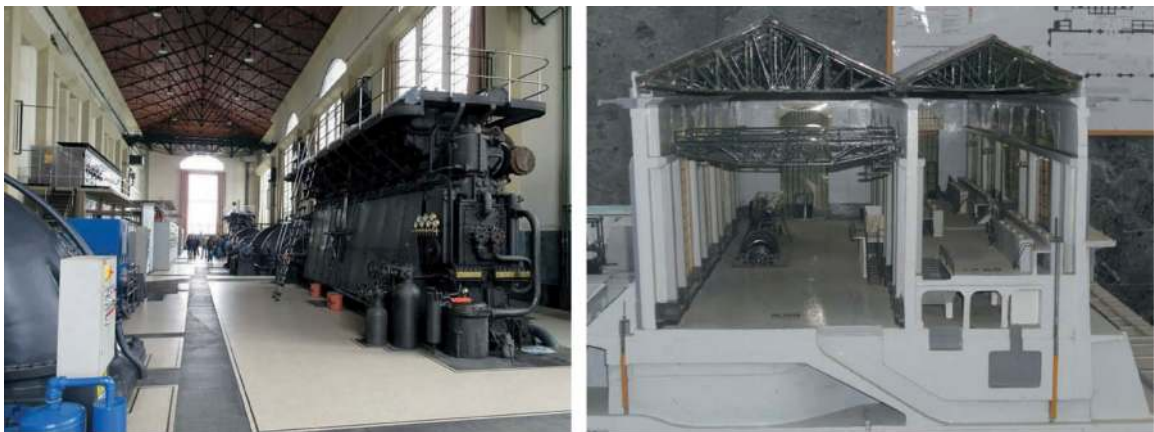
Figure 5. Pump room of the lifting plants of Mondine Pilastresi (Burana Reclamation Consortium) on the left and its scale model.

For these buildings considered part of cultural heritage patrimony, there is no possibility of operating deep interventions. This fact, as in the case of the Pilastresi plant, can at most allow a seismic improvement able to guarantee safety for seismic events with a return period of approximately 100-150 years.

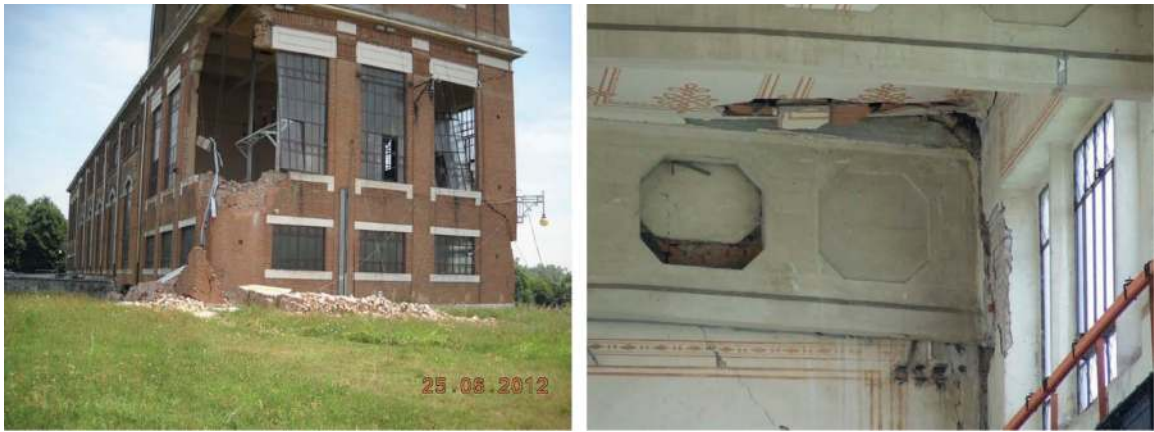
Figure 7. Mondine dewatering station, collapse of an angle of the turret and, at right, damages of the Vierendel beams supporting the floor of pumps room.

In particular, a deviation at the level of the link between the tower and the main body and the expulsion of the outer angles of the tower have occurred (see Figure 7). The level of damage has made the site completely unusable. Within four months, the structure was made safe, and a new drainage system was activated for a cost of about 20 million euros.

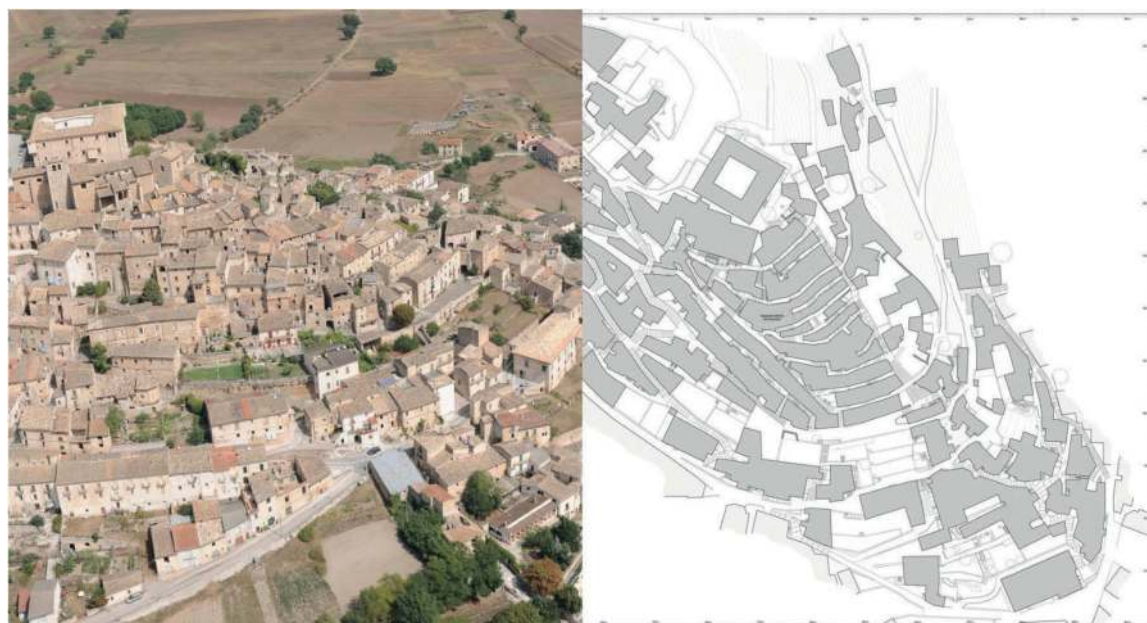
Figure 1. Aerial view of Navelli town centre and classic 2D representation of footprints at 1:500 scale.

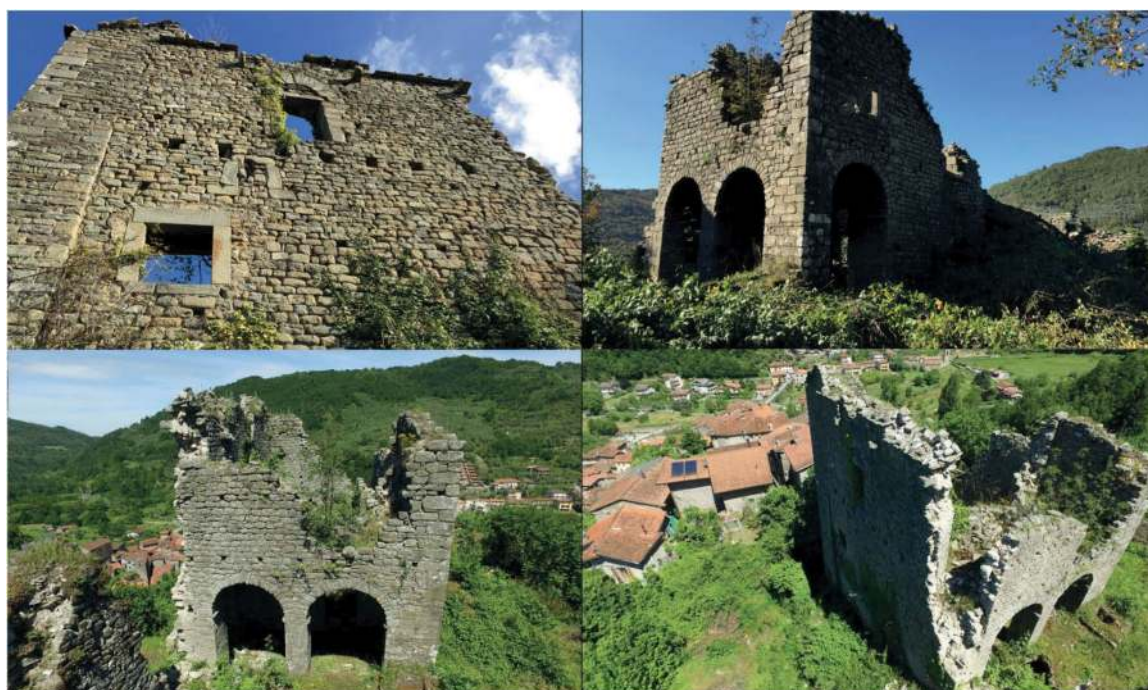
Figure 7. Aerial and close photo view of the ruined ancient castle in Codiponte.

The castle stands on steep, very rugged terrain covered with vegetation that infests the ruins. It was in fact necessary to remove a large part of vegetation to carry out the survey. As already mentioned, the castle is in a very precarious state of conservation, with many collapsed parts reduced to heaps of stones. Performing a complete and time-consuming direct survey with tapes and range finders, also in the less damaged parts, would have been dangerous for the safety of the surveyors, due to the precariousness of the structure.

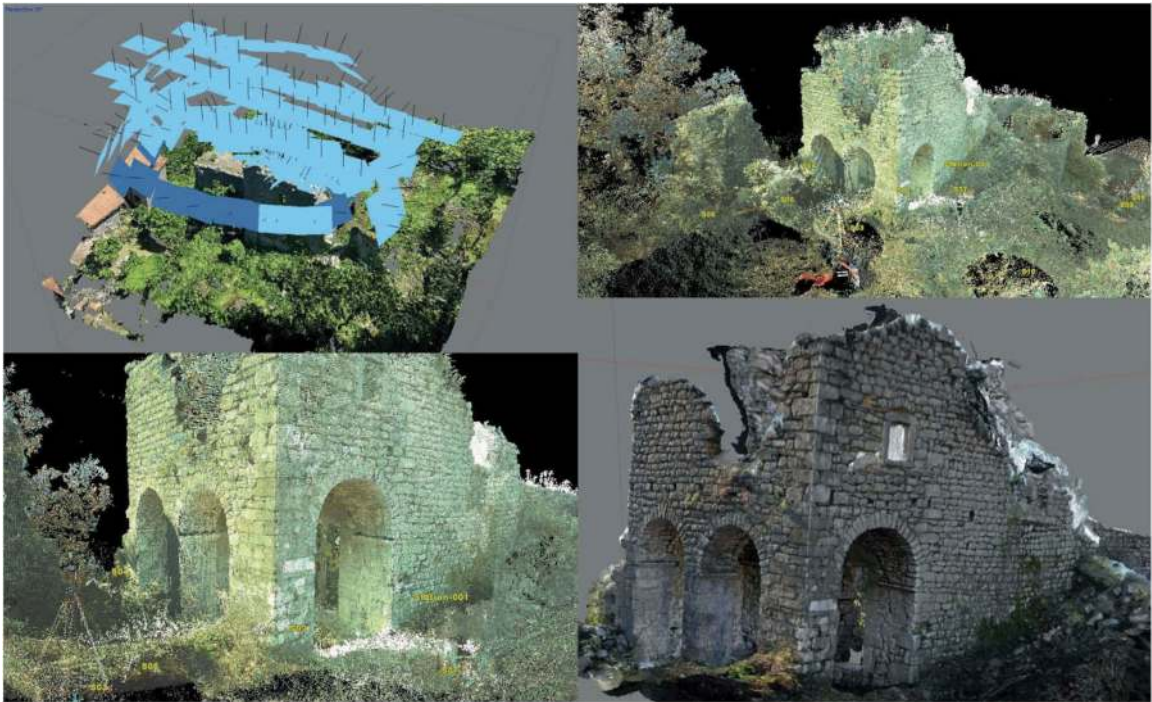
Figure 8. Photogrammetric block of the Castle, views of the dense point cloud and texturized 3D model.

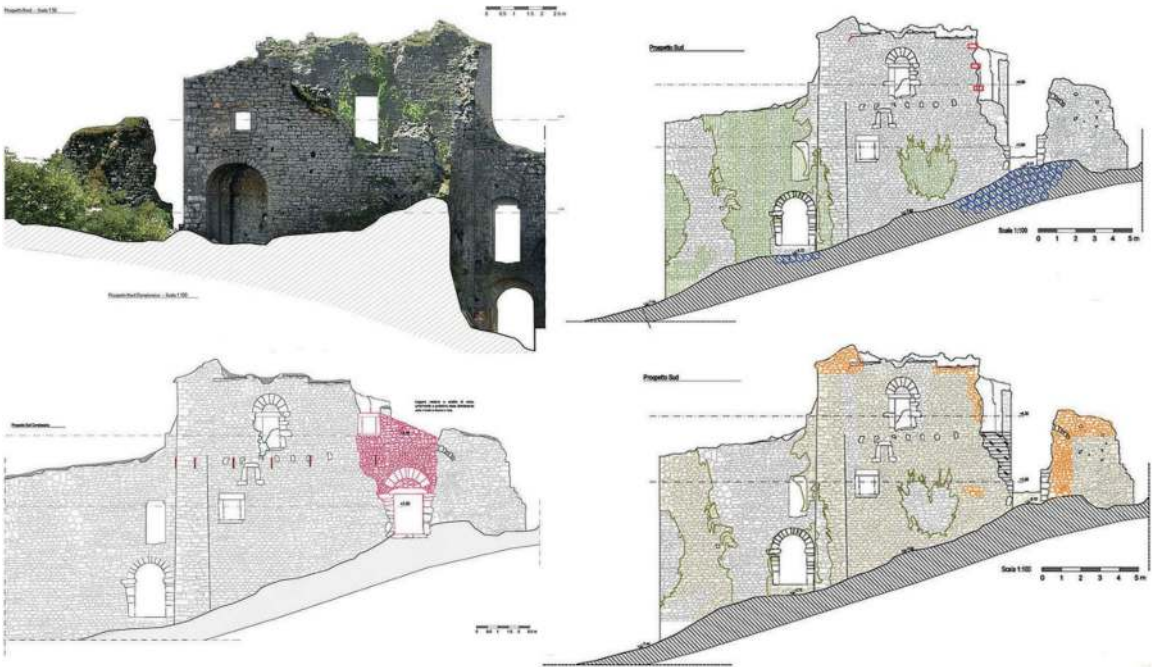
Figure 9. Excerpts of the drawings of graphic restitution of the geometric and thematic survey of the ancient castle in Codiponte.

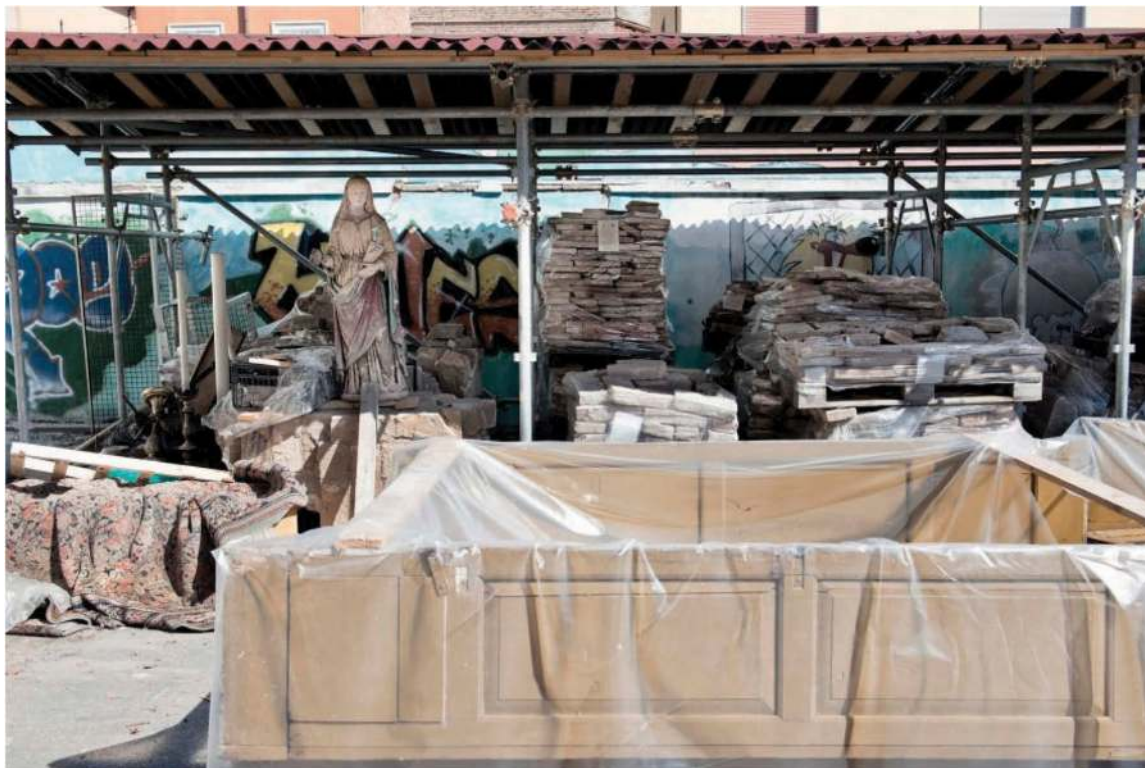
Figure 4. Immediate management of the rubble: debris have been selected and stocked according to their historical and artistic value. (From the archives of the UCCR, Ministry of Culture, Bologna).

During the visits a report was signed by all people participating, to define specific operations and criteria of selection, study, disposal or storage of the debris along with their characteristics, cultural value and potential interest for a future reconstruction.

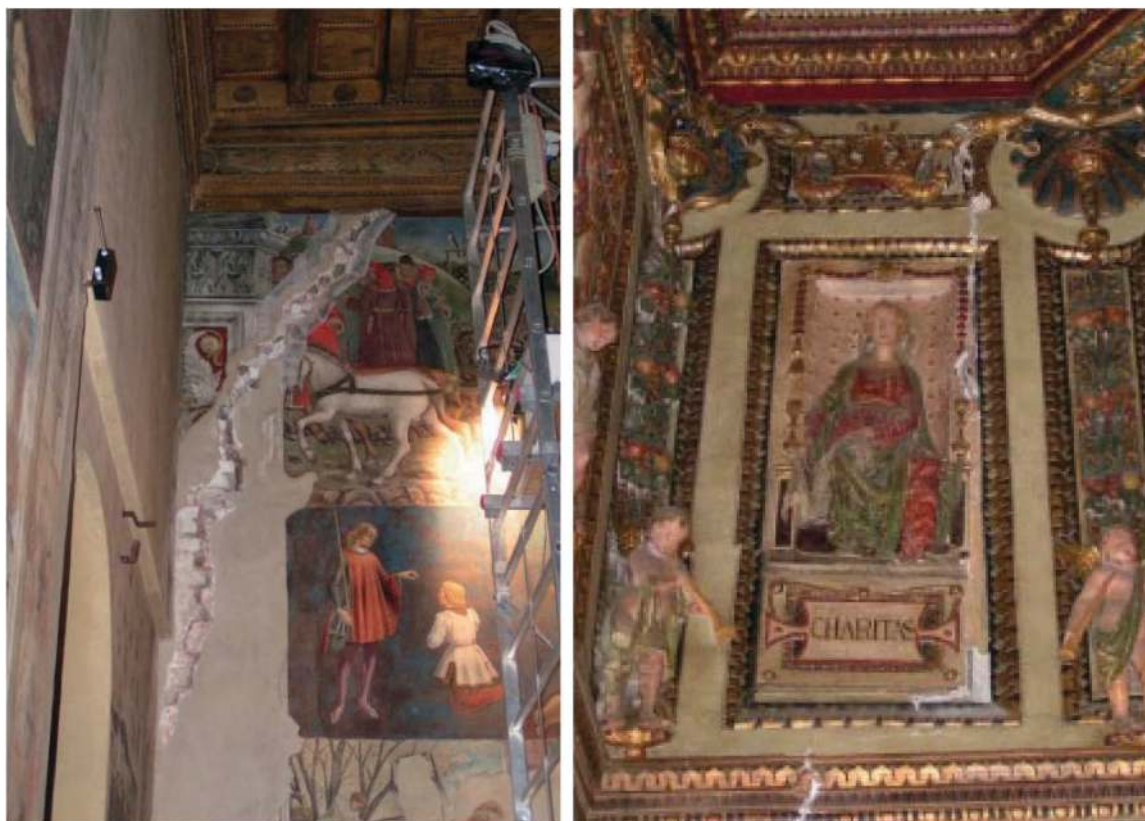
Figure 6. On the left, damages to the hall of the months side and re-opening of the damage caused by the 1570 earthquake. On the right, detail of the damage to the Vice and Virtute side.

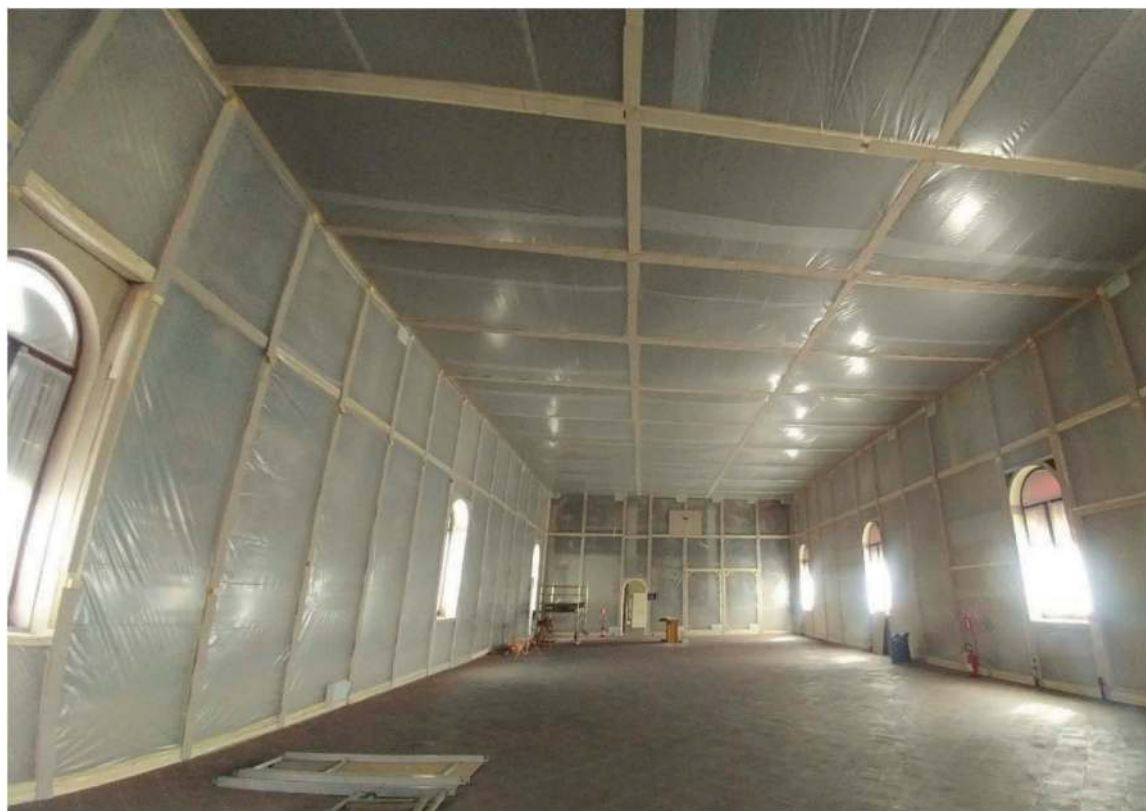
Figure 10. Salone dei Mesi with its structures in wood and panels in non-woven fabric and plastic material, created to protect the cycle of frescoes.

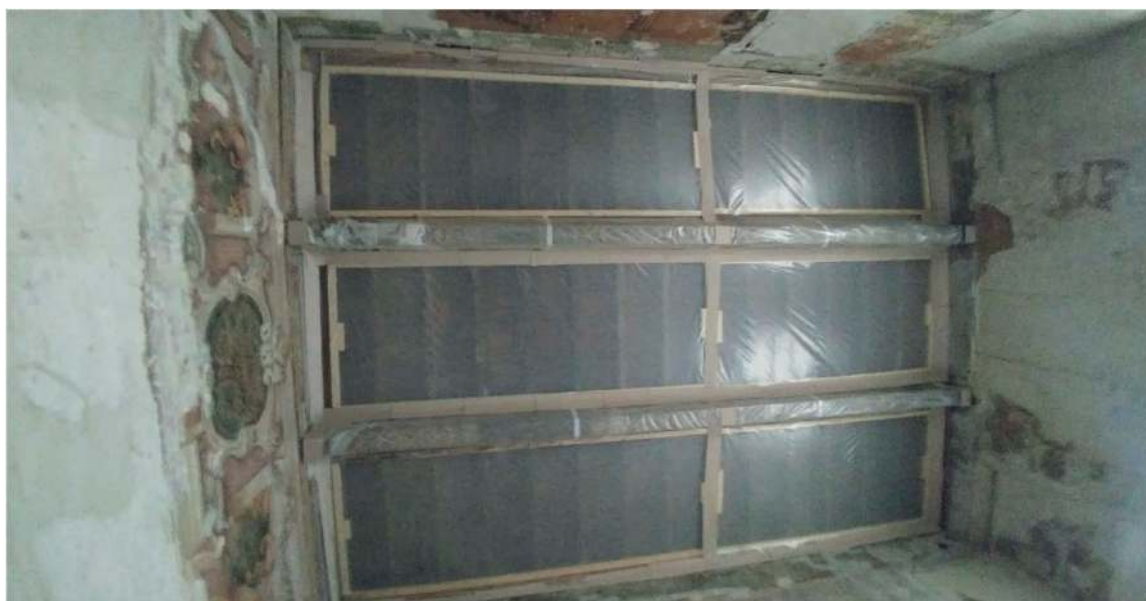
Figure 11. Hall on the main floor with structures in wood and panels in non-woven fabric and plastic material, created to protect the decorated wooden slab.

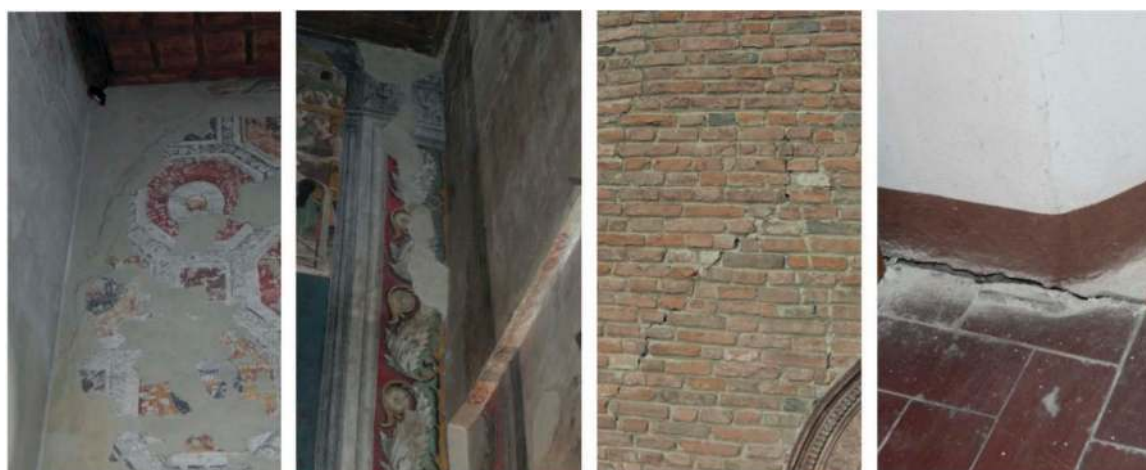
Figure 12. The reopening of old cracks and the formation of new ones.

The intervention had a major impact on the structures and systems. In order to be able to carry out the post-earthquake work on the slabs of the main floor and on the roofing structures of the 15th-century wing, where there are rooms that preserve decorative schemes of extraordinary historical and artistic value, protective structures had to be created, designed to fully protect the wall paintings and the wooden and stucco ceilings from vibrations, shaking, dust and anything else that might risk causing damage. Following the earthquakes of May 2012, many existing cracks re-opened (Figures 2-6) including those caused by the 1570 earthquake; in the past, these cracks had not been undergone proper and thorough repair, but only non-structural restoration. There was also a series of recurring cracks such as extensive cracking in the brick flanges of the over-windows and doors, diagonal cracks through the top corners of the transversal walls caused by the thrust exerted by the struts of the roof (which did not have chains in correspondence with the load-bearing walls) and signs of the start of tilting of the walls of the façade, extensive diagonal cracking in the transverse walls of the mezzanine floor, vertical cracks caused by the detachment of poorly toothed orthogonal walls, detachment of the wooden beams and joists of the horizontals from the perimeter walls, while non-structural elements such as cornices, chimneys and roof tiles had fallen (Figure 12).

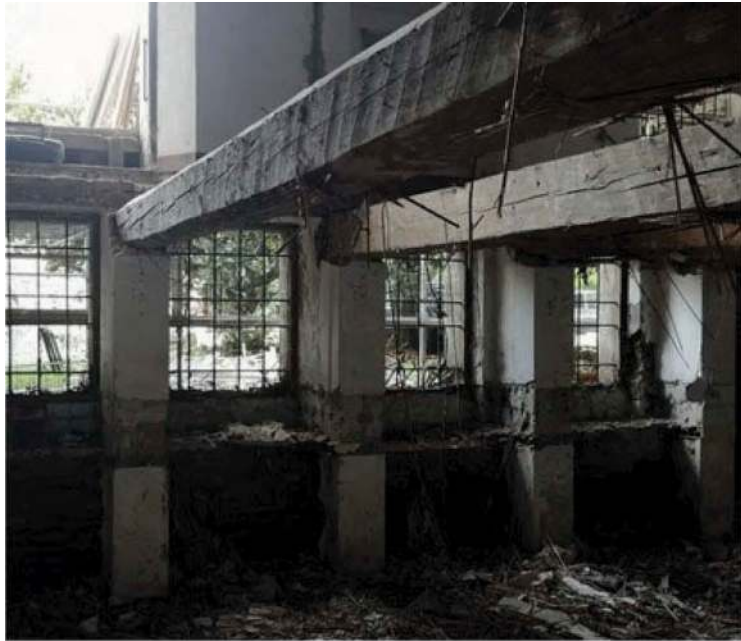
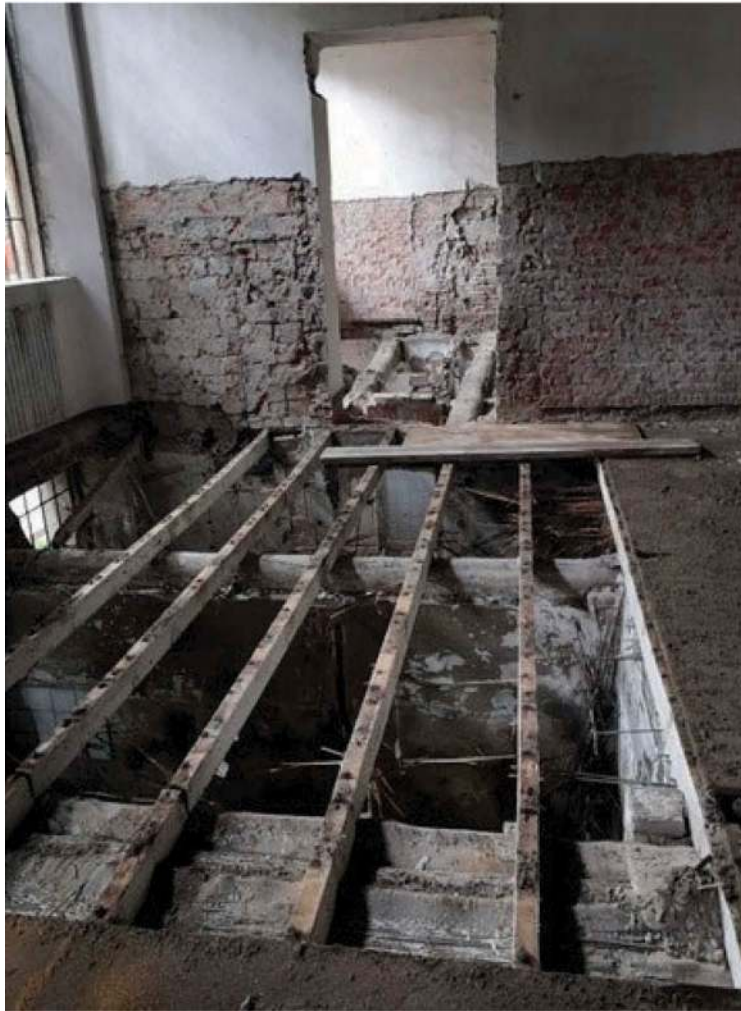
Figure 13-14. Removal of incongruous slabs.

The removal of a large part of the incongruous inter-floor slabs and the consequent elimination of the basement in the 15th-century wing in order to restore the original spatial characteristics of the Palazzo was the first intervention carried out on the 15th-century wing. During the work phases, it was possible to confirm the original volumes, by the traces of the ancient thresholds and floors found at the walls (Figures 13-14). The demolitions also revealed the recent date of the slabs removed, which had planks with machined joints (Figure 14). In addition, many cubic metres of material were removed from the floor slabs of the main floor (ineffective lightweight concrete), which had been laid during the previous restoration and which constituted a weight for the structure without performing a structural or stiffening function. The most important and demanding intervention concerned the stiffening and simultaneous static consolidation of the wooden slabs of the main floor: these are double-structure floors (beams and joists) with wooden planking, with the peculiarity that the main elements are composite beams (Figure 18). The consolidation was carried out, as planned, by making double boards crossed over the existing boards, anchored with hardware to the perimeter walls of each room and made to cooperate with the secondary joists and composite beams by means of metal pins in holes with resin (Figures 15-19). First of all, wooden segments (Figure 16) were inserted between the secondary joists and above the composite beams, suitably shaped and joined, in order to prevent the problem of inflection of the connection dowels between the “wooden slab” and the composite beams themselves. In some cases, it was necessary to integrate the intervention with thick metal plates (Figure 17)

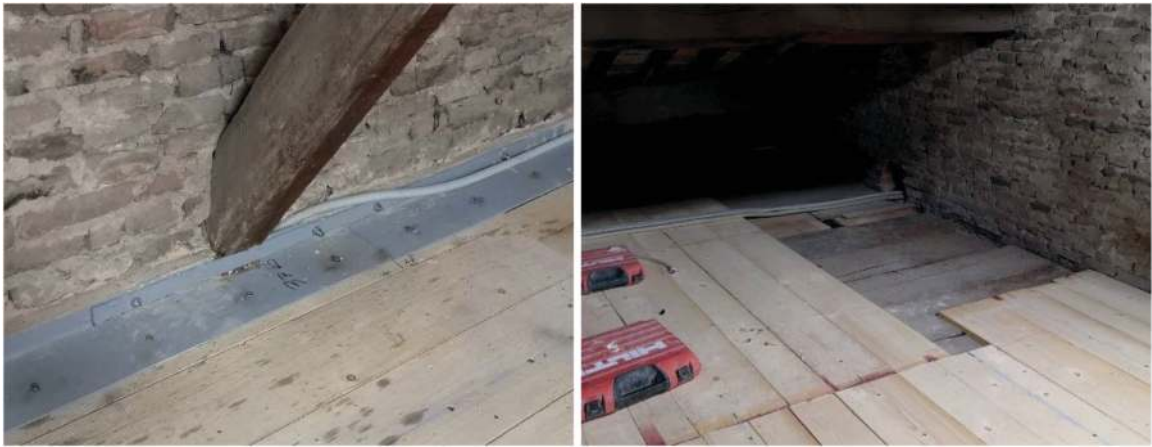
Figure 15. Stiffening of attic slabs and metal curbs.

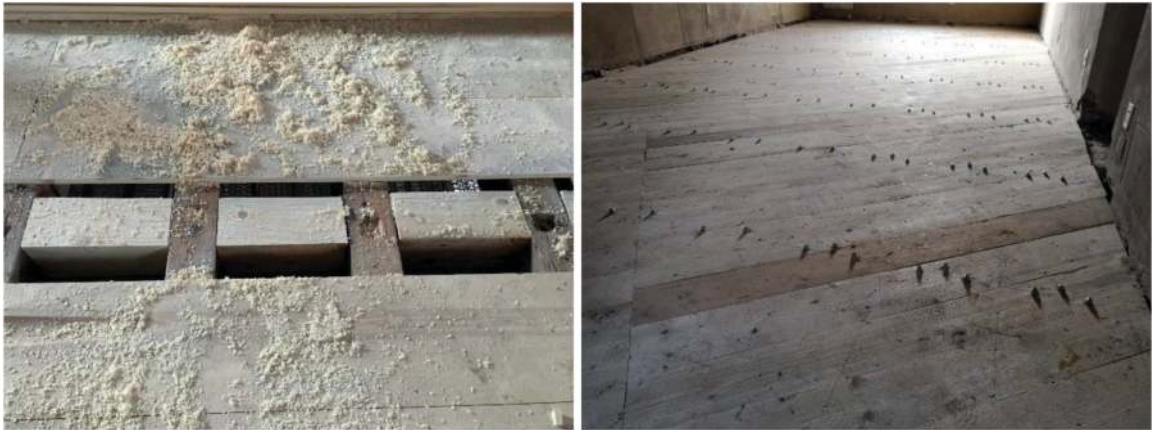
Figure 16. Insertion of wooden beam segments in the extrados between the rafters - Stiffening and consolidation of slabs by means of triple planking and connectors.

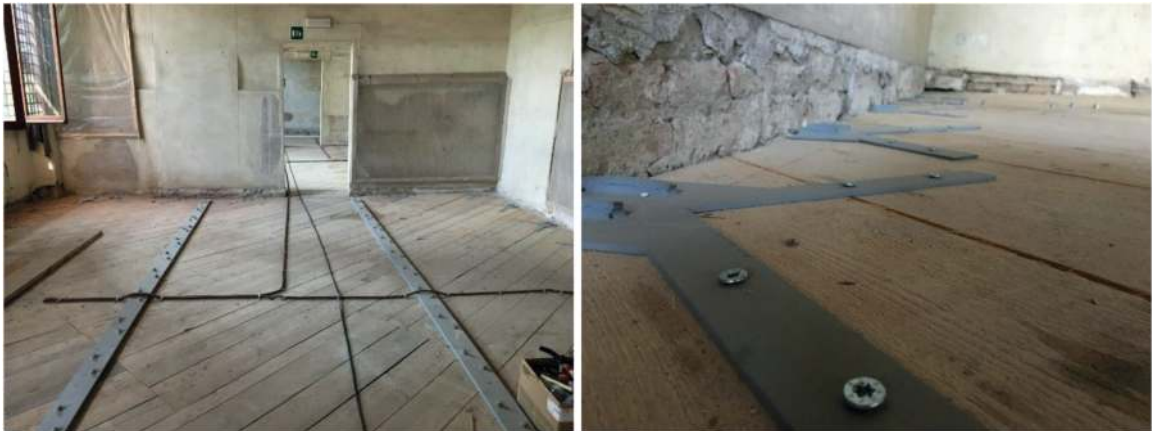
Figure 17. Stiffening and consolidation of slabs by means of triple planking, thick metal plate and connectors – Slab.

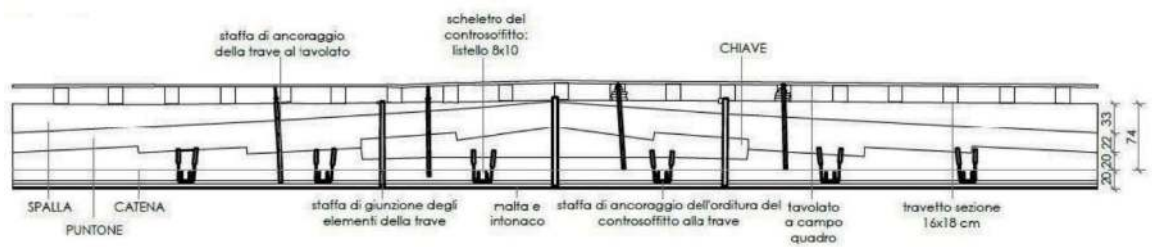
Figure 18. Composite beams of the Salone dei Mesi.

The work on the façade of the 15th-century portion of the building made it possible to remove the cement plasterwork and recover the earthenware moulding on the garden façade (Figures 20-21), to restore the entire 16th-century terracotta cornice by means of dowels, plasterwork and colour fixing (Figure 23), to restore the plaster fragments on the façade with injections of filling adhesives (Figure 21) and to consolidate the window surrounds (Figure 22). Interesting were the fortuitous fragments searched for and found throughout the work site. Removing the suspended ceilings on the ground floor revealed the Renaissance wooden slabs, which were then restored by cleaning, consolidating the paintings and toning the wooden parts (Figure 27). In the bookshop room, which occupies the former loggia, the fascia that also framed the large composite beams was recovered (Figure 28).

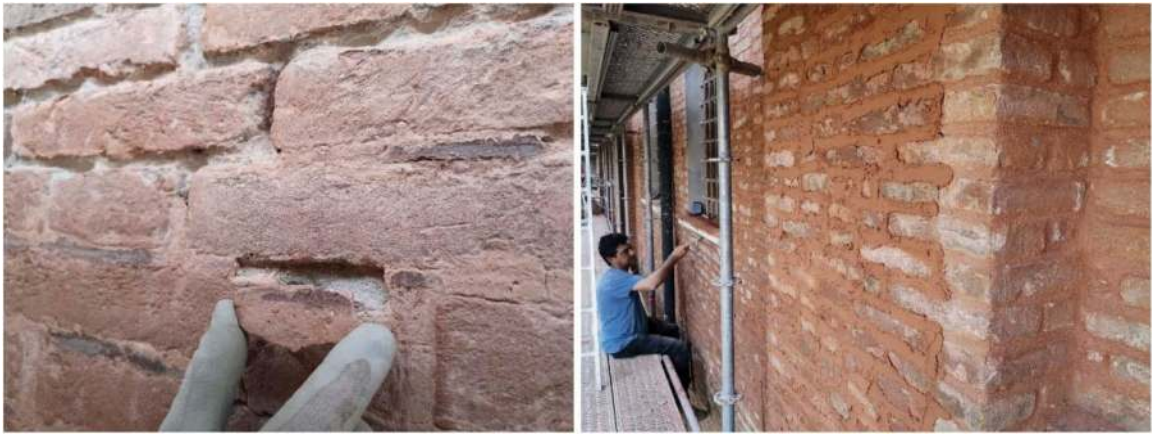
Figure 20. On the right, new earthenware moulding. On the left, resembling that found in the 18<sup>th</sup> century closure of the garden loggia.

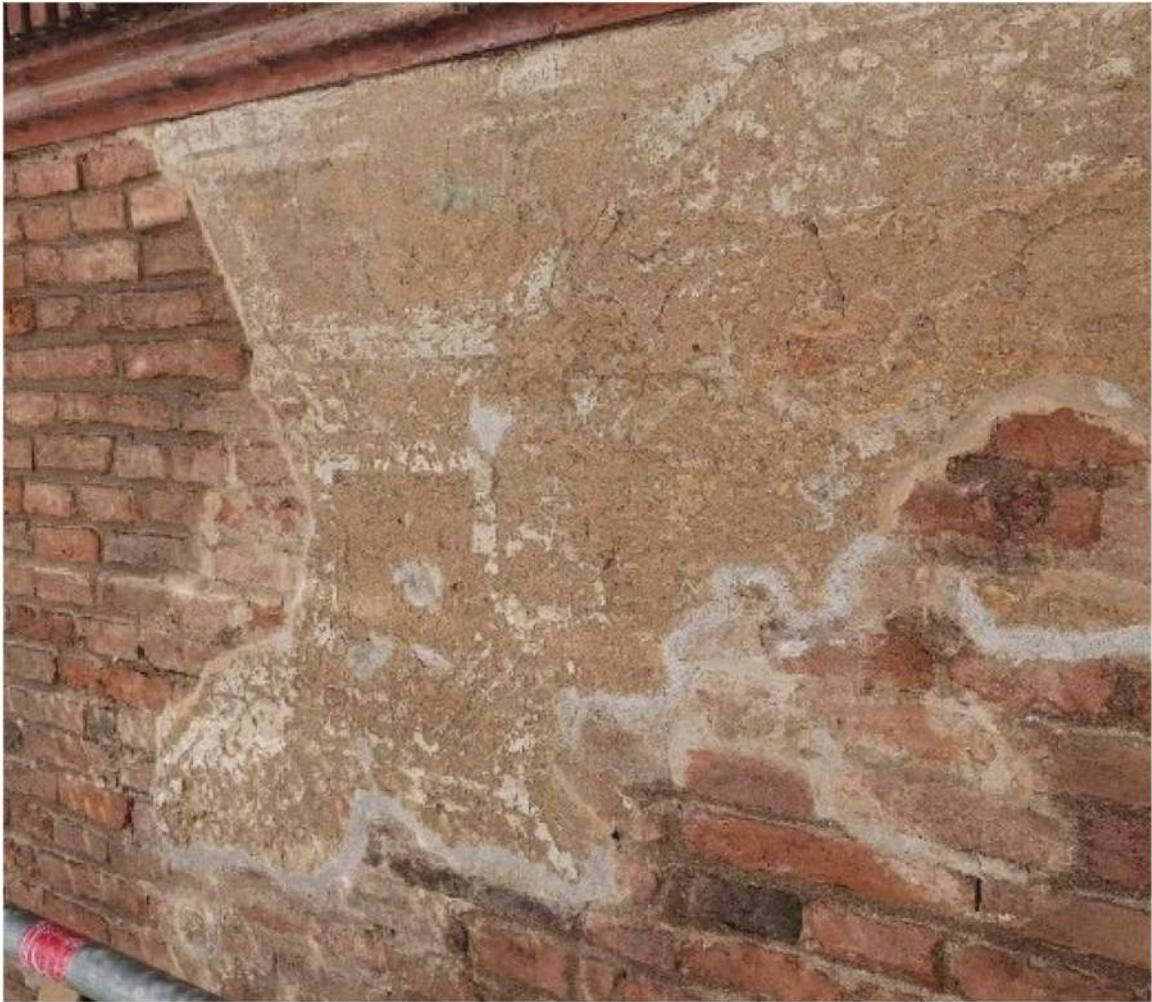
Figure 21. Restoration of plaster fragments.

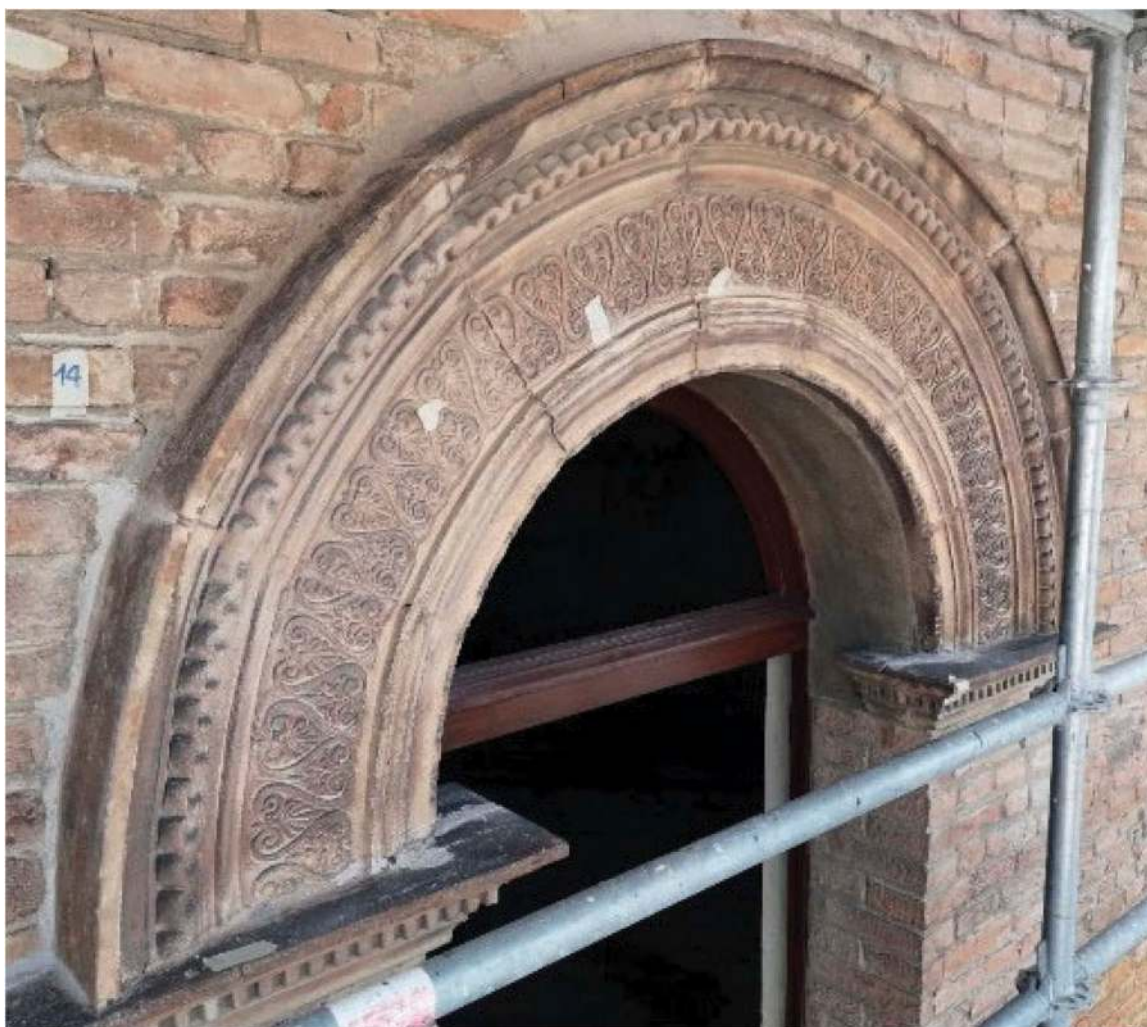
Figure 22. Restoration of plaster fragments and window surrounds.

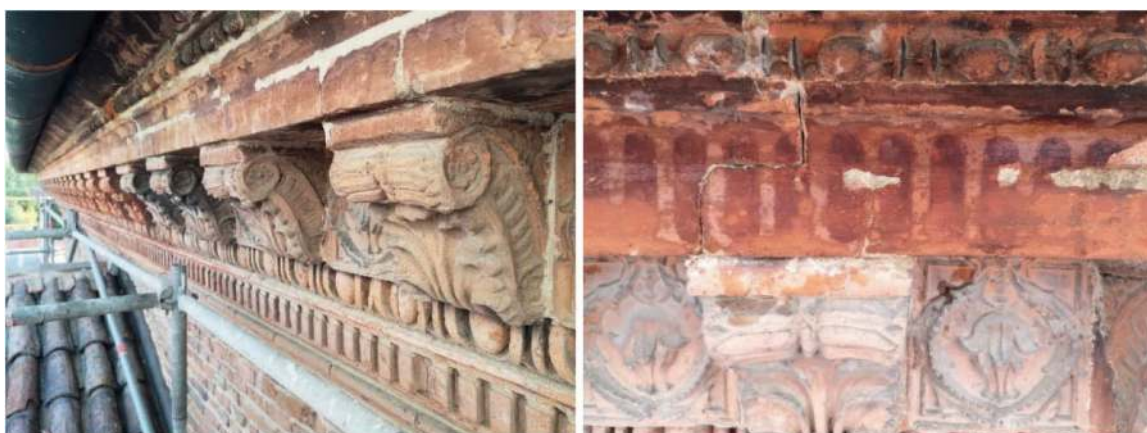
Figure 23. Restoration of the 16th-century terracotta cornice.

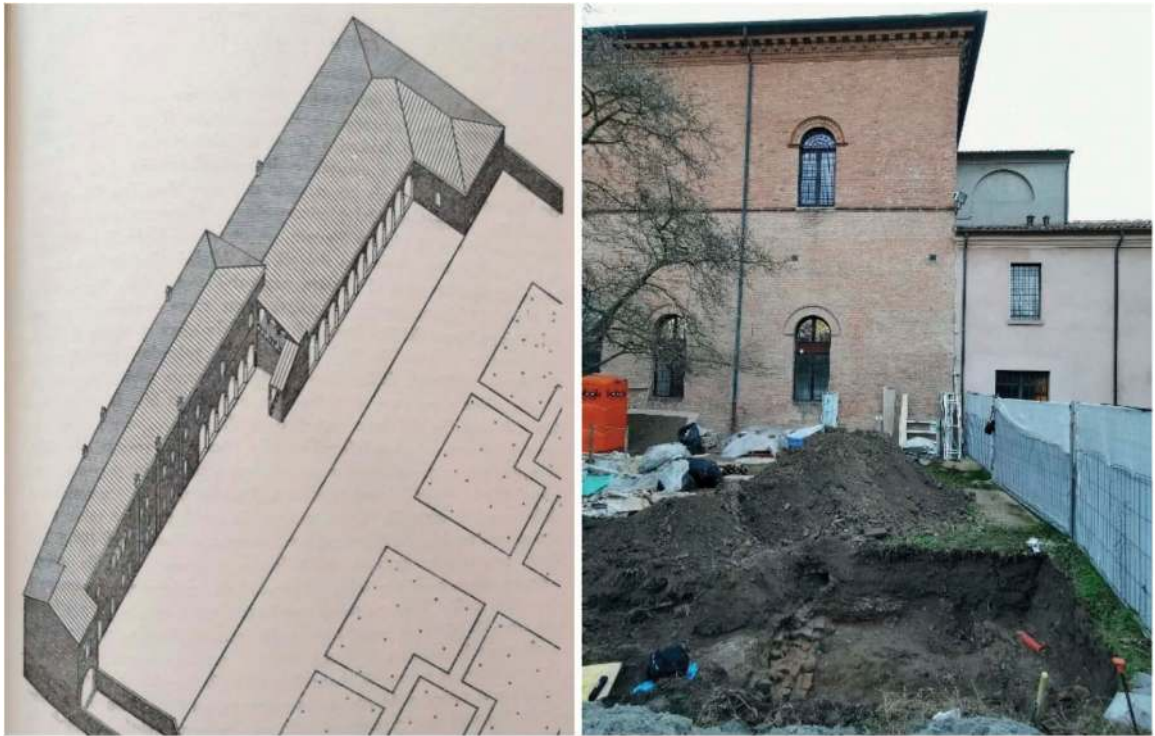
Figure 25. a. Reconstructive axonometry of the Schifanoia complex, 1493 simulation. (from S. Ghironi, F. Baroni, 1975, p.147). b. The foundations of the original external staircase for access to the Salone dei Mesi found by excavation based on measurements taken from a historical report.

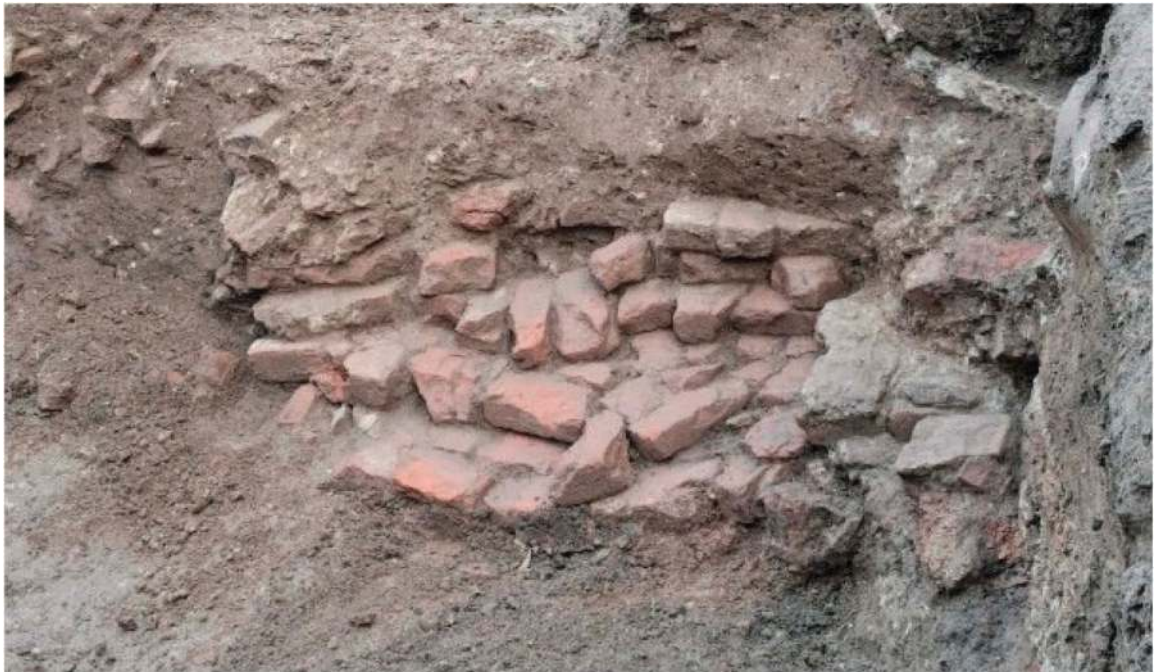
Figure 26. Detail of the foundations of the original external staircase for access to the Salone dei Mesi.

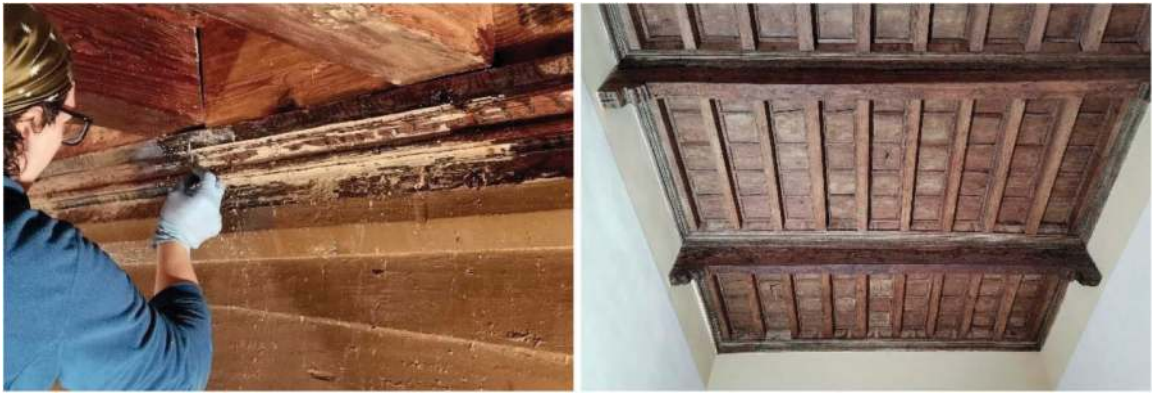
Figure 27. Restoration of the wooden slabs on the ground floor of the 15<sup>th</sup>-century part.
