# BUILT HERITAGE IN POST-DISASTER SCENARIOS

IMPROVING RESILIENCE  
AND AWARENESS TOWARDS  
PRESERVATION, RISK MITIGATION  
AND GOVERNANCE STRATEGIES

PROCEEDINGS OF THE 1ST EDITION OF THE INTERNATIONAL SUMMER SCHOOL  
“AFTER THE DAMAGES”, FERRARA, ITALY, 1-15 JULY 2020

# Built Heritage in post-Disaster Scenarios

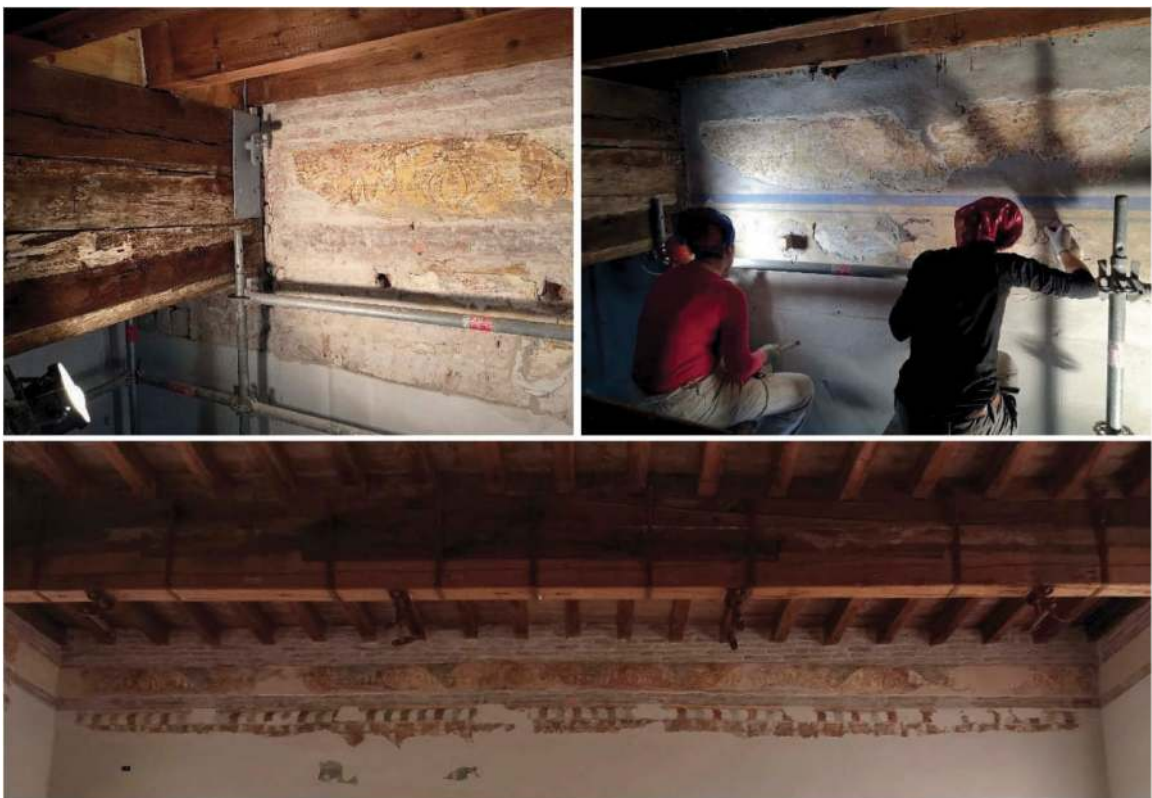
Figure 28a, b and c. Restoration of the painted fascia in the former loggia on the ground floor of the 15<sup>th</sup>-century part.

The work on the façade of the 15th-century portion of the building made it possible to remove the cement plasterwork and recover the earthenware moulding on the garden façade (Figures 20-21), to restore the entire 16th-century terracotta cornice by means of dowels, plasterwork and colour fixing (Figure 23), to restore the plaster fragments on the façade with injections of filling adhesives (Figure 21) and to consolidate the window surrounds (Figure 22). Interesting were the fortuitous fragments searched for and found throughout the work site. Removing the suspended ceilings on the ground floor revealed the Renaissance wooden slabs, which were then restored by cleaning, consolidating the paintings and toning the wooden parts (Figure 27). In the bookshop room, which occupies the former loggia, the fascia that also framed the large composite beams was recovered (Figure 28).

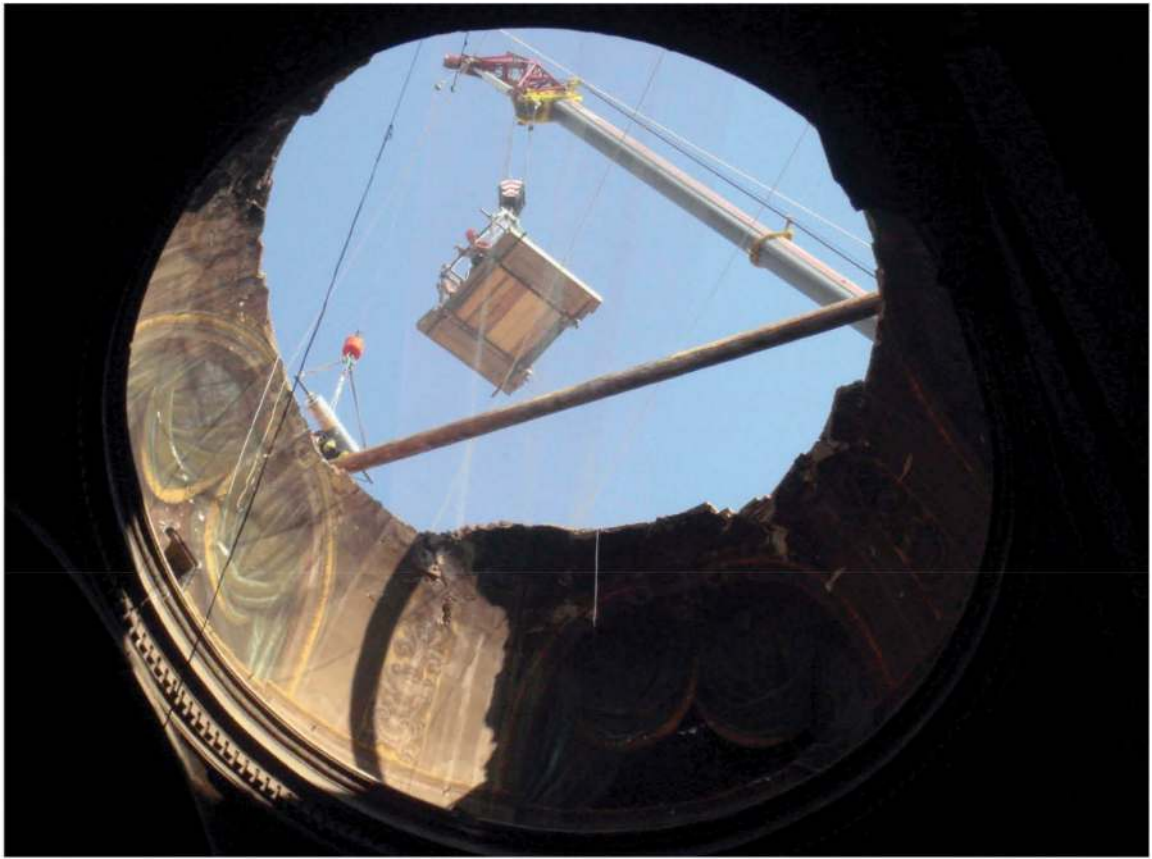
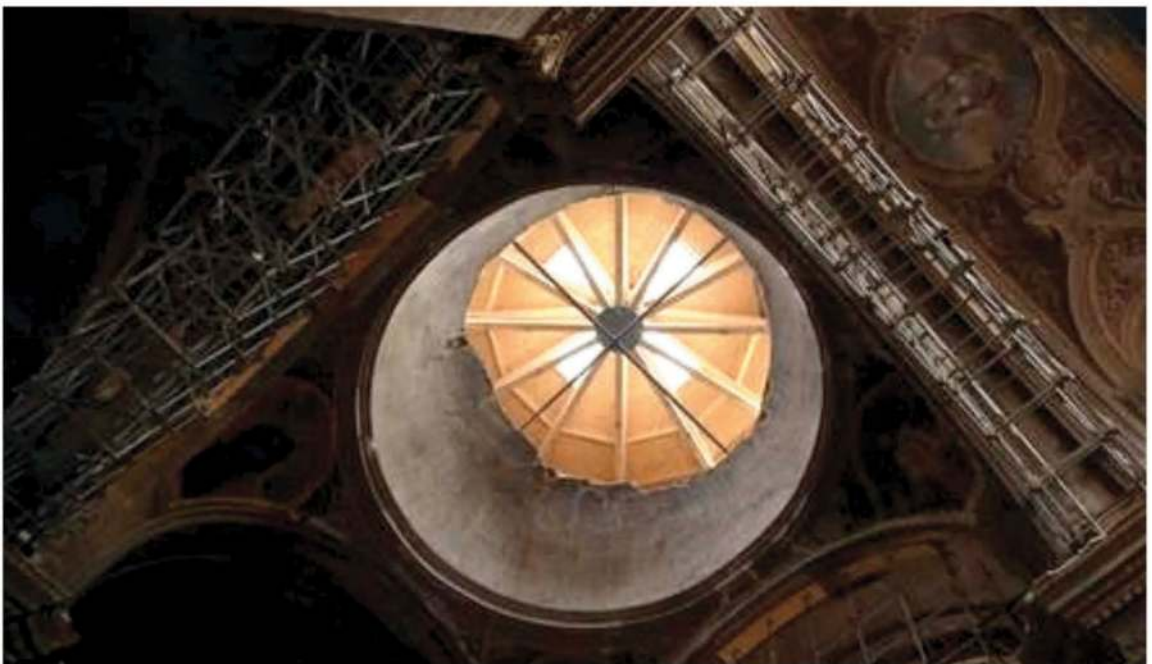
Figures 1-2. Picture of the dome seen from below before and after the temporary cover had been put in place.

In 2016, work started to make the building safe. The fundamental operation involved the construction of a temporary cover over the collapsed dome, carried out by creating a temporary structure designed to also be used during the restoration and reconstruction of the church that would take place in the following years.

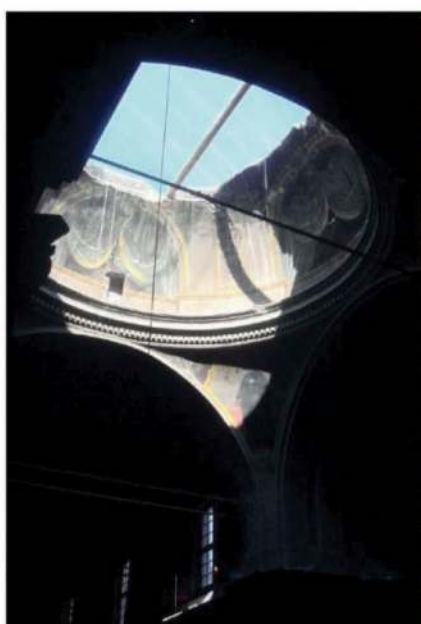
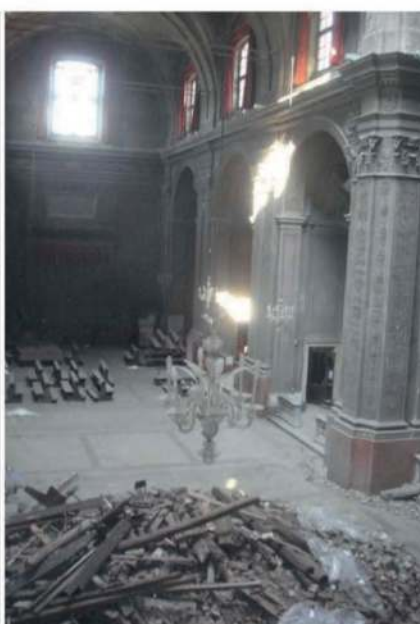
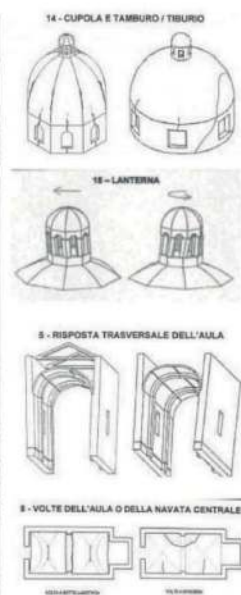
Figures 4-5. A few images of the damage, representative of the most prevalent damage found, with indications of the respective mechanisms as filled in in the damage survey forms.

The damage survey form, completed on 18/09/2012 by the competent official from the Ministry of Culture (i.e., MiC), reports a slight activation of all possible damage mechanisms on the facade, both at the top and the base. But the most obviously serious damage is the complete collapse of the lantern, and almost total collapse of the brick cupola.

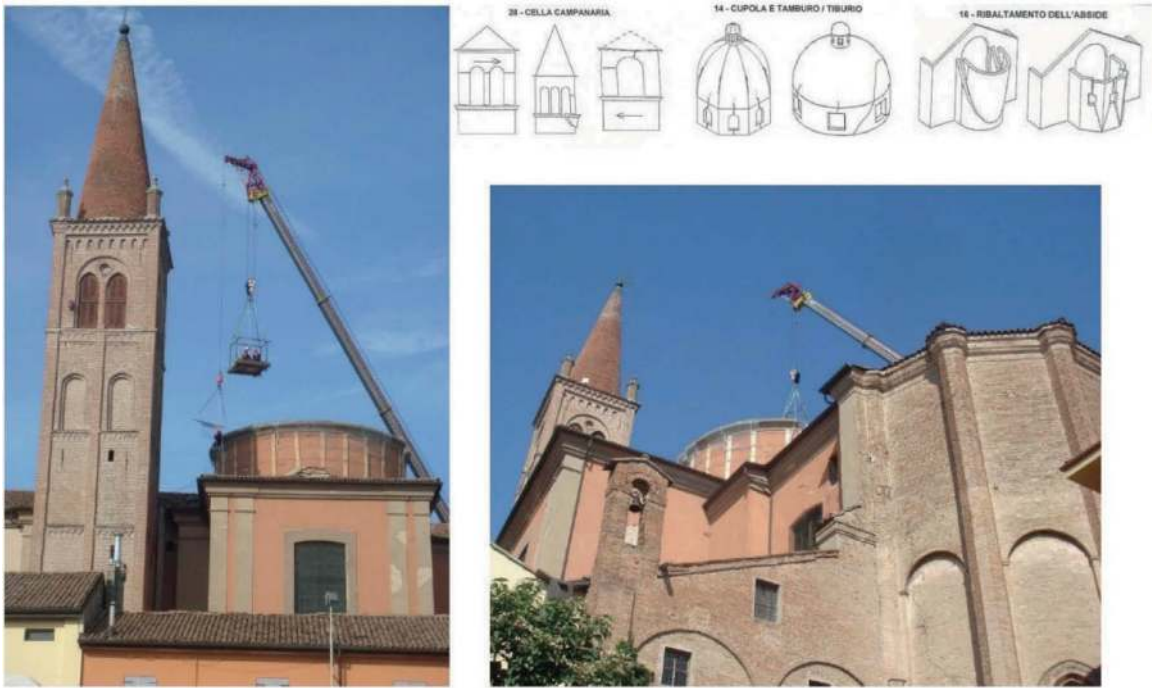
Figure 6. A few images of the damage, representative of the most prevalent damage found, with indications of the respective mechanisms as filled in the damage survey forms.

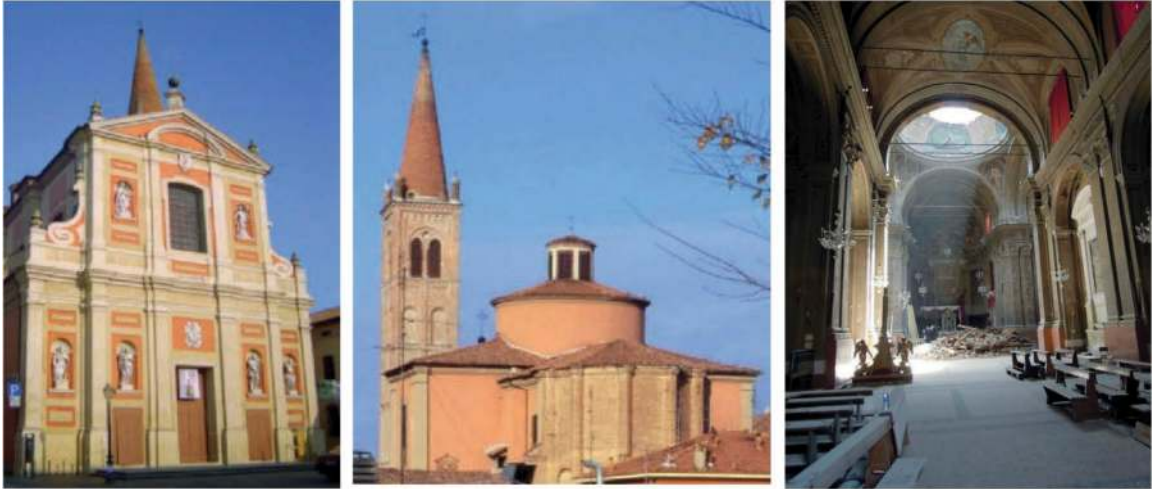
Figure 7. Images of the Collegiate before the 2012 earthquake (on the left) and an image of the collapse taken during the damage survey by the MiC official (on the right).

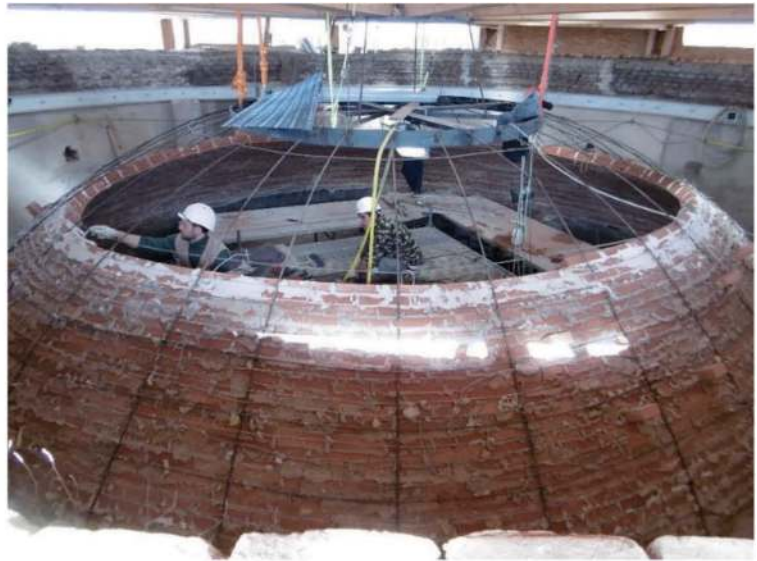
Figures 14-15. The phases and methodology of the construction: extradossal rib made of metal rods and laying of the brick elements from inside the wall cap under construction.

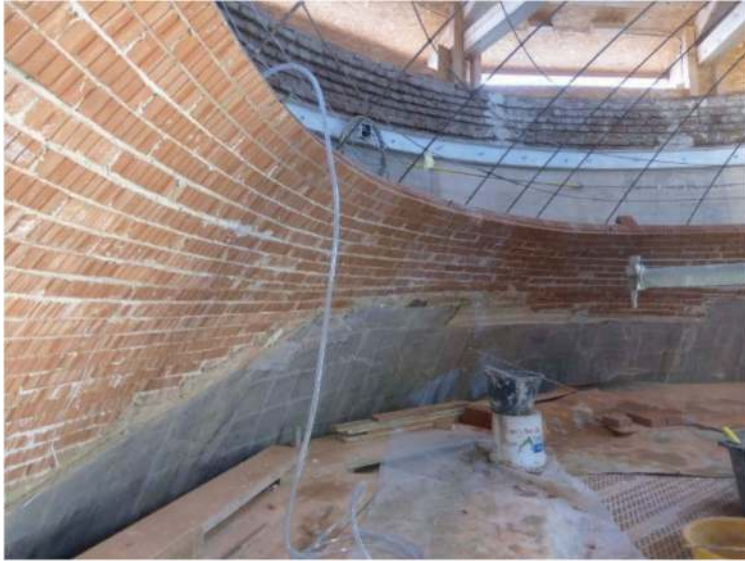
Figure 16. The internal brick elements from inside the wall cap.

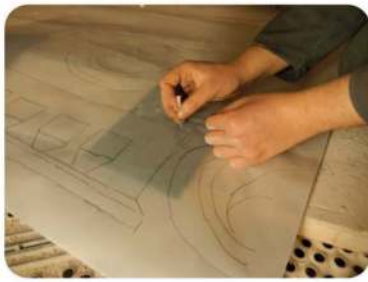
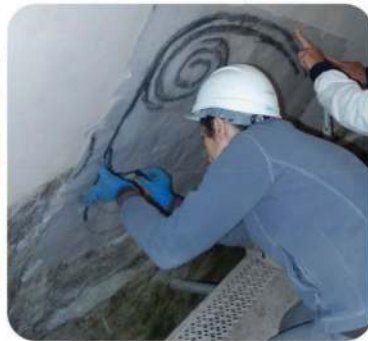
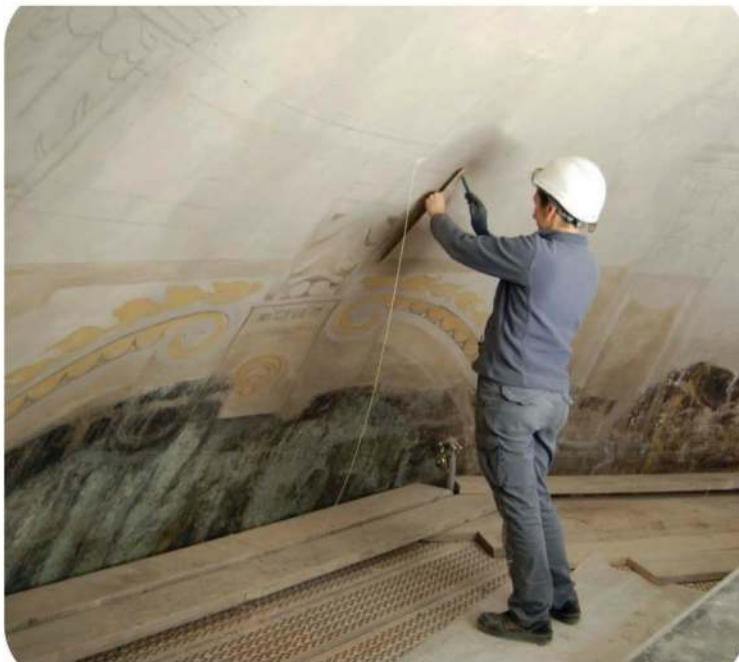
Figures 17-18. The dome during the painting supplementation phase.

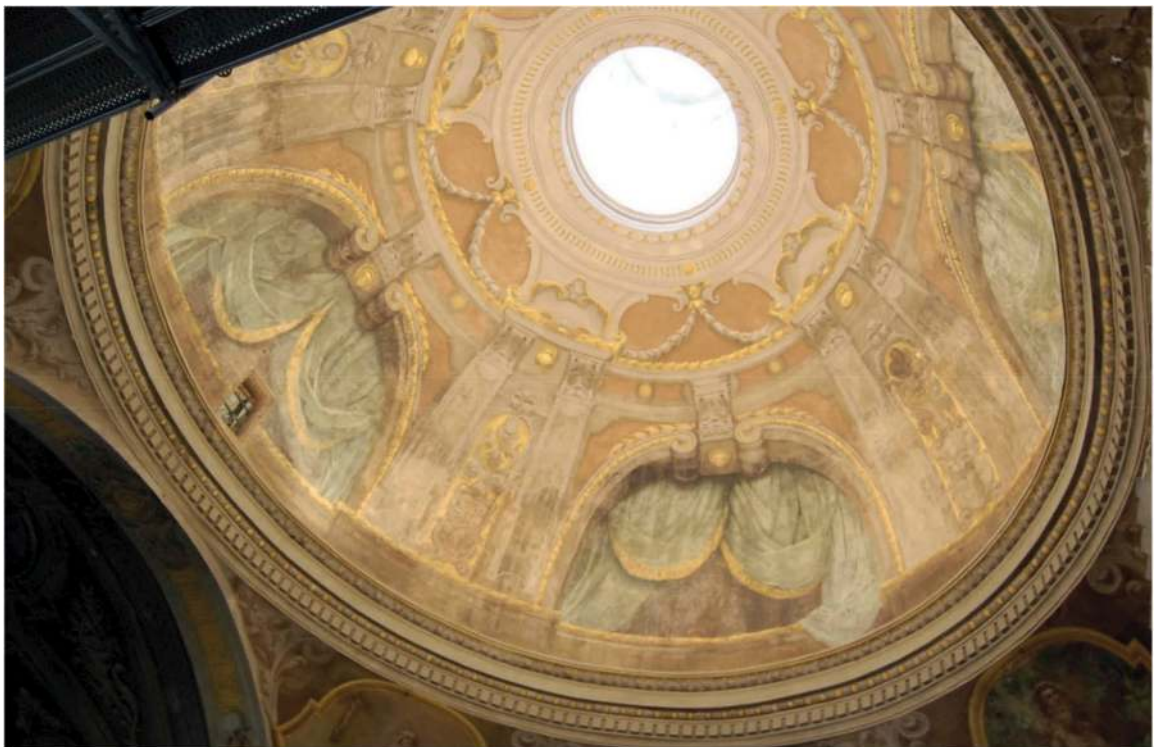
Figures 21. The decoration of the dome maintained the principle of recognition of the new and the previously existing.

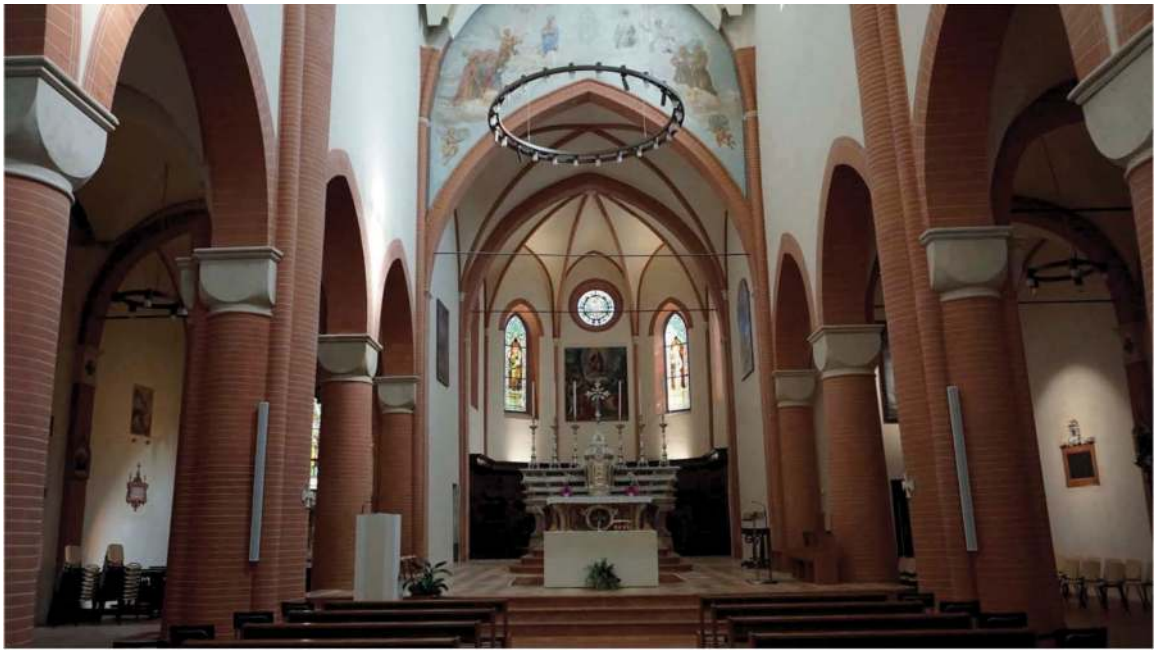
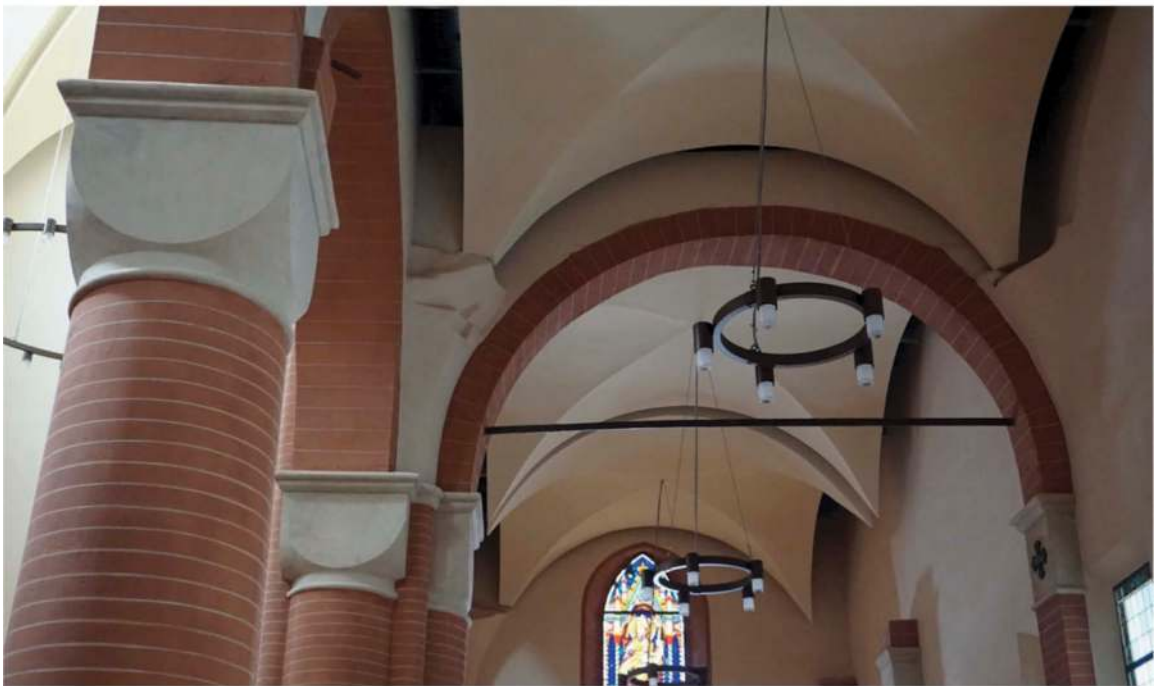
Figures 1-2. Mirandola Cathedral in its final state after restoration. Above, general view of the Central Nave; below, detail of the Left Side Nave.

The restoration of the Mirandola Duomo, with the reconstruction of the entire vaulting system using lightweight materials suspended from the new roof structure, is one of the first cases of post-earthquake reconstruction in Emilia that takes account of a new language that re-proposes ancient forms and fulfils the safety and protection aspects that the church had perhaps never possessed over the last six centuries.

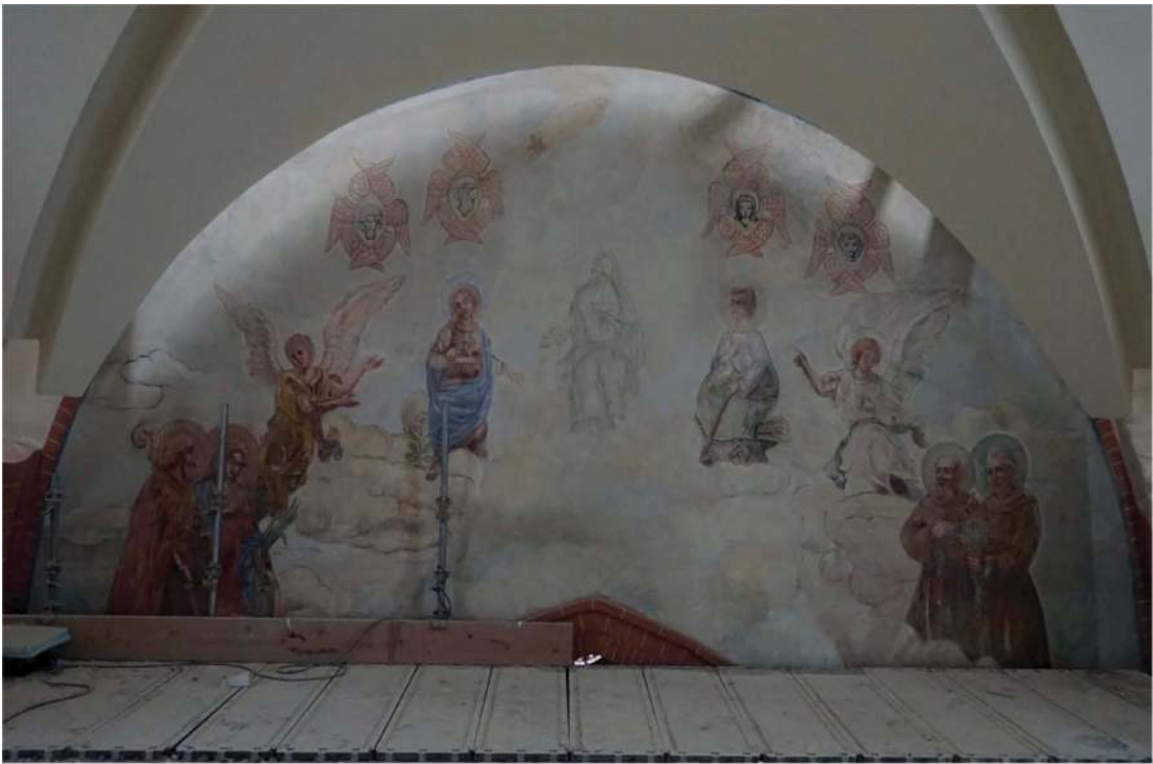
Figures 3-4. Gaps caused by the earthquake were treated and analyzed from case to case. In the image above, we can see how the gap in the Christ figure was filled in under the level with a fine charcoal drawing. In this way, the work was recomposed to become more coherent. In the case of the high altar, the small plastic gaps have been treated on the same level by repositioning the damaged profiles.

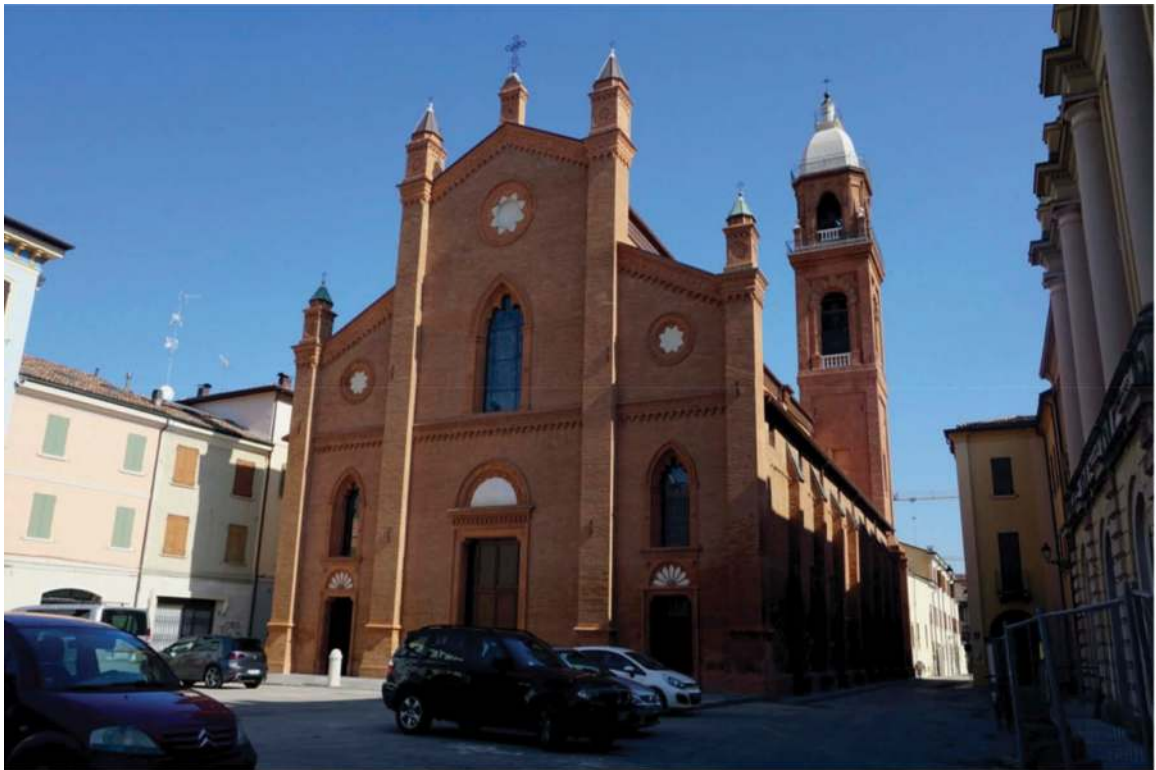
Figures 5-6. Above, the large gap on the top part of the façade has been repaired in the same manner as it was before the earthquake. The use of terracotta bricks and tiles cast from the originals allowed for the reconfiguration of the façade, which now only has a few scars marking the most significant lesions. To make the new additions chromatically consistent with the old ones, all surfaces were tonally glazed with lime water and coloring earths. Below, the right aisle, the only one not affected by the collapse of the vaults, after restoration. On the right, the gilded wooden altarpiece known as the Borelli altar.

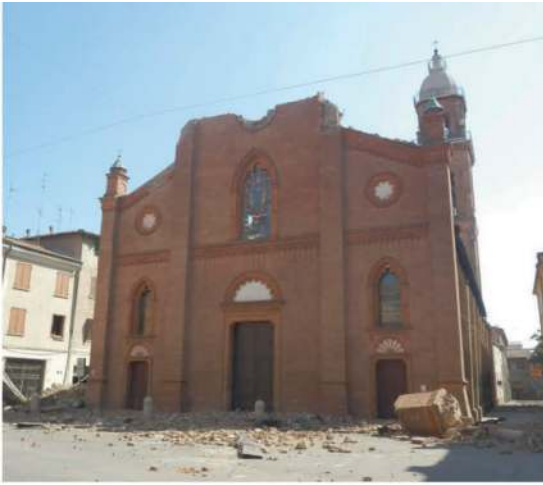
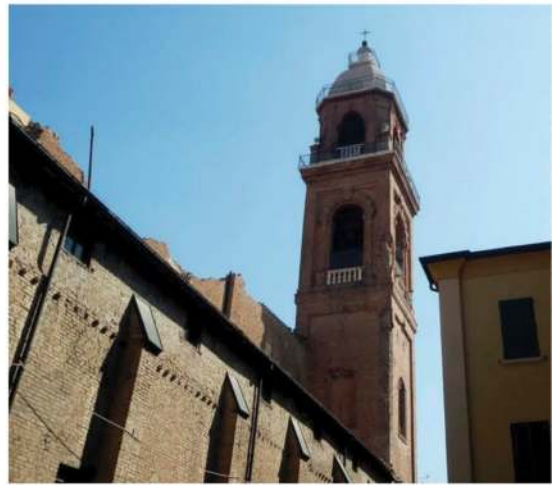
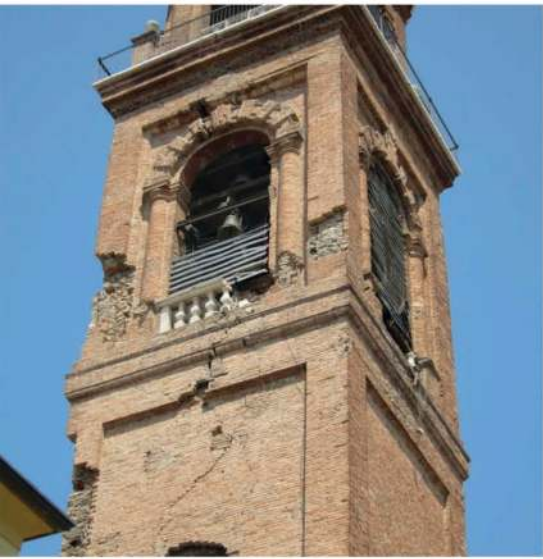
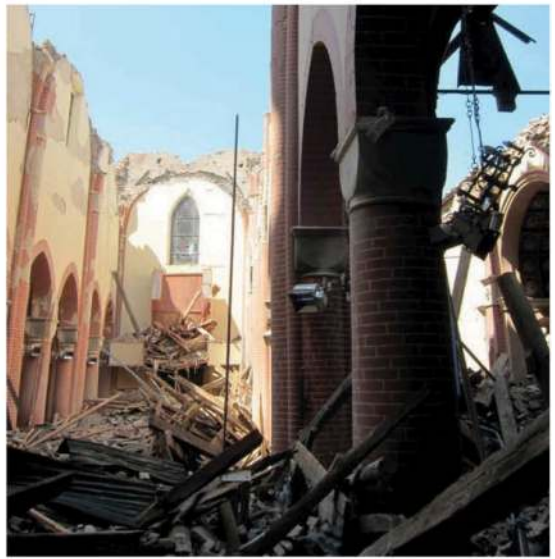
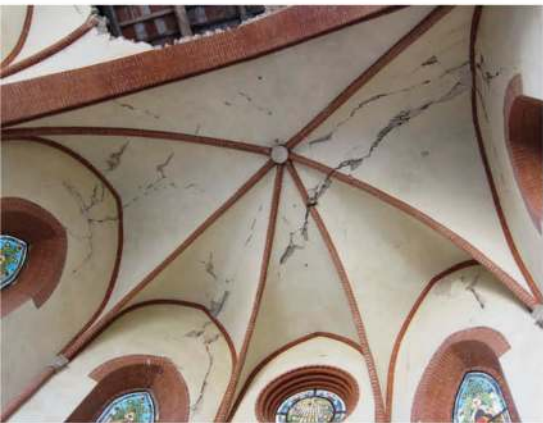
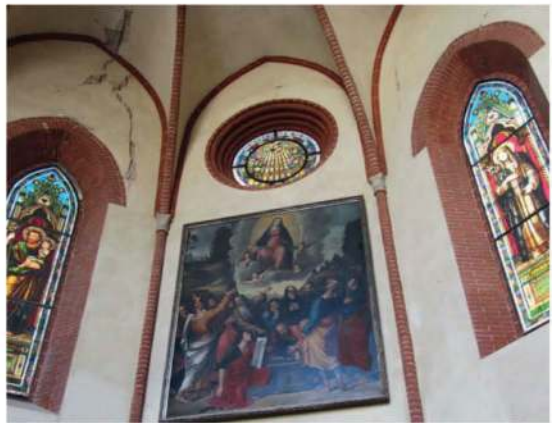
Figures 8-13. Images of the collapses and cracks on the outside and inside of the church and the bell tower, attached to the damage survey forms.

Indeed, several mechanisms were activated with the maximum level of damage. The earthquake caused the gable on the facade to completely topple, which, in relation to the left side aisle, underwent not only a rotation, but also a hammering action, which caused a crack along the roof line and a misalignment in the left spire. At the time of the second earthquake, the lateral walls of the clerestory and the central nave were already detached from the facade, meaning that the large movements caused the cross chains to break and the roof to collapse. The bell tower suffered serious damage to the spire, the belfry, the walls and the stairwell.

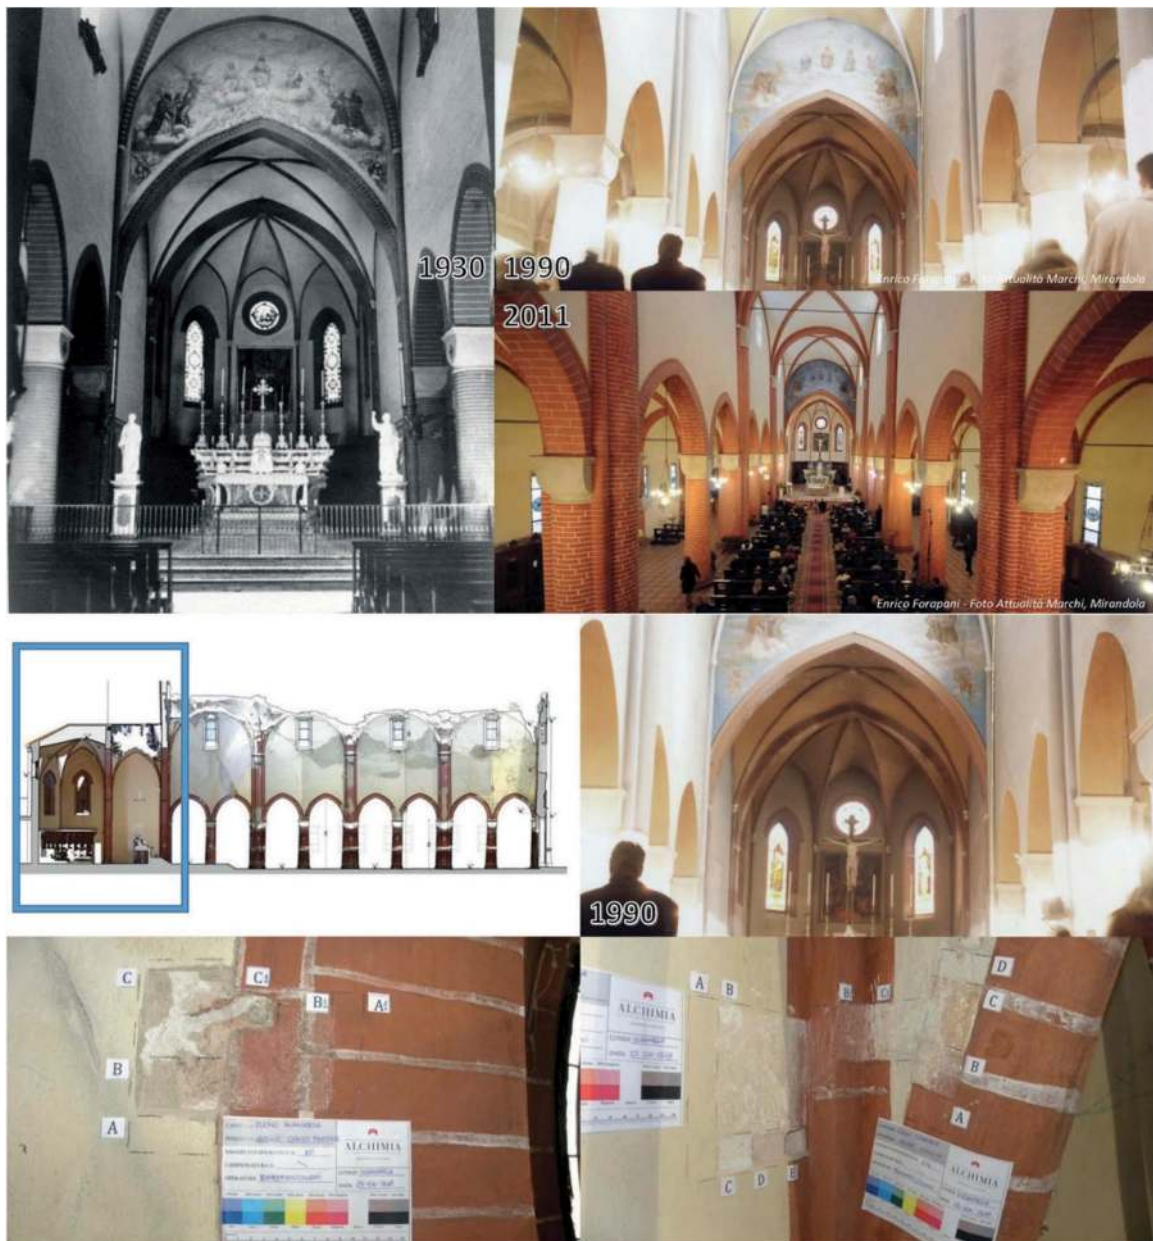
Figure 14. Historical research and a cognitive campaign using stratigraphic essays determined the metric and chromatic layout of the decorative system dating back to the early 20<sup>th</sup> century. As a result of an accurate study of the details and continuity solutions between the architectural parts, the threading system that traced the masonry apparatus was reproduced and applied to all the internal surfaces.

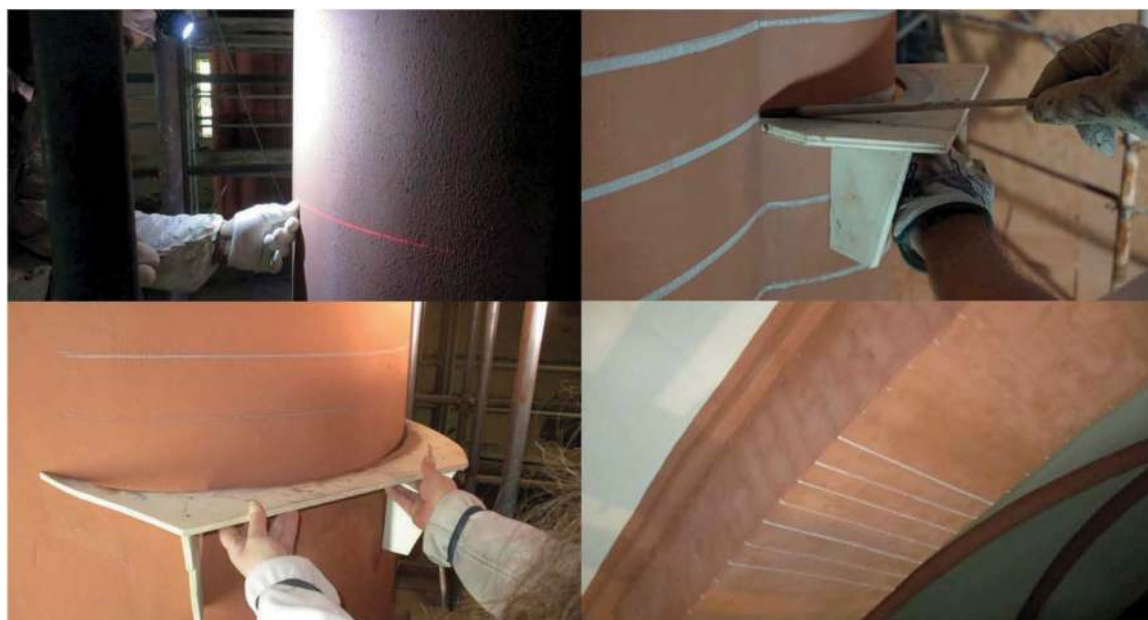
Figure 15. After tracing with a laser level and using shapes and templates with variable curvature to follow the splay of the columns, a pictorial reconstruction of the decorative draft on columns and arches was established using lime paints.

Over the centuries, the subsidence of the foundations of the bell tower had led to significant interventions, including the reinforcement of the colonnade, the construction of the external buttresses, the reconstruction of the foundations of the bell tower, the construction of a counter wall behind the counter façade and a wall adhering to the north side, as well as various reconstruction and restoration interventions following collapses, fires or wartime events. As a result of these events, no trace remains of the original 15th-century decorative scheme of frescoes on the perimeter walls and the counter-façade, which also showed signs of deterioration due to rising damp from the start. In the second half of the 19th century, the church was completely restored: the windows of the side aisles were changed and there was further massive and extensive restoration in 1937, during which the statues and Baroque altars were removed. Starting in 1990, there was extensive work on the church for a decade, involving the almost complete removal of all the interior plaster on the vaults and walls, and repainting, including the reproposal of a faux-brick plasterwork decoration that differed substantially from the photos taken in the 1930s which document the interior before the 1937 work. This explanation was necessary, and it justifies the new proposed decorative scheme, which differs substantially from the last work carried out in the 1990s, i.e. it corresponds to the faux-brick patterned decoration characterised and sized on the basis of photographs from the 1930s, partly found in the apse area through stratigraphic tests. This system is composed of horizontal fillets 8.5 centimetres apart, which is the pitch of the bricks of the colonnade exposed after the plaster had fallen off. The outlines of the fillets necessarily had to cope with dimensional anomalies and unevenness in both the vertical and horizontal planes of columns and arches due to all the events mentioned in the introduction. It is important to emphasise this aspect of the intervention, because the final regularity of the fillets is only apparent, since, particularly on arches and quadrilobed columns, the outlines follow a radial pattern that reflects the curvature of the architectural element and masks its distortion.

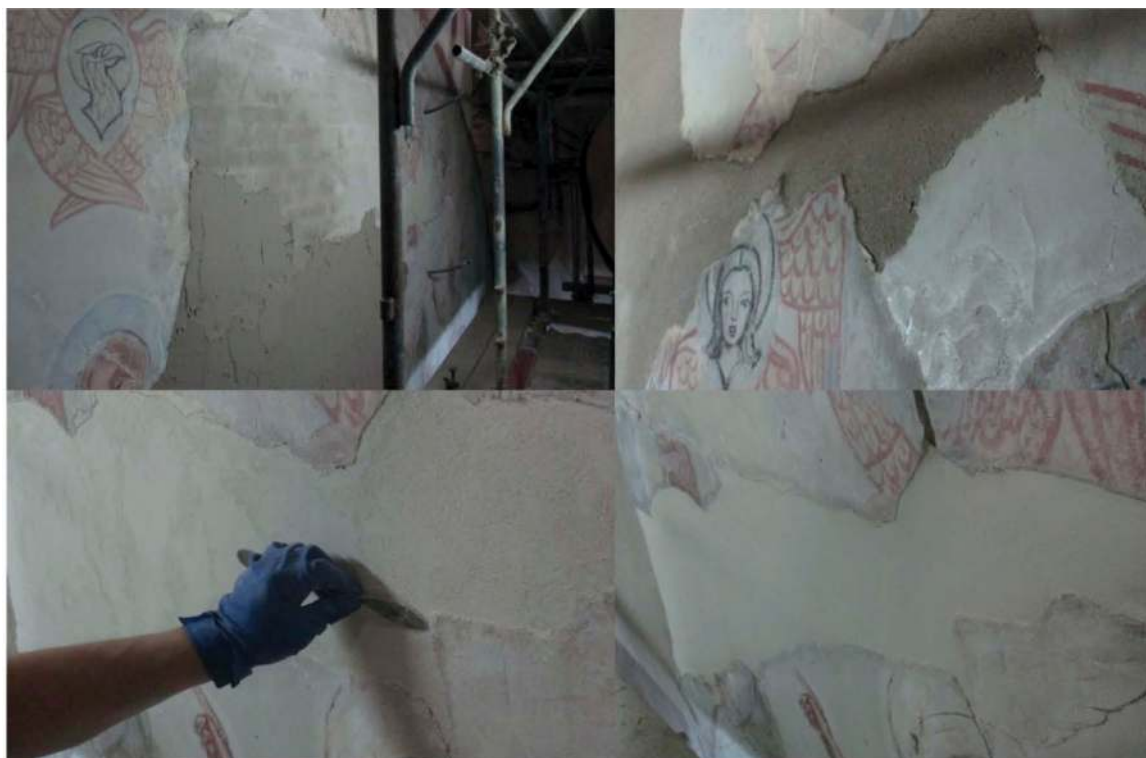
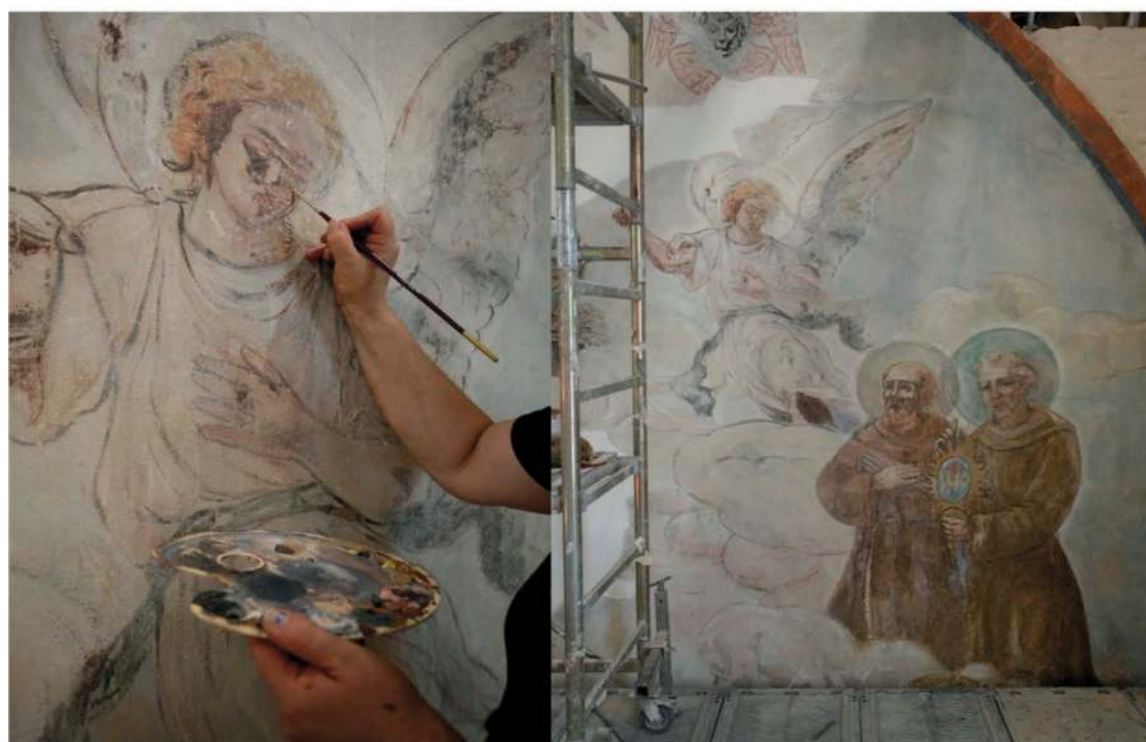
Figures 18-19. Above, underpainting of painted plaster gaps with lime mortar. Below, retouching and pictorial integration of the figures using tempera colours and watercolours, executed underpainting with mimeograph technique and pictorial integration of the neutrals by glazing with lime paints.

the wall support and supplementation of the central part showing Christ, which was missing because it was located in correspondence with an old infill which had fallen during the earthquake. Prior to the repair and consolidation of the fabric of the wall, fragments in danger of falling off were removed and the paint layer, which was particularly weak and lifted, was prefixed.

During the restoration, the large gaps in the plasterwork were filled in below level and the cracks and abrasions were carefully filled. The depiction of Christ was recovered from period photographs and printed full size on tracing paper, transferred to the wall and its main features outlined in charcoal to reconstitute the unity of the work, making the intervention distinguishable and reversible.

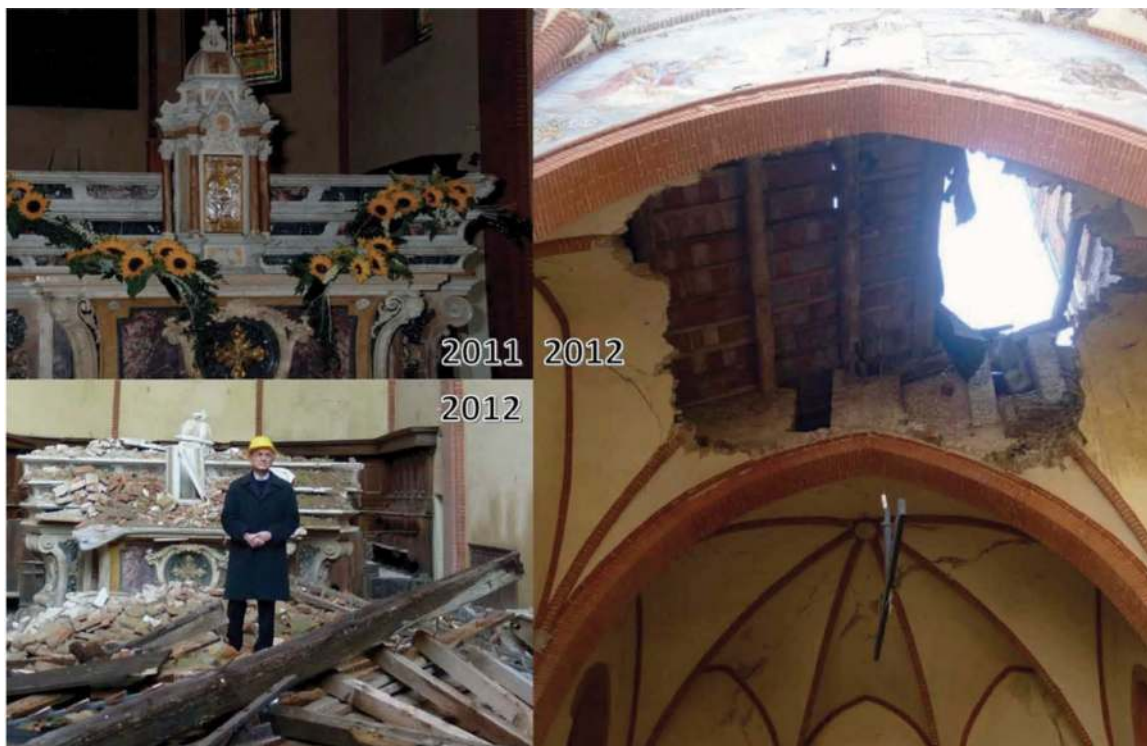
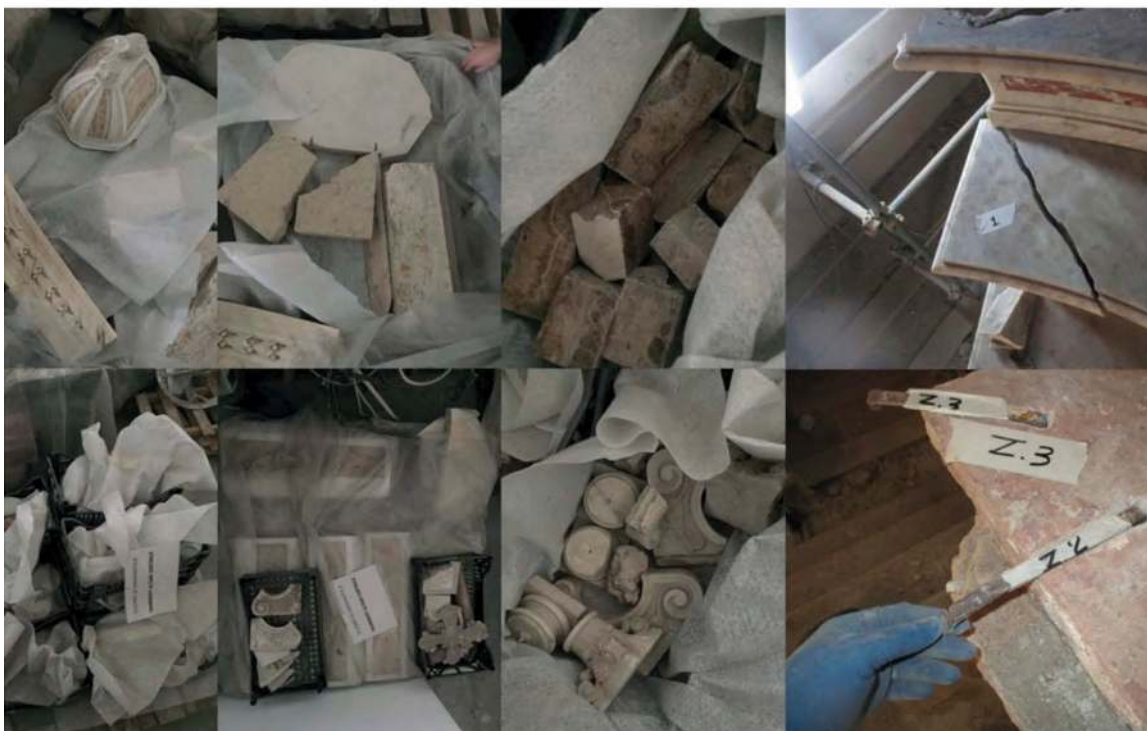
Figures 20-21. The high altar before and after the earthquake event is shown above. Documentation of the stone fragments recovered by the fire department is provided below. After several months of drywall reassembly tests, all of the fragmented artifacts were reassembled.

The high altar was built between 1771 and 1776 to replace the previous one dated 1660, at the same time the 16th-century choir was replaced with the current one in walnut from the church of Santa Maria del Paradiso in Mantua. The collapse of the presbytery vault severely damaged the altar, in particular the tabernacle and the upper mouldings, with stone fragments to be found among the rubble. The patient work of the fire brigade, coordinated and supervised by the officials of the Superintendency, made it possible to recover almost all the fragments, and this is confirmed by the fact that very few parts were missing after the altar had been put back together.

It took about four months to relocate and dry-fit the recovered stone fragments, and about the same amount of time for gluing and the actual restoration. Casts had to be made in situ to reproduce the few lost parts that were structurally necessary for the recomposition of the work. Similar work was carried out on the balustrades of the altar of the Blessed Sacrament and the chapel of the Rosary, and the statues of Faith and Hope located there, which were damaged by the collapse of the vaults in the left aisle.

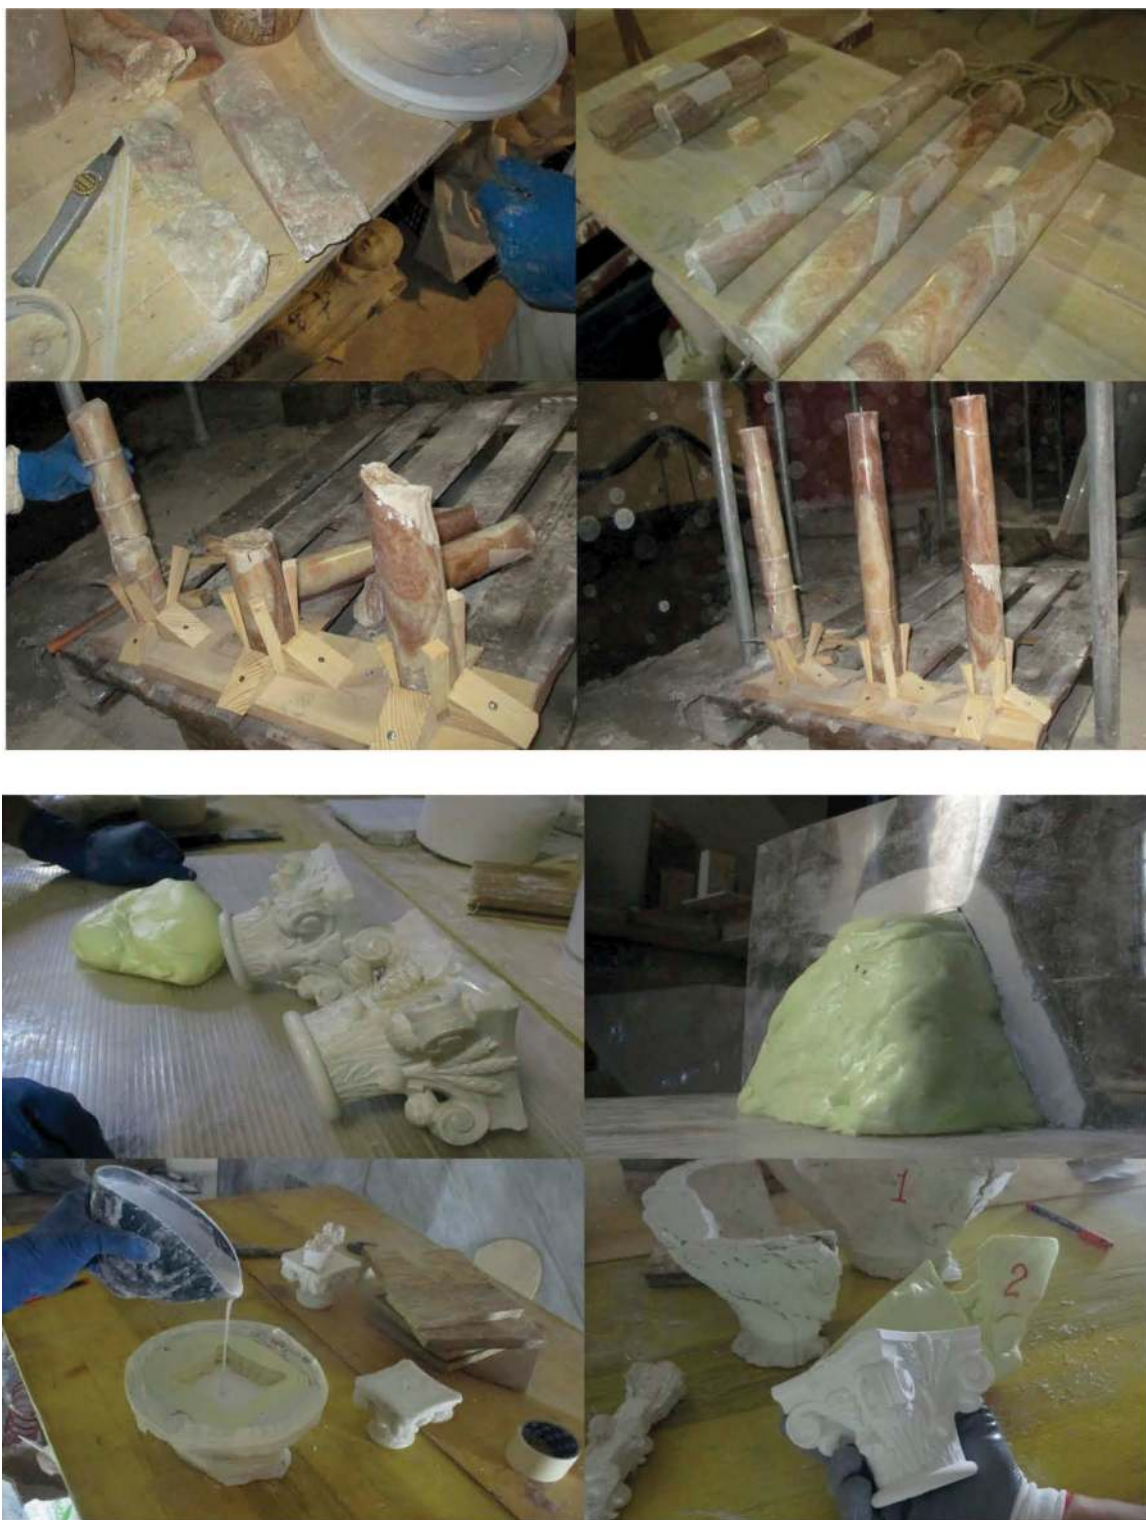
Figures 22-23. Above, the stone fragments of the Tabernacle columns are assembled with pins and epoxy resin. Bottom, a plaster casting in mouldable silicone rubber was used to recreate the missing Tabernacle capital from an intact original elements.
