# BUILT HERITAGE IN POST-DISASTER SCENARIOS

IMPROVING RESILIENCE  
AND AWARENESS TOWARDS  
PRESERVATION, RISK MITIGATION  
AND GOVERNANCE STRATEGIES

PROCEEDINGS OF THE 1ST EDITION OF THE INTERNATIONAL SUMMER SCHOOL  
“AFTER THE DAMAGES”, FERRARA, ITALY, 1-15 JULY 2020

# Built Heritage in post-Disaster Scenarios

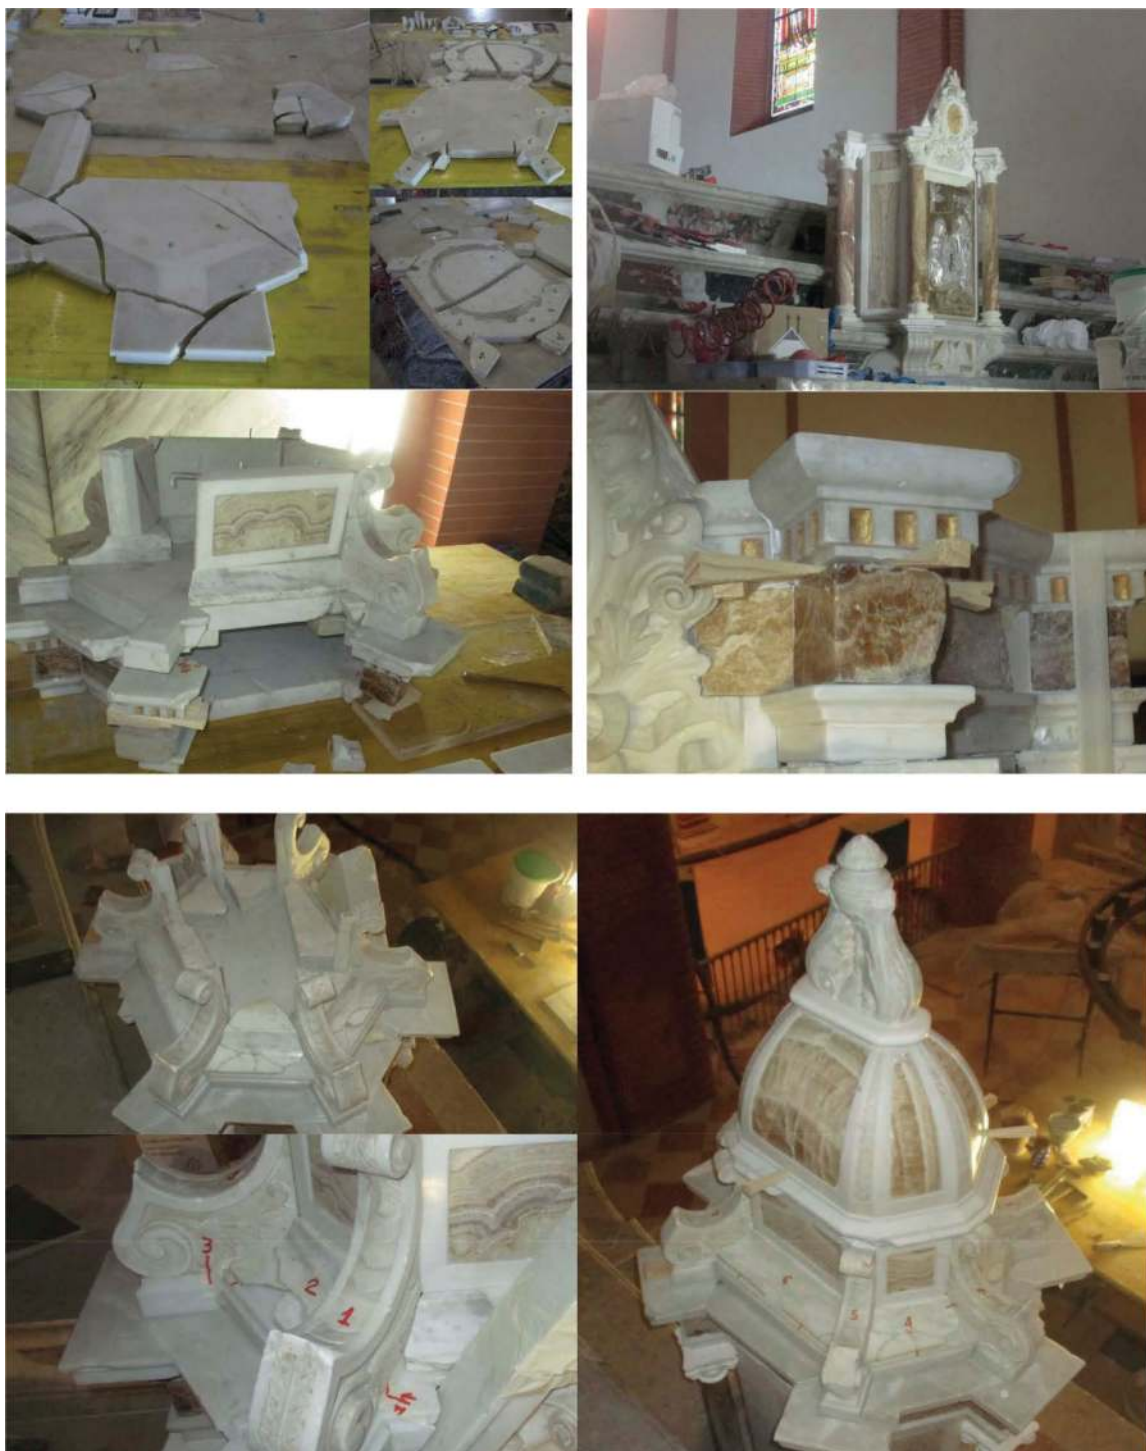
Figures 24-25. Top-left, the reconstruction of the Tabernacle of the High Altar: sorting and identifying the proper position of the fragments took a long and patient process. As stated in the introduction, the Fire Brigade's meticulous work in rescuing the rubble granted the recovery of nearly all of the fragments. Top-right, the high altar: dry composition tests of the tabernacle to identify the missing parts and establish the points of reference for the final assembly process. Below, the composition of the recovered stone elements for the upper part of the Tabernacle.

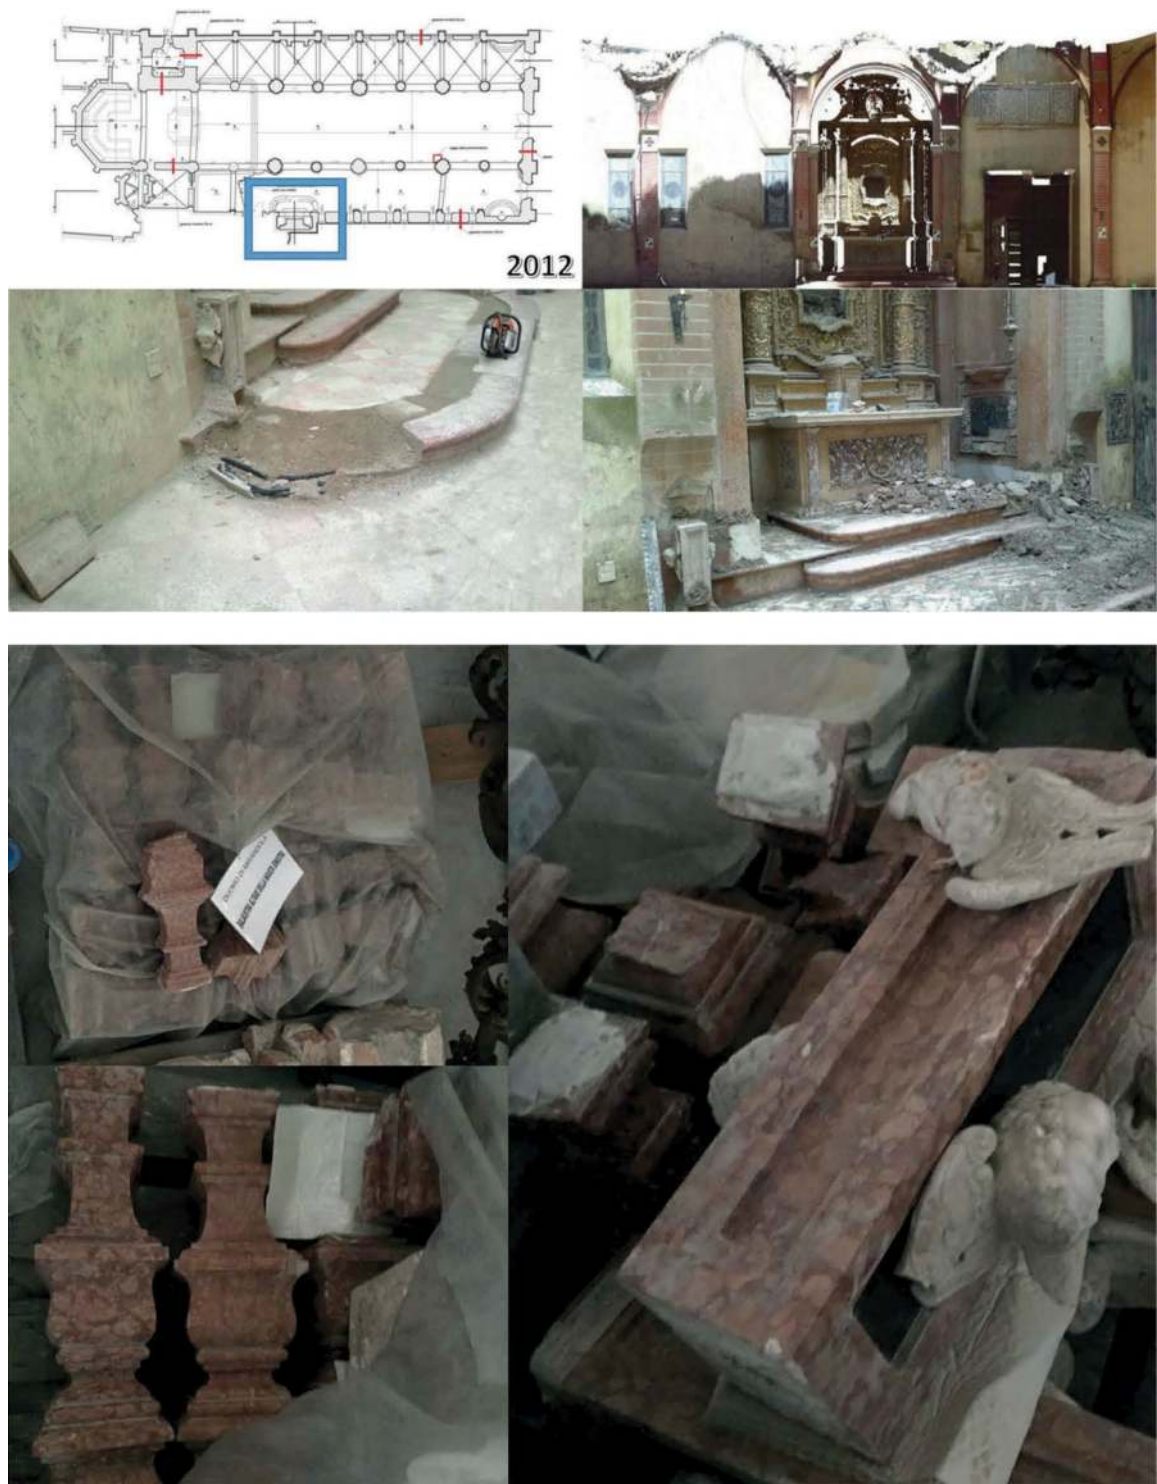
Figures 26-27. The altar of the Rosary, involved in the collapse of the vaults above, suffered extensive damage to the stone balustrade and the two statues located within the side niches. Above, the post-earthquake state of the altar. Below, the benches with all the recovered fragments including the winged putti and their fragmented parts.

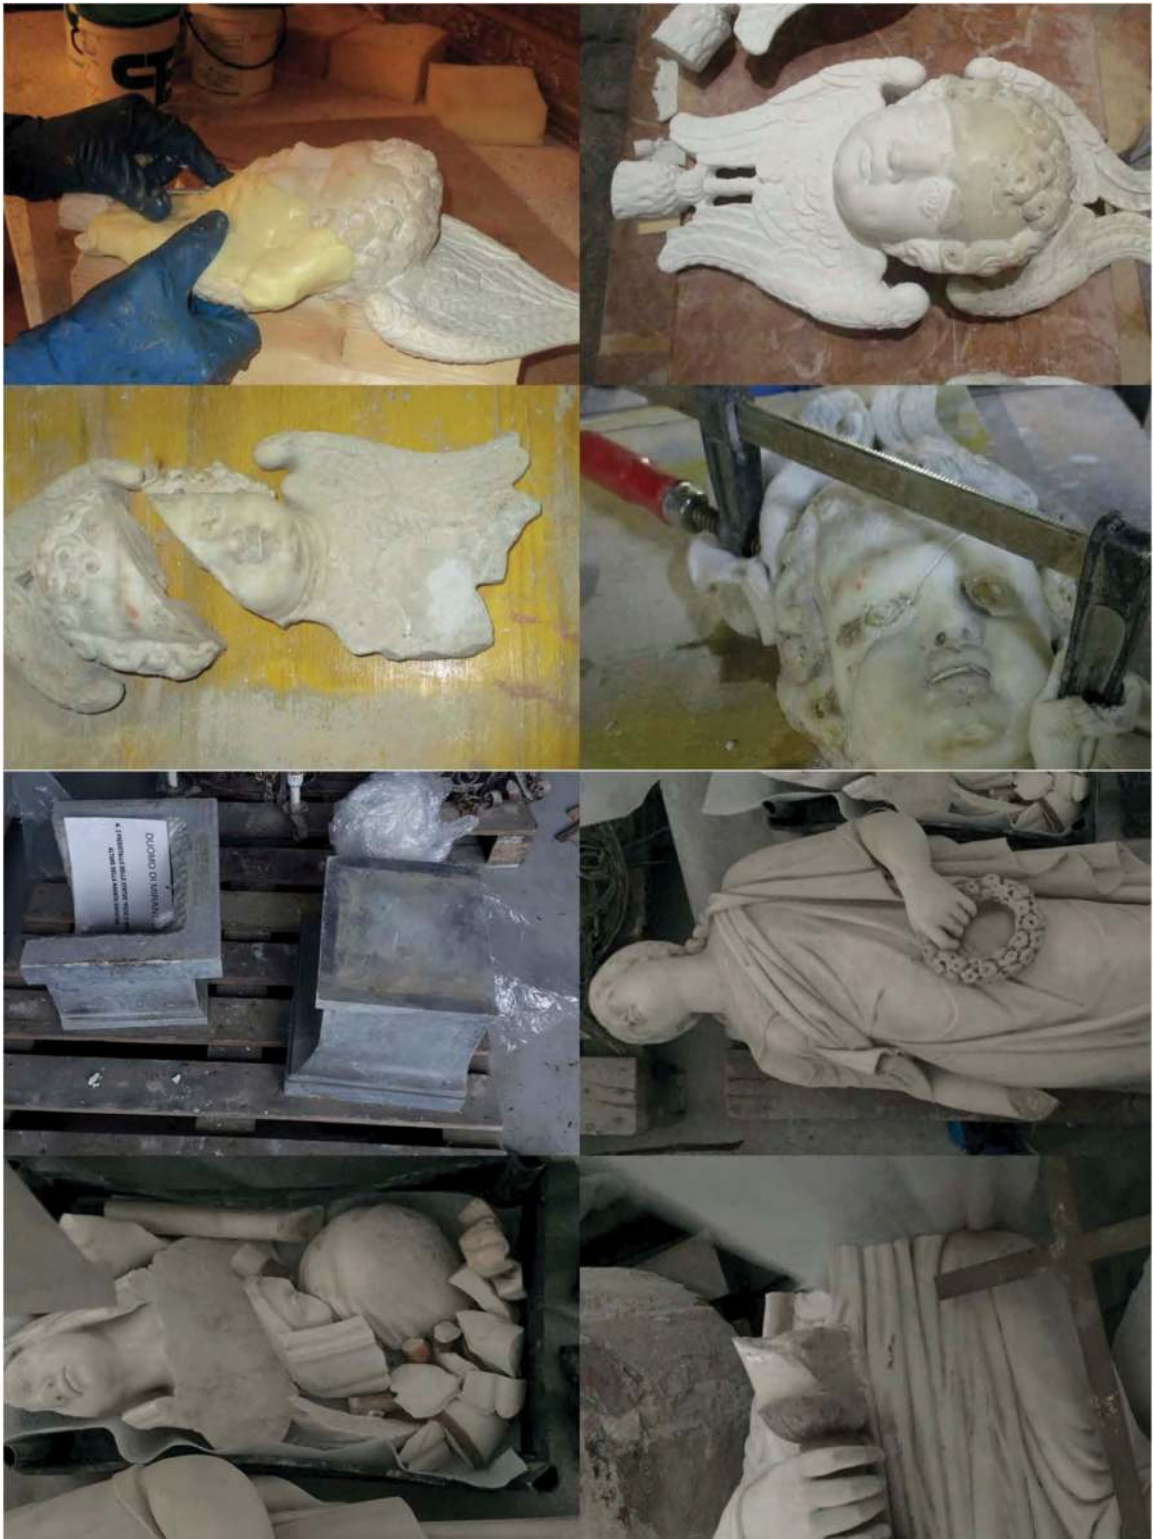
Figure 29. Above, the recomposition of the recovered stone winged putti with cast reconstruction of the missing portions. Below, the Statues of Faith and Hope with their fractured elements recovered from the rubble.

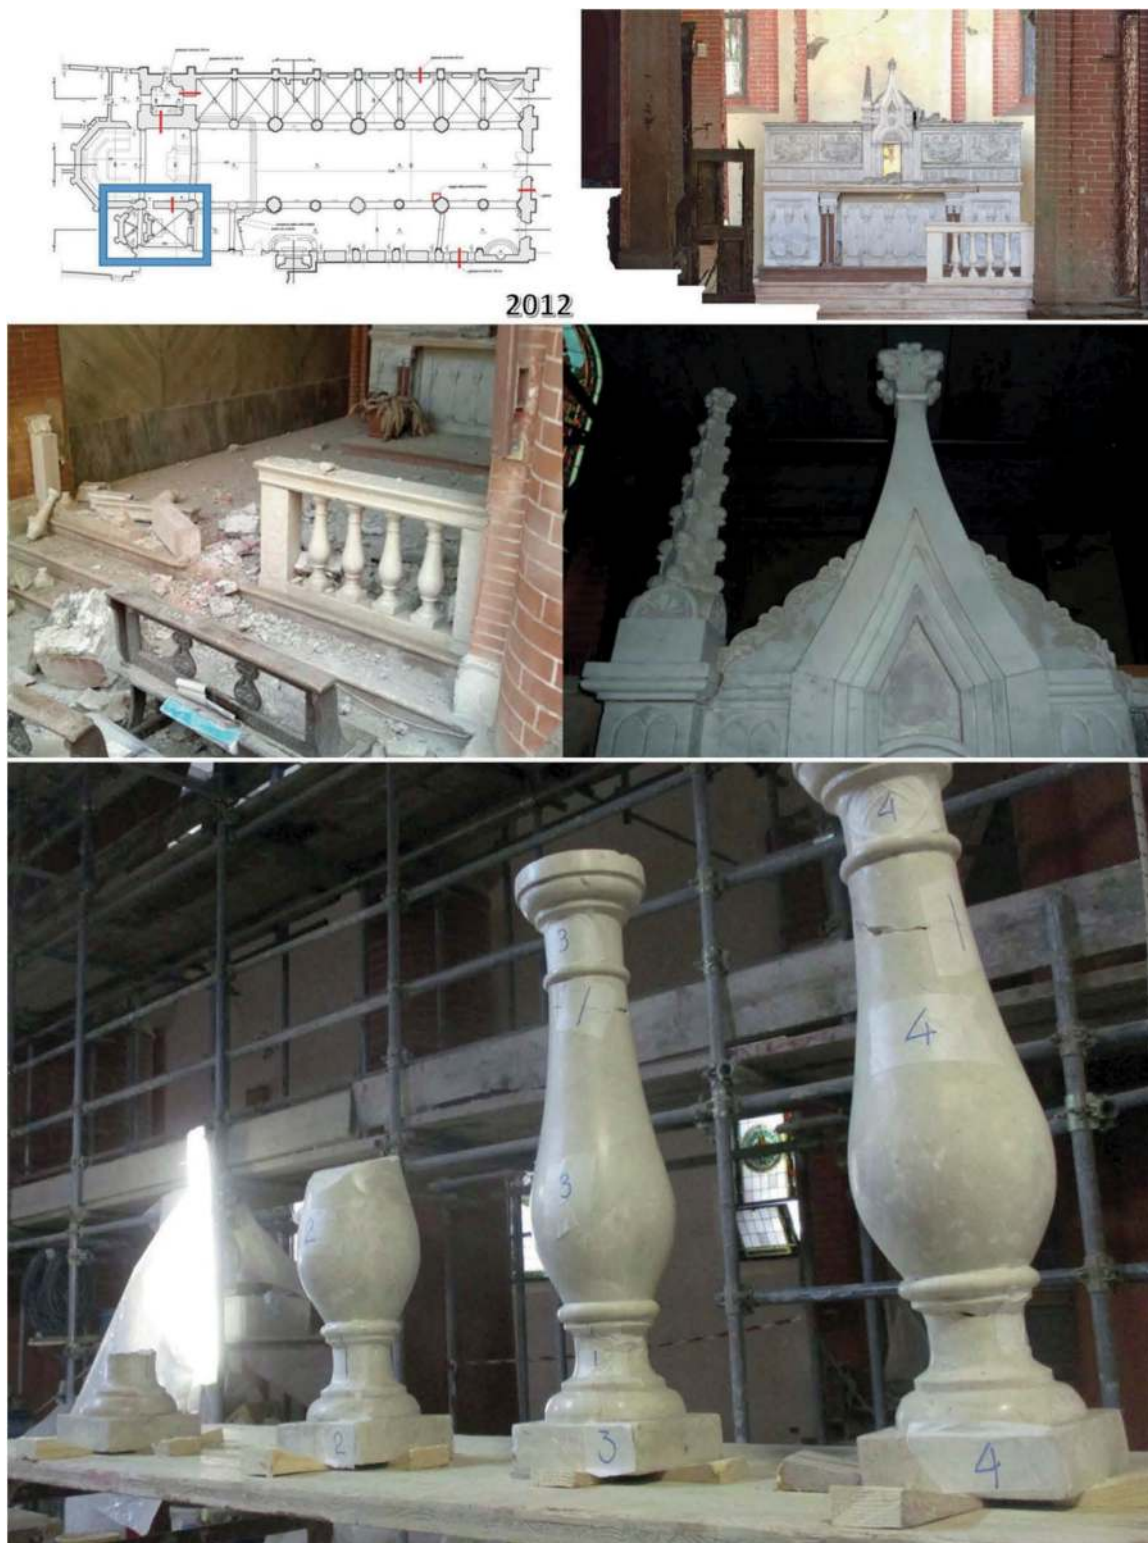
Figure 30. Above, the Altar of the Santissimo, details of the balustrade shattered and the destroyed Tabernacle spire by the collapse. Below, the identification and assembly of the recovered fragments of the balustrade columns.

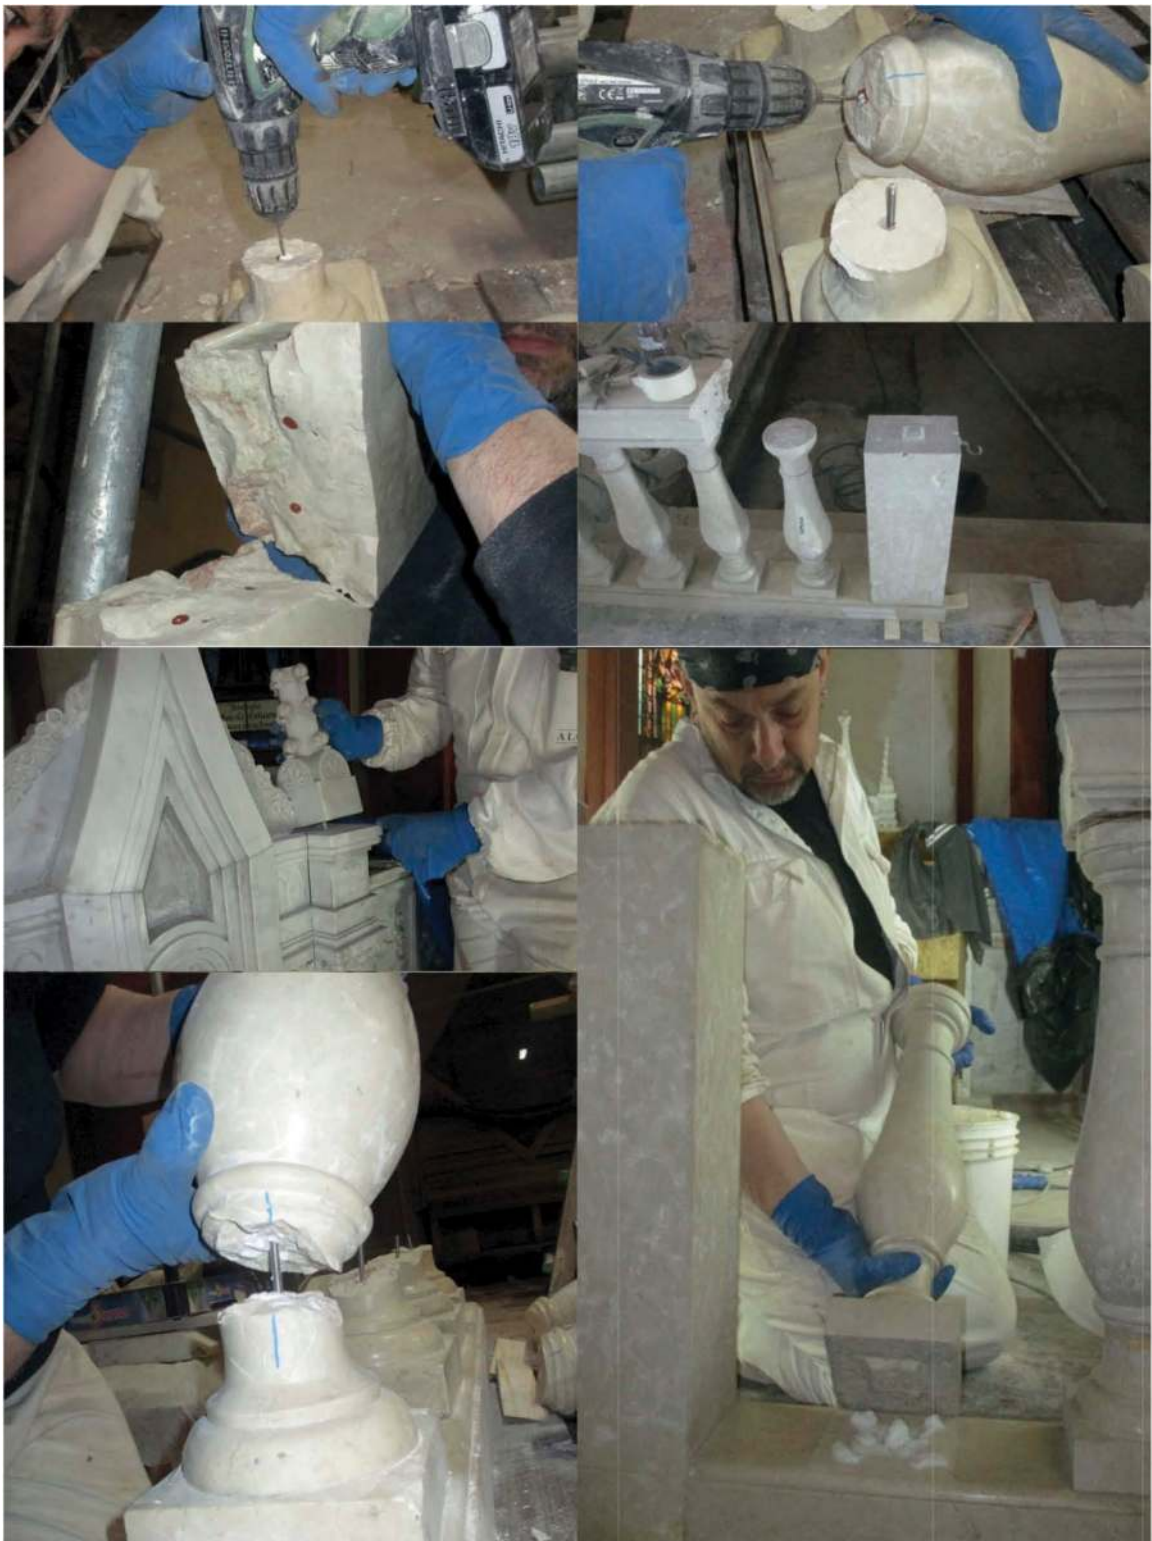
Figure 31. The Altar of the Most Holy Sacrament, assembly process of the stone fragments of the balustrade by gluing, pivoting and cast reconstruction of the missing cusp to the right of the Tabernacle.

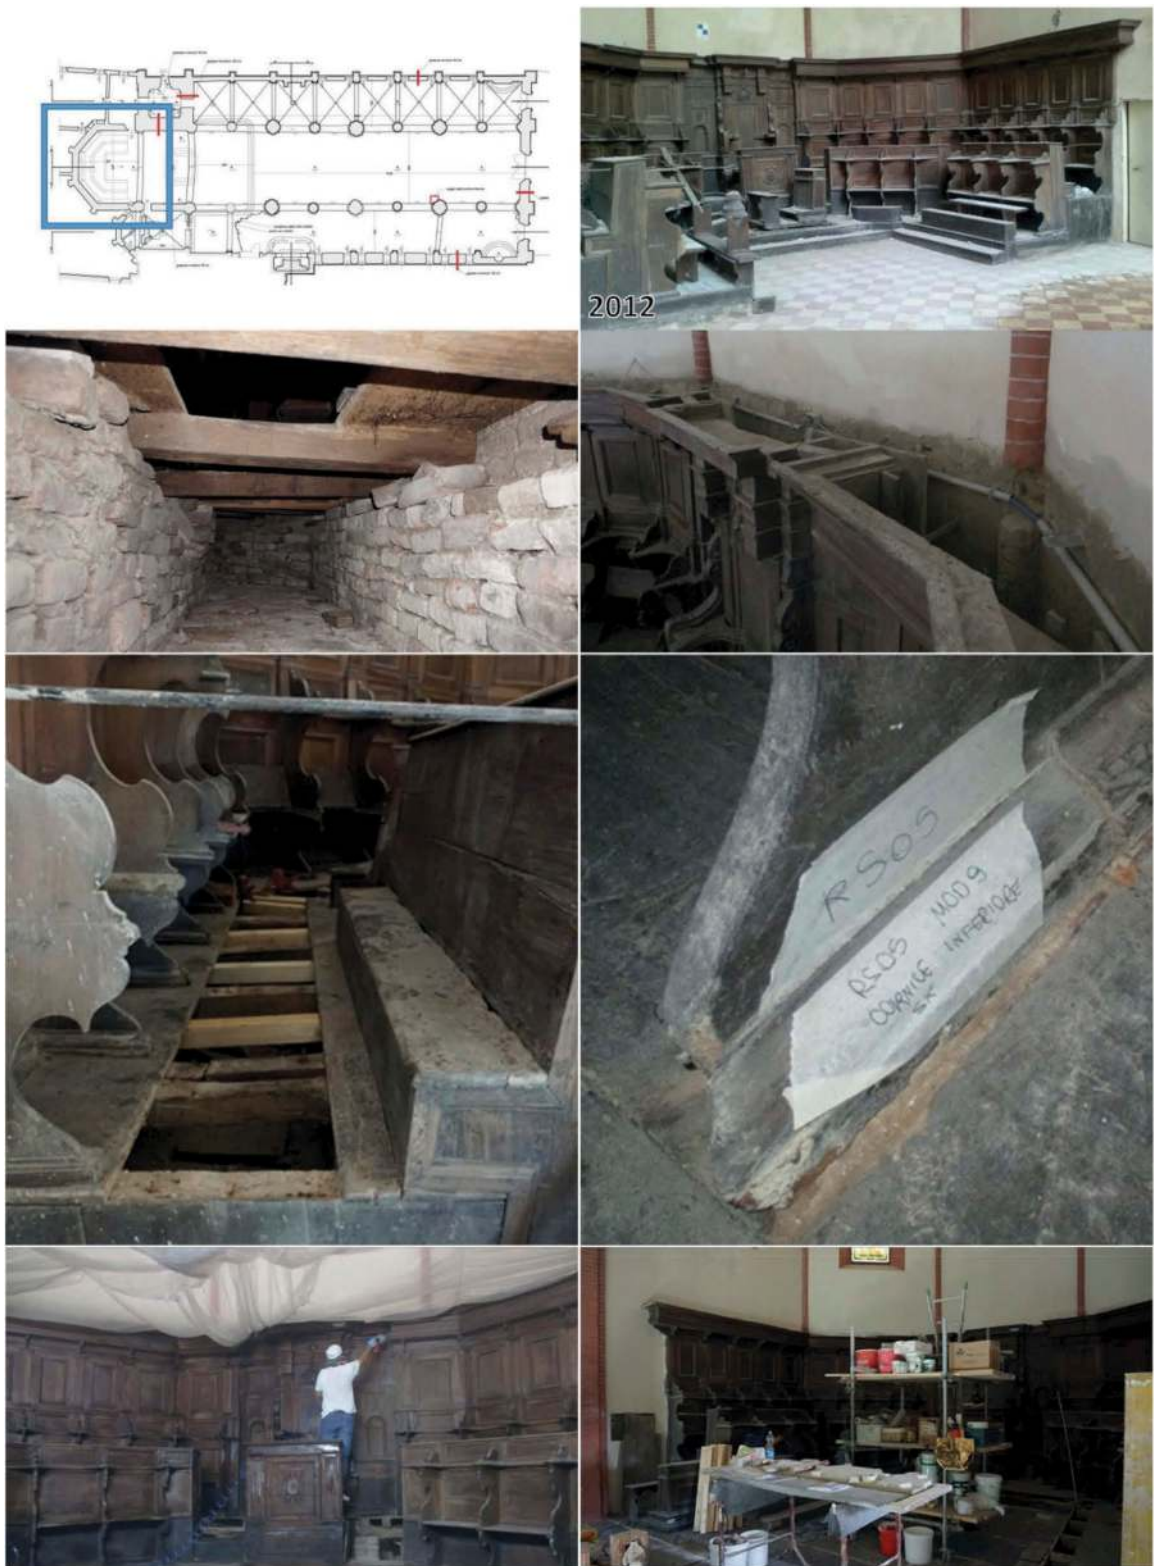
Figure 35. The wooden choir: disinfection, cleaning, repair and shellac treatment.

The work regarded all the elements of the historic building: wooden furnishings, doors and gates, altars, altarpieces, statues and paintings. The majestic wooden choir was partially dismantled and its supporting structure was consolidated and strengthened. And it was treated against woodworm, reassembled and restored. The Borelli altar and the altarpiece in the Rosary Chapel, carved and gilded wooden artefacts, were restored and their paintings put back, as were all the rest of the pictures, which were removed from temporary storage and relocated to the site.

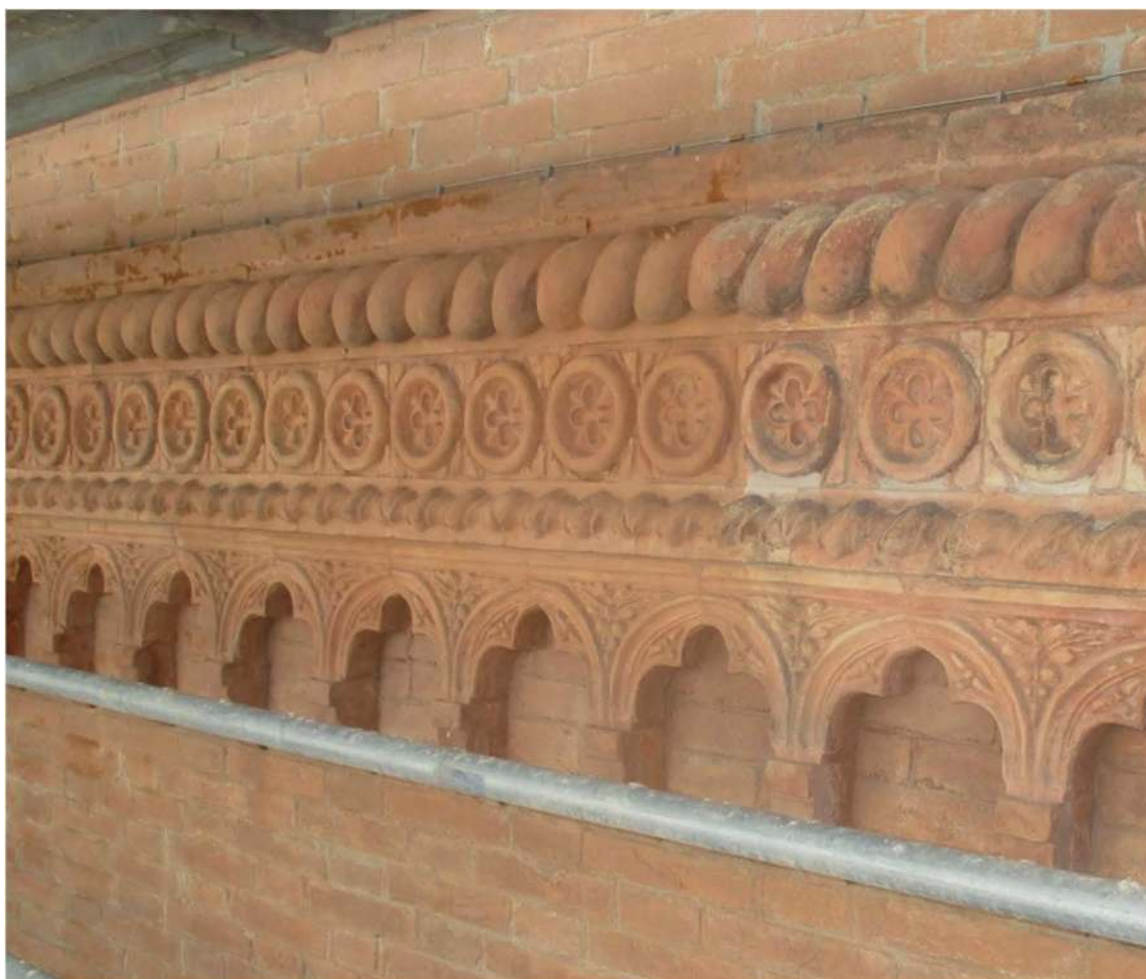
Figure 38. Tonal glazing of the decorative terracotta elements of the cornices: the glazing was formulated following calibrated on-site sampling aimed at unifying the face, which was noticeably heterogeneous as a result of the structural interventions and scuci e cuci.

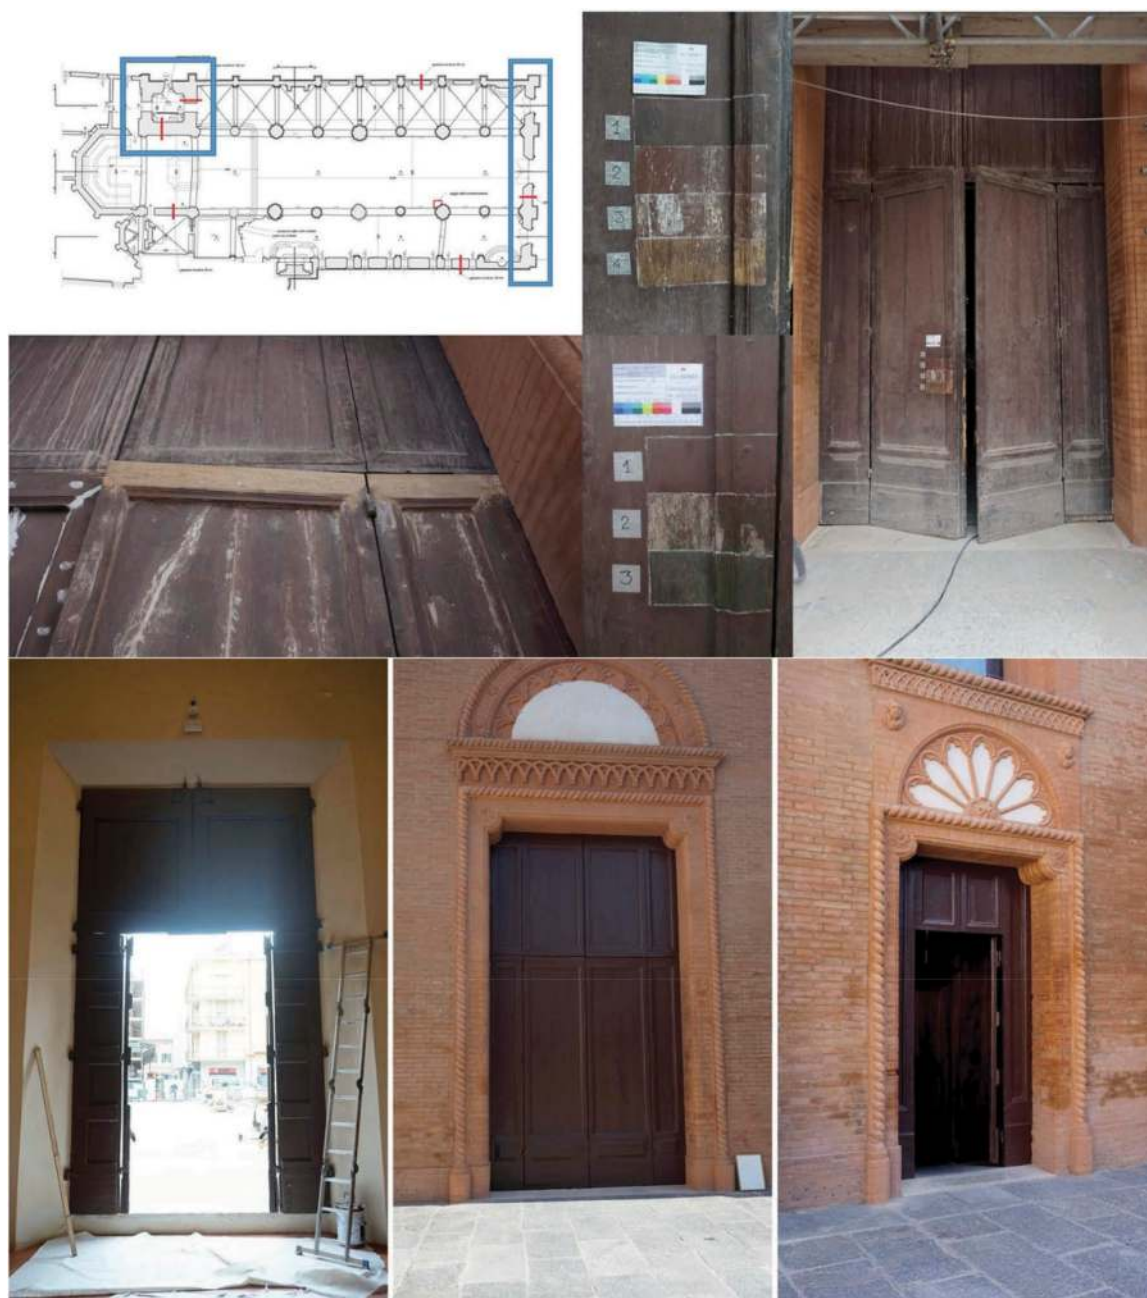
Figure 39. The state of conservation of the main and side entrance doors with images of the stratigraphies conducted to identify the restoration colours and the final state of the doors at the end of the restoration.

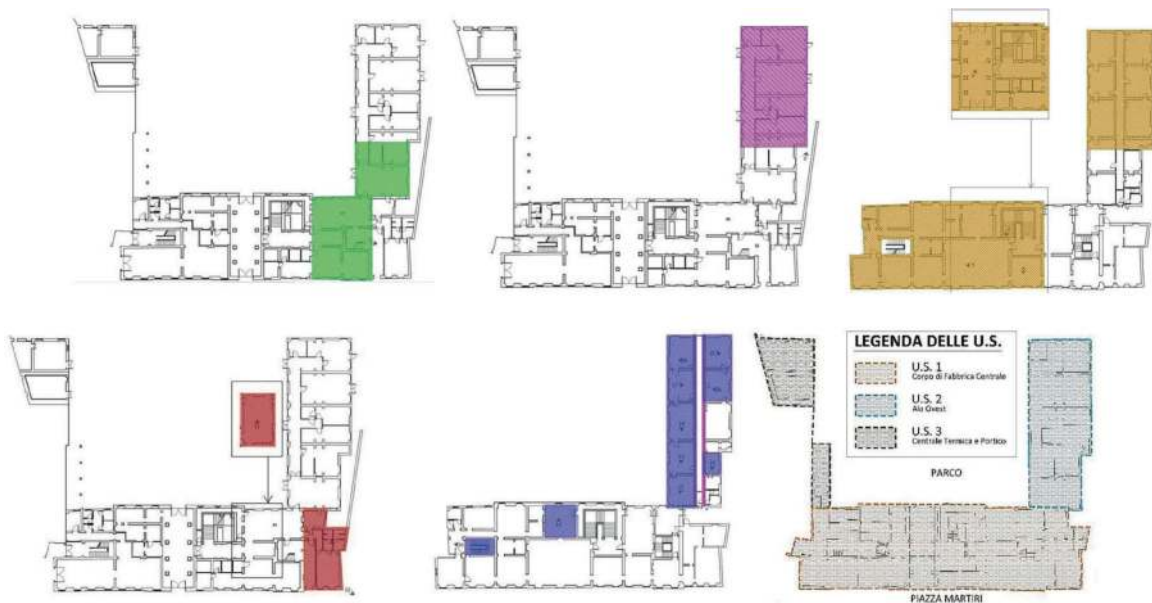
Figure 4. Top-left: Stage 1 (green), the building originated from a modestly sized building dating back to the early 1500s. Evidence of this is the staircase with rampant arches and a masonry parapet culminating in a finely crafted handrail. Top-centre: Stage 2 (magenta), at the end of the 18<sup>th</sup> century the building was enlarged and embellished with the addition of the west wing, which had been left unfinished after the earlier work. Top-right: Stage 3 (light brown), it was at the turn of the 18<sup>th</sup> and 19<sup>th</sup> centuries that the building took on its present palatial configuration. The fine lime decorations in the Salone delle Feste and the adjoining parlours date from this period. The creation of the Inner Park with access from the atrium used as a carriage way also dates back to this phase. Down-left: (red) in the early 1900s, probably with an increase in permanent residential activity, some of the rooms on the first floor of the west wing were refurbished, becoming an extension of the main floor, and the tempera decoration of the Sala dello Zodiaco was added. Down-right: (purple) the last phase of the process ended in the 1920s-30s with the insertion of the new volume on the side of the façade. The lime decoration of the Sala Neo-Medievale e Liberty with a false projecting balcony with a shelf and painted festoons of flowers and fruit also dates from this period.

A further transformation that significantly affects the morphology of the architectural complex took place in the 1920s-30s. This involved the insertion of the new volume on the side of the main façade on the right. The decoration with geometric modules and stylised floral motifs, a hybrid of neo-mediaeval and Art Nouveau decorative stylistic elements, in the room next to the ballroom overlooking the main staircase, dates from this same period. Another element to highlight is that

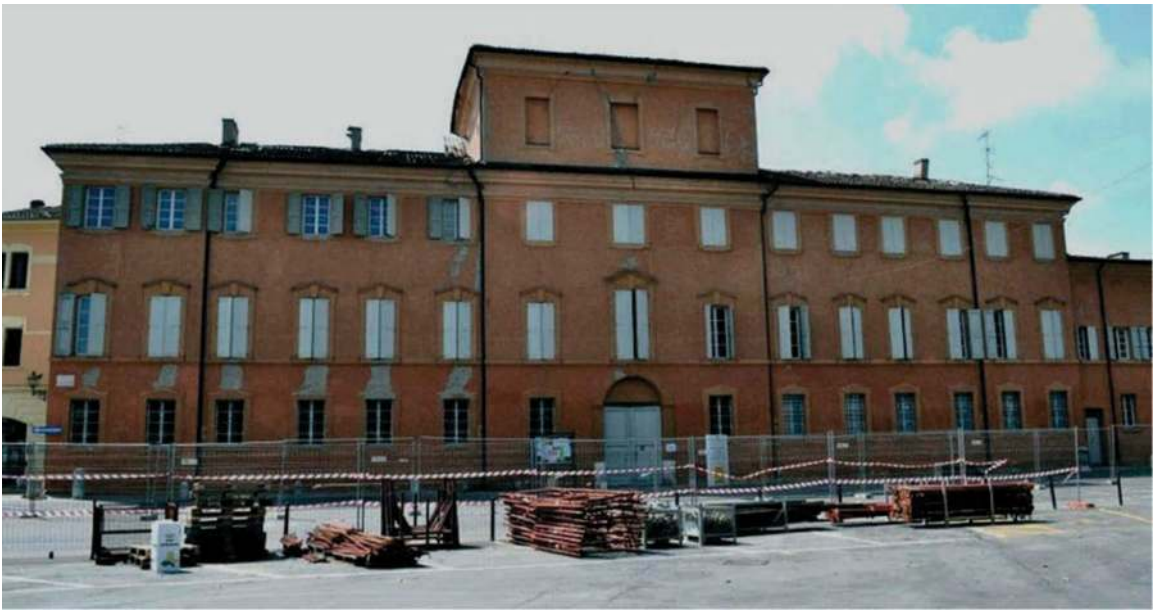
Figure 5. The main front of Palazzo Sartoretti, the backdrop of Piazza Martiri, as it looked after the 2012 earthquake.

Palazzo Sartoretti had already been damaged by the 1996 earthquake, following which both structural consolidation and surface restoration works were carried out. In spite of this, given the extent and type of seismic events that occurred in 2012, the Palazzo suffered extensive damage and was declared unfit for use and the subject of a series of Fire Department initiatives to make it safe, which, specifically, included the installation of boarding to support the windows, external and internal ties and shoring up of the most compromised and valuable areas, to ensure safe access and inspection, a fundamental aspect during the design phase. As has been made clear in the previous paragraphs, the Palazzo is the result of successive additions, modifications and changes of use over time.

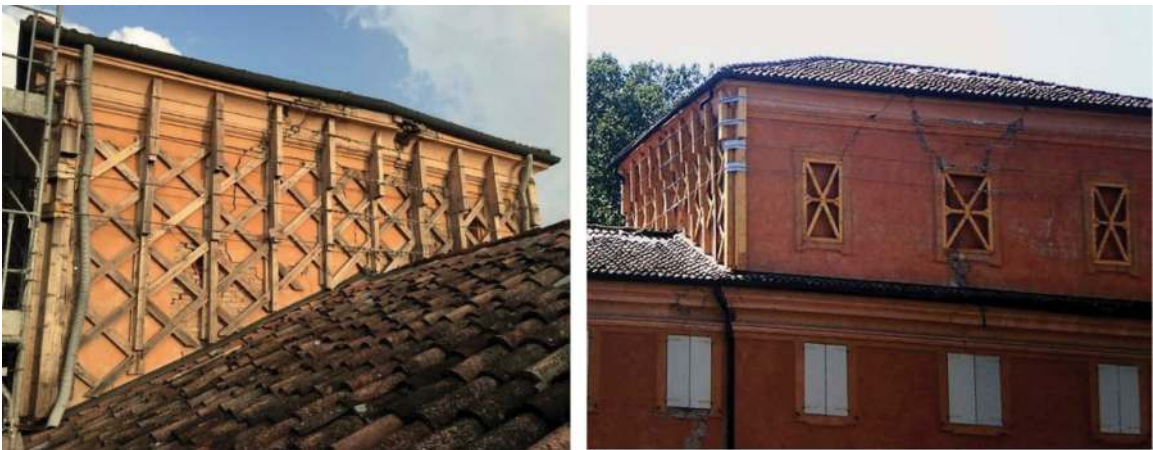
Figure 6. Safety operations by the Fire Department to preserve the central tower and the building from possible structural collapse.

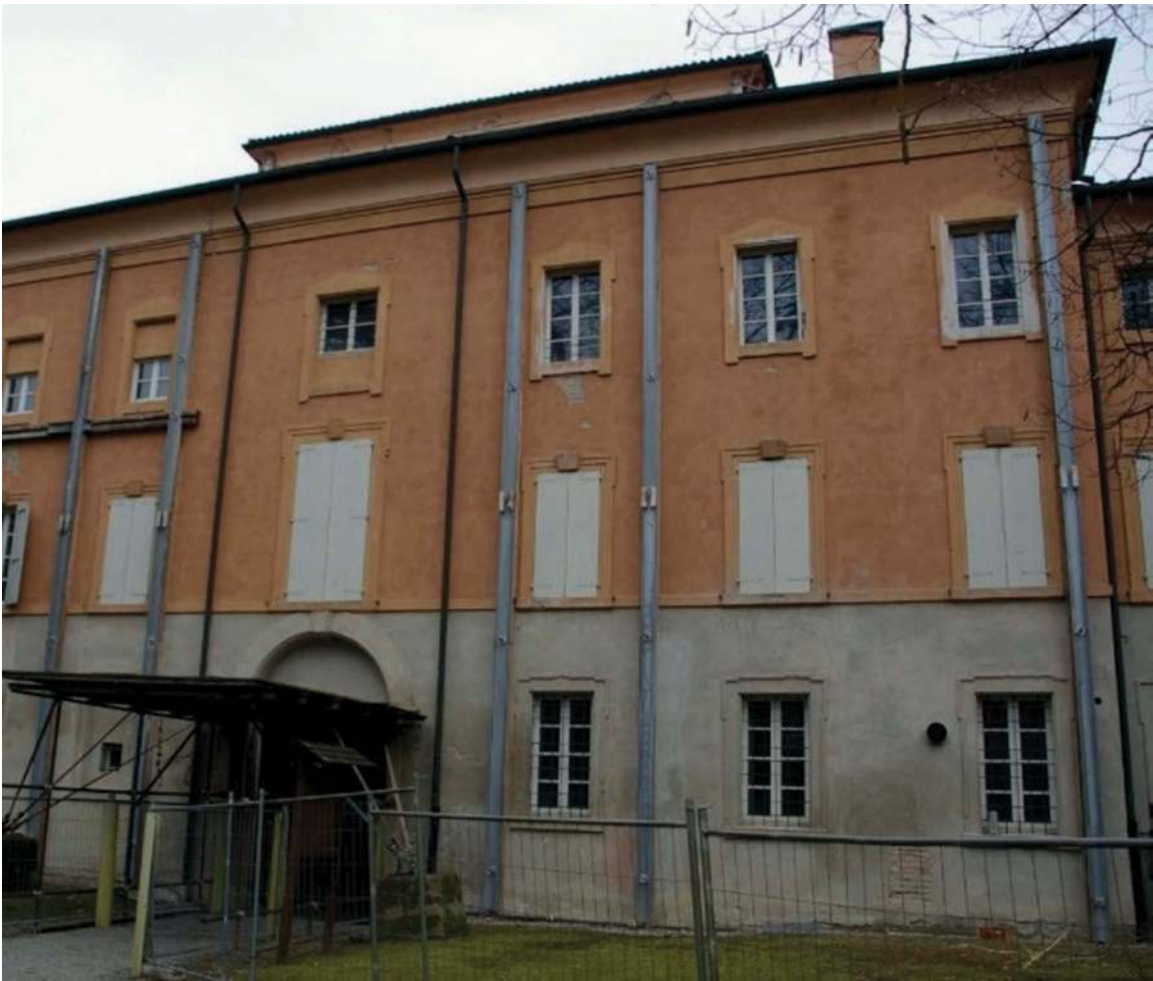
Figure 7. The back of Palazzo Sartoretti opening onto the large park. The works to make it safe included large steel pillars and chains to prevent the brick walls from collapsing out of level.

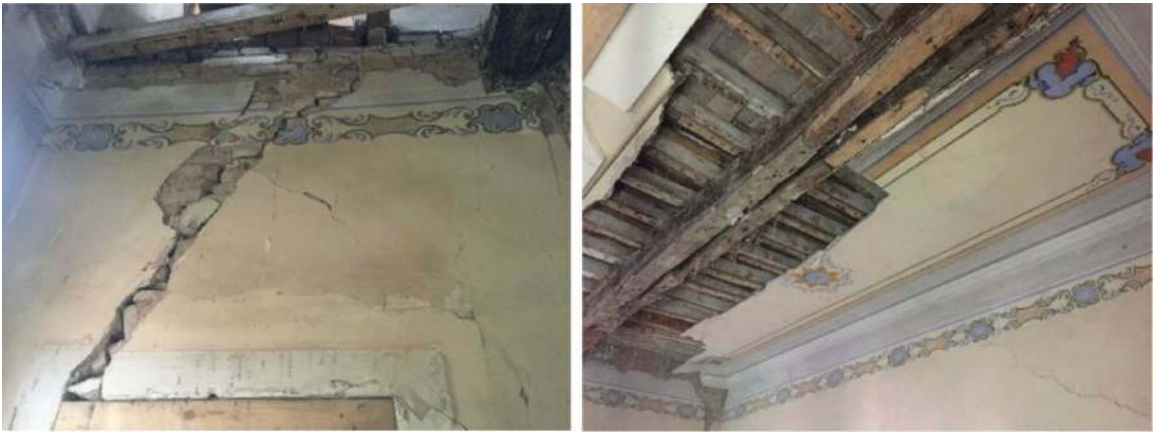
Figure 8. The first floor of the west wing was in a very critical condition, with deep cracks in the masonry, partial collapses of the suspended ceilings and widespread rotting of the wooden beams.

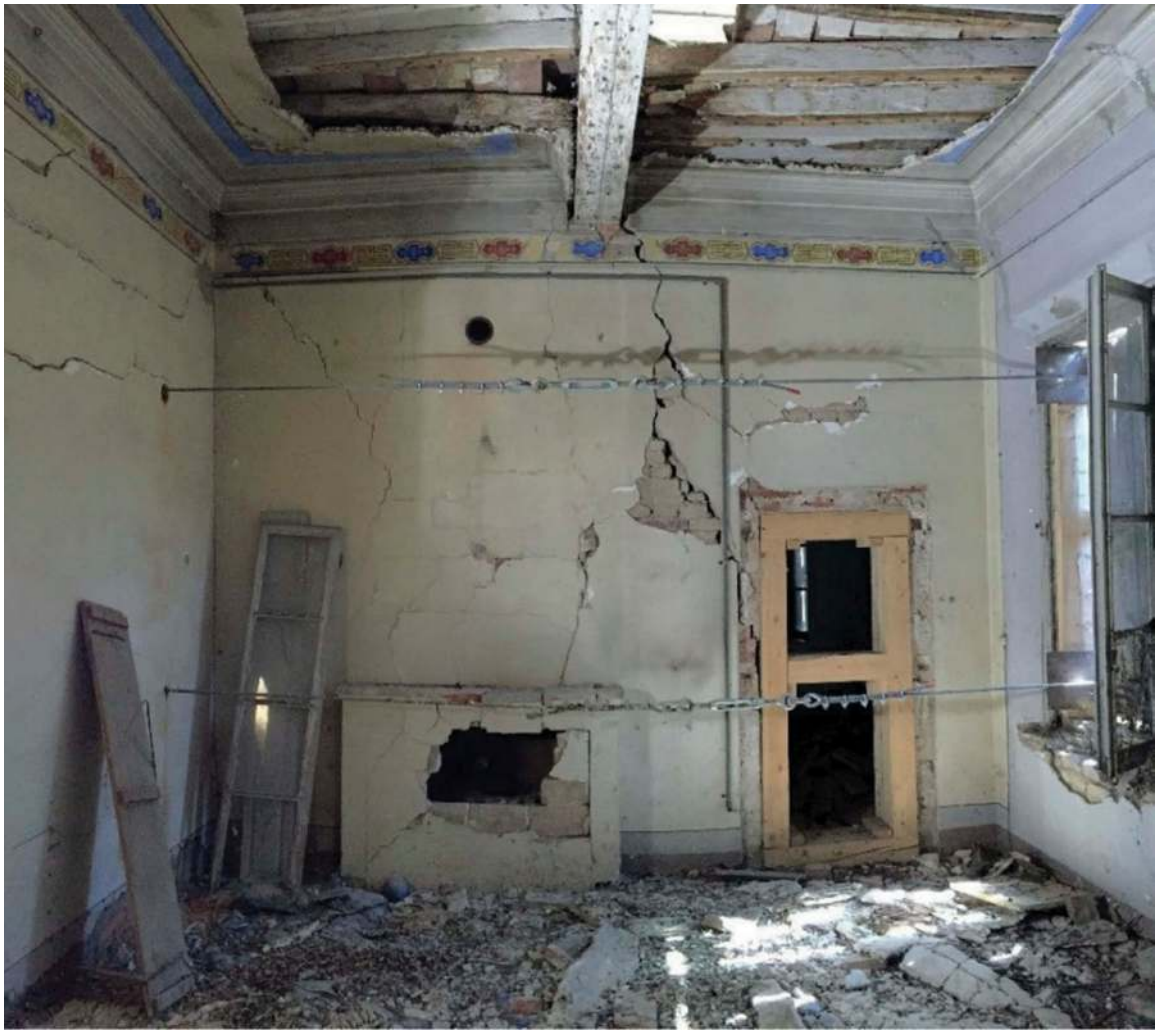
Figure 9. The critical condition in west wing's first floor with deep masonry cracks, partial collapses of suspended ceilings. In the foreground are the chainings for safety measures.

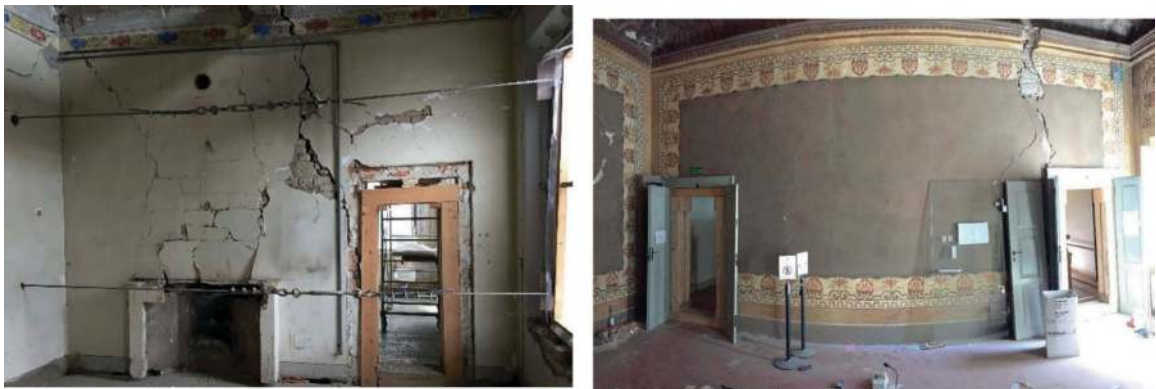
Figure 10. Some pictures of the rooms on the first floor of the west wing. The earthquake damage also caused large infiltrations of rainwater.

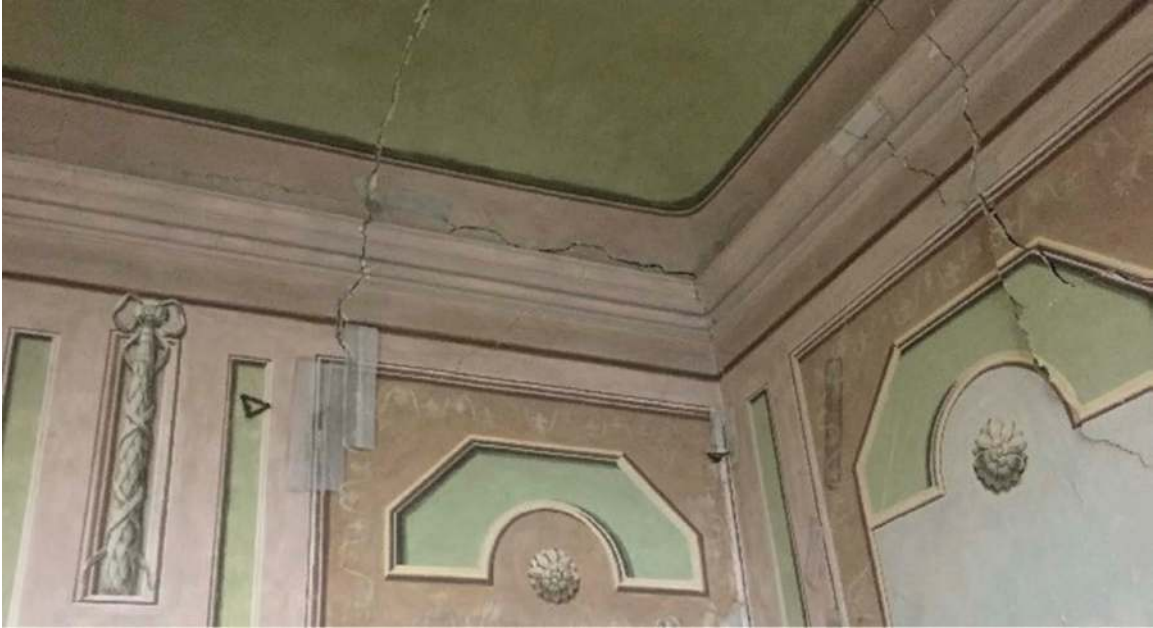
Figure 12. The decorations in the rooms on the main floor of the main body of the building were seriously damaged.

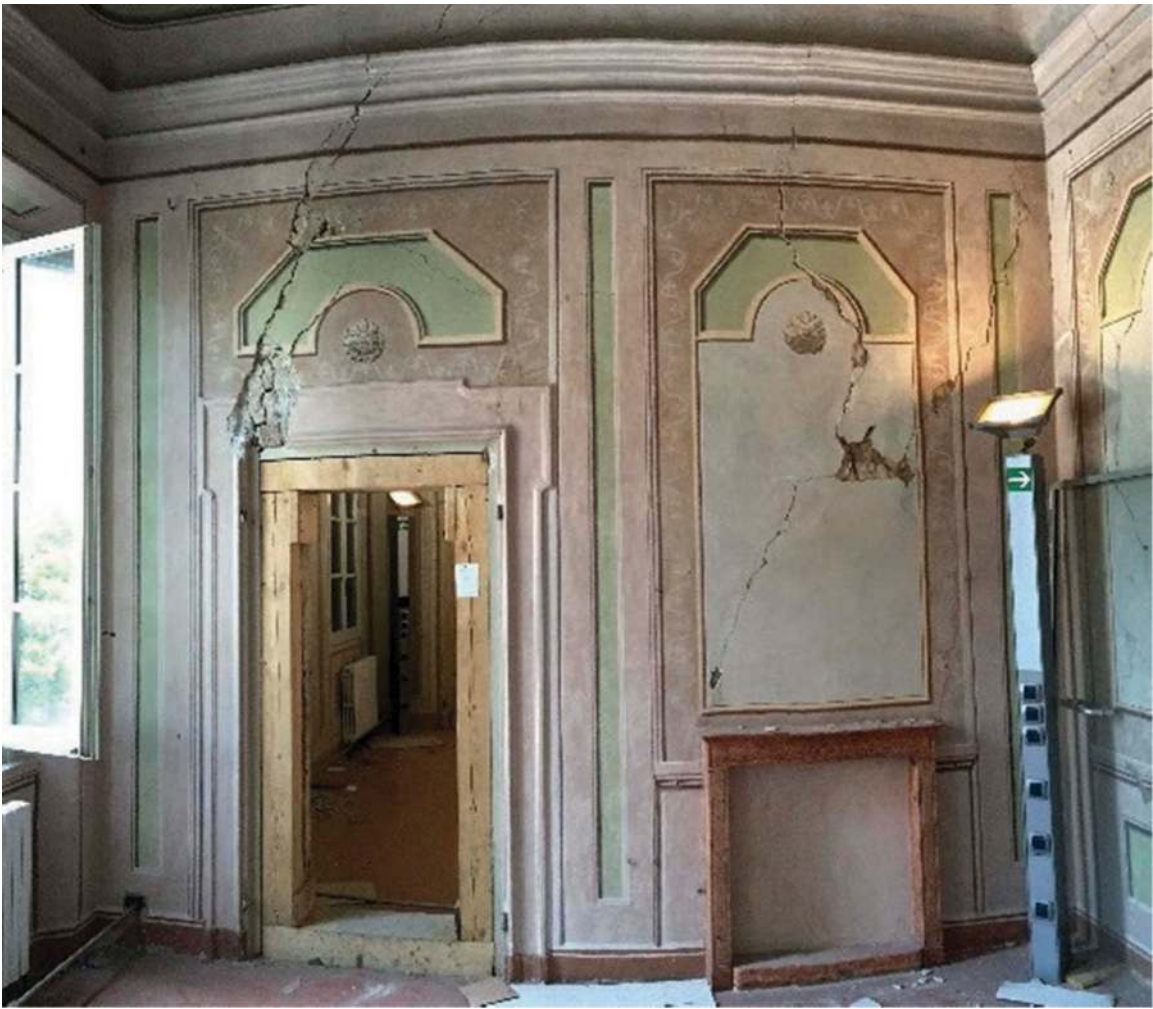
Figure 14. The decorations in the rooms on the main floor of the main body of the building were seriously damaged.

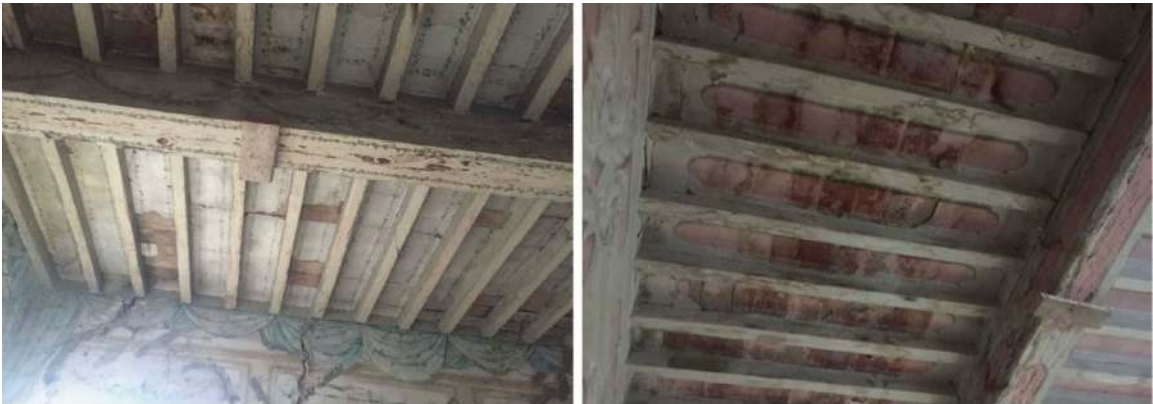
Figure 15. The rooms on the first floor of the western enfilade have wooden ceilings with lime-washed brick tiles and fine decorations that echo the motifs on the walls. There is evidence of water leaking from the roof as a result of the earthquake.
