# BUILT HERITAGE IN POST-DISASTER SCENARIOS

IMPROVING RESILIENCE  
AND AWARENESS TOWARDS  
PRESERVATION, RISK MITIGATION  
AND GOVERNANCE STRATEGIES

PROCEEDINGS OF THE 1ST EDITION OF THE INTERNATIONAL SUMMER SCHOOL  
“AFTER THE DAMAGES”, FERRARA, ITALY, 1-15 JULY 2020

# Built Heritage in post-Disaster Scenarios

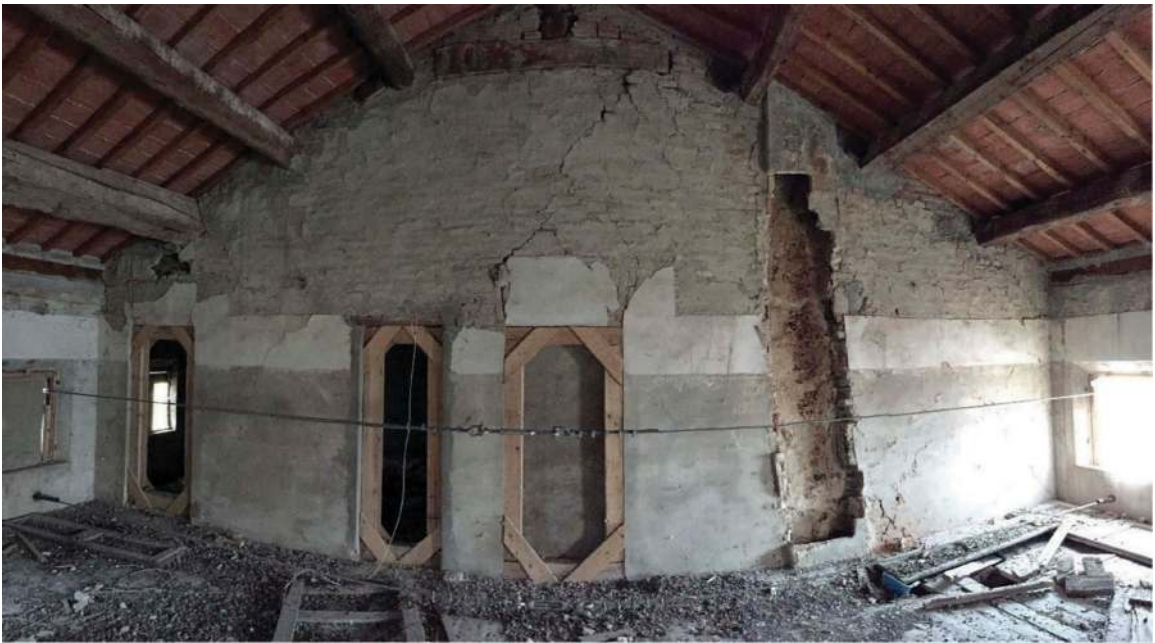
Figure 16. The condition of the rooms in the attic of the western body, which had been uninhabited for decades, was such that even accessing them during the survey was very difficult.

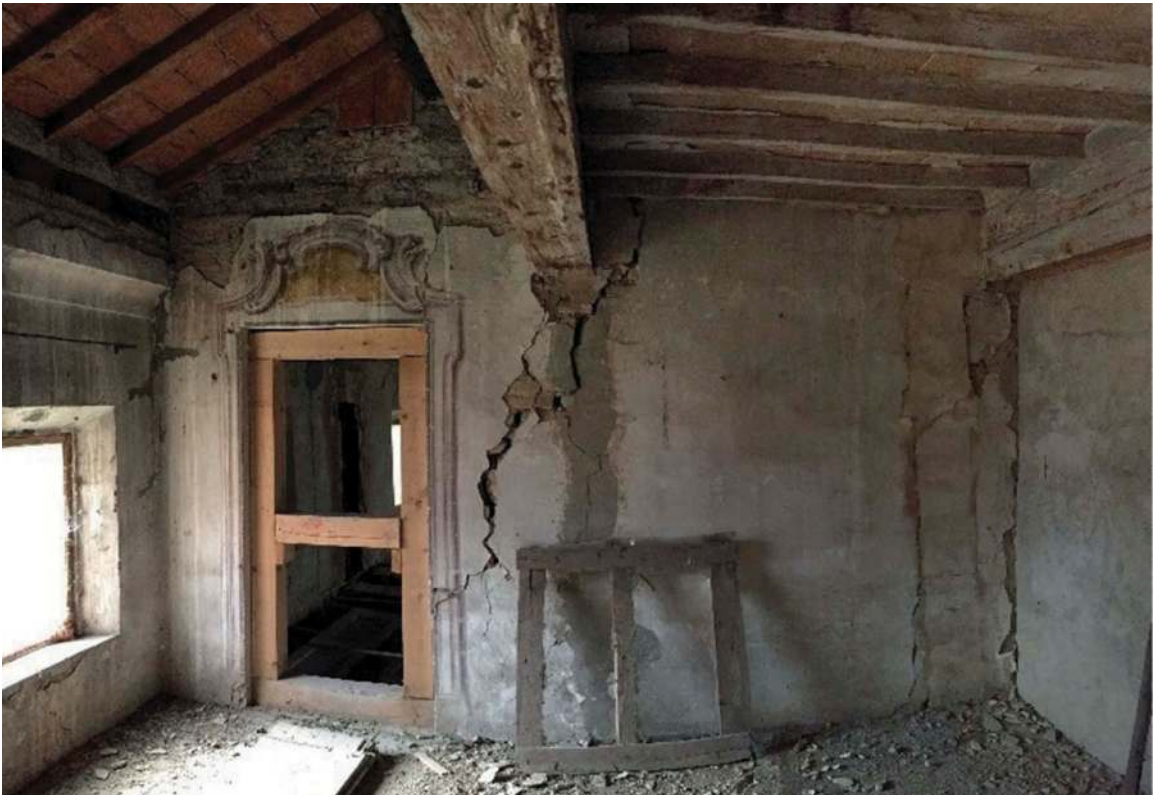
Figure 17. Partial collapses of floors and unsafe portions of the roof represented the main difficulty.

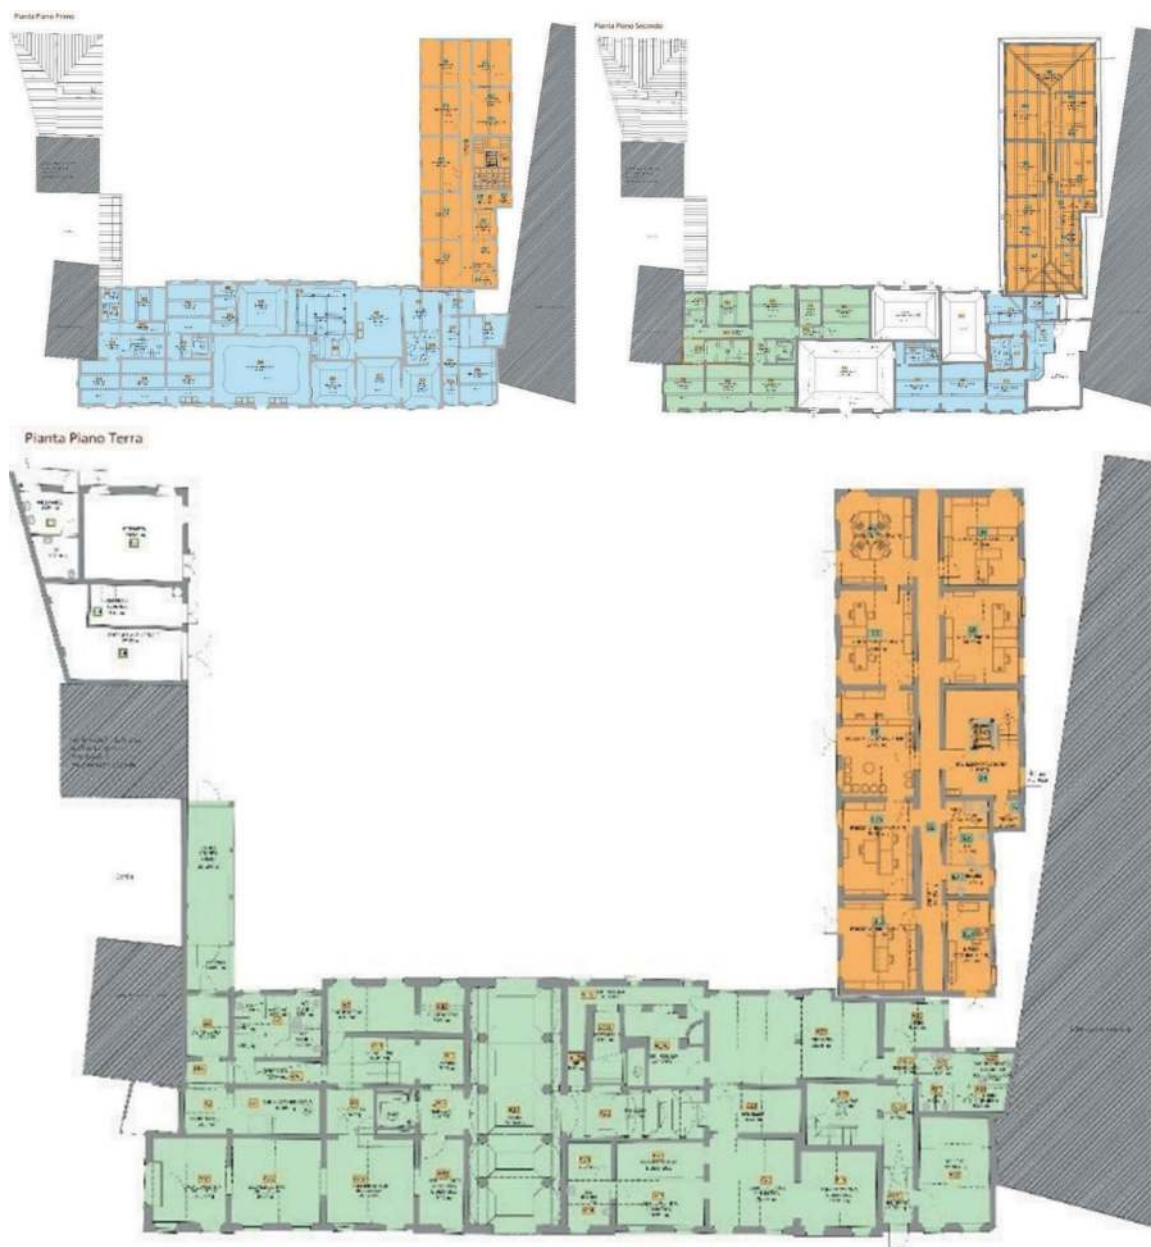
Figure 18. Project plans. The spaces in the west wing designated for municipal offices are highlighted in orange, the premises of the municipal library in light blue and the spaces for cultural events for public use in green.

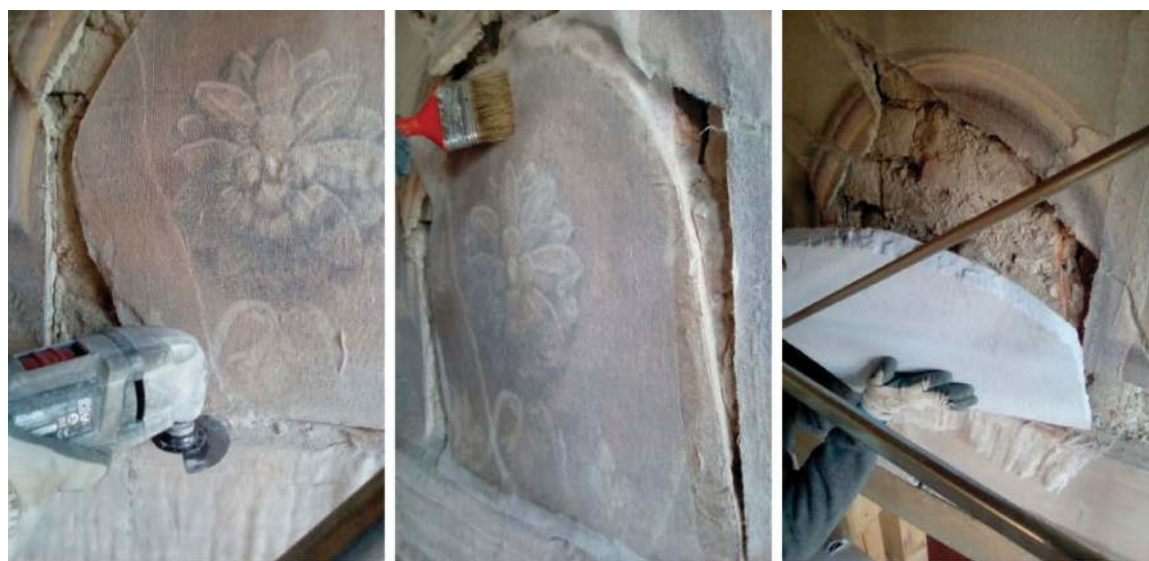
Figure 22. The pictures show the sequence of securing the decorations by sticking gauze and tissue to prevent any detach-ment of the decorated plaster. Micro-cutters, whose low vibration and absence of rotating blades ensure maximum precision, were used to cut the plaster. Laying the panels and cata-logging. In the panels, the ‘back’ of the decorated detached piece can be seen.

As mentioned above, the project included an initial phase of works aimed at securing the decorated surfaces in preparation for the consolidation of the walls. In particular, in addition to the more common interventions such as the application of facings and wraps, in some cases off-site repairs were done. Off-site repair was only undertaken for the portions of decorated plaster in correspondence with serious cracks and instabilities, where the project envisaged consolidation through like-for-like replacement. A support bandage was applied to the area to be detached by applying acrylic resin with a brush and using gauze or Japanese paper, depending on the size and thickness of the plaster. For each fragment, a panel the size of the portion

to be detached was then created off-site and glued onto facing to provide additional support for the detachment phases. Removal of these parts, which were cut with precision mechanical tools such as micro-cutters and sabre saws, traced the existing cracks and fissuring. Once the parts had been removed, they were catalogued by room and placed on special trays, and the first consolidation work was done on their backs.

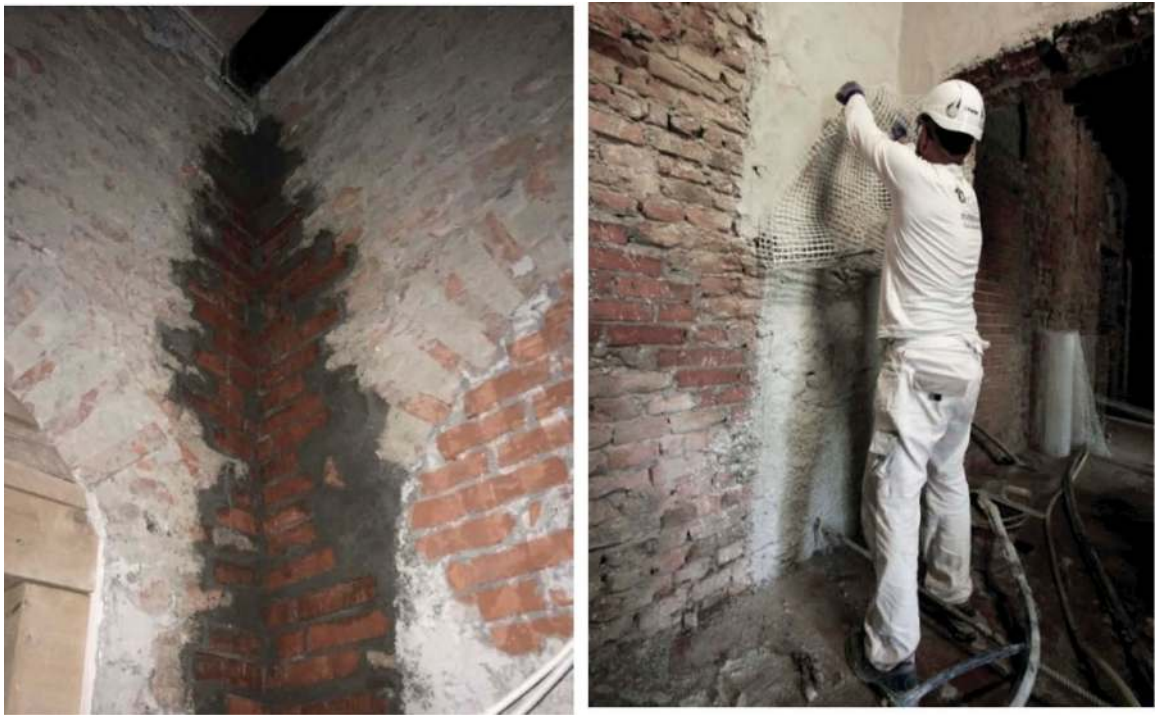
Figure 23. Several masonry walls had little or no tothing between corner walls. Two types of intervention are envisaged, angular like-for-like replacement or the laying of fibreglass fabrics, also placed at an angle, on lime-based adhesion promoters.

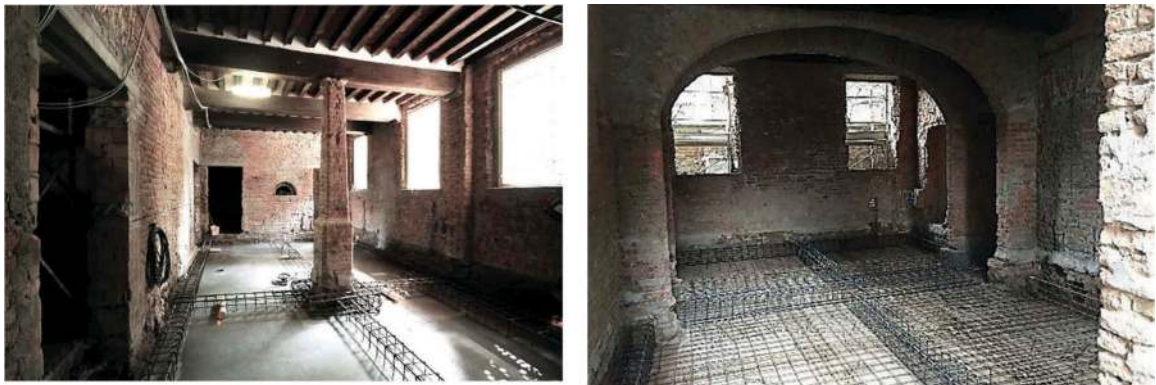
Figure 24. The construction of ventilated structural crawl spaces at the foundations. In correspondence with the wall-cutting sheath present along the entire perimeter, wall continuity was restored with the application of bidirectional glass fibre mesh.

After completing the wall consolidation, it was possible to work safely in the foundation.

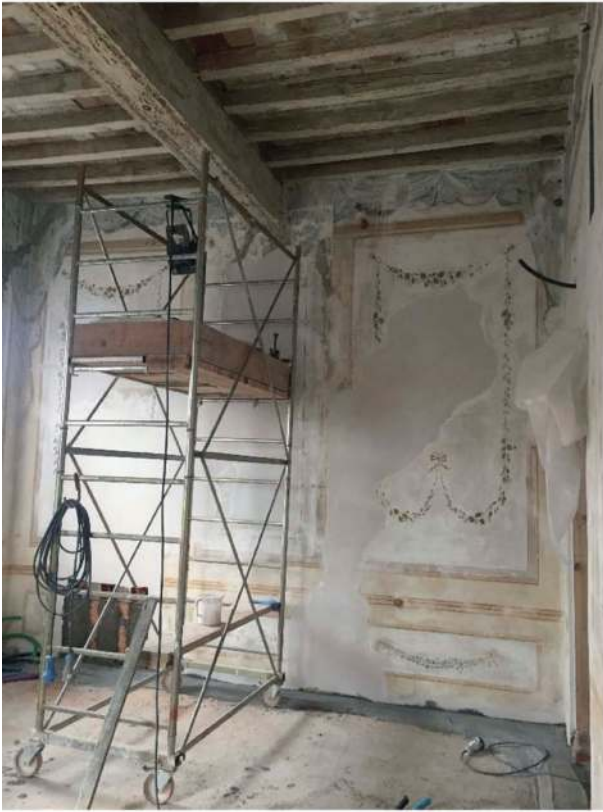
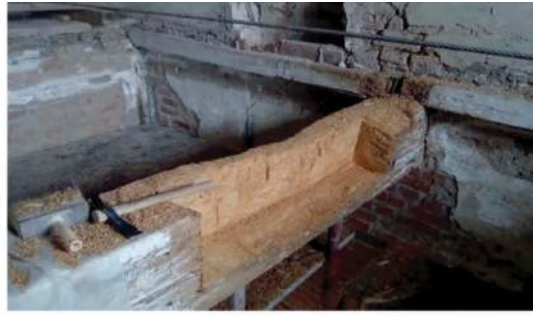
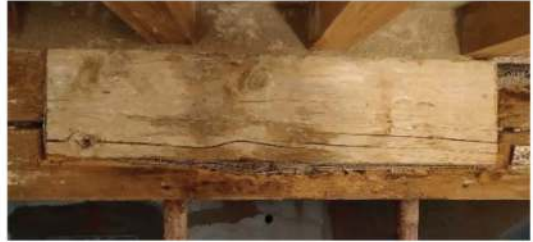
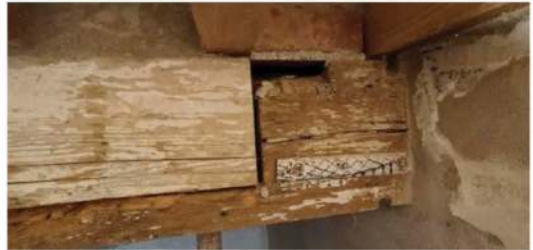
Figure 25. Prolonged exposure to the weather and parasite attack completely damaged a painted wooden beam head in one of the rooms on the main floor of the west wing, requiring the insertion of a wooden prosthesis. The rotting area was removed by carefully cutting down to the healthy part of the beam. The prosthesis of the same wood species was prepared and fixed with wood screws and threaded stainless steel bars.

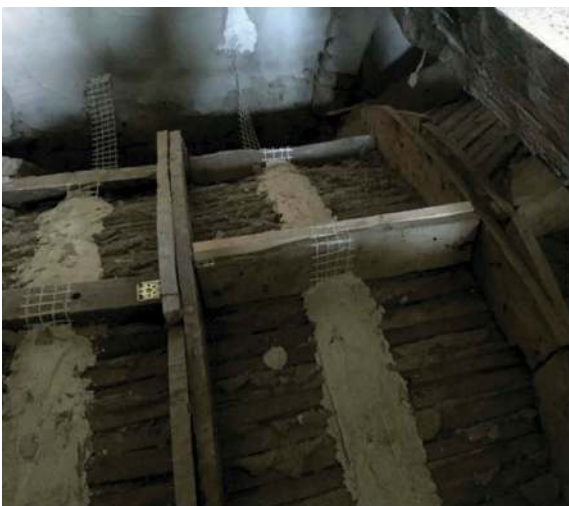
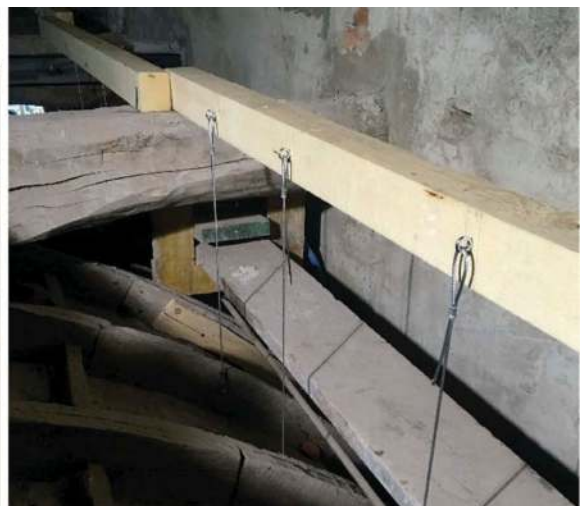
Figure 26. Images of the restoration of the wooden structures of the decorated vaults. In addition to some meticulous replacements of completely rotten elements, some doubling of the structures was carried out with new anchors, safety restraints with steel hangers and fibre matting with lime-based adhesion promoters.

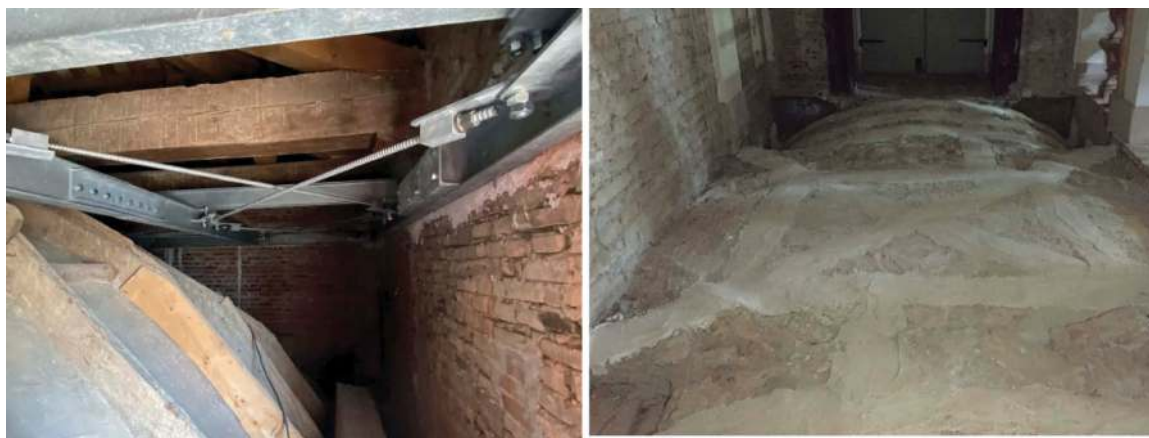
Figure 27. Images of structural reinforcements on the intrados of the vaults. A large two-dimensional steel girder lattice will make any movement of the central tower's masonry more difficult.

turret, the most vulnerable element and the one that suffered the most damage. In addition, the turret contains a majestic hall surrounded by decorated walls and surmounted by a plaster and plaster vault supported by wooden ribs anchored to the roof structures. For these reasons, metal stiffeners were provided at various levels, in some cases positioned in correspondence with projecting architectural elements capable of hiding their presence. Upon completion of the structural work, it was possible to remove the structures and provisional works installed by the Fire Department immediately after the earthquake, such as the structural scaffolding installed in the main hall, and to proceed with the completion of the finishes and technical facilities.

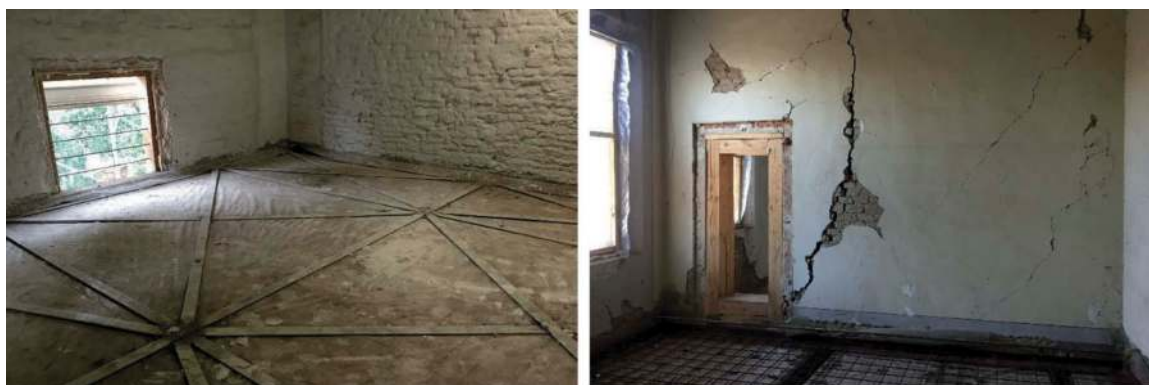
Figure 28. On the floor slabs, diagonal steel plates and lightweight concrete copings were used as rigid diaphragms in order to prevent their movement with respect to the vertical walls as much as possible.

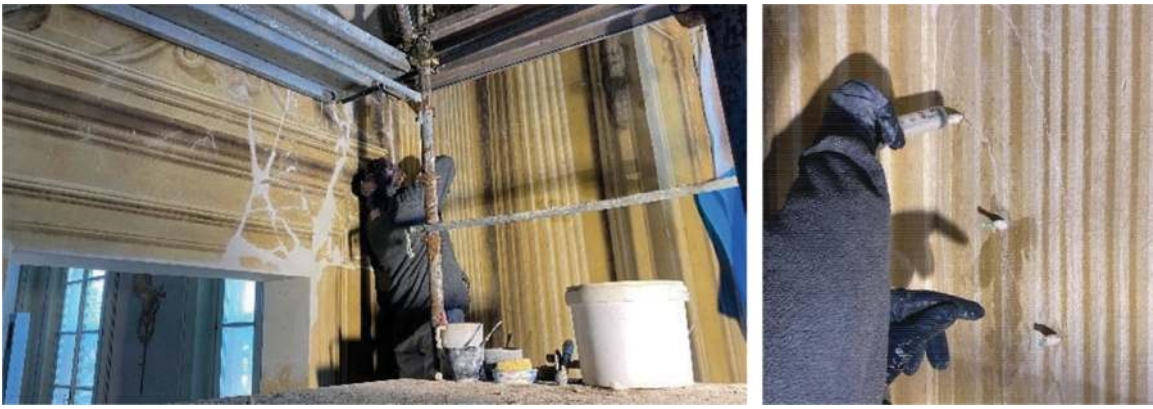
Figure 29. The photo shows an interesting moment of the restoration where, after the recovery and sealing of the cracks, and hand-beating of the entire areas (with the knuckles), the detached portions of plaster are identified and out-lined with chalk. Then, using a hand drill to avoid any vibration, holes are drilled, into which lime mortar with a low specific gravity is inserted.

To complete the intervention, the plastering and gaps were toned with glazes, giving chromatic unity to the surface. The reconstruction of the geometries and the architectural decorative scheme was possible because, even in the presence of numerous flaking or demolished parts of the decorated plaster, the restorers in the preliminary phases always tried to preserve the cornices in the corner parts, so that it was easier to reconstruct the entire architectural scheme of false stucco and false cornices. In general, the decorated rooms of Palazzo Sartoretti had different pathologies depending on the area in which they were located. In addition to the large number of cracks, and in addition to the portions that had to be removed for repair, there were portions of plaster that were severely damaged due to rainwater infiltration from the roof, particularly in the west enfilade and the large vault of the Salone delle Feste. In fact, the force of the rainwater percolating from the roof reached the vault, penetrating the canopy, then the plaster and then the decorated plaster. In the following drying phase, the plaster, loaded with salts, tends to solidify and crystallise, causing tension, flaking and breakage of the plaster. The photos show the restoration sequence of the de-tached portions of plaster.

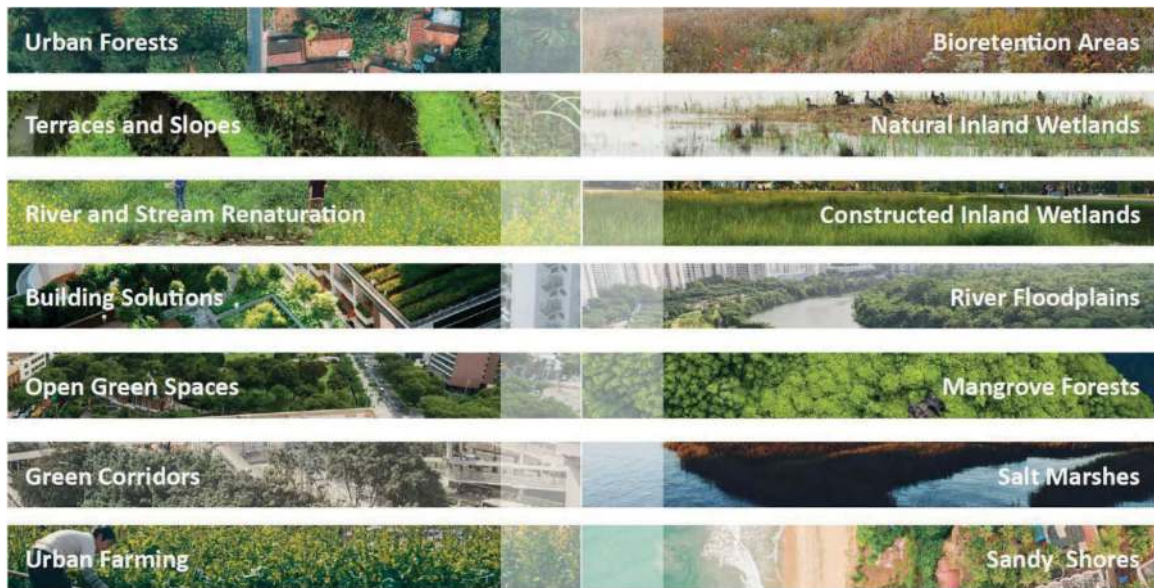
Figure 5. Areas of application of the NBS (GFDRR, World Bank Group, Global Program on Nature Based Solutions for Climate Resilience. 2021. A Catalogue of Nature Based Solutions for urban resilience).

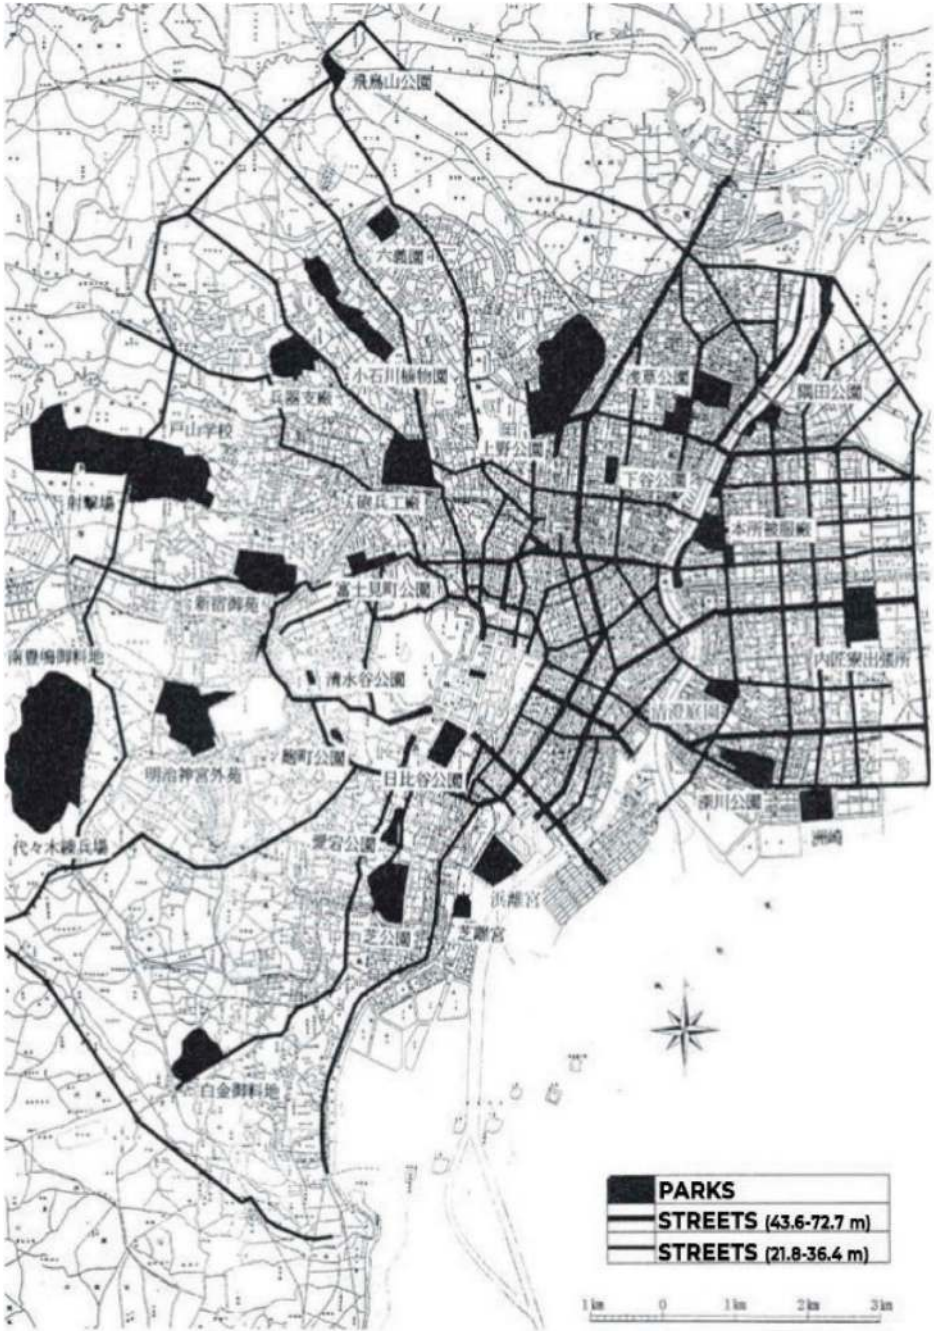
Figure 6. Reconstruction plan after Kanto Big Earthquake (1923), (Ishikawa, 2001).

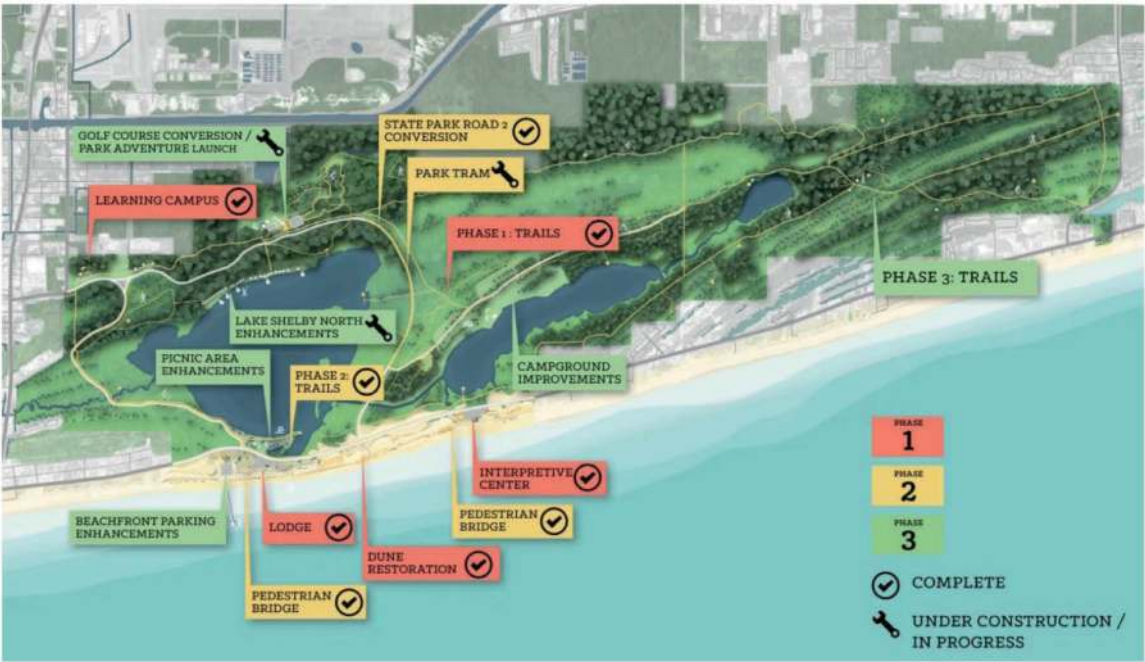
Figure 9. The new Master Plan of the Gulf State Park, project by SASAKI ([https://mygulfbestpark.com/wp-content/uploads/2016/10/160823\\_GSP\\_MasterPlan\\_Final\\_lowres.pdf](https://mygulfbestpark.com/wp-content/uploads/2016/10/160823_GSP_MasterPlan_Final_lowres.pdf)).

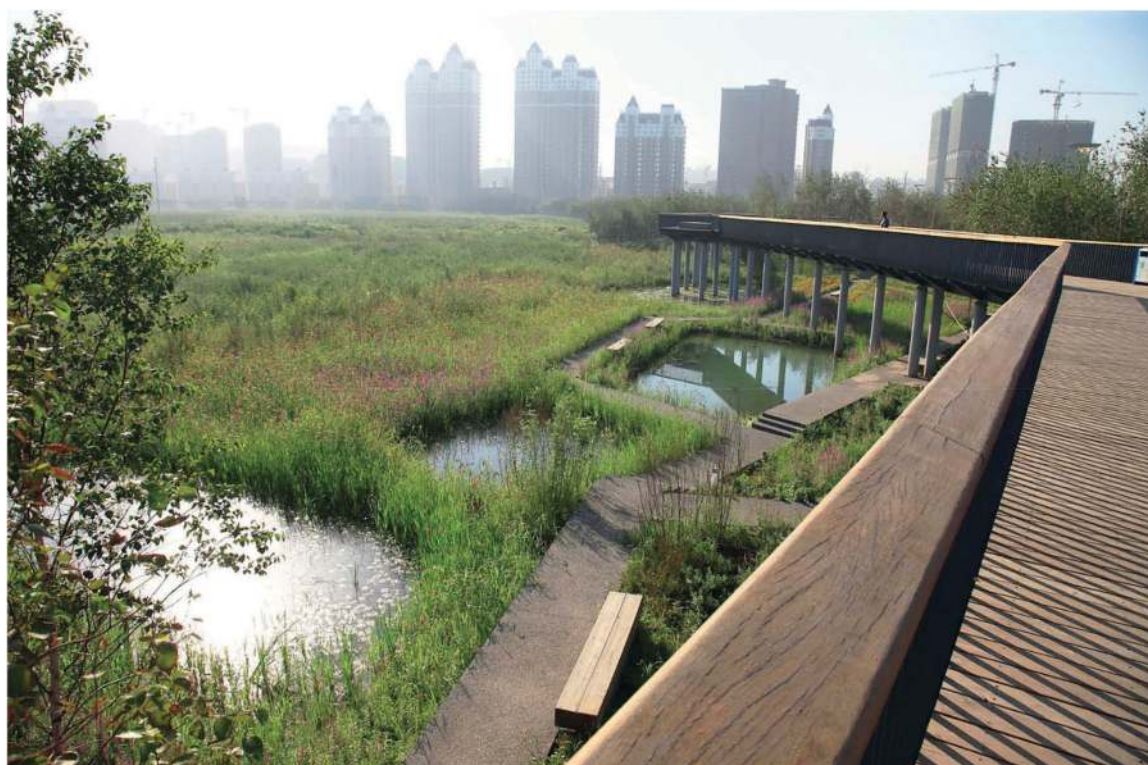
Figure 13. An example of a very interesting intervention: a wetland park of 34.2 hectares in the middle of this new town of Harbin, China, planned by Turenscape. (web-24).

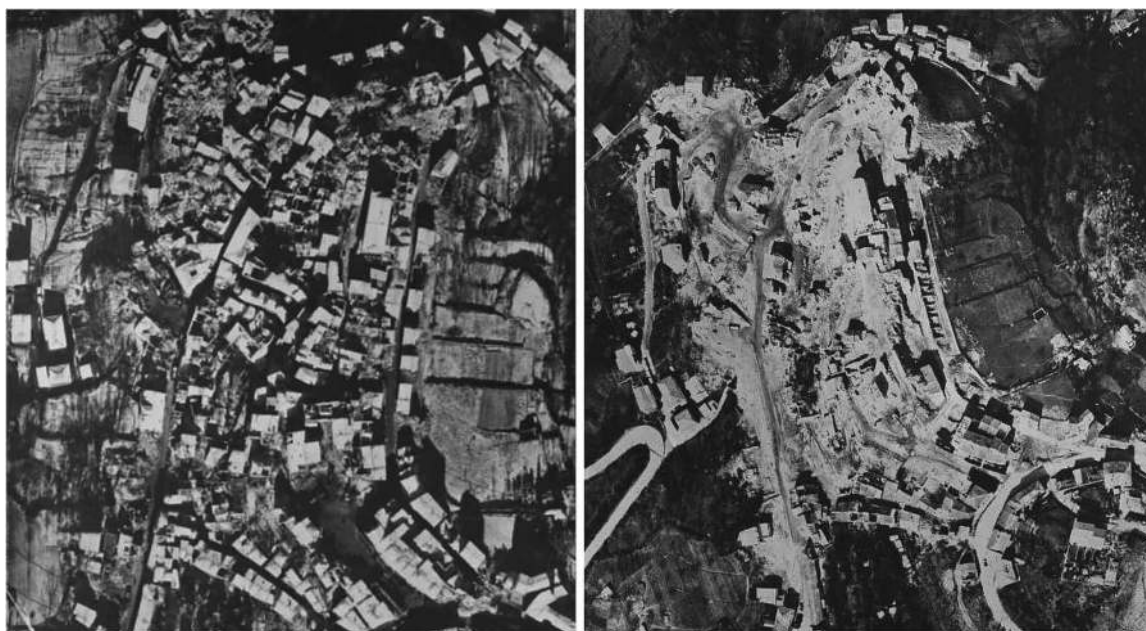
Figure 1. The municipality of Teora, Avellino, Italy. On the left, the aerial photo of the urban framework immediately after the earthquake of November 23, 1980. On the right, the aerial view cruelly documents the demolitions that took place to secure the area, severely affected by the earthquake, but which still testifies the typological process of the urban inplant. What was done a few years earlier in Gibellina, Trapani, or more recently in Amatrice, Rieti, denounces a simplistic approach to solving the problem.

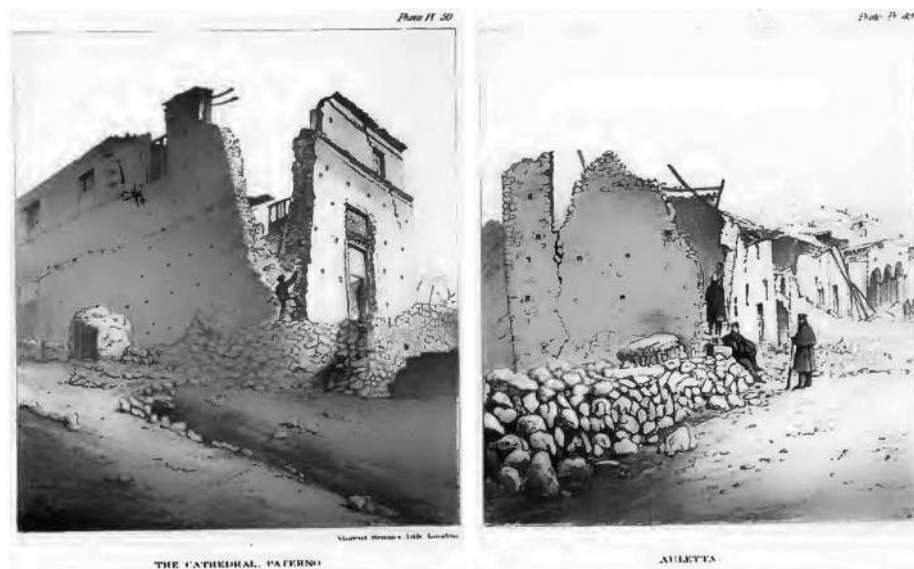
Figure 3. The young Irish engineer Robert Mallet experimentally verified his theories on the dynamics of earthquakes by conducting an on-site survey and analysis of the damages caused by the seismic events of December 16, 1857, in the territories of the higher Val d'Agri, Potenza, and the Vallo di Diano, Salerno, in the Kingdom of the Two Sicilies. Engravings elaborated from the stereoscopic pictures of the photographic reportage commissioned to Claude Grillet support the illustration of the phenomenological investigation.

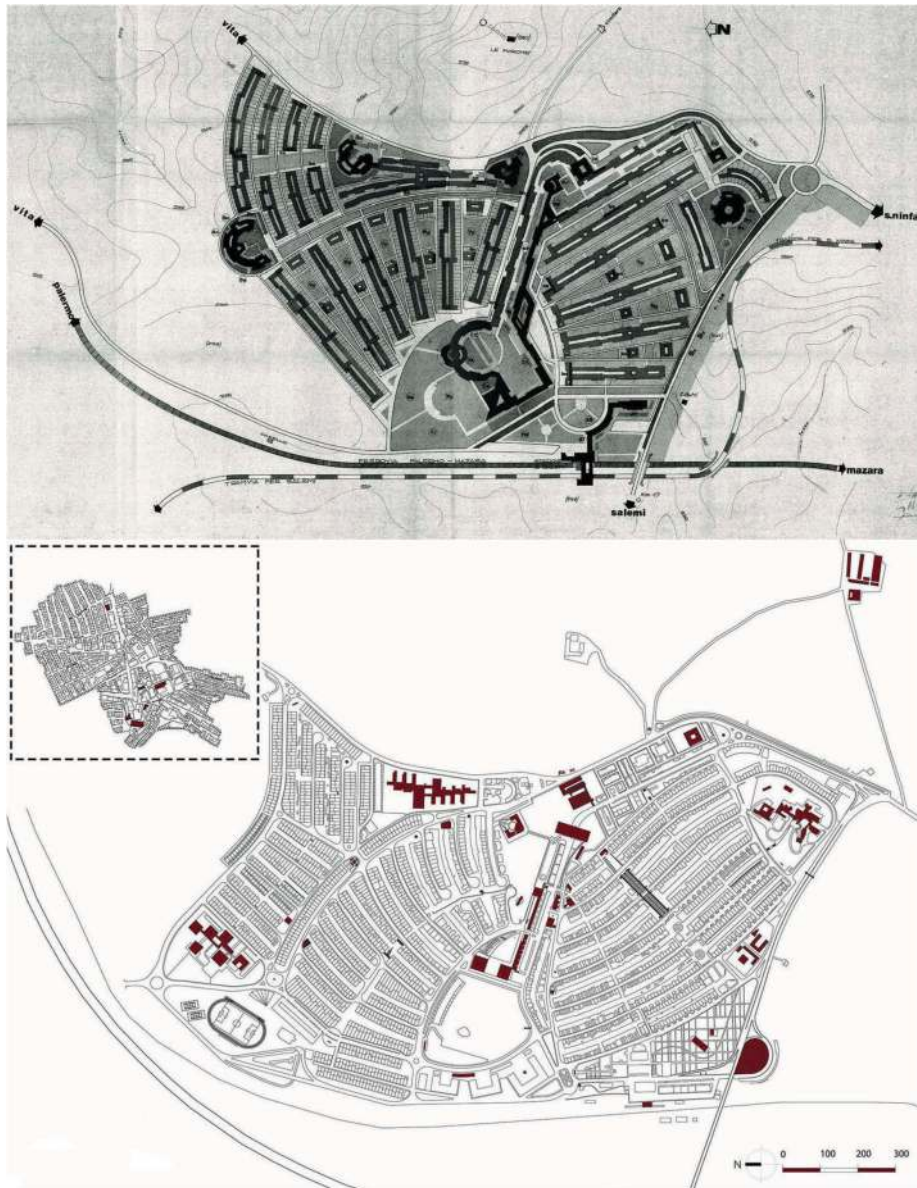
Figure 5. Above, Istituto Superiore per l'Edilizia Sociale, Marcello Fabbri, 1969. The Project for the relocation of the Gibellina population provides indications for the new areas to be allocated for building and represents a detailed plan completed by projects from architectural scale (1:50) to detailed scale (1:20). Below, Dimensional comparison between Gibellina Nuova and Gibellina Vecchia, in the box (Badami, 2019).

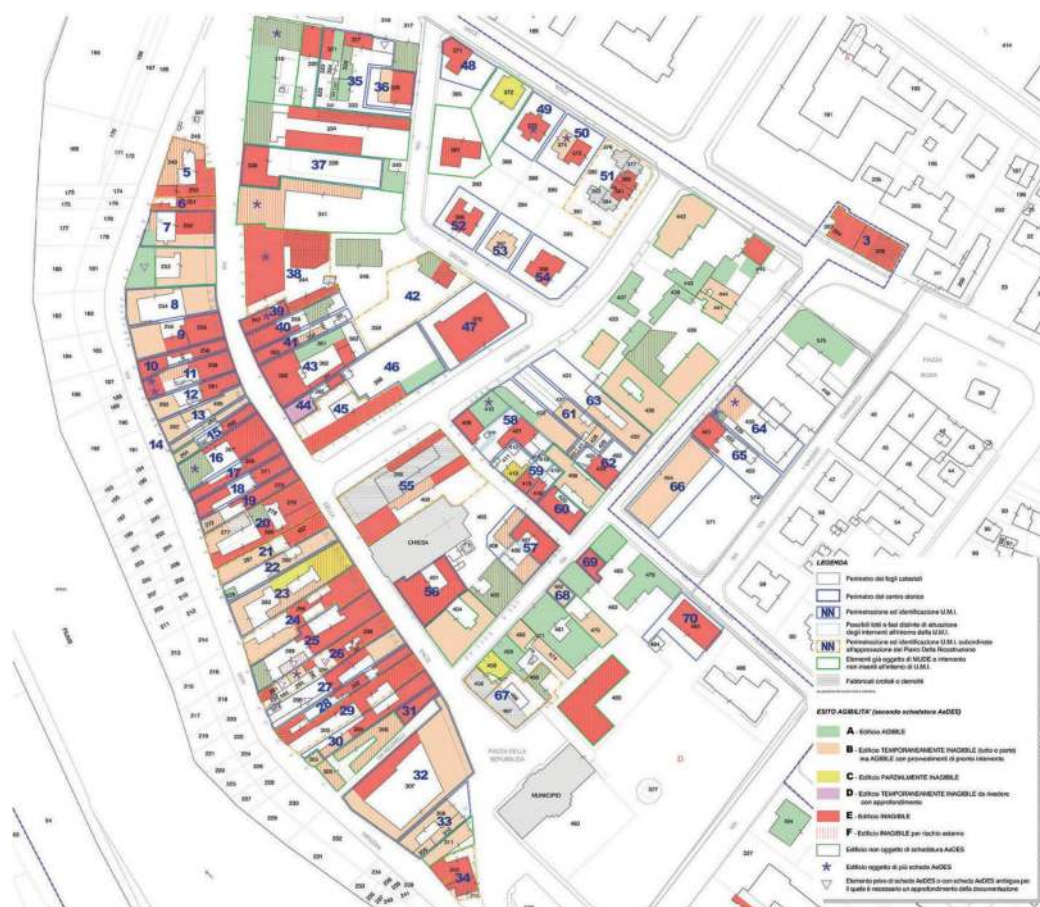
Figure 7. Concordia sulla Secchia, Modena. Definition of the Minimum Intervention Units (i.e., U.M.I.); in red the results of the inagibility assessment according to the AeDES methodology.

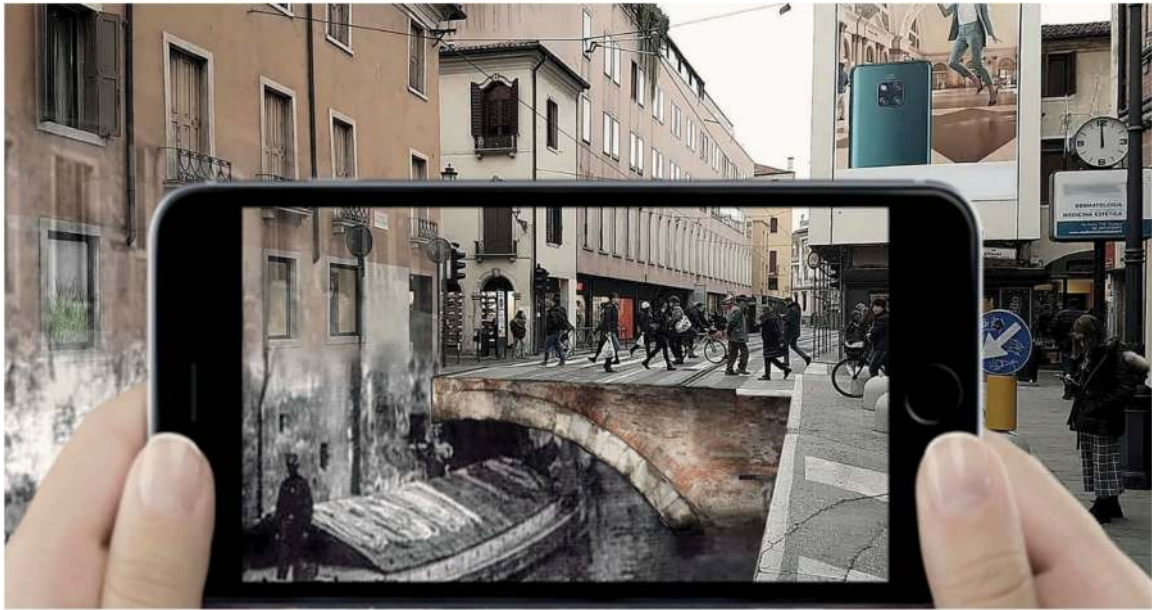
Figure 3. Ponte Altinate displayed in augmented reality - Riviera Ponti Romani, Padua Italy.

The laser scanning survey allowed the creation of the BIM model of the building, useful for cataloging the bridge elements, as well as for identifying critical issues and the state of decay (Bonetto et al. 2019). Two photogrammetric surveys; one performed with a reflex camera and the other performed with two Go-Pro 5.0, made it possible to structure a workflow to obtain correct management of the photorealistic 3D model for viewing in AR. The fourth phase concerns the optimization of the models generated by the point clouds, the conversion of complex meshes into

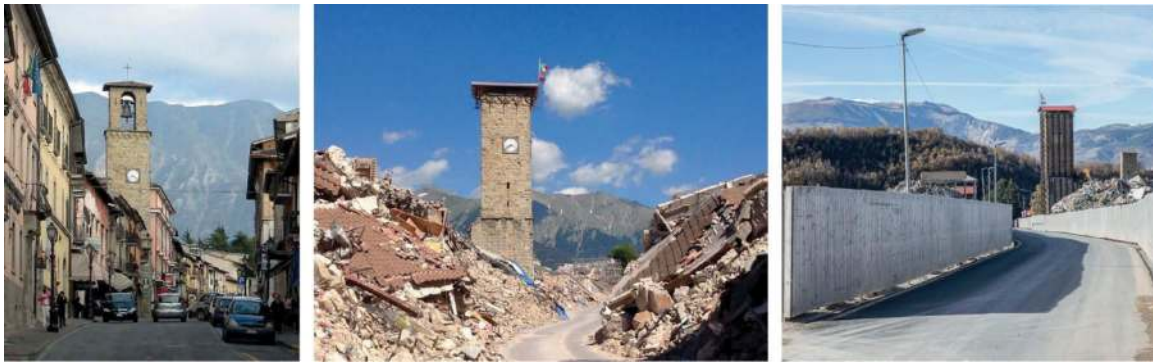
Figure 2. The Civic Tower of Amatrice in 2008 (left), 2017 (center) and 2018 (right). (Photographers: Francesco Gangemi, Francesco Gangemi and Enrico Fontolan; Source: Francesco Gangemi, Rossana Torlontano and Valentina Valerio in collaboration with the Photographic Collection, Focus on Amatrice, Bibliotheca Hertziana – Max Planck Institute for Art History, 2020. Source: Web-3).

For instance, access to a building's reliable geometrical survey is a key component for any further investigation, such as the realization of models for sophisticated structural-numerical simulations. Consequently, the importance of digitized information appears quite evident as a "digital twin" of physical materials can safeguard information lost through collapse mechanisms and other disaster-related damage. Vice versa, physical documents in their original form "back up" digitized information, a body of knowledge that has its own, rather underestimated conservation concerns relating, but not limited to calamities. Focusing on the engineering research activity carried out on the medieval Civic Tower in Amatrice after the 2016-2017 seismic events, very little data and few documents of engineering interest were found, despite the tower's strategic position at the intersection of the two main streets of the town, namely Via Roma and Corso Umberto I, and its role as one of the most important historic symbols of Amatrice's city center. Due to the lack of technical information, it was necessary to formulate some assumptions in order to characterize the tower from an engineering point of view and to realize a numerical model for computer-aided seismic simulations (Figure 3): the geometry of the building was deduced from photographic evidence gathered before the earthquakes. The material properties were hypothesized by comparing masonry fragments with the mechanical properties proposed by the Italian Building Code. Due to the lack of technical documentation from restoration work carried out on the tower in the 1980's, the reinforcement intervention was modelled in a rather simplified way. Nonetheless, this reinforcement was decisive in limiting damage and preventing the tower's total collapse.

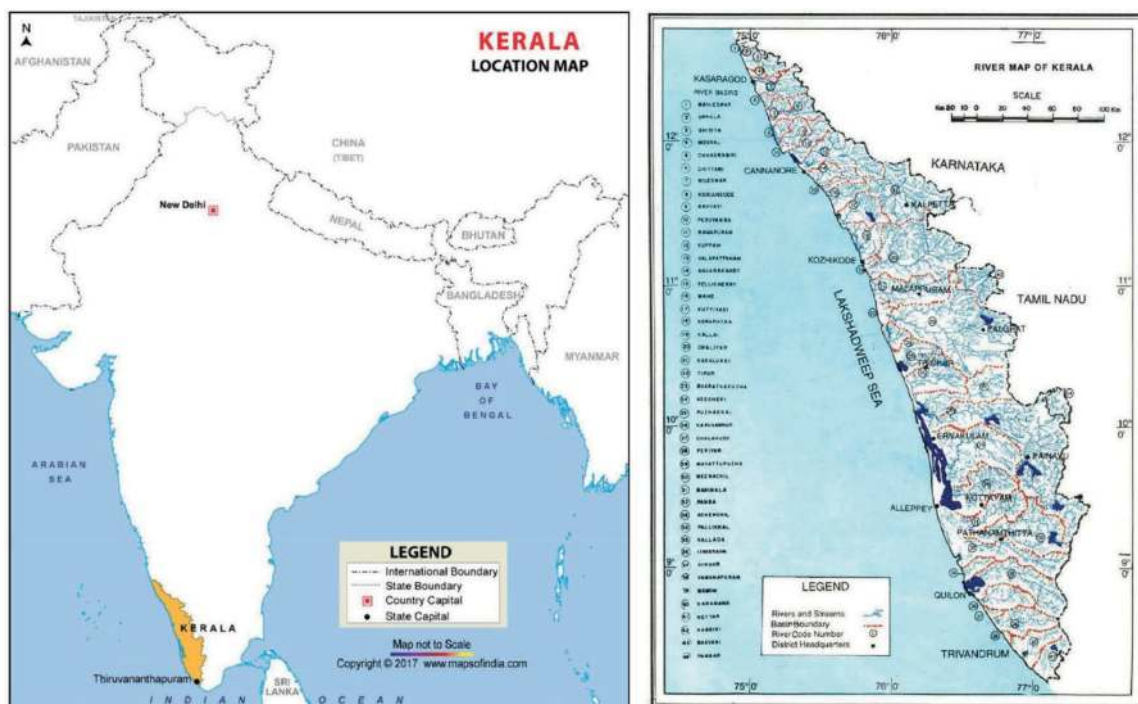
Figure 1. Map of India locating the state of Kerala on the extreme South-West part of the nation, exposed to the seasonal monsoon direction (left) (source: Maps of India). Map of Kerala representing the amount and location of rivers present in the state (right) (source: CWRDM, Govt. of India).

transformation of the atmosphere. However, it has also been responsible for a number of natural disasters, particularly in the region of Western Ghats. The state of Kerala occupies the southern portion of this region (Figure 1), thus being seemingly most susceptible to such hazards due to its exposure to the monsoon direction and the steep slopes of the terrain on the East. Floods are the most common natural disasters in the state.

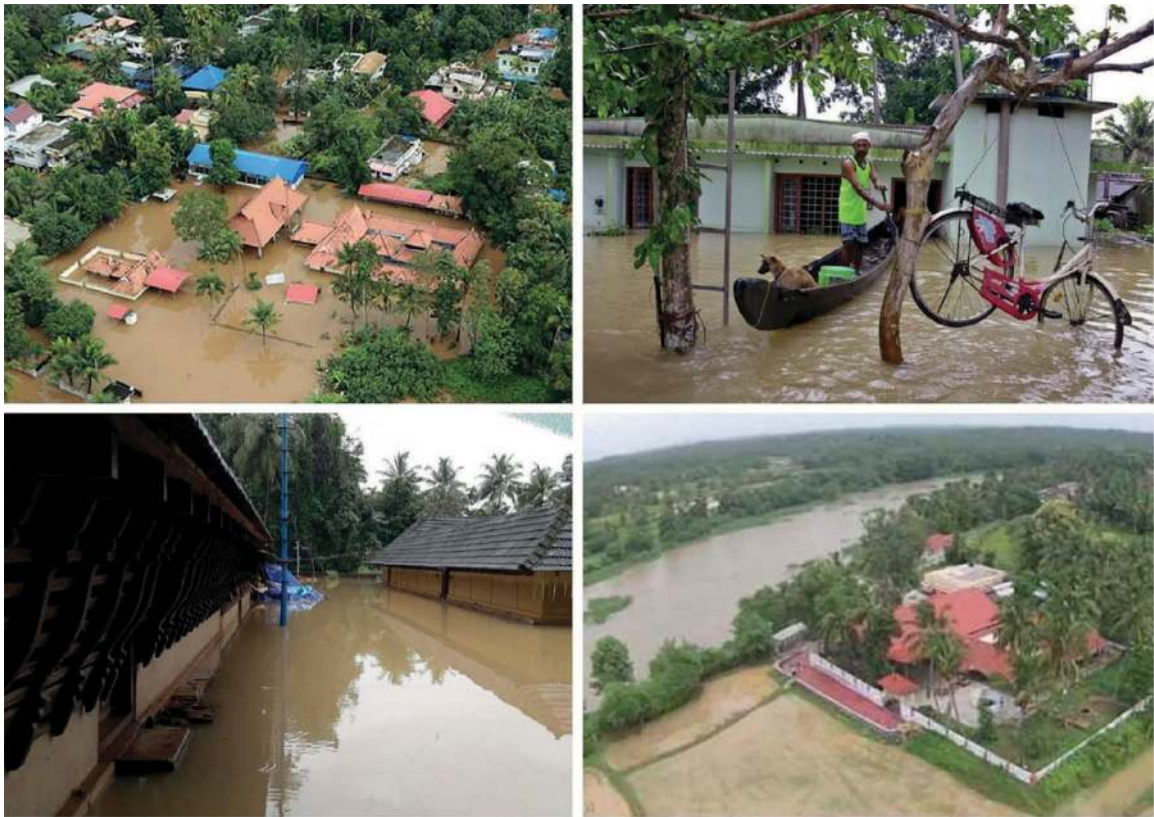
Figure 2. Flood affected areas of the state. One can see monuments of religious and cultural importance as well as common houses and agricultural fields under the influence of the floods (source from left to right: AFP, Thrissur; Tobin Augustine and Anamika Edathara).

excess water from 37 dams across the state, aggravating the flood impact (Figure 2). Nearly 341 landslides were reported from 10 districts. (Kerala 2018, 12) The devastating floods in Kerala have had a serious impact on the following cultural heritage of the state. (Kerala 2018, 152)

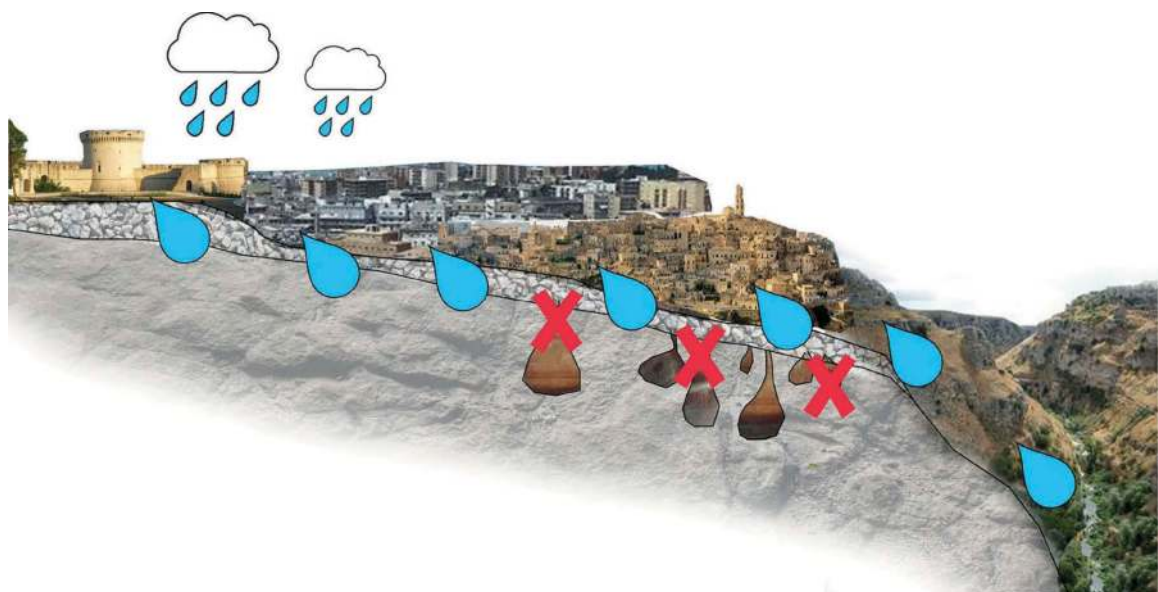
Figure 4. Images by author: scheme of the ground impermeabilization of the upper modern city of Matera and the consequent flood of Rioni Sassi, avoiding the ancient cisterns.

It is now easy to observe the situation like November 2019, when the Rioni Sassi of Matera were affected by a violent flooding with damages to the constructions and the commercial activities. This event impressed the public thanks to a huge resonance within media, however the cause has not to be caught in the hazard of the event, but in the current vulnerable condition of the Rioni Sassi and the upper town, because of a wrong alteration of a centennial balance. (Figure 4).
