# BUILT HERITAGE IN POST-DISASTER SCENARIOS

IMPROVING RESILIENCE  
AND AWARENESS TOWARDS  
PRESERVATION, RISK MITIGATION  
AND GOVERNANCE STRATEGIES

PROCEEDINGS OF THE 1ST EDITION OF THE INTERNATIONAL SUMMER SCHOOL  
“AFTER THE DAMAGES”, FERRARA, ITALY, 1-15 JULY 2020

# Built Heritage in post-Disaster Scenarios

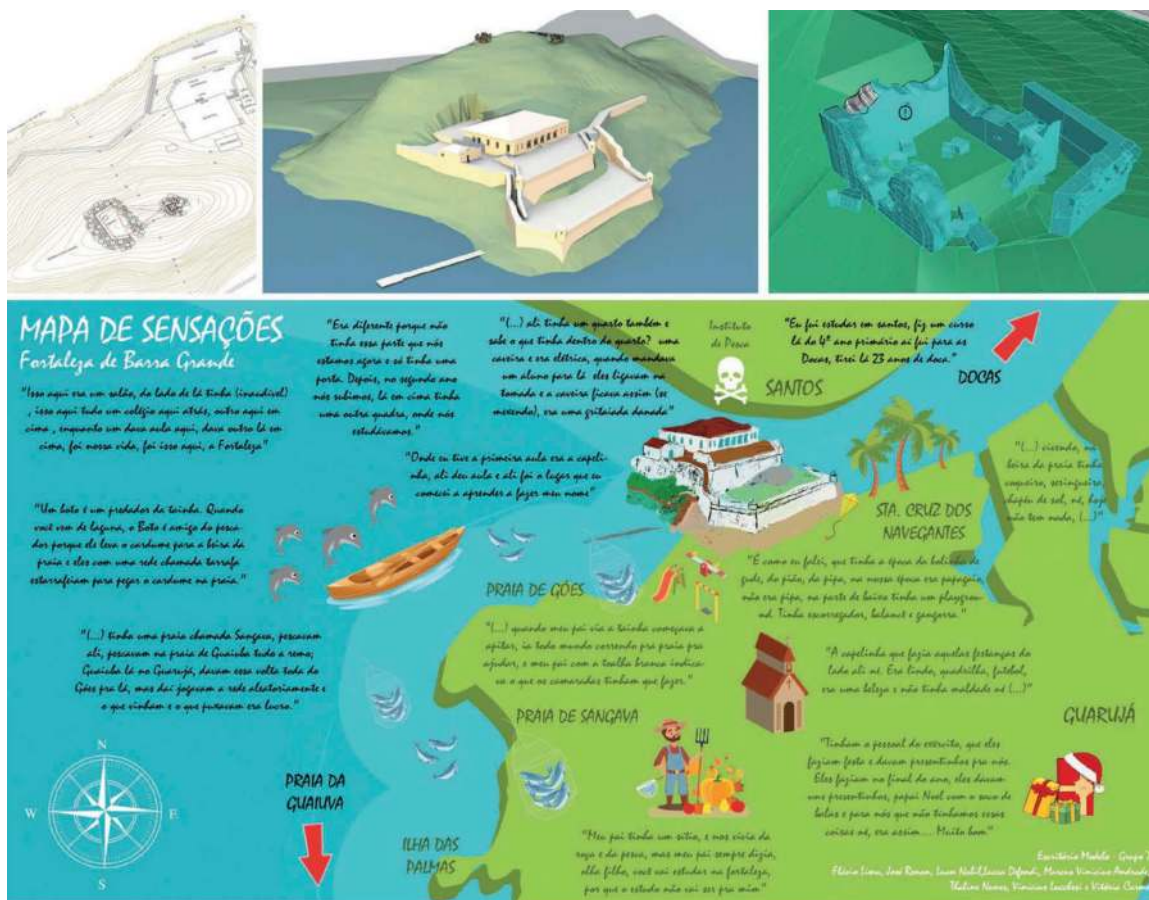
Figure 5. a: plan of the archaeological area; b: sketch of the fortress with the archaeological area; c: 3d model of the archaeological ruins; d: Sensation map (source: [a][b][c] Unicamp, 2019; [d] FIAM-FAAM, 2020).

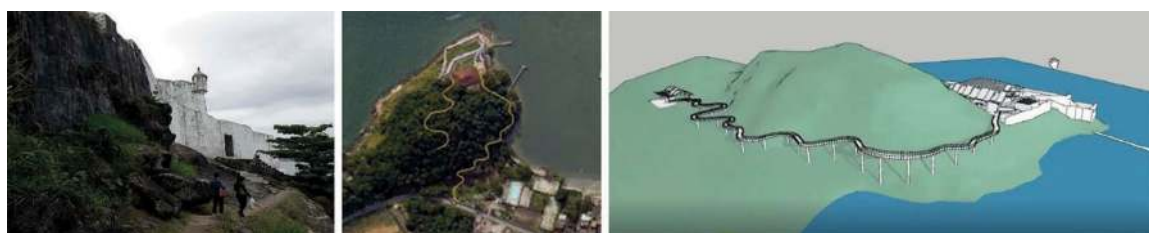
Figure 6. a: The existing path to the Fortaleza; b-c) plan and 3d model of a possible new path (source: FIAM-FAAM, 2020).

Considering the issue of accessibility, to improve the number of visitors it is necessary to create an easier and more comfortable path to reach the fortress, that can currently only be reached by boat. The improvement of the actual access to the area can be pursued with some new paths differentiated by type of users: staff vs. visitors. Furthermore, other footways can be planned to connect the fortress to the archaeological area, still today not easily accessible and the creation of another pathway can create new linking opportunities with the city of Santos (Figure 6 a,b,c). According to the actual conditions of the context, other studies can be referred to the structural aspects, also evaluating the impact of the maritime traffic to the architecture. Because of the presence of the Santos’ harbor, one of the biggest in Brazil, the coasts on which the fortress is located are exposed to several cycles of tides, with the variation of the sea level. This phenomenon exposed the foundations of the building to alternative waves which removed the foundation ground, causing the subsequent instability of the wall’s foundations. The possible insertion of micro-poles, which guarantee the stability of the foundation ground, can solve the problems related to accidental base failures; while, with the purpose of limiting the effect of the waves, the breakwaters represent a non-invasive and efficient intervention (Borri, 2010; Varagnoli, 2010).

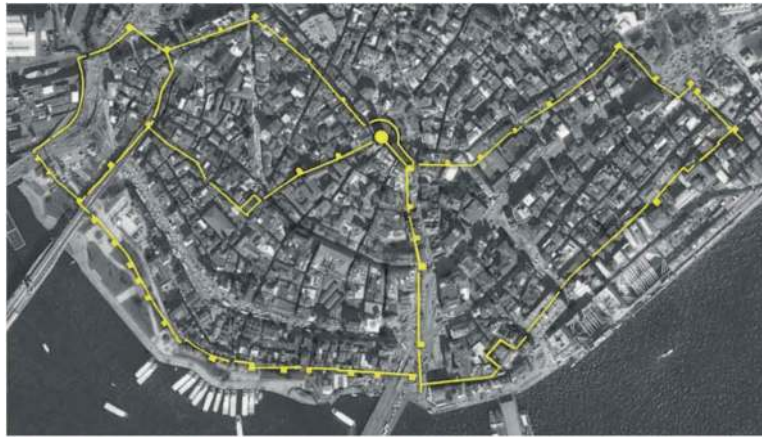
Figure 5. The hypothetical reconstruction plan of strong houses and defense walls in Galata, İstanbul. Graphic is prepared regarding information from Sağlam, 2018.

The damaged Genoese fortification in Galata, İstanbul, is placed in the city center (Figure 5). Galata, which was called “Sykai” (Eyice,1969) is located in the east coast of Golden Horn and has a history that dates back to the 2nd century. The first fortification of Galata was for securing the entrance from the sea and placing the chain extending between the castle and the coast where the imperial palace of Byzantium was. The Genoese settled to Pera in 1267, therefore the Venetian fleet attacked Genoese settlements along the Aegean Sea and Galata, during the Byzantine- Venetian War of 1296 – 1302. Following this event, the Genoese demanded to have security in Galata and gained the right to build houses with necessarily strong and secure walls in 1304, but constructing any kind of defense wall or a castle was not allowed. In 1316, the Genoese gained the right to build surrounding moats, but they violated the articles by building walls among strong houses and encircled Galata in 1335. What remains today from this fortification is only a number of strong houses and thin masonry stone walls connecting them. This research focuses on the largest piece, due to its heavily damaged current situation.

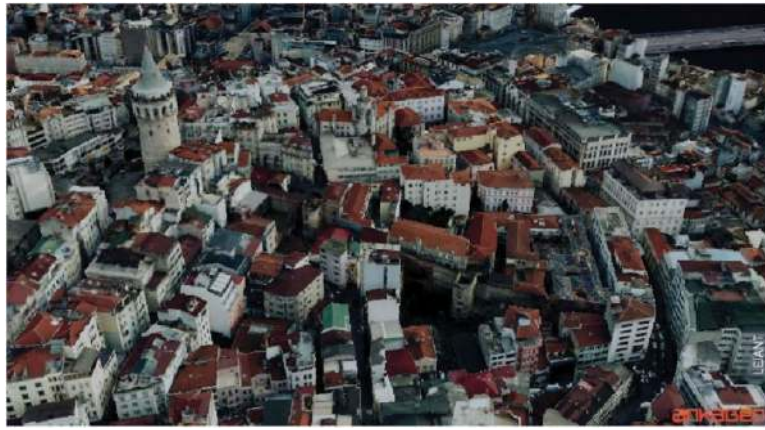
Figure 7. Location of the Genoese defense walls in İstanbul. The remaining walls are connected to Galata Tower on the left and reaches down to Bankalar Street.

The fortification walls in Galata are mostly demolished and the remaining parts are damaged by the calamities and by the buildings that have been attached to walls in the past. The foundations of the selected section of the wall are heavily damaged due to the lack of support from the soil, that has been taken away for the construction of a new building. Infilling the soil back or shoring with structural scaffoldings may help to keep the stability of the wall. Yet, unless the wall became a part of contemporary city in a proper way, it is hard to provide a long term solution.

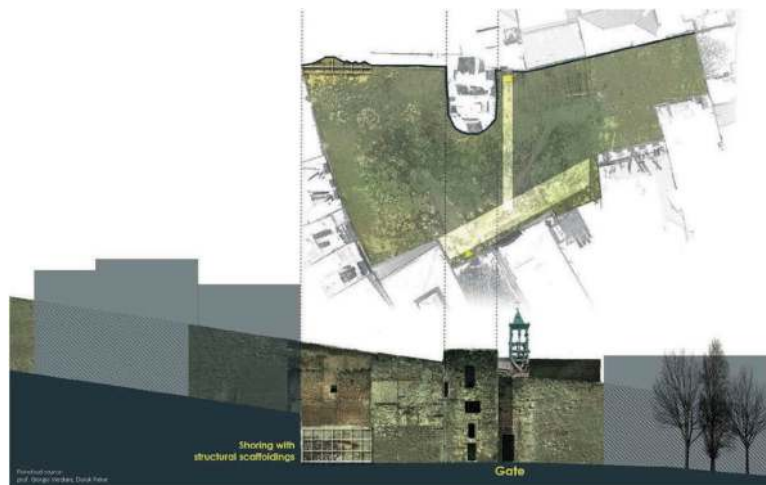
Figure 8. This section of the wall has been documented by the team led by prof. Giorgio Verdiani and Doruk Peker in 2019. The outcome is used for the preparation of the stabilization proposal for the defense wall.

The recommended intervention is the stabilization and strengthening of the structure, first by infilling the soil to cover the exposed foundations, then preventing possible landslides and ruptures on the wall by means of scaffoldings. The missing part of the foundations is considered as a wound to be repaired, but removing the remains of the demolished structures that were attached to the walls could cause further physical damage. The intervention proposal includes opening the gate near the tower, for gaining this desolated heritage as a part of the contemporary city (Figure 8).

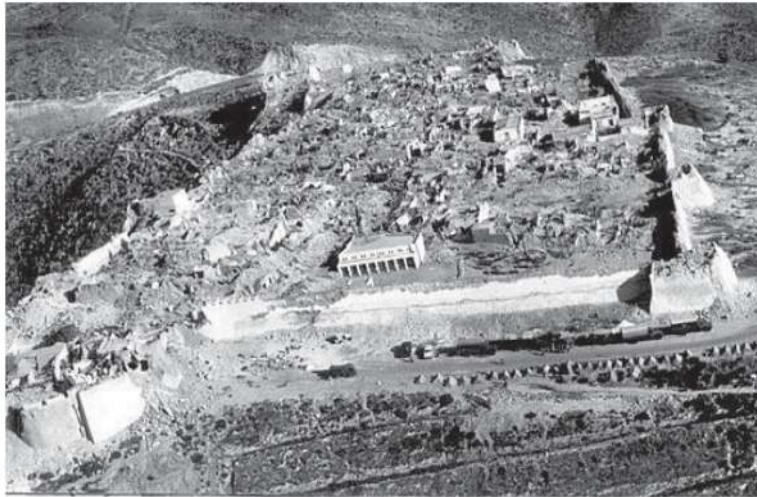
Figure 10. The Kasbah of Oufella after the earthquake.  
 Source: <https://www.alamy.com/stock-photo/agadir-earthquake.html>.

An earthquake of a magnitude of 5.71 on the Richter scale hit Agadir, leaving behind 12,000 (a third of the city's population) dead and 25,000 injured. Great international solidarity came to the aid of the citizens of Agadir. Because of the earthquake, the city suffered severe damage in its materiality, while the Kasbah of Oufella, built in 1540 (the old city of Agadir), almost entirely collapsed and only the surrounding walls partially survived (Figures 9, 10).

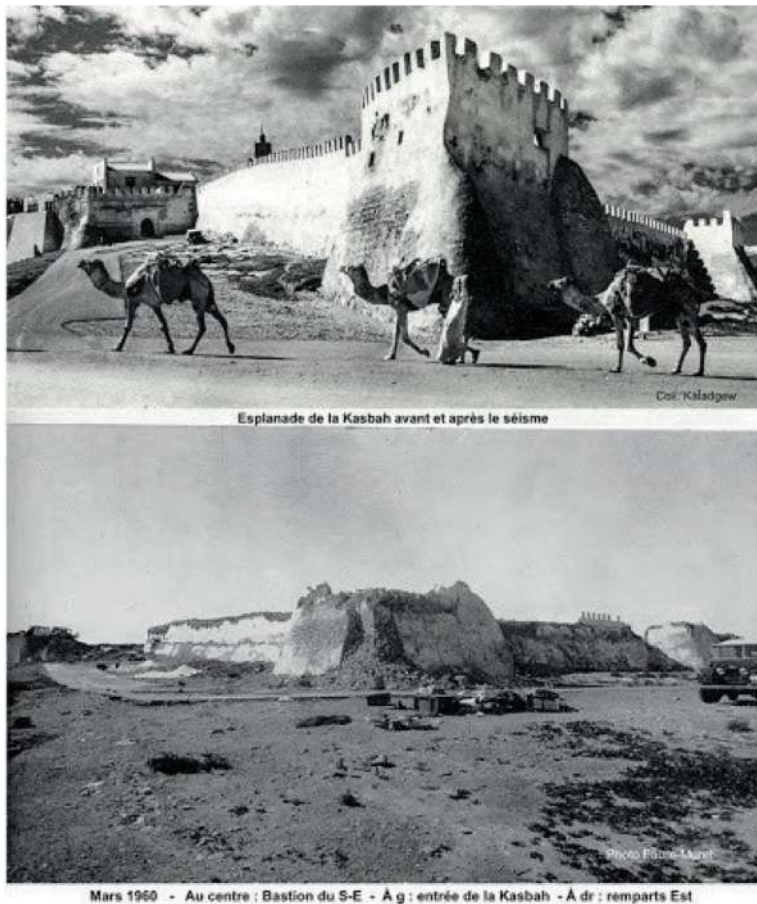
Figure 11. The Walls of the Kasbah, before and after the earthquake.

The walls of the Kasbah of Oufella, of 1110m in total linear length, survived partially the earthquake's disaster, but their height was reduced by a remarkable amount (dropping from 6m to 2m of height). The towers resisted remarkably and played a significant role in reinforcing the wall, preventing from its total collapse. The fortification walls showed great robustness and resistance to the disaster (compared with the total collapse of the inner-city walls) thanks to their build, their thickness, which exceeded 1m, and the material they were made of (stones). All these qualities prevented the walls from totally collapsing (Figure 11).

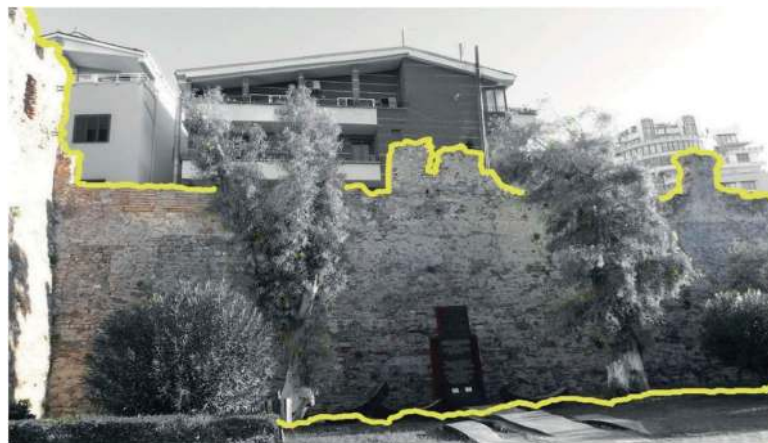
Figure 14. Walls of Durres, mixture of properties in the build.

The ancient town fortifications consisted of crenellated walls and towers that were built in different ages. However, of this original system of walls only a part is still standing today (Figure 12). The remaining structures clearly show the variety of interventions they have undergone in the centuries and the different wall typologies, styles and systems they were made of. As a matter of fact, while the Ottoman portions of the walls are made of bricks and thick layers of highly resisting mortar, other parts of the fortifications consist of stones and date back to the Venetian period. The foundations instead are built with big blocks of square rocks positioned on round stones cemented with mortar (Figures 13, 14).

This mixture of properties in the build translates into a more delicate structure, that in case of an earthquake, could be prone to easily damage in correspondence of these discontinuities. Another cause of vulnerability in many portions of the walls is the presence of shrubs and trees, whose roots have already damaged the masonry. Nonetheless, the walls being squat and short, with a height of 6-9 meters and a width of 3.5 meters, haven't suffered serious damage following the earthquake of 2019 and just some old cracks have reopened. The crenellations have also survived thanks to the quality of the mortar of the wall, none of them has collapsed and only a few have shown signs of rupture at the base (Figure 15). While most of the towers have suffered minor damages, a big portion of masonry in the tower C has collapsed, despite the good quality of the brickwork in this part of the fortification. The collapse was caused by the overturning produced by the earthquake in a portion of masonry that lacked anchoring to the rest of the structure and that was affected by the presence of vegetation and roots.

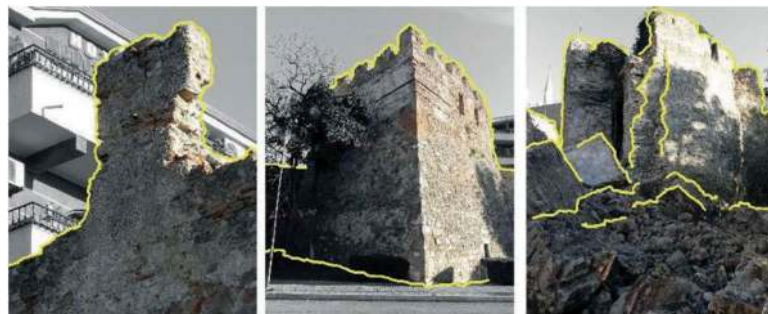
Figure 15. Walls of Durres, serious damage into crenellations.

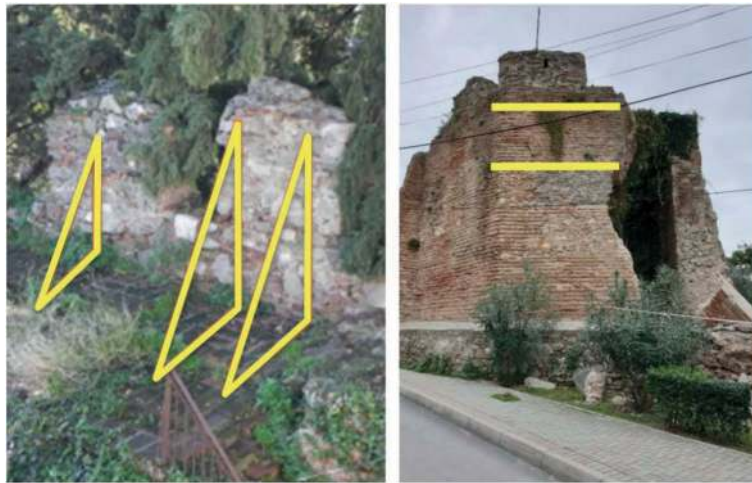
Figure 16. Walls of Durres, recommended interventions.

The recommended interventions consist of the stabilization and strengthening of the walls: touch ups (scuci-cuci) for the deteriorated parts of the masonry, supports and polyester fibers bandages for the crenellations and steel hoops for the circular towers. For the tower C, it would be recommended to consolidate the standing fractured wall adjacent to the collapsed part, by anchoring it with tie bars to the more solid portions of the tower in the background (Figure 16). To avoid further damages, unrelated to the earthquake, another important intervention would be removing the vegetation on all the walls and applying biocide to prevent its growth.

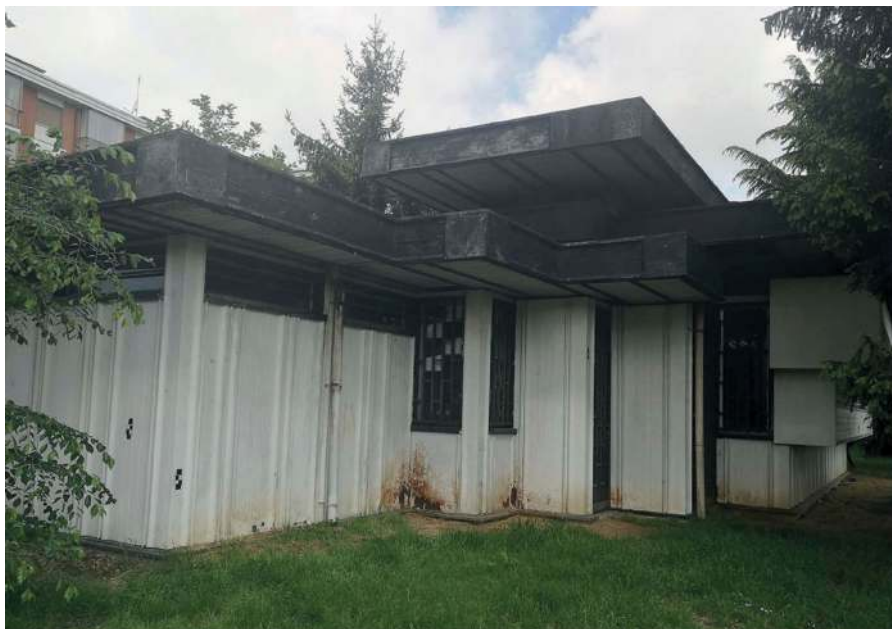
Figure 3. Picture of the actual State of the Library.

teamwork is seen here. As a first step, each element's geometric and photographic relief was done and codified in an abacus. After that, the main decays were identified. Most damages were due to the mismatch between the original design and the actual on-site applications, incorrect installations, and also the natural decay of materials and vandalism. The specific decays are missing parts, improper repair works, incoherent additions, dent, exfoliation, soiling, rust, superficial decay and loss of performance.

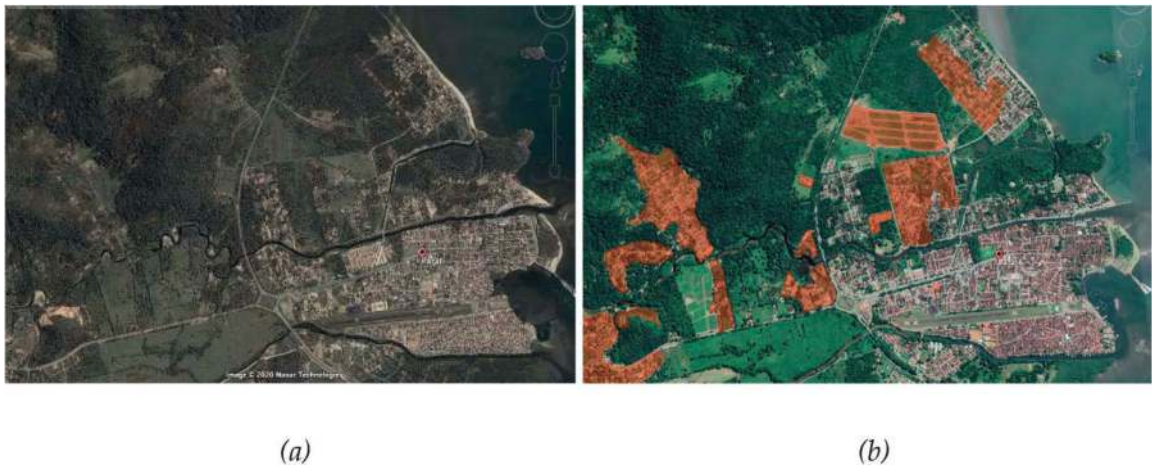
Figure 5. Google Earth (Web-10) aerial view showing the urban sprawl in Paraty in (a) 2001 and (b) 2020. The newly built areas are colored in orange.

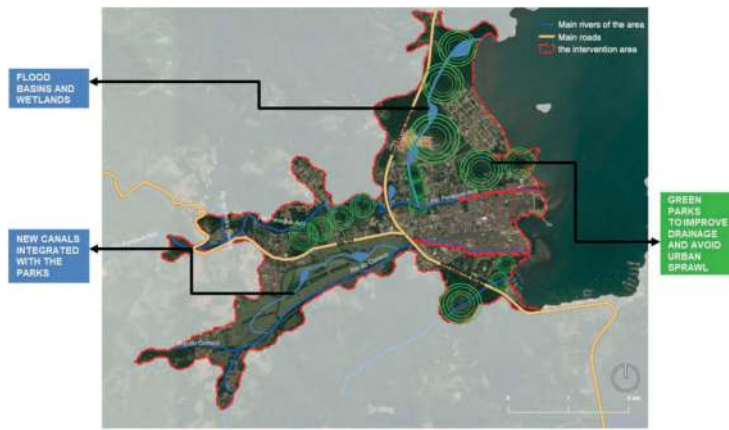
Figure 6. Scheme of the strategies to manage the flooding risk in Paraty, Rio de Janeiro State, Brazil. Prepared based on data from IBGE (Web-3) and ANA (Web-5). Satellite image: Bing (Web-7).

A schematic representation of the introduction of new parks and water basins in Paraty is illustrated in Figure 6. The new parks are indicated with a light-green colour, whereas the new basins and canals are in light-blue. Parks and green corridors have been installed based on the natural remnants in the territory, mainly located at the limits of the area in major flooding risk. Flood basins, wetlands, and new channels have been integrated to the aforementioned parks, aiming at improving the drainage of soil, collecting the surplus of water, and laminating the peak of the water flow during extreme events. The creation of new parks in order to limit the urban sprawl and the paved areas, as well as the introduction of new canals and flood basins, entails several benefits. In Figure 7, there is a schematic representation of the engineering process of lamination beneath these strategies. The main aim is to reduce (i.e., laminate) the amount of water flow through the main rivers of Paraty during an extreme flooding event, and to allow a gradual release of the water in time (Apollonio et al., 2021).
