Detection and Analysis of Petroleum Equipment Faults

Mihail Minescu and Ion Pana

2. Using fitness-for-service assessment method—case study

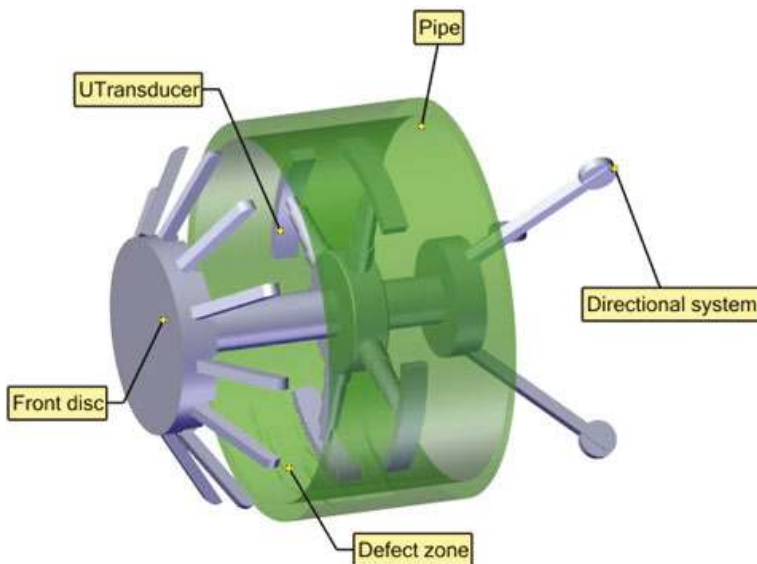
Figure 1. Pipeline intelligent gauge — tip Korsonic 324 — Cala & Cdria Pipeline Services Company Ltd: Ultrasonic Transducer (UT) is mounted inside the inspection device.

pipeline was inspected using an ultrasound method [the usual methods of inspection there are magnetic flux and ultrasound and the device is named pipeline intelligent gauge (PIG)], **Figure 1**. We used for the inspection a 20" Ultrasonic Intelligent Pig, Korsonic 324, with the following specifications: PIG diameter 350 mm; body length 850 mm; overall pig length 950 mm; temperature max. for PIG 65°C; pressure max. 50 barg; min. bend radius $3 \times$ Internal diameter; transducer frequency 0.5 MHz; transducer focus plane; min. measurable thk 3 mm; max. measurable thk 0.7 m; inspection sensitivity ± 0.1 mm; repetition rate 2300 kHz; inspection speed Max. 5 m/min; max. inspection capacity 120 h; axial sampling distance min. 3 mm; circumferential resolution 5.5 mm. The ultrasonic signal is induced directly in the wall to be inspected, EMAT technology. It notes that the procedure for determining defects of the pipelines uses three-dimensional images that are offered to users in the form of Excel files, **Table 1**. These images were obtained over the last 20 years with a precision increasingly better. The instrument measures the thickness of the pipeline in a network of points, **Figure 2**. The image is reported as an Excel file. An example is shown in **Table 1**. As the beneficiary of the contract imposed certain conditions of confidentiality, they have been used data from a pipeline segment of 8622 m. So the probability of failure calculation refers only to this segment and not to the entire pipeline. The total number of defects found was 56,824. These can be classified after the geometrical characteristics (**Table 2**) and the cause that determined the defect: manufacturing, construction, corrosion, mechanical damage and repair (**Table 3**, column 10).

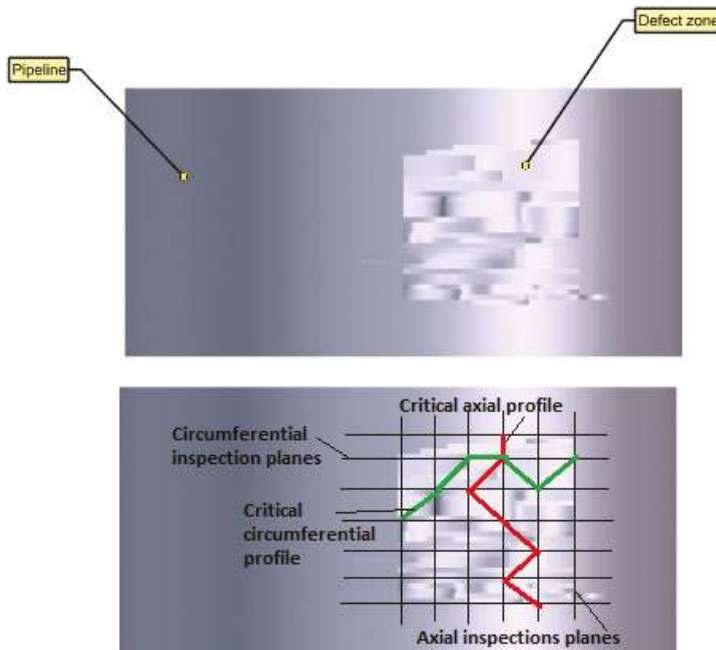
Figure 2. The results of the inspection: tridimensional images of the defects.

Table 1. The matrix of the measured thicknesses corresponding to a specific defect (Figure 2).

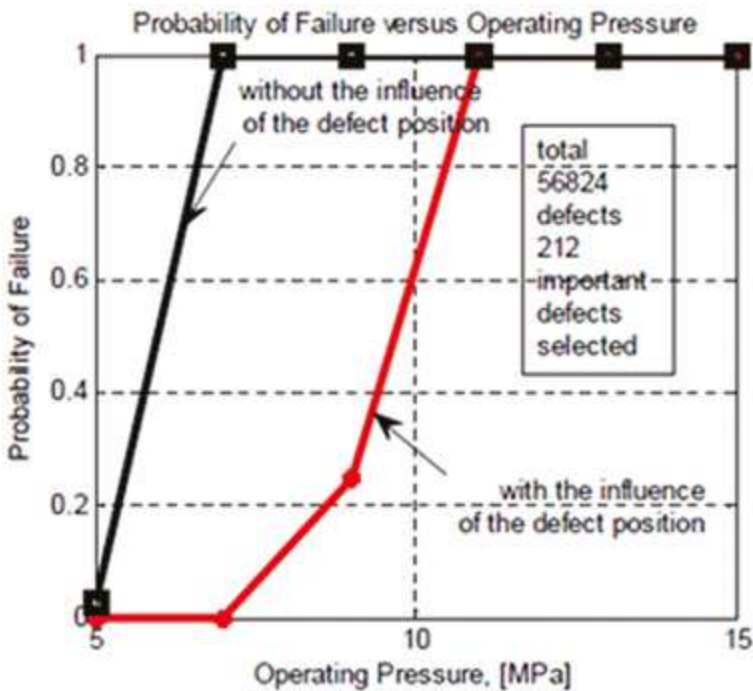
Figure 3. The influence of the defect position versus the probability of failure.

As it is seen a large number 55,162 corrosion defects reported by the inspection, but many of them are superficial. Defects have been chosen only to the depth of more than 20% of the thickness the pipeline; their number is 212. The geometrical elements of these defects are in **Table 3**. For the variables *D*, *UTS* and *PO* we considered the values from **Table 4**, [11, 21, 23]. After 8 years of operation ($T_0 = 8$ years), the probability of failure *FP* versus operating pressure is represented in **Figure 3** (calculated at the end of each working year).

The fault location is important to value of the probability of failure *FP*. If we consider the operating pressure of the pipeline: *FP* is 0.03 for *PO* of 5 MPa and equal to 1 for the other pressures of operation of the pipeline. If we consider pipeline pressure at fault position then for *PO* of 5 and 7 MPa, *FP* is zero, at 9 MPa *FP* is equal with 0.24 and equal with 1 at 11, 13 and 15 MPa. If we choose the limit of the probability of failure of 0.5 (highly conservative methods of calculus [4] justifies this value), the first case of assessment tells us that at the work pressures above 5 MPa we could not use the pipeline. The second case of assessment tells us that we can use the pipeline at the pressures of 7 and 9 MPa, too. We have thus a lower degree of conservatism. Based on the considerations we made, it can be appreciated the defect evolution in time. It is true that these considerations include several simplifying assumptions, but also includes the results of PIG measurements. In the situation where it is considered the pipeline

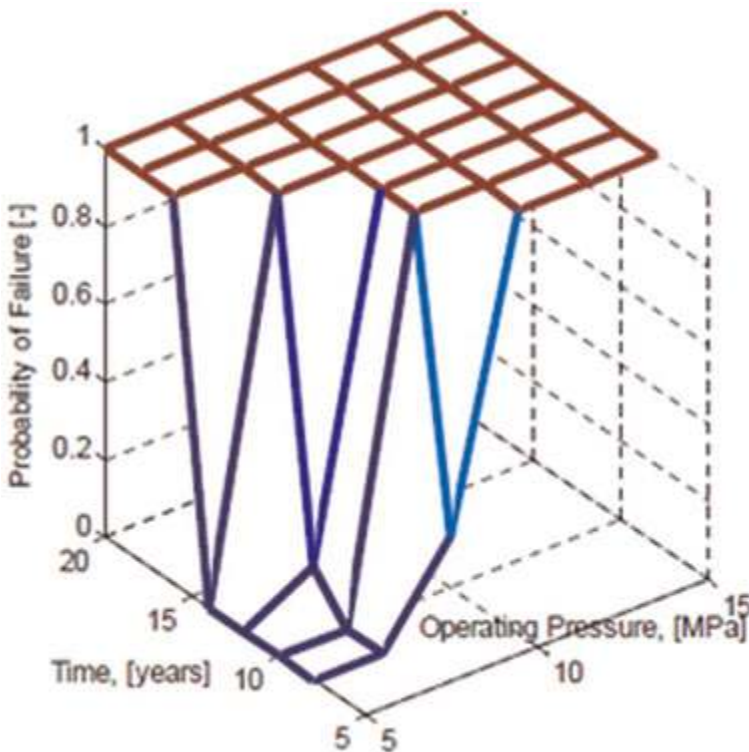
Figure 4. Probability of failure depending on operating pressure and time, if the critical defects are not remedied.

pressure at the defect position was represented the progress of defect probability of failure in time (with a step of 2 years) **Figure 4**. If the pipeline operating pressure is 5 MPa is observed that after 14 years FP grow rapidly, showing that the operator should perform repairs to the system. In the case of operating pressure of 7 MPa since the 12th year of exploitation, FP increases of and between years 12th to 14th FP rises further reaching value 1. Operation of the pipeline to 9 MPa shows a probability of failure which reaches 1 (sure failure) between years from 8th to 12th. Obviously, in situations where the probability of failure is high (it has chosen the 0.5 limit) should intervene to repair the pipeline. By choosing this limit, some defects become critical. The list of defects which should be repaired is given in **Table 5**. If these defects are repaired, then the pipeline FP falls, and it can be used safely for many years, and over a range of operating pressures as shown in **Figure 5**. The method described above was implemented on programs (in Matlab) made by the authors [22, 23]. It is generated a list of defects to be repaired every year, **Table 5** (an example for two pressures 5 and 7 MPa). If the number of the defects is high, an economic analysis of whether a repair or a replacement of the section of the pipeline is required. So we have a procedure of action based on the results of inspection and the accomplished analysis, useful in the maintenance process. The effect of the repair is seen immediately; the pipeline is less likely to fail. However, at higher operating

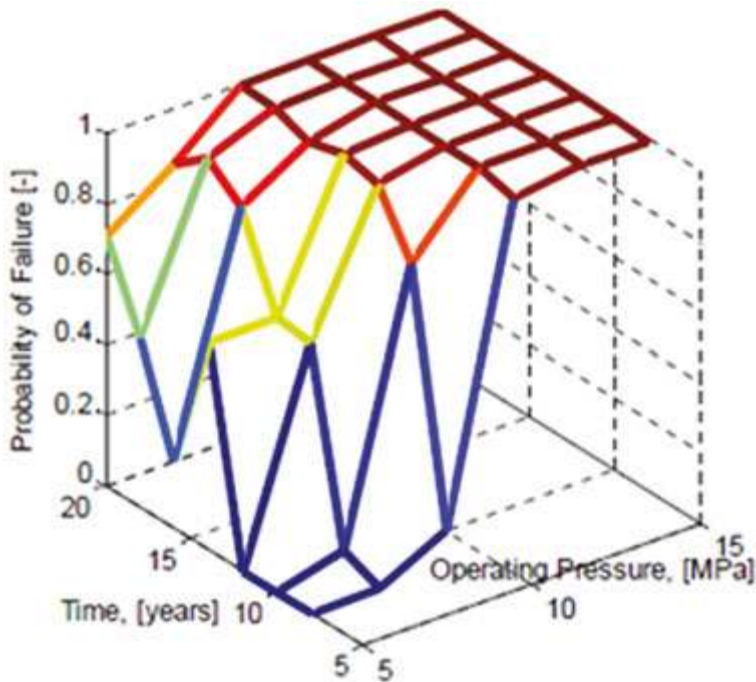
Figure 5. Probability of failure depending on operating pressure and time, when the critical defects are repaired.

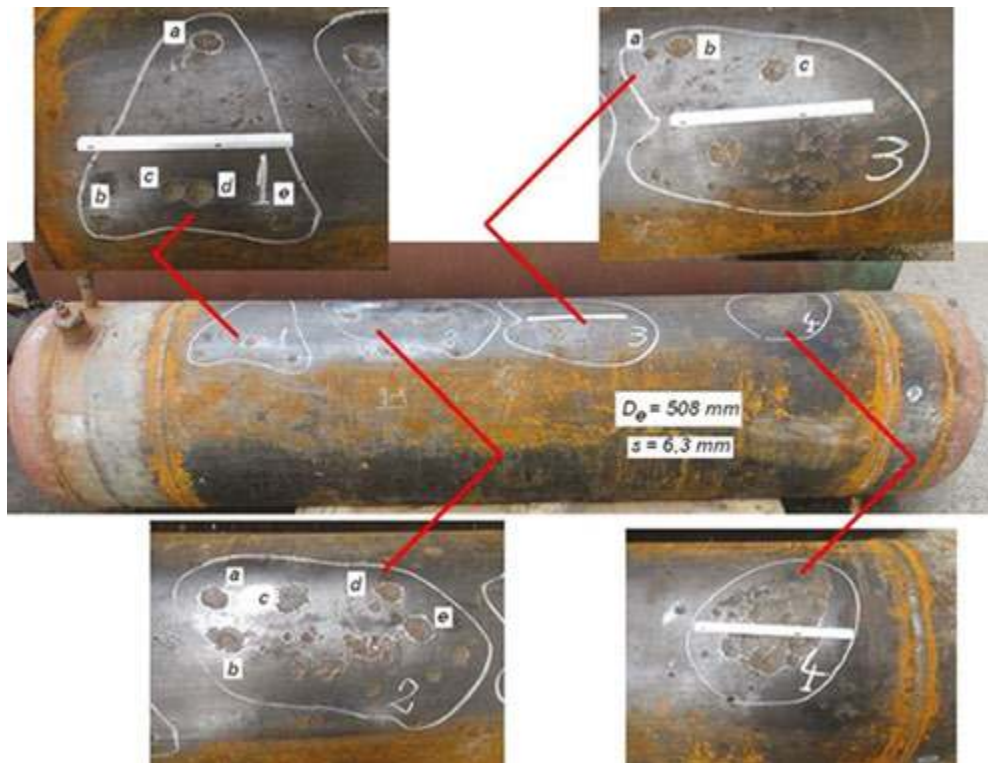
Figure 6. Defects loss of material from the sample being tested.

Table 6. The geometric characteristics of the defects type loss of material subjected to the burst pressure test.

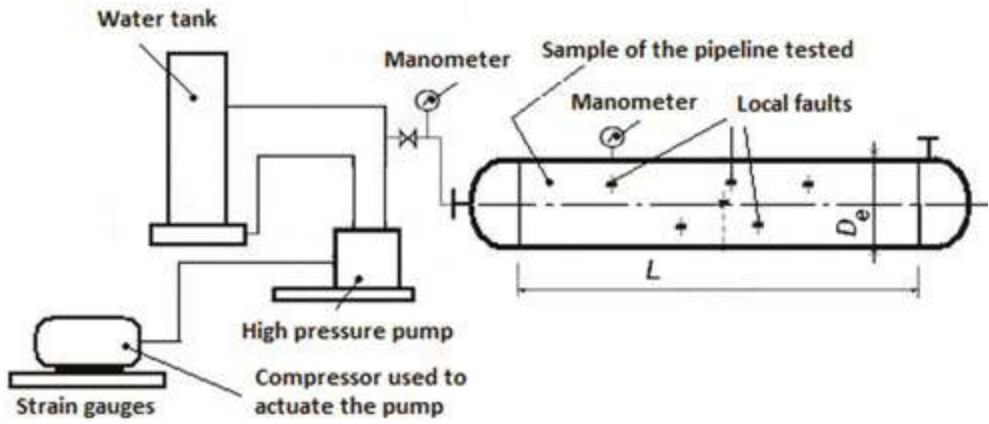
Figure 7. Sketch of the stand used to inner pressure test of pipe samples with local surface defects type loss of material.

sample with water and pressurizing it. The stand that has been tested the sample to internal pressure (up to burst) was conducted at the Petroleum—Gas University of Ploiesti and reproduce diagram in **Figure 7**, which presents the constructive elements: the high pressure pump and a platform working in the organization of the stand, **Figure 8**. While conducting the experiment, on the sample of pipeline were applied around the fault with code 2c (defect considered to be the most dangerous depending on the geometrical characteristics), transducers in two directions, circumferential direction TER 1 and the axial direction TER 2. During work, the computer controls data acquisition by using the SPIDER 8 by means of specialized software Catman, which has multiple facilities on determining the number of channels, frequency of data acquisition, storing them in formats that allow the processing with specialized programs, etc. Results of the experimental analysis by resistive tensometry are summarized in the graphs in **Figures 9** and **10**.

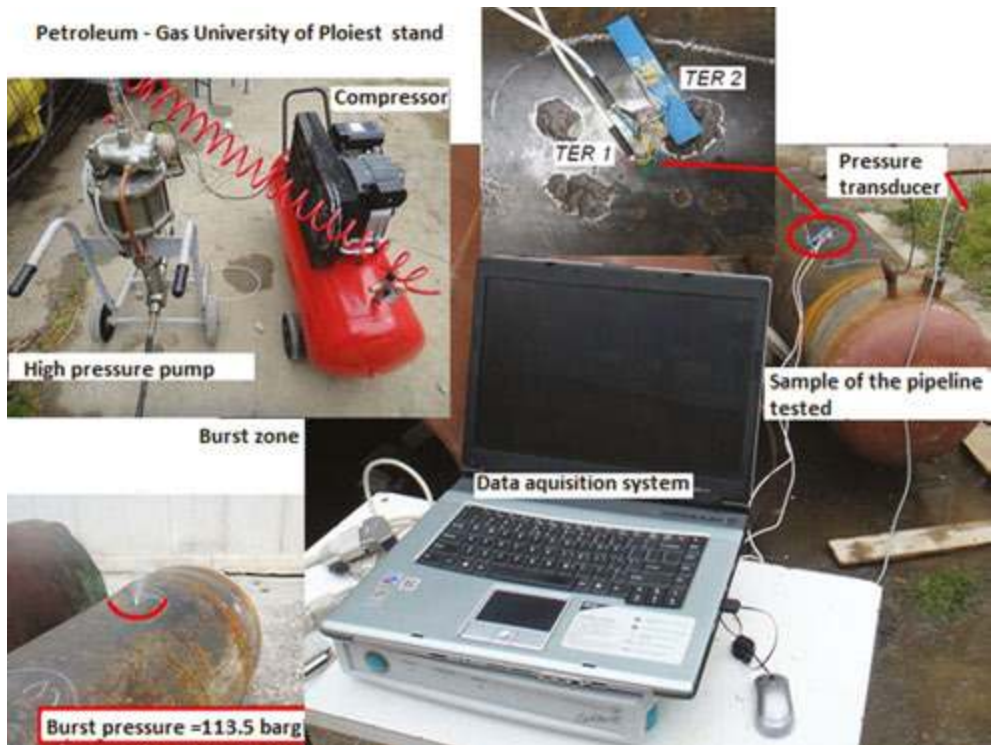
Figure 8. Main components of the stand used to inner pressure test of pipe samples.

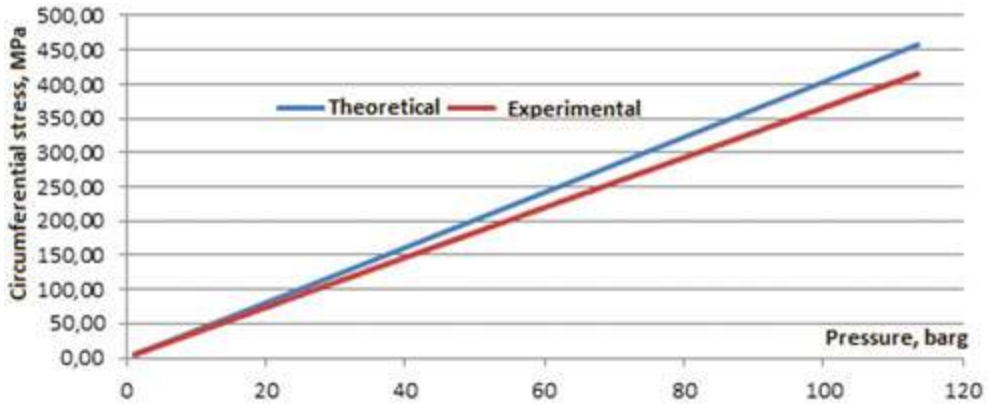
Figure 9. The results of experimental analysis (method of resistive tensometry) for sample with defects type material loss: circumferential stress.

Processing of the experimental results was performed as follows: Mechanical tensions were measured in the circumferential direction $\sigma_{\theta ij}$ and axial direction $\sigma_{z ij}$, using known formulas [24]:

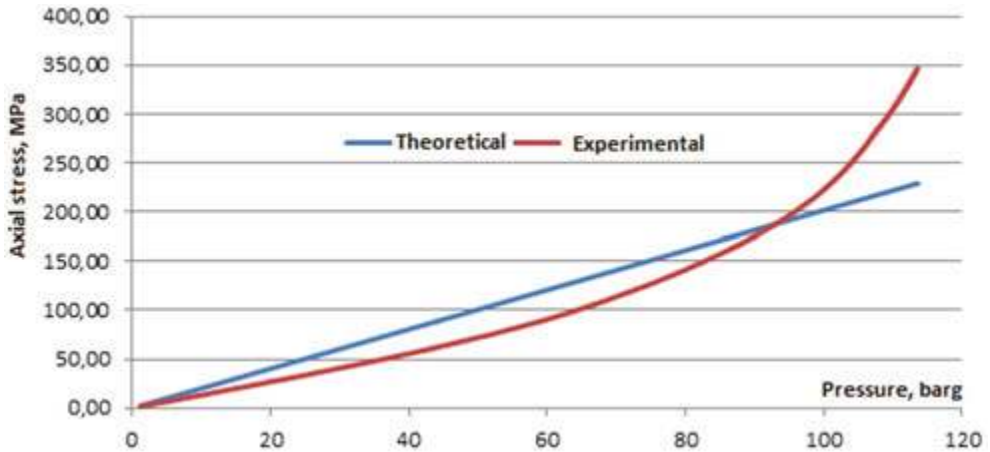
Figure 10. The results of experimental analysis (method of resistive tensometry) for sample with defects type material loss: axial stress.

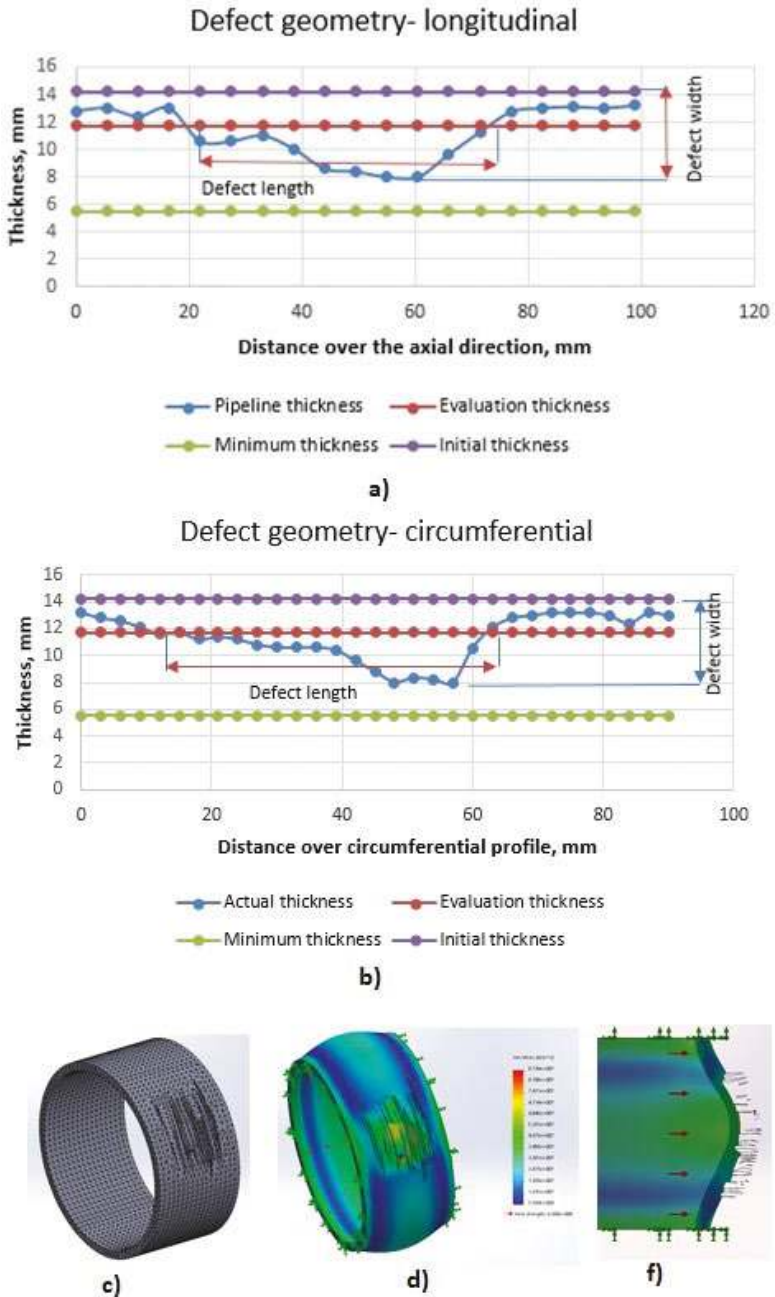
Figure 11. Using different levels of analysis: (a) critical axial profile used in a Level 2 analysis; (b) critical circumferential profile used in a Level 2 analysis; (c) treedimensional model and the mesh of finite elements for a Level 3 analysis; (d) simulation model (solidworks simulation); a detail with the defect zone.

The analyzes use only defect length and depth of the defect (level 1); critical profile of the defect in the longitudinal and transverse direction (level 2) **Figure 11a** and **b**; a tridimensional image of the defect generated based on readings during inspection stage, transformed into a solid object and subjected to finite element analysis (level 3) **Figure 11c–e**. Based on the defect report (**Table 1**), we can achieve a three-dimensional model, using a mesh (**Figure 11c**) and the analyze with finite element method (**Figure 11d**). In **Figure 11, e** is a detail with defect zone.
